## SITE VISIT BRIEF

**DATE:** 23 September 2022

**SITE ID:** RW-296: 1704 North Huntington Lane, Spokane, WA 99224

**PURPOSE:** To visually observe water pressure and conditions at all fixtures.

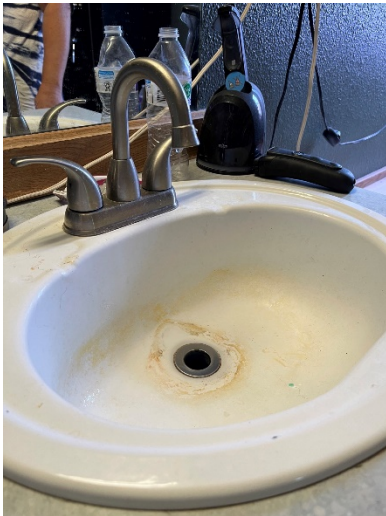
Master Sink Dribble

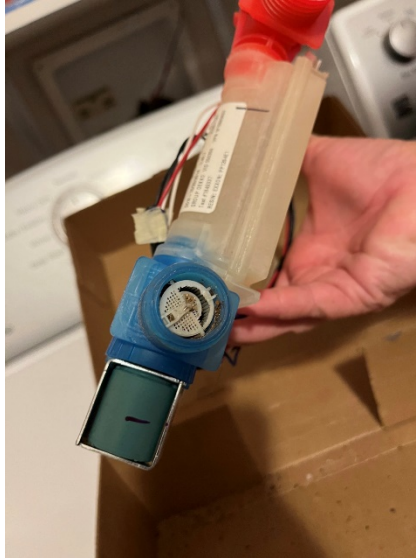
Replaced Washer Part with sediment

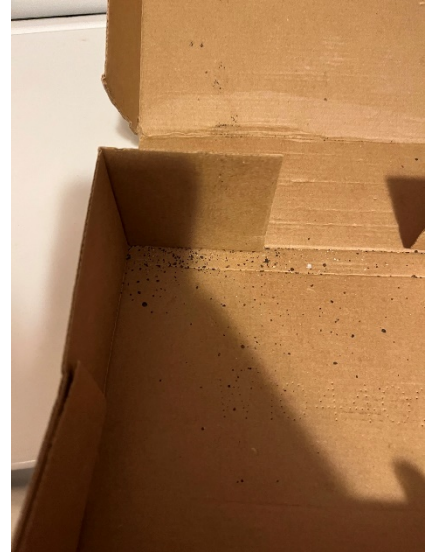
Dirt from Washer Part

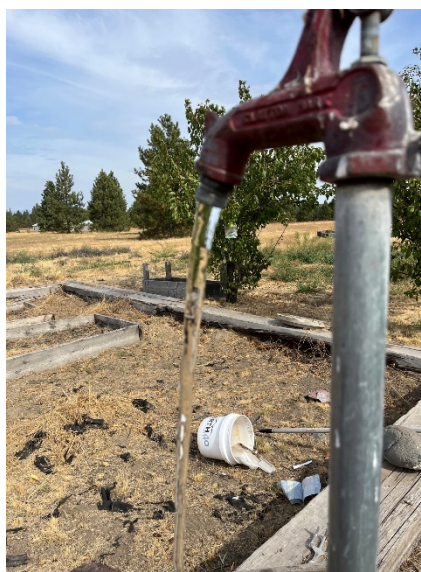
The above values were observed with only one fixture being turned on at a time. When more than one fixture is turned on, the above values are reduced to VL or N.

South Hydrant while East hydrant is running

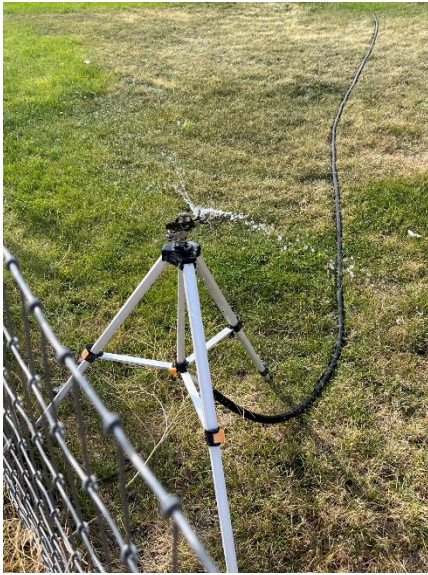
Sprinkler attached to East hydrant while south hydrant runs

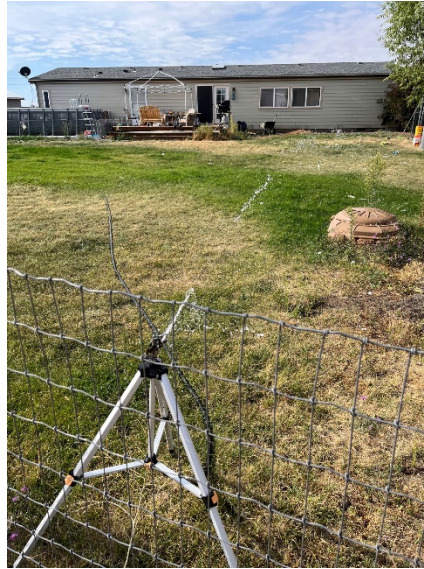
Sprinkler attached to East Hydrant with South hydrant off
