DRAFT
VOLUME II
ASBESTOS CONTAINING MATERIAL &
LEAD CONTAINING PAINT
SURVEY REPORT
BUILDING 49/52

VISN 1
Bedford VA Medical Center
200 Springs Road
Bedford, Massachusetts

Project No. 2009023.008

November 2, 2010

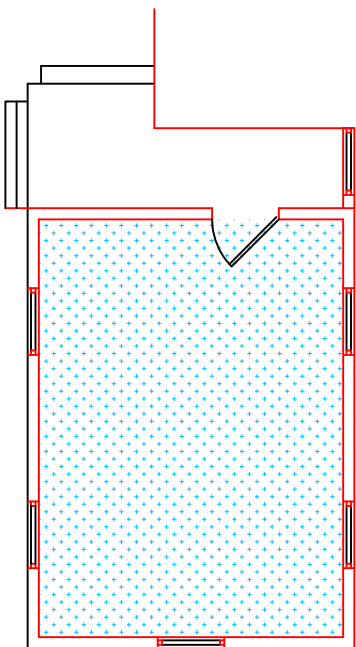
Drawing Title BUILDING 52	Project Title LEAD SURVEY	DATE SEPTEMBER 2010
Floor FIRST FLOOR	Building Number 52	PROJ. NO. 2009022.008
Location BEDFORD	CHECKED WJP	DMC. NO. 6
SCALE: NOT TO SCALE	Dwg. 1 OF 1

These Building Components Depicted in Red Are Assumed To Contain Lead Containing Paint (LCP) at Greater Than 0.1 mg/cm² unless otherwise determined.

COMPONENT	SUBSTRATE	SYMBOL
WALL	WOOD (EXTERIOR)

COLUMN	WOOD

<p>If Present in the Hatched Area These Other Building Components Are Assumed To Be Lead Containing Paint (LCP) at Greater Than 0.1 mg/cm² unless otherwise determined.</p>		SYMBOL
CEILING	WOOD

TRIM	WOOD

PLEASE SEE THE SAFETY OFFICE PRIOR TO PERFORMING
MAINTENANCE/RENOVATION ACTIVITIES ON ANY OF THE FOLLOWING COMPONENTS IN
HATCHED AREAS.
