# **ASBESTOS INSPECTION REPORT**

## **WHITERIVER INDIAN HOSPITAL**

**Buildings 301, 303, 305, 307, and 309**

**AUGUST 6, 2021**

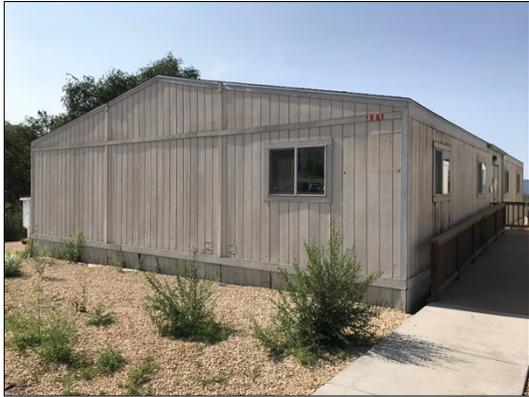
Exterior – no asbestos

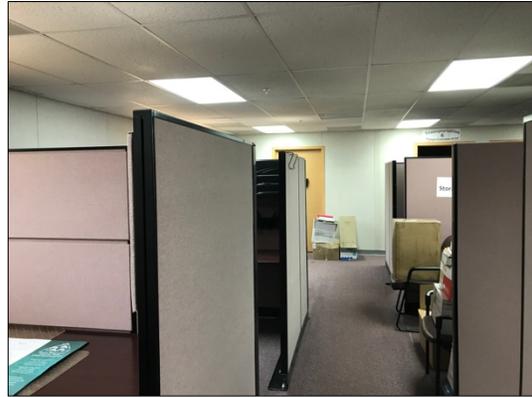
Walls and dividers – no asbestos

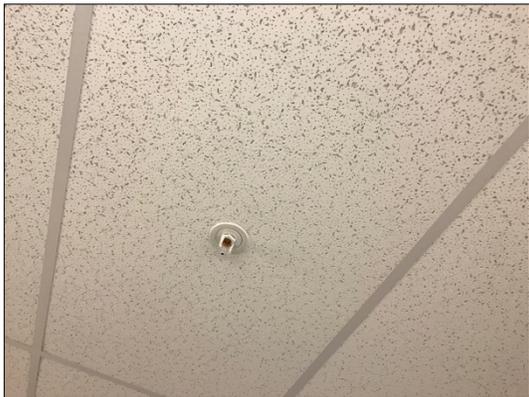
Ceiling tile – no asbestos

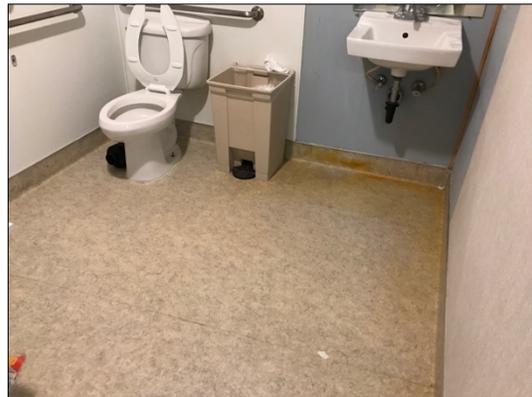
Flooring – no asbestos

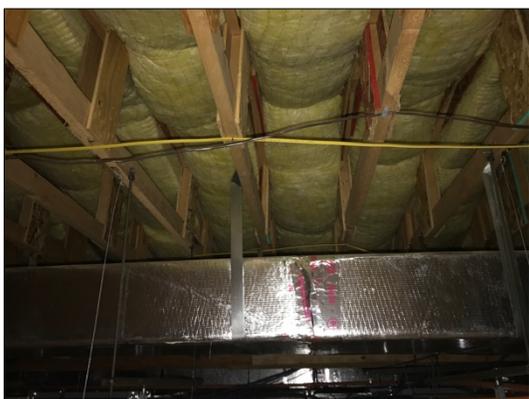
Above ceiling – no asbestos

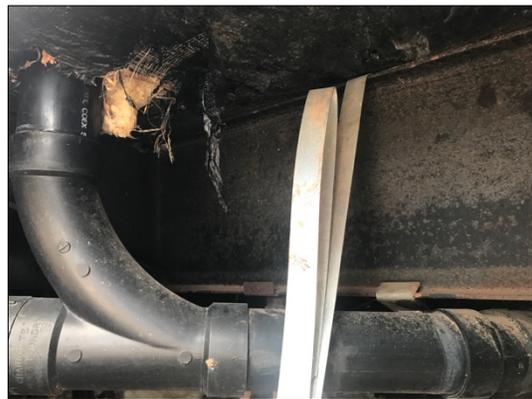
Crawl space – no suspect ACM

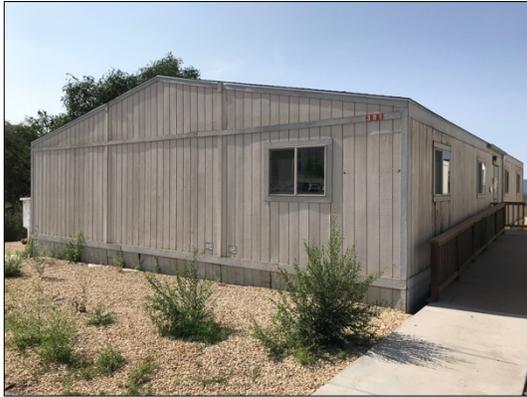
Exterior – no asbestos

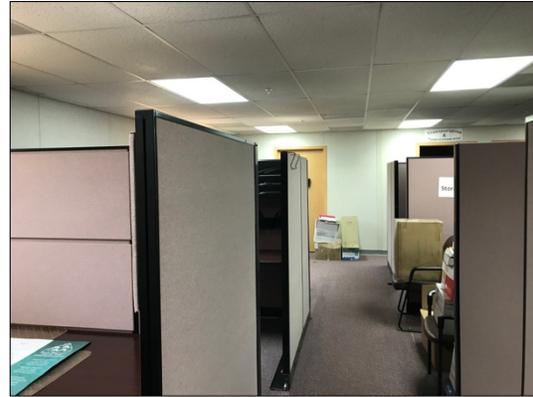
Walls and dividers – no asbestos

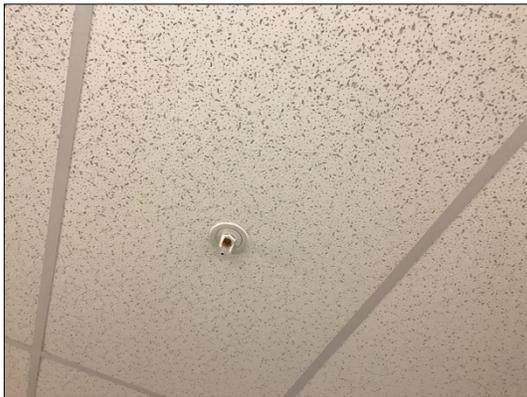
Ceiling tile – no asbestos

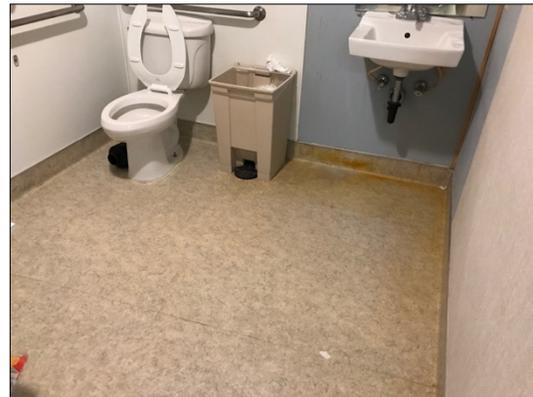
Flooring – no asbestos

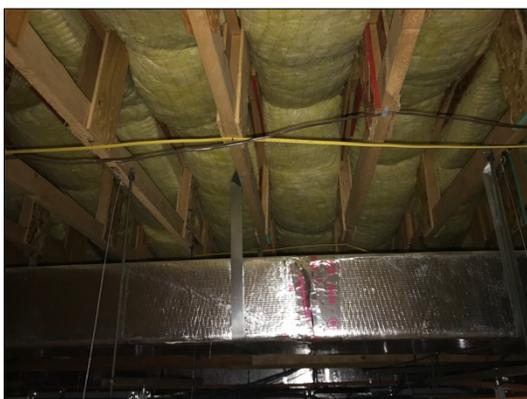
Above ceiling – no asbestos

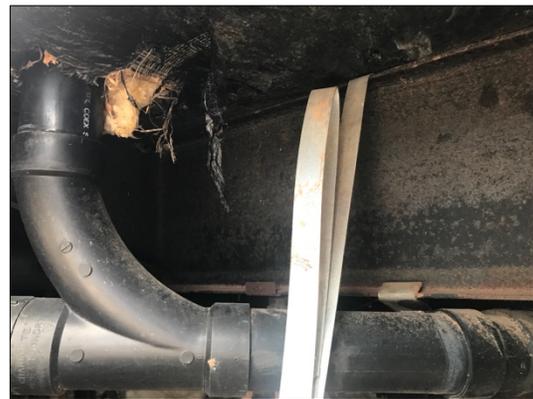
Crawl space – no suspect ACM

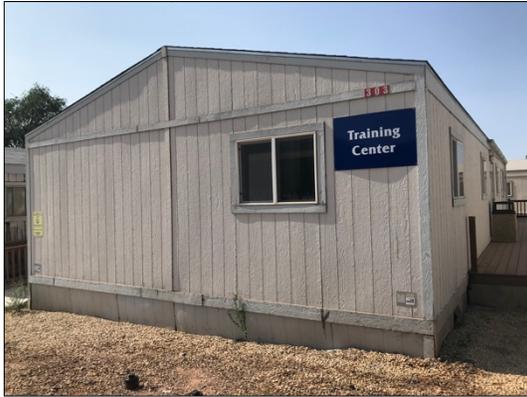
Exterior – no asbestos

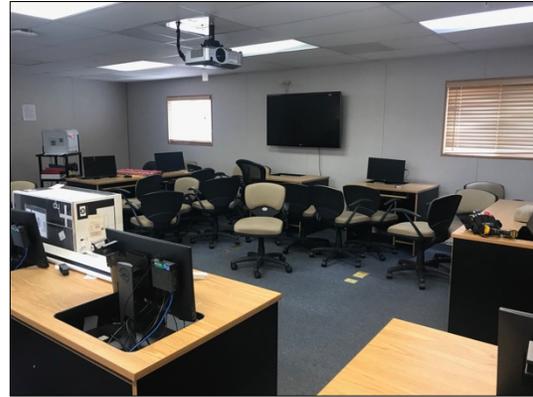
Main training room walls – no asbestos

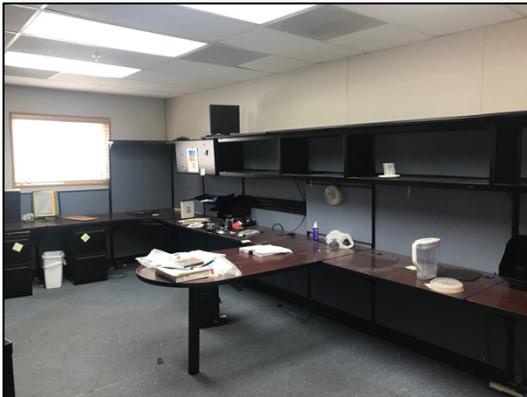
South room carpet – no asbestos

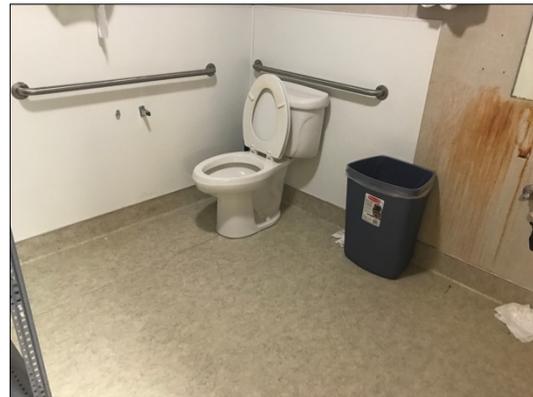
Vinyl flooring in restroom – no asbestos

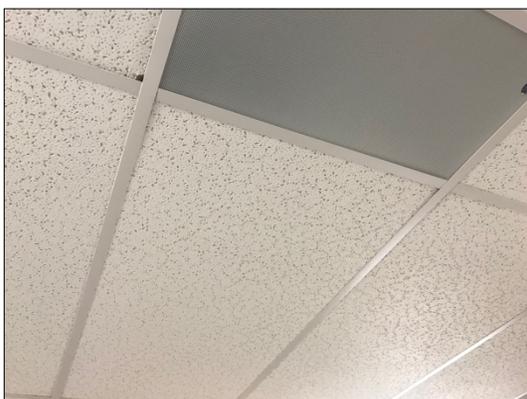
Ceiling tile – no asbestos

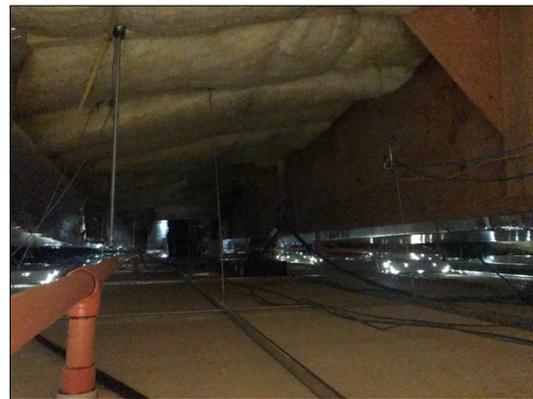
Above ceiling – no suspect ACM

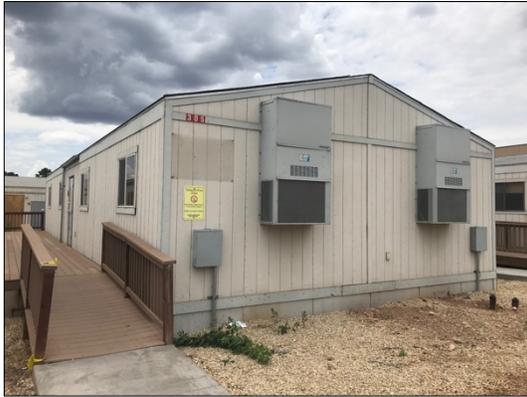
Exterior paint – no asbestos

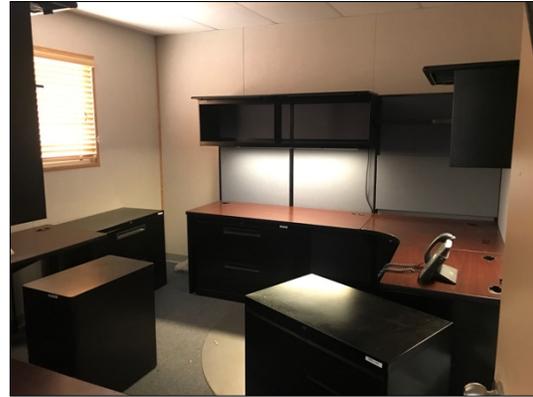
Walls and carpet – no asbestos

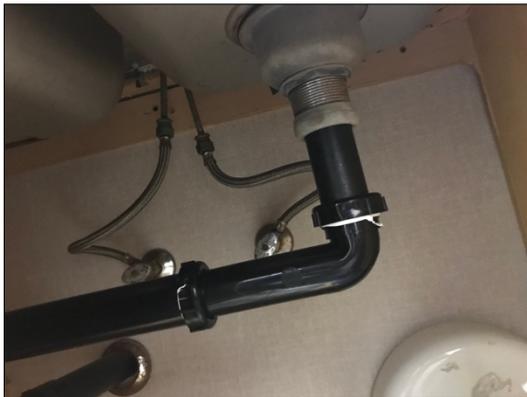
Underside of sinks – no suspect ACM

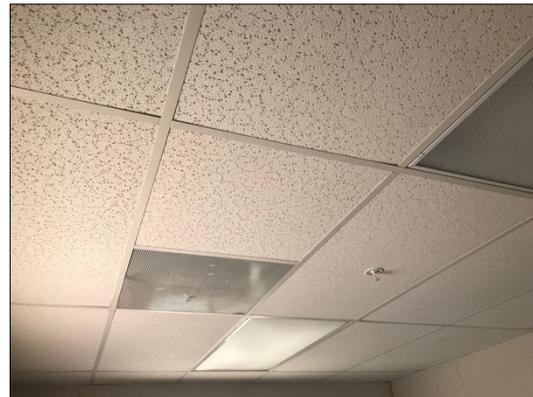
Ceiling tile – no asbestos

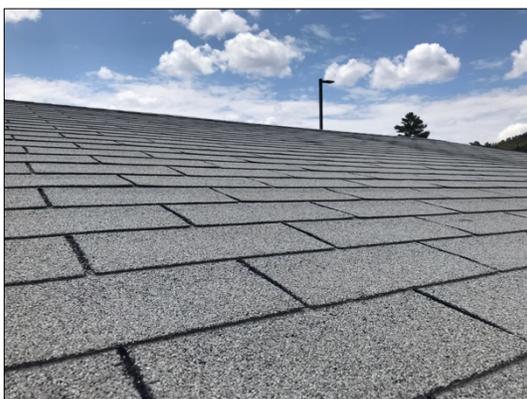
Roof – no asbestos

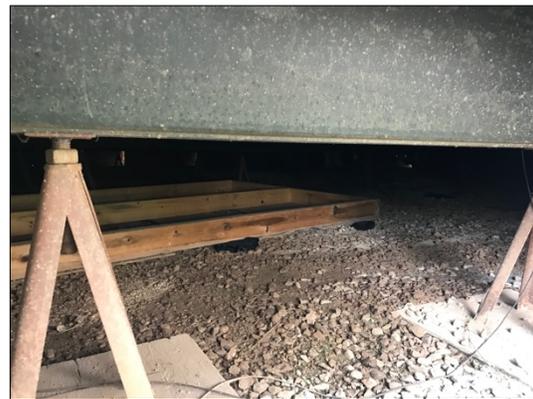
Crawl space – no suspect ACM

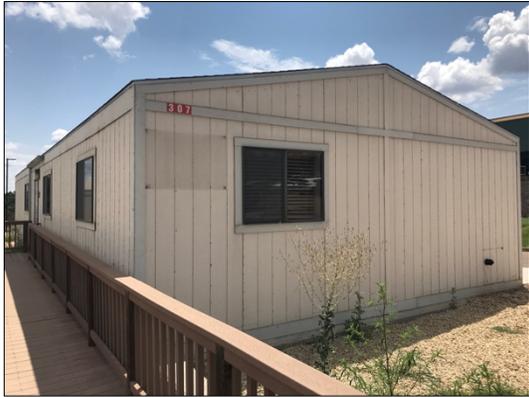
Exterior paint – no asbestos

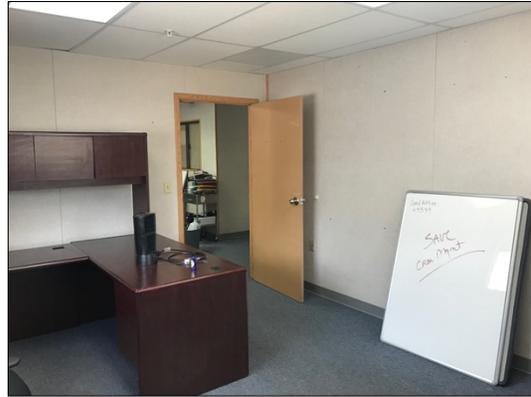
Walls – no asbestos

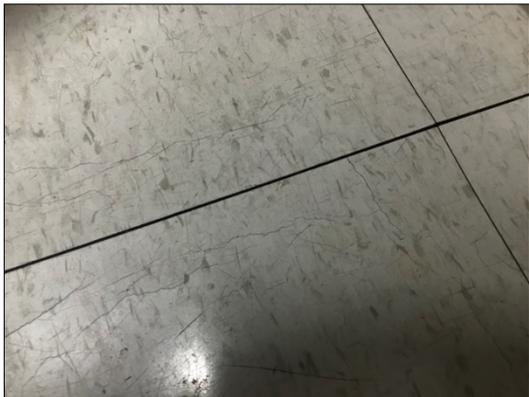
Floor tile – no asbestos

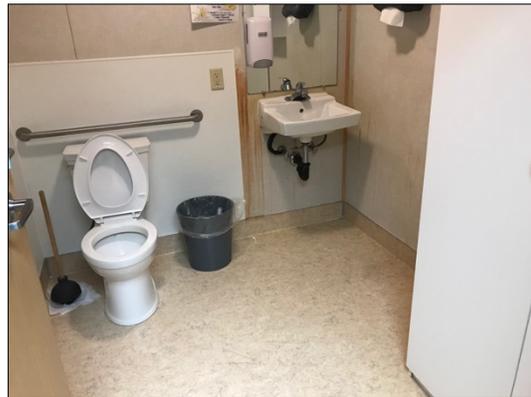
Vinyl flooring – no asbestos

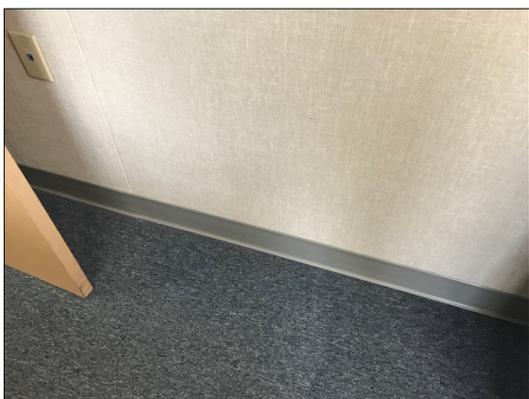
Carpet and cove base – no asbestos

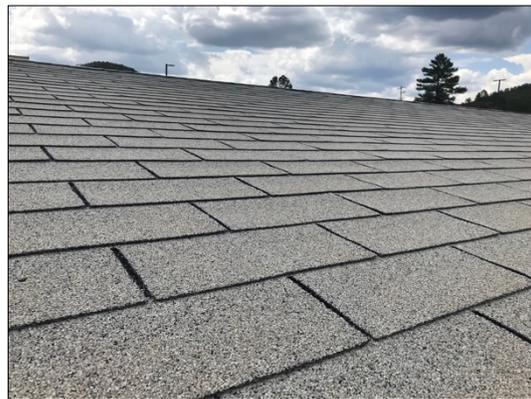
Roof – no asbestos

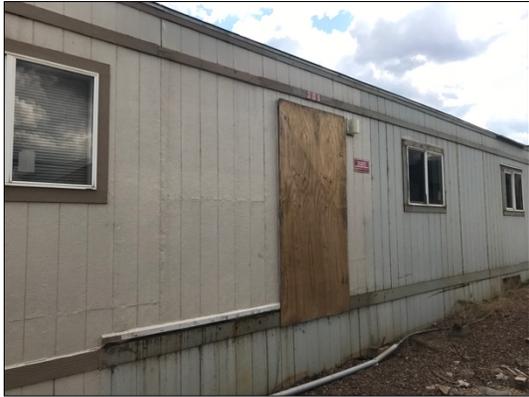
Exterior – no asbestos

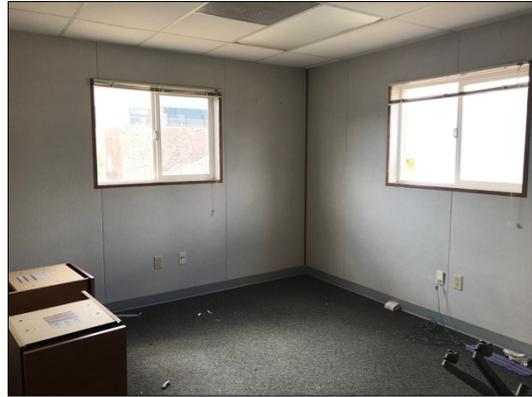
Walls, ceiling tile and carpet– no asbestos

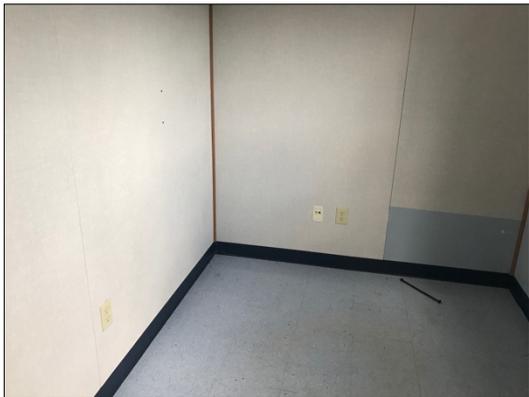
Floor tile and cove base – no asbestos

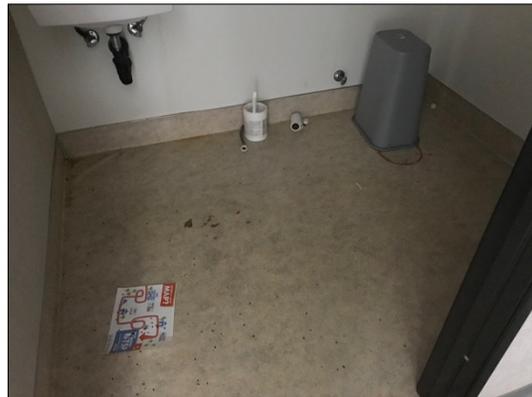
Vinyl flooring – no asbestos

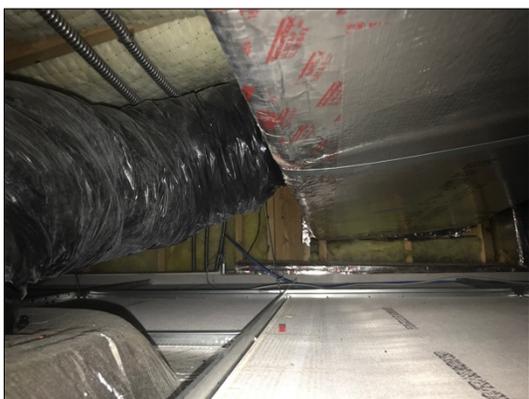
Above ceiling – no asbestos

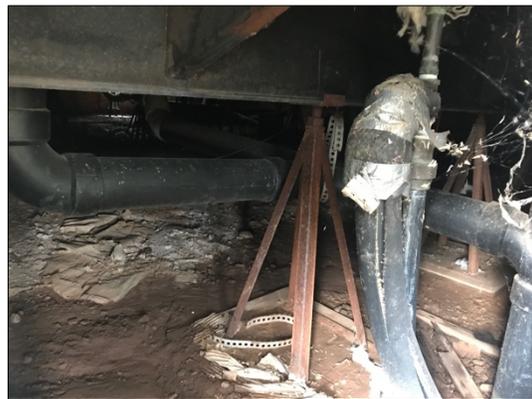
Crawl space – no suspect ACM

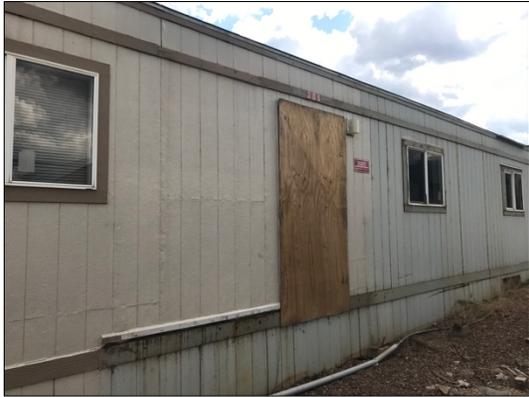
Exterior – no asbestos

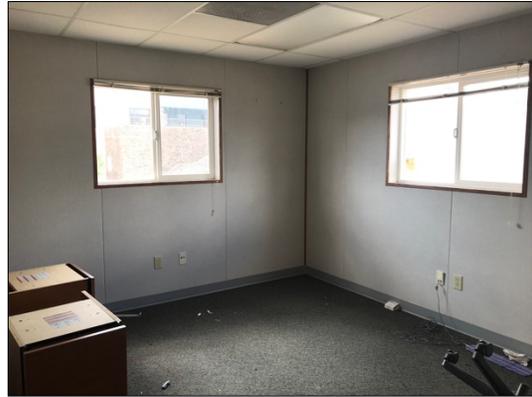
Walls, ceiling tile and carpet– no asbestos

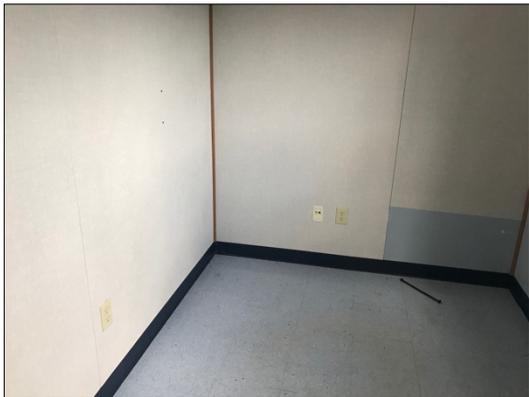
Floor tile and cove base – no asbestos

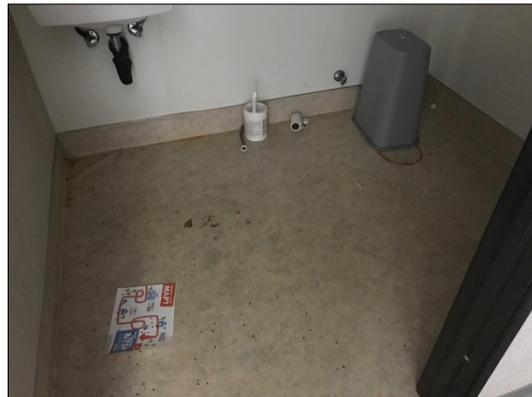
Vinyl flooring – no asbestos

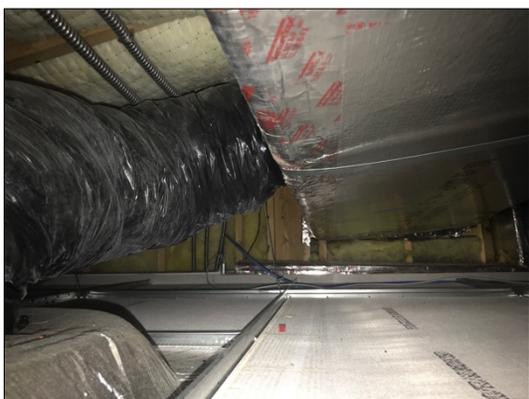
Above ceiling – no asbestos

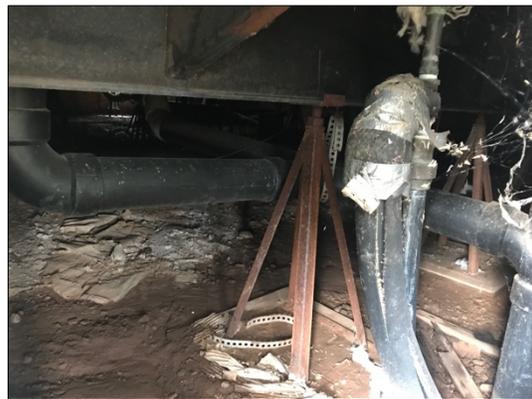
Crawl space – no suspect ACM
