BUILDING 28

1898 Fort Road

Sheridan, Wyoming

Asbestos Findings and Management Recommendations

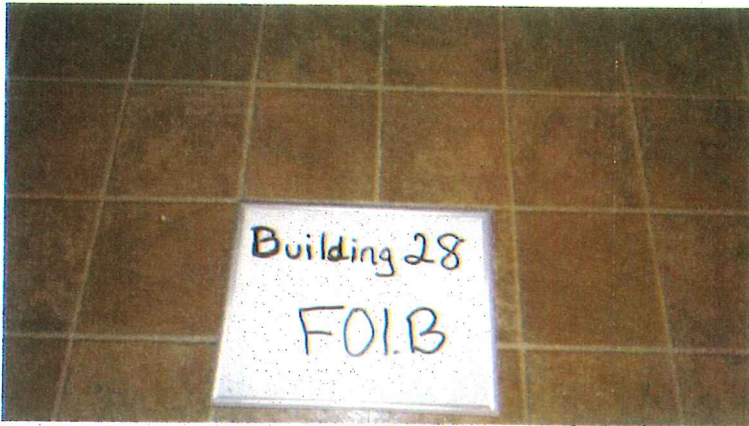
Photograph 1
F01.B Linoleum (HGS 2008)

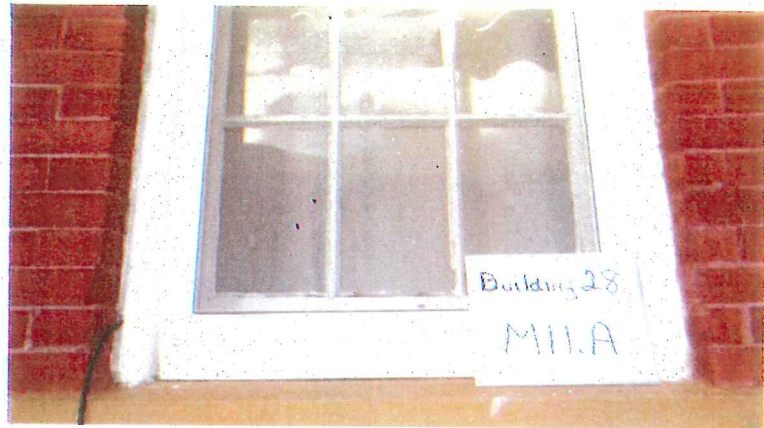
Photograph 2
M11.A Caulking, window/door sealant, black

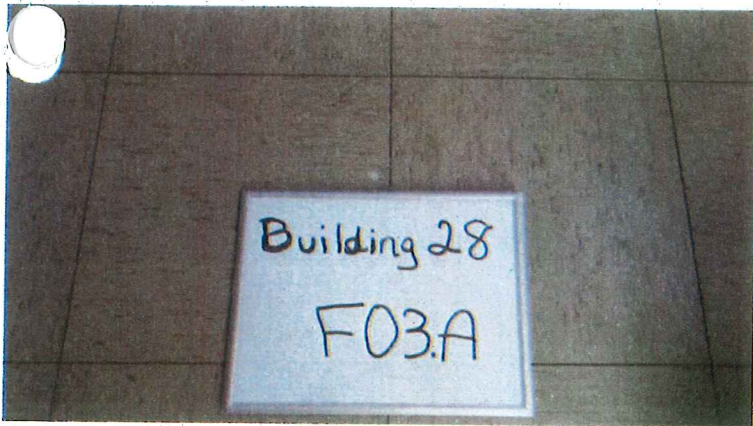
Photograph 3
F03.A 12"x12" Floor tile and Mastic (HGS 2008)

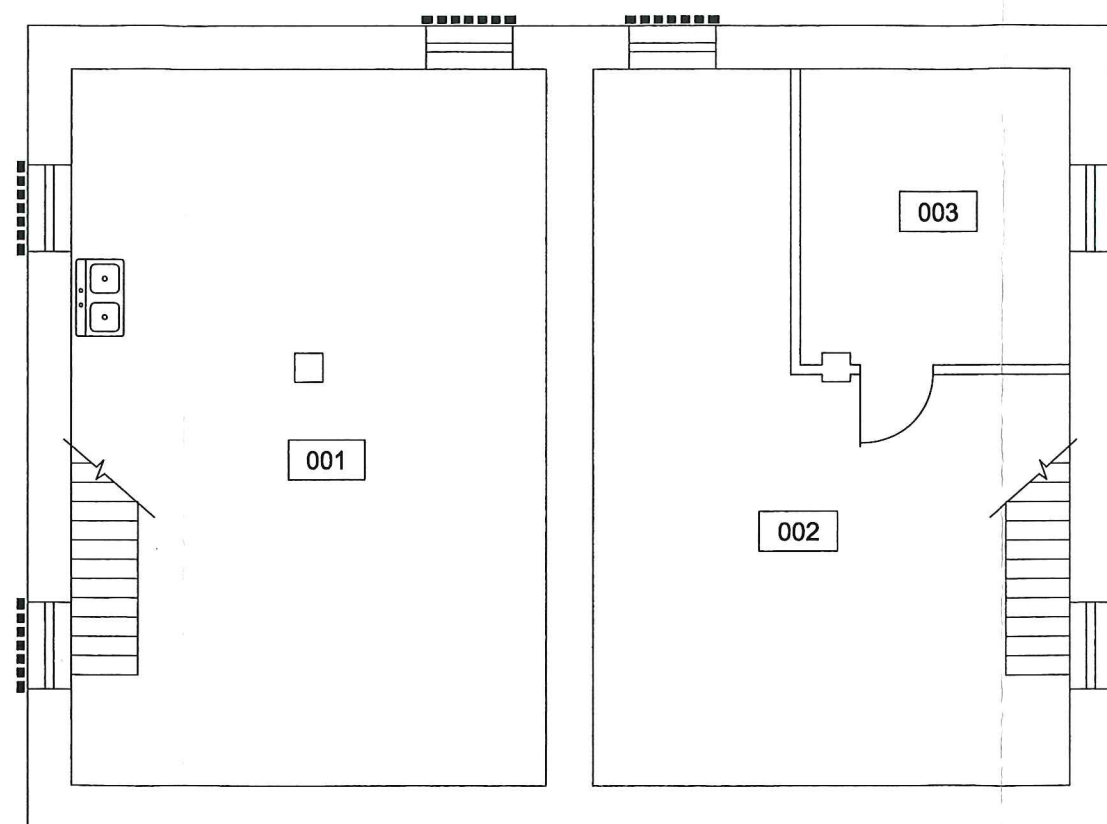
BASEMENT FLOOR ACM LOCATION PLAN

1. DRYWALL AND PLASTER CONTAIN
TRACE AMOUNTS OF ACTINOLITE/
TREMOLITE

12"X12" FLOOR TILE AND MASTIC

LINOLEUM SHEET FLOORING

ACM CONTAINING EXTERIOR WINDOW
AND DOOR CAULKING

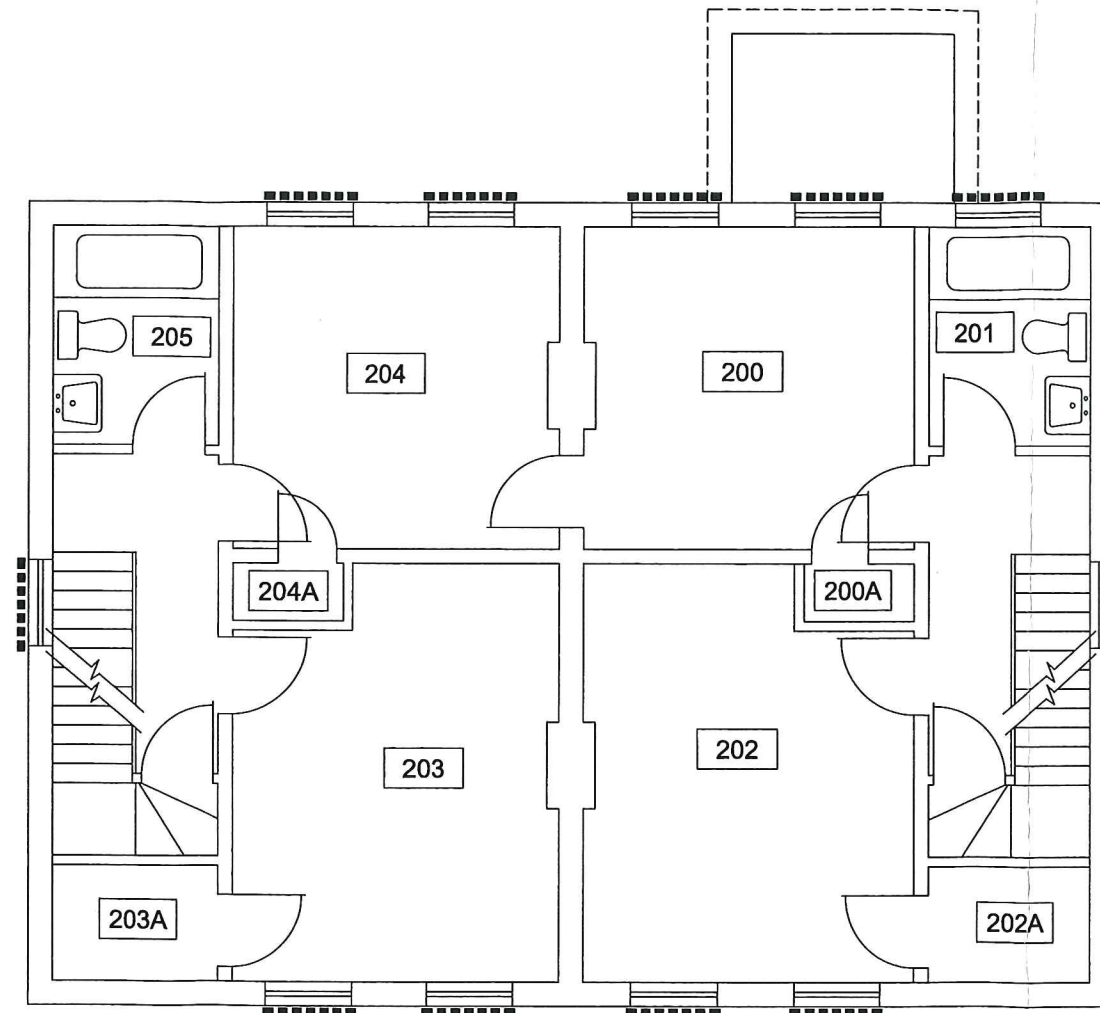
SECOND FLOOR ACM LOCATION PLAN

■■■■■ ACM CONTAINING EXTERIOR WINDOW AND DOOR CAULKING

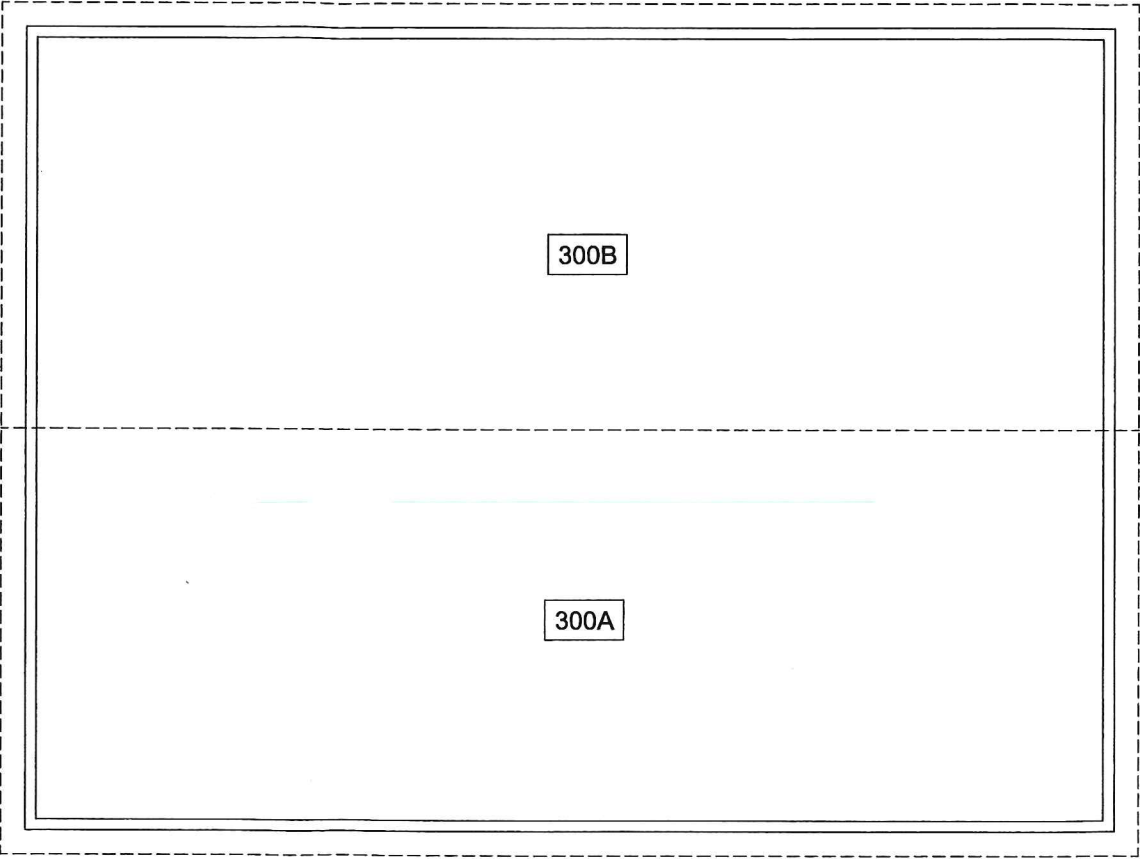
**ATTIC FLOOR ACM
LOCATION PLAN**

1. NO ASBESTOS CONTAINING MATERIALS
IDENTIFIED ON THIS FLOOR OF THIS
BUILDING.
