## CHICKAMIN BARGE

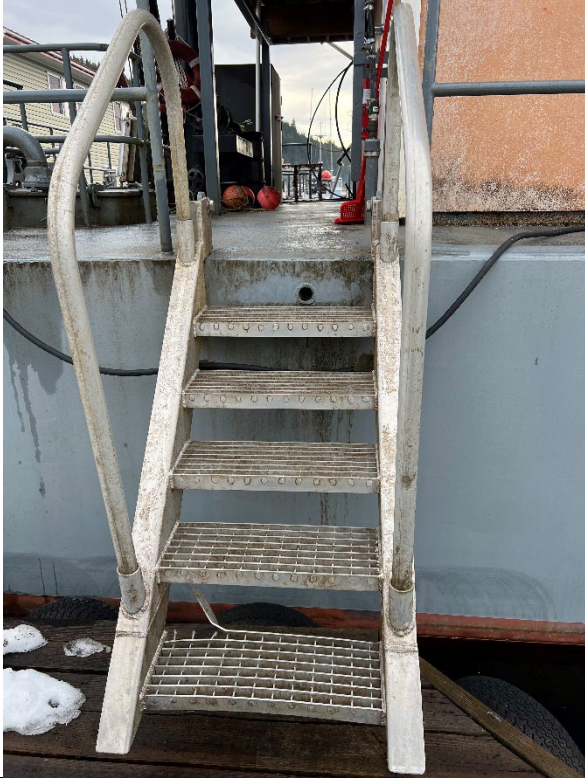
Aluminum Staircase - Fix bent outside rib on bottom stair

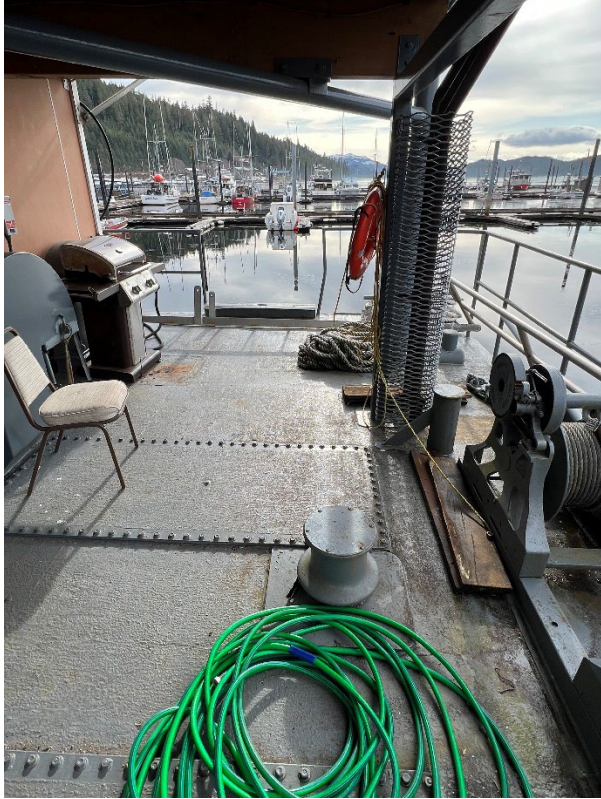
Aft – Bent handrail to be corrected. Also shown is a capstan and two winches.

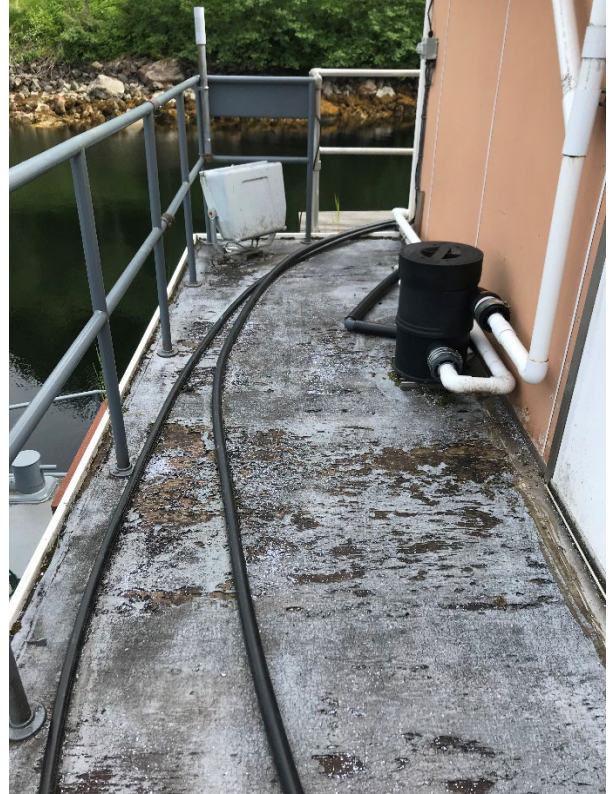
Forward rotting plywood deck

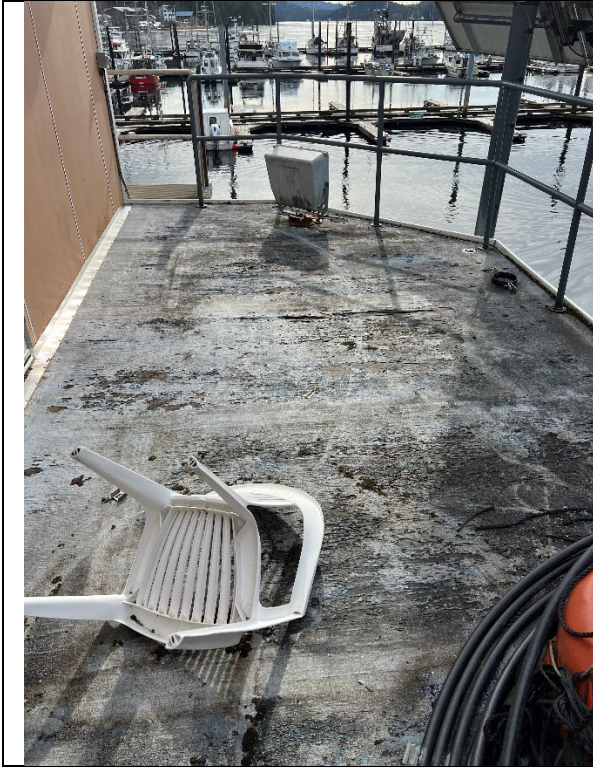
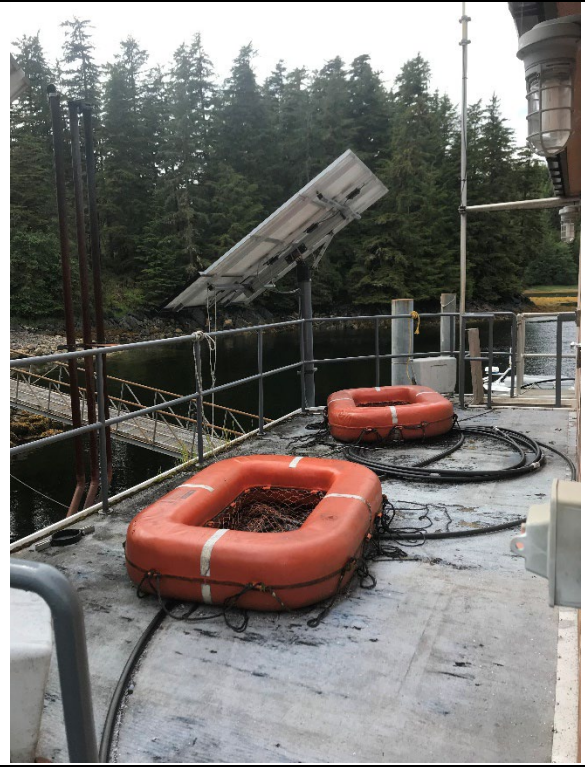
Aft Upper Exterior Deck to be replaced with aluminum decking.

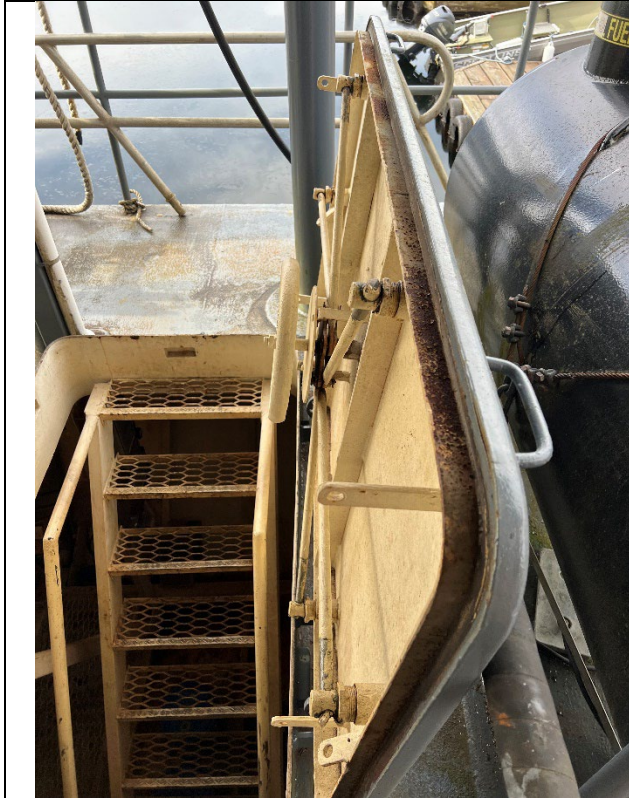
Main Hatch has rust around lip observed

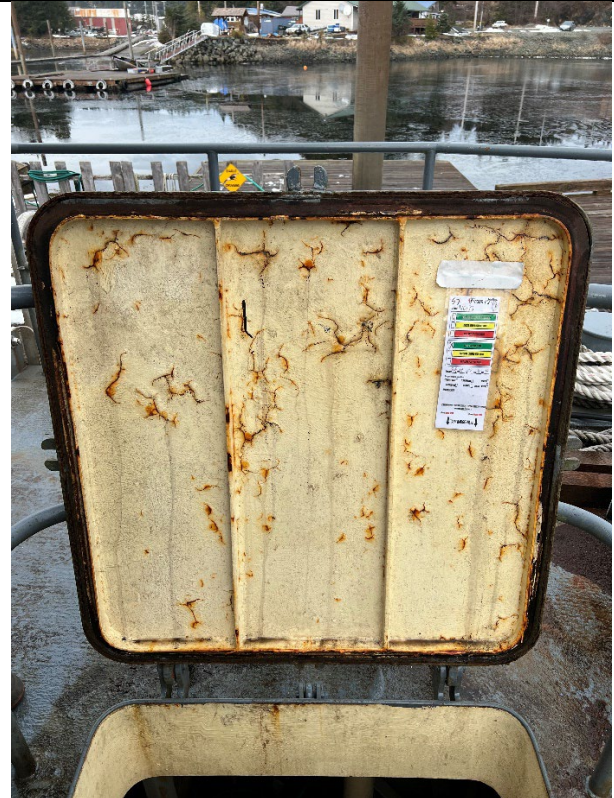
Hatch lid to be repainted and seal replaced

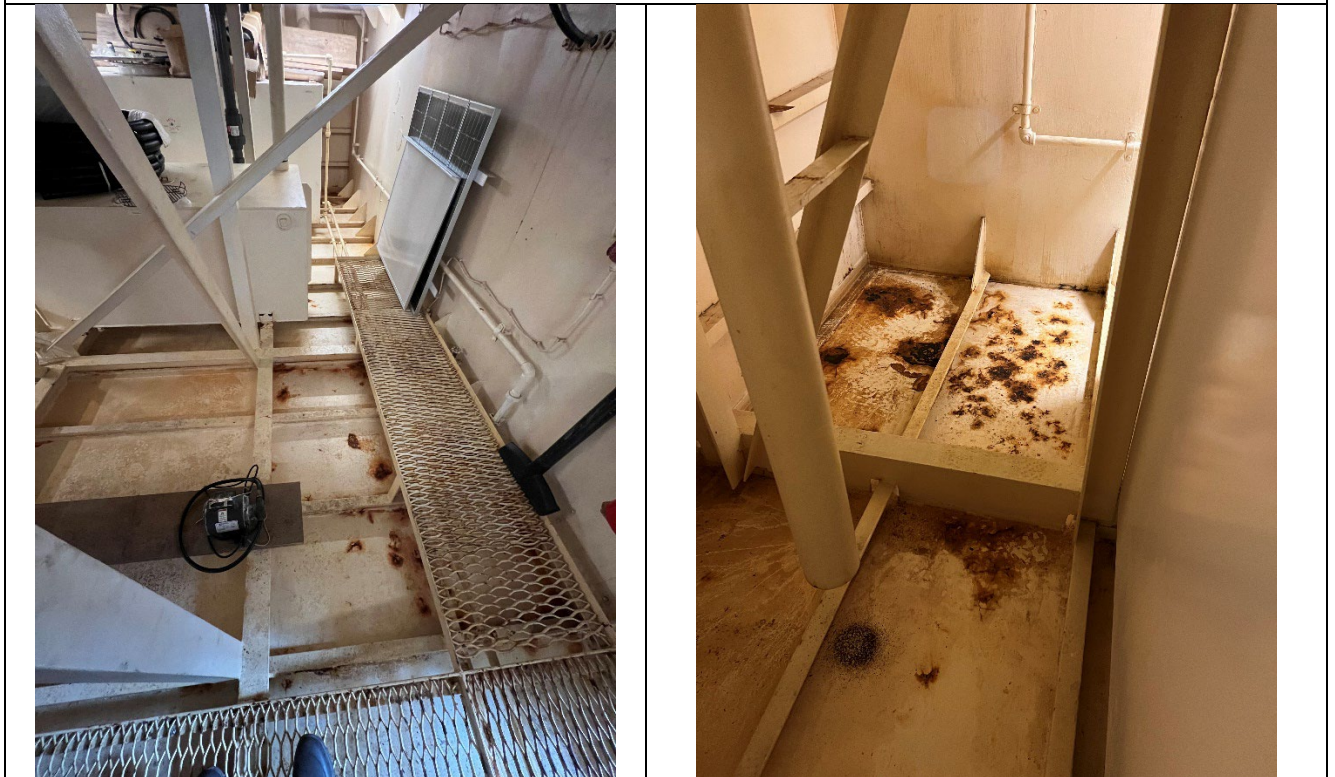
Spot paint areas of rust in main compartment

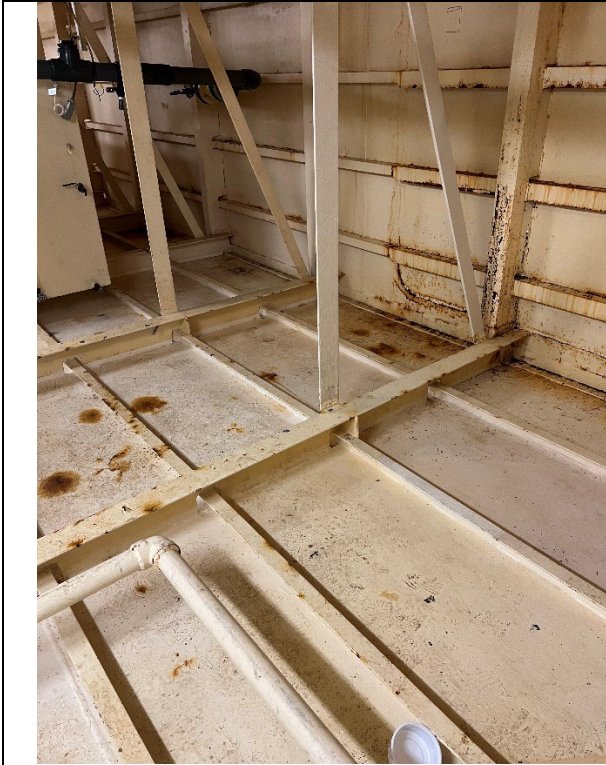
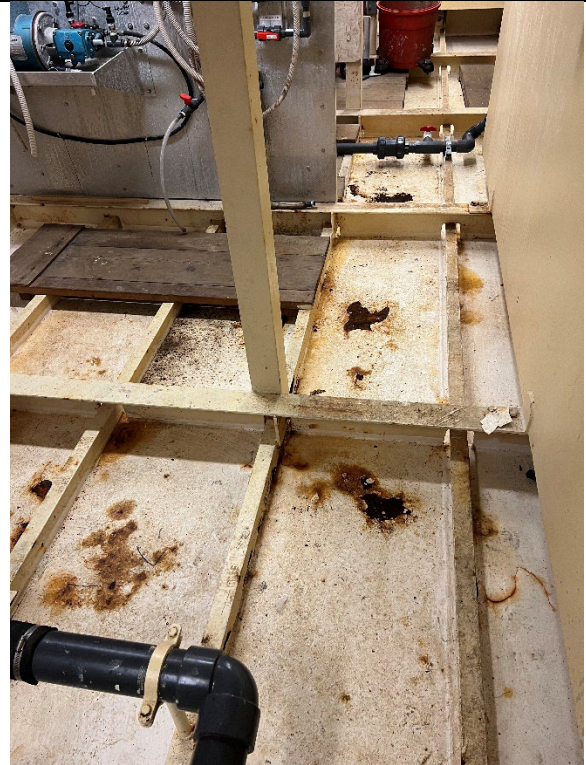
Spot paint areas of rust in main compartment

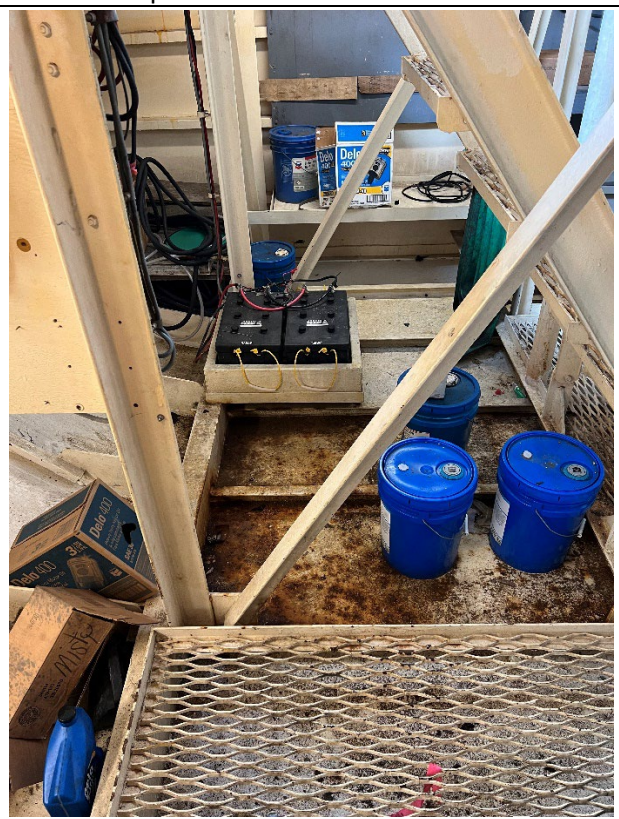
Areas of rust in generator/aft compartment
