VOLUME I GENERAL ASBESTOS/LEAD CONTAINING PAINT SUMMARY REPORT

**VISN 1
Brockton VA Medical Center
940 Belmont Street
Brockton, MA 02301**

Project No. 2009023.003

June 21, 2010

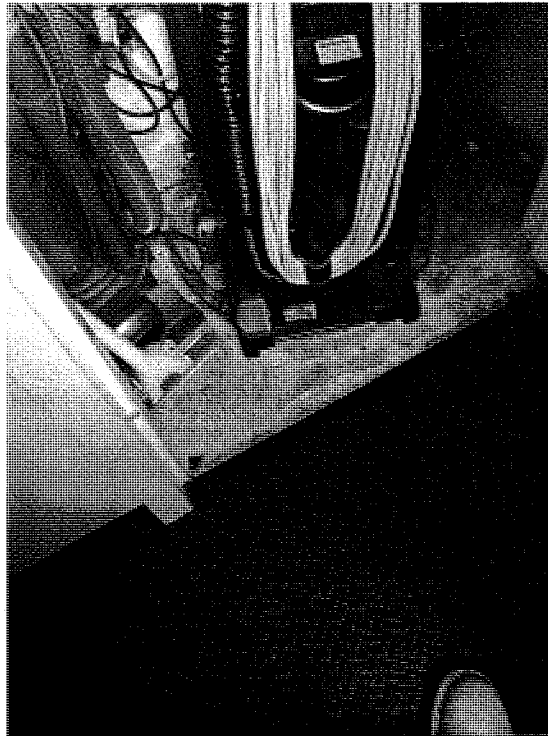
Photo 1-View of residual mastic in closet.

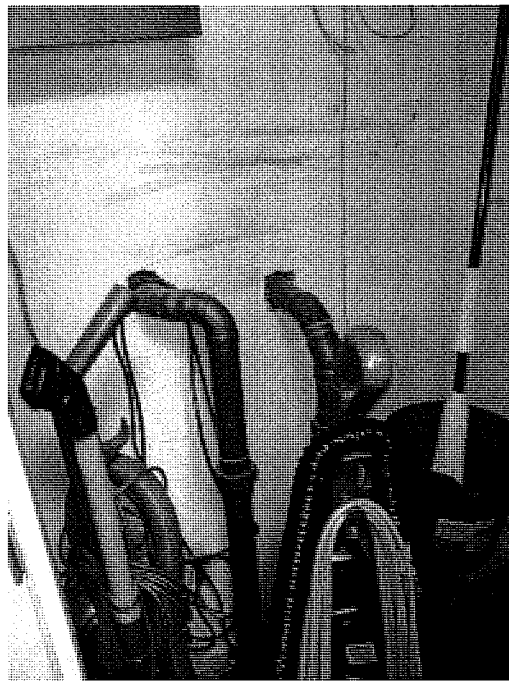
Photo 2 – View of Wallboard and Joint Compound inside Utility Closet.

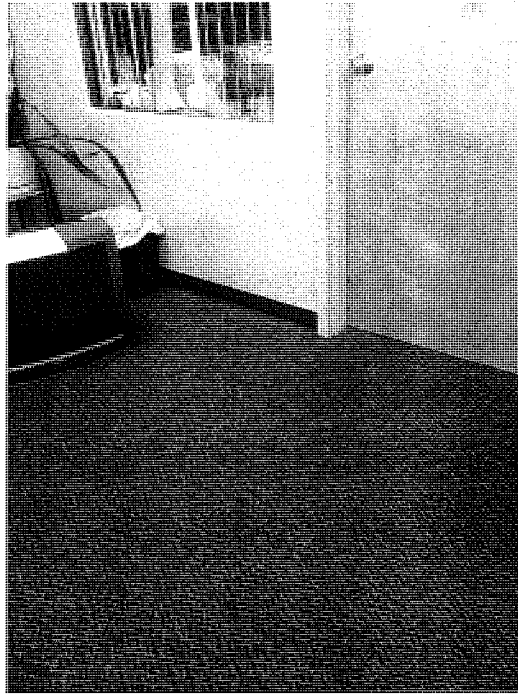
Photo 3 – View of Carpet and Cove-Base Main office area.

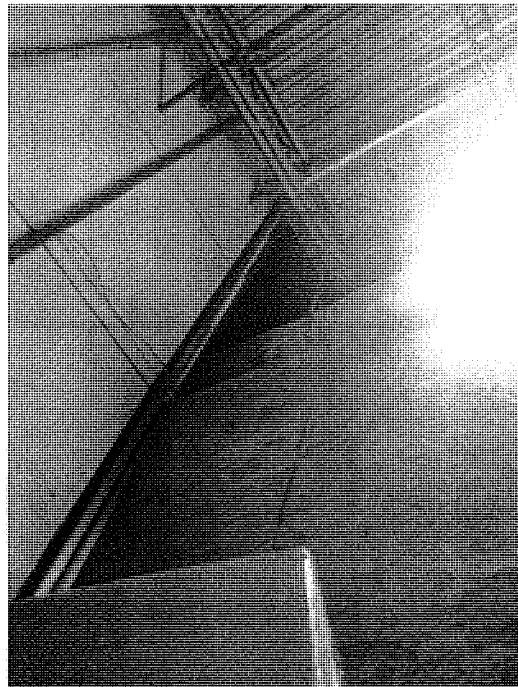
Photo 4 – View of wallboard, plenum and air duct from inside Utility Area.

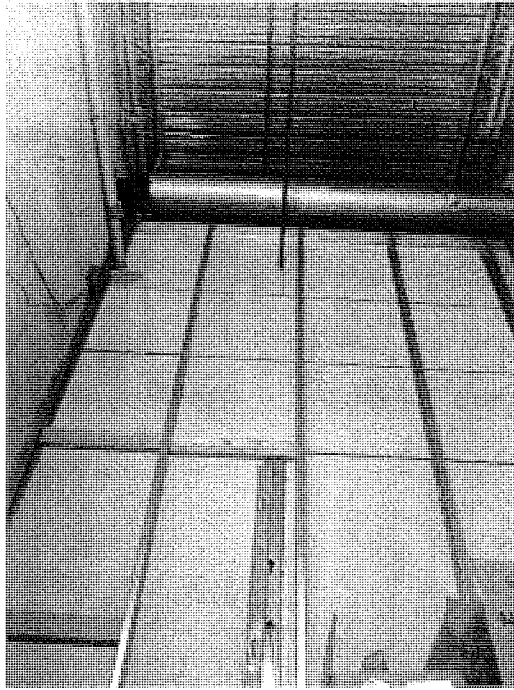
Photo5 – View of Roof Deck and wallboard from inside utility area.

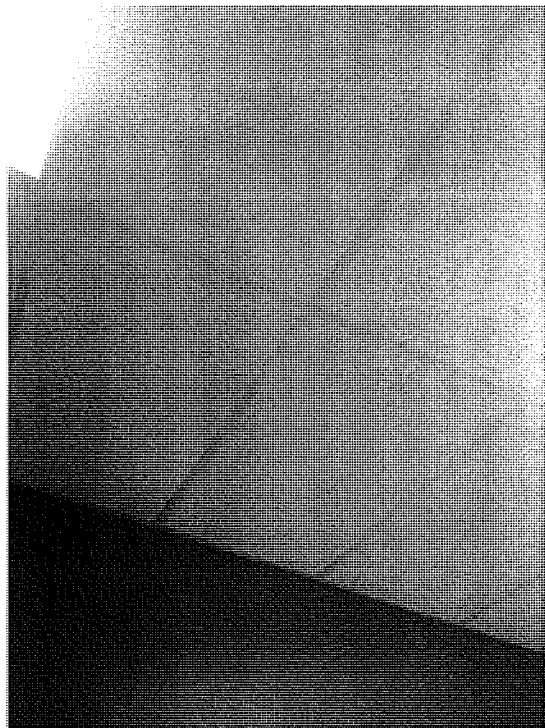
Photo 6 – View of 2x4 Ceiling Tile inside main office area.

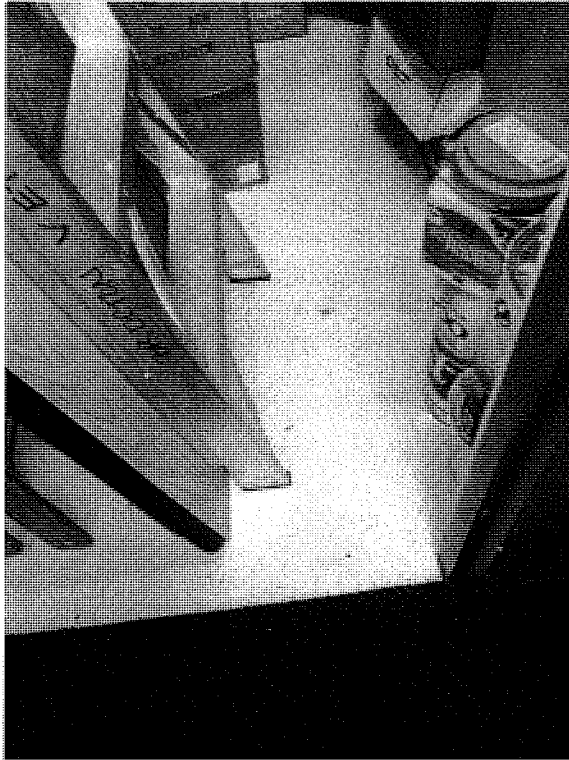
Photo 7 – View of 12x12 White Floor Tile remaining under carpeting from inside closet.
