## Technical Report: Fort Peck Butterfly Valve#4 Inspection Report

### FT. PECK PH#2 BUTTERFLY VALVE NDT

Date: 12/5/2019

**Inspected by:** Thomas R. Hay, P.E., ASNT Level 3#107162  
TECHKNOWSERV CORP.  
2134 Sandy Dr., Suite 14  
State College PA, 16803  
(814) 237-0144

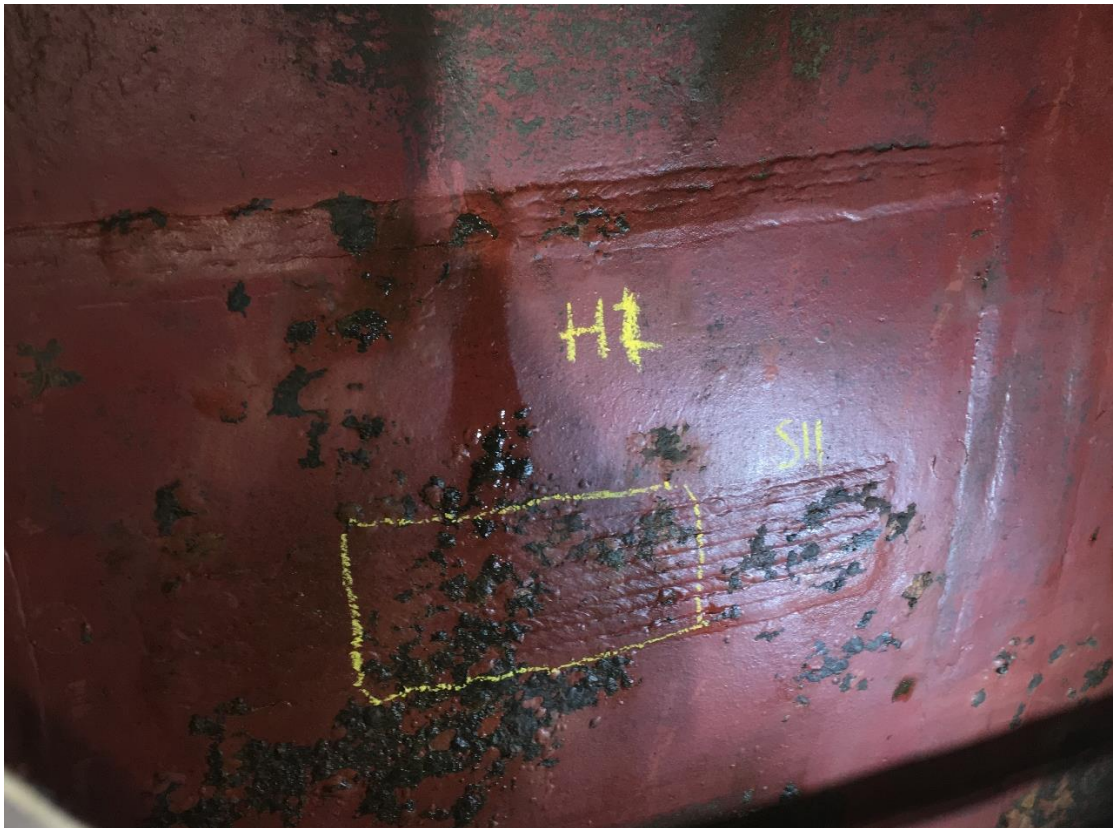
Figure 2.3: Example cleaned surfaces on Valve 4 upstream welds H1 and S11.

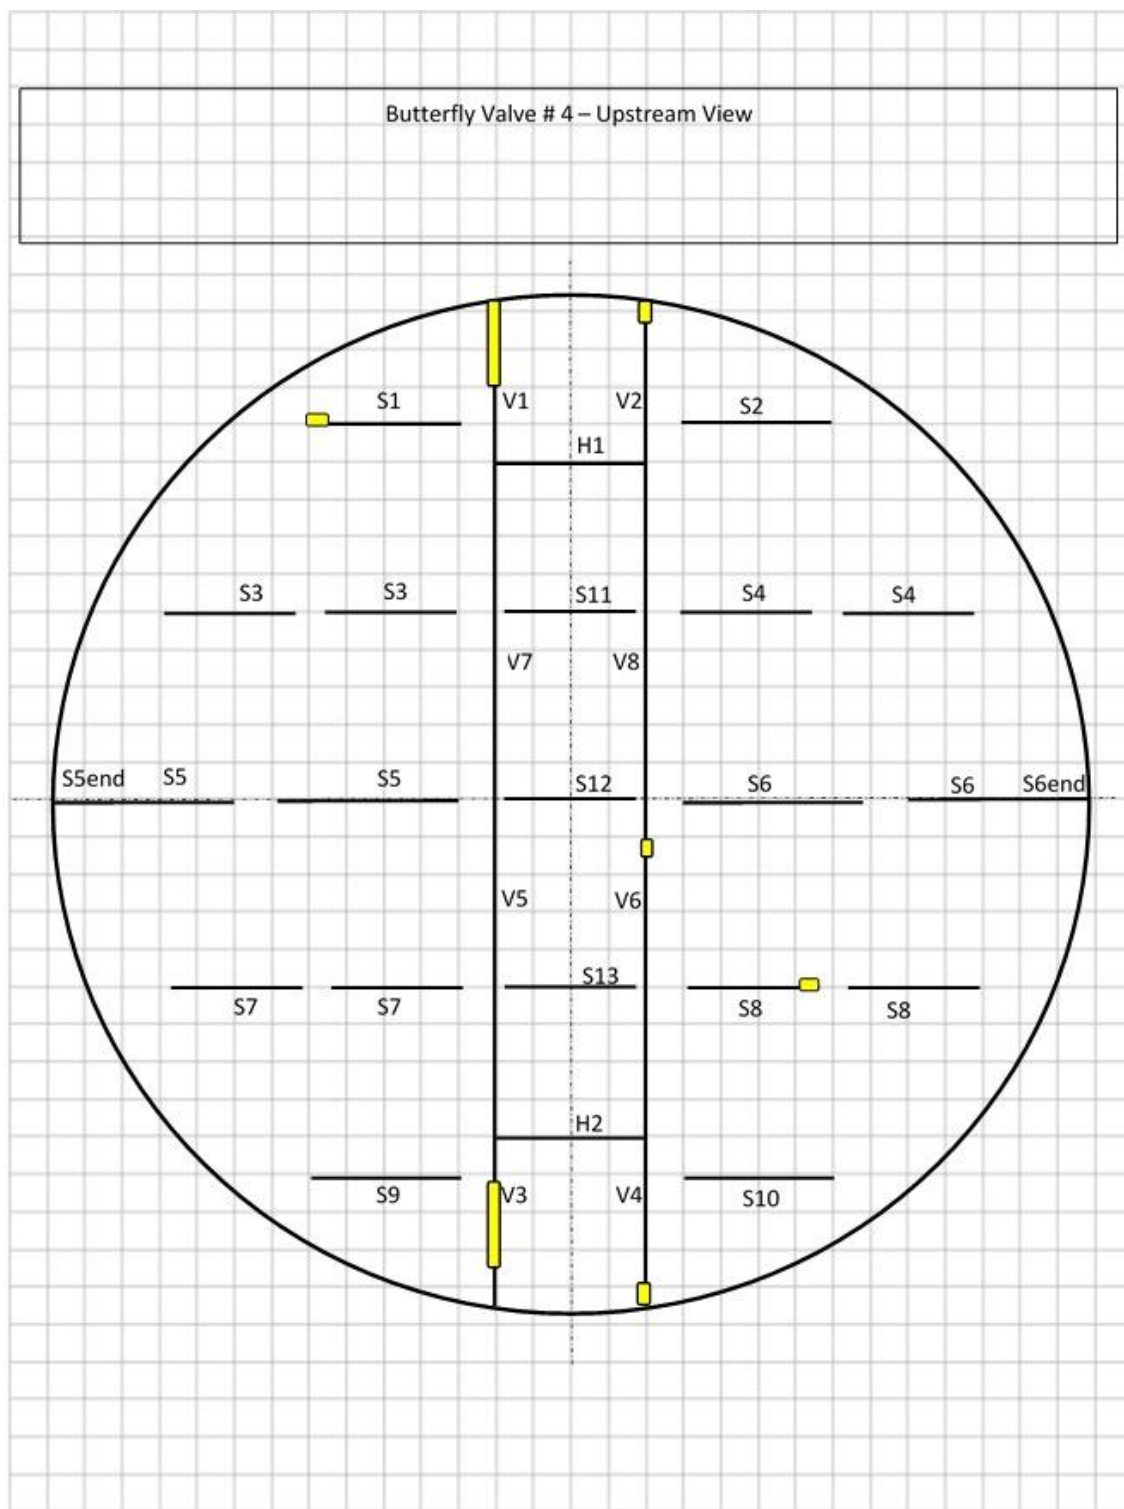
The locations of the notable coating breakdown and surface corrosion on the upstream and downstream sides are shown in Figures 2.4 and 2.5, respectively, via the yellow areas superimposed onto the valve welds. Details on each weld are presented in Table 2.3.

Figure 2.4: Locations of coating breakdown and surface corrosion on Valve 4 upstream side.

2. **Welds and shell with corrosion and blistering:** Remove lead paint with industry standard practices, blast to bare metal, and clean all welds on which coating breakdown and corrosion were observed and perform a detailed inspection in accordance with AWS D1.1. Additional welds may need to be considered at the time of the maintenance event. Apply new coating system to these areas after inspection.

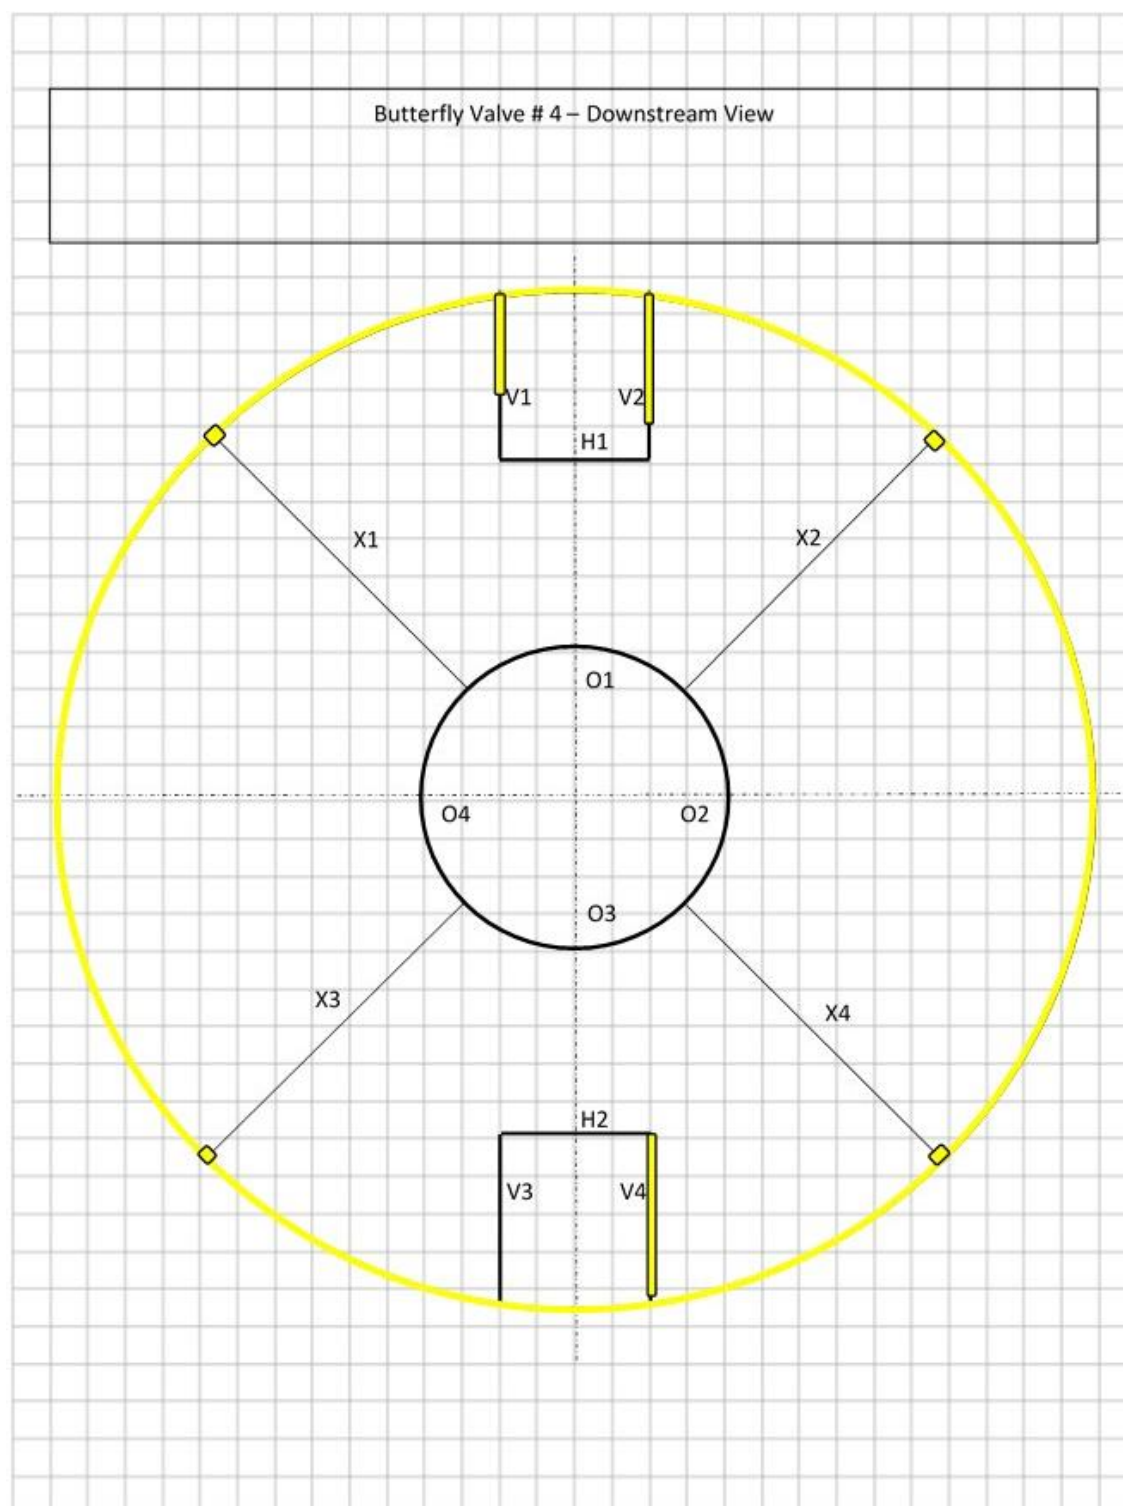
Figure 2.5: Locations of coating breakdown and surface corrosion on Valve 4 downstream side.

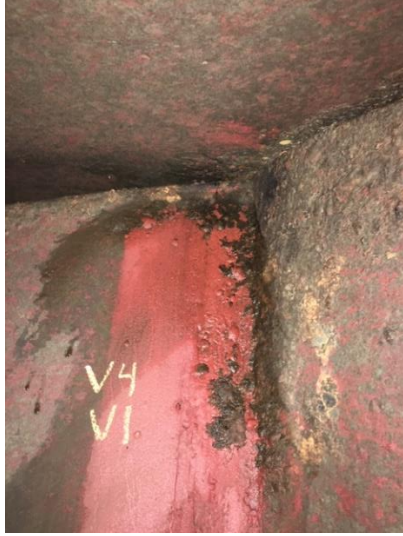
V1	<p>20" of blistering and surface corrosion at top of weld. Coating in good condition over remainder of weld.</p>

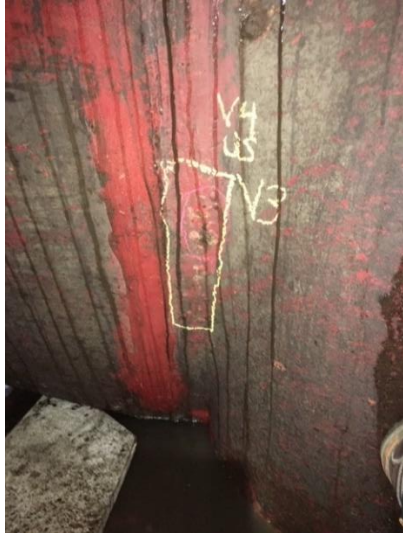
V2	<p>4" of blistering and surface corrosion at top of weld. Coating in good condition over remainder of weld.</p>
V3	<p>18" of blistering and surface corrosion over bottom half of weld. Coating in good condition over remainder of weld.</p>

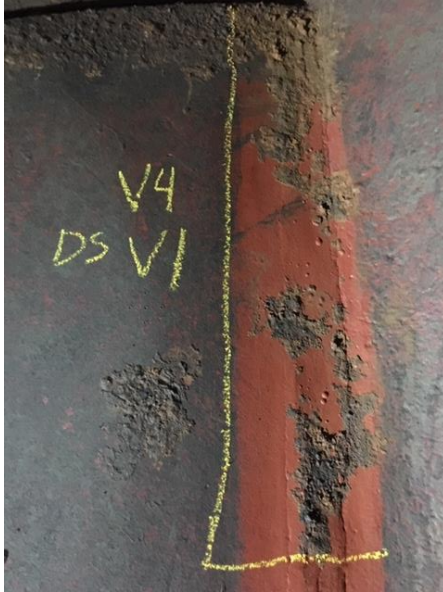
<i>Valve 4 Downstream Side</i>	
H1	No blistering or surface corrosion, coating in good condition over length of weld.
H2	No blistering or surface corrosion, coating in good condition over length of weld.
V1	<p>24" of blistering and surface corrosion at top of weld. Coating in good condition over remainder of weld.</p>

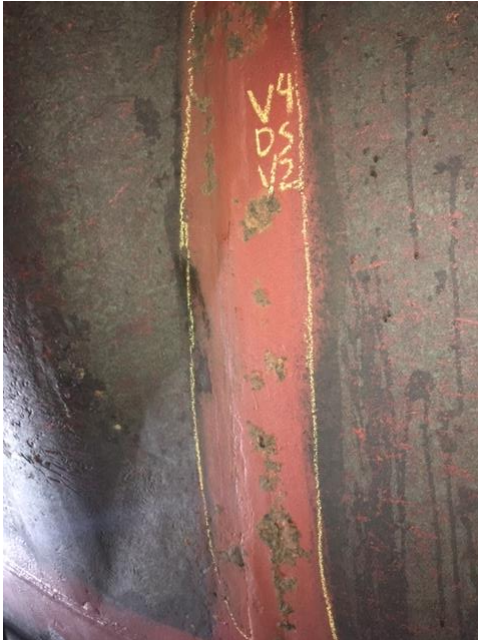
V2	<p>36" of Intermittent blistering and surface corrosion at top of weld. Coating in good condition over remainder of weld.</p>

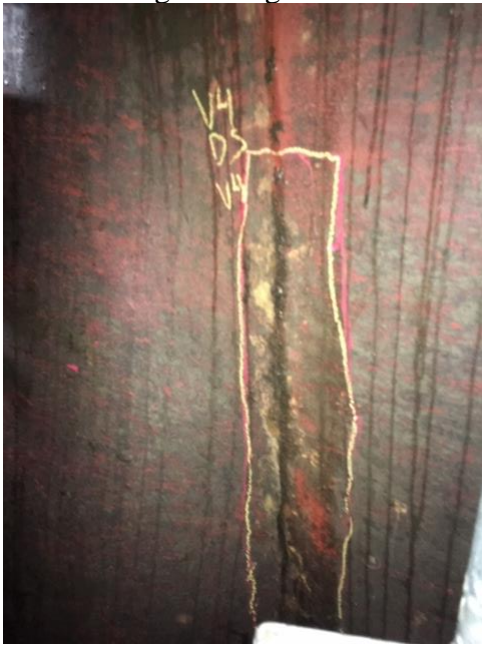
V4	<p>Blistering and surface corrosion along the length of the weld.</p>

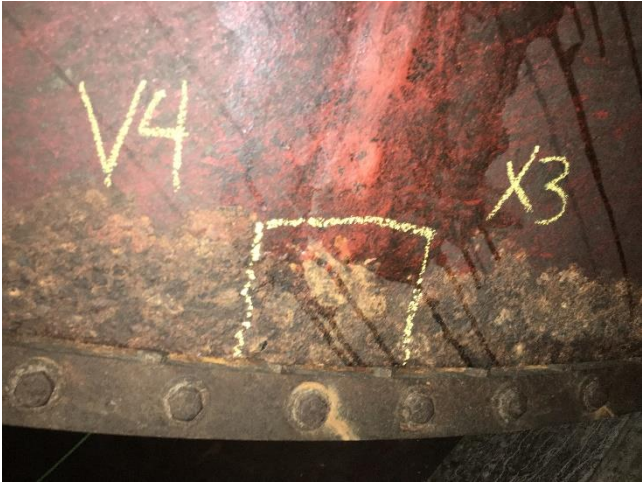
X1	<p>6" blistering and surface corrosion at end of weld towards OD. Coating in good condition over remainder of weld.</p> <p>See X3 picture for reference.</p>
X2	<p>6" blistering and surface corrosion at end of weld towards OD. Coating in good condition over remainder of weld.</p> <p>See X3 picture for reference.</p>
X3	<p>6" blistering and surface corrosion at end of weld towards OD. Coating in good condition over remainder of weld.</p>

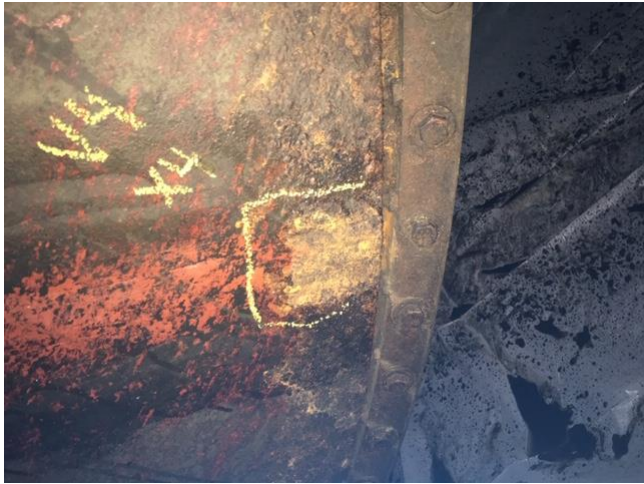
X4	5" blistering and surface corrosion at end of weld towards OD. Coating in good condition over remainder of weld.

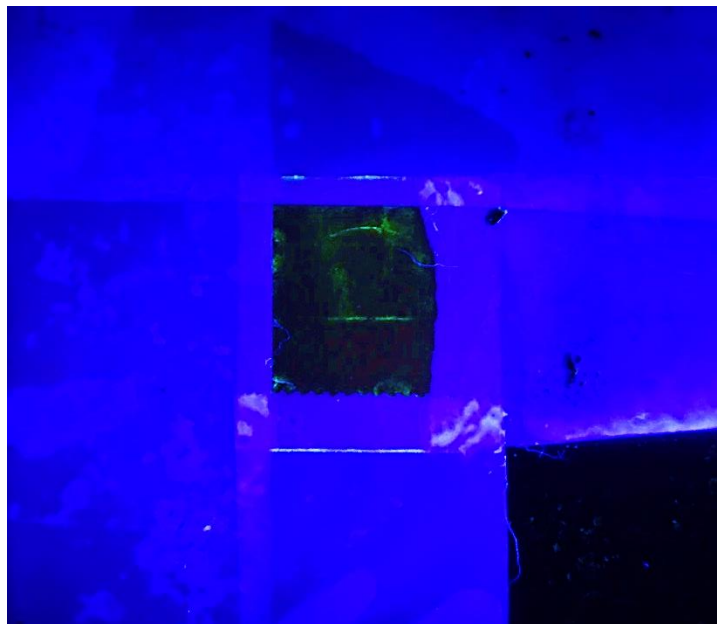
The performance of the total WFMT system was confirmed on-site using a Quantitative Quality Shim (QQI) shim with a 0.0006” deep EDM notch. The horizontal indication generated with the MT yoke, wet bath, and UV light is shown in Figure 3.1.

Figure 3.1: WFMT indication from QQI shim.

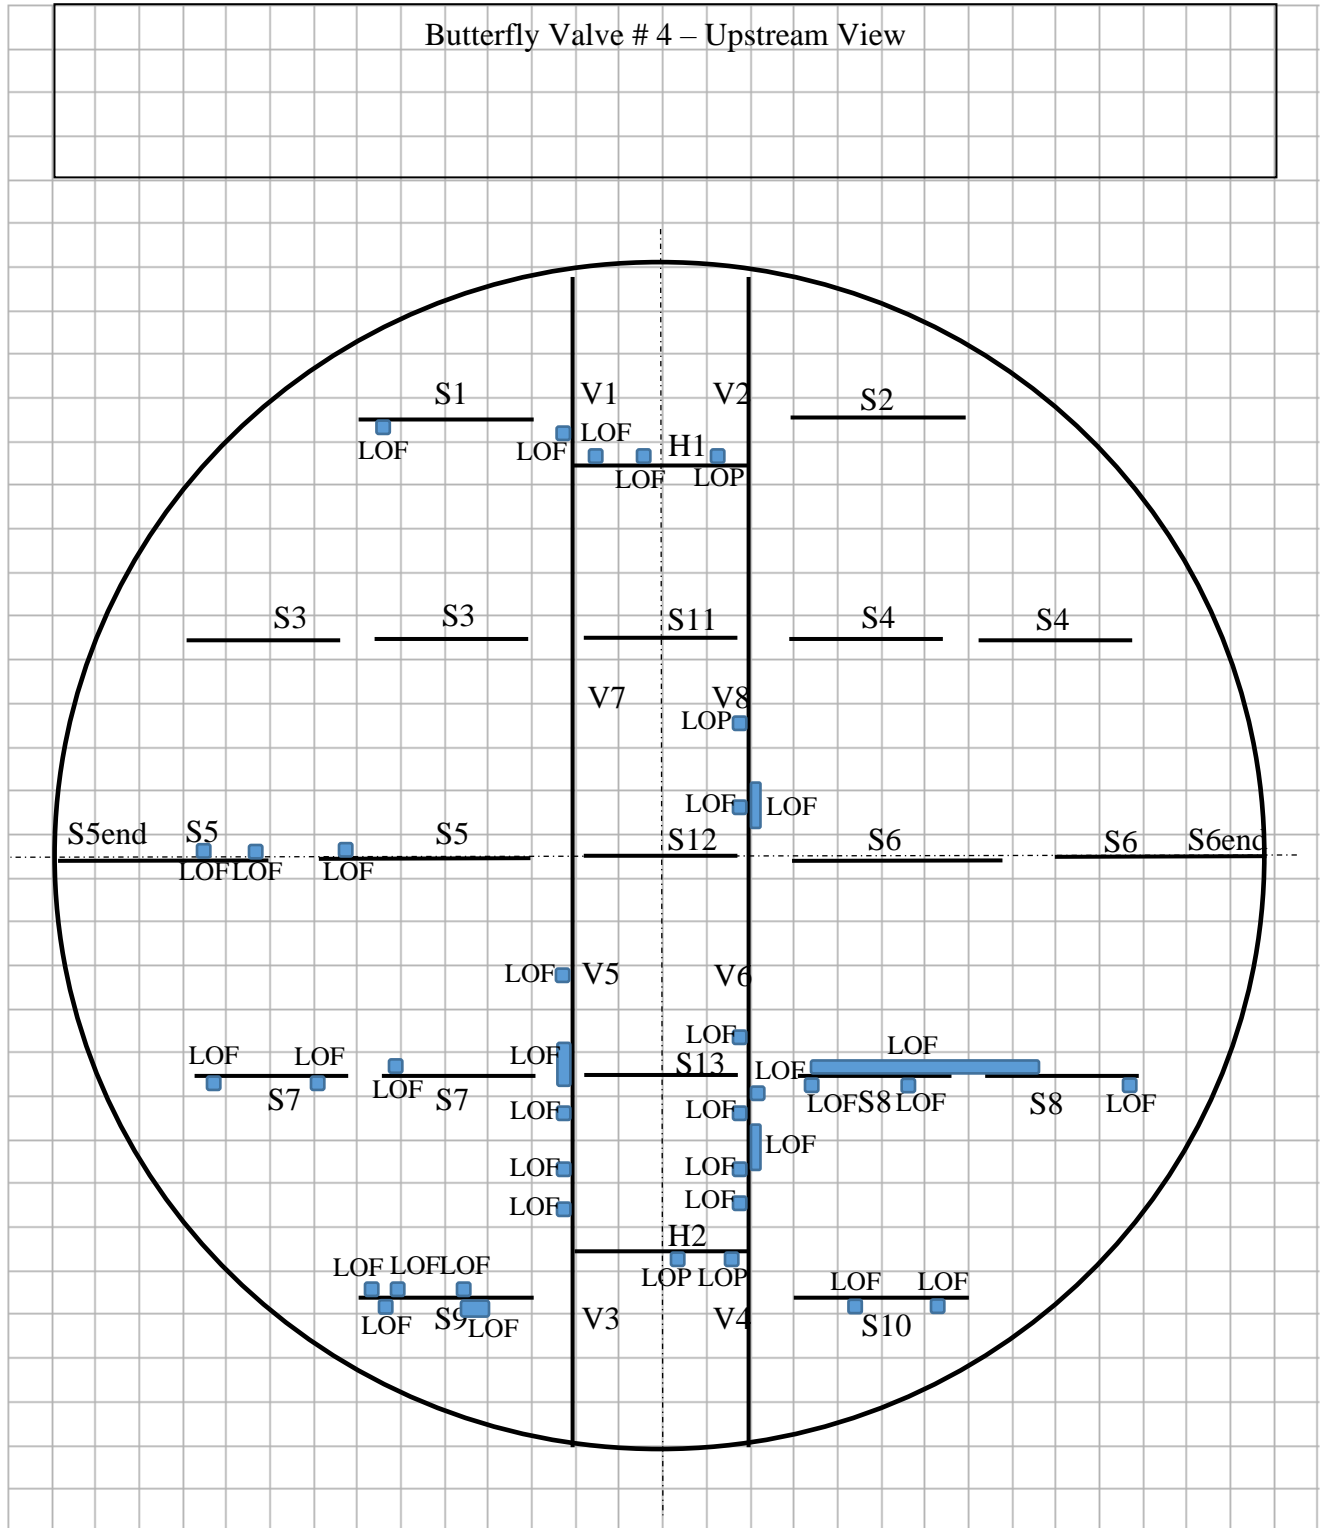
The upstream side contained 17 weld discontinuities longer than 1” as shown in Table 4.1. The upstream side contained 4 weld discontinuities with a height greater than 0.375”. The most severe discontinuity was found in S8a with a length of 23.303” and a height of 0.372”. The PAUT inspection details for all welds inspected is presented in Section 5. The data for Weld s8A, for example, shows that the discontinuity was found mid-wall and was classified as lack of fusion (LOF).

Figure 4.6: All PAUT weld discontinuities for Valve #4 upstream.

3. **Re-asses risk matrix color-coded red welds after abatement, blasting, and cleaning:** Perform encoded PAUT to more accurately locate and size the weld discontinuities. Apply new coating system to these areas after inspection. Re-assess possible repair action after new sizing data is made available. Determine if discontinuity has grown and, if so, repair immediately.

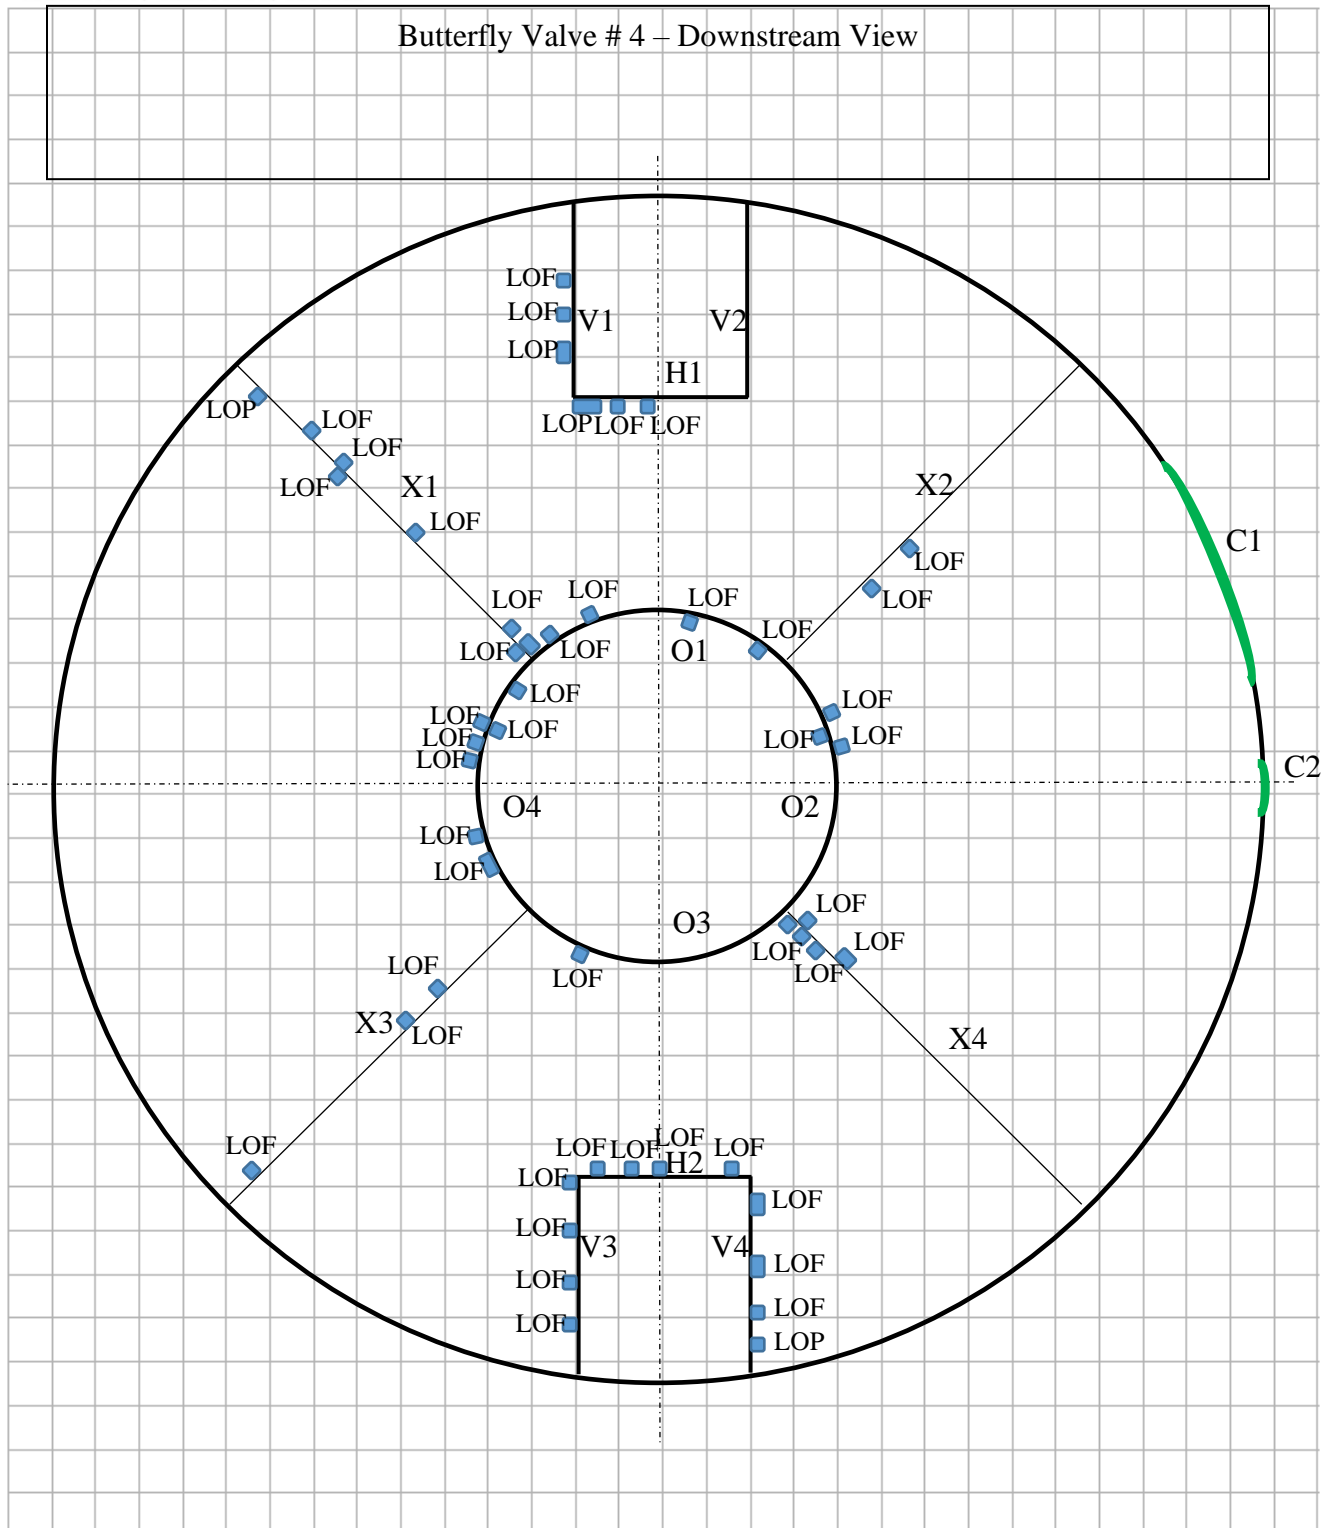
The downstream side contained 16 weld discontinuities longer than 1” as shown in Table 4.2. The downstream side contained 1 weld discontinuities with a height greater than 0.375”. The most severe discontinuity was found in H1 with a length of 2.074” and a height of 0.408”. The PAUT inspection details for all welds inspected is presented in Section 5. The data for Weld H1 shows that the discontinuity was found towards the weld bottom and was classified as lack of penetration. (LOP).

Figure 4.8: All PAUT weld discontinuities for Valve #4 downstream.

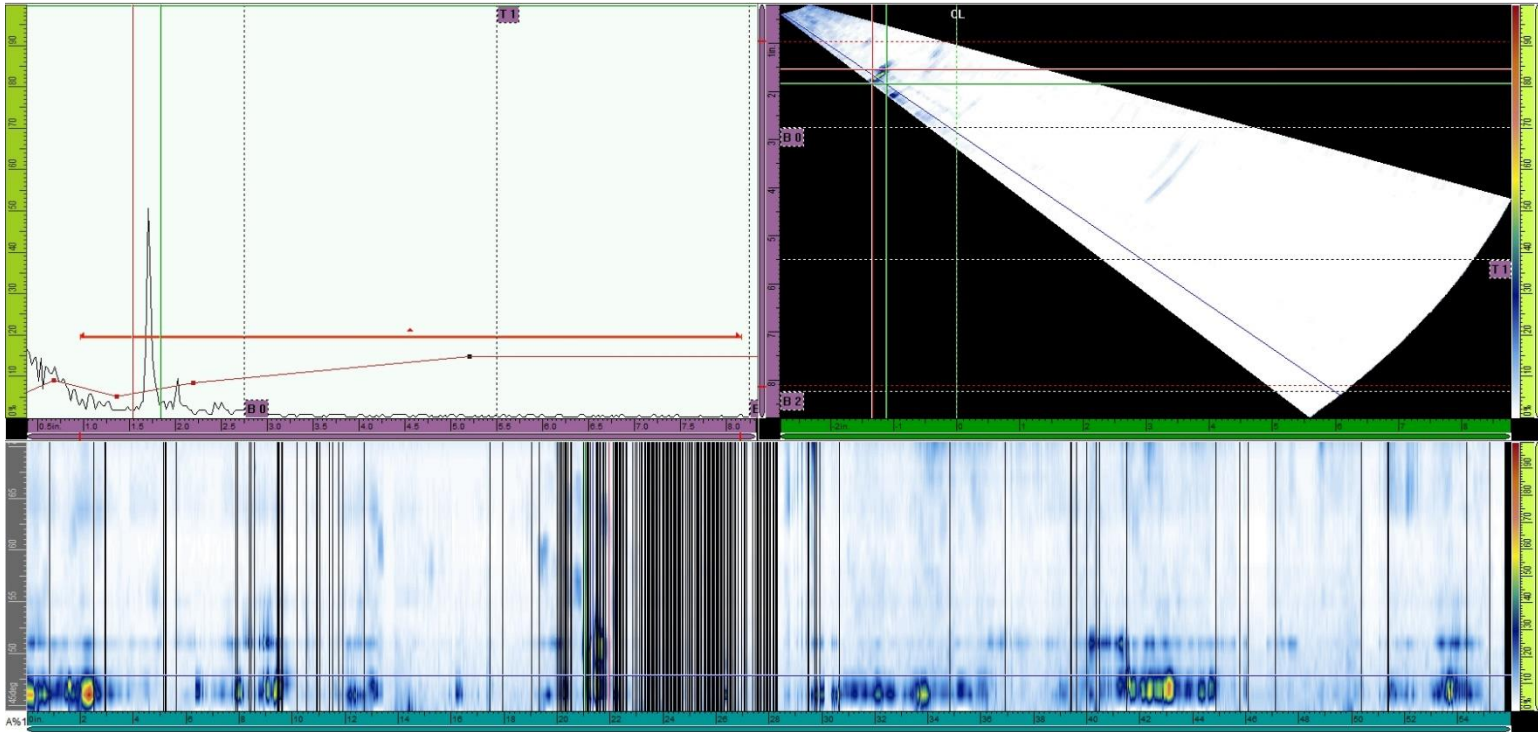
The upstream side contained 17 weld discontinuities longer than 1” and the upstream side contained 4 weld discontinuities with a height greater than 0.375”. The most severe discontinuity, a lack of penetration, was found in weld S8a with a length of 23.303” and a height of 0.372”.

Gain (dB)	Indication #	Scan (in)	Index (in)	Group	Channel	A%1 (%)	DA/1 (in)	PA/1 (in)	SA/1 (in)	U(m-r) (in)	I(m-r) (in)	I•U(m-r) (in)	S(m-r) (in)	Type
52.66	1	34.062	-6.500	PA 1	48.00°	78.8	1.653	1.171	2.470	0.372	0.391	0.540	23.303	LOF

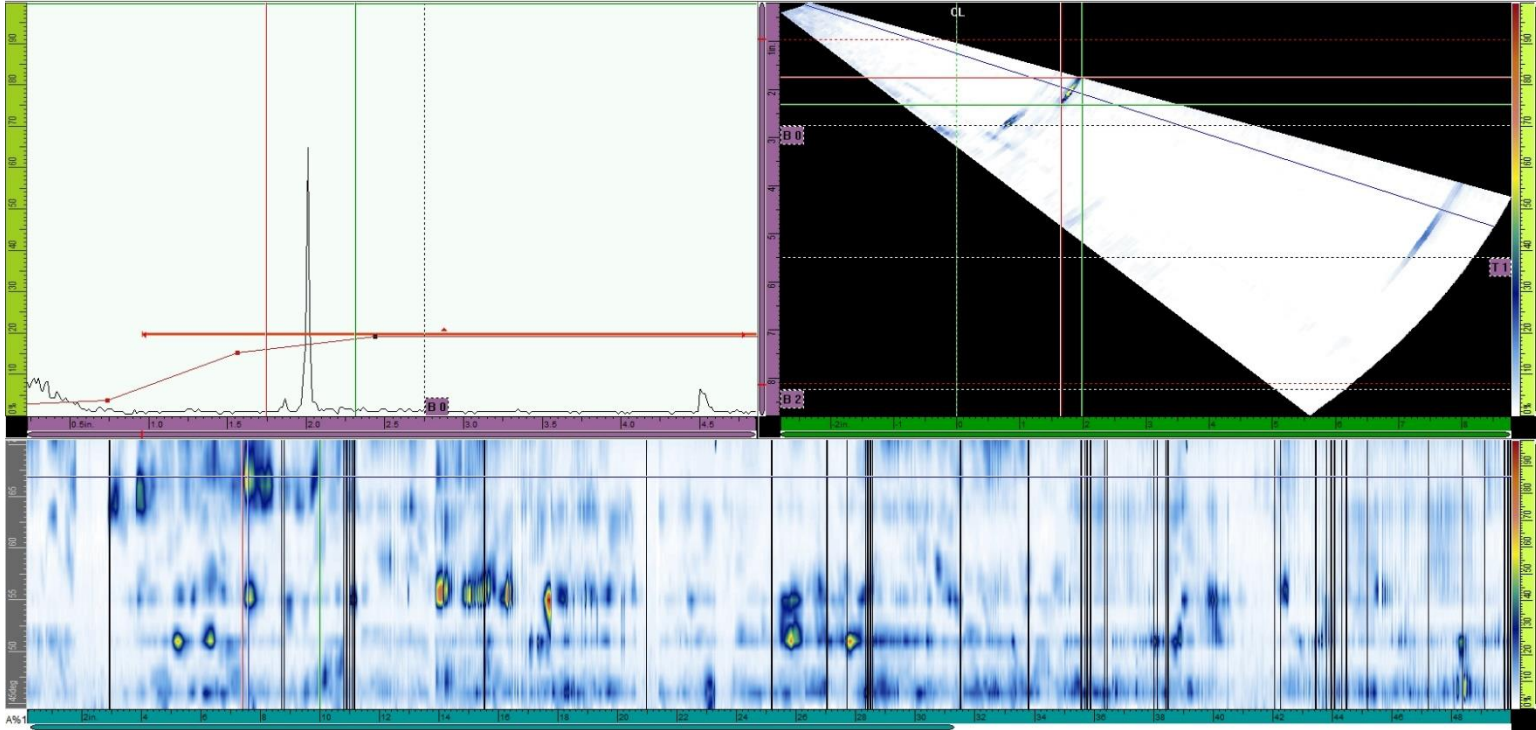
Weld	Comments														
V1	Gain (dB)	Indication #	Scan (in)	Index (in)	Group	Channel	A%1 (%)	DA/1 (in)	PA/1 (in)	SA/1 (in)	U(m-r) (in)	I(m-r) (in)	I•U(m-r) (in)	S(m-r) (in)	Type
	46.66	1	7.559	-6.500	PA 1	67.00°	64.3	2.008	4.300	5.138	0.567	0.337	0.660	2.599	LOF
