Report of Pre-Renovation Hazardous Materials Assessment – Rocky Mountain Research Station Shed 7

Subject Property:
Rocky Mountain Research Station
5775 U.S. Hwy 10 W.
Missoula, MT 59808

Contract: AG-82FT-P-15-0058

December 15, 2015

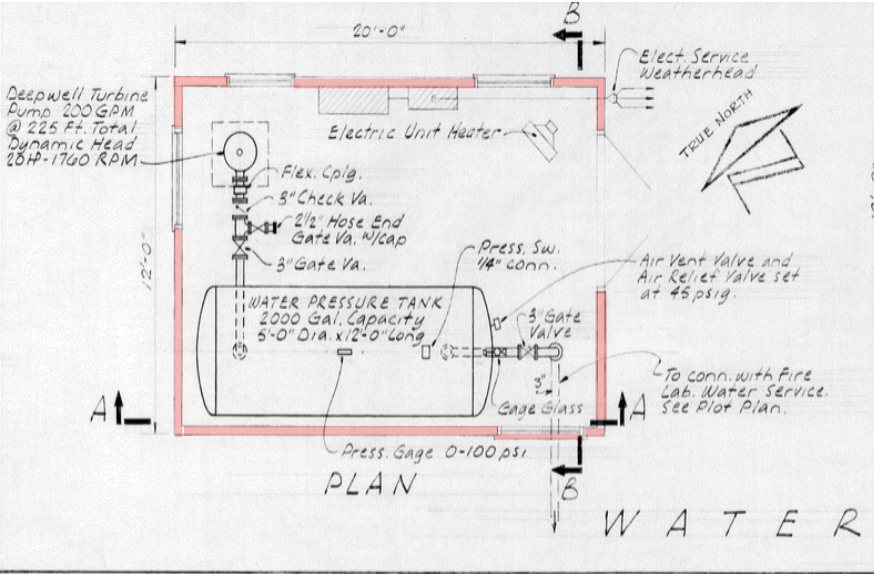
Asbestos Containing Material Location - SHED 7

HA No.	HA Description	Location	% Asbestos	Condition	SQFT/LF	Response Action
TRNST.1	cement asbestos board	Walls of Shed 7	20%	good condition non friable	1000 SQFT	(Intact Removal) prior to renovation

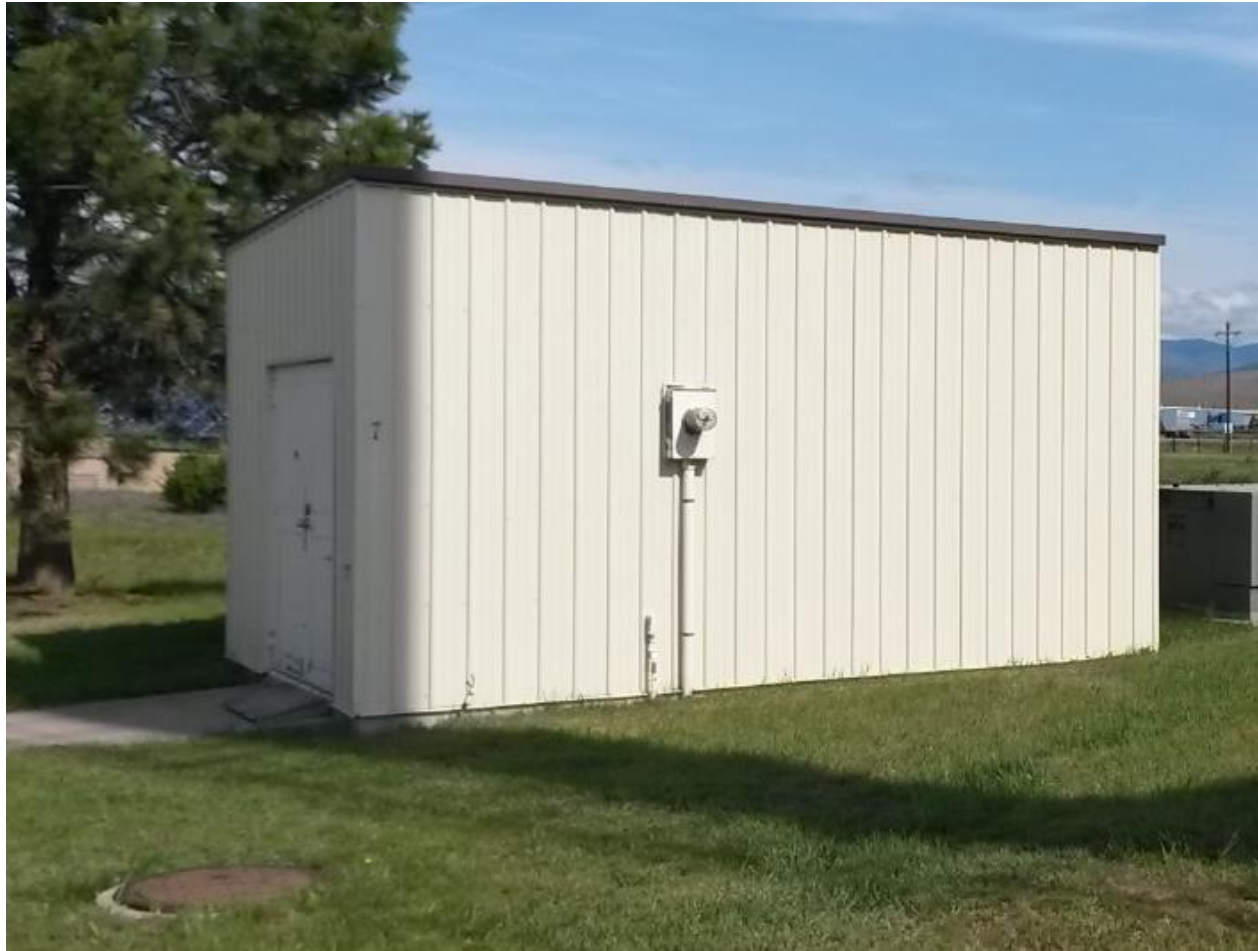
Cement asbestos board (transite)
is located on the walls and ceiling
