DESIGN NARRATIVE – SID BUILDING D PRESS ROOM RENOVATION

HAZARDOUS MATERIALS EVALUATION

**HAZARDOUS MATERIALS EVALUATION
(ASBESTOS, & LEAD-BASED PAINT)**

**19-G009-0100 Building D Press Room
Government Printing Office
723 N. Capital Street NW
Washington, DC 20401**

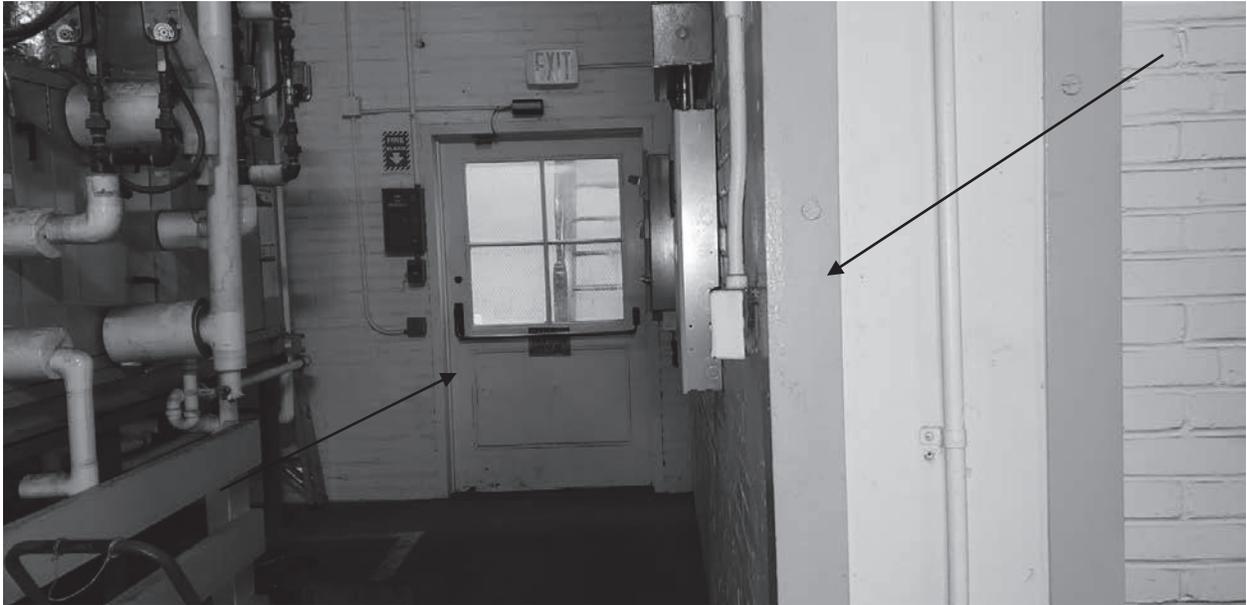
Photograph 1 – Corner on right is positive for LBP (Lead Based Paint). Door to stairs is positive.

In the event the renovation efforts include impact or removal of any lead painted building components, the workmen should be formally trained in a lead paint remediation class.

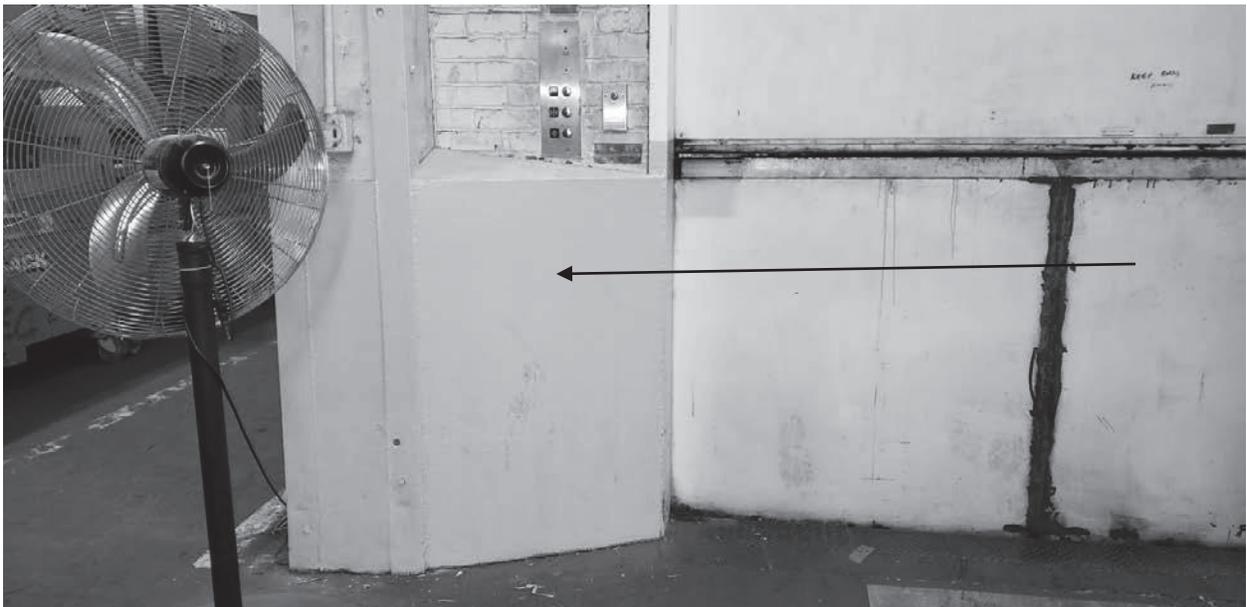
Photograph 2 - Bollard with LBP

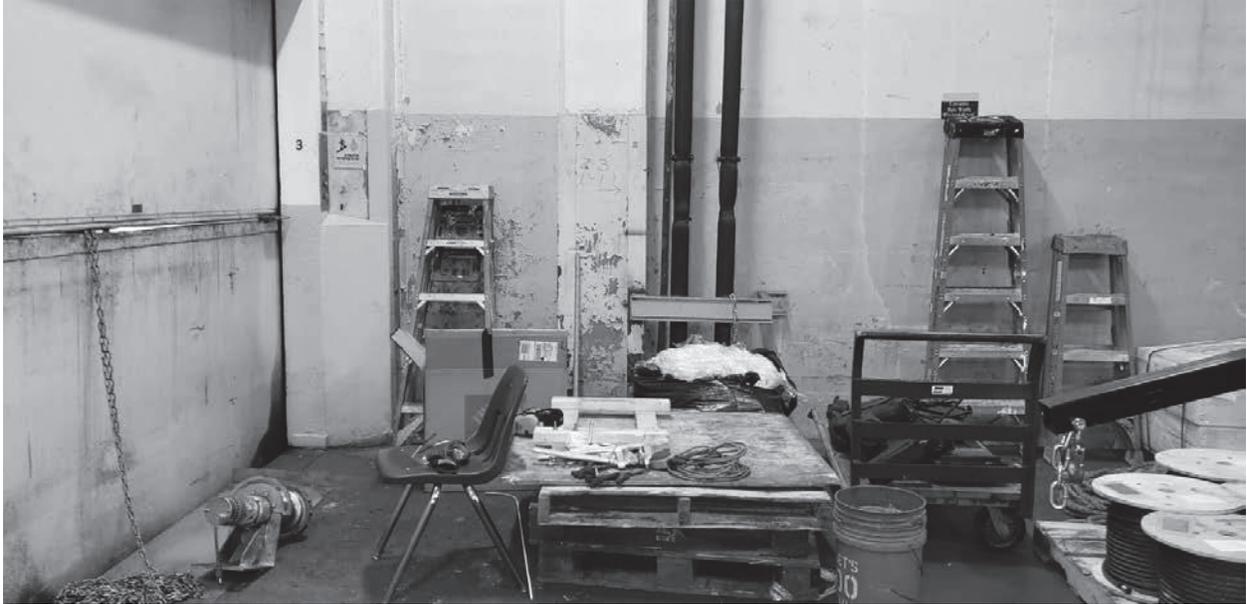
Photograph 3 – Elevator door frame is positive for LBP at 5.5.

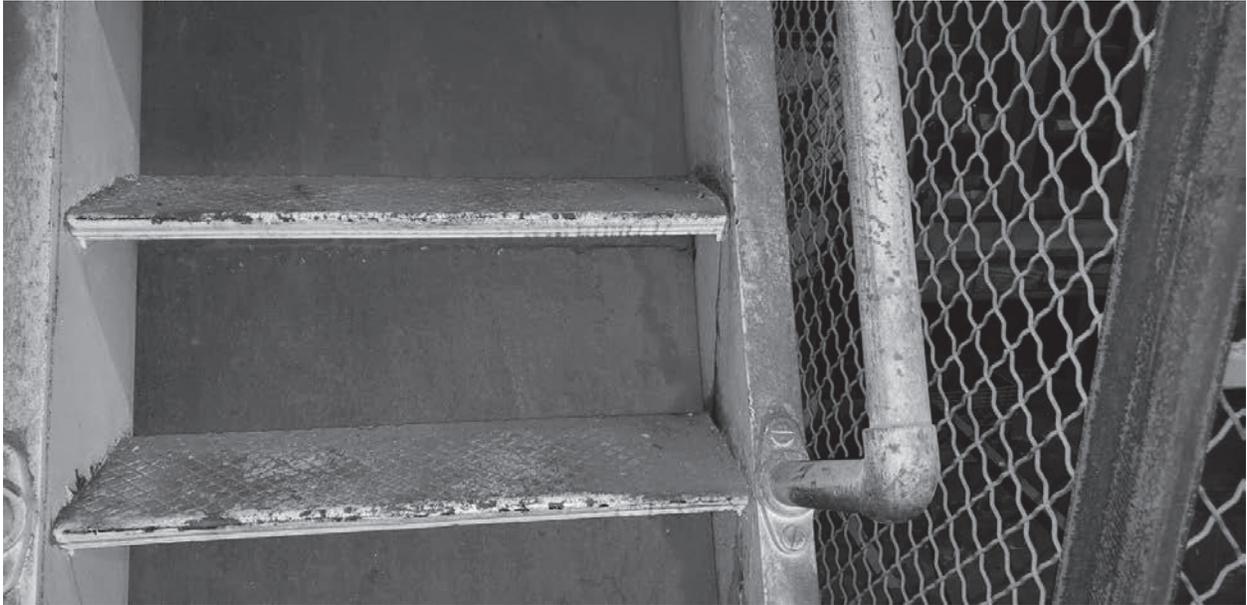
Photograph 4 - North wall staircase with factory applied lead primer on rails, treads, and stringer.

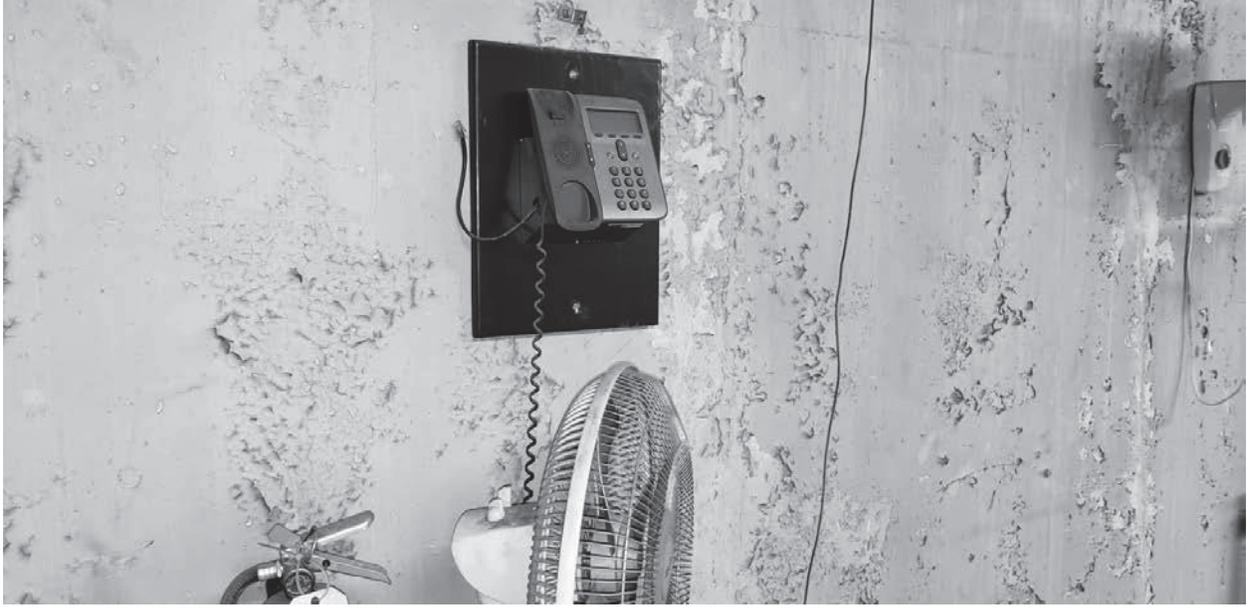
Photograph 5 –Peeling paint is negative for LBP.

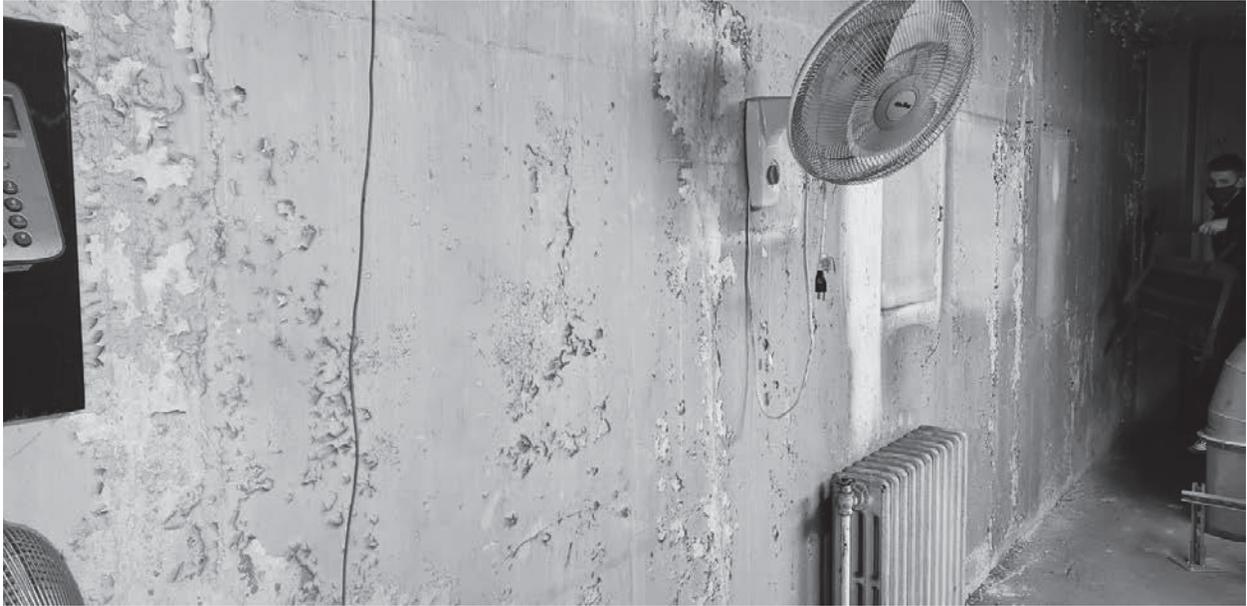
Photograph 6 - Peeling paint is negative for LBP.

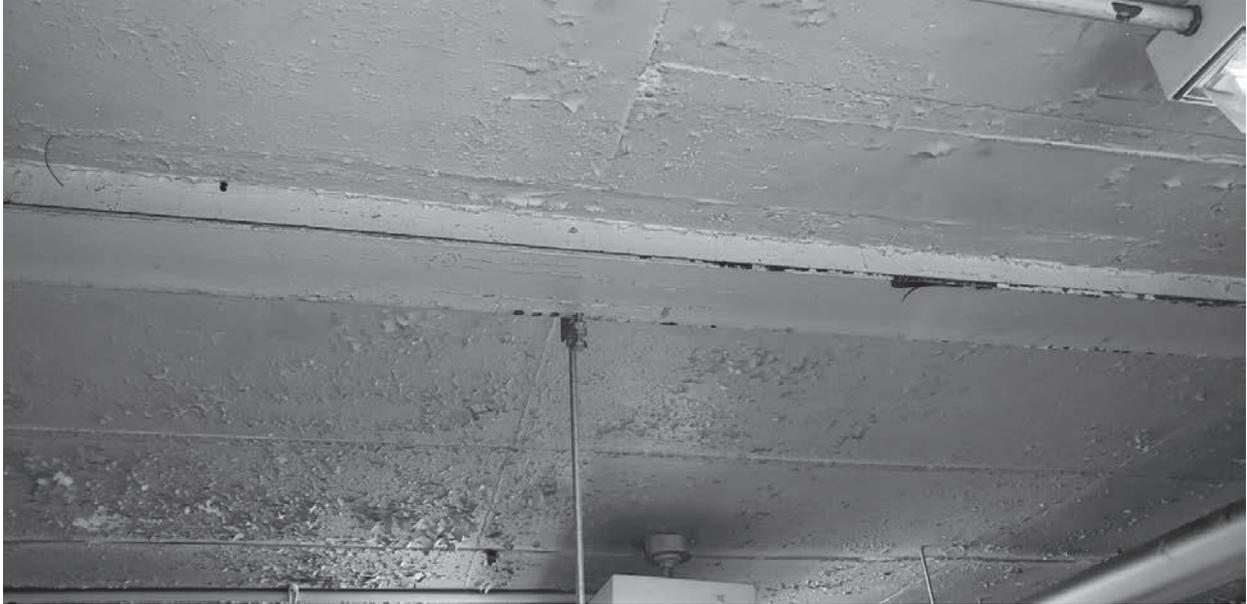
Photograph 7 – Ceiling of small elevated room off North wall is negative (concrete).

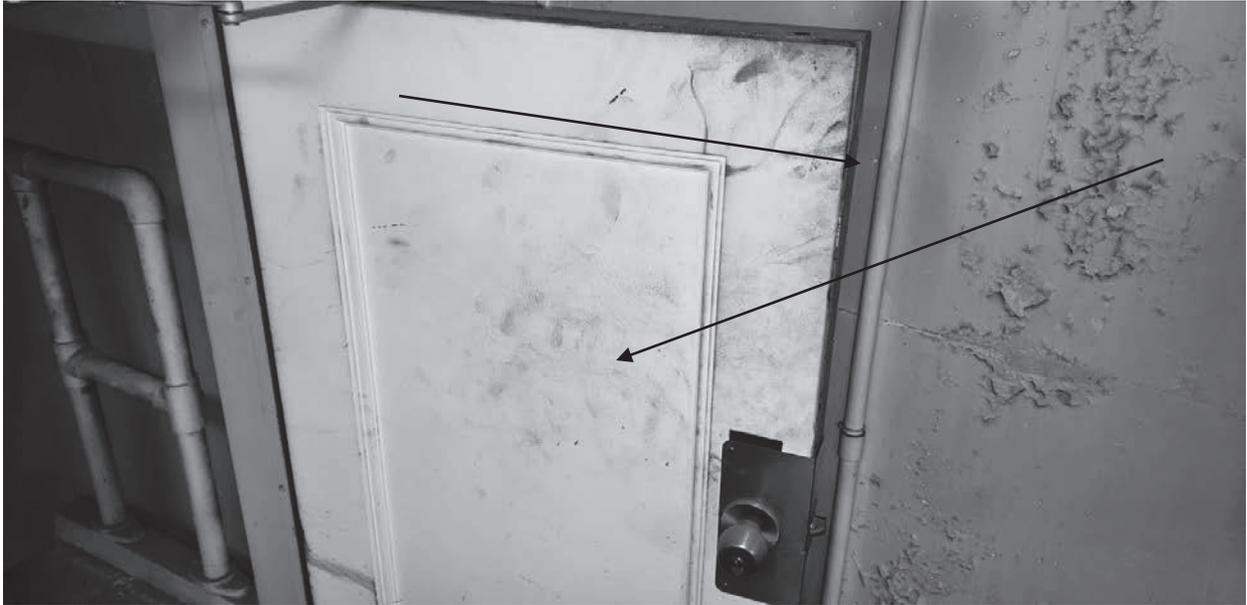
Photograph 8 - Double door & frame is positive for LBP. (2' X 3')

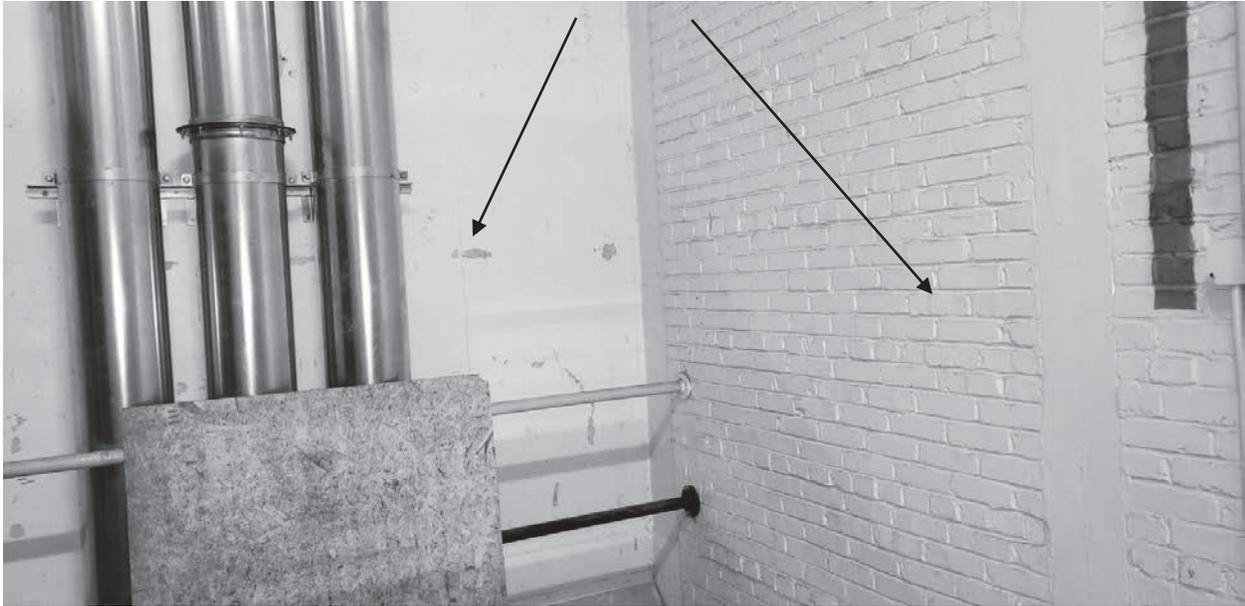
Photograph 9 – Small office on north side. Brick wall is negative but north wall is positive - lead-based painted concrete.

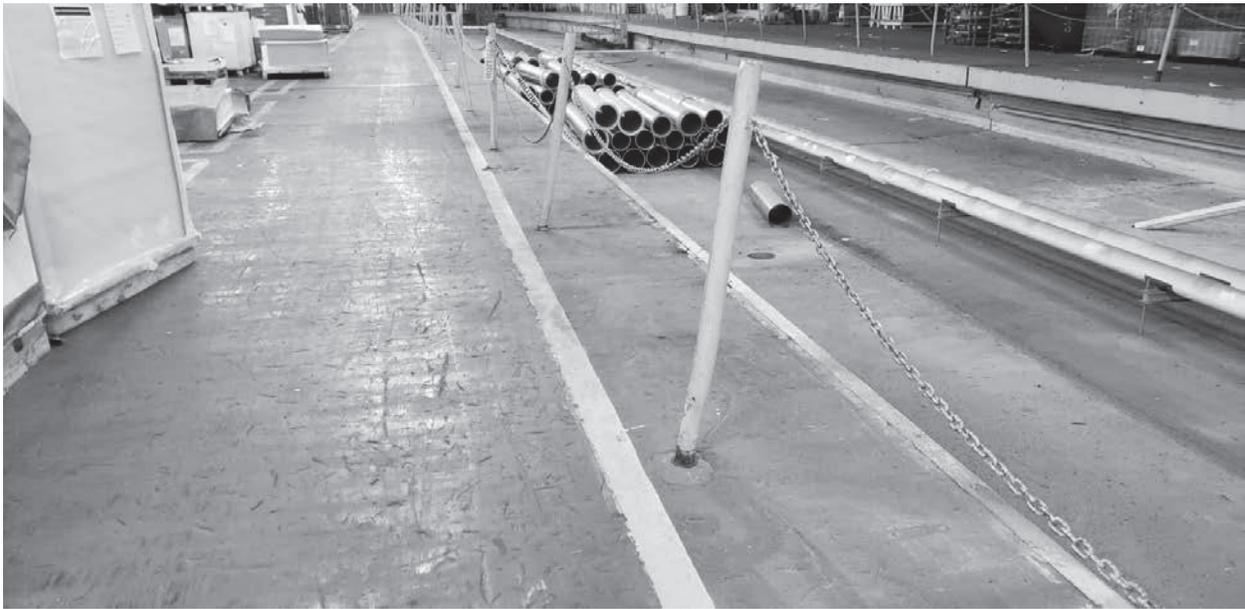
Photograph 10 - Painted rubber floor is positive but yellow post is negative.

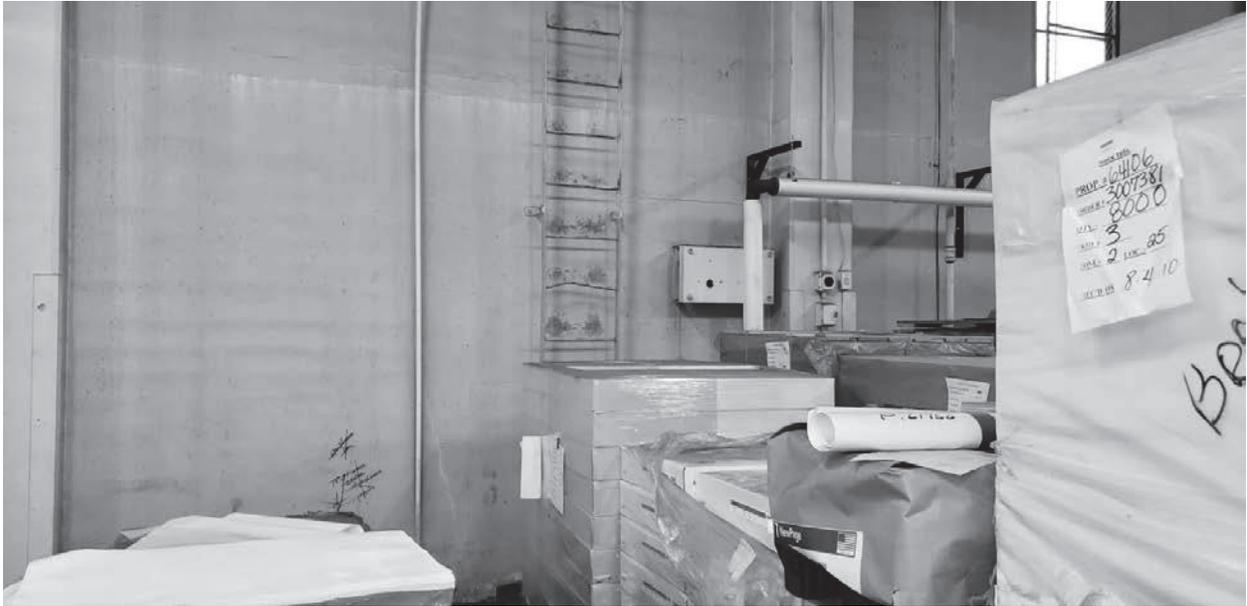
Photograph 11 – North wall ship ladder is factory applied and positive.

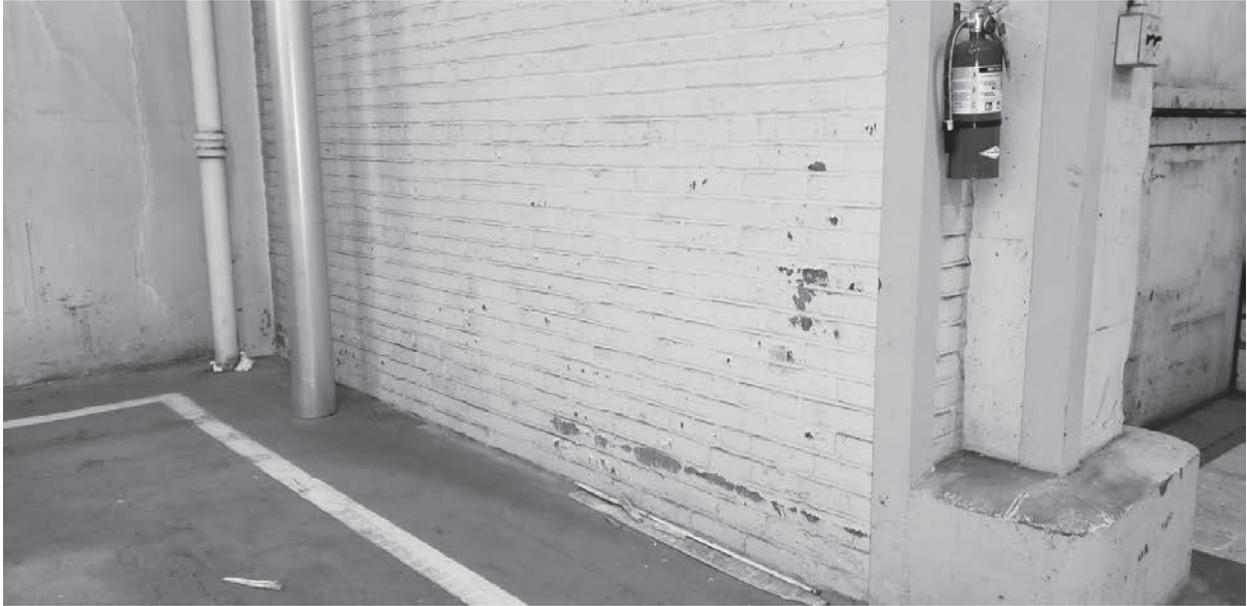
Photograph 12 - South Elevator wall is painted brick with latex. No LBP.

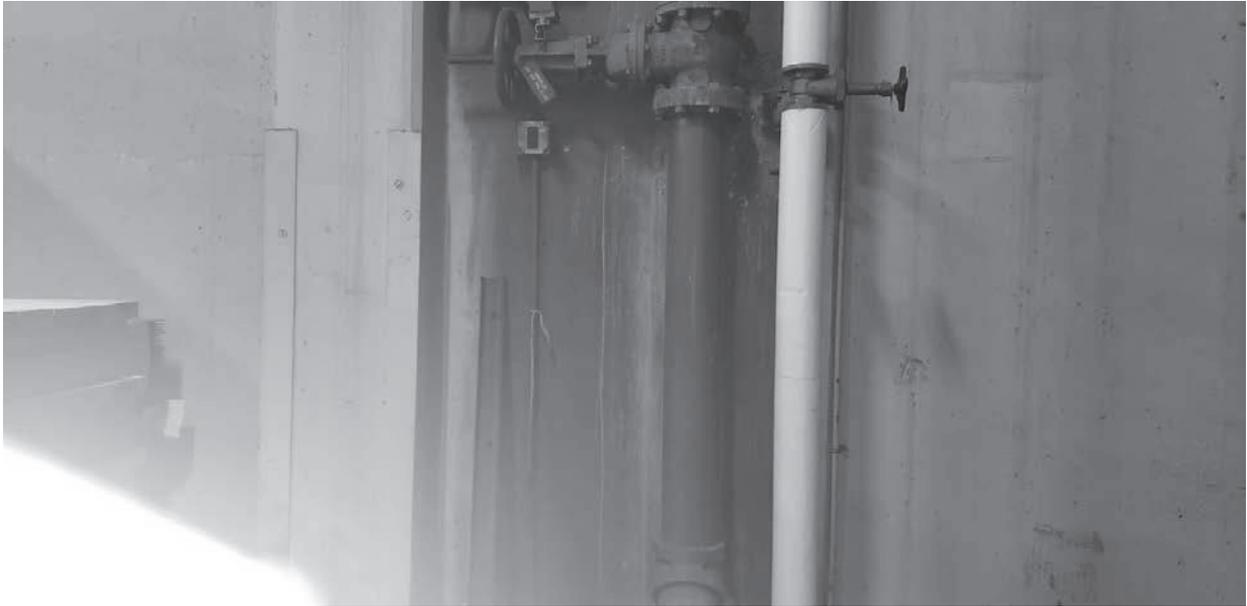
Photograph 13 – Sprinkler paint is negative.

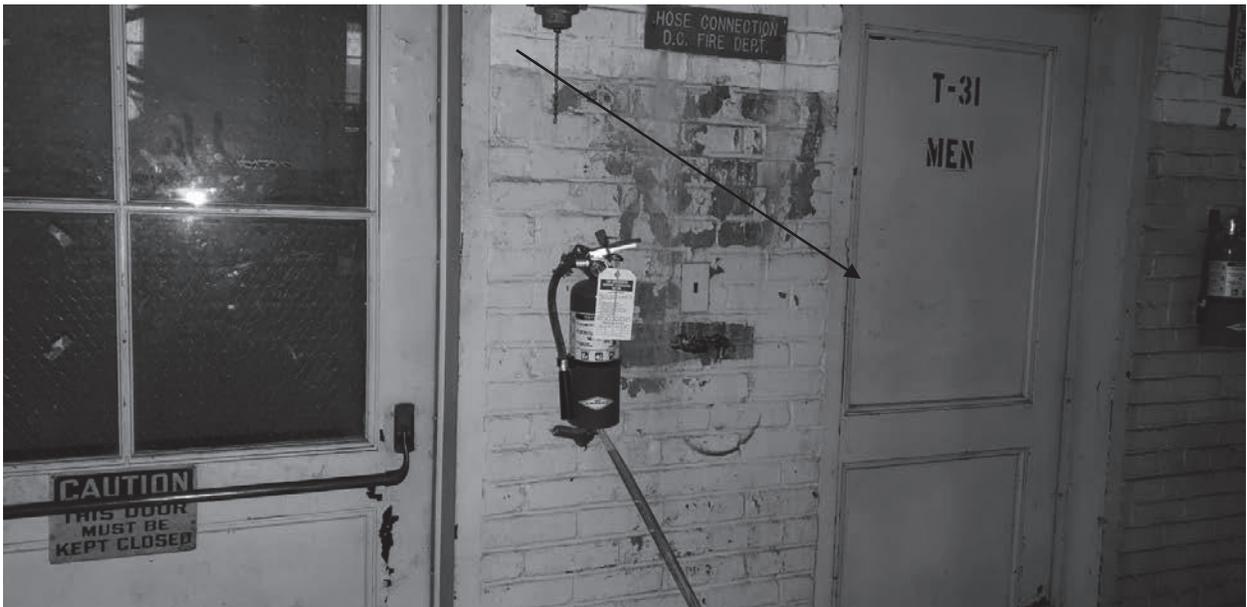
Photograph 14 – Men's room door is positive for LBP. Assume other door is positive as well.

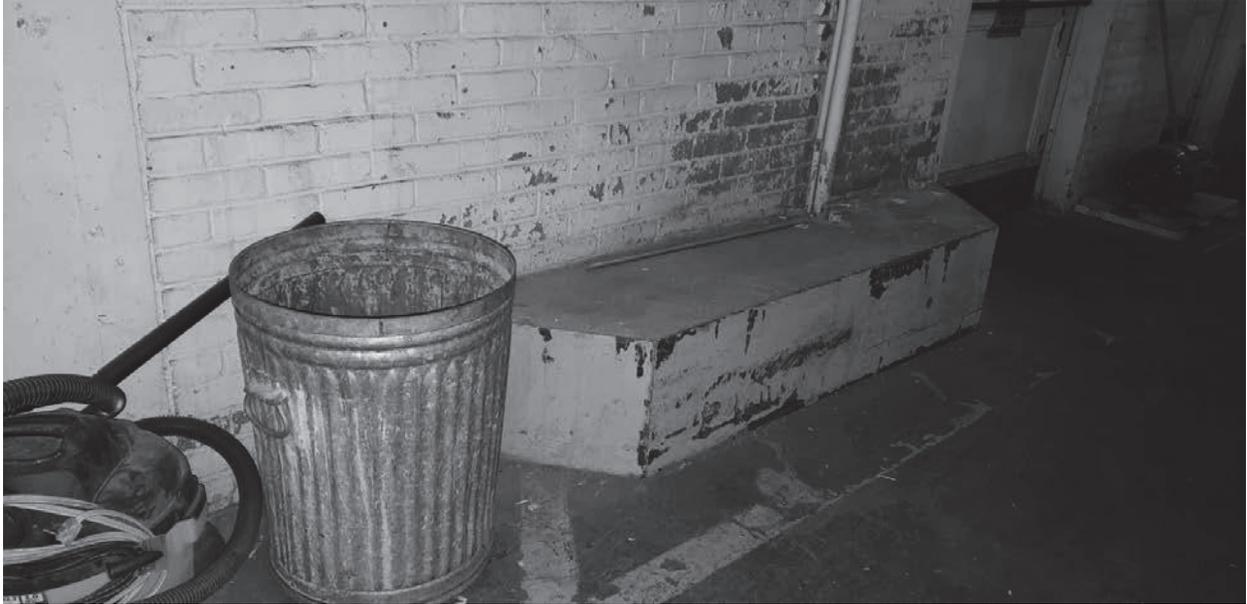
Photograph 15 - Yellow paint is positive on all equipment as well.

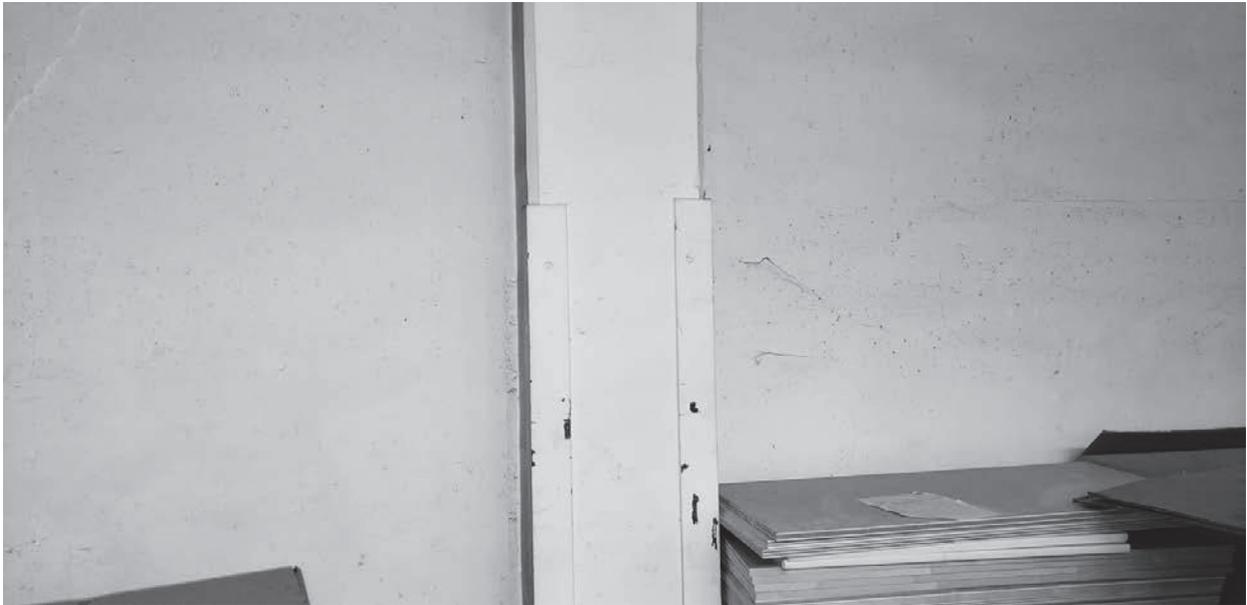
Photograph 16 - Column is negative for lead paint.

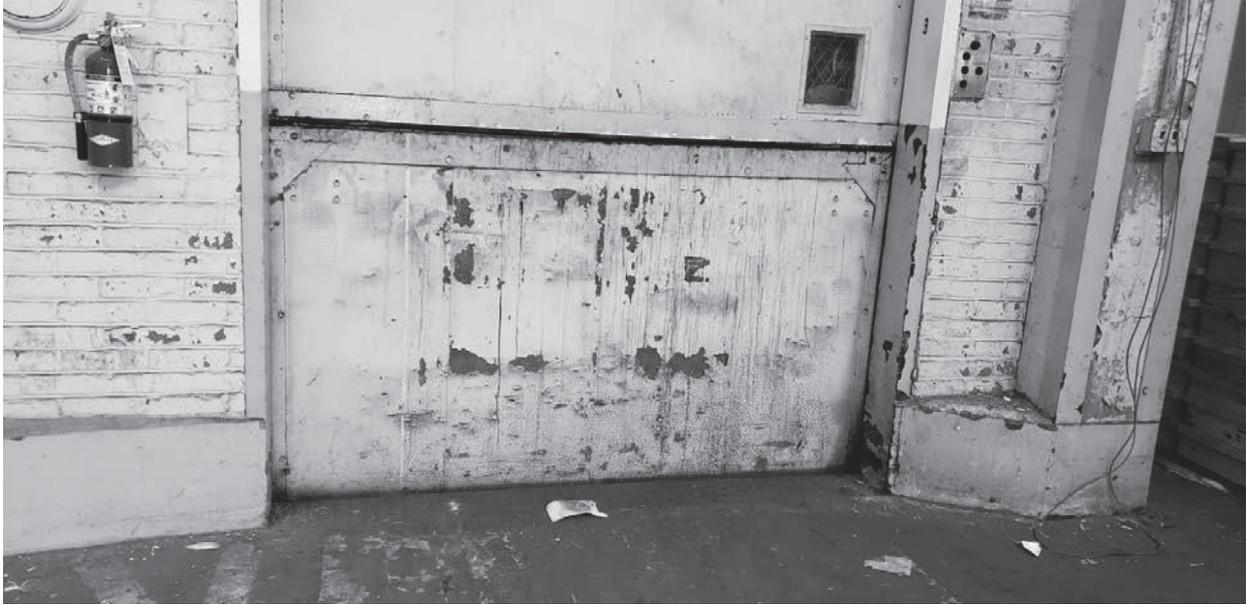
Photograph 17 – Consider all these components are positive for lead paint.

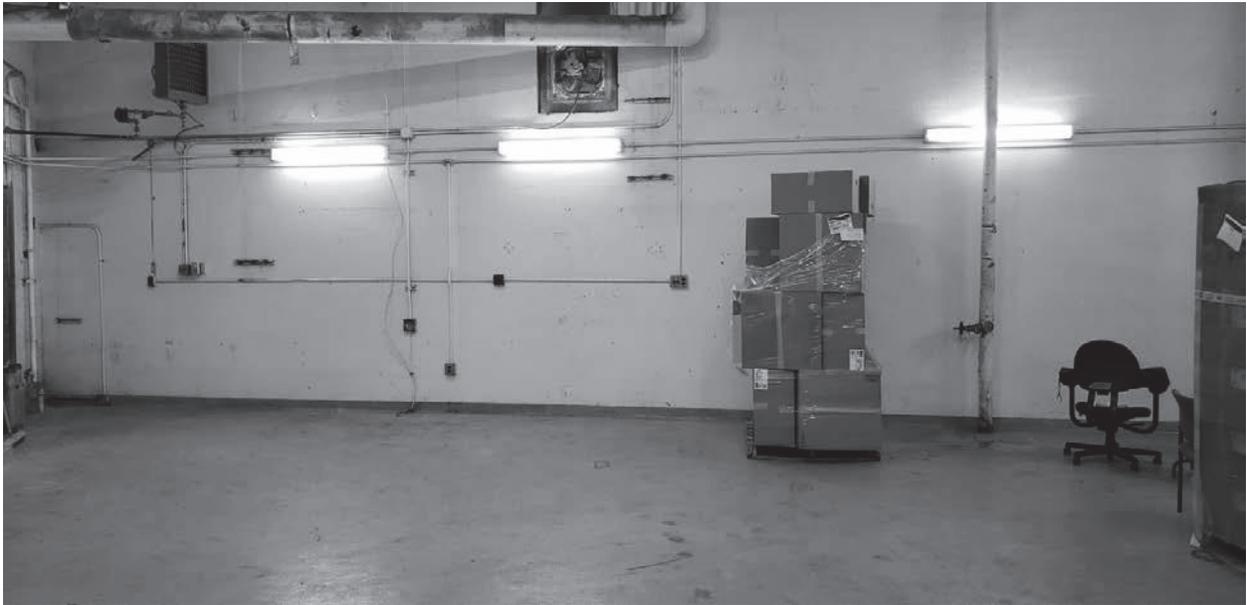
Photograph 18 – Air handler equipment room, East wall is positive for LBP.

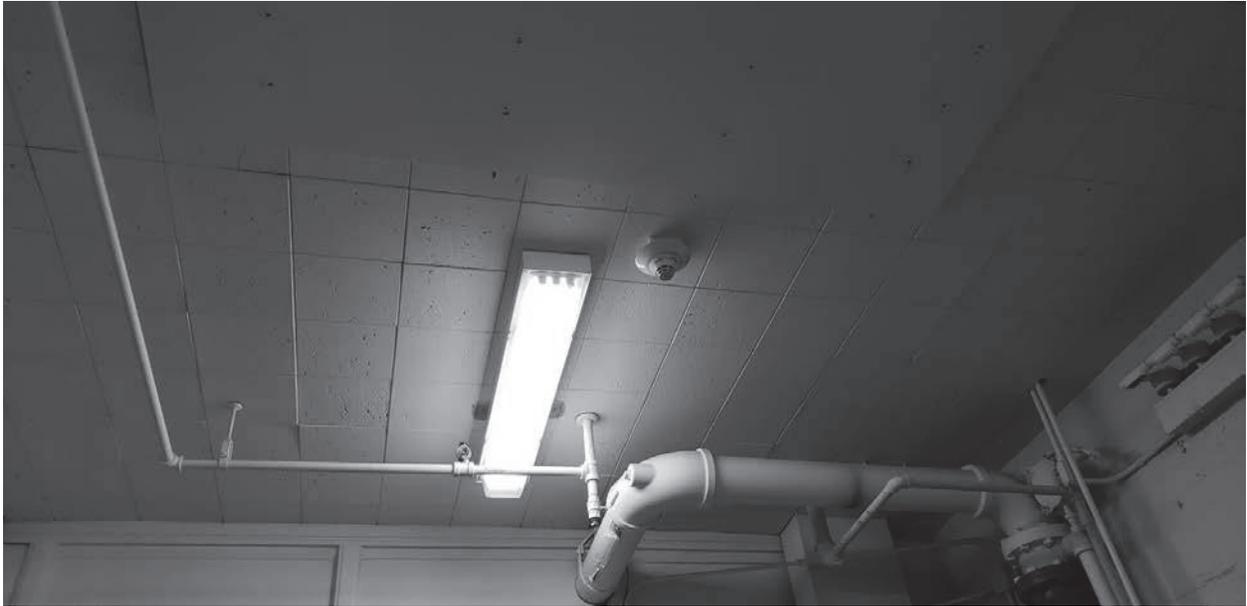
Photograph 19 – Small office off north wall with 12” ceiling tile (negative) for asbestos.

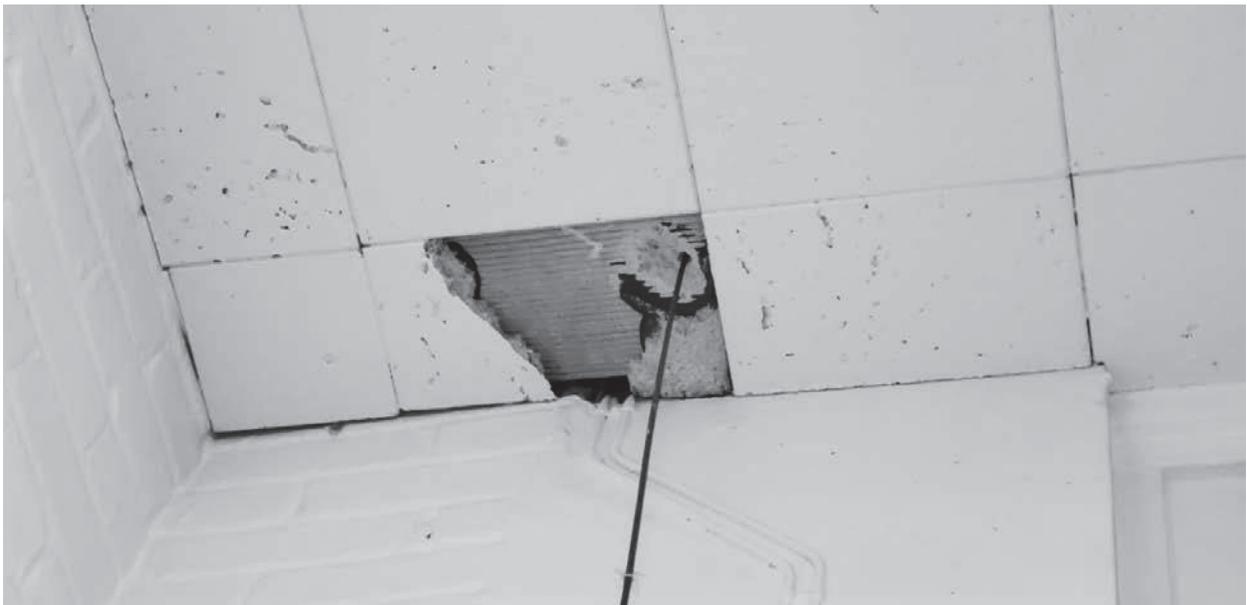
Photograph 20 - Same office with 12” ceiling spline tile – negative for asbestos

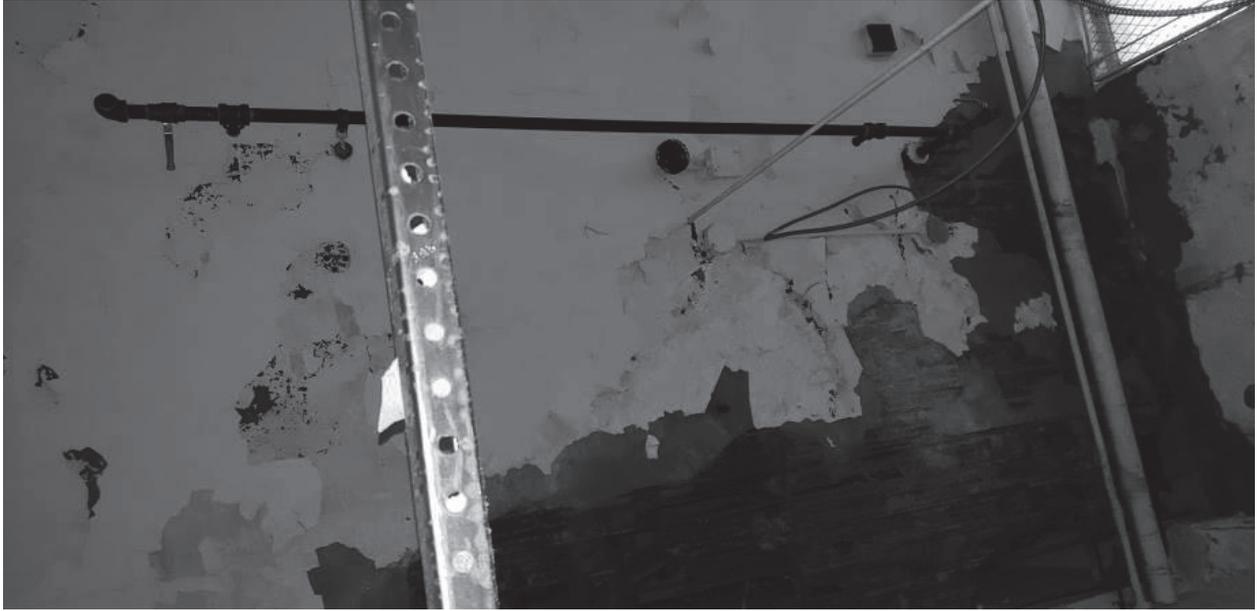
Photograph 21 – Assume higher ceiling in bathroom is positive for lead paint.

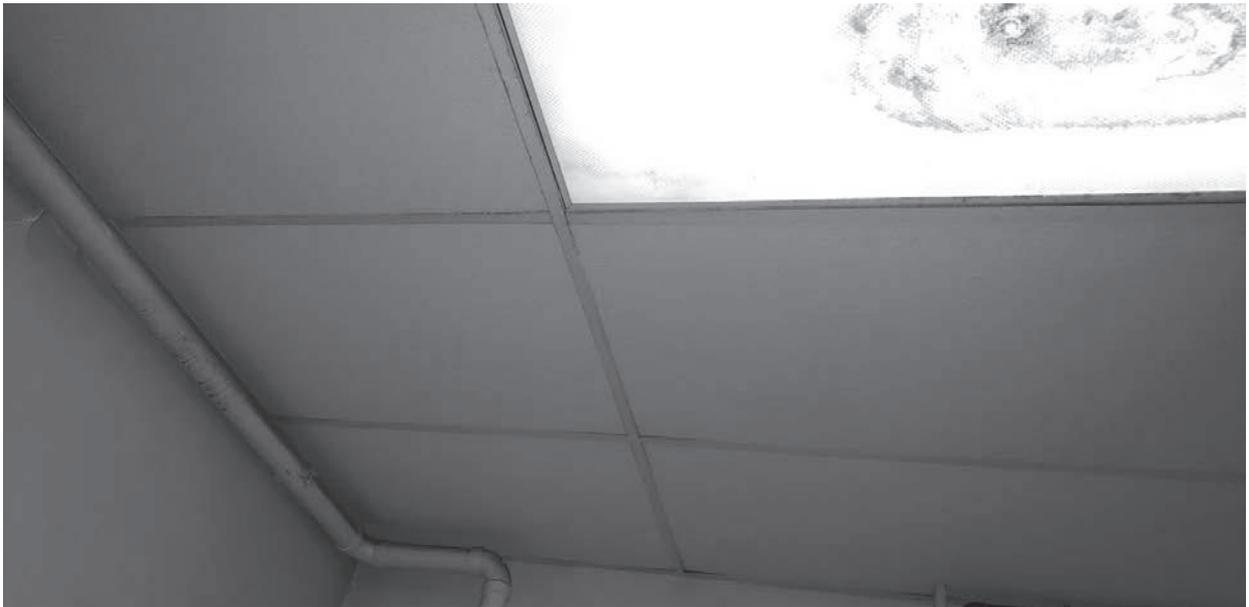
Photograph 22 - Ceiling tile in men's room of Photograph 23 – was negative for asbestos.

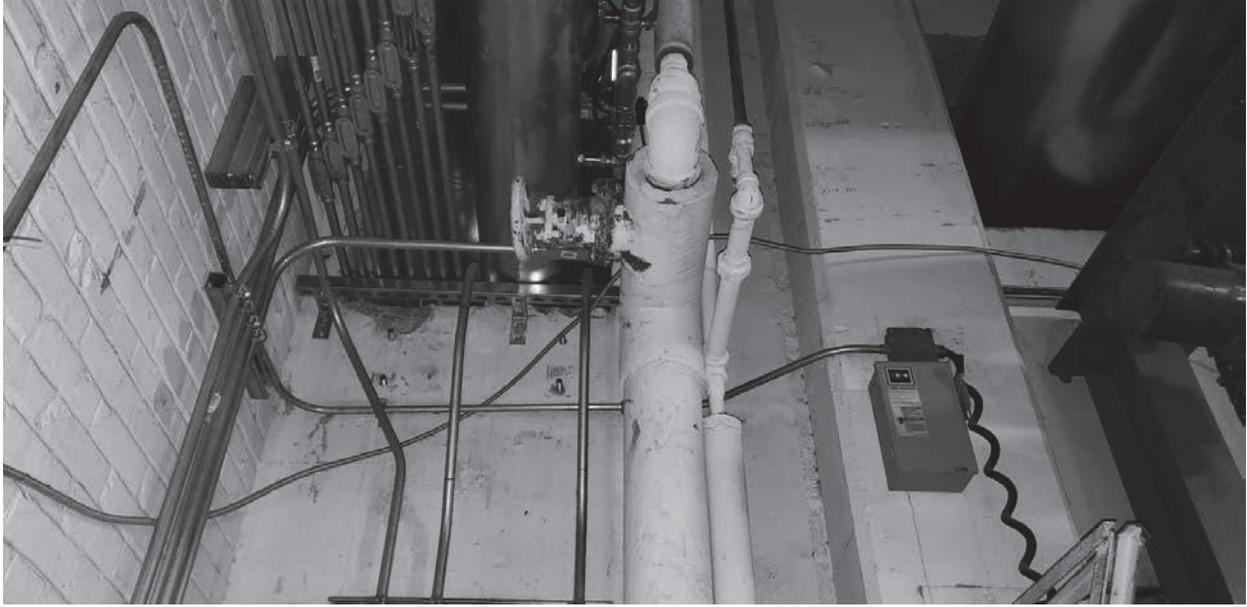
Photograph 24 - Pipe insulation flange is negative for asbestos.

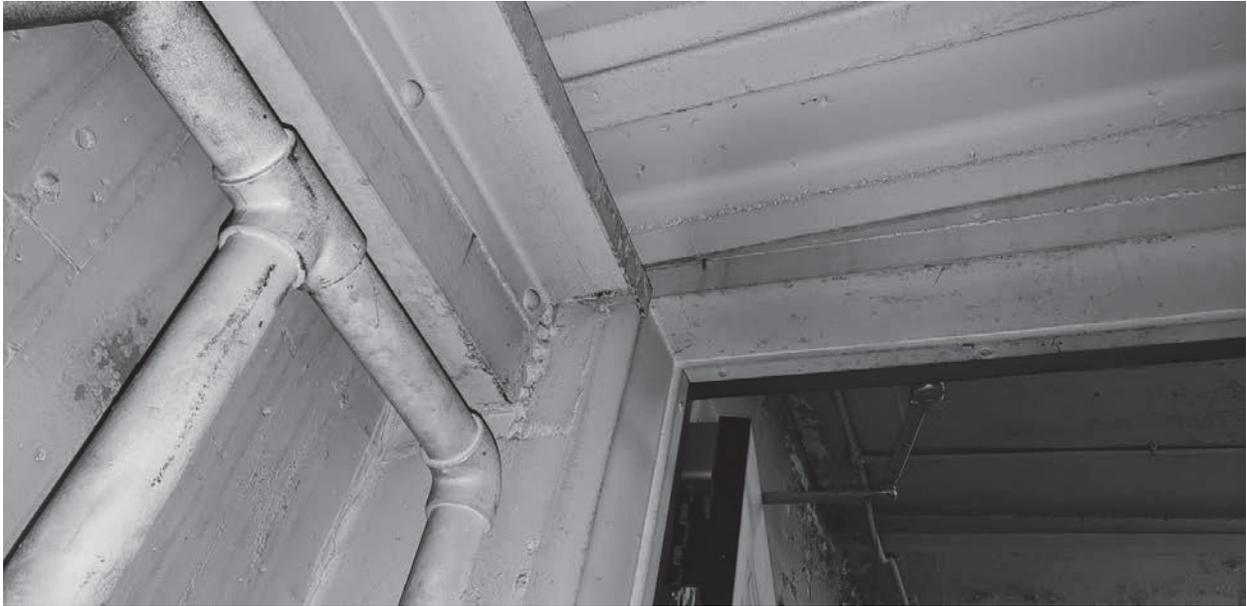
Photograph 26 – Assume all structural steel is positive for lead paint.
