**US Army Corps of Engineers
Omaha District
API 653 Out-of-Service
Inspection Report**

**Andrews Air Force Base, Morningside, Maryland
Facility 5025
Tank 25**

**US Army Corps of Engineers Center of Expertise for Petroleum, Oils and Lubricants
USACE POL-MCX**

16 January 2018

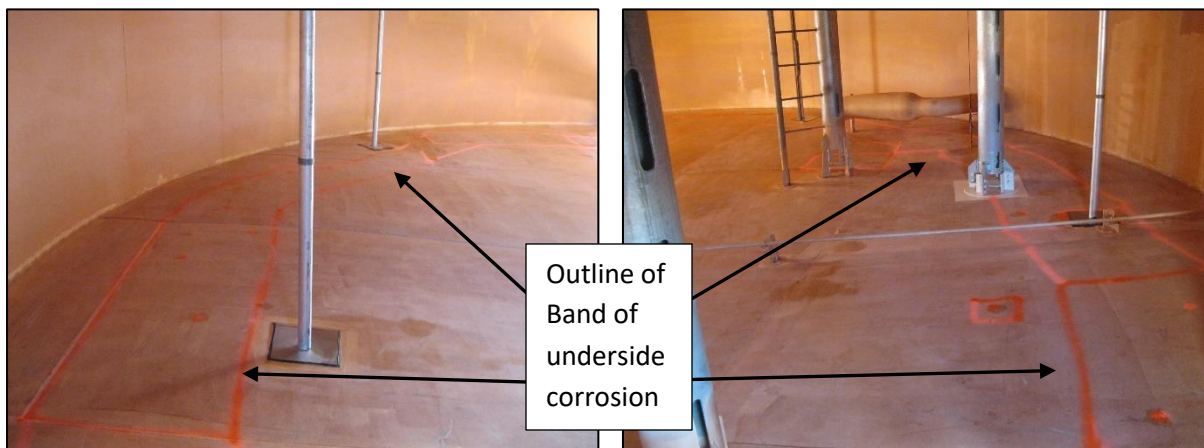
a. Replace the Tank Bottom

OBSERVATION: MFL examination of the tank bottom identified a band of corrosion approximately 3 feet in from the shell and extending all around the tank bottom with thinning to less than 0.050 inches of remaining thickness, and many areas within the band with remaining thickness less than 0.100 inches. It should be noted that the technology is not capable of scanning areas within 2 inches of the lap welds or obstructions. There are four 16-inch monitoring wells located in the dike basin. The monitoring wells are sealed with 16-inch threaded PVC plugs and are difficult to access. Vacuuming the water out of one of the wells and opening the 2-inch leak detection valve in that well allowed a significant amount of water to drain out from under the tank bottom. While the cathodic protection system appears to be putting out somewhat less electrical current than indicated in the June 2017 inspection report, it is unlikely the corrosion occurred in the few months since then. The pattern of corrosion suggests it is above the level of the water (at the air-water interface) and above the settled sand pad, and therefore above the area where the cathodic protection system could have been effective.

REFERENCE: API 653 paragraph 4.4.5.3 and Table 4.4 require the tank bottom to be repaired or replaced when the remaining thickness of a tank bottom with leak detection and secondary containment is less than 0.050 inches.

RECOMMENDATION: Replace the tank bottom by the shell slotting method, and under the new tank bottom, provide a liner, sand pad, cathodic protection, and leak detection. Arrange to have an API 653 Inspector review the repairs and make recommendations for scheduling the next internal inspection.

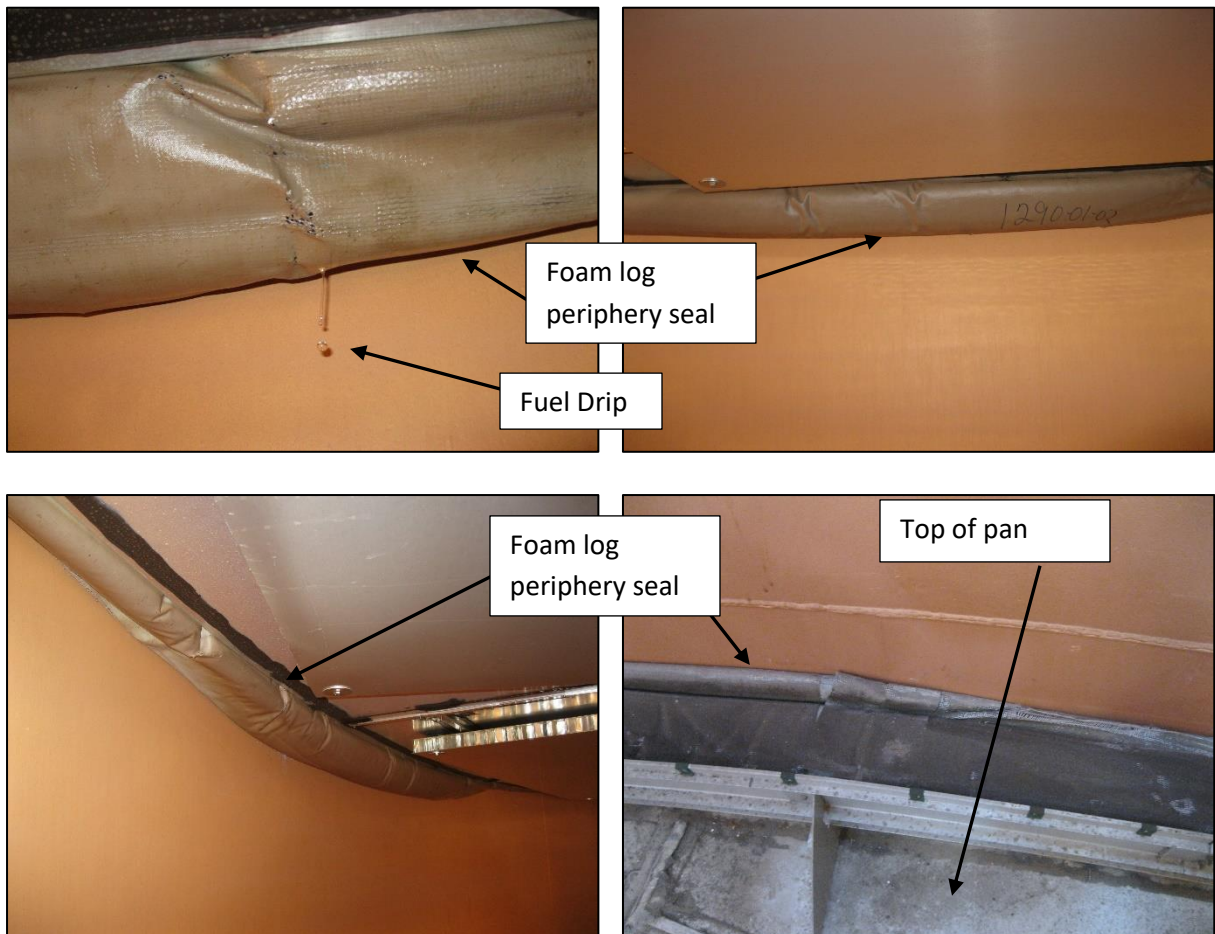
b. Replace the Floating Pan Perimeter and Penetration Seals

OBSERVATION: The internal floating pan perimeter foam log seal was found to have failed and was dripping fuel all around the perimeter. A ten-foot long section of the foam log perimeter seal is collapsed and is starting to fall apart. The penetration seals are also deteriorated.

RECOMMENDATION: Replace the internal floating pan periphery foam log seals with closed cell cast urethane flexible wiper squeegee primary and secondary seals. Replace the floating pan penetration seals with material similar to the periphery seals.

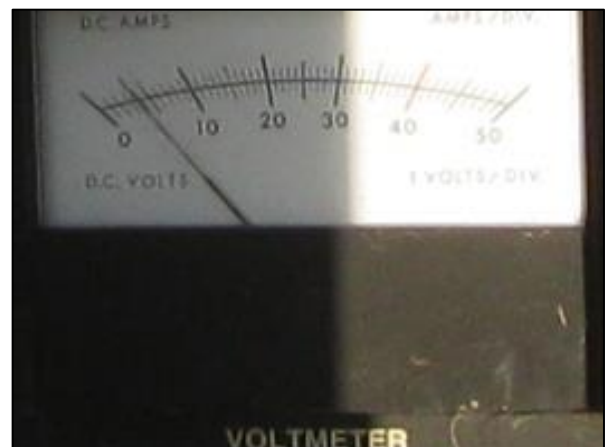
**b. Replace the Cathodic Protection System**

OBSERVATION: The tank was built in 1998 with the impressed current cathodic protection system under the tank bottom. The cathodic protection (CP) system rectifier multiuse meters indicate 4 volts, and only 0.2 amps. Review of cathodic protection inspection reports indicate the readings for this tank and the sister tank have been historically much higher. The system may be near the end of its useful life.

RECOMMENDATION: When the tank bottom is replaced, replace the cathodic protection system.

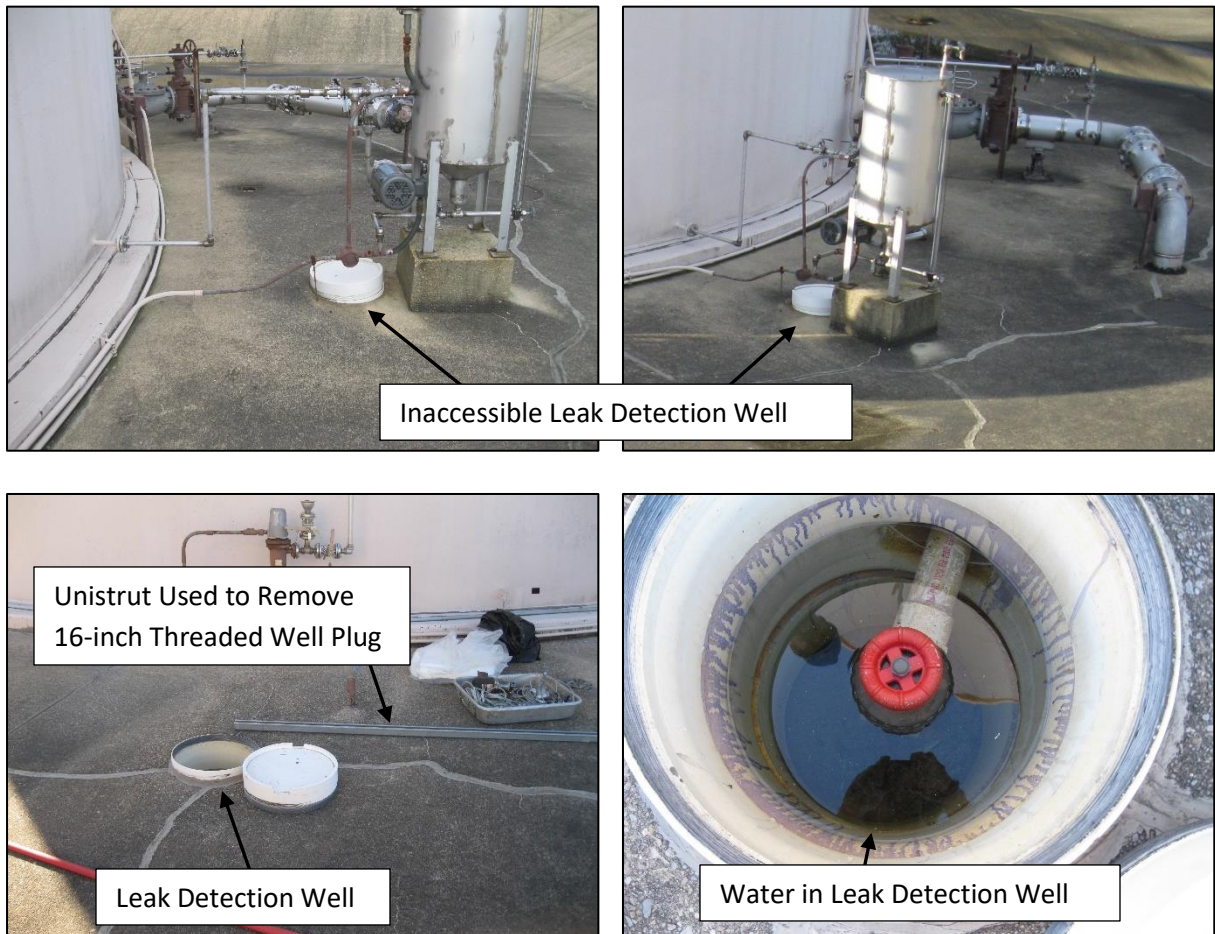
c. Provide Leak Detection

OBSERVATION: The design drawings included in Appendix D indicate that each of the four 2-inch tank bottom leak detection tell-tale pipes extend under the tank bottom only halfway to the bottom sump and terminate on the outside with a valve located in one of the four 16-inch monitoring wells located in the dike basin. The drawings do not indicate means to drain the center portion of the underside of the tank bottom. The monitoring wells are sealed with 16-inch threaded plugs, which are difficult to open. The wells are non-standard design and were not recognized as monitoring wells by POL personnel prior to the inspection. However, one of the leak detection wells was opened using a 6-foot long piece of 1 1/2-inch unistrut to apply torque. Some of the wells are located where there are obstructions that would complicate opening. The non-standard leak detection pipes and wells resulted in the buildup of water under the tank bottom, which may have contributed to the underside corrosion and necessity of replacing the tank bottom.

REFERENCE: Guidance for replacing tank bottoms provided in API 653 paragraph 9-10.2.6 and UFC 3-460-01 paragraph 12-3.3 includes providing a new bottom above the existing bottom, and providing leak detection piping that penetrates the shell below the new bottom for easy access. Guidance for new construction provided in DoD Standard Design AW 78-24-27 includes leak detection/drain piping extending to under the tank bottom sump.

RECOMMENDATION: When the tank bottom is replaced by the shell slotting method, provide leak detection piping per the latest military criteria.

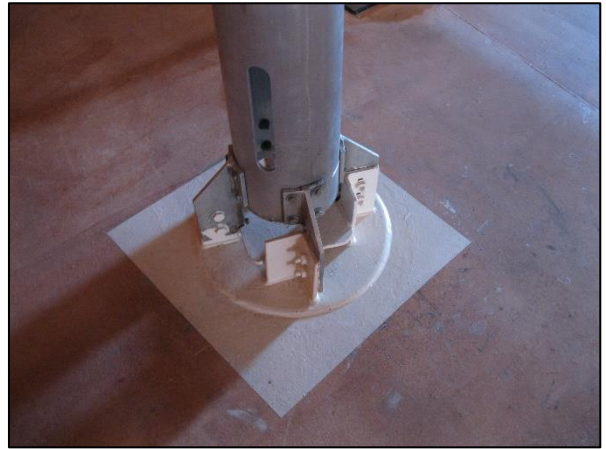
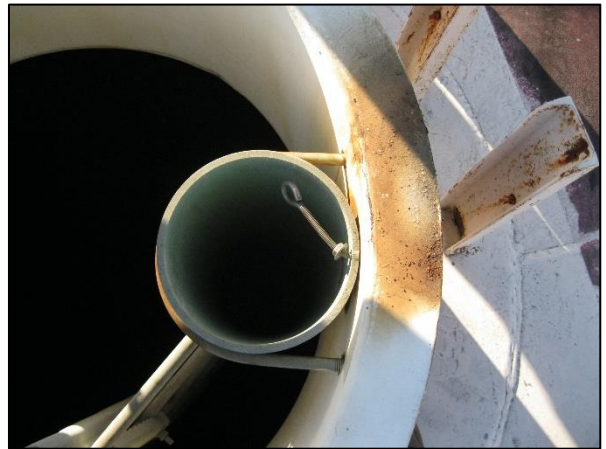
d. Modify Stilling Well Guides

OBSERVATION: The ATG well, manual gauging well and internal ladder are attached to the tank roof as well as bolted to their bottom end guides, which are welded to the tank bottom. The bolts attaching the ATG well to the bottom end guides protrude through to the inside of the well and could cause the ATG to hang up.

RECOMMENDATION: When the tank bottom is replaced provide new well guides in accordance with current military criteria. Ensure the U-bolts at the top of the ladder side rails are double nutted to the ladder access opening and do not restrict the vertical movement of the ladder.

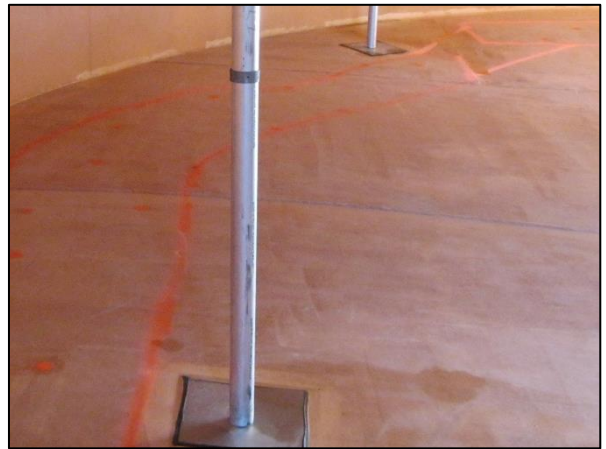
e. Remove Stainless Steel IFR Striker Plates

OBSERVATION: The internal floating pan support leg striker plates are stainless steel and glued to the tank bottom. Galvanic corrosion of the interior of the tank may occur, if water is present and the stainless steel striker plates make contact with the tank bottom, or the pan support legs make contact with the stainless steel striker plates.

RECOMMENDATION: When the tank bottom is replaced, provide PTFE feet on the bottoms of the IFR support legs. Ensure that stainless steel IFR support leg striker plates are not installed.

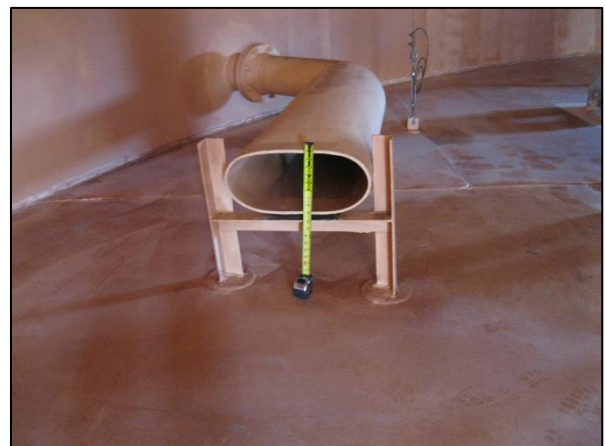
**f. Modify the Diffuser**

OBSERVATION: The receipt diffuser discharges horizontally approximately one foot above the tank bottom.

RECOMMENDATION: Modify the diffuser to limit free falling of the fuel and creation of static by angling the diffuser down to within 4 inches of the tank bottom.

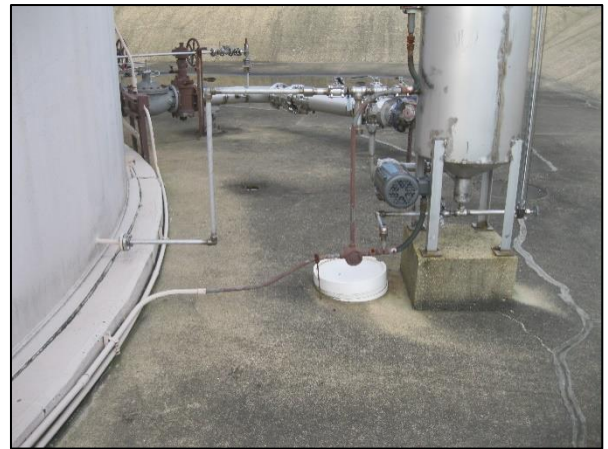
g. Provide Valve on Water Draw-off Nozzle

OBSERVATION: There is no isolation valve or electrical isolation flange kit on the water draw-off nozzle. The product saver tank piping is stainless steel. The product saver tank is not grounded.

RECOMMENDATION: Provide an electrical isolation flange kit and an isolation valve on the water draw-off nozzle. Provide a grounding system for the product saver tank. Do not bond the product saver tank to the grounding of the tank in order to maintain some degree of electrical isolation.

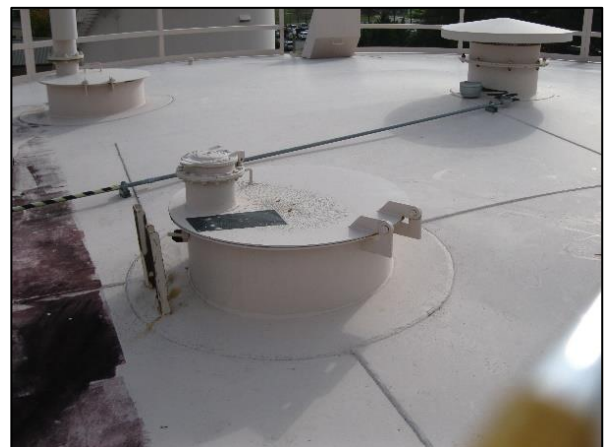
**h. Provide OSHA Compliant Internal Ladder Access Hatch**

OBSERVATION: The 36-inch internal ladder access manhole provides approximately only 28 inches of clearance on the climbing side of the ladder. The cover is not bolted and does not have a rain lip.

RECOMMENDATION: Provide an OSHA compliant internal ladder access hatch with a rain lip.

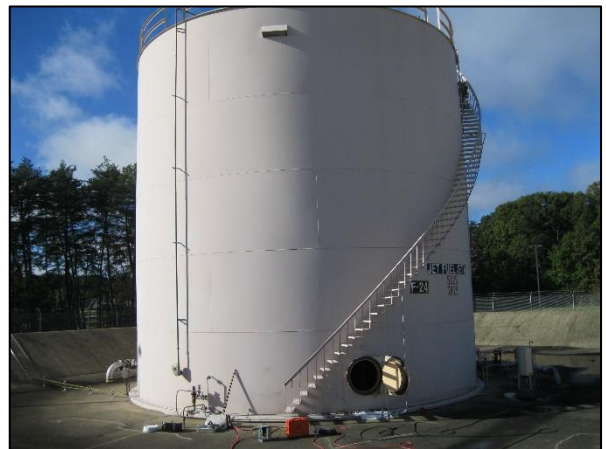
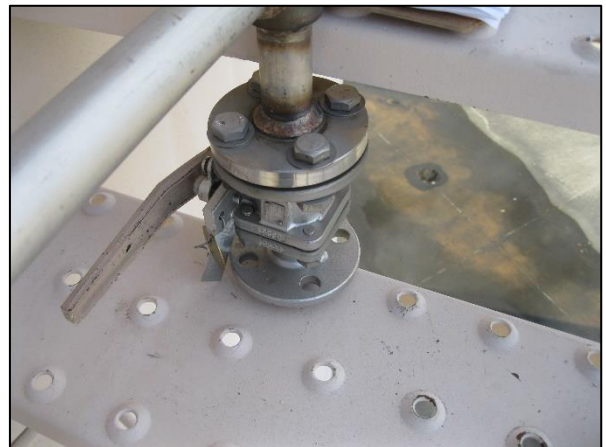
i. Modify Stairway

OBSERVATION: Clearance between the stairway handrail and the high level alarm piping is only 12 inches. The high-high level alarm is untestable due to interference with the stairway. The rise of the stairway steps is generally 9 1/2 inches; however, the bottom step is approximately 15 1/2 inches above the dike basin. There is no upper shell manhole or intermediate landing for accessing an upper shell manhole.

RECOMMENDATION: Provide an upper shell manhole. Modify the circumferential stairway to provide lower and intermediate landings to access level alarms, controls, and the new upper shell manhole while providing 28 inches of horizontal clearance and a continuous rise from ground level or a bottom landing.

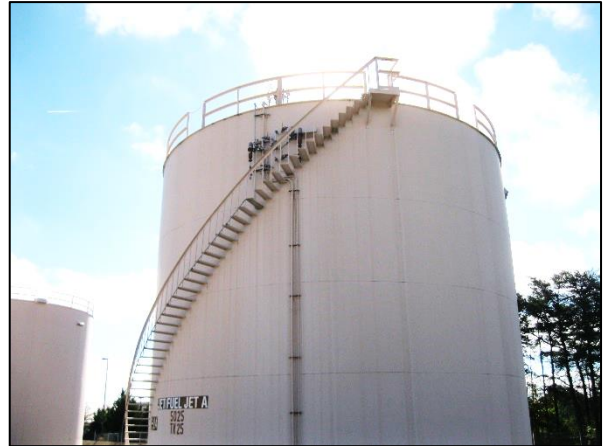
j. Provide Level Alarm Test Tubing

OBSERVATION: There is no alarm test tubing for testing the high level alarms and controls using the product saver tank return pump. Manual testing requires personnel raise a bucket of fuel high above the stairway and pour fuel into a funnel on top of the alarm piping, which often results in spilled fuel covering the tank, the dike basin, and personnel.

RECOMMENDATION: Provide alarm and control test tubing from the product saver tank return pump for testing the high level alarms and controls.

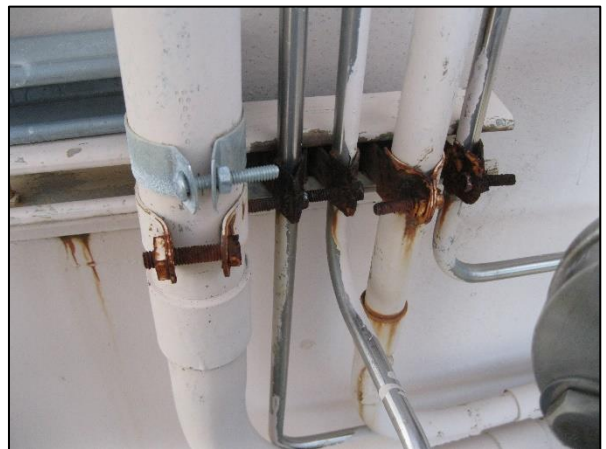
**k. Replace Nuts and Bolts**

OBSERVATION: The bolting on the Enraf chamber flanges, pan installation hatch, and roof center vent as well as the clamps on the high level alarm conduit are corroded.

RECOMMENDATION: Provide new with corrosion resistant bolting on the Enraf chamber flanges, pan installation hatch, and roof center vent. Replace the high level alarm conduit clamps.

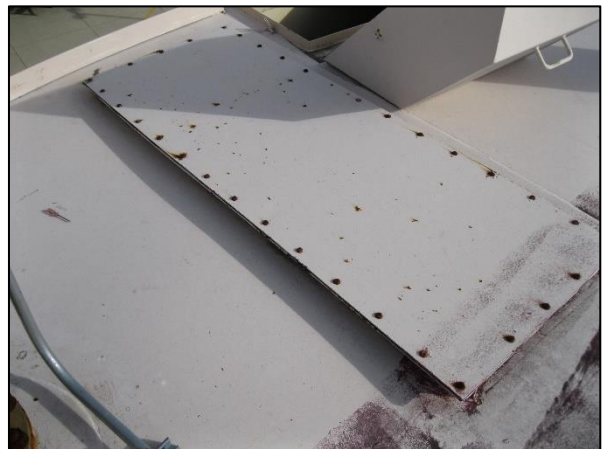
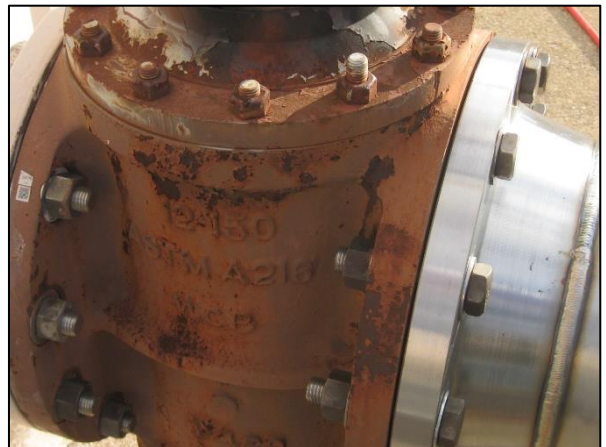
I. Repair Coatings

OBSERVATION: There is scattered coating failure on the exterior of the roof, and coating failure and corrosion on the floating plug retriever nozzle flange, pan installation hatch cover, roof guardrail, autogauge guide pipe, interior of the roof manhole cover and flange, and the interior of the roof perimeter vent/inspection hatch hoods. There is also coating failure and corrosion on the receipt and issue DBB valves, and on the level alarm sensor chambers.

RECOMMENDATION: Replace the coatings on the exterior of the roof including on the floating plug retriever nozzle flange, pan installation hatch cover, the roof guardrail, autogauge guide pipe, interior of the roof manhole cover and flange, and interior of the roof perimeter vent/inspection hatch hoods. Replace the coatings on the receipt and issue DBB valves, and on the level alarm sensor chambers.

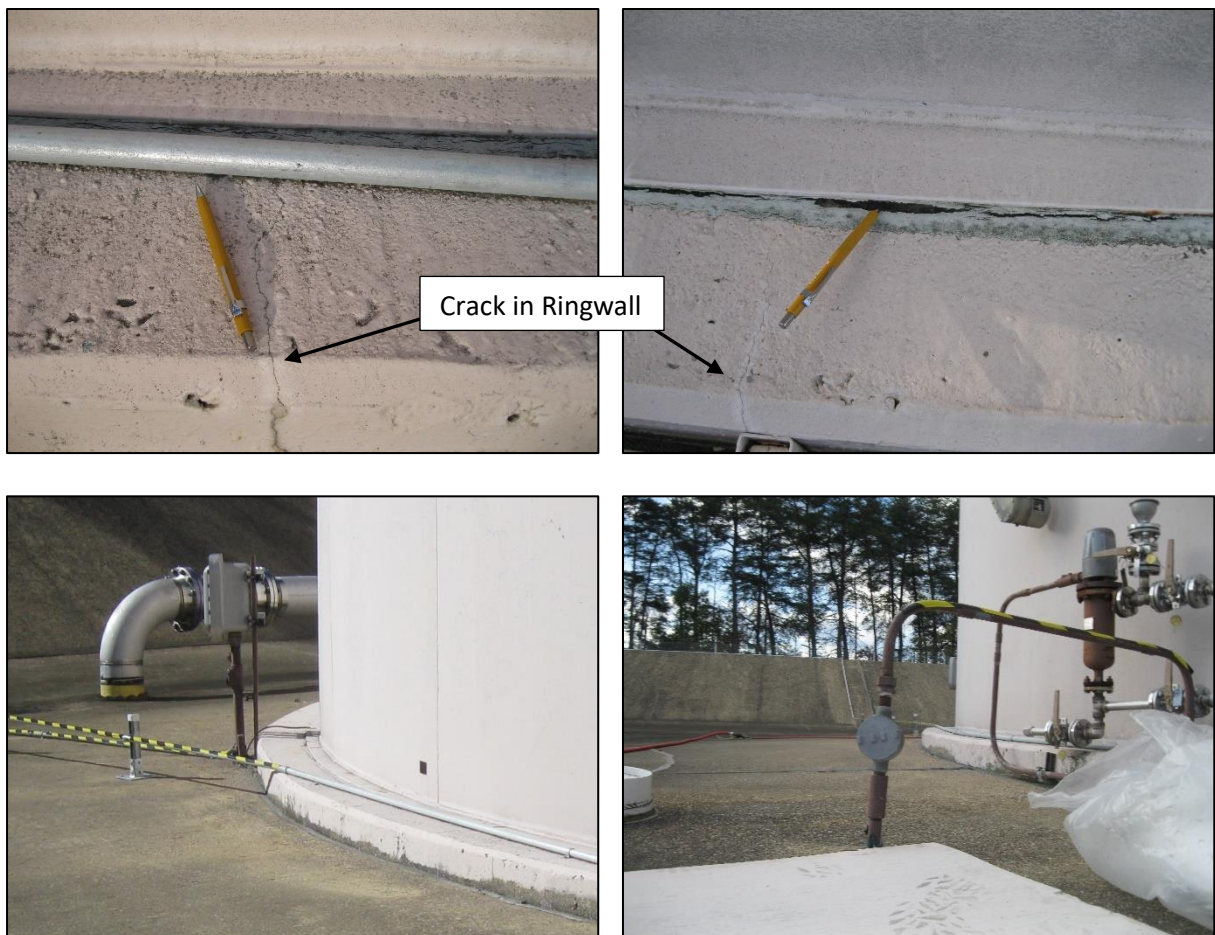
m. Rehabilitate the Foundation

OBSERVATION: The tank bottom to foundation seal has generally failed. There are approximately 25 radial cracks in the concrete ringwall foundation. The ringwall foundation is sloped toward the tank bottom which forces rain water under the tank bottom.

REFERENCE: NFPA 30 paragraph 22.11.2.4 and CFR 112.7(c)(1) require secondary containment to be liquid tight. Guidance for new construction provided in DoD Standard Design AW 78-24-27 and UFGS Specification 33 56.13.13 include installation of the tank bottom to foundation seal to be performed by a coating contractor and sloping the exposed foundation away from the tank bottom. API 650 Figures B.1 and B.2 require the top of the ring wall to be level or sloped away from the tank bottom. Guidance for new construction provided in DoD Design Standard AW 78-24-27 also includes sloping the top of the ring wall away from the tank bottom. The example inspection checklist included in API 653 Appendix C includes item – C.1.1.1.d), which cites examining the ringwall foundation to note if runoff rainwater from the shell drains away from the tank.

RECOMMENDATION: Slope the exposed top of the concrete ringwall foundation away from the tank bottom. Seal the cracks in the concrete foundation. Coat the underside perimeter of the tank bottom and replace the tank bottom to foundation perimeter seal. Seal coat the foundation.

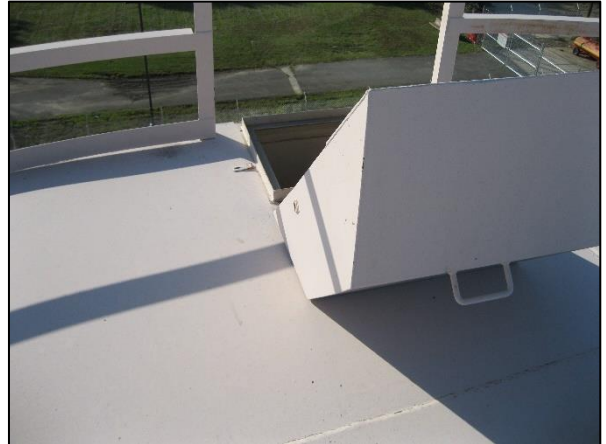
n. Provide Latches

OBSERVATION: The four (4) roof perimeter vent/inspection hatches have one latch each. Two of the hatches have broken latches.

RECOMMENDATION: Provide new latches on two of the roof perimeter vent Inspection hatches.

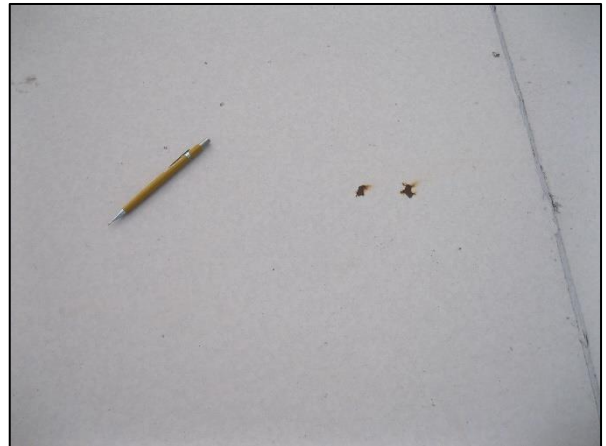
OBSERVATION: Bird droppings were observed on the roof and guardrails. Scattered coating failure was also noted on the roof. There is isolated stain from water ponding on the perimeter of the roof. The lower portion of the shell is coated with mold and algae.

REFERENCE: API 570 paragraph 4.3.2.3.h) reads, "bird turds can also cause accelerated corrosion and unsightly stains."

RECOMMENDATION: In the periodic maintenance checklist, include pressure washing of the lower portion of the shell and the tank roof to remove bird droppings and loose debris.

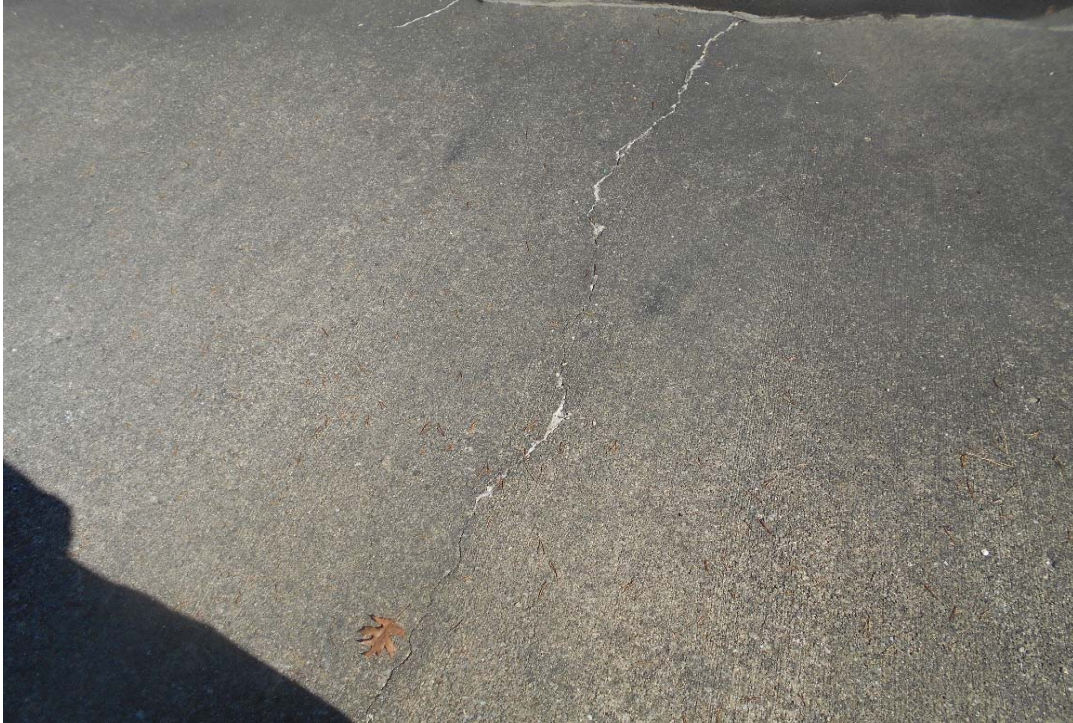
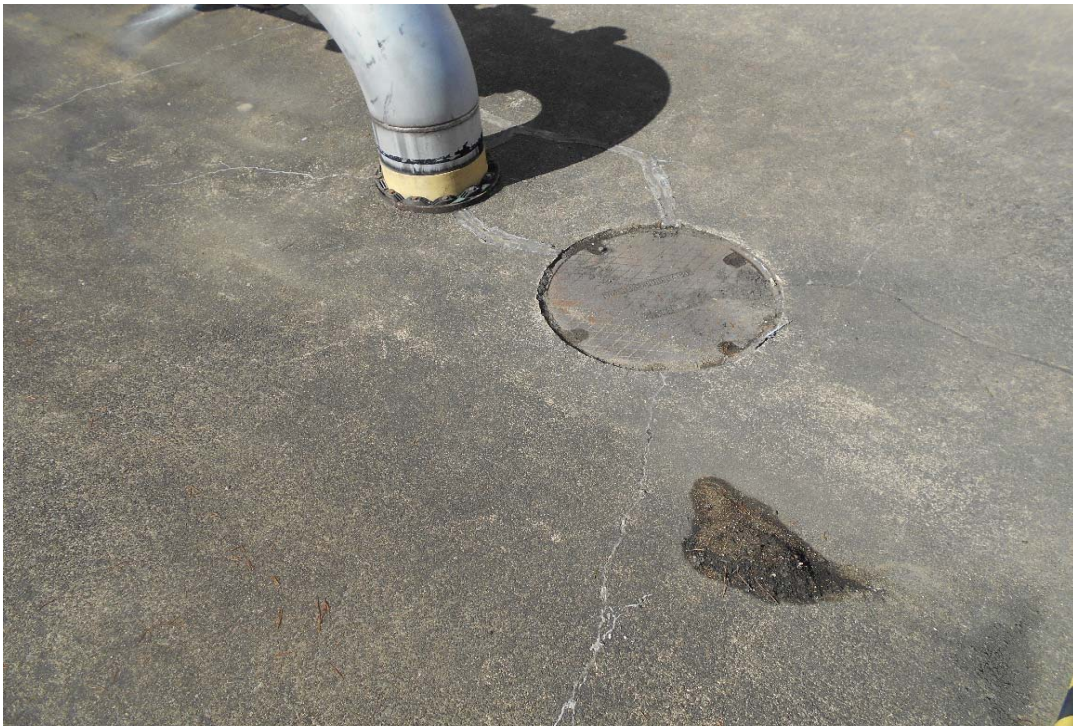
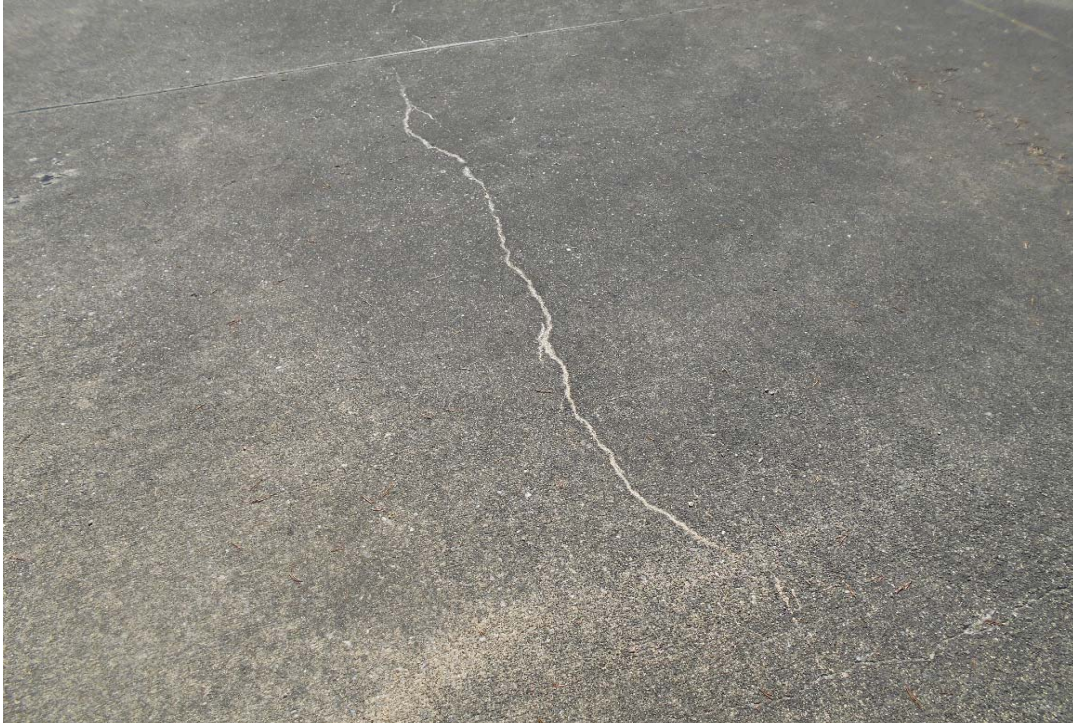
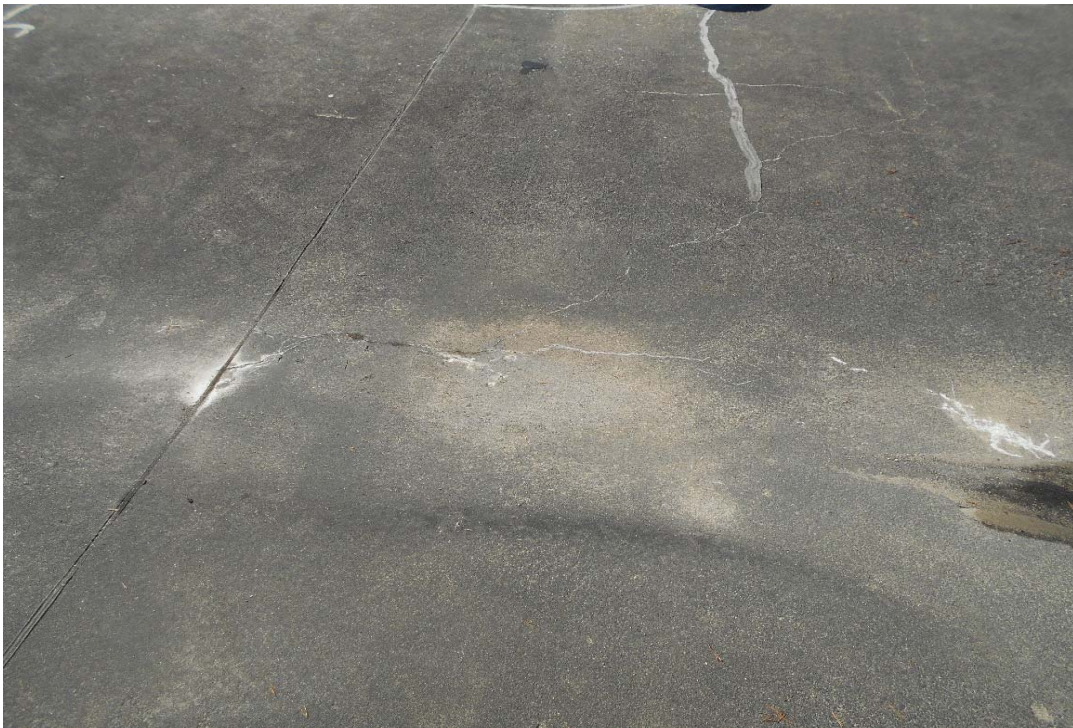
E9: Cracks in Secondary Containment Floor

E10: Cracks in Secondary Containment Floor

E11: Cracks in Secondary Containment Floor

E12: Cracks in Secondary Containment Floor

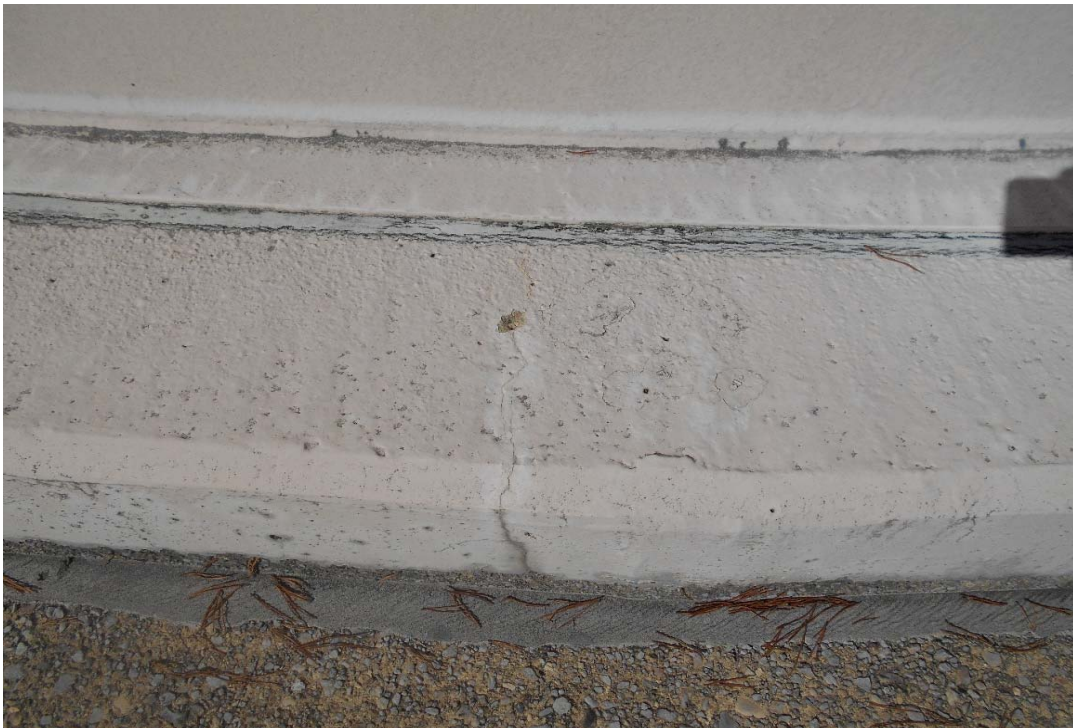
E16: Ringwall-to-Chime Sealant Failure

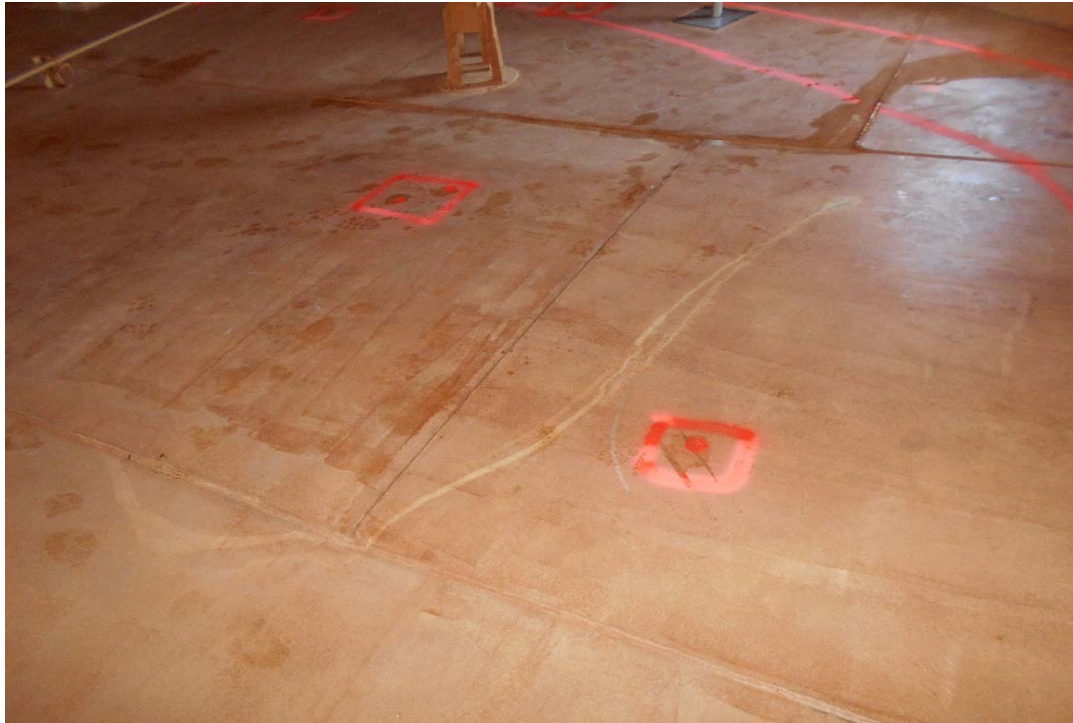
E33: Underside Corroded Areas Outside Corrosion Band

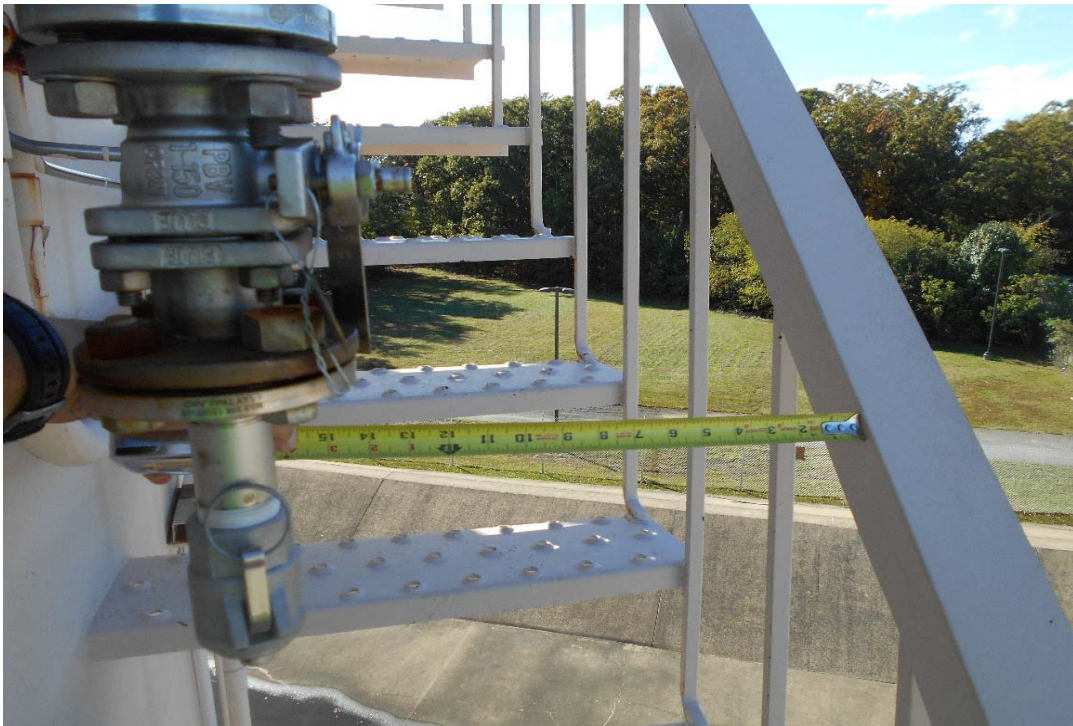
E48: Inadequate Stairway Clearance

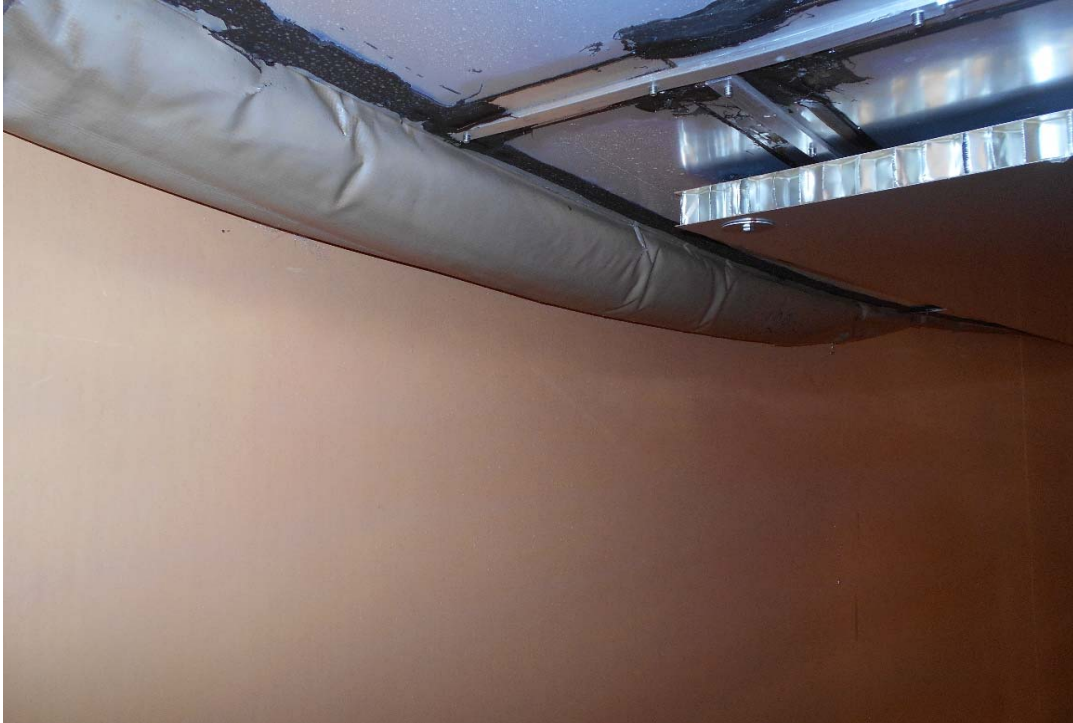
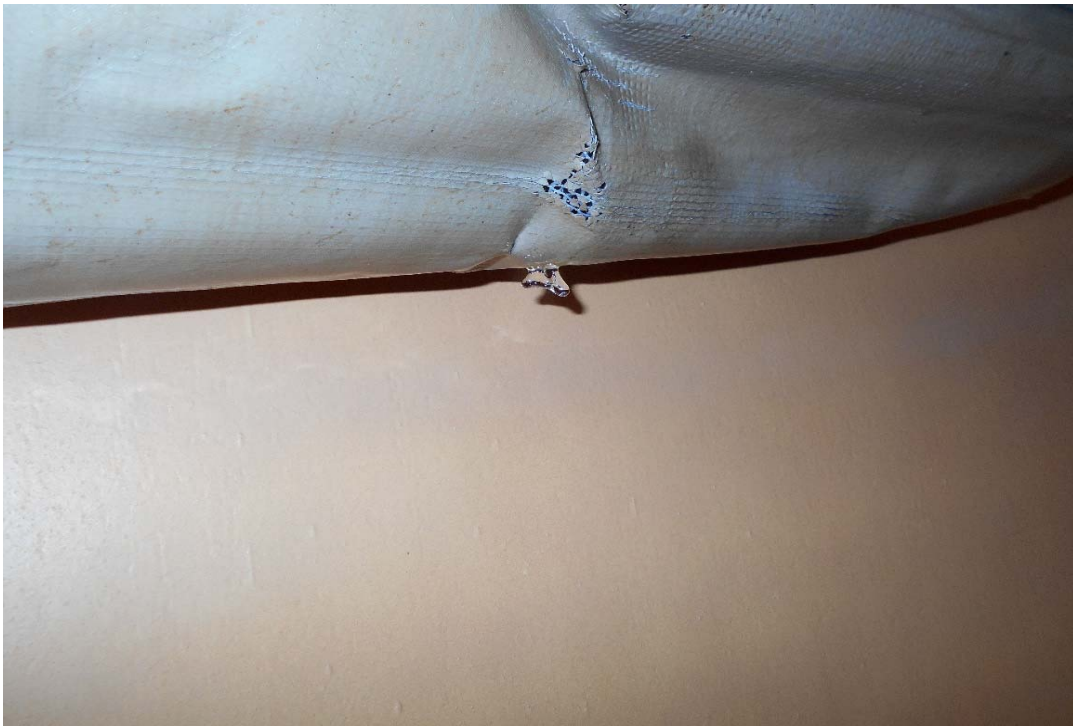
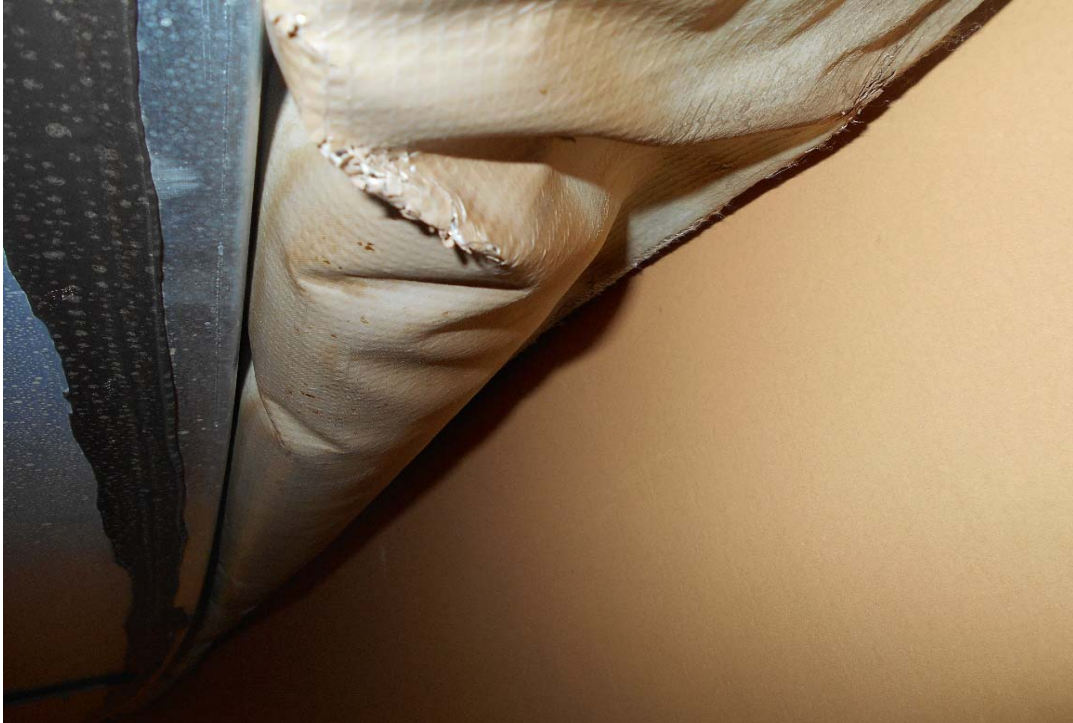
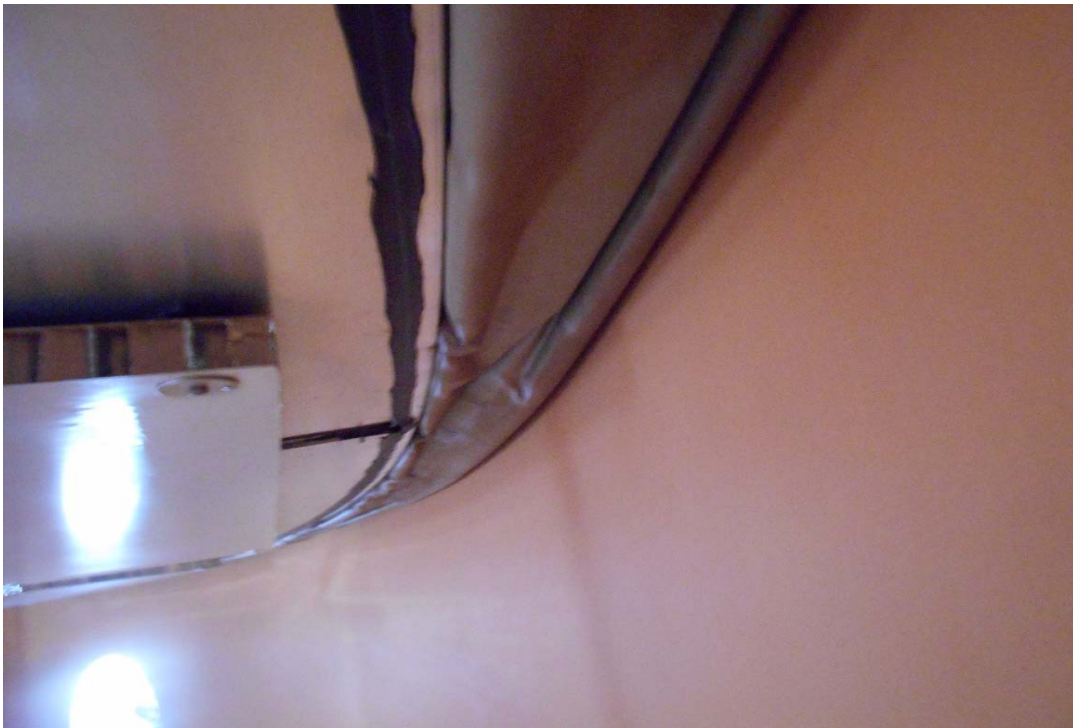
E49: Deteriorated Floating Roof Foam Log Seal

E50: Deteriorated Floating Roof Foam Log Seal

E51: Deteriorated Floating Roof Foam Log Seal

E52: Deteriorated Floating Roof Foam Log Seal

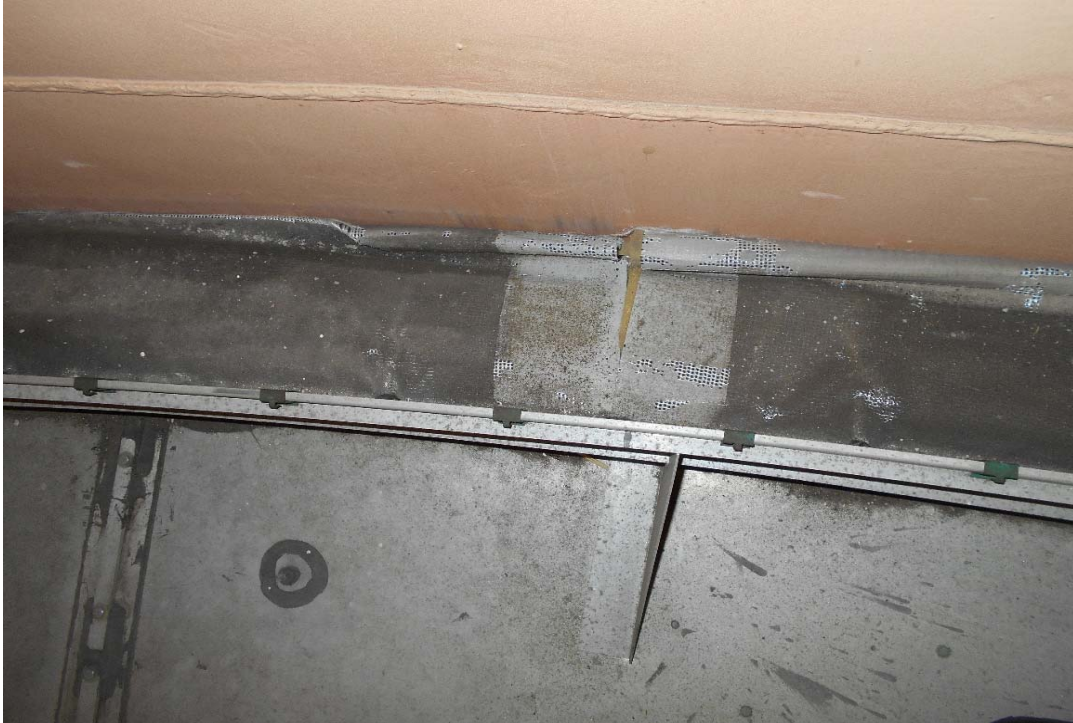
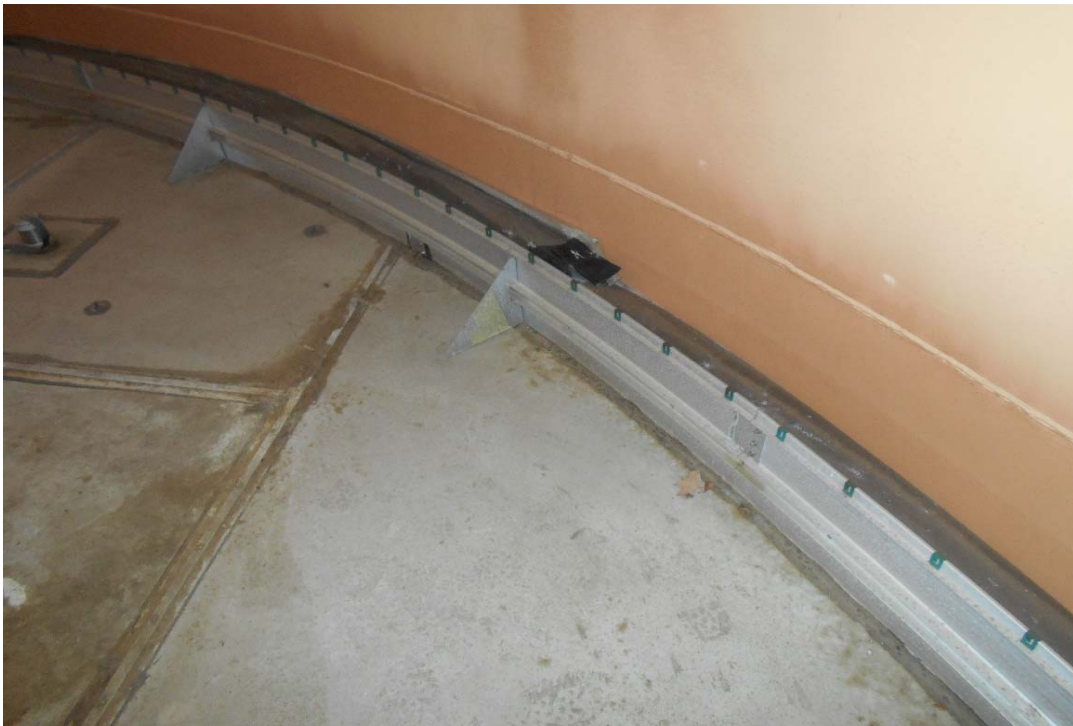
E55: Deteriorated Floating Roof Foam Log Seal

E56: Deteriorated Floating Roof Foam Log Seal

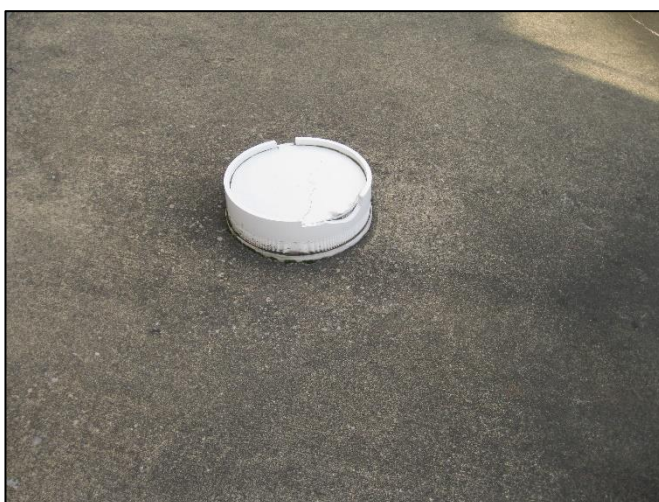
B.6: Damaged Leak Detection Well Cover

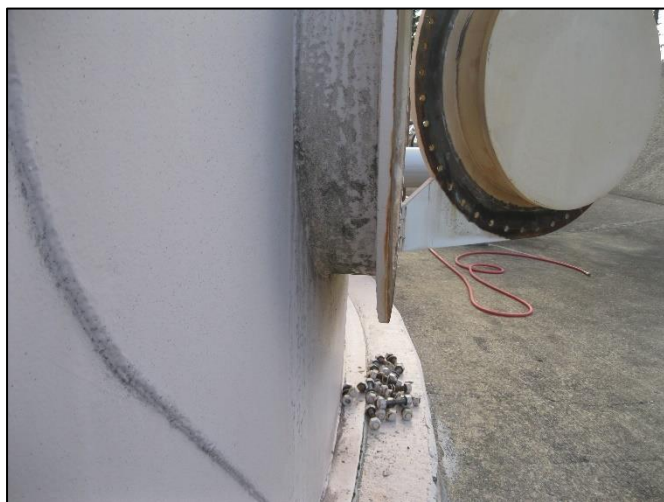
B.7: Algae on Underside of Manhole Neck
