FINAL ASSESSMENT REPORT

Department of Veterans Affairs
Bay Pines VA Healthcare System
10000 Bay Pines Boulevard
Bay Pines, FL 33744

Project No. 516-22-120
Correct Structural System for Building 1

J.S. Held, LLC No: 22050462

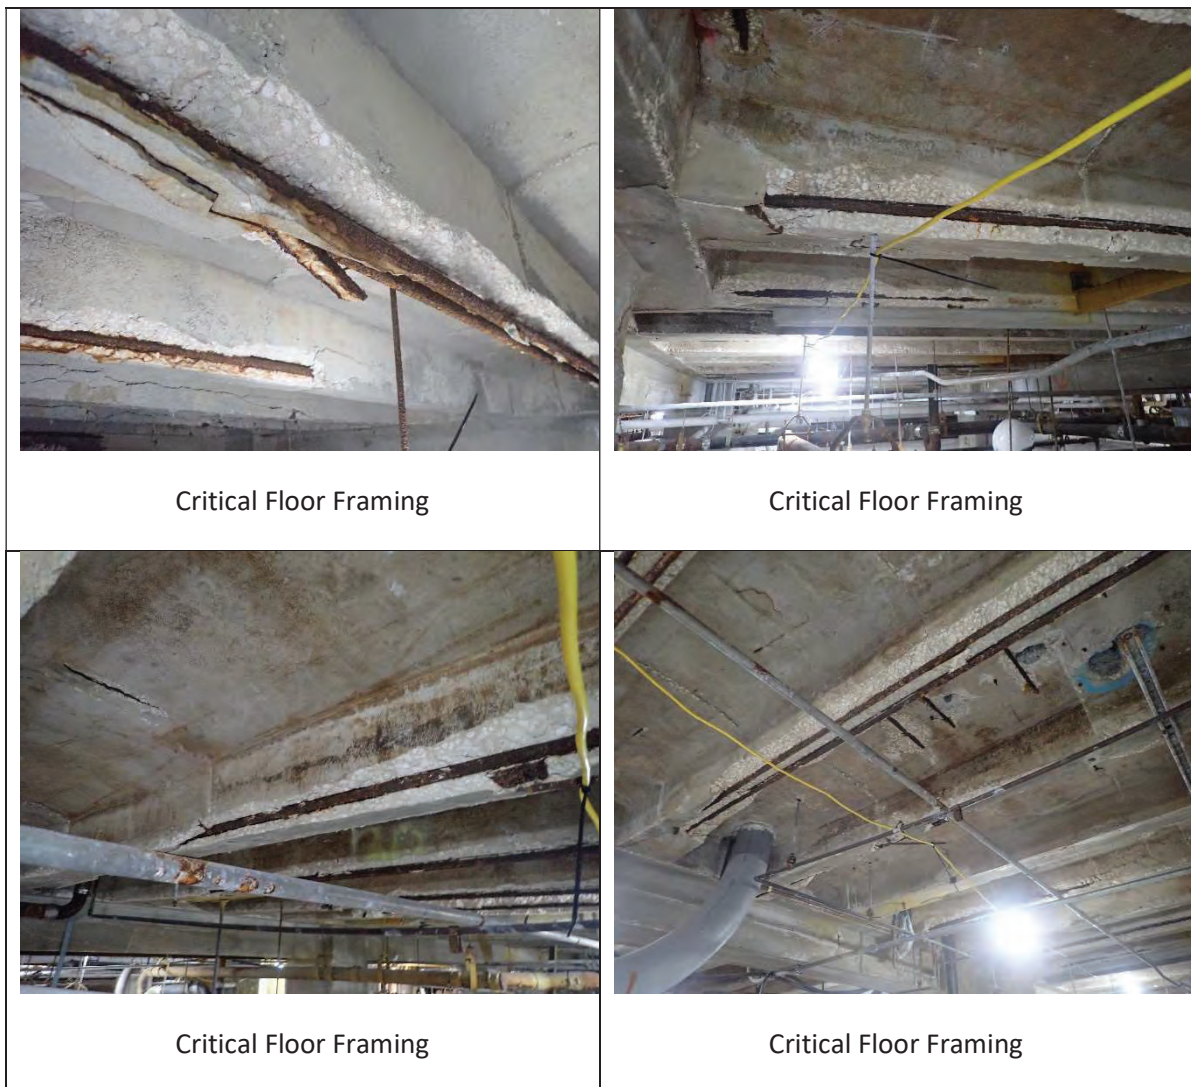
Figure 1: Critical area bound by columns 29-30-50-53-73-91-87-29 in Crawlspace A

- The floor joists and slab area bound between columns 29-30-50-53-73-91-87-29 below the kitchen (Crawlspace A) are in critical condition. Approximately 30 floor joists exhibited significant concrete cracking and spalling and the rebar was exposed. The steel reinforcement exhibited advanced corrosion and section loss which has resulted in a significant reduction in load capacity in the floor joists.

- Multiple structural elements of the first-story concrete floor structure were deemed to be in critical condition. It is recommended that temporary shoring be installed within the crawlspaces to support these areas prior to the conclusion of the ongoing renovation and return to full building occupancy.

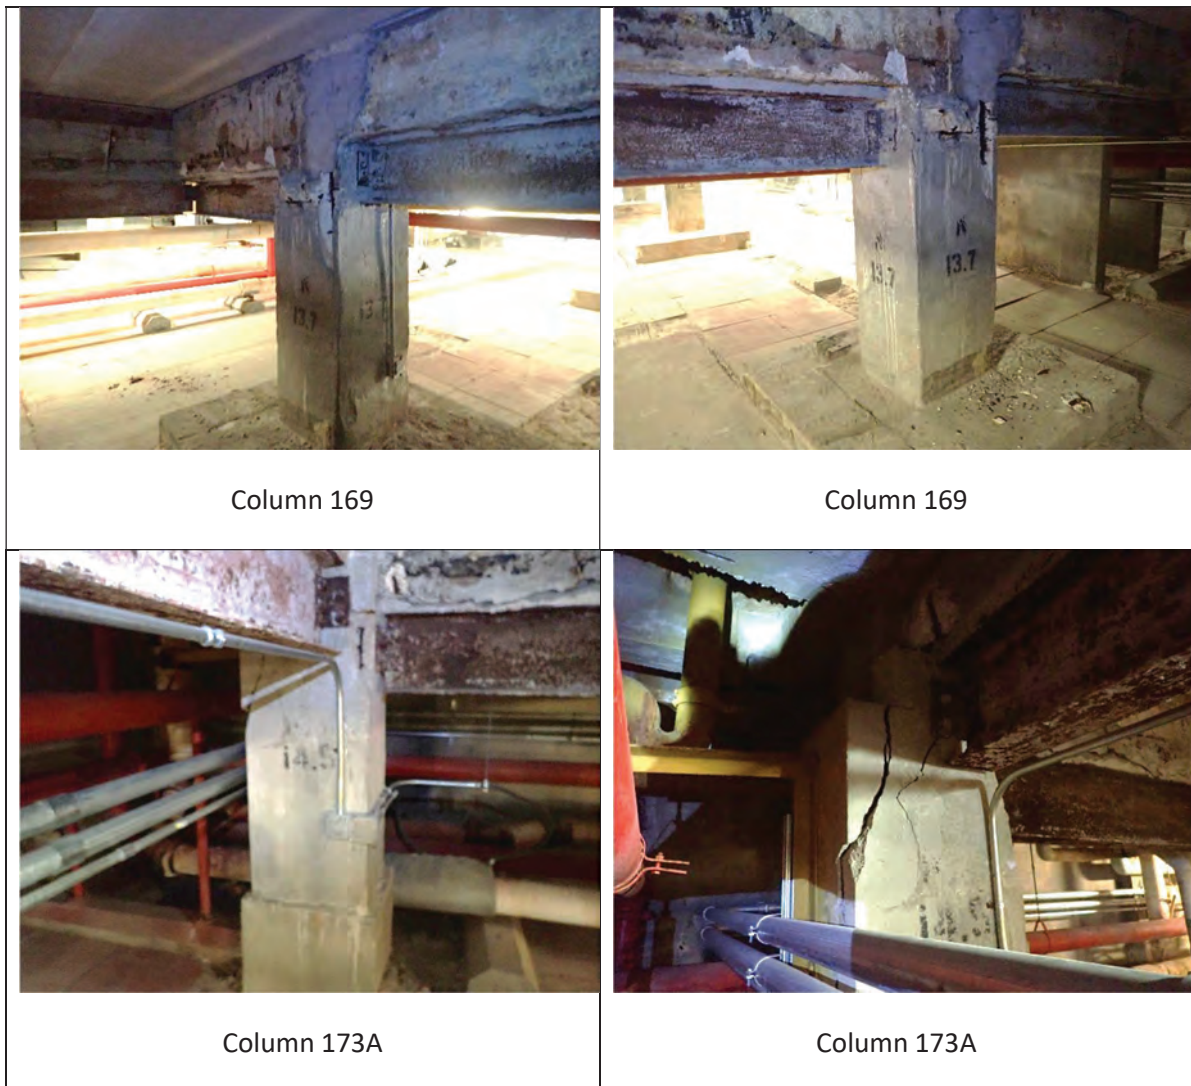
Figure 2: Critical columns 169 and 173A in Crawlspace B

- Columns 169 and 173A (Crawlspace B) are spalling at the corners of areas with previous structural modification where loads were transferred from the steel beams through the bolted connections to the concrete columns. The failed repair resulted in a critical condition. This area is below the equipment room at the northwest corner of the west building extension

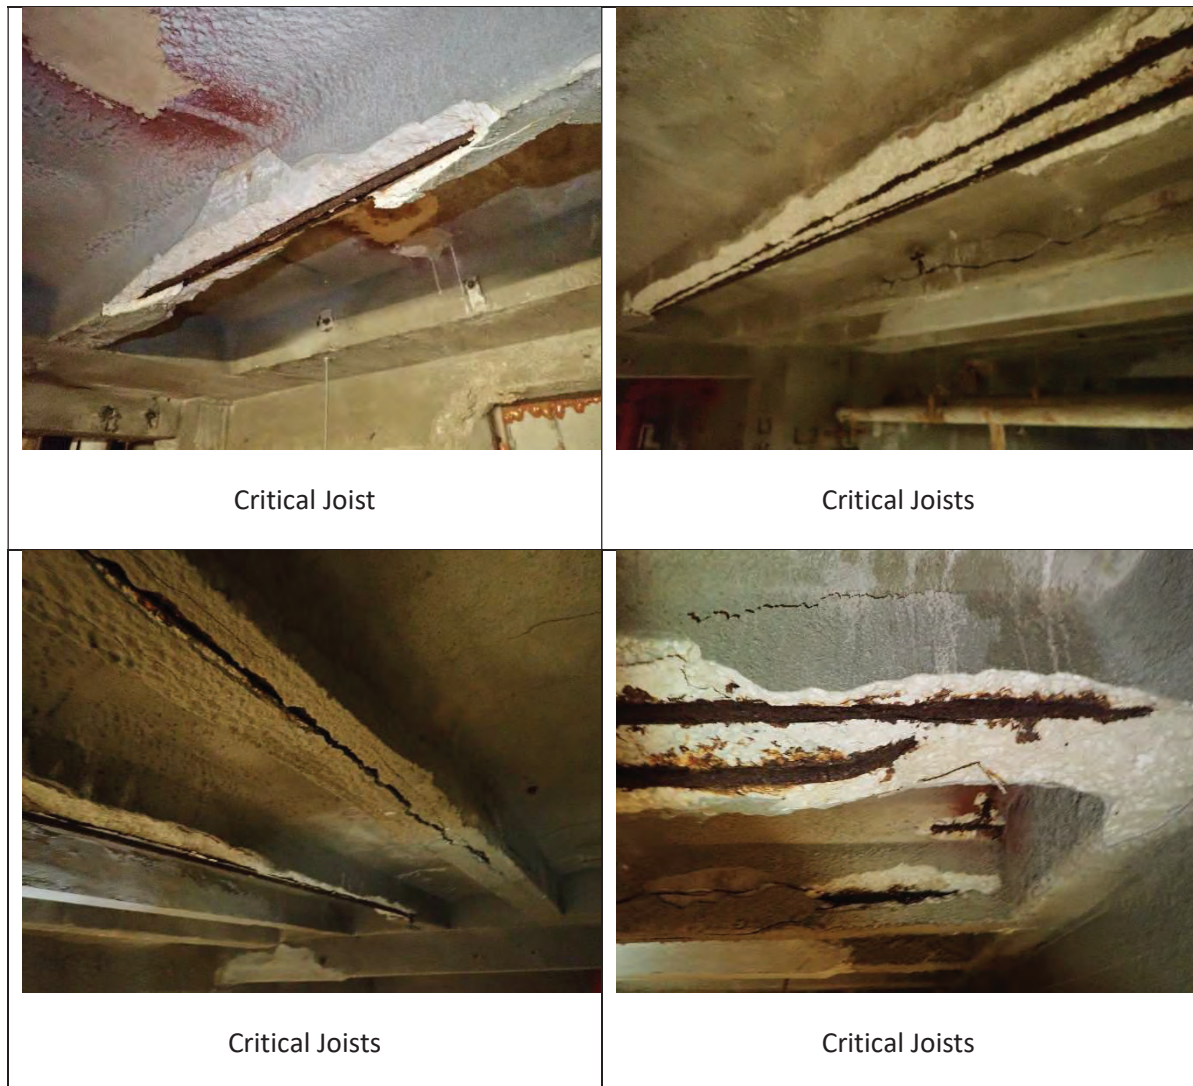
Figure 3: Critical joists bound by columns 167-180-181-172-172A-168-167 in Crawlspace B

- Three floor joists between columns 167-180-181-172-172A-168-167 (Crawlspace B) are in critical condition. The floor joists exhibited significant concrete cracking and spalling and the rebar was exposed. The steel reinforcement exhibited advanced corrosion and section loss which has resulted in a significant reduction in load capacity in the floor joists.

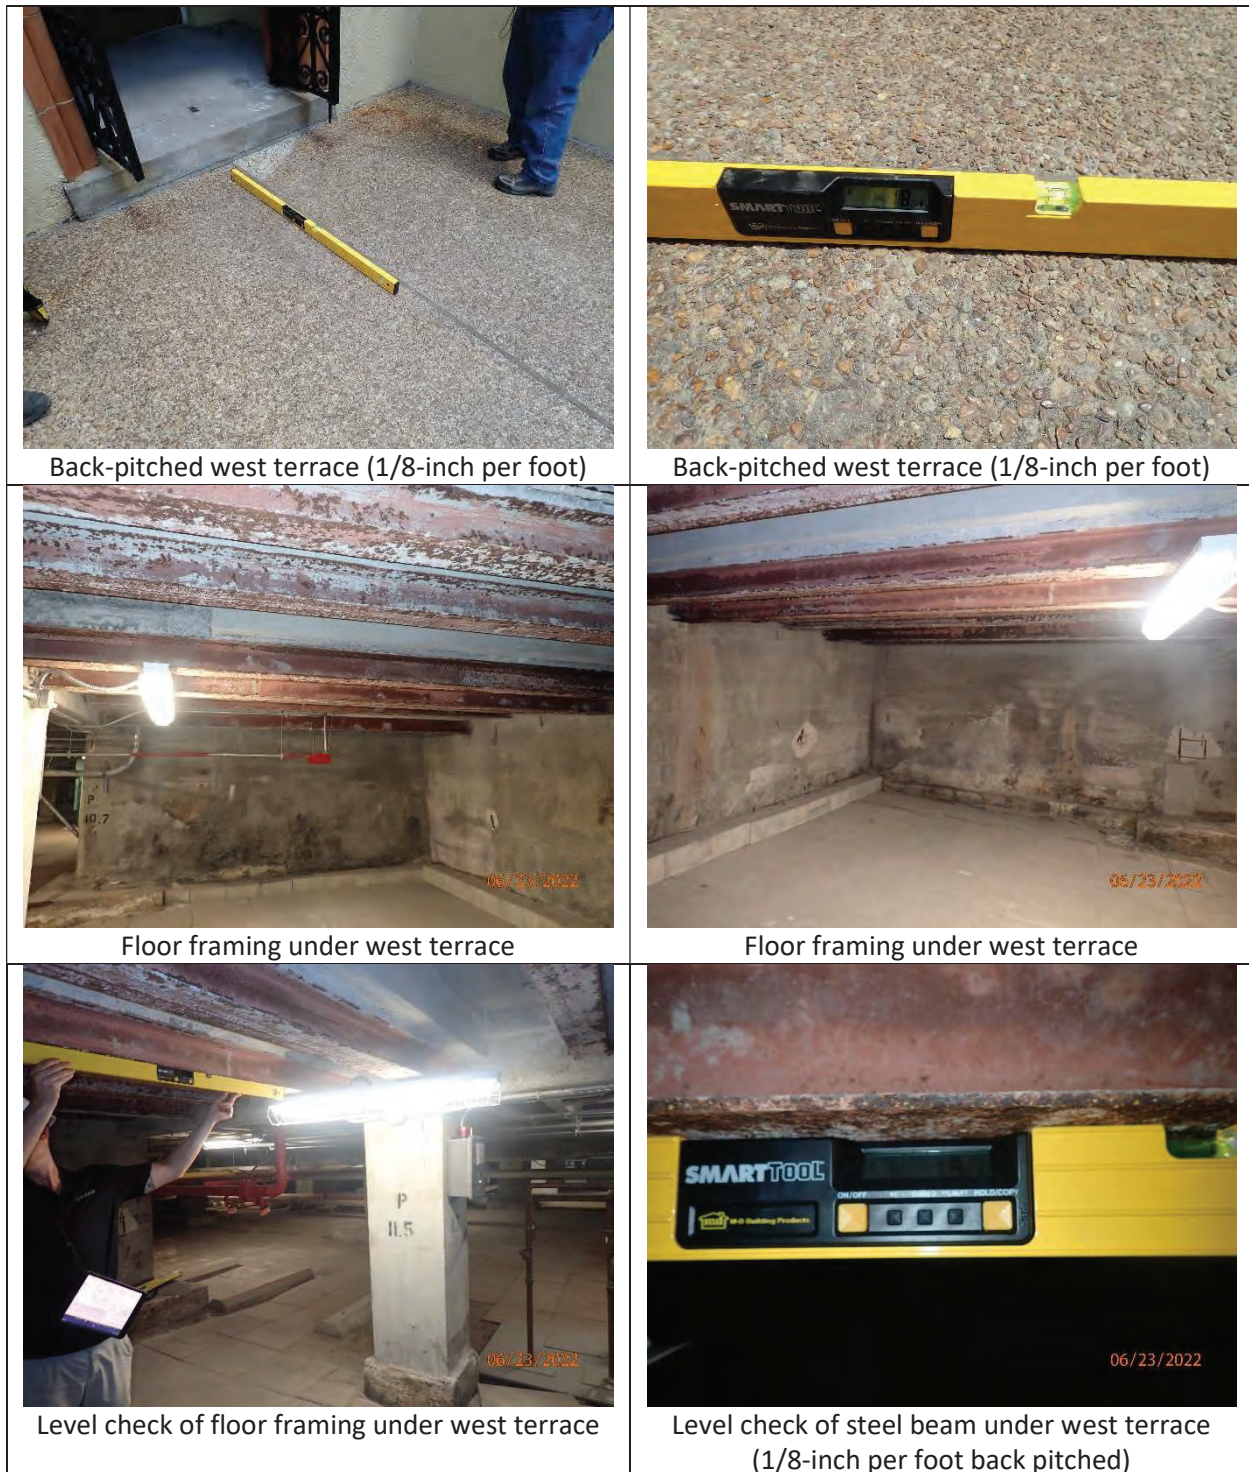
Figure 4: West terrace and corresponding area of Crawlspace B below

Ponding water was reported on the surface of the terrace outside the west entrance above Crawlspace B, particularly during periods of heavy rainfall. The finished floor of the terrace was back-pitched toward the doorstep when checked with a hand level. No visible evidence of deformation or vertical displacement was observed on the steel framing joists or concrete slab substrate under the west terrace within Crawlspace B. A slope check of the wide flange (W) steel joists with a hand level indicated that these floor framing components were back-pitched toward the interior, which caused site storm runoff to accumulate near the doorstep. This condition is attributable to the initial improper installation. (See Figure 4 on the next page).

It is recommended that the back pitching be corrected by providing a new suitable tapered topping to a new finish flooring that would allow site storm runoff to drain away promptly.

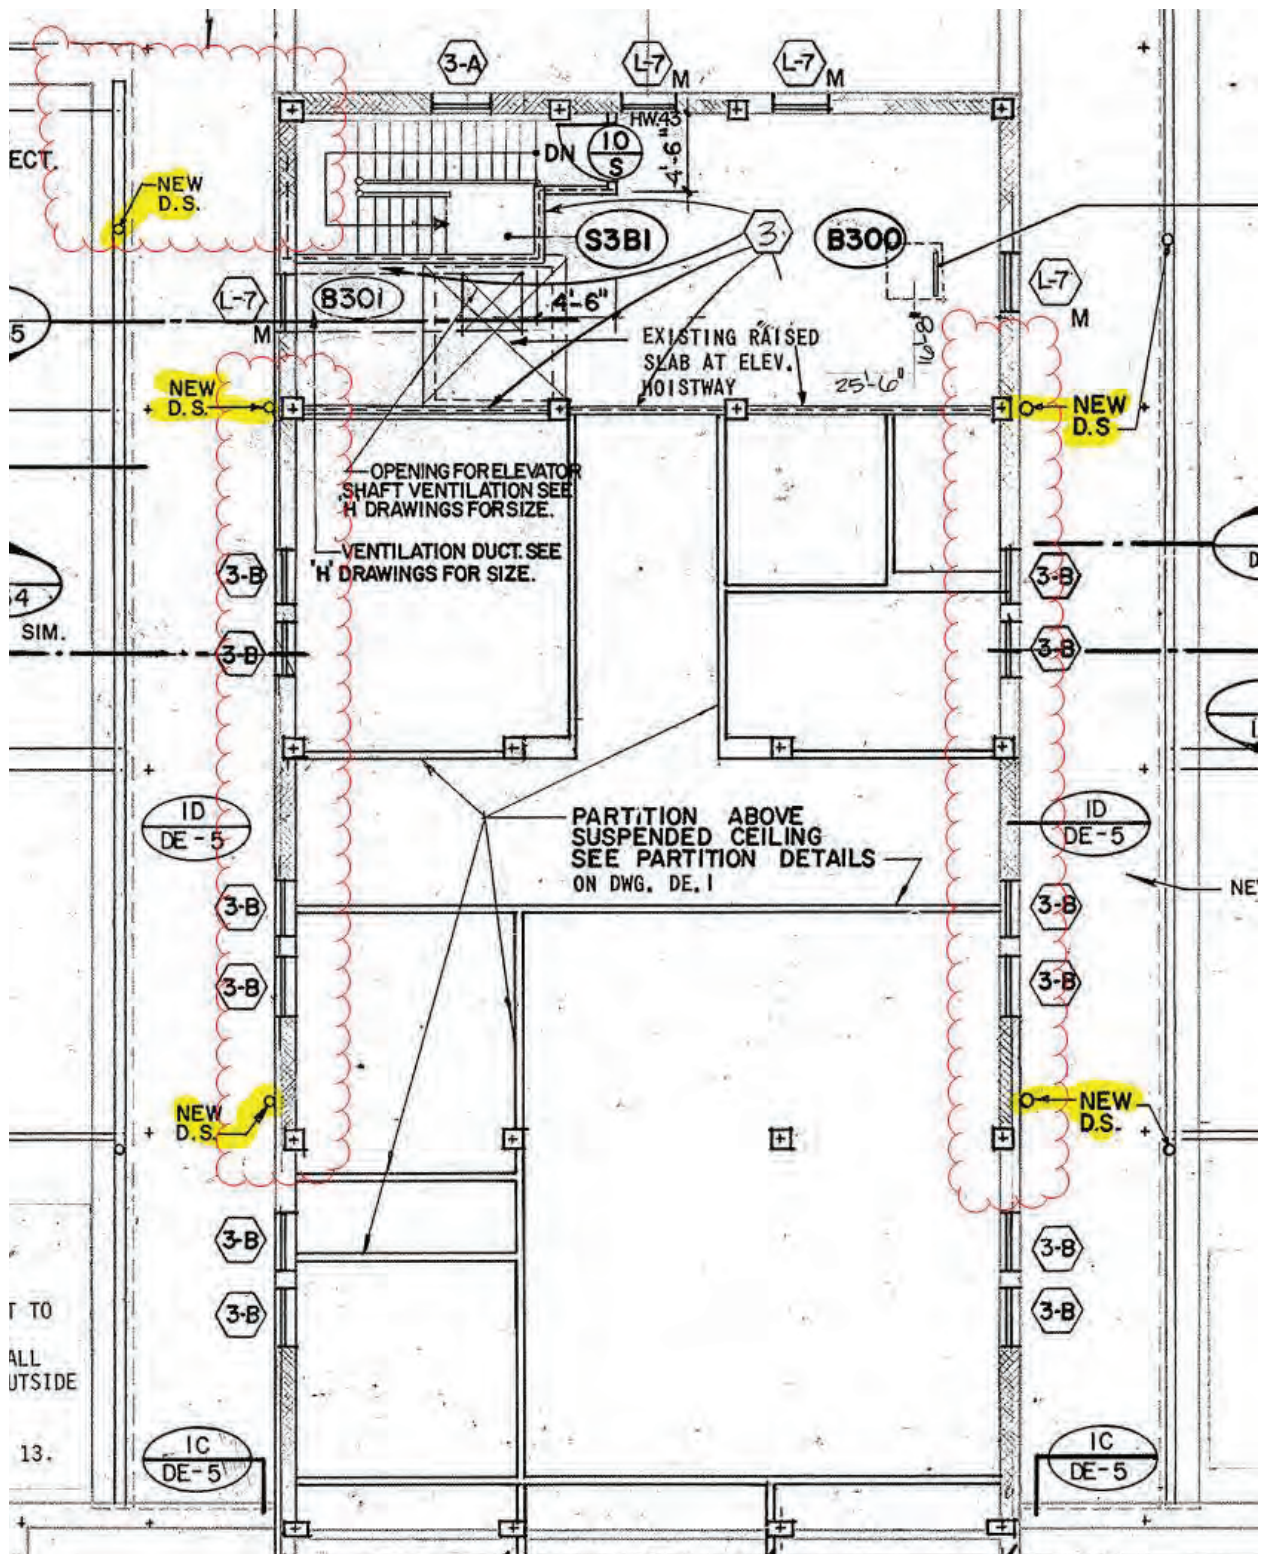
Figure 5: Areas with reported leaks in Area B as noted on 1983 renovation drawings.

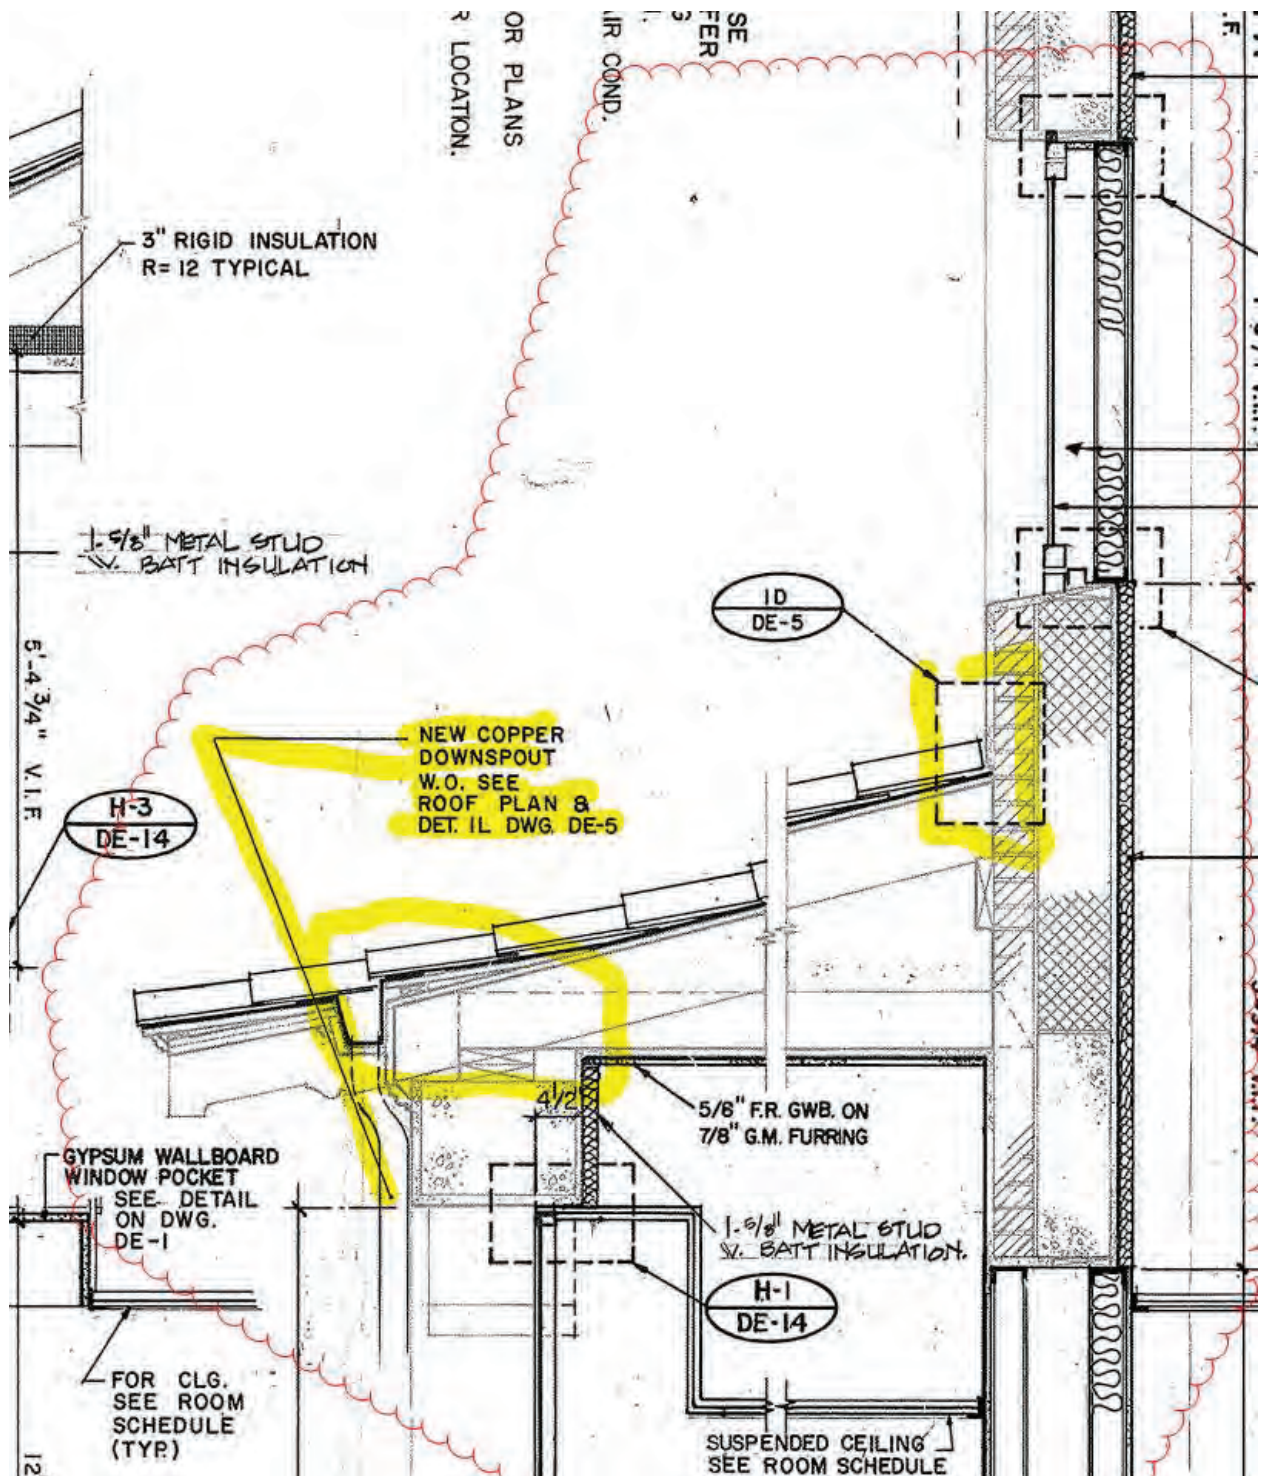
Figure 6: Area B where leaks reported as shown in detail section from 1983 renovation drawings.

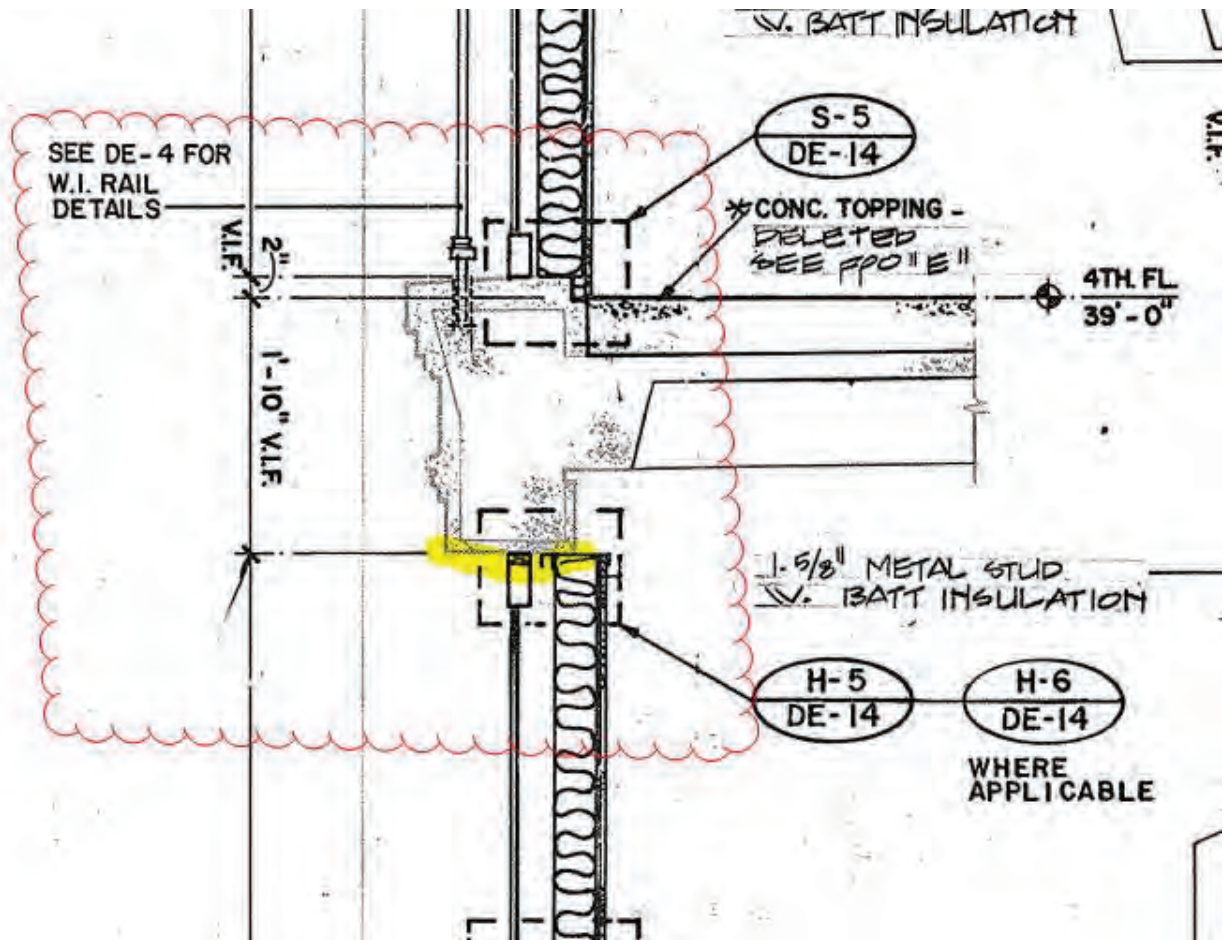
Figure 7: Third-story window head condition from 1983 renovation drawings

2. East building 1 (Area A) third-story window south side.
 - a. Reported water intrusion (active leak) at the head condition of the window from the exterior and sill above. The 1983 renovation drawings show details consistent with this location and condition (Figure 7).

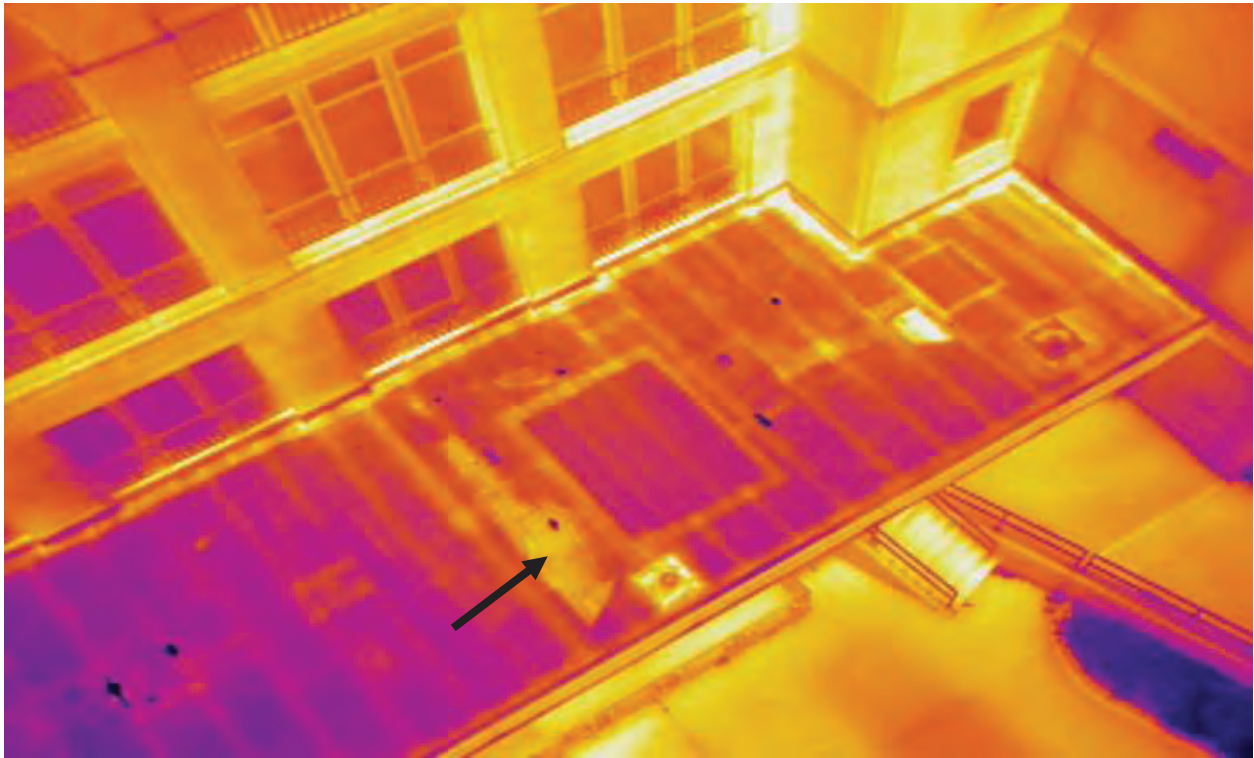
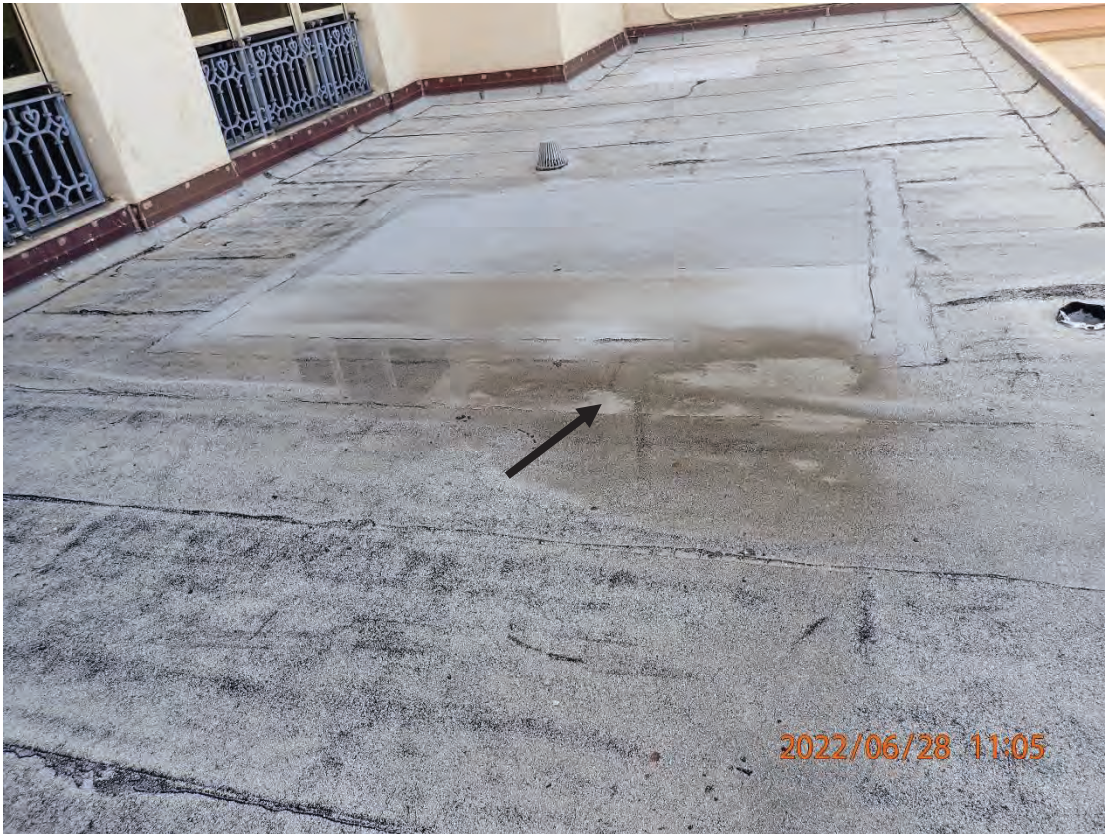
- a. Good – The tile roofing and the majority of the low slope roofing observed did not reveal any anomalies.
- b. Fair – An infrared anomaly was observed near the center of the loading dock's low slope roofing. Water was ponding on this roof area. The roofing should be pitched to prevent ponding water.
- c. Poor – No poor conditions were observed via the Infrared observations

Figure 10: Overview of IR Anomaly at Area A Loading Dock Roof (arrow)

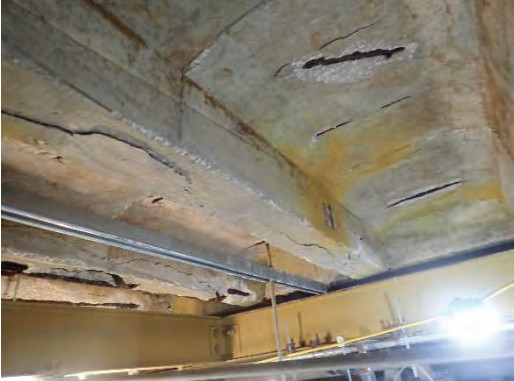
Location	Structural Component	Label/ Grid	Condition	Distress Description	Photo
Crawlspace A	Joists and Slab	52-53, 72-73	Critical	Spalled concrete, exposed and corroded rebar with section loss

For concrete members that exhibit spalled concrete and exposed rebar, a partial-depth repair is required. A partial-depth repair involves the removal of the corroded steel reinforcement and the surrounding concrete past the affected area until sound steel reinforcement and concrete are identified. Minimally, if corroded reinforcement in the repair is exposed and found to have loose oxidation products or is not bonded to the surrounding concrete, it is recommended that the concrete be removed from around the bar. The clear space behind the reinforcing steel should be not less than ¼ inch plus the dimension of the maximum size aggregate in the repair material (typically a total of three inches or more). In addition, concrete removal along the reinforcing bar shall continue until the bar is essentially free from corrosion products. In some cases of advanced corrosion, it may be appropriate to replace the affected reinforcement and concrete along the entire length of the member. Once the affected concrete and rebar are removed, new reinforcement steel should be spliced with the existing steel by doweling into the existing concrete adjacent to the existing steel. Appropriate epoxy adhesives and bonding agents should be used to complete a proper partial-depth repair.

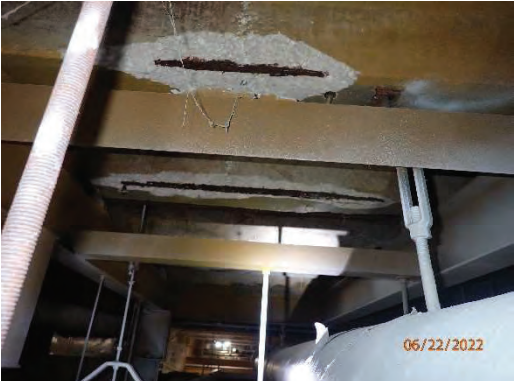
Crawlspace A	Joists	79-80, 97-98	Poor	Spalled concrete

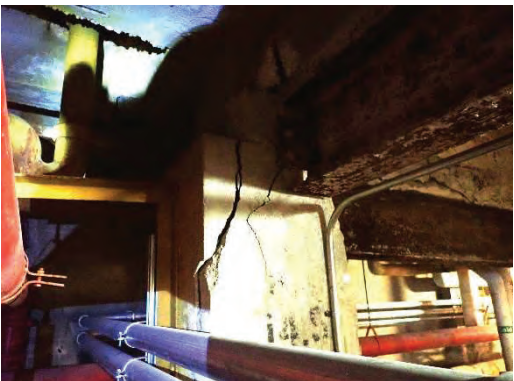
Crawlspace B	Column	N.5-14.9 (173A)	Critical	Spalled concrete, failed repair

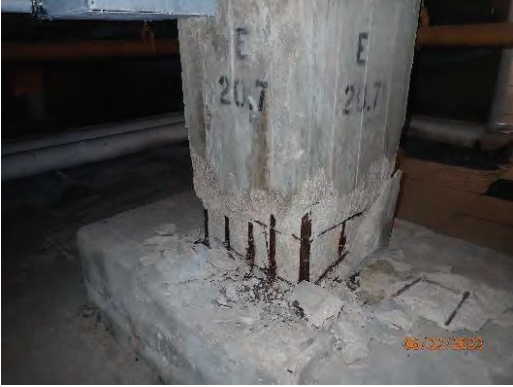
Location	Structural Component	Label/ Grid	Condition	Distress Description	Photo
Crawlspace A	Column	E-20.7	Poor	Spalled concrete

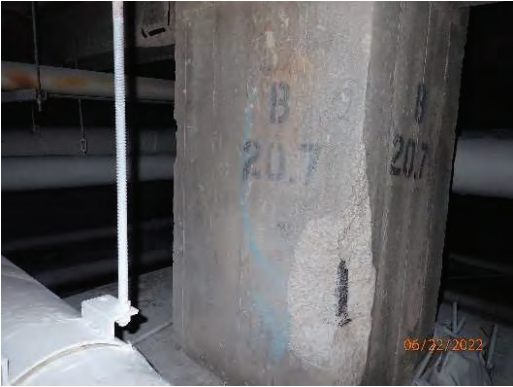
Crawlspace A	Column	B-20.7	Fair	Spalled concrete

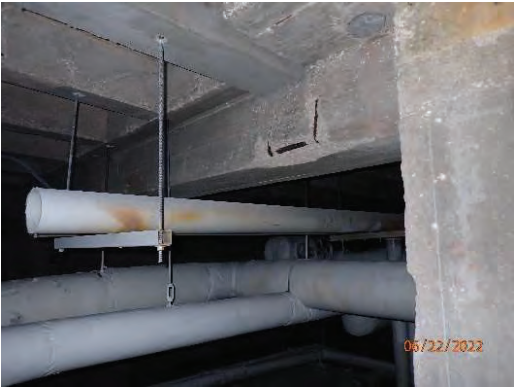
Location	Structural Component	Label/ Grid	Condition	Distress Description	Photo
Crawlspace A	Beam	C.1-19 – C.1-20.7	Fair	Spalled concrete

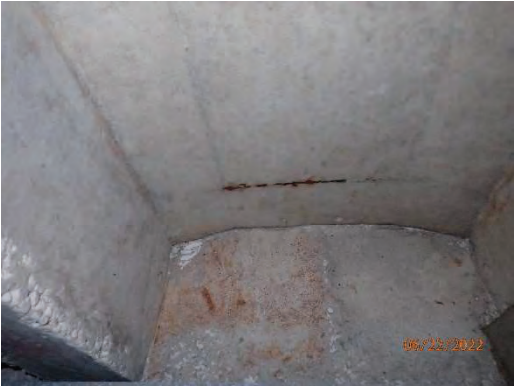
Crawlspace A	Slab underside	23-24, 47-48	Fair	Exposed rebar

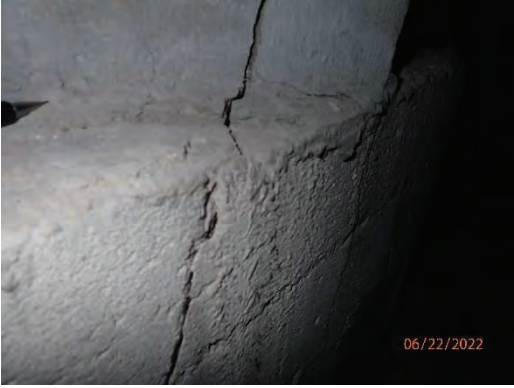
Crawlspace A	Pile cap	64	Poor	Cracked pile cap and column

J.S. Held recommends that repairs of the observed distressed reinforced concrete elements consist of epoxy injection or partial-depth repairs. Epoxy injection should be utilized for cracks within concrete members that have not induced corrosion of the reinforcement or spalling of the concrete. This type of distress was typically found in members classified as ‘**Good**’ or ‘**Fair**’ condition. Epoxy injection restores the integrity of the concrete member when epoxy adhesives are injected within the crack through drilled port holes, filling in the voids between the fractured portions of the concrete. The epoxy also acts as a sealant and prevents moisture penetration along the crack.

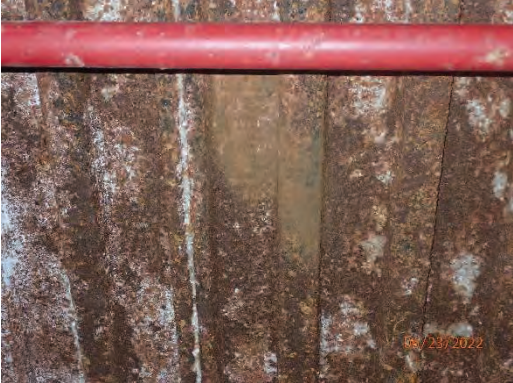
Within the basement, approximately ten (10) locations of surface corrosion of the composite metal deck underside were brushed with the use of a steel brush and the claw of a welder's hammer. The scratched (brushed) surfaces were inspected for pitting or flaking. No instances of pitting or flaking, indicative of potential loss of structural load-bearing capacity were observed during our inspection. The tested areas were thus rated ***'Fair'***.

Location	Structural Component	Label/ Grid	Condition	Distress Description	Photo
Basement	Composite metal deck underside	K-J	Fair	Light surface corrosion

Recommended repairs/maintenance methods include non-abrasive cleaning to remove the surface corrosion and then application of intumescent paint to prevent exposure to the humid environment of the basement as well as restoration of the fireproofing that has been reportedly removed.

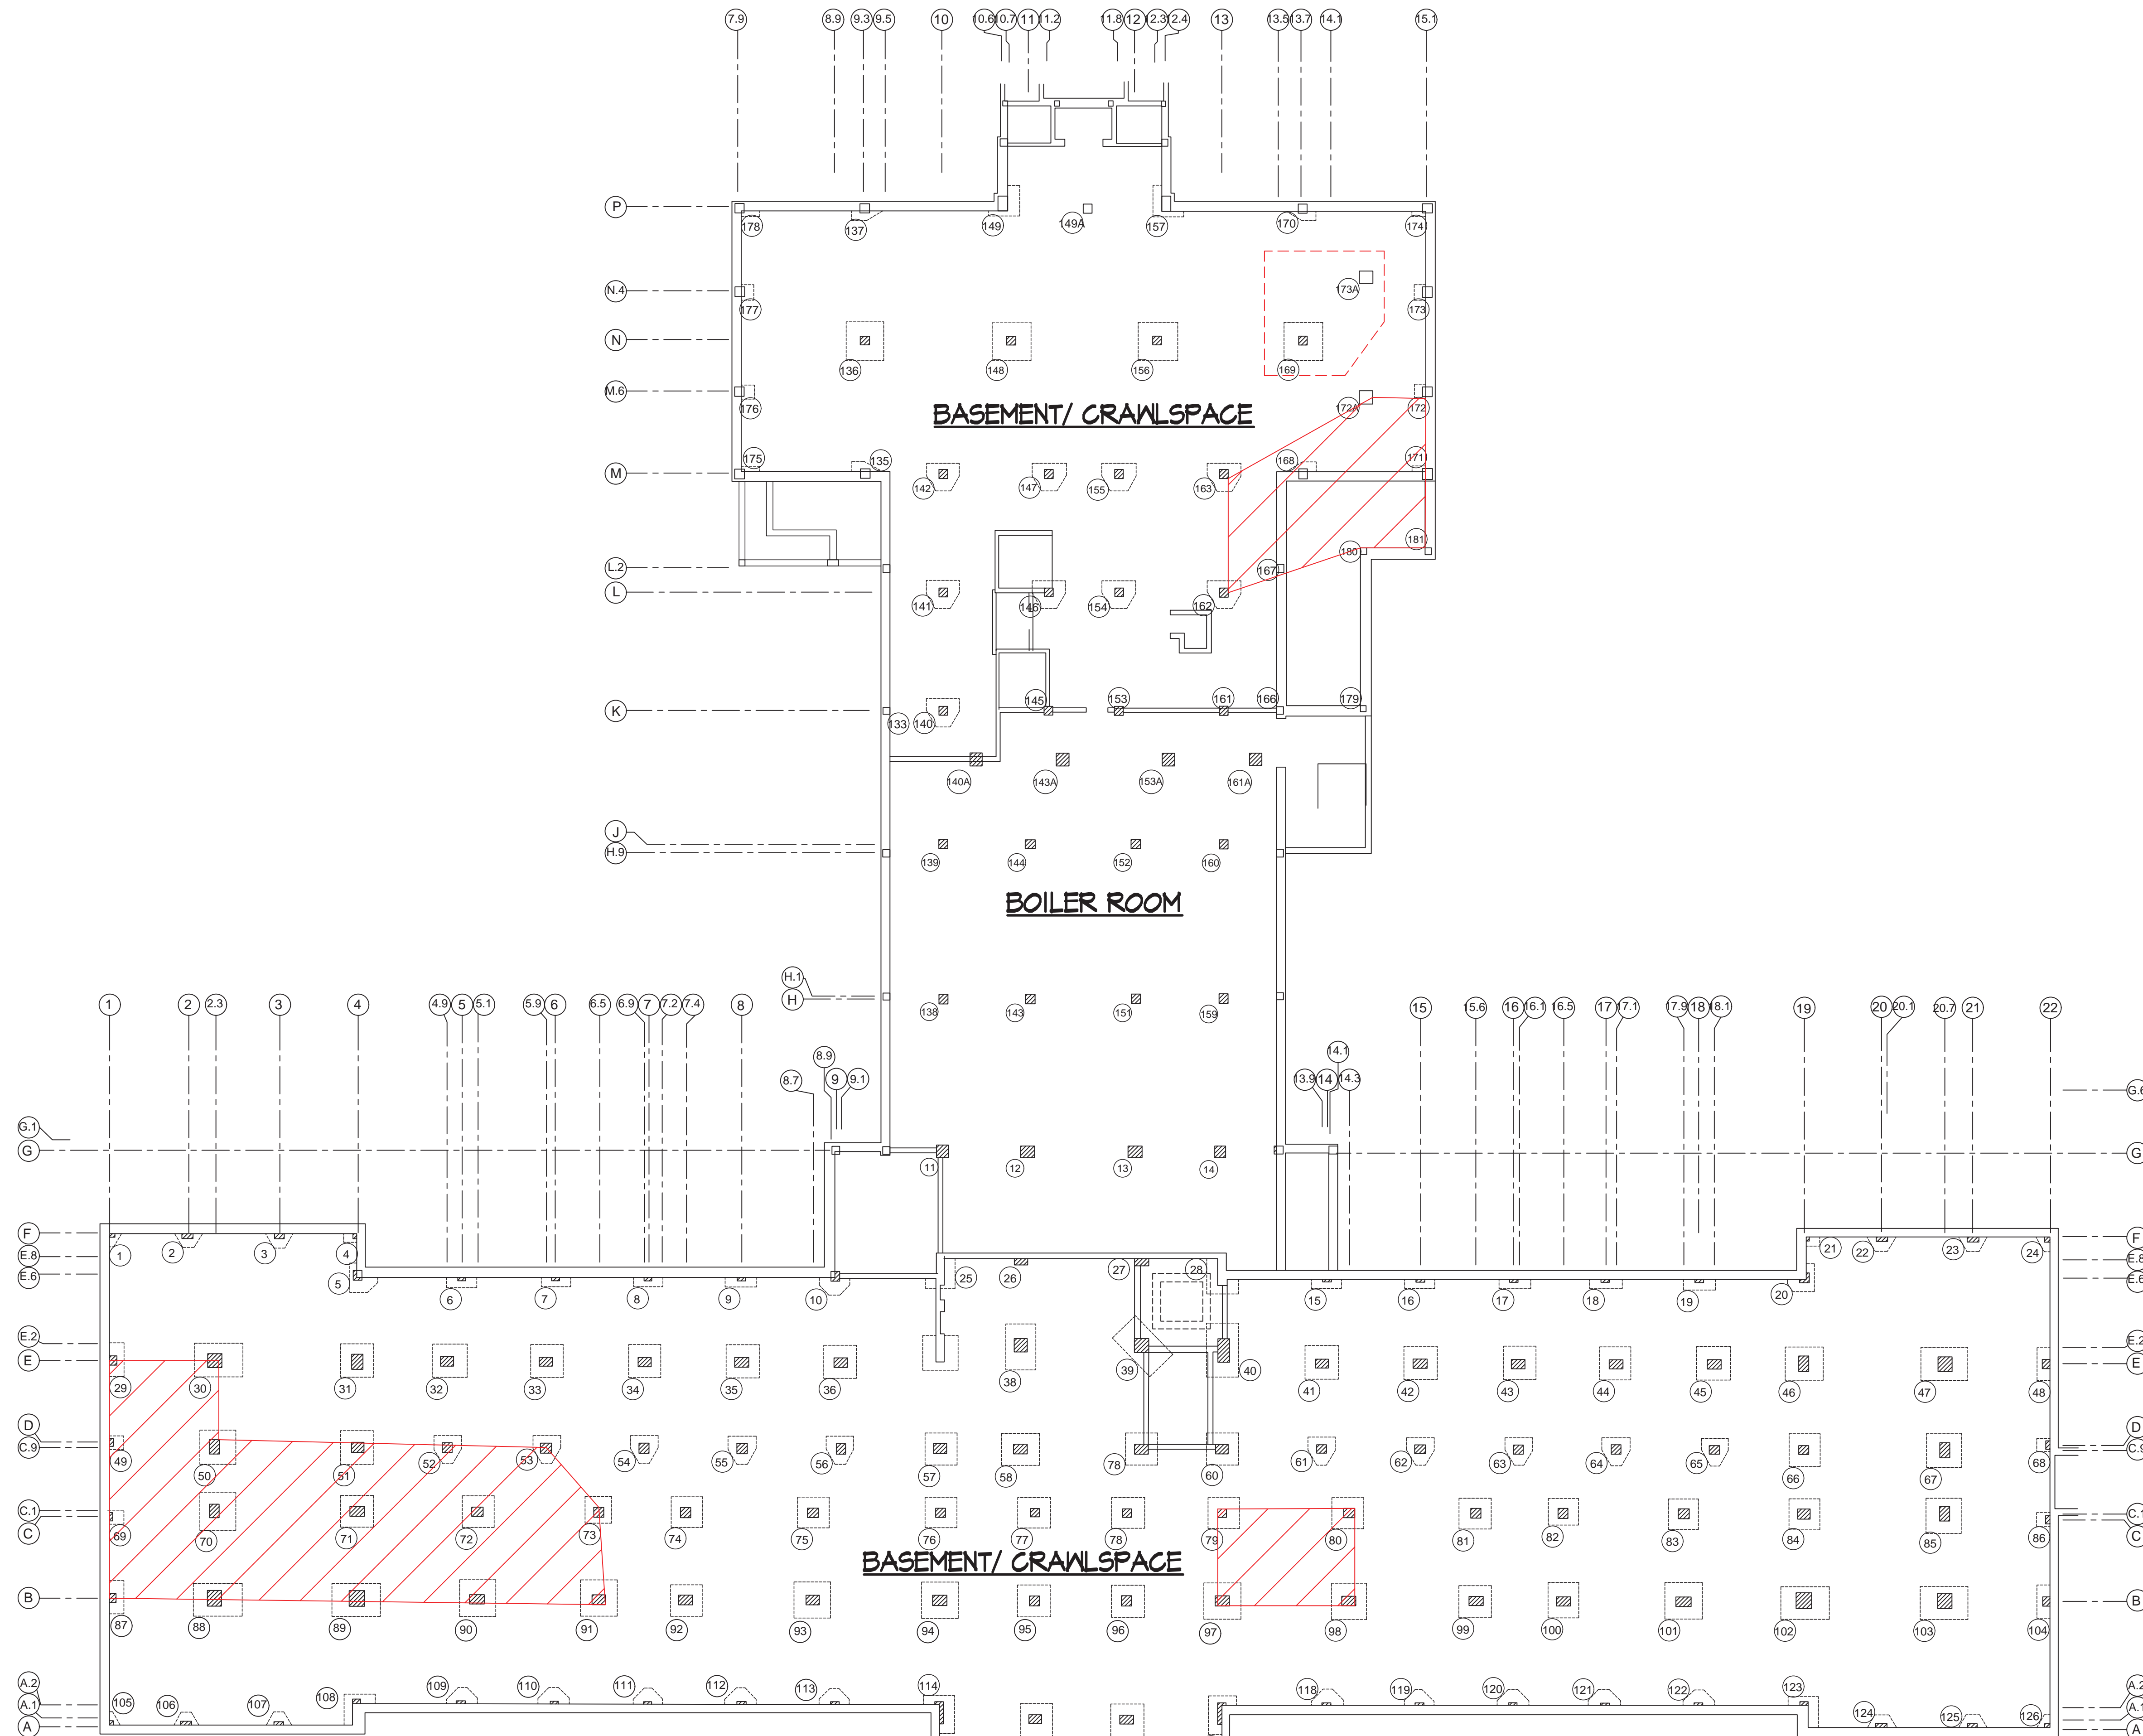
CRITICAL AREAS REQUIRING SHORING
BUILDING 1

While the majority of the cast-in-place concrete columns, beams, and floor joists were in fair to poor condition, there were three (3) ‘**Critical**’ areas identified where temporary shoring should be installed until permanent repairs can be implemented. These areas were identified at the following locations and are shown in the floor plan diagram of **Appendix B: Shoring of Basement and Crawlspace Critical Areas**.
