**US Army Corps of Engineers  
Omaha District  
API 653 Out-of-Service  
Inspection Report**

**Andrews AFB  
Facility 3474  
Tank 2**

**US Army Corps of Engineers Center of Expertise for Petroleum, Oils and Lubricants  
(USACE POL-MCX)  
2/5/2018**

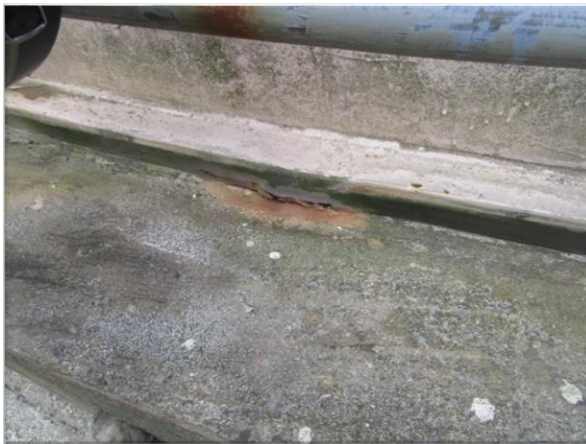
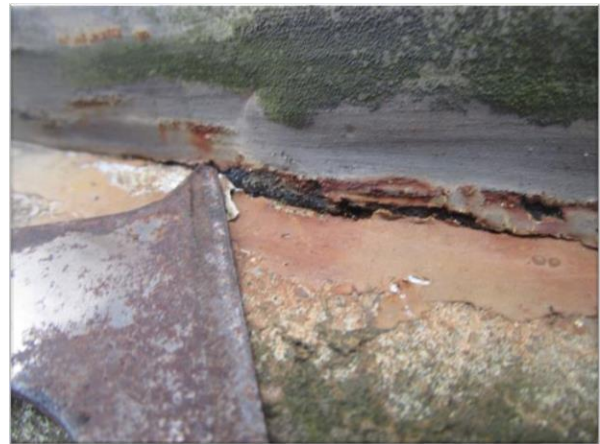
**OBSERVATION:** Sealant provided for the tank chime displays cracking and staining.

**CODE REFERENCE:** UFC 3-460-03 SECTION 8-4.1.B

**RECOMMENDATION:** Provide approximately 5 linear feet of sealant repair at the tank chime-to-ring wall interface.

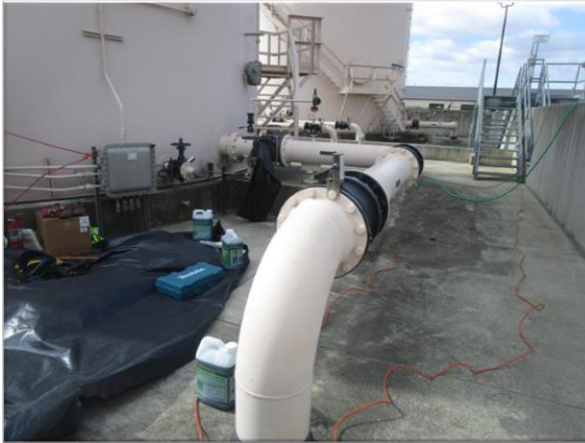
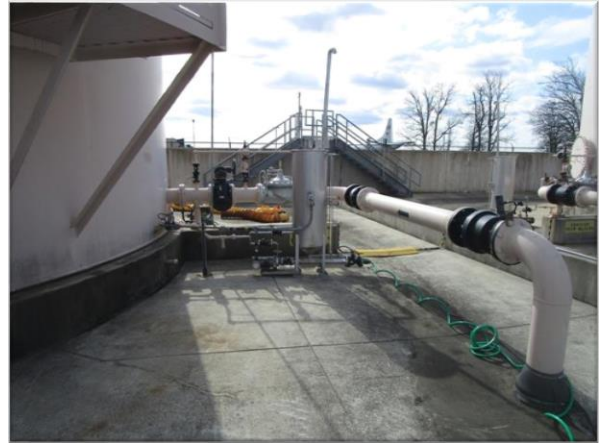
**b. Pipeline Labeling**

**OBSERVATION:** Piping within the containment dike is not provided with standard military labeling.

**CODE REFERENCE:** UFC 3-460-01, 2-18

**RECOMMENDATION:** Provide MIL-STD-161H labeling and flow arrows on the receipt and main suction line.

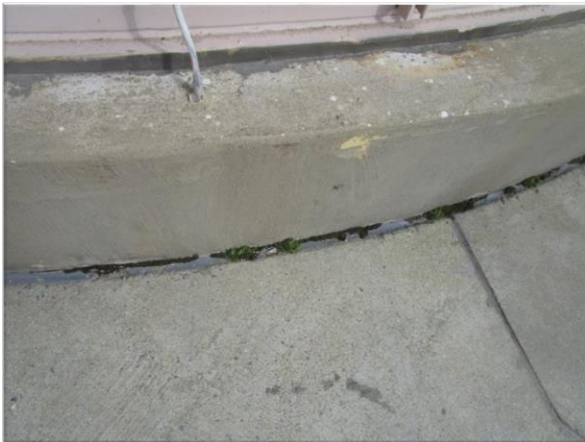
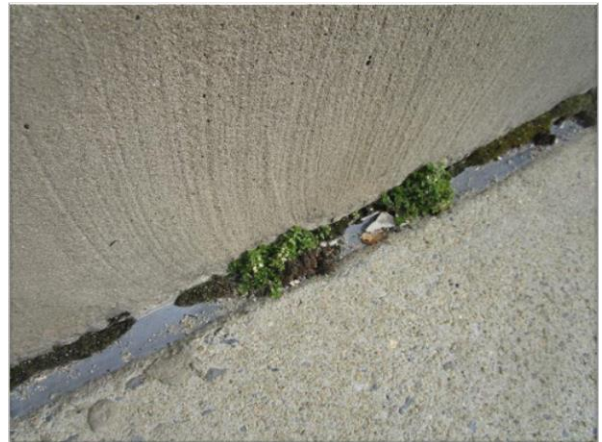
**c. Ring Wall Control Joint**

**OBSERVATION:** The tank ring wall-to-containment interface exhibits voids, cracking, disbondment, and vegetation growth.

**CODE REFERENCE:** UFC 3-460-03 SECTION 8-10.2.2 (C)

**RECOMMENDATION:** Provide approximately 100 linear feet (100%) of sealant repair at the tank ring wall-to-containment interface with a flexible, UV protective, and fuel resistant sealant.

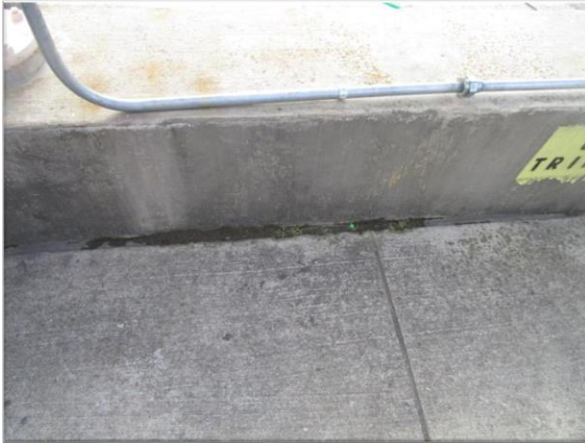
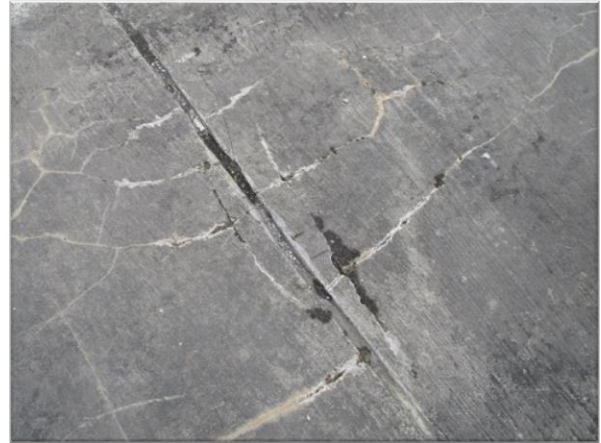
**d. Control Joint Sealant**

**OBSERVATION:** Sealant provided for control joints located in the containment dike exhibit voids, cracking, disbondment, and vegetation growth.

**CODE REFERENCE:** UFC 3-460-03 SECTION 8-10.2.2 (C)

**RECOMMENDATION:** Provide approximately 50 linear feet of sealant repair at control joints within the containment dike with a flexible, UV protective, and fuel resistant sealant.

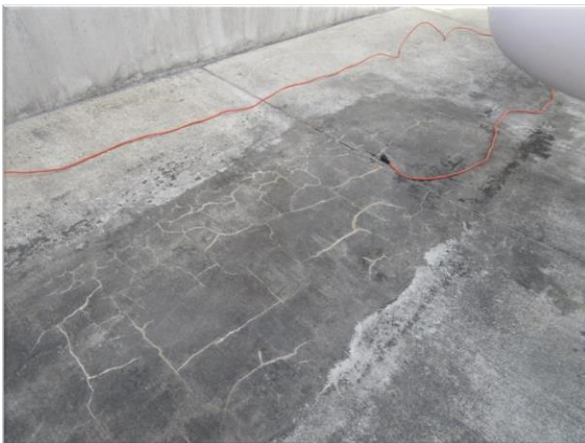
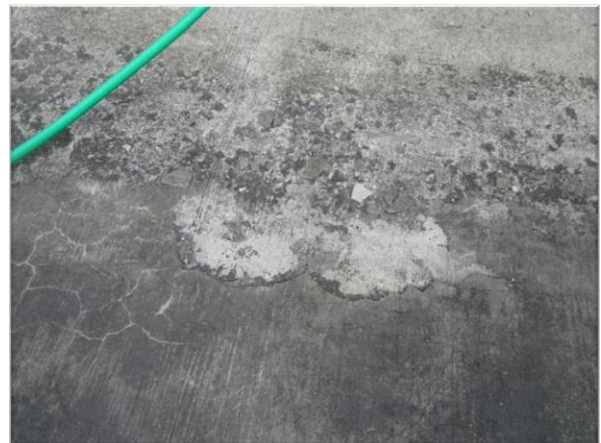
**e. Containment Floor Cracking**

**OBSERVATION:** Cracking was observed throughout the containment dike floor.

**CODE REFERENCE:** UFC 3-460-03 SECTION 8-10.2.2 (C)

**RECOMMENDATION:** Provide approximately 25 linear feet of sealant to cracking located throughout the containment dike.

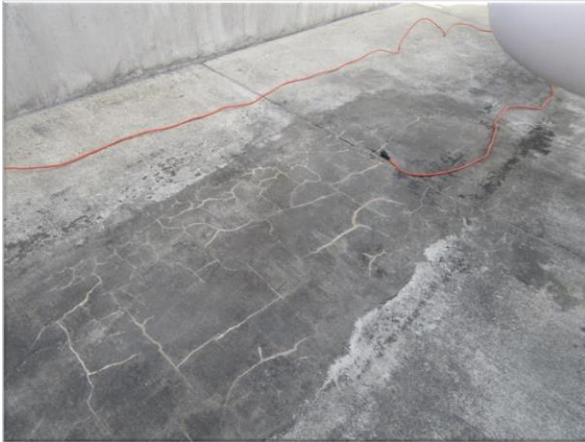
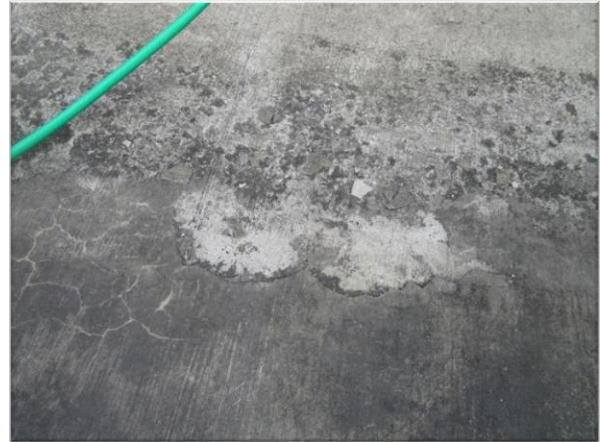
**f. Containment Floor Spalling**

**OBSERVATION:** Spalling and damage was observed throughout the containment dike floor.

**CODE REFERENCE:** UFC 3-460-03 Section 8-10.2.2 (B)

**RECOMMENDATION:** Repair concrete dike floor. Existing floor exhibits approximately 10 ft<sup>2</sup> of spalling and damage.

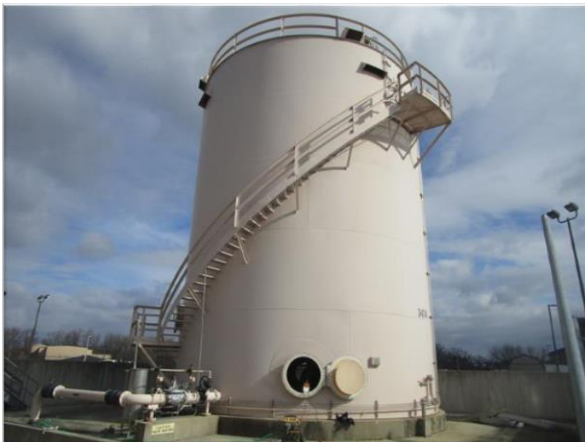
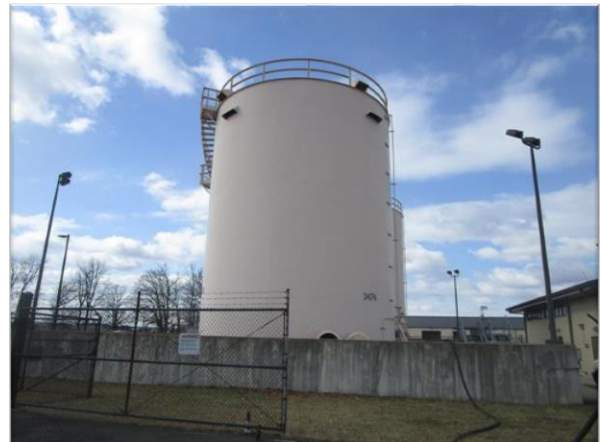
**g. Emergency Responder Diamond**

**OBSERVATION:** The tank is not provided with an emergency responded diamond.

**CODE REFERENCE:** UFC 3-460-01 2-18 (C)

**RECOMMENDATION:** Provide emergency responder diamond in accordance with NFPA 704.

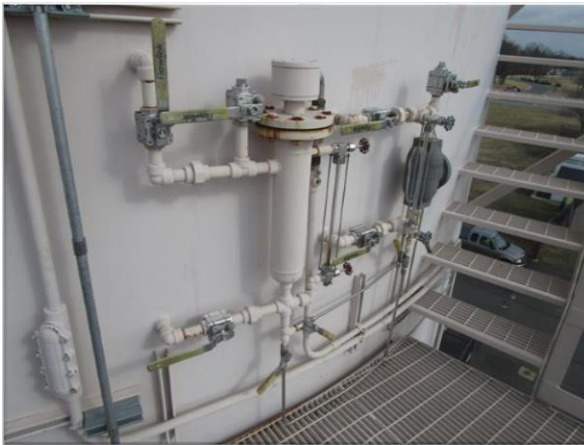
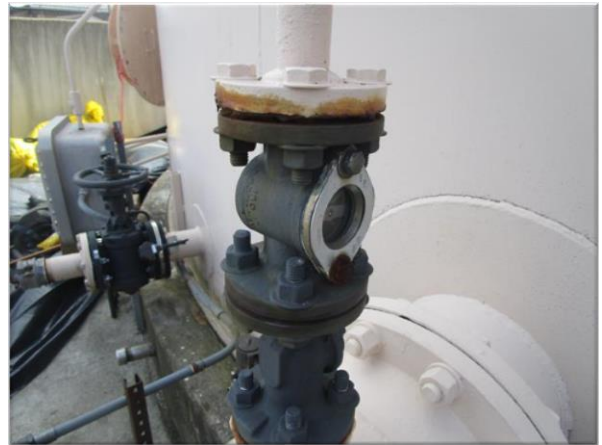
**h. Coating Failure**

**OBSERVATION:** Coating provided for various piping, nozzles, and appurtenance displays flaking, corrosion staining, and deterioration.

**RECOMMENDATION:** Provide approximately 12 ft<sup>2</sup> of coating repair at the following piping, nozzles, and appurtenances:

- Main suction crossover piping – 2 ft<sup>2</sup>
- Receipt crossover piping – 2 ft<sup>2</sup>
- HLA, HHLA, and high level control valve (HLCV) shutoff switch – 2 ft<sup>2</sup>
- LLA and LLLA – 3 ft<sup>2</sup>
- Center sump – 1 ft<sup>2</sup>

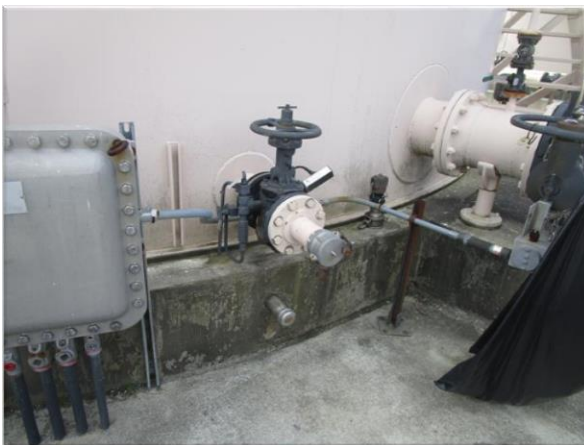
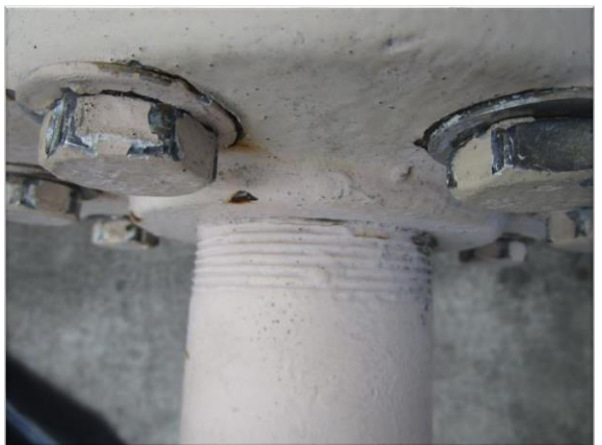
**i. Low Suction Piping**

**OBSERVATION:** The low suction line is provided with 4" threaded piping. Threaded piping is not recommended for piping larger than 2".

**CODE REFERENCE:** UFC 3-460-01, 7-5.2 (a)

**RECOMMENDATION:** Replace 1 linear foot of threaded piping located on the 4" low suction line.

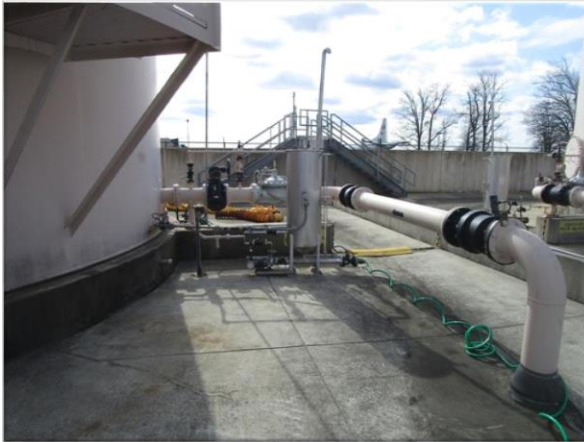
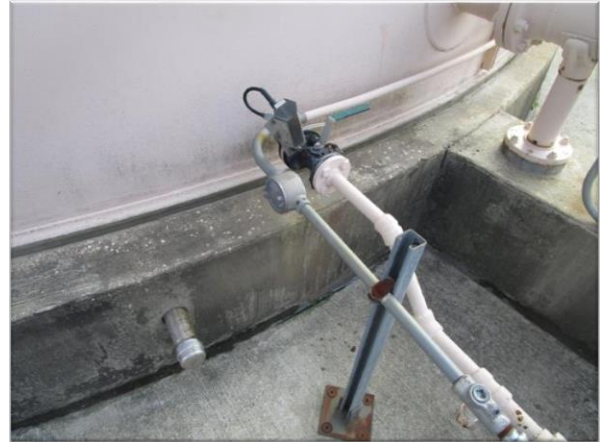
**j. Water Draw-Off Line**

**OBSERVATION:** The water draw-off line is provided with a ball valve at the skin location. Ball valves may not provide adequate isolation during maintenance and inspection operations.

**CODE REFERENCE:** UFC 3-460-01, Table 8-1 (Z)

**RECOMMENDATION:** Replace 1" ball valve with a 1" DB&B valve on the water draw-off line.

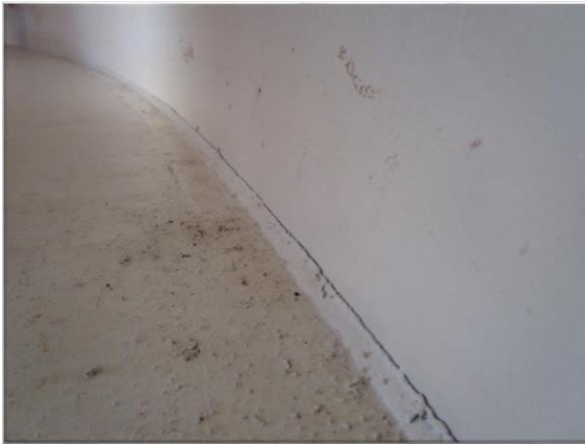
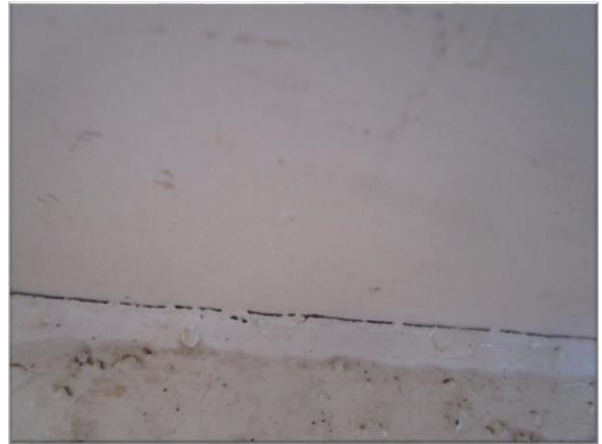
**k. Internal Shell-to-Bottom Weld**

**OBSERVATION:** Coating along the shell-to-bottom weld displayed cracking and disbondment.

**CODE REFERENCE:** UFC 3-460-03, Section 8-3.2

**RECOMMENDATION:** Recoat 100 ft<sup>2</sup> (100%) of internal shell-to-bottom weld.

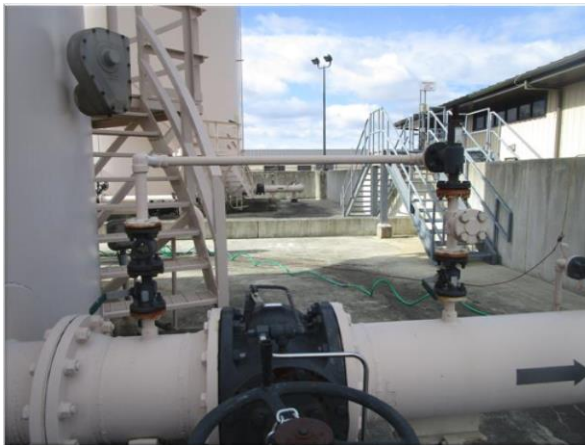
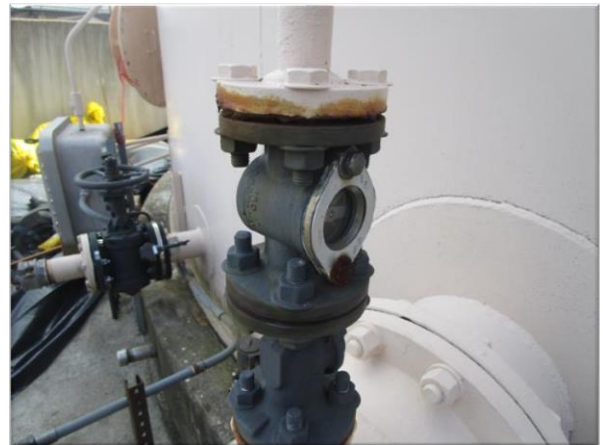
**I. Sight Flow Indicators**

**OBSERVATION:** Sight flow indicators are located in crossover piping for the main suction and receipt line. Sight flow indicators are no longer used in this application as they present potential leak paths.

**CODE REFERENCE:** UFC 3-460-01 9-3.5.1

**RECOMMENDATION:** Remove two (2) sight flow indicators located in the crossover piping provided for the receipt and main suction lines.

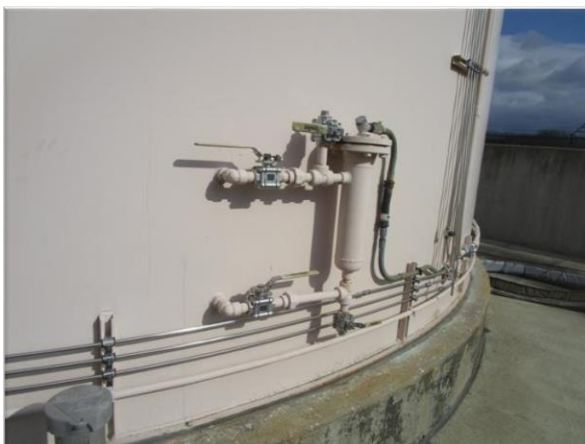
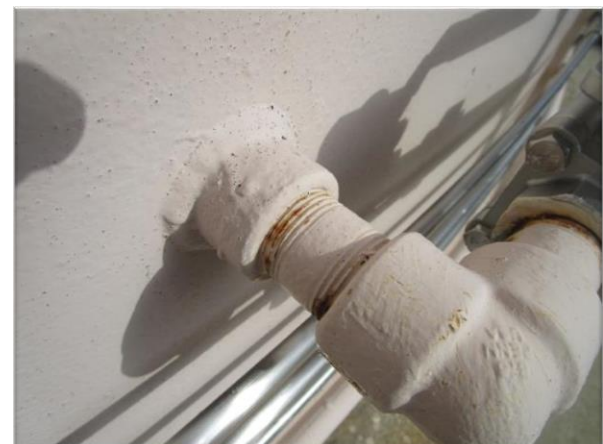
**m. HLA, HHLA, HLCV, LLA, and LLLA**

**OBSERVATION:** Piping provided for the HLA, HHLA, HLCV, LLA, and LLLA and provided with threaded connections.

**CODE REFERENCE:** UFC 3-460-01, 7-5.2 (b)

**RECOMMENDATION:** Either replace the HLA, HHLA, HLCV, LLA, and LLLA piping with welded/flanged connections or seal weld existing threaded connections.

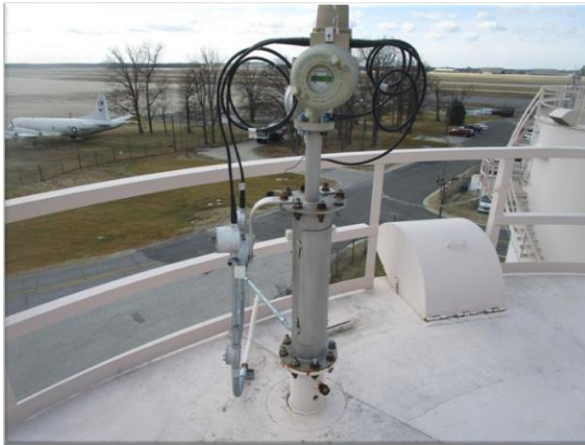
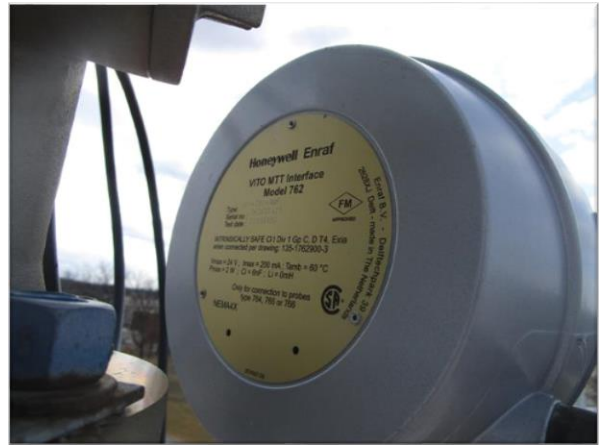
**n. VITO Temperature/Water Probe**

**OBSERVATION:** The VITO temperature/water probe shares a nozzle riser and stilling well with the Enraf ATG.

**CODE REFERENCE:** UFC 3-460-01, Table 8-1 (S) / DLA-E ATG Policy

**RECOMMENDATION:** Provide the VITO temperature/water probe with an 8" riser and 6" fully slotted stilling well as close to the center sump as feasible.

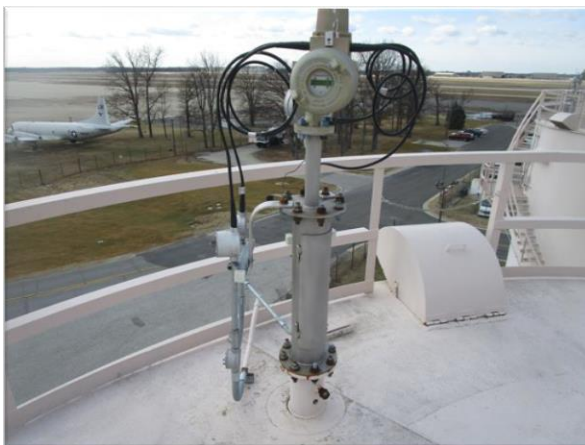
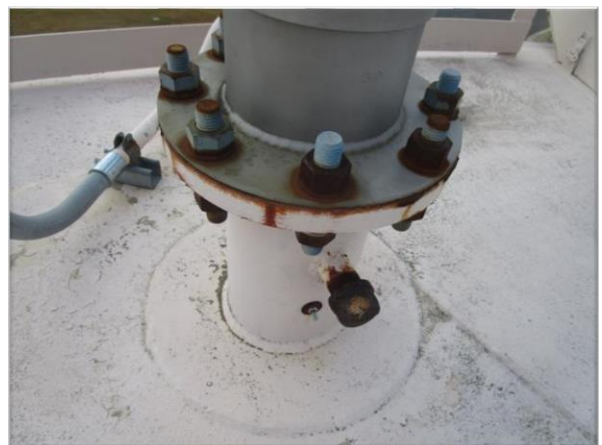
**o. Enraf ATG Fasteners**

**OBSERVATION:** Fasteners provided for the Enraf ATG flanges display coating failure and surface corrosion.

**CODE REFERENCE:** UFC 3-460-01, 9-8 (f)

**RECOMMENDATION:** Replace sixteen (16) corroded fasteners located in the Enraf ATG flange.

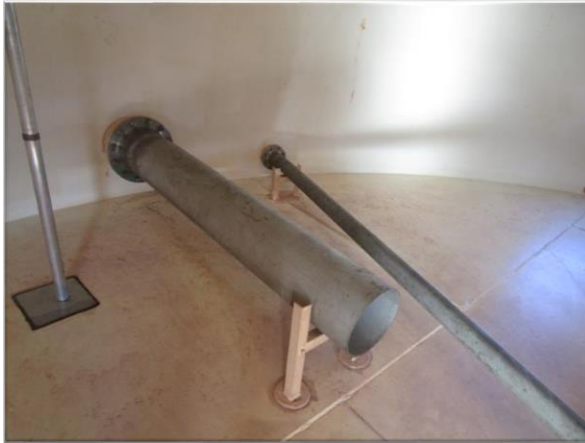
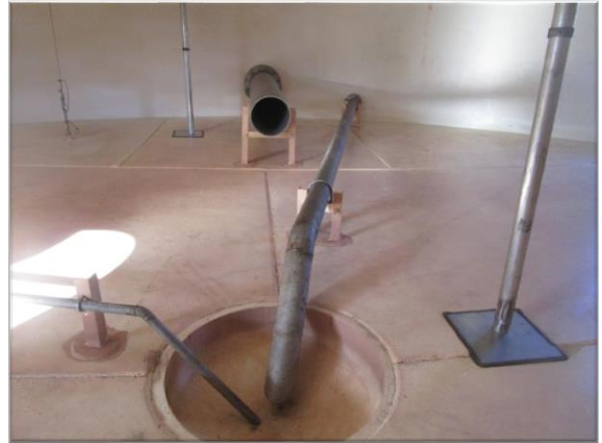
**p. Main Suction Internal Piping**

**OBSERVATION:** Internal piping provided for the main suction line does not turn down, and is not provided with an anti-vortex plate.

**CODE REFERENCE:** AW 78-24-27, D.08 (4)

**RECOMMENDATION:** Provide the 12" main suction line with a short radius elbow and anti-vortex plate.

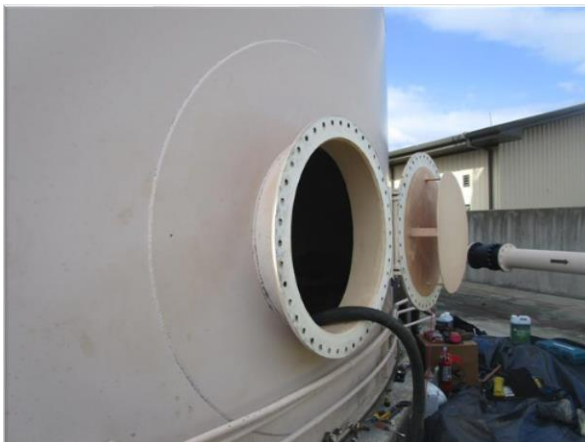
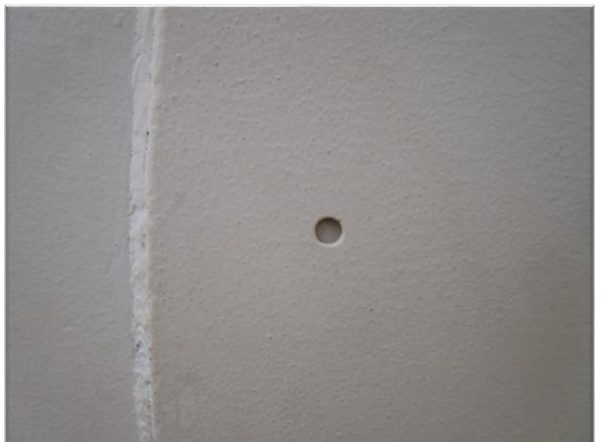
**q. Tell-Tale Hole**

**OBSERVATION:** Tell-tale holes provided for nozzle reinforcement pads are opened to the atmosphere allowing water ingress, and place for insects nesting.

**CODE REFERENCE:** UFC 3-460-03, 8-9.13.4.1

**RECOMMENDATION:** Provide a heavy lithium grease to all nozzle reinforcement pad tell-tale holes to prevent water ingress.

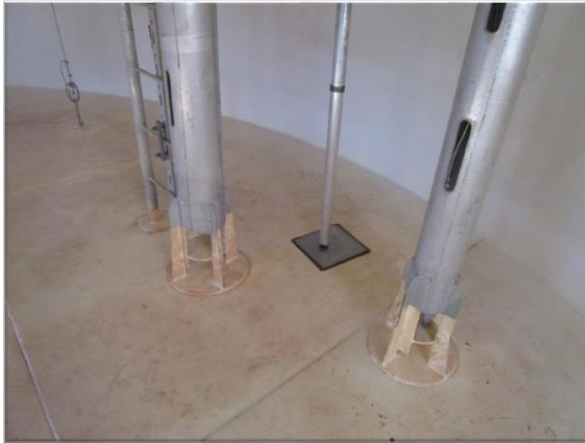
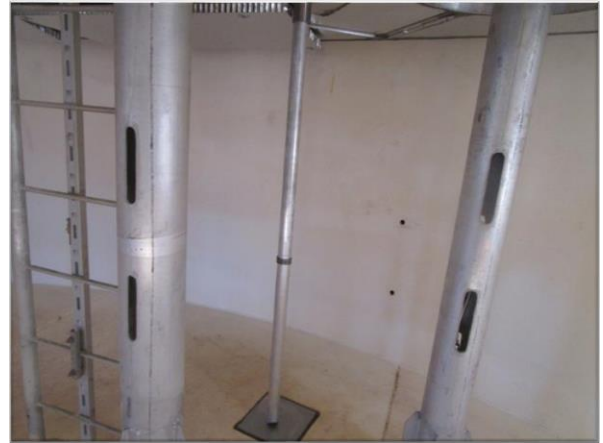
**r. Gauging Stilling Wells**

**OBSERVATION:** Stilling wells provide for the Enraf ATG and manual gauging hatch are partially slotted, with slots only running up to initial 4 ft of the stilling well.

**CODE REFERENCE:** UFC 3-460-01, Table 8-1 (R)/(S) / DLA-E ATG Policy

**RECOMMENDATION:** Fully slot stilling wells provided for the manual gauging hatch and Enraf ATG.

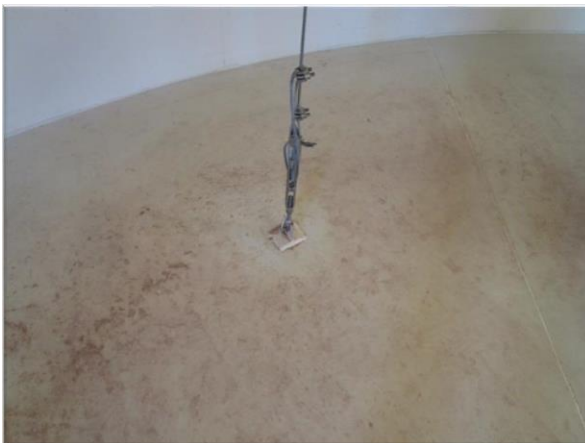
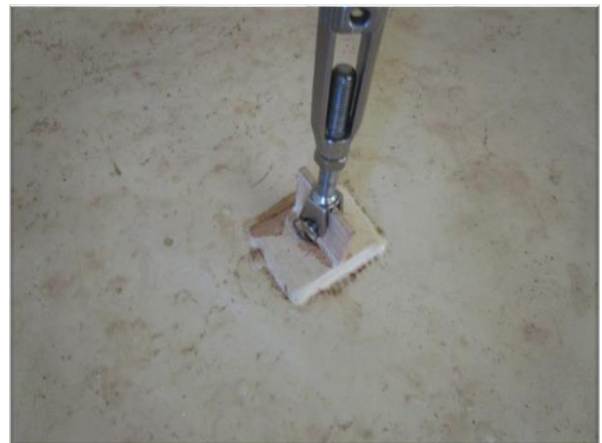
**s. Anti-Rotation Cable**

**OBSERVATION:** Two (2) anti-rotation cables are attached directly to the tank bottom via square corner attachments.

**CODE REFERENCE:** API 653 Figure 9-13

**RECOMMENDATION:** Provide two (2) circular bearing plates for both anti-rotation cables.

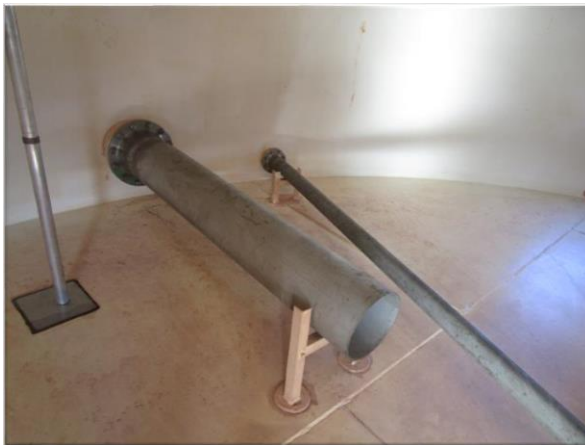
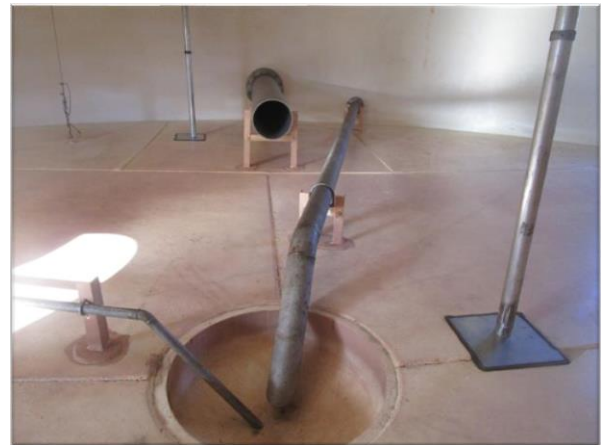
**t. U-bolt**

**OBSERVATION:** The main suction and low suction lines are not provided with U-bolts, used to limit lateral movement of the piping during regular operations.

**CODE REFERENCE:** AW 78-24-27, D.08 (6)

**RECOMMENDATION:** Provide one (1) stainless steel u-bolt restraint with loosened nuts for both the internal main suction and low suction line. Internal piping must be allowed to move vertically with the tank bottom.

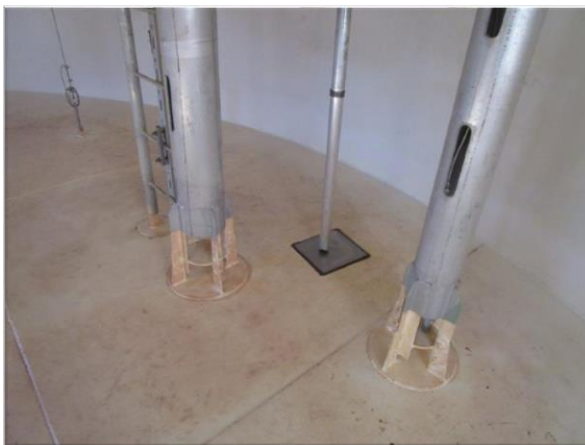
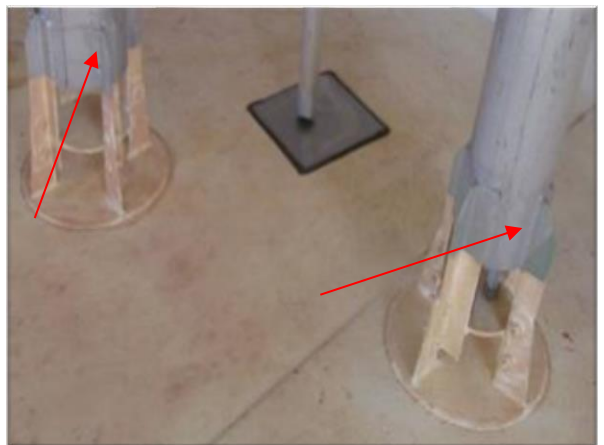
**u. Attached Stilling Wells**

**OBSERVATION:** Stilling wells provided for the manual gauging hatch and Enraf ATG are attached directly to well guides. This attachment may cause severe damage to the tank bottom should the tank begin to settle.

**CODE REFERENCE:** AW 78-24-27, D.08 (6)

**RECOMMENDATION:** Rework stilling wells for the manual gauging hatch and Enraf ATG by removing welds attaching the stilling wells to well guides.

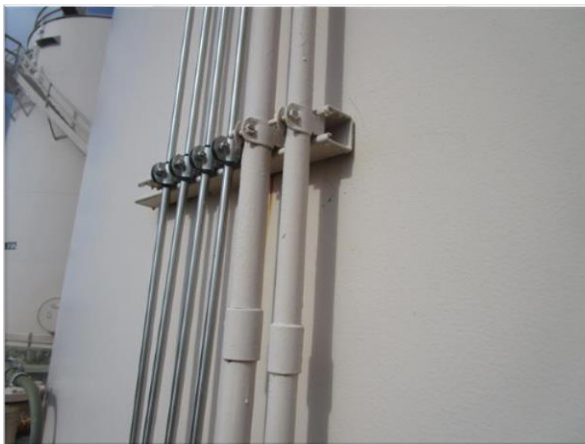
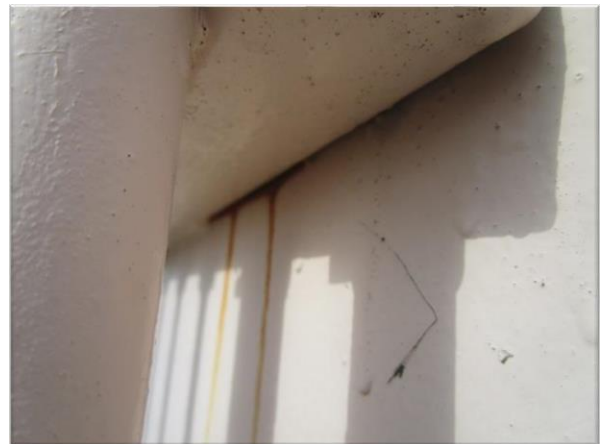
**OBSERVATION:** Conduit supports provided for the HLCV and visible alarm conduit is stitch-welded. Crevice corrosion and staining was observed between the conduit-to-shell interfaces.

**CODE REFERENCE:** BMP

**RECOMMENDATION:** Provide sealant or fully weld eighteen (18) stitch-welded conduit supports provided for both the HLCV conduit and the visible alarm conduit.

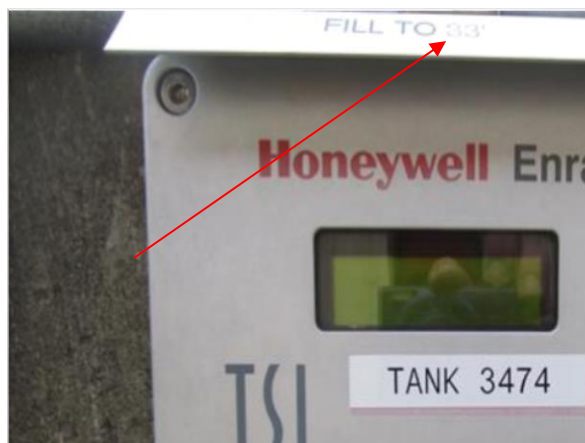
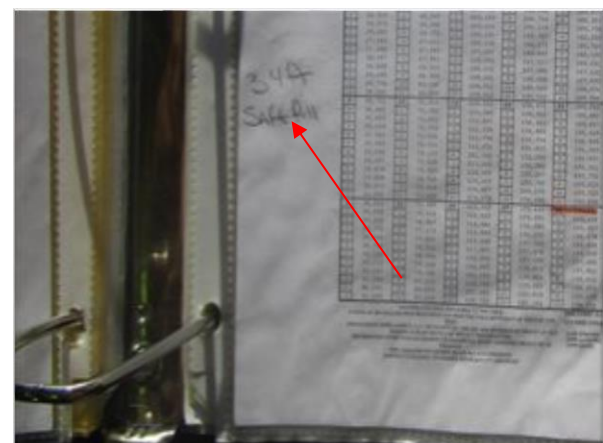
#### b. Fill Height

**OBSERVATION:** A white label is placed on the Enraf ATG stating a fill height of 33'-0" while the strapping charts list the safe fill height as 34'-0".

**CODE REFERENCE:** BMP

**RECOMMENDATION:** Correct safe fill limit shown on the Enraf ATG display.

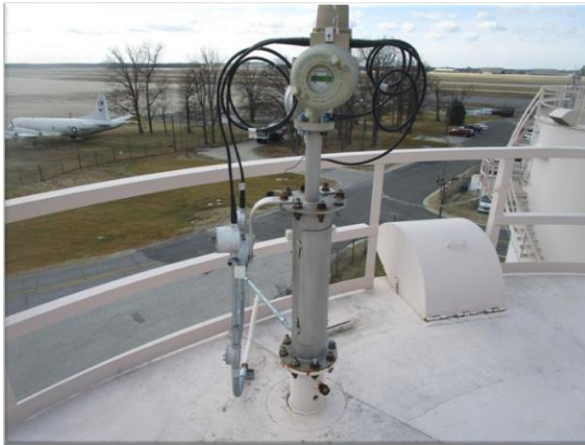
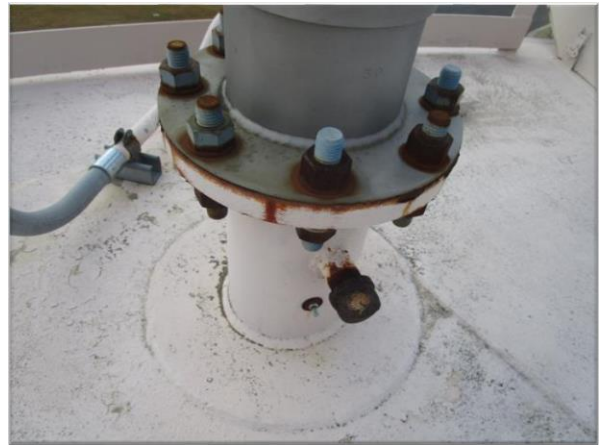
**c. Pipe Cap**

**OBSERVATION:** Cap located on piping extruding from the Enraf ATG riser displays significant surface corrosion with noticeable metal loss.

**CODE REFERENCE:** BMP

**RECOMMENDATION:** Replace corroded cap located on the 1" pipe extruding from the Enraf ATG riser.

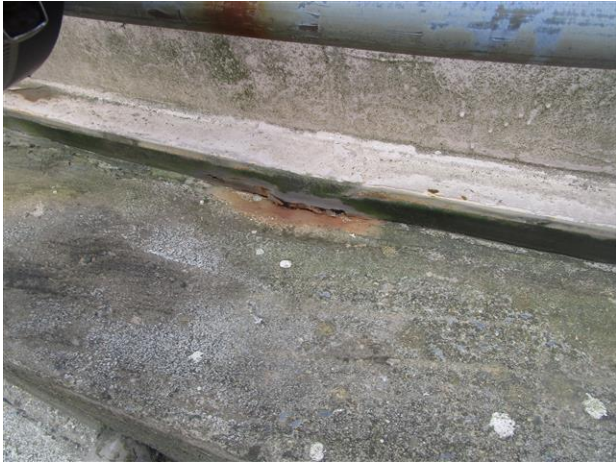
C18: Conduit Support w/ Crevice Corrosion

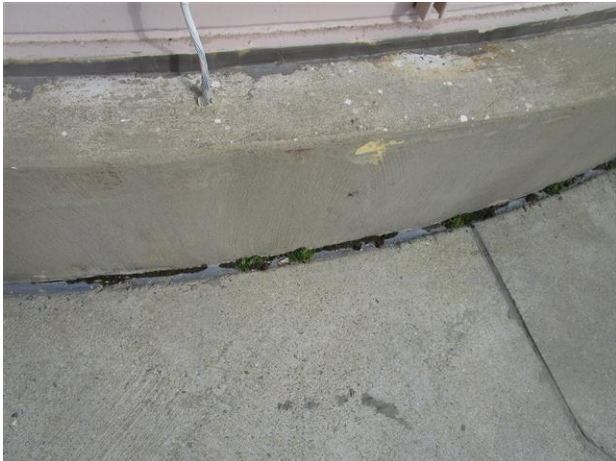
C20: Tank Chime Sealant Failure

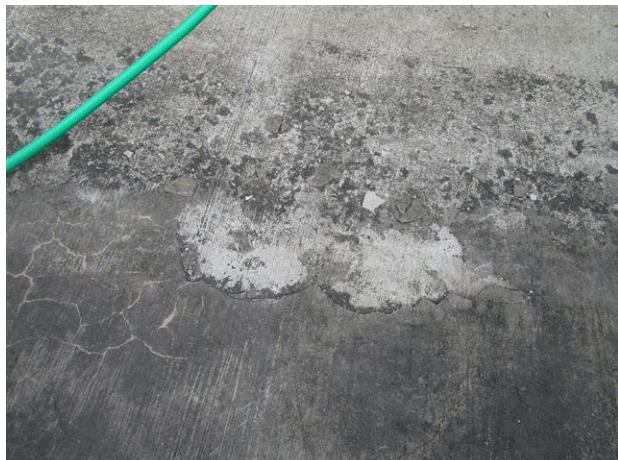
C23: Cracking in Containment Dike

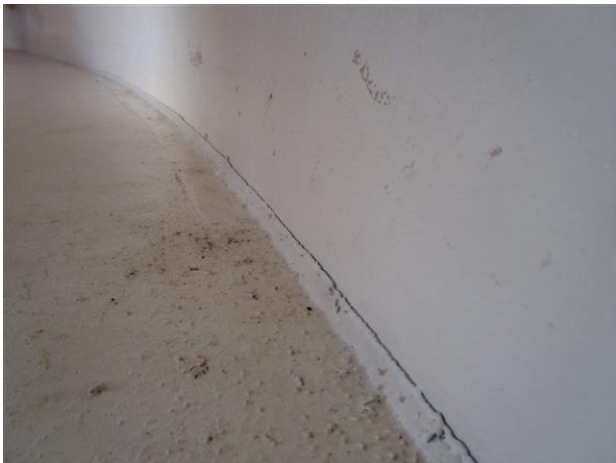
C38: Wide Spread Pitting along the Tank Bottom

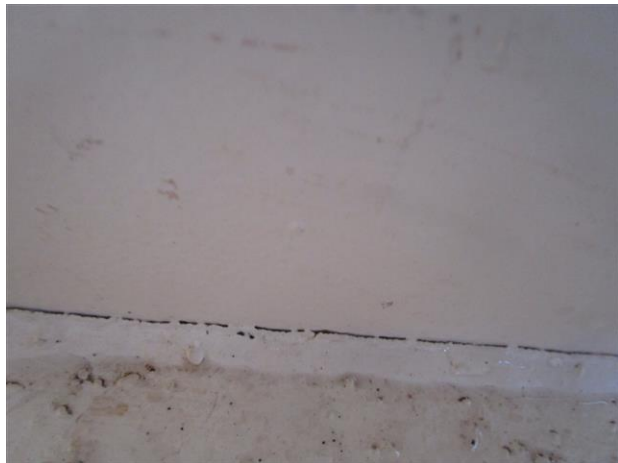
C39: Cracked Coating along the Internal Shell-to-Bottom Weld

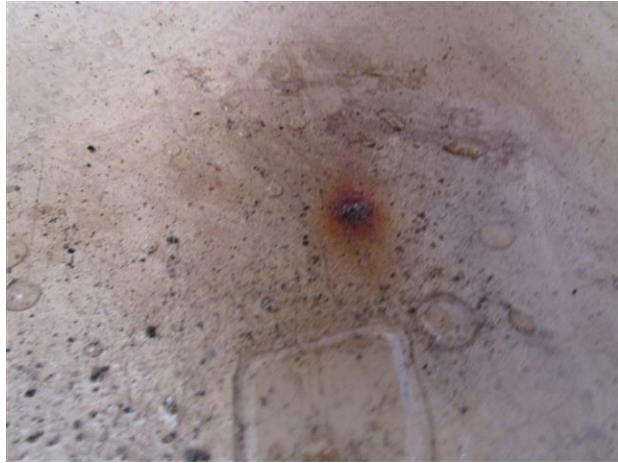
C43: Coating Failure at Center Sump
