API-653 Engineering Inspection Report Tank # 2110 (Tank #6)

US Air Force - McGuire AFB; McGuire AFB, NJ

February 22, 2018

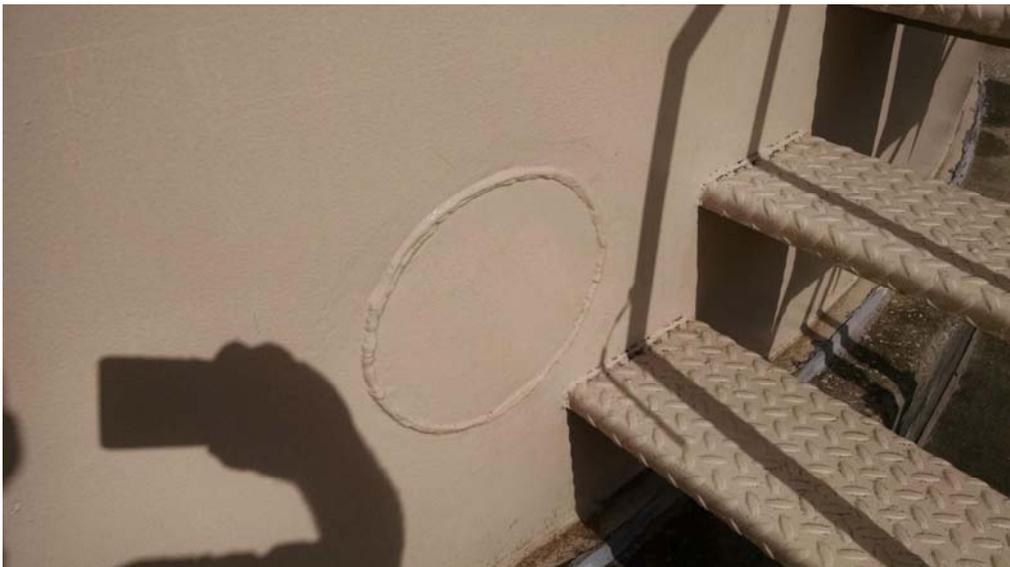
E.15 Replaced Butt-Welded Insert Plate

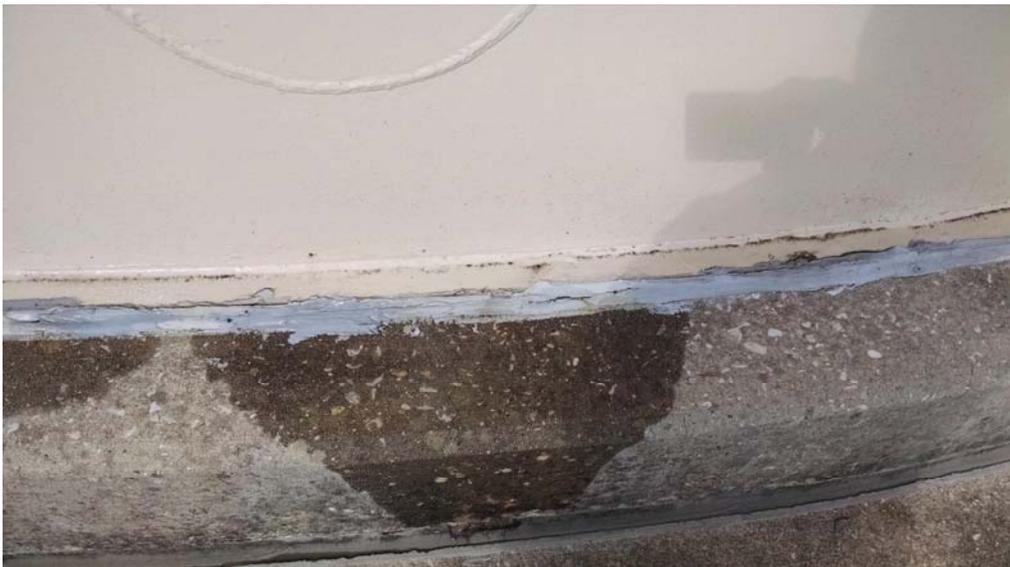
E.21 Failed Area of Bottom-to-Foundation Sealant

Repair or replace the bottom-to-foundation seal.

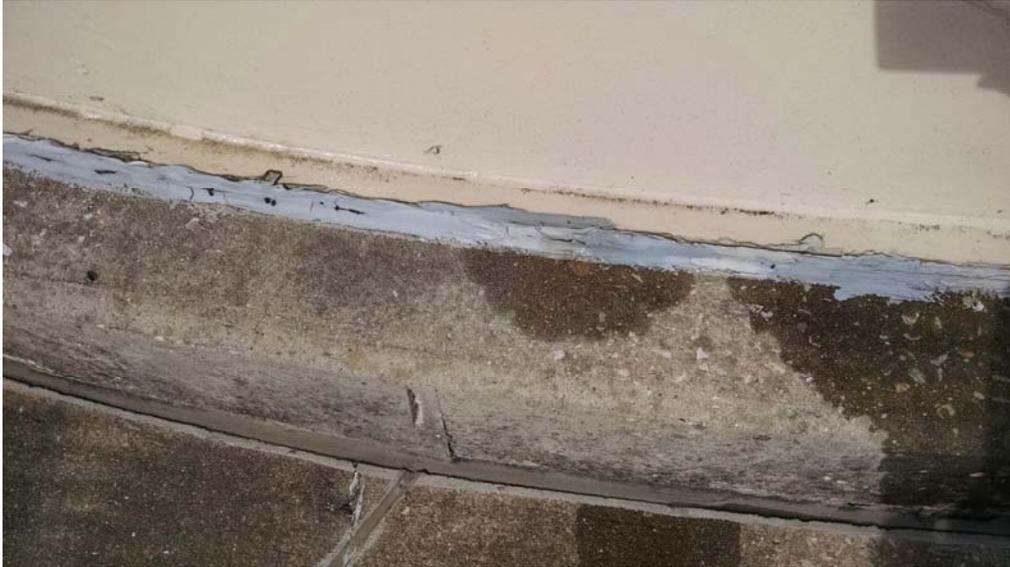
E.22 Failed Area of Bottom-to-Foundation Sealant

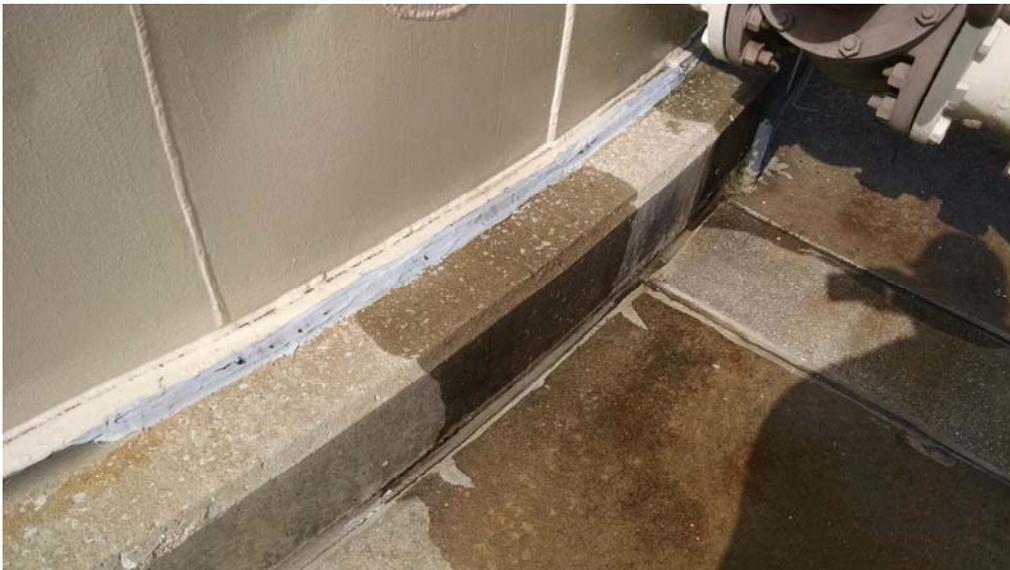
E.23 Failed Area of Bottom-to-Foundation Sealant

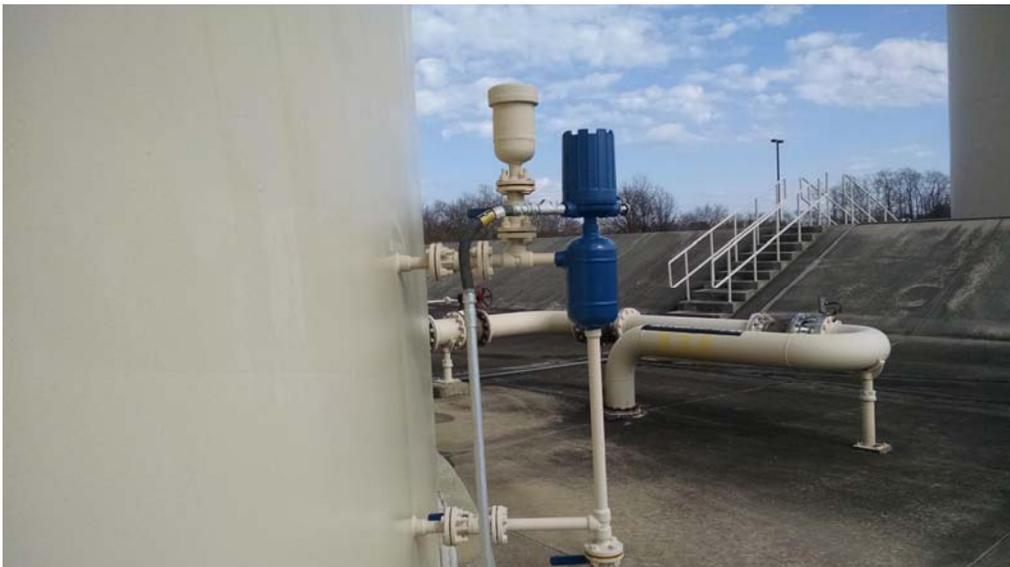
4.1.7 **Painting/Insulation:** The tank shell, roof, stairway, piping and appurtenances are coated. The coating is in good condition on all areas, with the exception of the 1-inch flanges associated with the high-level alarms.

E.24 Shell Nozzles E and F, 1" Low Level Alarm

4.2.7 **Painting/Insulation:** Mechanically clean and recoat areas of coating failure on the high-level system flanges. All coating repairs should be accomplished using an epoxy-based coating system or equivalent.

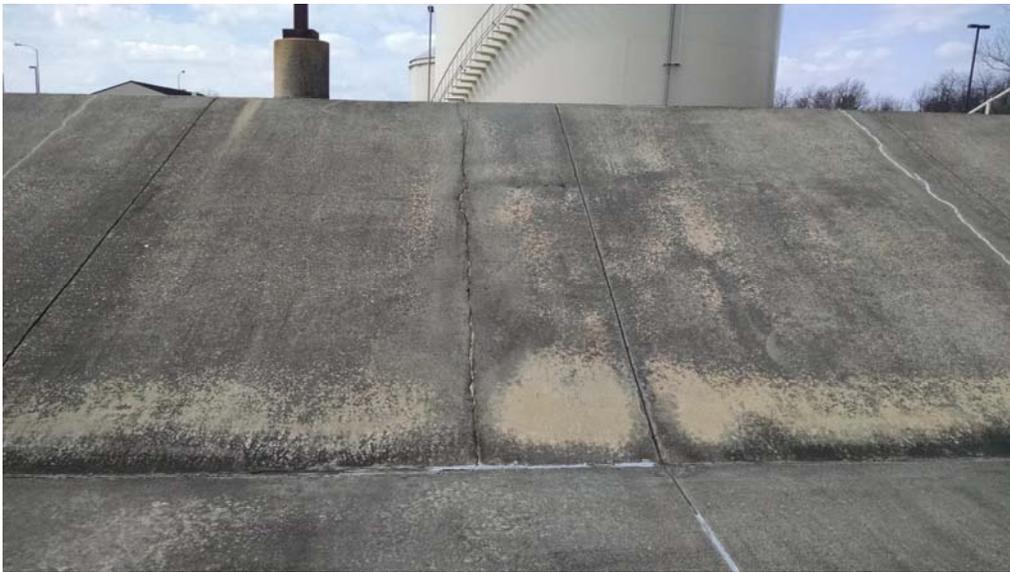
E.32 Large Crack in Containment Wall

4.2.2 **Containment:** Seal the crack in the containment wall (approximately 14 LF).

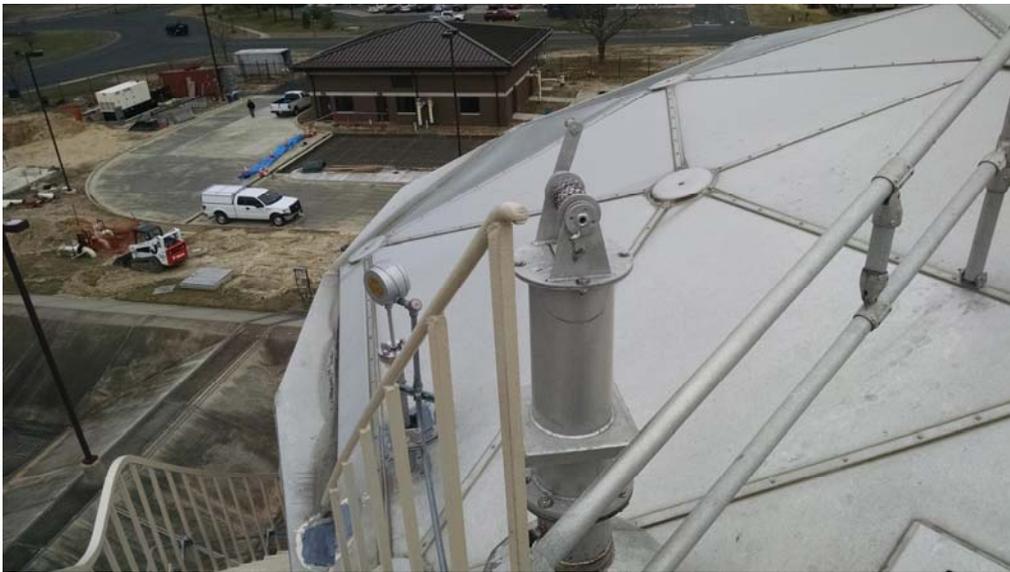
E.35 View of Geodesic Dome

4.1.4 **Roof:** The fixed roof is an aluminum geodesic dome with proper screening located at the shell attachment junctures. Fuel personnel reported that the geodesic dome leaks during heavy rainfall.

4.2.4 **Roof:** Replace the bad sealant material in the geodesic dome.
