**US Army Corps of Engineers  
Omaha District  
API 653 Out-of-Service  
Inspection Report**

**Andrews Air Force Base, Morningside, Maryland  
Facility 3473  
Tank 73**

**US Army Corps of Engineers Center of Expertise for Petroleum, Oils and Lubricants  
USACE POL-MCX**

**22 February 2017**

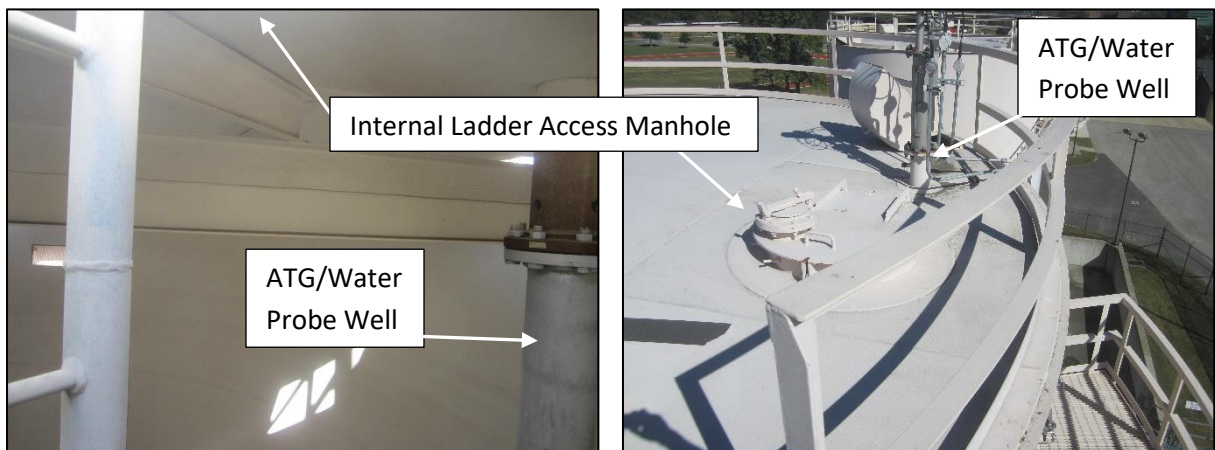
**OBSERVATION:** The internal ladder side rail well, which is accessible through a roof manhole cover provides the only means of manual gauging, is not slotted above 5-foot level, and does not have a floating plug retriever. The Enraf ATG and Vito Water/Temperature Probe share a 6-inch well located near the perimeter of the tank. The 6-inch ATG/Water Probe well transitions to stainless steel just under the roof and is not slotted above the 5-foot level. The stainless steel may result in galvanic corrosion under any interior coating flaws, if water is present. If the well were made of aluminum it could provide some passive cathodic protection.

**RECOMMENDATION:** Provide a 10-inch roof nozzle with an 8-inch aluminum full length slotted stilling well for the ATG and a separate 8-inch roof nozzle with a 6-inch aluminum stilling well in or near the bottom sump for the Vito Water/Temperature probe. Eliminate the stainless steel stilling well. Full length slot the ladder well.

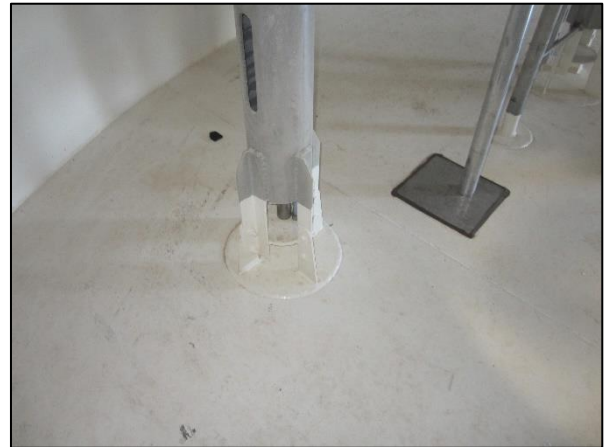
**b. Modify Stilling Well Guides**

**OBSERVATION:** The 6-inch combination ATG and Vito Water Probe well is bolted to the tank bottom, as well as attached to the tank roof. In addition, the internal ladder is attached to the tank roof manhole neck as well as bolted to its bottom end guides, which are welded to the tank bottom.

**RECOMMENDATION:** Loosen the U-bolts attaching the internal ladder to the roof manhole neck, and double nut the U-bolts to the manhole neck. If the well is not demolished, remove the welds attaching the combination ATG and Vito Water Probe well to the bottom guides.

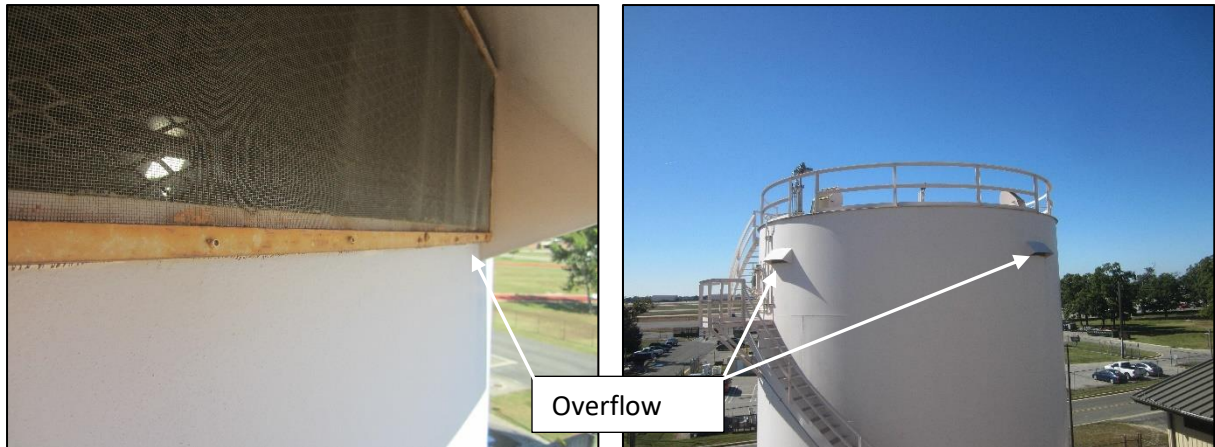
**REFERENCE:** API 650 paragraph H-5.2.2 requires vent screens with 1/2-inch openings.

**RECOMMENDATION:** Remove the insect screen from the shell overflow opposite the stairway and product nozzles.

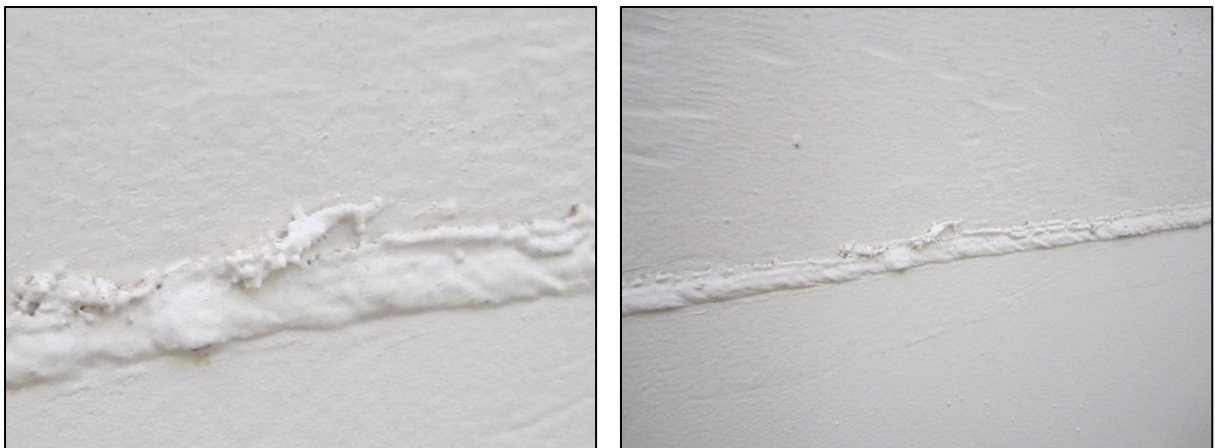
**e. Smooth the Interior Horizontal Welds**

**OBSERVATION:** As observed from on top of the floating pan at high leg position, the interior horizontal welds appear to have a rougher profile and more weld splatter than allowed by the current UFGS Specification 33 56 13.13 for new construction. Rough surfaces of welds may reduce the life of the floating pan perimeter seals and the interior coating.

**RECOMMENDATION:** When the interior coating is replaced grind the interior horizontal weld surfaces smooth and remove weld splatter.

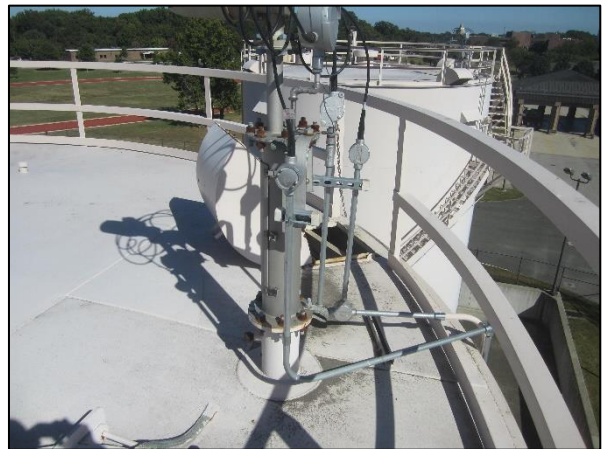
**b. Adjust Enraf Door Latches**

**OBSERVATION:** The Enraf ATG access door latches are out of adjustment and do not properly engage the door seal so as to prevent rainwater from entering the tank.

**RECOMMENDATION:** Adjust the Enraf access door latches so that all latches engage the door seal.

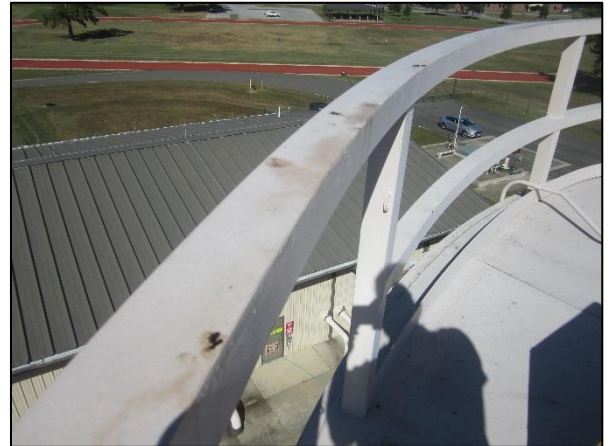
**OBSERVATION:** The isolated areas of the exterior of the shell and roof are covered with mold and algae, which can lead to coating failure. In addition, bird droppings were observed on the roof guardrail. API 570 paragraph 4.3.2.3.h) reads, “bird turds can also cause accelerated corrosion and unsightly stains.”

**RECOMMENDATION:** Pressure wash the exterior of the tank regularly.

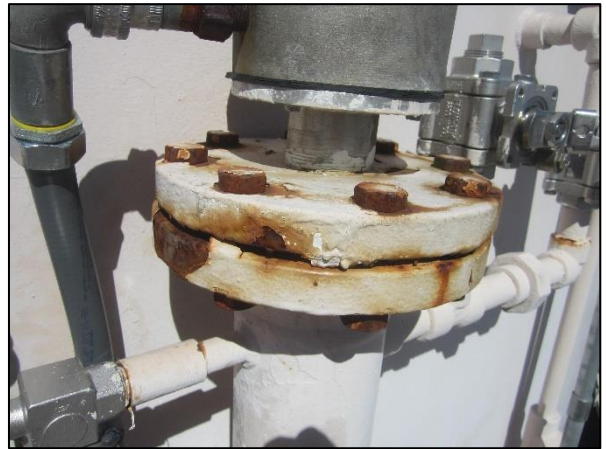
**j. Repair Appurtenance Coatings**

**OBSERVATION:** There is coating failure and corrosion on the receipt and issue DBB valves, TRV valves and their connecting flanges, and on the roof perimeter vent/inspection hatches at the roof penetration frames, hinges and edges of the covers. There is coating failure on the cathodic protection conduit, underside of the roof manhole cover and on the flange; level alarm sensor mounting flanges, and underside of the center vent cover.

**RECOMMENDATION:** Repair the coatings on the cathodic protection conduit, receipt and issue DBB valves; TRV valves and their connecting flanges; the roof perimeter vent/inspection hatches at the roof penetration frames, hinges, and edges of the covers; level alarm sensor mounting flanges; underside of the roof manhole cover and on the flange; and underside of the center vent cover.

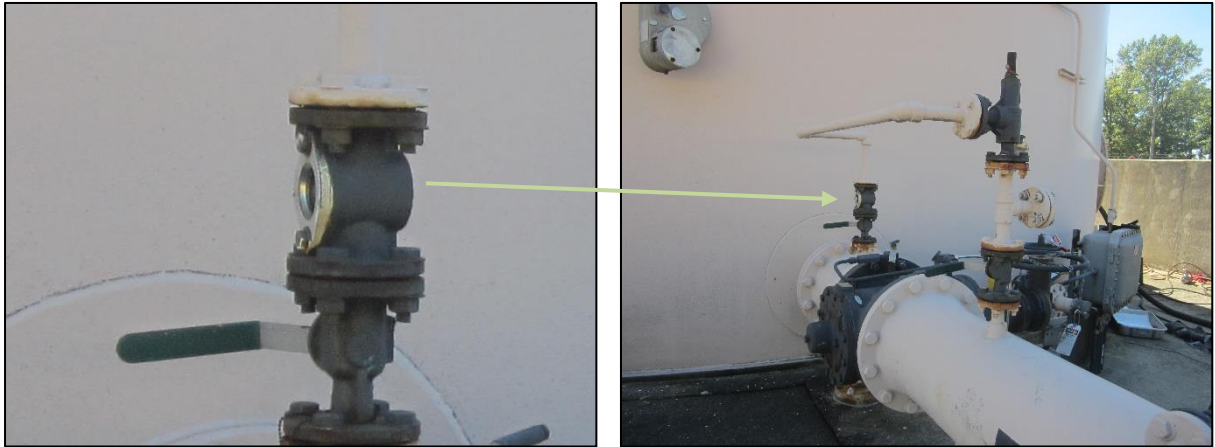
**d. Modify Thermal Relief Piping**

**OBSERVATION:** The receipt and issue thermal relief piping includes sight flow indicators. Facility personnel indicated they want to keep the sight flow indicators.

**RECOMMENDATION:** If Facility personnel agree, modify the thermal relief piping to eliminate the site flow indicators.

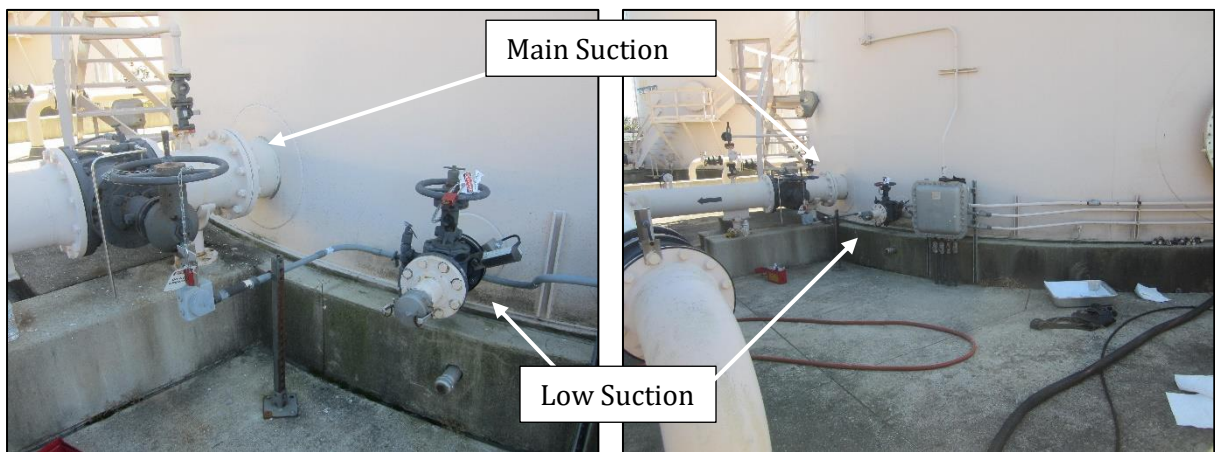
**e. Pipe low Suction to Main Suction**

**OBSERVATION:** The low suction nozzle is not piped to allow using the issue pumps to drain the tank in preparation for tank cleaning and entry. In theory, the location of the internal low suction piping could potentially reduce the self-cleaning action of the cone down bottom.

**RECOMMENDATION:** If the time and cost of removing the last few hundred barrels of fuel from the tank in preparation for cleaning and or maintenance is an issue, consider providing piping and valves to connect the low suction to the main suction.

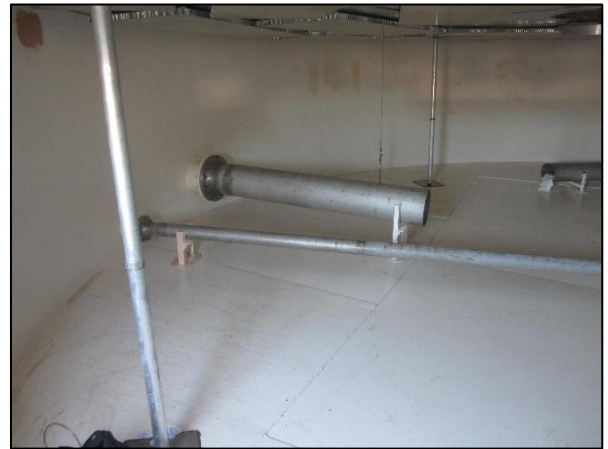
**f. Adjust Internal Pipe Supports**

**OBSERVATION:** The internal issue piping is not resting on its pipe support. The internal pipe supports are adjustable. However, the tank bottom may be expected to flex downward and piping to flex upward, due to the weight of the fuel and buoyancy of the pipe, when the tank is filled, thus widening the gap between the piping and the supports.

**RECOMMENDATION:** If supporting the internal piping when the tank is empty is a concern continue to readjust the internal pipe supports whenever the tank is taken out of service for cleaning.

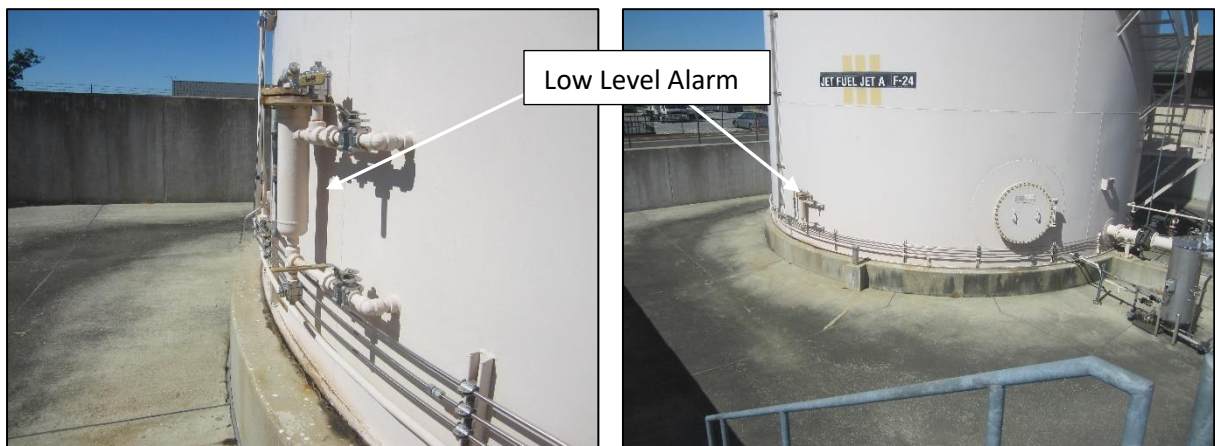
**i. Provide Low-low Level Alarm**

**OBSERVATION:** The only shell mounted low level alarm is located below the low leg level of the floating pan and has threaded connections.

**RECOMMENDATION:** If ensuring the operating level of the fuel is high enough to realize the benefit of a full contact floating pan is desired, demolish the existing low level alarm chamber, nozzles, piping, and sensors. Provide new shell mounted low and low-low level alarms at the proper levels.

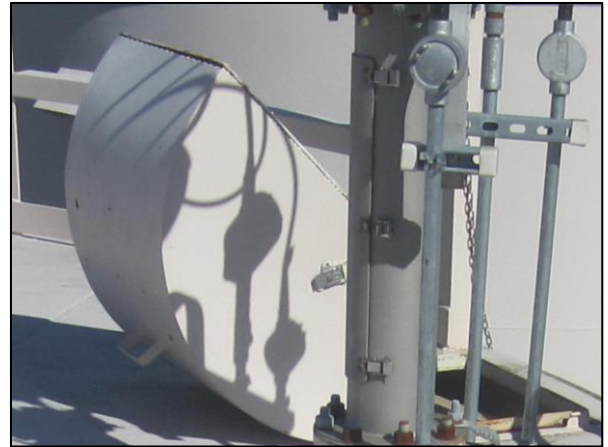
**j. Reinstall Latch**

**OBSERVATION:** The roof perimeter vent/inspection hatches have two latches each. However, one of the latches on the roof perimeter vent/inspection hatch counter clockwise of the ATG has one latch that is inoperable due to faulty installation.

**RECOMMENDATION:** The next time other welded repairs are performed on the tank, reinstall the faulty latch on one of the roof perimeter vent inspection hatches so that the latch is operable.

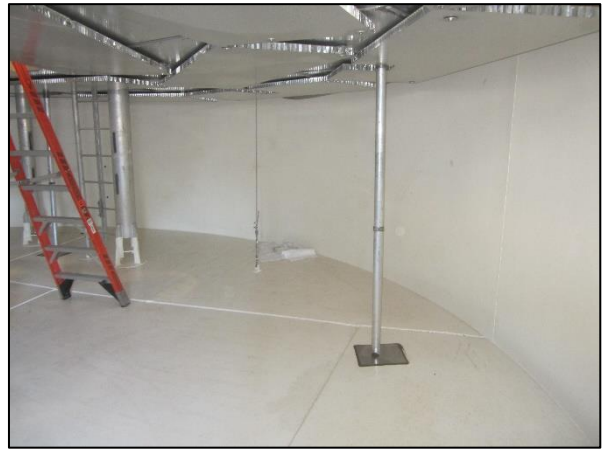
**m. Remove Stainless Steel IFR Striker Plates**

**OBSERVATION:** The internal floating pan support leg striker plates are stainless steel and glued to the tank bottom. Galvanic corrosion of the interior of the tank may occur, if water is present and the stainless steel striker plates make contact with the pan support legs or the tank bottom.

**RECOMMENDATION:** When major repairs to the internal coating are performed, remove the stainless steel IFR support leg striker plates, examine the tank bottom under the striker plates, repair the tank bottom and internal coating if indicated, and provide PTFE feet on the IFR support legs.

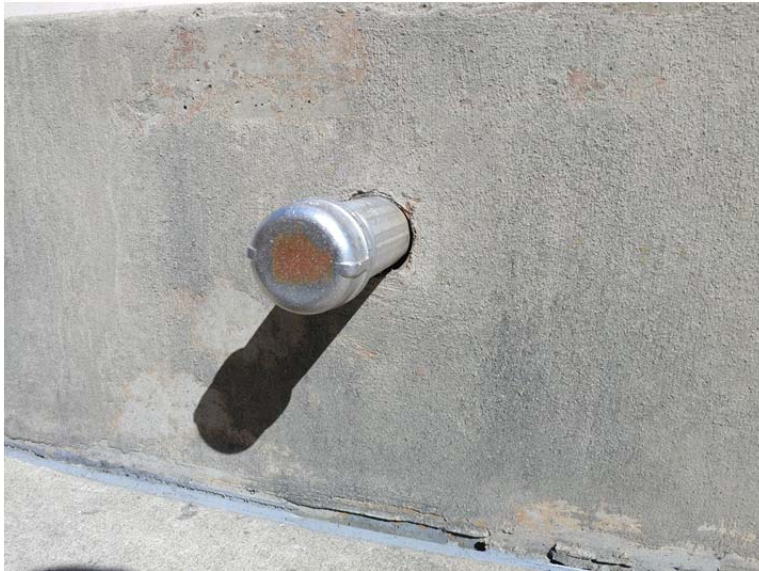
E.5 Leak Detection(Not Sealed)

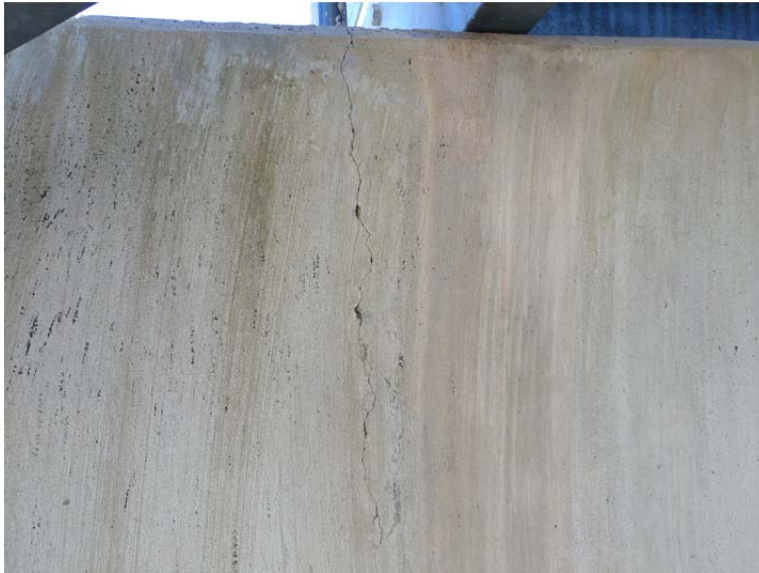
E.10 Crack in Secondary Containment Wall

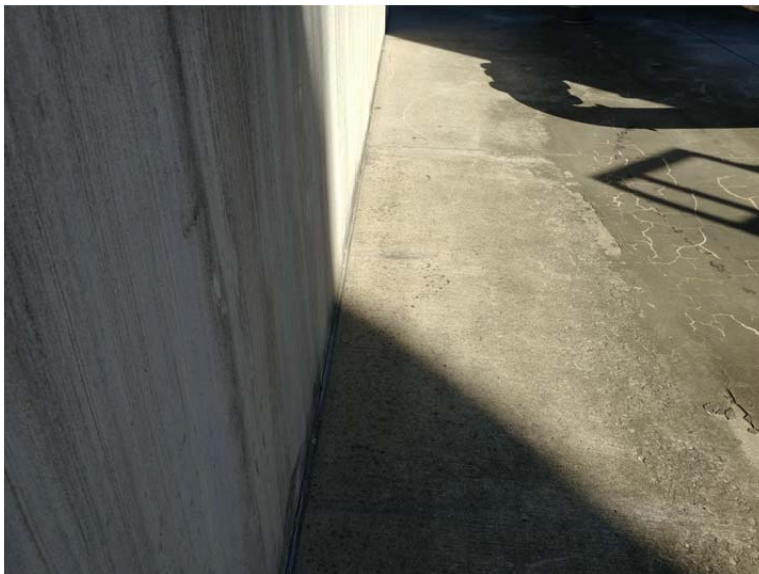
E.11 Failed Secondary Containment Wall to Floor Sealant.

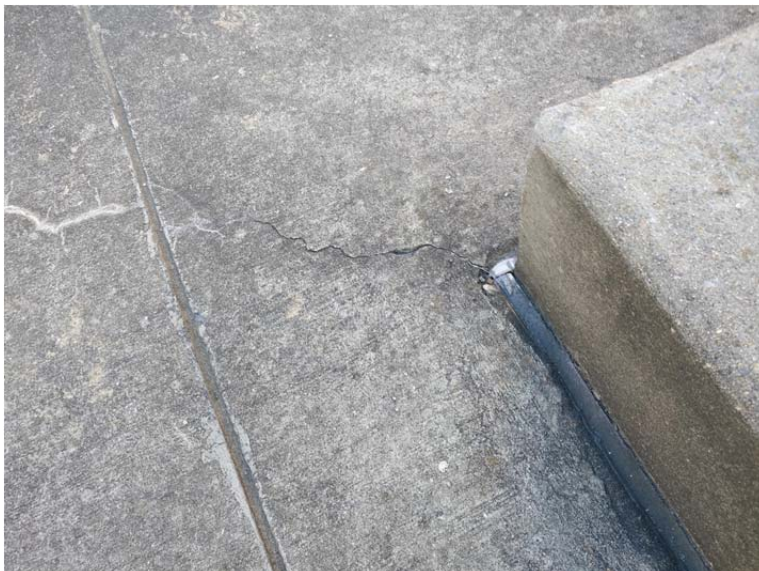
E.12 Cracks in Secondary Containment Floor

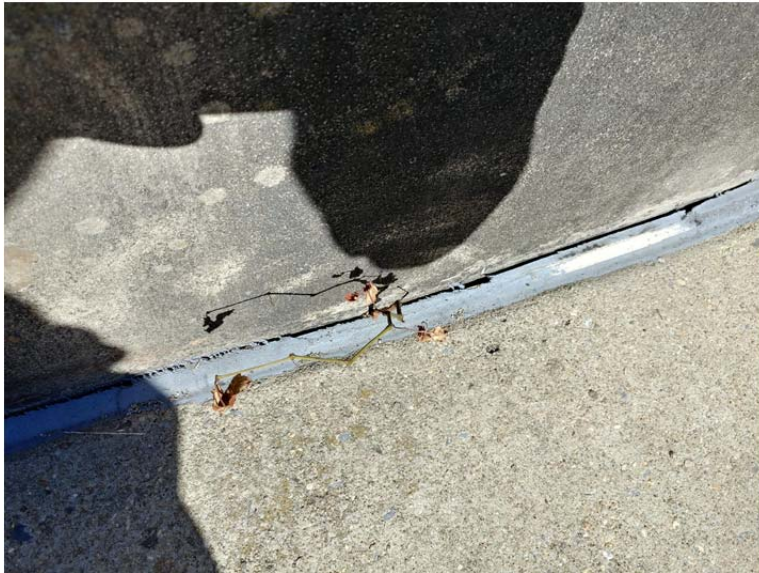
E.13 Failed Joint Sealant in Secondary Containment Floor

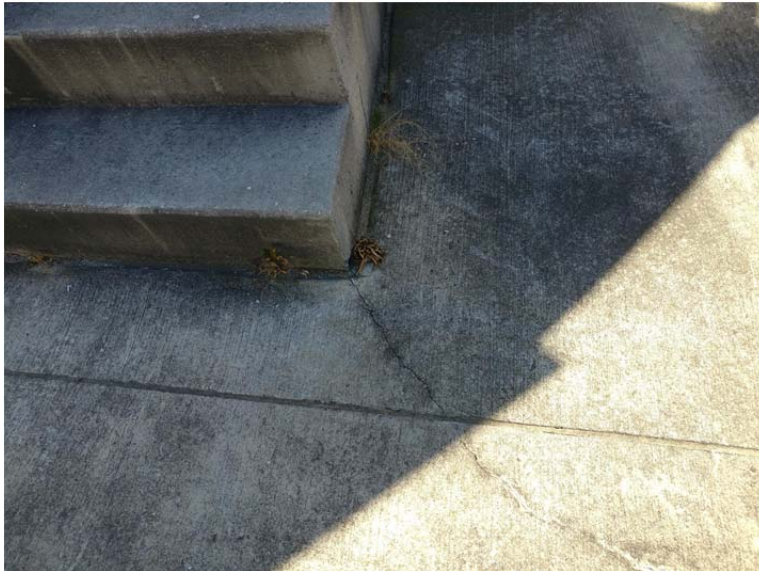
E.14 Cracks and Vegetation in Secondary Containment Floor

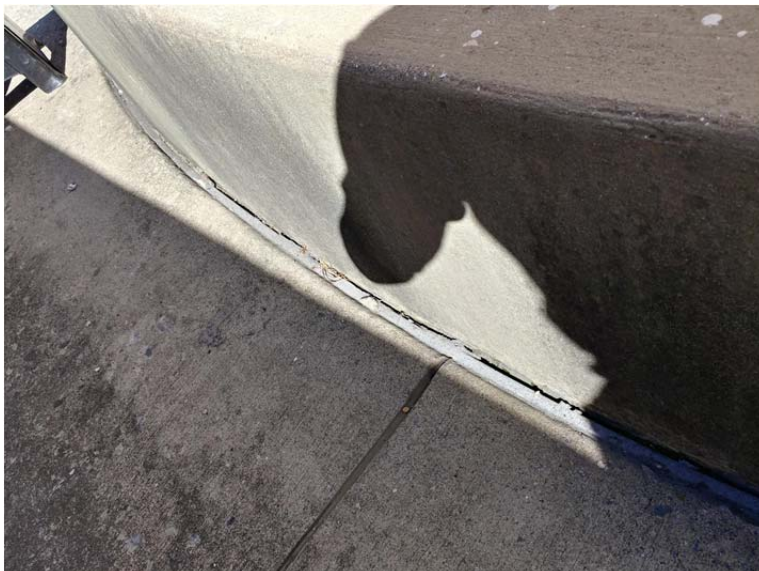
E.15 Failed Ringwall Joint Sealant

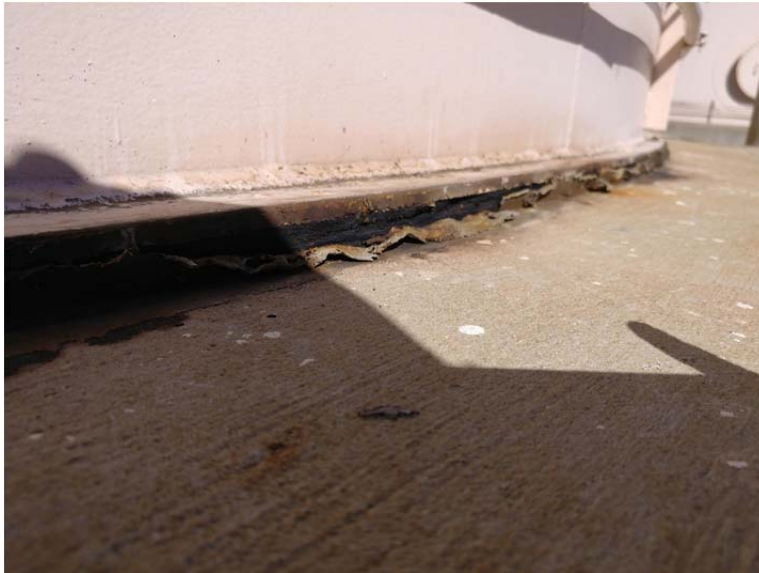
E.16 Ringwall Seal Failure

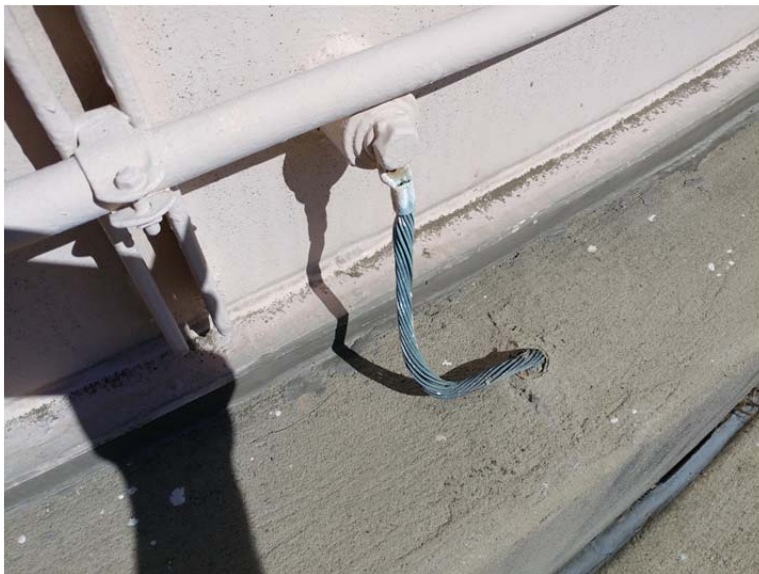
E.17 Unsealed Grounding Cable

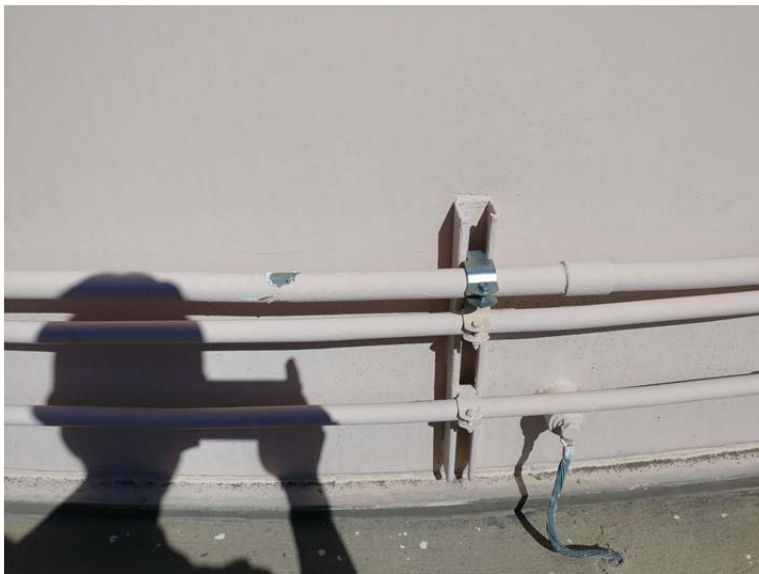
E.20 Corrosion on Conduit

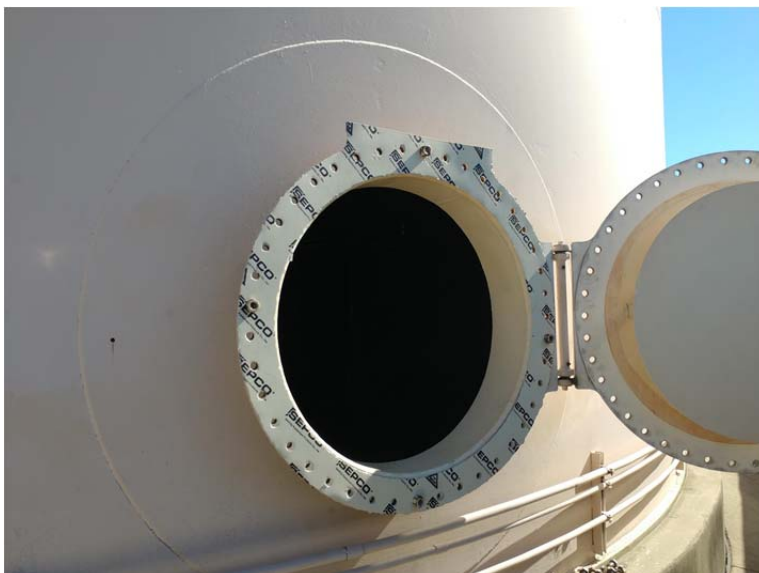
E.21 Nozzle A, 36" Manhole with 74" Repad

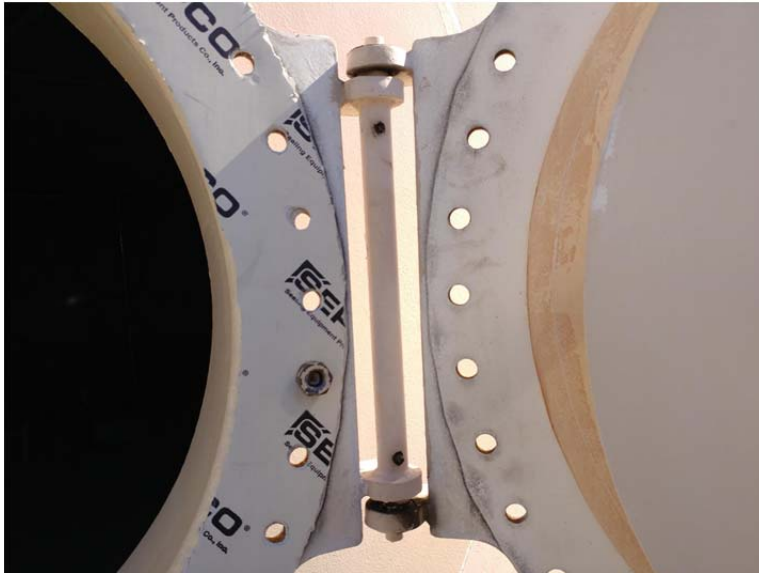
E.22 Manhole Missing Grease Fitting on Hinge

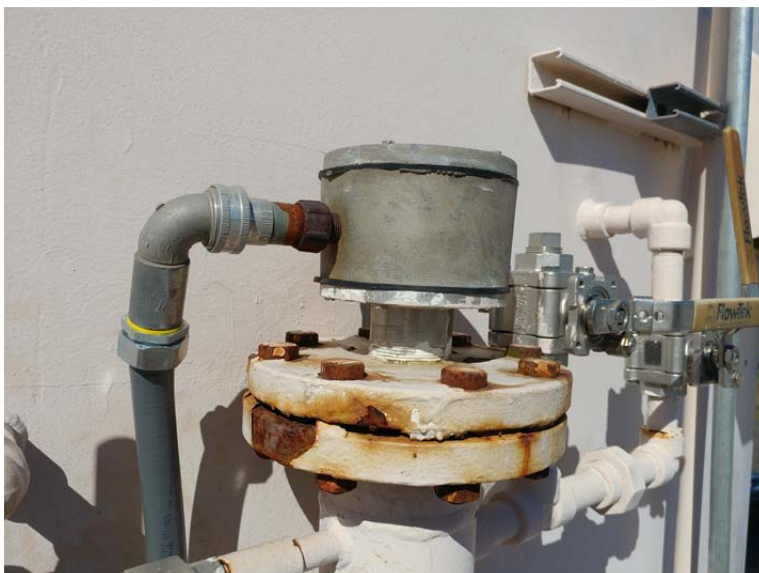
E.24 Coating Failure on Low and High Level Alarms

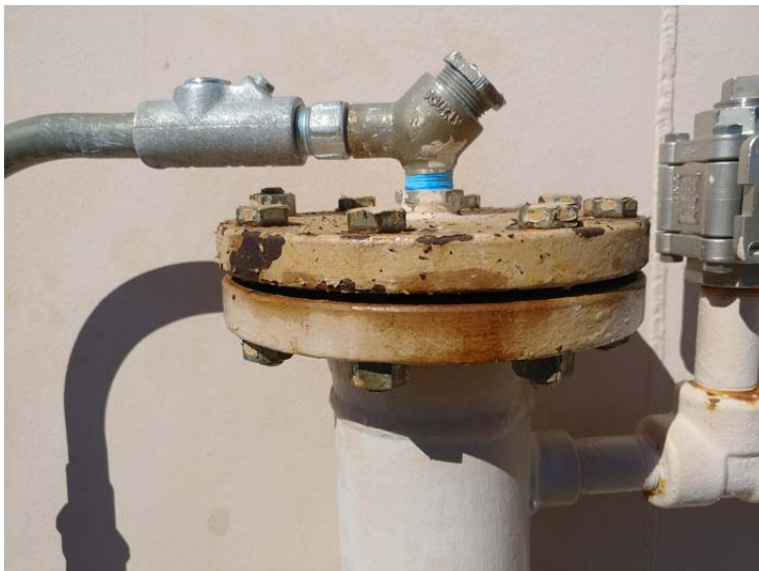
E.27 Coating Failure on Low Level Alarm

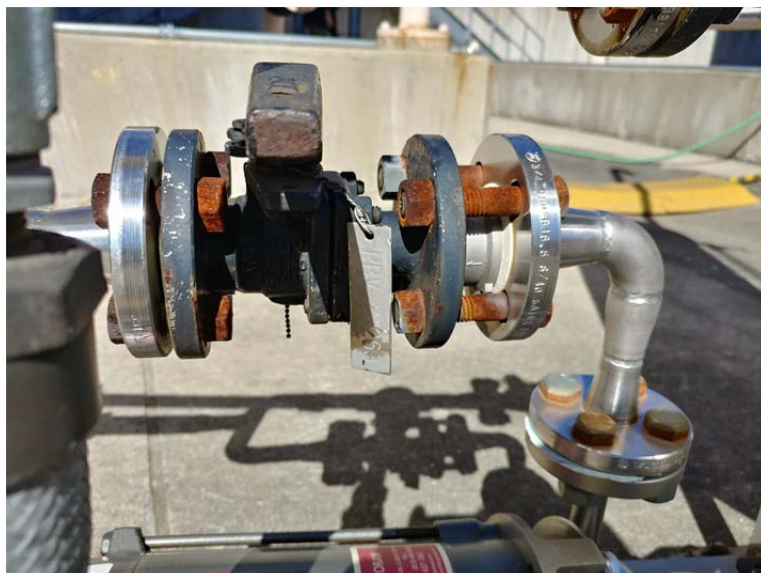
E.30 Water Draw-Off Piping Galvanic Corrosion

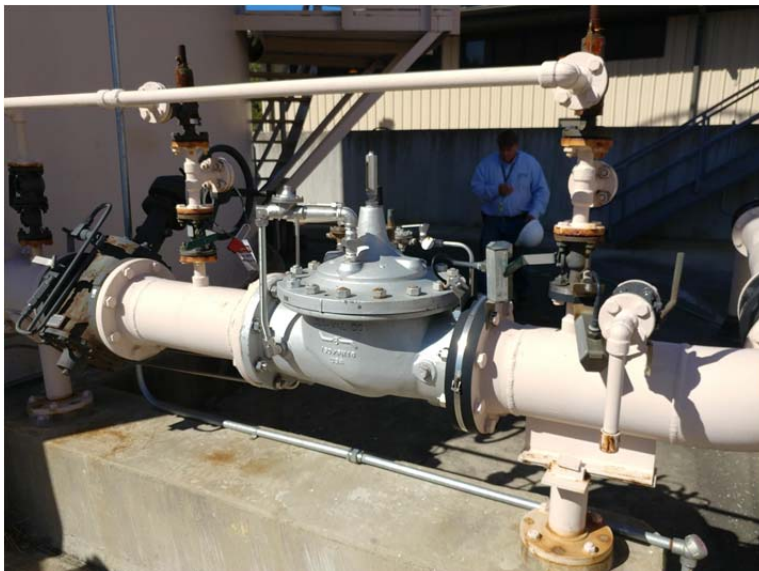
E.33 Coating Failure on 8" Receipt

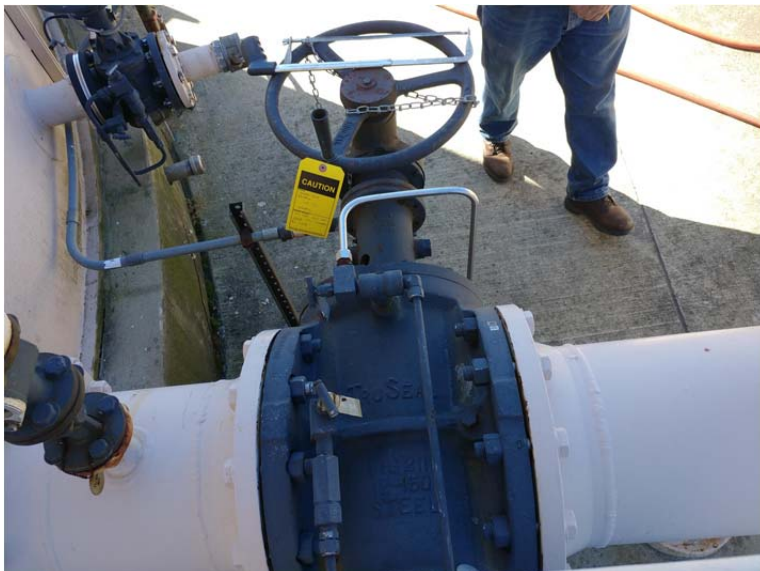
E.42 Coating Failure on 12" Issue

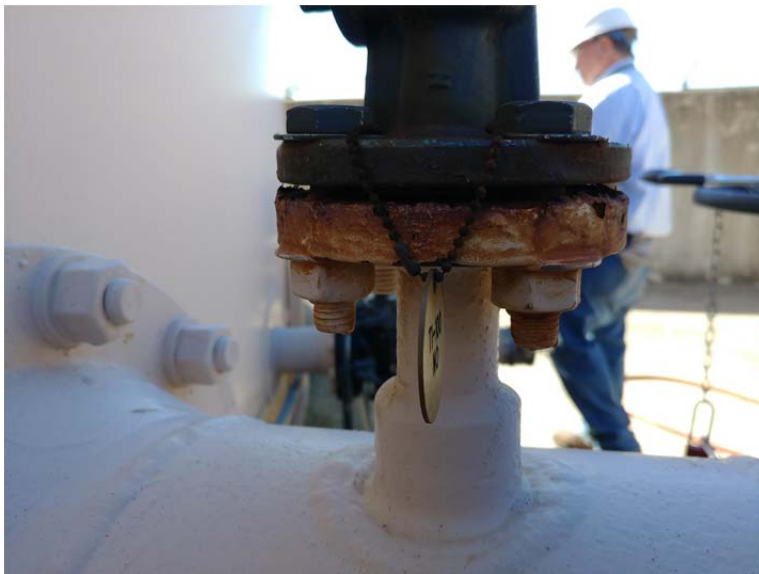
E.44 Coating Failure on Low Suction Flange

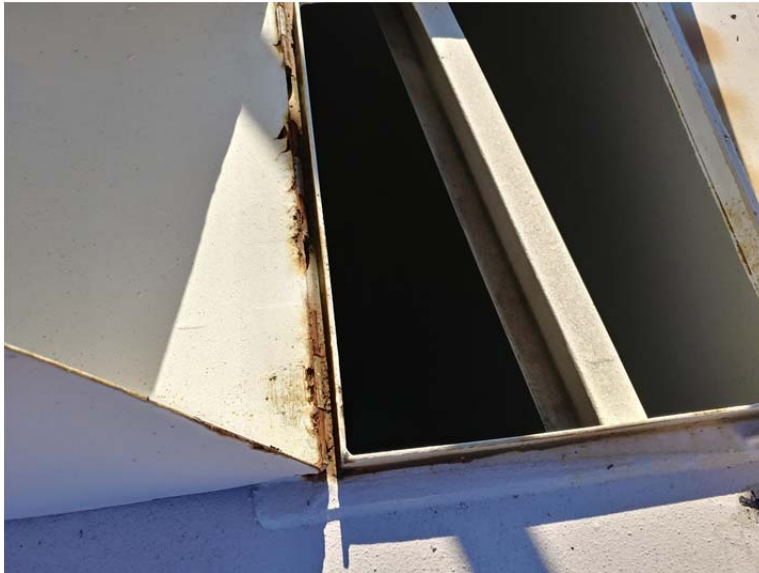
E.58 Coating Failure/Corrosion on Hood

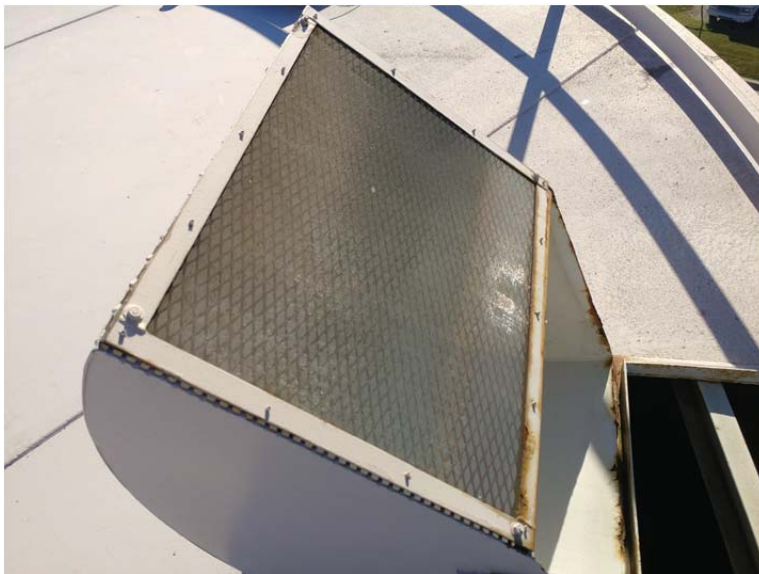
E.59 Inspection Hatch Screen

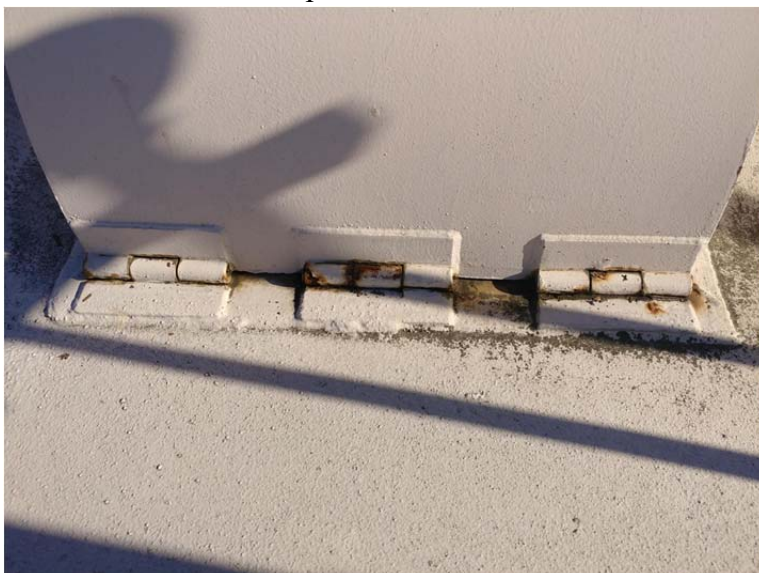
E.60 Coating Failure on Hood Hinge

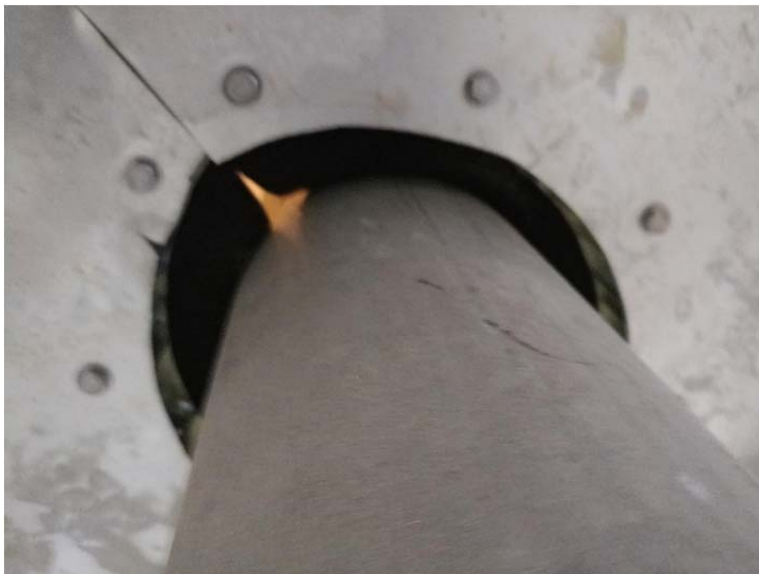
E.80 Penetration Seal Deteriorated

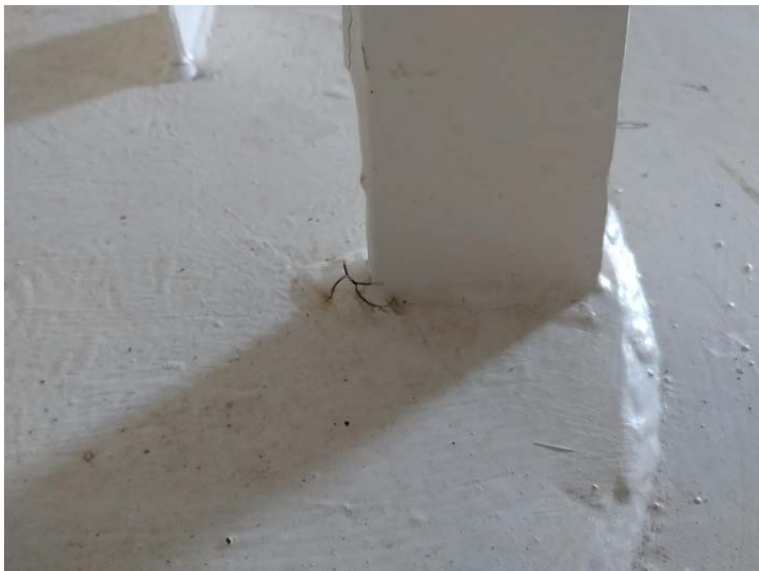
E.81 Minor Coating Failure on Manual Gauge Well Reinforcement Pad

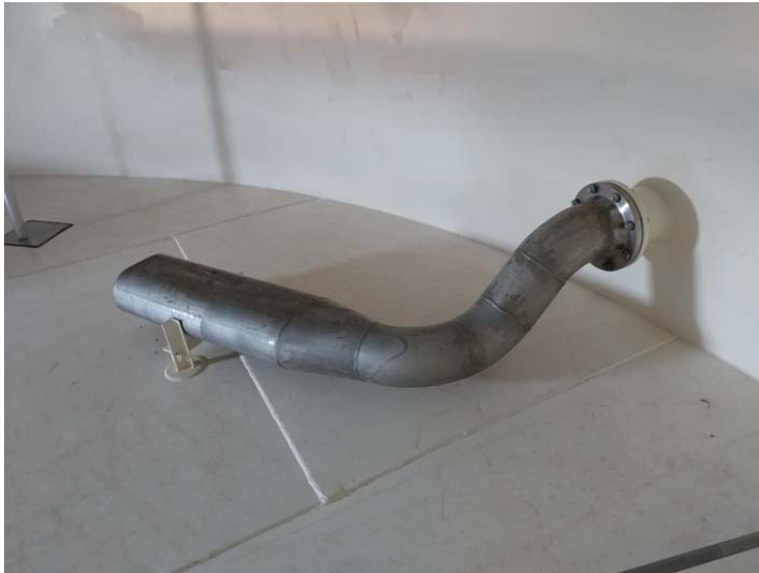
E.91 Carbon Steel Connected to Stainless Steel Flange

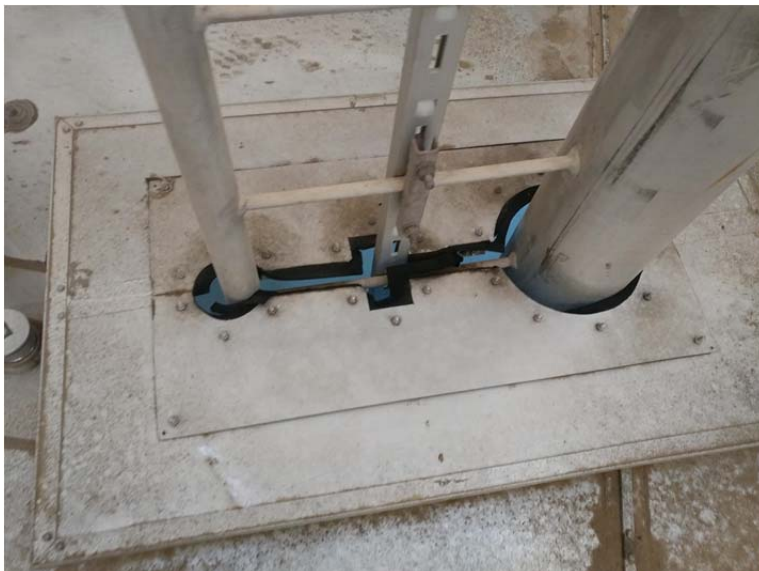
E.96 IFR Ladder Penetration Deteriorated

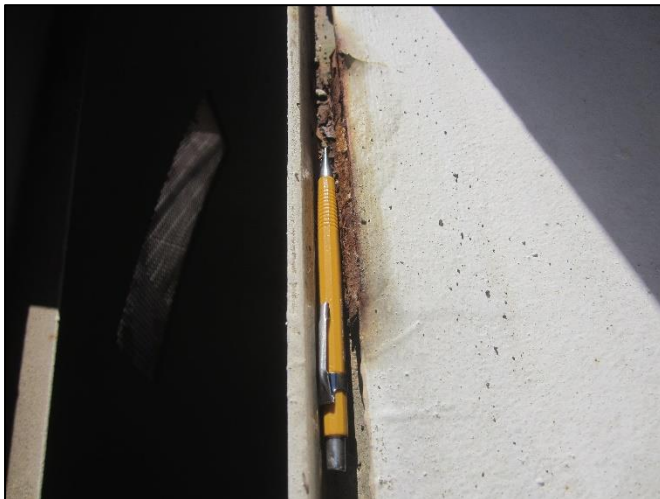
**B.15: Roof Perimeter Vent Opening Frame Corrosion**

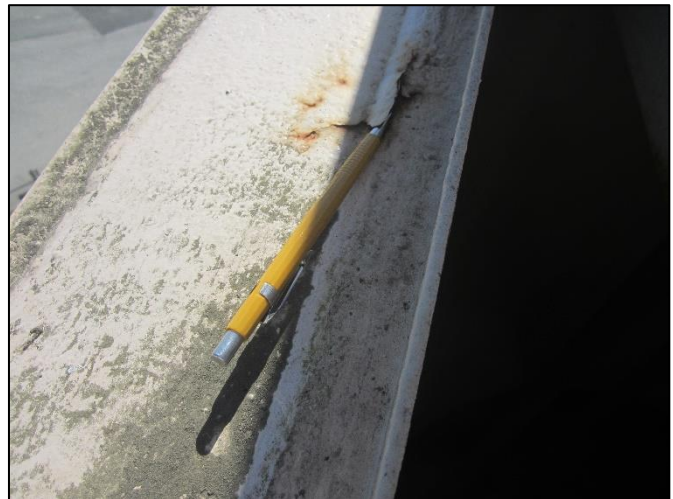
**B.16: Coating Failure on Roof at Roof Perimeter Vent**
