Technical Report: Fort Peck Butterfly Valve#5 Inspection Report

FT. PECK PH#2 BUTTERFLY VALVE NDT

Date: 5/5/2020

U.S. ARMY CORPS OF ENGINEERS OMAHA DIST.
CONTRACTING OFFICE
1616 CAPITOL AVENUE
OMAHA NE 68102-4901

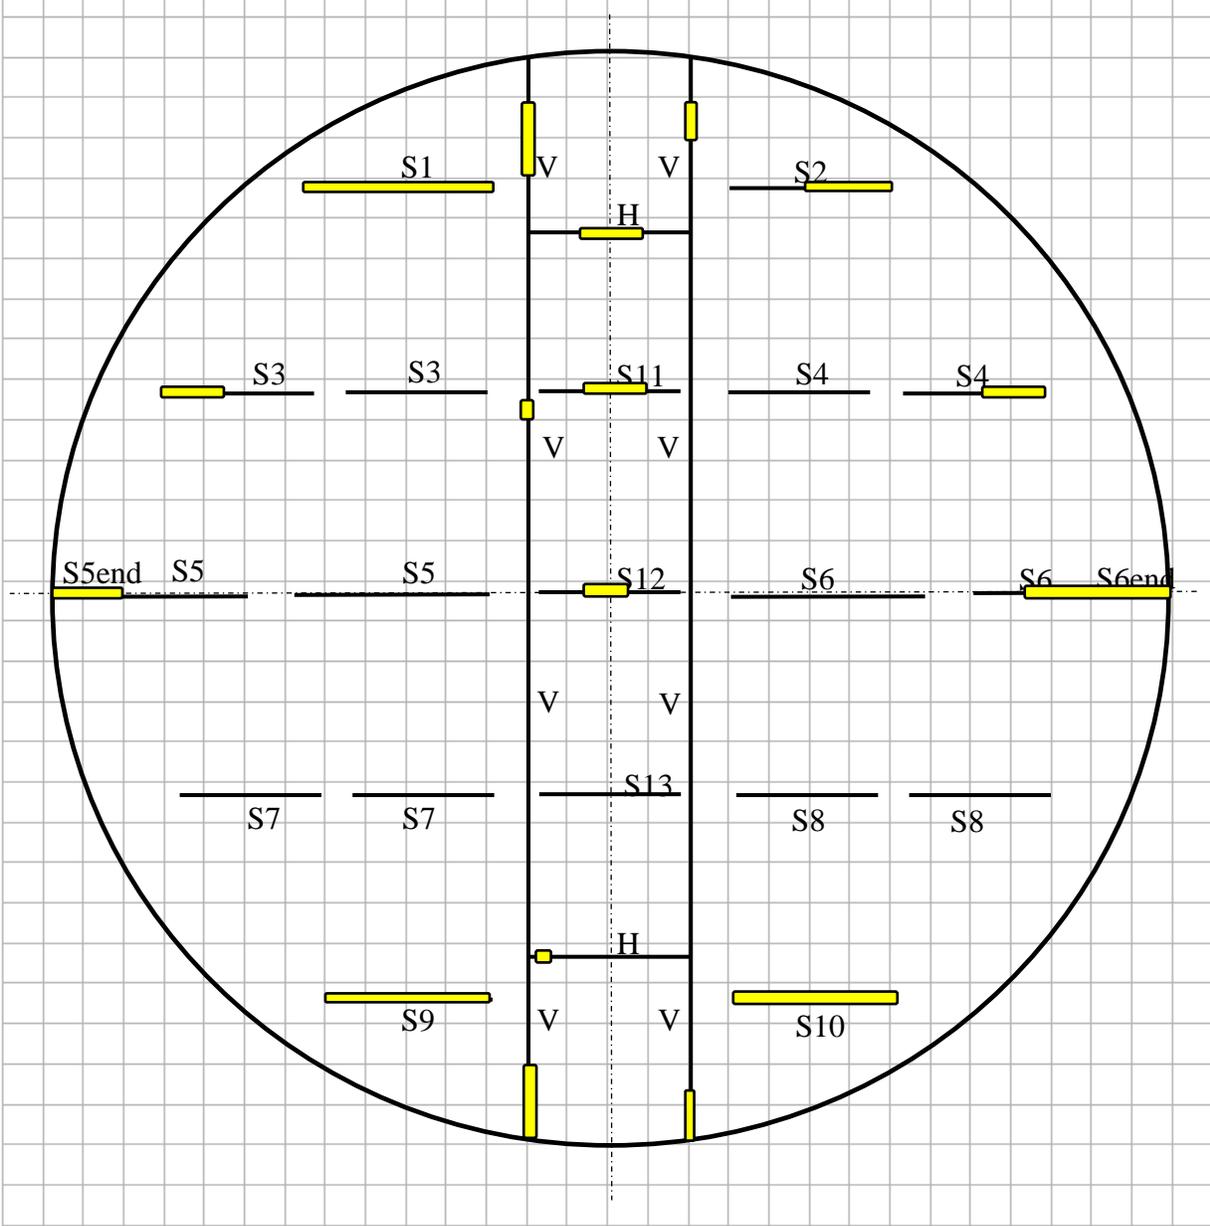
Figure 2.4: Locations of coating breakdown and surface corrosion on Valve 5 upstream side.

The locations of the notable coating breakdown and surface corrosion on the upstream and downstream sides are shown in Figures 2.4 and 2.5, respectively, via the yellow areas superimposed onto the valve welds. Details on each weld are presented in Table 2.3.

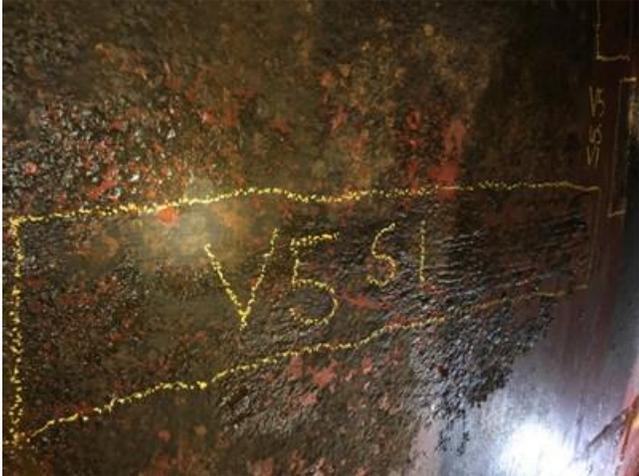
Table 2.3: Visual Inspection Summary of Valve #5	
<i>Valve 5 Upstream Side</i>	
Weld	Comments
S1	<p>Advanced blistering and surface corrosion over length of weld.</p>

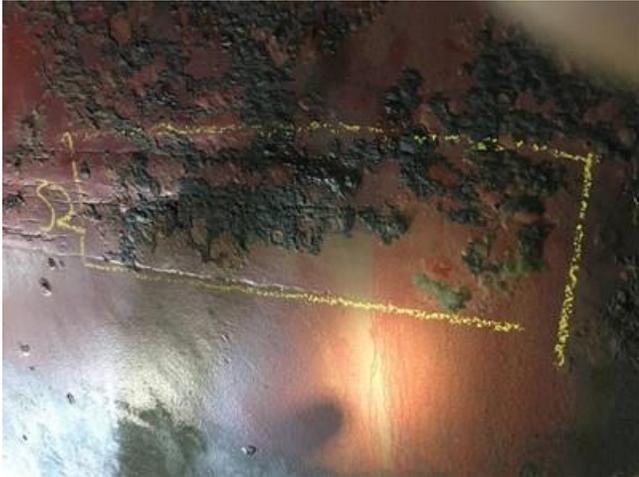
S2	<p>Blistering and surface corrosion at 20"- 40" from left to right. Coating in good condition over remainder of weld.</p>

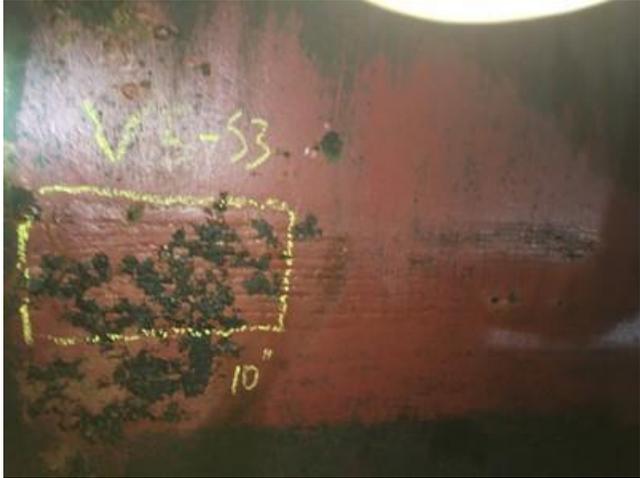
S3	<p>Blistering and surface corrosion at 0"- 10" from left to right. Coating in good condition over remainder of weld.</p>

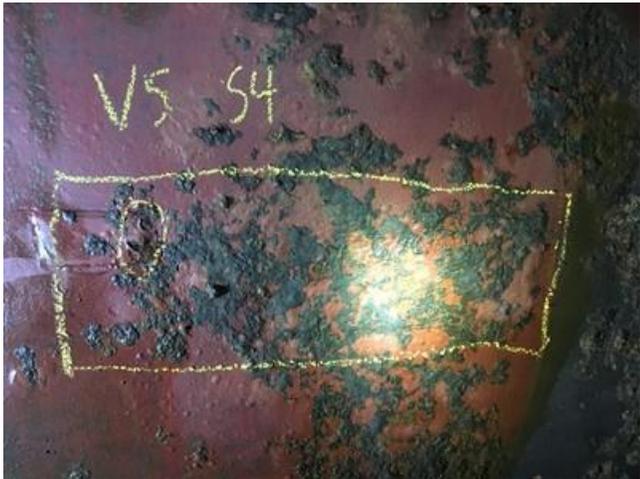
S4	<p>Blistering and surface corrosion at 20"- 40" from left to right. Coating in good condition over remainder of weld.</p>

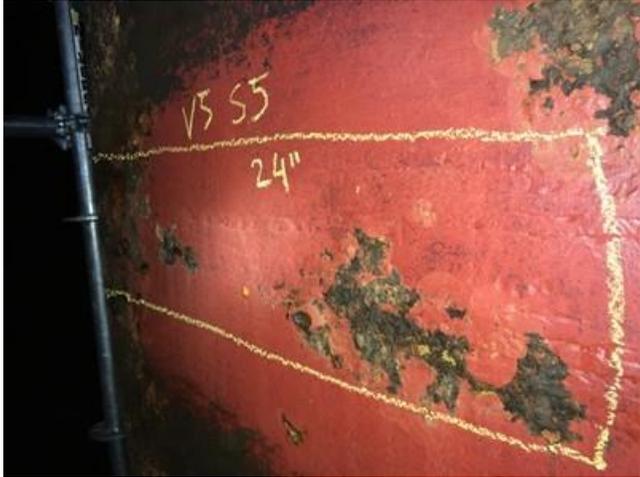
S5	<p>Blistering and surface corrosion at 0"- 20" from left to right. Coating in good condition over remainder of weld.</p>

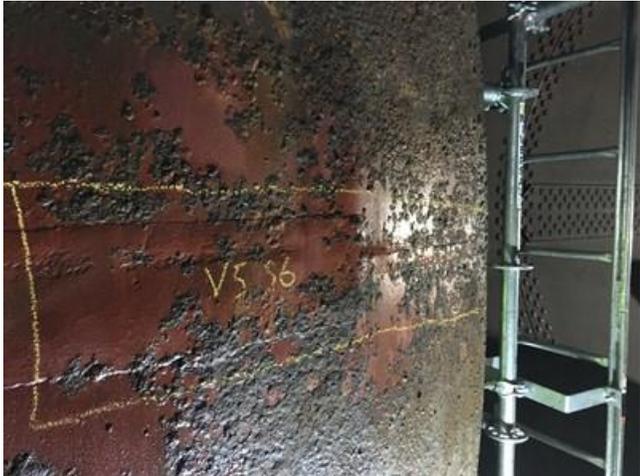
S6	<p>Blistering and surface corrosion at 40" to end of weld from left to right. Coating in good condition over remainder of weld.</p>

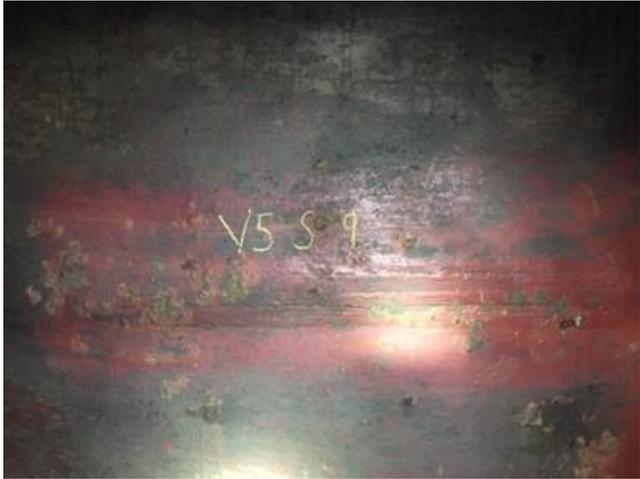
S9	<p>Intermittent blistering and surface corrosion over length of weld.</p>

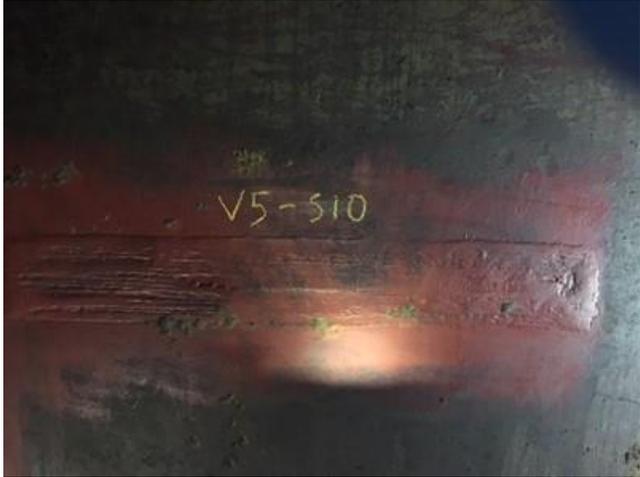
S10	<p>Intermittent blistering and surface corrosion over length of weld.</p>

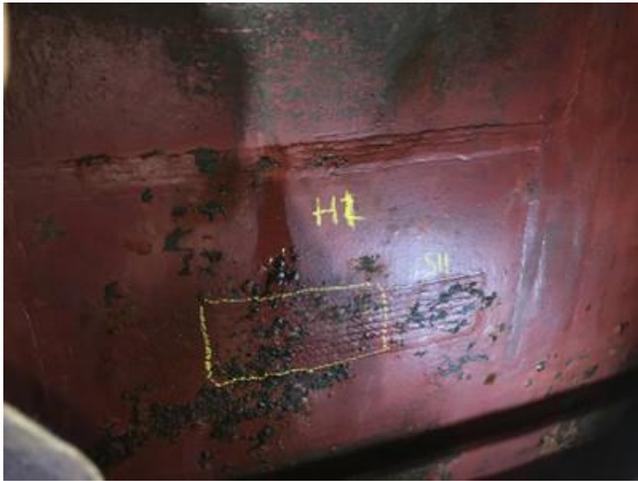
S11	Intermittent blistering and surface corrosion over length of weld.

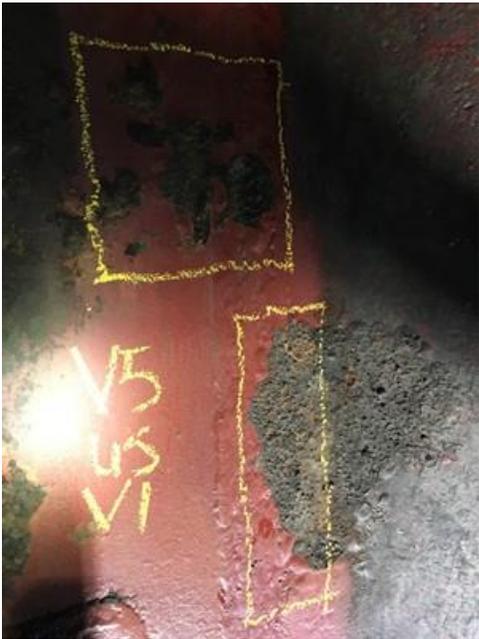
S12	Intermittent blistering and surface corrosion 16"-24" from left to right.
S13	No blistering or surface corrosion, coating in good condition over length of weld.
V1	Blistering and surface corrosion at 21"- 41" from top of weld. Coating in good condition over remainder of weld.

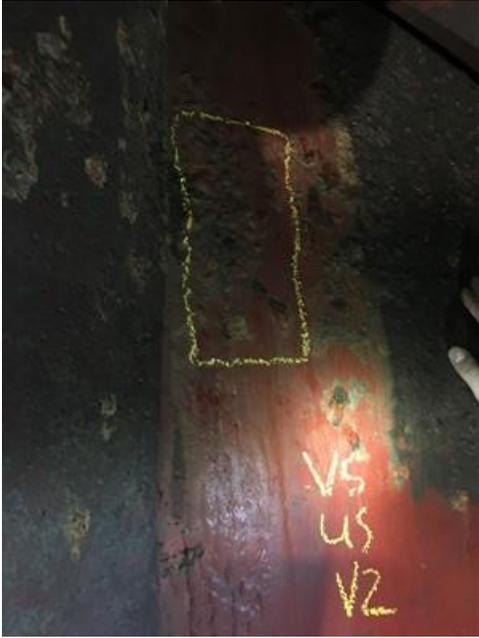
V2	<p>Intermittent blistering and surface corrosion 13"-25" from top of weld. Coating in good condition over remainder of weld.</p>

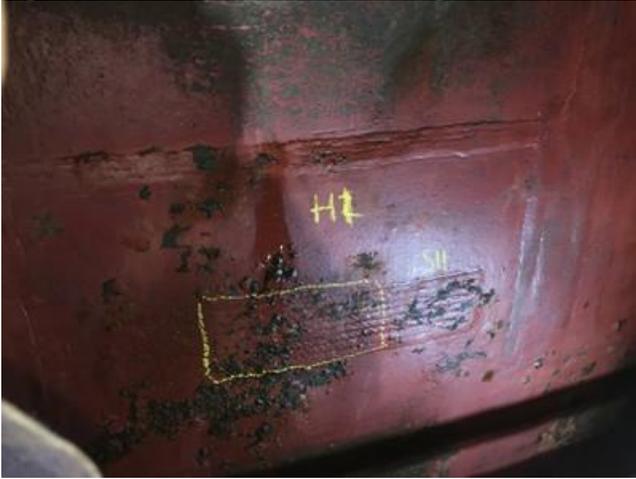
V3	<p>24" of blistering and surface corrosion at bottom of weld. Coating in good condition over remainder of weld.</p>
V4	<p>14" of blistering and surface corrosion at bottom of weld. Coating in good condition over remainder of weld.</p>
V5	<p>No blistering or surface corrosion, coating in good condition over length of weld.</p>
V6	<p>No blistering or surface corrosion, coating in good condition over length of weld.</p>
V7	<p>1.5" diameter surface corrosion, 0.040" depth, 12" from top of weld.</p>
V8	<p>No blistering or surface corrosion, coating in good condition over length of weld.</p>
H1	<p>Intermittent blistering and surface corrosion over length of weld.</p>

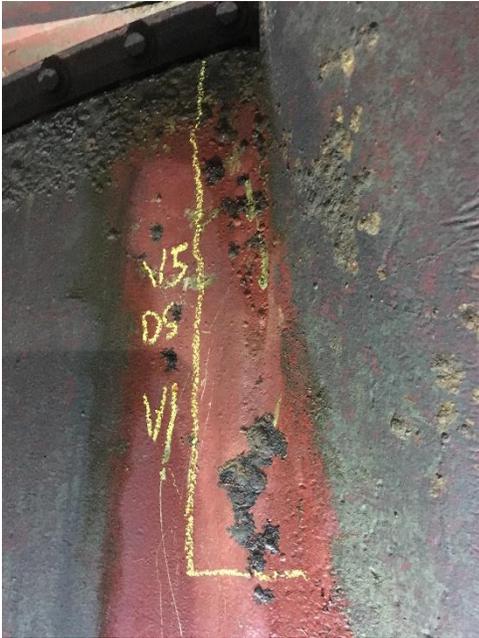
<i>Valve 5 Downstream Side</i>	
V1	<p>23" of blistering and surface corrosion from top of weld. Coating in good condition over remainder of weld.</p>

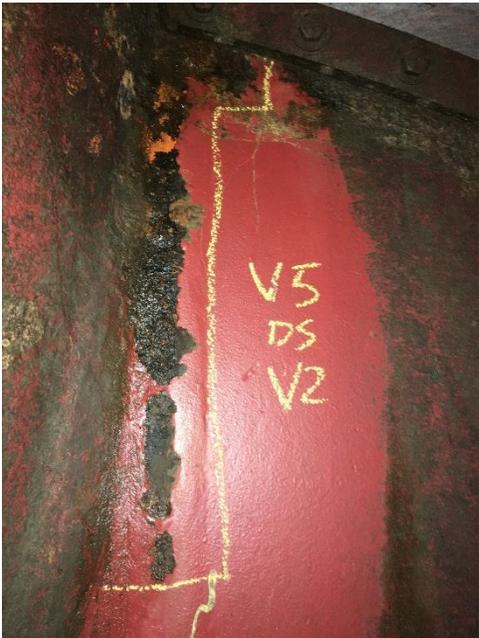
V2	<p>21" of blistering and surface corrosion from top of weld. Coating in good condition over remainder of weld.</p>

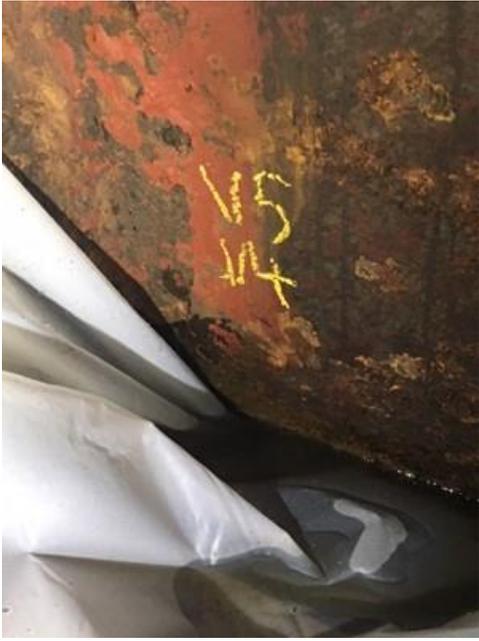
V4	<p>8" of blistering and surface corrosion at bottom of weld. Coating in good condition over remainder of weld.</p>

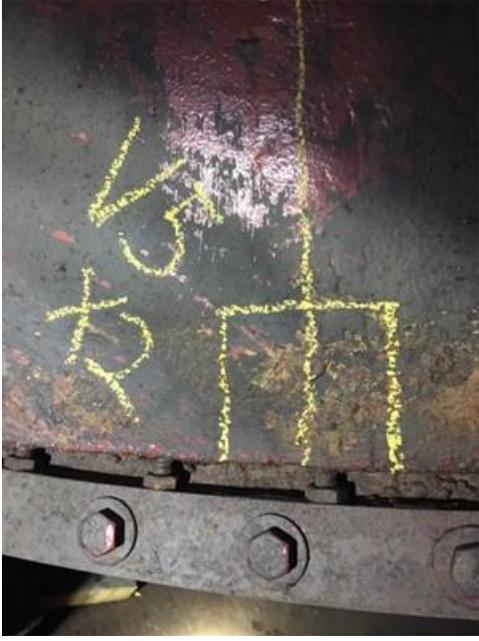
X1	<p>6" of blistering and surface corrosion at end of weld towards OD. Coating in good condition over remainder of weld. See X2 picture for reference.</p>
X2	<p>5" of blistering and surface corrosion at end of weld towards OD. Coating in good condition over remainder of weld.</p>

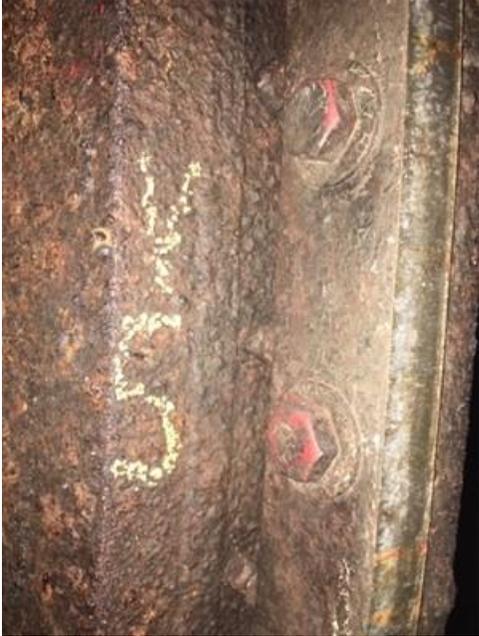
<i>Circumferential Weld</i>	
Circ	<p>Weld showed advanced blistering and surface corrosion over entire circumference.</p>

1. Remove lead paint with industry standard practices, blast to bare metal, and clean the circumferential weld and shell to at least 6 inches radially from the valve OD. Perform a detailed visual inspection in accordance with AWS D1.1 guideline. Magnetic particle test same areas. Apply new coating system to these areas after inspection.
2. Remove lead paint with industry standard practices, blast to bare metal, and clean all welds on which coating breakdown and corrosion were observed and perform a detailed inspection in accordance with AWS D1.1. Additional welds may need to be considered at the time of the maintenance event. Apply new coating system to these areas after inspection.
3. Remove lead paint with industry standard practices, blast to metal, and clean all shell areas that exhibit coating breakdown and corrosion. Apply new coating system to these areas after inspection.

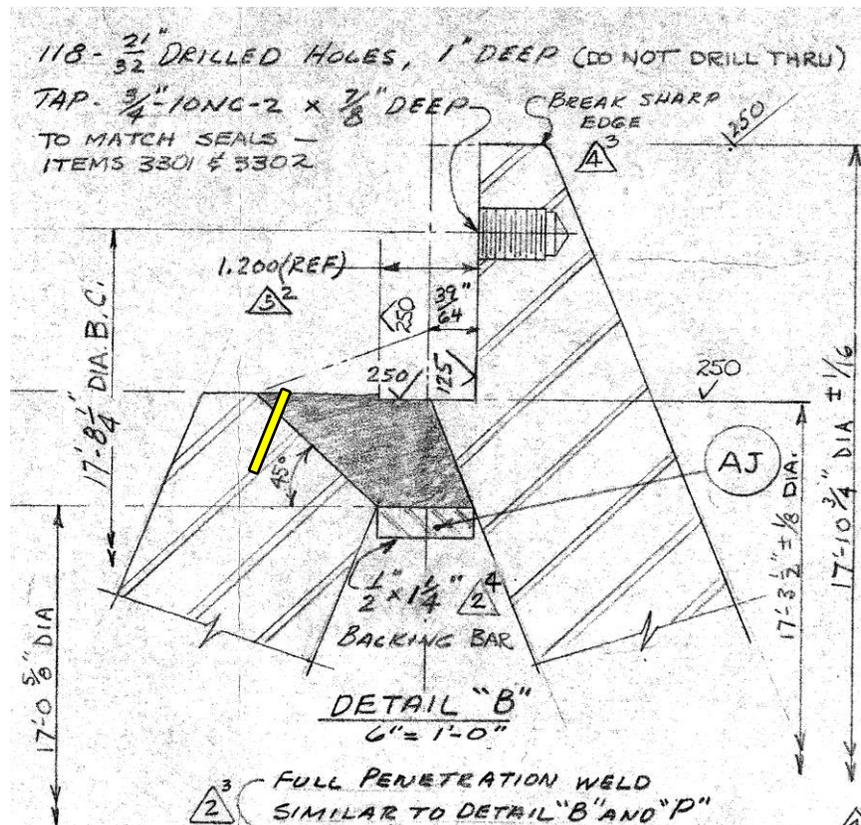
Figure 4.5: Estimated location of discontinuities detected with PAUT at C1 and C2 locations.

Only a total of 177" of the circumferential weld were scanned with PAUT. Discontinuities over approximately 21" of this area that were not attributable to an inherent feature from the valve drawing. The discontinuities were approximately 1.25" deep from the skin surface. The estimated location is shown in Figure 4.2. The indications were representative of a lamination or other planar defect parallel skin surface. The remainder of the circumferential weld was not inspected due to advanced corrosion and surface roughness.

C1 and C2 were located 30-45" and 60-66", respectively, from Weld V2 in the clockwise direction looking at the downstream face.

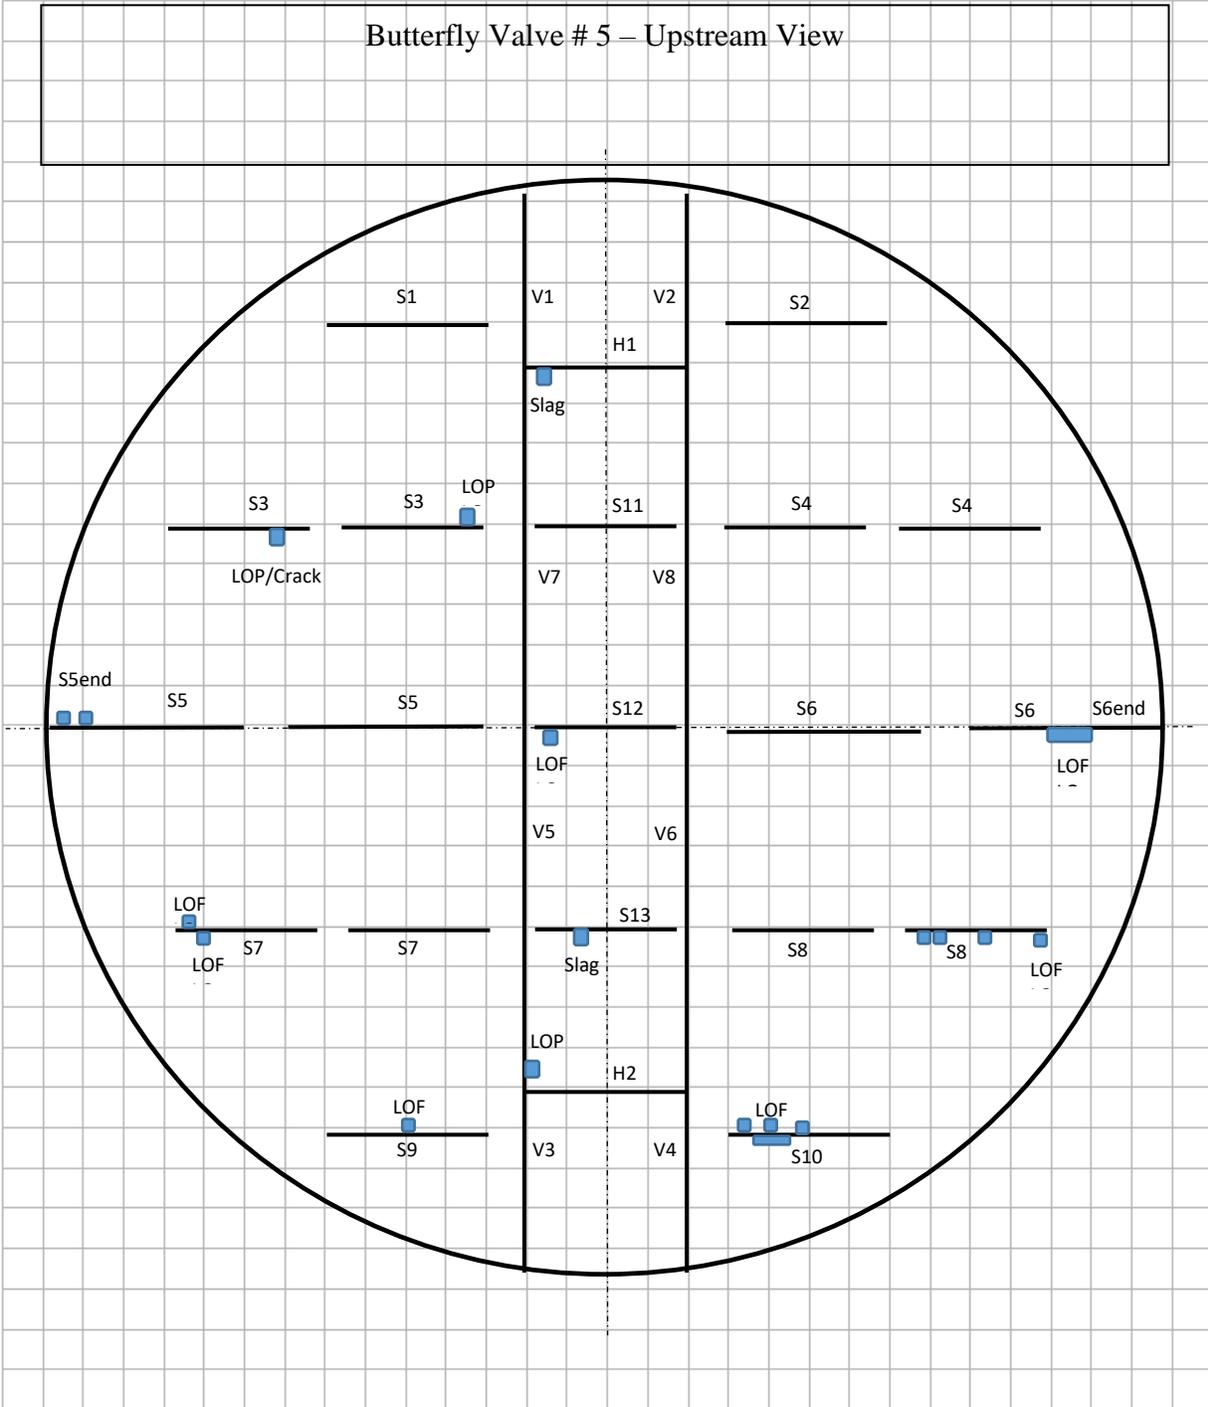
Figure 4.7: Valve #5 upstream PAUT weld discontinuities longer than 0.20”.

The upstream side contained 1 weld discontinuity longer than 1” as shown in Table 4.1. The upstream side contained 3 weld discontinuities with a height greater than 0.375”. The most severe discontinuity was found in weld S6b with a length of 11.100” and a height of 0.603”. The PAUT inspection details for all welds inspected is presented in Section 5. The data for Weld S6b, for example, shows that the discontinuity was found mid-wall and was classified as lack of fusion (LOF). In addition, a possible in-service crack was detected at the root of weld S3b 0.917” long and 0.284” high.

1. For all color-coded red welds in Tables 4.1 and 4.2. remove lead paint with industry standard practices, blast to bare metal, and clean the weld surfaces 6” back from the toe. Perform encoded PAUT to more accurately locate and size the weld discontinuities. Apply new coating system to these areas after inspection. Re-assess possible repair action after new sizing data is made available.

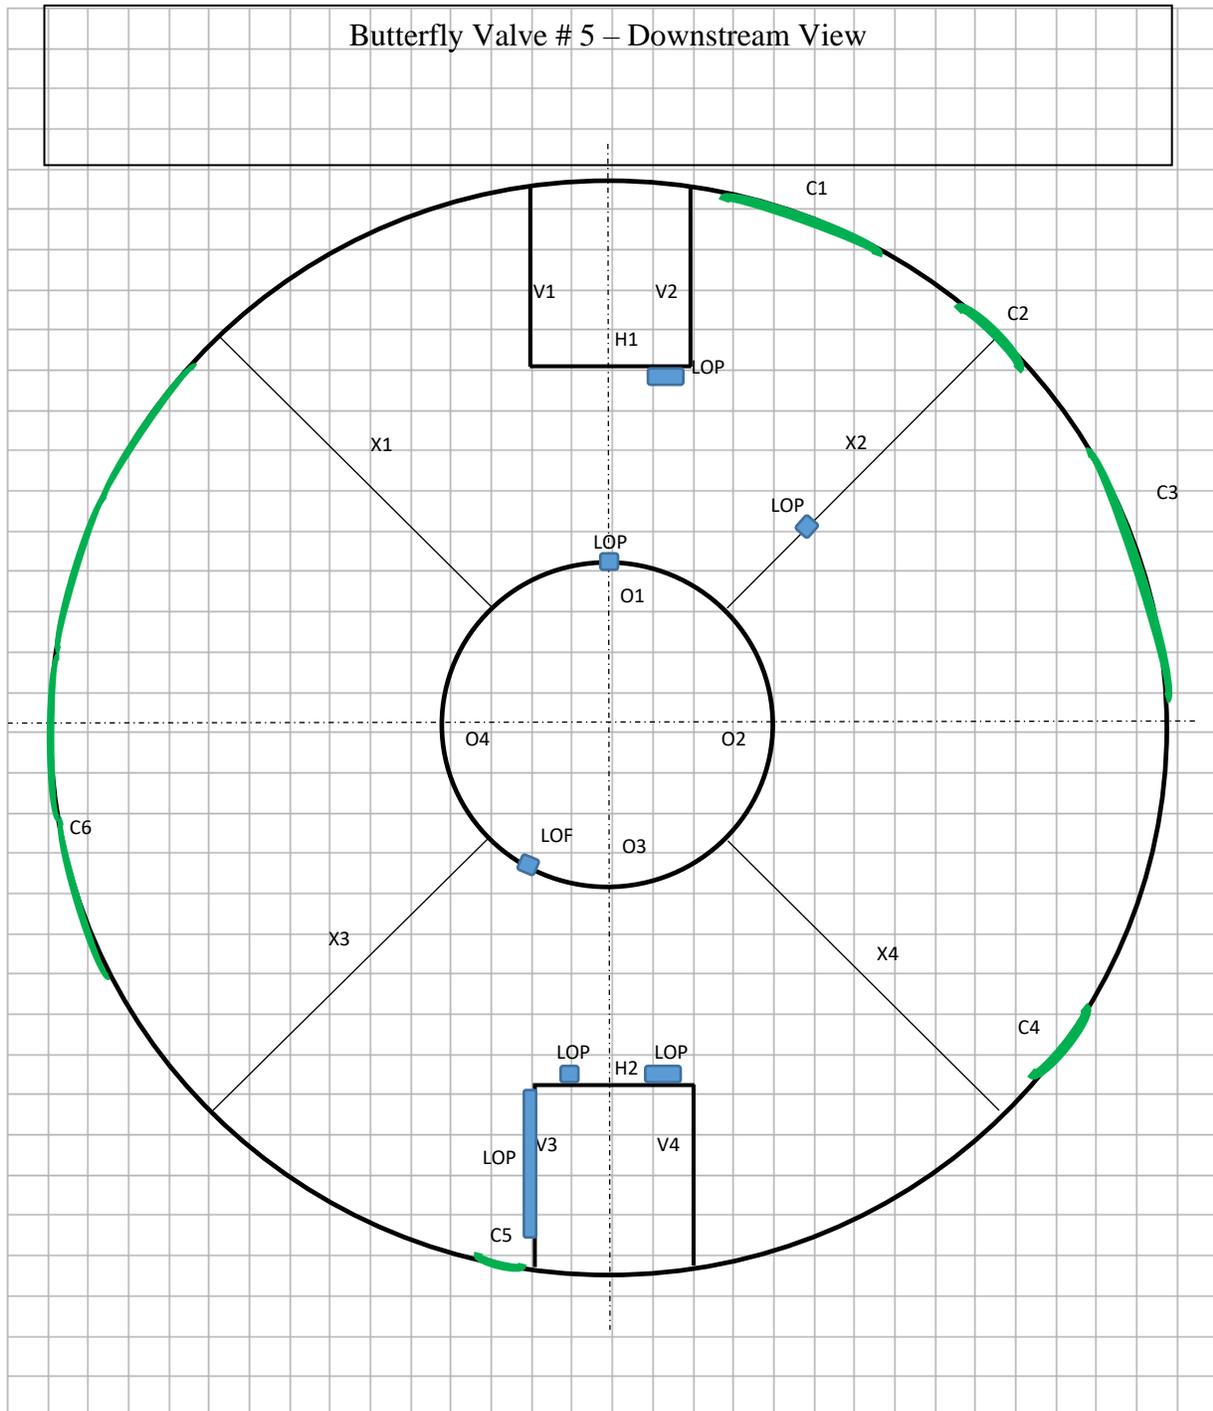
Figure 4.9: Valve #5 downstream PAUT weld discontinuities longer than 0.20" and areas over which the circumferential weld was manually scanned with PAUT (green). C1 is located at 30 to 45" in the clock-wise direction from V2. C2 is located at 60 to 66" in the clock-wise direction from V2.

The downstream side contained 6 weld discontinuities longer than 1” as shown in Table 4.2. The downstream side contained 1 weld discontinuities with a height greater than 0.375”. The most severe discontinuity was found in H2 with a length of 5.963” and a height of 0.301”. The PAUT inspection details for all welds inspected is presented in Section 5. The data for Weld H2 shows that the discontinuity was found mid-wall and was classified as lack of penetration. (LOF).

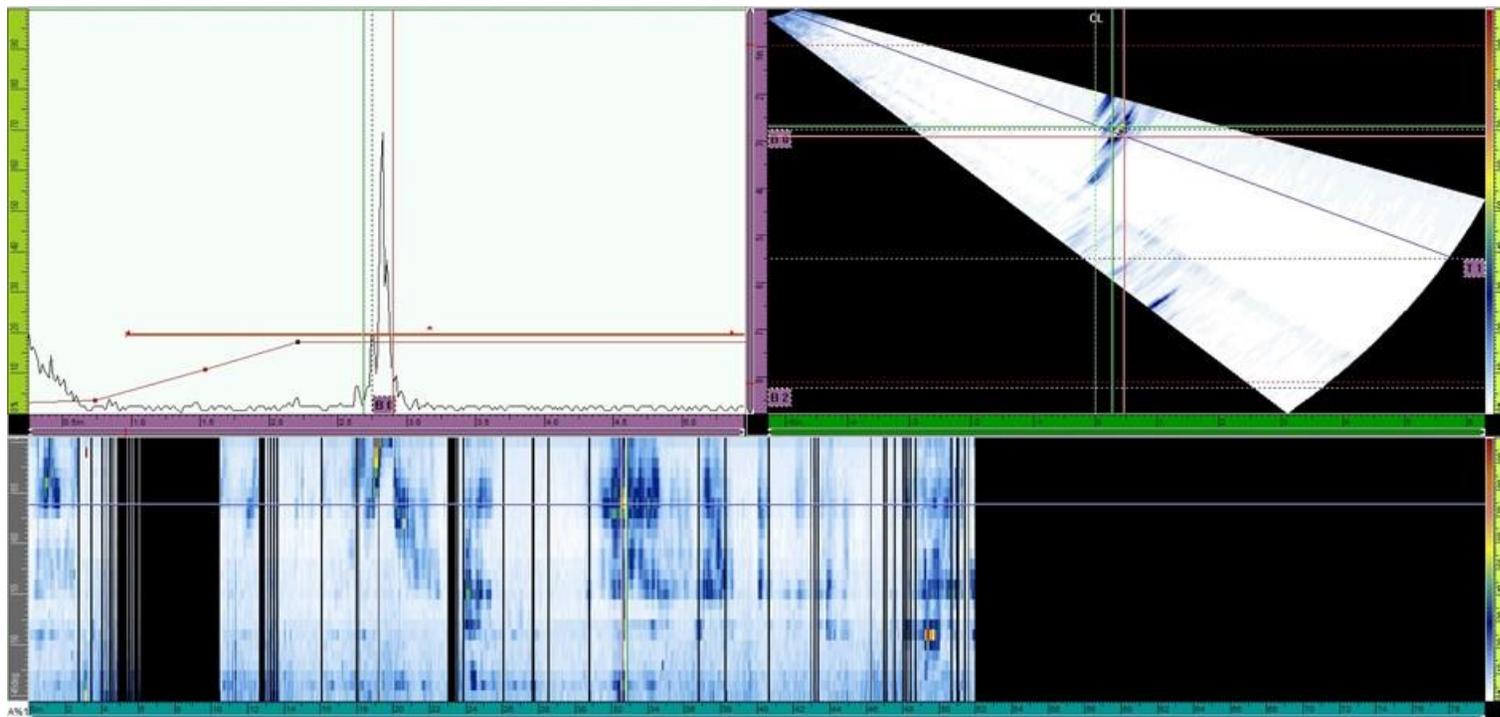
The upstream side contained 1 weld discontinuity longer than 1” and 3 weld discontinuities with a height greater than 0.375”. The most severe discontinuity was found in weld S6b with a length of 11.100” and a height of 0.603”. In addition, a possible in-service crack was detected at the root of weld S3b 0.917” long and 0.284” high.

S3b Lack of penetration / possible crack observed at bottom surface.

Gain (dB)	Indication #	Scan (in)	Index (in)	Group	Channel	A%1 (%)	DA/1 (in)	PA/1 (in)	SA/1 (in)	U(m-r) (in)	I(m-r) (in)	I•U(m-r) (in)	S(m-r) (in)	Type
46.66	1	32.795	-6.500	PA 1	64.00°	19.6	2.745	5.186	6.286	0.284	0.148	0.320	0.917	LOP/ Crack

3. Upstream Side Weld S3b: A possible in-service fatigue crack was detected in Weld S3b at the weld root. It is recommended to remove lead paint with industry standard practices, blast to bare metal, and clean the weld area for follow-up inspection at the next maintenance event.
