October 31, 2019

Re: Buildings 27, 28, 31, and 16
Connecticut Air National Guard, 100 Nicholson Road, East Granby, CT
Building Survey Findings
RPF File No. 199476

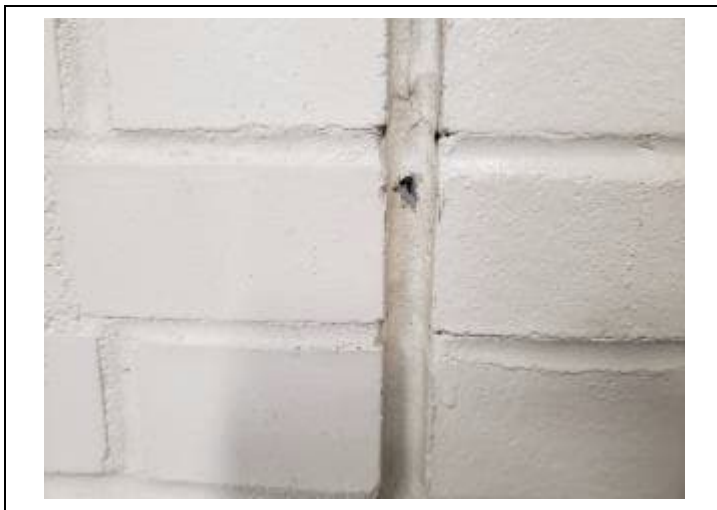
2. Building seam caulking present in the main entry area, no asbestos detected.

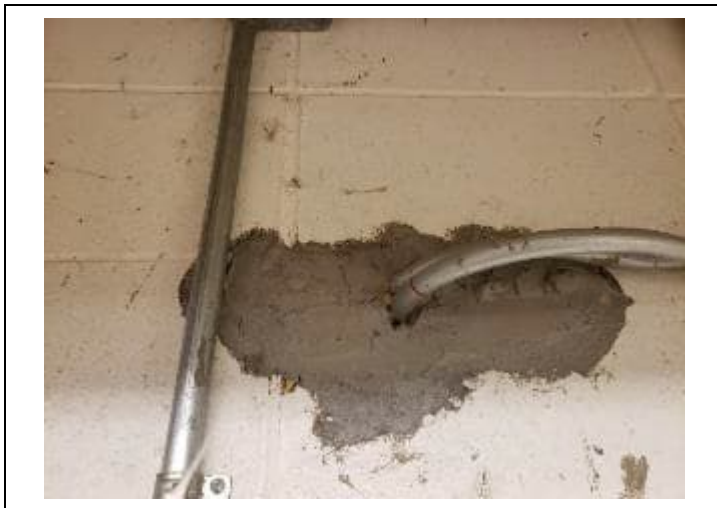
4. Mechanical Room, grey putty around pipe penetration above door. No asbestos detected.

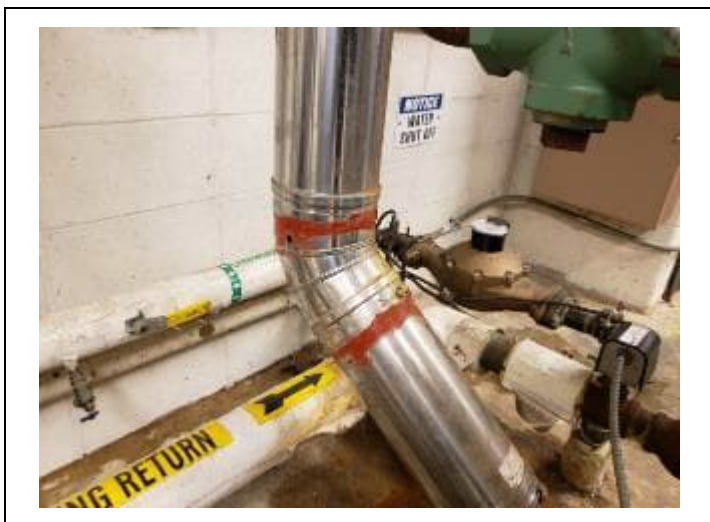
5. Mechanical Room, red caulking on furnace vent pipe. No asbestos detected.

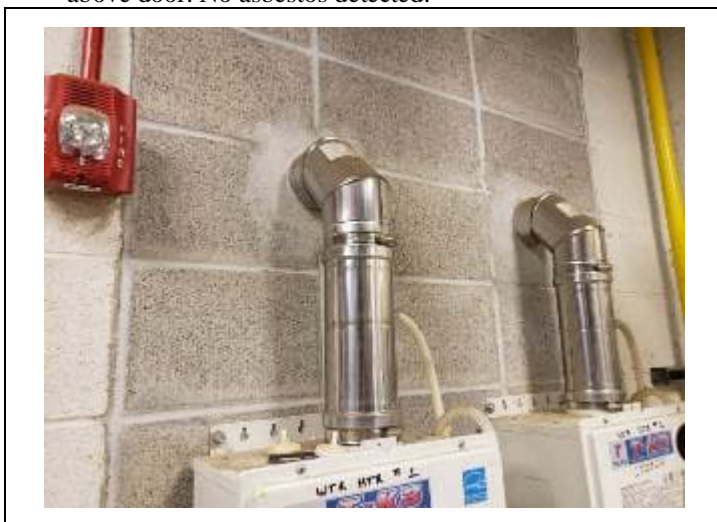
6. Mechanical Room, grey flue cement around vent penetrations. No asbestos detected.

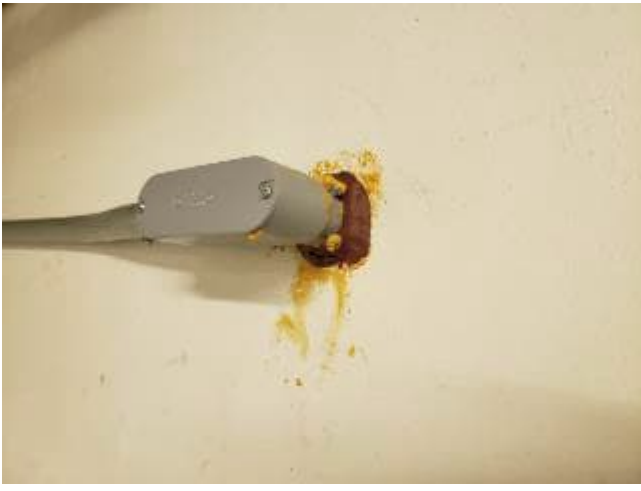
7. Garage Bay G5, red putty around pipe penetration. No asbestos detected.

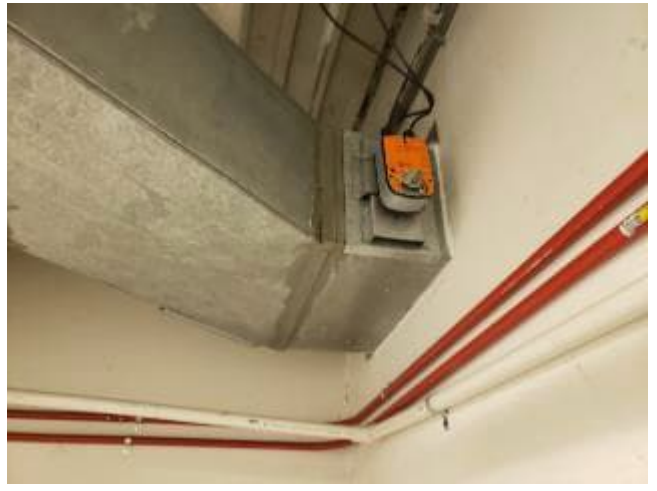
8. Garage Bay G1, grey duct caulking. No asbestos detected.

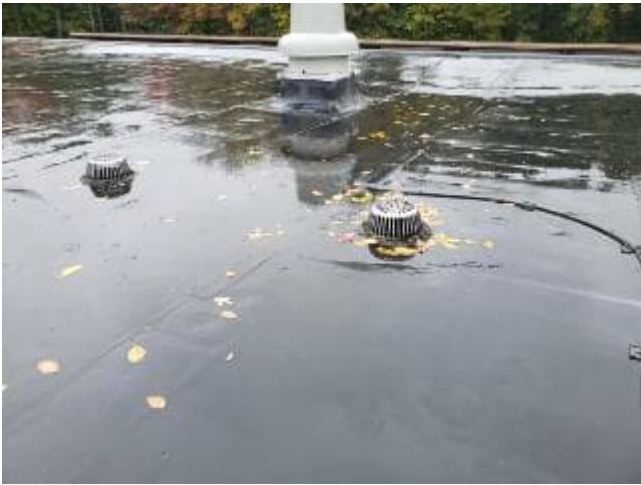
9. Building 27 roof, exterior portions of the buildings were not included in the scope of this survey.

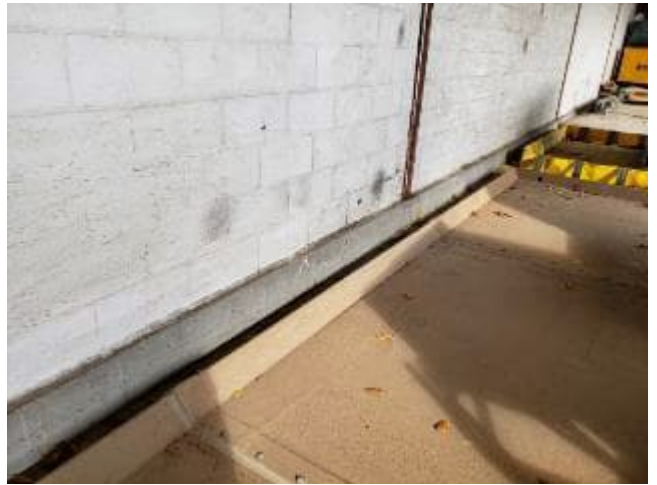
10. Building 28, textured paint and caulking, no asbestos detected.

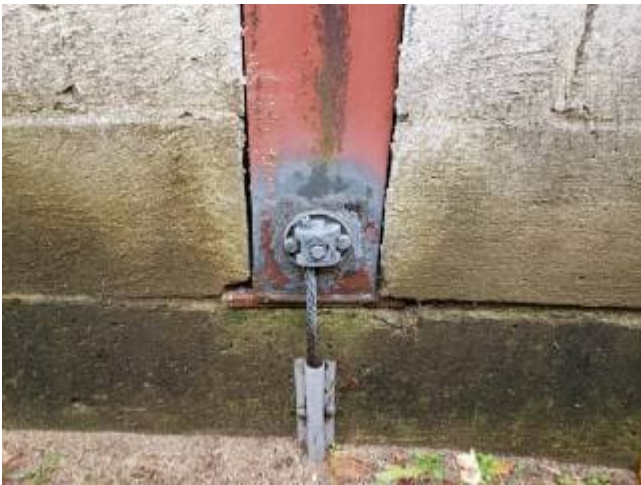
11. Building 28, blue flue cement, no asbestos detected.

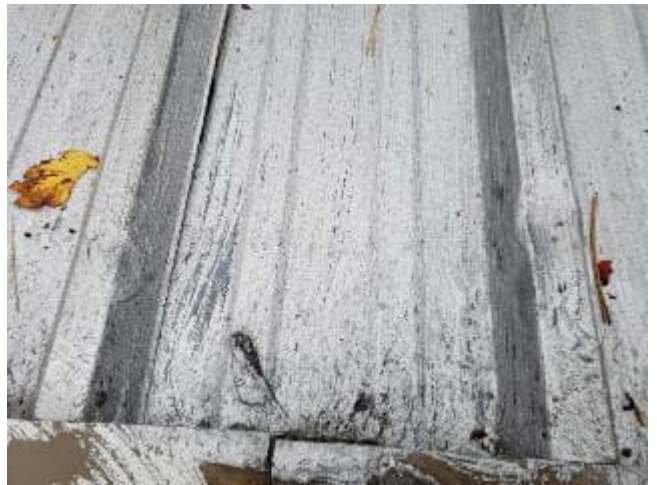
12. Building 28, silver compound present on the roof. Exterior building materials was outside the scope of work.

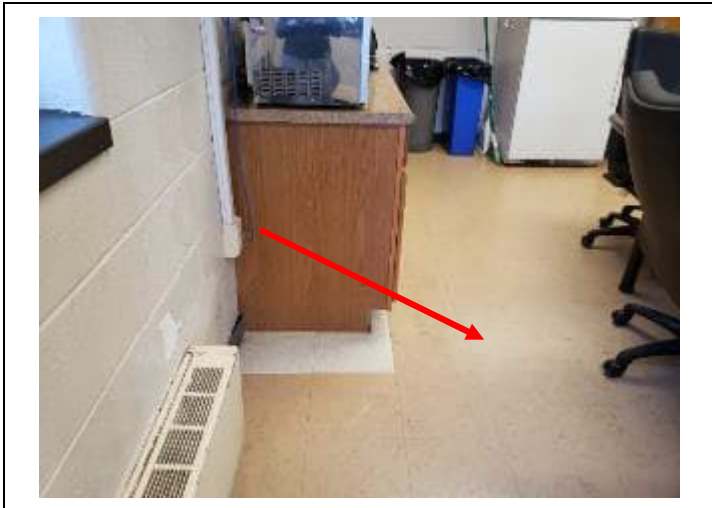
The ACBM identified during this survey consists of nonfriable material. The nonfriable ACBM was observed to be in good to fair condition and, left undisturbed and properly managed, is unlikely to cause any major fiber release episodes.

15. ACBM tan 12" floor tile on ACBM black mastic in breakroom 003.

Although the standard polarized light method of analysis was completed pursuant to current state and federal regulations, it is recommended that some of the 12" floor tile and mastic samples collected in buildings 16 and 27 that were found to be non-detect for asbestos, as detailed on the attached results, be confirmed using gravimetric preparation methods for nonfriable ACBM for more definitive results. If you would like to arrange for this additional lab work, please contact our office as soon as possible.

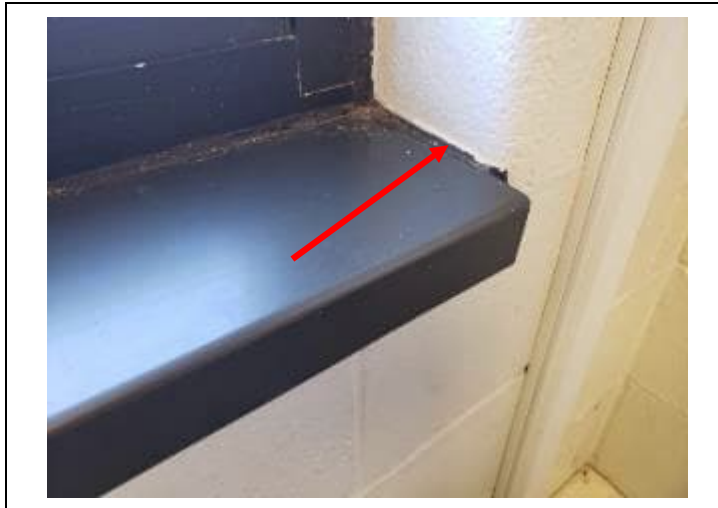
16. Breakroom 003, brown window caulking. No asbestos detected.

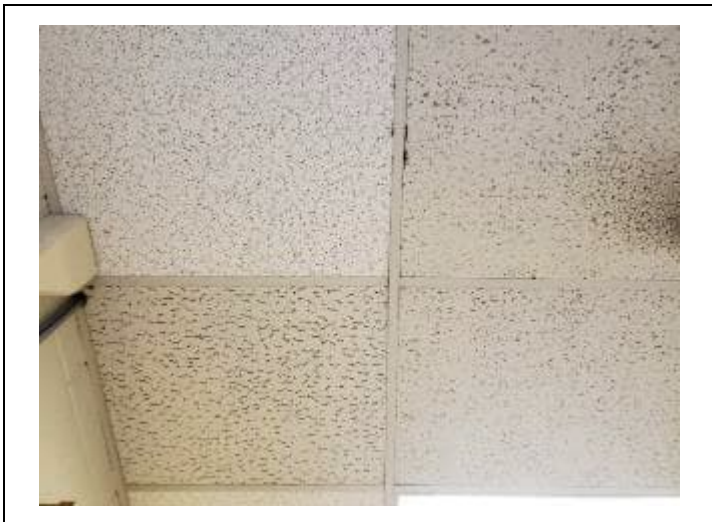
17. Breakroom 003, various types of suspended ceiling tiles present. No asbestos detected.

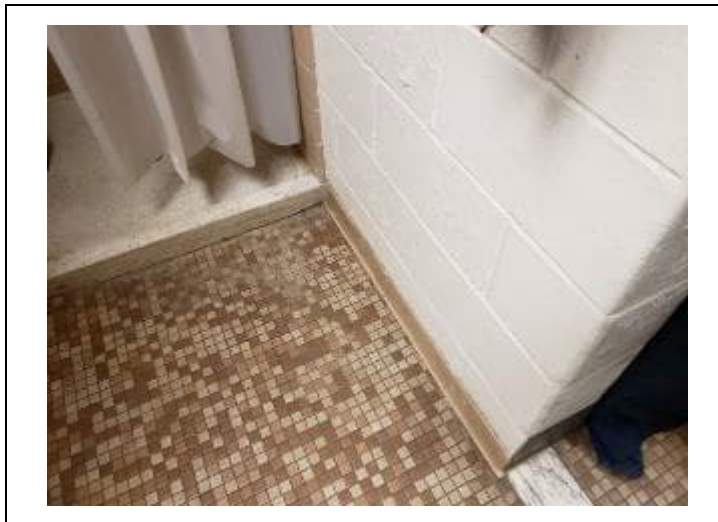
18. Men's Restroom 013, various grouts, mortars, and mastics around ceramic tile. No asbestos detected.

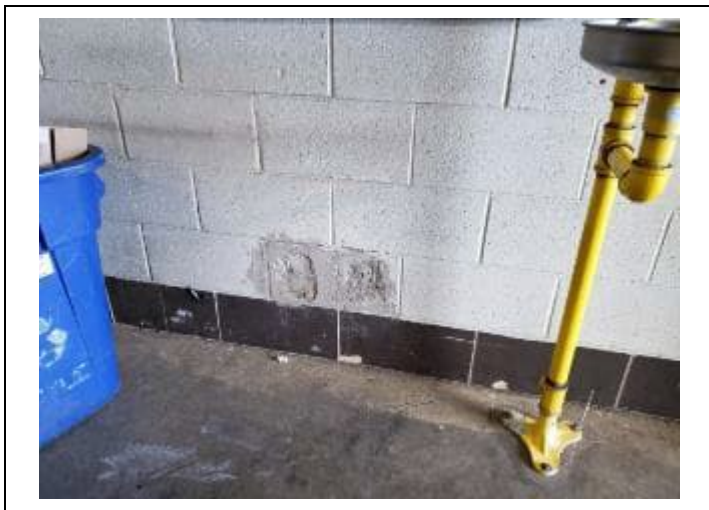
19. Maintenance area 017, white patch caulking along north wall. No asbestos detected.

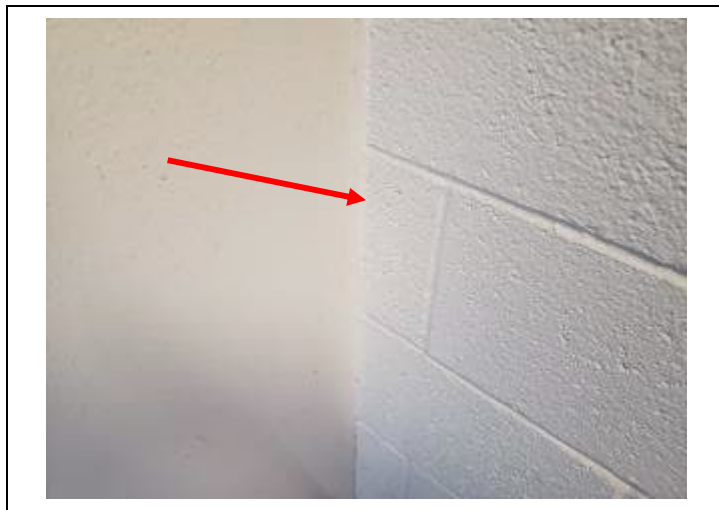
20. Vestibule 006, building seam caulking between gypsum wall and CMU block. No asbestos detected.

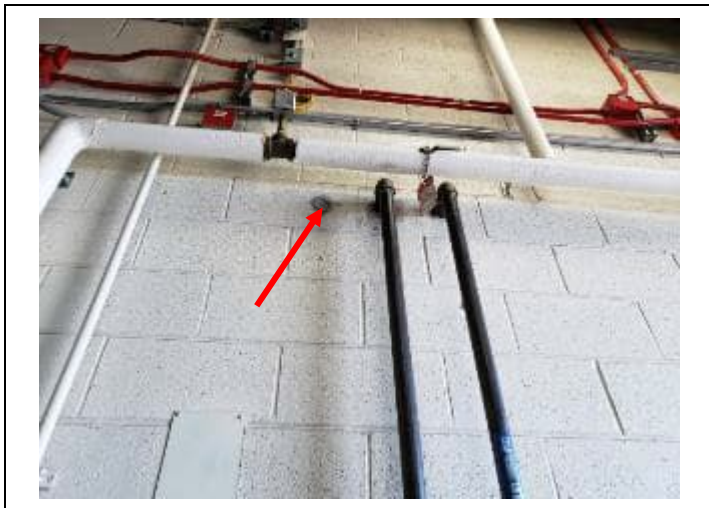
21. Maintenance area 017, grey putty around pipe penetrations. No asbestos detected.

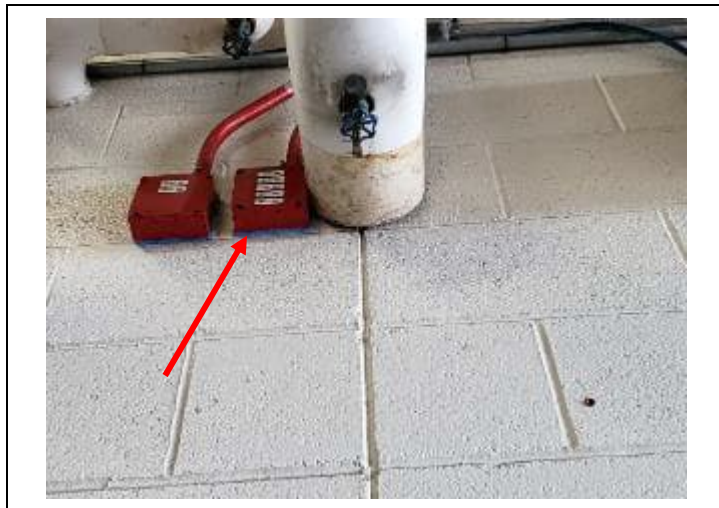
22. Maintenance area 017, blue putty around red electrical boxes. No asbestos detected.

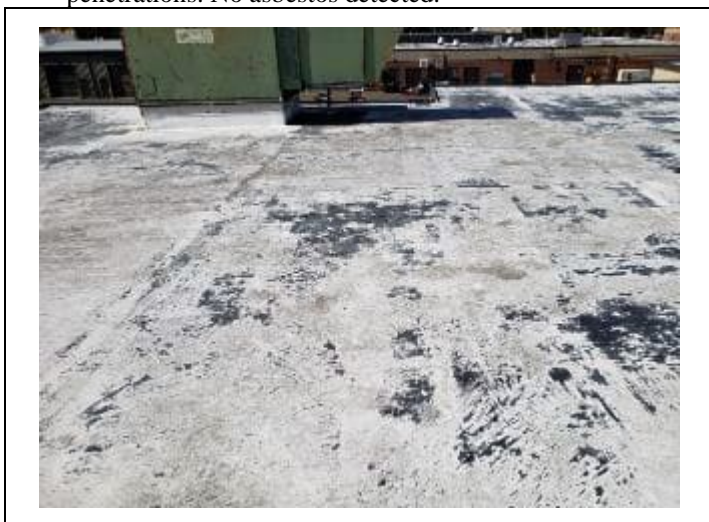
23. Building 16, sampling the roof was outside the scope of work for this survey.

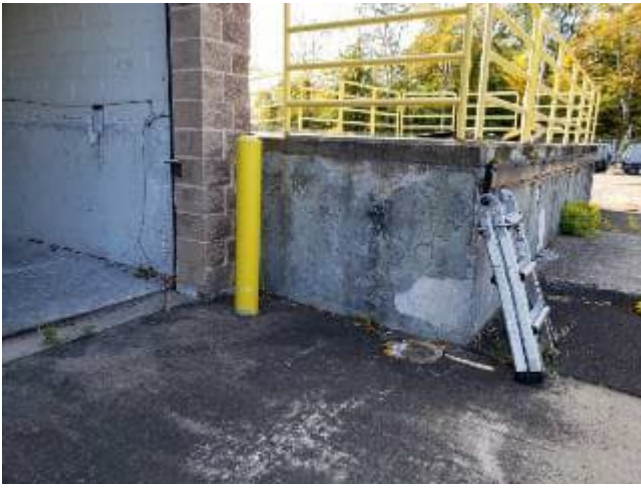
25. Building 31, exterior view of the platform and ramp.
Exterior materials were inventoried only.

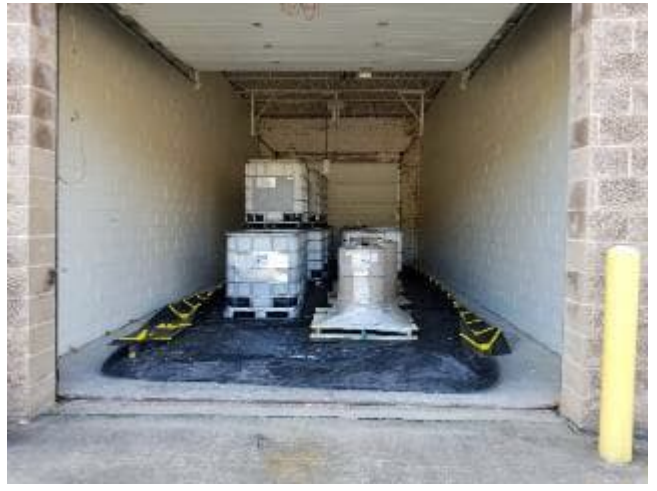
26. Building 31 includes 5 garage bays that open on either side.
One of the bays was used to store chemicals.
