**VOLUME II
ASBESTOS CONTAINING MATERIAL &
LEAD CONTAINING PAINT
SURVEY REPORT
BUILDING 62**

VISN 1
Bedford VA Medical Center
200 Springs Road
Bedford, Massachusetts

Project No. 2009023.008

February 15, 2011

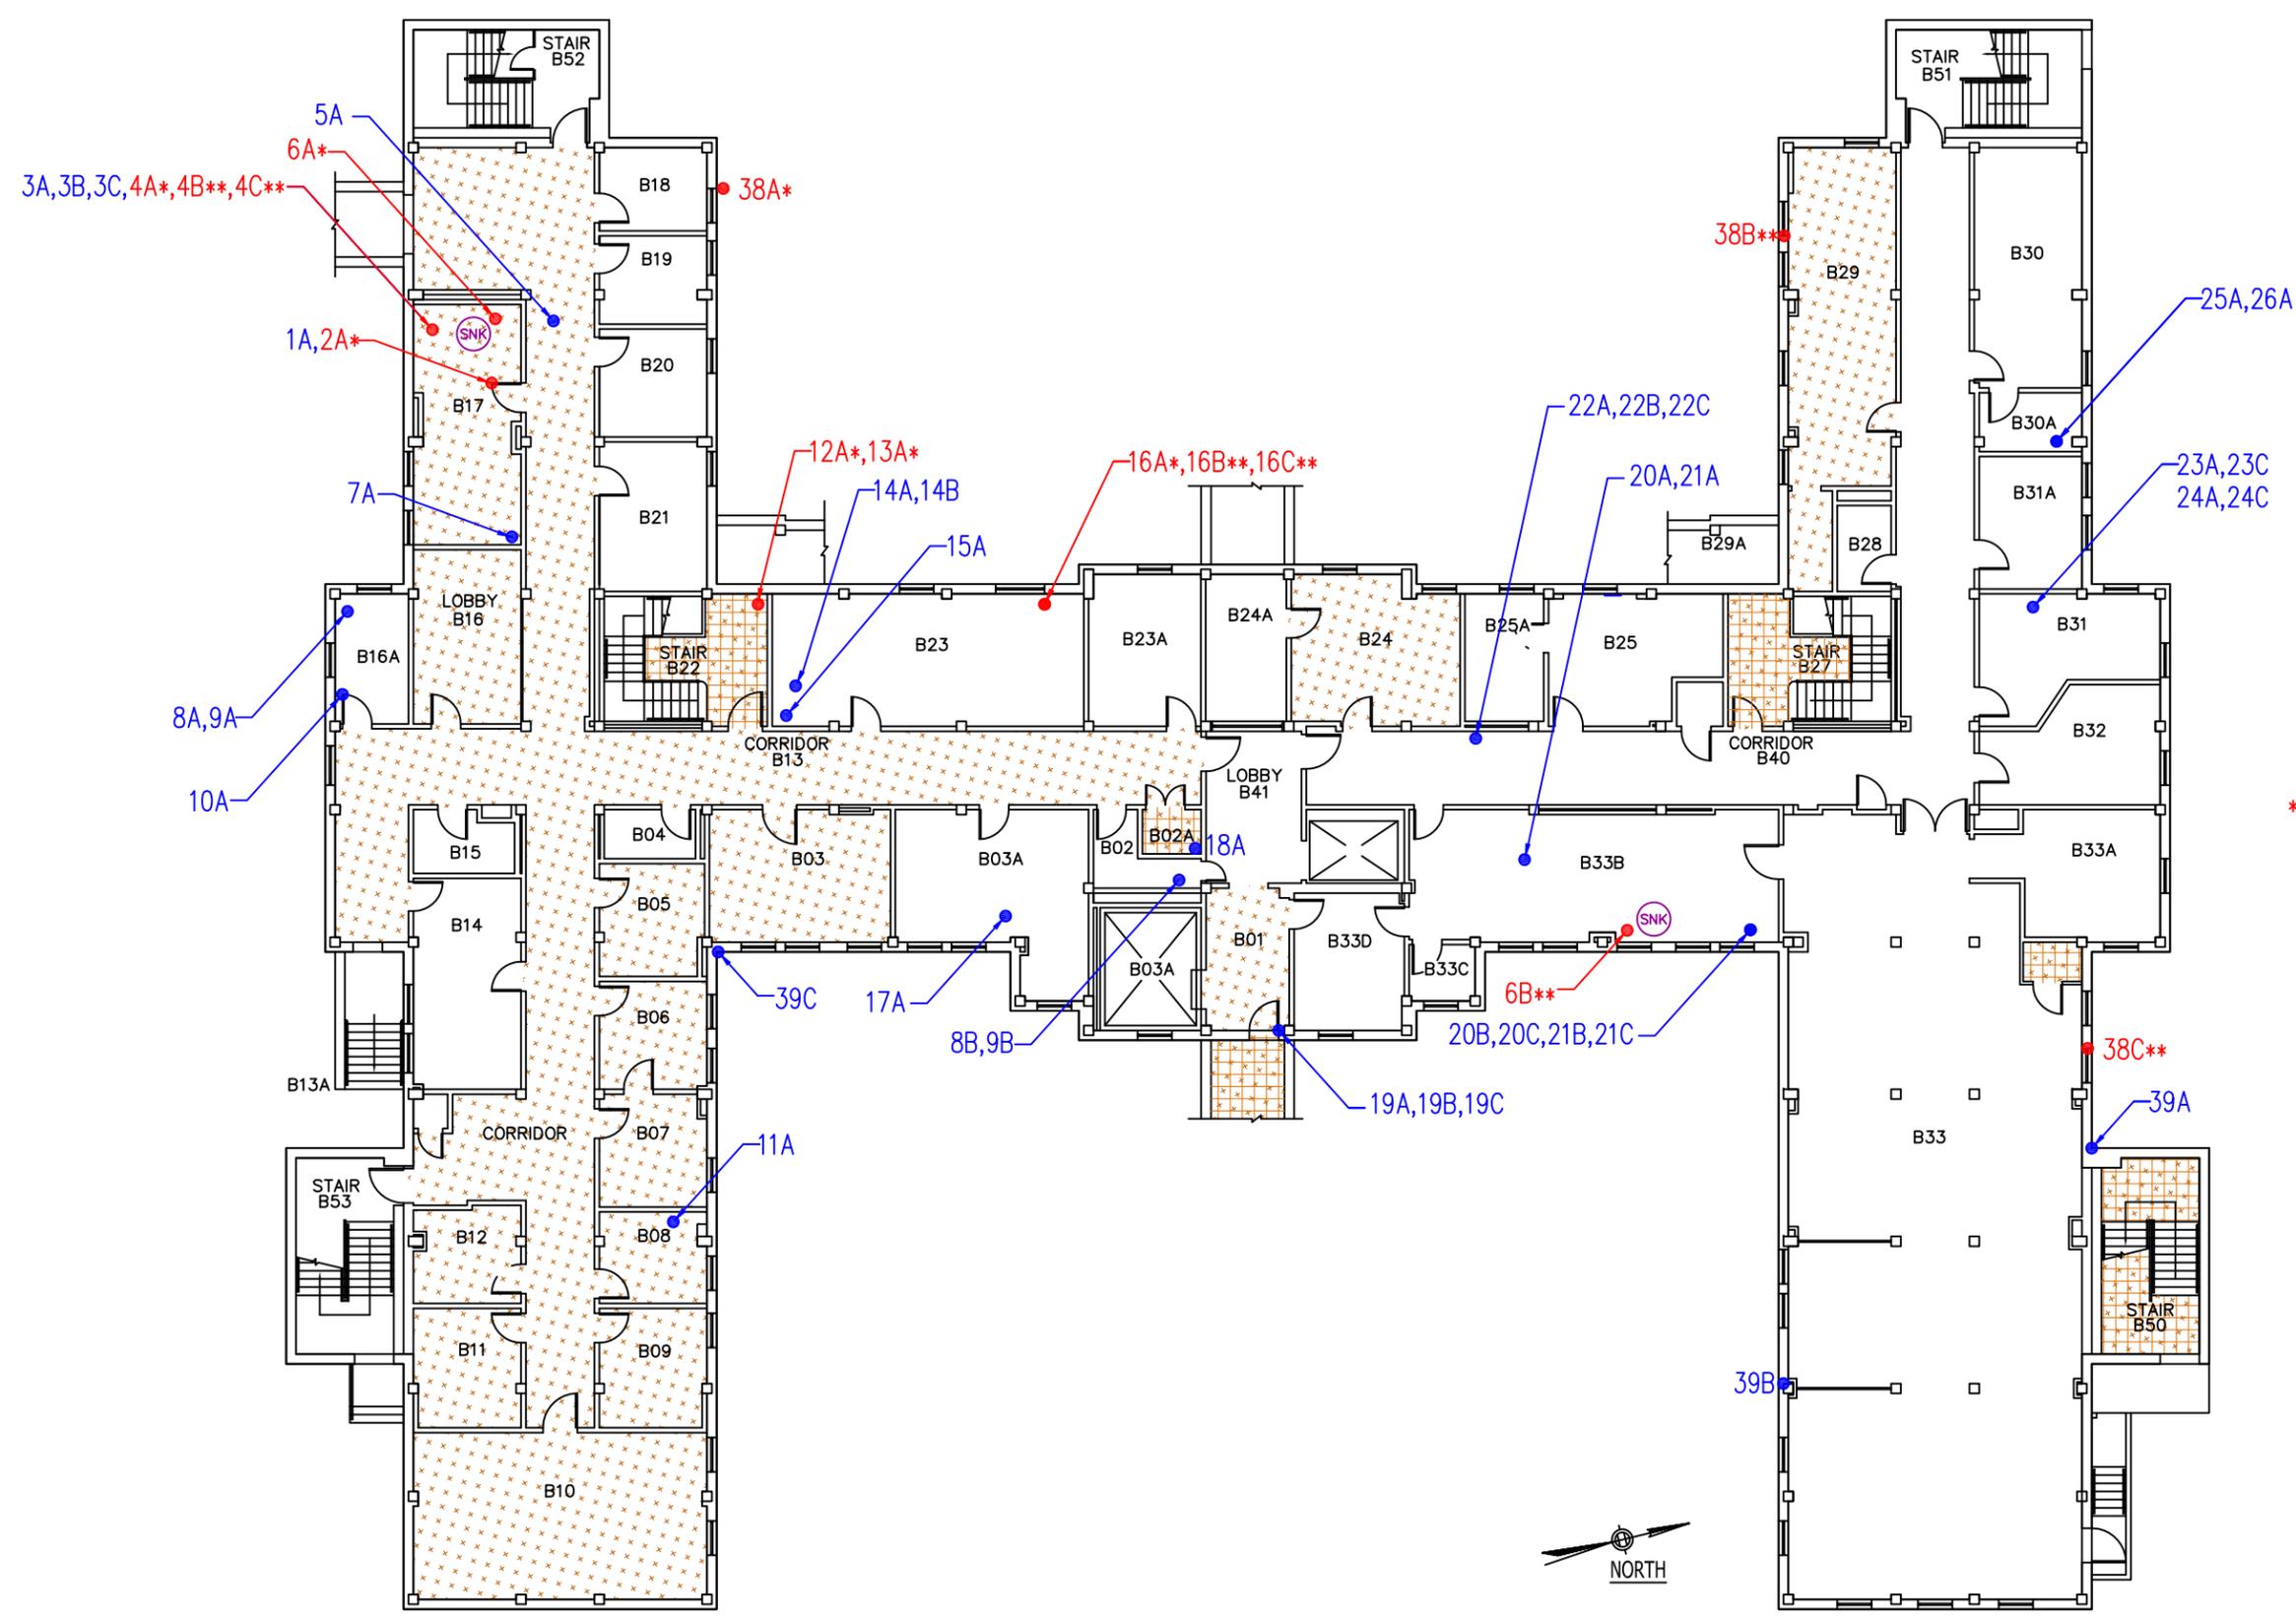
ASBESTOS SURVEY SUMMARY PLAN

- *EXTERIOR WINDOW CAULKING IS ACM*
- *EXTERIOR DOOR CAULKING IS ACM*
- *EXTERIOR VENT & BRICK CAULKING IS ACM*

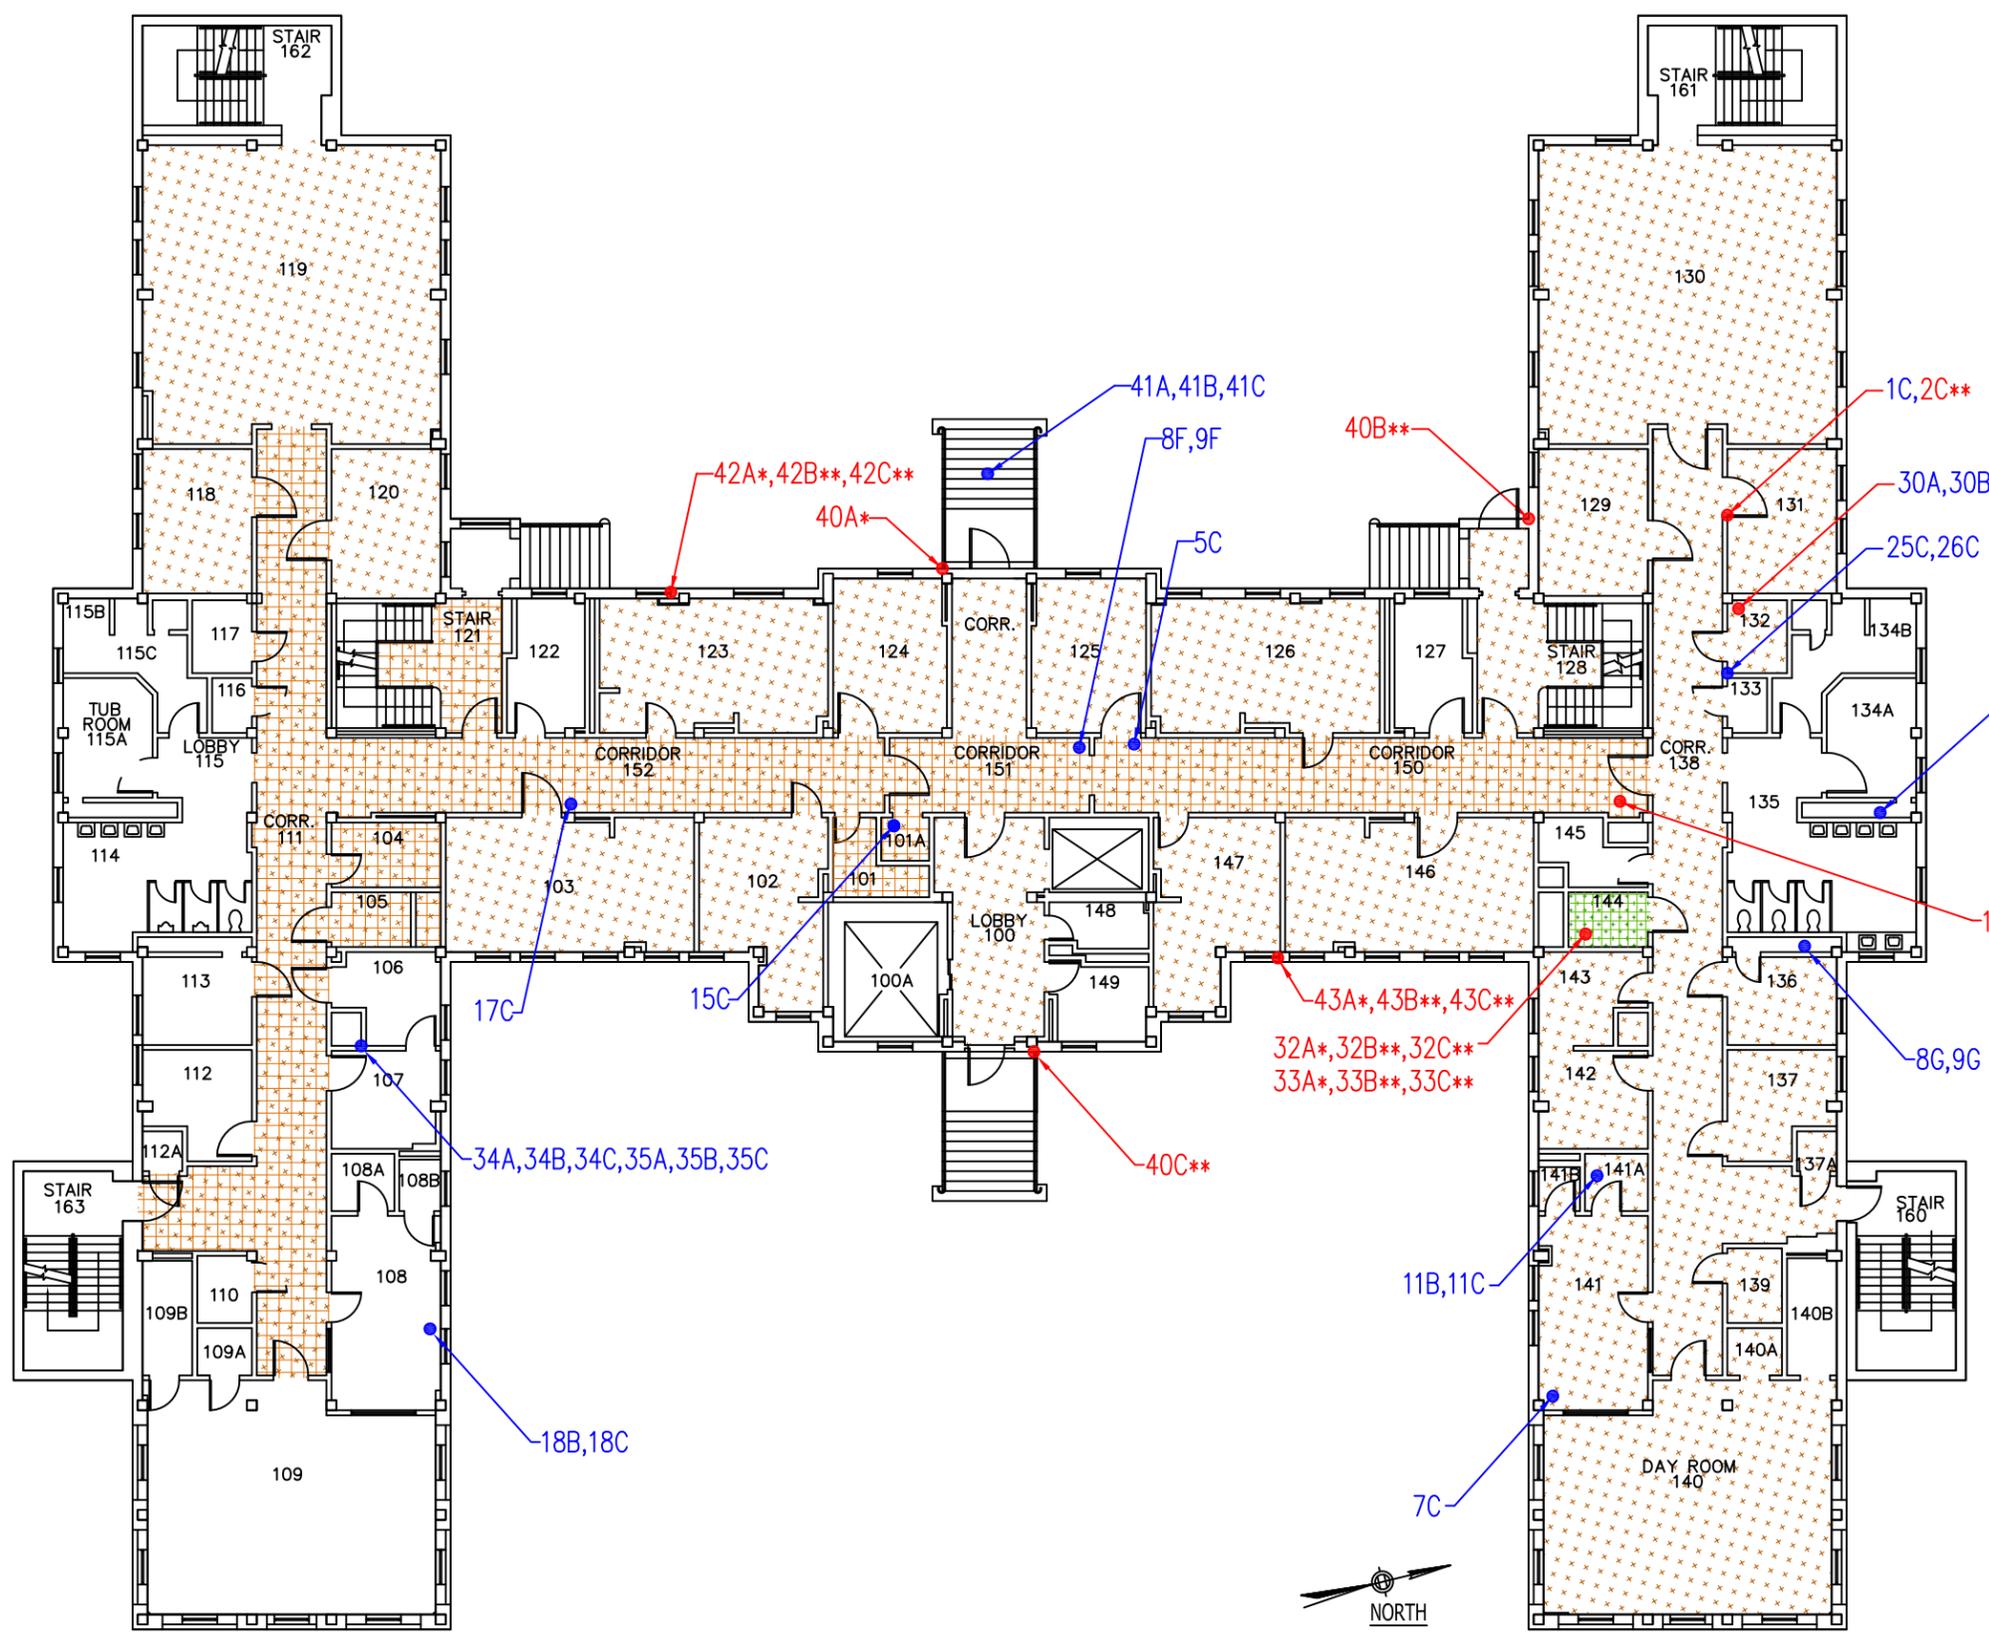
ASBESTOS SURVEY SUMMARY PLAN

- 12"x12" FLOOR TILE
- 12"x12" FLOOR TILE MASTIC
- 9"x9" FLOOR TILE
- 9"x9" FLOOR TILE MASTIC

- *EXTERIOR WINDOW CAULKING IS ACM*
- *EXTERIOR DOOR CAULKING IS ACM*
- *EXTERIOR VENT & BRICK CAULKING IS ACM*

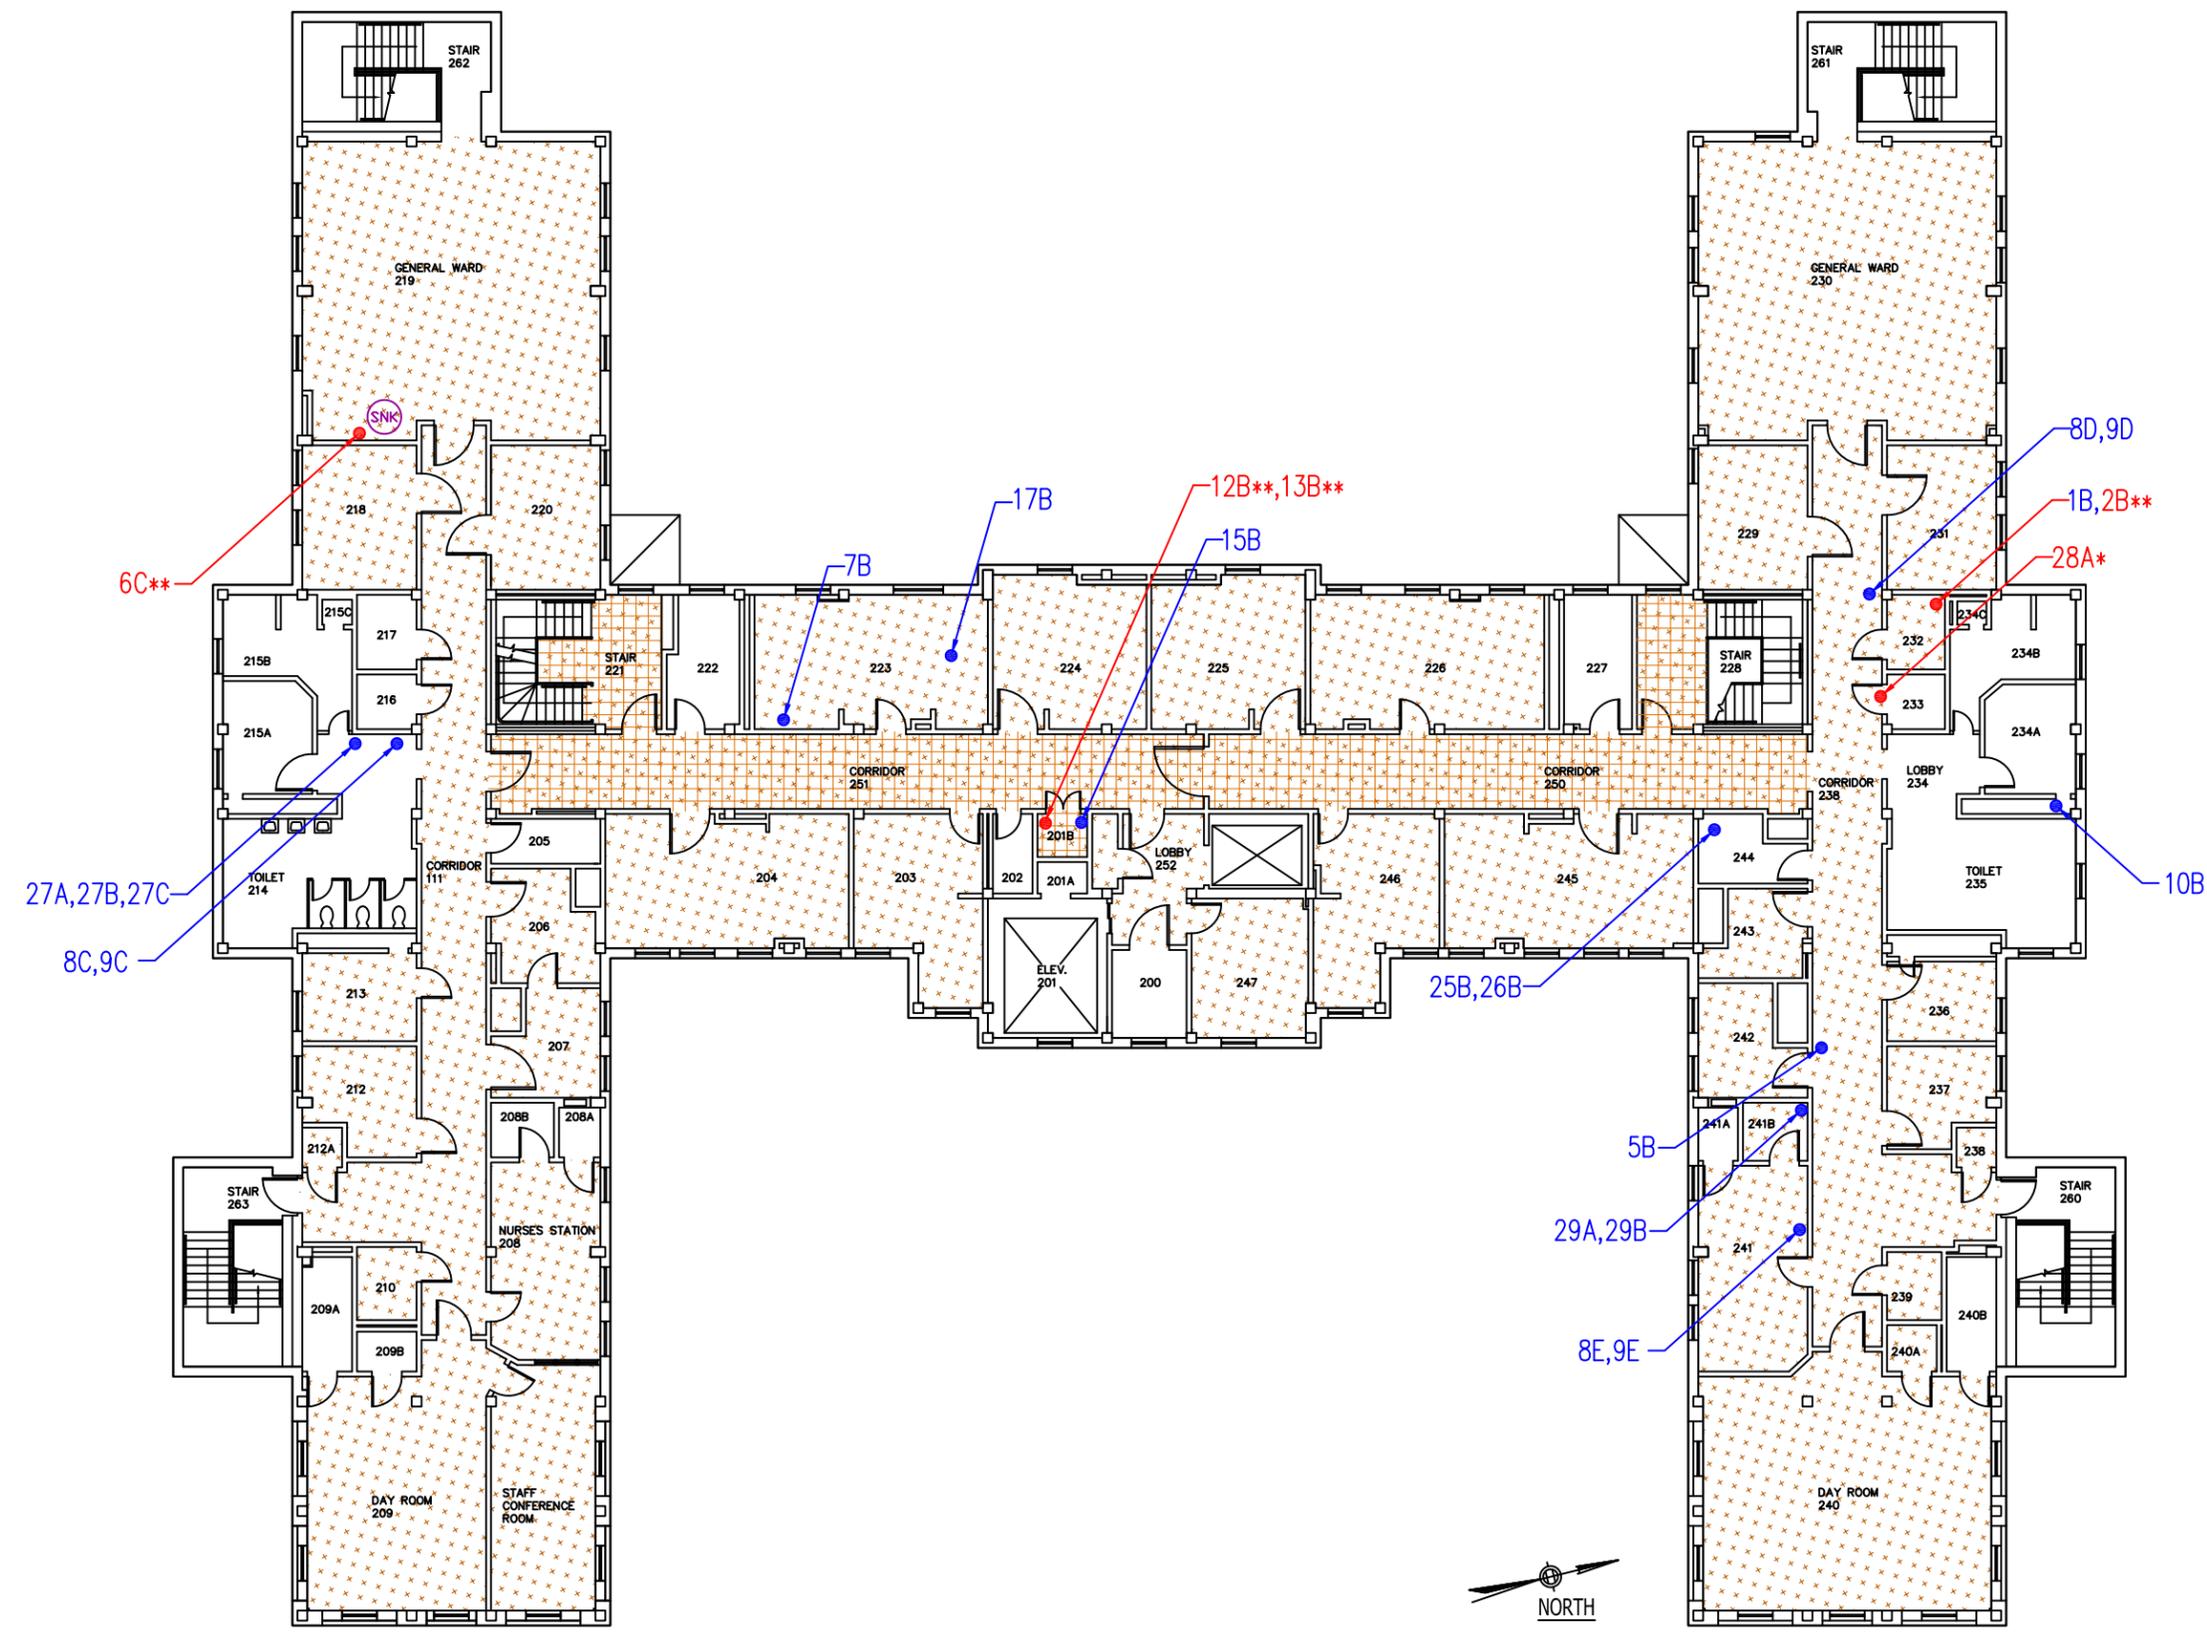
ASBESTOS SURVEY SUMMARY PLAN

EXTERIOR WINDOW CAULKING IS ACM
 EXTERIOR DOOR CAULKING IS ACM
 EXTERIOR VENT & BRICK CAULKING IS ACM

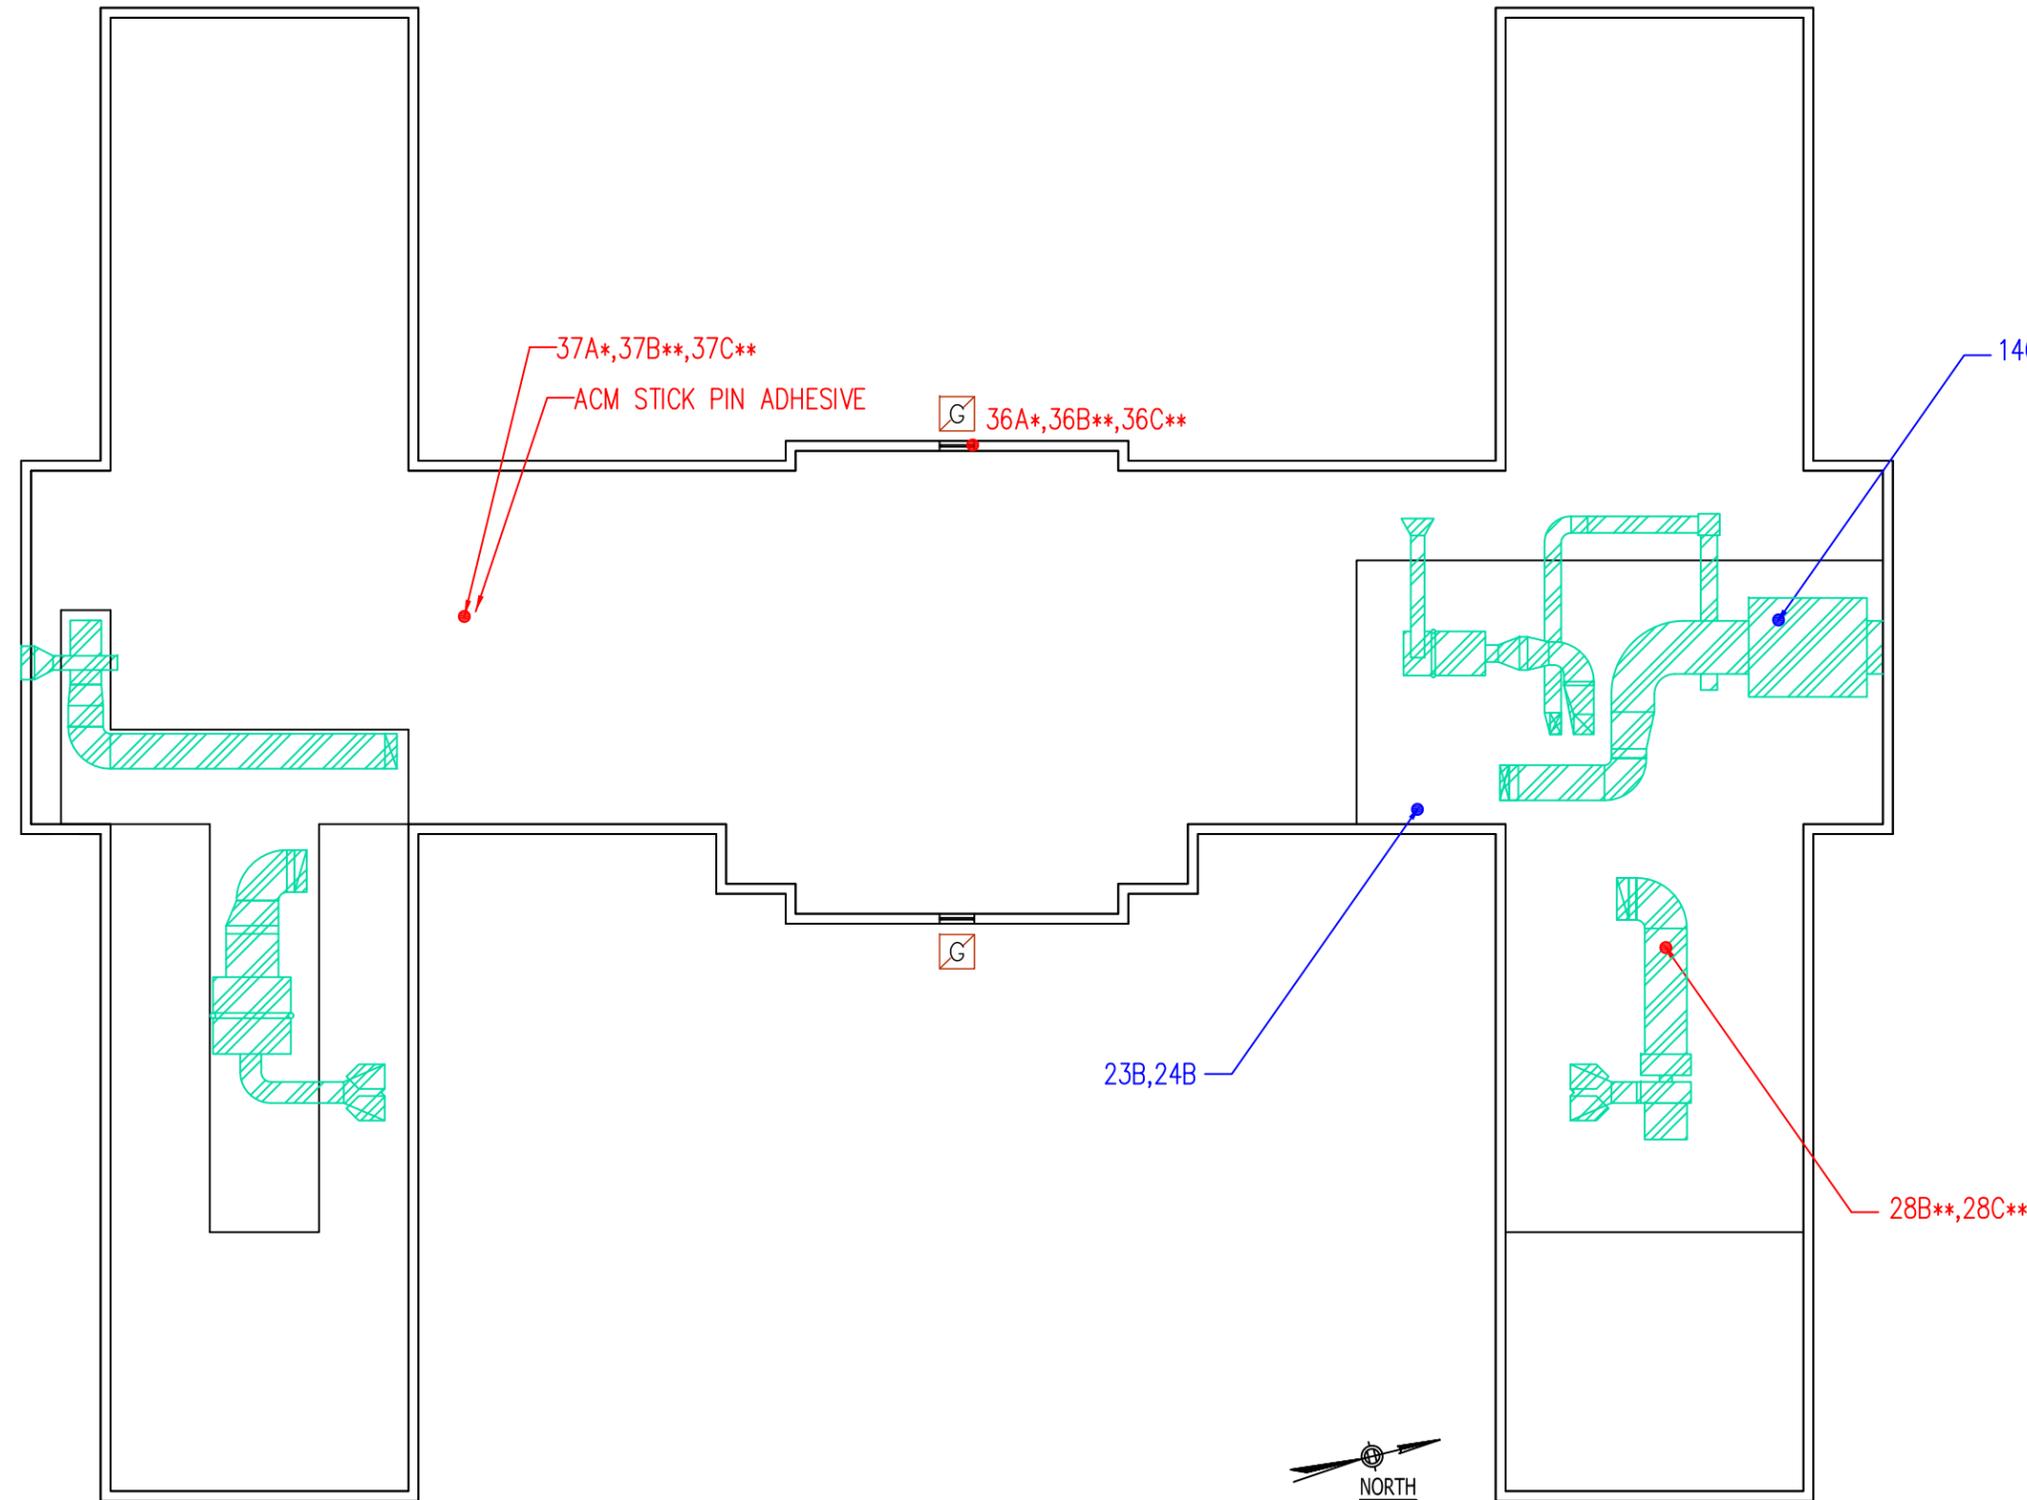
ASBESTOS SURVEY SUMMARY PLAN

- 1,2 APPROXIMATE SAMPLE LOCATION
- 25x SAMPLE GREATER THAN 1% ASBESTOS
- 25** STOP POSITIVE SAMPLE FOR ASBESTOS
- 25 NO ASBESTOS DETECTED (NAD)
- HATCHED AREAS INDICATE POSITIVE DETECTION OF ASBESTOS CONTAINING BUILDING COMPONENTS
- ACM DUCT MASTIC
- ACM WINDOW GLAZING

- *EXTERIOR WINDOW CAULKING IS ACM*
- *EXTERIOR DOOR CAULKING IS ACM*
- *EXTERIOR VENT & BRICK CAULKING IS ACM*

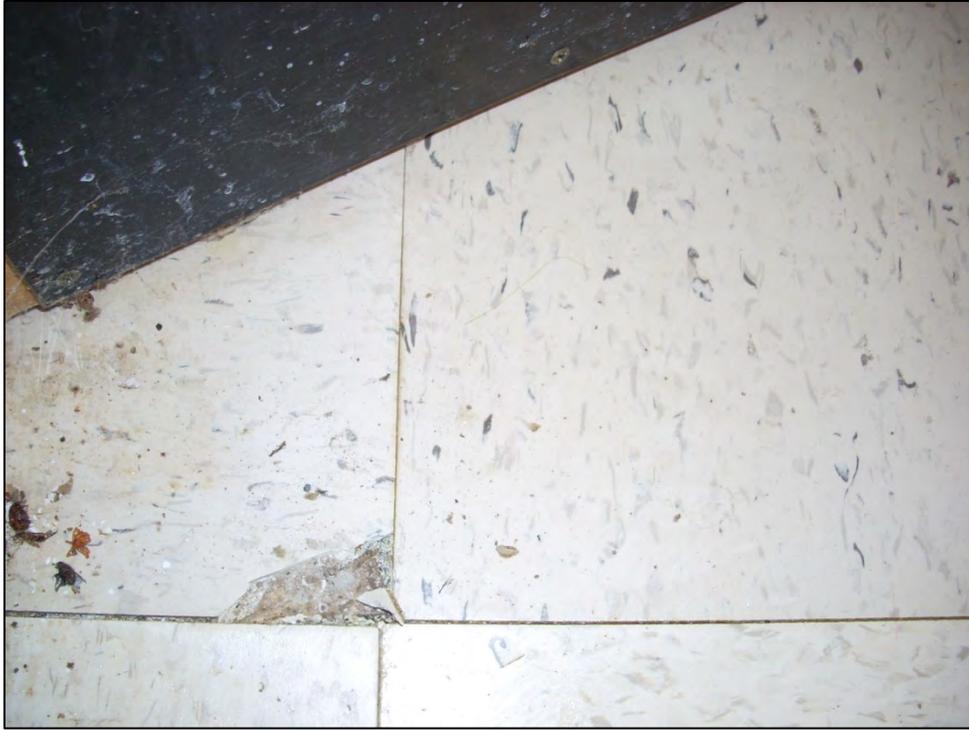
12"x12" White with Black Fleck Floor Tile Mastic
Sample 02A

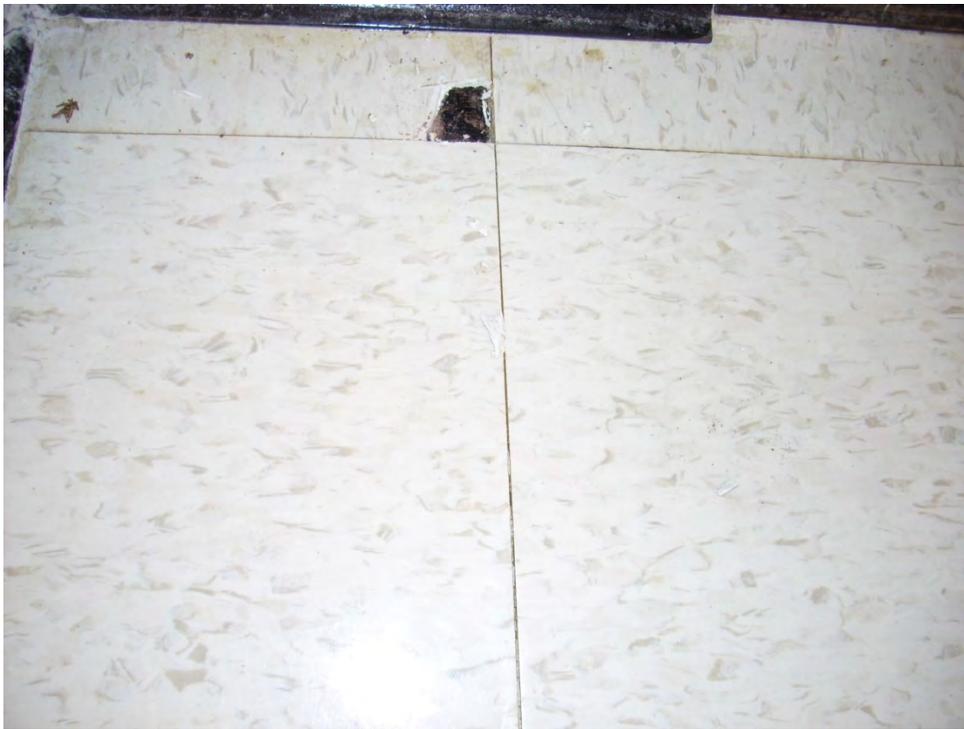
12"x12" White with Gray Fleck Floor Tile Mastic
Sample 04A

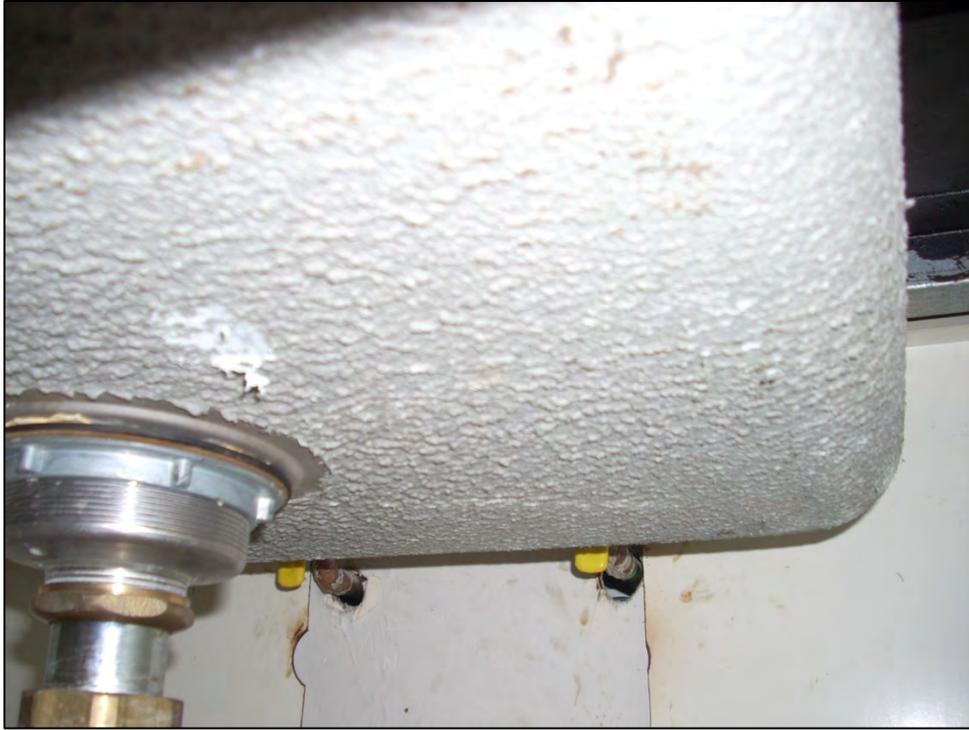
Gray Sink Undercoating
Sample 06A

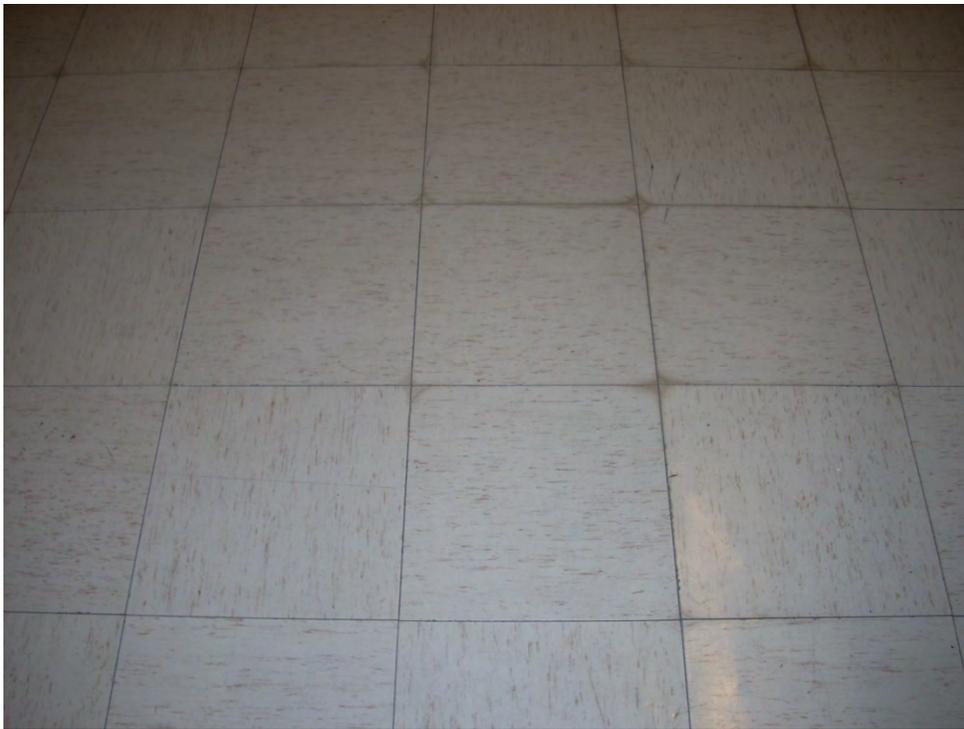
12"x12" Tan with Brown Streaks Floor Tile and Mastic
Samples 12A and 13A

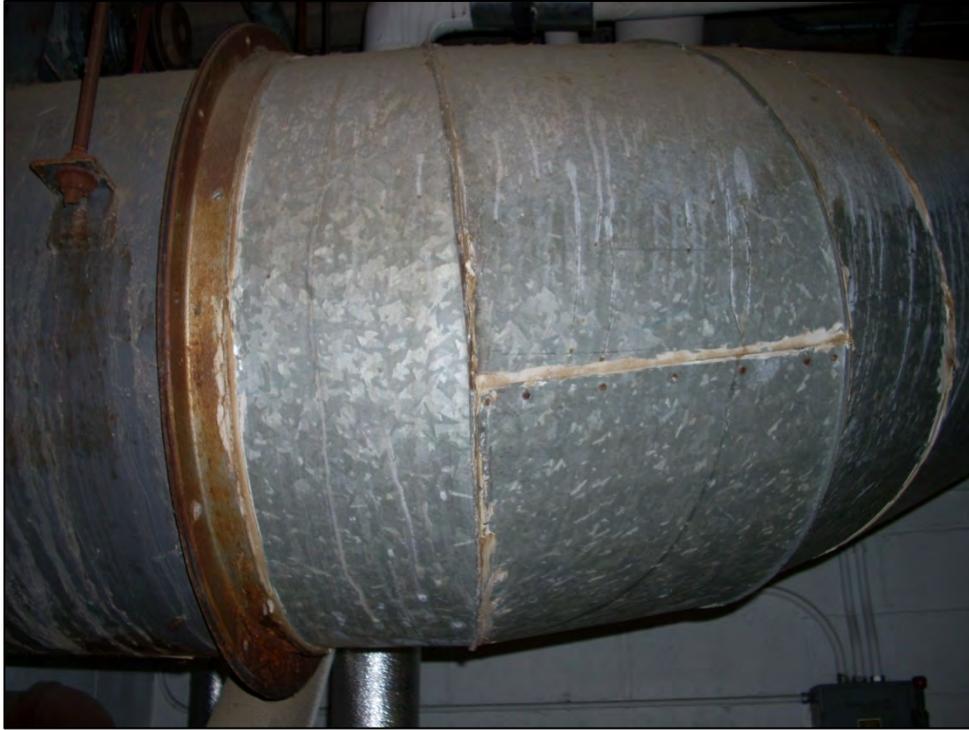
White Duct Mastic
Sample 16A

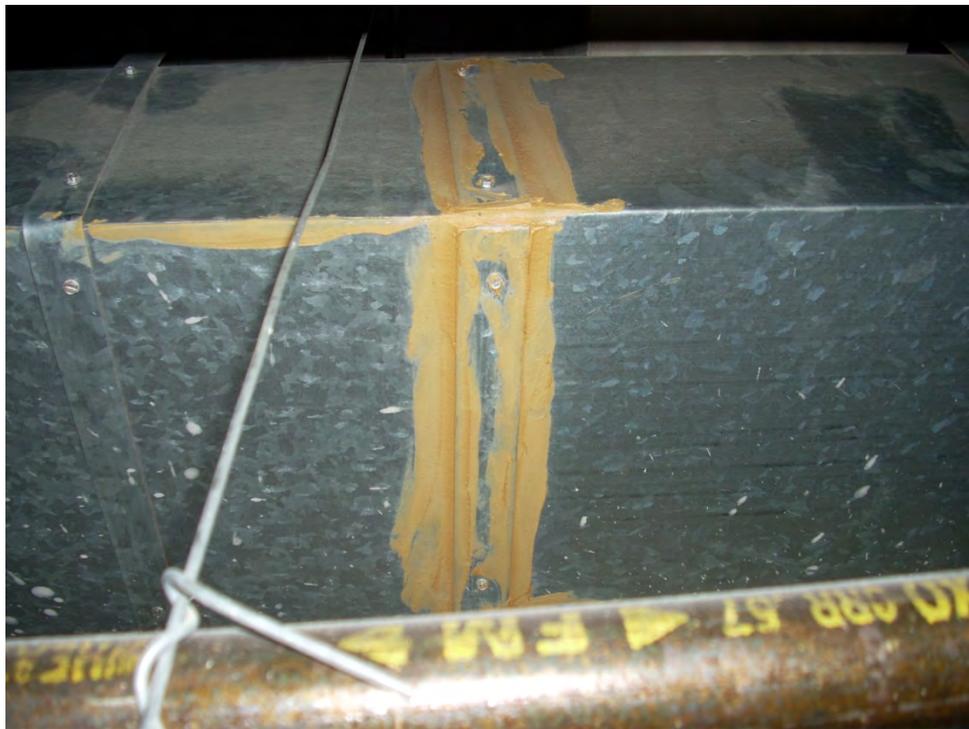
Tan Duct Mastic
Sample 28A

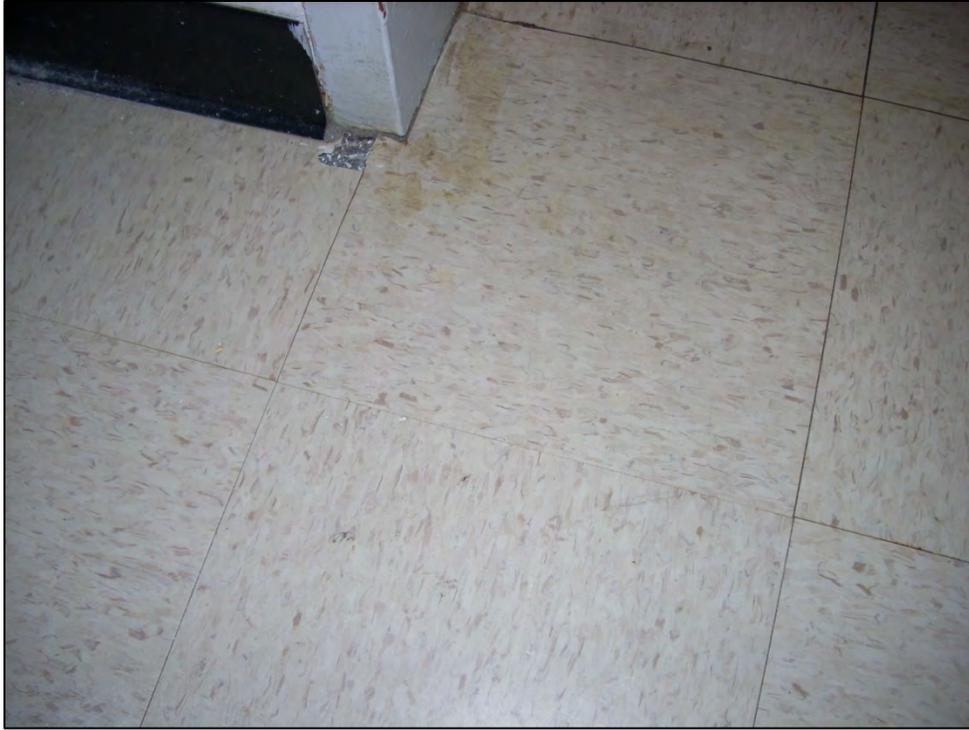
12"x12" Tan With Brown Fleck Floor Tile Mastic
Sample 31A

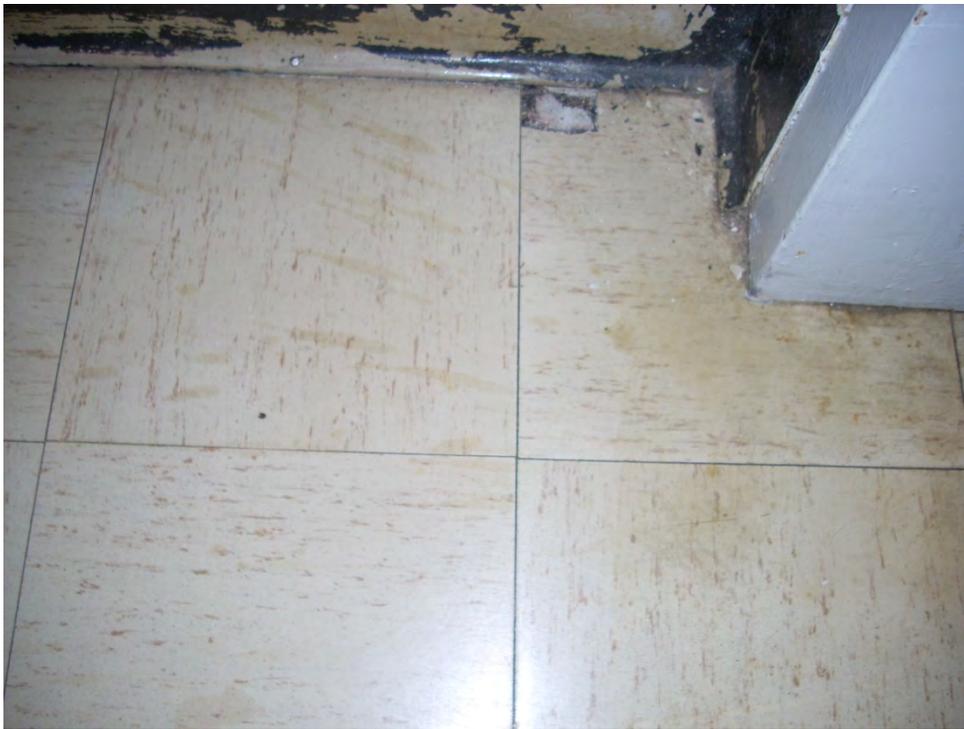
9"x9" Tan With Brown Streaks Floor Tile and Mastic
Samples 32A and 33A

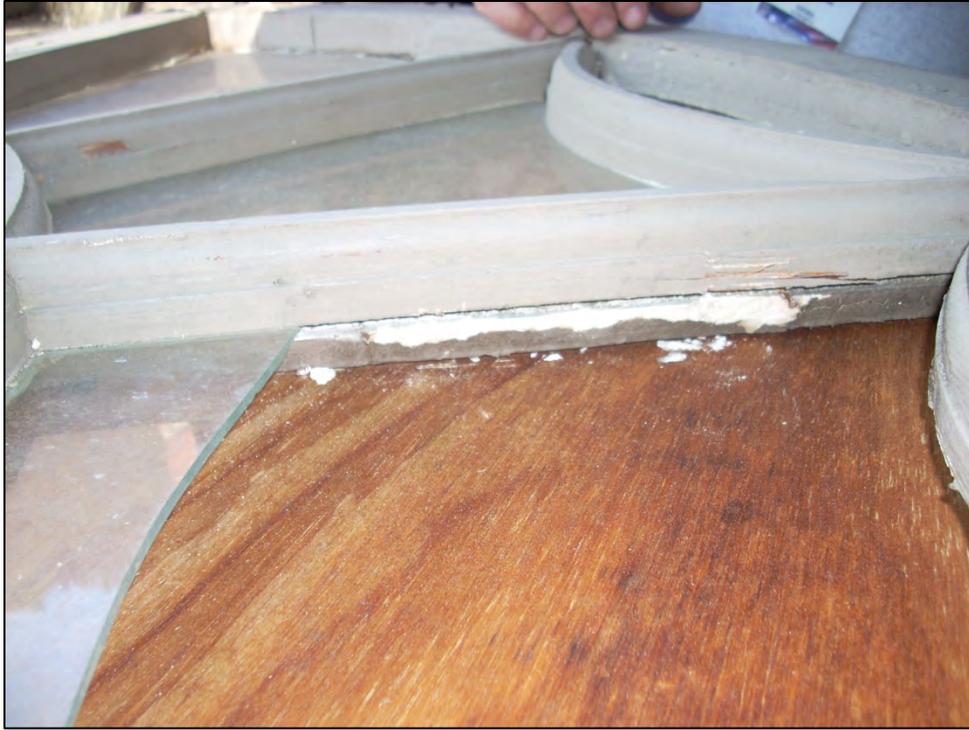
Window Glazing
Sample 36A

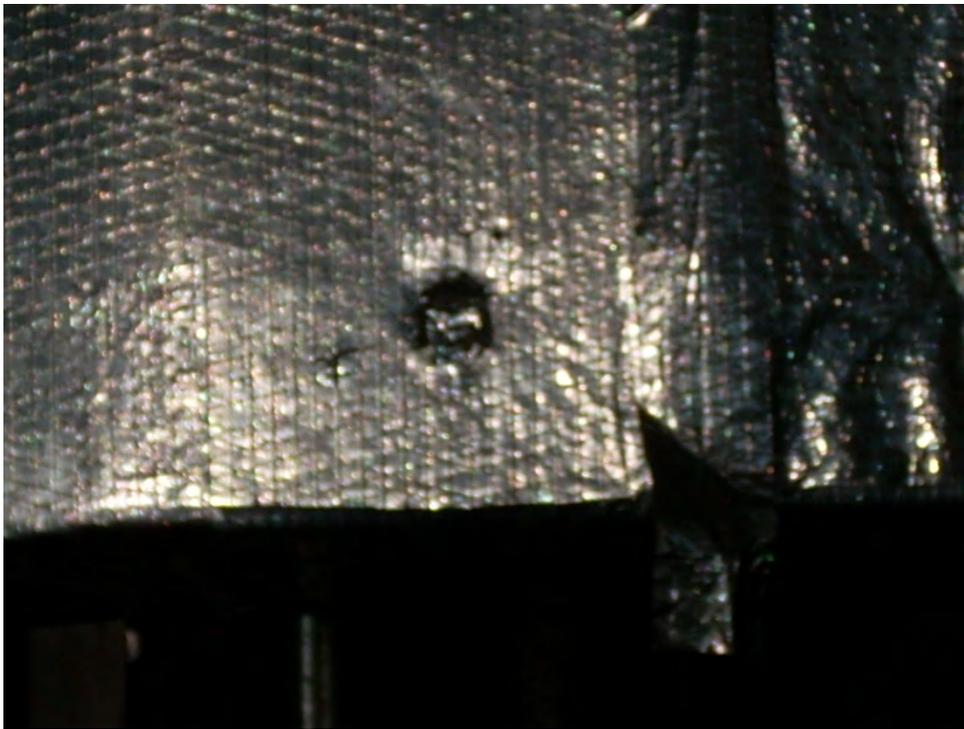
Stick Pin Adhesive
Sample 37A

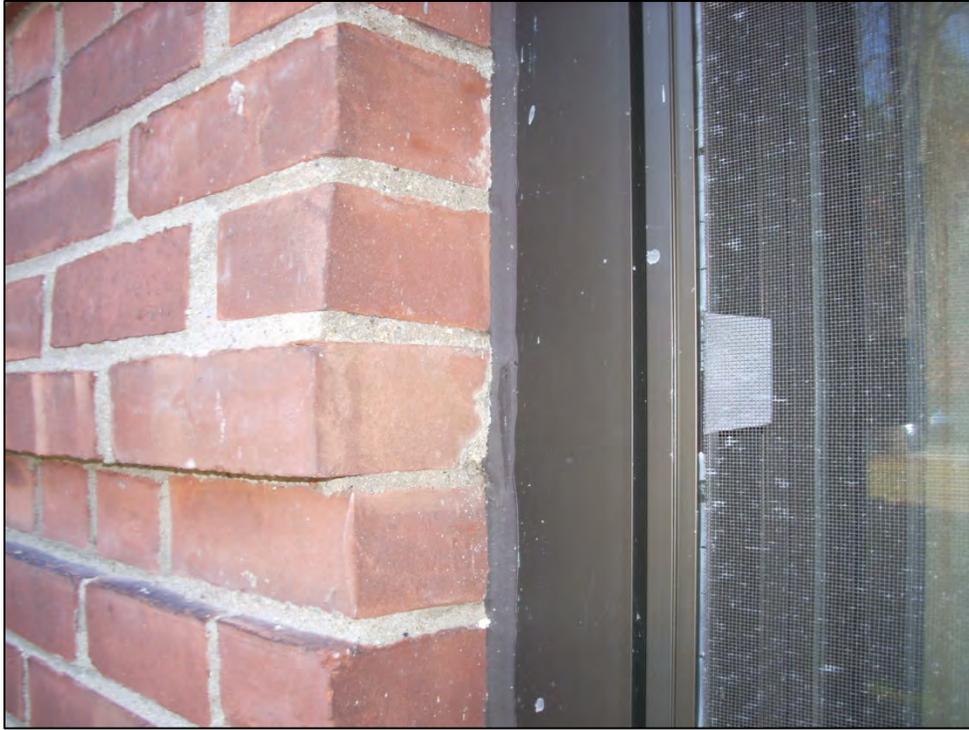
Black Window Caulking
Sample 38A

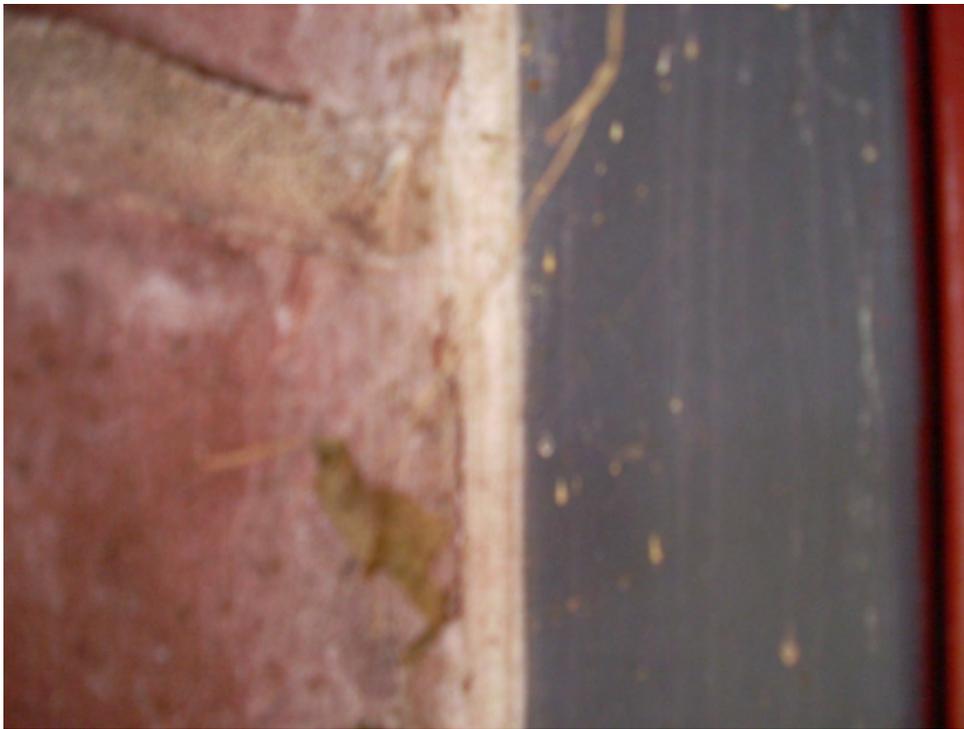
White Door Caulking
Sample 40A

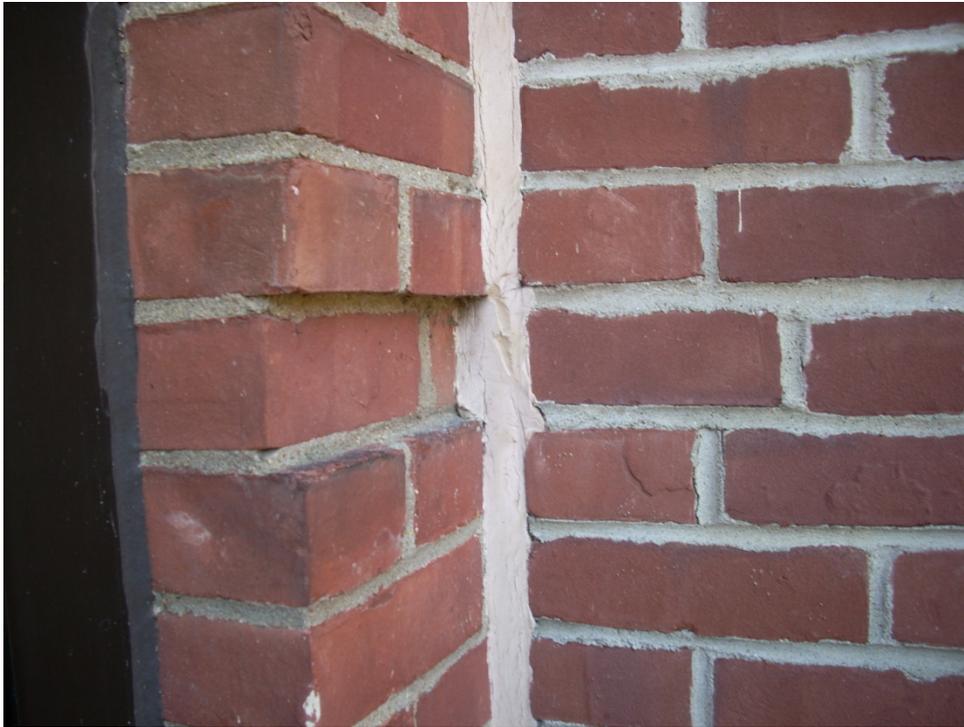
White Brick Caulking
Sample 43A
