## **VOLUME II ASBESTOS CONTAINING MATERIAL & LEAD CONTAINING PAINT SURVEY REPORTS**

**VISN 1**  
**Brockton VA Medical Center**  
940 Belmont Street  
Brockton, Massachusetts

Project No. 2009023.003

June 21, 2010

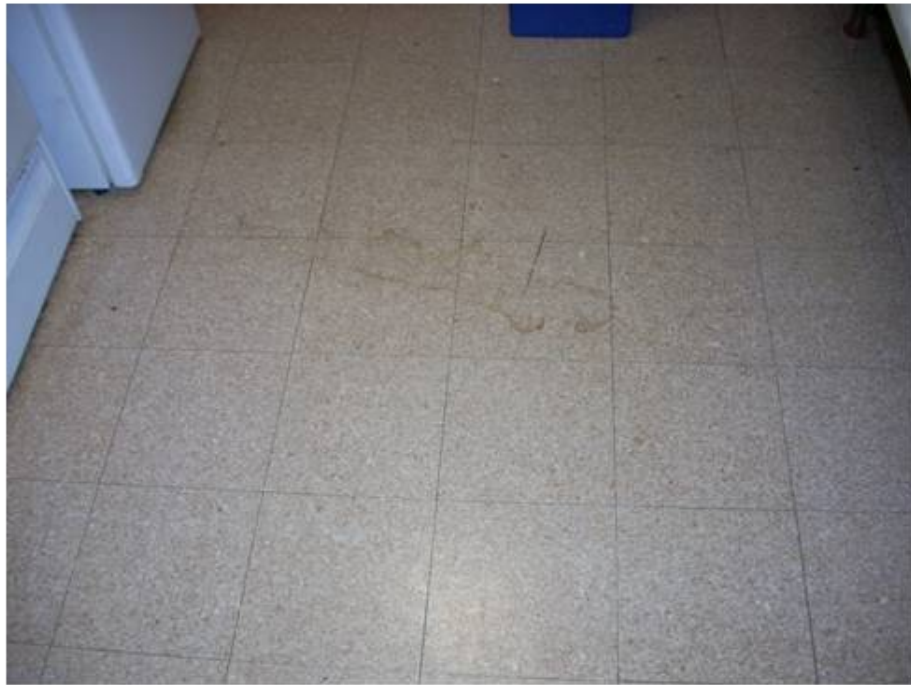
Mastic Associated with 12"x12" Light Brown Floor Tile, Sample 13A

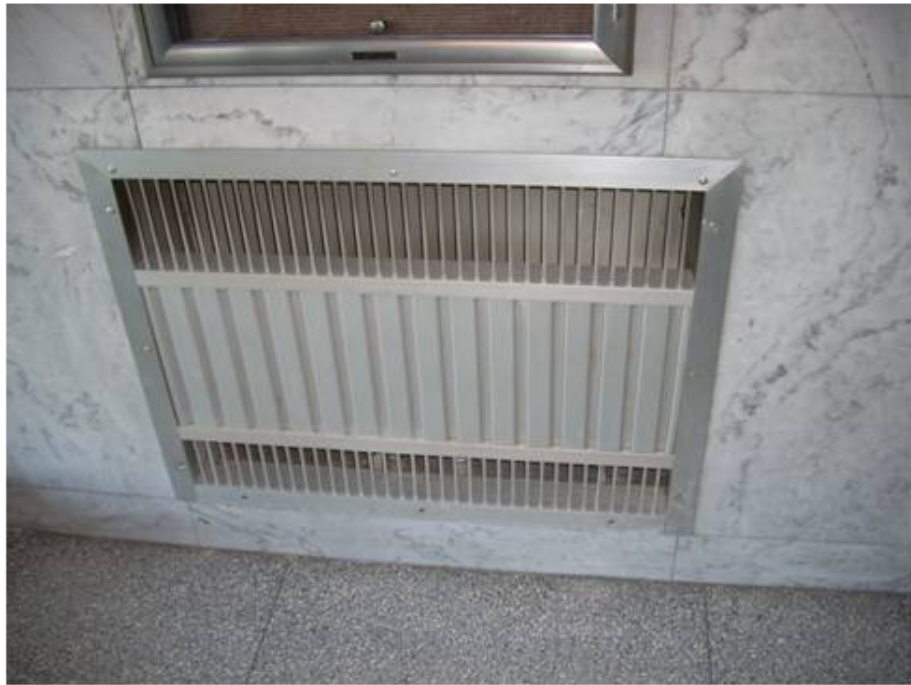
Transite Covering Inside Heater, Sample 18A

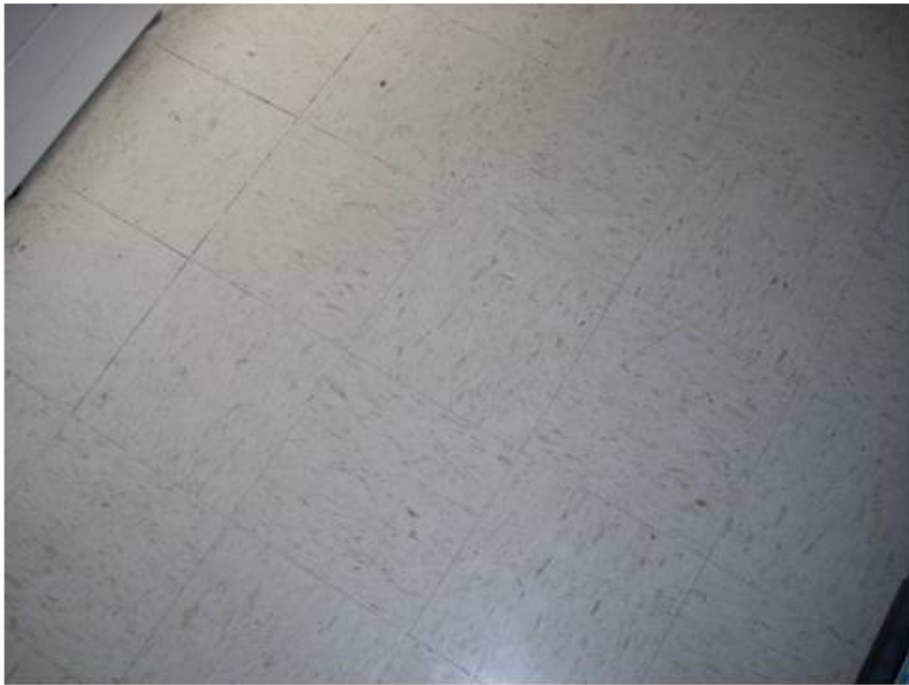
12"x12" Off White Floor Tile, Sample 21A

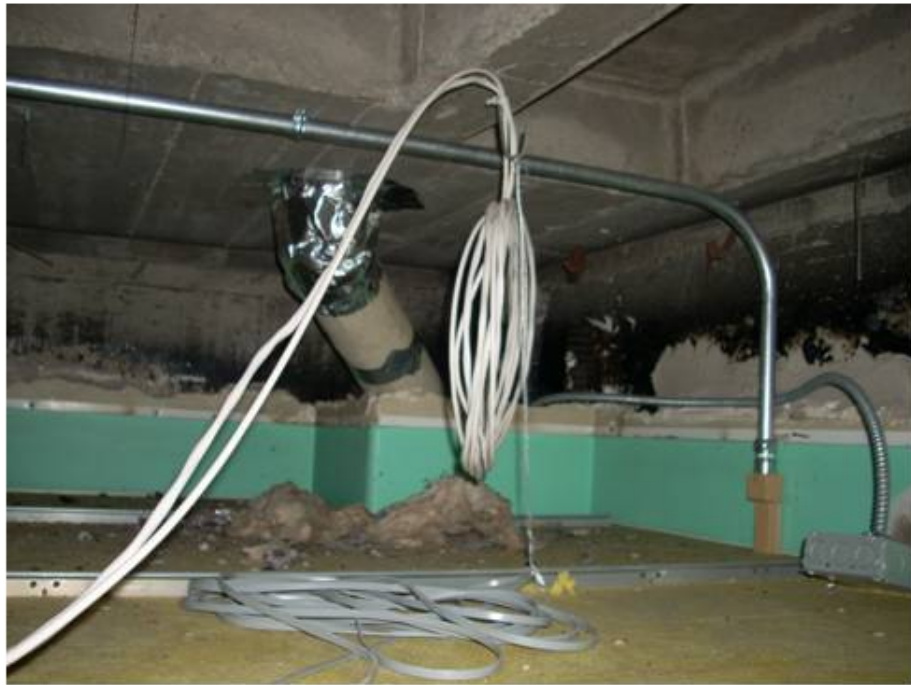
6" Pipe Insulation, Sample 24A

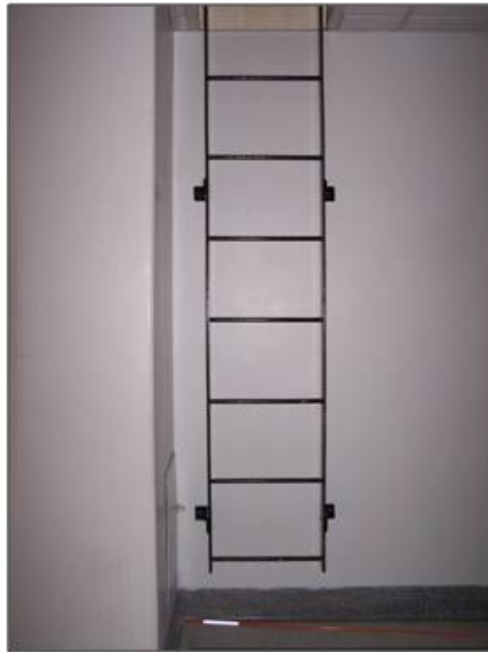
Metal ladder, Reading 222

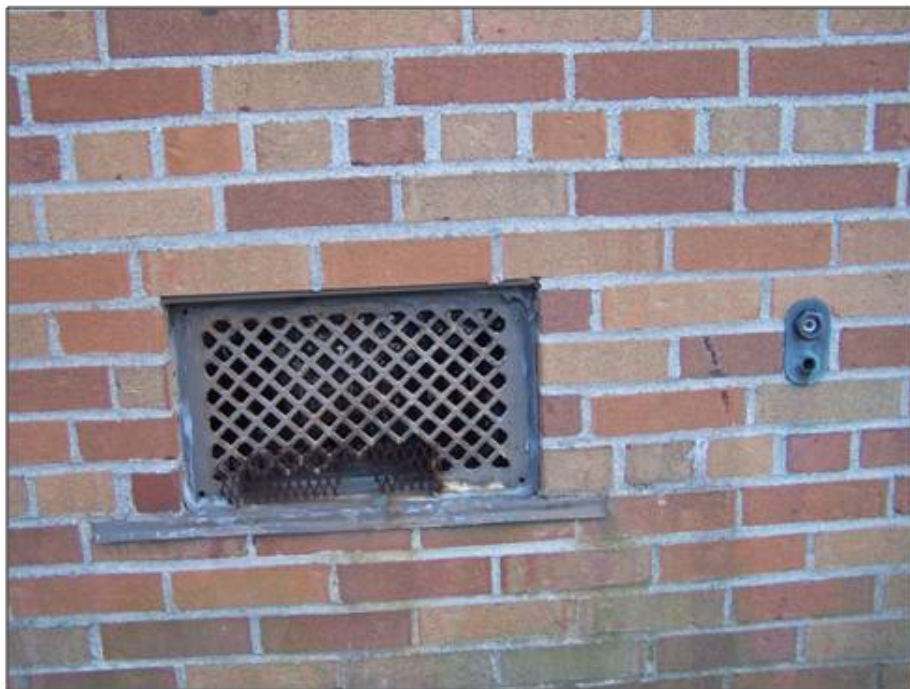
Metal Grill Cover, Reading 435

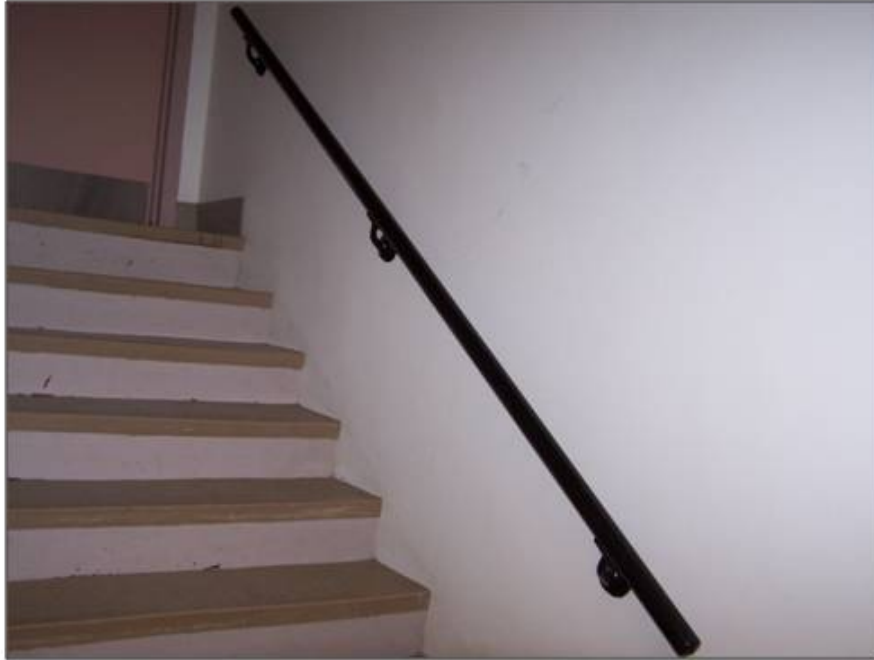
Metal Handrail, Reading 1251

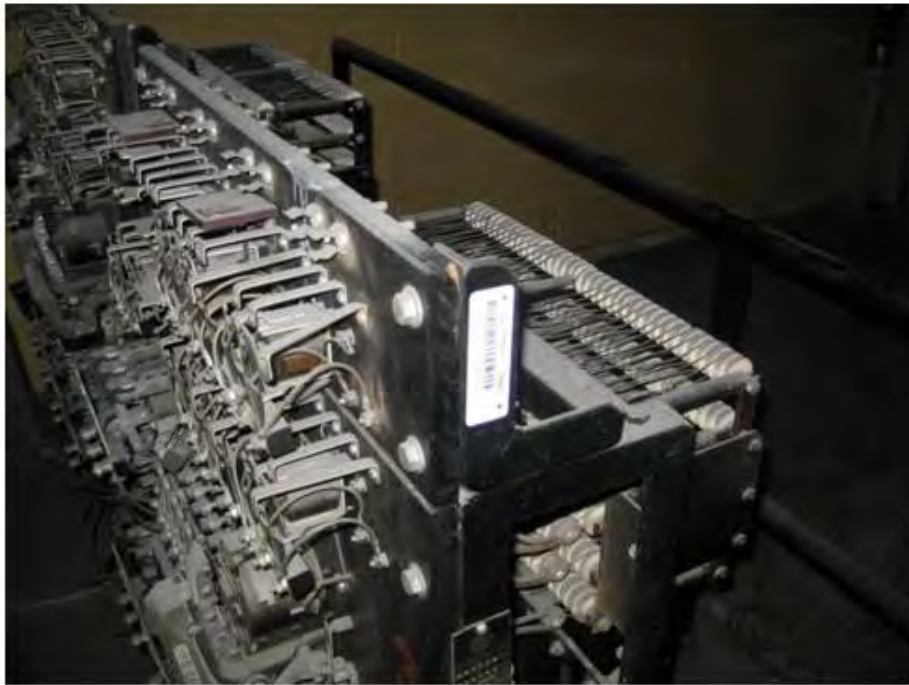
Black Ebony Board, Sample 9A

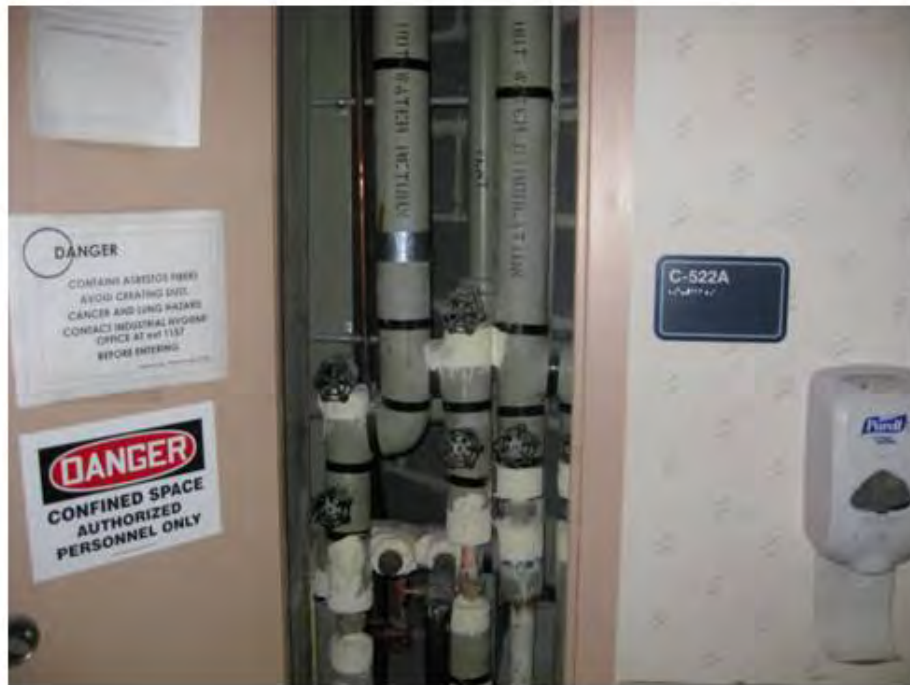
4" Pipe Insulation, Sample 17A

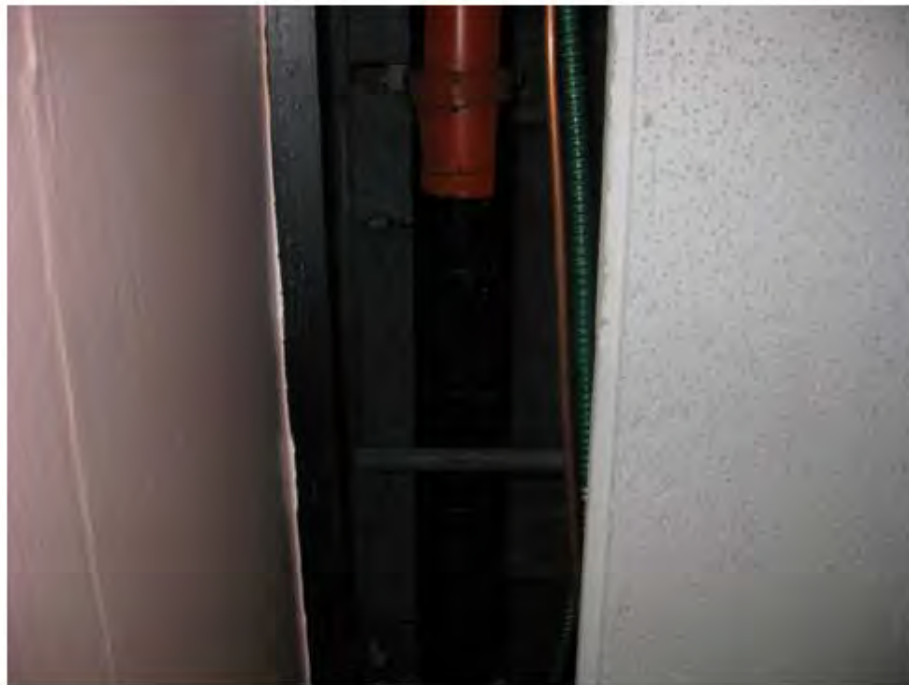
Black Cork Pipe Insulation, Sample 22A

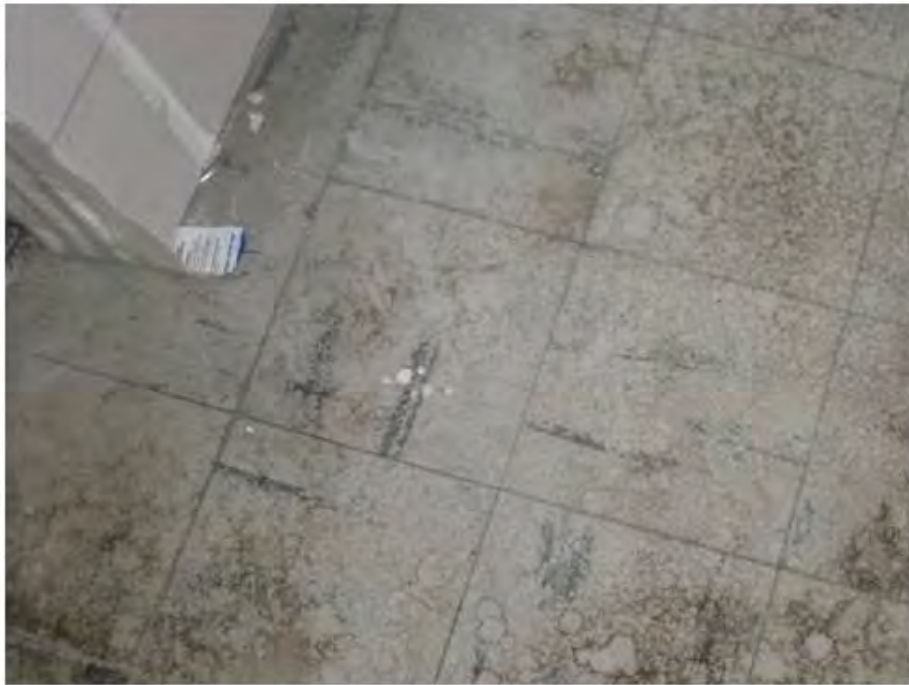
9"x9" Floor Tile-Type I, Sample 29A

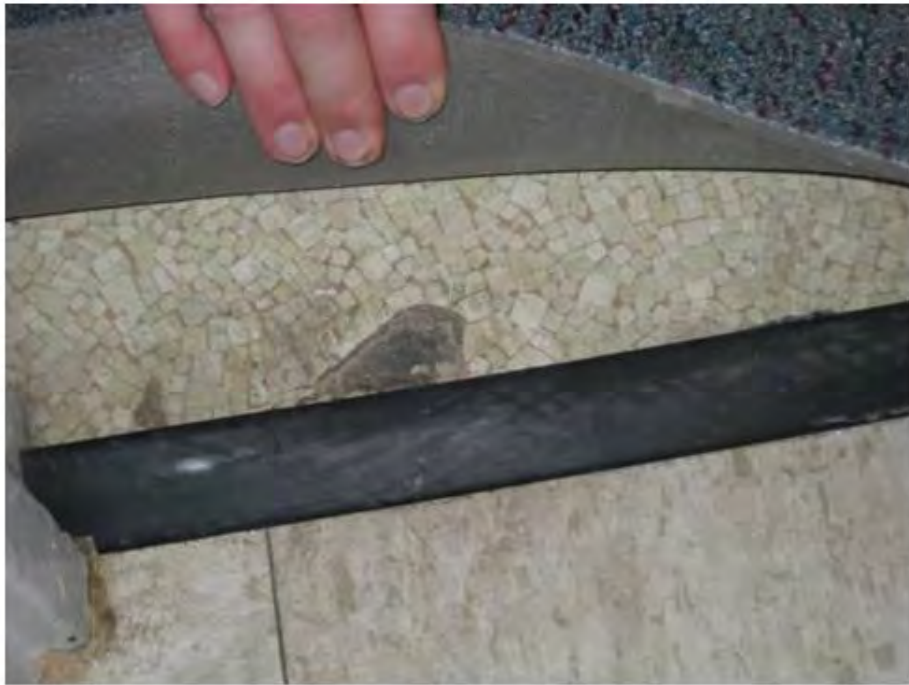
SheetFlooring-Type I (Old), Sample 34A

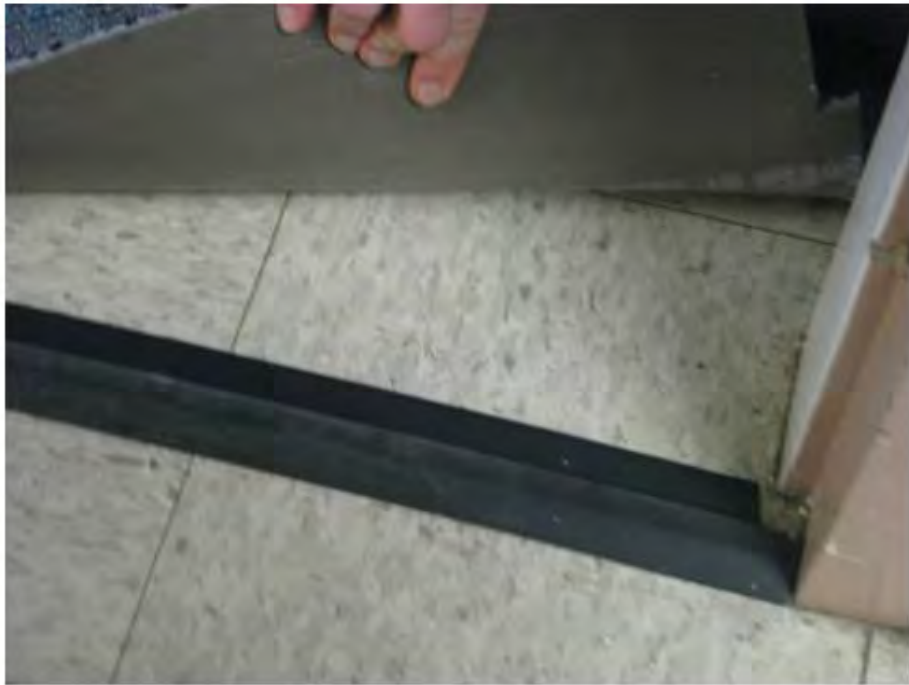
12"x12" Floor Tile and Mastic (5<sup>th</sup> Floor Old), Samples 41A and 42A

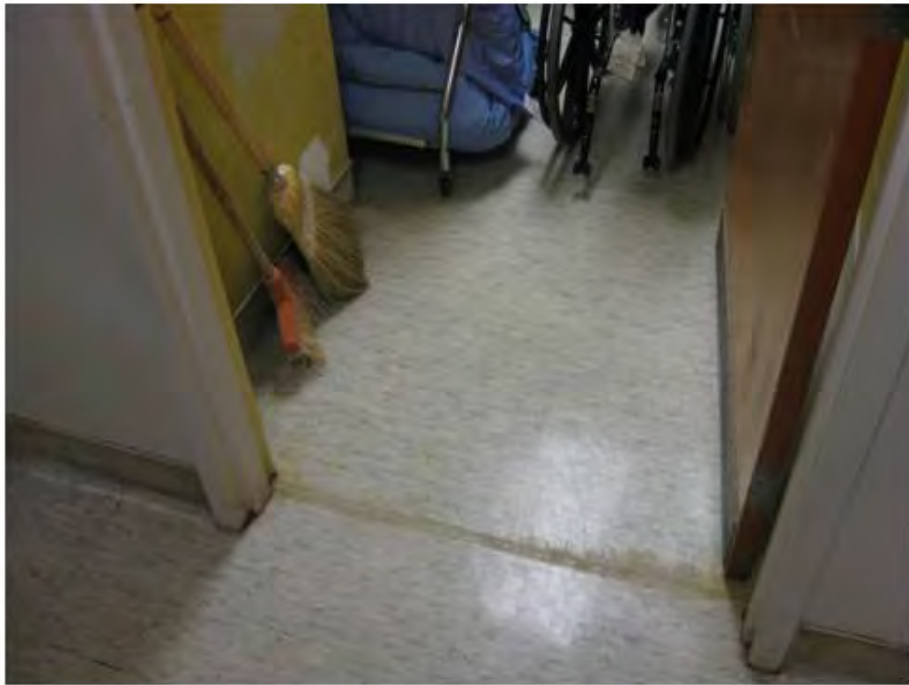
Sheet Flooring- Type II Adhesive (4<sup>th</sup> Floor New), Sample 48A

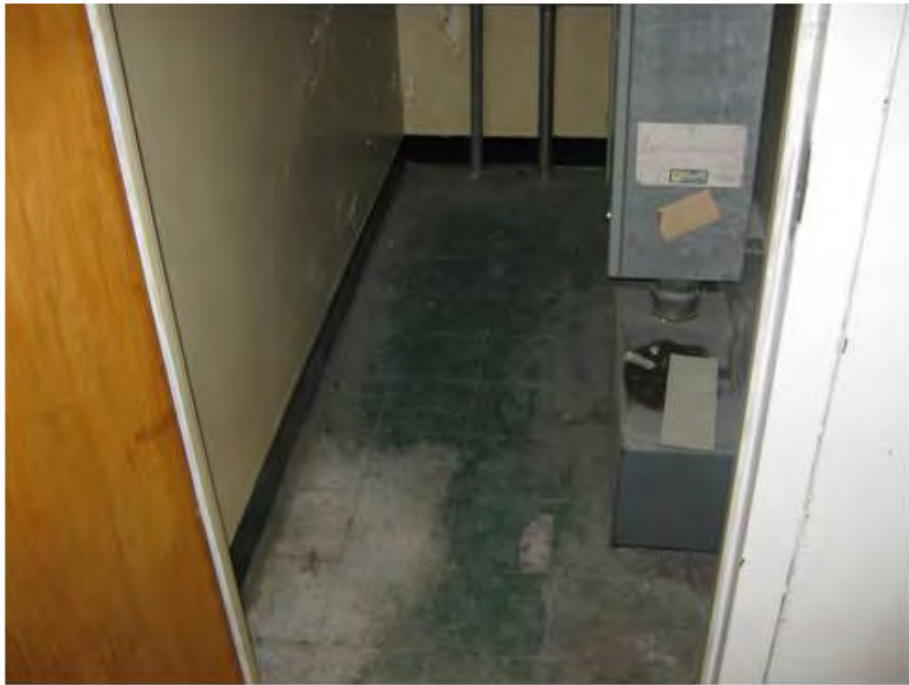
9"x9" Floor Tile- Type II, Sample 53A

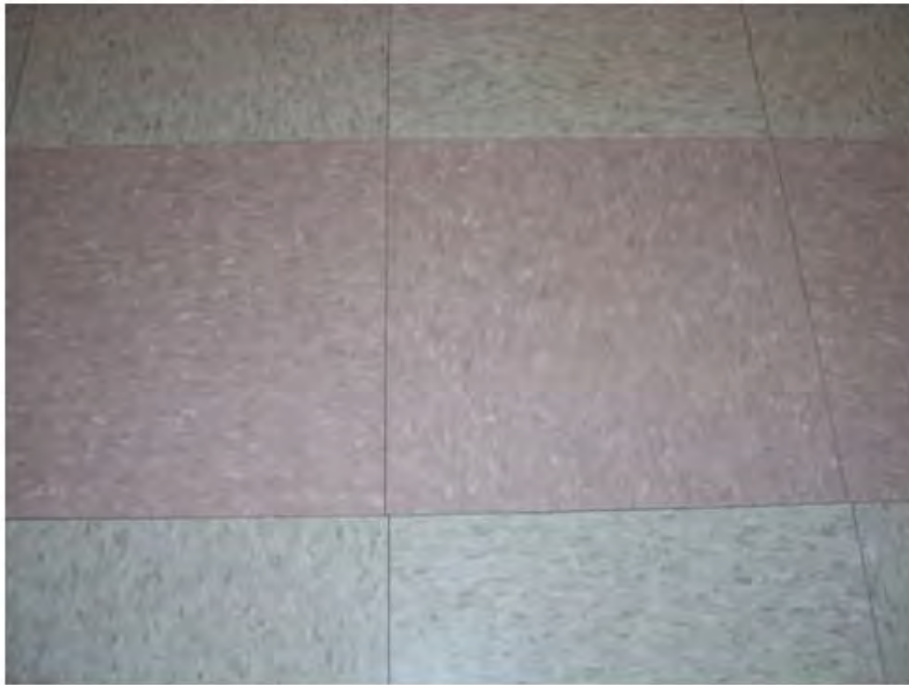
12"x12" Floor Tile Mastic (1<sup>st</sup> Floor Old), Sample 60A

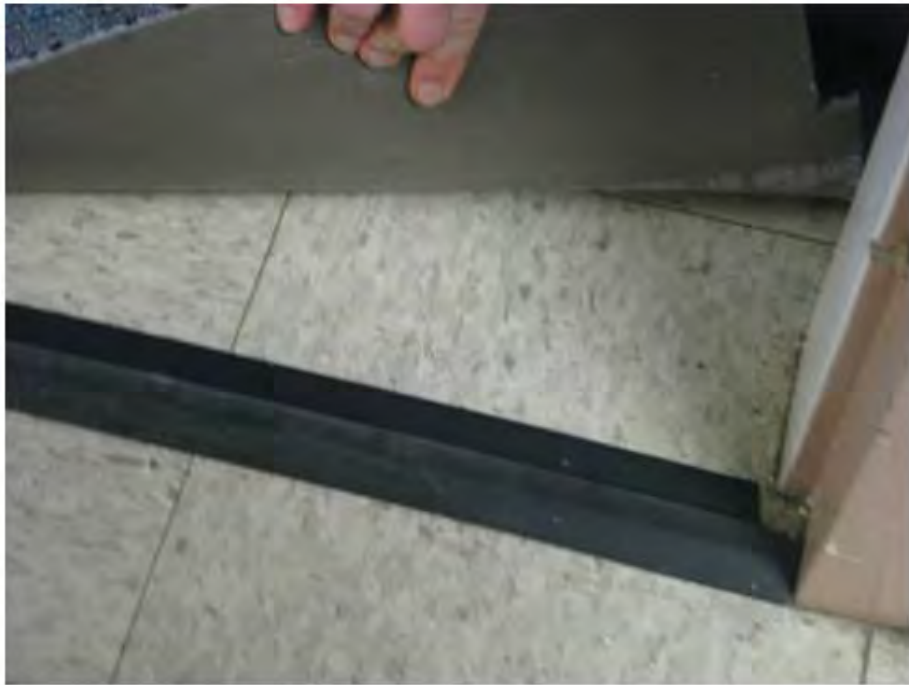
2<sup>nd</sup> Layer of Floor Tile and Mastic under 12"x12" Floor Tile and Mastic (5<sup>th</sup> Floor Old),  
Samples 64 and 65

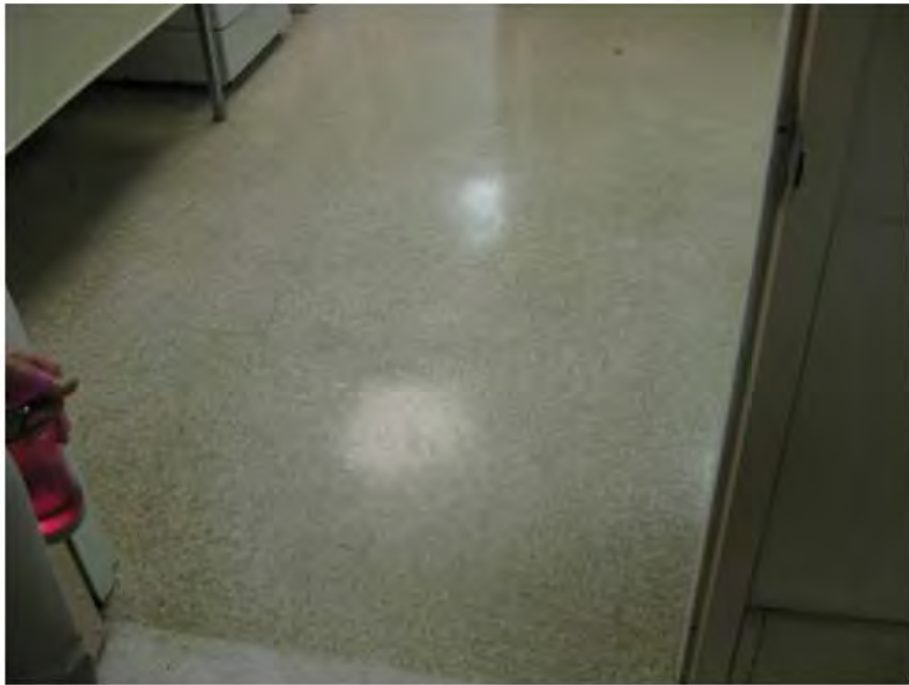
12"x12" Floor Tile Mastic (Basement new), Sample 69A

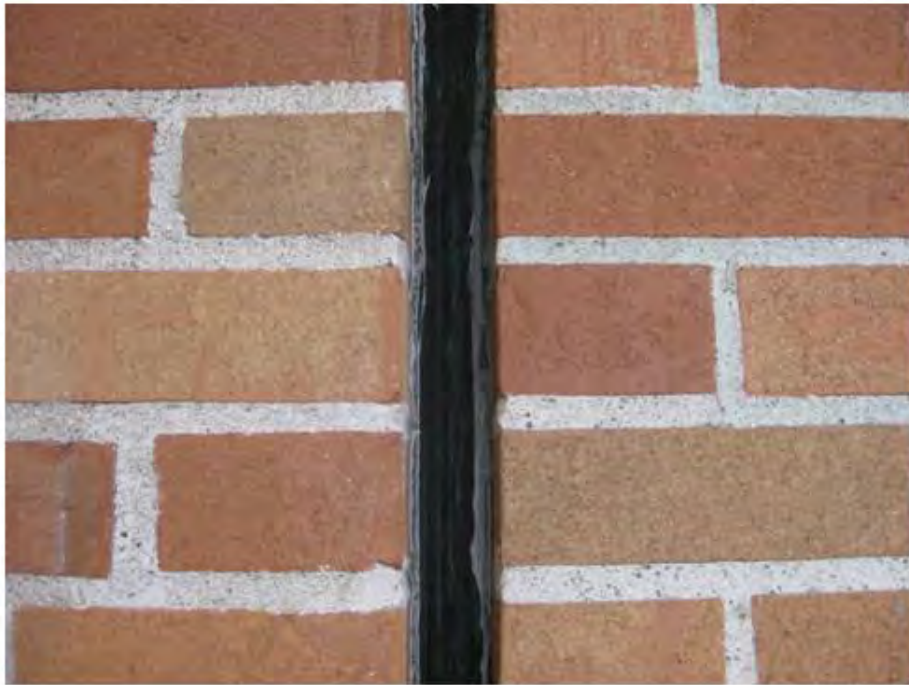
Expansion Joint Caulk, Sample 72A

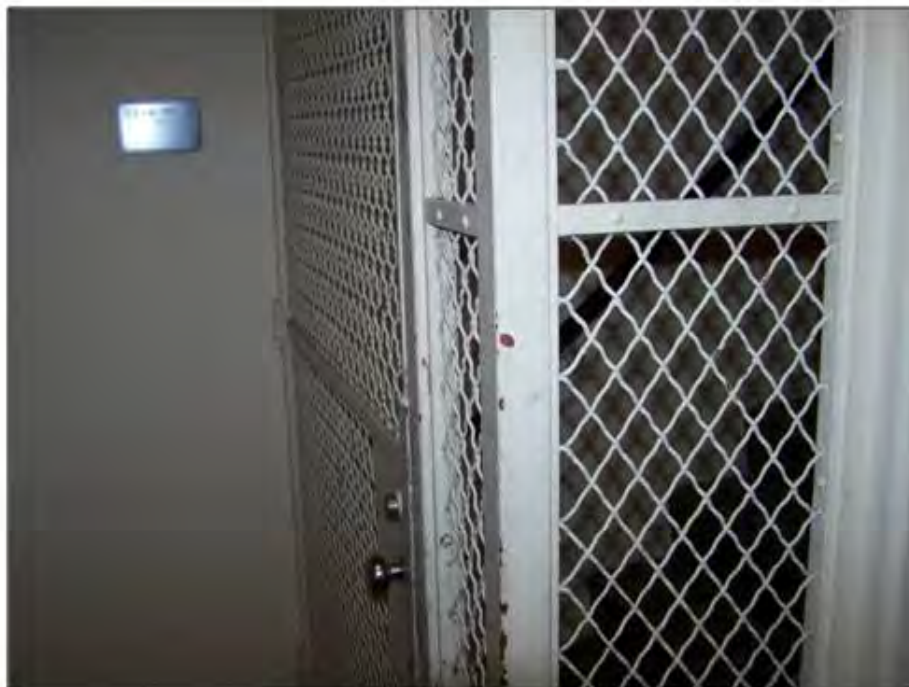
Metal Fence, Reading 973

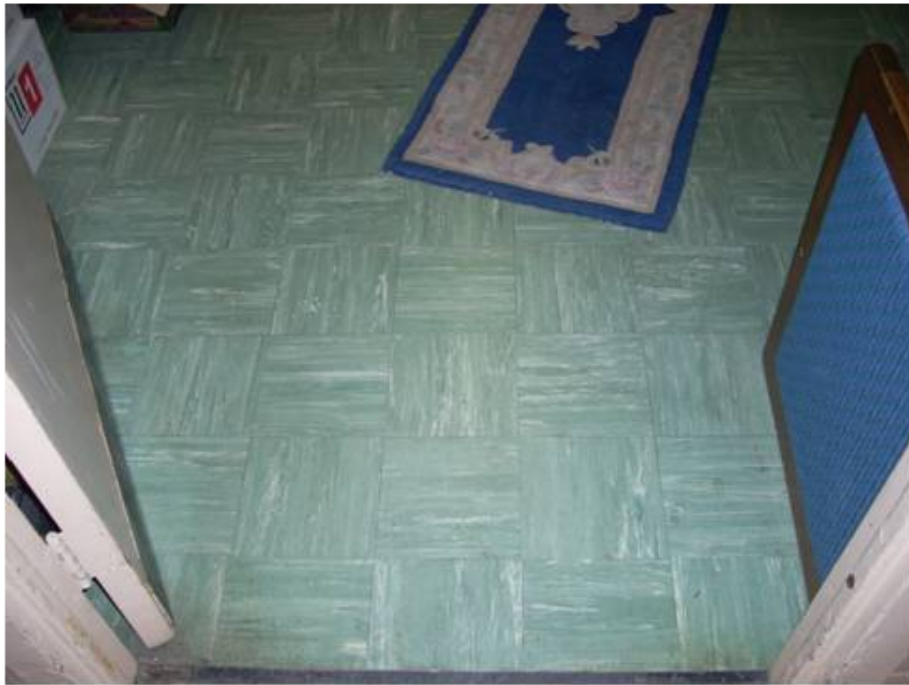
Mastic Associated with 9"x9" Green Floor Tile, Sample 27A

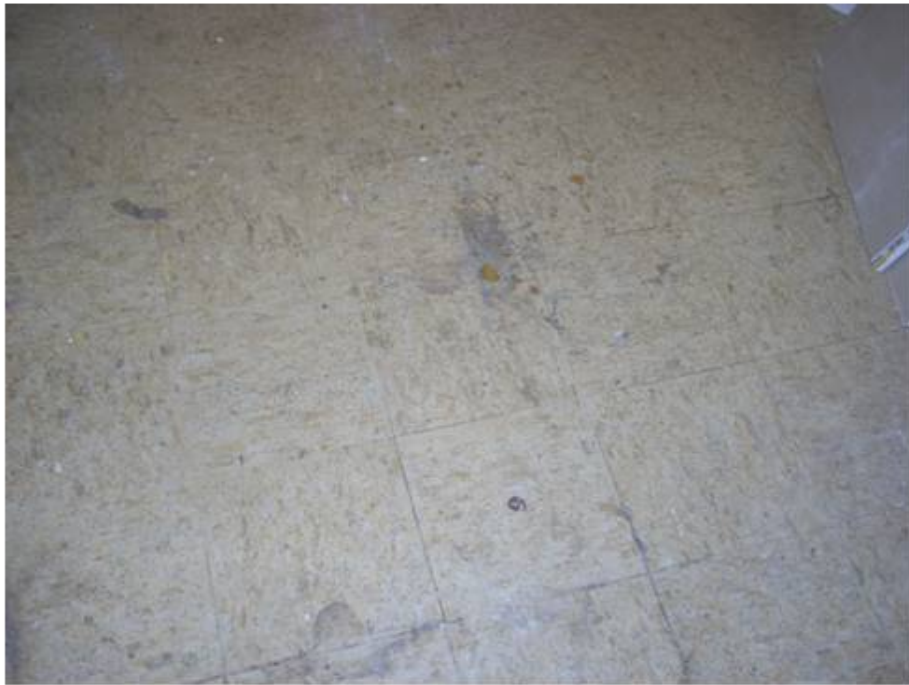
12"x12" Tan Floor Tile and Mastic, Samples 31A and 32A

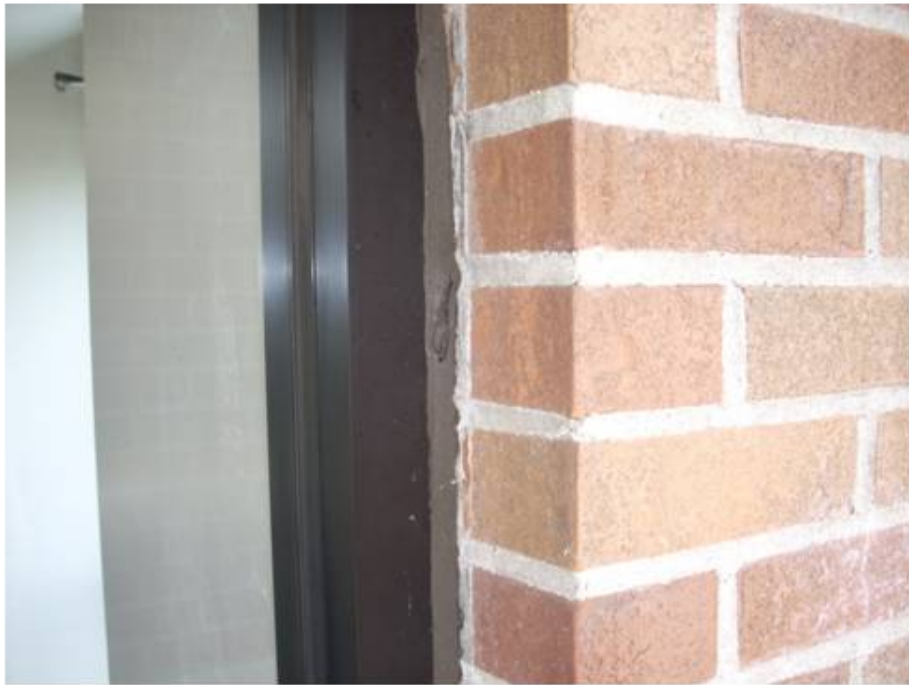
Exterior Door Caulk, Sample 40A

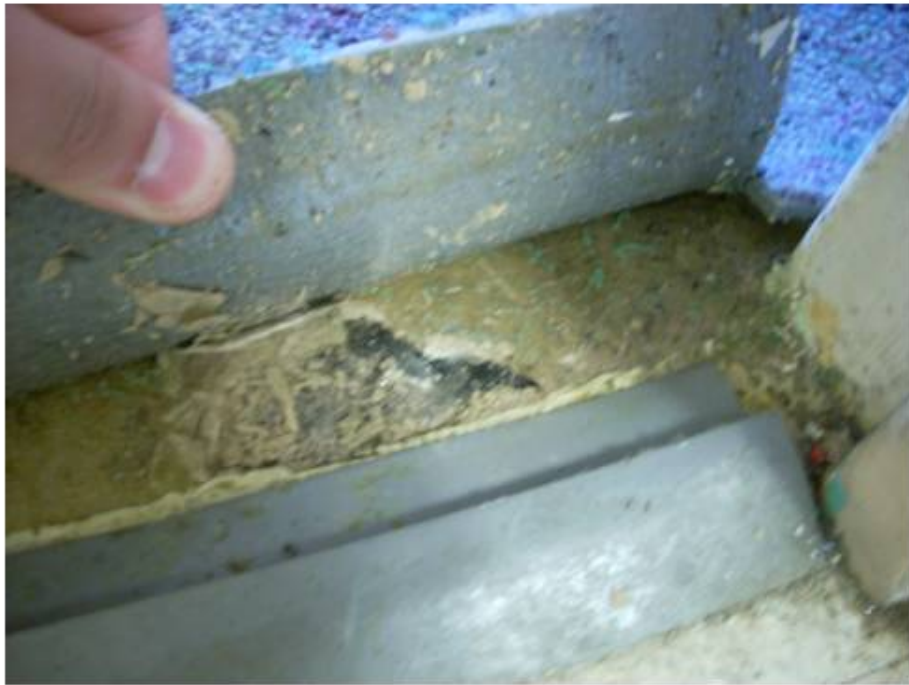
12"x12" Floor Tile Underneath Carpet, Sample 44A

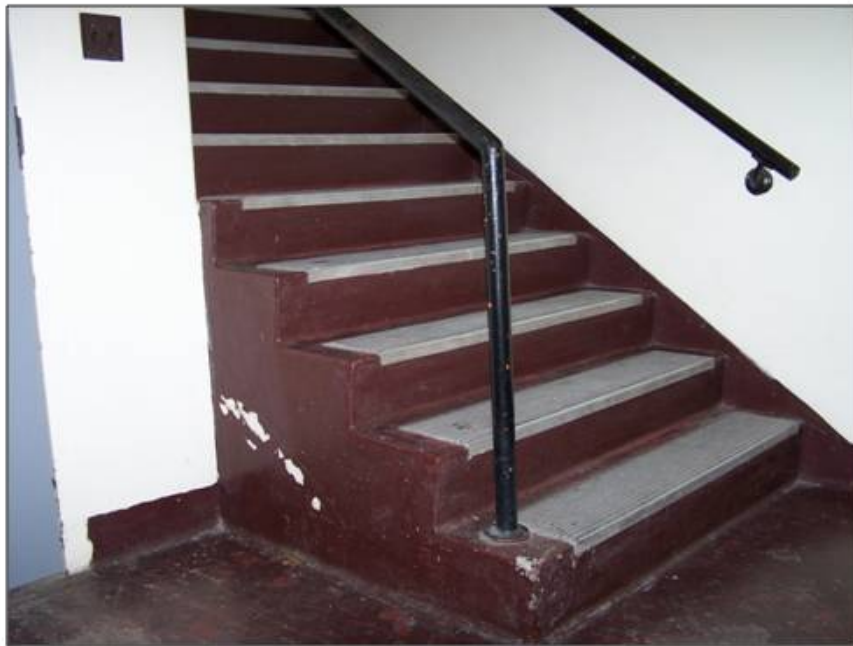
Metal Handrail, Readings 1447

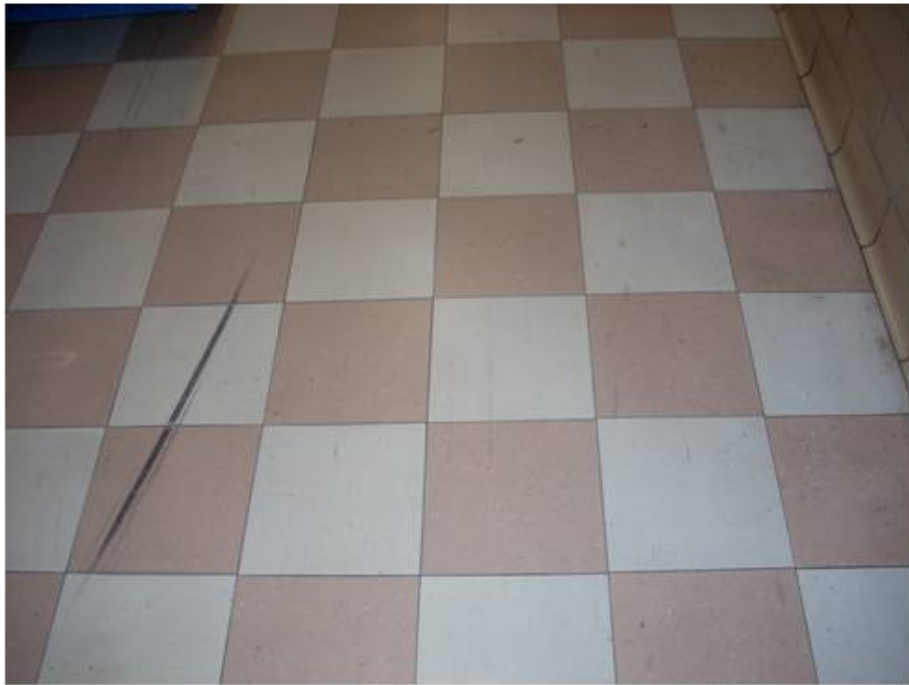
Mastic Associated with 9"x9" Flat White and Pink Floor Tile, Samples 15B and 17B

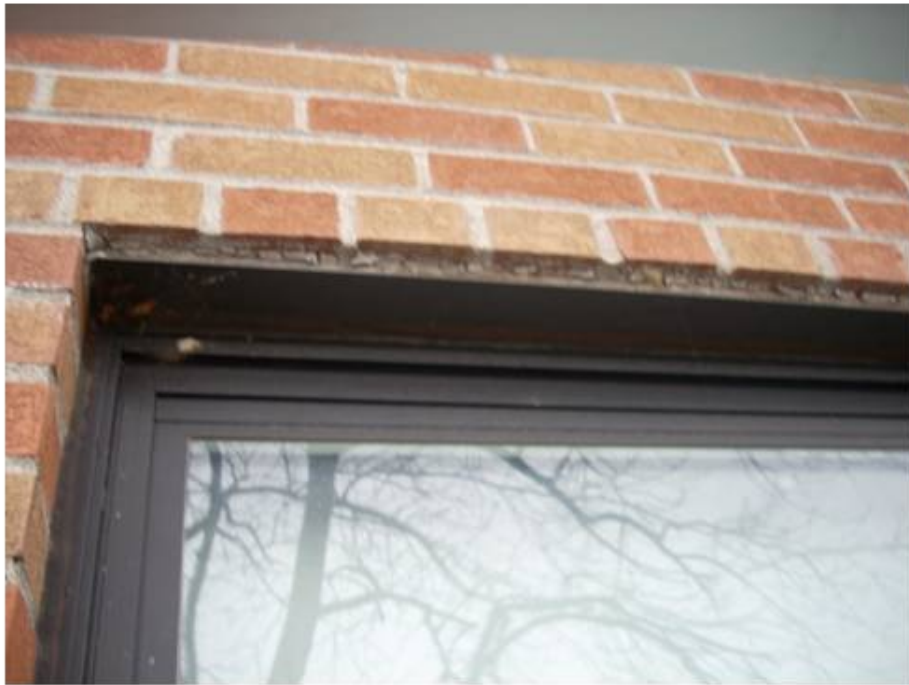
Exterior Window Caulking, Sample 21A

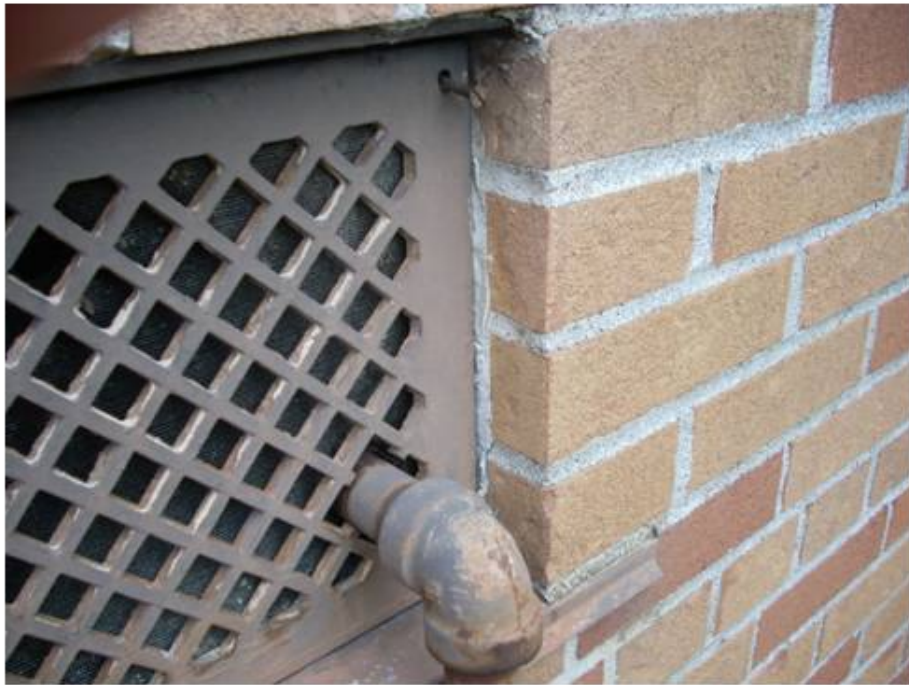
Sub-basement Vent Caulking, Sample 23A

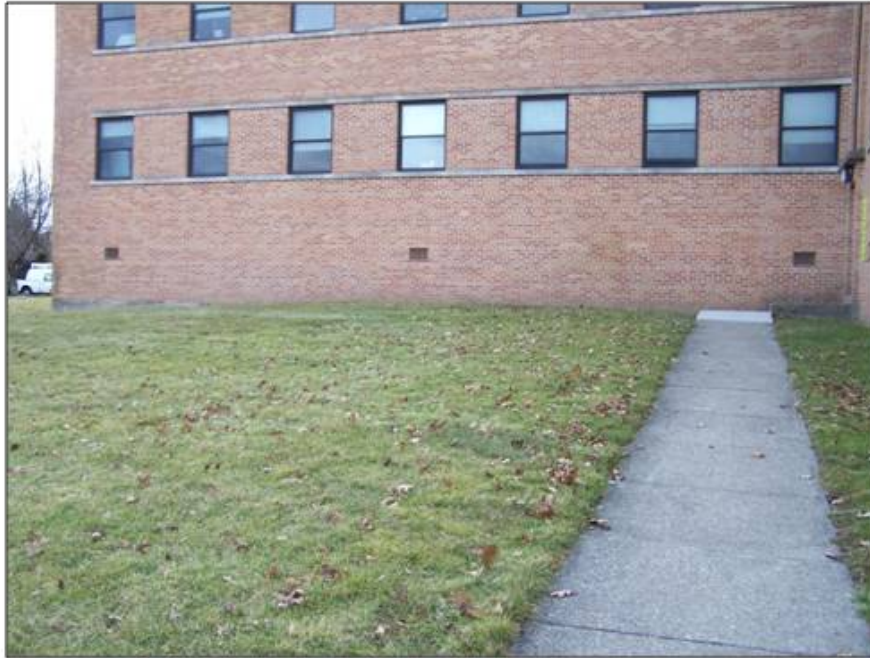
Metal Vent, Reading 210

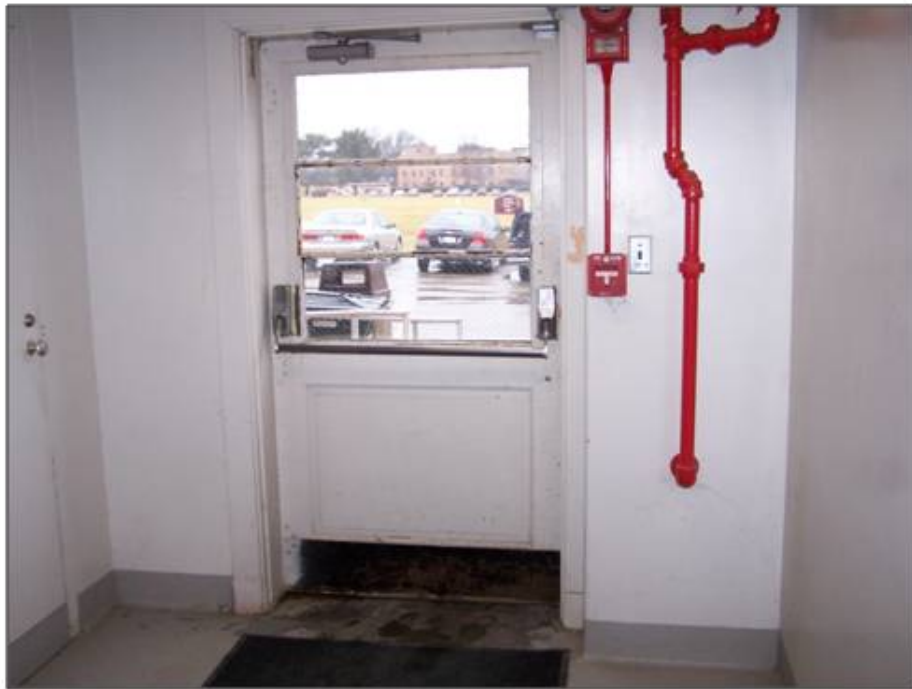
Wood Door and Wood Door Casing, Readings 2343 and 2344

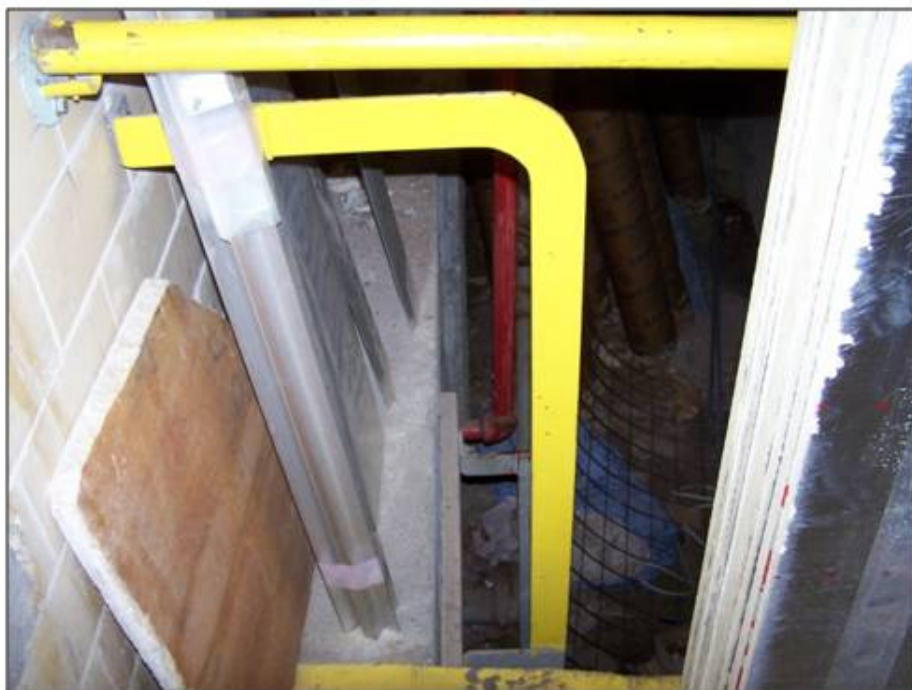
Metal Ladder, Reading 2367

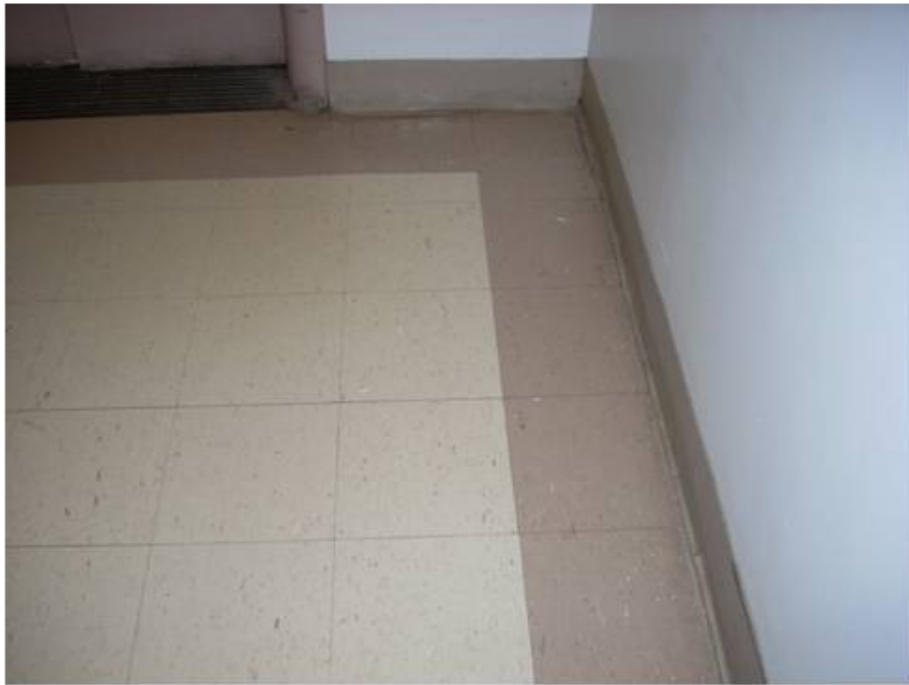
Mastic Associated with 12"x12" Tan and Brown Floor Tile, Samples 8A and 28A

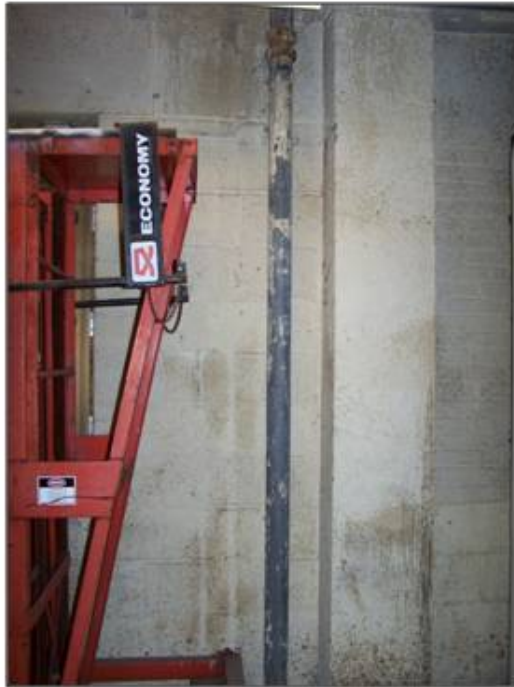
Metal Pipe, Reading1922

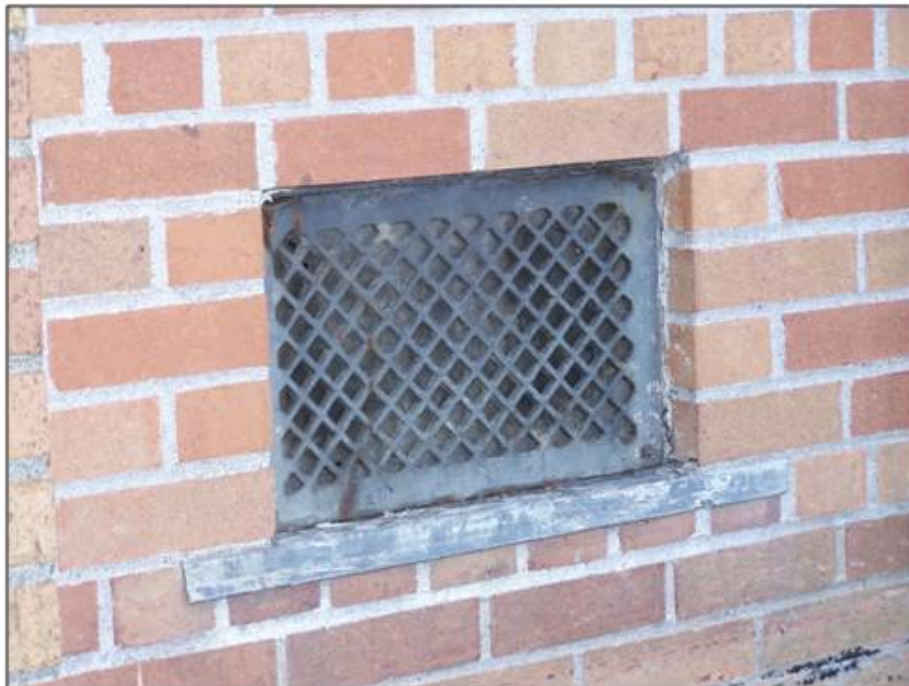
Metal Vent, Reading 1978

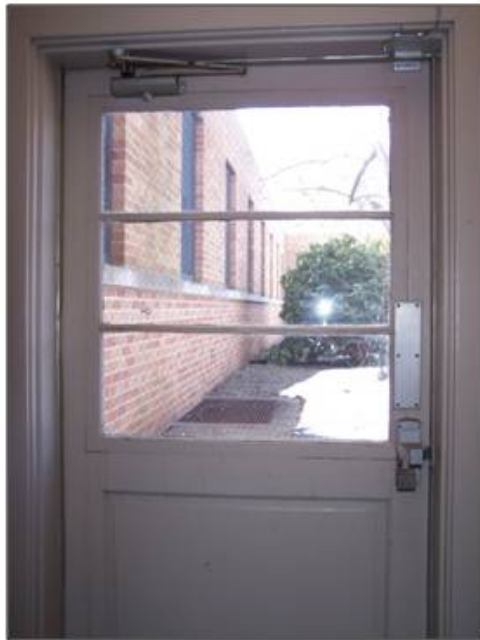
Wood Door and Wood Door Casing, Readings 1691 and 1692

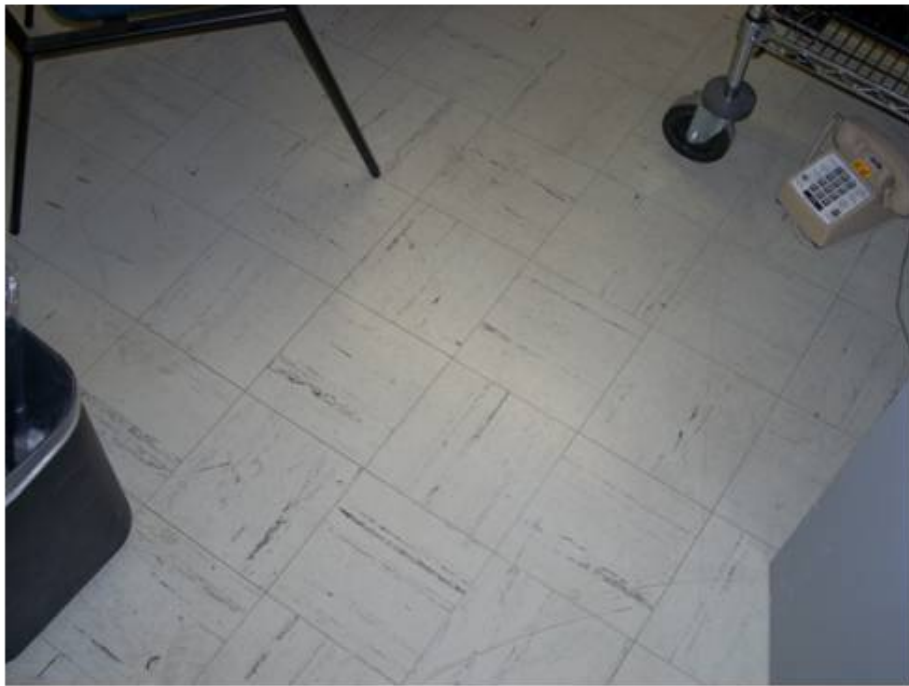
9"x9" White Floor Tile and Mastic, Samples 6A and 7A

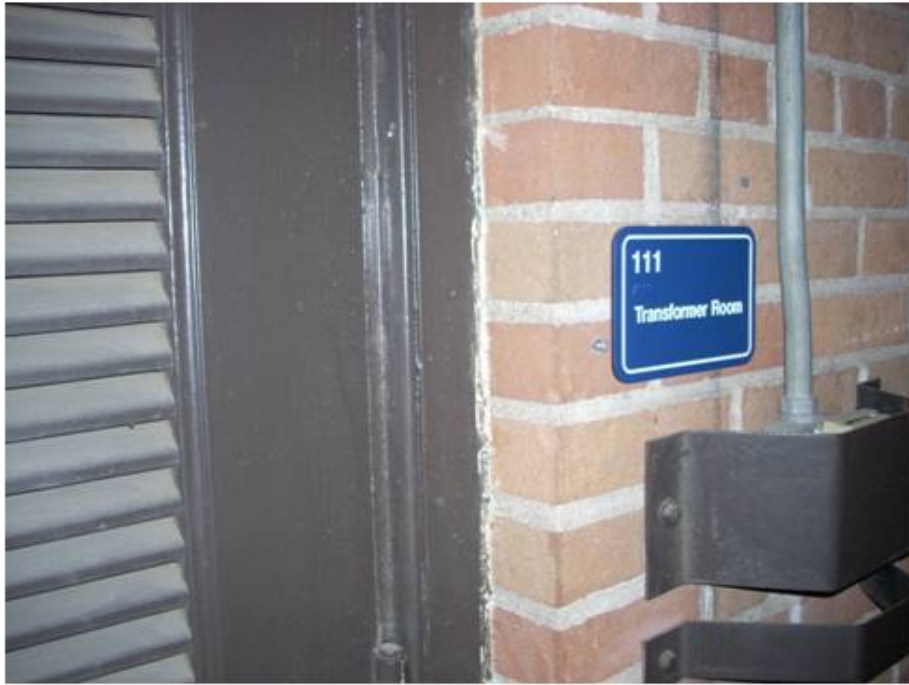
Exterior Door Caulking (Old), Sample 42C

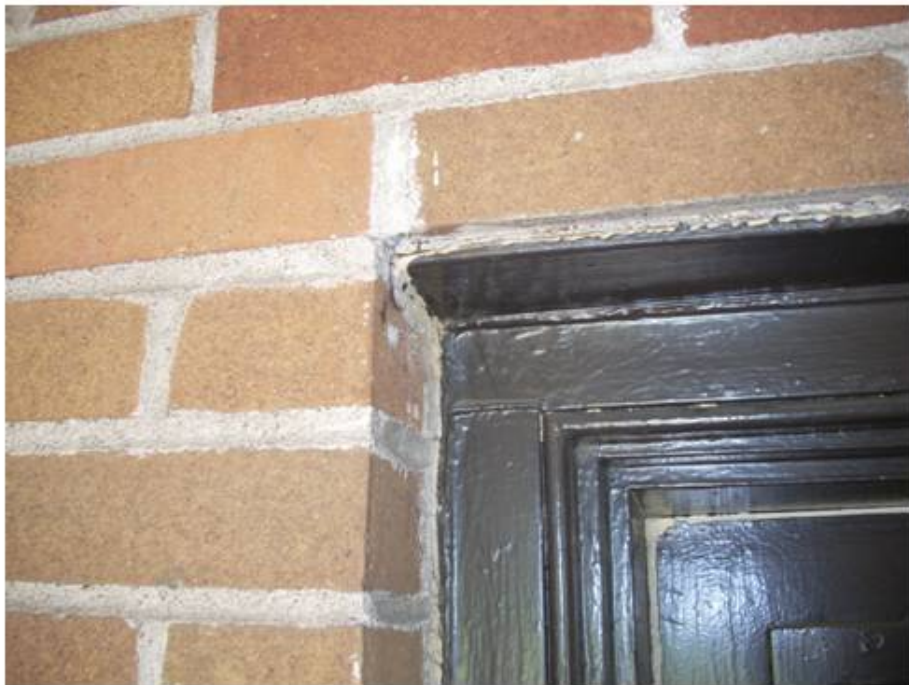
Exterior Door Caulking, Sample 43B
