## **VOLUME II ASBESTOS CONTAINING MATERIAL & LEAD CONTAINING PAINT SURVEY REPORTS**

**VISN 1**  
**Brockton VA Medical Center**  
940 Belmont Street  
Brockton, Massachusetts

Project No. 2009023.003

June 21, 2010

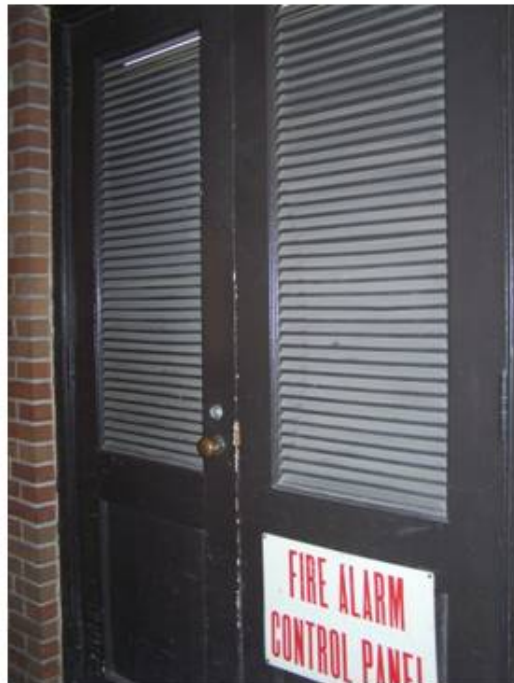
Wood Door and Wood Door Casing, Readings 40 and 41

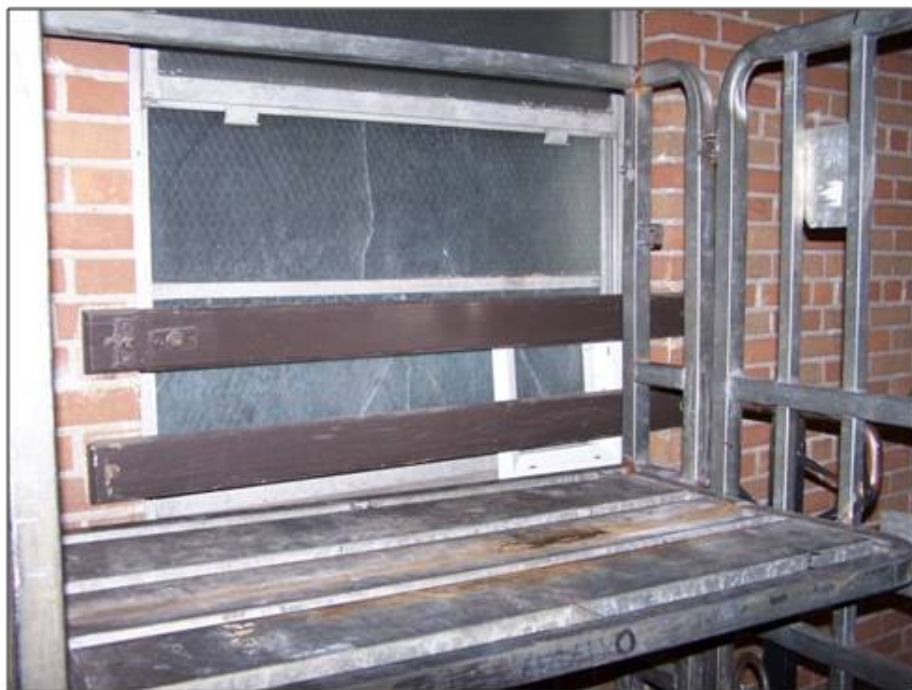
Wood Safety Rails Over Window, Reading 42

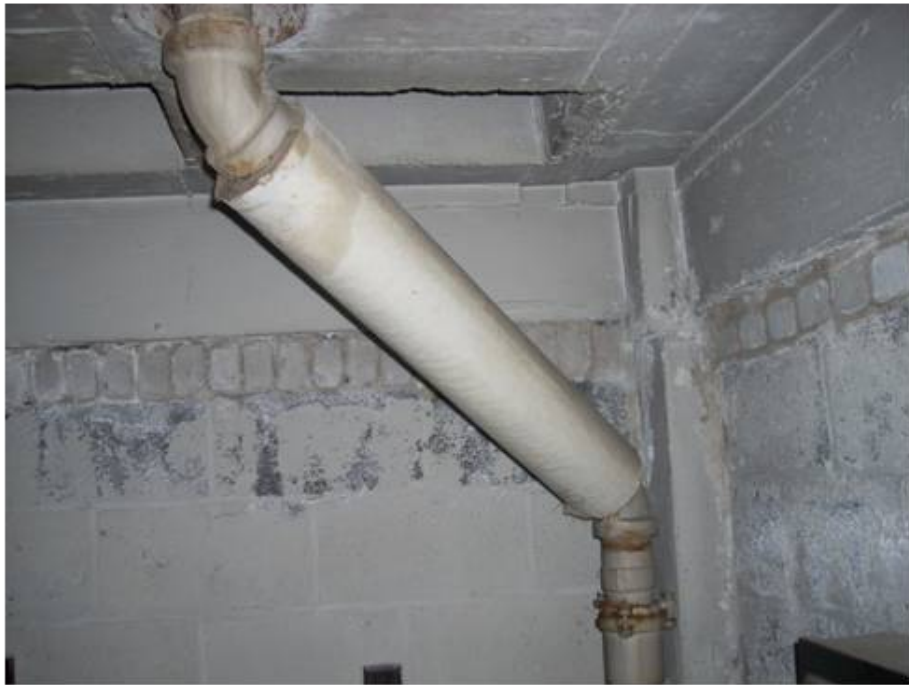
Pipe Insulation, Sample 2A

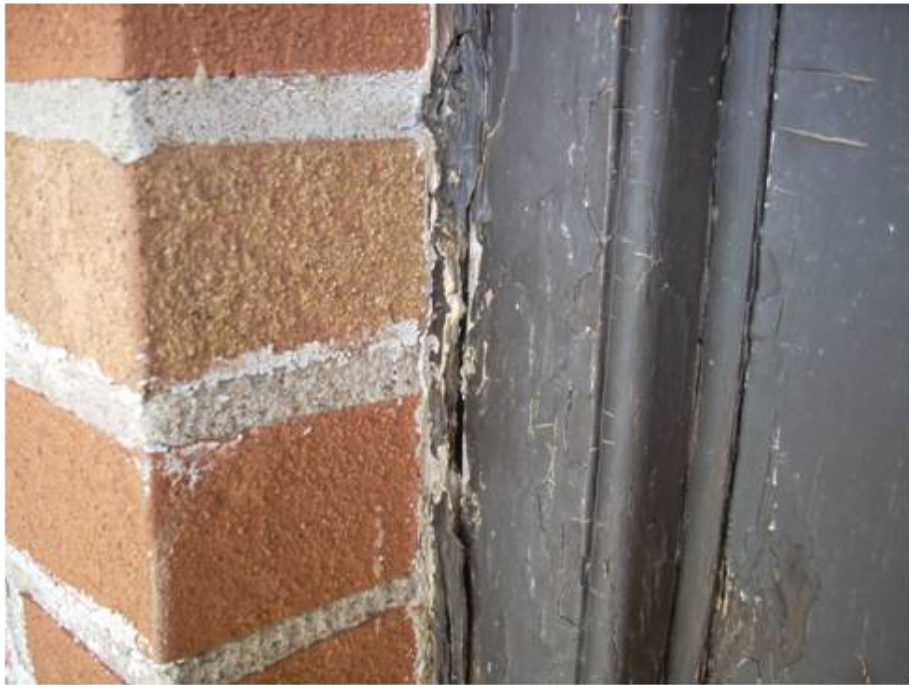
Exterior Door Caulk, Sample 12B

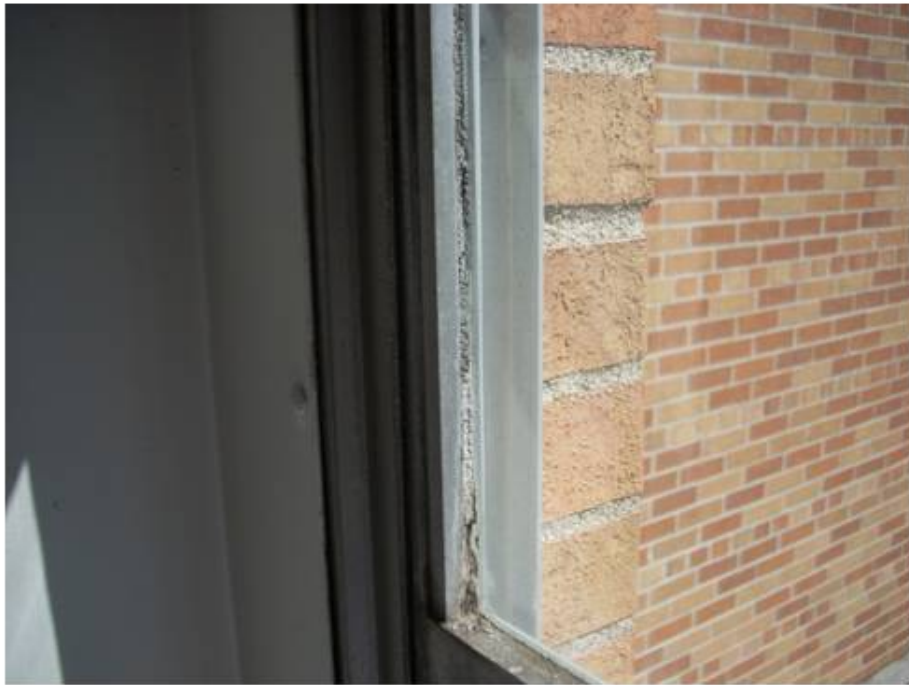
Interior Window Glazing, Sample 15A

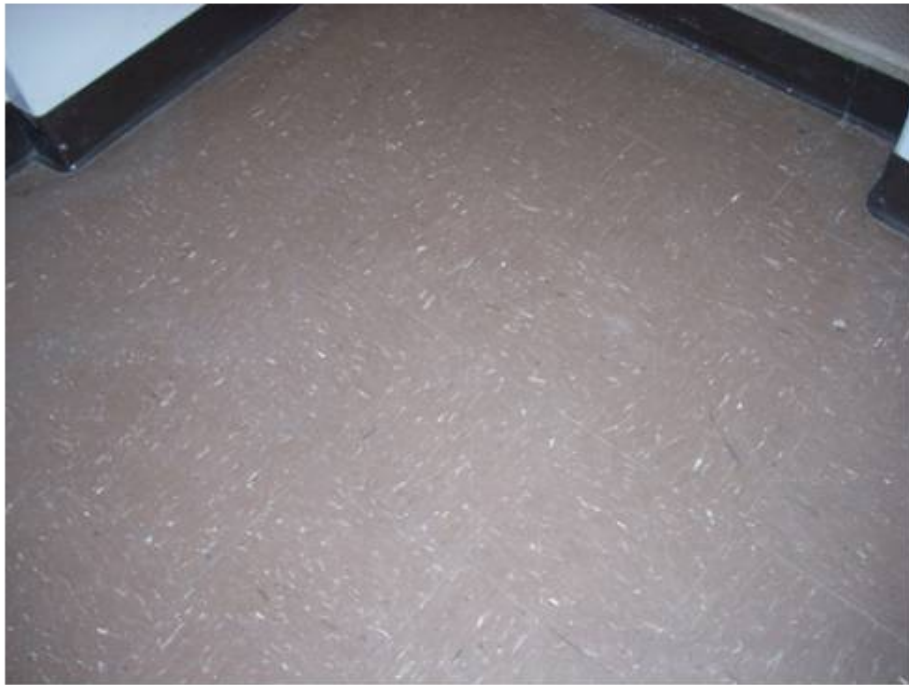
12"x12" Brown Floor Tile and Mastic, Samples 20A and 21A

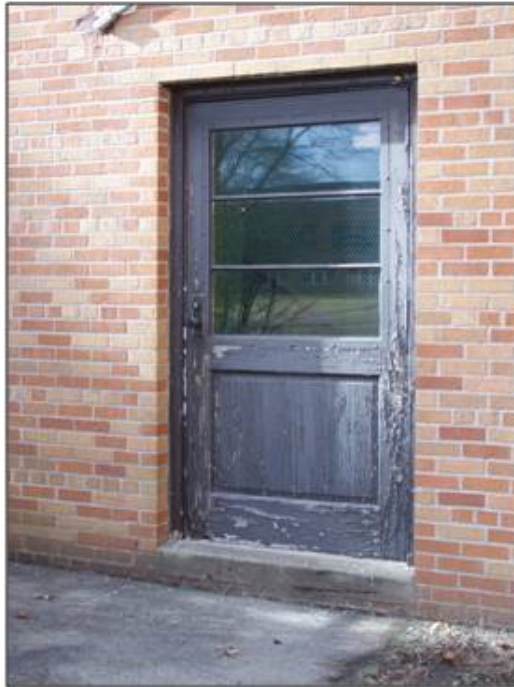
Wood Door Casing, Reading 207

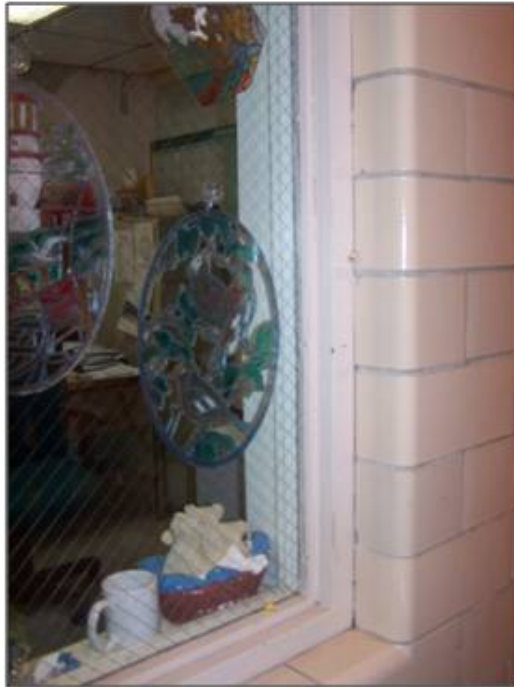
Metal Window Casing, Reading 2207

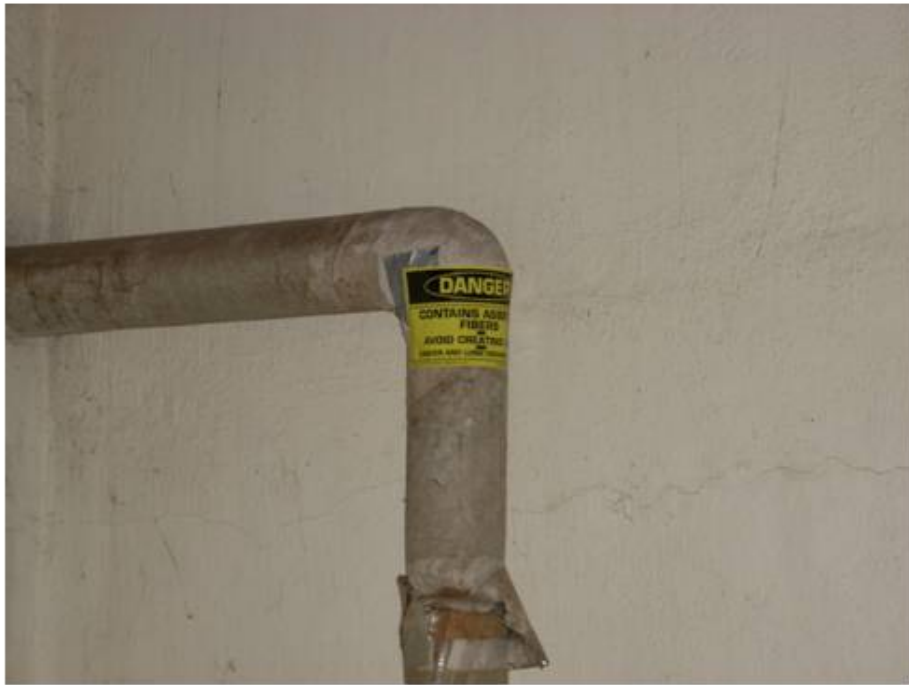
Mudded Fitting, Sample 3

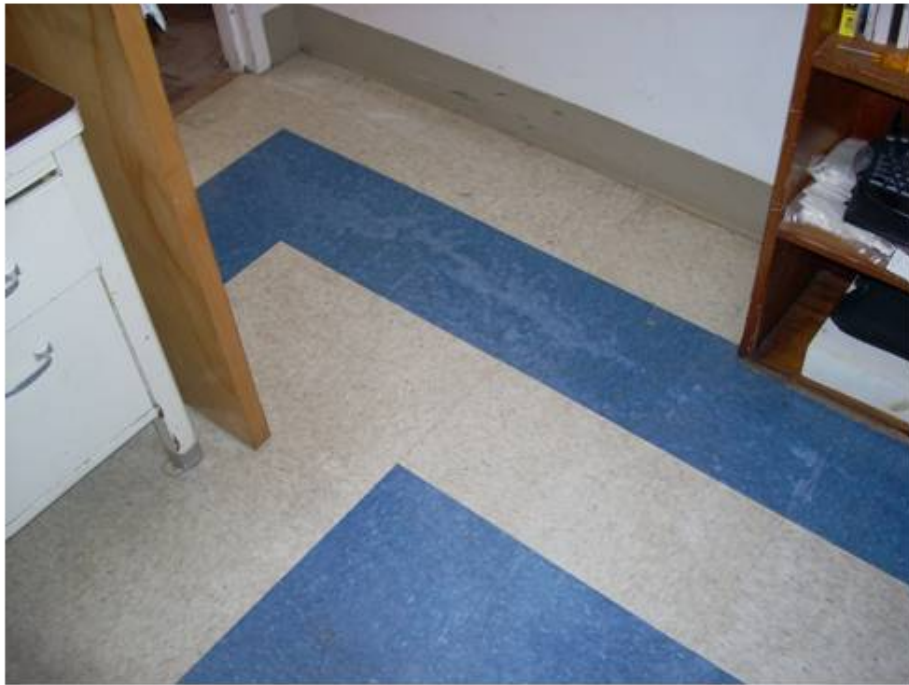
12"x12" White Floor Tile, Sample 12A

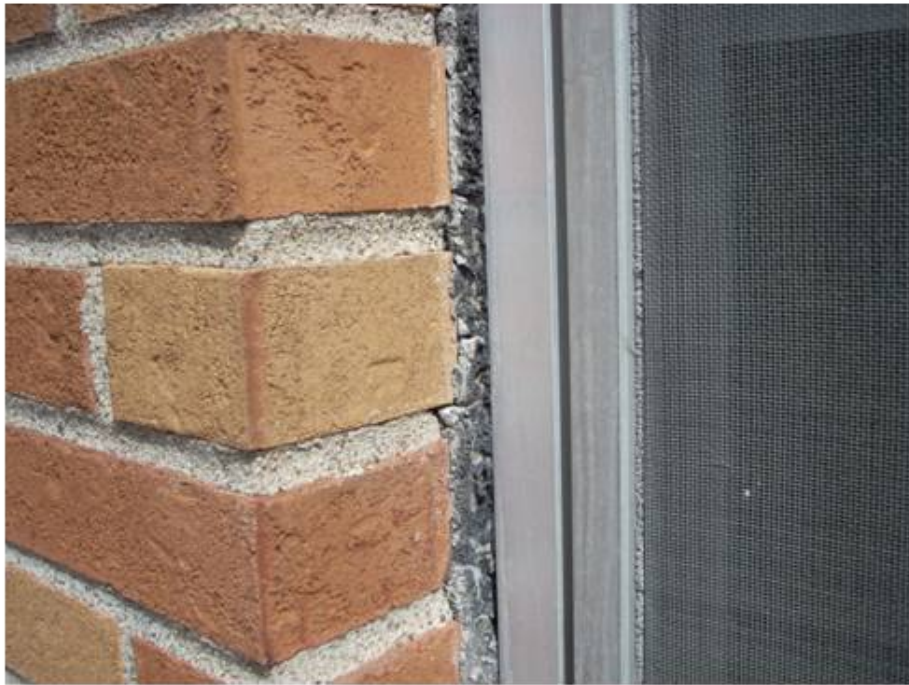
Exterior Window Caulk, Sample 28A

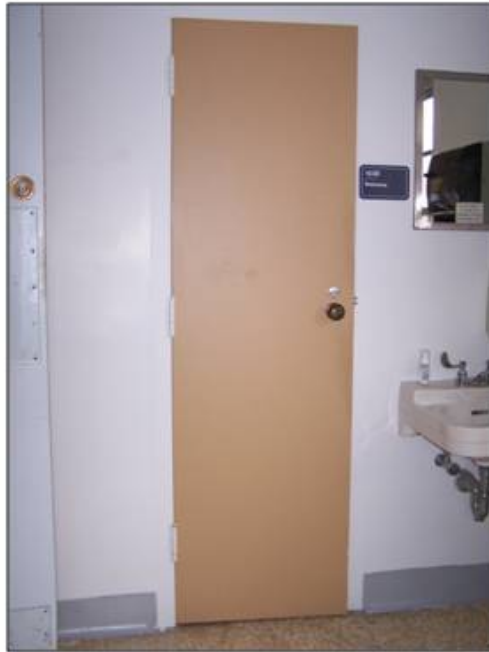
Wood Door and Wood Door Casing, Readings 1634 and 1635

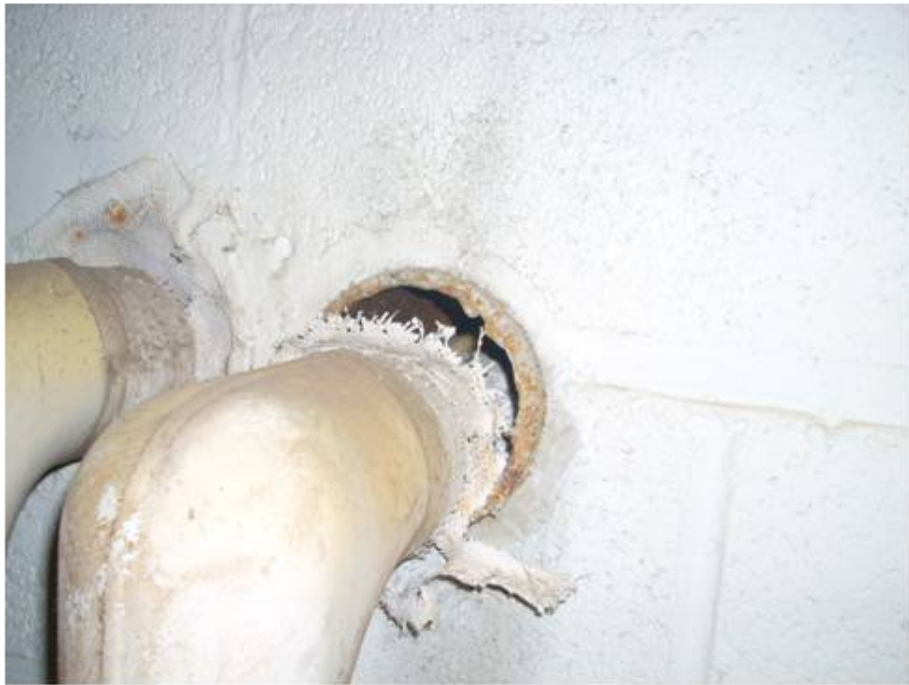
Pipe Insulation Inside Wall Cavity, Sample 1

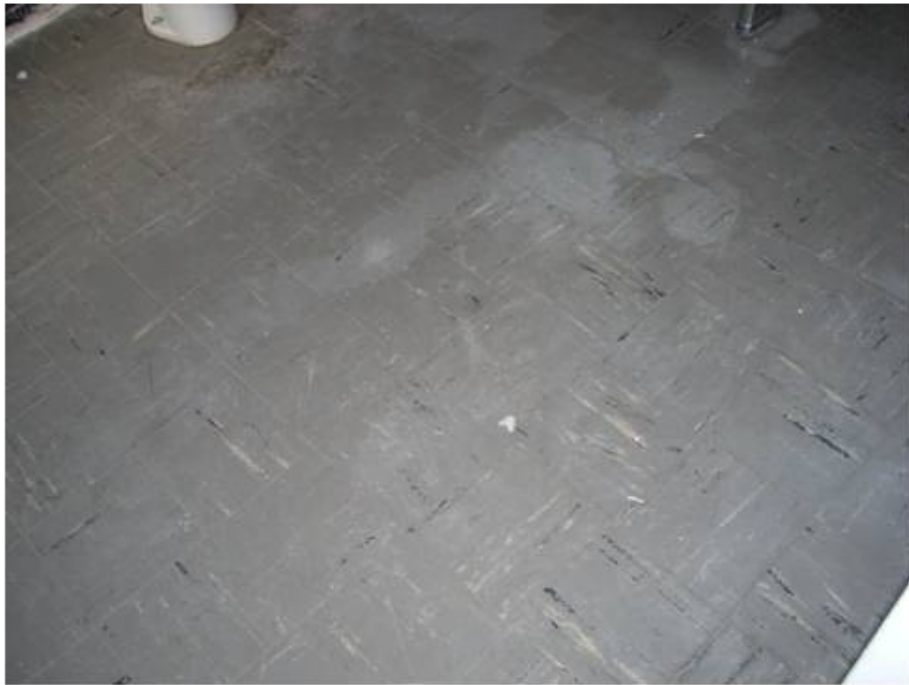
9"x9" Gray Floor Tile, Sample 16A

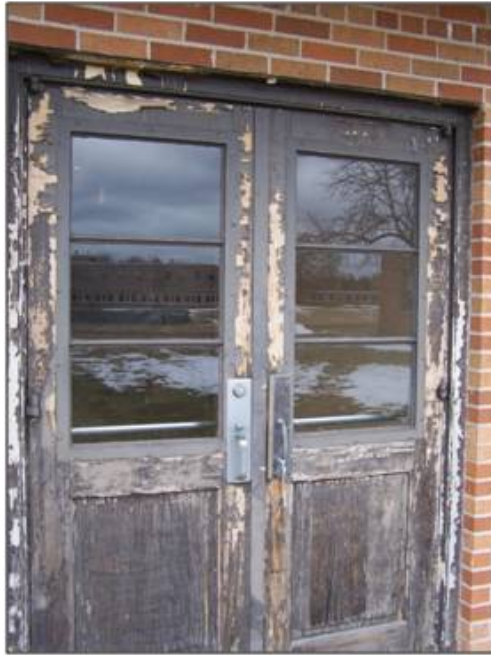
Wood Door Casing, Reading 2139

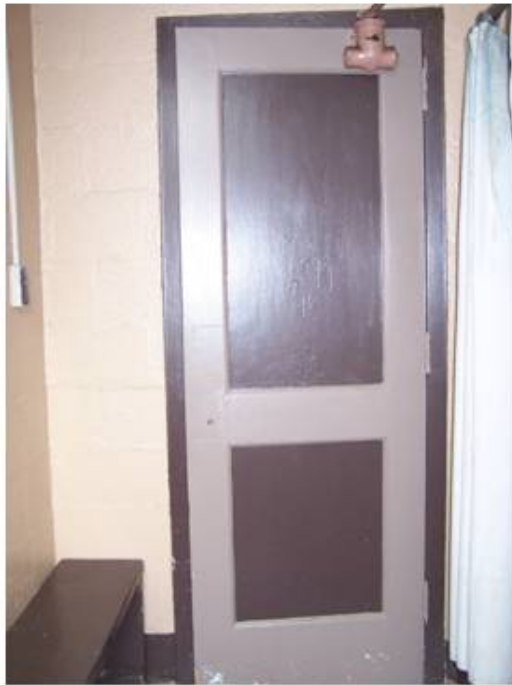
Wood Door, Reading 161

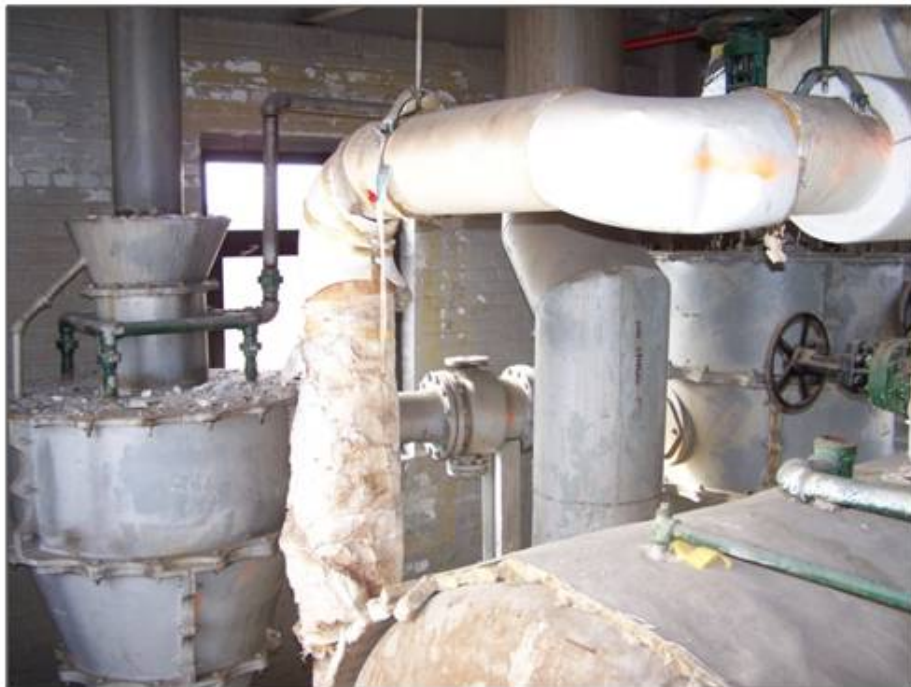
Metal Duct, Metal Hopper, Metal Pipe, and Metal Column, Readings 176, 177, 178 and 179

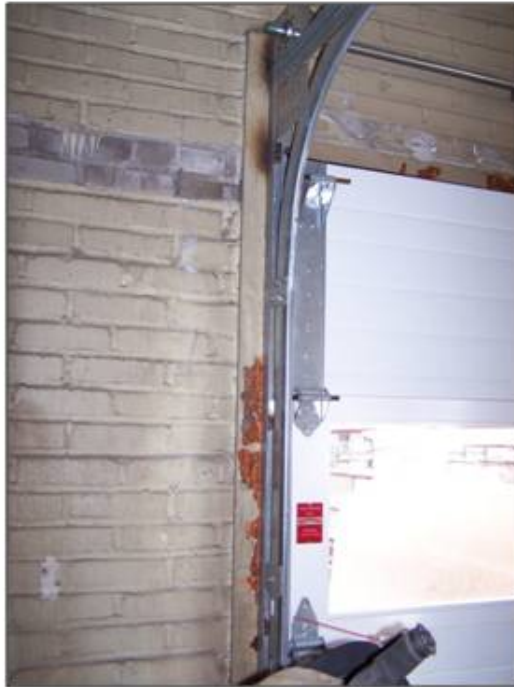
Metal Door Casing, Reading 12

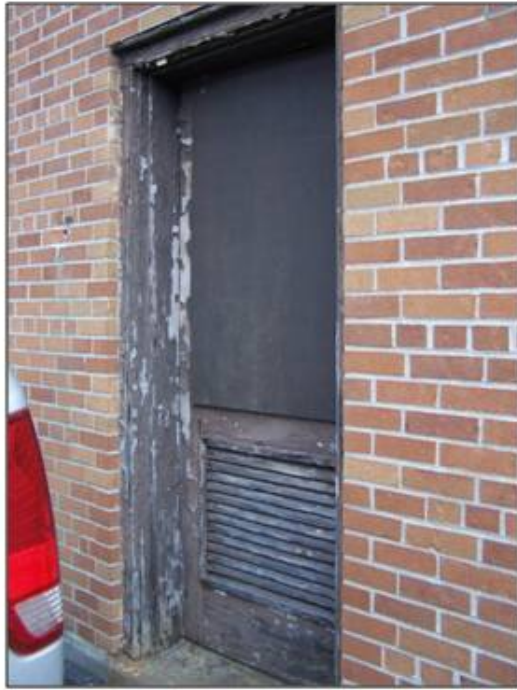
Wood Door and Wood Door Casing, Readings 39 and 41

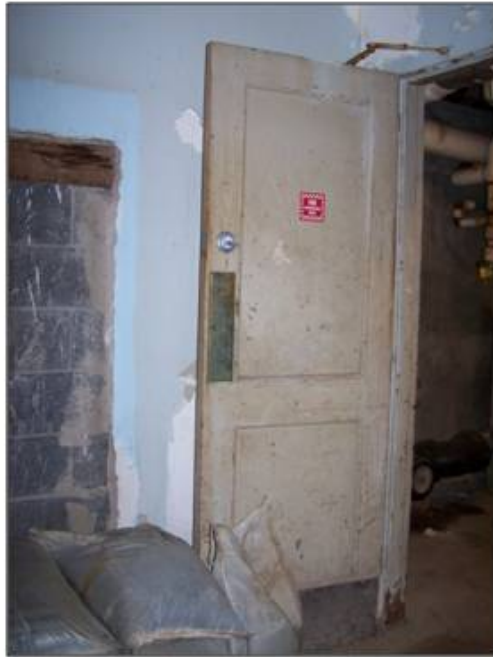
Wood Door, Reading 200

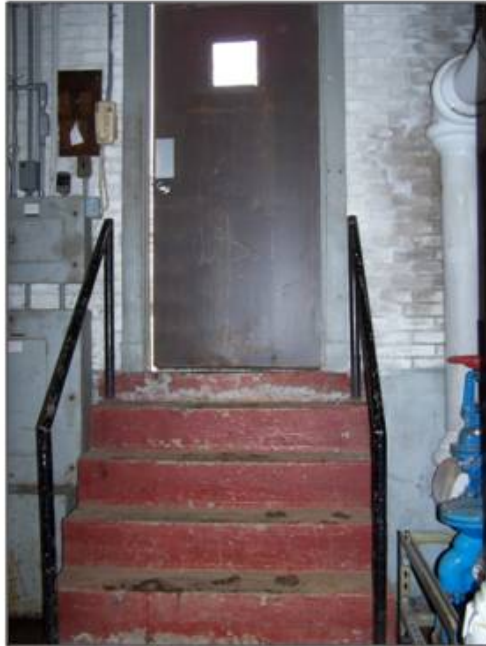
Metal Handrail and Wood Door Casing, Readings 412 and 413

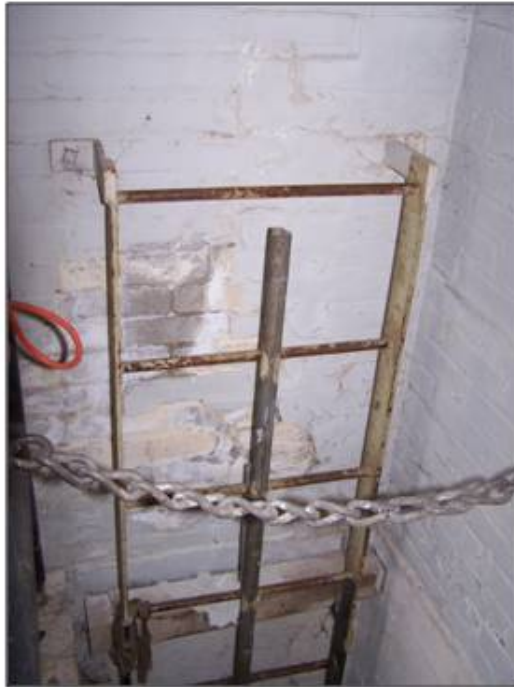
Metal Ladder, Reading 314

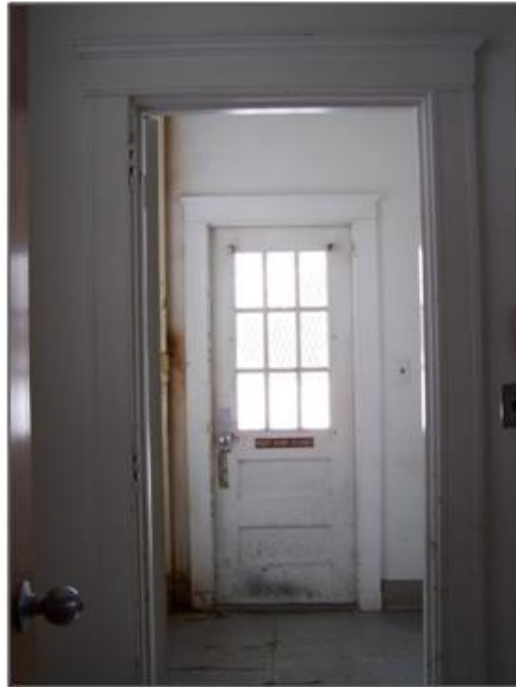
Wood Door Casing, Reading 483

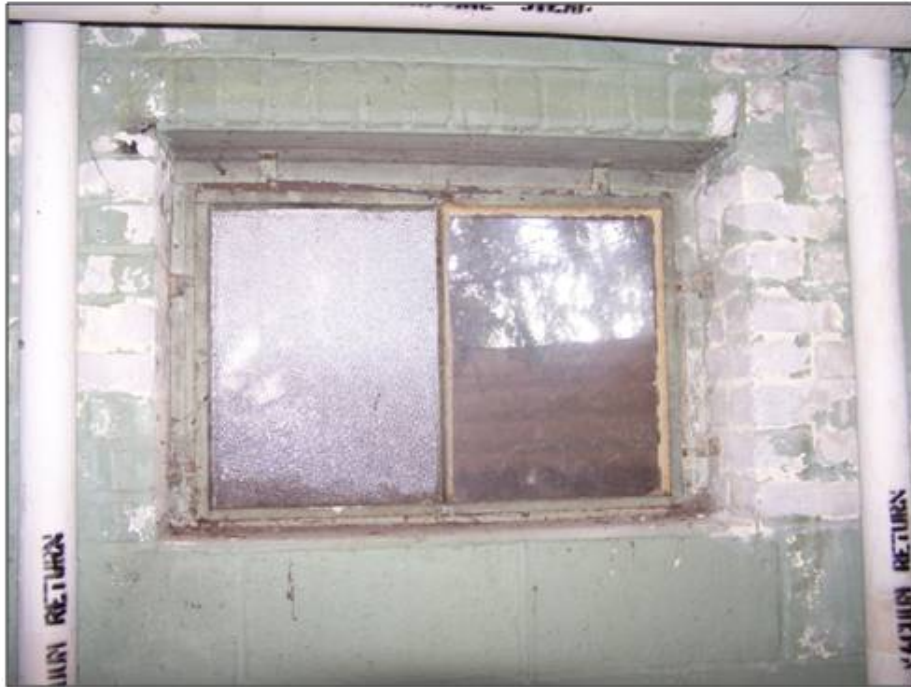
Metal Lintel, Reading 16

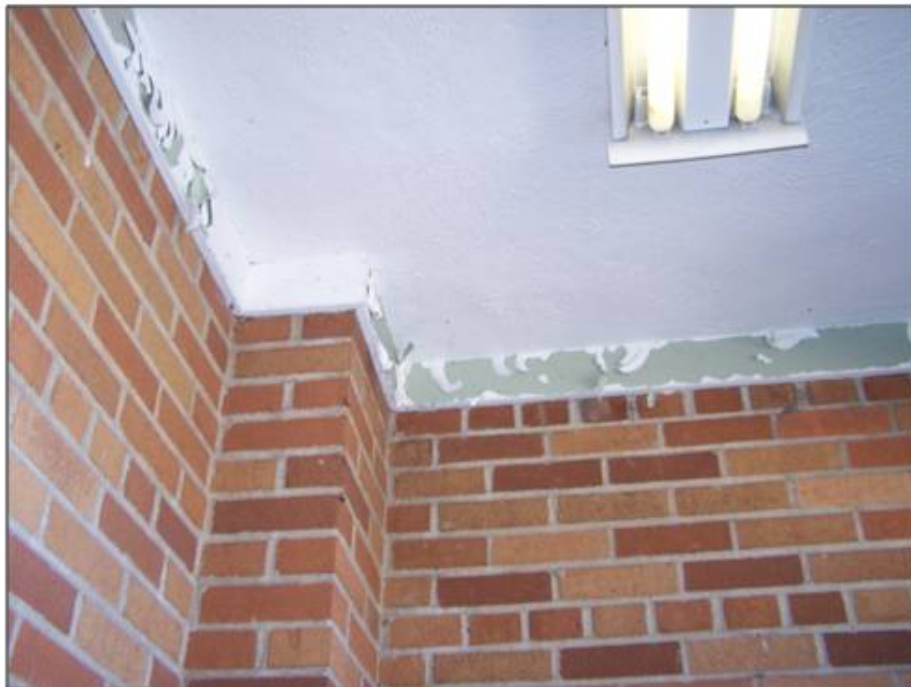
Wood Trim, Reading 75

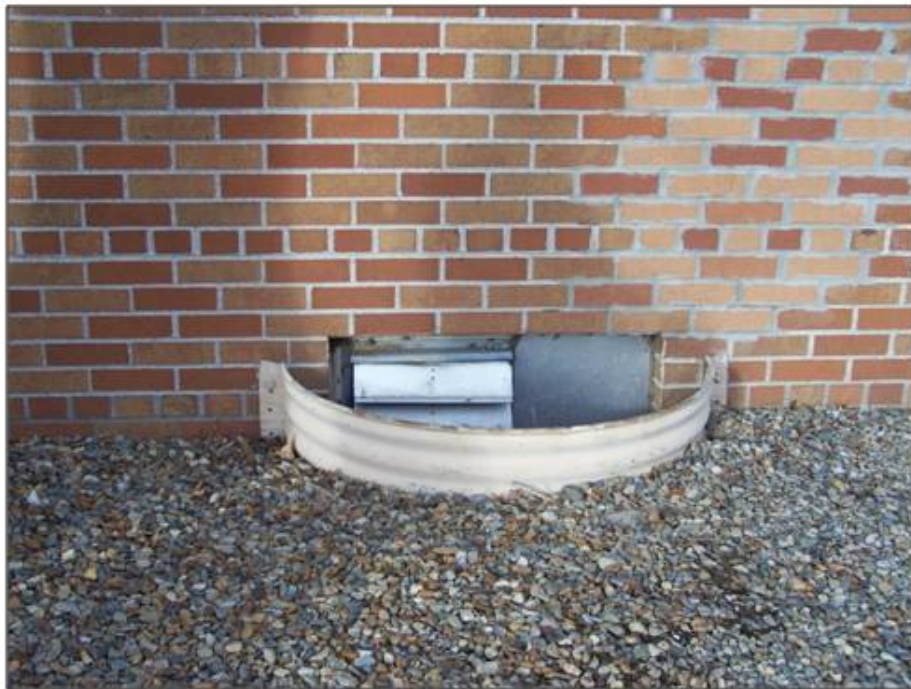
Metal Window Well Guard, Reading 187

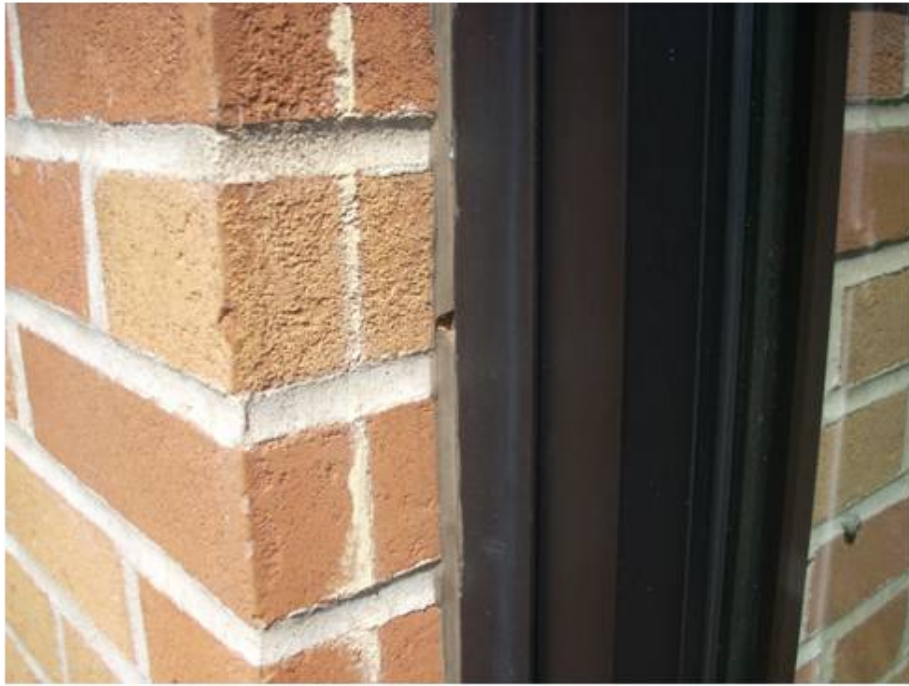
Door Caulk, Sample 10C

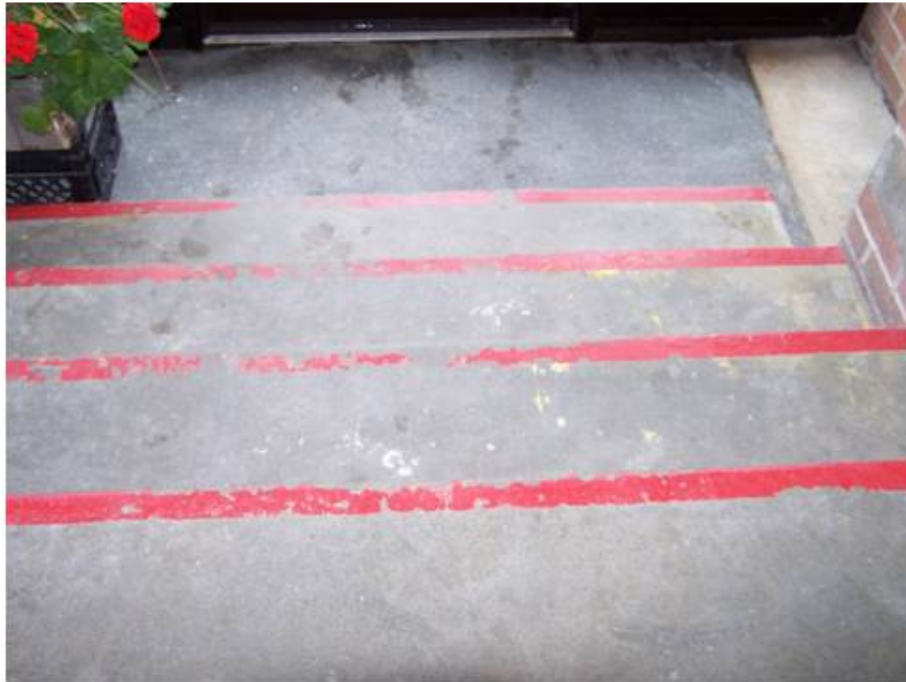
Concrete Safety Stripe, Reading 337

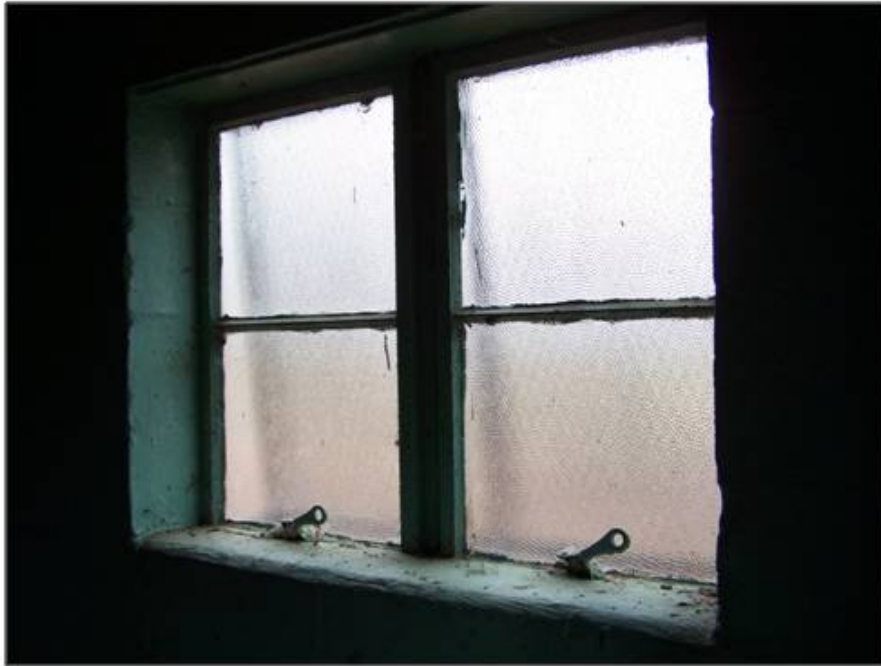
Metal Window Sash, Reading 320

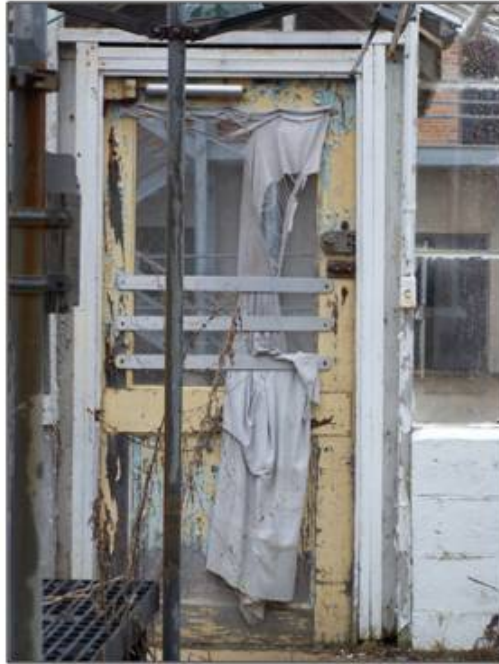
Wood Door and Wood Door Casing, Readings 285 and 286
