Hazardous Building Materials Assessment

**USDA Forest Service
Thomas Creek Work Center
Lakeview, OR 97630**

Project Title	USDA Forest Service – Thomas Creek Work Center Hazardous Building Materials Assessment
Assessment Conducted by	DH Environmental, Inc. 1011 SW Klickitat Way, Suite 107 Seattle, WA 98134
Project Owner	USDA Forest Service
Contract Vehicle	USDA Forest Service IDIQ Contract Contract # 12046W18C0007
USDA Forest Service Contracting Officer	Jared Machgan Contract Specialist
Assessment Personnel	Brian Johnson, OHST, CIT AHERA Accredited Building Inspector Certified Lead Risk Assessor (WA State) Stacy Fox, CHMM Senior Project Scientist
Survey Date(s)	12 May 2021
Report Delivery Date	28 May 2021
Report Prepared by

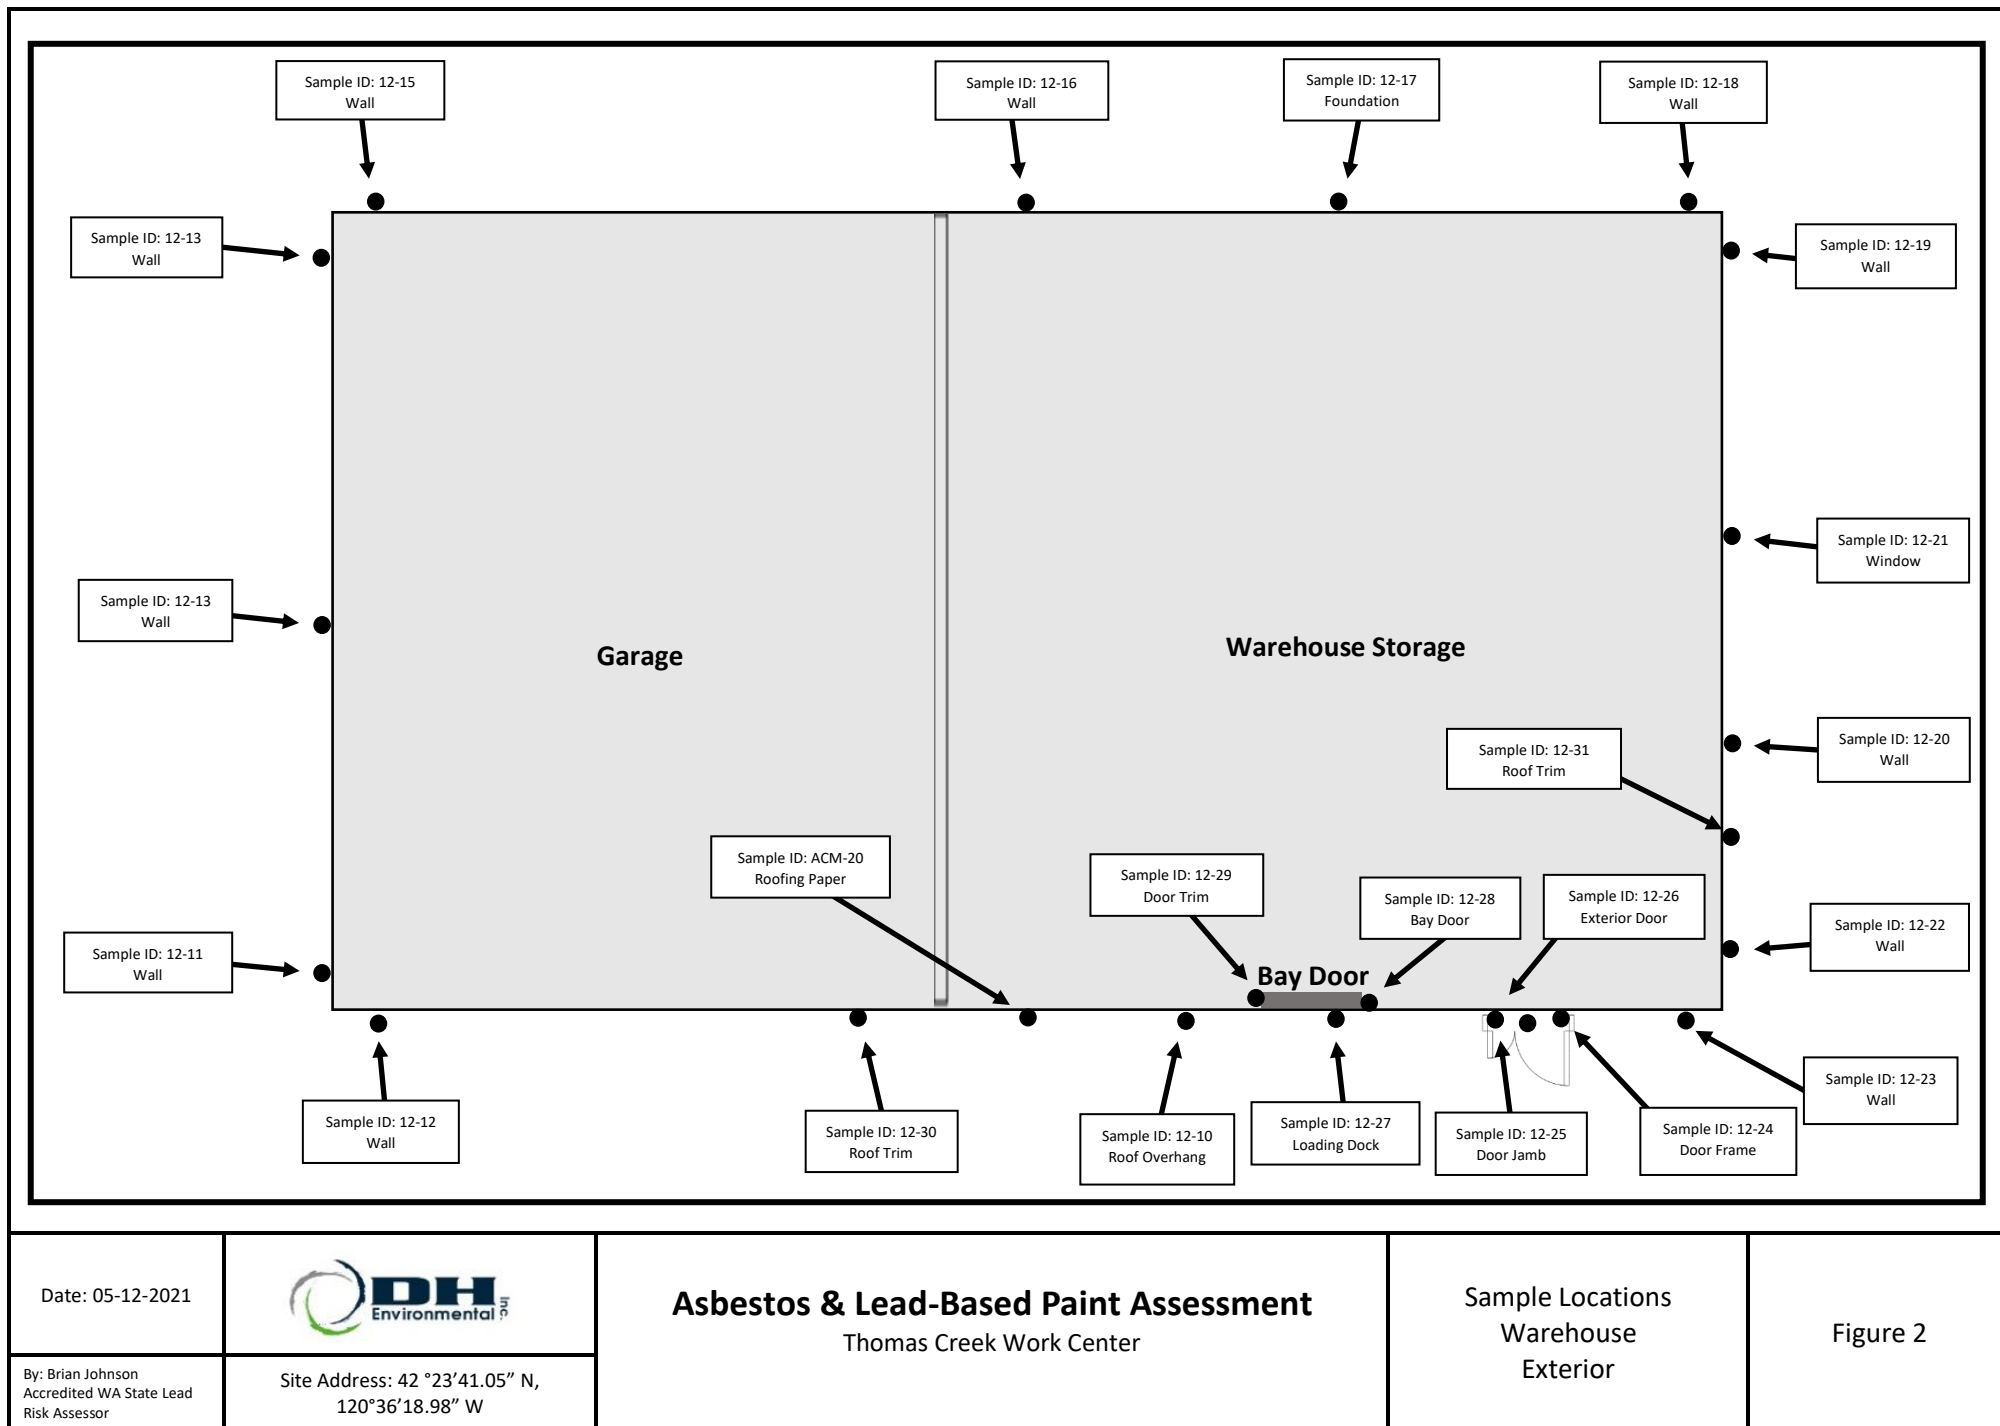
Figure 2 Warehouse – Lead Paint Assessment

Sample Locations
Warehouse
Exterior

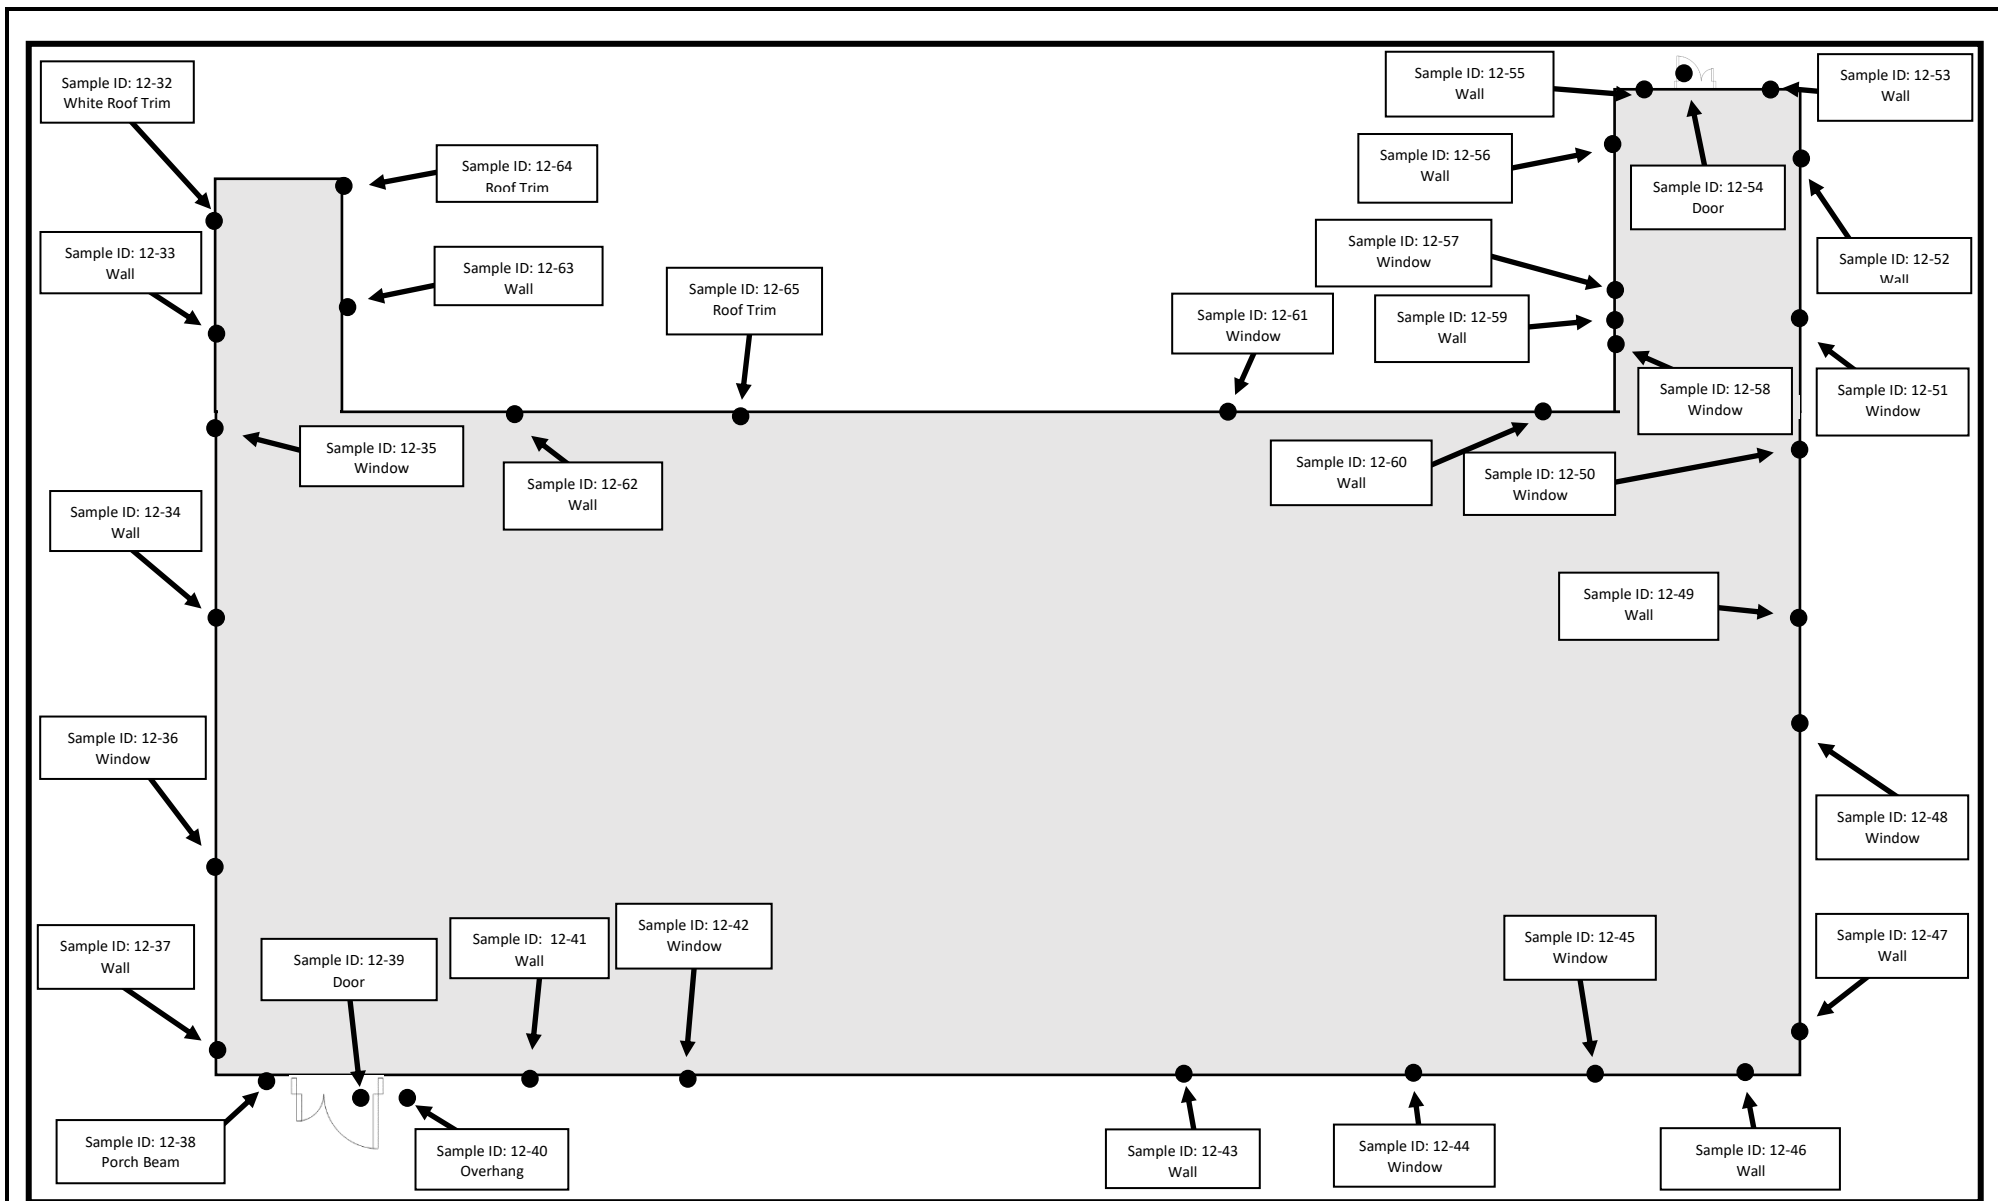
Figure 3 Barracks Exterior - Lead Paint Assessment

One-hundred and thirteen (113) samples were collected and analyzed using an X-ray fluorescence analyzer (XRF). Five of the samples were found to contain lead above the established threshold of 1 mg/cm². These materials were found on the exterior of the barracks.

Sample Locations:
Barracks
Exterior

Lead was detected in some of the building materials sampled. Therefore, we recommend implementation of engineering and work practice controls to reduce and maintain employee exposure to lead to or below the permissible exposure limit¹ to the extent that such controls are feasible in accordance with 29 CFR 1926.62(d) construction standards.

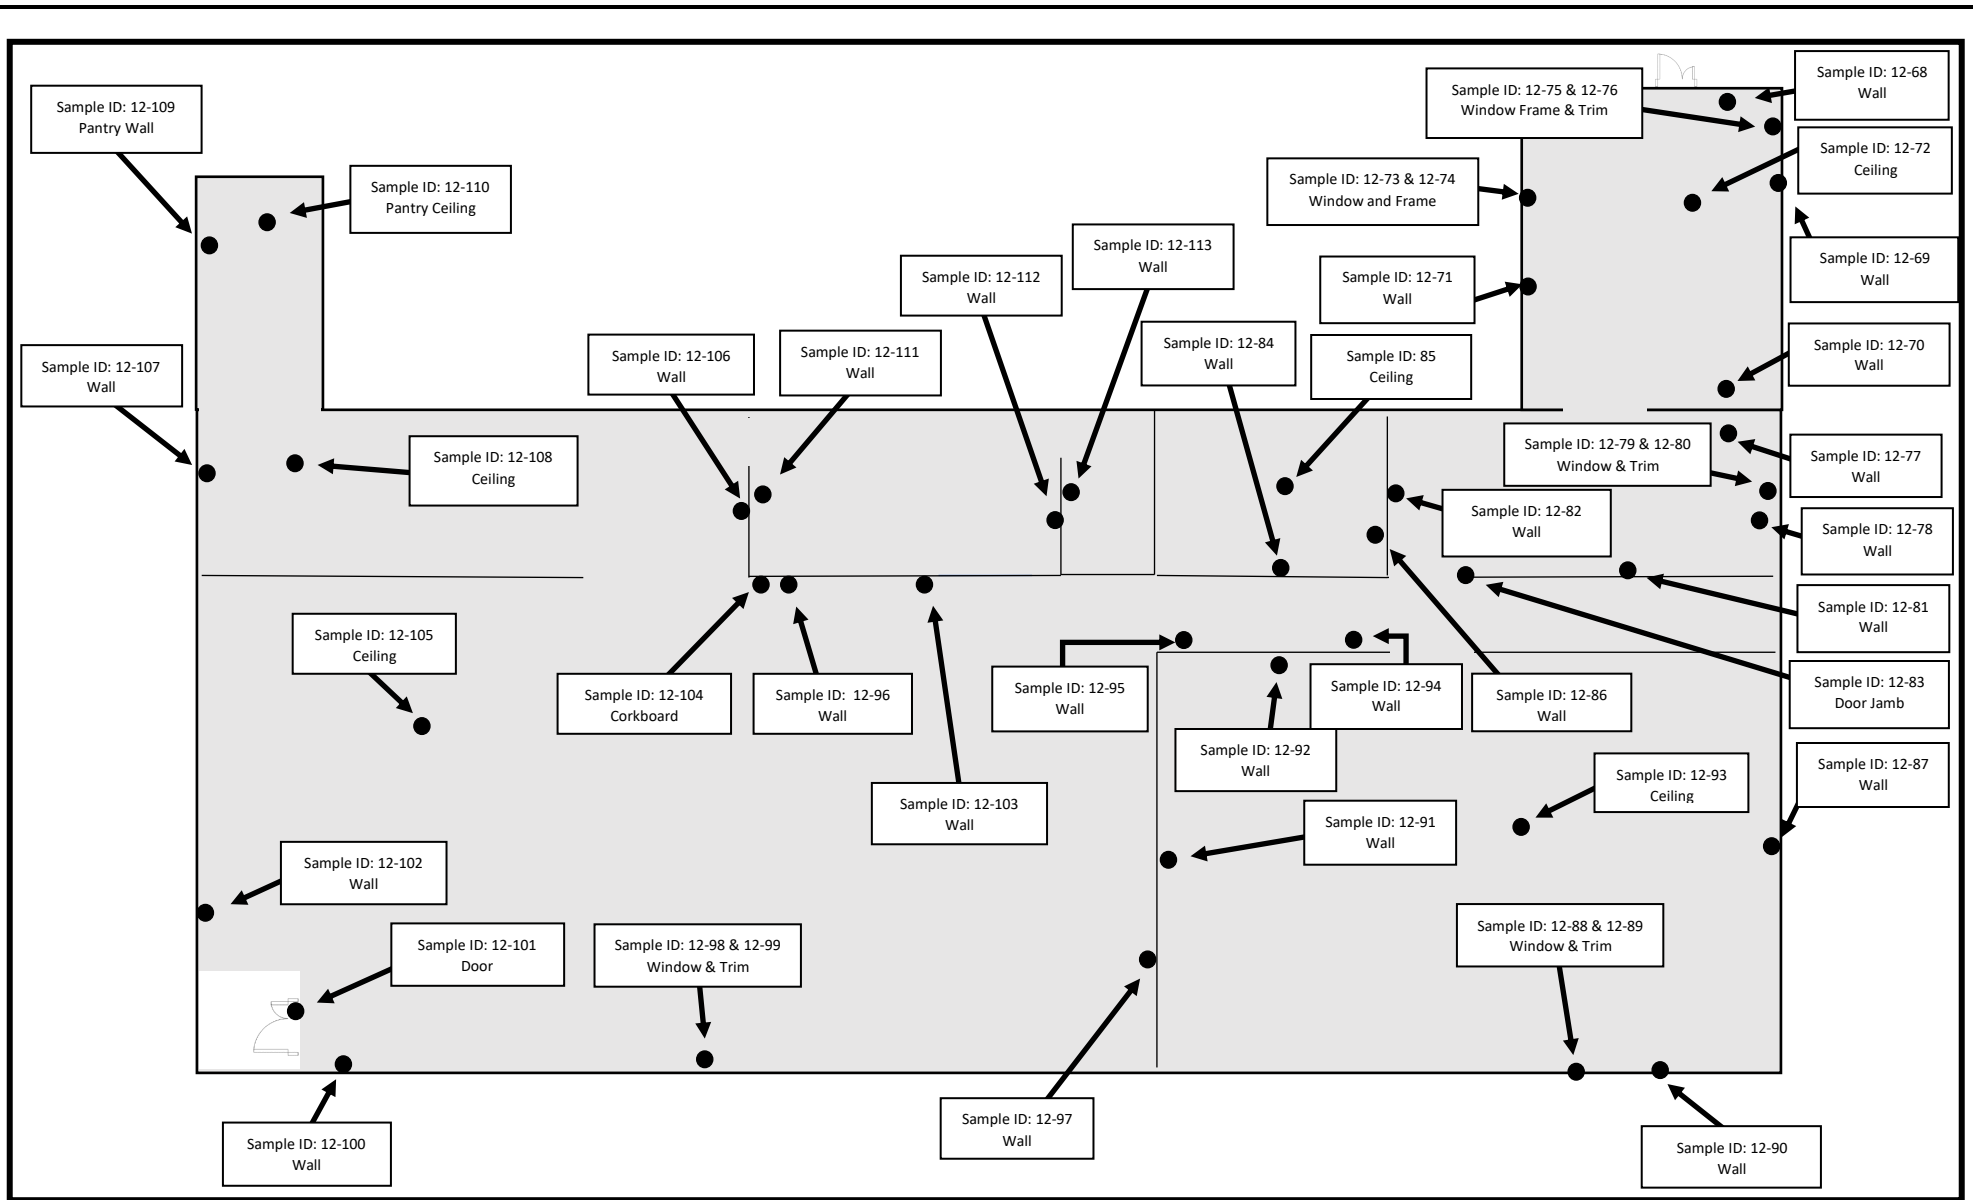
Figure 4 Barracks Interior – Lead Paint Assessment

Sample Locations:
Barracks
Interior

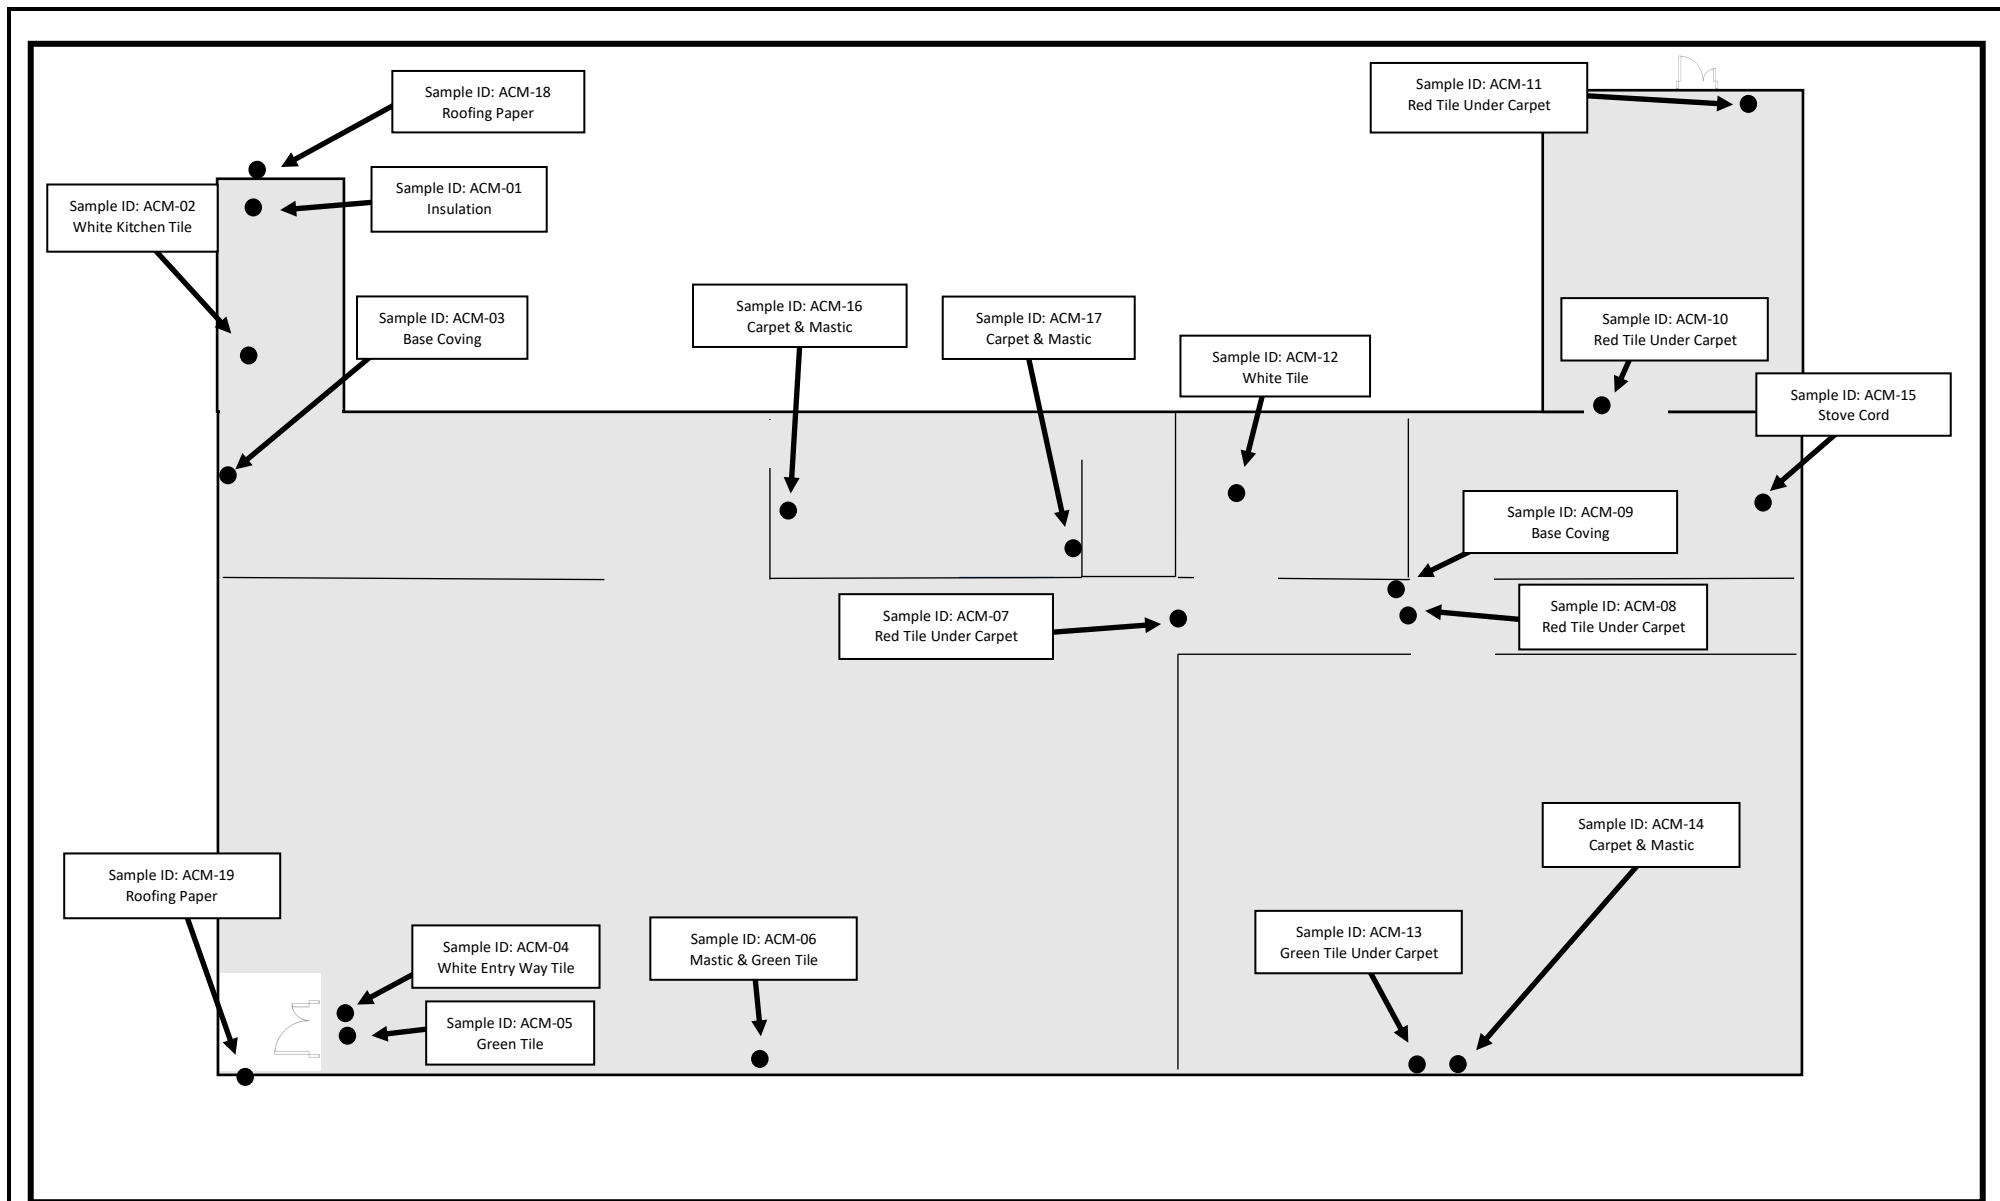
Figure 5 Barracks Interior & Exterior – Asbestos Assessment

Asbestos Assessment Thomas Creek Work Center	Sample Locations Barracks Interior/Exterior	Figure 5
By: Brian Johnson Accredited WA State Lead Risk Assessor	Site Address: 42 °23'41.05" N, 120°36'18.98" W

ACM was detected in the areas where the work was understood to be conducted. Therefore, we recommend that this work should be considered an “Asbestos Abatement Project” as defined in the DEQ Regulation OAR 340-248-0010.

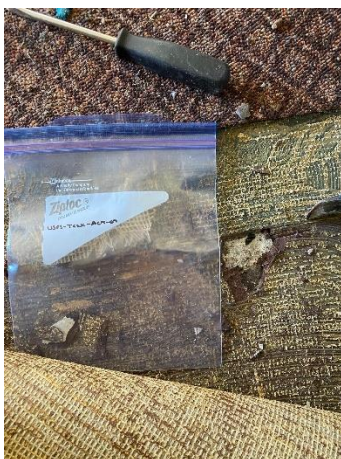
Sample ID: USFS-TCWC-ACM-07

USFS-TCWC-ACM-07	Layer 1: Yellow soft mastic with debris Layer 2: Dark red vinyl tile	Building 1320	ACM (%): Chrysotile 7% (Layer 2) Chrysotile 3% (Layer 3)	39 ft ²

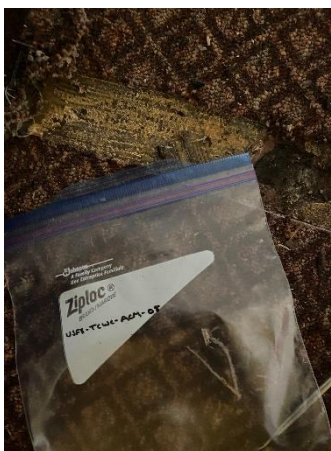
Sample ID: USFS-TCWC-ACM-08

Layer 3: Black asphaltic mastic Layer 4: Beige crumbly material			
USFS-TCWC-ACM-08	Layer 1: Yellow soft mastic with debris Layer 2: Dark red vinyl tile Layer 3: Black asphaltic mastic	Building 1320	ACM (%): Chrysotile 7% (Layer 2) Chrysotile 4% (Layer 3)	Same as sample USFS-TCWC-ACM-07
USFS-TCWC-ACM-09	Layer 1: Brown rubbery material Layer 2: Brown brittle mastic	Building 1320	ACM (%): ND	NA
USFS-TCWC-ACM-10	Layer 1: Yellow brittle mastic with debris Layer 2: Dark red vinyl tile Layer 3: Black asphaltic mastic	Building 1320	ACM (%): Chrysotile 7% (Layer 2) Chrysotile 4% (Layer 3)	425 ft ²
USFS-TCWC-ACM-11	Layer 1: Tan soft mastic with debris Layer 2: Dark red vinyl tile Layer 3: Black asphaltic mastic	Building 1320	ACM (%): Chrysotile 7% (Layer 2) Chrysotile 4% (Layer 3)	Same as sample USFS-TCWC-ACM-10
USFS-TCWC-ACM-12	Layer 1: Off-white vinyl tile Layer 2: Black asphaltic mastic	Building 1320	ACM (%): Chrysotile 3% (Layer 2)	72 ft ²

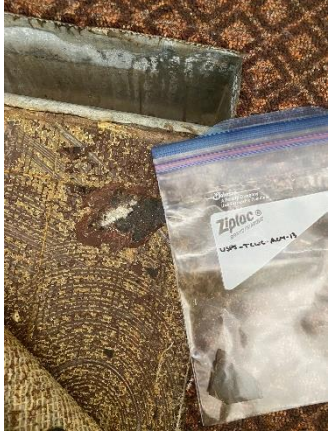
Sample ID: USFS-TCWC-ACM-13

USFS-TCWC-ACM-13	Layer 1: Yellow soft mastic with debris Layer 2: Red vinyl tile Layer 3: Black asphaltic mastic	Building 1320	ACM (%): Chrysotile 7% (Layer 2) Chrysotile 4% (Layer 3)	252 ft ²
USFS-TCWC-ACM-14	Layer 1: Multicolored woven fibrous material with beige and yellow mastic	Building 1320	ACM (%): ND	NA

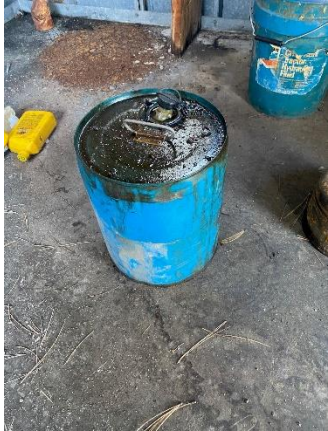
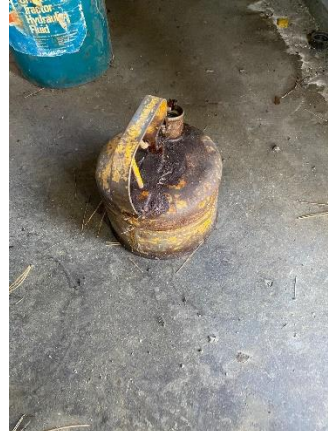
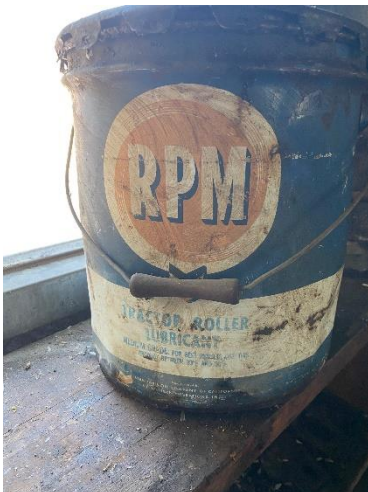
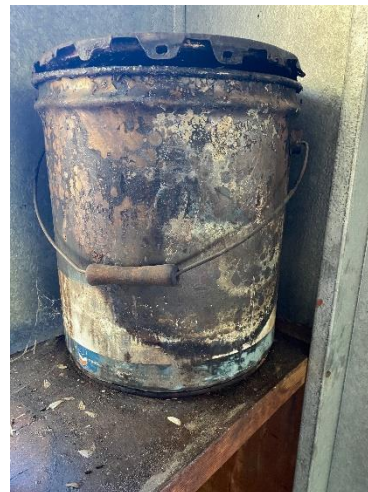
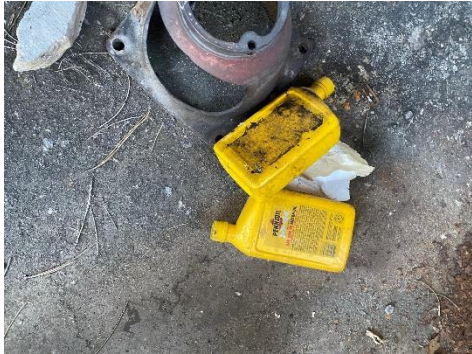
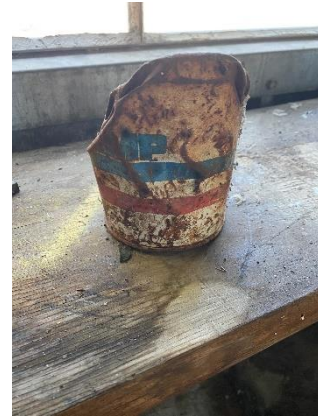
Gas House: Misc. Petroleum Products

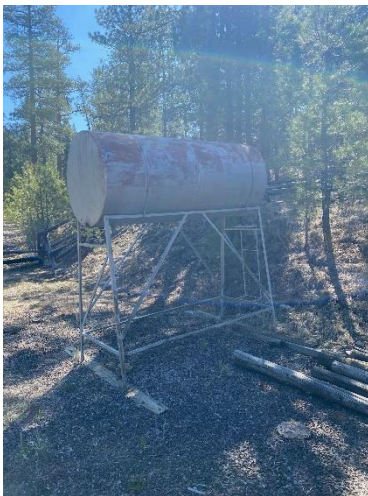
Elevated Empty Gasoline Tank

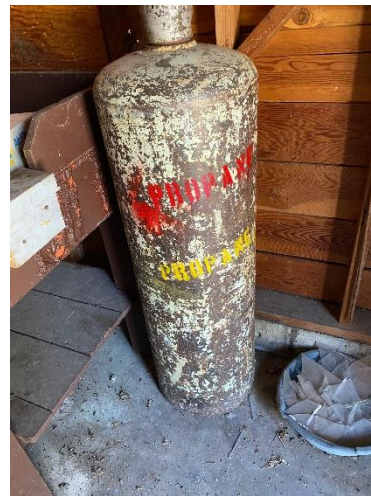
Warehouse: Propane Cylinder

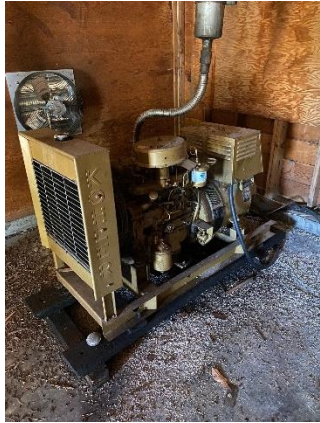
Warehouse: Generator

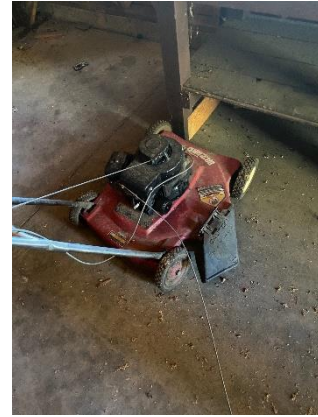
Warehouse: Lawn Mower

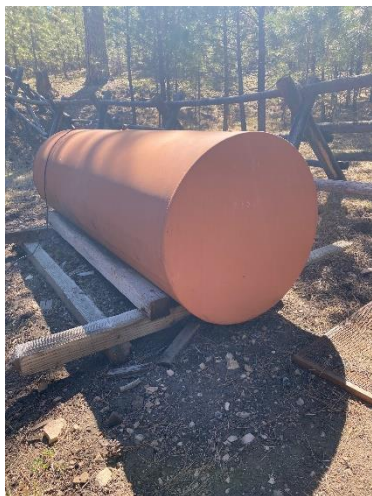
Outside: Diesel Tank

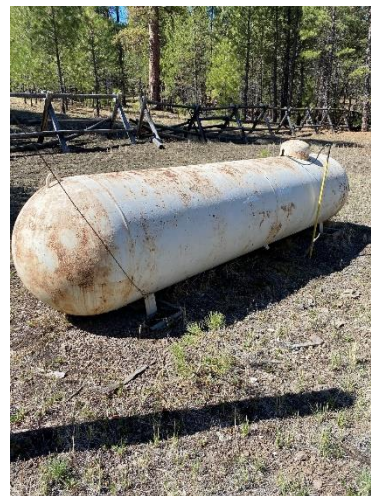
Outside: Propane Tank

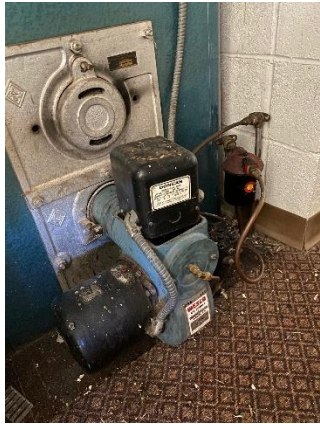
Barracks: Oil Furnace
