## API-653 Engineering Inspection Report Tank # 2111 (Tank #7)

US Air Force - McGuire AFB; McGuire AFB, NJ

February 22, 2018

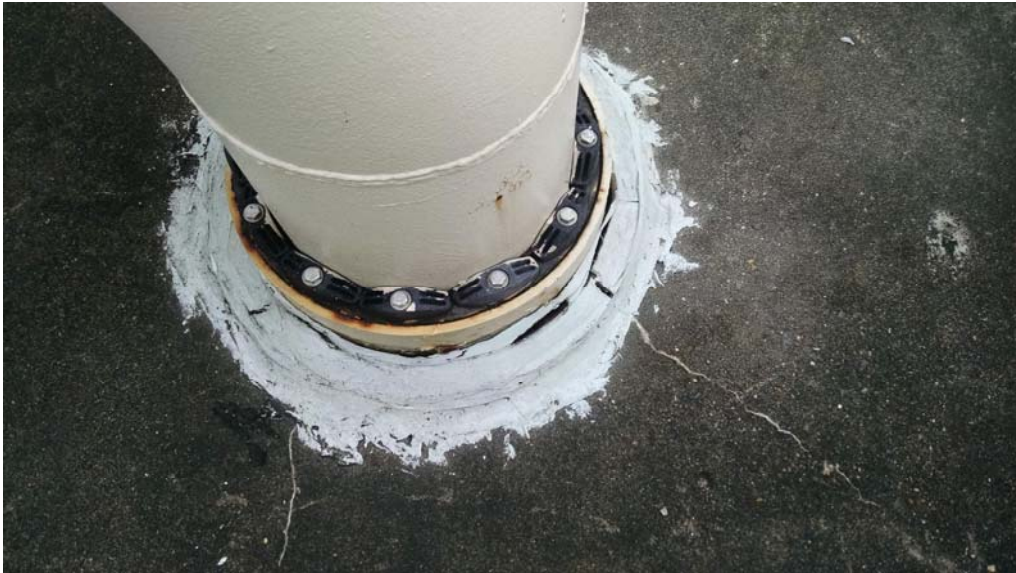
Penetrations through the containment floor for the 12" issue and 10" receipt piping are not properly sealed. Except as noted above, the containment appears to be in satisfactory condition.

E.13 Piping Penetration into Containment Floor

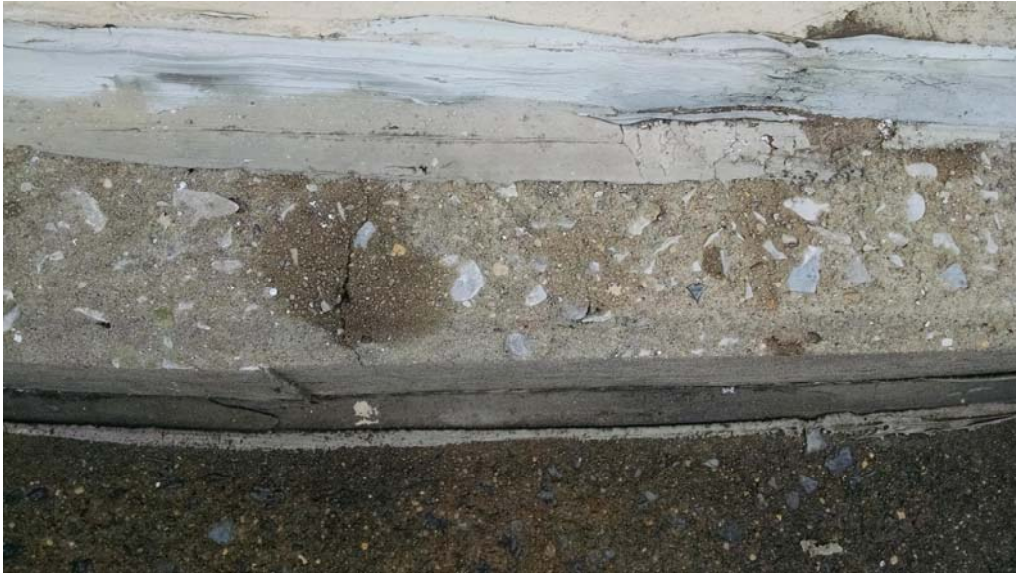
Minor hairline cracks (temperature cracks) are present in the concrete containment floor. Hairline cracks do not seriously affect the strength of concrete structures; however, these cracks can be potential access points for moisture or water seepage that could corrode the reinforcing steel (rebar). In addition, during cold weather, these moisture pockets are susceptible to freezing and naturally resulting expansion. This could lead to the cracks becoming larger and impacting structural integrity as well as permeability.

E.17 Crack in Concrete Foundation

4.2.1 **Foundation:** Seal the hairline cracks in the foundation with a Sherwin Williams two-part Corobond Flexible Joint Sealant, Corobond Crack Filler, and Corobond 100 Epoxy Primer/Sealer or equivalent.

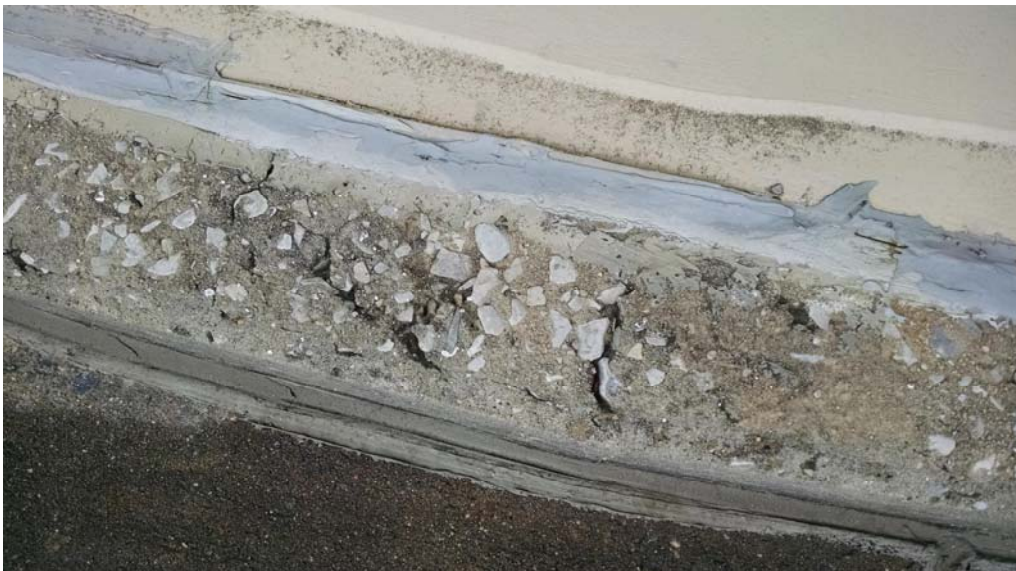
E.18 Crack in Concrete Foundation

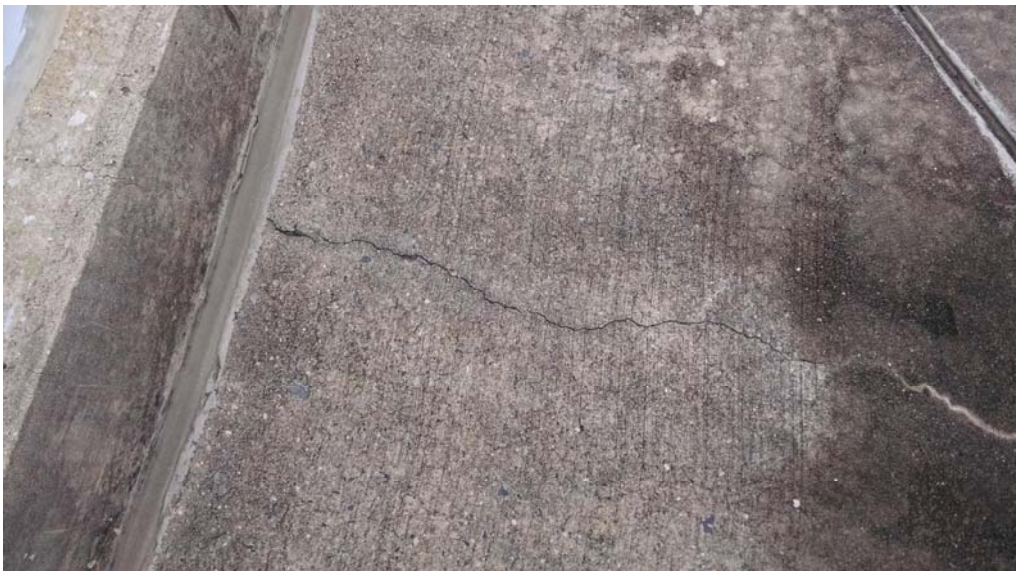
E.21 Crack in Containment Floor (Typical)

4.2.2 **Containment:** Seal the containment floor cracks with a Sherwin Williams two-part Corobond Flexible Joint Sealant, Corobond Crack Filler, and Corobond 100 Epoxy Primer/Sealer or equivalent.

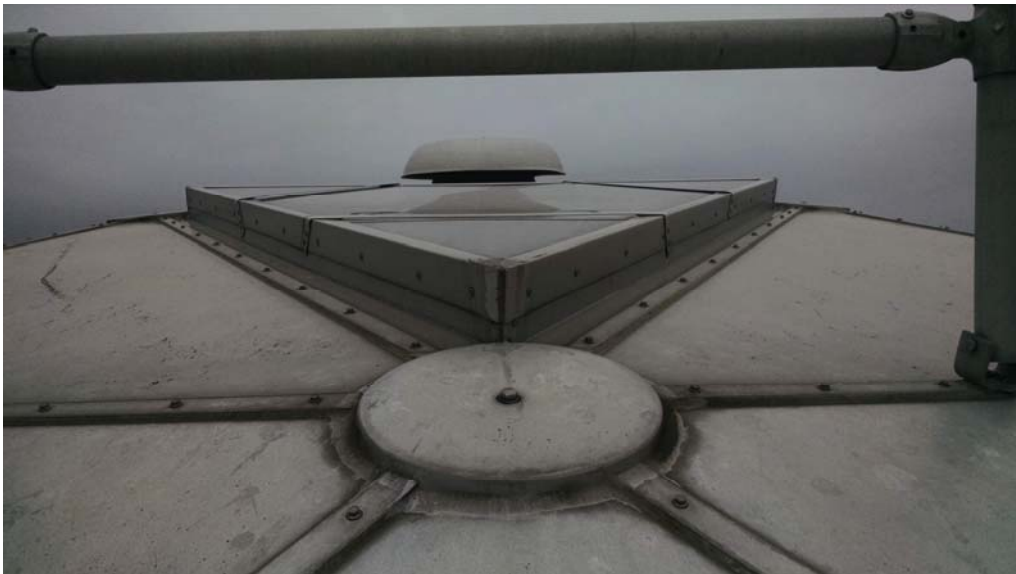
**4.1.4 Fixed Roof:** The fixed roof is an aluminum geodesic dome with proper screening located at the shell attachment junctures. Fuel personnel reported that the geodesic dome leaks during heavy rainfall.

E.41 Fixed Roof (Geodesic Dome)

4.2.4 **Roof:** Replace the bad sealant material in the geodesic dome.

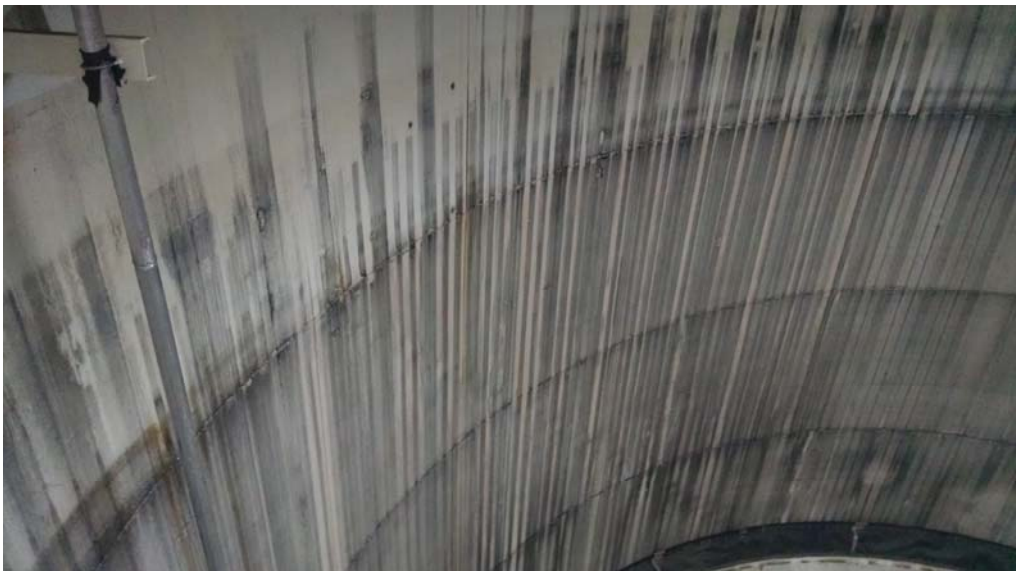
E.45 Heavy Rubber Streaking on Shell

4.3.5 **Internal Floating Roof:** Replace the failing/failed periphery shoe type seal in the tank. It is recommended that a double wiper type seal be installed.

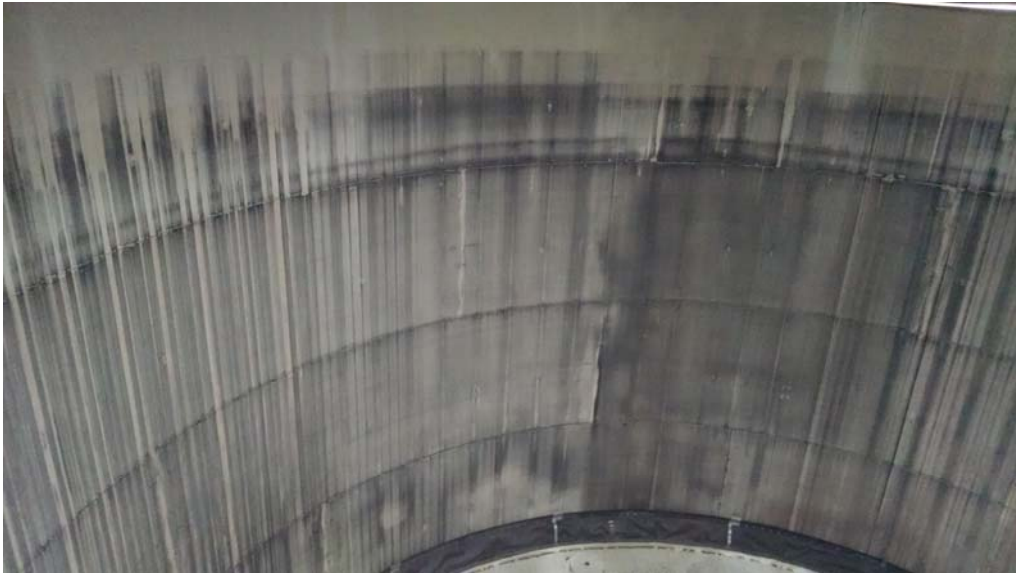
E.46 Heavy Rubber Streaking on Shell

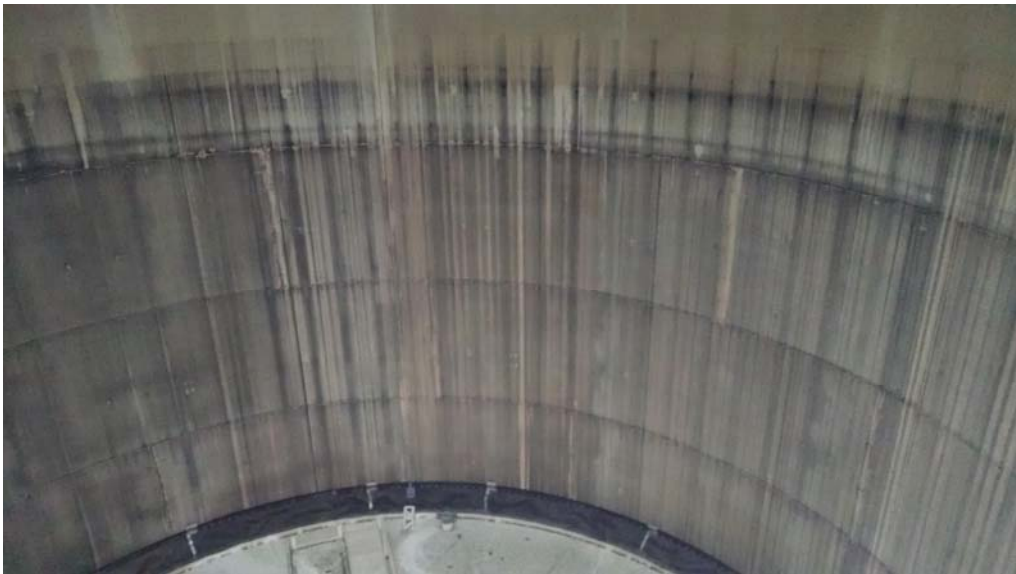
E.47 Heavy Rubber Streaking on Shell

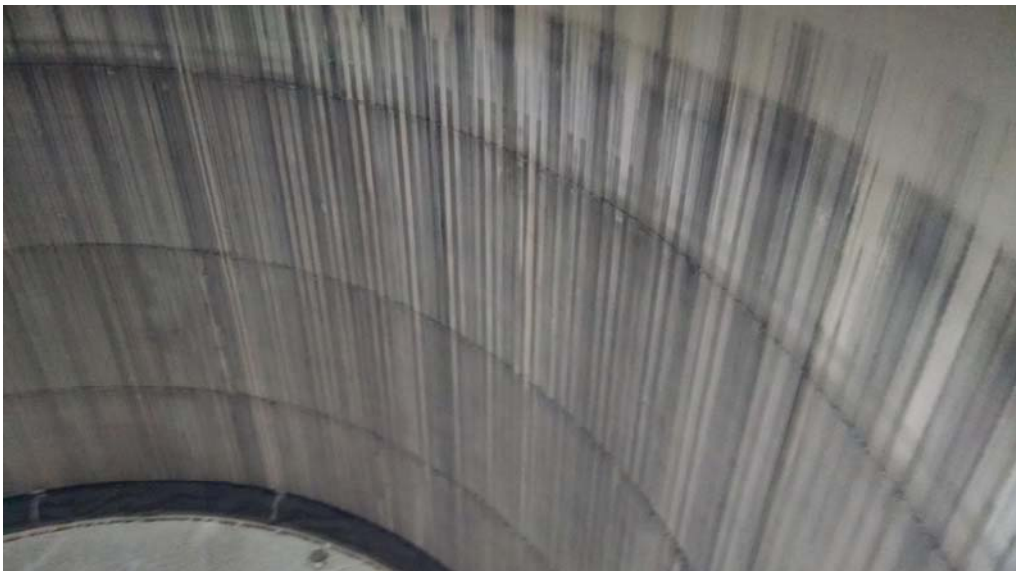
E.48 Heavy Rubber Streaking on Shell
