LIMITED ASBESTOS & LEAD INSPECTION REPORT

Building 455
Fort Richardson, AK 99505

Prepared for
673 CES CENMP
730 Quartermaster Road
JBER, AK 99505

September 20, 2022

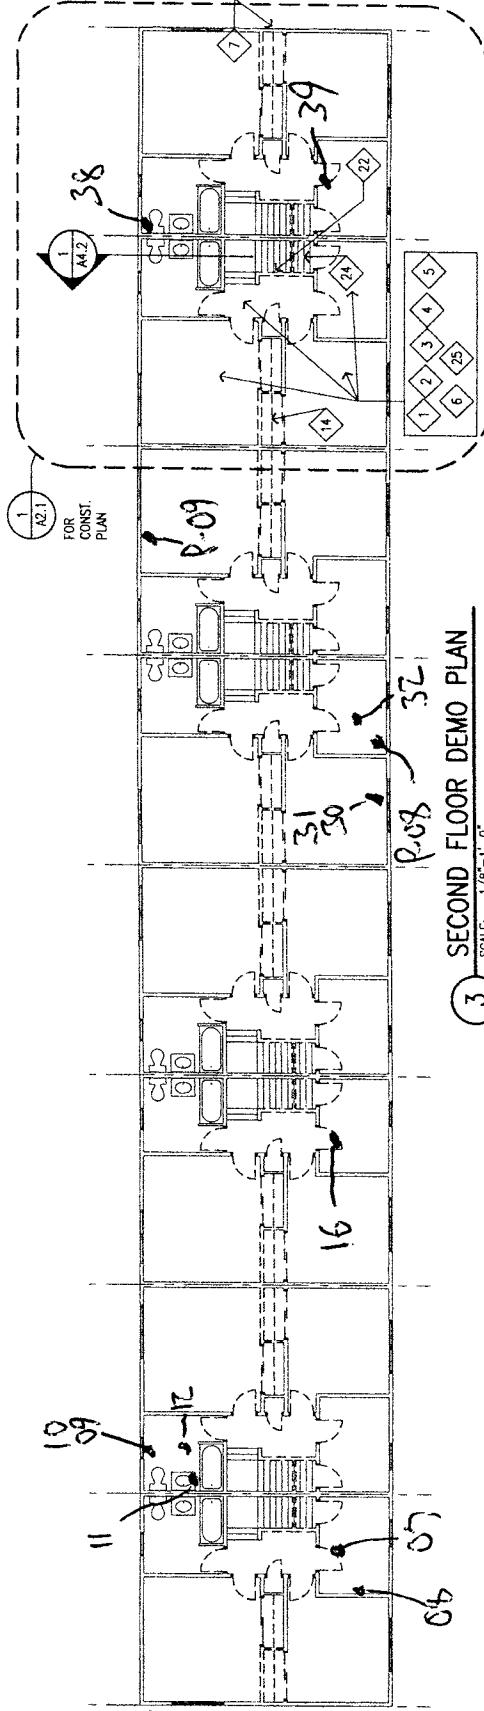
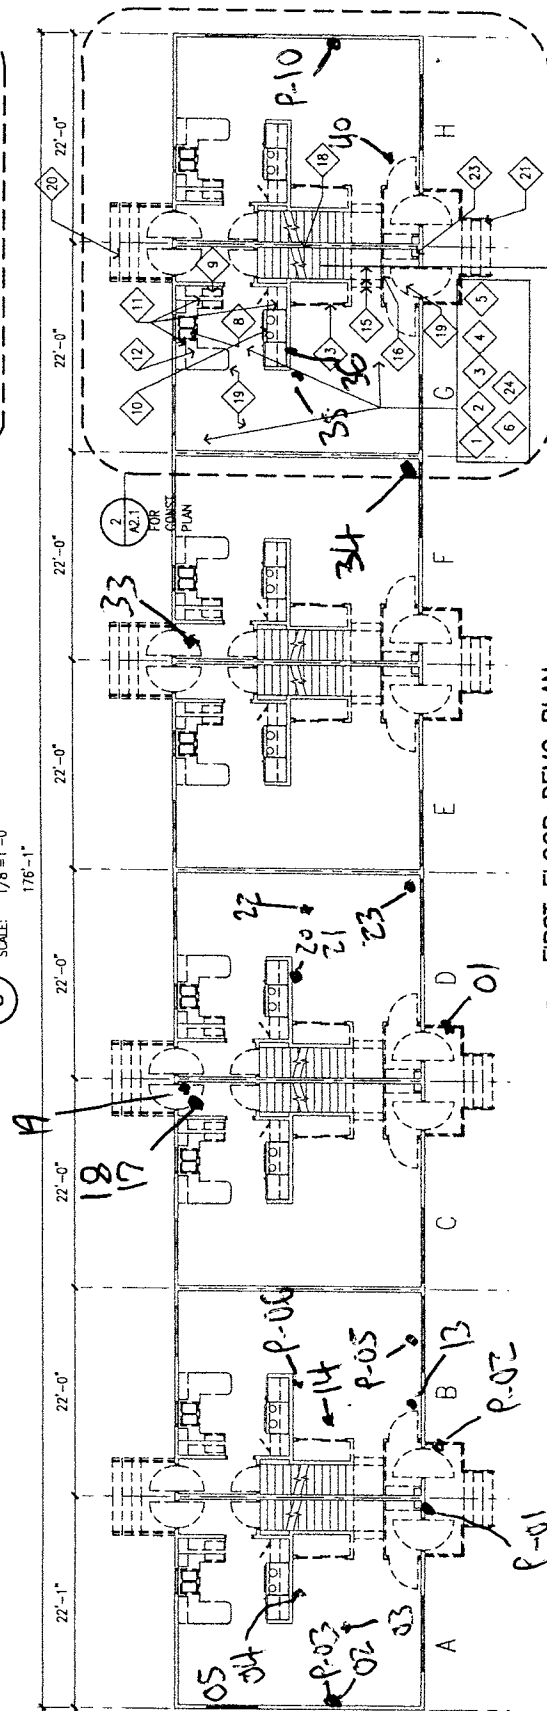
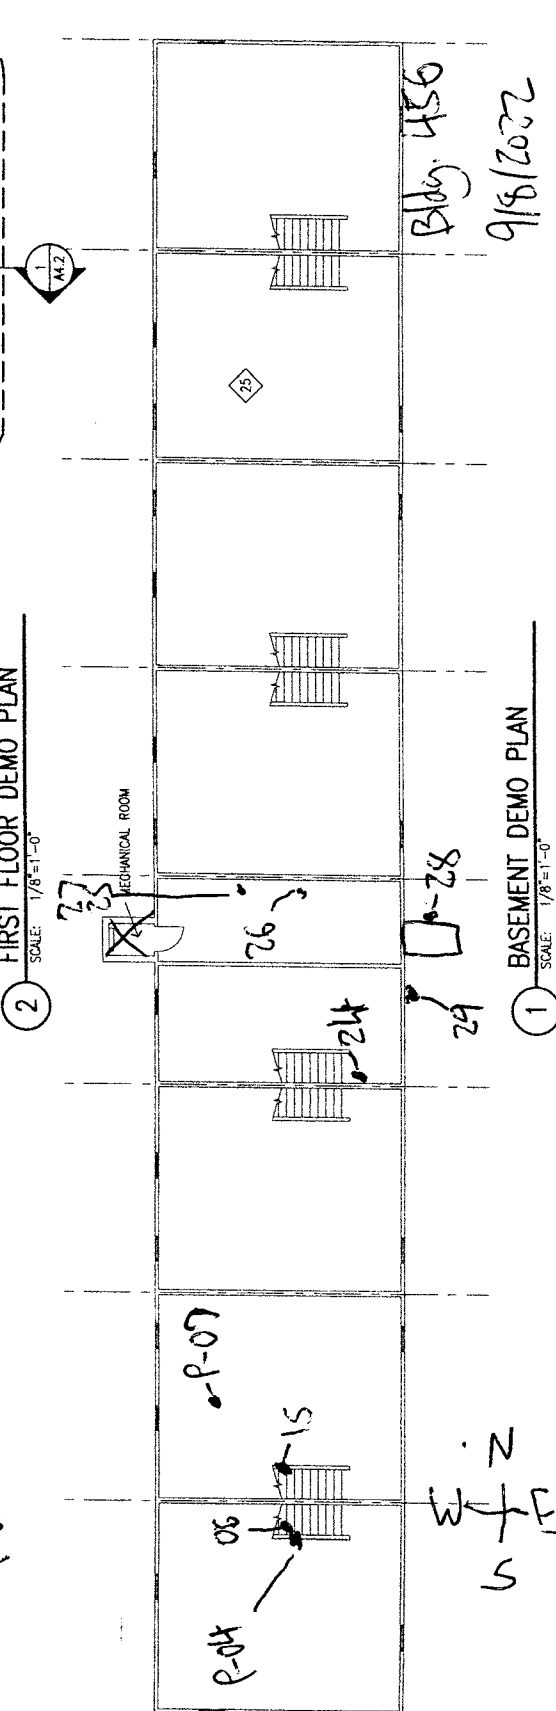
Blkg. 456
9/8/2022

- 23 REMOVE EXISTING HALF WALL AND TRIM (ASSUME LEAD BASED PAINT IN TRIM)
- 24 REMOVE EXISTING PIPE CHASE
- 25 DEMO EXISTING CLOSET IN LAUNDRY ROOM
- 26 BUILDINGS WILL BE TURNED OVER TO CONTRACTOR IN GOOD CONDITION. ALL SELF HELP WORK IN THE BASEMENT WILL BE REMOVED BY FT. RICHARDSON DPW PRIOR TO CONSTRUCTION START

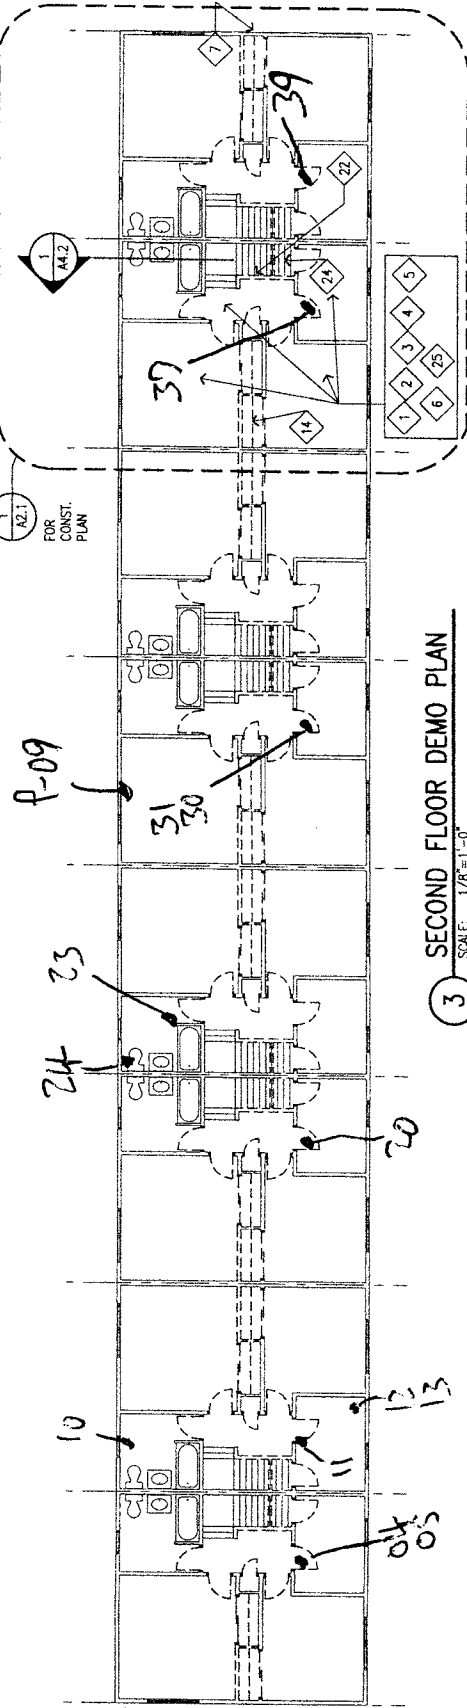
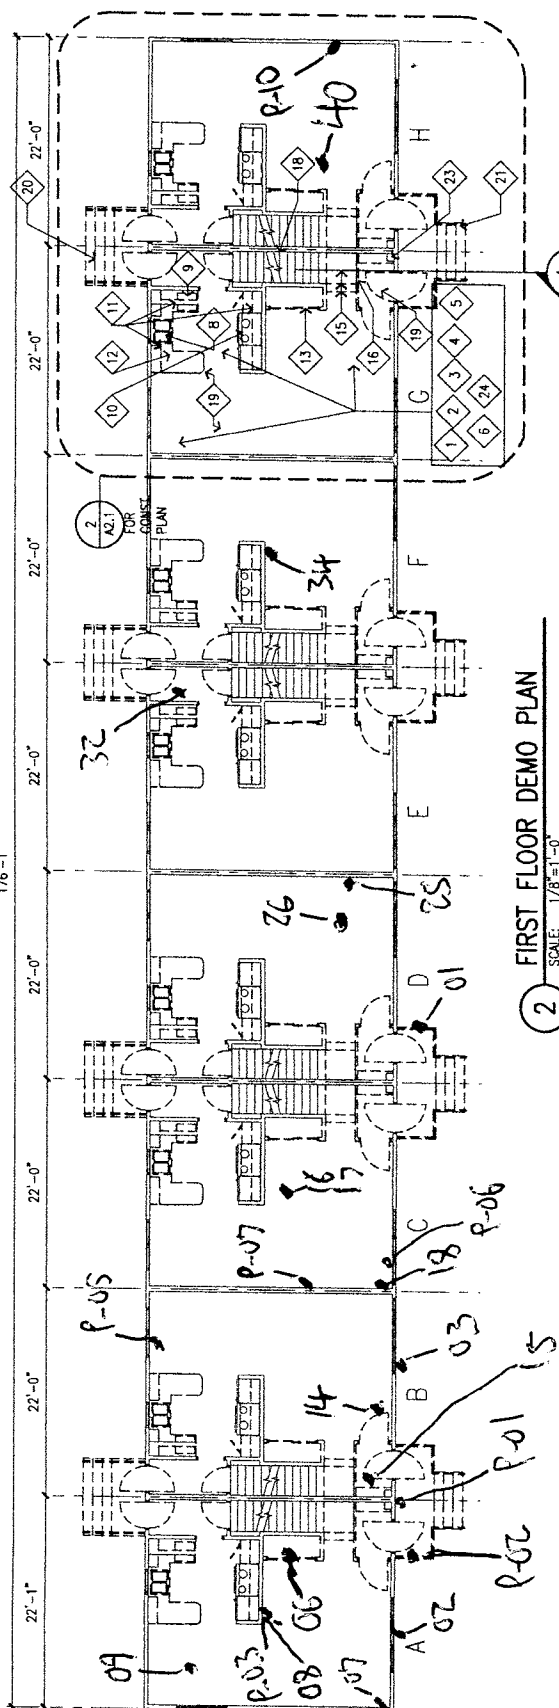
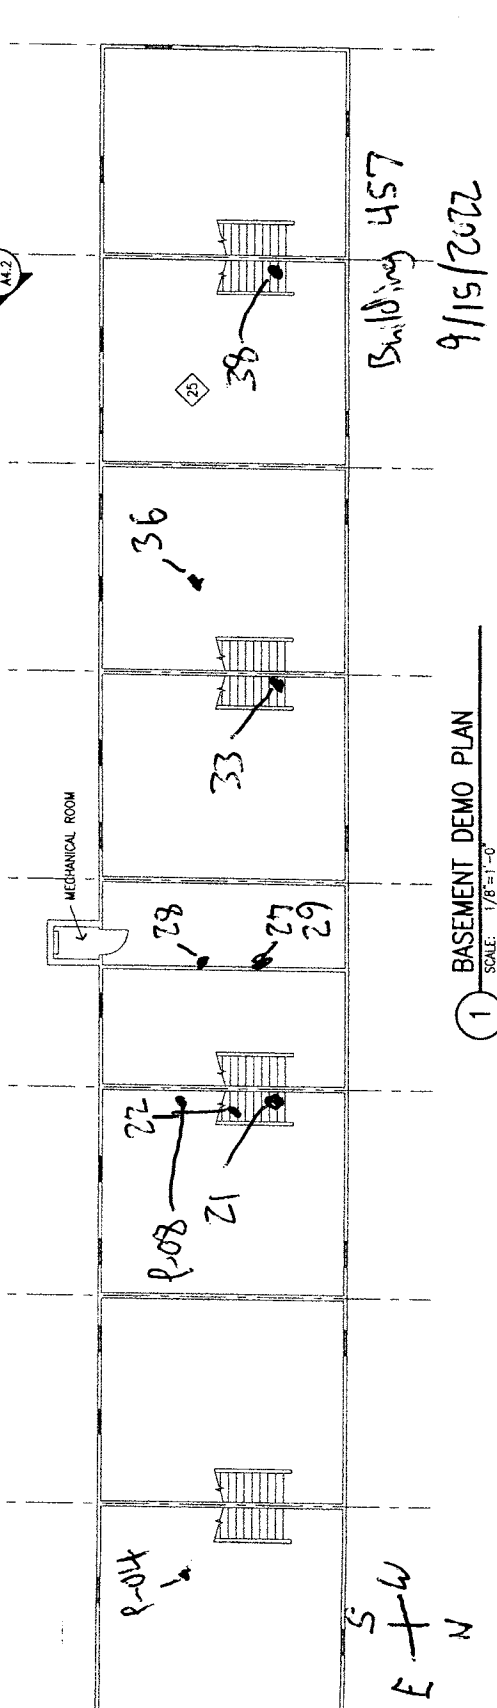
Building 457
9/15/2022

22. REMOVE EXISTING HALF WALL AND TRIM (ASSUME LEAD BASED PAINT IN TRIM).
23. REMOVE EXISTING PIPE CHASE.
24. DEMO EXISTING CLOSET IN LAUNDRY ROOM.
25. BUILDINGS WILL BE TURNED OVER TO CONTRACTOR IN GOOD CONDITION. ALL SELF HELP WORK IN THE BASEMENT SHALL BE REMOVED BY FT. RICHARDSON DEP PRIOR TO CONSTRUCTION START.

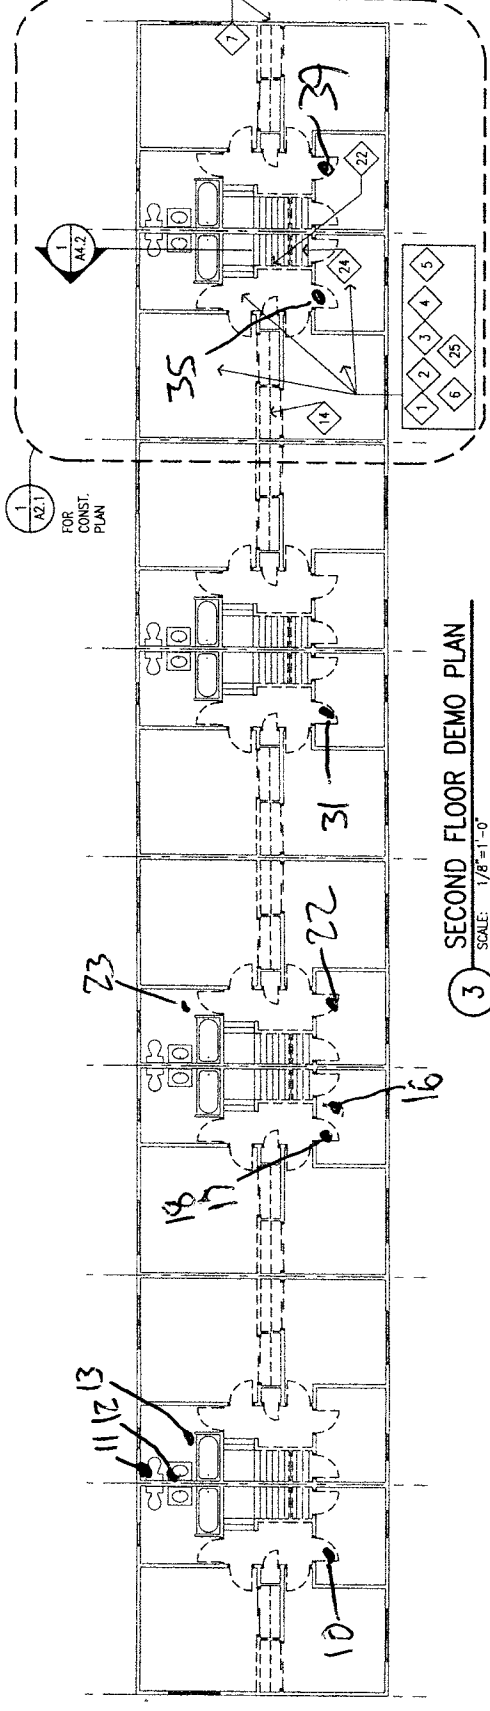
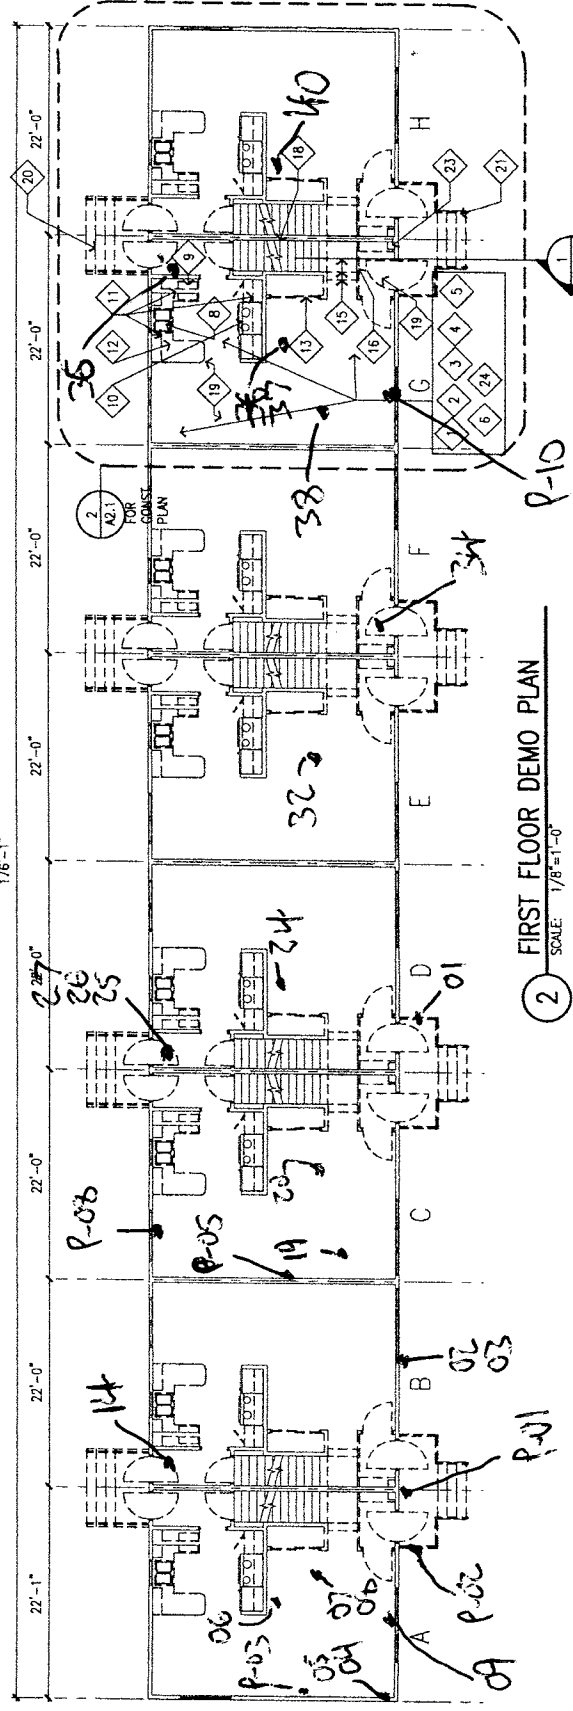
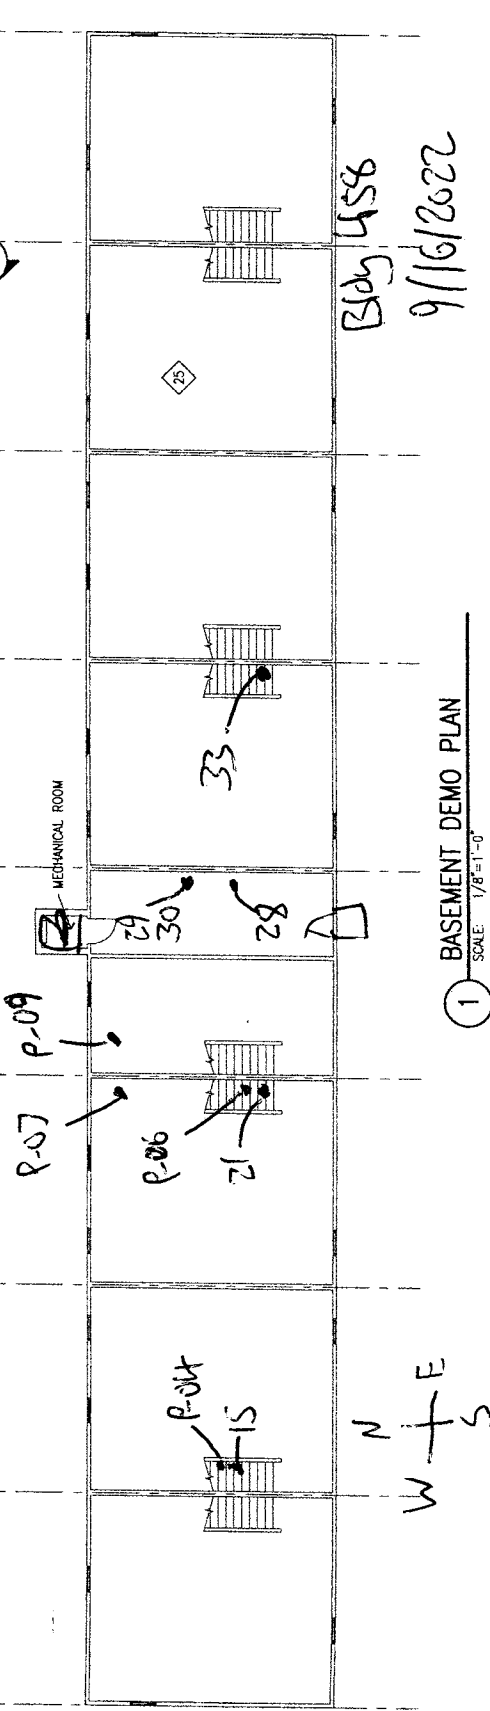
Blg 458
9/16/2022

- 23. REMOVE EXISTING HALF WALL AND TRIM (ASSUME LEAD BASED PAINT IN TRIM)
- 24. REMOVE EXISTING PIPE CHASE
- 25. DEMO EXISTING CLOSET IN LAUNDRY ROOM
- 26. BUILDINGS WILL BE TURNED OVER TO CONTRACTOR IN GOOD CONDITION. ALL SELF HELP WORK IN THE BASEMENT SHALL BE REMOVED BY FT. RICHARDSON DPW PRIOR TO CONSTRUCTION START
