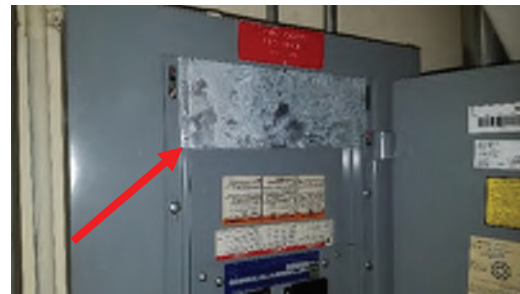
Panels C2MR (rm. EB60-1) and C2R1 (Biomed Hall) in building 1 have been locally modified as represented by the picture to the right. This supplemental cover is not a manufacturer-approved cover and needs to be replaced.

National Electric Code section 110.2 requires electrical equipment covered by the code to be “approved” by a testing laboratory. There is no evidence to show this equipment is in compliance with the standards outlined in the National Electric Code section below.

Panels C2MR (rm. EB60-1) and C2R1 (Biomed Hall) in building 1 need to have a manufacturer-approved covers installed to replace the locally-modified cover presently used to protect the energized, internal components.
