HAZARDOUS MATERIALS SUMMARY
Buildings 990, 1319, 1351
Naval Undersea Warfare Center
Naval Station Newport, Newport, RI
Contract No.: N40085-18-D-8703

February 2021

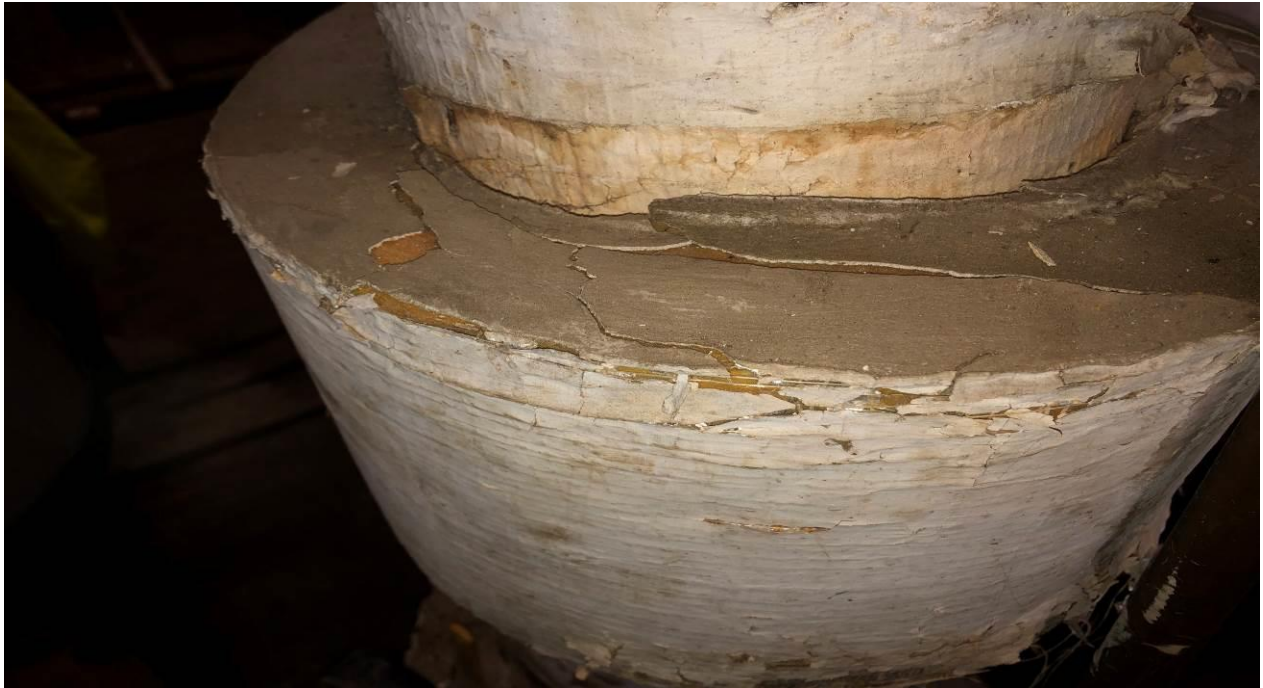
Field ID	Material	Location	Result % Asbestos
990-2A, 990-2B, 990-2C	Gray Seam Sealant	On Fiberglass Pipe Fitting at Chilled Water Supply	5% Chrysotile
990-3A, 990-3B, 990-3C	Gray Flex Connector Cloth	On Large HVAC Unit – Mechanical Room	ND
990-4A, 990-4B, 990-4C	Pipe Insulation on Saddle Blocks	Main Mechanical Room – Near Chilled Water Supply	ND
990-5A, 990-5B, 990-5C	Mudded Pipe Fitting on Gaskets	HWS #1 & 2 at Pumps -Mechanical Room	ND
990-6A, 990-6B, 990-6C	White Insulation on Hot Water Tank	Main Mechanical Room	ND
990-7A, 990-7B, 990-7C	End Cap Sealant on 4” Diameter Fiberglass Fitting FG Fitting	1 st Floor – Above Ceiling	3% Chrysotile
990-8A, 990-8B, 990-8C	Penetration Sealant	Main Mechanical Room	ND
990-9A, 990-9B, 990-9C	2” Diameter Gray Pipe Fitting	1 st Floor above Ceiling	ND
990-10A, 990-10B, 990-10C	4” Diameter Gray Pipe Fitting	1 st Floor above Ceiling	ND
990-11A, 990-11B, 990-11C	Pipe Insulation Fitting	At Hot Water Tank Y Connection	ND

**ACM Containing Gray Seam Sealant on Fiberglass Fitting-
Mechanical Room**

Prior to disturbance, the ACM identified must be abated by a Rhode Island licensed asbestos abatement contractor following all federal, state & local regulations governing asbestos abatement. A copy of the asbestos waste shipment record must be received within 30 days of removal from the Site. Asbestos air quality sampling must be conducted under USEPA and RIDOH regulations following asbestos abatement and prior to re-occupancy of the spaces. If additional materials are discovered that have not been sampled, those materials should be considered ACMs until laboratory analysis determines otherwise. Additionally, all abatement programs must follow the requirements outlined in the Unified Facilities Guide Specifications.

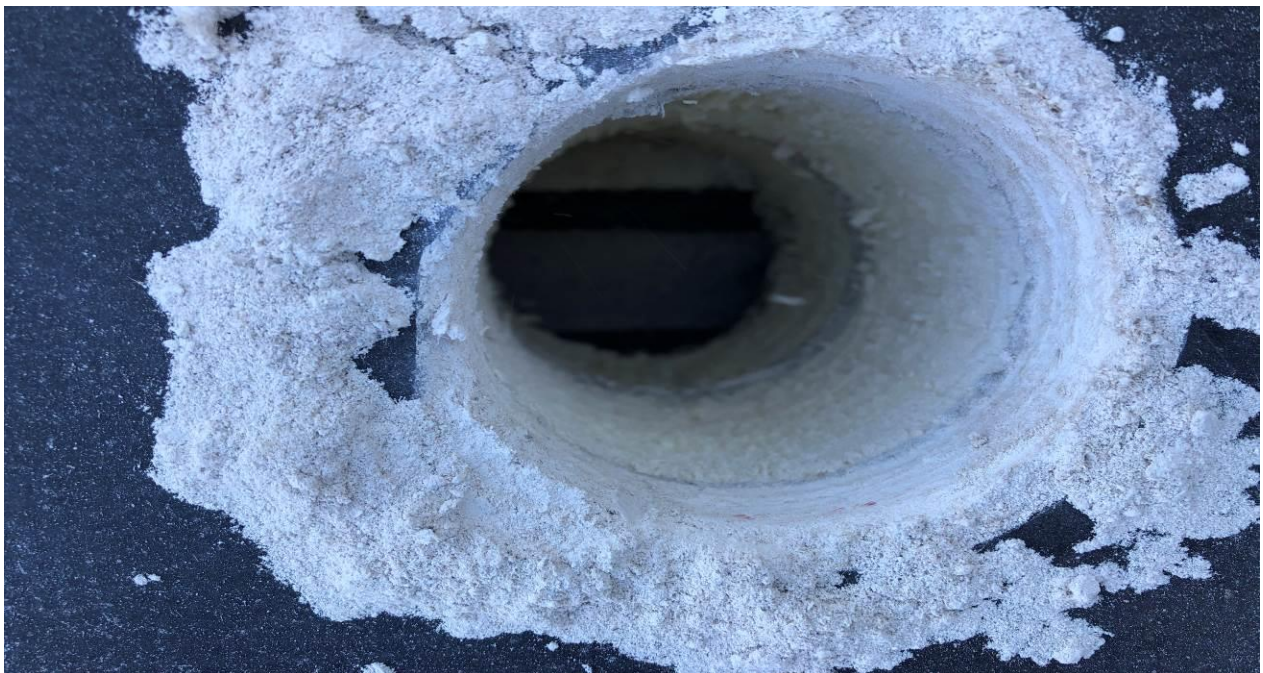
Roof Core – Non-ACM

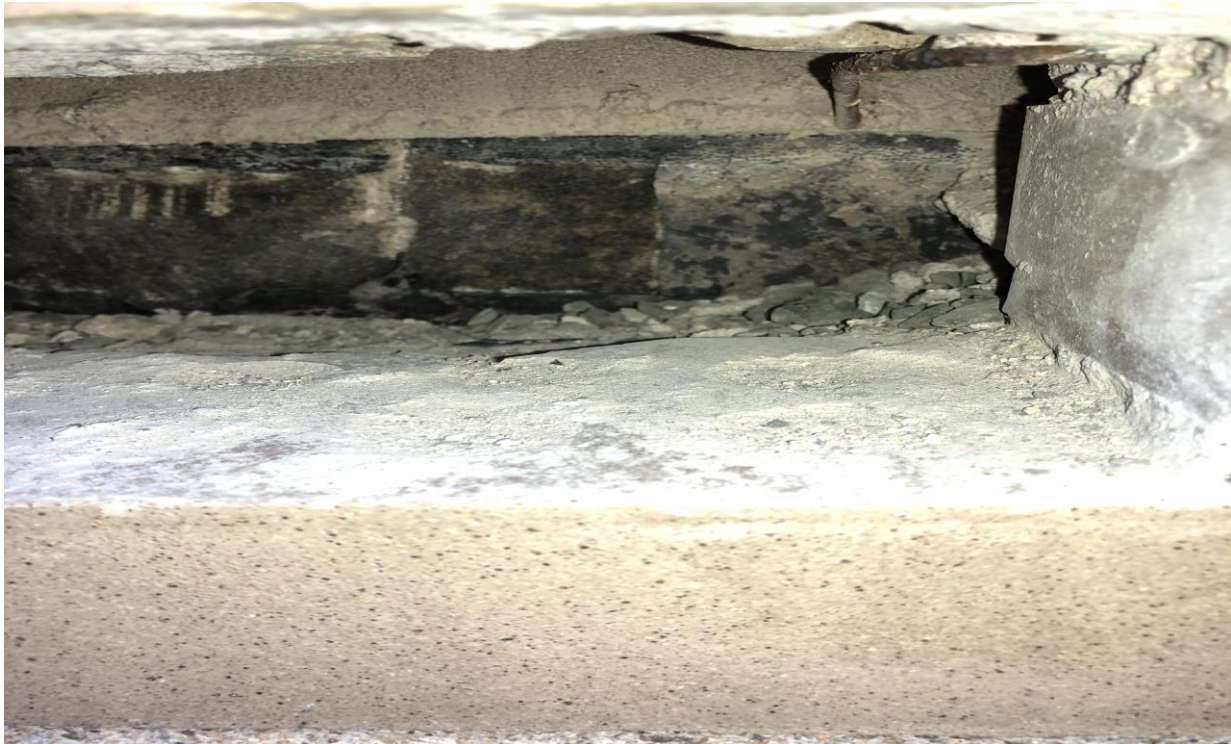
Behind Brick Cut – ACM Gray Mastic Located Behind the Flashing

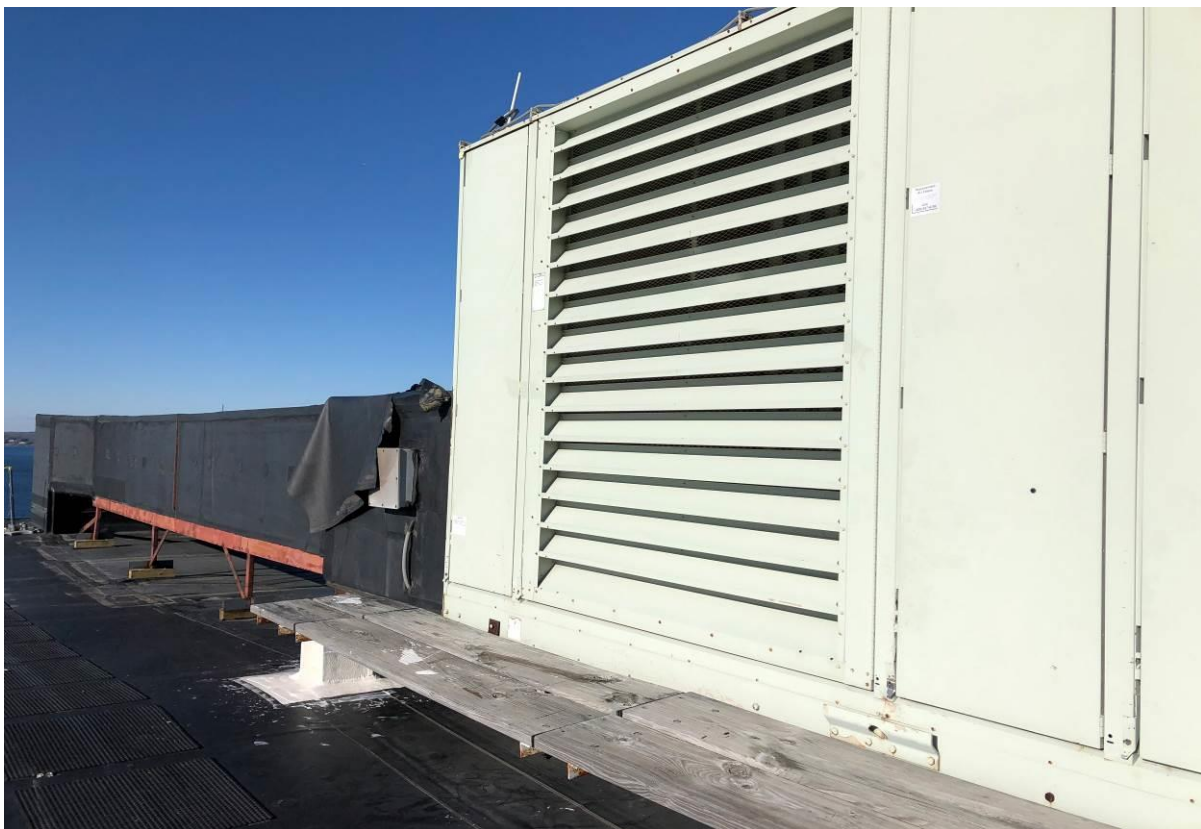
Roof Top Unit – No ACM Detected on Components

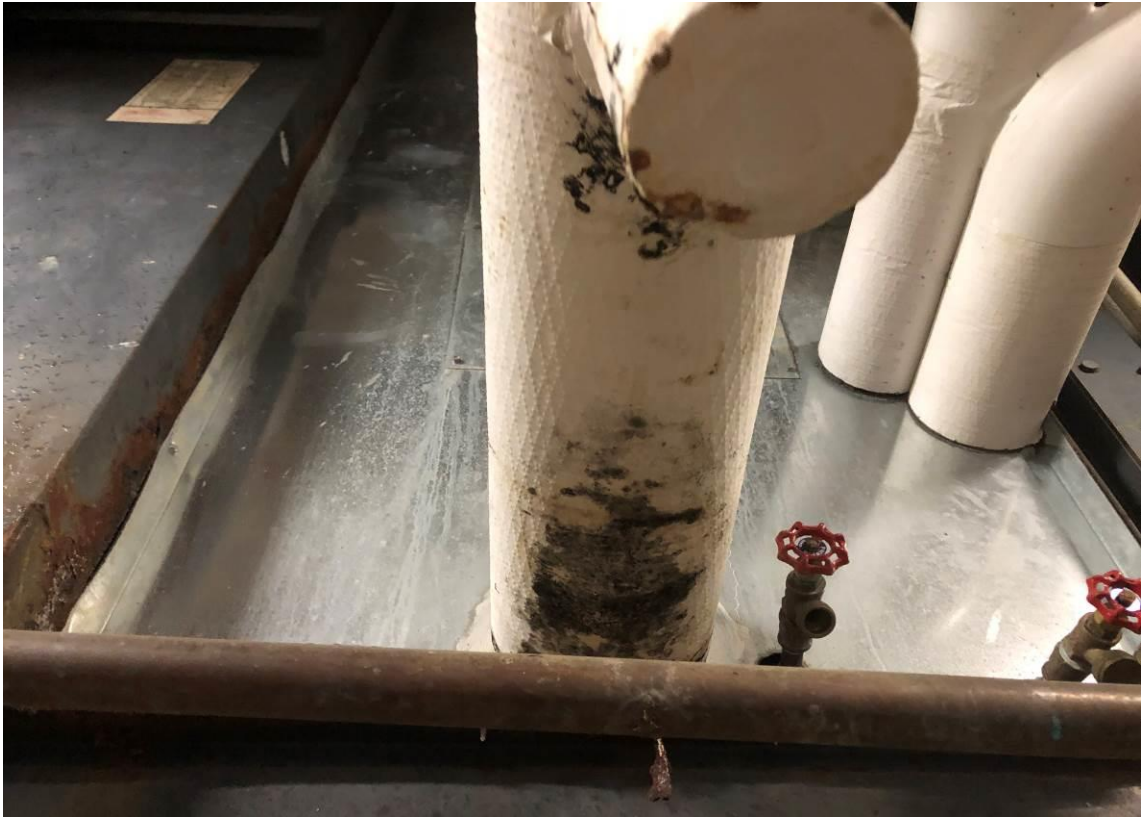
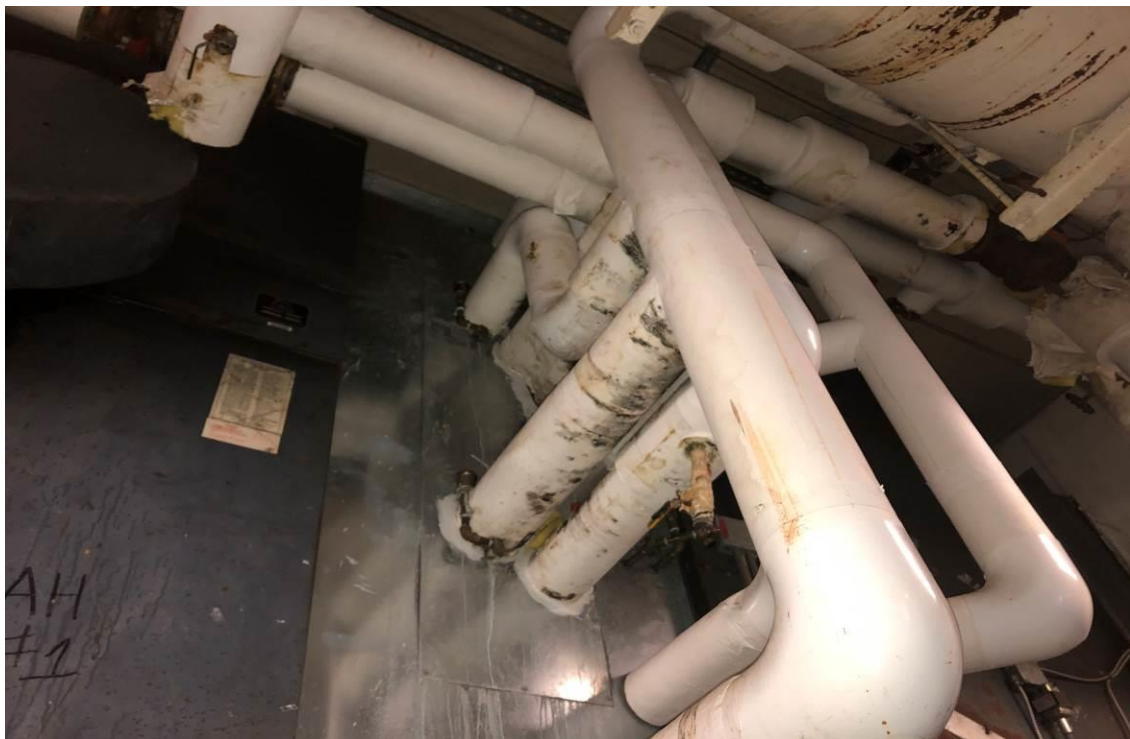
The building is supplied with medium pressure steam from a base wide steam system. The building has a steam to hot water heat exchangers which provides heating hot water. The heating hot water is pumped throughout the building in steel insulated piping. The hot water serves various terminal pieces of equipment including fin tube, unit heaters and provides heating hot water to the air handling unit that provides conditioned air to the office spaces. The cooling system includes water chillers and condensers which provides chilled water which is pumped throughout the building in steel insulated piping. Observed pipe insulation within the mechanical room and above drop ceilings on other floors primarily consist of fiberglass with some suspect ACM fittings. Additionally, mold was observed in the main mechanical room on pipes and equipment.

Mold – Mechanical Room

Due to visible mold associated with piping and other mechanical components in Buildings 990, 1319 and 1351, a limited mold survey is also recommended.

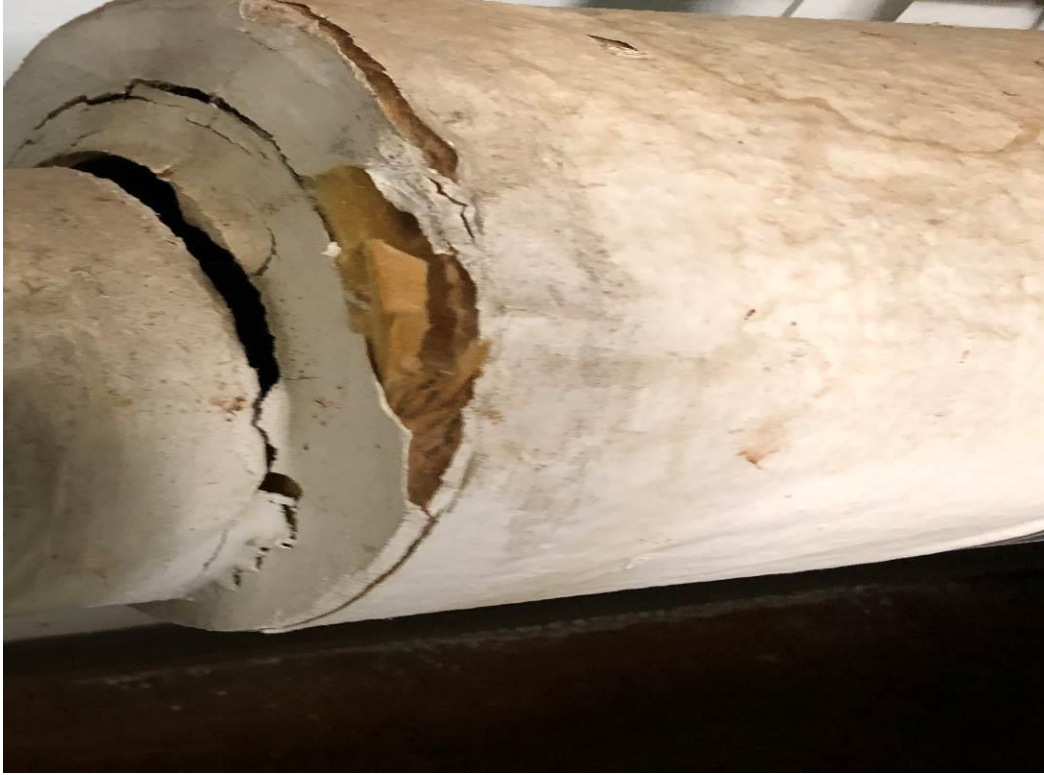
ACM in Seam Sealant on Fiberglass Pipe Fitting Above Ceiling 1st Floor
