**VOLUME II  
ASBESTOS CONTAINING MATERIAL &  
LEAD CONTAINING PAINT  
SURVEY REPORT  
BUILDING 80**

VISN 1  
**Bedford VA Medical Center**  
200 Springs Road  
Bedford, Massachusetts

Project No. 2009023.008

February 15, 2011

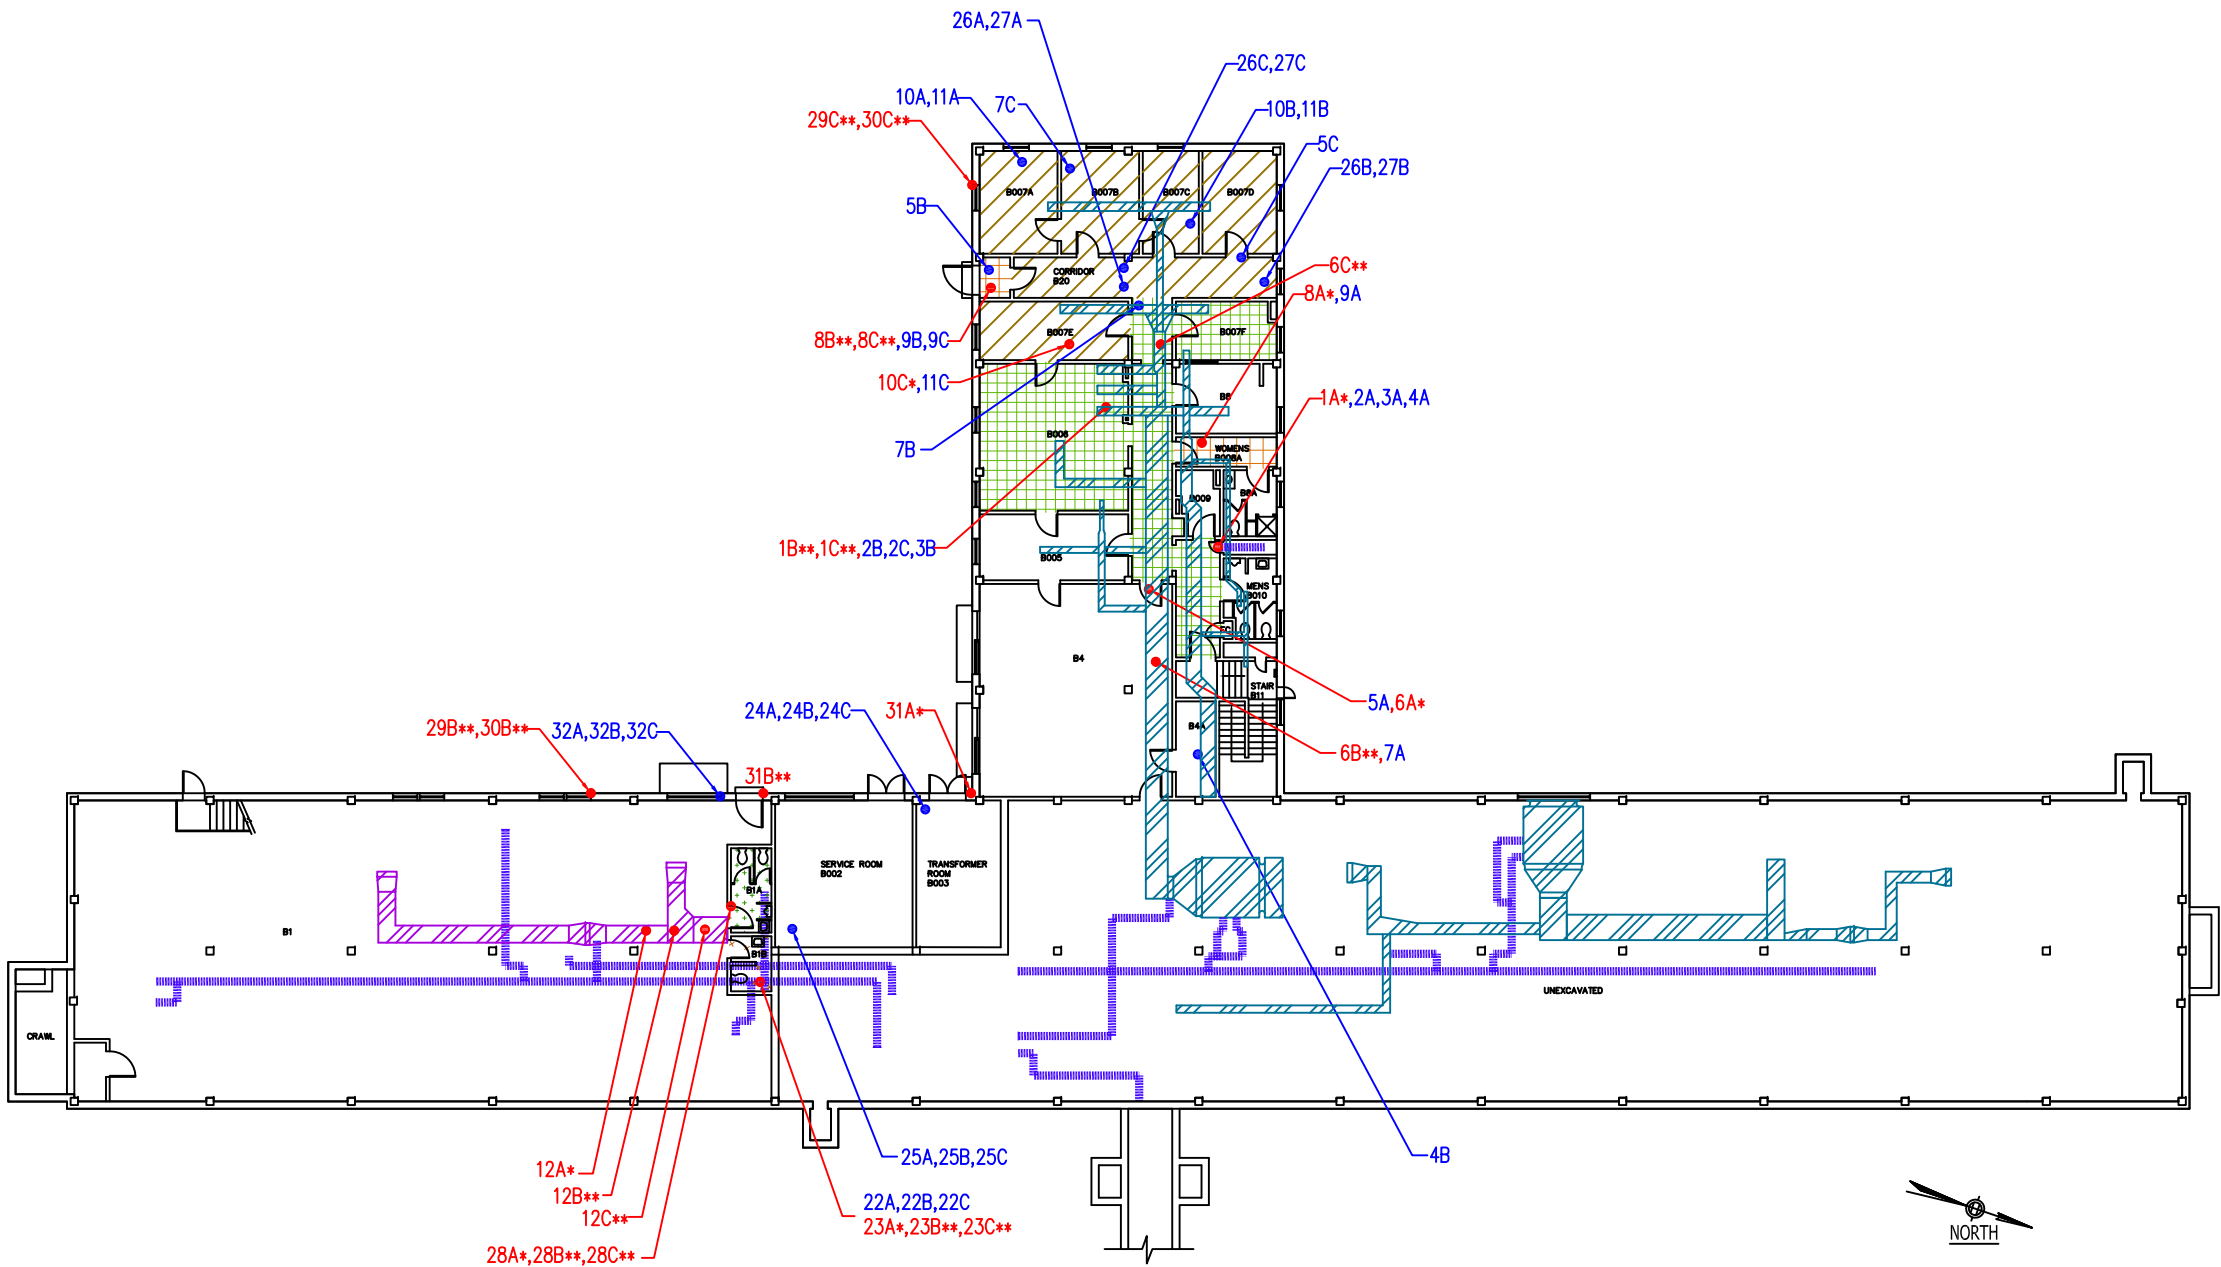
ASBESTOS SURVEY SUMMARY PLAN

- \*EXTERIOR WINDOW CAULK & GLAZE IS ACM\*
- \*EXTERIOR DOOR CAULKING IS ACM\*
- \*EXTERIOR BUILDING CAULKING IS ACM\*

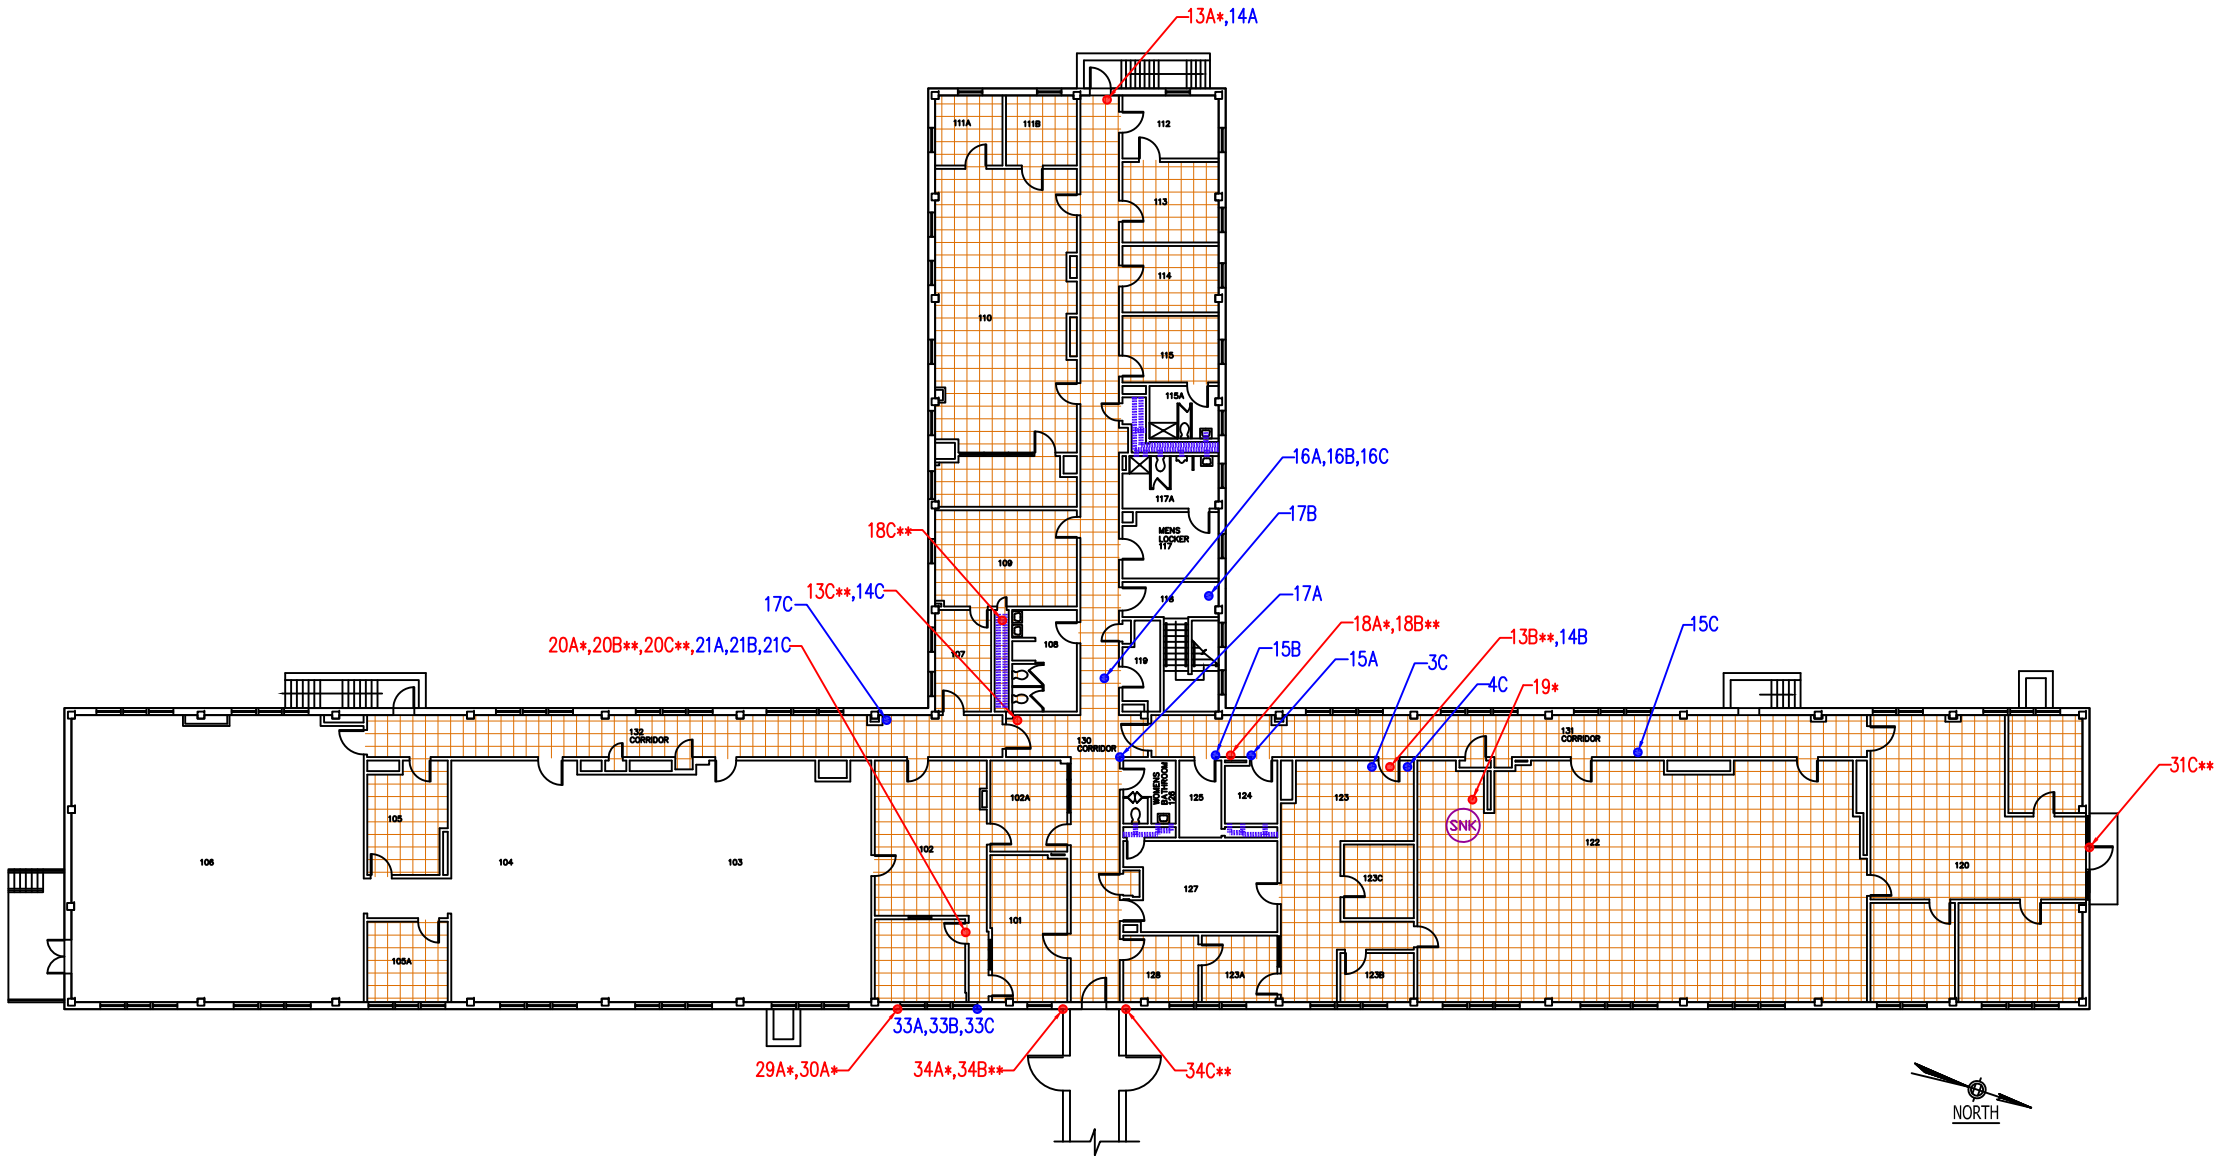
ASBESTOS SURVEY SUMMARY PLAN

\*EXTERIOR WINDOW CAULK & GLAZE IS ACM\*

\*EXTERIOR DOOR CAULKING IS ACM\*

\*EXTERIOR BUILDING CAULKING IS ACM\*

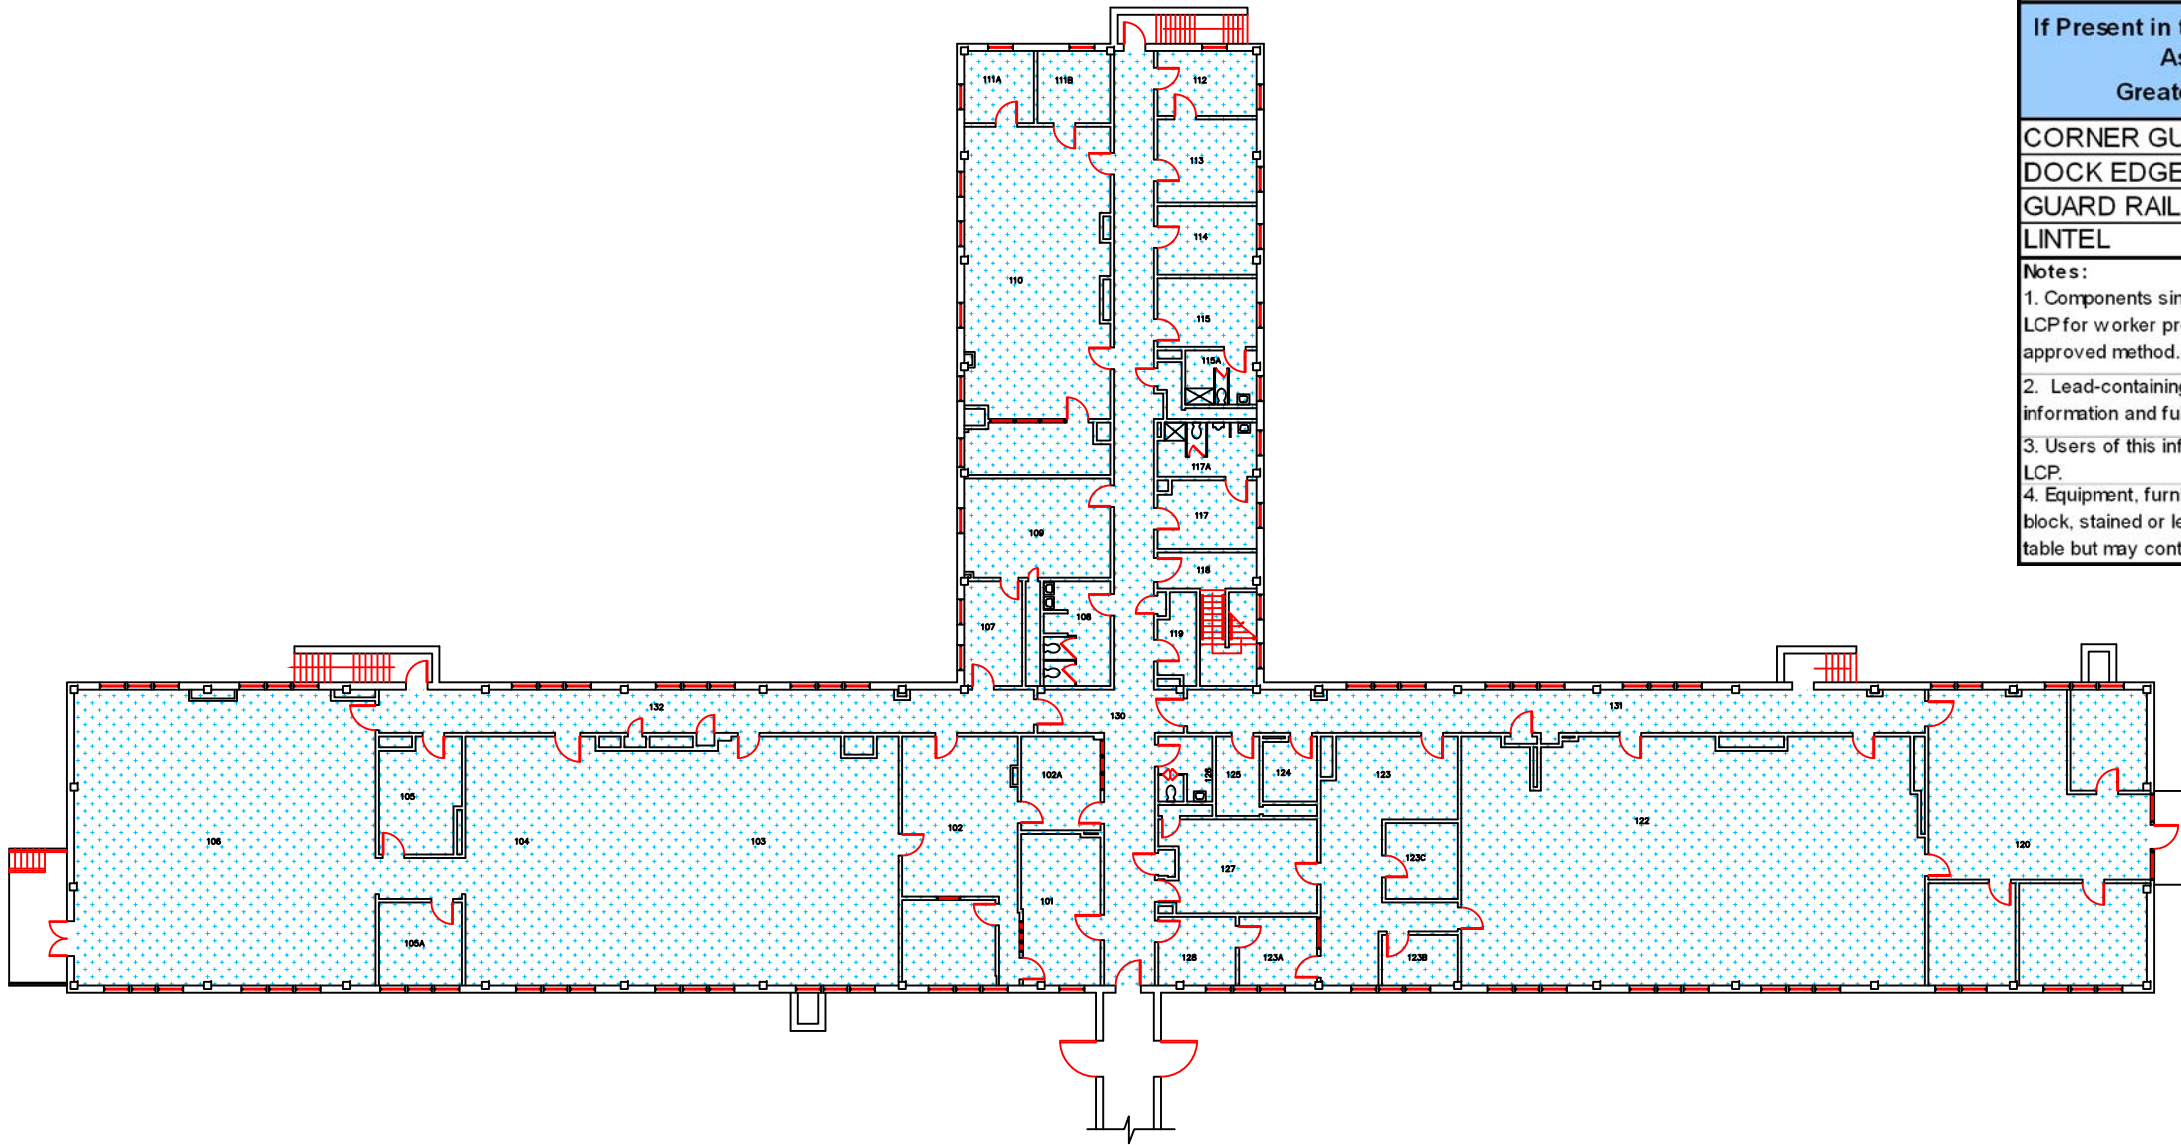
LEAD SURVEY SUMMARY PLAN

These Building Components Depicted in **Red** Are Assumed To Contain Lead Containing Paint (LCP) at Greater Than 0.1 mg/cm<sup>2</sup> unless otherwise determined.

PLEASE SEE THE SAFETY OFFICE PRIOR TO PERFORMING MAINTENANCE/RENOVATION ACTIVITIES ON ANY OF THE FOLLOWING COMPONENTS IN HATCHED AREAS.

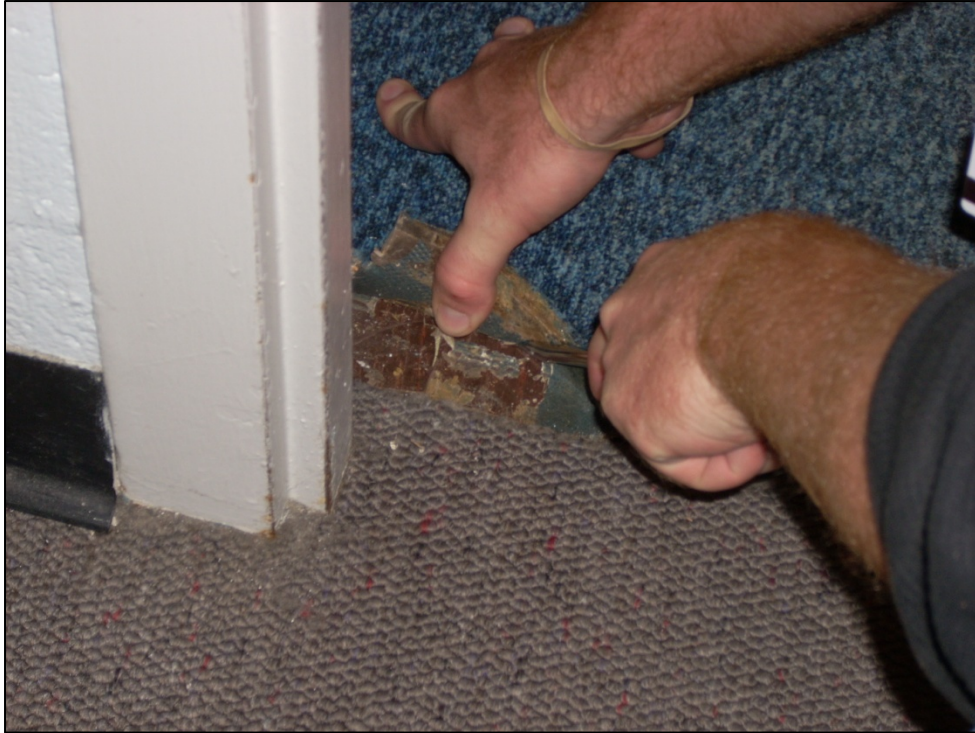
9"x9" Brown Floor Tile  
Sample 01A

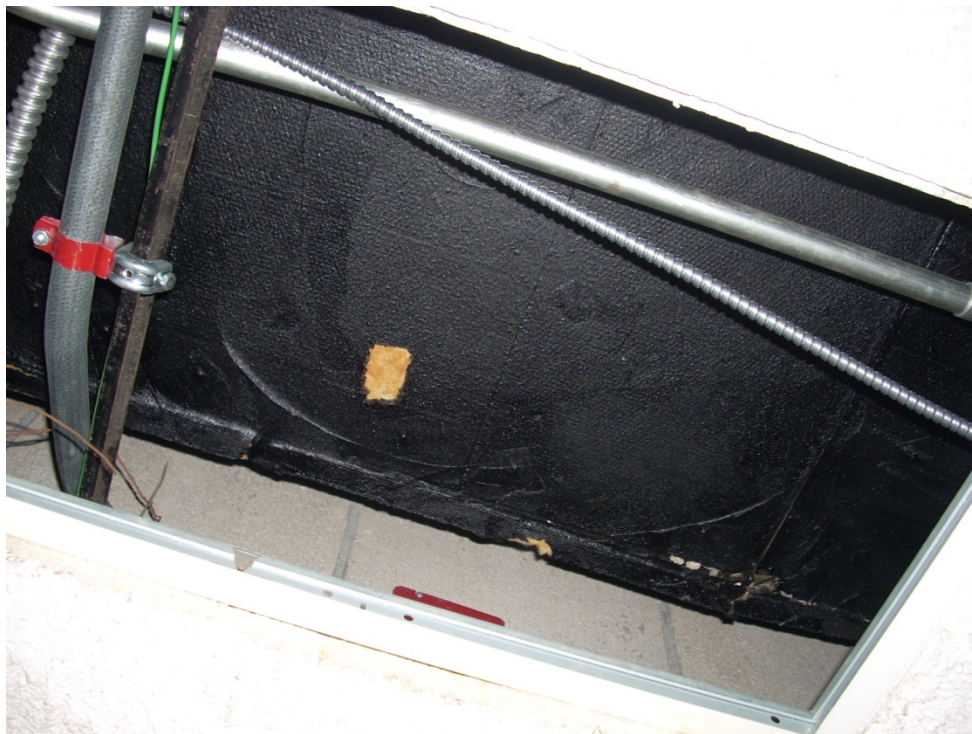
Duct Mastic  
Sample 06A

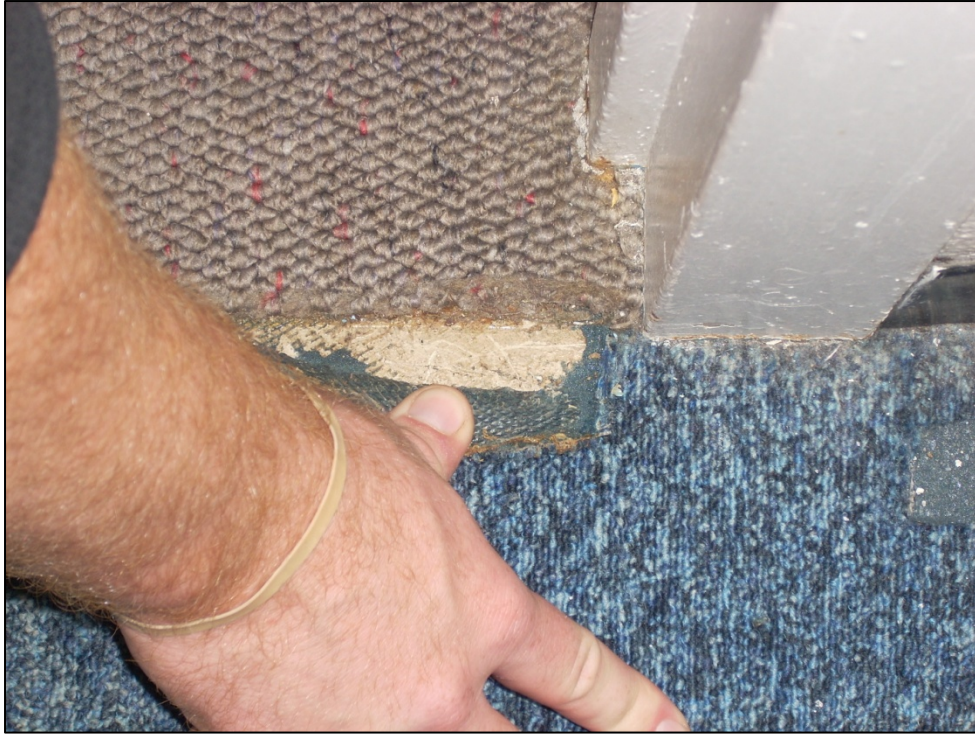
12"x12" Tan Floor Tile  
Sample 08A

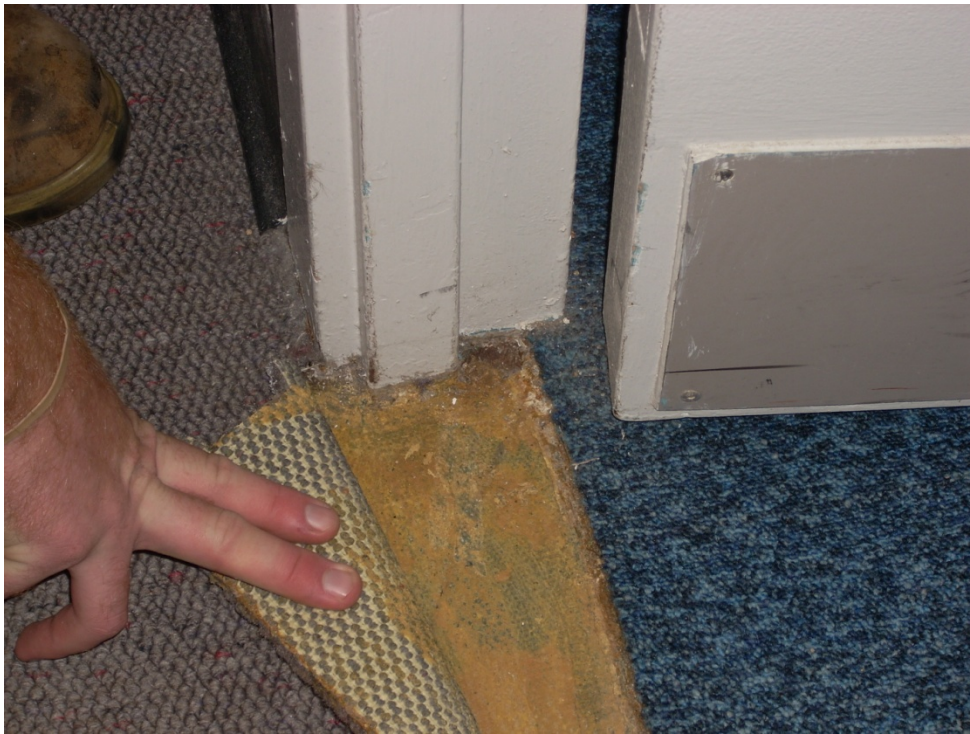
Brown Sheet Flooring  
Sample 10C

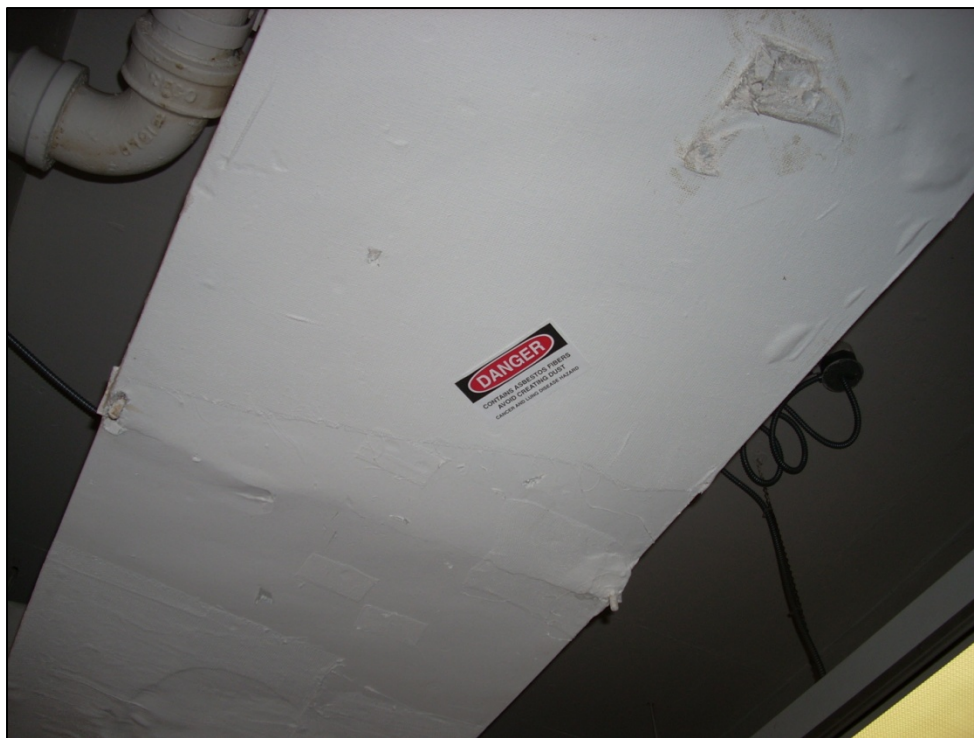
Duct Insulation  
Sample 12A

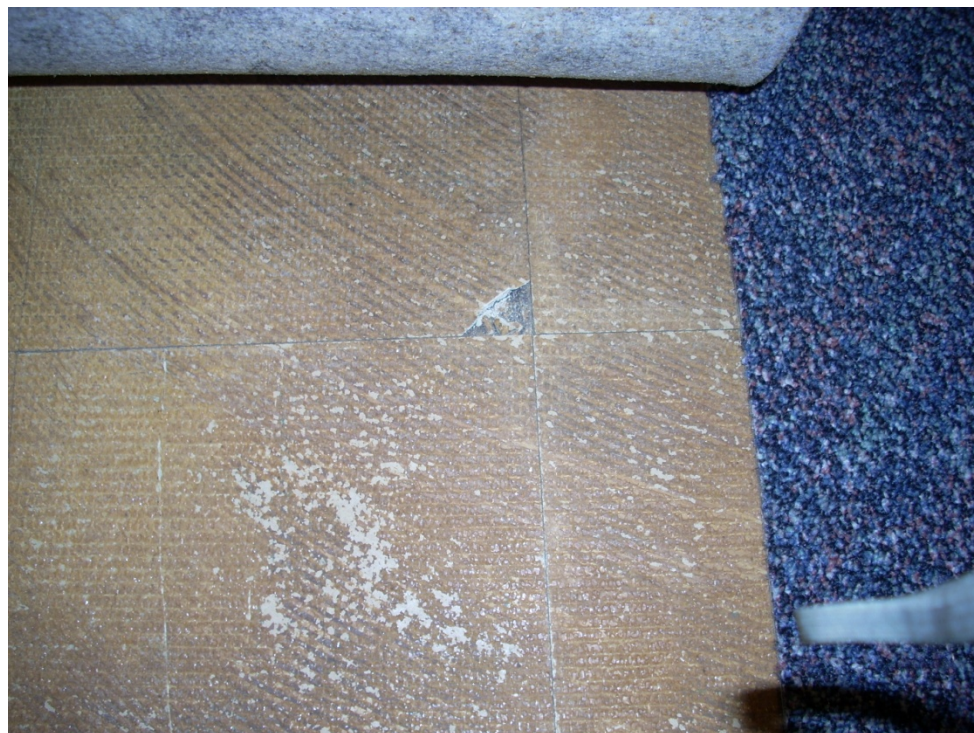
12"x12" Off White Floor Tile  
Sample 13A

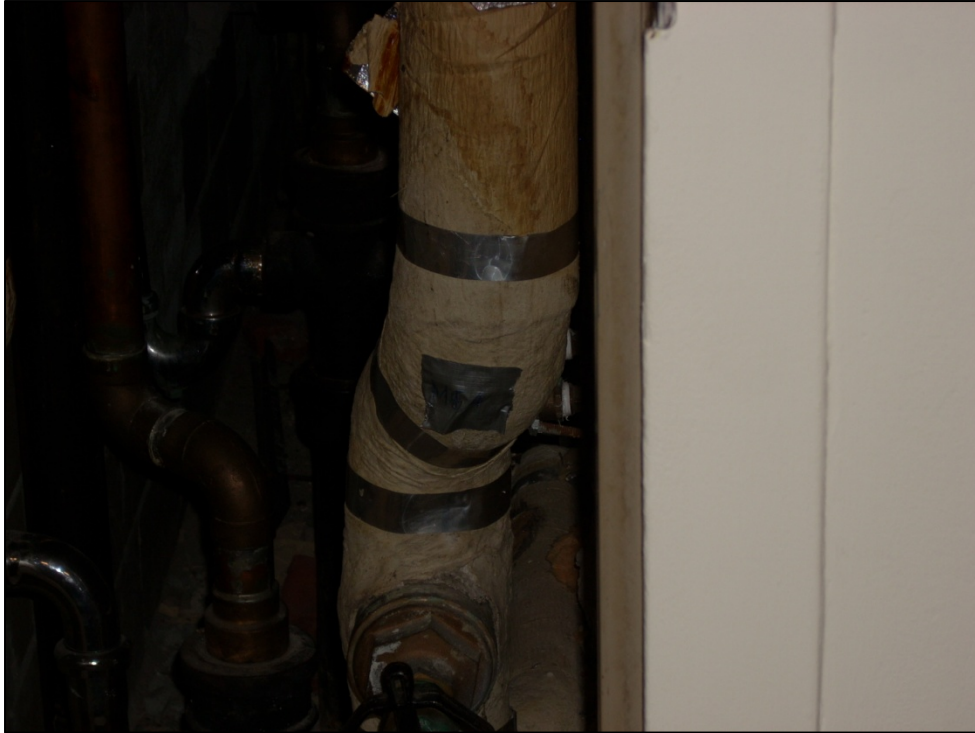
Pipe Fitting Insulation  
Sample 18A

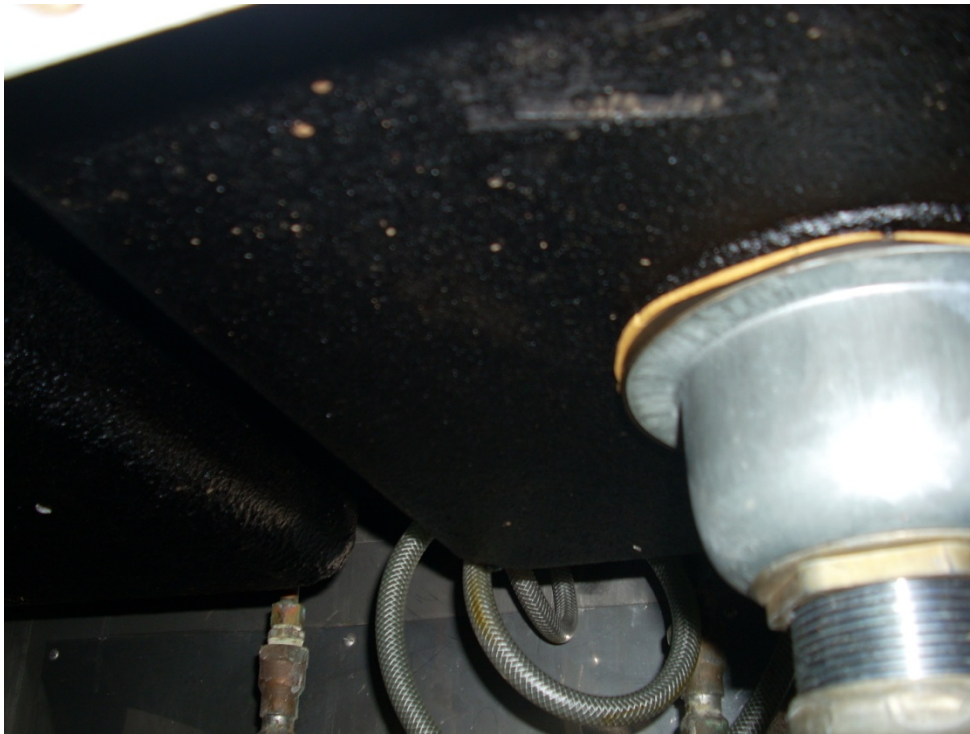
Black Sink Undercoating  
Sample 19

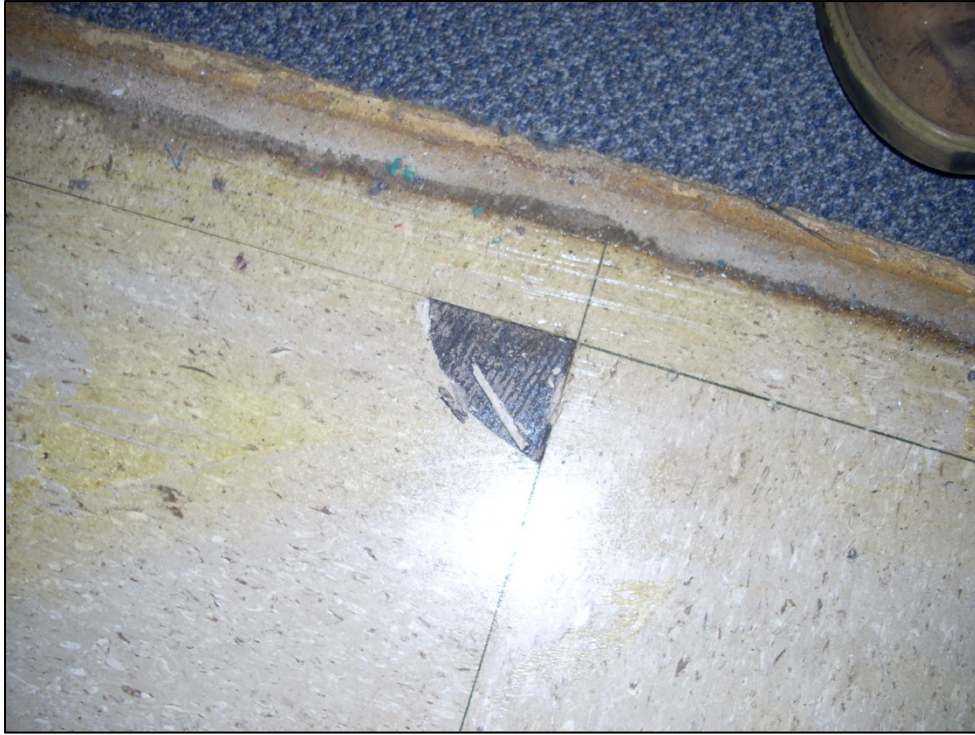
12"x12" Gray Floor Tile  
Sample 20A

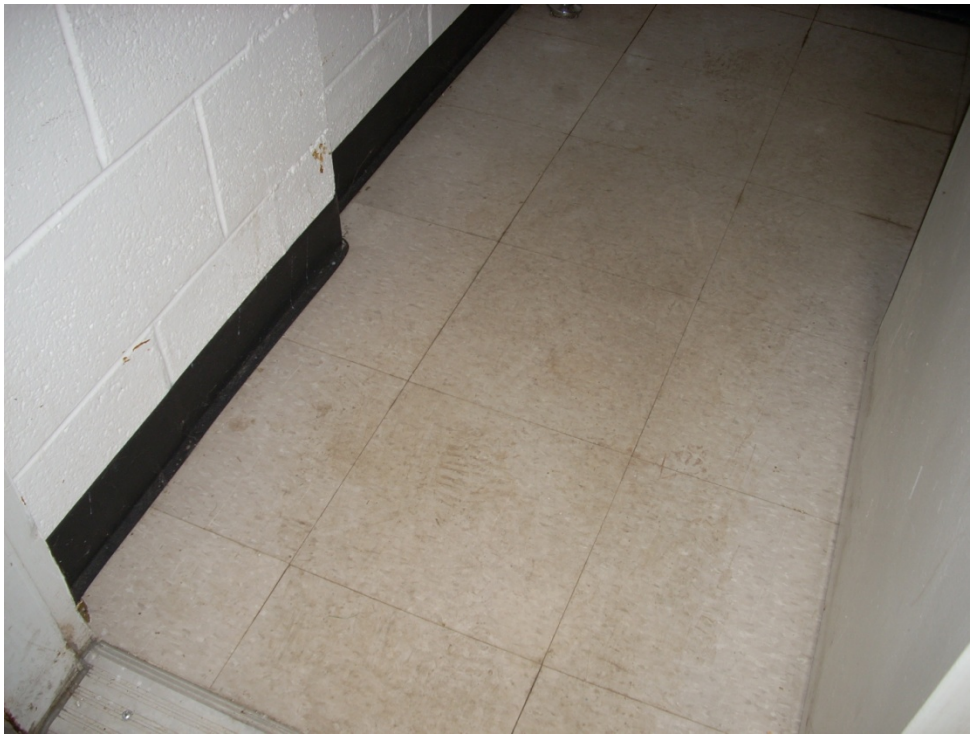
12"x12" Beige Speckled Floor Tile Mastic  
Samples 23A

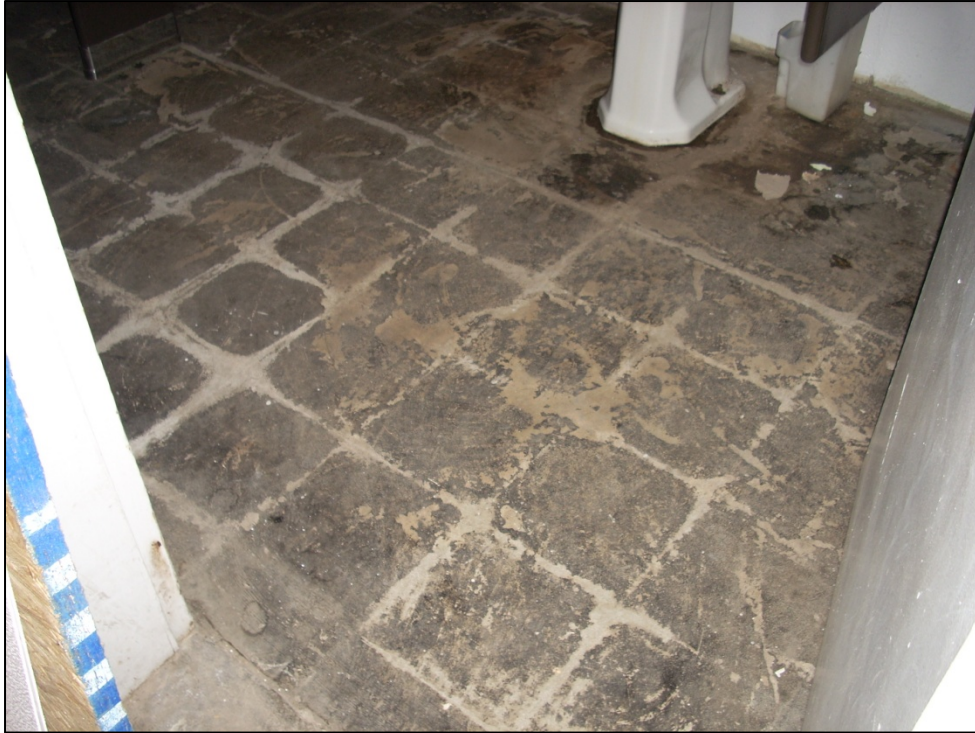
Residual Black Mastic  
Sample 28A

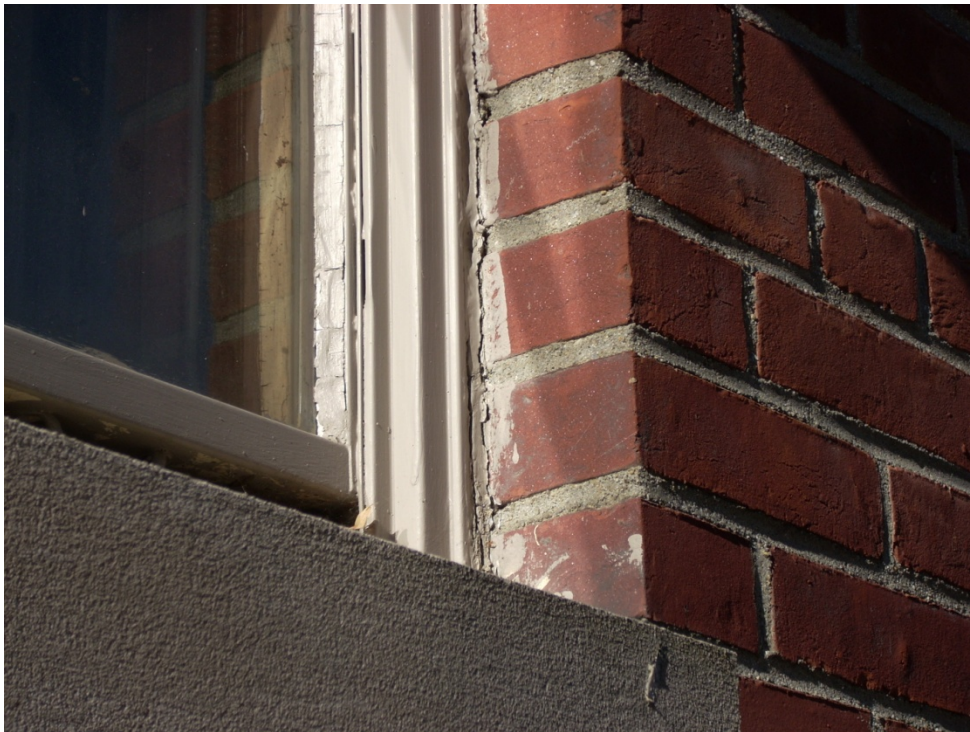
Window Glazing  
Sample 29A

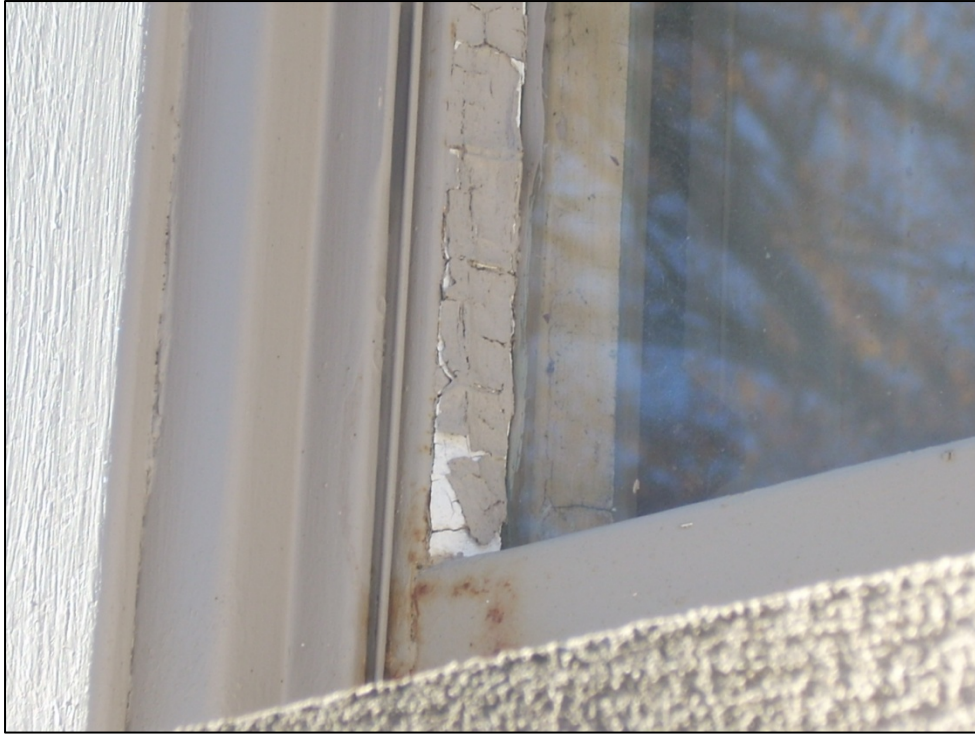
Window Caulking  
Sample 30A

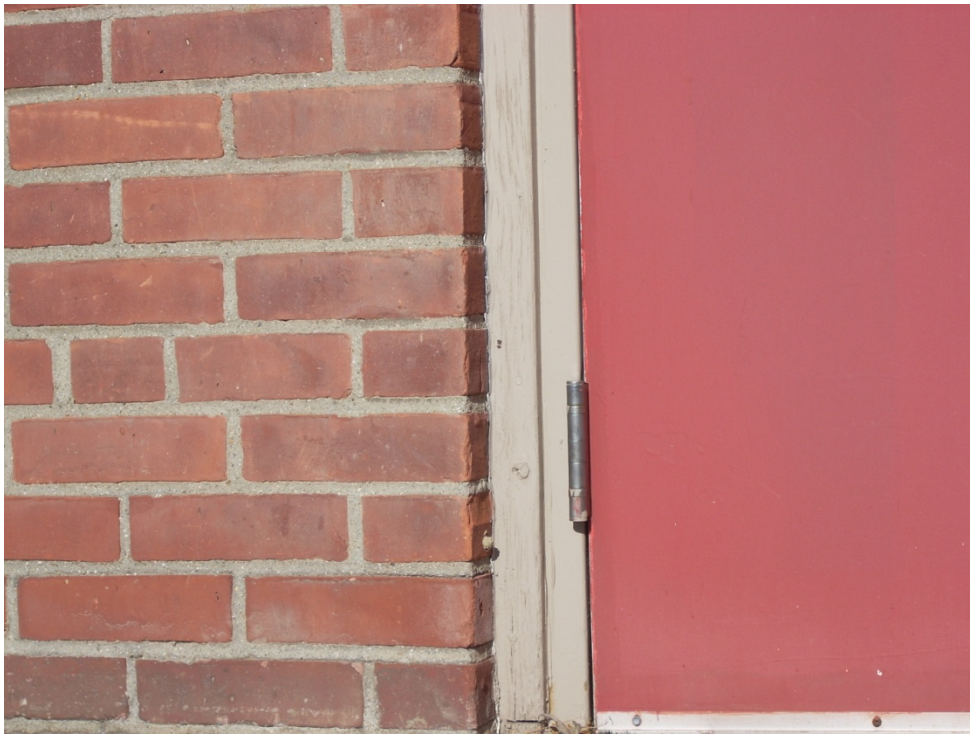
Door Caulking  
Sample 31A

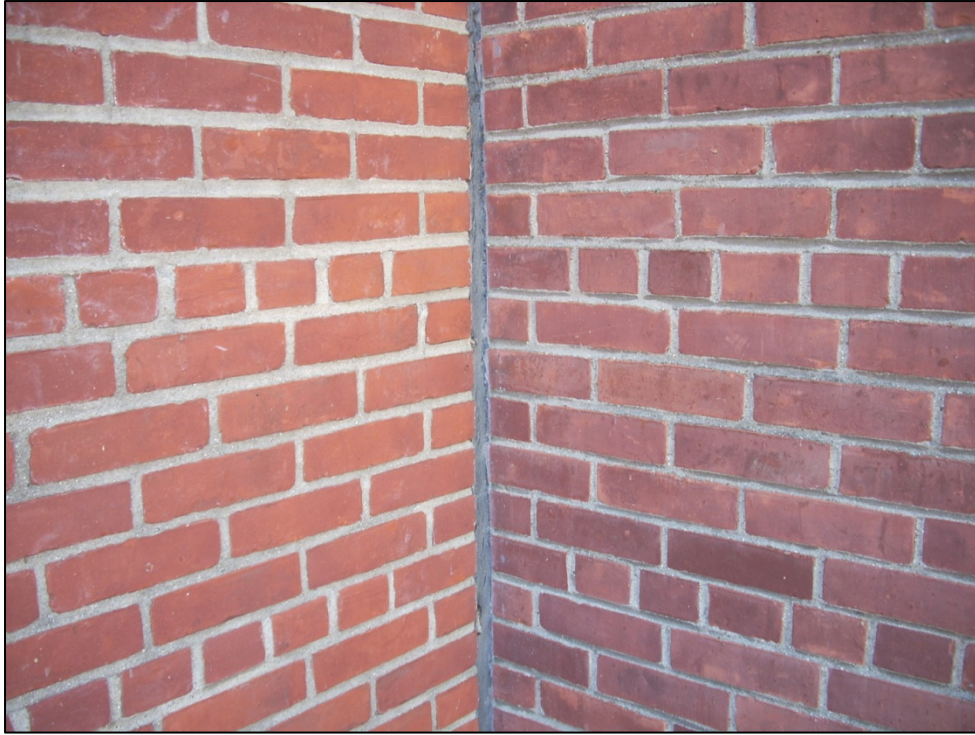
Expansion Joint Caulking  
Sample 34A

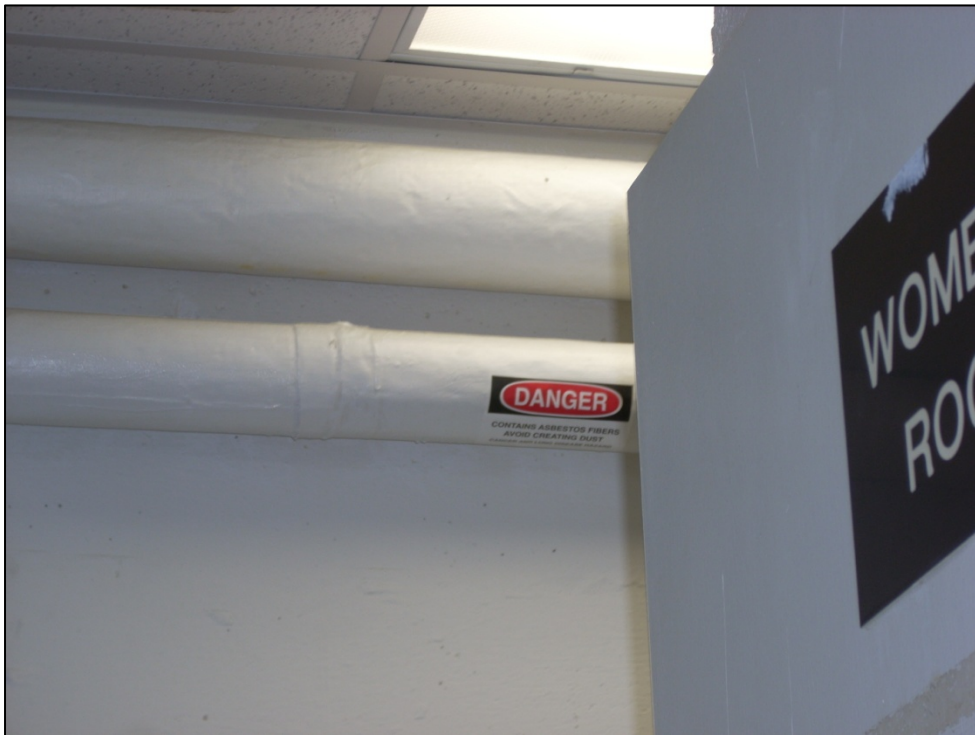
Pipe Insulation Identified in Previous Survey Confirmed
