Environmental Baseline Survey for Building 4666 Area

January 2023

**National Aeronautics and Space Administration
George C. Marshall Space Flight Center**

**Huntsville, Alabama
EPA I.D. # AL 1800013863**

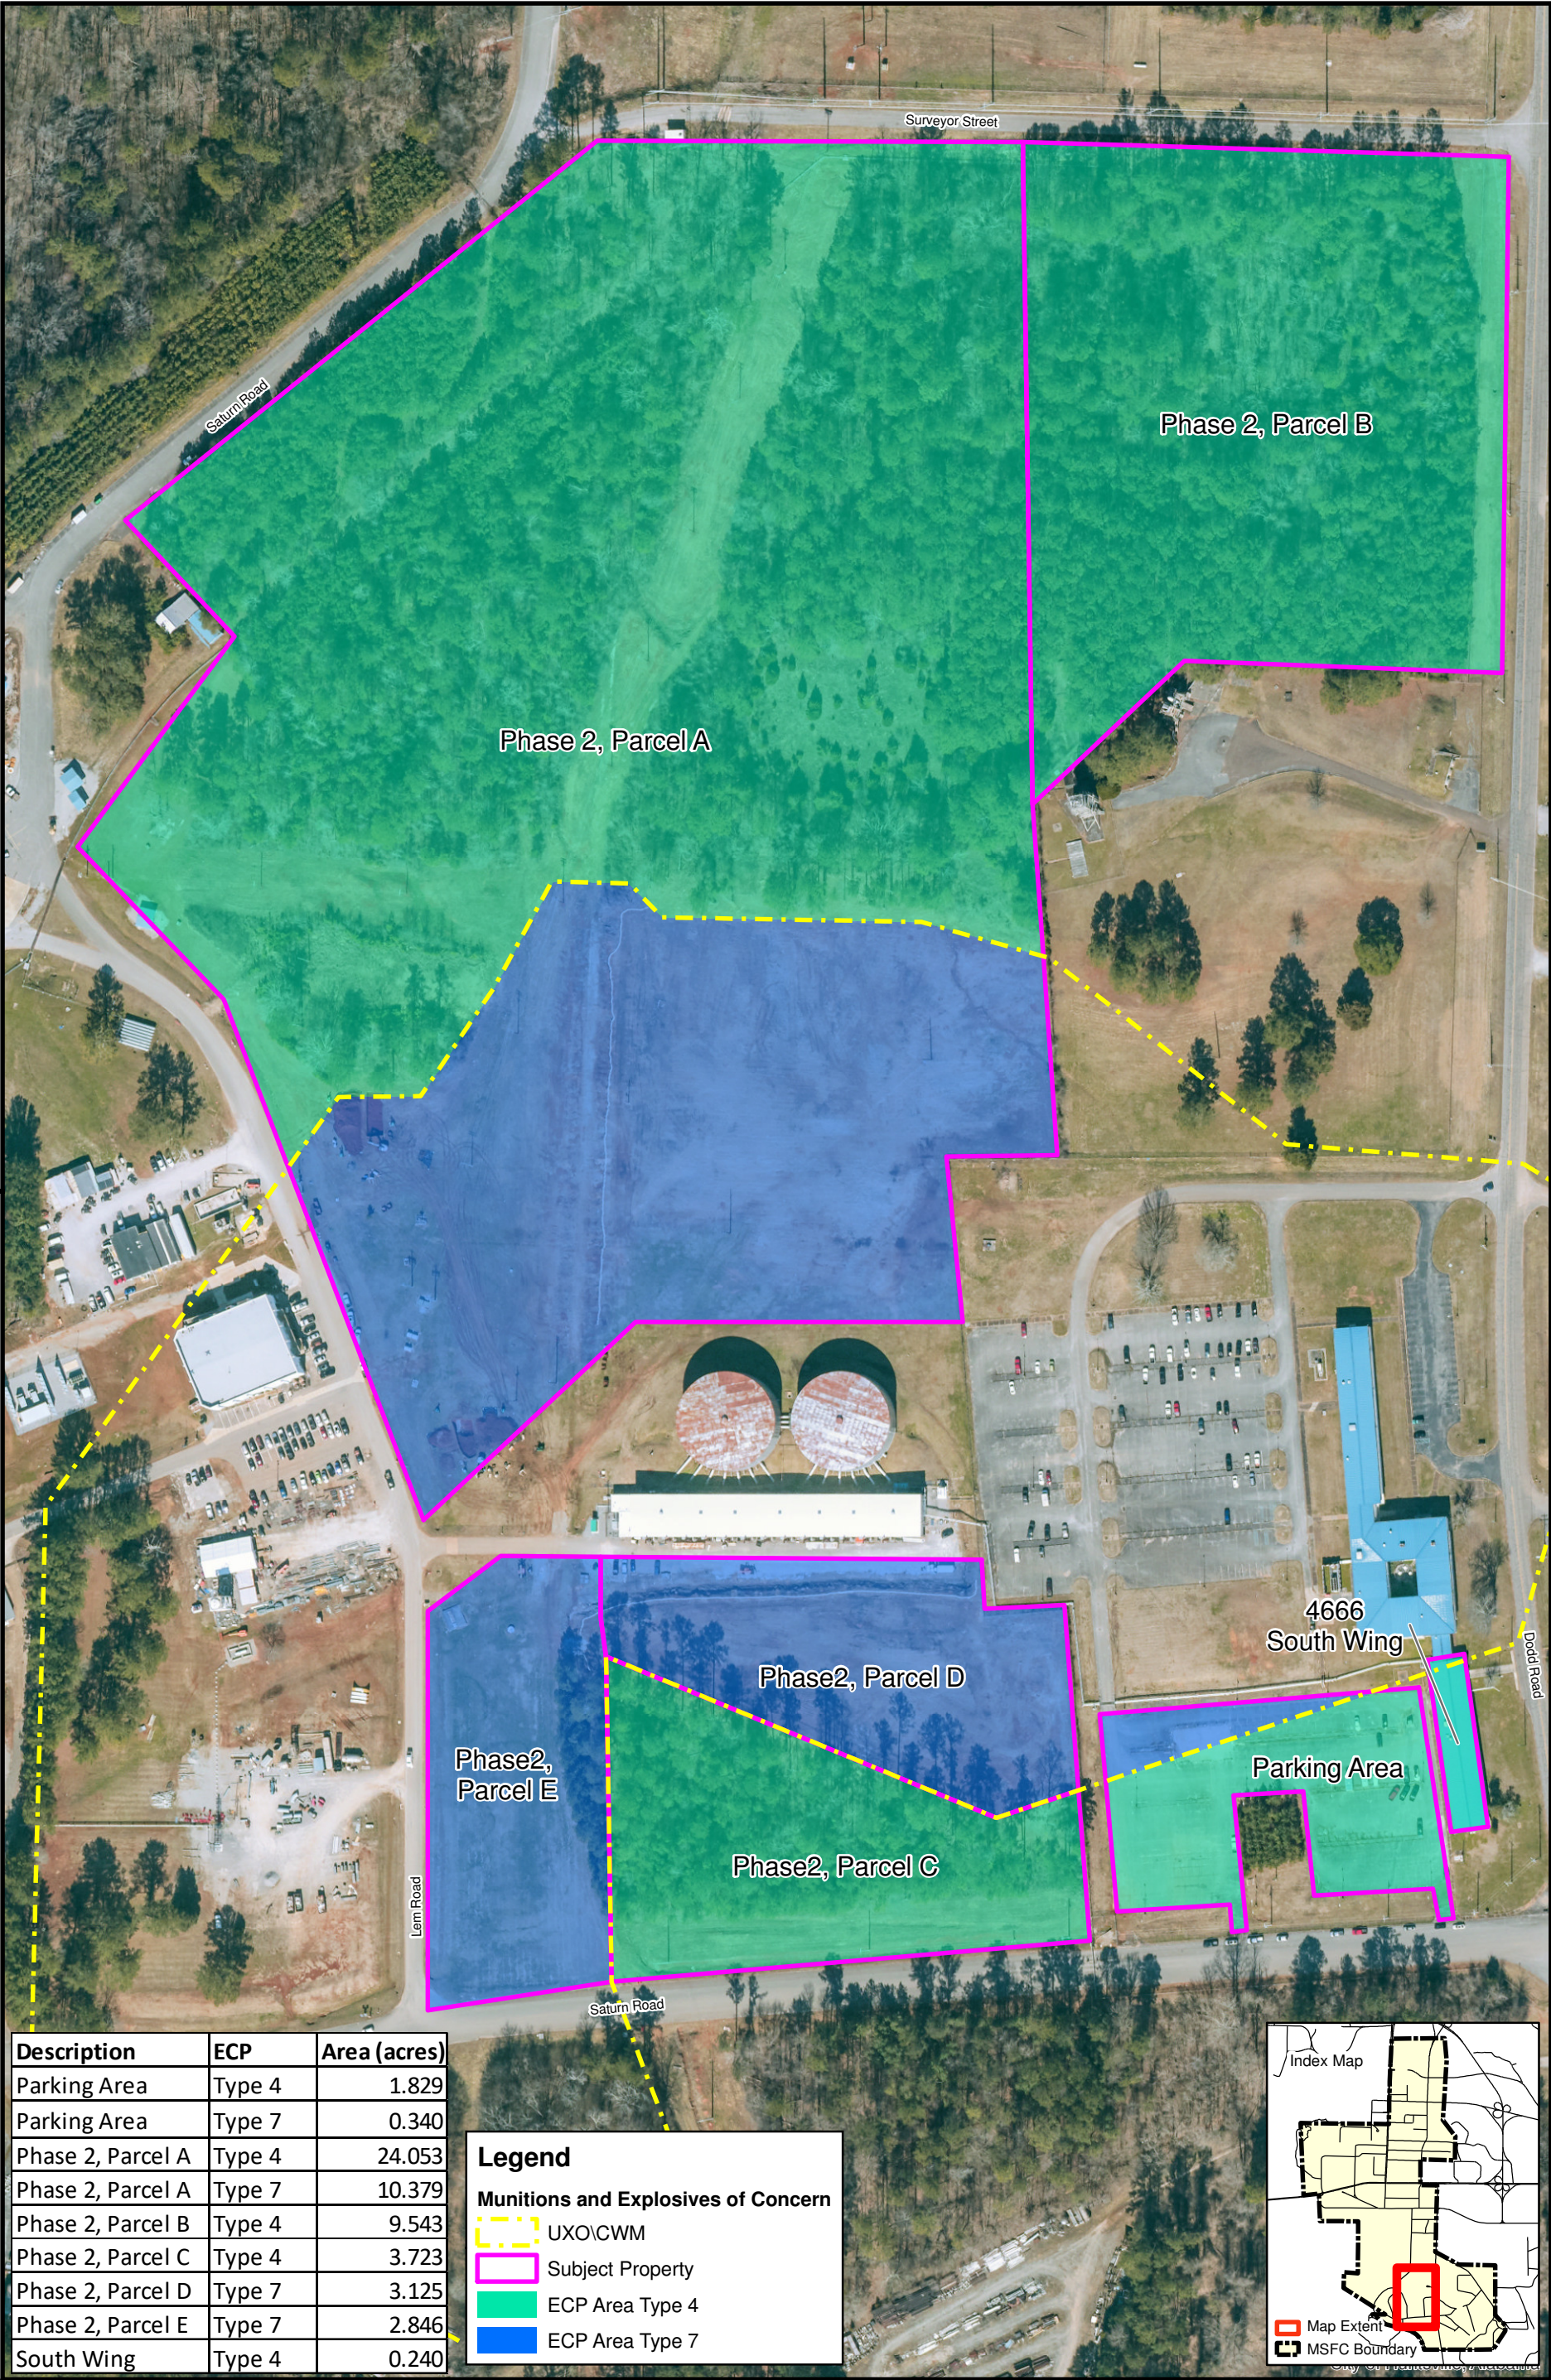
Figure ES-1
Environmental Condition of Property Areas
NASA MSFC Building 4666 Area Environmental Baseline Survey

To support the Environmental Condition of Property (ECP) classification for the subject property, a visual inspection, interviews with NASA staff, and reviews of documentation detailing previous environmental investigation and remediation efforts within the subject property were completed in general accordance with ASTM International D6008-96, *Standard Practice for Conducting Environmental Baseline Surveys* (ASTM 2014). Based on the findings from these activities, different portions of the 55.8-acre subject property have been assigned either ECP Area Type 4 or ECP Area Type 7 (Figure ES-1), as follows:

ECP Area Type 4

- Phase 2 Parcel B
- Phase 2 Parcel C
- South wing of Building 4666
- 24 acres of Phase 2 Parcel A
- 1.8 acres of the parking area

ECP Area Type 7

- Phase 2 Parcel D
- Phase 2 Parcel E
- 10.4 acres of Phase 2 Parcel A
- 0.3 acre of the parking area

The subject property is 55.8 acres within the southwestern portion of MSFC. Based on the findings from these activities, different portions of the 55.8-acre subject property have been assigned either ECP Area Type 4 or ECP Area Type 7, as summarized in Table 5-1 and shown in Figure 5-1. ECP Area Type 4 is defined as: “[a]reas where release, disposal, or migration of hazardous substances has occurred, and all remedial actions necessary to protect human health and the environment have been taken.” ECP Area Type 4 determinations for the subject property are based on the presence of groundwater contamination beneath these areas, the LUCs implemented under the OU-3 IRA that prevent exposure to these contaminants, and the completeness of investigations identifying no potentially unacceptable risk in surface media (soil, sediment, and surface water).
