BUFFALO CROSSING BRIDGE
APACHE-SITGREAVES NATIONAL FOREST
GREENLEE COUNTY, AZ
AZ FS 24(1)

FINAL Geotechnical Report
Report No. AZ-FX-0024-20-01

Prepared by
Federal Highway Administration
Central Federal Lands Highway Division

Geotechnical Services Branch
April 2021

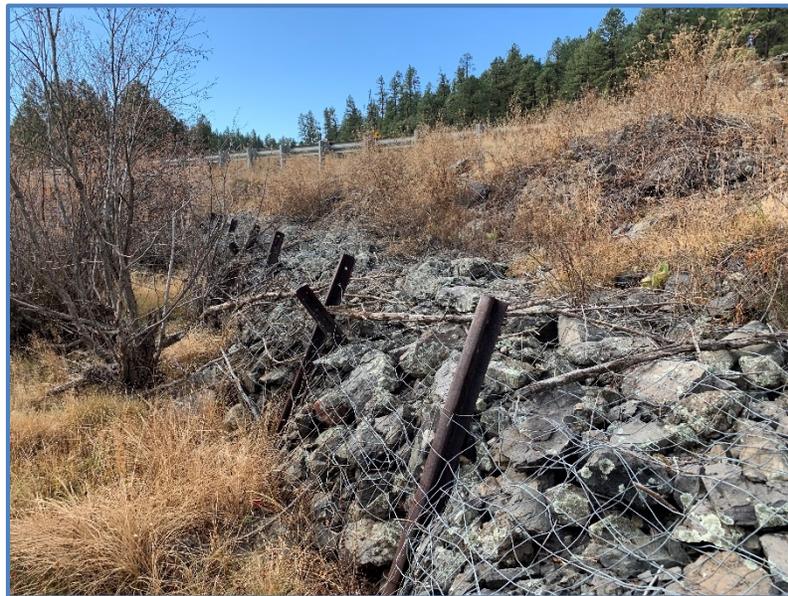
Figure 1 - Existing Rock Basket Structure

The designer has proposed to raise the roadway grade leading to the north bridge abutment by approximately 7 feet. Adjacent to the northeast bridge abutment is a designated wetland area that is prohibited from environmental impact and harm, as well as an existing rock basket structure of questionable integrity. This existing structure, as mentioned in Section 3.3.2, can be seen in Figure 1. Therefore, it has been proposed to construct an earth retaining structure at the northeast quadrant of the bridge to retain the new embankment material from the bridge approach (roadway) grade raise, allow widening for the proposed guardrail sections, and to avoid impacts to the protected wetland. The following sections discuss the design alternatives that were considered as well as the design approach and methodology for the chosen earth retaining structure.

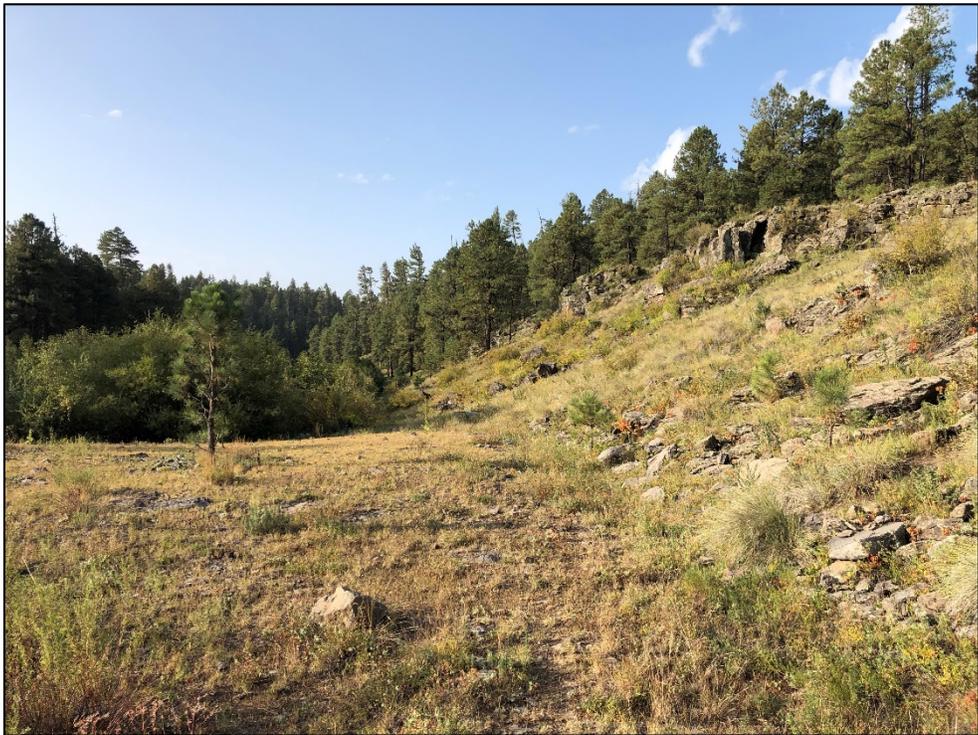
Photo 4: Rock Outcroppings in Cut Slope Northwest of Bridge Site

present at the parking area and a short footpath begins near this sign and terminates at the river. Rock outcroppings again line the southwest river bank and trail area and boulders measured to be up to 3 feet in diameter were observed.

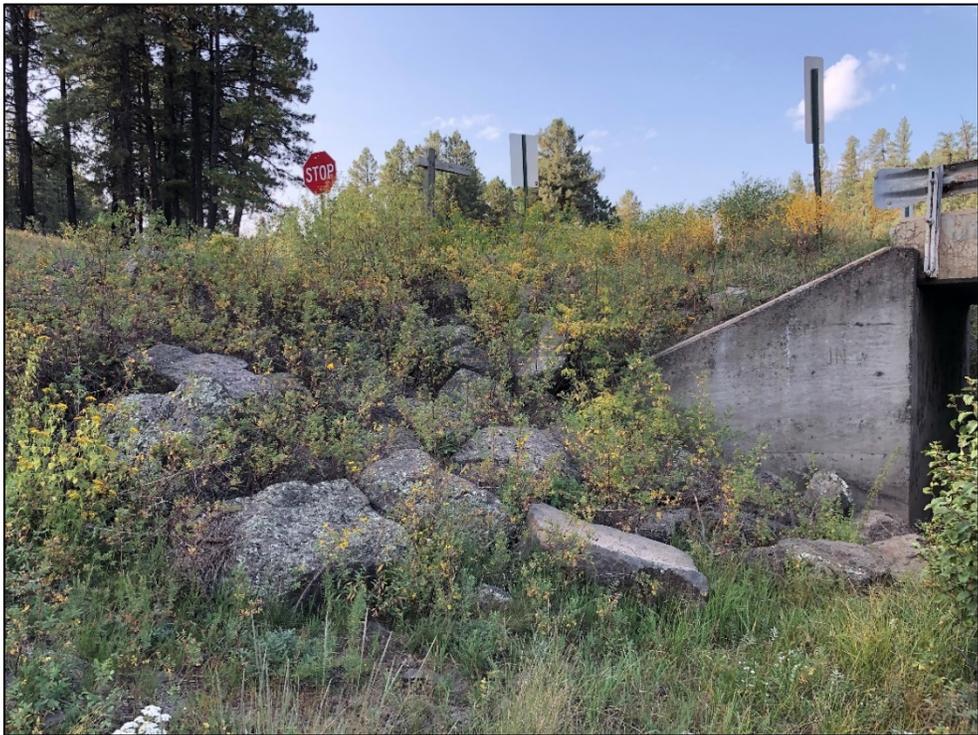
Photo 6: Rock Embankment at Southeast Corner of South Abutment

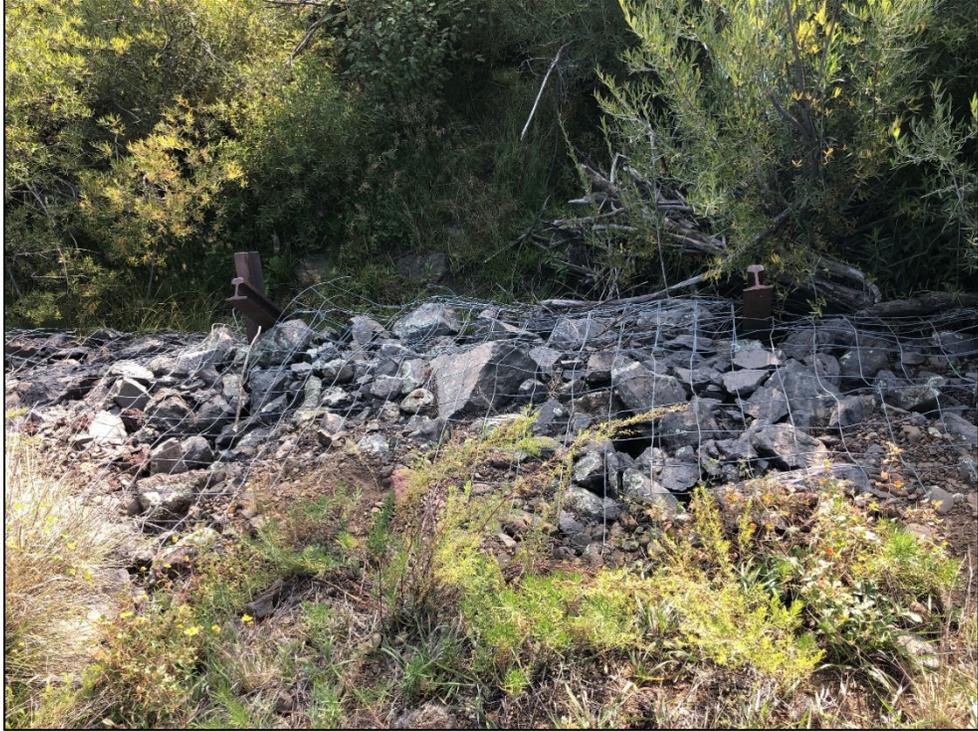
Photo 9: Rock Baskets Near Northeast Corner of North Abutment

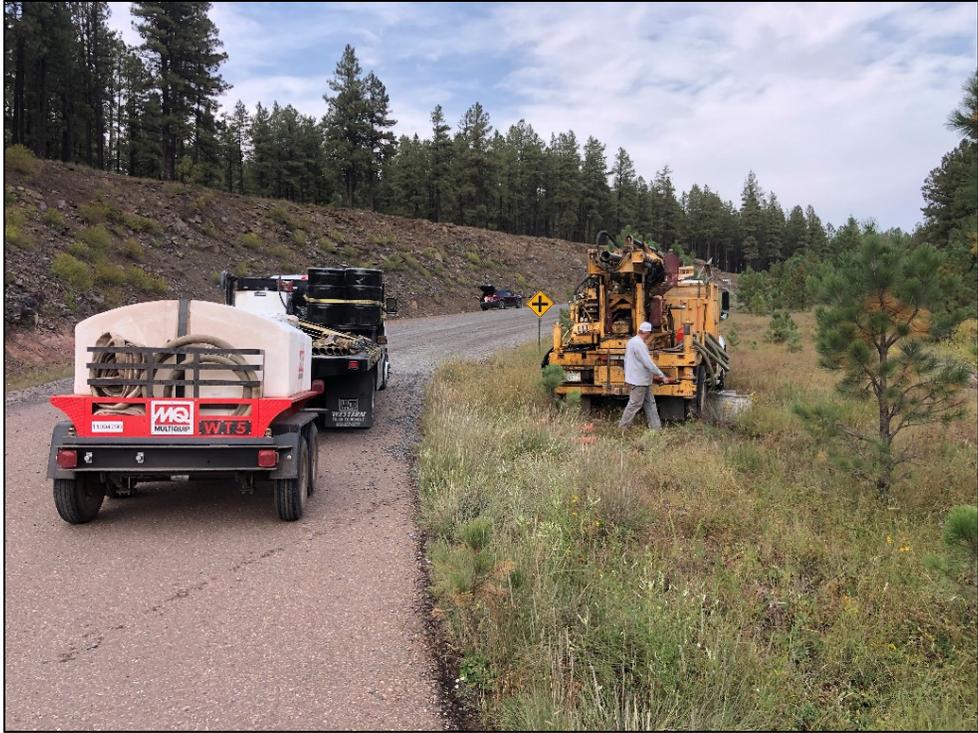
Photo 12: Drilling Setup, Boring BH20-01

The subsurface conditions at the north abutment of the Buffalo Crossing Bridge were investigated by drilling boring BH20-01. The ground surface surrounding the boring location consisted of typical alluvial soils: namely silt, sand, and some gravel. The boring encountered sandy silt with gravel to a depth of approximately 4 feet. The material then transitioned to cobbles and basalt rock boulders less than 1 foot in diameter to a depth of approximately 15 feet. The upper 2 feet of the aforementioned cobble and boulder layer was intermixed with lean clay and gravel. The lower 9 feet of the boulders were intermixed with poorly graded sand with gravel. Tuffaceous bedrock was encountered beneath the cobbles and boulders and extended to the termination depth of 26 feet. This rock was light red, slightly to moderately weathered, and classified as weak rock (R2).

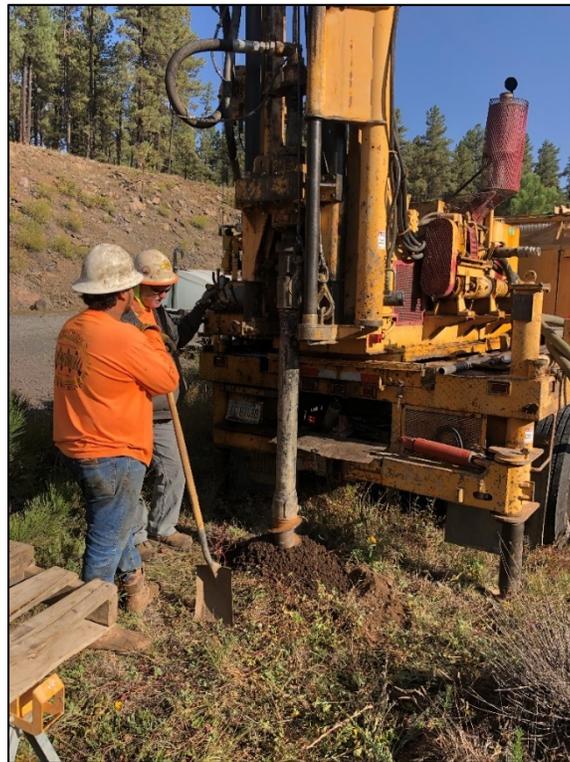
Photo 13: Hollow Stem Auger Drilling, Boring BH20-01

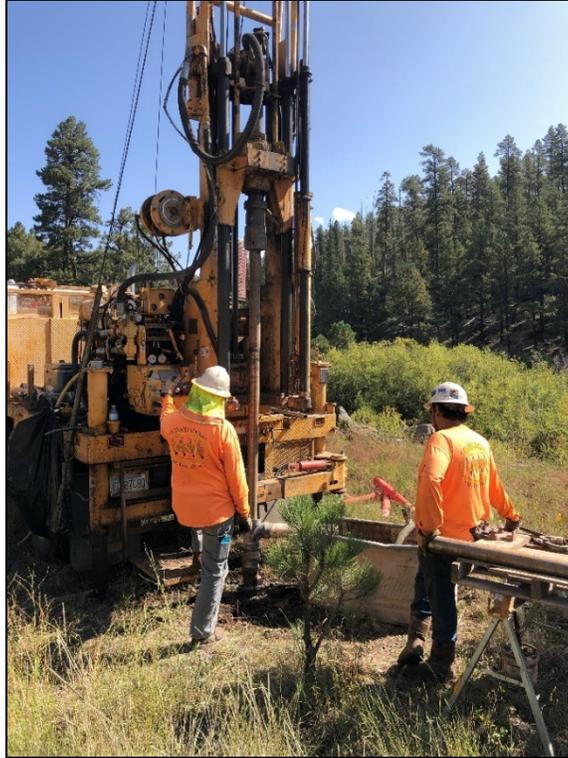
Photo 14: Rock Coring, Boring BH20-01

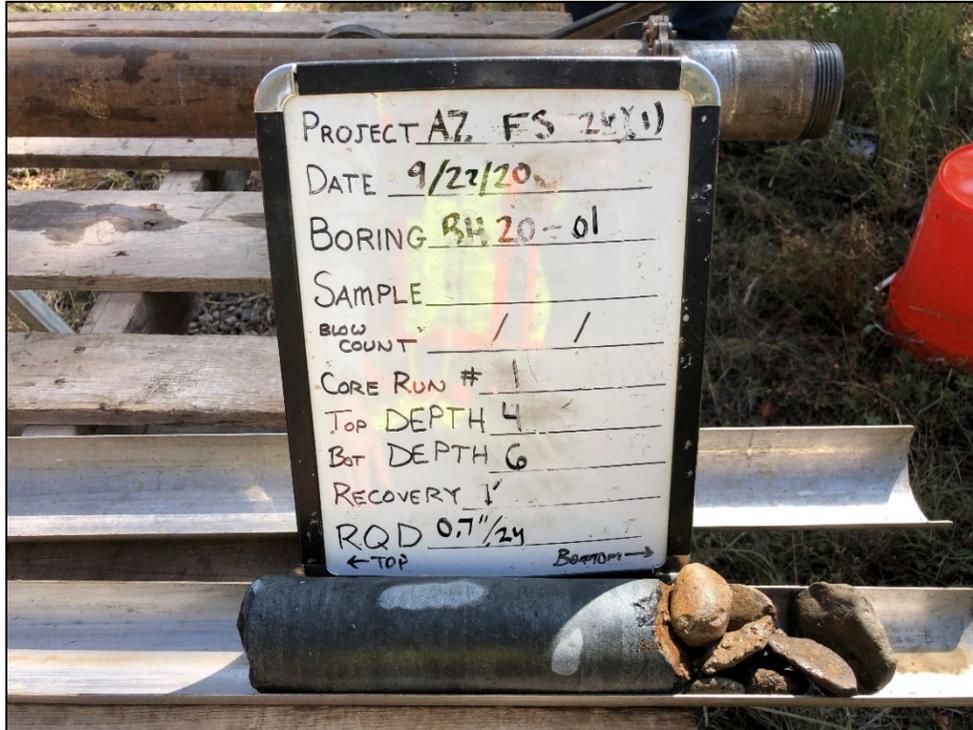
Photo 15: Core Run #1, Boring BH20-01

(Note: width of whiteboard is 8.5 inches)

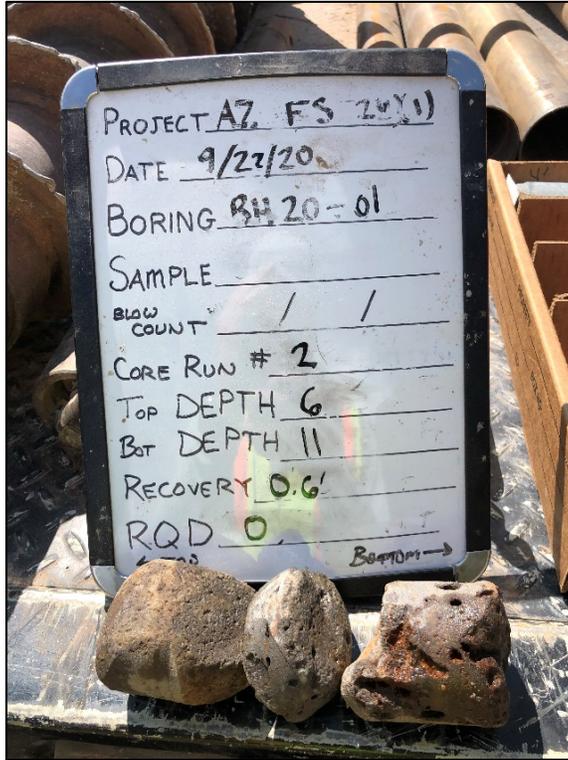
Photo 16: Core Run #2, Boring BH20-01

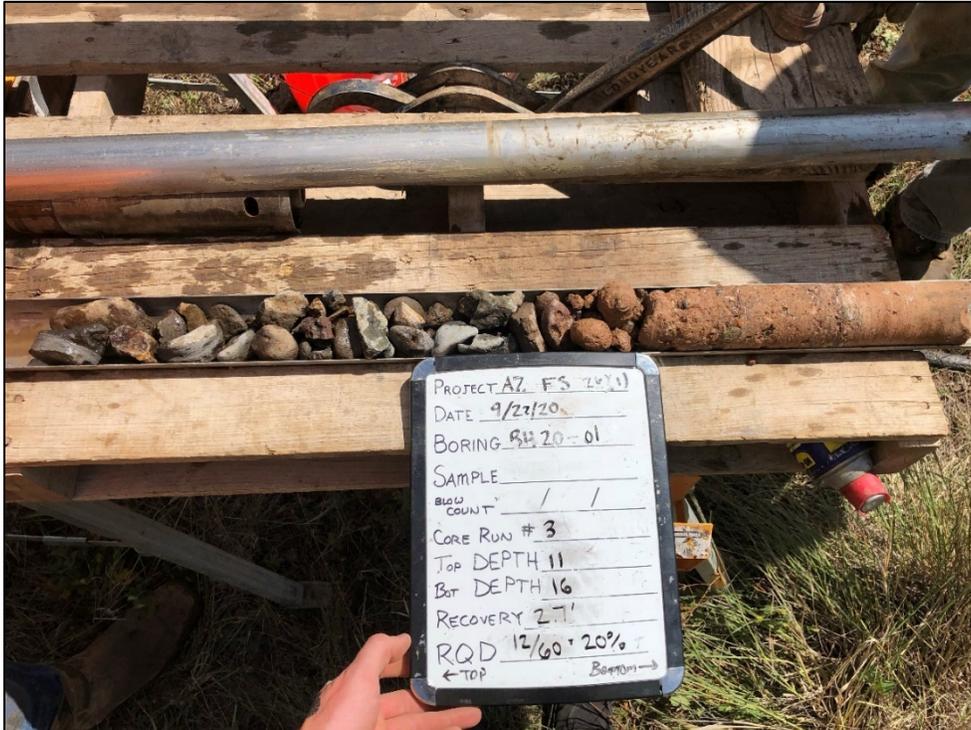
Photo 17: Core Run #3, Boring BH20-01

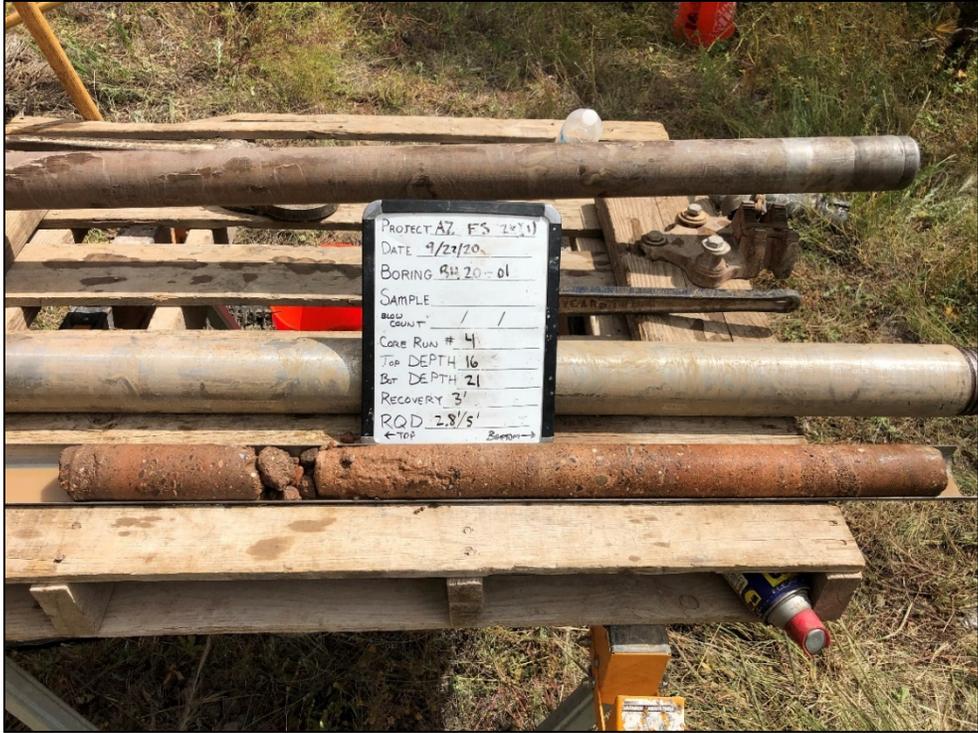
Photo 18: Core Run #4, Boring BH20-01

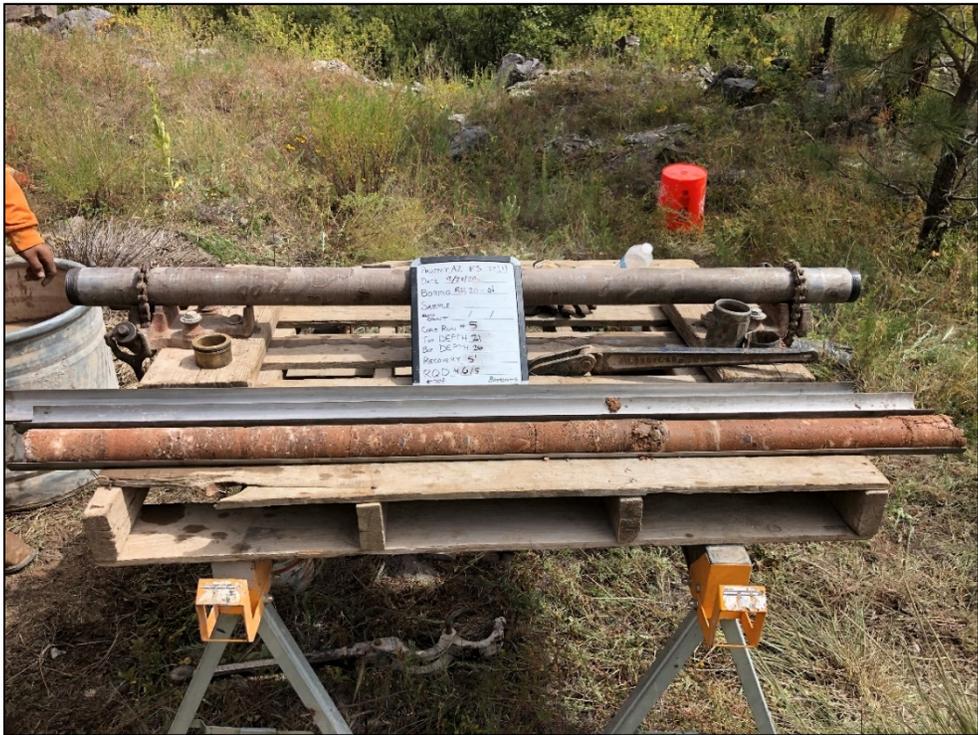
Photo 19: Core Run #5, Boring BH20-01

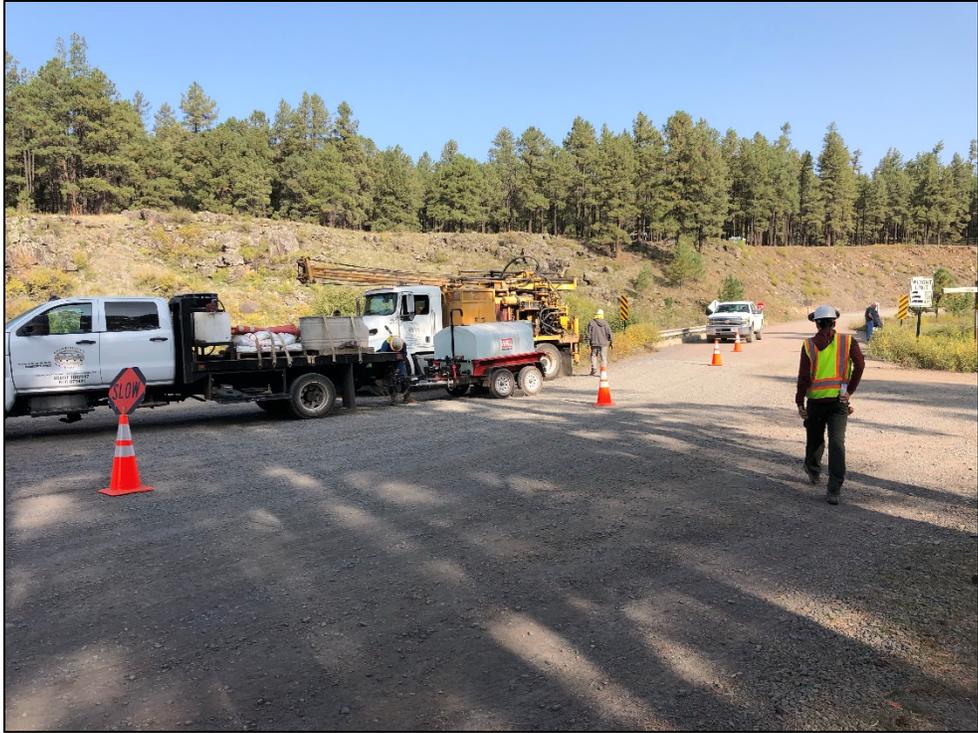
Photo 20: Drilling Setup, Boring BH20-02

The subsurface conditions at the south bridge abutment were investigated by drilling boring BH20-02. Similarly, the ground surface consisted of silt, sand, and varying amounts of gravel. The boring encountered cobbles and boulders less than 1 foot in diameter intermixed with sandy silt and gravel to a depth of approximately 4 feet. The cobbles and boulders continued and became intermixed with lean clay with gravel from roughly 4 feet to 6 feet. The cobbles and boulders then became intermixed with poorly graded sand with gravel from roughly 6 to 16 feet. Tuffaceous bedrock was encountered beneath the cobbles and boulders and extended to the termination depth of 26 feet. This rock was light red, moderately weathered, and classified as weak rock (R2).

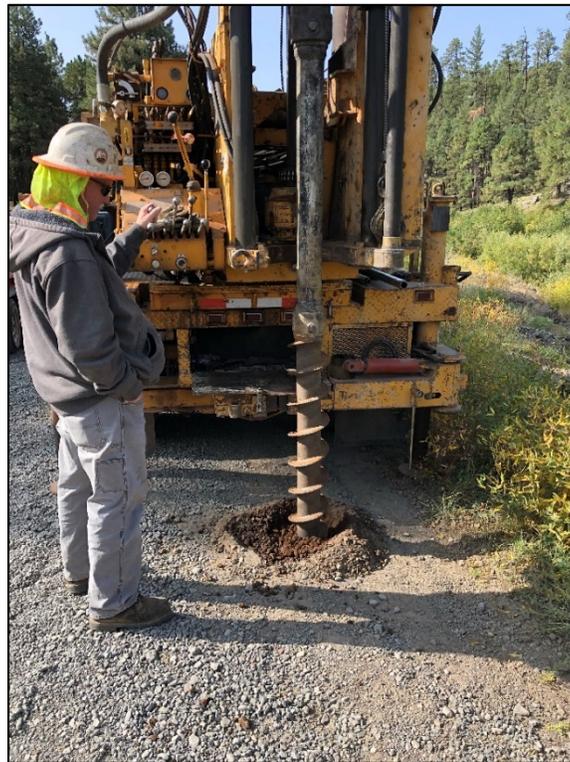
Photo 21: Hollow Stem Auger Drilling, Boring BH20-02

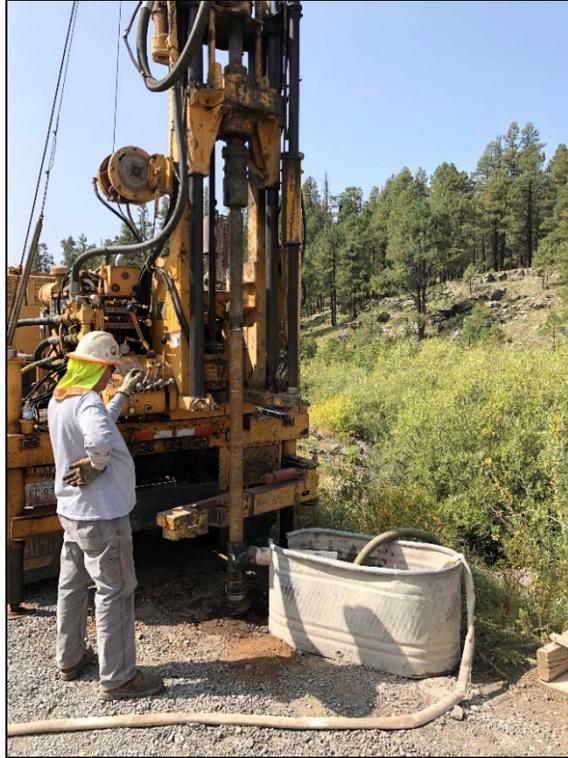
Photo 22: Rock Coring, Boring BH20-02

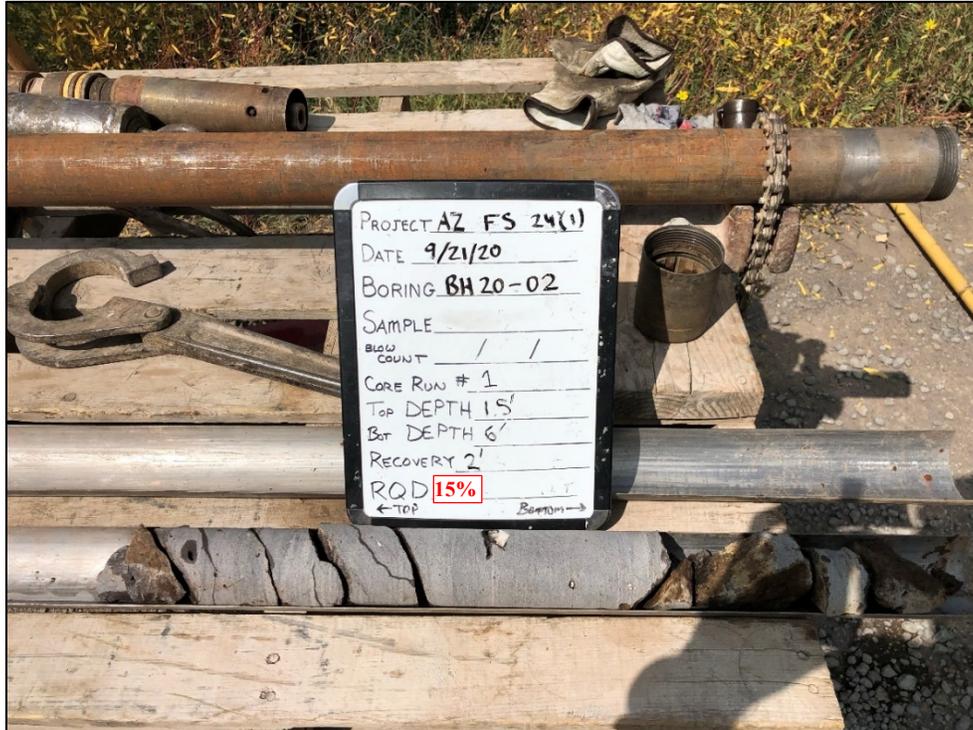
Photo 23: Core Run #1, Boring BH20-02

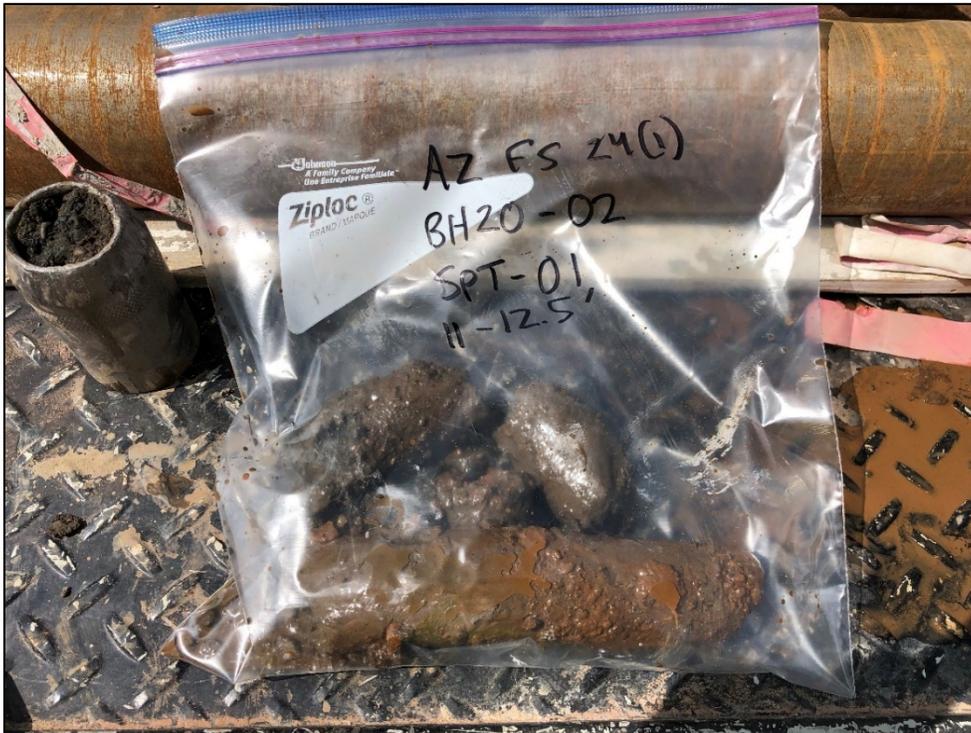
Photo 25: SPT-01, Boring BH20-02

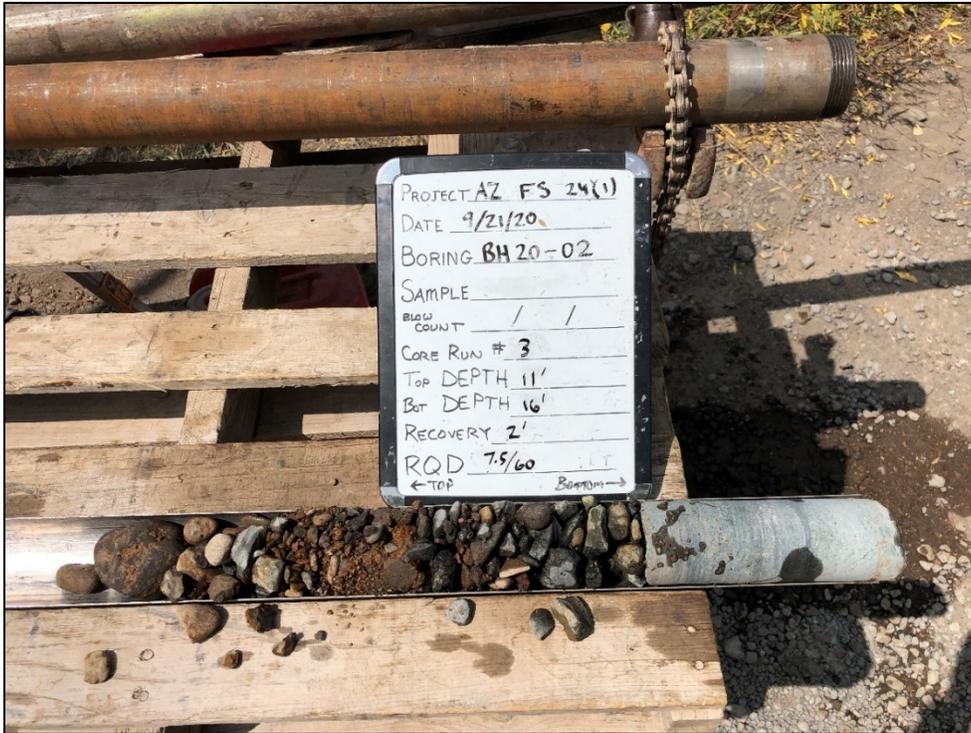
Photo 26: Core Run #3, Boring BH20-02

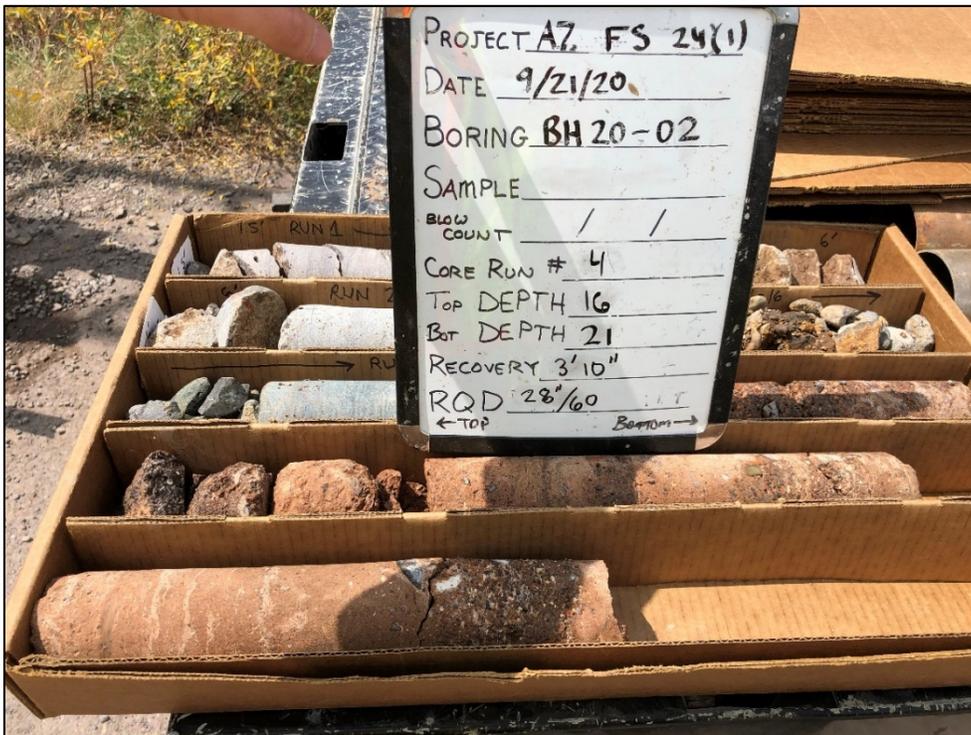
Photo 27: Core Run #4, Boring BH20-02

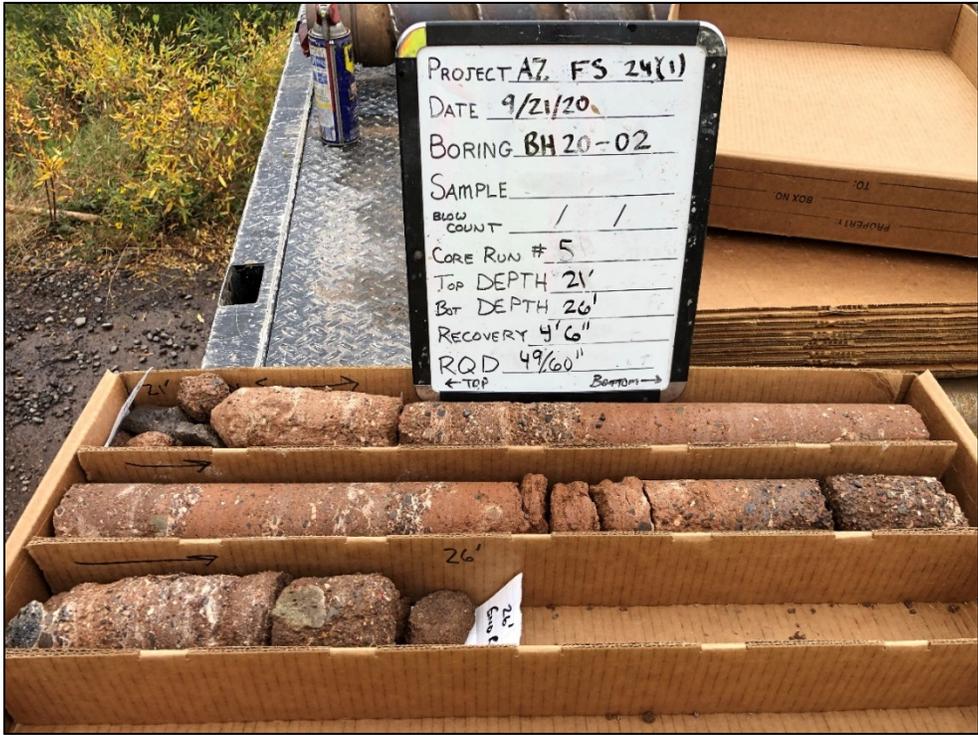
Photo 28: Core Run #5, Boring BH20-02
