Project ID#: 64498  
Date of Assessment: Feb. 10, 2023  
Type of Assessment: Mold

Project: Building 243

The assessment was conducted on February 10, 2023, at the request of Mark Quinn, CES Operation Manager, representing the 157<sup>th</sup> CES, located at the Pease ANG in Newington, NH. The object of the assessment was to establish the indoor air quality and to inspect areas for mold in Building 243.

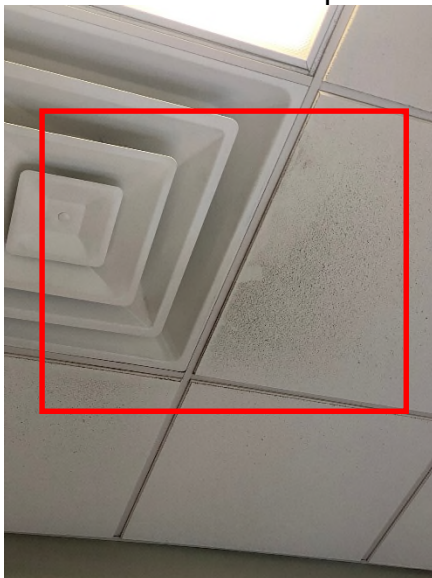
Fig 1. Diffuser in Room 203

1. Heavy visible dust was observed on the diffusers in the FACC area, dining room, and several of the bunk rooms on the second floor. Samples were collected to determine if mold was present.

1. An indoor air quality (IAQ) sample was collected in bunk room 203 while the heat was running. The sample results identified **normal** indoor air quality conditions.
2. An IAQ sample was collected in the FACC/Captain's Office area. The sample results elevated levels of the mold type ***Cladosporium sp.*** This type of was also identified from the surface sample collected from the diffuser in the same room.

1. The mechanical parts of the air handling systems are to be hygienically cleaned. The AHU system, parts, associated mechanics and ducting is to be HEPA vacuumed and wiped down with an appropriate EPA licensed disinfectant. *(Note) Precaution is always to be used when using any chemicals within an AHU system or ducting. All precautions are to be understood to avoid further health effects of individuals that may or may not be sensitized to these chemicals or any product being used to clean or is placed into an AHU system and ducting.*

2. All internal housing is to be cleaned.
3. The blower fan is to be removed and cleaned.
4. All coils are to be cleaned.
5. All drip pans are to be cleaned.

6. All associated ducting is to be cleaned. Ensure vents are covered to prevent contamination inside the home.
7. All return and supply vents are to be cleaned.

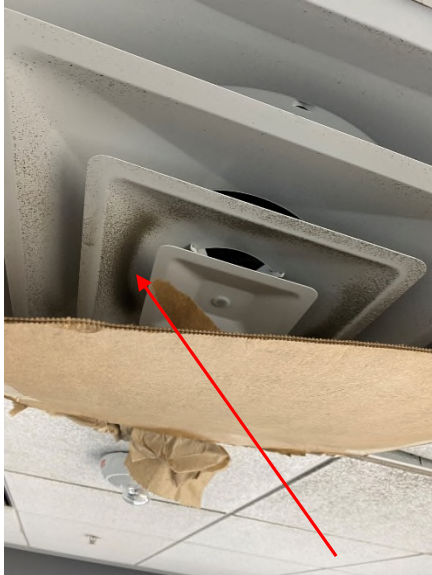
Fig 3. Diffuser in FACC

1. Moisture is the main reason mold will grow on organic material. It is always imperative to find the source of mold and correct the moisture intrusion, or the mold will return.
2. The source for the mold growth on the diffusers is condensation associated with the HVAC system.

1. A surface sample was collected from the diffuser in FACC (Fig 3 above). The sample results identified heavy growth of the mold types ***Cladosporium sp.***
2. A surface sample was collected from the uncovered duct in dining room located over the sinks. The sample results identified the spores only for the mold types ***Cladosporium sp.***, ***Curvularia sp.***, and ***Pithomyces sp.*** No growth was identified in the sample or settled mold spores.
