# Big Bend Dam (SD01092)

## Geotechnical Data Report

**TOE DRAIN AND RELIEF WELL COLLECTOR PIPE REPLACEMENT GEOTECHNICAL REPORT**

## TOE DRAIN AND RELIEF WELL COLLECTOR PIPE REPLACEMENT

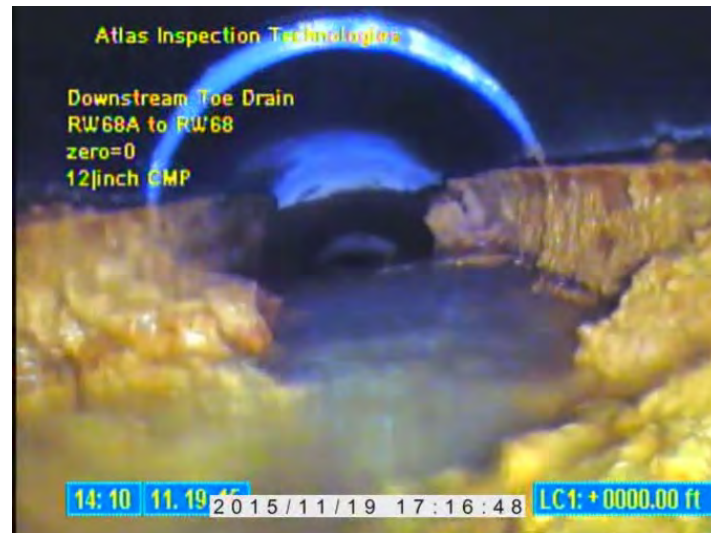
Figure 1-8: Left abutment relief well collector system RW-68A to T-outfall

In 2015, a camera inspection was conducted on the relief well collector system. Over eight inches of sediment was reported to be present in the drain approximately 20 feet from the outfall which prohibited further inspection. The contractor subsequently jetted the pipe and was able to inspect additional segments. Significant biofouling was observed in the outfall line of relief wells RW-68B and RW-68A to the T-outfall as shown in Figure 1-8 (note that this section of pipe was not jetted prior to inspection). Overall, the footage showed the pipe itself to be in good condition. However, from an area approximately 95 feet south of MH-1 to relief well outfall RW-68A, the pipe appears to be pressurized (Figure 1-9 and Figure 1-10). The camera inspection showed multiple locations where water was observed to be shooting through the perforations. Pressurized areas where flow was observed above the flowline along the relief well collector drain are shown on Figure A1 in Appendix A.

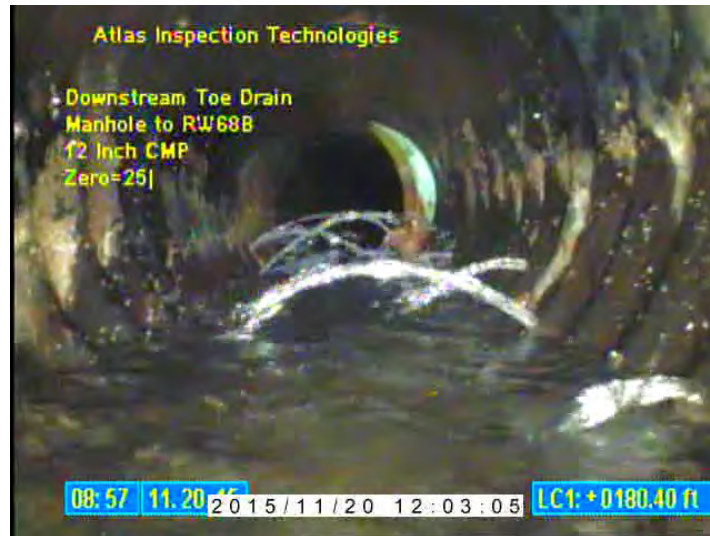
Figure 1-10: Left abutment relief well collector system pressurized area by RW-68B T-outfall

The most pressurized area appears to be near relief well RW-68B, where water was observed shooting out of several perforations above the flowline in the pipe (Figure 1-10) indicating either an area of localized high pressure or inadequate collection efficiency of the drain possibly due to plugging. Piezometric levels near relief wells RW-68B and RW-68A typically range from four to five feet above the inverts of the

relief well collector pipe (see PZ-25R and PZ-19 on Figure A2 in Appendix A). It is possible that the filter material around the relief well collector pipe has become plugged over the 55 years since the system has been installed. The gradation of the filter material is unknown and it is unclear whether or not the filter material is compatible with embankment and foundation materials.

Based on the recent 2019 PA identifying backward erosion piping (BEP) through the left abutment as a potential risk-driving failure mode, along with the age of the system (55 years), and the current condition of the subdrain system (areas of pressurization), Omaha District Dam Safety has identified the replacement of the toe drain and left abutment relief well collector system as an interim risk reduction measure (IRRM).

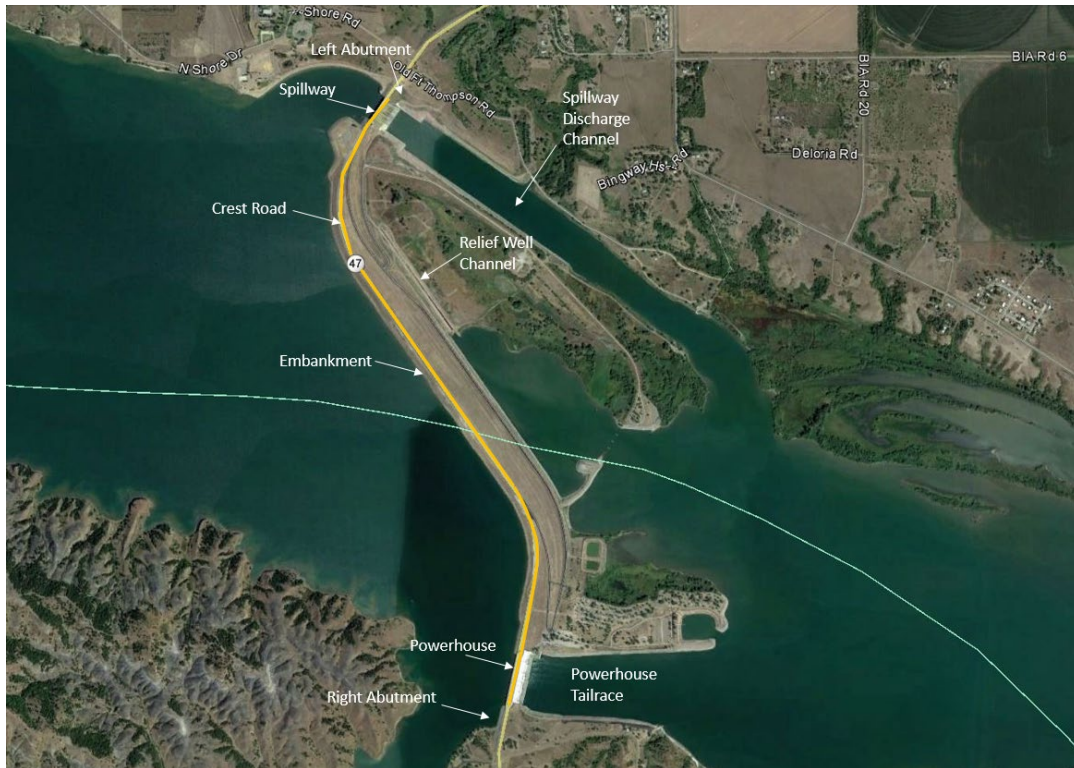
Figure 3: Aerial photo showing project features

Big Bend Dam is a multiple purpose project consisting of a rolled earthfill embankment, hydroelectric generating power plant, spillway, and reservoir (Figure 2 and Figure 3). The reservoir has a capacity of 1,859,000 acre feet for flood control, irrigation, conservation, navigation, power development, and other uses. Conventional outlet works structures were not constructed at Big Bend; releases are made either through the spillway or the power plant.
