AM WWTP Pond Washouts

Sequoia and Kings Canyon National Parks
National Park Service
U.S. Department of the Interior

Exhibit 1

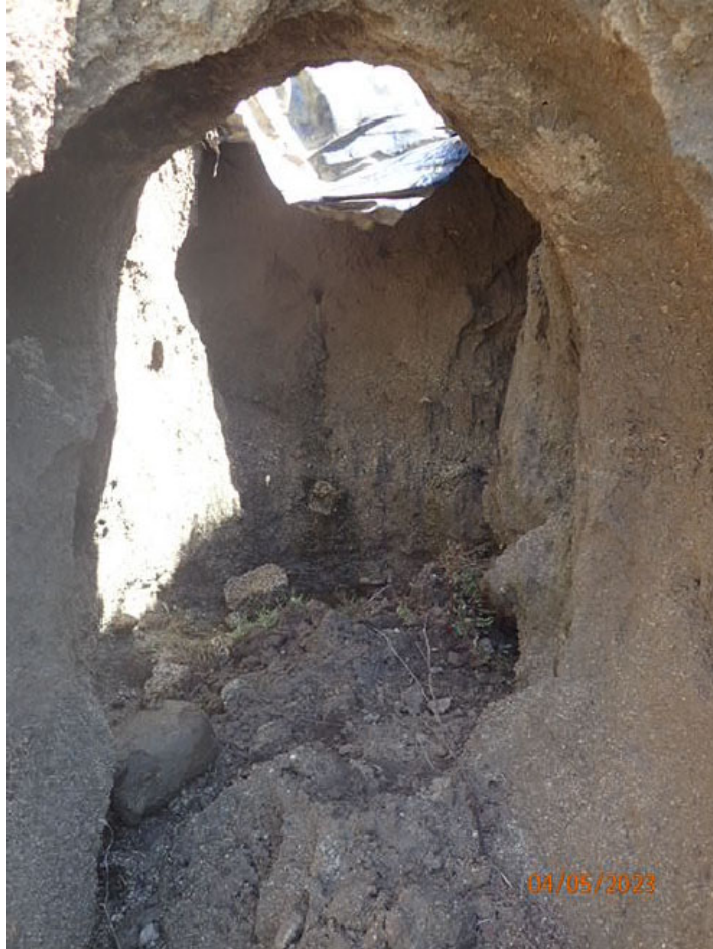
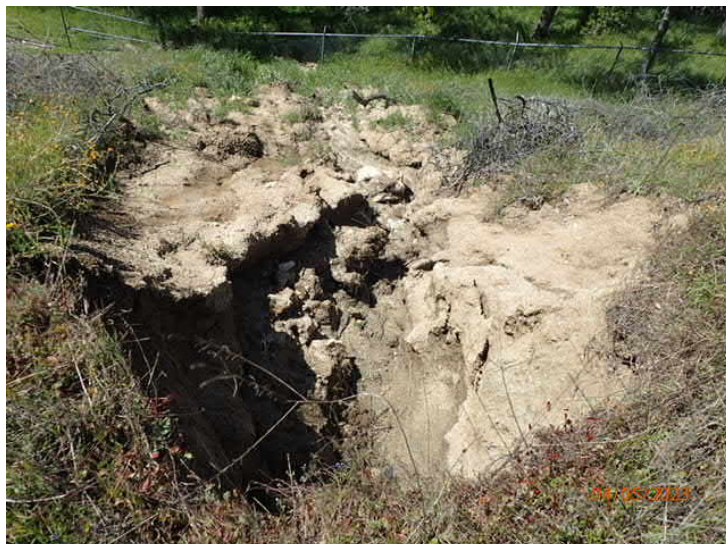
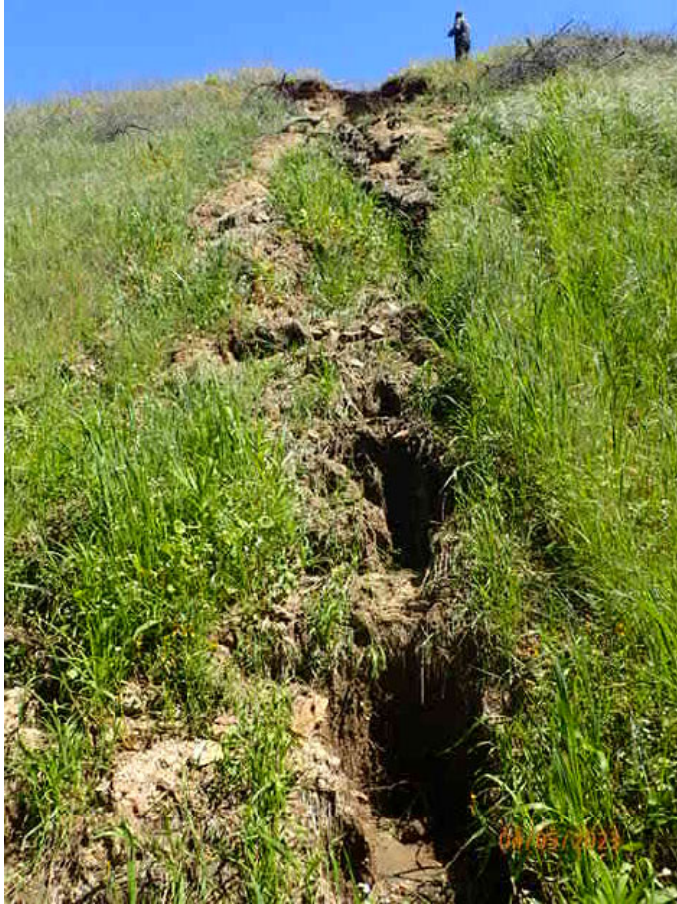
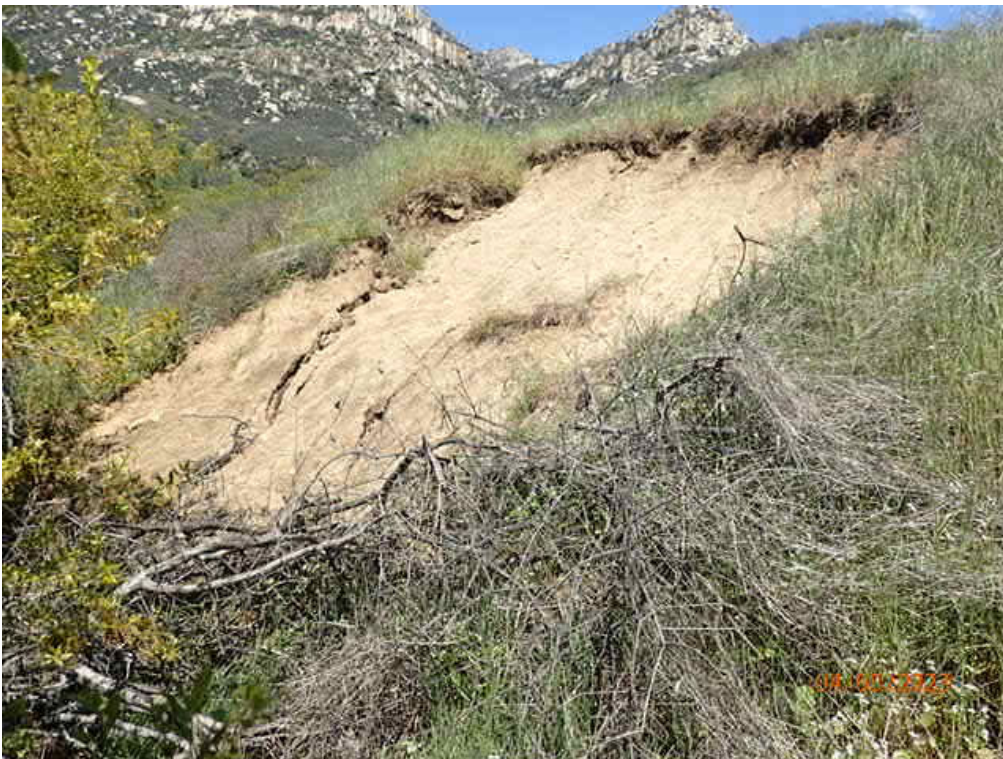
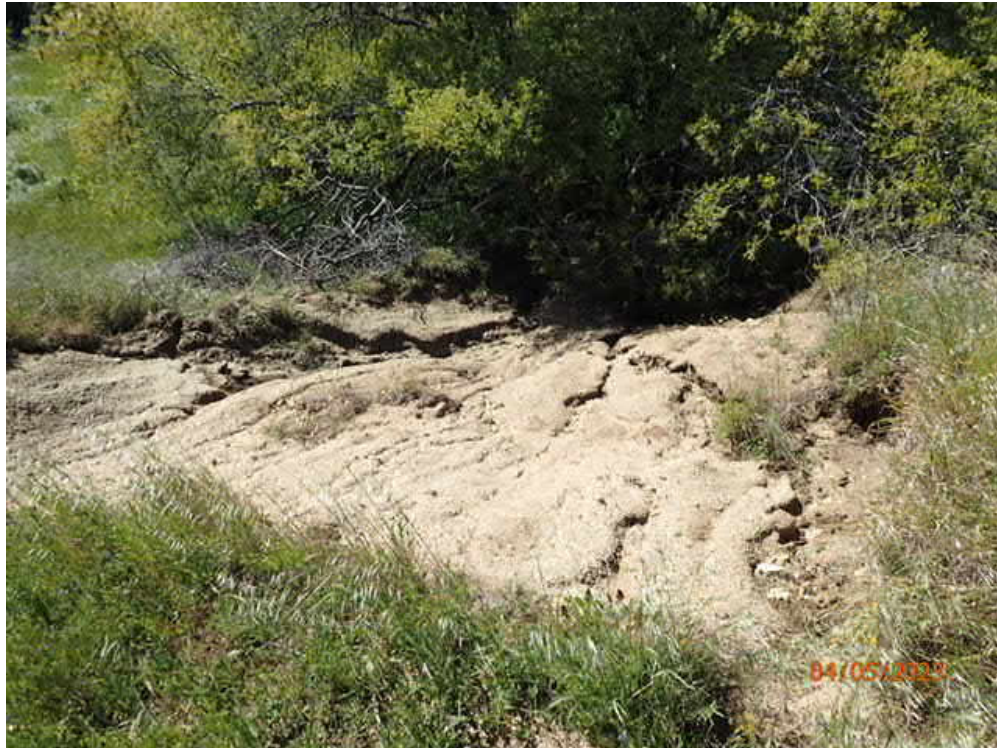
Photos of the washout from storm

In recent winter storms at Sequoia National Park, the west side of the west pond (see attached exhibit 1) has washout. For these locations, contractor to backfill to pre-storm condition or the proposed project grade.

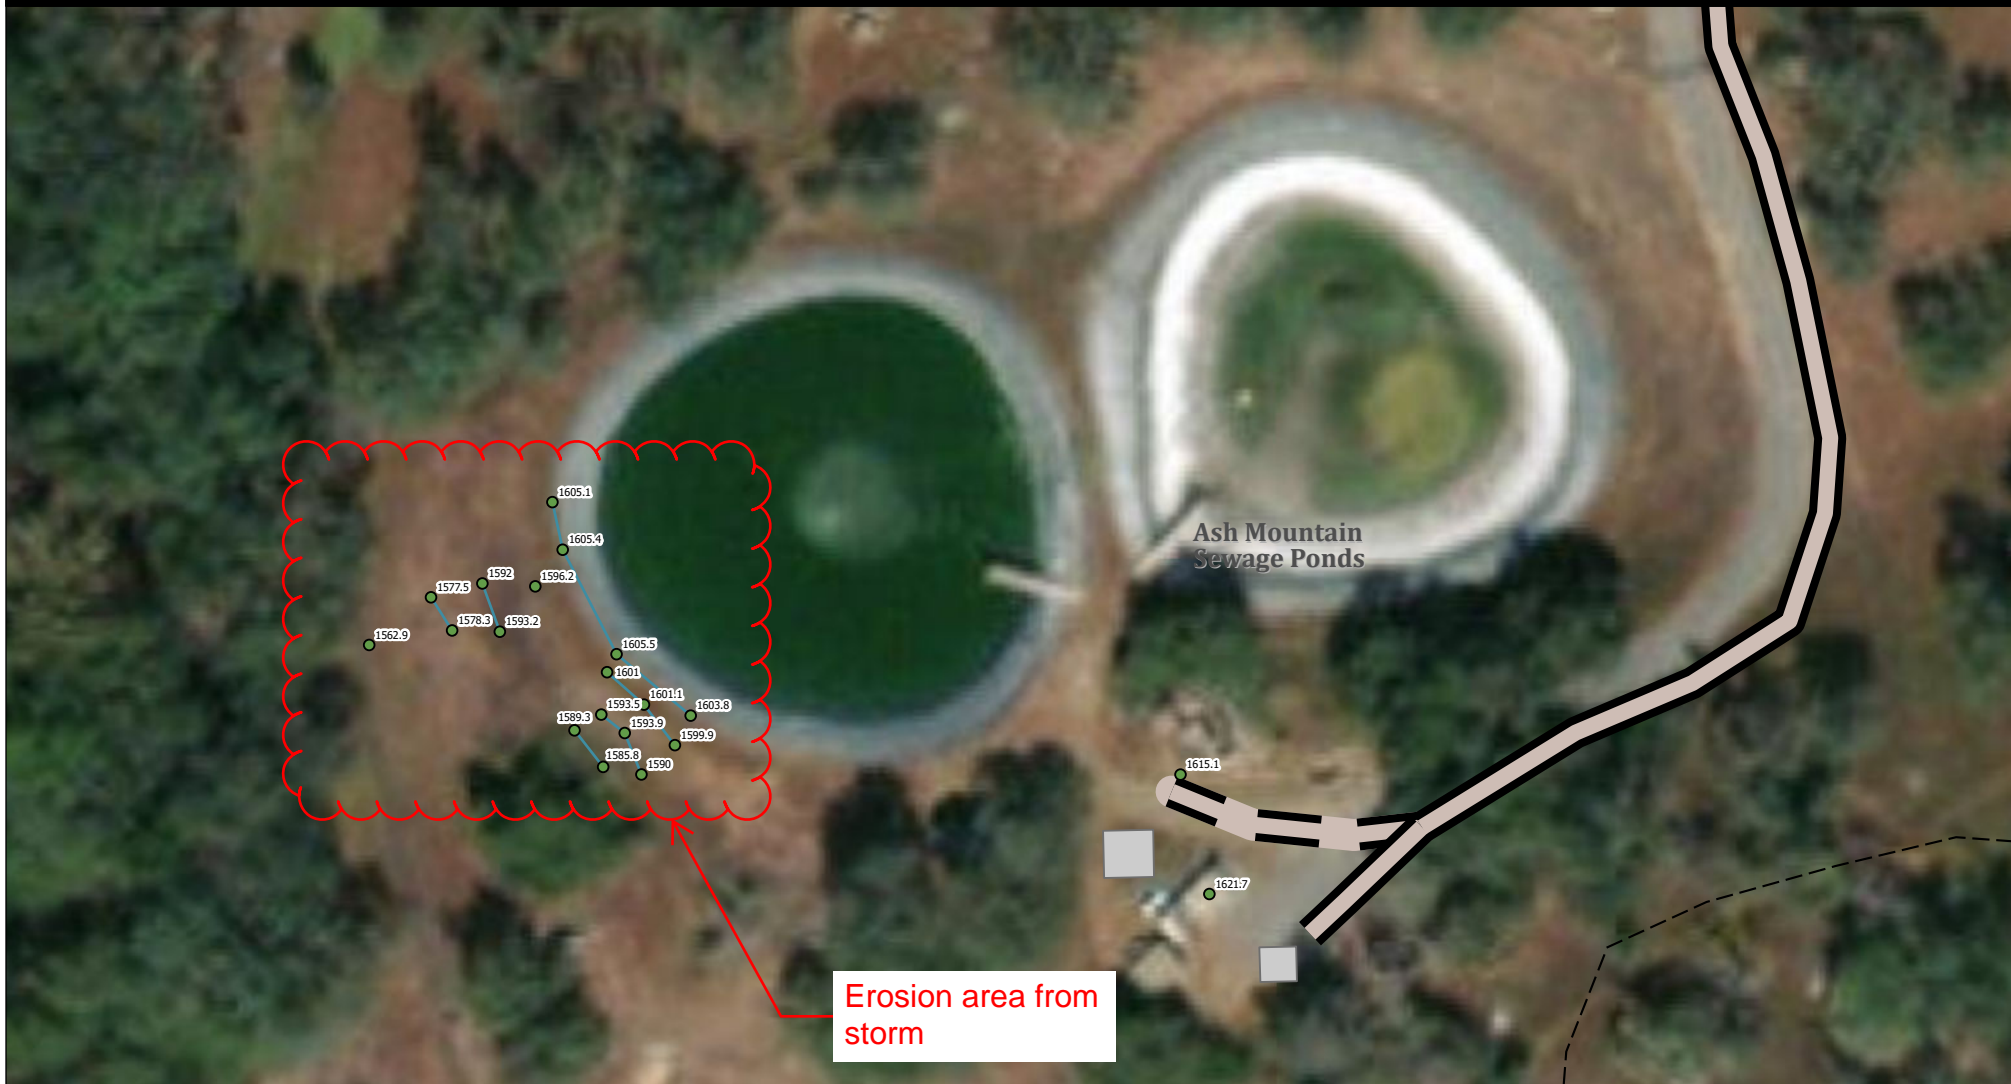
Elevation points shown on exhibit to illustrate locations of the erosion only. Accuracy of the elevations to be verified.

This map shows elevation dimensions at two washouts along the Ash Mountain waste water treatment plant ponds. GPS data was collected in the standard NPS NAD83 coordinate system and converted to State Plane for interoperability with CAD. A vertical transformation of 95.975 ft was also applied to the GPS altitude to convert to a geometric height.
