OVERVIEW OF LIBBY TRANSFORMER T1 REHAB

Teresa Casper, PE
Electrical Engineer
USACE Hydroelectric Design Center
Generation Equipment Section
Date: 22 March 2023

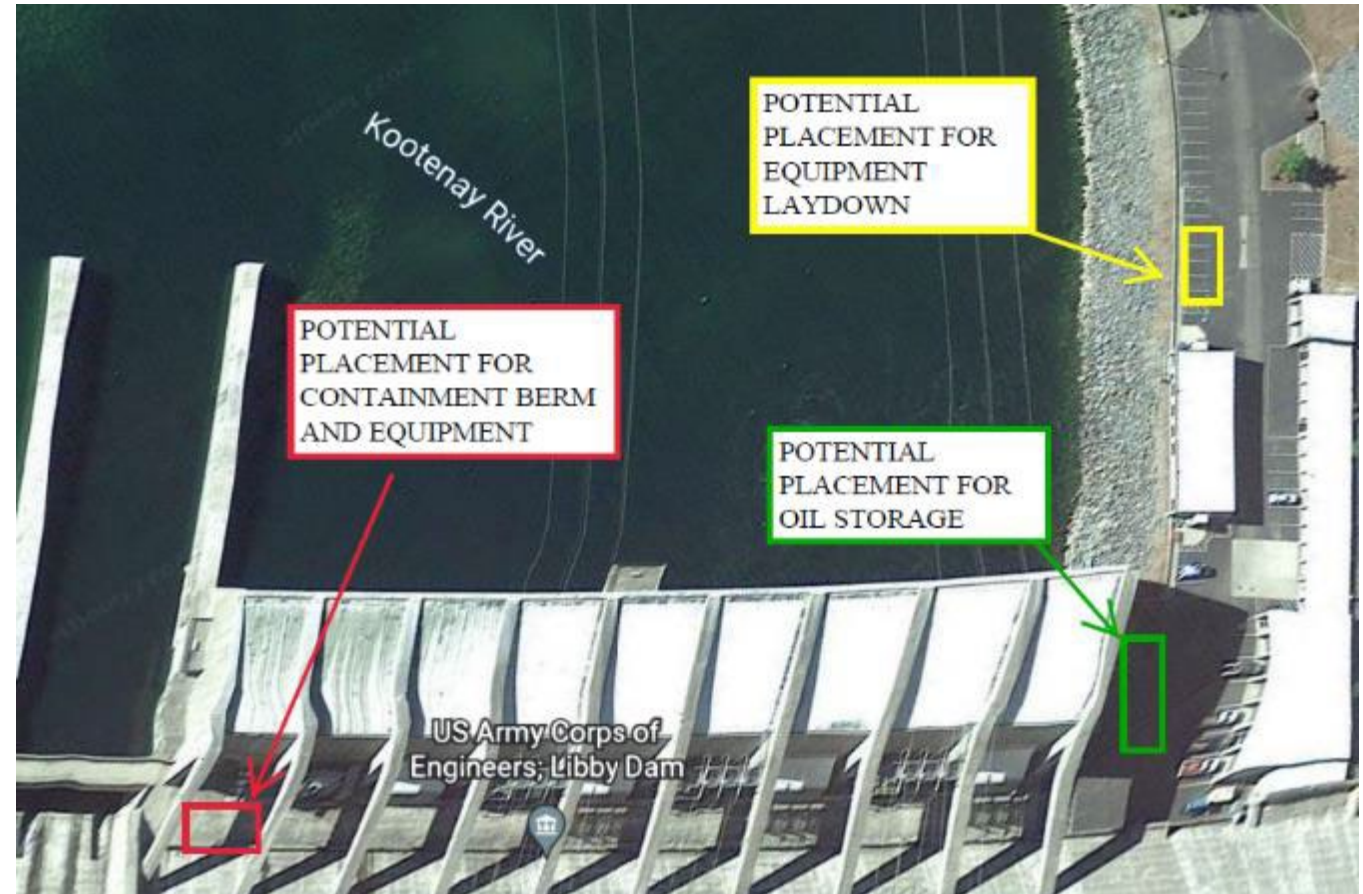
Contractor will need to coordinate with the Project to determine location for oil processing equipment and, containment berm and oil storage container.

- Drain oil from T1 (14,030 gallons) into **oil storage container** located in the parking area adjacent to the end of the powerhouse and entrance to the transformer service deck
- Process oil with an **oil processing trailer** located on the deck and add oxidation inhibitor. Contractor must determine amount of inhibitor to add
- Provide 300 gallons of make-up oil for re-filling
- Remove radiators that show signs of leaking and place radiators and any other leaky equipment in **containment berm**
- Equipment that must fit on the deck includes, crane and oil processing trailer.

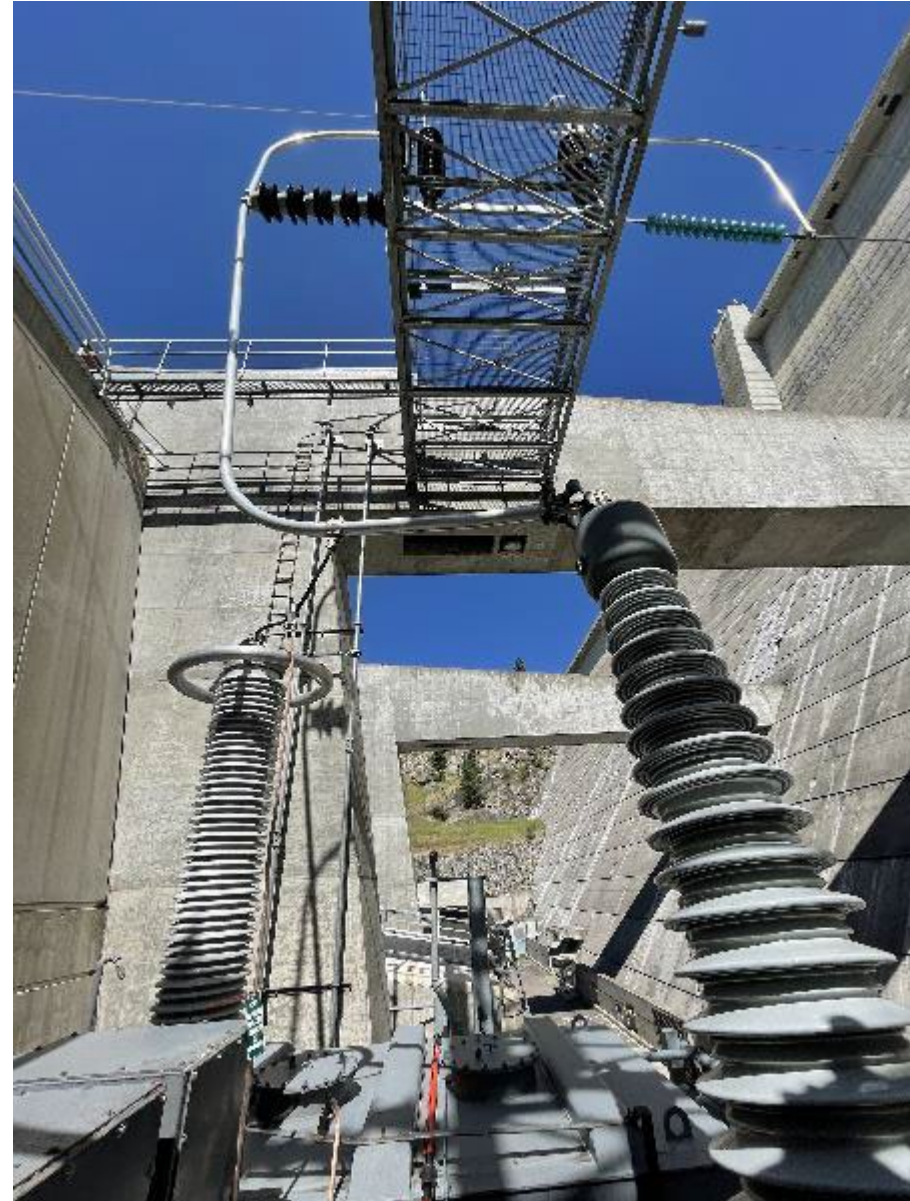
High-voltage bushing

ABB Type O-Plus-Dry, Style 230N1200AA

- 230kV type 1,200A current rating, and are referred to as 'O Plus Dry'.
- This type of bushing is the same as that on T3 transformer and the project spare bushing.

- Replacement bushing is 8-inches shorter than the existing bushing.
- Modify high voltage tubular bus connecting to the bushing terminal Cut section and weld longer section of bus to reach the replacement bushing terminal.
- Recommended reusing bottom connector and the bolting hardware from old bushing be reused for the replacement HV bushing.

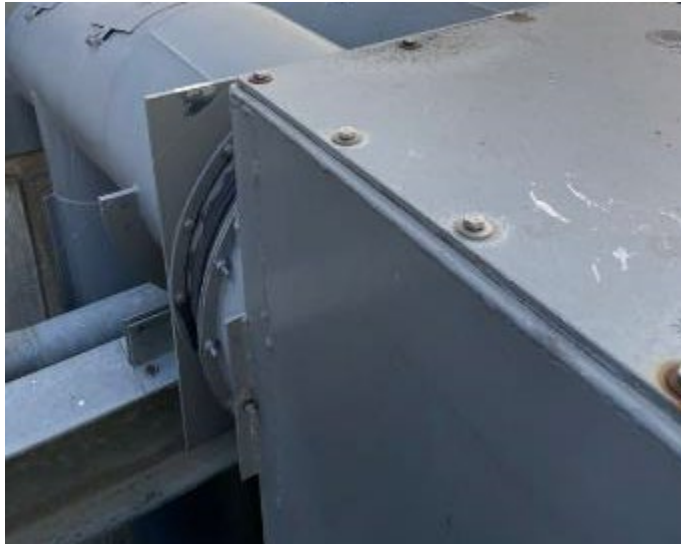
Low-voltage bushings

ABB Type LCRJ

- Direct replacement, no modifications necessary
- Rated for high-temperature applications, of a low-corona design and is considered a direct replacement of the existing bushing
- Gaskets must be fluoroelastomeric rubber (also known by the industry name of Viton) gaskets which are designed for high temperatures

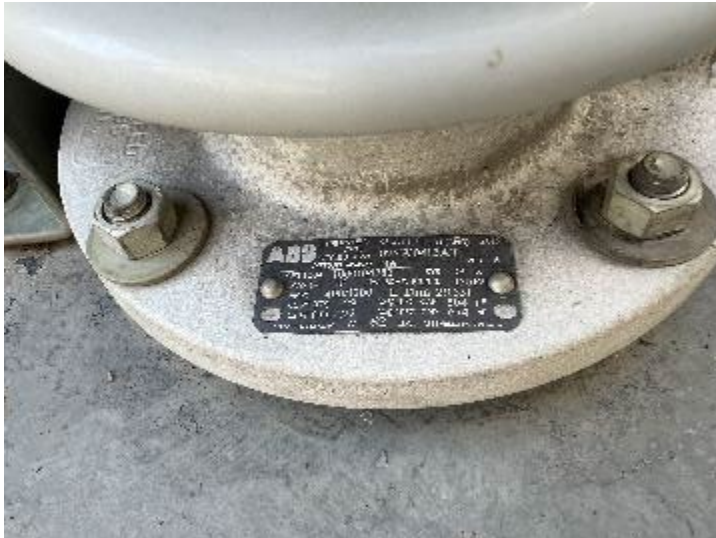
Neutral bushing

ABB Type O-Plus-Dry, Style 025N0412AA

- Direct replacement, no modifications necessary
- Original neutral bushing was replaced in 2015 with an ABB O+C type bushing
- Existing spare bushing is ABB 025N0412AA
- Gaskets must be fluoroelastomeric rubber (also known by the industry name of Viton) gaskets which are designed for high temperatures

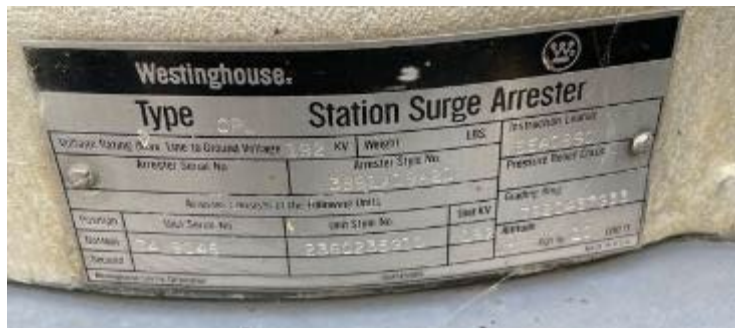
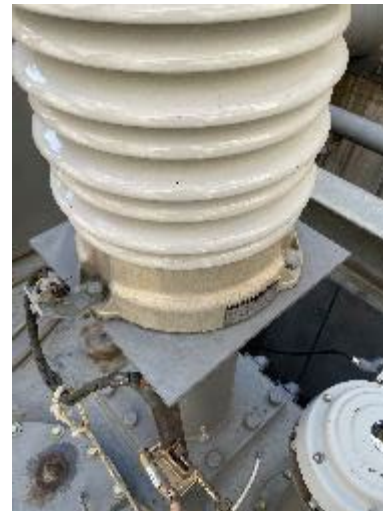
Surge Arrester

- Replacement arresters researched have mounting bolt patterns with a smaller dimension than the original arresters. Contractor must either drill new mounting holes, or provide a mounting adapter.
- If length of conductor from the arrester terminal to the HV bus is different, may require replacement.

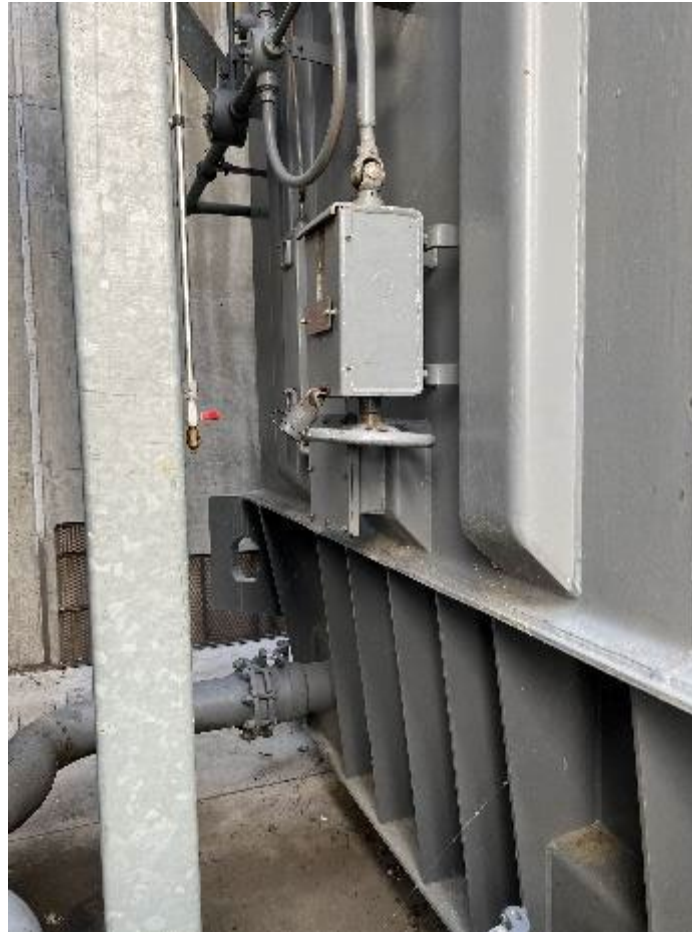
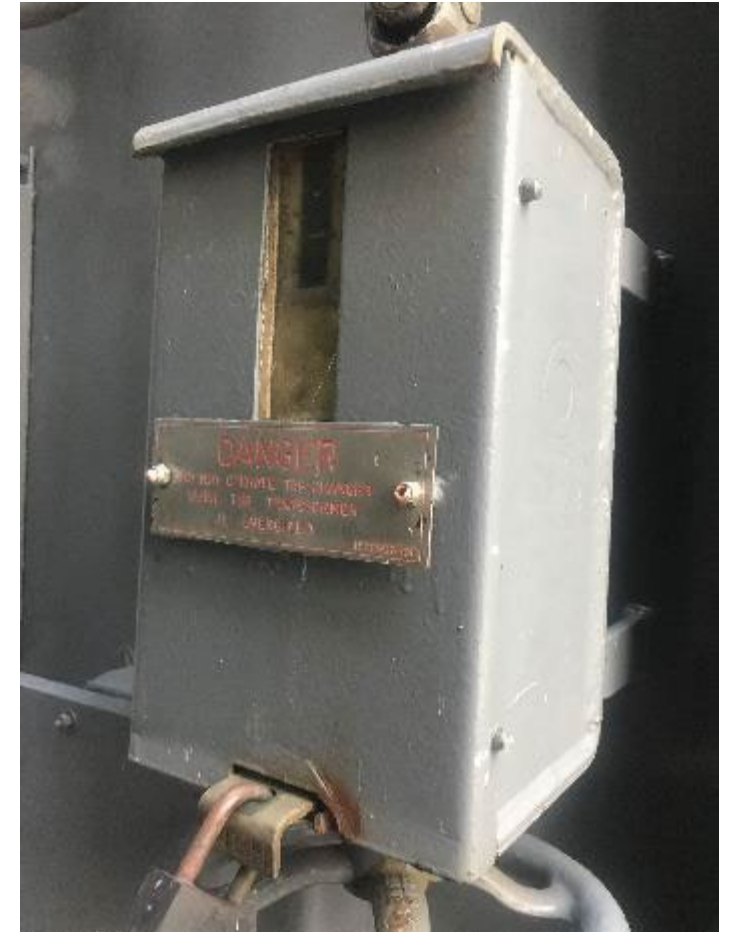
DE-ENERGIZED TAP
CHANGER

- Inspect de-energized tap changer.
- Service de-energized tap changer handwheels mechanism.

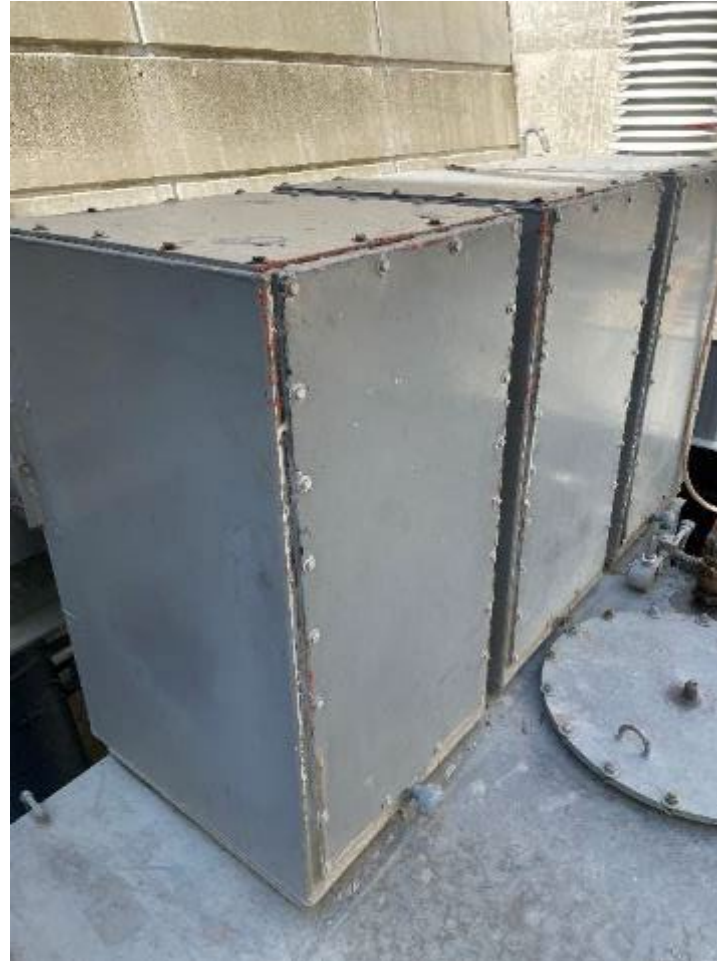
LOW VOLTAGE BUSHING
DOG HOUSE

- Replace low-voltage connectors.

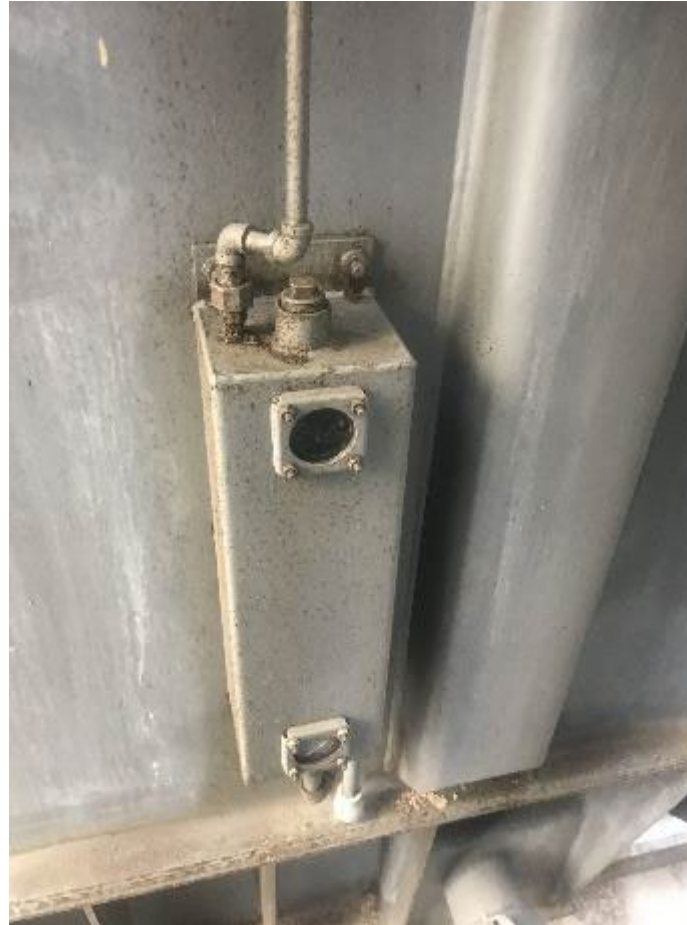
DEHYDRATING
BREATHER

- Replace dehydrating breathers
- New conduit will need to be routed to the control cabinet for each dehydrating breather's power and annunciation wiring.
- The conduit can be routed along the transformer tank seam flange using parallel beam clamps which are secured to the flange

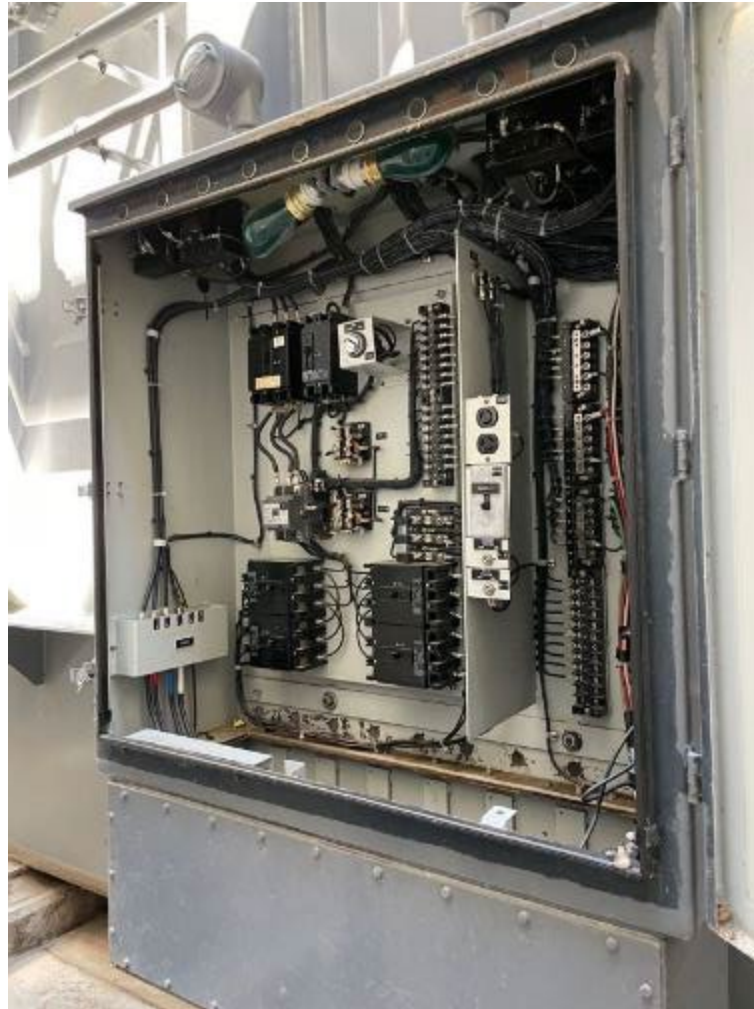
CONTROL CABINET

- Install new rapid pressure rise seal-in relay in control cabinet.

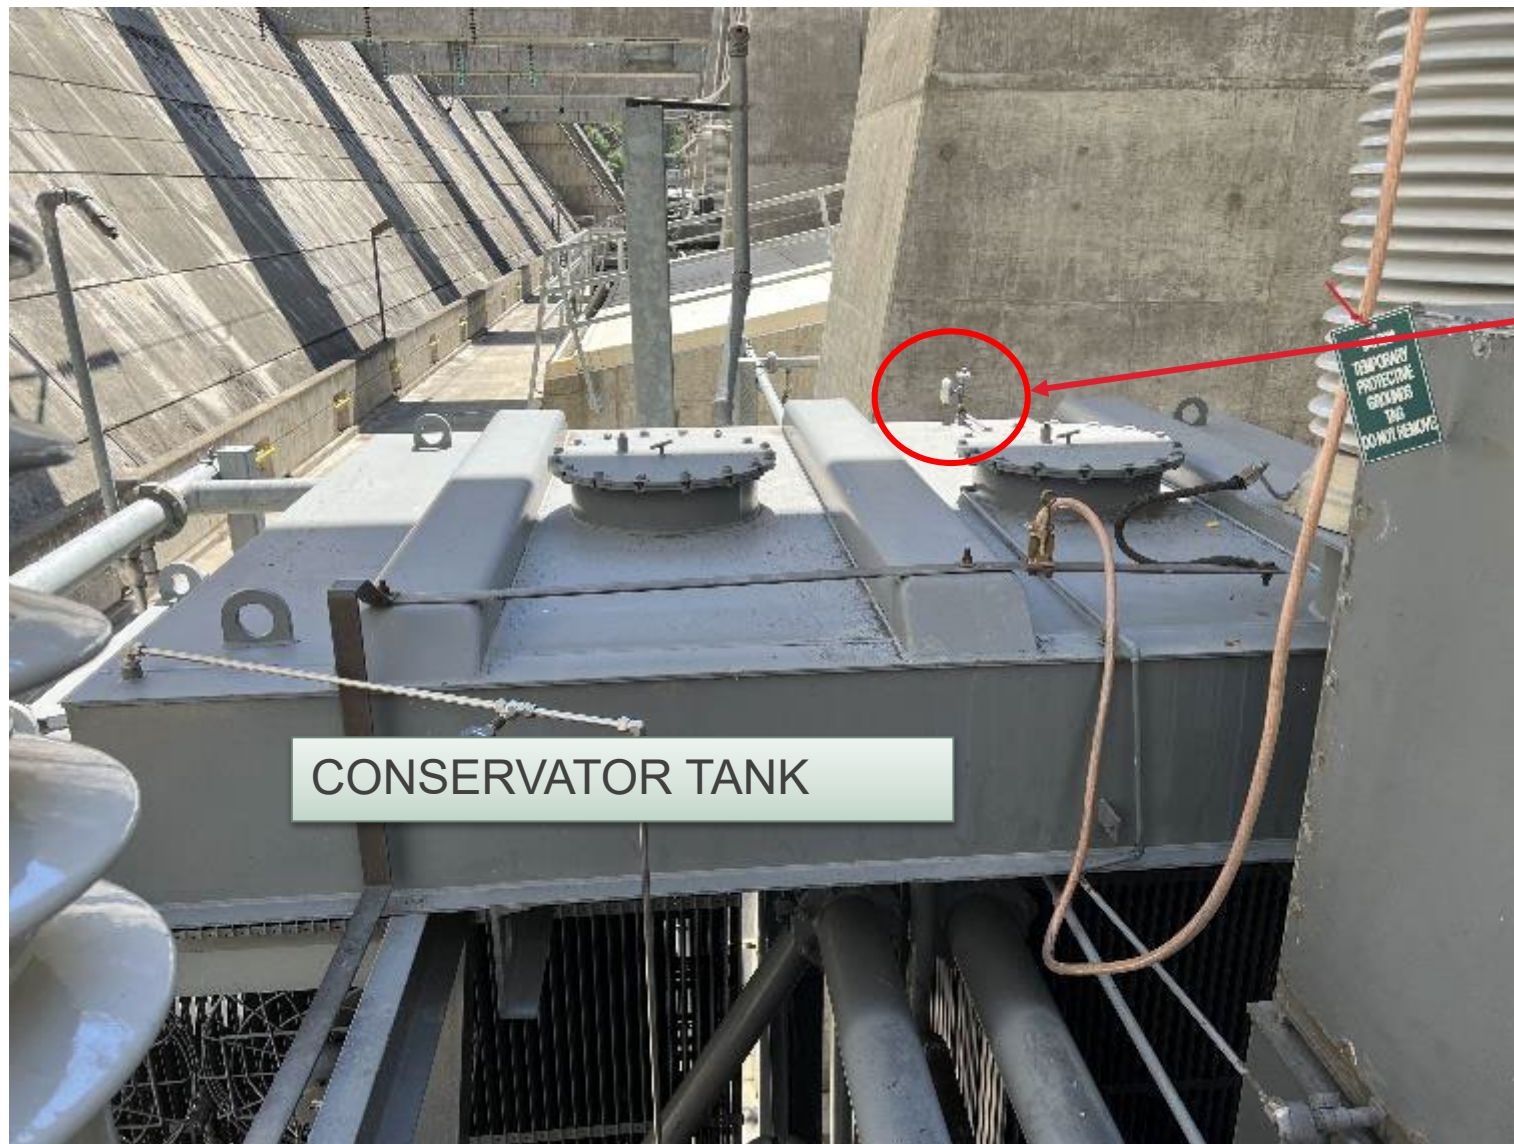
CONSERVATOR TANK

PRESSURE VACUUM
BLEEDER VALVE

- Replace conservator tank bladders and pressure vacuum bleeder valves.

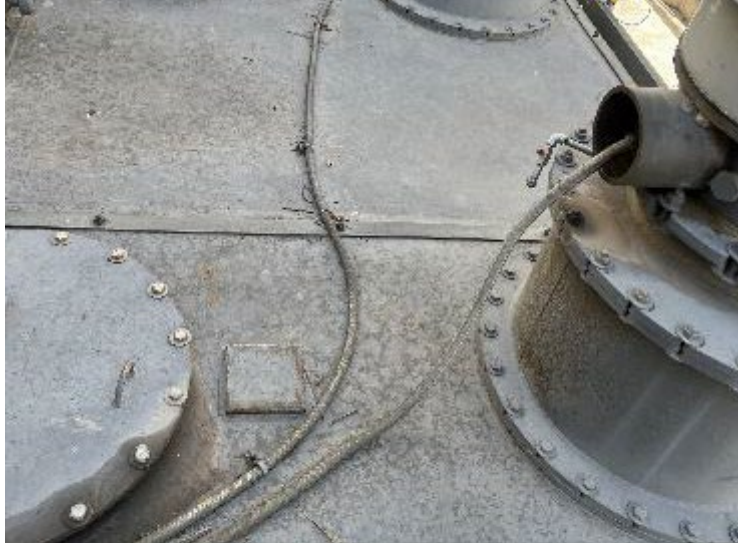
MANHOLE GASKET AND
BUSHING POTENTIAL TAP

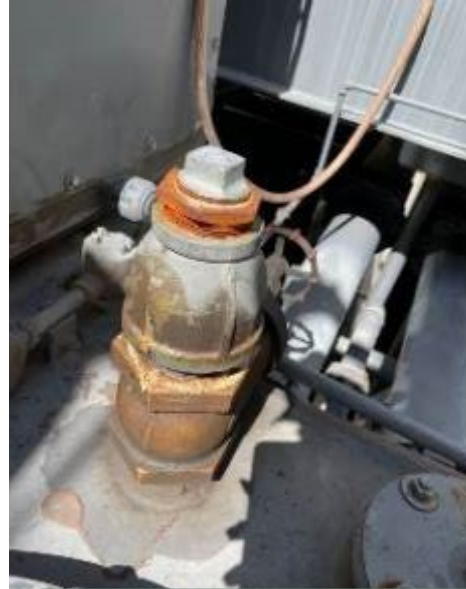
VACUUM VALVE

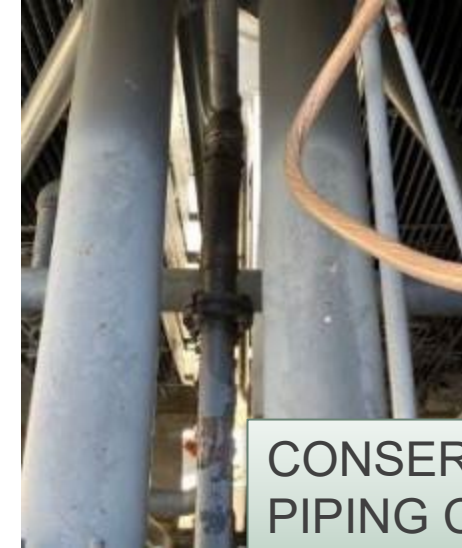
CONSERVATOR TANK OIL
PIPING CONNECTION

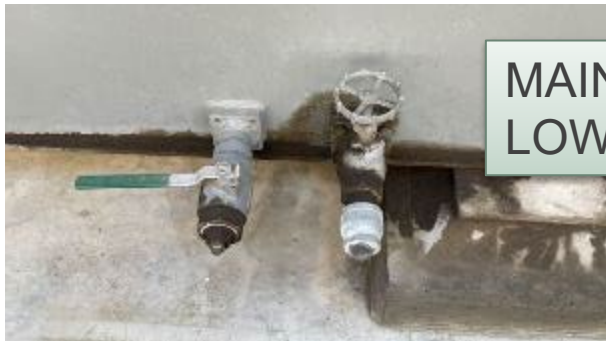
MAIN DRAIN VALVE AND
LOWER FILTER VALVE

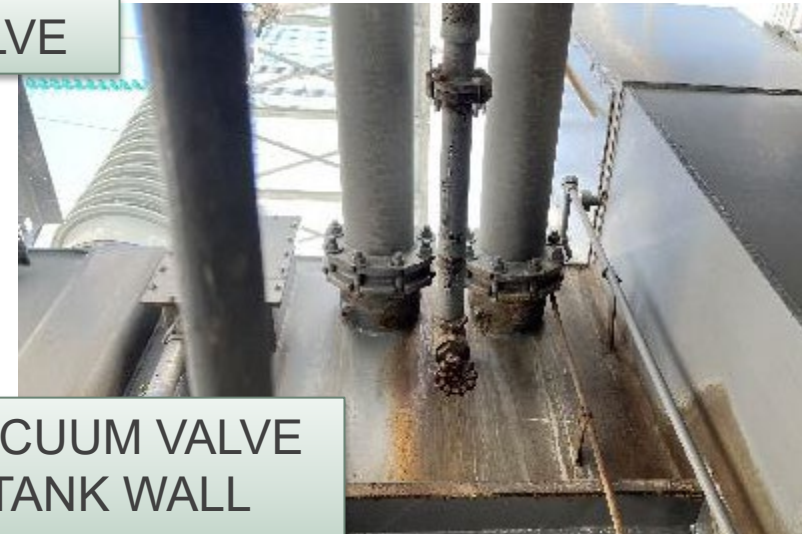
LEAK FROM VACUUM VALVE
GOING DOWN TANK WALL

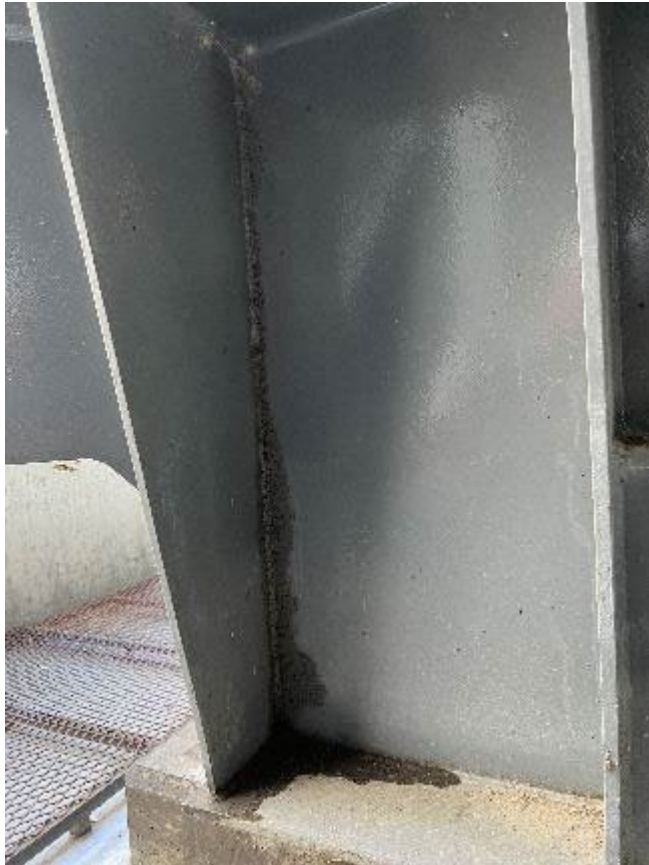
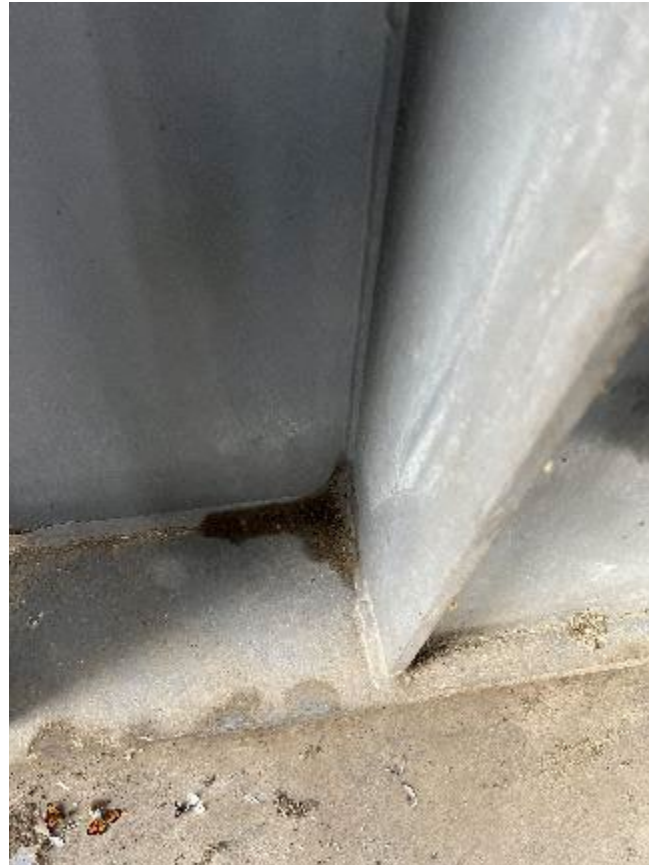
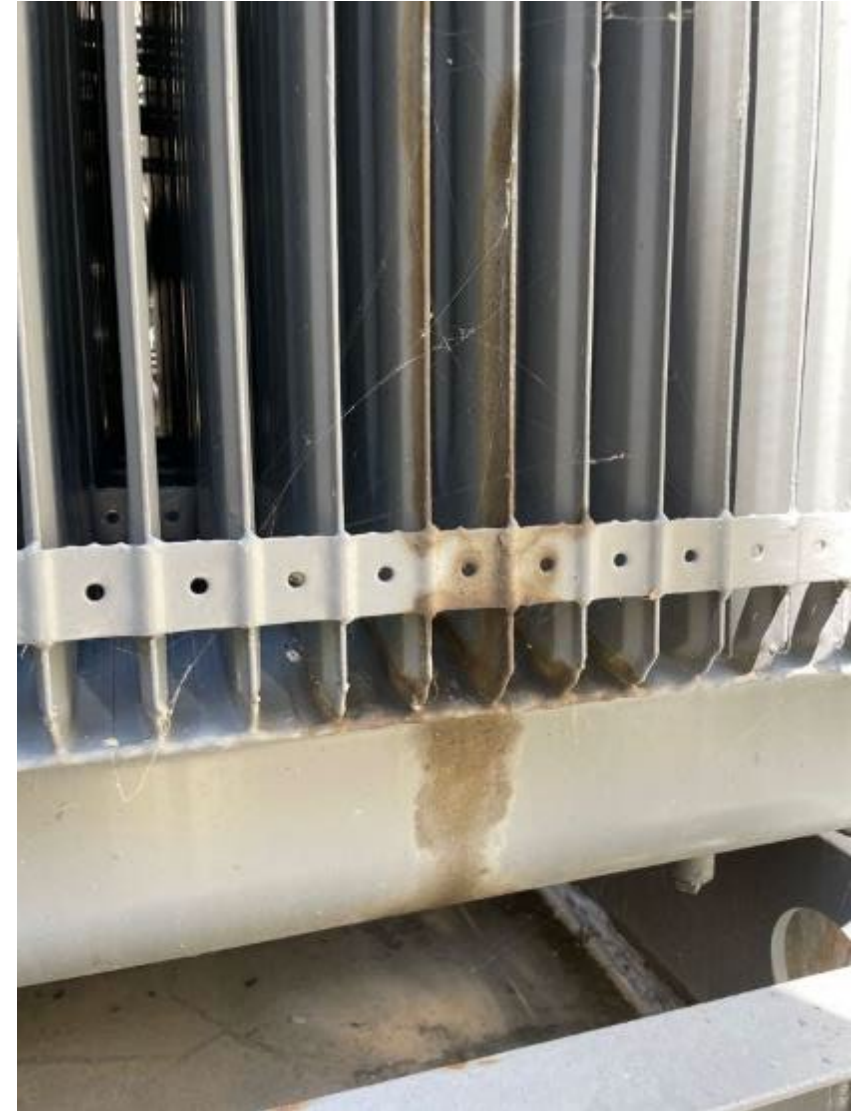
OVERVIEW: WELD LEAKS

- Repair weld leaks using Belzona 1161
- Two tank weld leak locations were identified on Segment 2
- Two radiator fin weld leak locations were identified on Segment 4
