LAKESHORE ROAD  
ELEPHANT BUTTE STATE PARK  
SIERRA COUNTY, NM  
NM FLAP SIE 10(1)

FINAL Geotechnical Report

Prepared by  
Federal Highway Administration  
Central Federal Lands Highway Division

Geotechnical Services Branch  
June 2022

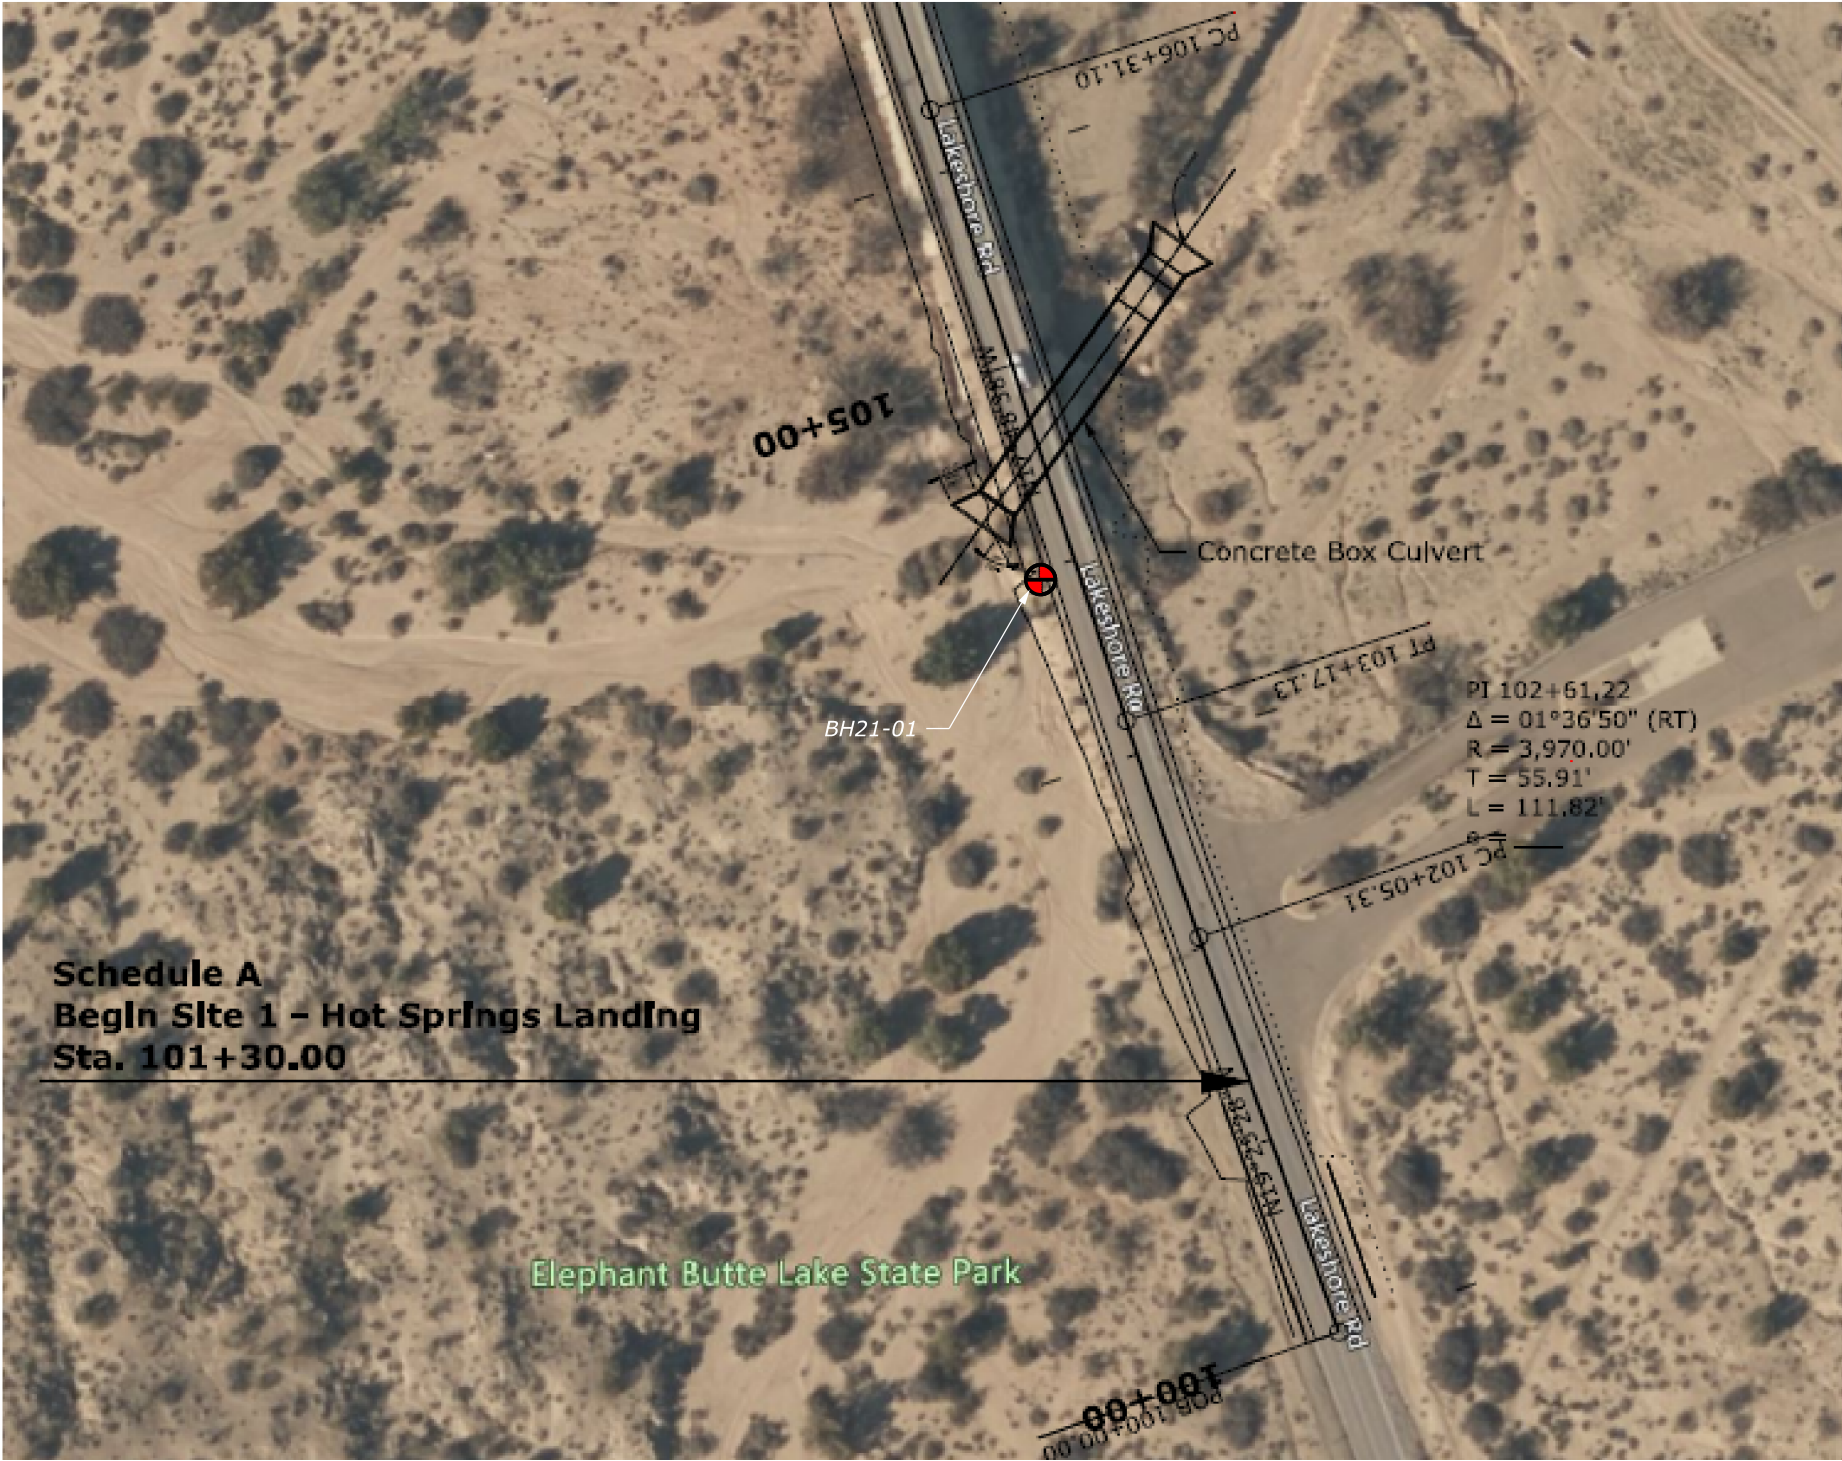
**GEOLOGY MAP**

Qah

**Historic channelized alluvium**—Poorly or non-vegetated gravels lying along and beneath active drainage channels. Gravels are loose and matrix-poor, commonly in medium-thick, lenticular, often trough cross-stratified beds. Gravel compositions are reflective of upstream exposed materials. No notable soil development. Not uncommon to overtop surrounding **Qay** deposits as thin channel splay or fluvial fan deposits. The deposit thicknesses are <1 to 2 m.

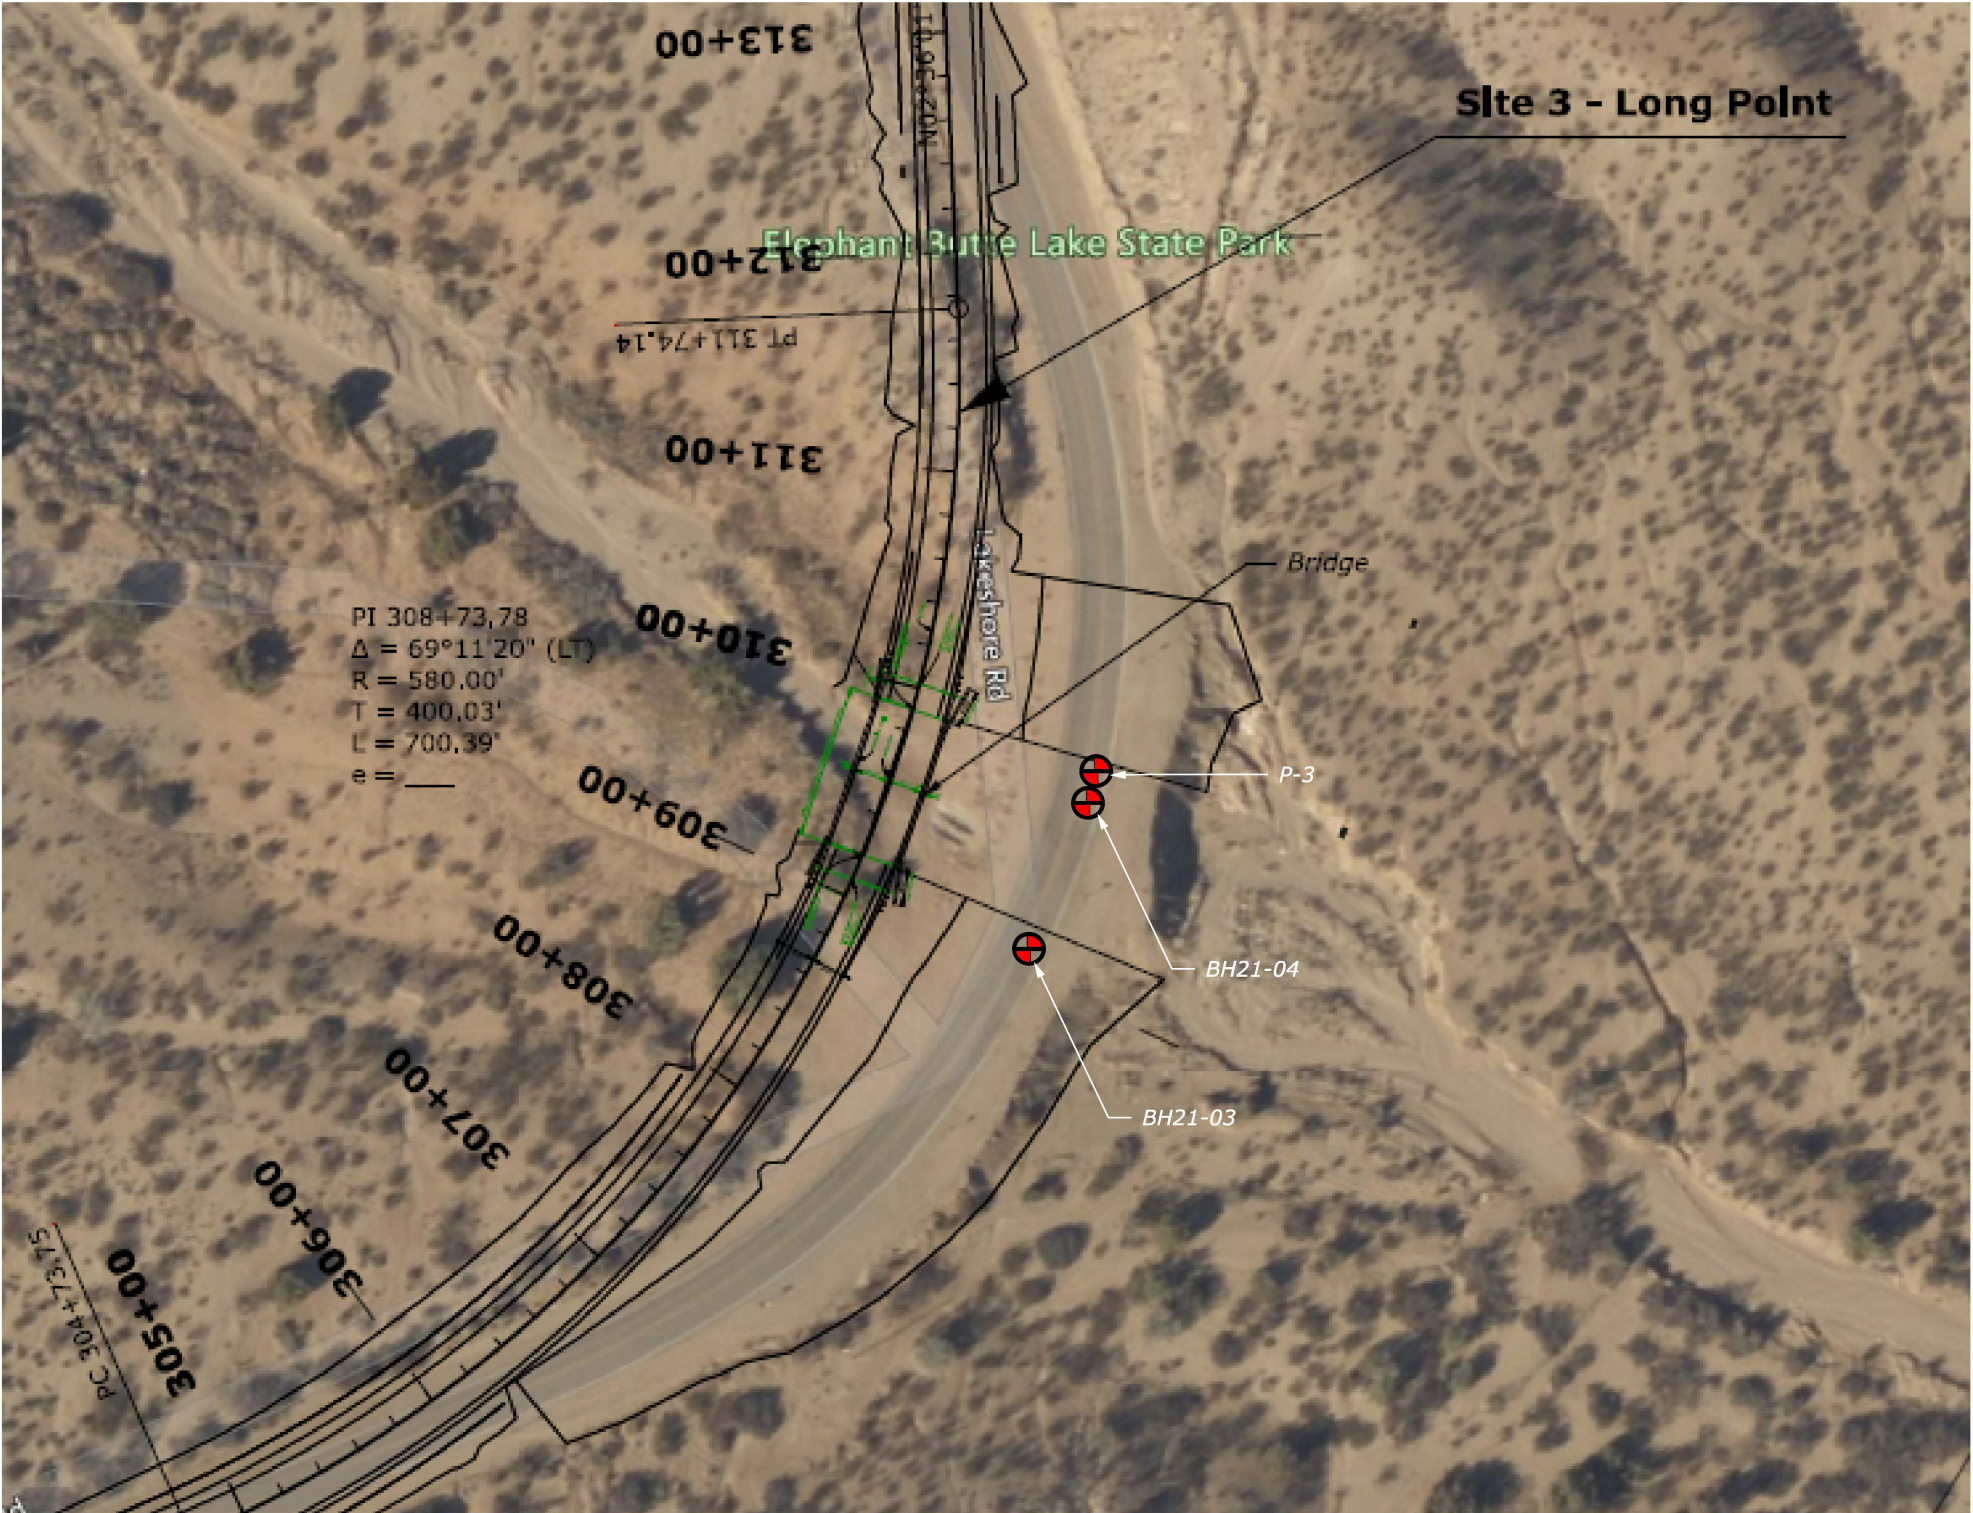
GEOTECHNICAL BORING  
LOCATIONS

Boring Locations				
Boring	Location	Latitude	Longitude	Elevation
P-2	STA 205+61, 8 ft Lt.	33.229267°	-107.213797°	4462 ft
BH21-02	STA 205+65.5, 8 ft Lt.	33.229275°	-107.213792°	4462 ft

Boring locations are approximate. Elevations are estimated from Google Earth.

The subsurface conditions at Site 2, proposed double box culvert location, were investigated by drilling boring BH21-02. ODEX drilling was used from 0 to 39 feet. Similar to Site 1 subsurface conditions, the ground surface consisted of silt, sand, gravel, and cobbles. Additionally, weak to moderately cemented sand layers were observed near the roadway surface. The boring encountered medium dense, well graded silty sand to a depth of approximately 10 feet, with a 1-foot-thick gravel layer at 7 feet. The soil then transitioned to dense silty sand with trace gravel and extended to the termination depth of approximately 39 feet. The subsurface conditions at Site 2 were also investigated by drilling boring P-2. Hollow stem auger drilling was used from 0 to 5 feet. The boring encountered silty sand with gravel to the termination depth. Neither groundwater nor bedrock was encountered in boring BH21-02 or P-2.

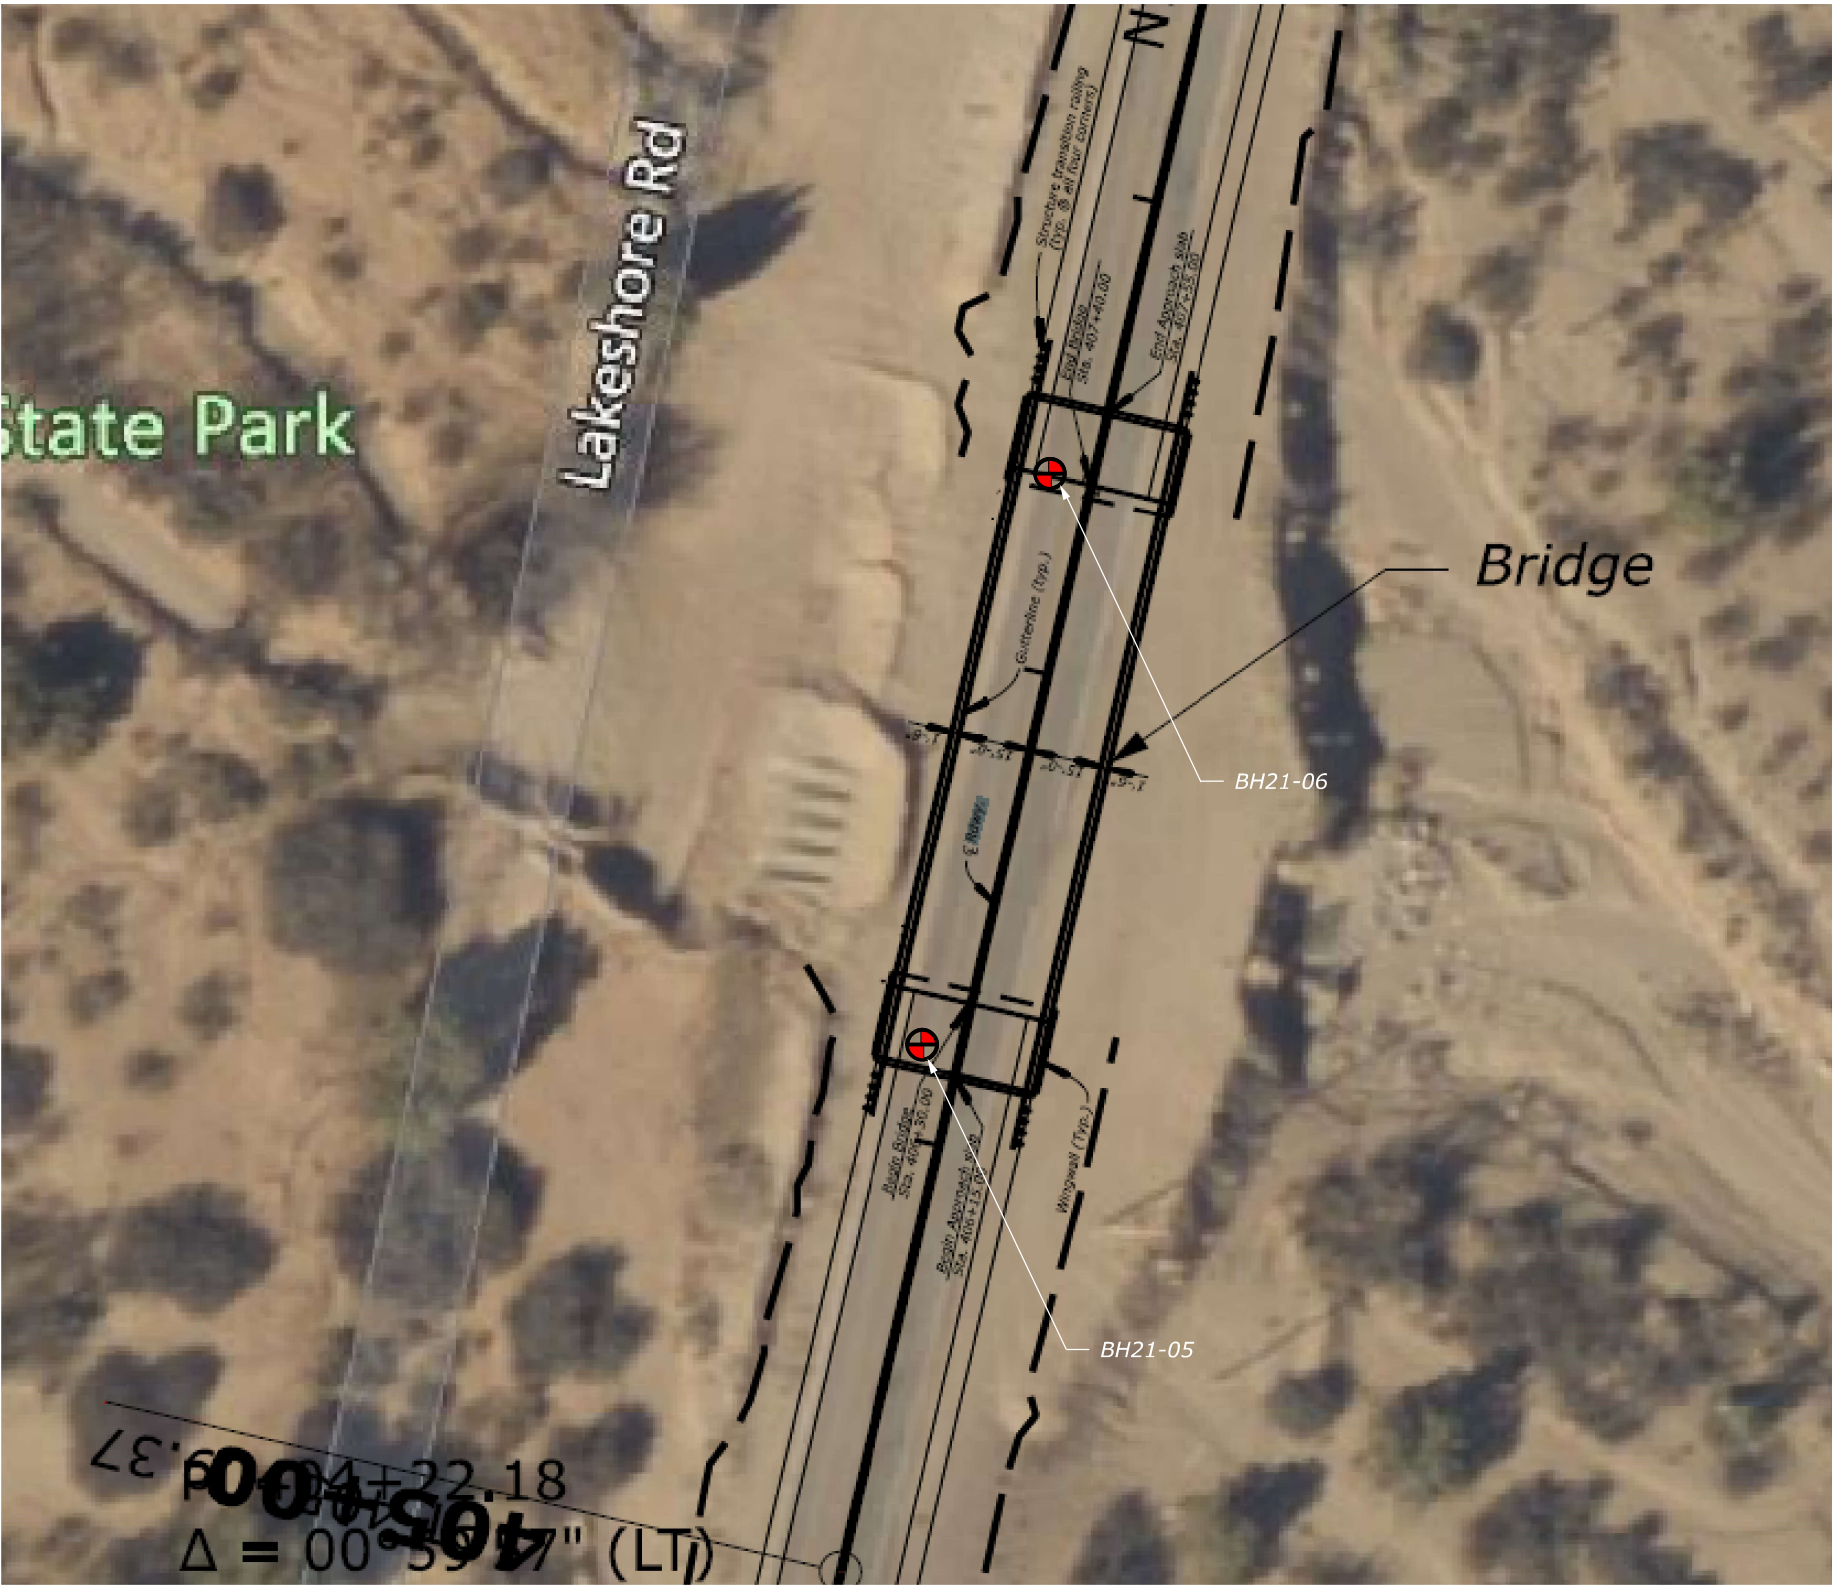
SHEET 3 OF 5

Boring Locations				
Boring	Location	Latitude	Longitude	Elevation
BH21-03	STA 309+10, 8 ft Rt.	33.229275°	-107.213792°	4487 ft
BH21-04	STA 309+80, 7 ft Rt.	33.241417°	-107.202636°	4487 ft
P-3	STA 309+87, 7 ft Rt.	33.241439°	-107.202544°	4487 ft

Boring locations are approximate. Elevations are estimated from Google Earth.  
Stationing based on new alignment and was projected out to existing roadway.

The subsurface conditions at Site 3, south abutment of proposed bridge location, were investigated by drilling boring BH21-03. ODEX drilling was used from approximately 0 to 59 feet, where the casing locked up and could no longer advance. Hollow stem auger drilling was then used to the termination depth of approximately 100 ft. The ground surface surrounding the boring location consisted of silt, sand, gravel, and cobbles. Additionally, the downstream channel displayed weak

The subsurface conditions at Site 3, north abutment of proposed bridge location, were investigated by drilling boring BH21-04. ODEX drilling was used from approximately 0 to 84 feet. Drilling was terminated at 84 feet where the casing locked up and could no longer advance. Like the south abutment boring BH21-03, the ground surface surrounding the boring location consisted of silt, sand, gravel, and cobbles. Additionally, the downstream channel displayed weak to moderately cemented sand layers and up to 3-foot diameter boulders, presumably placed for scour protection. The boring encountered medium dense silty sand with gravel to a depth of approximately 12 feet. The material then transitioned to very dense, poorly graded sand with silt until a depth of approximately 84 feet. Very stiff clay seams were encountered at approximately 29 feet, 40 feet, 44 feet, 46.5 feet, and 70.5 feet with thicknesses of roughly 3, 1.5, 2, 1.5, and 2 feet, respectively. A weak to moderately cemented sand was encountered at approximately 29 feet within the clay layer. The subsurface conditions at Site 3 were also investigated by drilling boring P-3. Hollow stem auger drilling was used from 0 to 5 feet. The boring encountered silty sand with gravel and varying amounts of clay to the termination depth. Neither groundwater nor bedrock was encountered in boring BH21-03 or P-3.

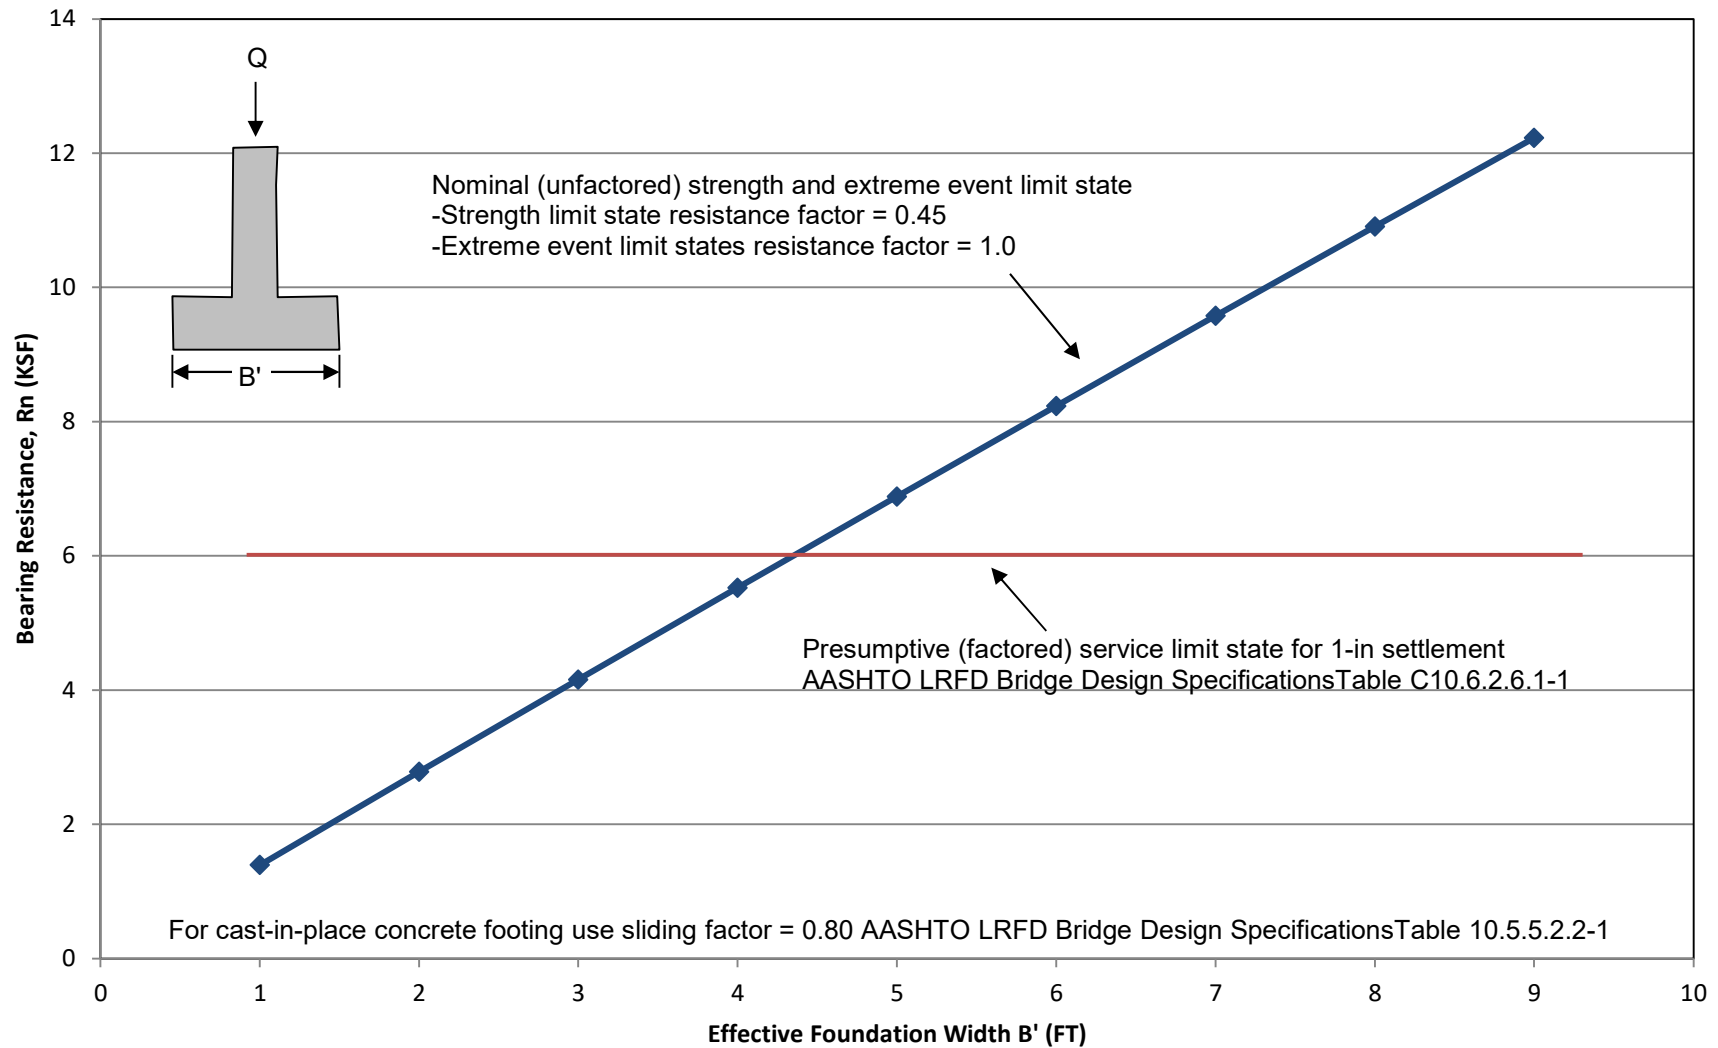
**PLATE 8 - Bearing Resistance for Site 1 Box Culvert**

## EFFECTIVE WIDTH vs. BEARING RESISTANCE (LRFD)

### Box Culvert (Site 1) - Lakeshore Road (NM FLAP SIE 10(1))

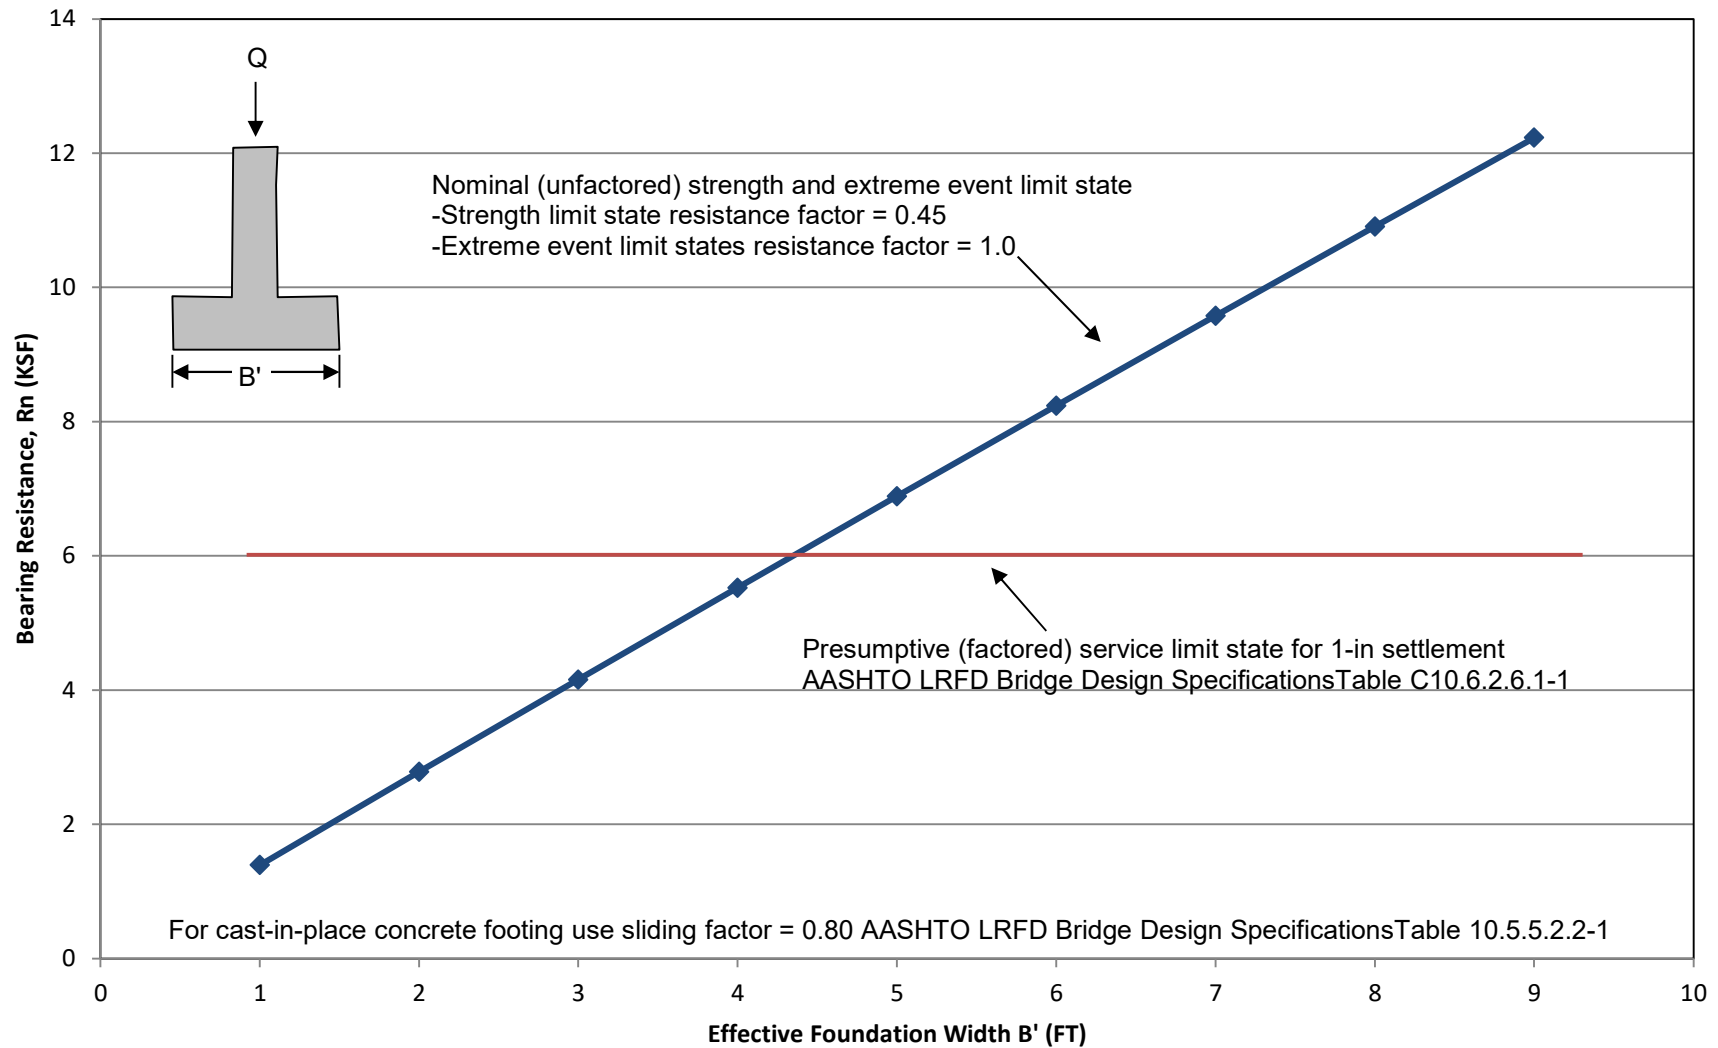
**PLATE 9 - Bearing Resistance for Site 2 Box Culvert**

## EFFECTIVE WIDTH vs. BEARING RESISTANCE (LRFD)

### Box Culvert (Site 2) - Lakeshore Road (NM FLAP SIE 10(1))

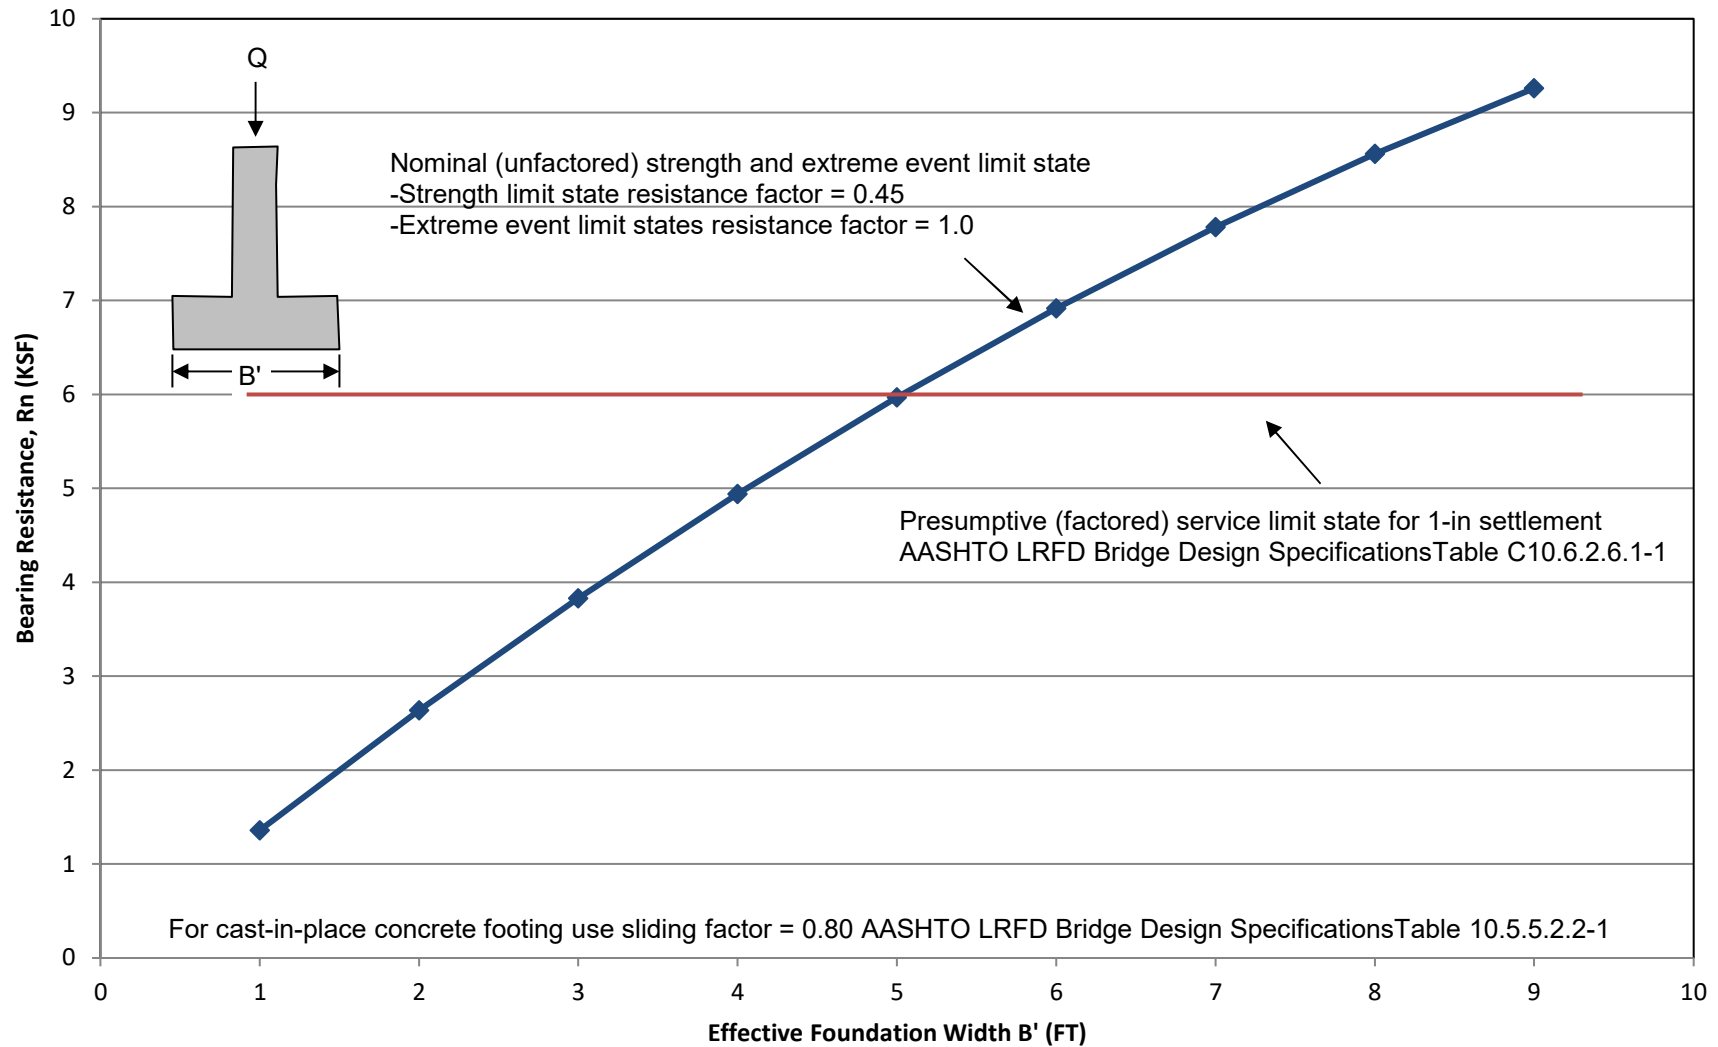
PLATE 10 - Bearing Resistance for Site 1 Wingwalls

## EFFECTIVE WIDTH vs. BEARING RESISTANCE (LRFD)

### Wingwalls (Site 1) - Lakeshore Road (NM FLAP SIE 10(1))

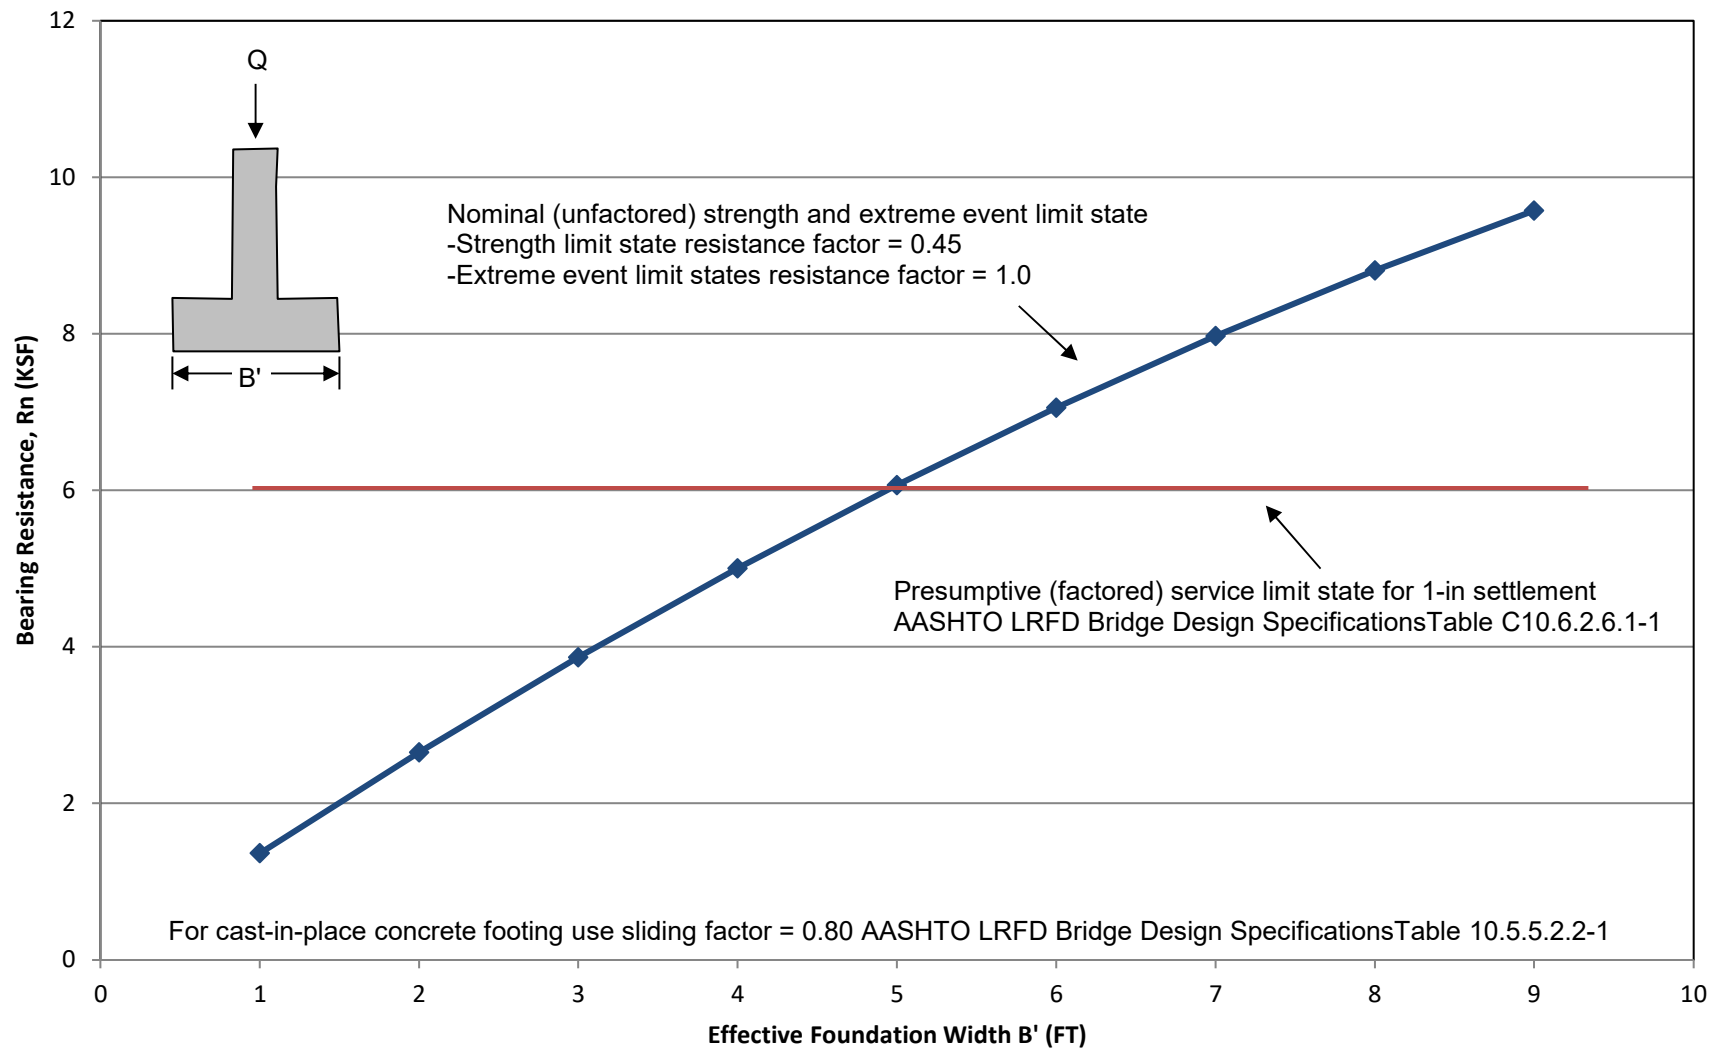
**PLATE 11 - Bearing Resistance for Site 2 Wingwalls**

## EFFECTIVE WIDTH vs. BEARING RESISTANCE (LRFD)

### Wingwalls (Site 2) - Lakeshore Road (NM FLAP SIE 10(1))

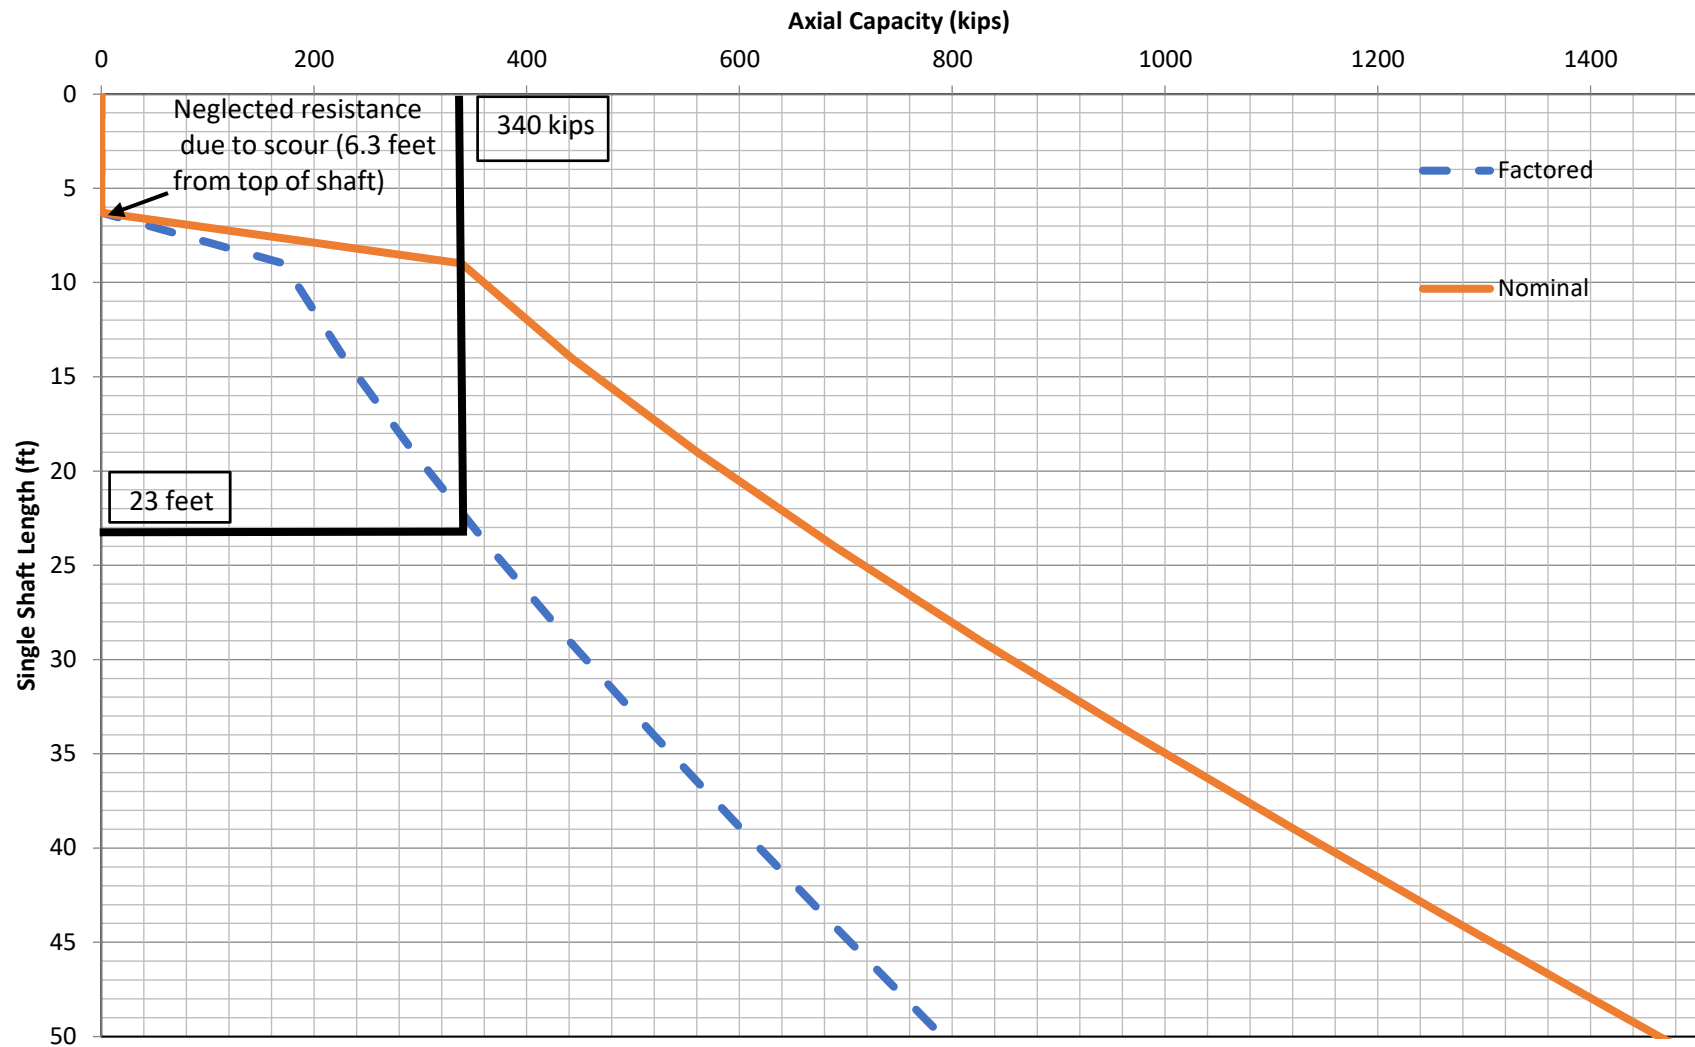
PLATE 12 - Axial Single Shaft Capacity, Lost Canyon Bridge Abutment 1 (Site 3)

# SINGLE SHAFT LENGTH vs. AXIAL CAPACITY (Strength Limit State) Bridge Abutment 1 (Site 3) - Lakeshore Road (NM FLAP SIE 10(1))

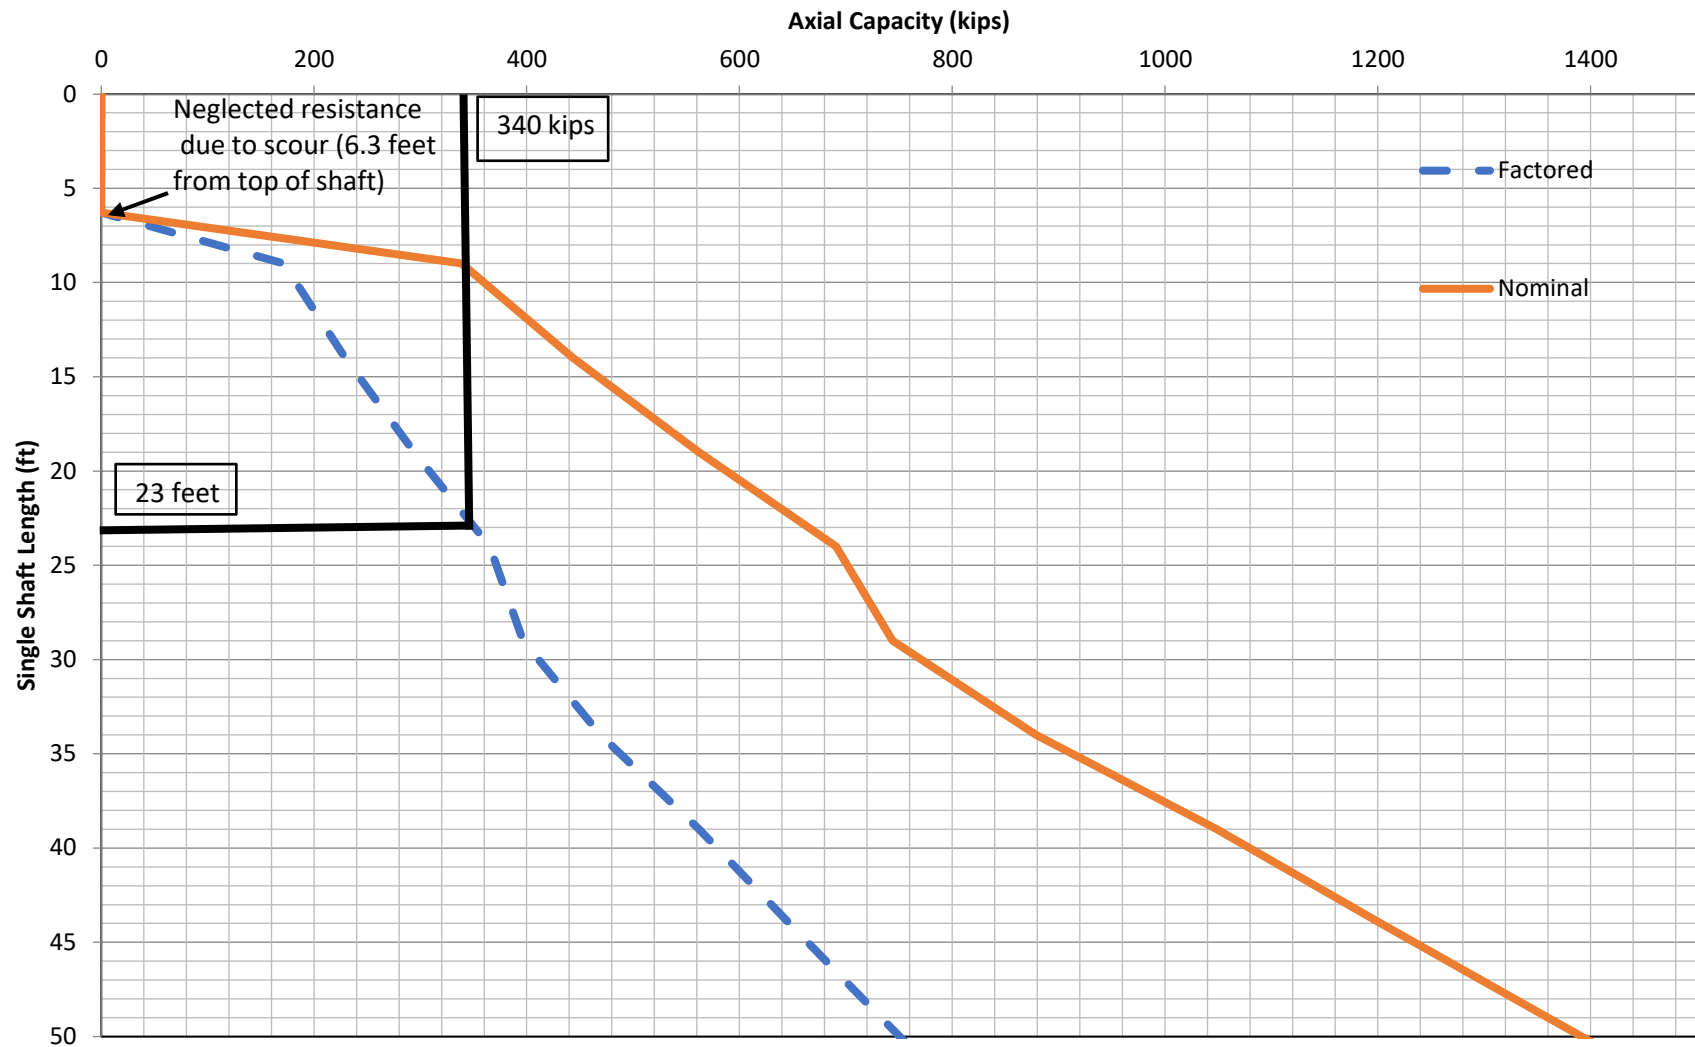
PLATE 13 - Axial Single Shaft Capacity, Lost Canyon Bridge Abutment 2 (Site 3)

# SINGLE SHAFT LENGTH vs. AXIAL CAPACITY (Strength Limit State) Bridge Abutment 2 (Site 3) - Lakeshore Road (NM FLAP SIE 10(1))

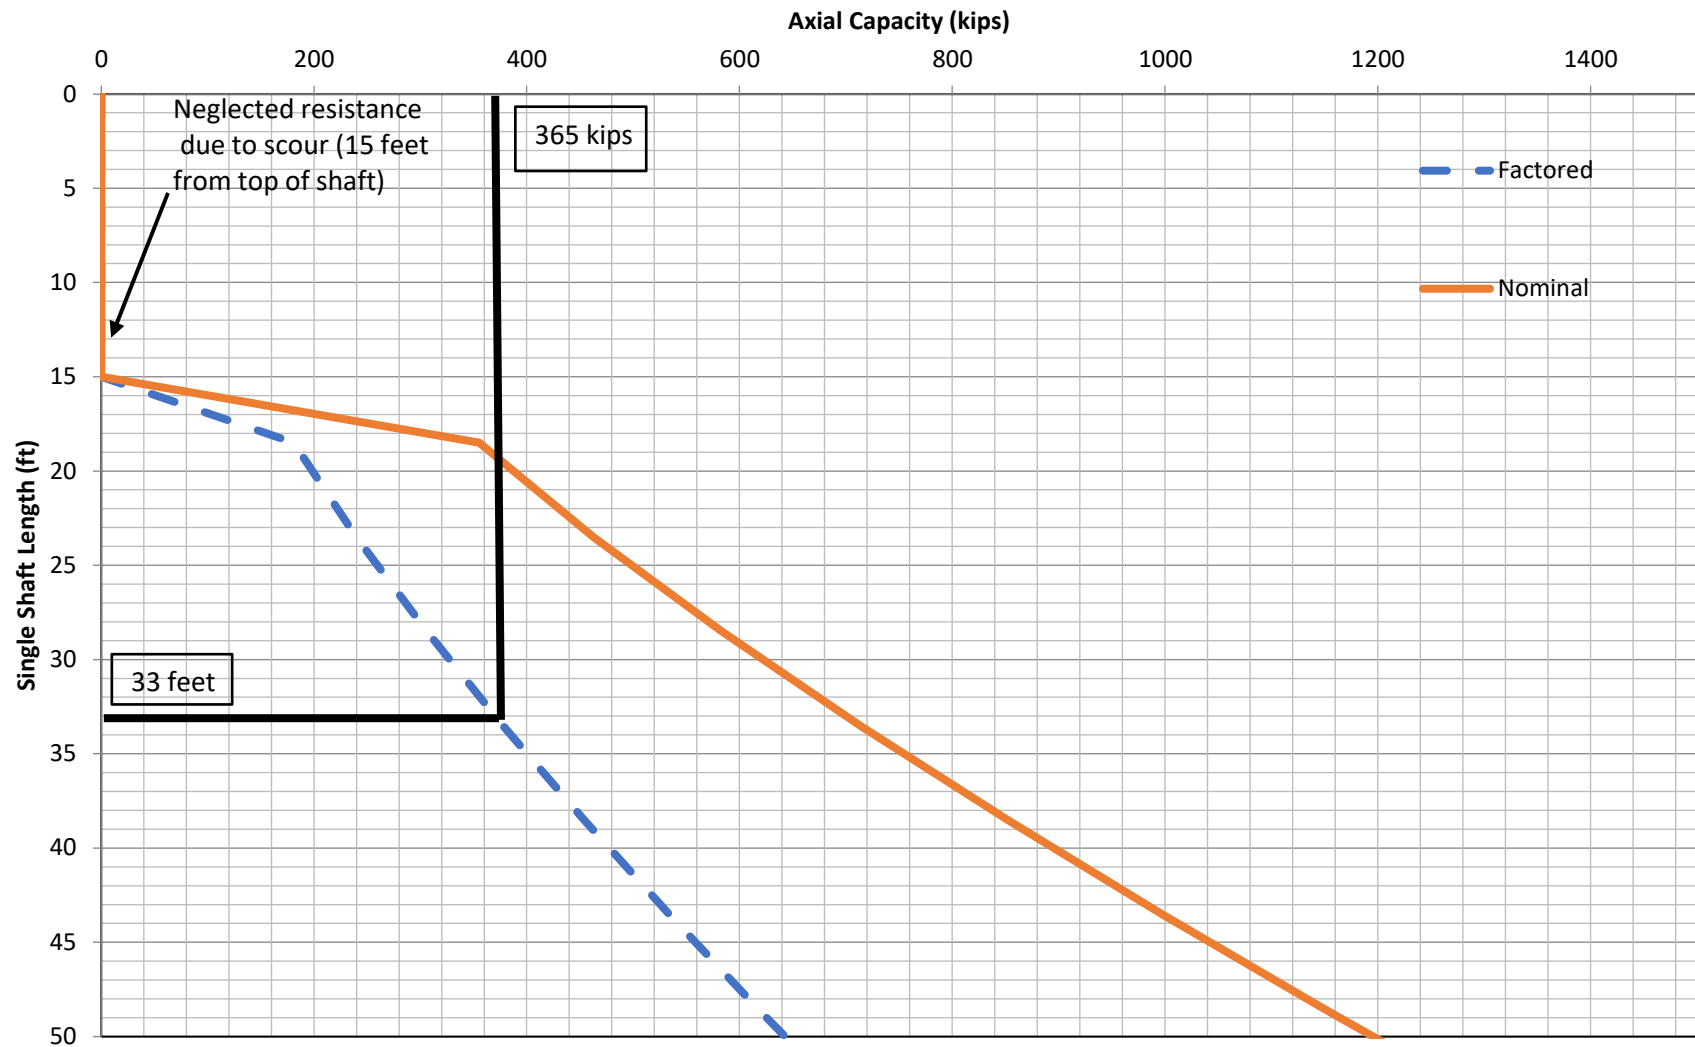
PLATE 14 - Axial Single Shaft Capacity, Cedar Canyon Bridge Abutment 1 (Site 4)

# SINGLE SHAFT LENGTH vs. AXIAL CAPACITY (Strength Limit State) Bridge Abutment 1 (Site 4) - Lakeshore Road (NM FLAP SIE 10(1))
