LAKESHORE ROAD  
ELEPHANT BUTTE STATE PARK  
SIERRA COUNTY, NM  
NM FLAP SIE 10(1)

FINAL Geotechnical Report

Prepared by  
Federal Highway Administration  
Central Federal Lands Highway Division

Geotechnical Services Branch  
June 2022

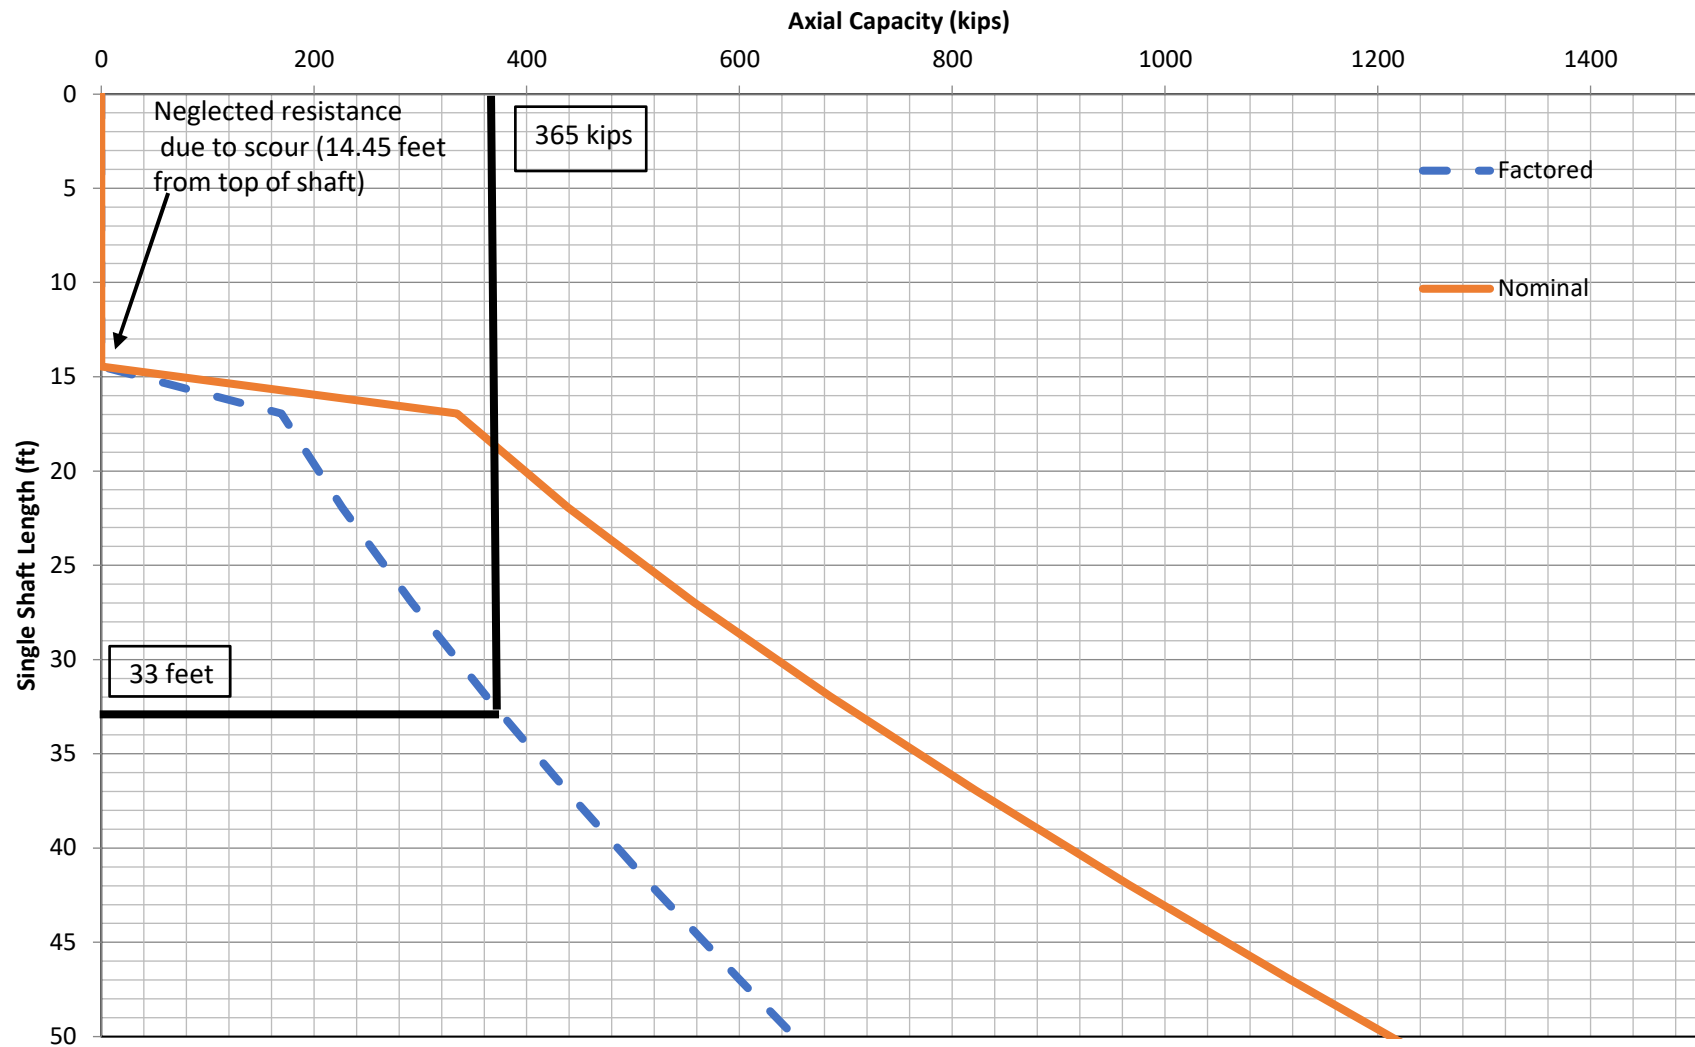
PLATE 15 - Axial Single Shaft Capacity, Cedar Canyon Bridge Abutment 2 (Site 4)

# SINGLE SHAFT LENGTH vs. AXIAL CAPACITY (Strength Limit State) Bridge Abutment 2 (Site 4) - Lakeshore Road (NM FLAP SIE 10(1))

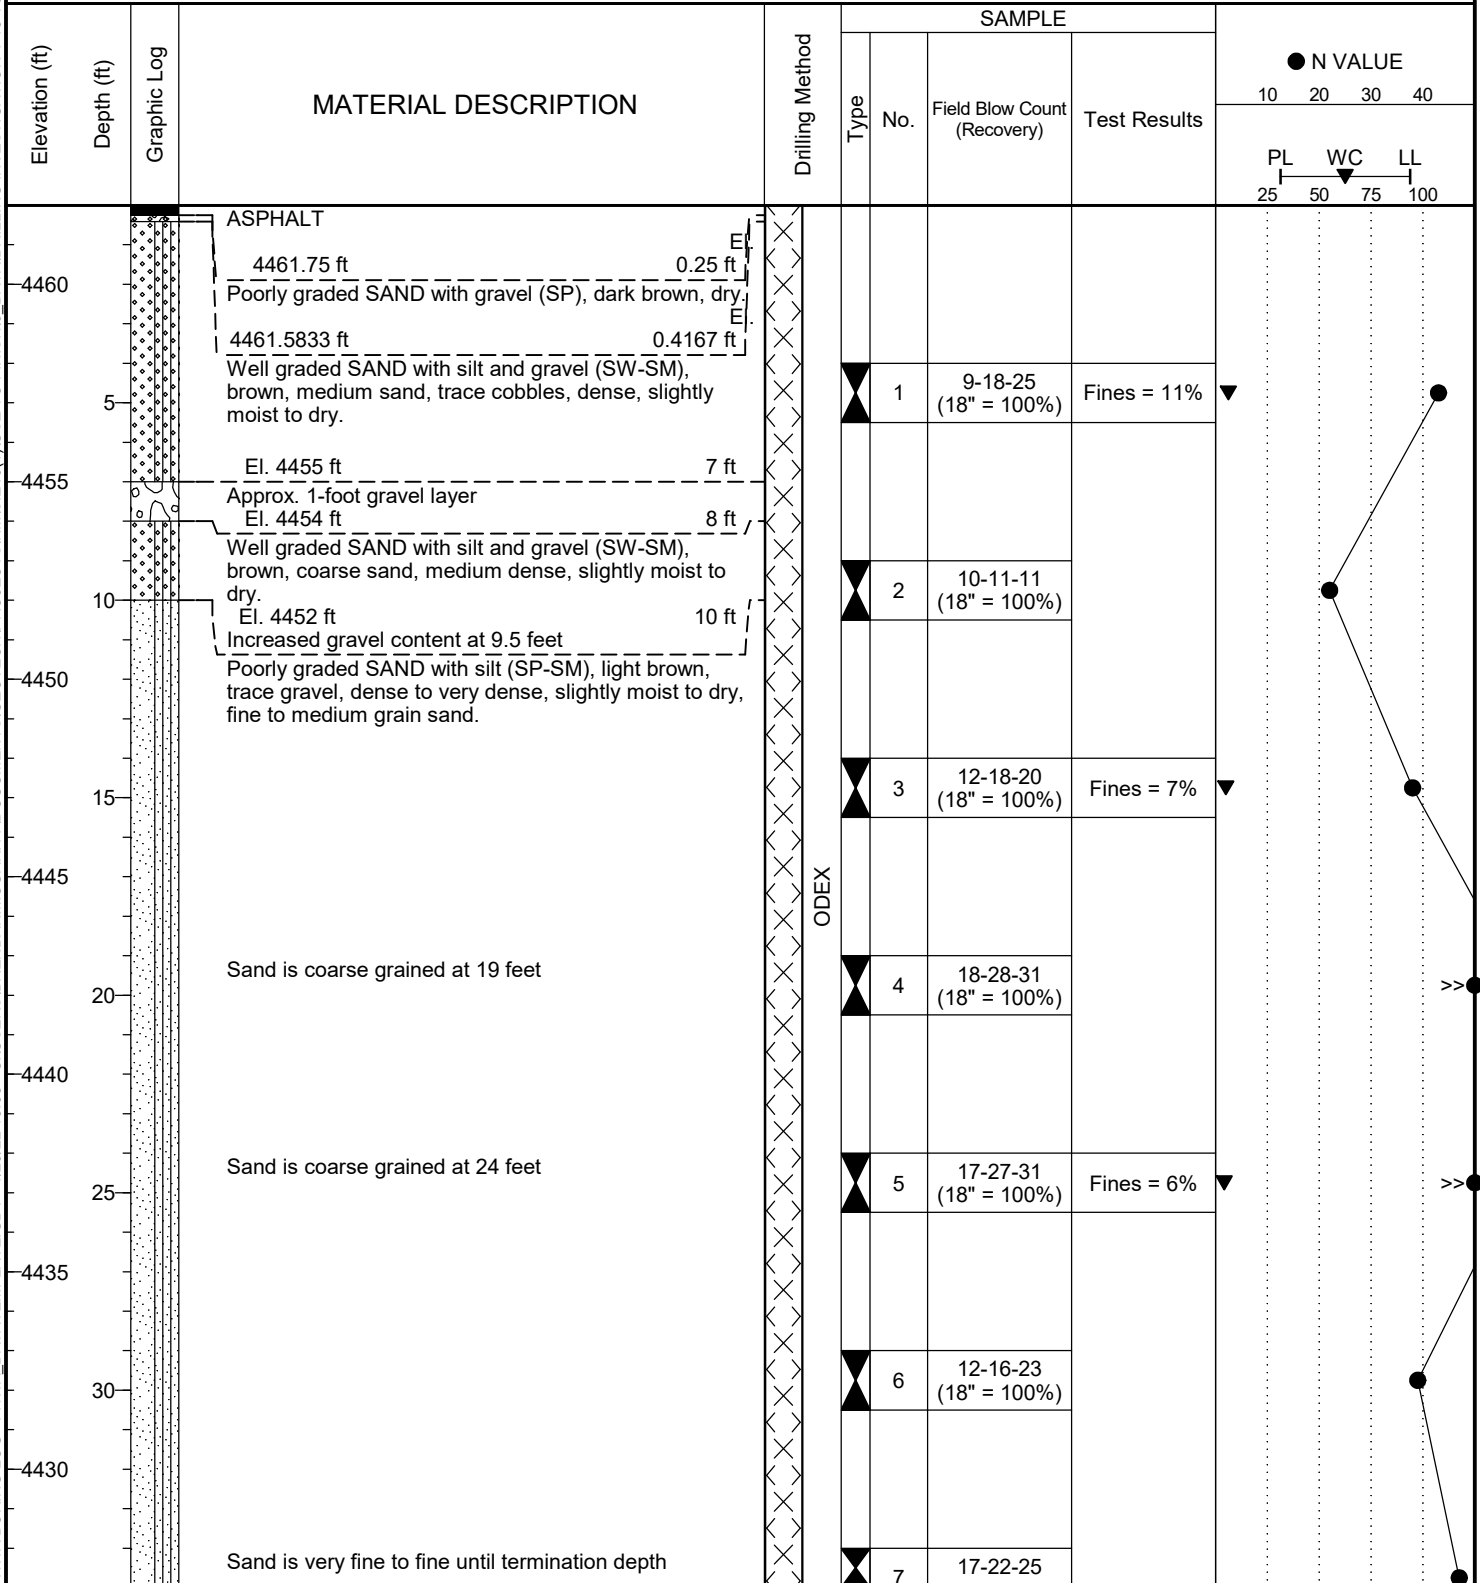
# BORING LOG BH21-02

Project Name: Lakeshore Road	Surface Elevation: 4462 ft	Sheet: 1 of 2
Project Location: Elephant Butte State Park, New Mexico	Station and Offset: 205+65.5 8 ft Lt.	
Groundwater Depth: ---	Date Started: 1/20/21	Date Completed: 1/20/21
While Drilling: ---	Driller/Company: Brian Schilling/Vine Laboratories	Drill: CME 55
At Completion: ---	Hammer Type: 140 lbs Automatic	Hammer Efficiency: 85 %
After Drilling: ---	Logger/Company: B. McGarity/FHWA-CFL	
Notes: For lab testing, select soil samples of similar composition were combined. The testing results presented in these logs are shown for the highest depth of those samples.	Weather: 45F, cloudy

The subsurface conditions at Site 2, proposed double box culvert location, were investigated by drilling boring BH21-02. ODEX drilling was used from 0 to 39 feet. Similar to Site 1 subsurface conditions, the ground surface consisted of silt, sand, gravel, and cobbles. Additionally, weak to moderately cemented sand layers were observed near the roadway surface. The boring encountered medium dense, well graded silty sand to a depth of approximately 10 feet, with a 1-foot-thick gravel layer at 7 feet. The soil then transitioned to dense silty sand with trace gravel and extended to the termination depth of approximately 39 feet. The subsurface conditions at Site 2 were also investigated by drilling boring P-2. Hollow stem auger drilling was used from 0 to 5 feet. The boring encountered silty sand with gravel to the termination depth. Neither groundwater nor bedrock was encountered in boring BH21-02 or P-2.

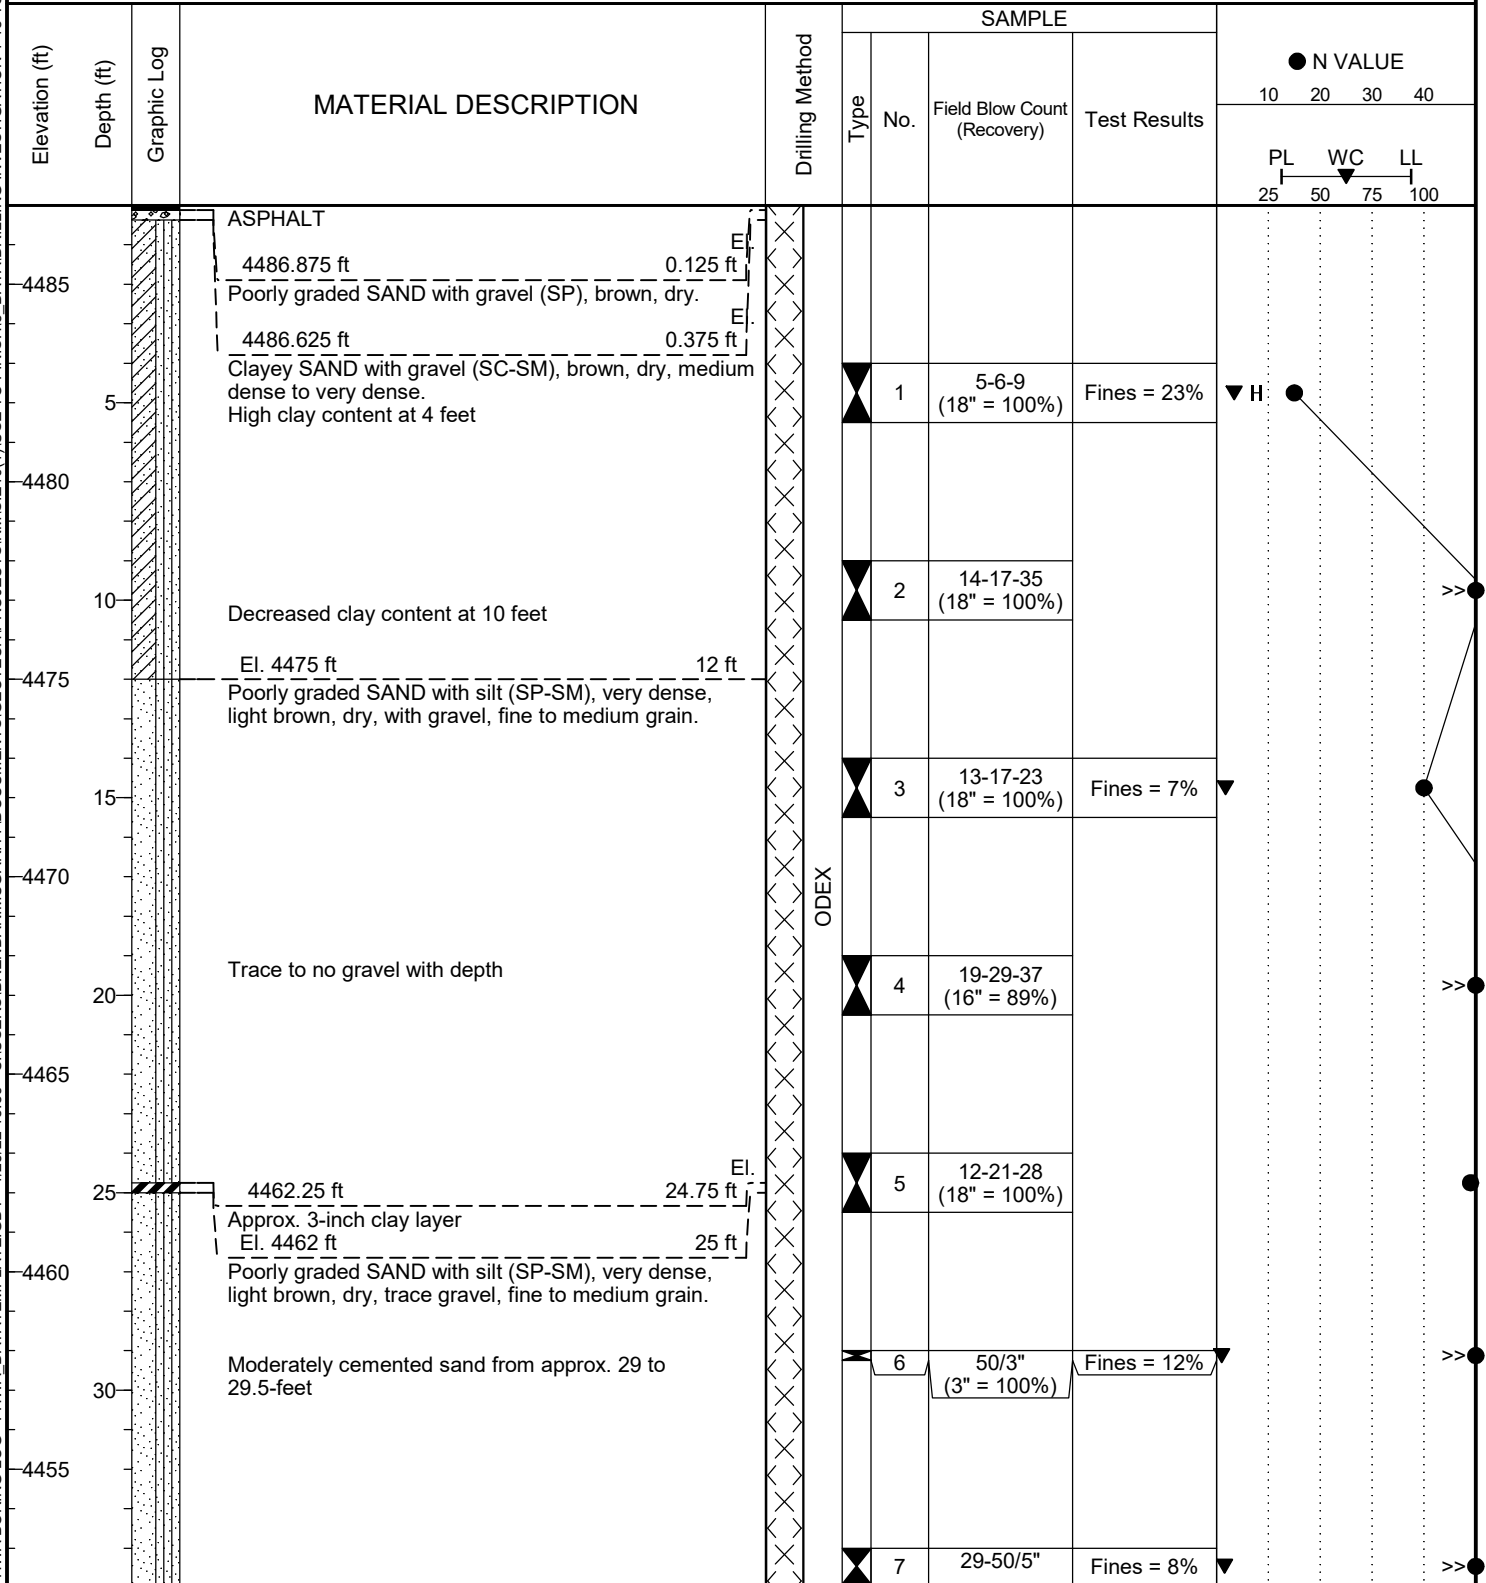
# BORING LOG BH21-03

Project Name: Lakeshore Road	Surface Elevation: 4487 ft	Sheet: 1 of 3
Project Location: Elephant Butte State Park, New Mexico	Station and Offset: 309+10 8 ft Rt.	
Groundwater Depth:	Date Started: 1/20/21	Date Completed: 1/21/21
While Drilling: ---	Driller/Company: Brian Schilling/Vine Laboratories	Drill: CME 55
At Completion: ---	Hammer Type: 140 lbs Automatic	Hammer Efficiency: 85 %
After Drilling: ---	Logger/Company: B. McGarity/FHWA-CFL	
Notes:	Weather: 39F, snow, cloudy	
For lab testing, select soil samples of similar composition were combined. The testing results presented in these logs are shown for the highest depth of those samples.

The subsurface conditions at Site 3, south abutment of proposed bridge location, were investigated by drilling boring BH21-03. ODEX drilling was used from approximately 0 to 59 feet, where the casing locked up and could no longer advance. Hollow stem auger drilling was then used to the termination depth of approximately 100 ft. The ground surface surrounding the boring location consisted of silt, sand, gravel, and cobbles. Additionally, the downstream channel displayed weak

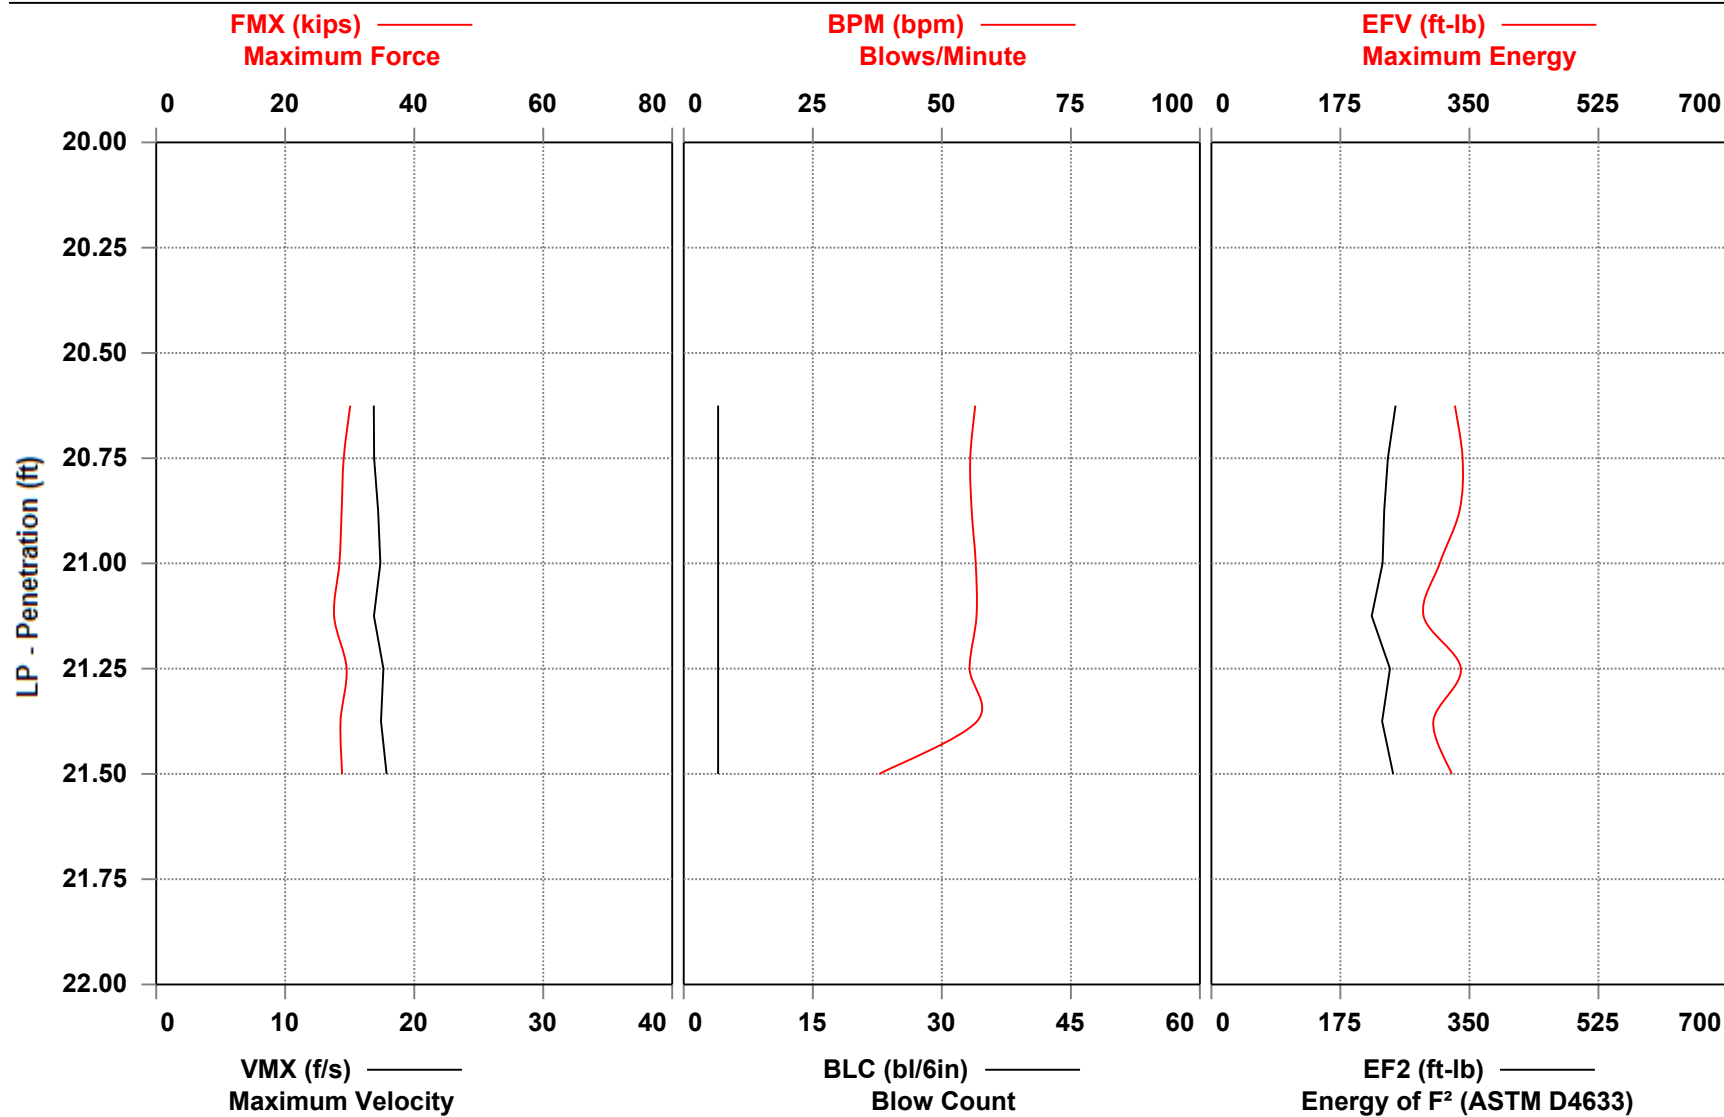
Case Method & iCAP® Results

CME 55 Serial Number 332955 - CME 55 at 20.0 to 21.5 feet

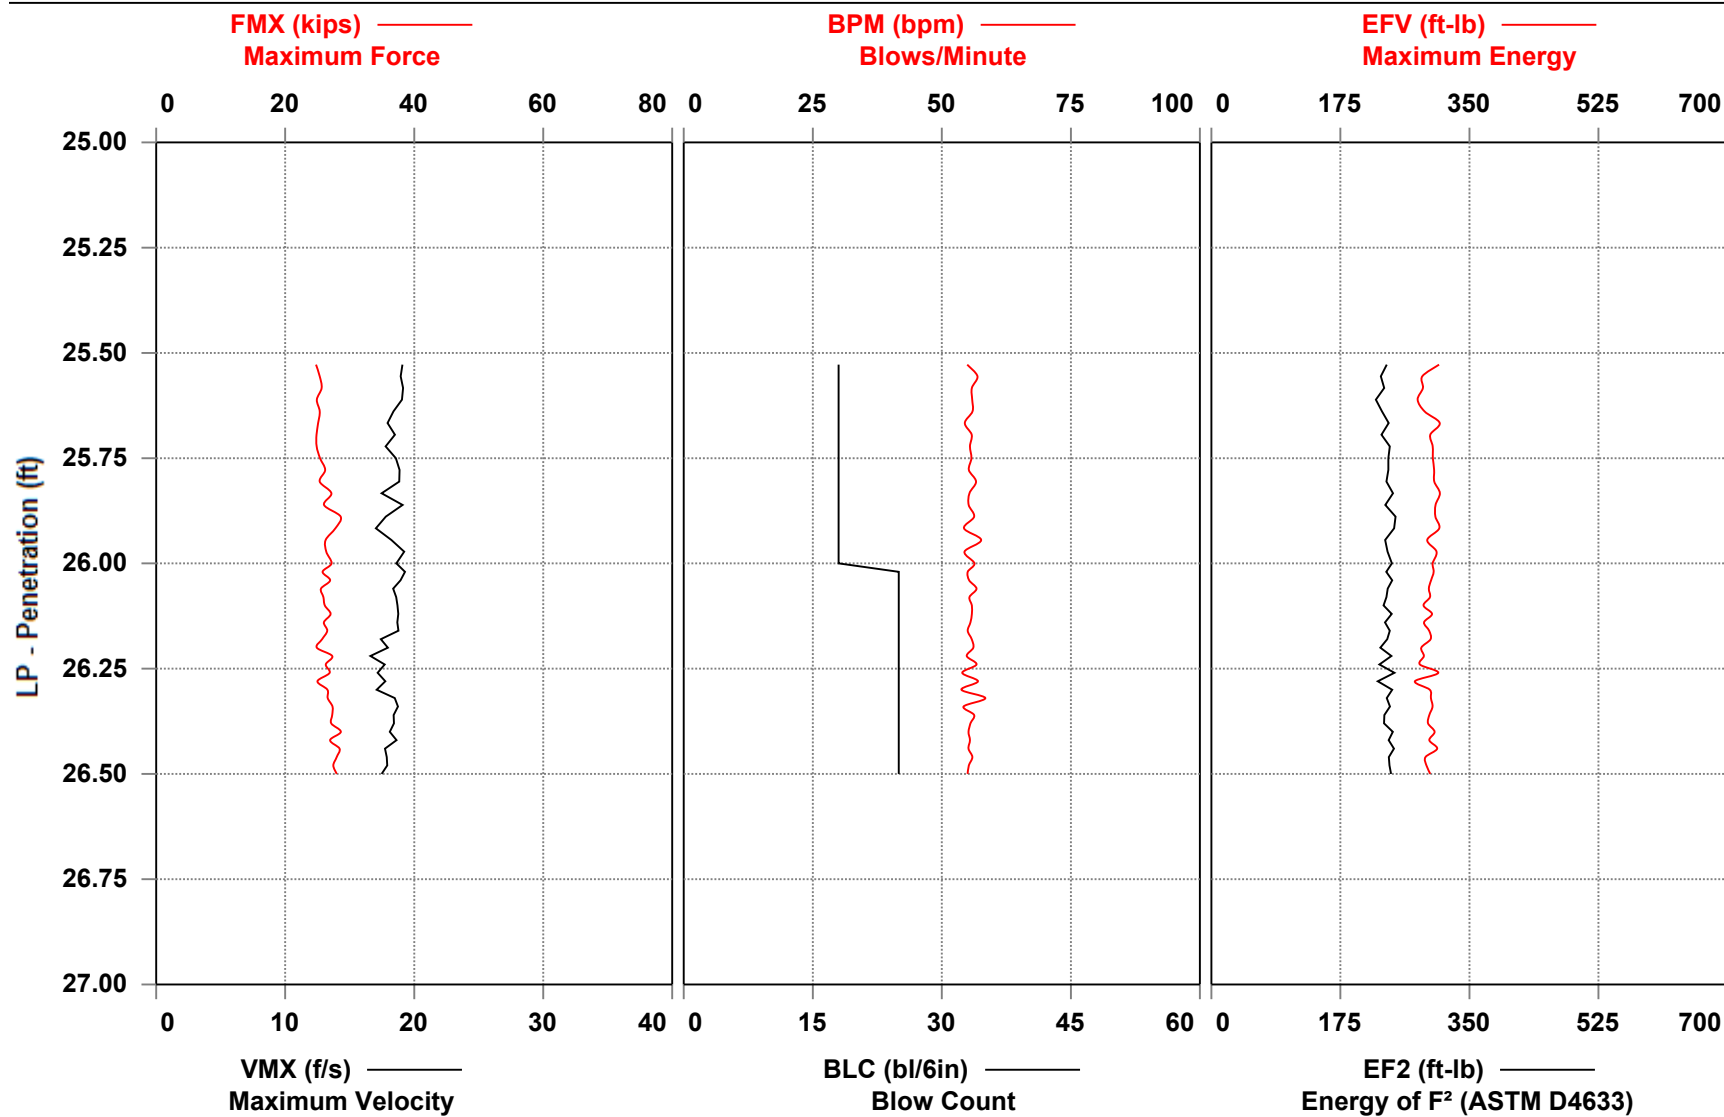
Case Method & iCAP® Results

CME 55 Serial Number 332955 - CME 55 at 25.0 to 26.5 feet

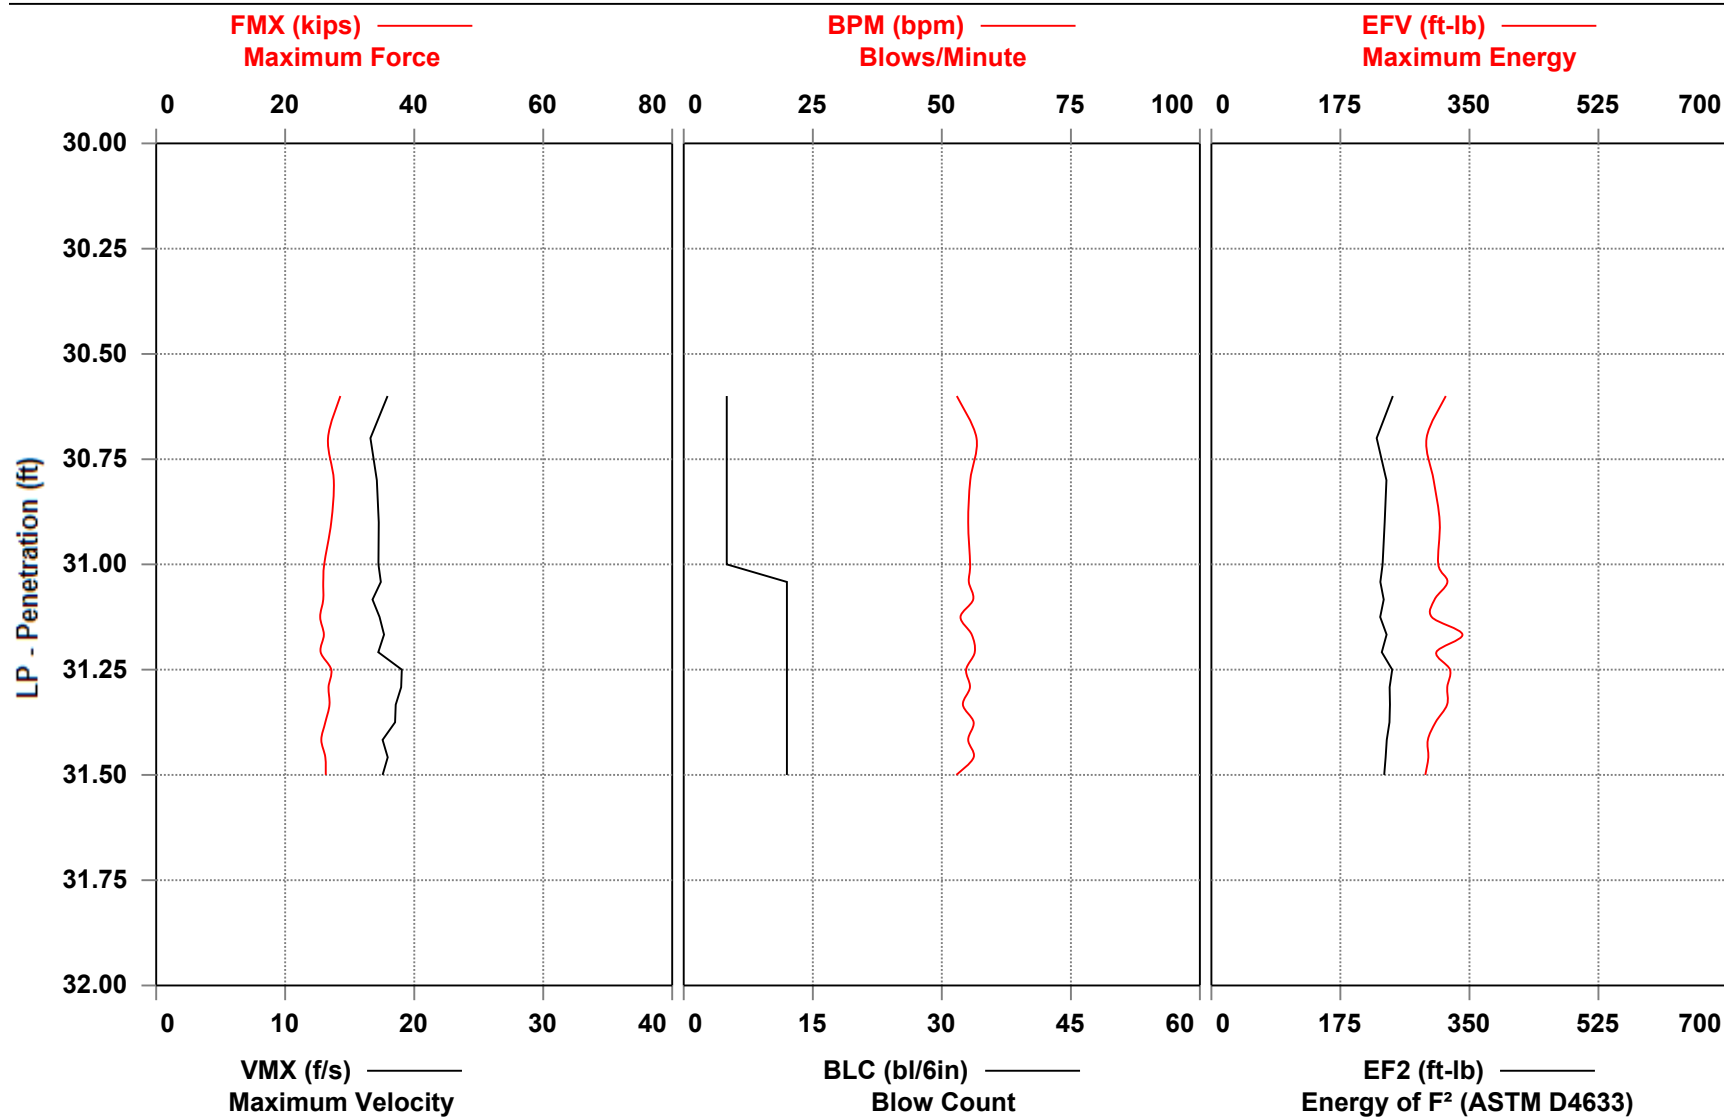
Case Method & iCAP® Results

CME 55 Serial Number 332955 - CME 55 at 30.0 to 31.5 feet

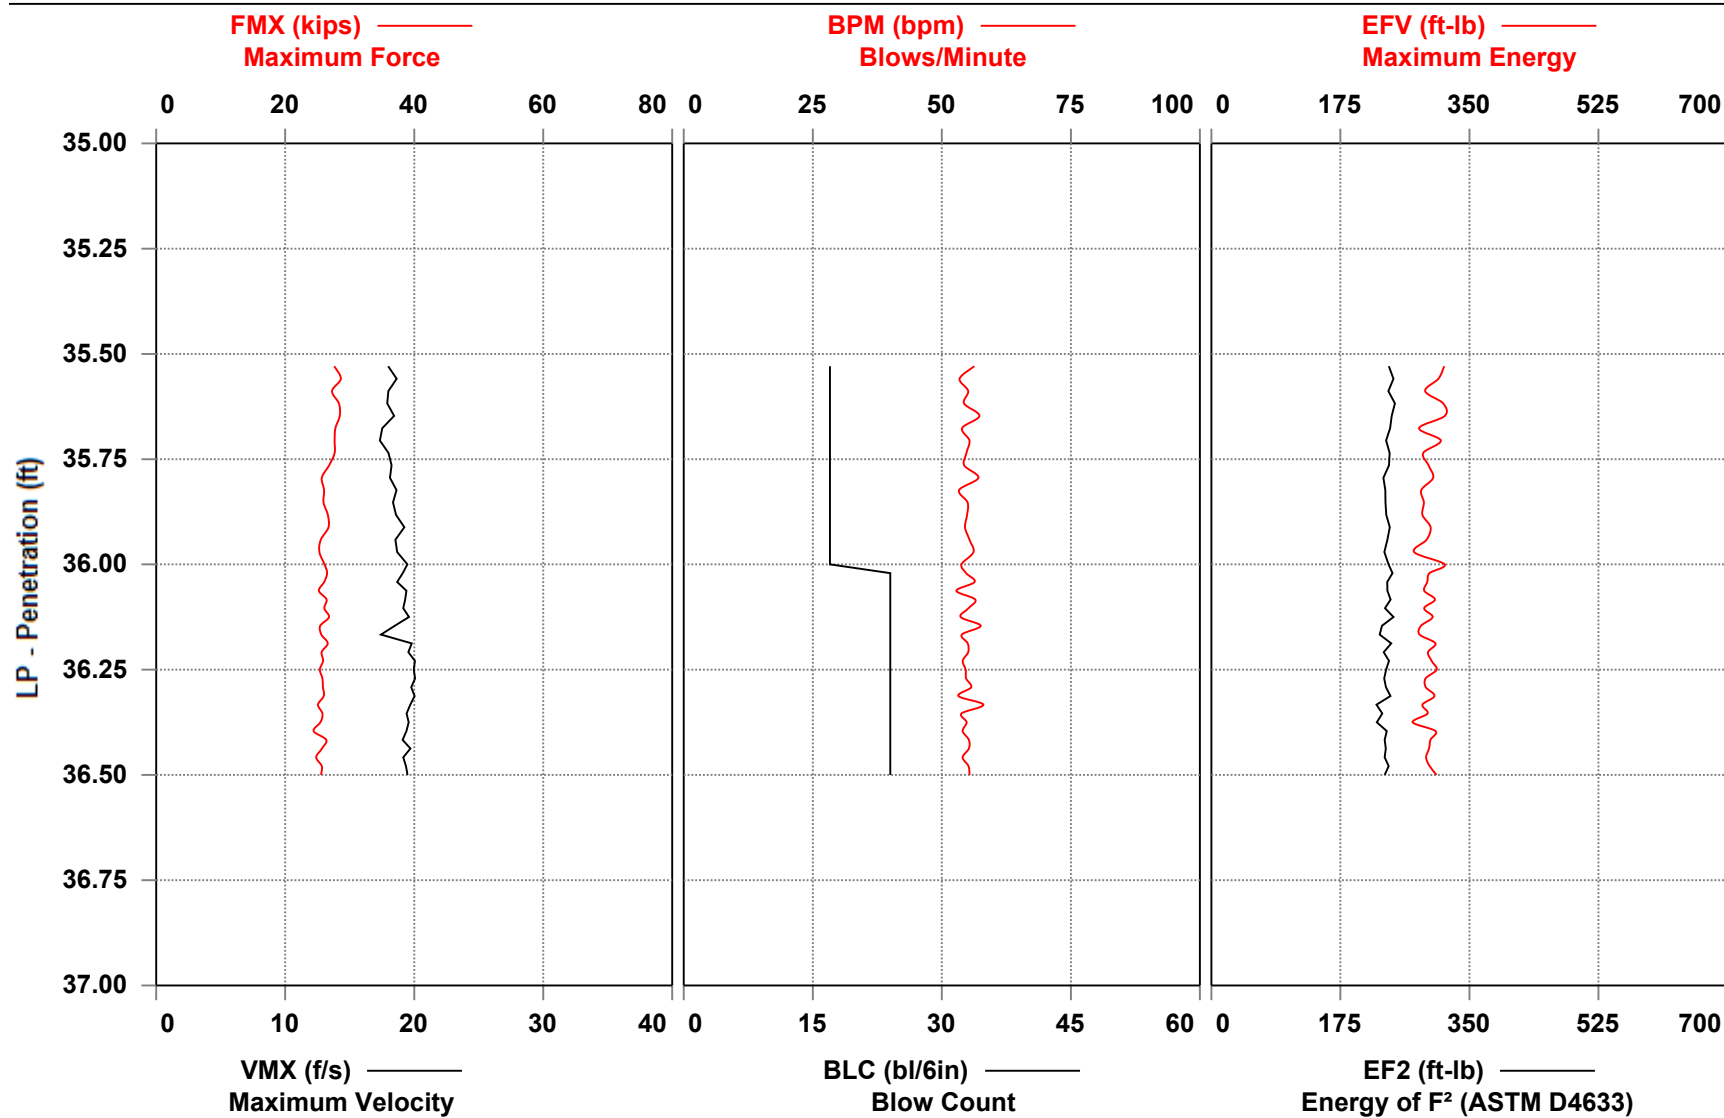
Case Method & iCAP® Results

CME 55 Serial Number 332955 - CME 55 at 35.0 to 36.5 feet

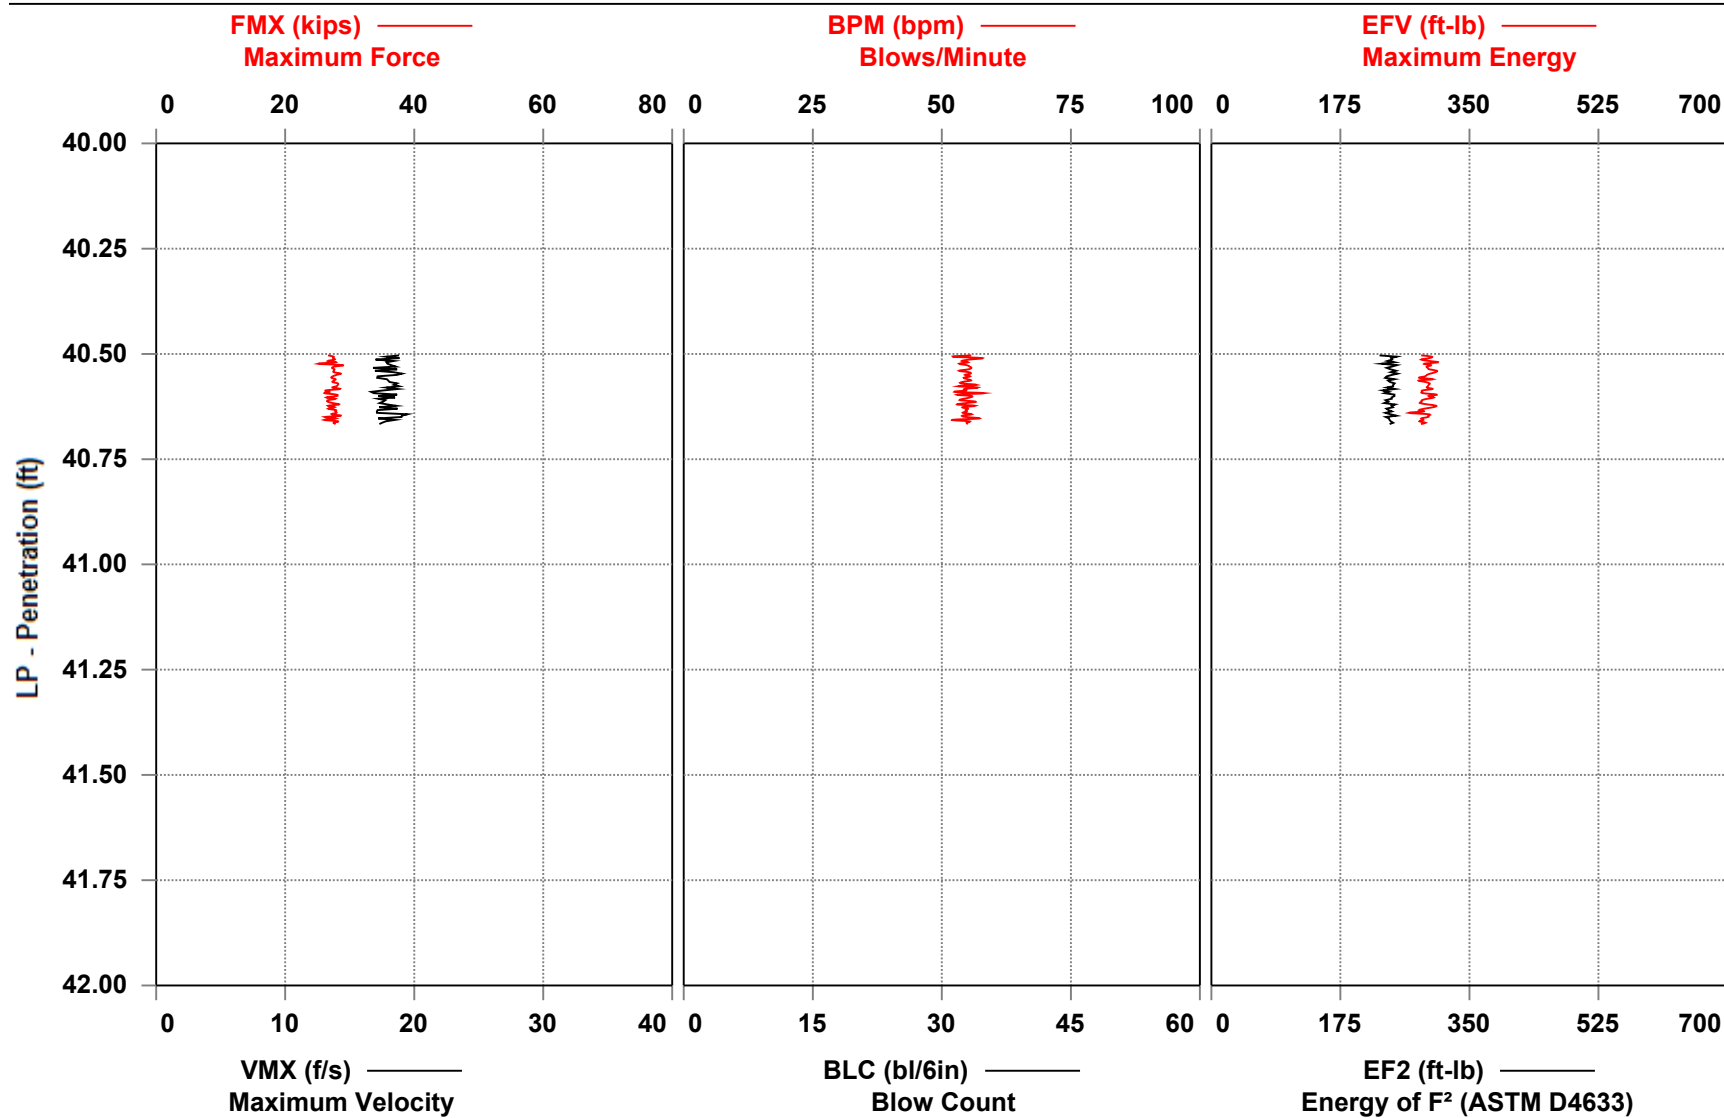
Case Method & iCAP® Results

CME 55 Serial Number 332955 - CME 55 at 40.0 to 40.7 feet

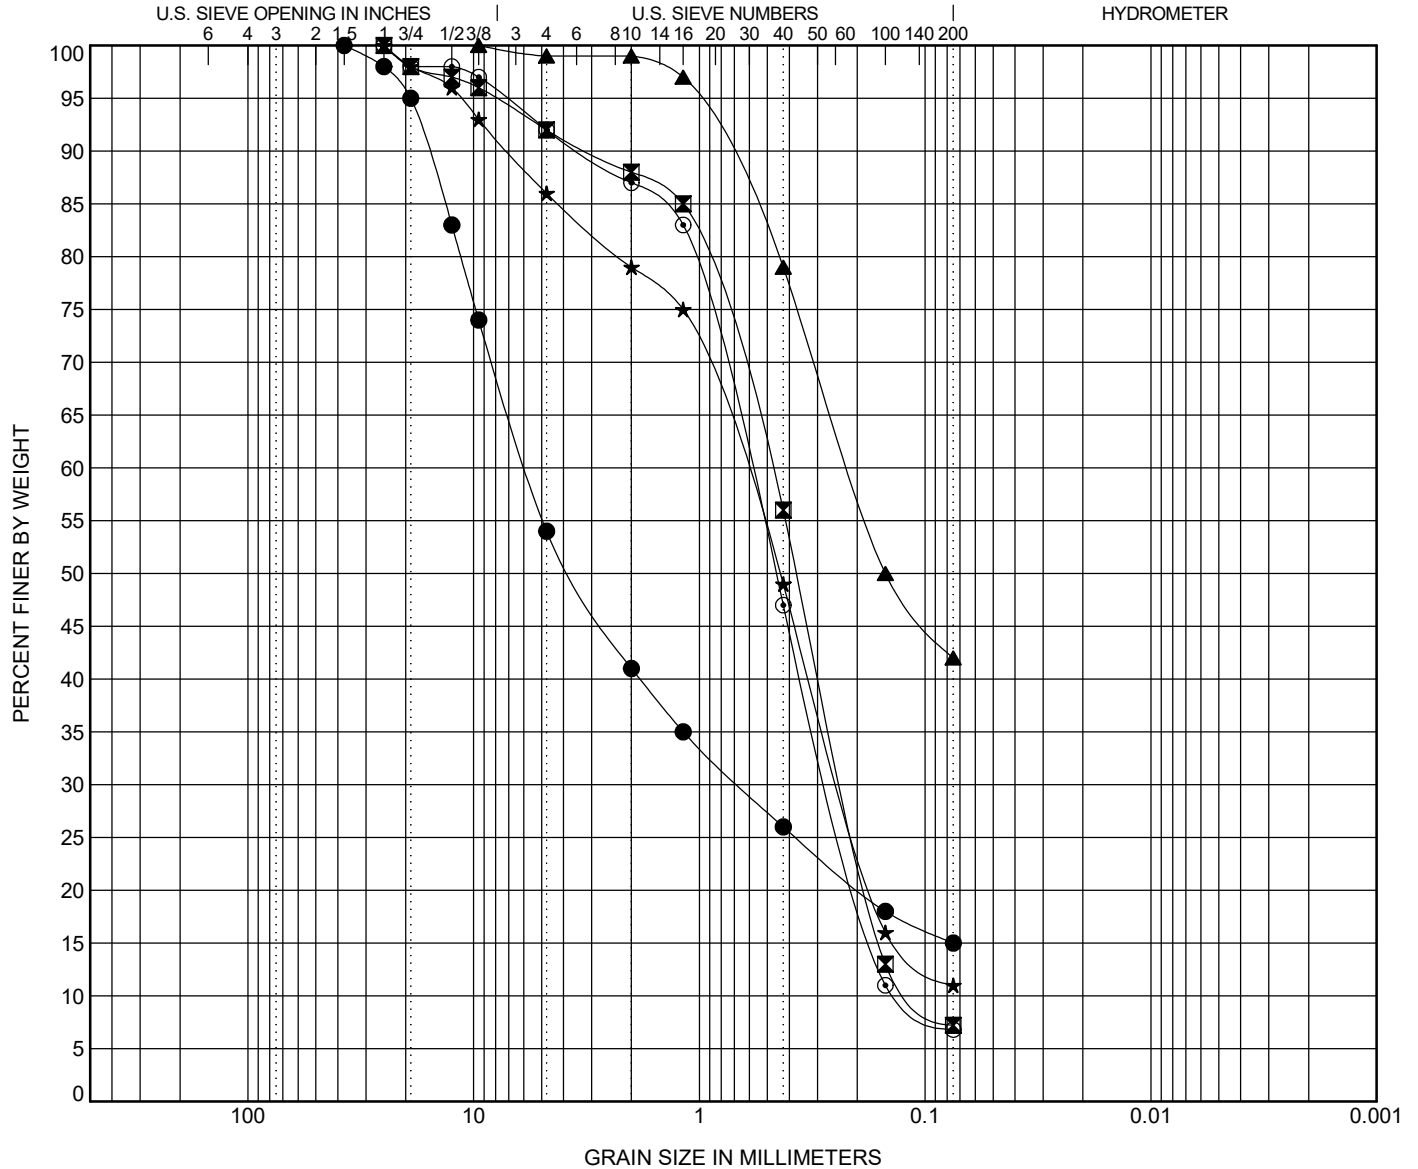
## GRAIN SIZE DISTRIBUTION

BOREHOLE	DEPTH	Classification					LL	PL	PI	Cc	Cu
● BH21-01 (P-1)	2.0	CLAYEY GRAVEL with SAND(GC)					29	14	15		
☒ BH21-01 (P-1)	10.0									1.00	4.67
▲ BH21-01 (P-1)	15.0										
★ BH21-02	4.0									1.27	10.03
⊙ BH21-02	14.0									0.86	4.83
BOREHOLE	DEPTH	D100	D60	D30	D10	%Gravel	%Sand	%Silt		%Clay	
● BH21-01 (P-1)	2.0	37.5	5.848	0.669		46.0	39.0	15.0			
☒ BH21-01 (P-1)	10.0	25	0.489	0.226	0.105	8.0	84.8	7.2			
▲ BH21-01 (P-1)	15.0	9.5	0.215			1.0	57.0	42.0			
★ BH21-02	4.0	25	0.655	0.233		14.0	75.0	11.0			
⊙ BH21-02	14.0	25	0.615	0.26	0.127	8.0	85.2	6.8

Soil samples recovered from the borings by SPT were tested in the laboratory to support the field classifications and to provide an estimate of the engineering characteristics and mechanical properties of the soil. Laboratory tests included moisture content (AASHTO T255), sieve analysis (AASHTO T 11 and T27), classification (AASHTO M145 and ASTM D 2487), and Atterberg limits (AASHTO T89 and T90). When the necessary tests were completed, samples were classified using the Unified Soil Classification System (USCS) and AASHTO soil classification system. Results of the testing are summarized below in Table 3.2 and are presented in Appendix B.

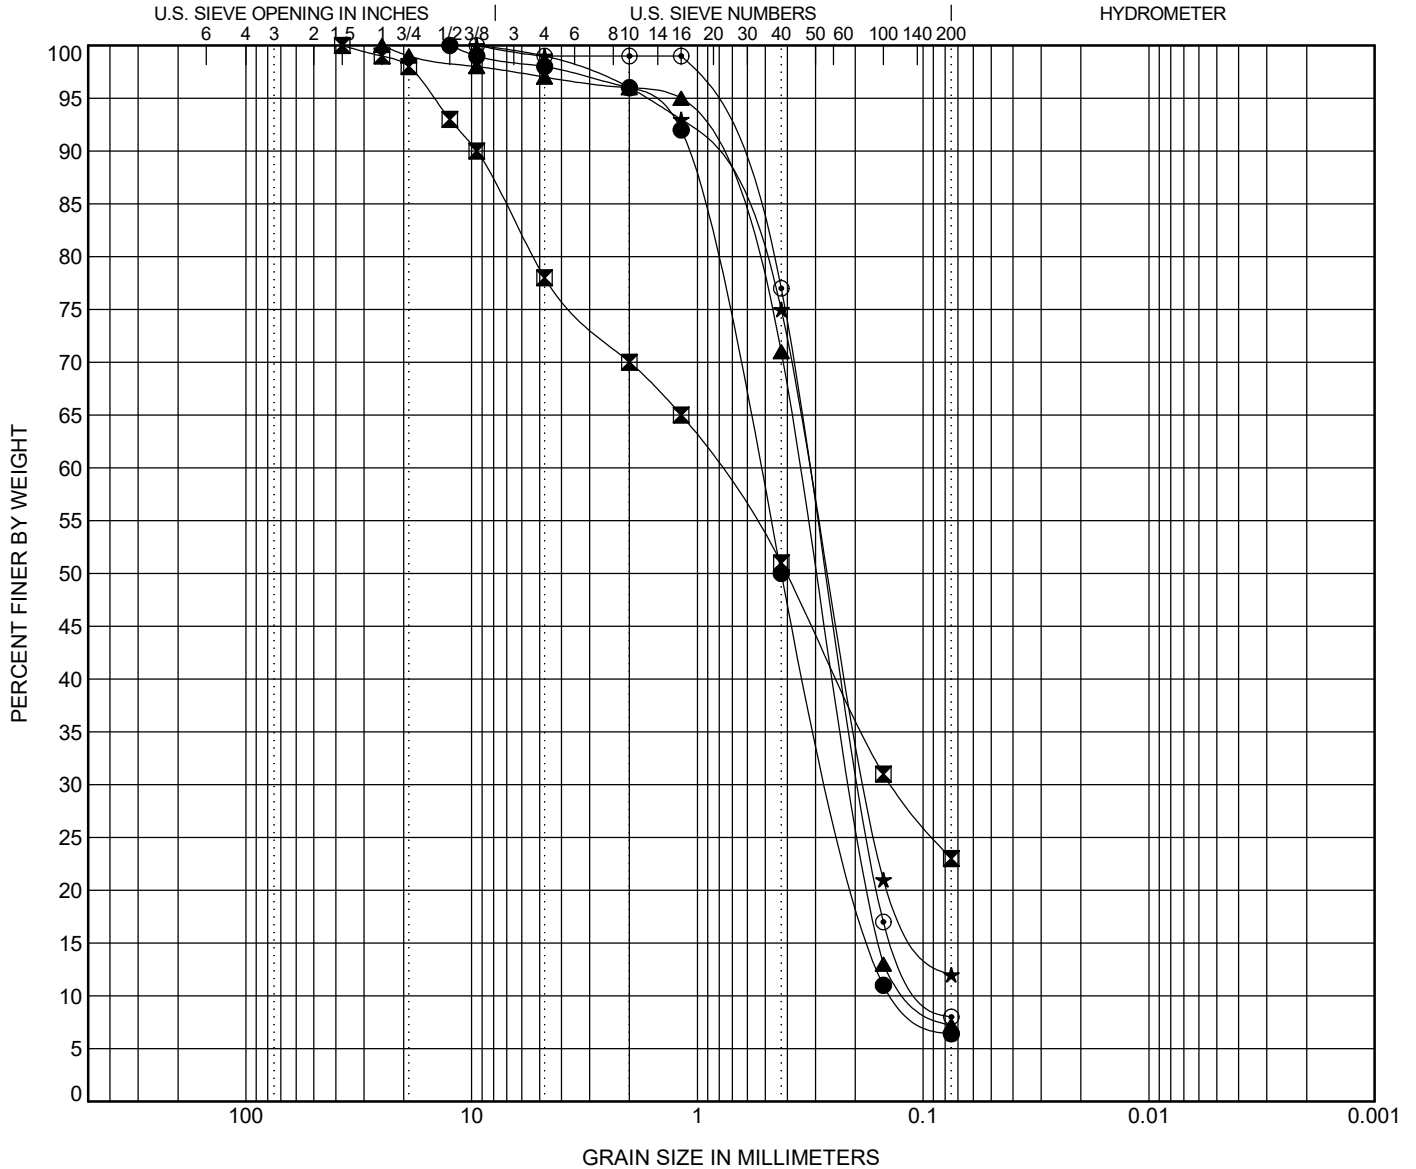
## GRAIN SIZE DISTRIBUTION

BOREHOLE	DEPTH	Classification					LL	PL	PI	Cc	Cu
● BH21-02	24.0									0.89	4.20
☒ BH21-03	4.0	SILTY, CLAYEY SAND with GRAVEL(SC-SM)					21	17	4		
▲ BH21-03	14.0									1.13	3.33
★ BH21-03	29.0									1.56	4.95
⊙ BH21-03	34.0									1.28	3.62
BOREHOLE	DEPTH	D100	D60	D30	D10	%Gravel	%Sand	%Silt		%Clay	
● BH21-02	24.0	12.5	0.542	0.249	0.129	2.0	91.6	6.4			
☒ BH21-03	4.0	37.5	0.819	0.138		22.0	55.0	23.0			
▲ BH21-03	14.0	25	0.349	0.204	0.105	3.0	89.8	7.2			
★ BH21-03	29.0	9.5	0.318	0.178		1.0	87.0	12.0			
⊙ BH21-03	34.0	9.5	0.316	0.188	0.087	1.0	91.0	8.0

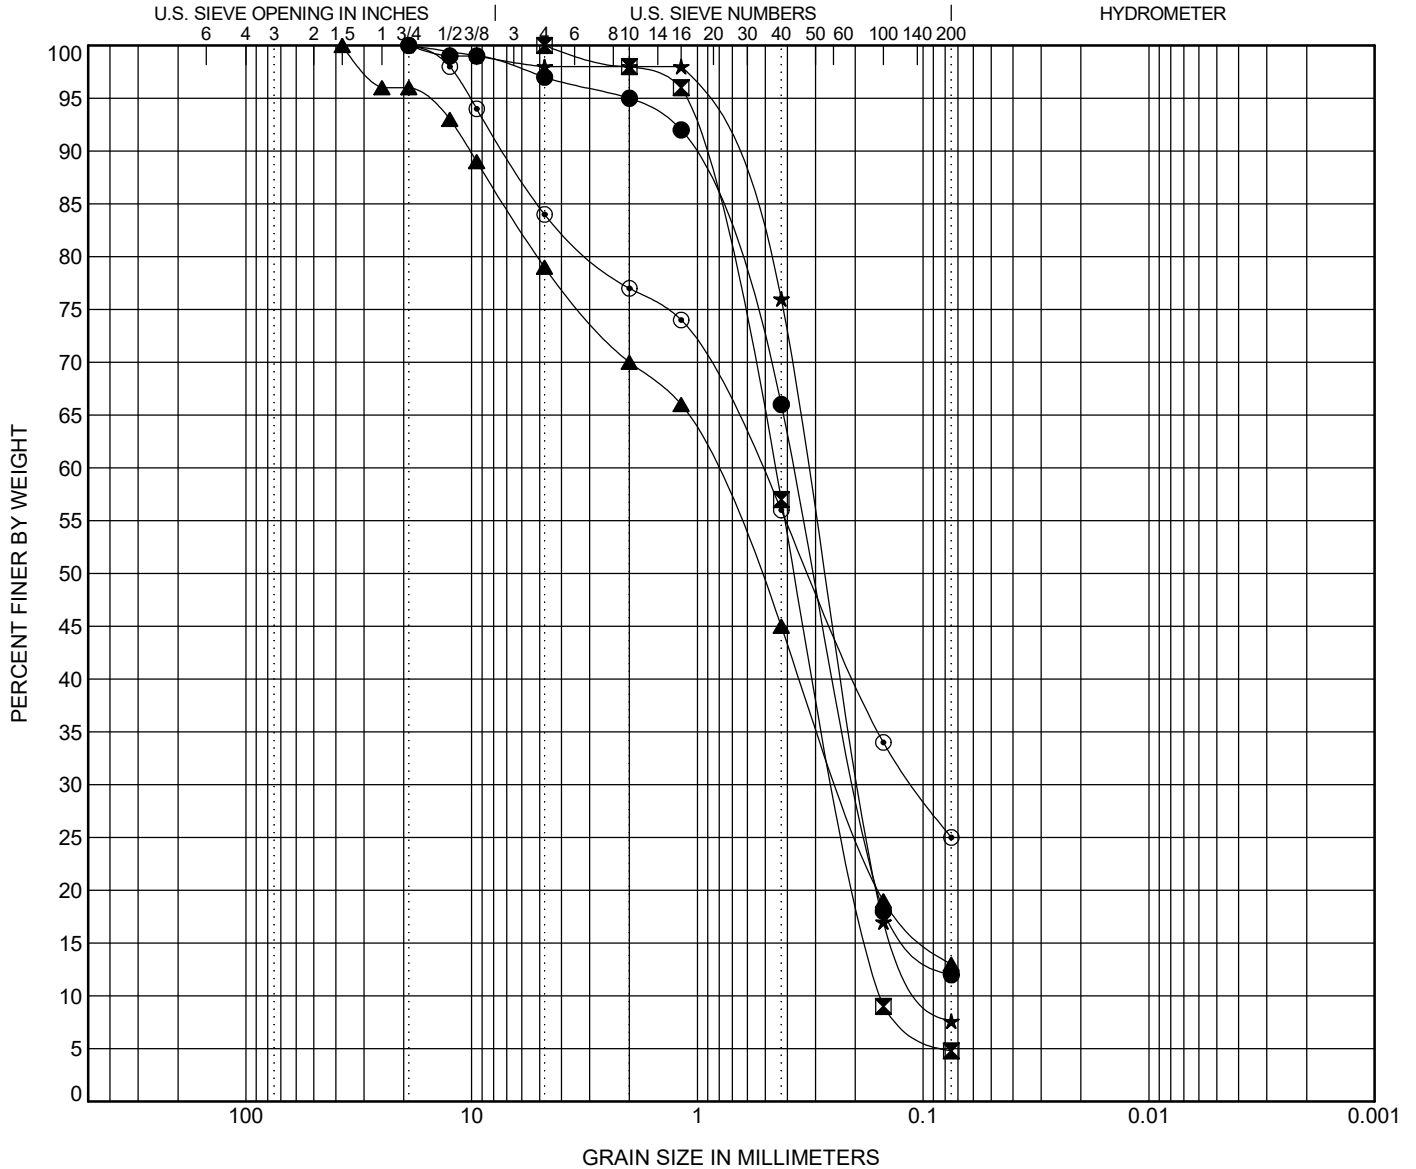
## GRAIN SIZE DISTRIBUTION

BOREHOLE	DEPTH	Classification					LL	PL	PI	Cc	Cu
● BH21-03	59.0									1.71	6.27
☒ BH21-03	80.0	POORLY GRADED SAND(SP)								0.79	3.00
▲ BH21-04	9.0										
★ BH21-04	19.0									1.24	3.58
◎ BH21-04	29.0										
BOREHOLE	DEPTH	D100	D60	D30	D10	%Gravel	%Sand	%Silt		%Clay	
● BH21-03	59.0	19	0.373	0.195		3.0	85.0	12.0			
☒ BH21-03	80.0	4.75	0.46	0.237	0.153	0.0	95.2	4.8			
▲ BH21-04	9.0	37.5	0.881	0.233		21.0	66.0	13.0			
★ BH21-04	19.0	19	0.32	0.189	0.09	2.0	90.4	7.6			
◎ BH21-04	29.0	19	0.533	0.11		16.0	59.0	25.0
