LAKESHORE ROAD  
ELEPHANT BUTTE STATE PARK  
SIERRA COUNTY, NM  
NM FLAP SIE 10(1)

FINAL Geotechnical Report

Prepared by  
Federal Highway Administration  
Central Federal Lands Highway Division

Geotechnical Services Branch  
June 2022

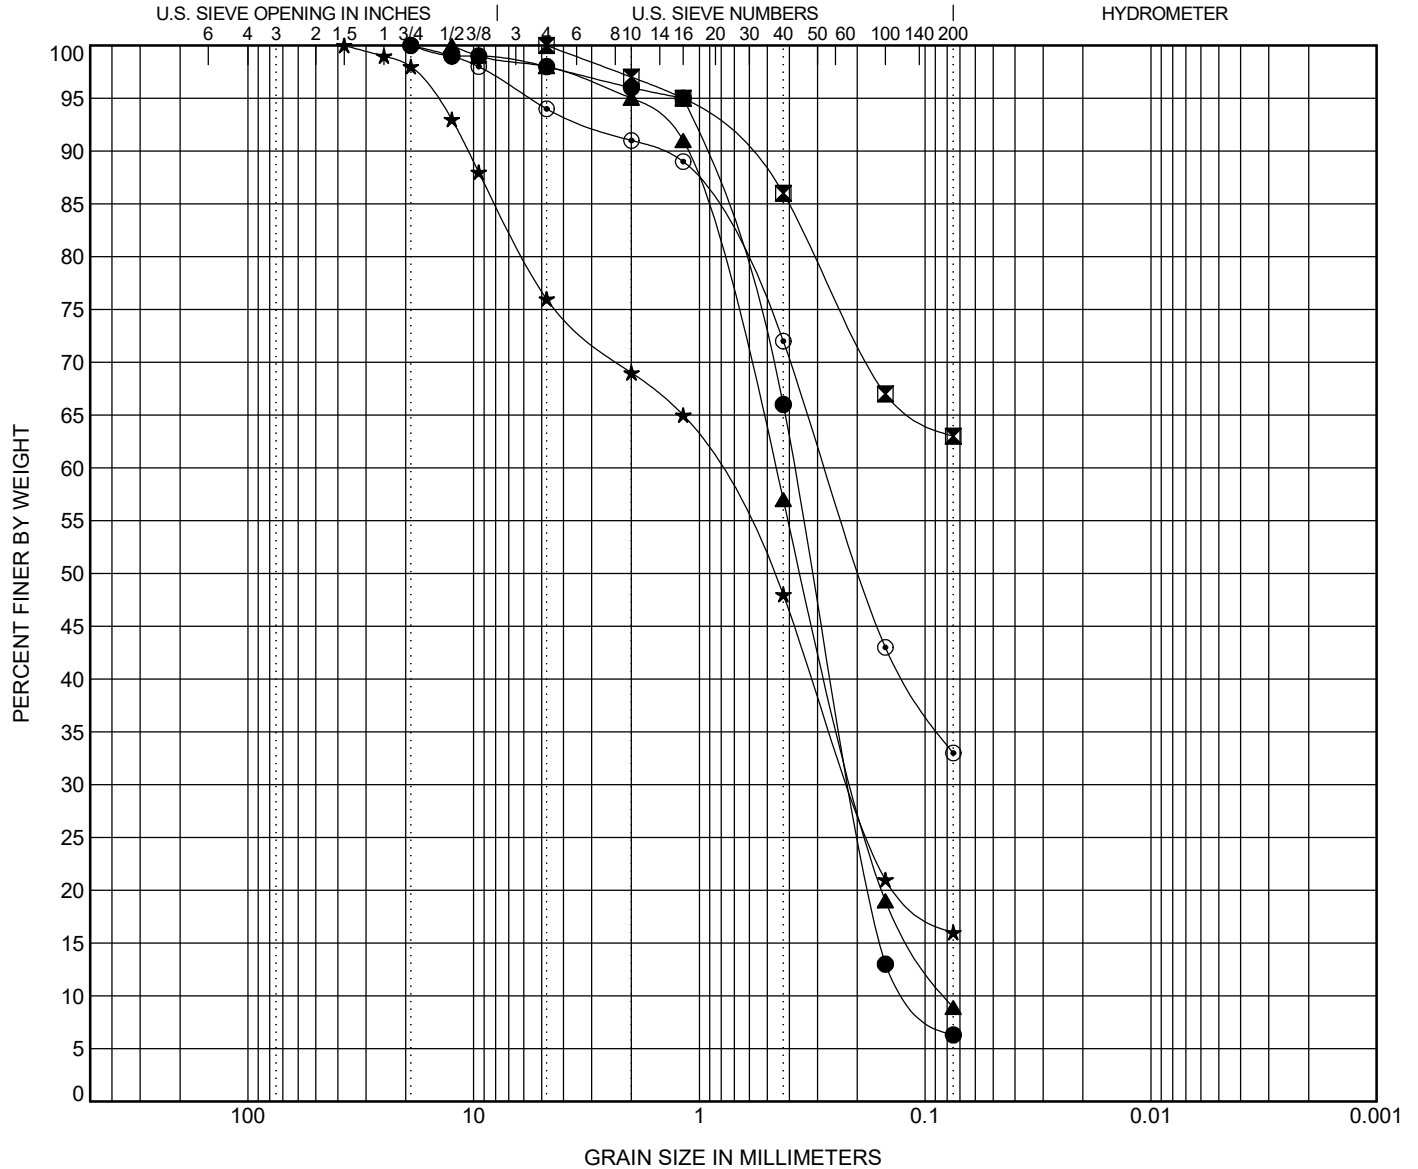
## GRAIN SIZE DISTRIBUTION

BOREHOLE	DEPTH	Classification					LL	PL	PI	Cc	Cu
● BH21-04	34.0									1.06	3.43
☒ BH21-04	39.0										
▲ BH21-04	74.0									1.09	5.75
★ BH21-05 (P-4)	2.0	SILTY, CLAYEY SAND with GRAVEL(SC-SM)					21	16	5		
⊙ BH21-05 (P-4)	5.0	SILTY, CLAYEY SAND(SC-SM)					23	18	5		
BOREHOLE	DEPTH	D100	D60	D30	D10	%Gravel	%Sand	%Silt		%Clay	
● BH21-04	34.0	19	0.378	0.209	0.11	2.0	91.7	6.3			
☒ BH21-04	39.0	4.75				0.0	37.0	63.0			
▲ BH21-04	74.0	12.5	0.465	0.203	0.081	2.0	89.1	8.9			
★ BH21-05 (P-4)	2.0	37.5	0.874	0.212		24.0	60.0	16.0			
⊙ BH21-05 (P-4)	5.0	19	0.276			6.0	61.0	33.0

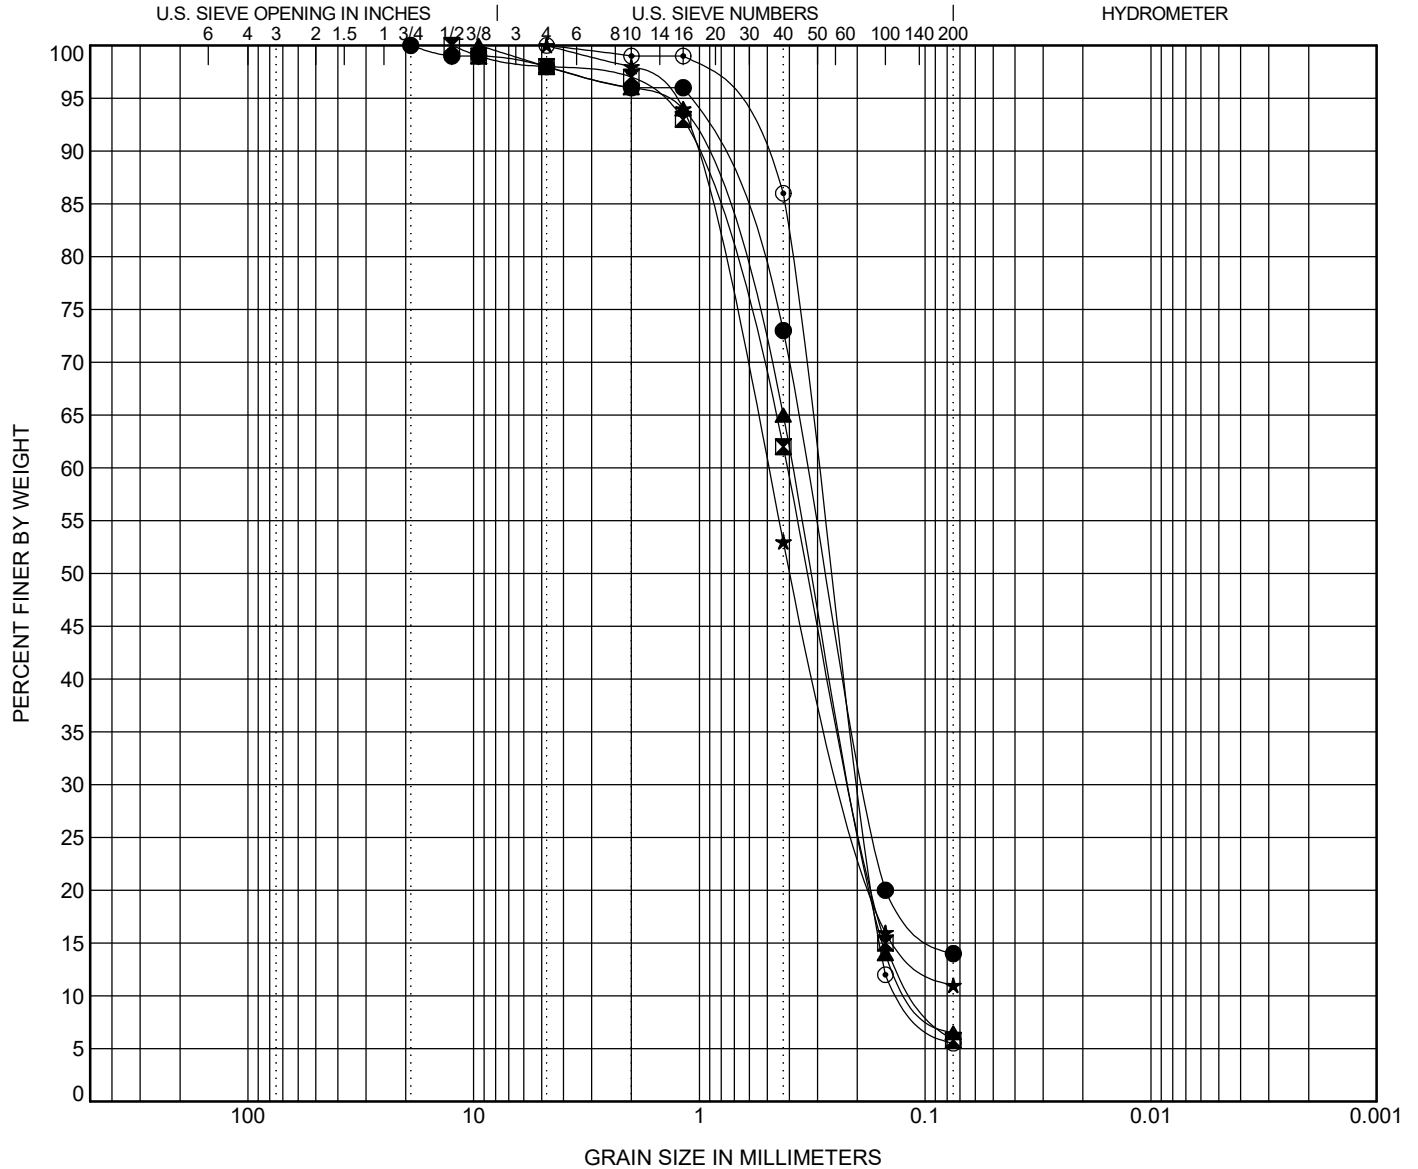
## GRAIN SIZE DISTRIBUTION

BOREHOLE	DEPTH	Classification					LL	PL	PI	Cc	Cu
● BH21-05 (P-4)	15.0										
▣ BH21-05 (P-4)	25.0									1.05	3.95
▲ BH21-05 (P-4)	50.0									1.09	3.70
★ BH21-05 (P-4)	75.0									1.50	7.75
⊙ BH21-05 (P-4)	90.0									1.05	2.43
BOREHOLE	DEPTH	D100	D60	D30	D10	%Gravel	%Sand	%Silt		%Clay	
● BH21-05 (P-4)	15.0	19	0.329	0.183		2.0	84.0	14.0			
▣ BH21-05 (P-4)	25.0	12.5	0.407	0.209	0.103	2.0	92.2	5.8			
▲ BH21-05 (P-4)	50.0	9.5	0.384	0.208	0.104	2.0	91.5	6.5			
★ BH21-05 (P-4)	75.0	4.75	0.506	0.222		0.0	89.0	11.0			
⊙ BH21-05 (P-4)	90.0	4.75	0.295	0.193	0.121	0.0	94.5	5.5

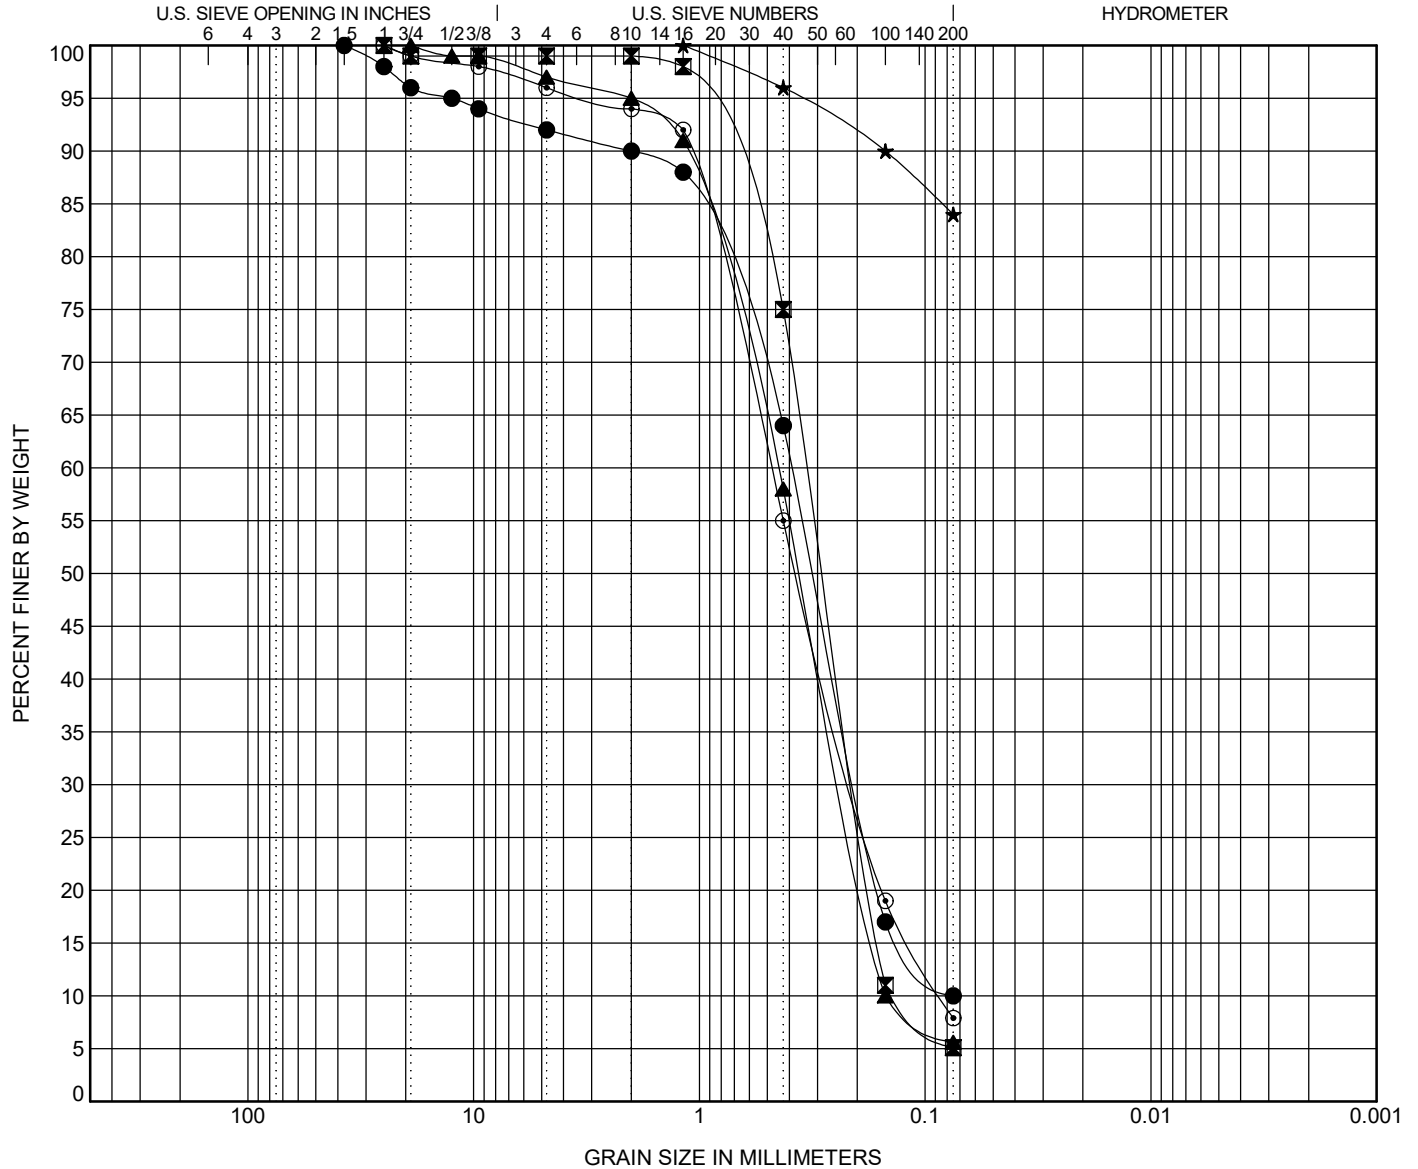
## GRAIN SIZE DISTRIBUTION

BOREHOLE	DEPTH	Classification					LL	PL	PI	Cc	Cu
● BH21-06	5.0									1.37	5.19
☒ BH21-06	35.0									0.94	2.50
▲ BH21-06	60.0									0.79	3.01
★ BH21-06	65.0	FAT CLAY with SAND(CH)					63	21	42		
⊙ BH21-06	80.0									1.02	5.71
BOREHOLE	DEPTH	D100	D60	D30	D10	%Gravel	%Sand	%Silt		%Clay	
● BH21-06	5.0	37.5	0.389	0.2	0.075	8.0	82.0	10.0			
☒ BH21-06	35.0	25	0.333	0.204	0.133	1.0	93.9	5.1			
▲ BH21-06	60.0	19	0.452	0.231	0.15	3.0	91.4	5.6			
★ BH21-06	65.0	1.18				0.0	16.0	84.0			
⊙ BH21-06	80.0	25	0.488	0.206	0.086	4.0	88.1	7.9

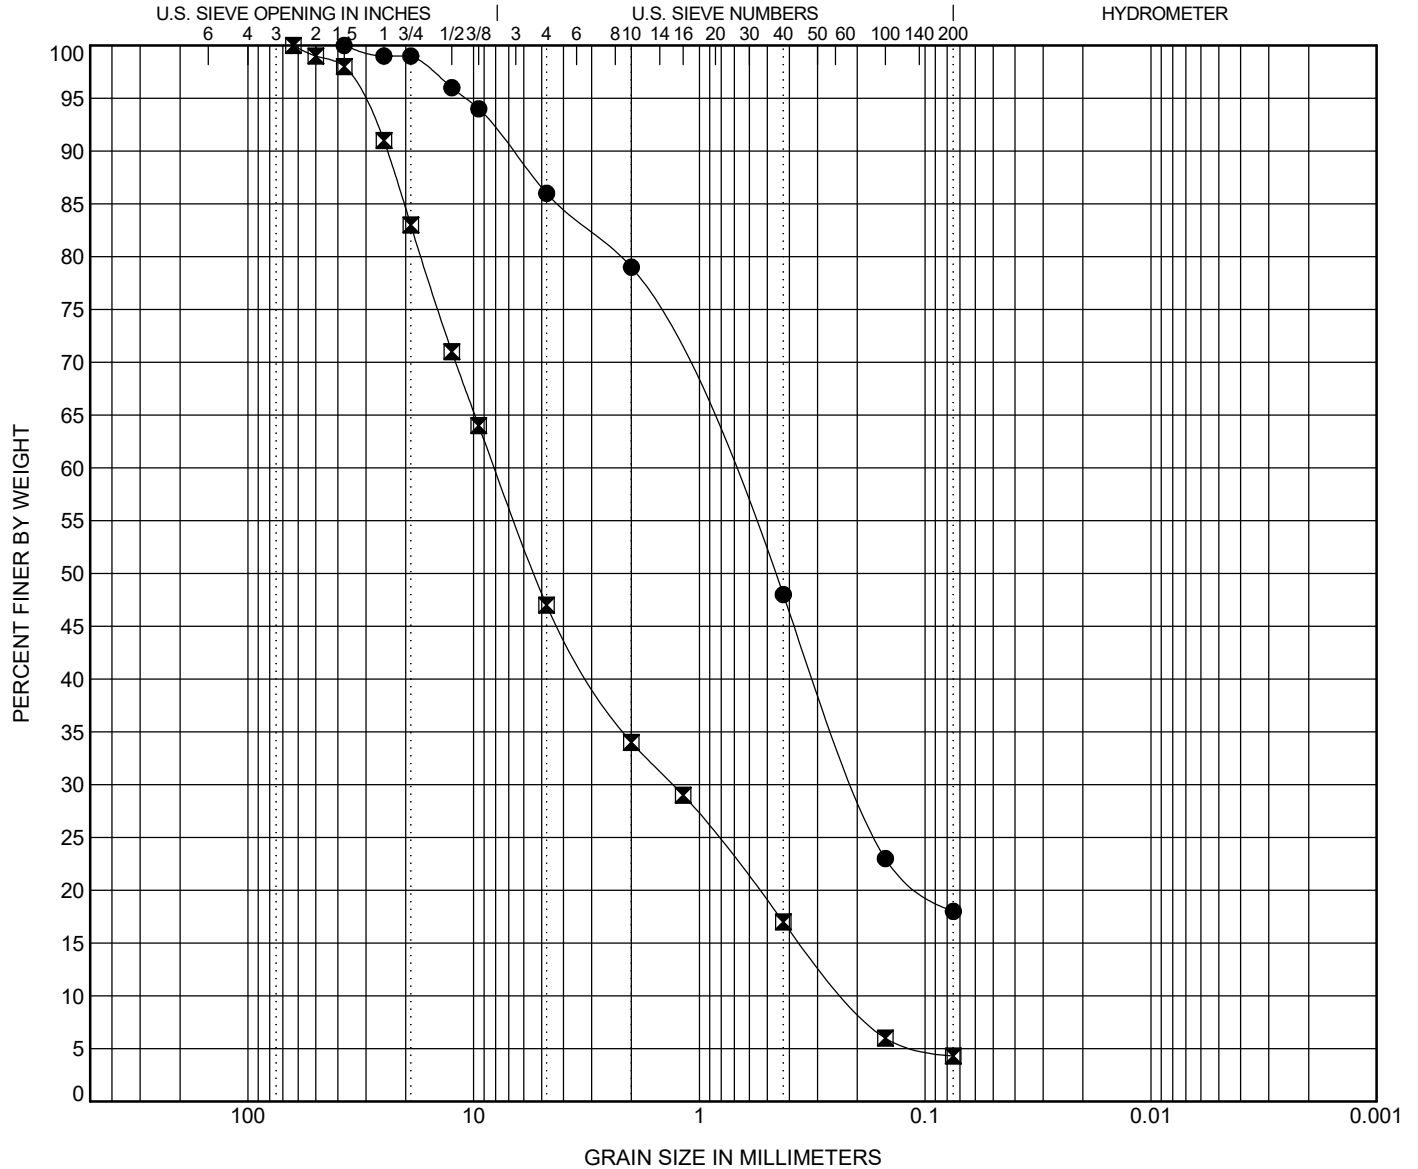
## GRAIN SIZE DISTRIBUTION

BOREHOLE	DEPTH	Classification					LL	PL	PI	Cc	Cu
● P-3	2.0	SILTY SAND(SM)					19	17	2		
☒ P-5	2.0	POORLY GRADED GRAVEL with SAND(GP)								0.97	36.84
BOREHOLE	DEPTH	D100	D60	D30	D10	%Gravel	%Sand	%Silt		%Clay	
● P-3	2.0	37.5	0.774	0.201		14.0	68.0	18.0			
☒ P-5	2.0	63	8.07	1.311	0.219	53.0	42.7	4.3

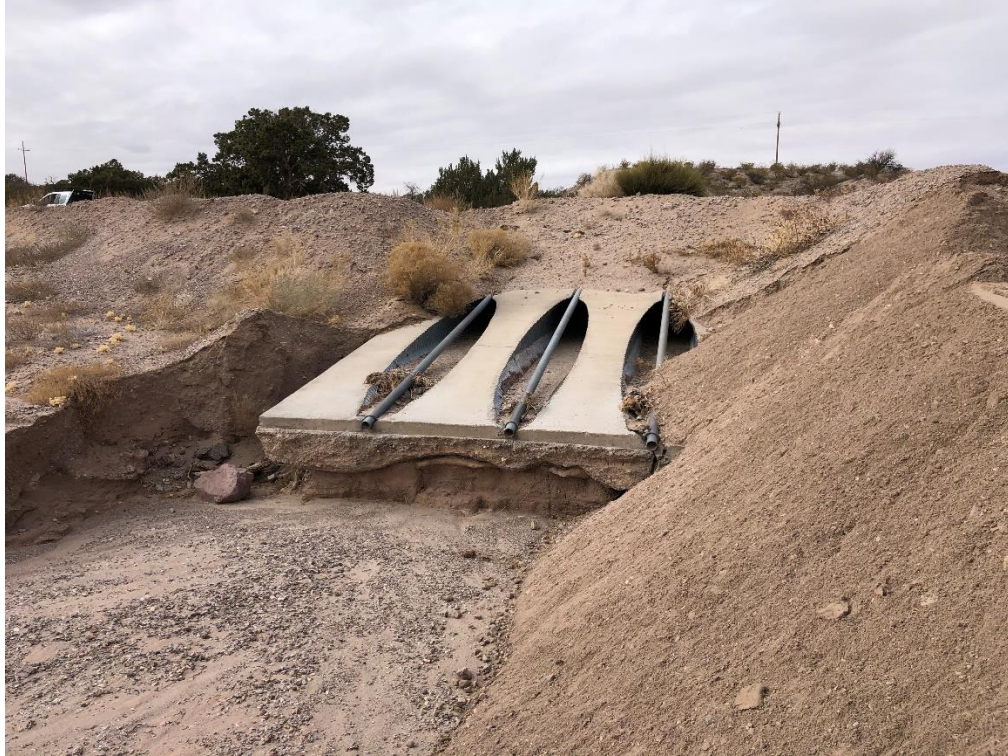
**Photo 8: CMPs View from Downstream**

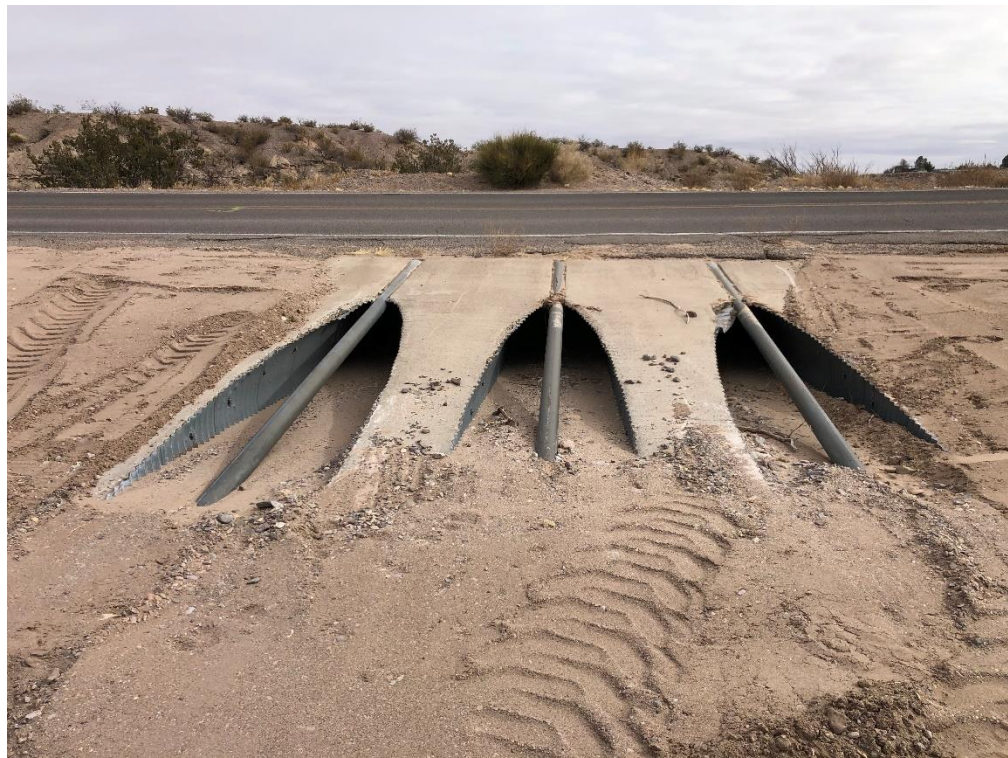
**Photo 9: CMPs View from Upstream**

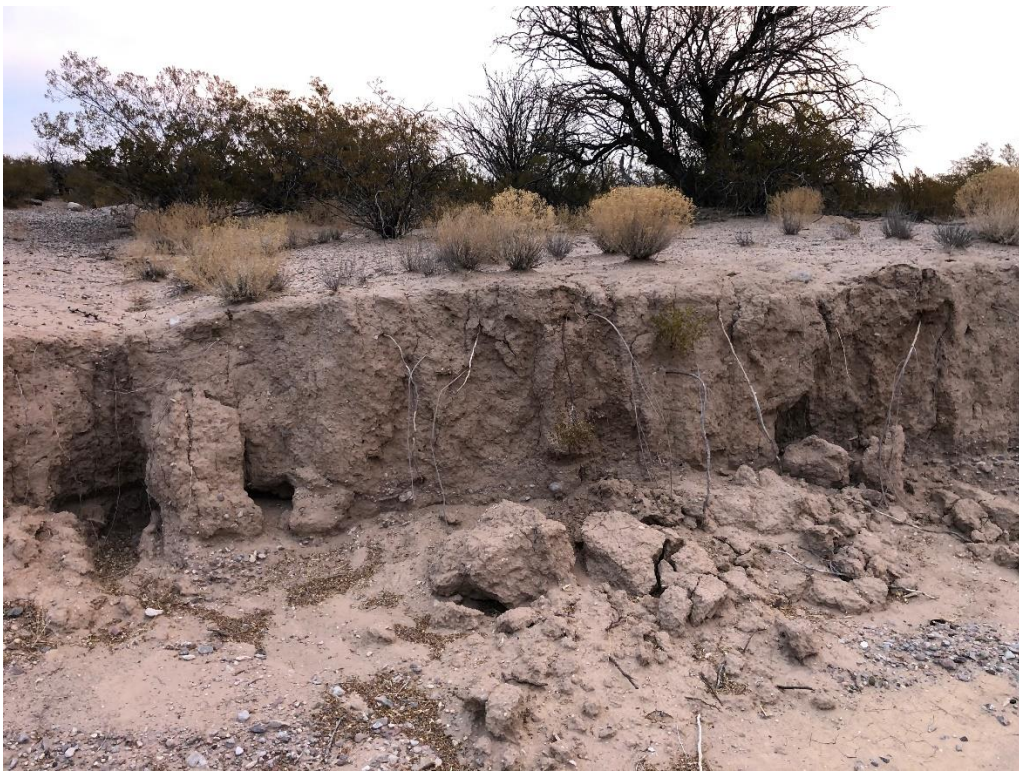
**Photo 23: Downstream Channel Wall View**

Drainage structures currently exist at each project site except Site 5. Other minor drainage structures may exist between site locations based on surficial sediment flow patterns crossing the existing alignment but are not easily identified. Existing structures consist of corrugated metal pipes (CMPs) of various sizes. CMPs were found to either be clear of debris or partially filled (approximately 1/3 or less). In general, the CMPs have grouted riprap or concrete aprons at the outlets. Heavy erosion is present underneath culvert outlets at Sites 1, 2, and 4 (Site 3 less severe). Scour has caused deep and severe undercutting of the CMPs and surrounding concrete protection. The downstream channels are generally deeply incised, ranging in depth from 3 to 10-feet, with locations of near vertical cuts in alluvial soils of the active stream channel.

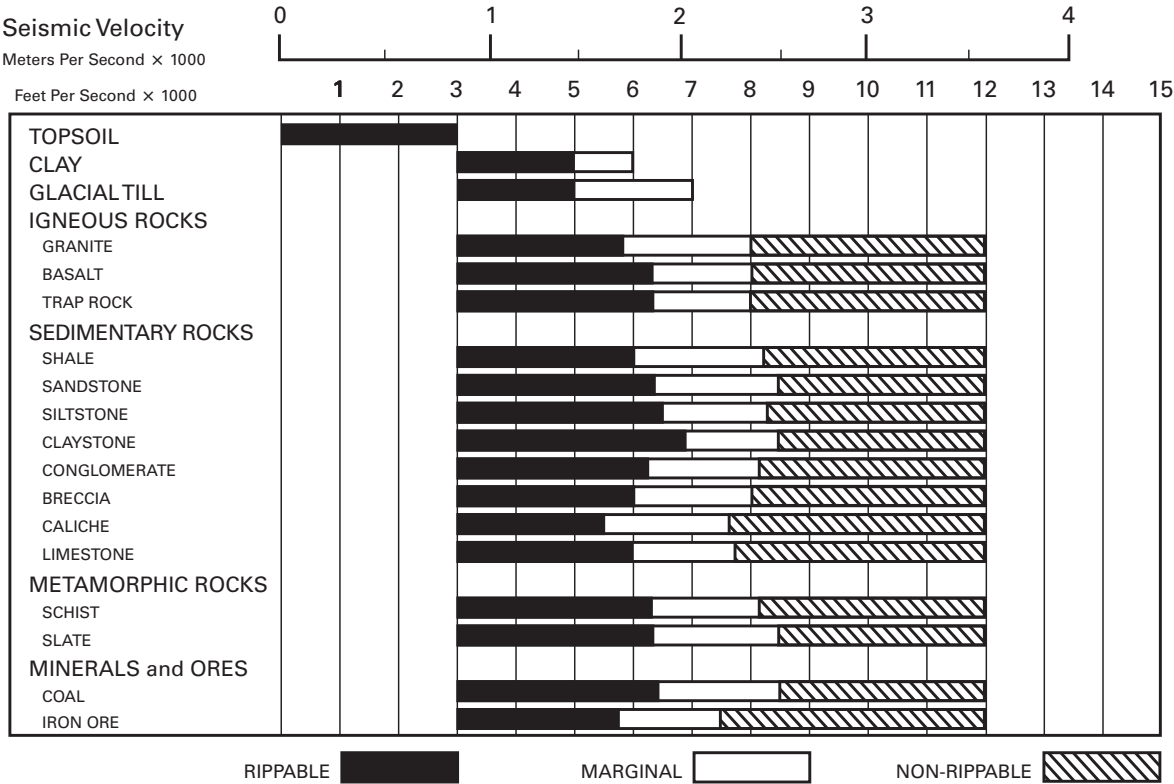
D8R/D8T

- Multi- or Single Shank No. 8 Ripper
- Estimated by Seismic Wave Velocities

- Machine rips full-time — no dozing.
- Power shift tractors with single shank rippers.
- 100% efficiency (60 min hour).
- Charts are for all classes of material.
- In igneous rock with seismic velocity of 8000 fps (2450 mps) or higher for the D11T, and 6000 fps (1830 mps) or higher for the D10T2, D9R/D9T and D8R/D8T, the production figures shown should be reduced by 25%.
- Upper limit of charts reflect ripping under ideal conditions only. If conditions such as thick lamination, vertical lamination or any factor which would adversely affect production are present, the lower limit should be used.

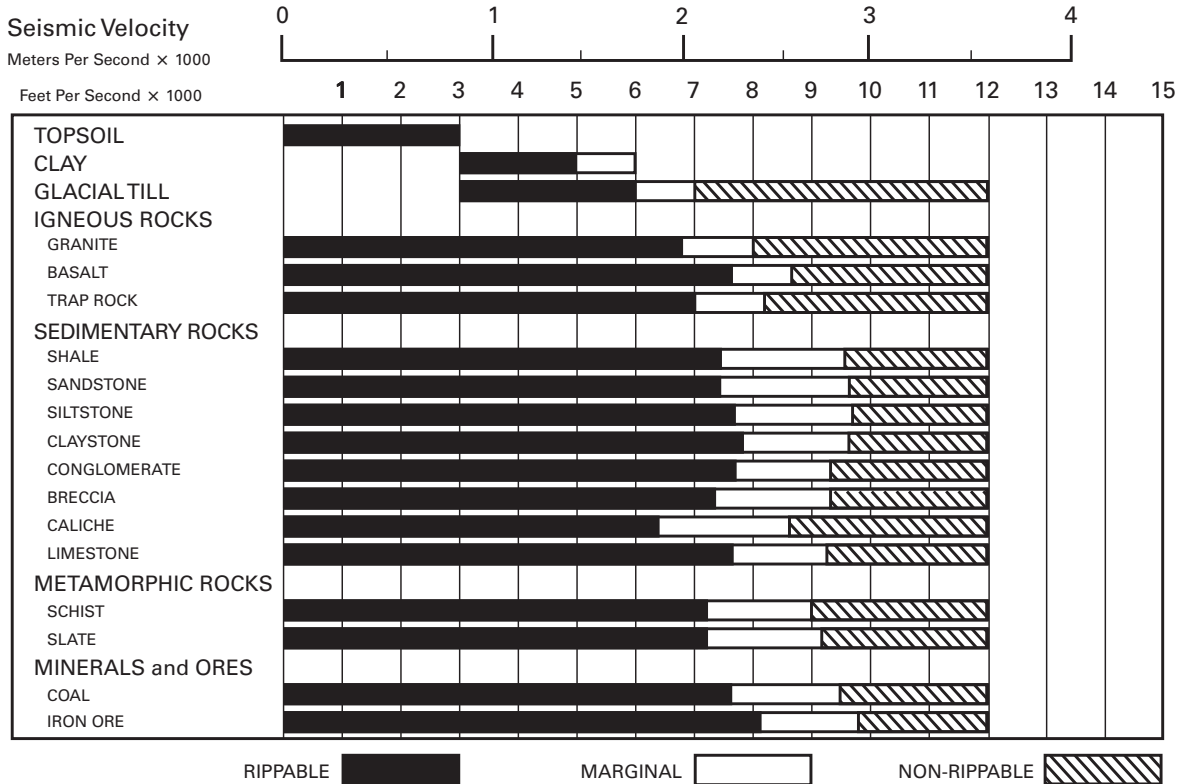
## D9R/D9T

- Multi- or Single Shank No. 9 Ripper
- Estimated by Seismic Wave Velocities

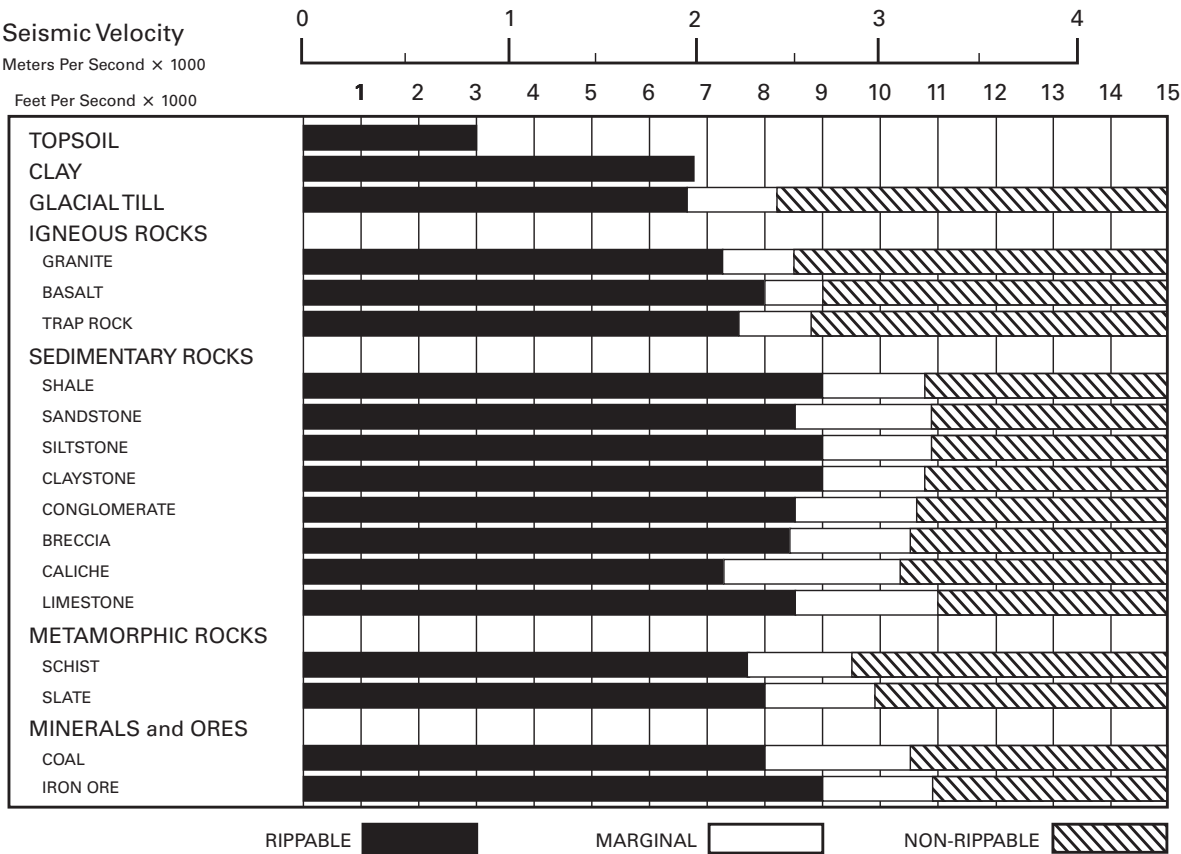
D10T2

- Multi- or Single Shank No. 10 Ripper
- Estimated by Seismic Wave Velocities

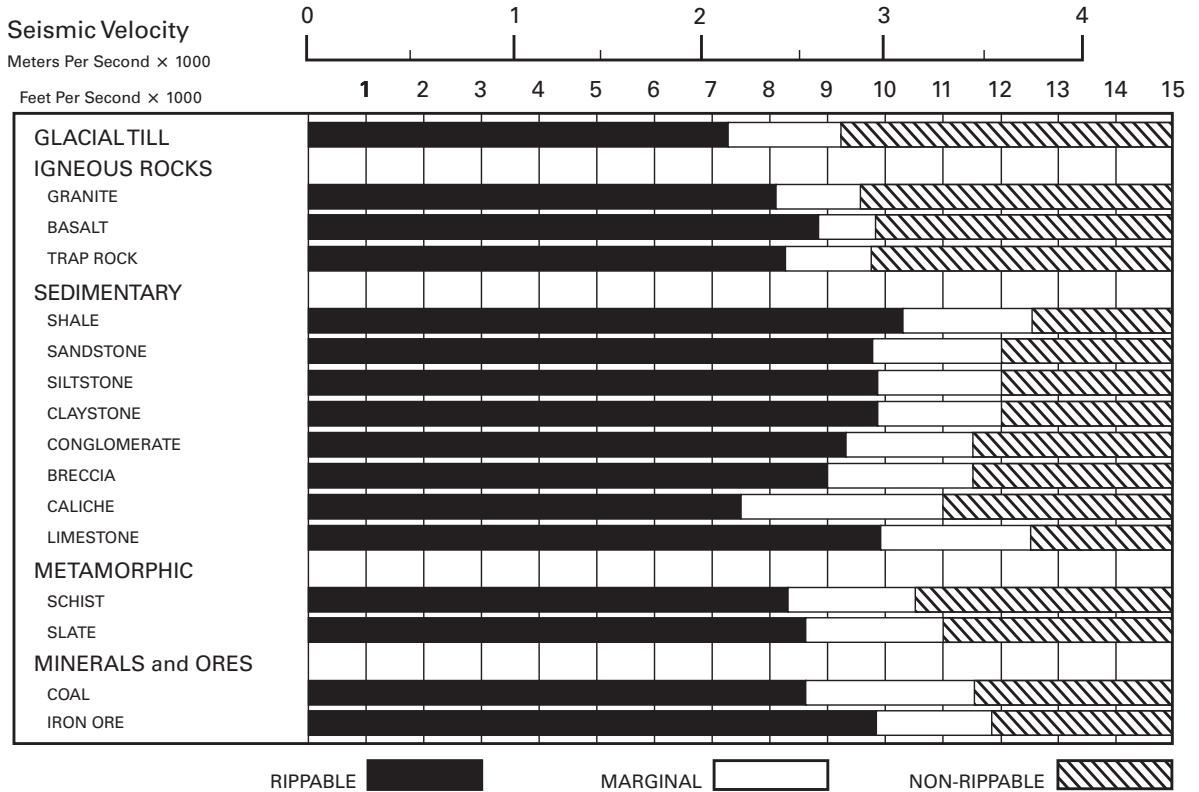
## D11T

● Multi- or Single Shank No. 11 Ripper

● Estimated by Seismic Wave Velocities

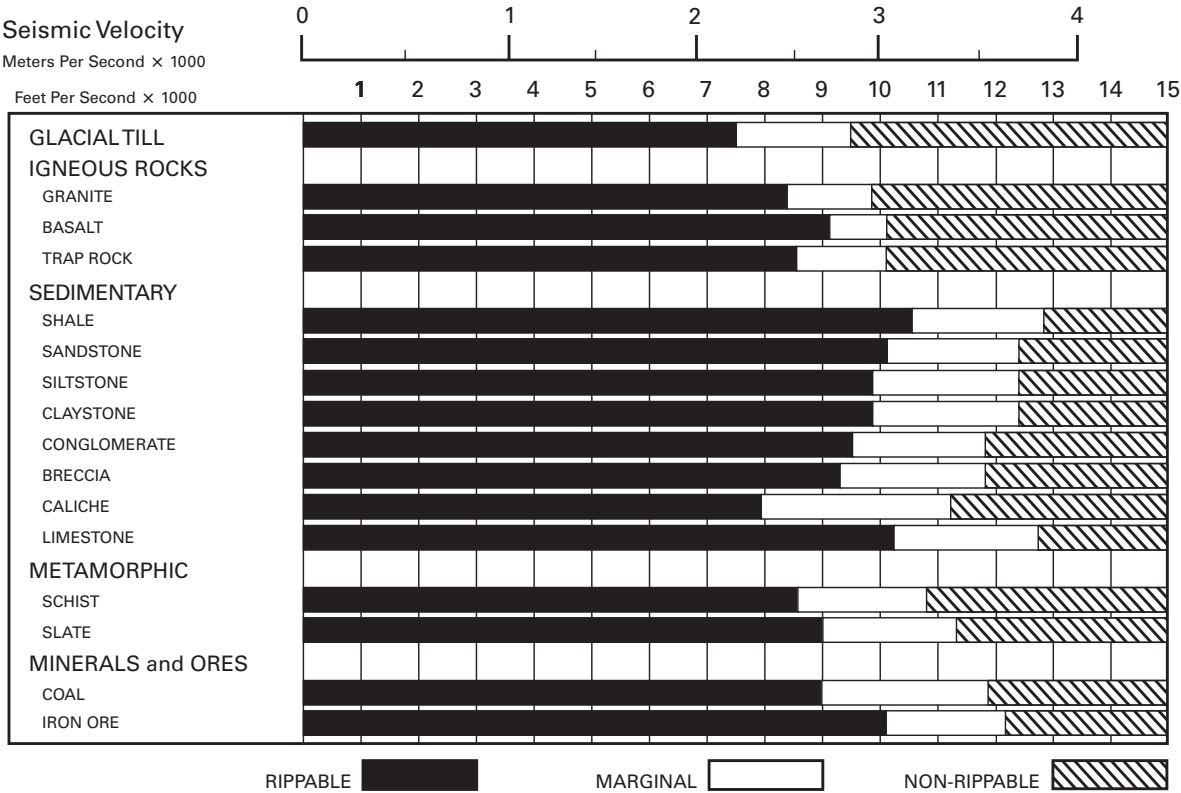
D11T CD

- Single Shank No. 11 Ripper
- Estimated by Seismic Wave Velocities
