Biological Assessment Undi Road Bypass Improvements

Jefferson/Clallam Counties, Washington

November 2021

DEA project number: FHAX00000280

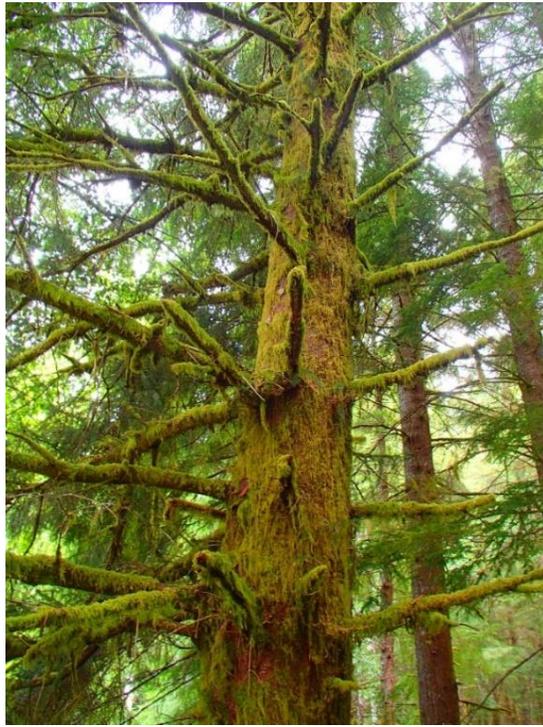
PHOTO 1

1. Conifer trees with suitable nest platforms near Site 1
2. Conifer trees with suitable nest platforms near Site 1

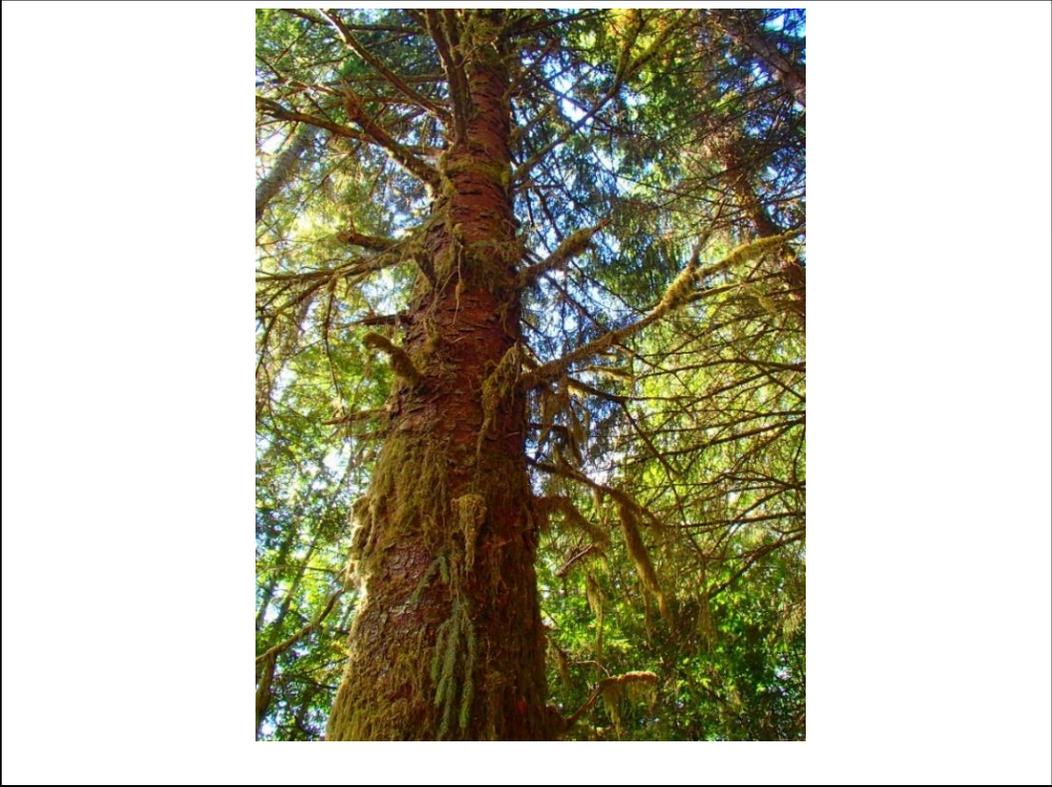
**P
H
O
T
O
4**

- 3. Conifer trees with suitable nest platforms near Site 2
- 4. Conifer trees with suitable nest platforms near Site 2

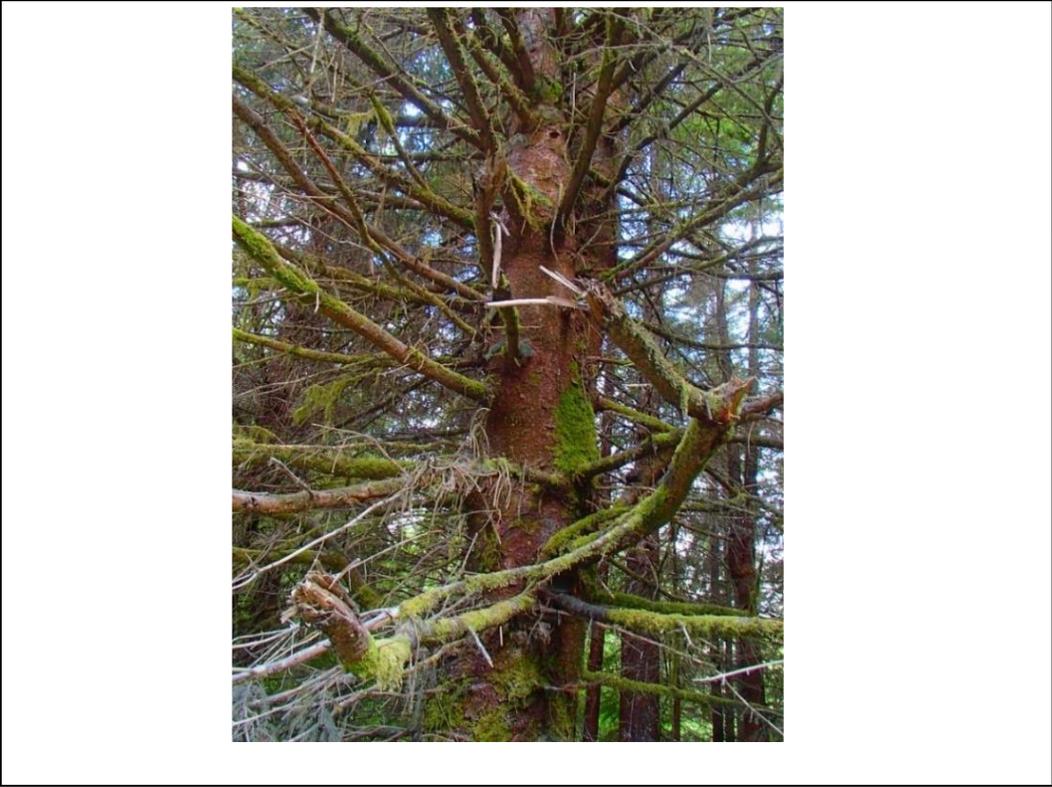
**P
H
O
T
O
5**

- 5. Conifer trees with suitable nest platforms near Site 3
- 6. Conifer trees with suitable nest platforms near Site 3

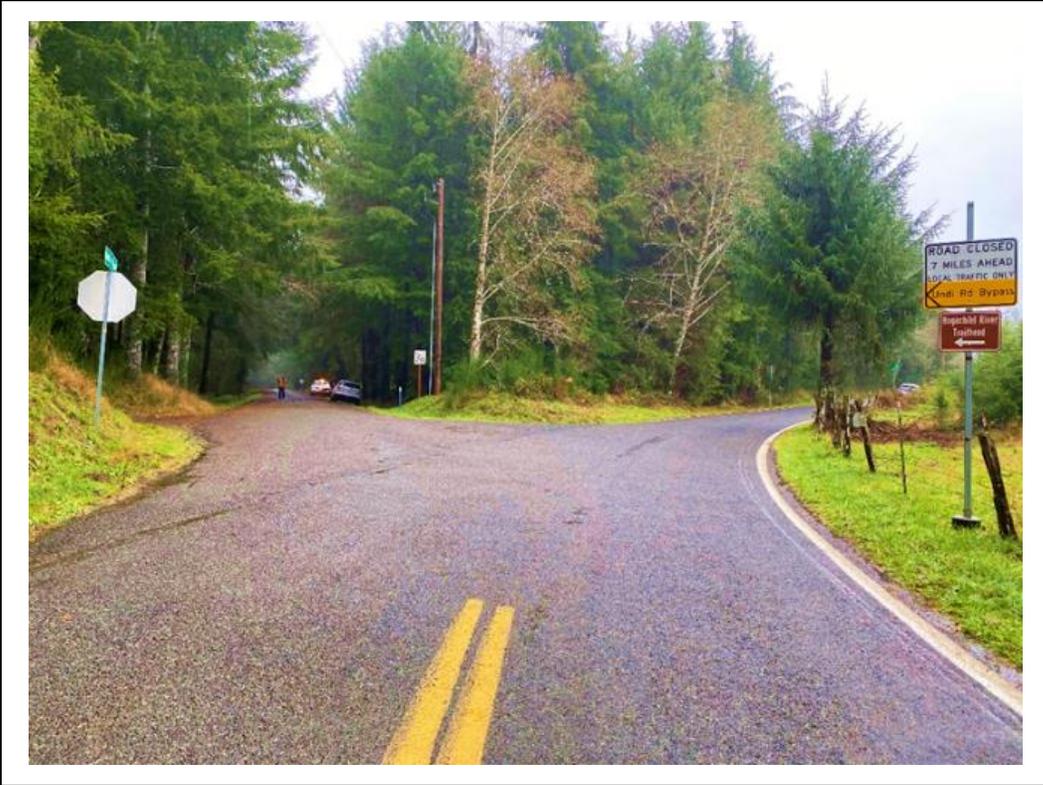
**P
H
O
T
O
9**

9. Intersection of Undi Road and Undi Bypass Road (Road Improvement Site 1)

Road Improvement Site 1 is located at the intersection of Undi Road and the Undi Road Bypass (MP 0.0). Most of the improvements at this site are intended to allow drivers to smoothly transition to the bypass road from the original Undi Road. These improvements include a realignment of the Undi Road approach to a “T” configuration. Hard surfacing using a Type 2 double chip seal over an 18-inch aggregate base is proposed.

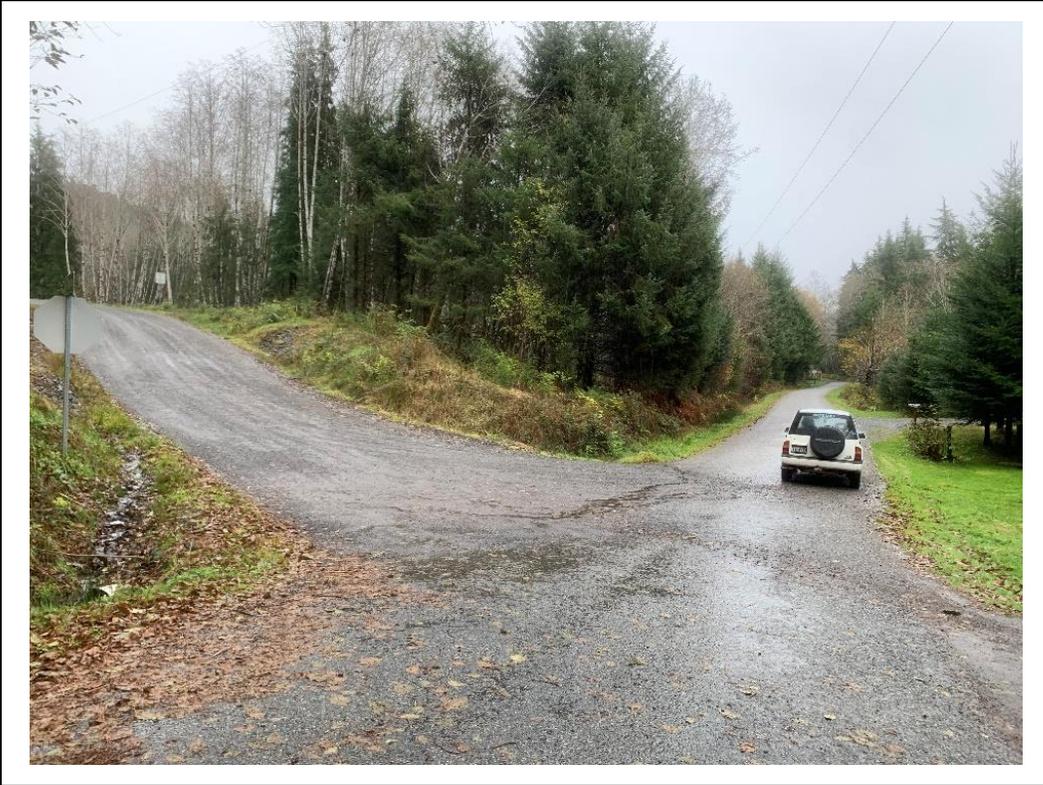
**P
H
O
T
O
1
1**

- 11. Intersection of Undi Road and Undi Bypass Road (Road Improvement Site 3)
- 12. Culvert passing underneath Undi Bypass Road, connecting small wetland areas.

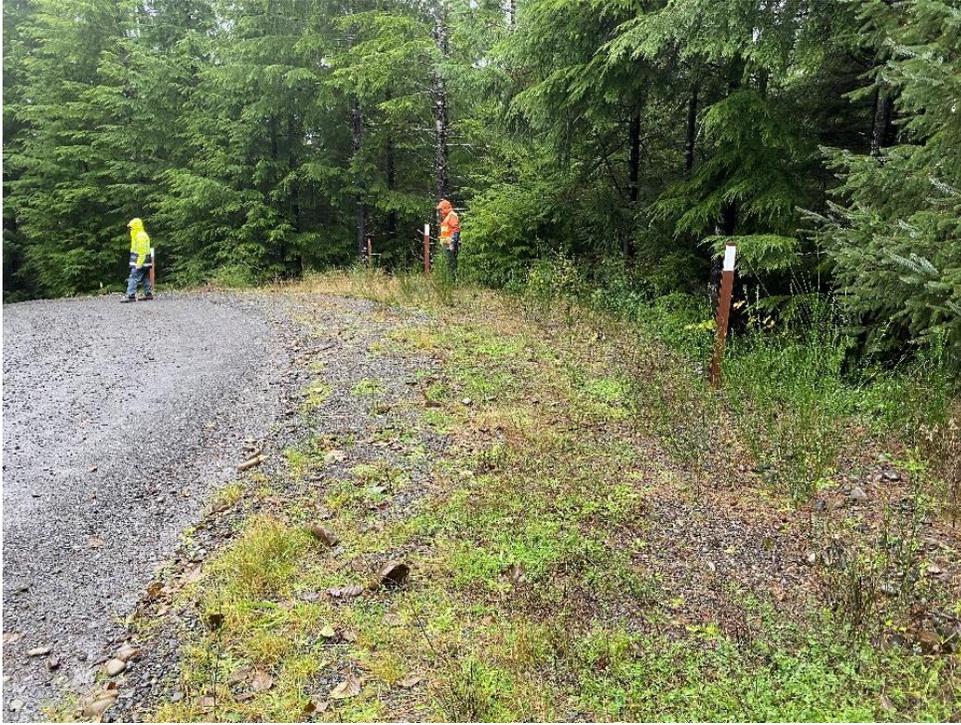
13. Typical existing vehicle pullout area.

Three vehicle pullouts will be improved, located at existing widened areas of the Undi Road Bypass between Road Improvement Sites 1 and 2 (**Figure 5**). Compacted gravel material is currently present at these areas, though not as thick as the existing road surfaces, suggesting that the areas have been used in the past as rough pullouts. Though not as developed as the existing gravel road surfaces, the areas are likely considered impervious because of existing compacted soils.
