PUMP TEST CAPACITY REPORTS

Big Bend Dam (SD01092)

FY20 DAM SAFETY INSTRUMENTATION REHABILITATION

ENGINEERING GEOLOGY REPORT

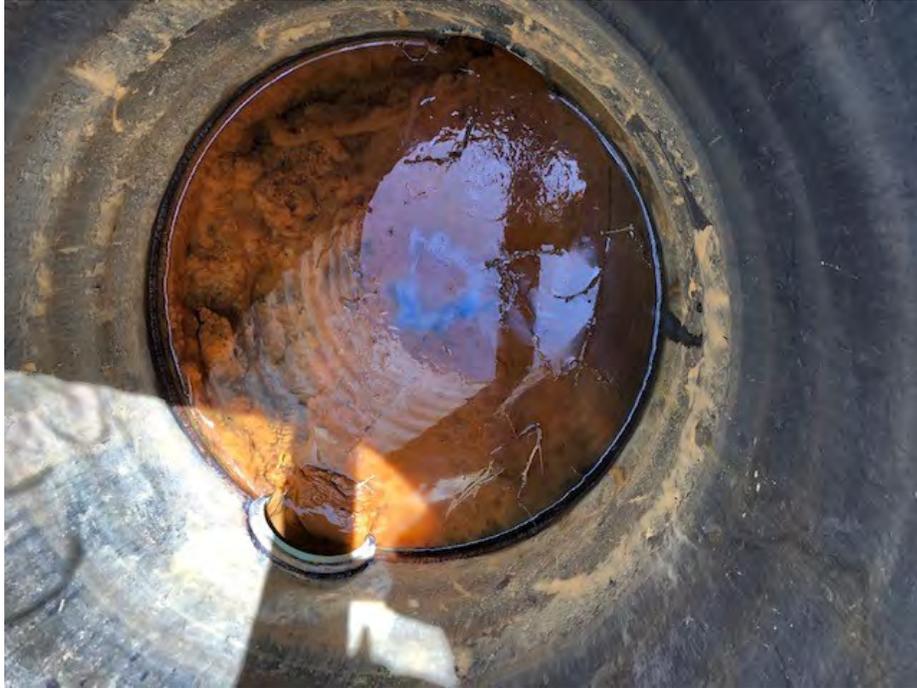
As shown in Table 3, sump pumps were required in several of the relief well manholes due to algae/debris that had accumulated in the bottom of the vaults. The growth had to be removed with a sump pump prior to testing to avoid drawing the material into the well during testing and rehabilitation. Groundwater was also observed to be flowing around the outside of the riser pipe at the base of the vault in three of the relief wells, RW-66C, RW-67B, and RW-68A. It appears that the seal between the bottom of the vault and the riser pipe has been compromised in these three wells and groundwater is flowing up through the seal.

Figure 7: Photograph of biological materials in manhole for relief well RW-67A

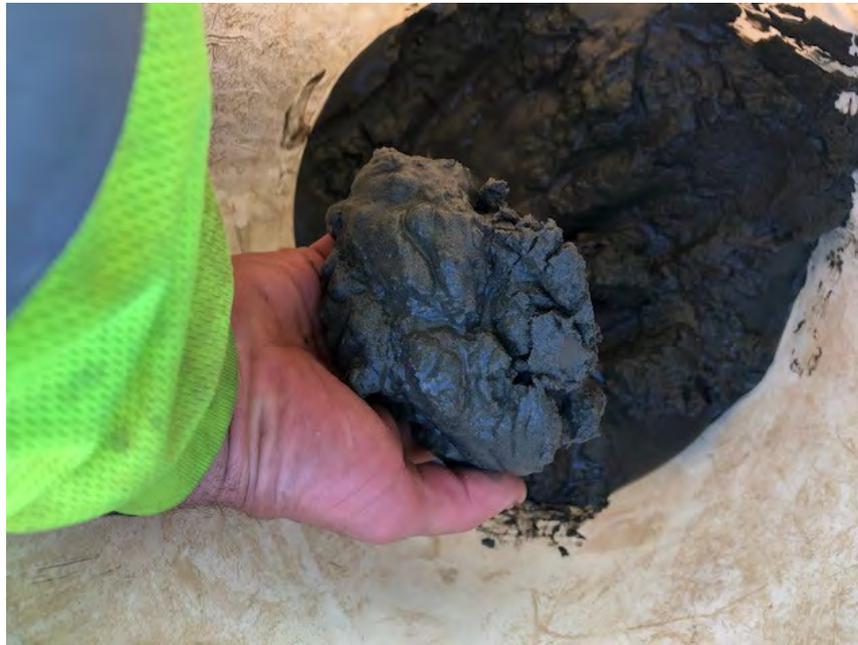
At the completion of brushing and airlifting, the stainless steel relief wells were surged with a Q-water development tool (with built-in relief valve) to attempt to break up any bridged fines around the filter pack and increase the capacity of the well. Each well screen was surged in sections with the stroke length not exceeding 10 feet with a stroke rate of no more than 4 feet/second. Each 10-foot length of rehabilitation zone proceeded for 15 minutes. Most of the material that entered the wells was noted to be fines and fine sand, as shown in Figure 9. Relief wells RW-68A and RW-68B had significant amounts of sand in the discharge, as shown in Figure 10. Once surging was complete, the water column in the well was pumped utilizing an airlift method until the well was clear of biomass and sediment. After airlifting was complete, the bottom depth was measured to confirm that all material at the bottom of the well from surging has been removed.

Figure 10: Airlifted material (post-surge) from relief well-68A

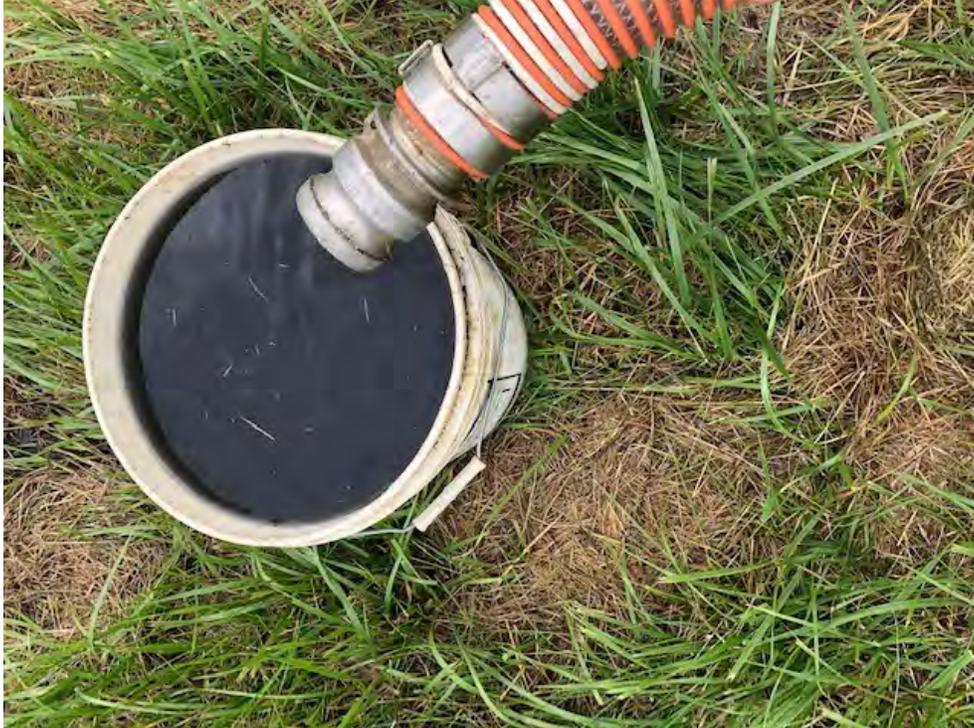
Because the wood-stave wells are more than 50 years old and more fragile/susceptible to collapse, surge blocks were not utilized for these wells (RW-66, RW-67, and RW-68). Instead, the wells were rehabilitated by creating a surging action with the airlift mechanism by alternately drawing the water column down to a depth just above the top of the screen and shutting the air off allowing the well to recharge. This process continued until the recharge improved enough to allow continuous pumping at which time continuous airlifting was conducted until the water was free and clear of fines.

Figure 11: Initial discharge water at the start of post-surge airlifting (RW-68)

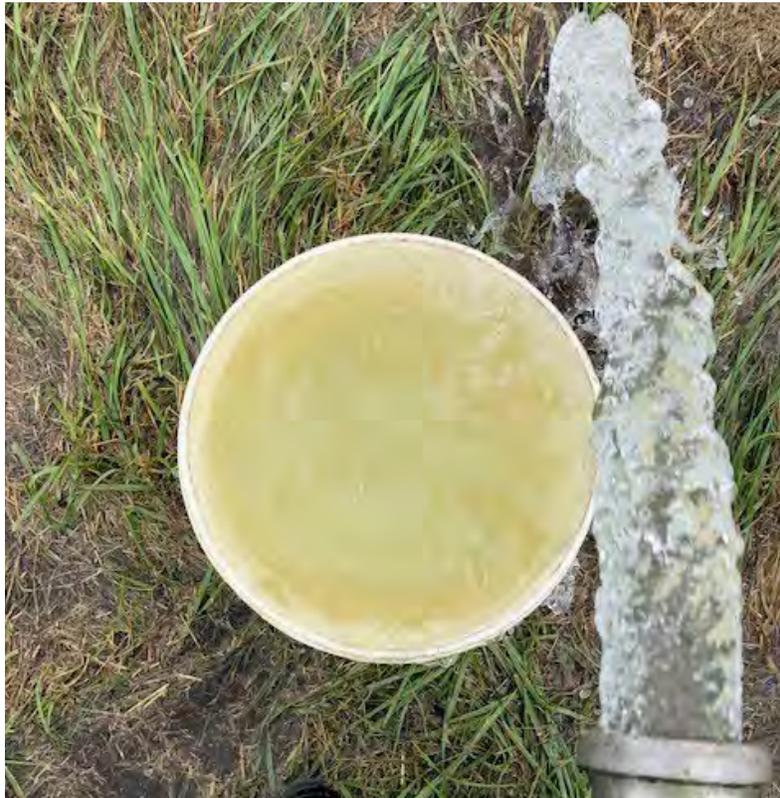
Figure 12: Final discharge water at the end of post-surge airlifting (RW-68)

35/18.7 (1.9)				
	49/28.2 (1.7)				
RW-68	7.2	10.1/9.8 (1.0)	16/8.8 (1.8)	Specific capacity increased from 1.0 to 1.8 gpm/ft drawdown after rehabilitation. Recovery improved from 200 seconds to 105 seconds.	Relief well is currently at ~25% of original capacity. Relief well should be evaluated and considered for abandonment and replacement (if determined to be necessary) due to its age and the decrease in capacity. If not replaced, relief well should be capacity tested again in five years and rehabilitated as required.
RW-68A	23.5/1.7 (13.8)	21.2/11.4 (1.9)	33/26.5 (1.2)	Specific capacity decreased from 1.9 to 1.2 gpm/ft drawdown after rehabilitation. Recovery decreased from 40 seconds to 120 seconds. More substantial sediment was drawn into the well during pumping than other relief wells tested.	Relief well is currently at ~10% of original capacity and had significant sediment drawn in during testing. Relief well design should be investigated and the well should be considered for abandonment, redesign, and replacement. If not replaced, relief well should be capacity tested again in five years and rehabilitated as required. Repair leak around outside of pipe (bottom of vault).

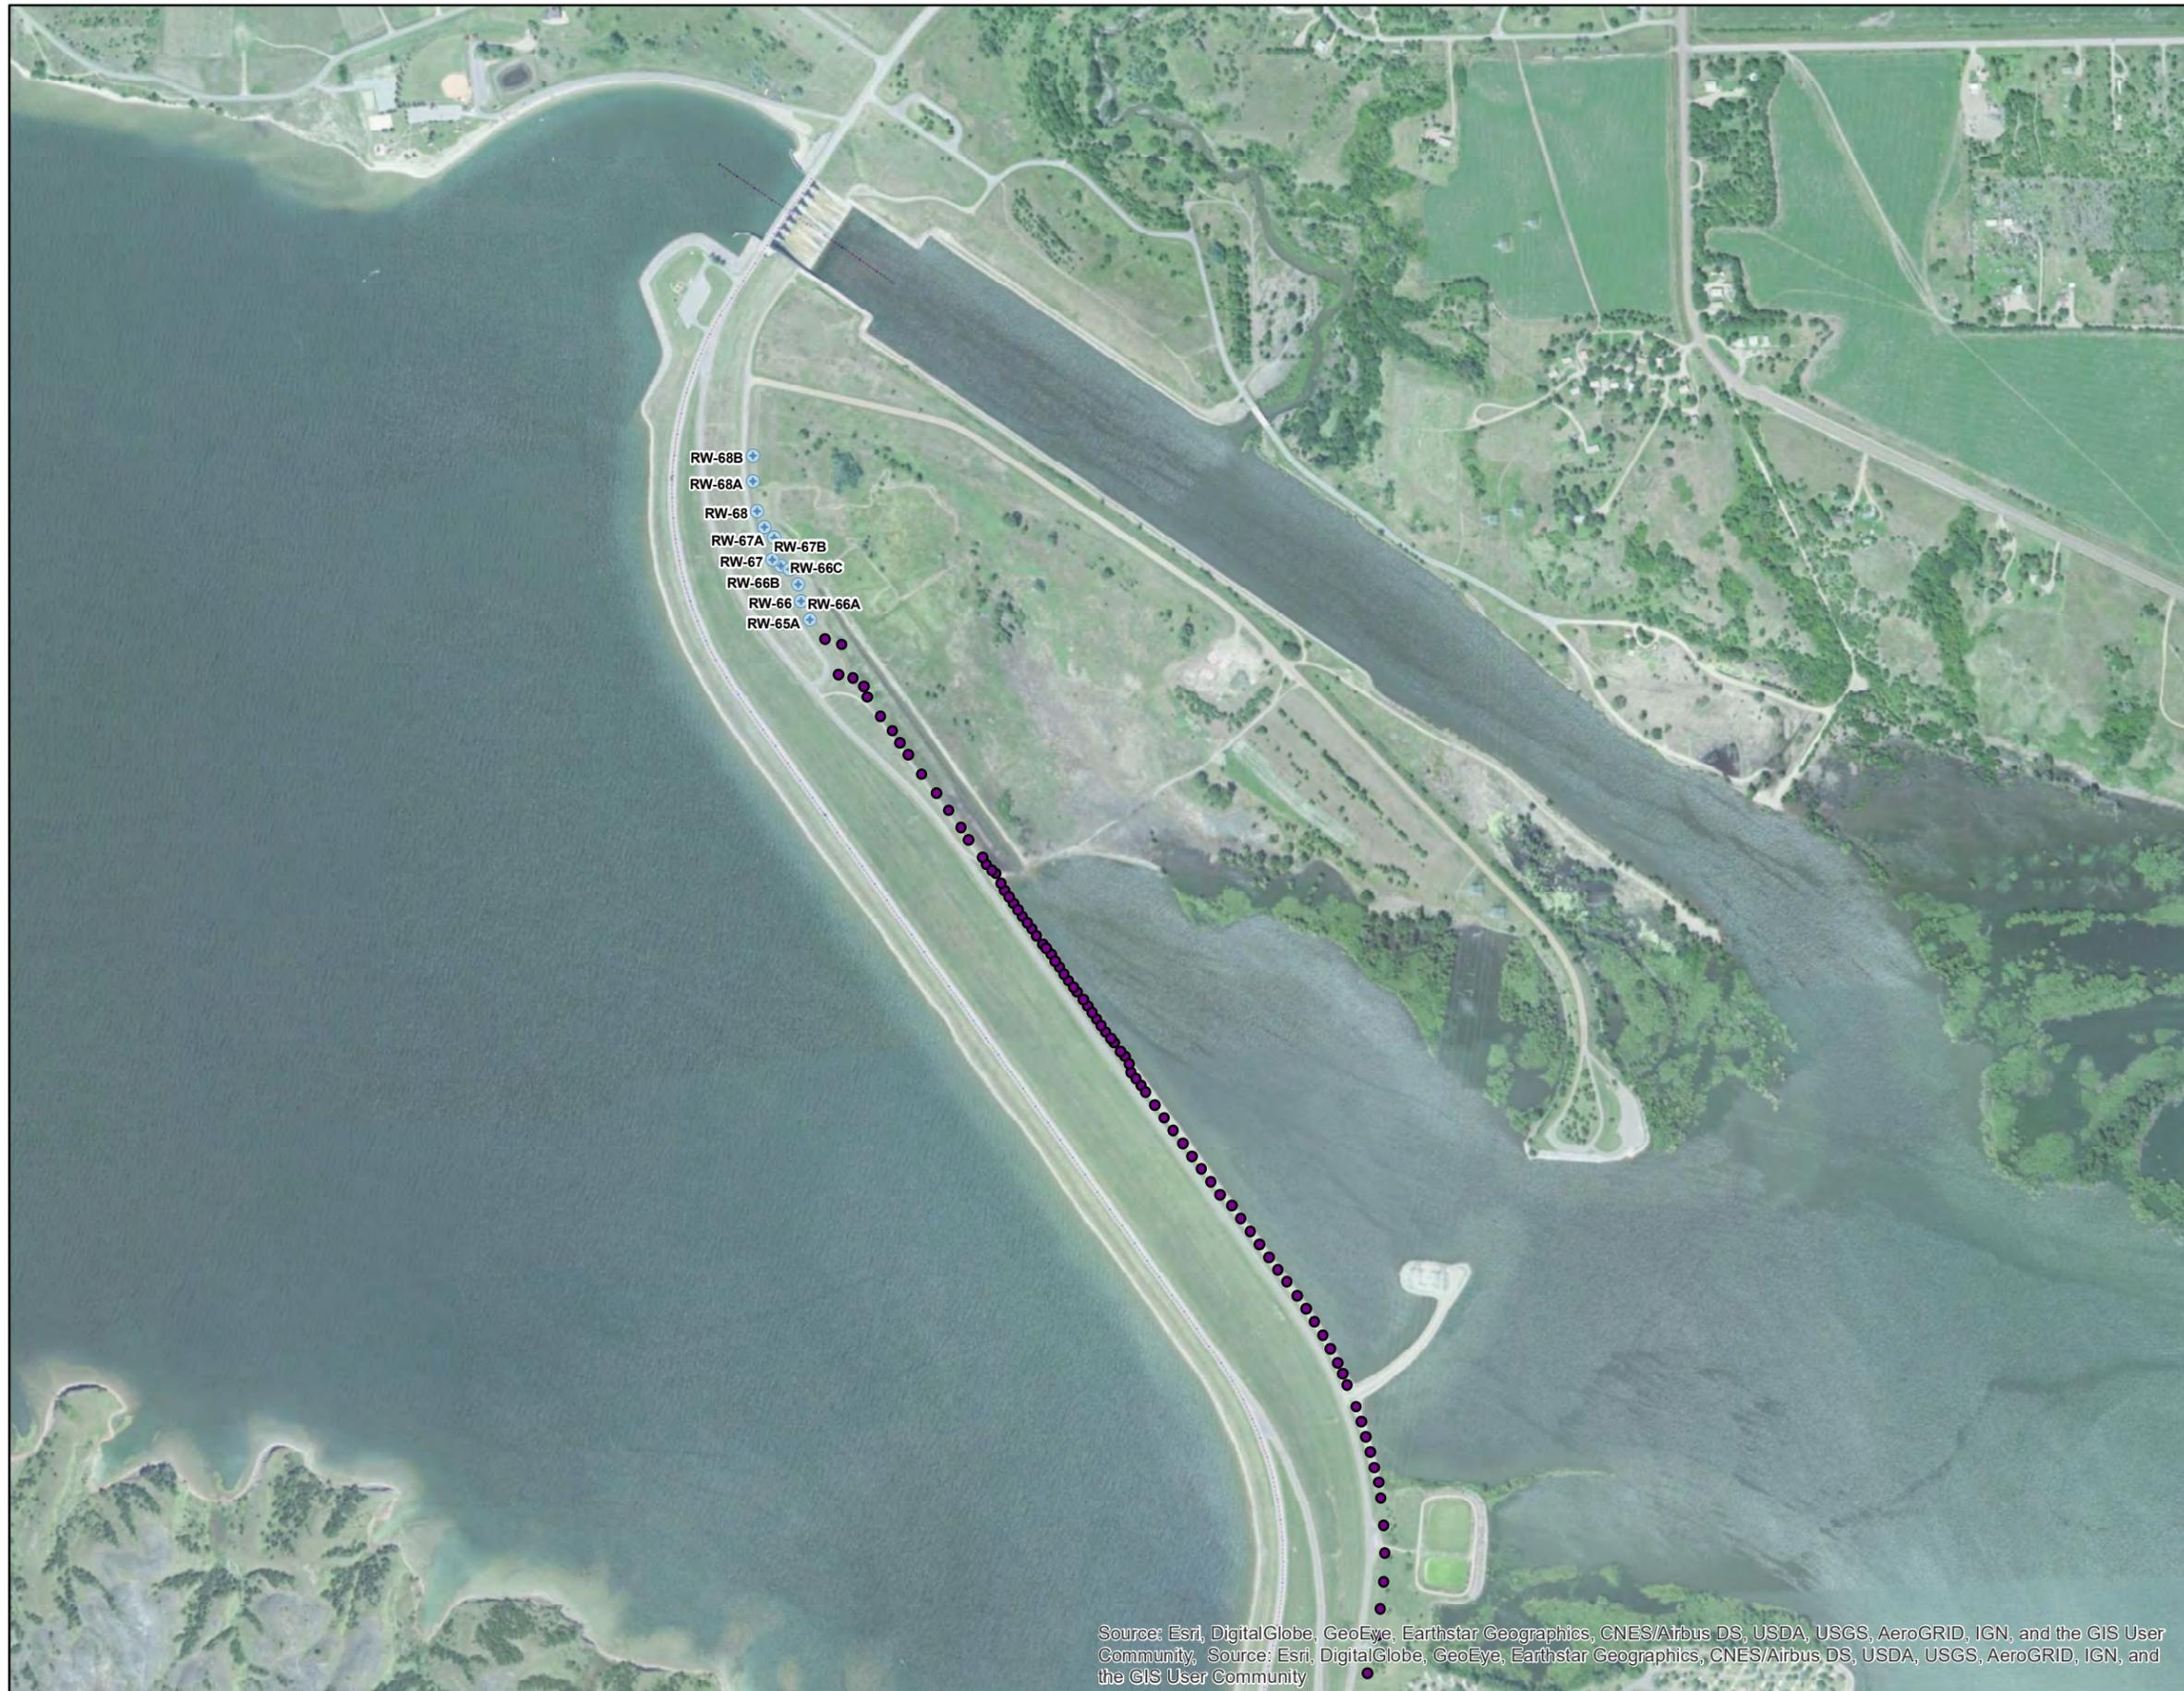
FIGURE A1

- Relief Wells Rehabilitated and Capacity Tested (FY20)
- Relief Wells not Rehabilitated or Capacity Tested (FY20)

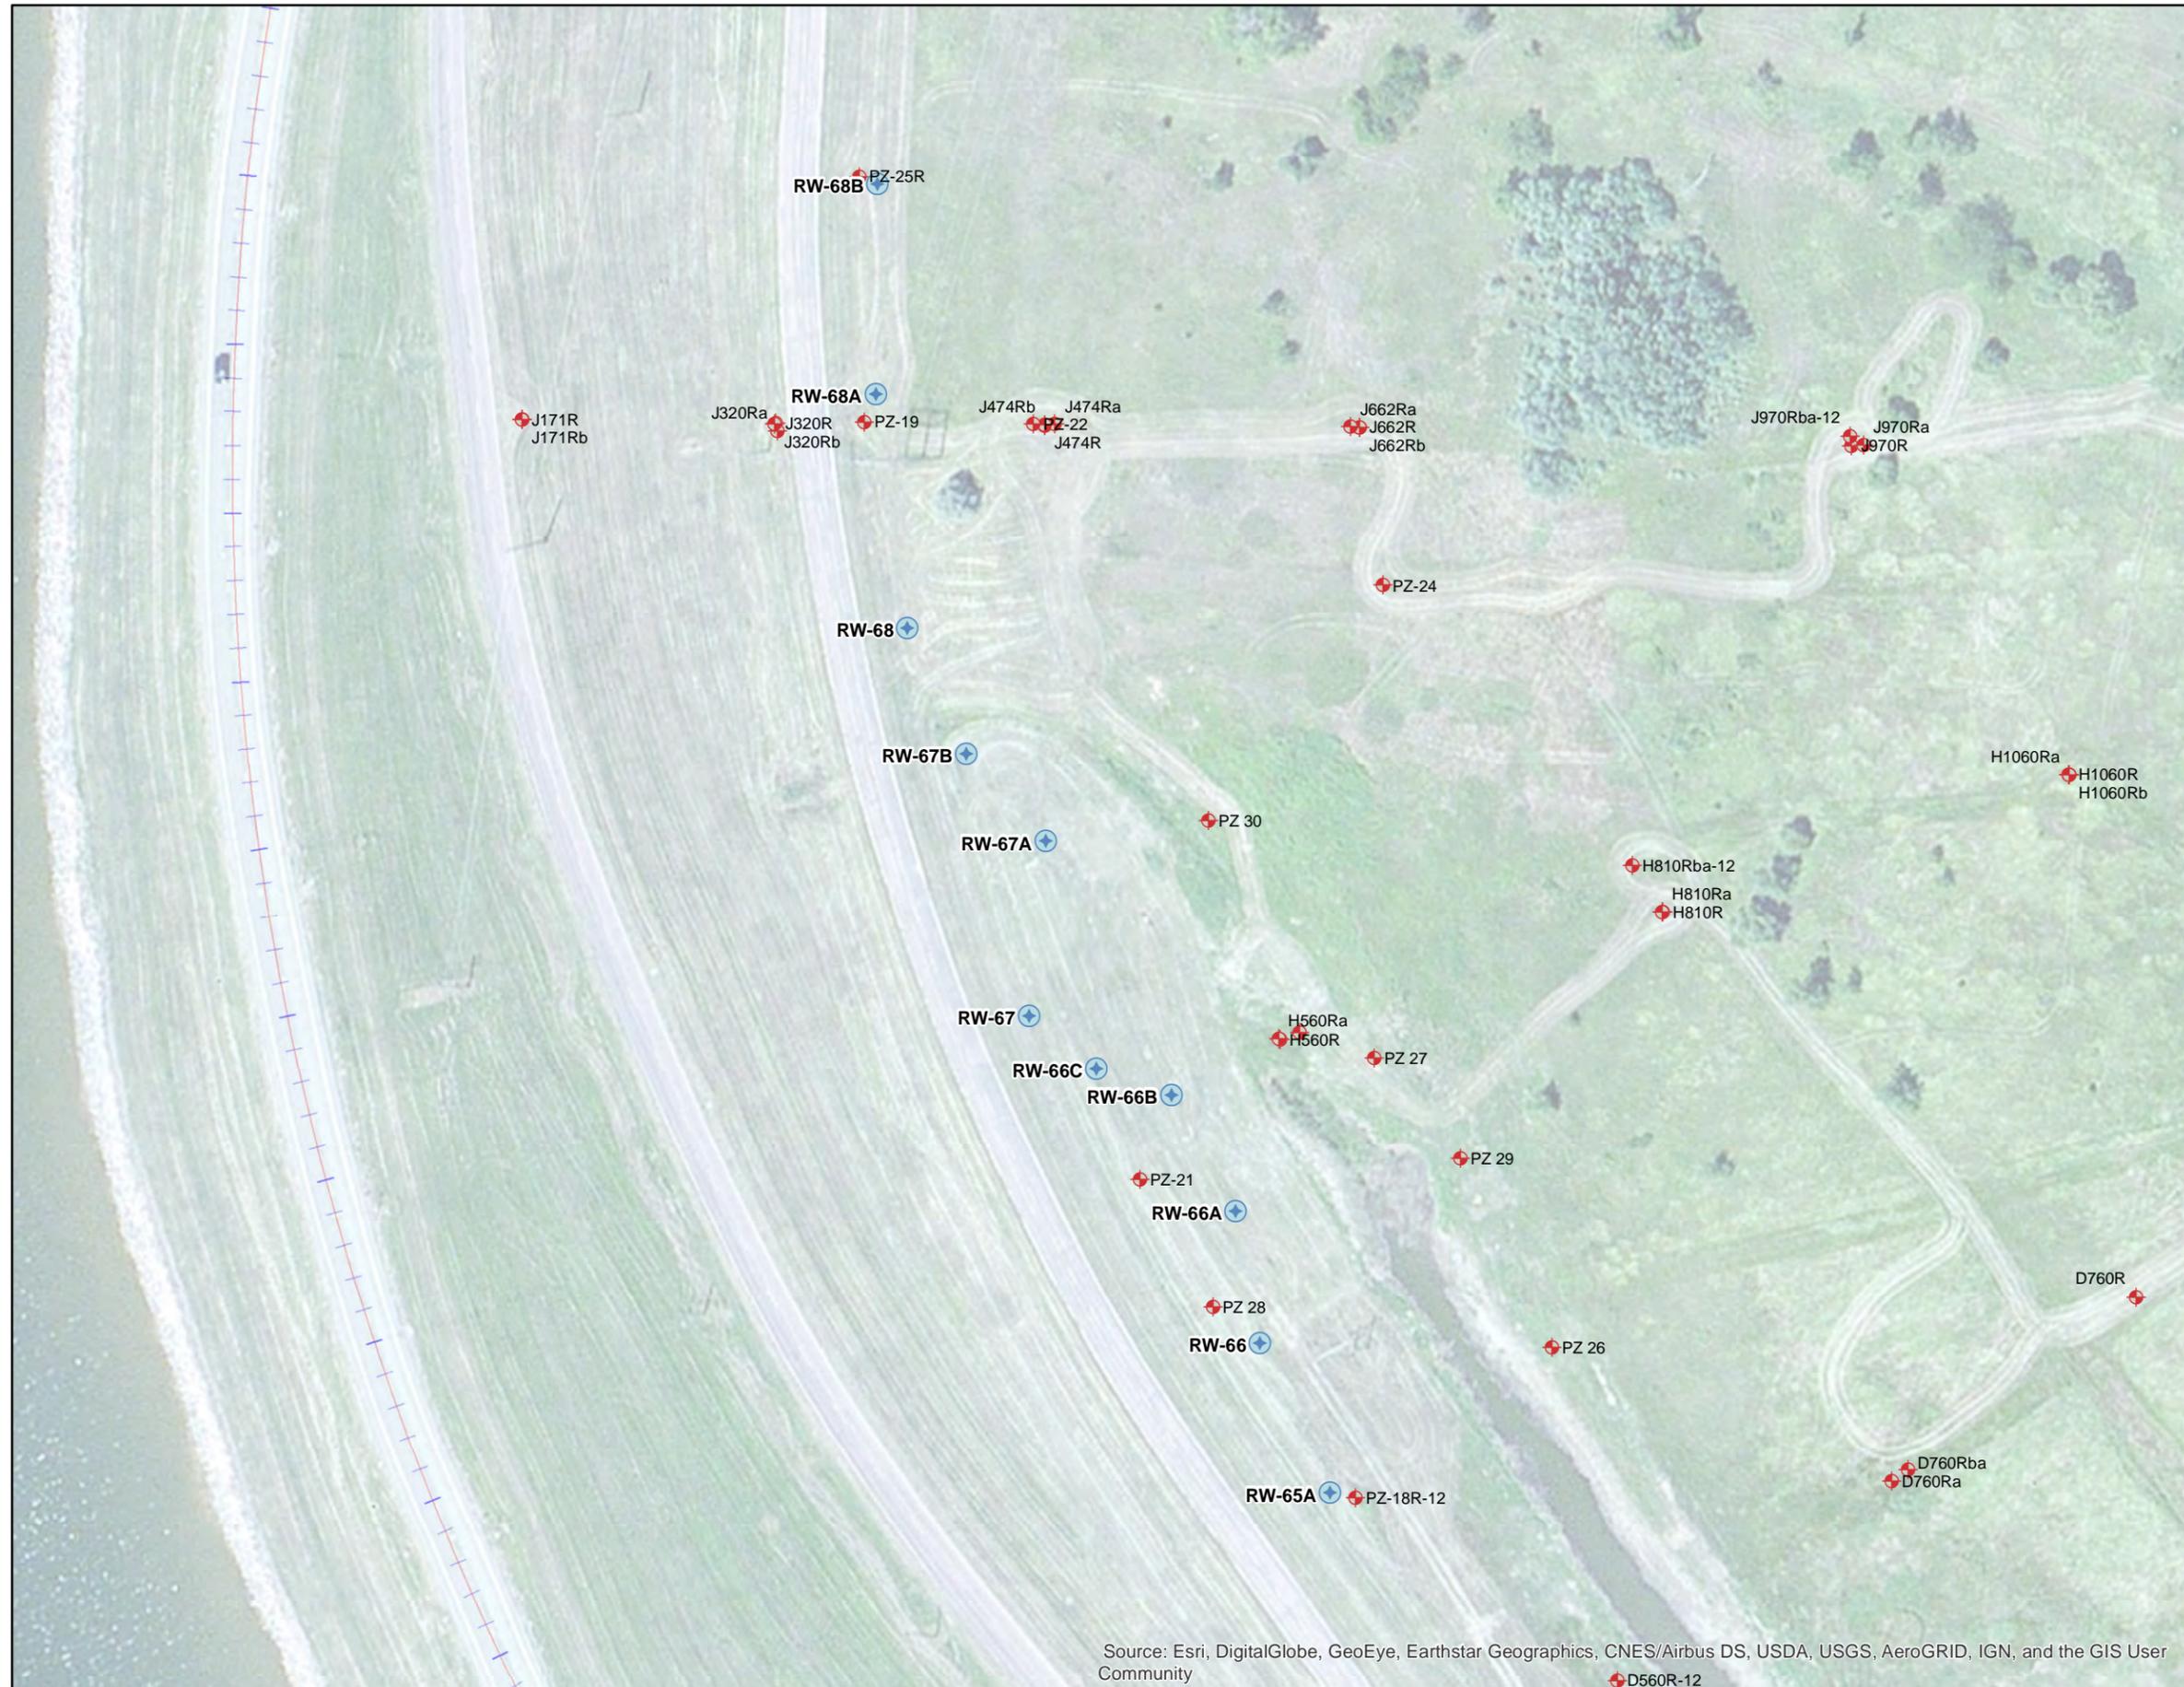
U.S. Army Corps of Engineers Omaha District	
Big Bend Dam Buffalo and Lyman Counties, SD	
Relief Well Rehabilitation Location Map	
March 2020	FIGURE A2

- ⊕ Relief Wells to be Rehabilitated and Capacity Tested (FY20)
- ⊕ Existing Piezometer
