DRAFT
VOLUME II
ASBESTOS CONTAINING MATERIAL &
LEAD CONTAINING PAINT
SURVEY REPORT
BUILDING 49/52

VISN 1
Bedford VA Medical Center
200 Springs Road
Bedford, Massachusetts

Project No. 2009023.008

November 2, 2010

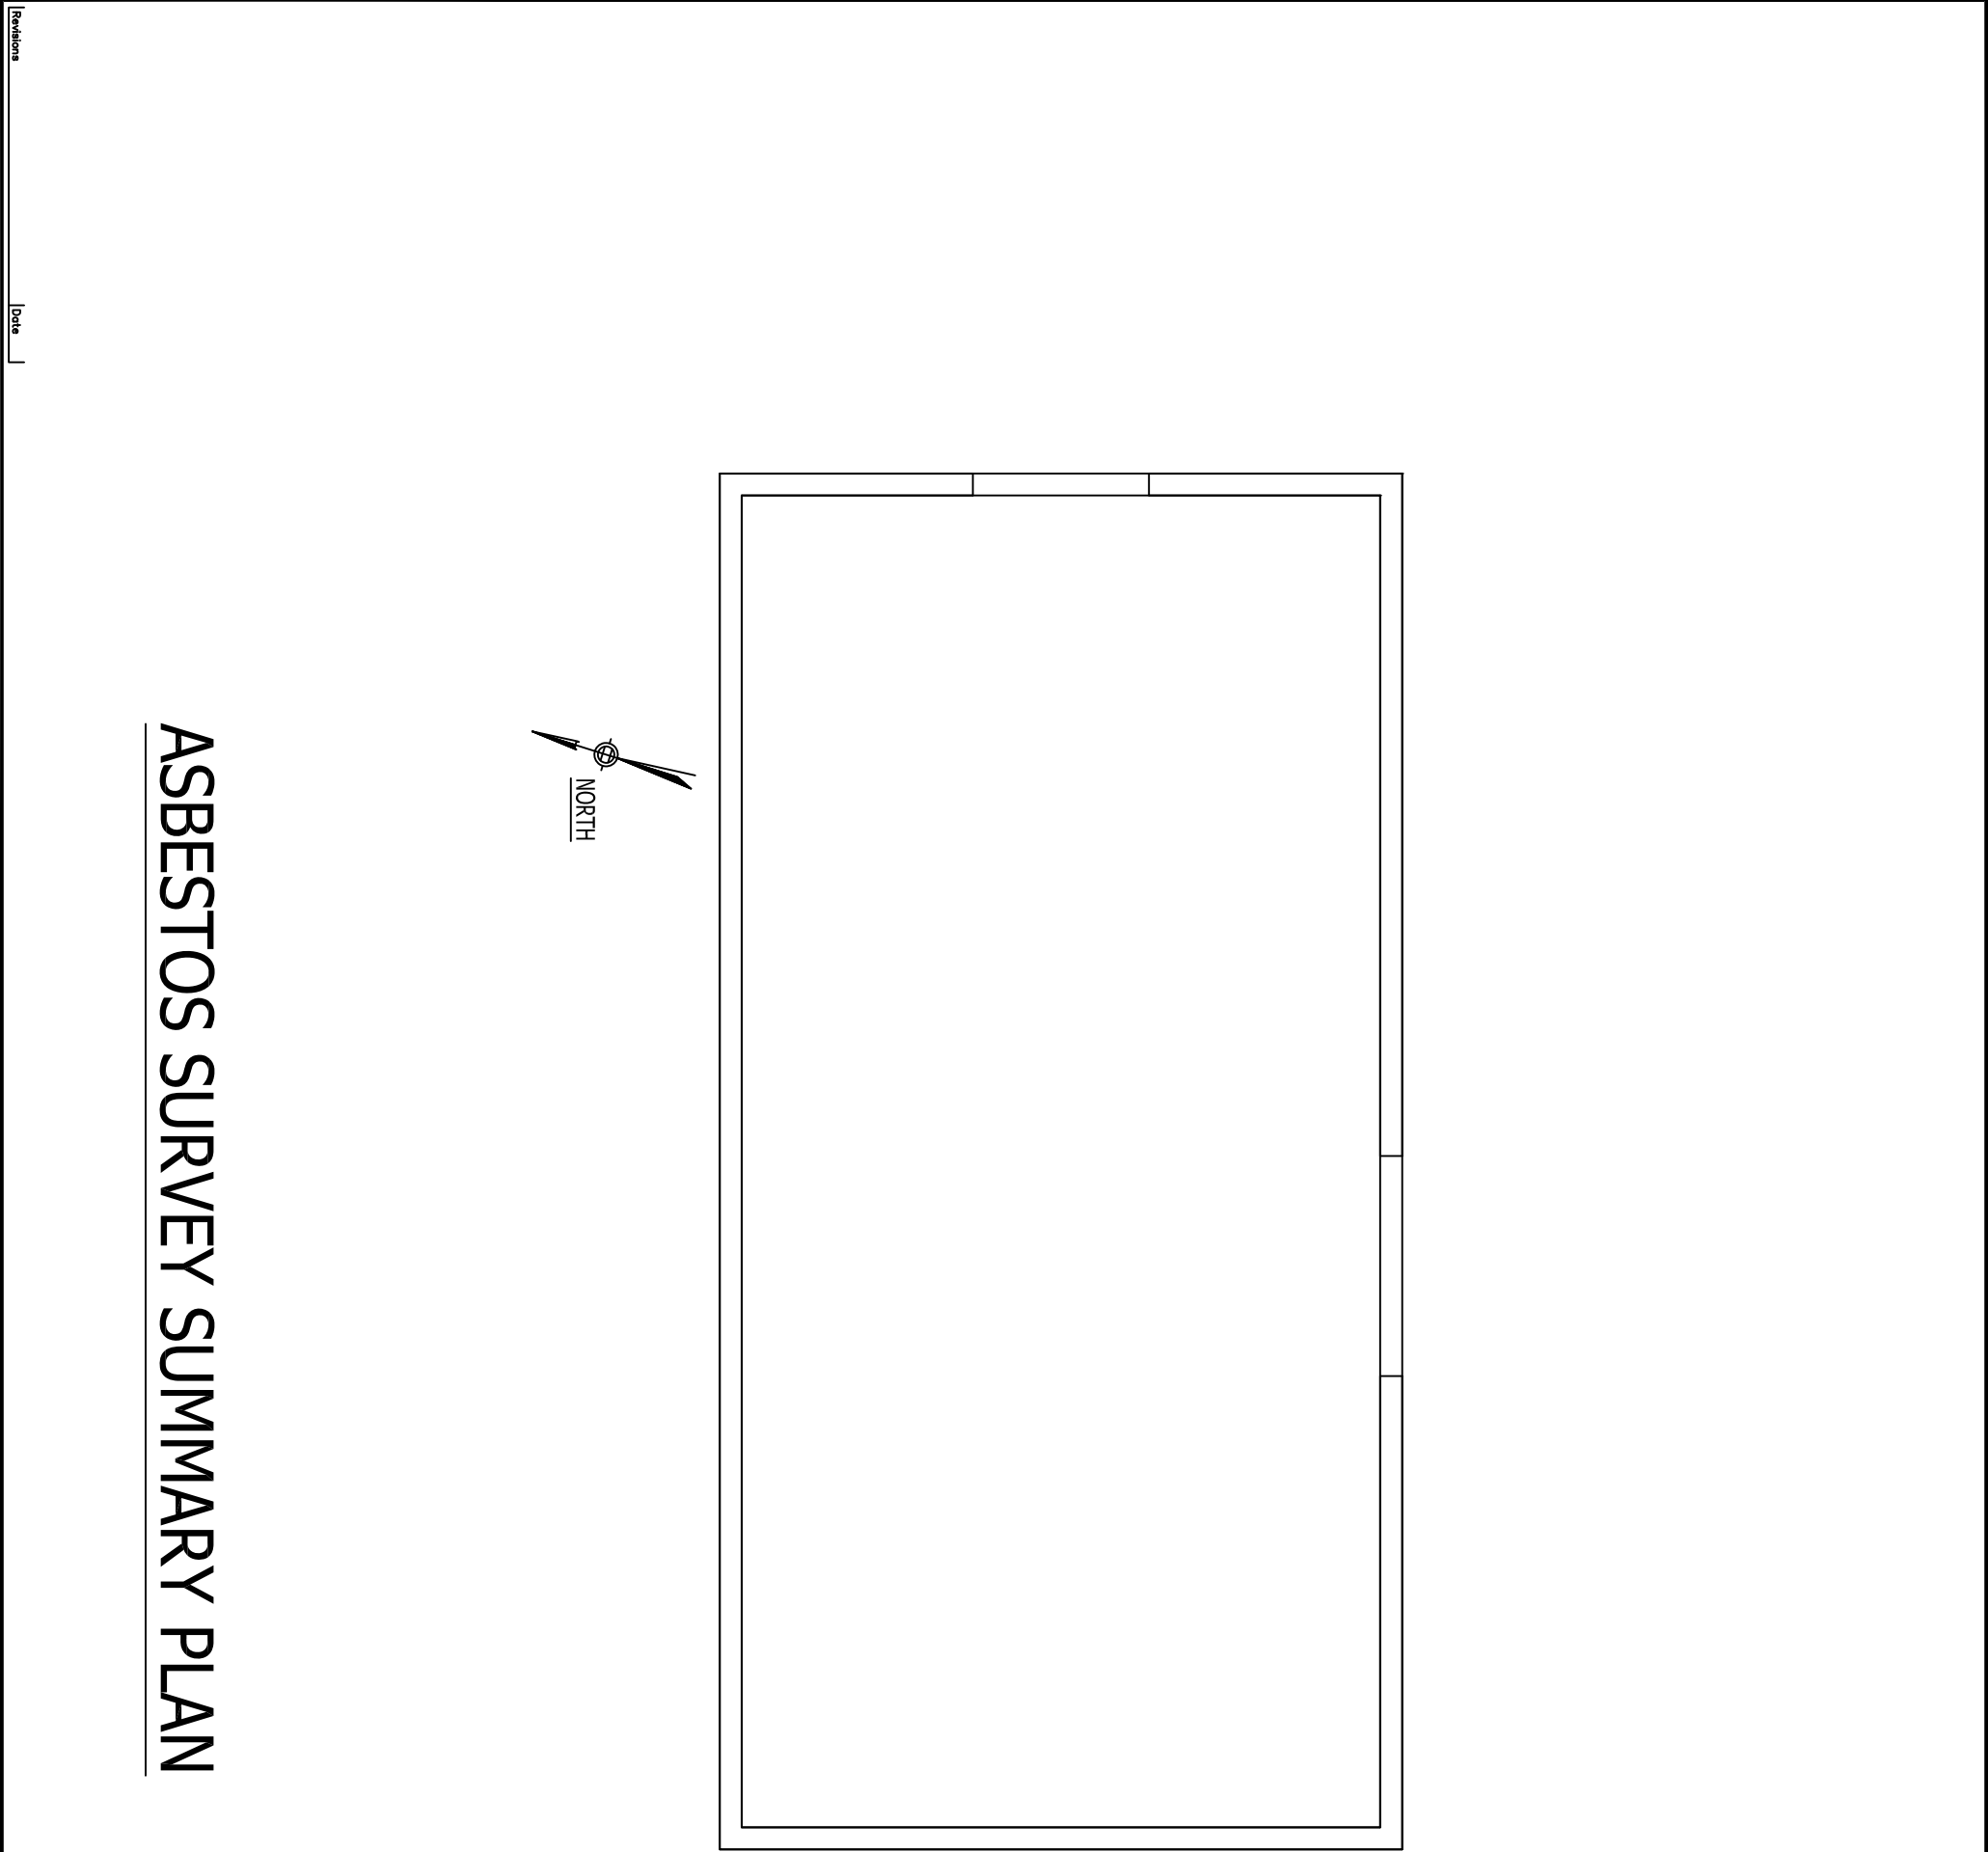
Drawing Title		Project Title		DATE	
BUILDING 49		ASBESTOS SURVEY		OCTOBER 2010	
Floor				PROJ. NO.	
BASEMENT				2009023.008	
		Building Number		CHECKED	DRAWN
		49		CAL	
		Location		DWG. NO.	
		BEDFORD		1	
SCALE: NOT TO SCALE				Dwg. 1 of 1

HATCHED AREAS INDICATE POSITIVE DETECTION OF ASBESTOS CONTAINING BUILDING COMPONENTS

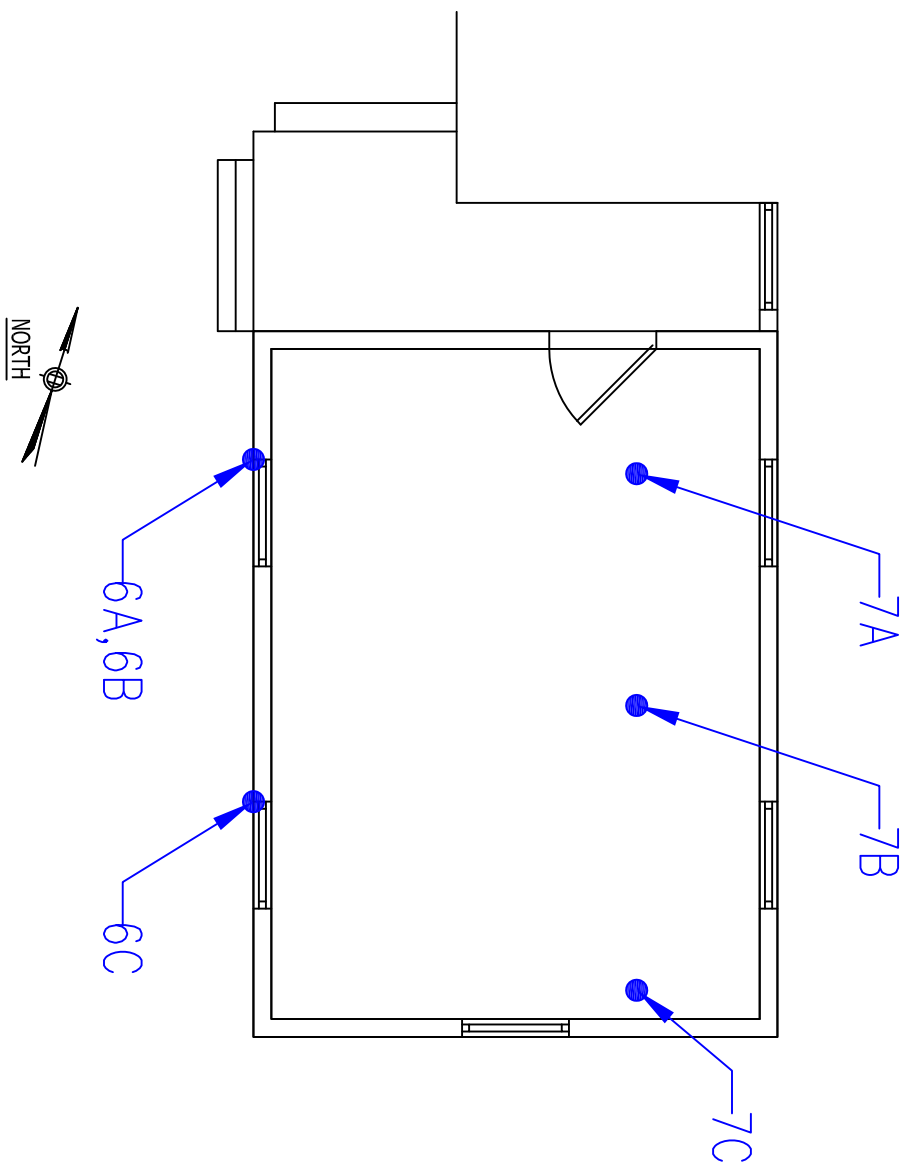
Drawing Title BUILDING 52	Project Title ASBESTOS SURVEY	DATE OCTOBER 2010
Floor FIRST FLOOR	Building Number 52	PROJ. NO. 2009023.008
	Location BEDFORD	DWG. NO. 3
SCALE: NOT TO SCALE	CHECKED	Dwg. 1 of 1
	DRAWN CAL

HATCHED AREAS INDICATE POSITIVE DETECTION OF ASBESTOS CONTAINING BUILDING COMPONENTS

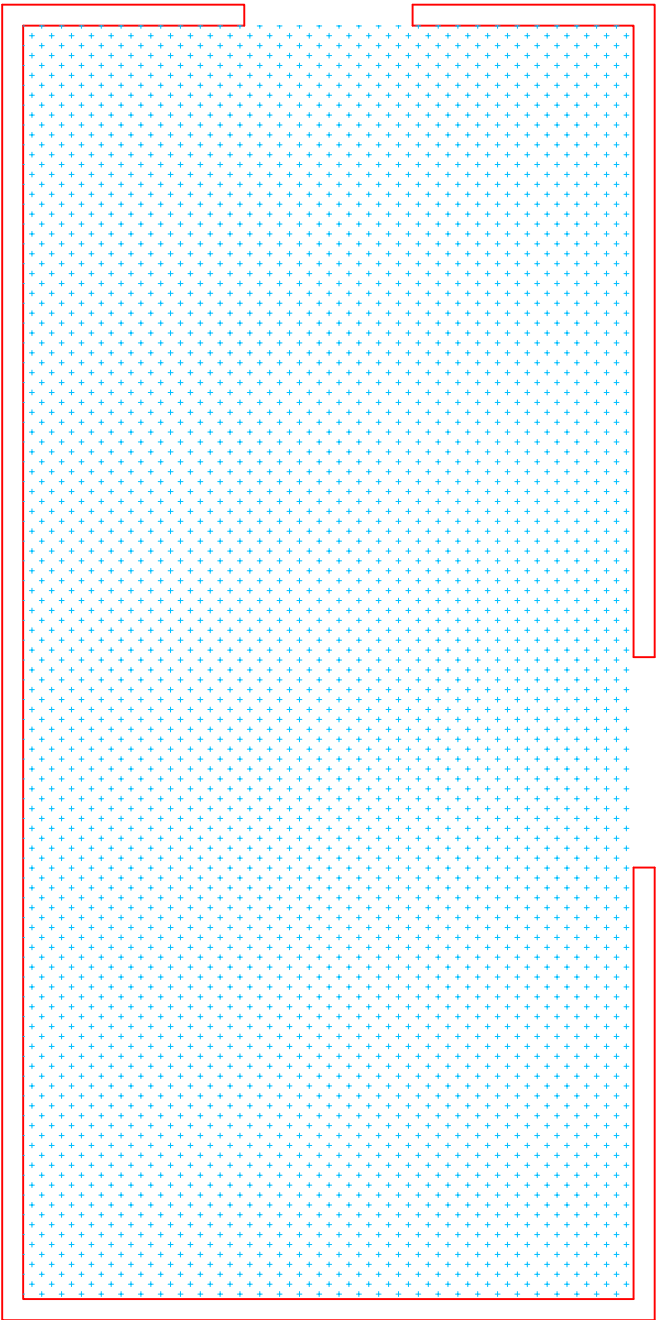
Drawing Title	Project Title	DATE
BUILDING 49	LEAD SURVEY	SEPTEMBER 2010
Floor		PROJ. NO.
BASEMENT		2009023.008
	Building Number	CHECKED
	49	WJP
	Location	DWG. NO.
	BEDFORD	4
		Dwg. 1 of 1
SCALE: NOT TO SCALE

PLEASE SEE THE SAFETY OFFICE PRIOR TO PERFORMING MAINTENANCE/RENOVATION ACTIVITIES ON ANY OF THE FOLLOWING COMPONENTS IN HATCHED AREAS.		
These Building Components Depicted in Red Are Assumed To Contain Lead Containing Paint (LCP) at Greater Than 0.1 mg/cm ² unless otherwise determined.		
COMPONENT	SUBSTRATE	SYMBOL
WALL	WOOD (EXTERIOR)	
DOOR	WOOD	
DOOR CASING	WOOD	
If Present in the Hatched Area These Other Building Components Are Assumed To Be Lead Containing Paint (LCP) at Greater Than 0.1 mg/cm ² unless otherwise determined.		SYMBOL
CEILING	WOOD	
Notes: 1. Components similar to those listed in the table above found in the hatched areas should be assumed to contain LCP for worker protection, maintenance, renovation, disposal, etc. purposes unless otherwise determined by an approved method. 2. Lead-containing paint (LCP) screening measurements were collected using an XRF analyzer. For additional information and full screening results refer to the M&A, Asbestos & LCP building report. 3. Users of this information should not rely on color alone to decide whether similar building components contain LCP. 4. Equipment, furniture, non structural items, and non-painted building components such as glazed tile, glazed block, stained or leaded glass, unpainted piping, etc. were not included in the survey and are not included in the table but may contain Lead
