# **ASBESTOS INSPECTION REPORT**

## **WHITERIVER INDIAN HOSPITAL**

**Buildings 301, 303, 305, 307, and 309**

**AUGUST 6, 2021**

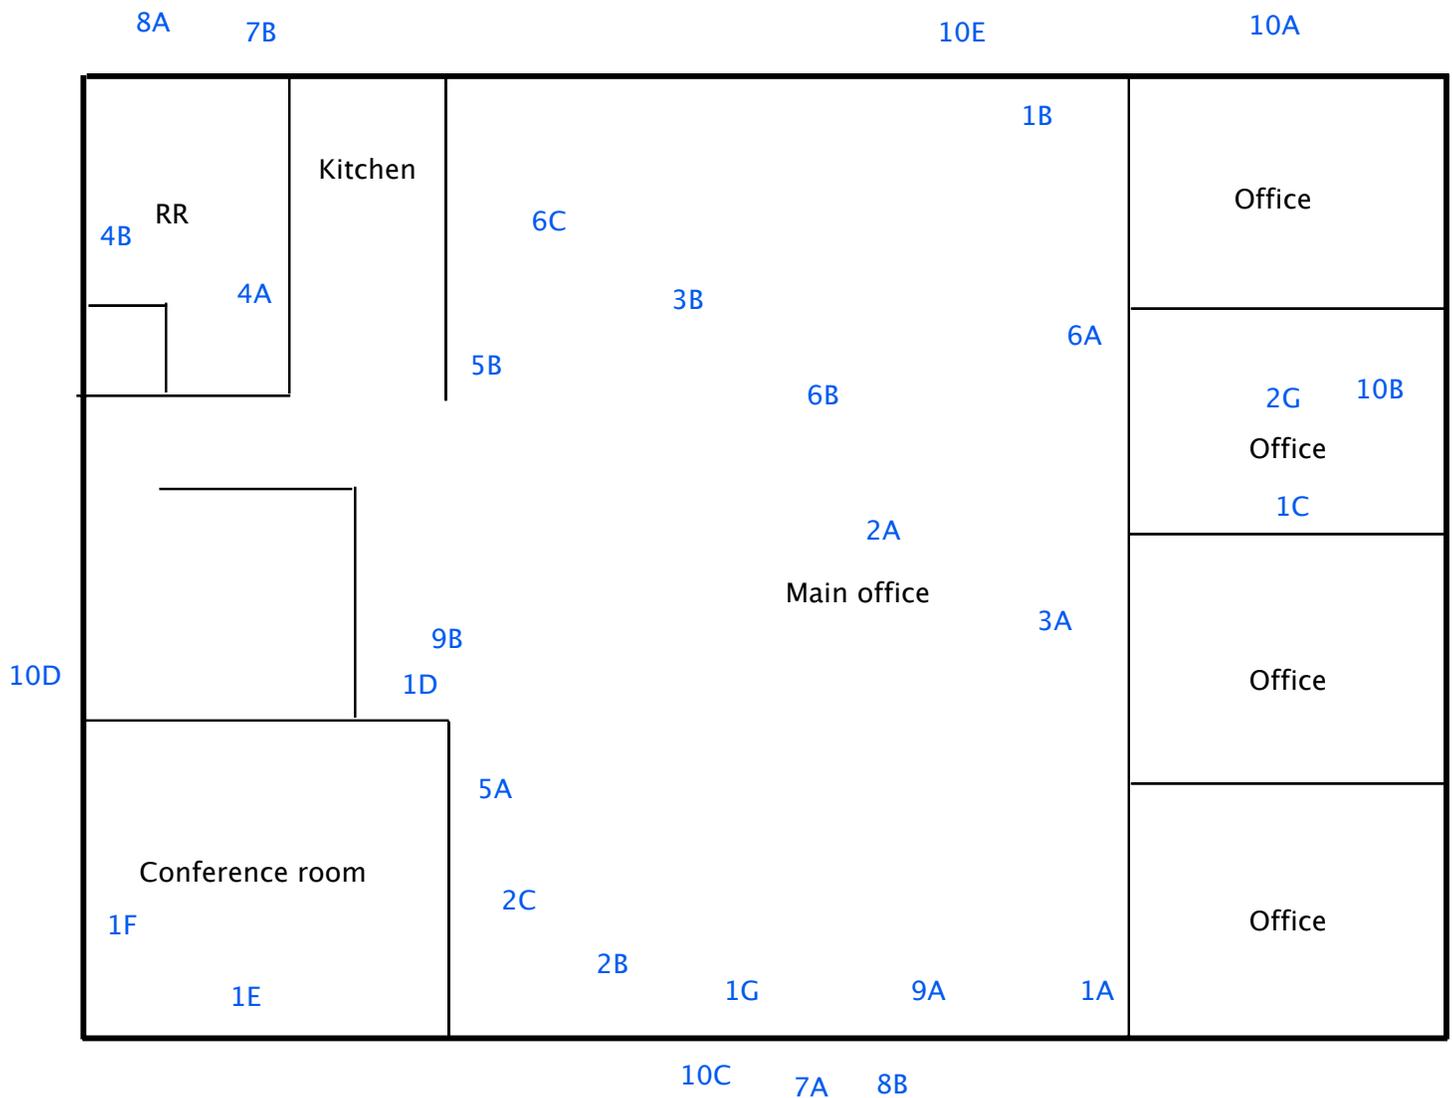
# Building 301, Whiteriver Indian Hospital 200 West Hospital Drive, Whiteriver, AZ 85941 Asbestos Sample Locations Sketch

All Building 301 locations were accessed. The crawl space was inspected, as was the space above the ceiling. We determined that all material types were homogeneous. Sample locations are identified in Appendix 1, Table and Sketch. Samples were randomly collected and were representative of all functional spaces. Samples were characterized for condition, damage potential and friability, both visually and by touch.

**No asbestos was found.** No further asbestos inspection or testing is required prior to demolition, disposal or reuse.

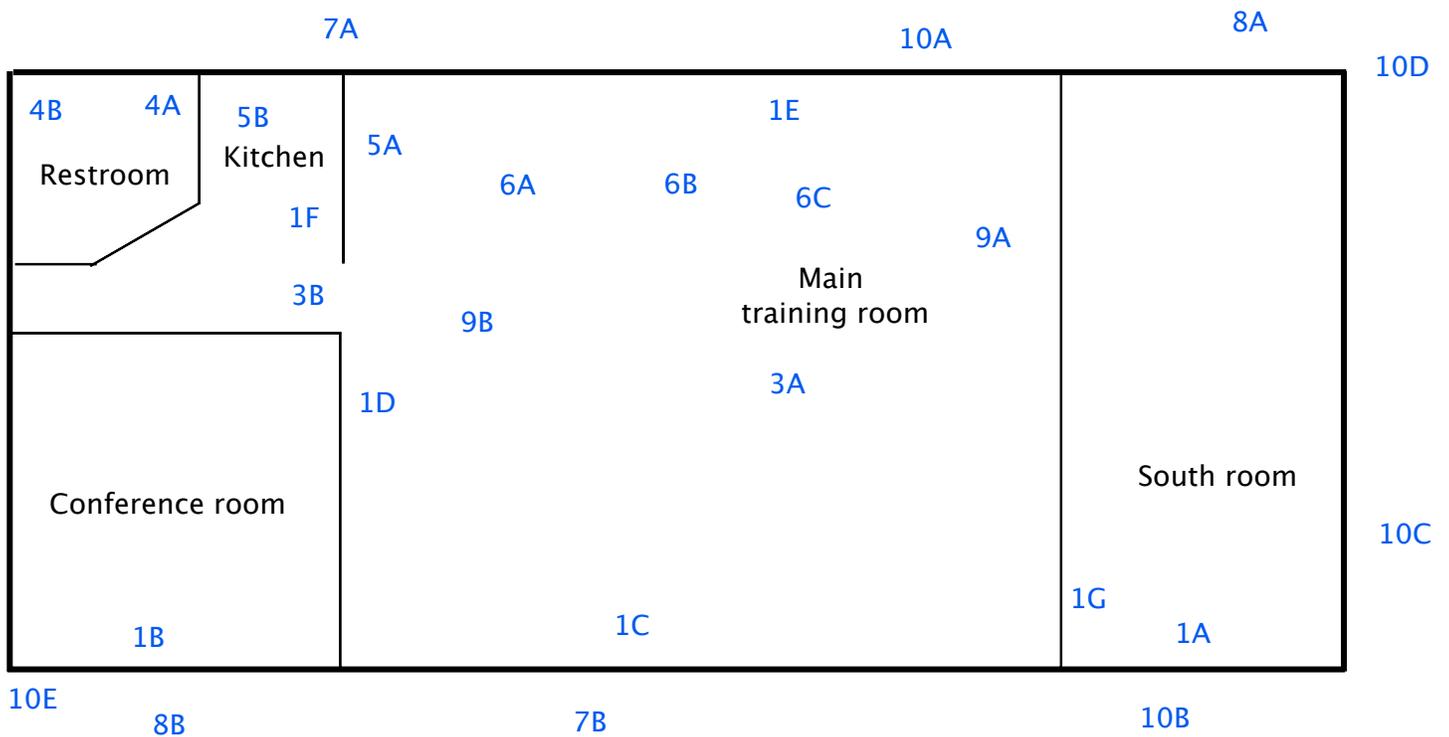
Building 303, Whiteriver Indian Hospital  
 200 West Hospital Drive, Whiteriver, AZ 85941  
 Asbestos Sample Locations Sketch

All Building 303 locations were accessed. The crawl space was inspected, as was the space above the ceiling. We determined that all material types were homogeneous. Sample locations are identified in Appendix 1, Table and Sketch. Samples were randomly collected and were representative of all functional spaces. Samples were characterized for condition, damage potential and friability, both visually and by touch.

**No asbestos was found.** No further asbestos inspection or testing is required prior to demolition, disposal or reuse.

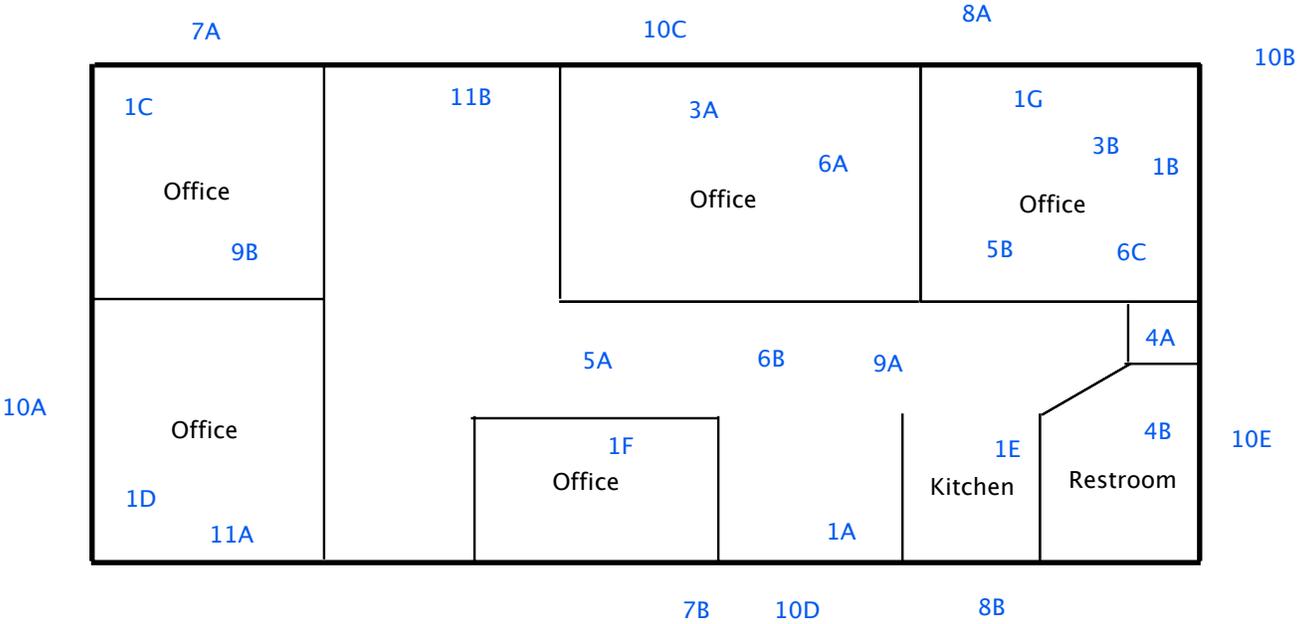
Building 305, Whiteriver Indian Hospital  
 200 West Hospital Drive, Whiteriver, AZ 85941  
 Asbestos Sample Locations Sketch

**No asbestos was found.** No further asbestos inspection or testing is required prior to demolition, disposal or reuse.
