## Technical Report: Fort Peck Butterfly Valve#4 Inspection Report

### FT. PECK PH#2 BUTTERFLY VALVE NDT

Date: 12/5/2019

**Inspected by:** Thomas R. Hay, P.E., ASNT Level 3#107162  
TECHKNOWSERV CORP.  
2134 Sandy Dr., Suite 14  
State College PA, 16803  
(814) 237-0144

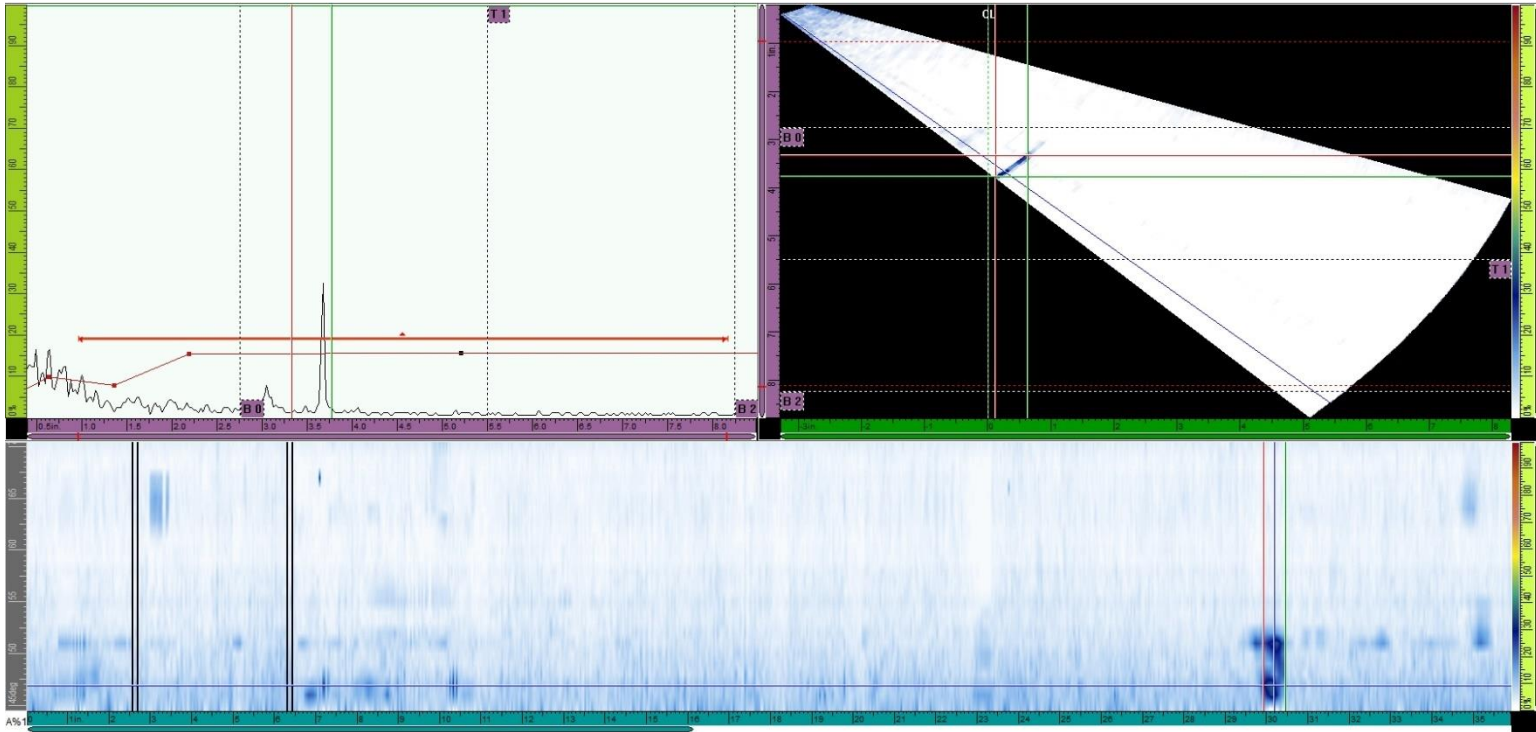
Weld	Comments
S2a	<p data-bbox="296 264 646 305">No reportable indications.</p>

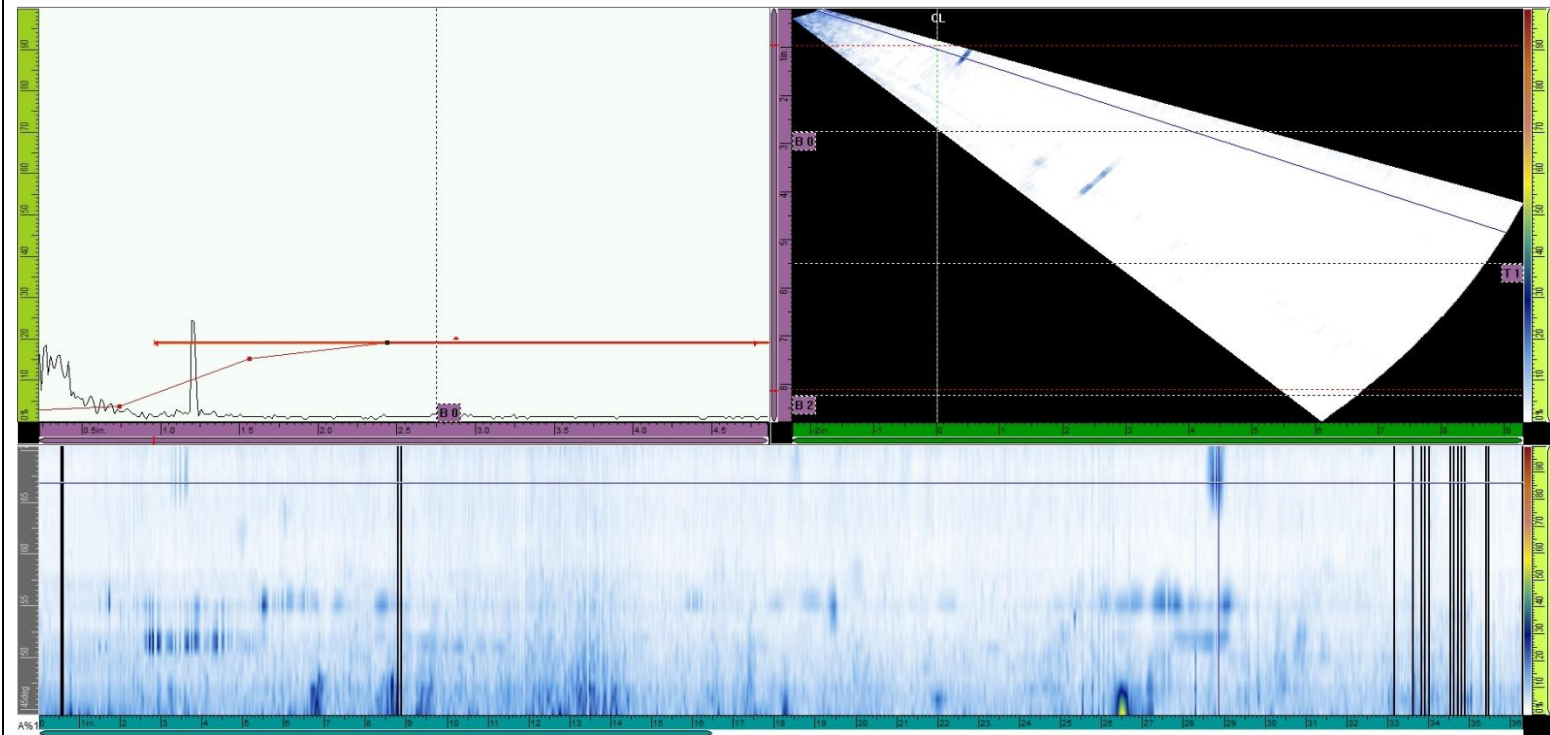
S2b

No reportable indications.

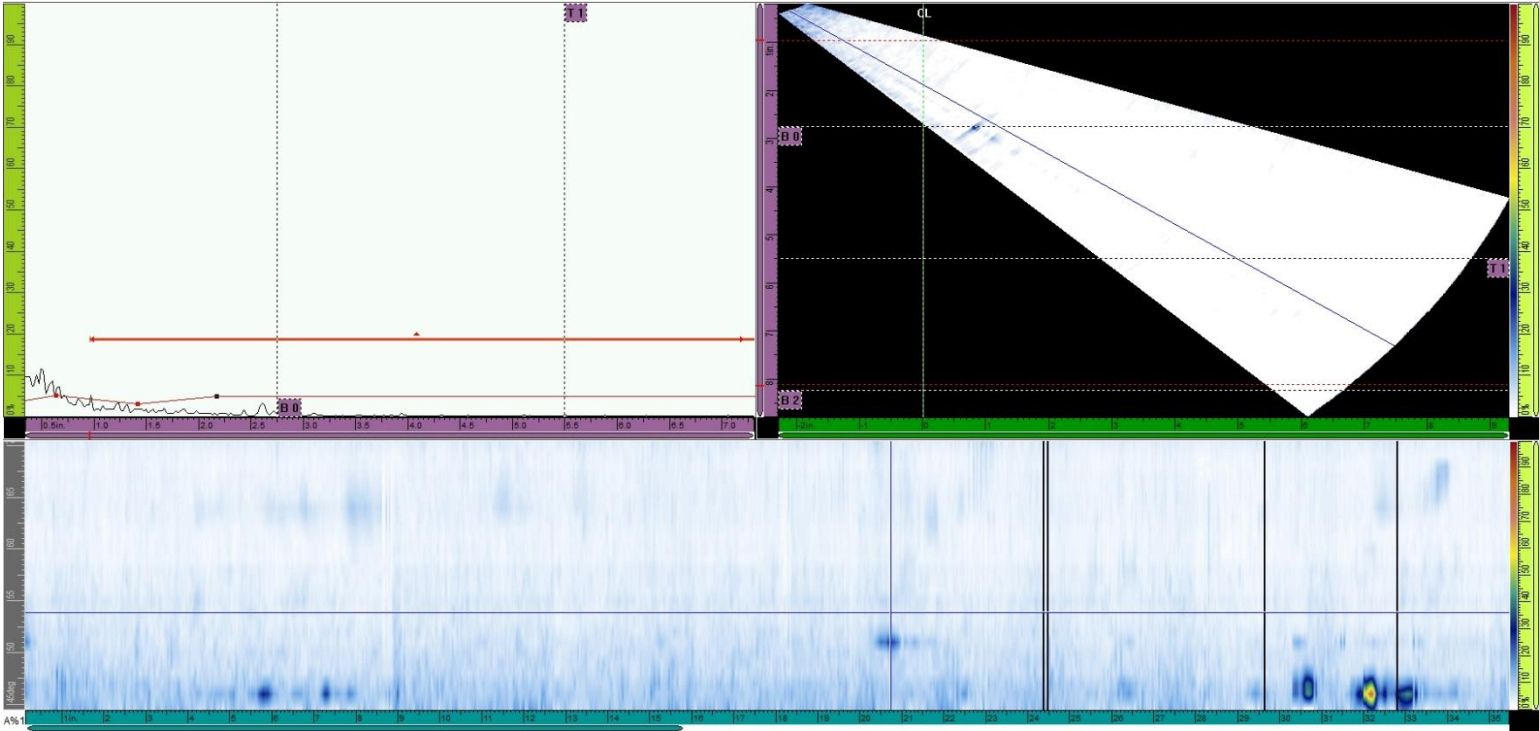
Weld	Comments
S3a	<p data-bbox="296 264 646 305">No reportable indications.</p>

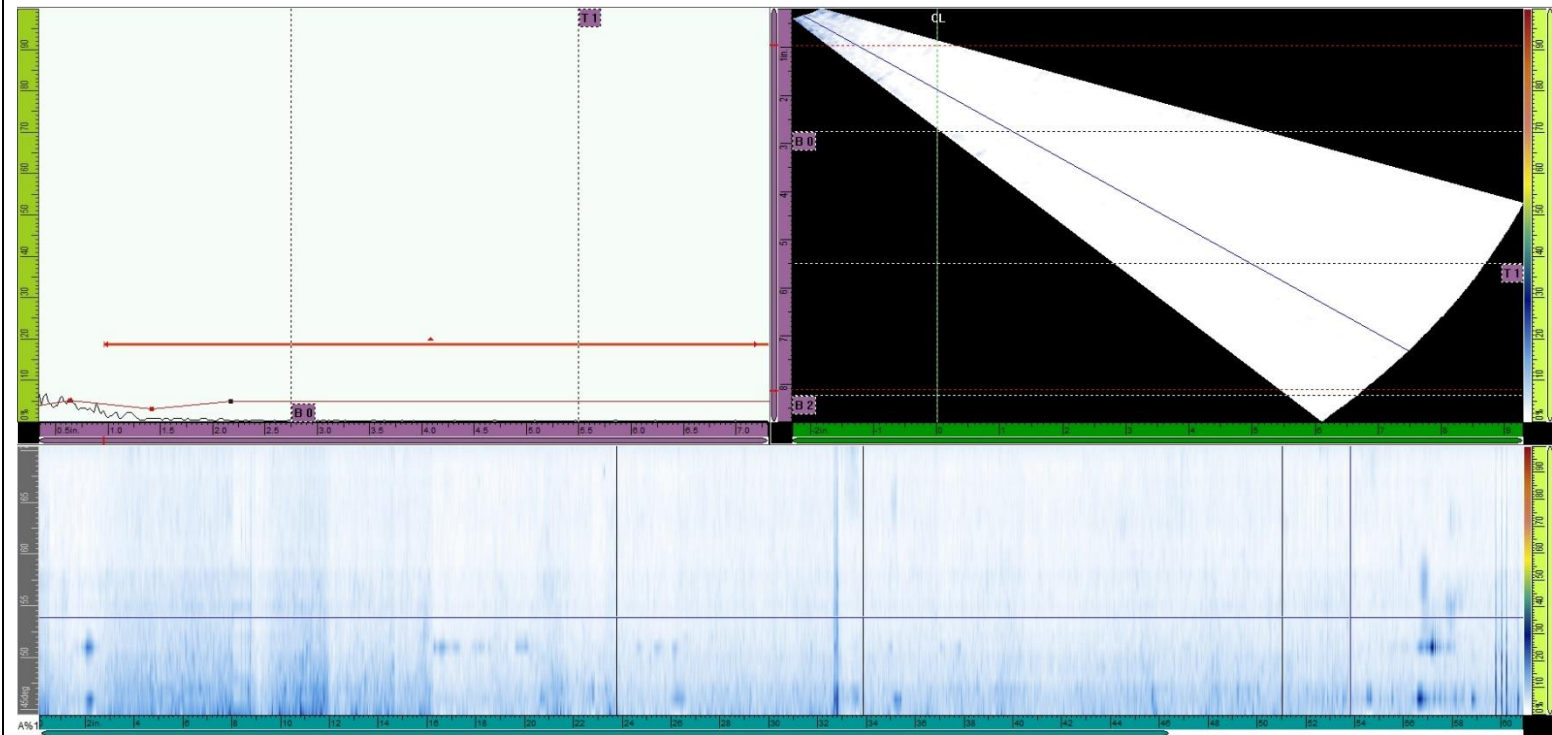
Weld	Comments
S3b	<p data-bbox="296 264 646 305">No reportable indications.</p>

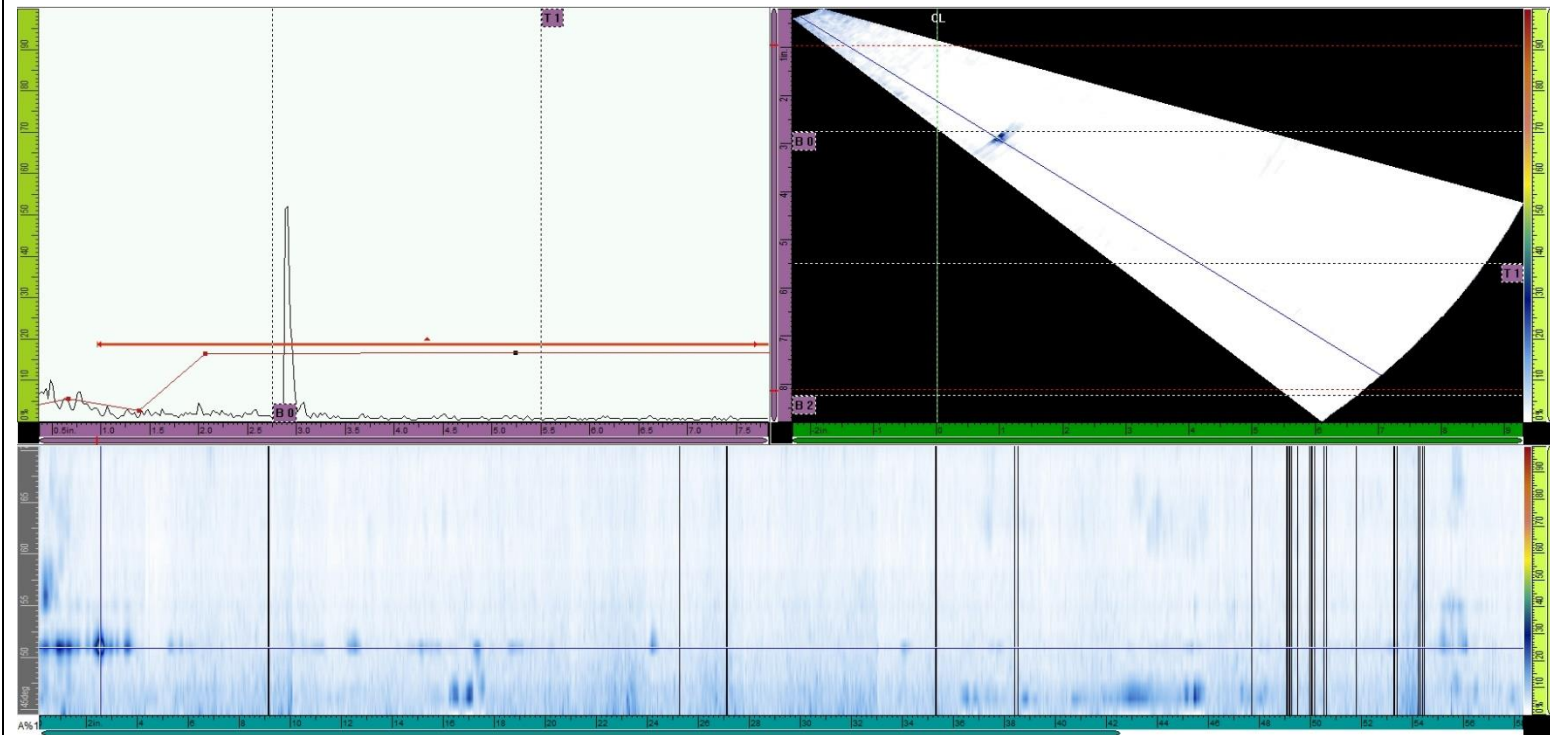
Weld	Comments
S4a	<p data-bbox="296 264 646 305">No reportable indications.</p>

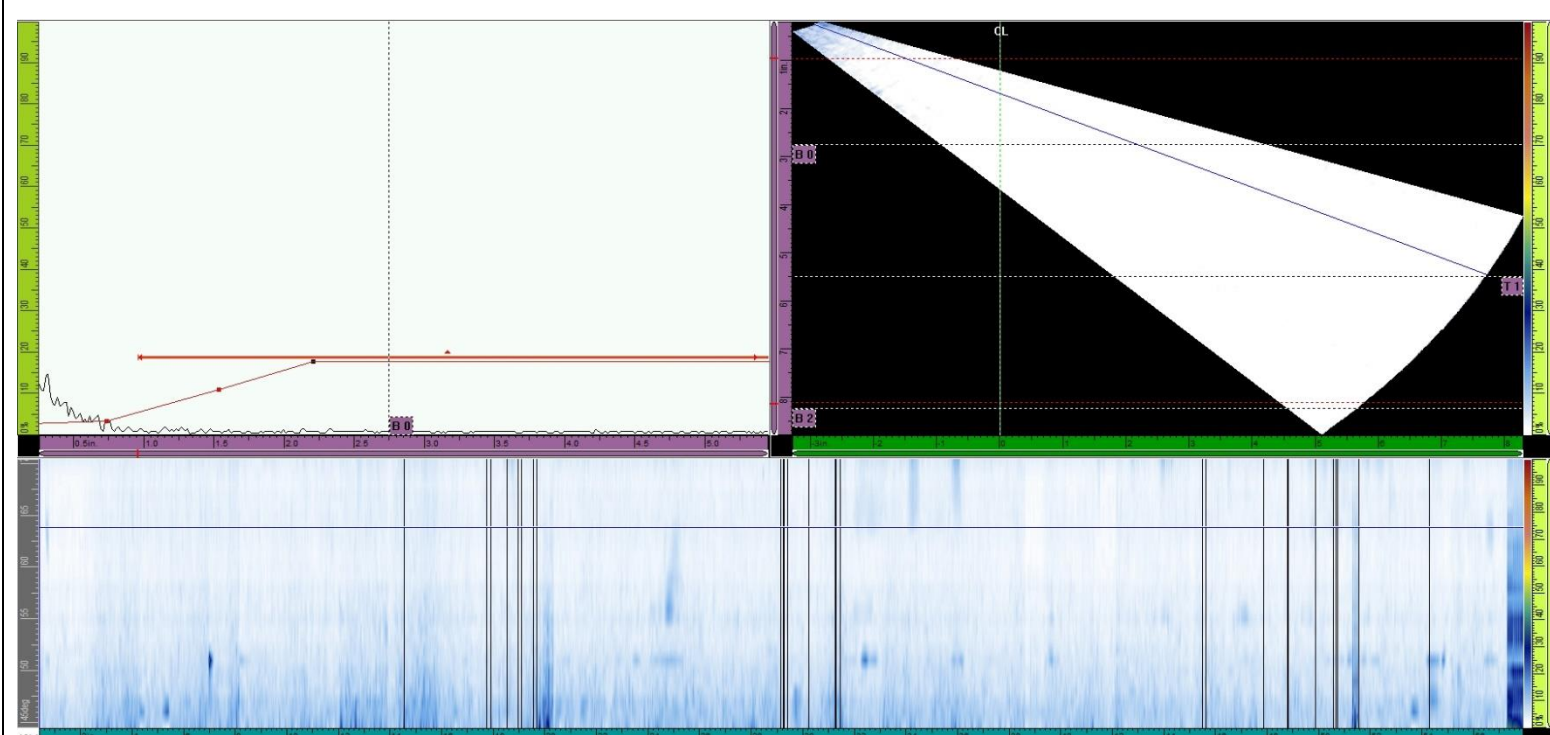
Weld	Comments
S4b	<p data-bbox="296 264 646 305">No reportable indications.</p>

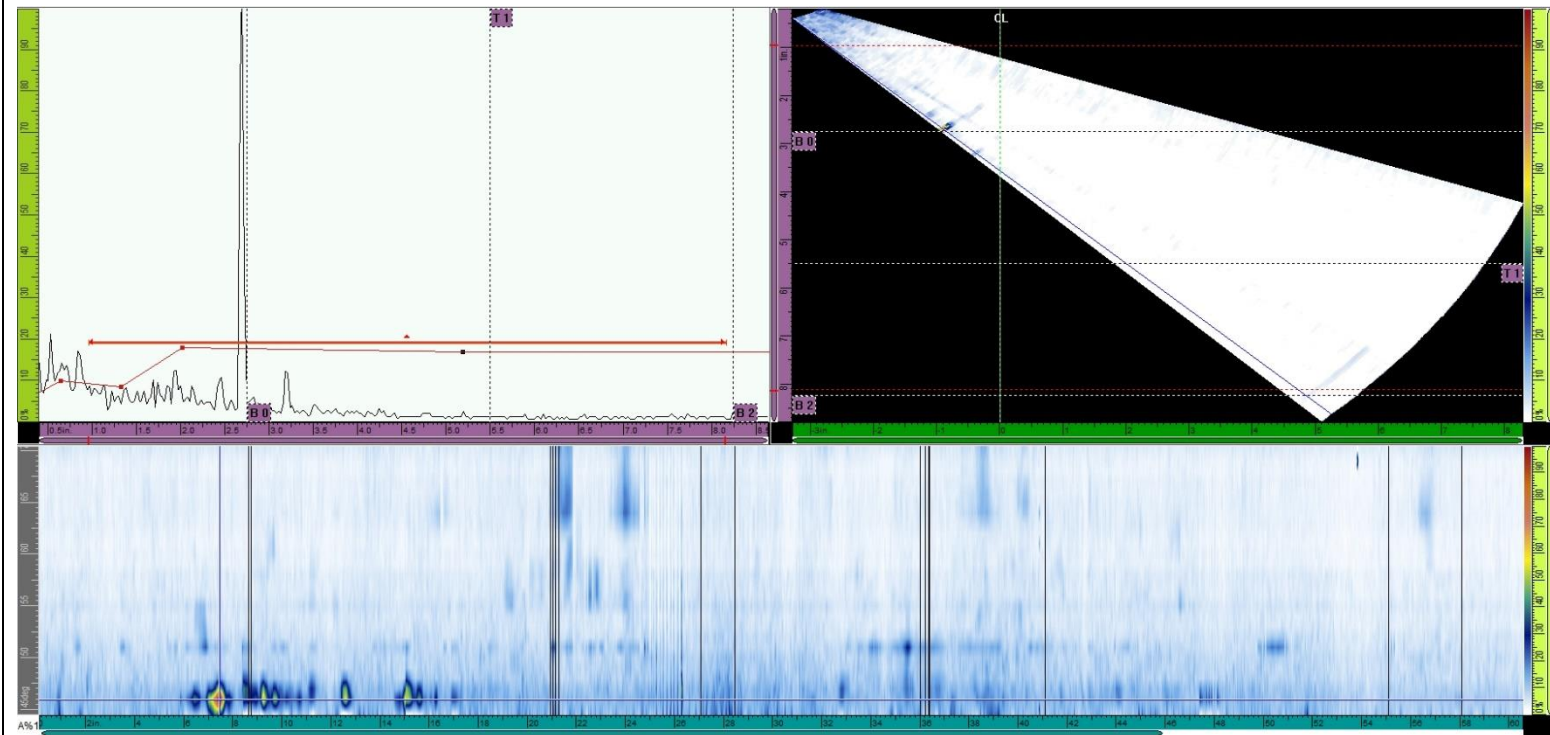
Weld	Comments														
S5a	Gain (dB)	Indication #	Scan (in)	Index (in)	Group	Channel	A%1 (%)	DA/1 (in)	PA/1 (in)	SA/1 (in)	U(m-r) (in)	I(m-r) (in)	I•U(m-r) (in)	S(m-r) (in)	Type
	40.66	1	7.606	-6.500	PA 1	61.00°	49.9	1.018	1.336	2.099	0.248	0.202	0.320	0.688	LOF
	40.66	2	12.217	-6.500	PA 1	46.00°	58.6	2.368	2.553	4.508	0.250	0.202	0.322	1.526	LOF
	40.66	3	25.813	-6.500	PA 1	46.00°	46.7	2.214	2.713	4.730	0.298	0.243	0.384	0.752	LOF

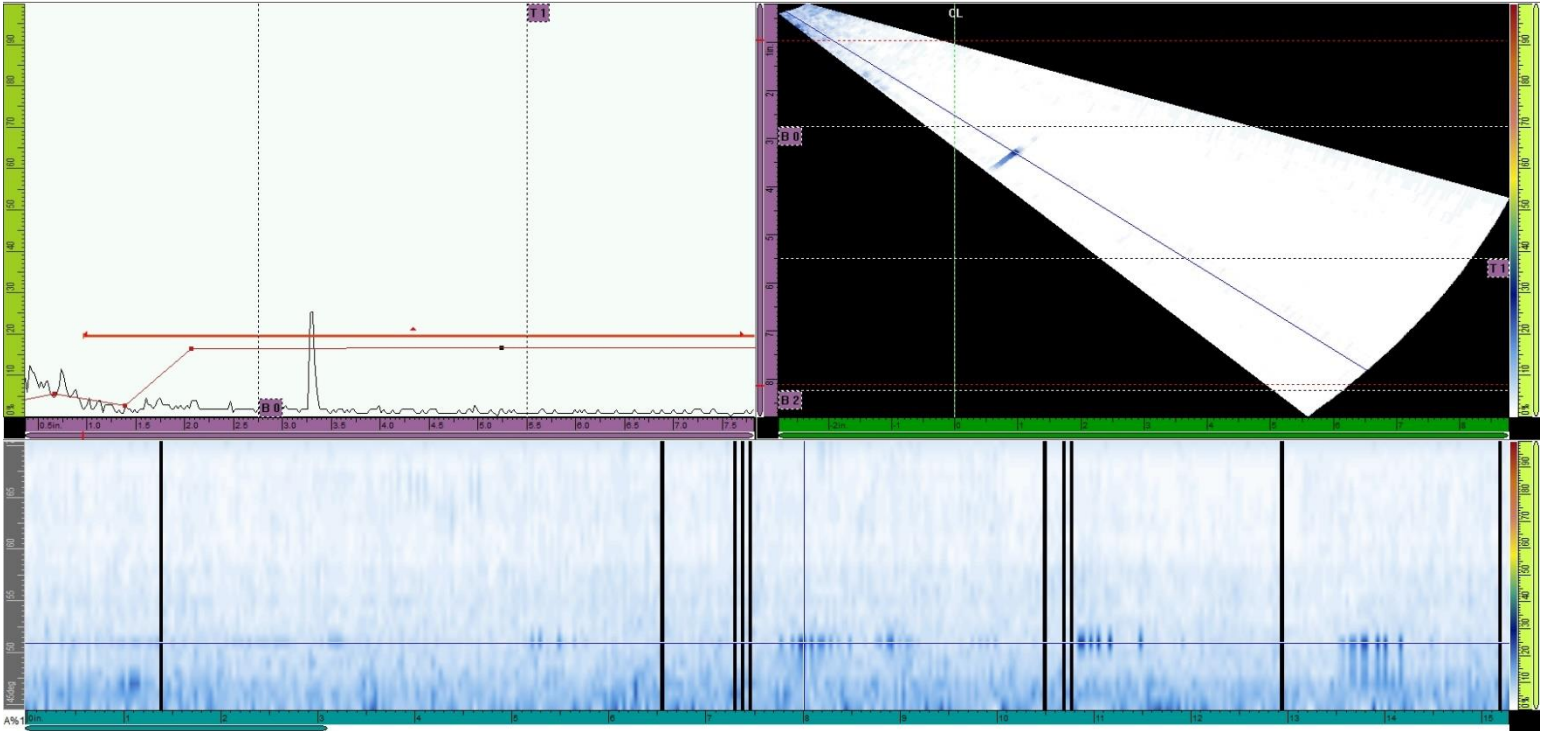
Weld	Comments
S5b	<p data-bbox="296 264 646 305">No reportable indications.</p>

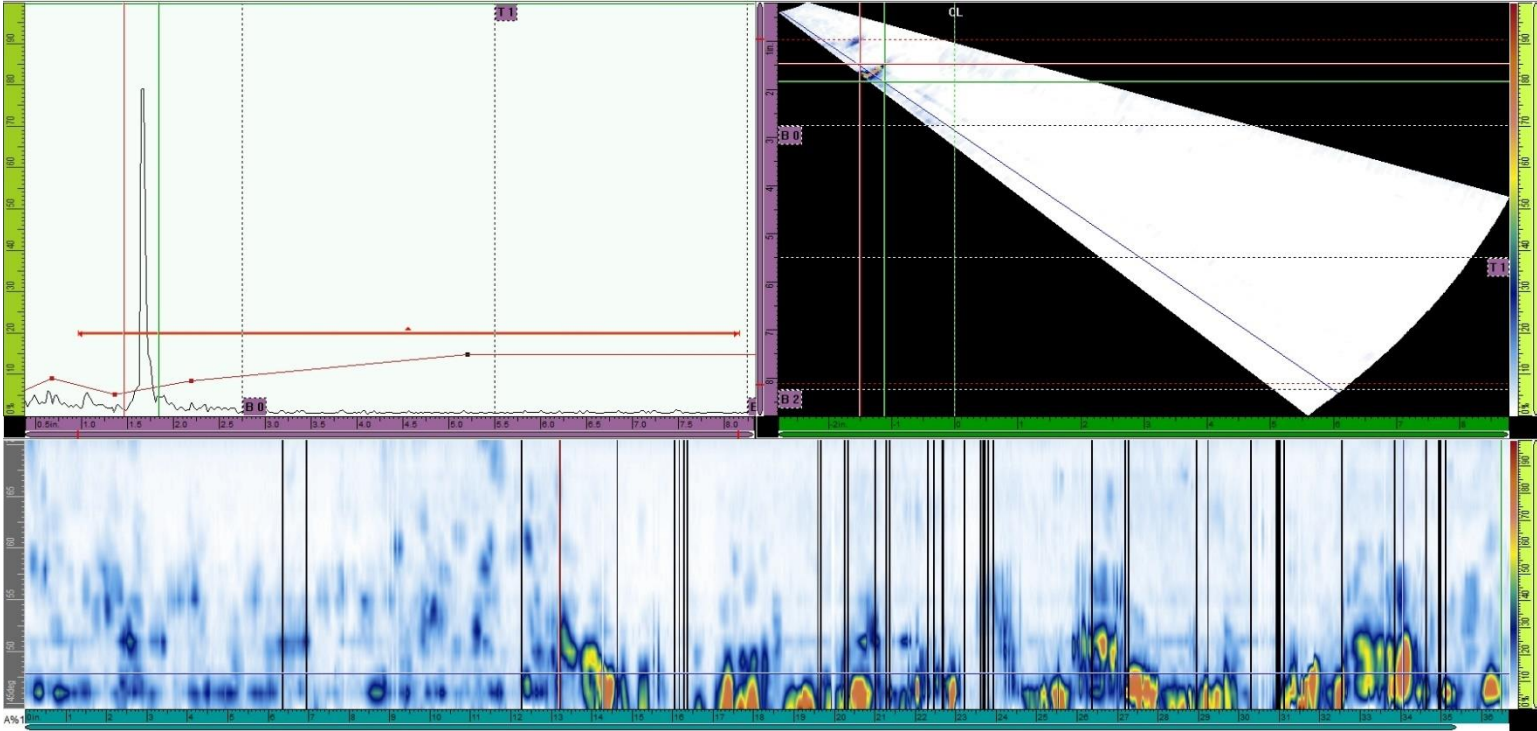
The upstream side contained 17 weld discontinuities longer than 1” and the upstream side contained 4 weld discontinuities with a height greater than 0.375”. The most severe discontinuity, a lack of penetration, was found in weld S8a with a length of 23.303” and a height of 0.372”.

Gain (dB)	Indication #	Scan (in)	Index (in)	Group	Channel	A%1 (%)	DA/1 (in)	PA/1 (in)	SA/1 (in)	U(m-r) (in)	I(m-r) (in)	I•U(m-r) (in)	S(m-r) (in)	Type
52.66	1	34.062	-6.500	PA 1	48.00°	78.8	1.653	1.171	2.470	0.372	0.391	0.540	23.303	LOF

3. **Re-asses risk matrix color-coded red welds after abatement, blasting, and cleaning:** Perform encoded PAUT to more accurately locate and size the weld discontinuities. Apply new coating system to these areas after inspection. Re-assess possible repair action after new sizing data is made available. Determine if discontinuity has grown and, if so, repair immediately.

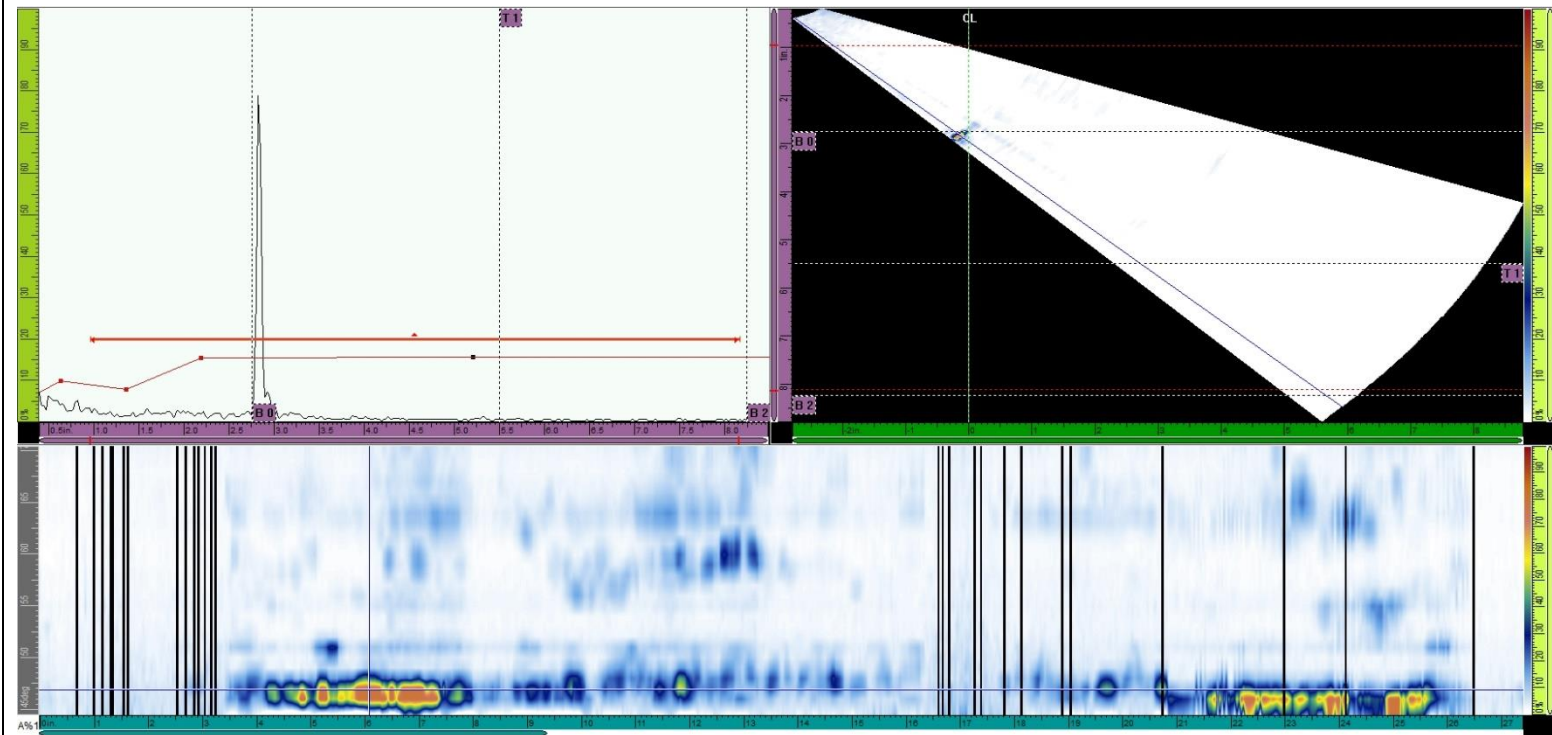
Weld	Comments
S11a	<p data-bbox="296 264 646 305">No reportable indications.</p>

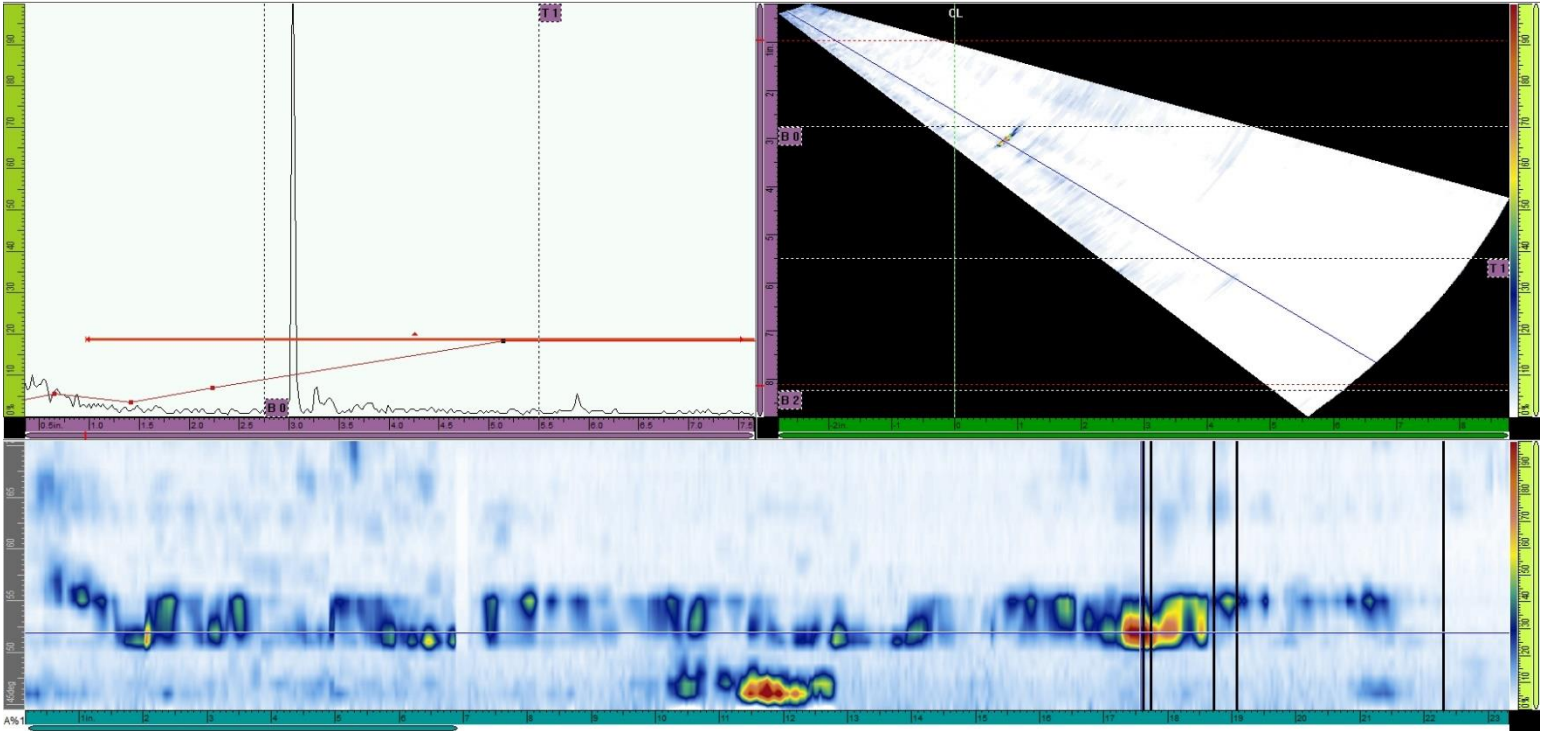
Weld  
S11b

No reportable indications.

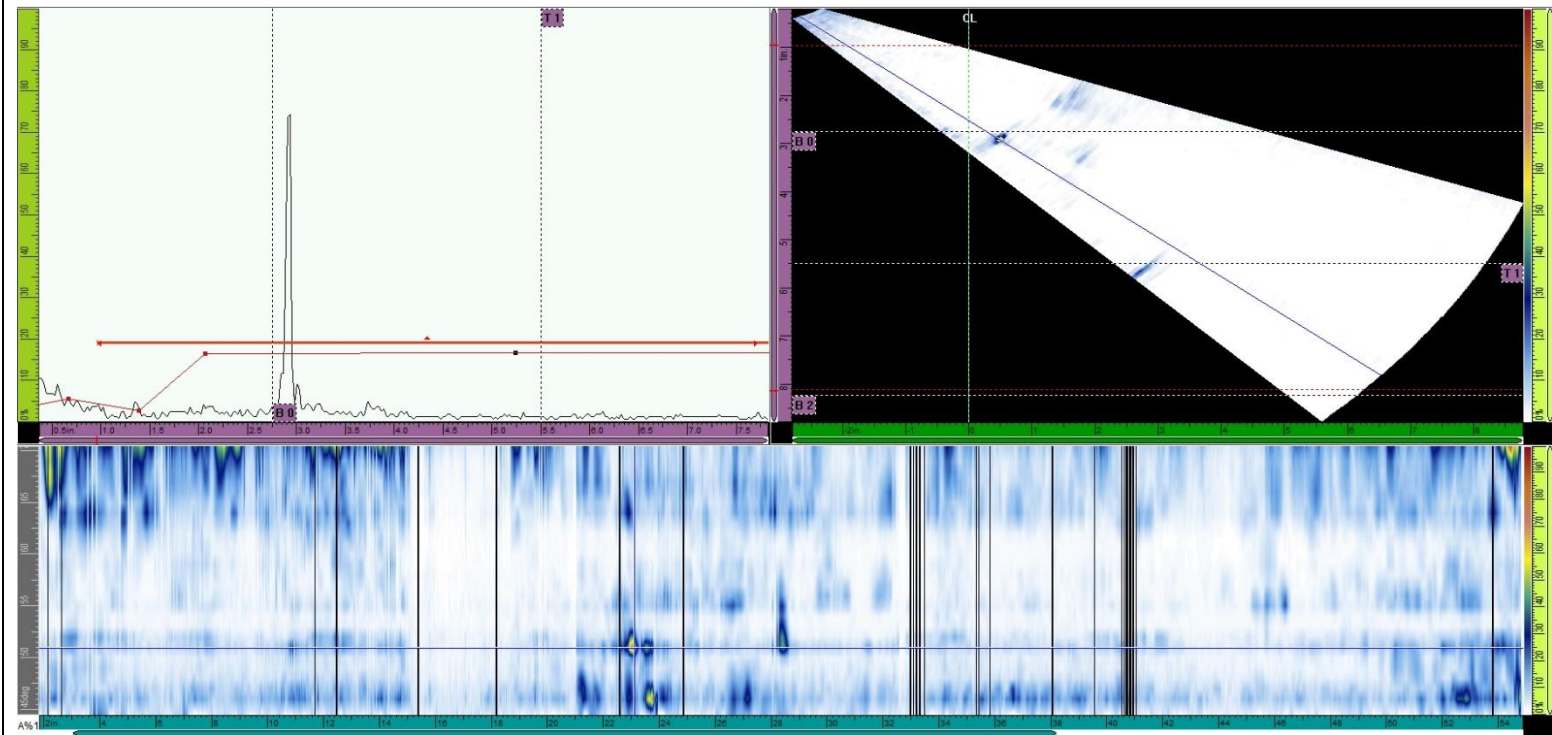
Weld	Comments
V2	<p data-bbox="296 264 646 305">No reportable indications.</p>

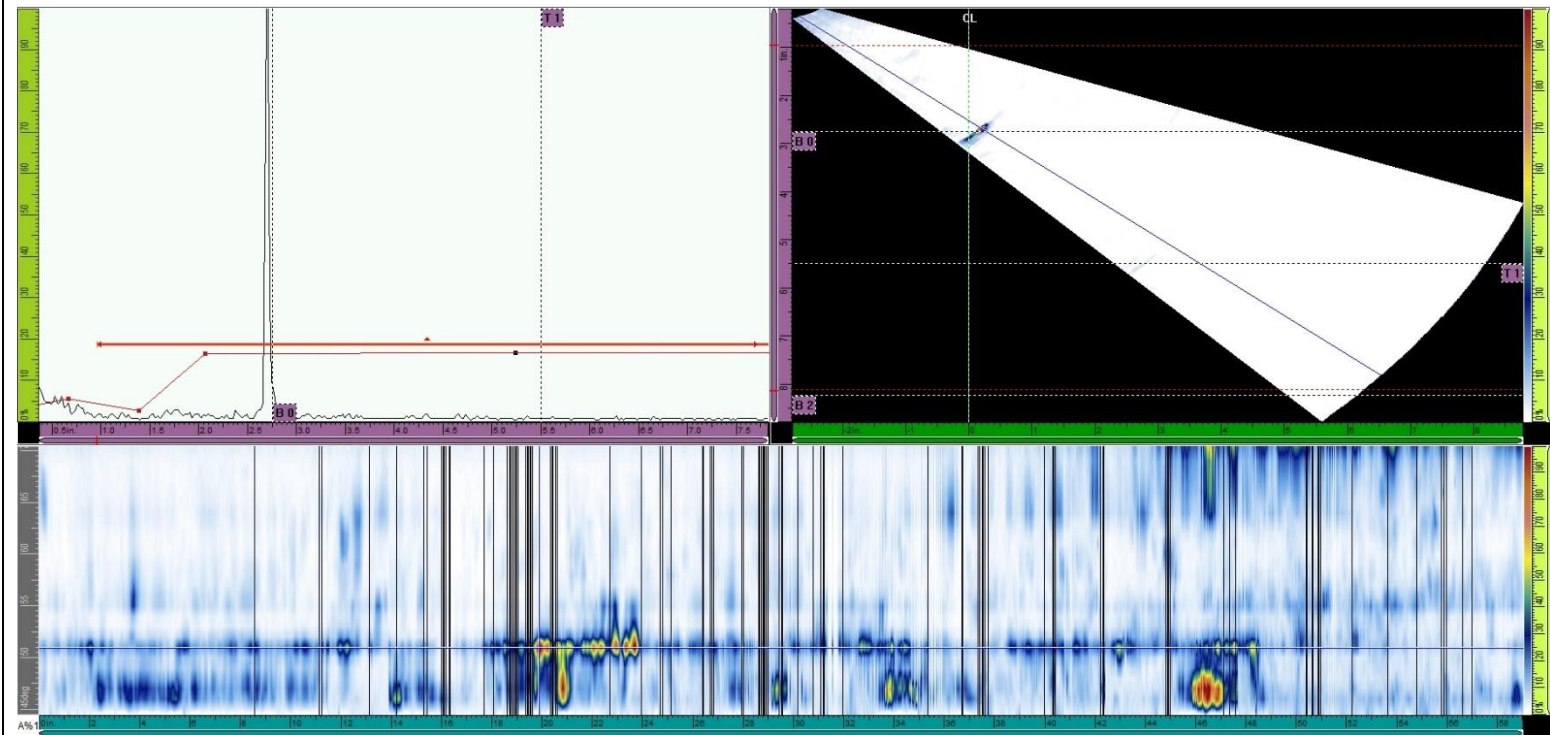
Weld	Comments
V3	<p data-bbox="296 264 646 305">No reportable indications.</p>

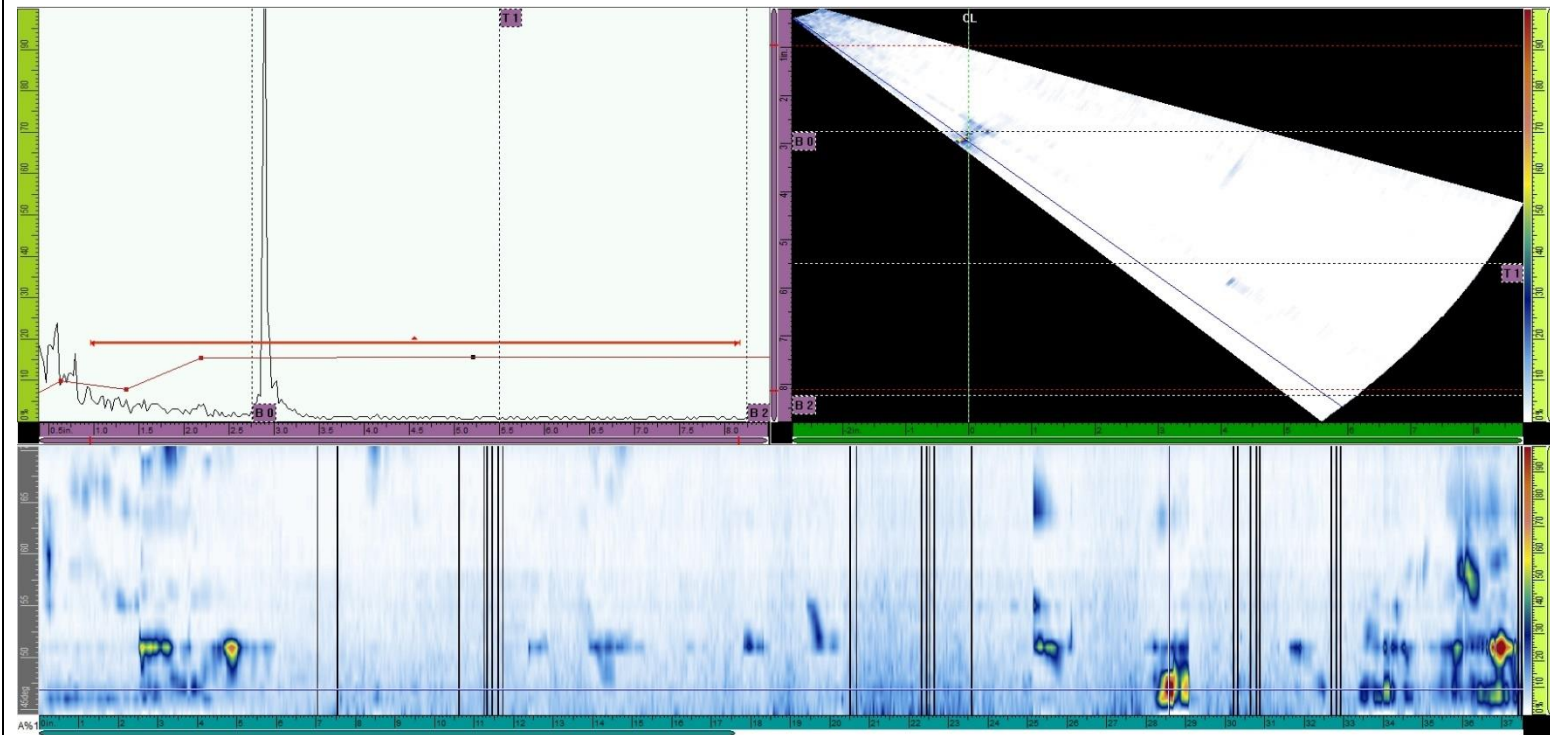
V8a

Gain (dB)	Indication #	Scan (in)	Index (in)	Group	Channel	A%1 (%)	DA/1 (in)	PA/1 (in)	SA/1 (in)	U(m-r) (in)	I(m-r) (in)	I•U(m-r) (in)	S(m-r) (in)	Type
46.66	1	34.207	-6.500	PA 1	58.00°	76.3	0.996	1.057	1.879	0.271	0.175	0.323	2.074	LOF

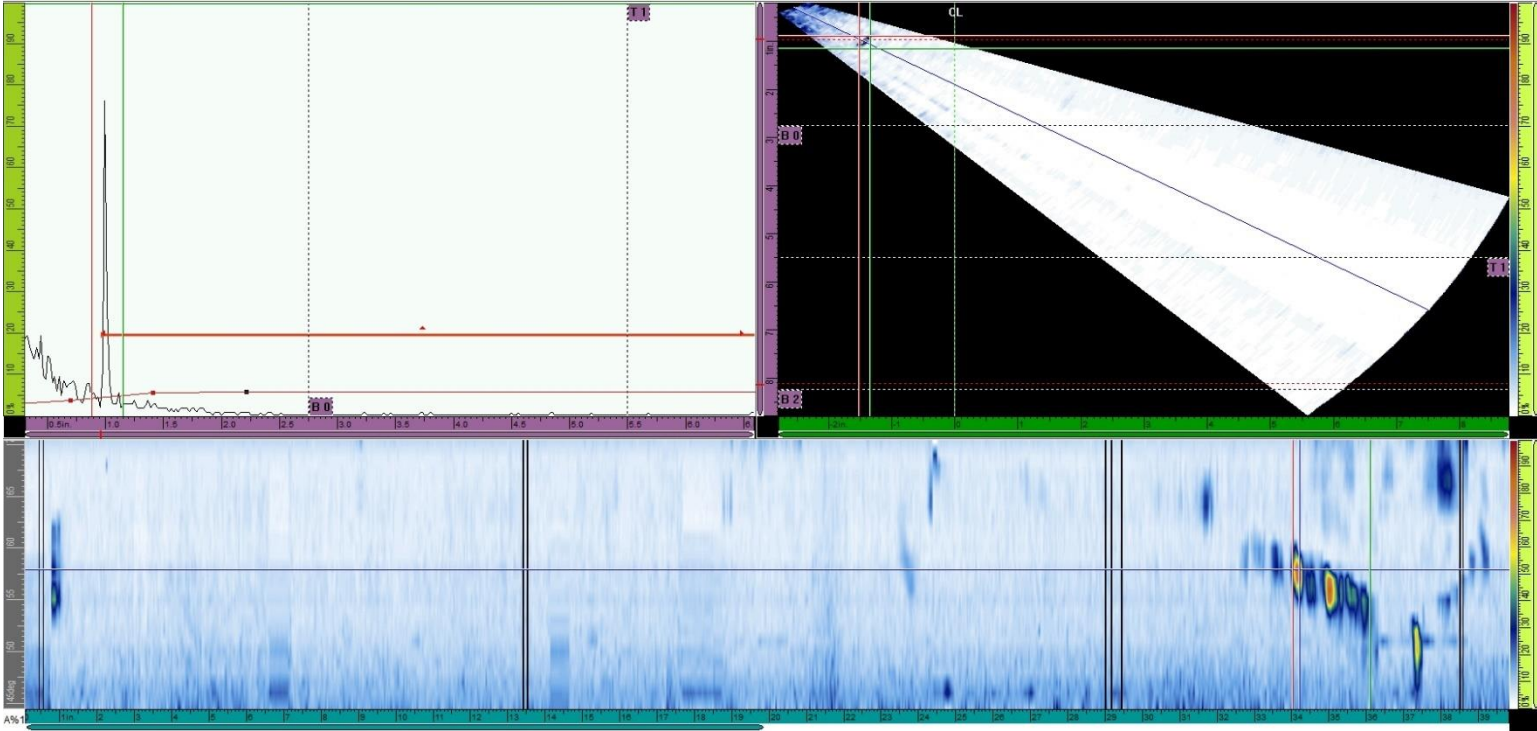
Weld	Comments														
V8b	Gain (dB)	Indication #	Scan (in)	Index (in)	Group	Channel	A%1 (%)	DA/1 (in)	PA/1 (in)	SA/1 (in)	U(m-r) (in)	I(m-r) (in)	I•U(m-r) (in)	S(m-r) (in)	Type
	46.66	1	12.729	-6.500	PA 1	55.00°	58.6	2.331	2.754	4.063	0.266	0.216	0.342	0.397	LOF
	46.66	2	7.330	-6.500	PA 1	66.00°	71.4	1.321	2.527	3.248	0.301	0.175	0.349	0.190	LOP

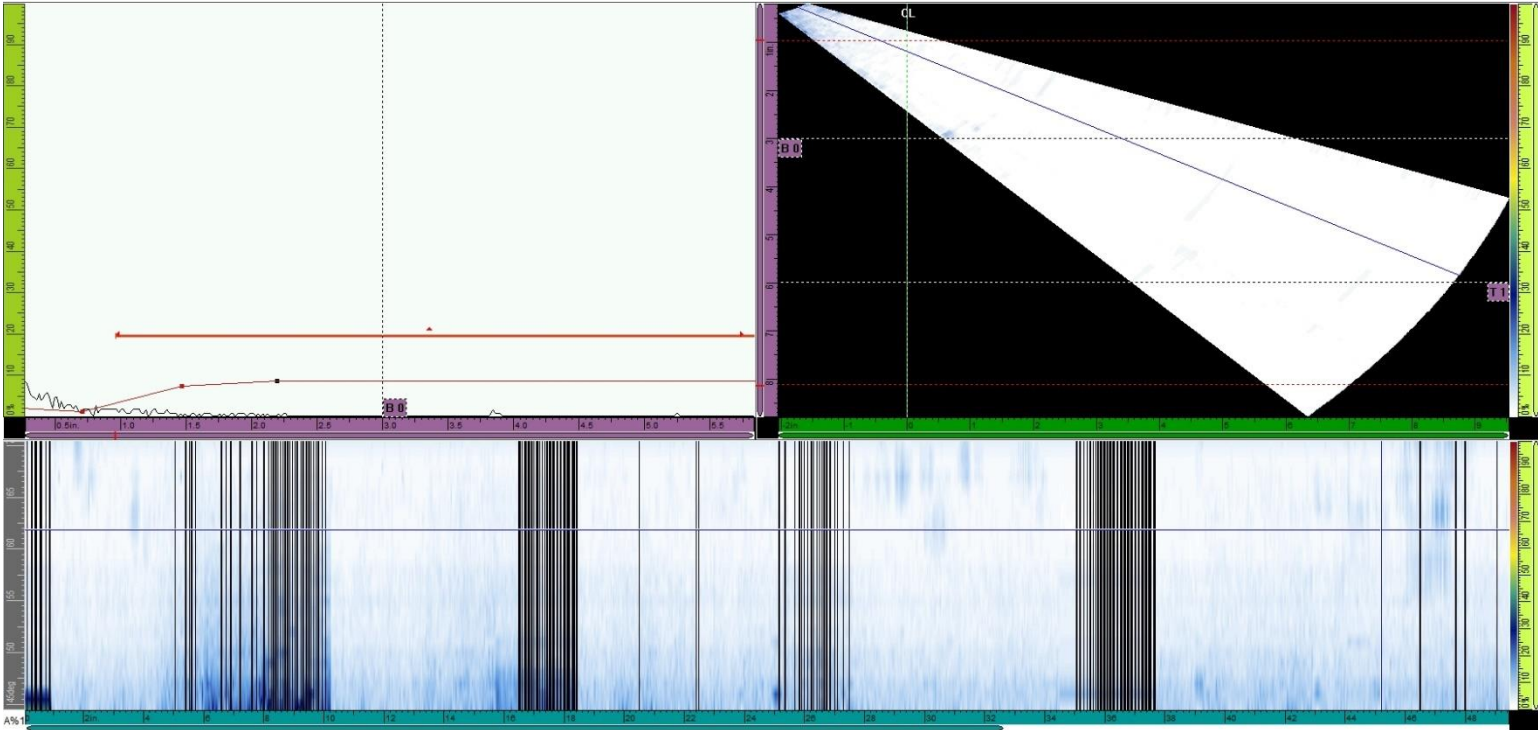
Weld	Comments														
V3	Gain (dB)	Indication #	Scan (in)	Index (in)	Group	Channel	A%1 (%)	DA/1 (in)	PA/1 (in)	SA/1 (in)	U(m-r) (in)	I(m-r) (in)	I•U(m-r) (in)	S(m-r) (in)	Type
	52.66	1	1.063	-6.500	PA 1	51.00°	133.3	1.671	1.438	2.655	0.284	0.283	0.401	1.083	LOF
	52.66	2	16.818	-6.500	PA 1	51.00°	80.1	1.694	1.467	2.692	0.142	0.094	0.170	0.237	LOF
	52.66	3	32.848	-6.500	PA 1	50.00°	74.6	1.683	1.367	2.618	0.142	0.148	0.205	0.237	LOF
	52.66	4	36.353	-6.500	PA 1	50.00°	76.7	1.635	1.310	2.544	0.160	0.121	0.200	0.305	LOF

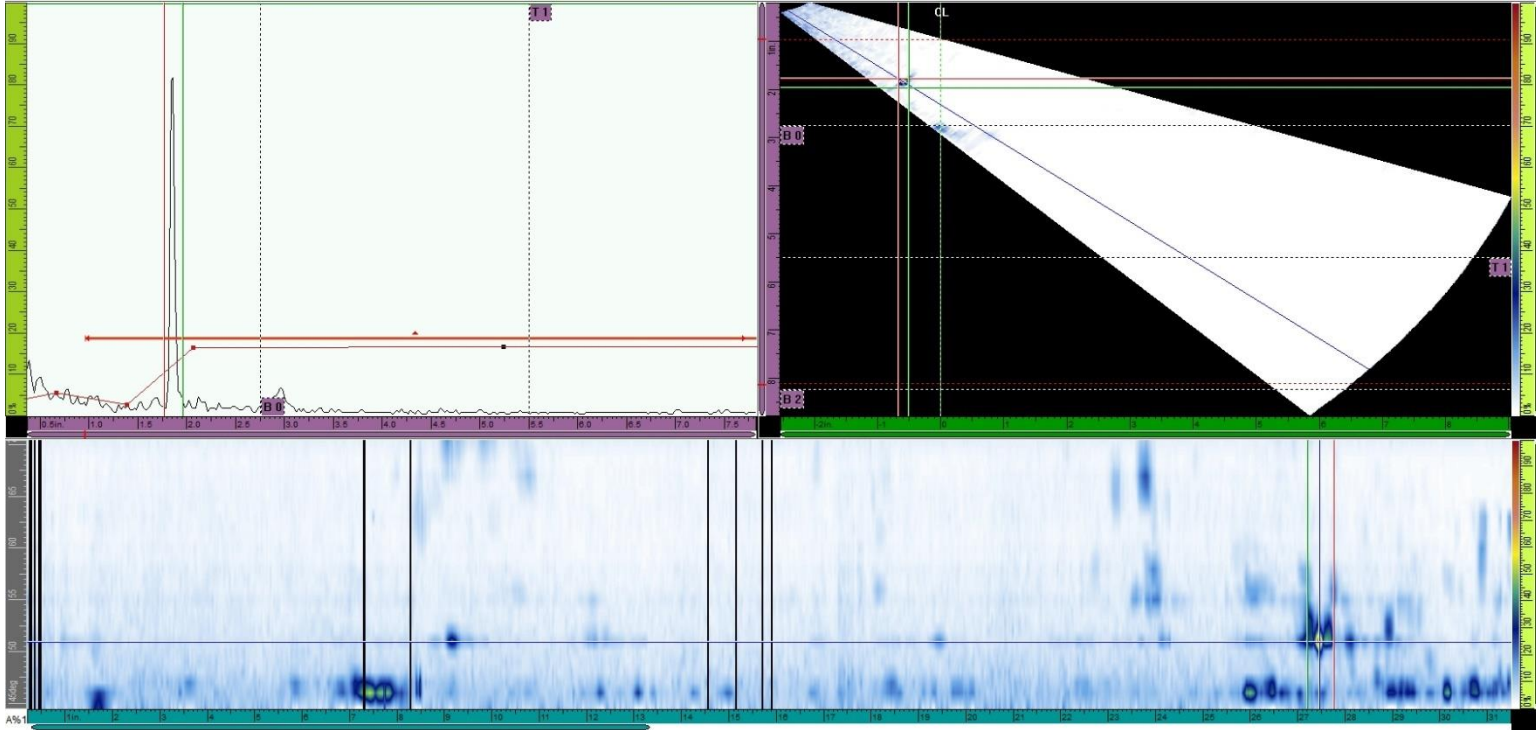
O3a

Gain (dB)	Indication #	Scan (in)	Index (in)	Group	Channel	A%1 (%)	DA/1 (in)	PA/1 (in)	SA/1 (in)	U(m-r) (in)	I(m-r) (in)	I•U(m-r) (in)	S(m-r) (in)	Type
40.66	1	31.575	-6.500	PA 1	62.00°	54.4	1.299	1.955	2.766	0.195	0.148	0.245	0.234	LOF

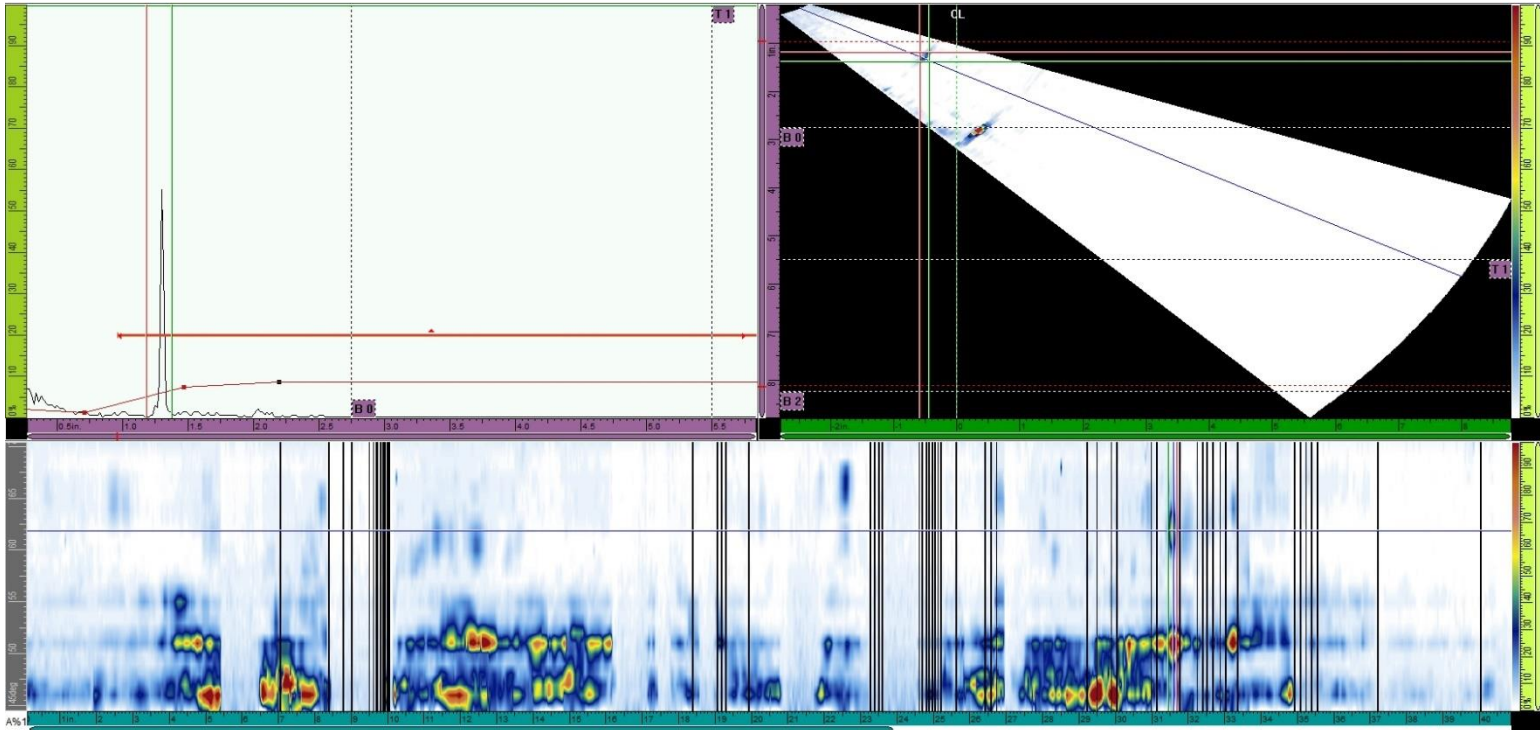
O3b

No reportable indications.

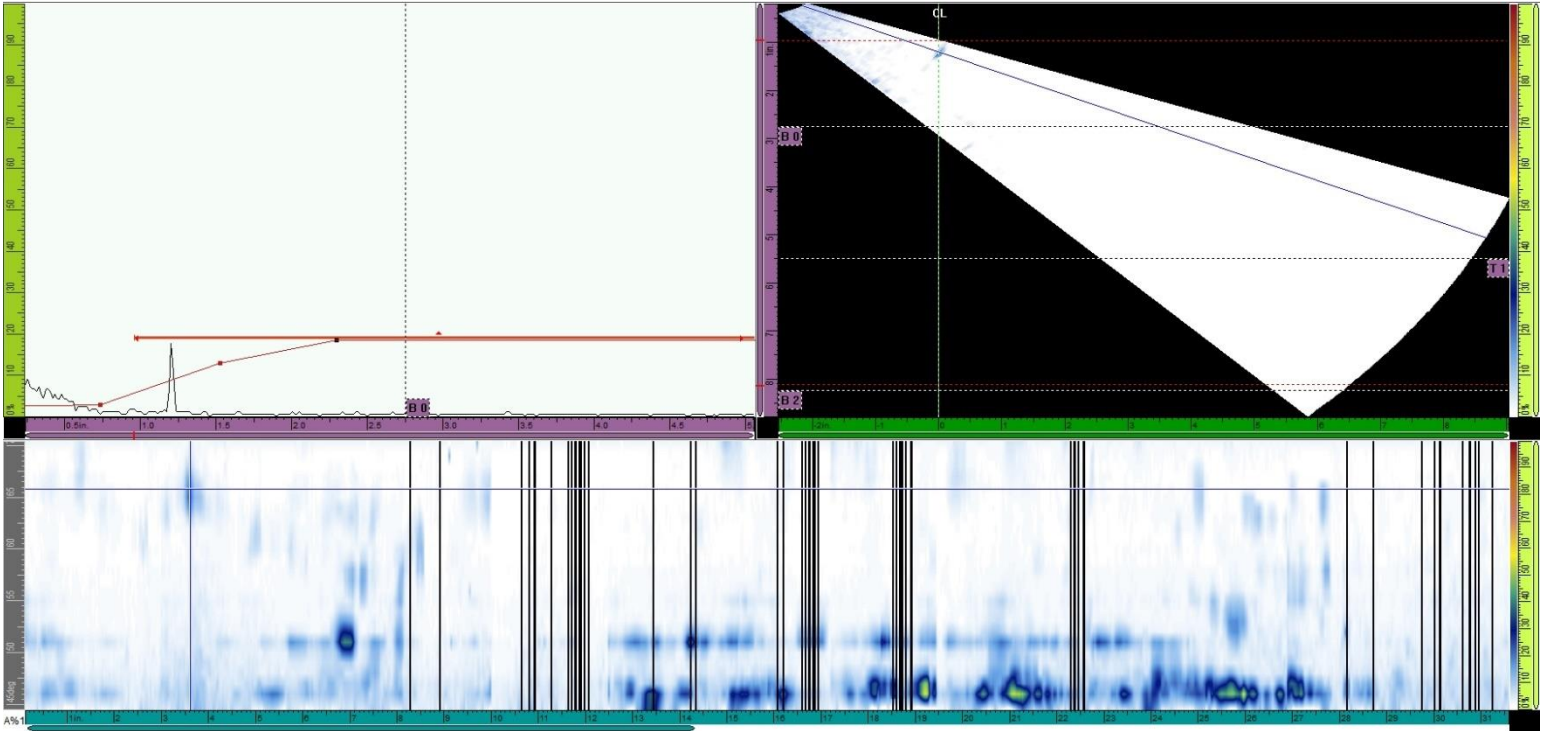
Weld	Comments														
O4a	Gain (dB)	Indication #	Scan (in)	Index (in)	Group	Channel	A%1 (%)	DA/1 (in)	PA/1 (in)	SA/1 (in)	U(m-r) (in)	I(m-r) (in)	I•U(m-r) (in)	S(m-r) (in)	Type
	46.66	1	13.289	-6.500	PA 1	58.00°	78.8	1.741	2.249	3.285	0.284	0.216	0.356	2.162	LOF
	46.66	2	15.260	-6.500	PA 1	69.00°	55.7	1.031	2.279	2.877	0.230	0.175	0.290	0.270	LOF
	46.66	3	23.186	-6.500	PA 1	69.00°	78.8	1.084	2.417	3.026	0.177	0.243	0.301	0.748	LOF
	46.66	4	26.932	-6.500	PA 1	66.00°	68.0	1.200	2.256	2.951	0.203	0.216	0.296	0.520	LOF
	46.66	5	28.233	-6.500	PA 1	59.00°	48.2	1.596	2.132	3.100	0.207	0.148	0.254	0.333	LOF
	46.66	6	15.260	-6.500	PA 1	69.00°	55.7	1.031	2.279	2.877	0.167	0.162	0.232	0.291	LOF
