## Technical Report: Fort Peck Butterfly Valve#4 Inspection Report

### FT. PECK PH#2 BUTTERFLY VALVE NDT

Date: 12/5/2019

**Inspected by:** Thomas R. Hay, P.E., ASNT Level 3#107162  
TECHKNOWSERV CORP.  
2134 Sandy Dr., Suite 14  
State College PA, 16803  
(814) 237-0144

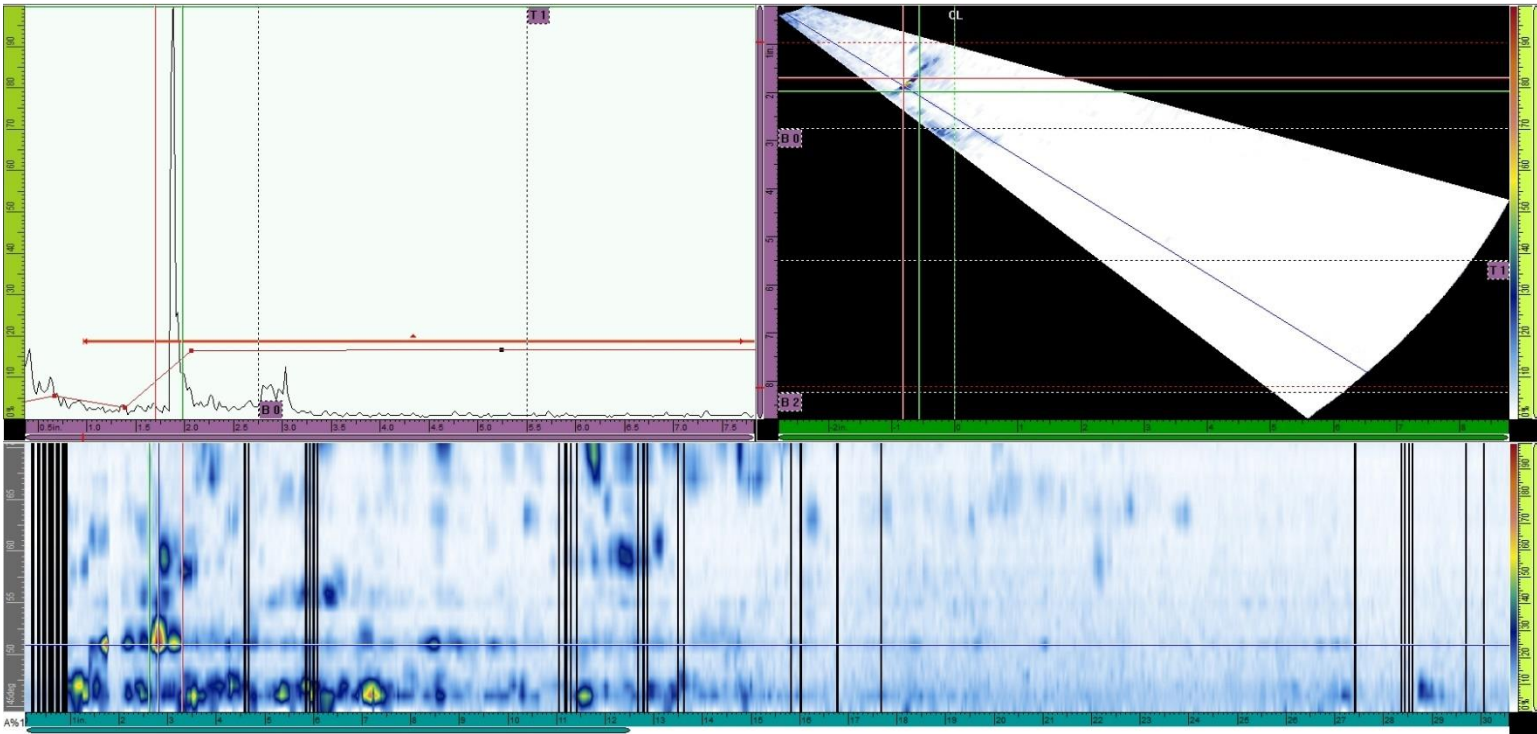
Weld	Comments														
X1a	Gain (dB)	Indication #	Scan (in)	Index (in)	Group	Channel	A%1 (%)	DA/1 (in)	PA/1 (in)	SA/1 (in)	U(m-r) (in)	I(m-r) (in)	I•U(m-r) (in)	S(m-r) (in)	Type
	46.66	1	14.038	-6.500	PA 1	56.00°	41.3	2.065	2.500	3.693	0.230	0.162	0.282	0.429	LOF
	46.66	2	21.491	-6.500	PA 1	67.00°	36.4	1.313	2.663	3.359	0.248	0.175	0.304	0.858	LOF
	46.66	3	43.770	-6.500	PA 1	64.00°	44.4	1.245	2.089	2.840	0.209	0.229	0.310	1.170	LOF
	46.66	4	62.145	-6.500	PA 1	46.00°	77.0	1.947	1.327	2.803	0.355	0.256	0.437	0.507	LOF
	46.66	5	68.691	-6.500	PA 1	50.00°	50.5	1.278	0.884	1.988	0.248	0.243	0.347	1.521	LOF

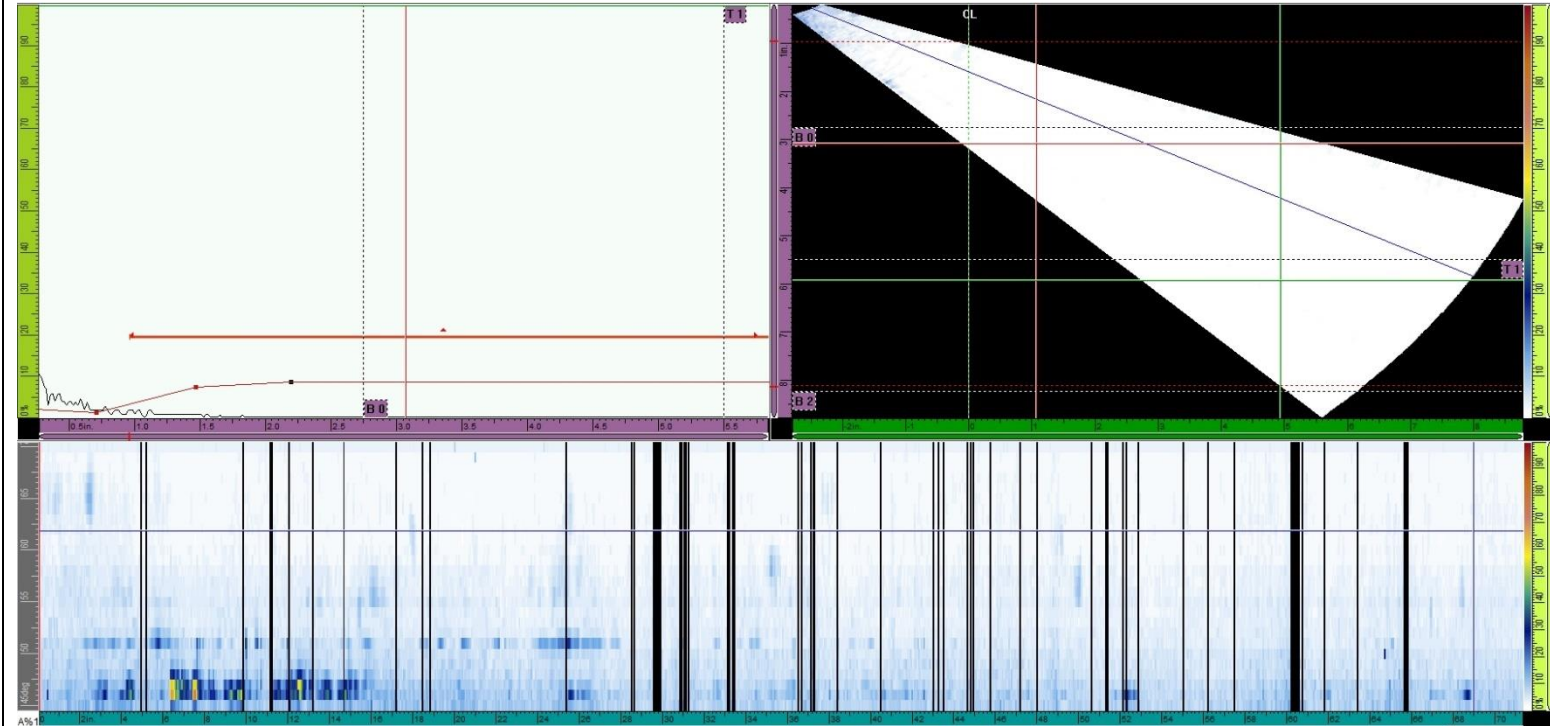
X2b

Gain (dB)	Indication #	Scan (in)	Index (in)	Group	Channel	A%1 (%)	DA/1 (in)	PA/1 (in)	SA/1 (in)	U(m-r) (in)	I(m-r) (in)	I•U(m-r) (in)	S(m-r) (in)	Type
40.66	1	47.161	-6.500	PA 1	51.00°	66.0	2.067	1.927	3.285	0.160	0.121	0.200	0.887	LOF
40.66	2	37.421	-6.500	PA 1	46.00°	120.4	2.333	1.727	3.359	0.177	0.162	0.240	0.591	LOF

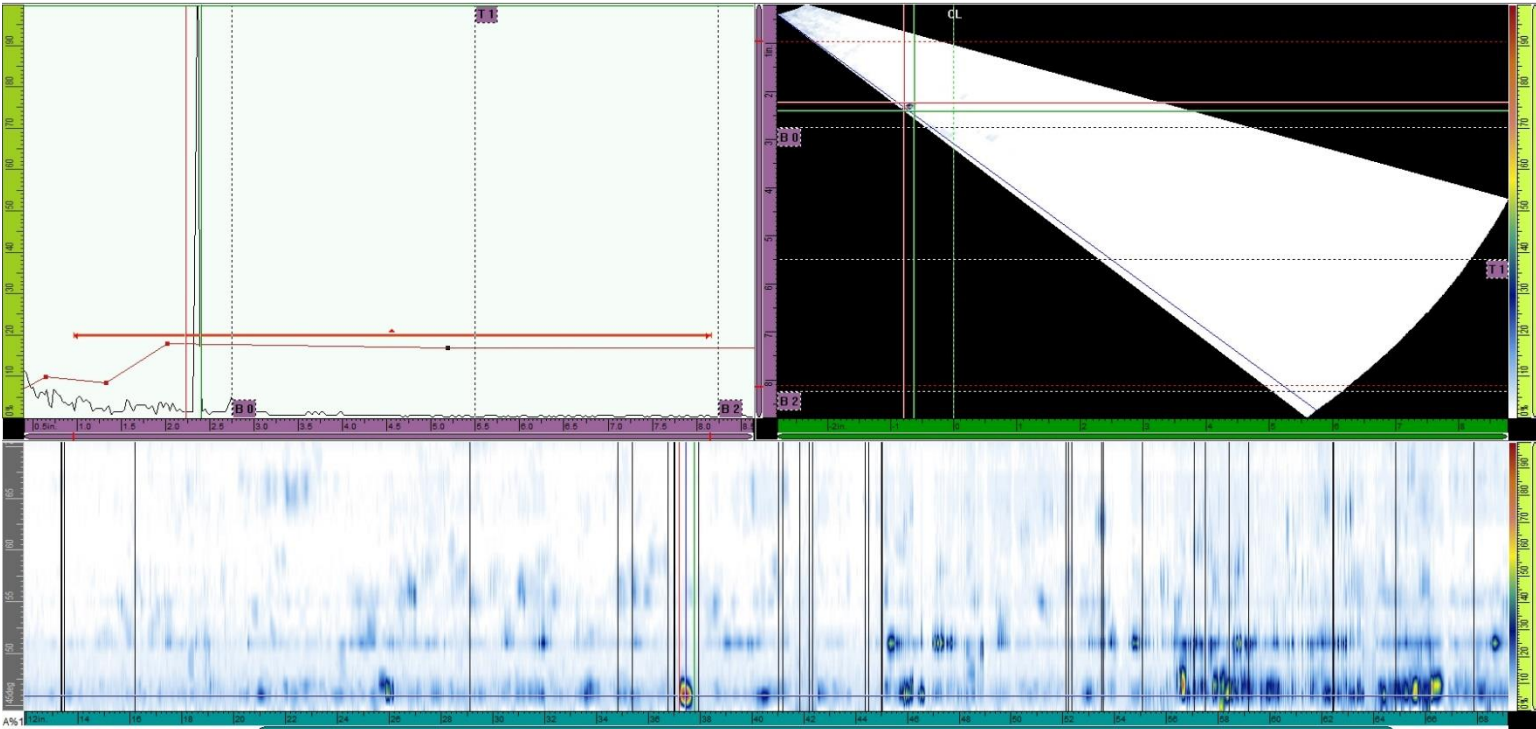
Weld	Comments														
X3a	Gain (dB)	Indication #	Scan (in)	Index (in)	Group	Channel	A%1 (%)	DA/1 (in)	PA/1 (in)	SA/1 (in)	U(m-r) (in)	I(m-r) (in)	I•U(m-r) (in)	S(m-r) (in)	Type
	40.66	1	21.260	-6.500	PA 1	46.00°	85.7	2.076	1.460	2.988	0.195	0.135	0.237	0.402	LOF
	40.66	2	28.150	-6.500	PA 1	62.00°	42.8	1.194	1.758	2.544	0.225	0.135	0.263	0.522	LOF
	40.66	3	65.866	-6.500	PA 1	51.00°	101.6	1.717	1.495	2.729	0.248	0.256	0.357	1.124	LOF

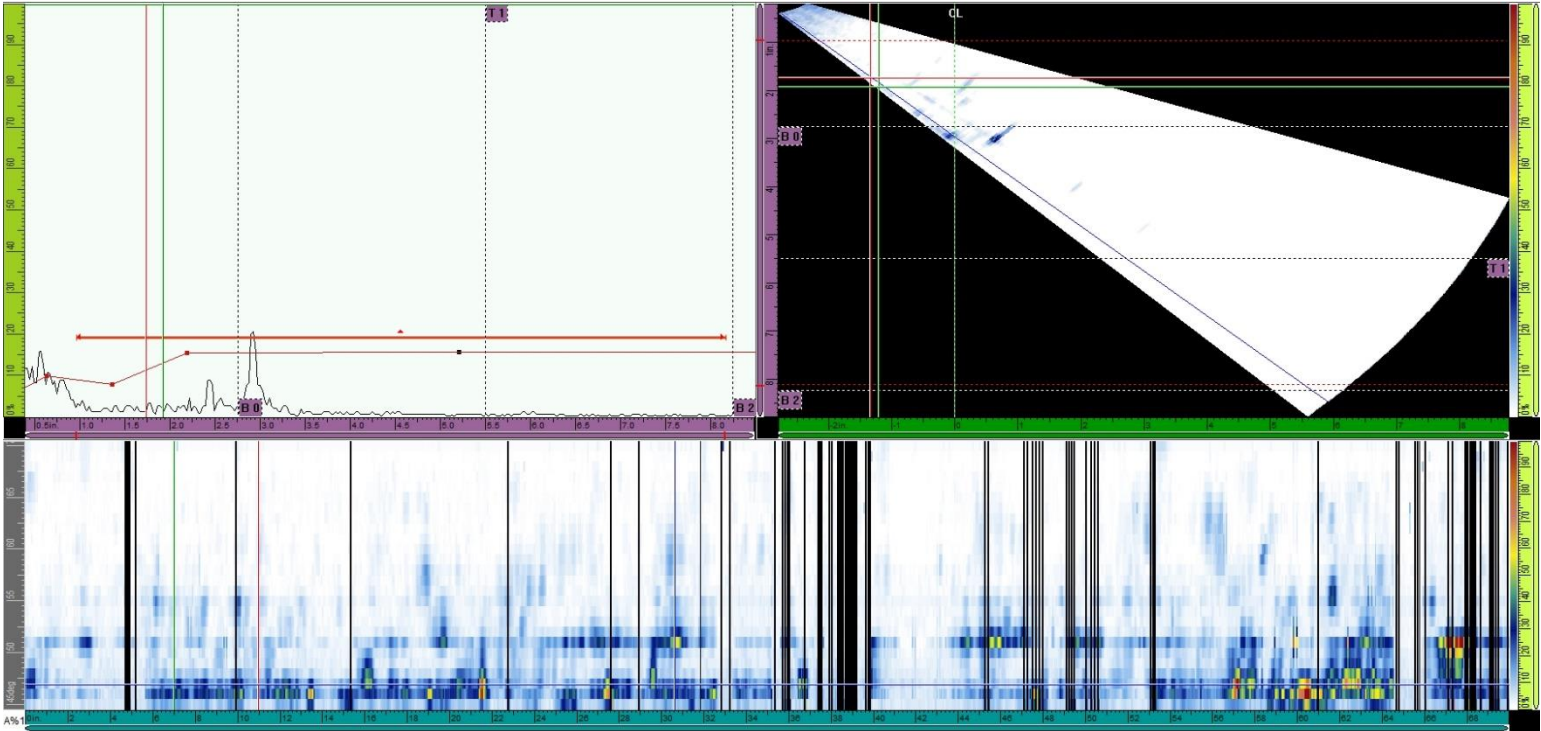
Weld	Comments														
X4a	Gain (dB)	Indication #	Scan (in)	Index (in)	Group	Channel	A%1 (%)	DA/1 (in)	PA/1 (in)	SA/1 (in)	U(m-r) (in)	I(m-r) (in)	I•U(m-r) (in)	S(m-r) (in)	Type
	40.66	1	57.205	-6.500	PA 1	46.00°	175.5	1.973	1.354	2.840	0.288	0.175	0.337	1.686	LOF
	40.66	2	64.606	-6.500	PA 1	51.00°	175.5	2.137	2.014	3.396	0.213	0.216	0.303	1.244	LOF

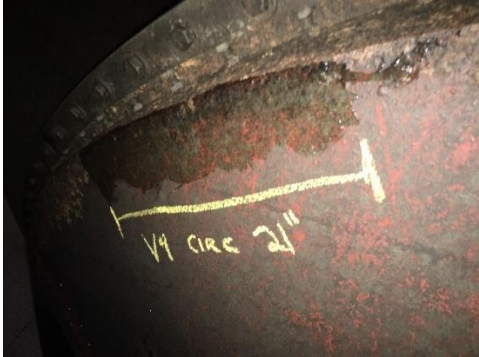
Valve 4 Downstream Side	
Weld	Comments
C1	<p>The C1 area shown in Figure 4.4 was inspected with manual PAUT. Approximately 21" of weld were inspected. No indications were detected.</p>

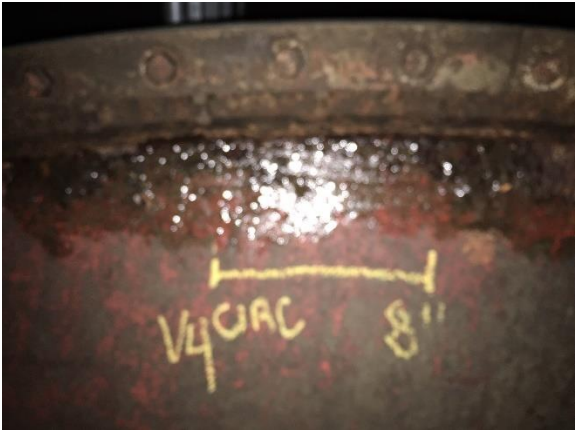
C2	<p>The C2 area shown in Figure 4.4 was inspected with manual PAUT. Approximately 8" of weld were inspected. No indications were detected.</p>
