Technical Report: Fort Peck Butterfly Valve#5 Inspection Report

FT. PECK PH#2 BUTTERFLY VALVE NDT

Date: 5/5/2020

U.S. ARMY CORPS OF ENGINEERS OMAHA DIST.
CONTRACTING OFFICE
1616 CAPITOL AVENUE
OMAHA NE 68102-4901

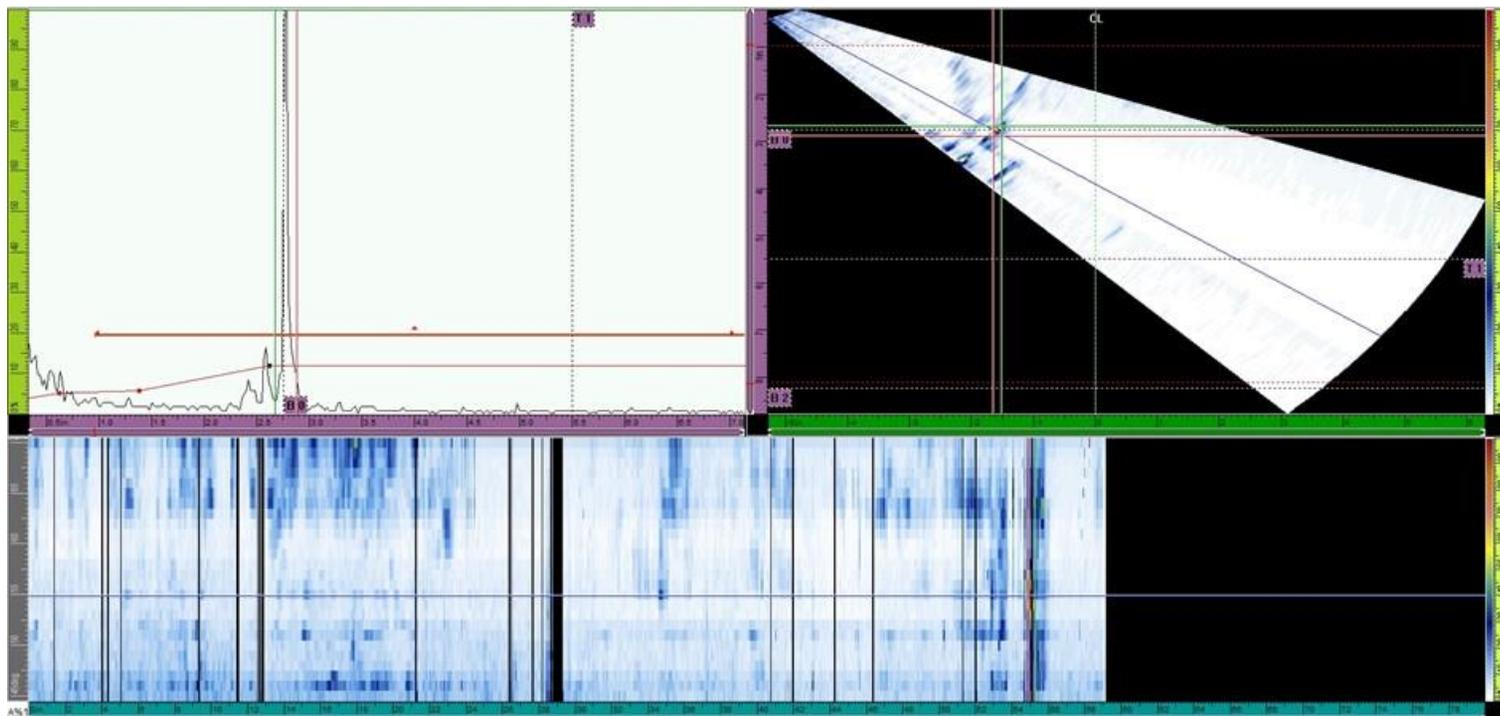
S3a Lack of penetration at root.

Gain (dB)	Indication #	Scan (in)	Index (in)	Group	Channel	A%1 (%)	DA/1 (in)	PA/1 (in)	SA/1 (in)	U(m-r) (in)	I(m-r) (in)	I•U(m-r) (in)	S(m-r) (in)	Type
46.66	1	54.921	-6.500	PA 1	55.00°	120.3	2.731	3.380	4.828	0.248	0.202	0.320	0.439	LOP

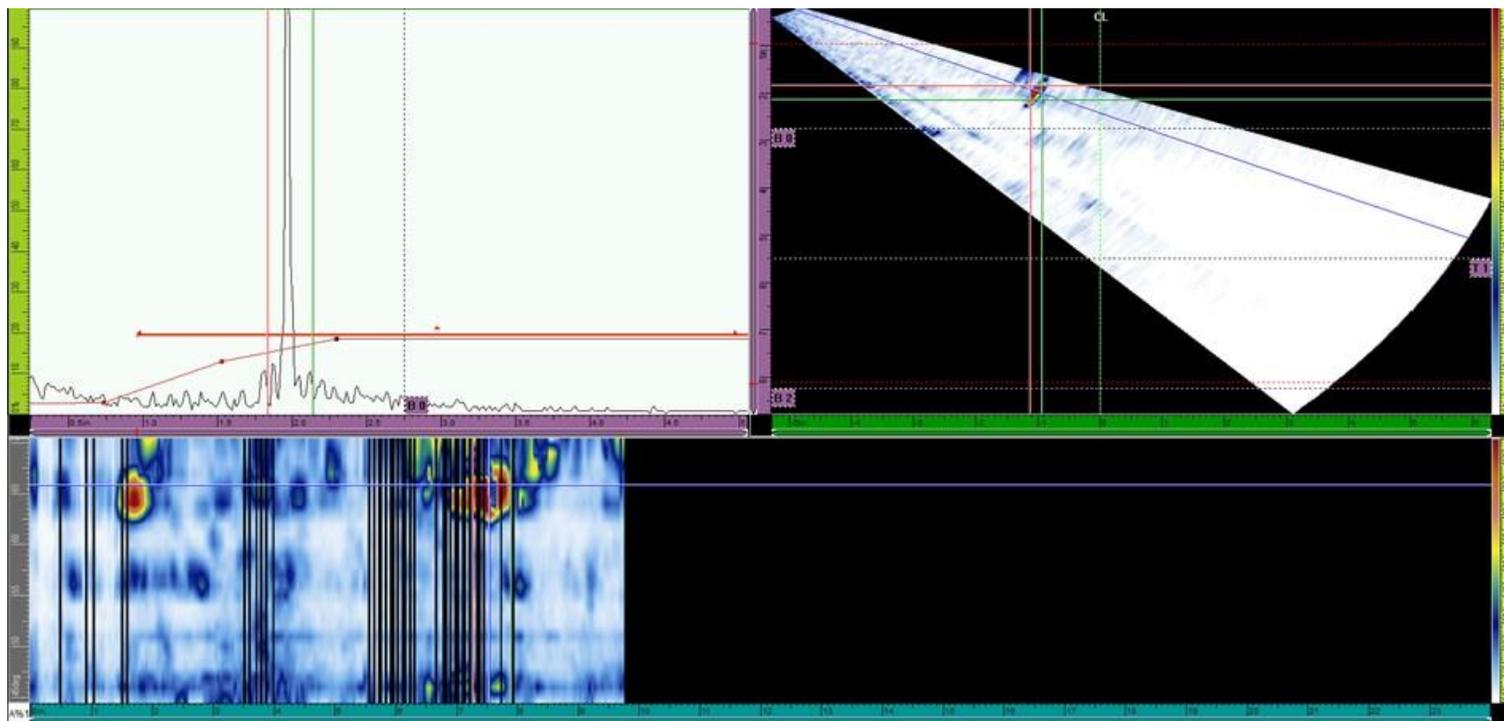
S5a-End 2 LOF detected 0.5" in length each.

Gain (dB)	Indication #	Scan (in)	Index (in)	Group	Channel	A%1 (%)	DA/1 (in)	PA/1 (in)	SA/1 (in)	U(m-r) (in)	I(m-r) (in)	I•U(m-r) (in)	S(m-r) (in)	Type
40.66	1	7.685	-6.500	PA 1	64.00°	104.7	2.100	3.843	4.792	0.390	0.283	0.482	0.358	LOF
40.66	2	1.655	-6.500	PA 1	65.00°	98.8	1.985	3.805	4.697	0.248	0.216	0.329	0.400	LOF

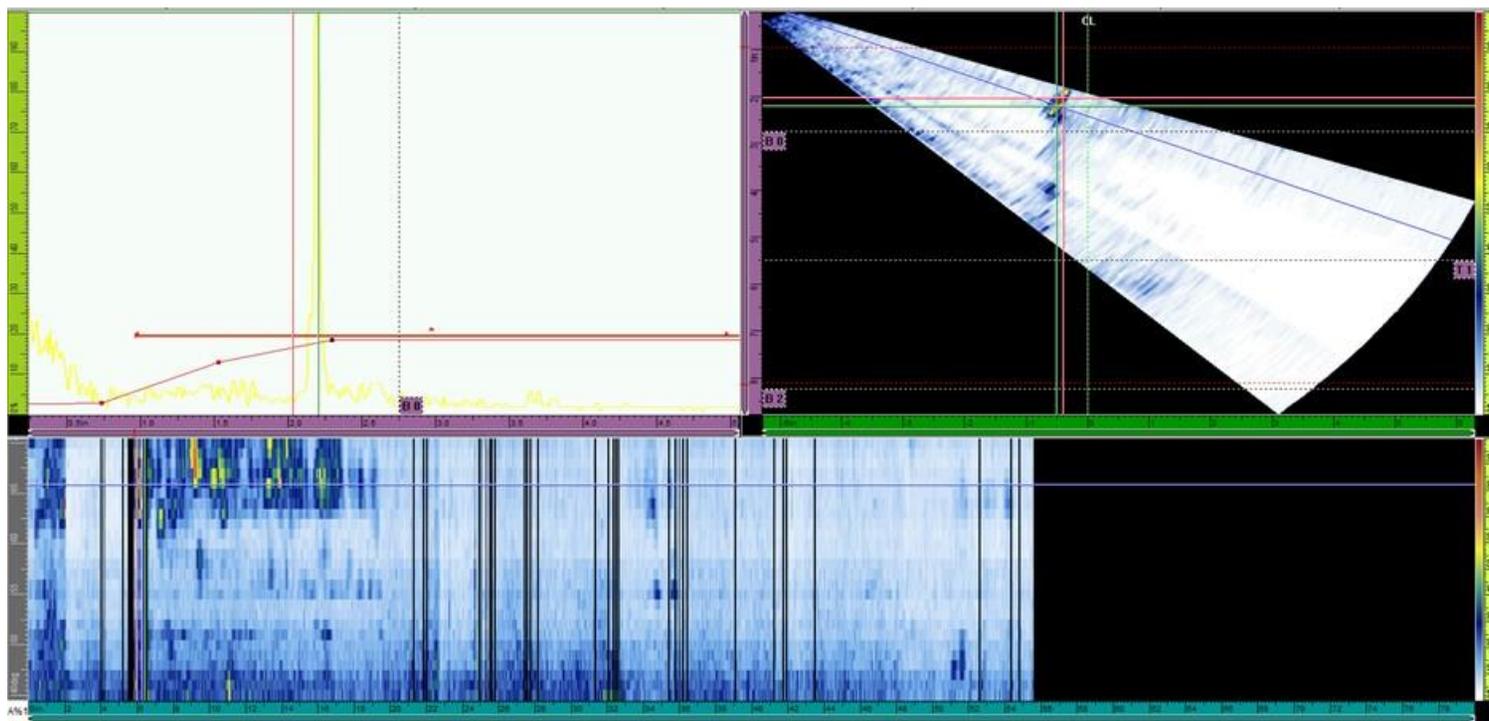
The upstream side contained 1 weld discontinuity longer than 1” and 3 weld discontinuities with a height greater than 0.375”. The most severe discontinuity was found in weld S6b with a length of 11.100” and a height of 0.603”. In addition, a possible in-service crack was detected at the root of weld S3b 0.917” long and 0.284” high.

S6b Lack of fusion 11" long

Gain (dB)	Indication #	Scan (in)	Index (in)	Group	Channel	A%1 (%)	DA/1 (in)	PA/1 (in)	SA/1 (in)	U(m-r) (in)	I(m-r) (in)	I•U(m-r) (in)	S(m-r) (in)	Type
46.66	1	6.345	-6.500	PA 1	67.00°	22.5	2.062	4.427	5.276	0.603	0.337	0.691	11.100	LOF

4. **Re-asses risk matrix color-coded red welds after abatement, blasting, and cleaning:** Perform encoded PAUT to more accurately locate and size the weld discontinuities. Apply new coating system to these areas after inspection. Re-assess possible repair action after new sizing data is made available. Determine if discontinuity has grown and, if so, repair immediately.

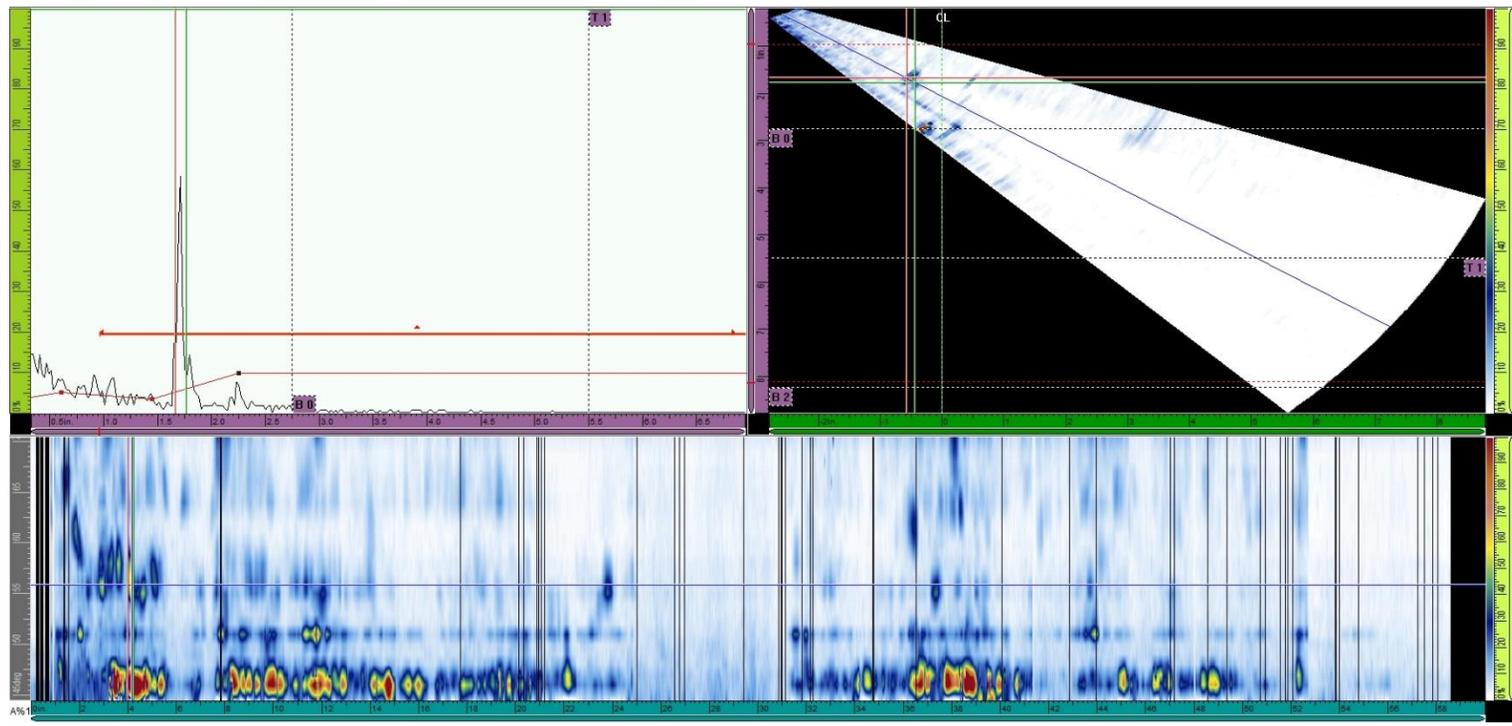
S7a Slag.

Gain (dB)	Indication #	Scan (in)	Index (in)	Group	Channel	A%1 (%)	DA/1 (in)	PA/1 (in)	SA/1 (in)	U(m-r) (in)	I(m-r) (in)	I•U(m-r) (in)	S(m-r) (in)	Type
40.66	1	4.100	-2.500	PA 1	56.00°	58.7	1.704	1.965	3.048	0.106	0.135	0.172	0.241	Slag

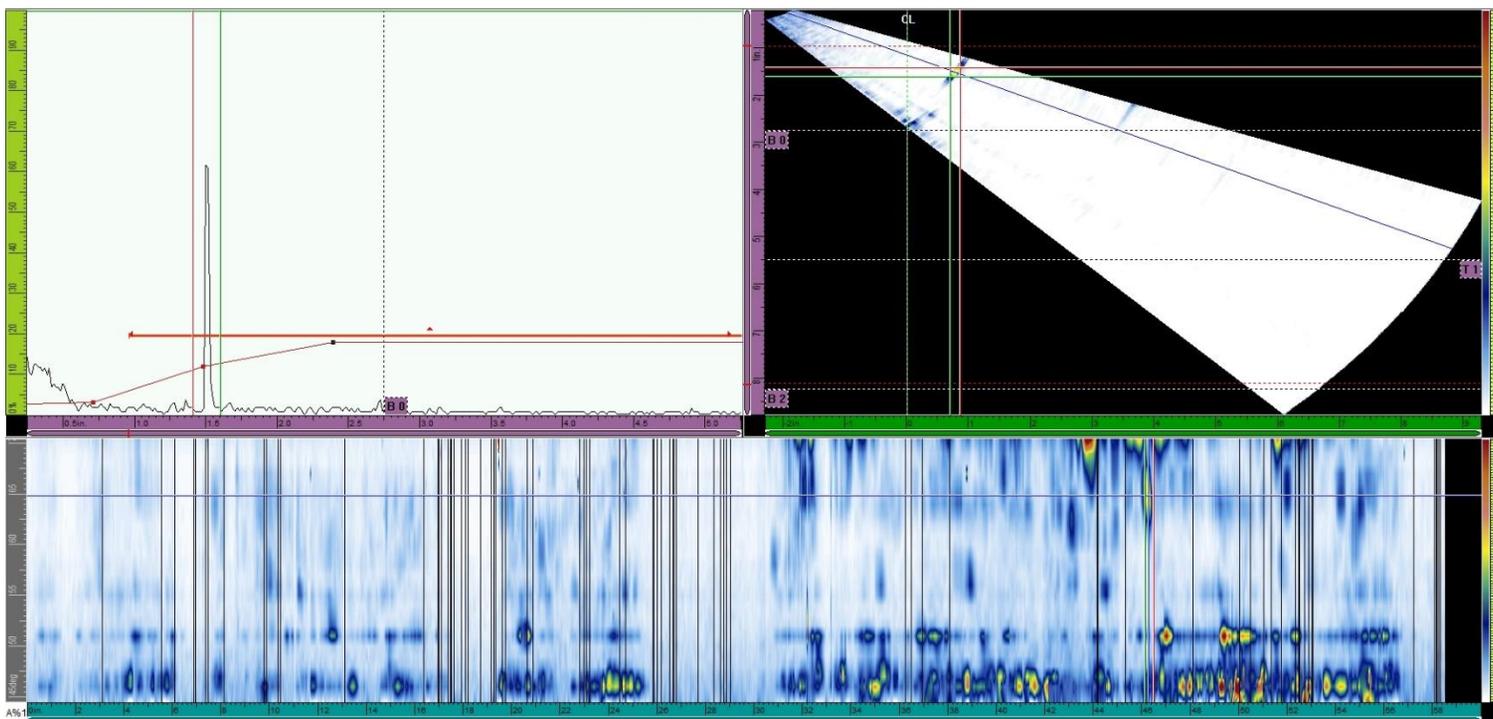
S7b Lack of fusion – 0.344” long.

Gain (dB)	Indication #	Scan (in)	Index (in)	Group	Channel	A%1 (%)	DA/1 (in)	PA/1 (in)	SA/1 (in)	U(m-r) (in)	I(m-r) (in)	I•U(m-r) (in)	S(m-r) (in)	Type
40.66	1	46.242	-2.000	PA 1	65.00°	61.6	1.504	2.774	3.560	0.195	0.162	0.253	0.344	LOF

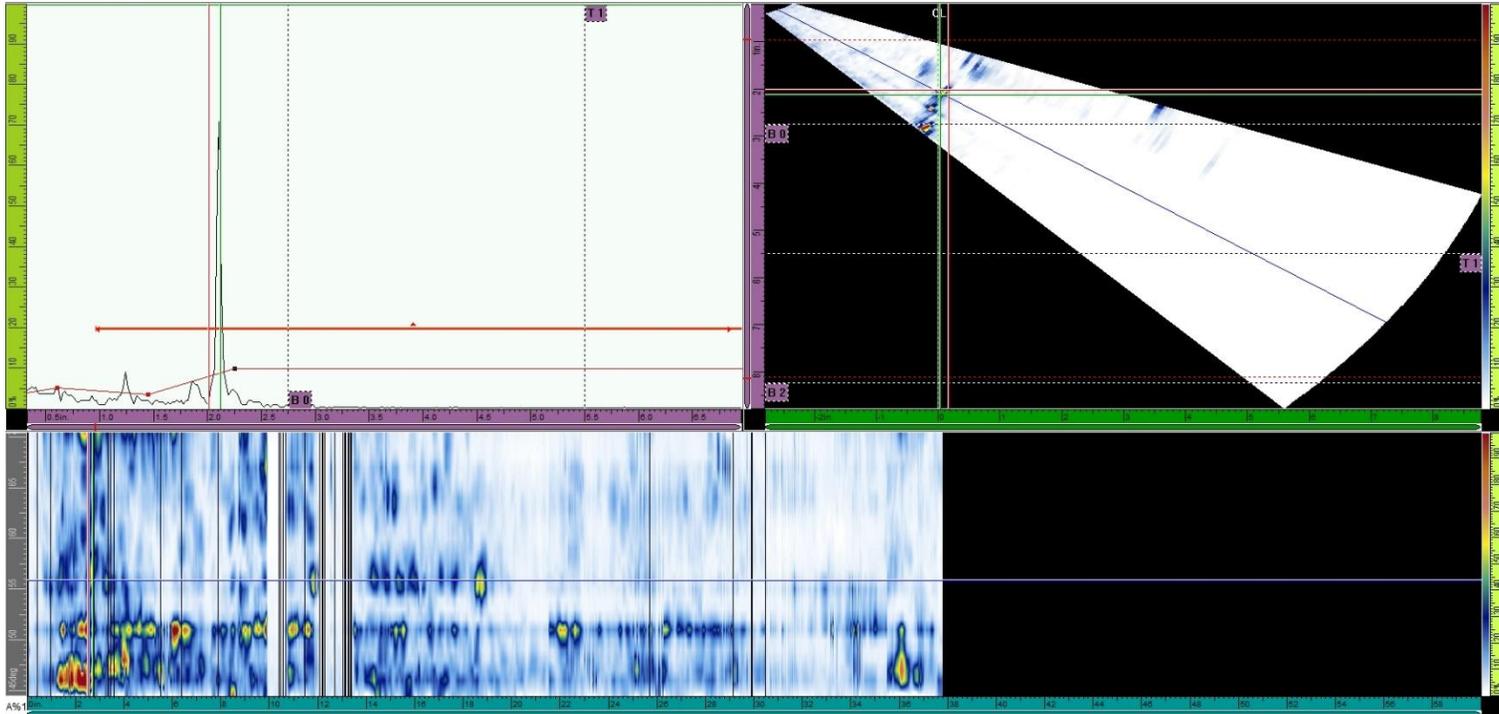
Gain (dB)	Indication #	Scan (in)	Index (in)	Group	Channel	A%1 (%)	DA/1 (in)	PA/1 (in)	SA/1 (in)	U(m-r) (in)	I(m-r) (in)	I•U(m-r) (in)	S(m-r) (in)	Type
40.66	1	2.523	-6.500	PA 1	56.00°	70.4	2.086	2.530	3.730	0.106	0.135	0.172	0.206	LOF
40.66	2	11.827	-6.500	PA 1	56.00°	72.6	2.044	2.469	3.656	0.071	0.094	0.118	0.172	LOF
40.66	3	18.686	-6.500	PA 1	56.00°	52.2	2.127	2.592	3.804	0.160	0.243	0.290	0.378	LOF

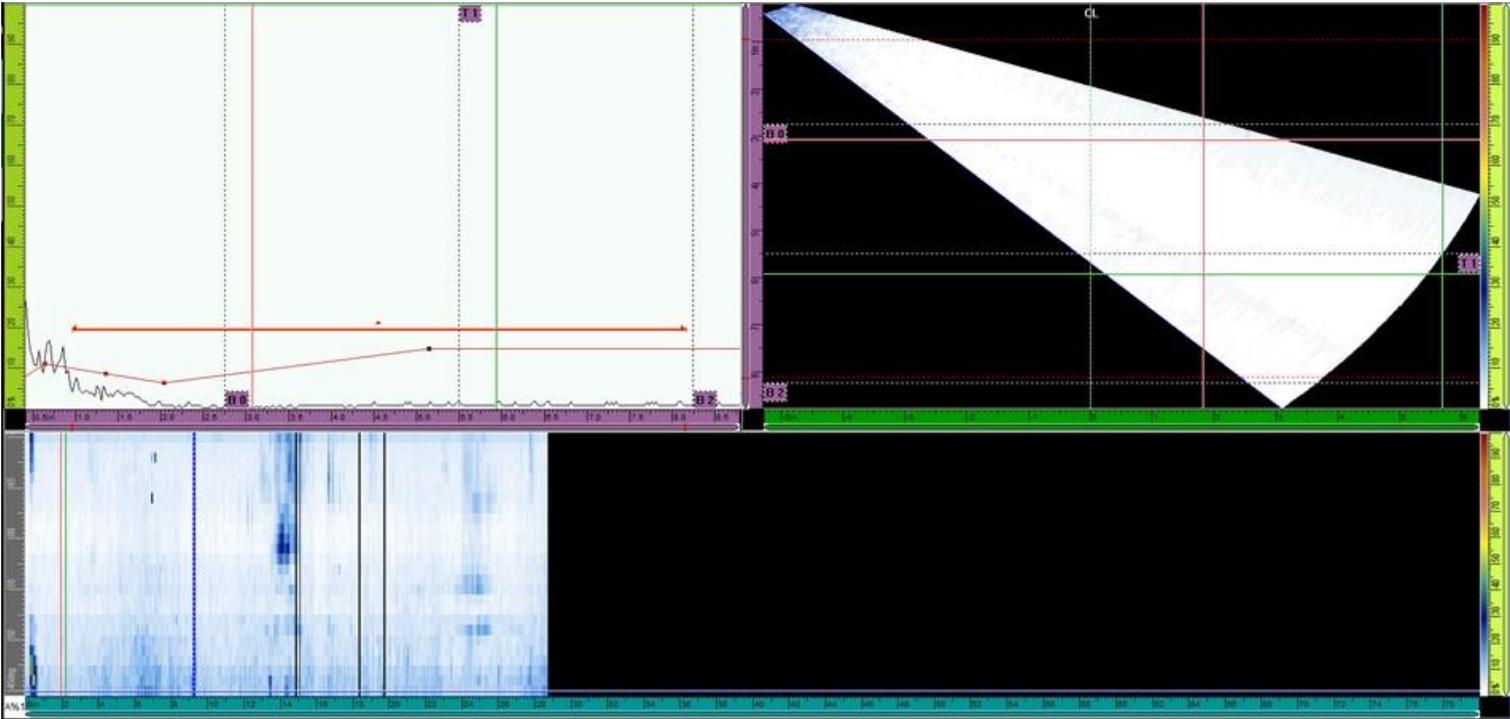
Weld	Comments													
S10b	Intermittent LOF over 8".													
Gain (dB)	Indication #	Scan (in)	Index (in)	Group	Channel	A%1 (%)	DA/1 (in)	PA/1 (in)	SA/1 (in)	U(m-r) (in)	I(m-r) (in)	I•U(m-r) (in)	S(m-r) (in)	Type
40.66	1	27.359	-6.500	PA 1	56.00°	59.9	1.941	2.315	3.470	0.142	0.108	0.178	0.654	LOF
40.66	2	30.986	-6.500	PA 1	63.00°	64.3	1.424	2.319	3.137	0.195	0.135	0.237	0.206	LOF
40.66	3	33.745	-6.500	PA 1	55.00°	99.0	2.118	2.450	3.693	0.177	0.162	0.240	0.378	LOF
40.66	4	35.480	-6.500	PA 1	58.00°	91.8	1.898	2.501	3.581	0.230	0.148	0.274	0.585	LOF

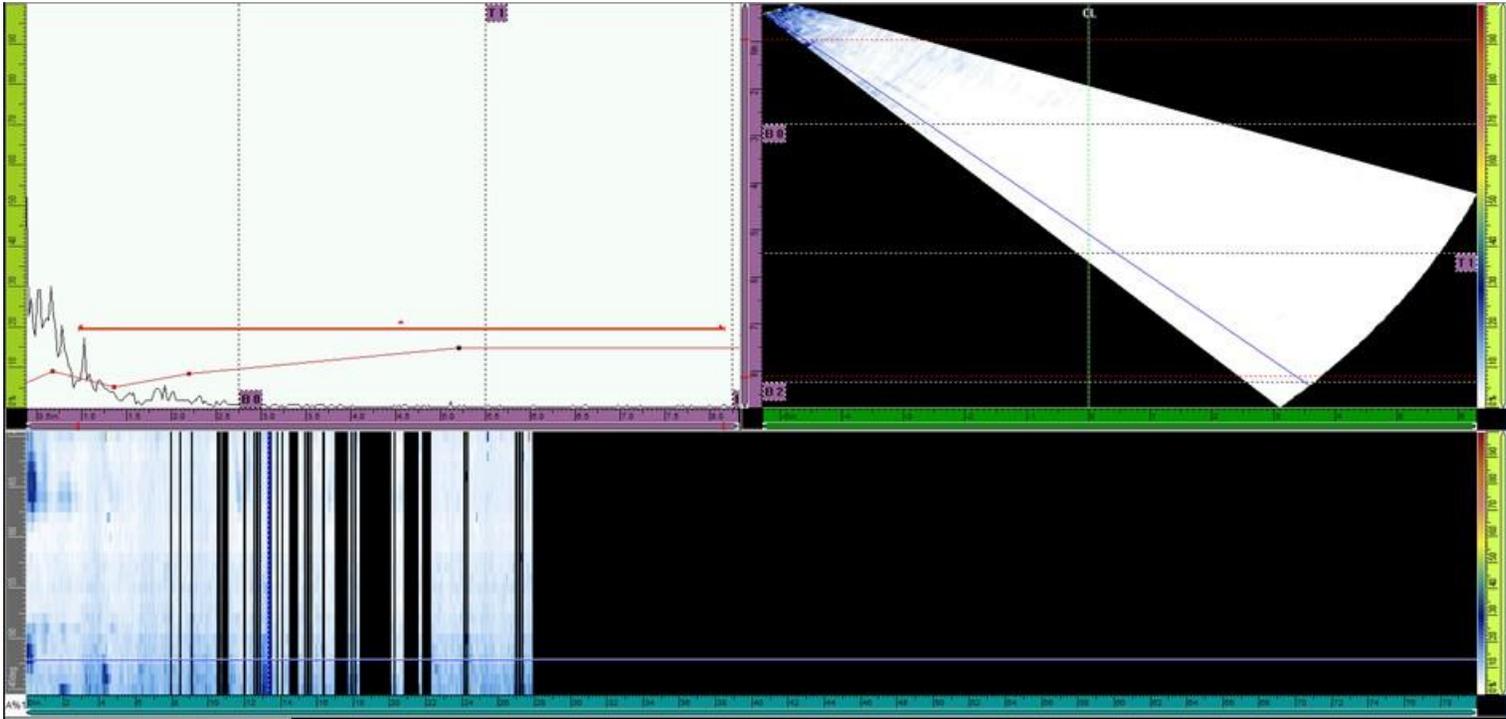
Weld	Comments													
S11b														
Gain (dB)	Indication #	Scan (in)	Index (in)	Group	Channel	A%1 (%)	DA/1 (in)	PA/1 (in)	SA/1 (in)	U(m-r) (in)	I(m-r) (in)	I•U(m-r) (in)	S(m-r) (in)	Type
46.66	1	13.740	-6.500	PA 1	56.00°	63.6	2.349	4.109	5.634	0.142	0.121	0.187	0.459	LOF

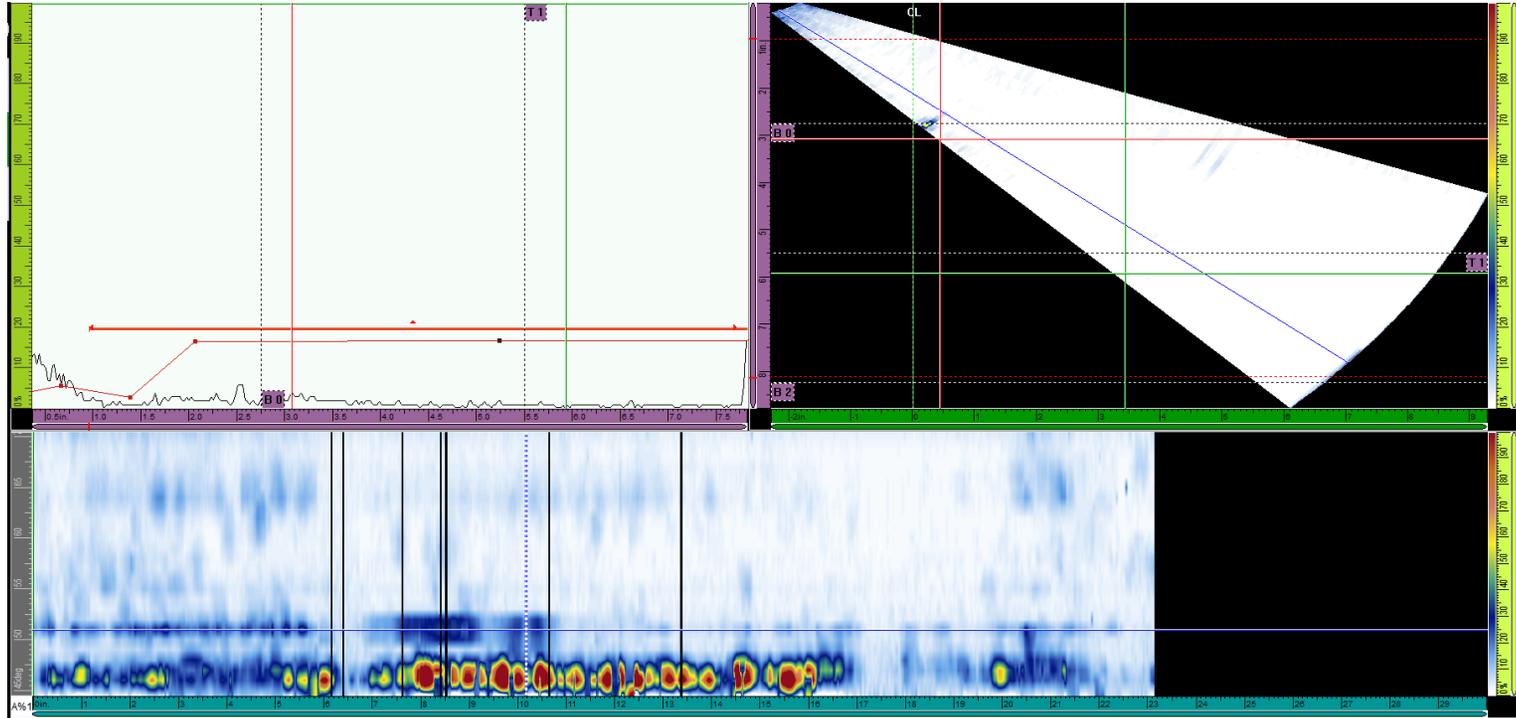
Weld	Comments													
S12b														
Gain (dB)	Indication #	Scan (in)	Index (in)	Group	Channel	A%1 (%)	DA/1 (in)	PA/1 (in)	SA/1 (in)	U(m-r) (in)	I(m-r) (in)	I•U(m-r) (in)	S(m-r) (in)	Type
46.66	1	27.665	-6.500	PA 1	64.00°	62.6	2.162	3.969	4.932	0.160	0.121	0.200	0.321	LOF

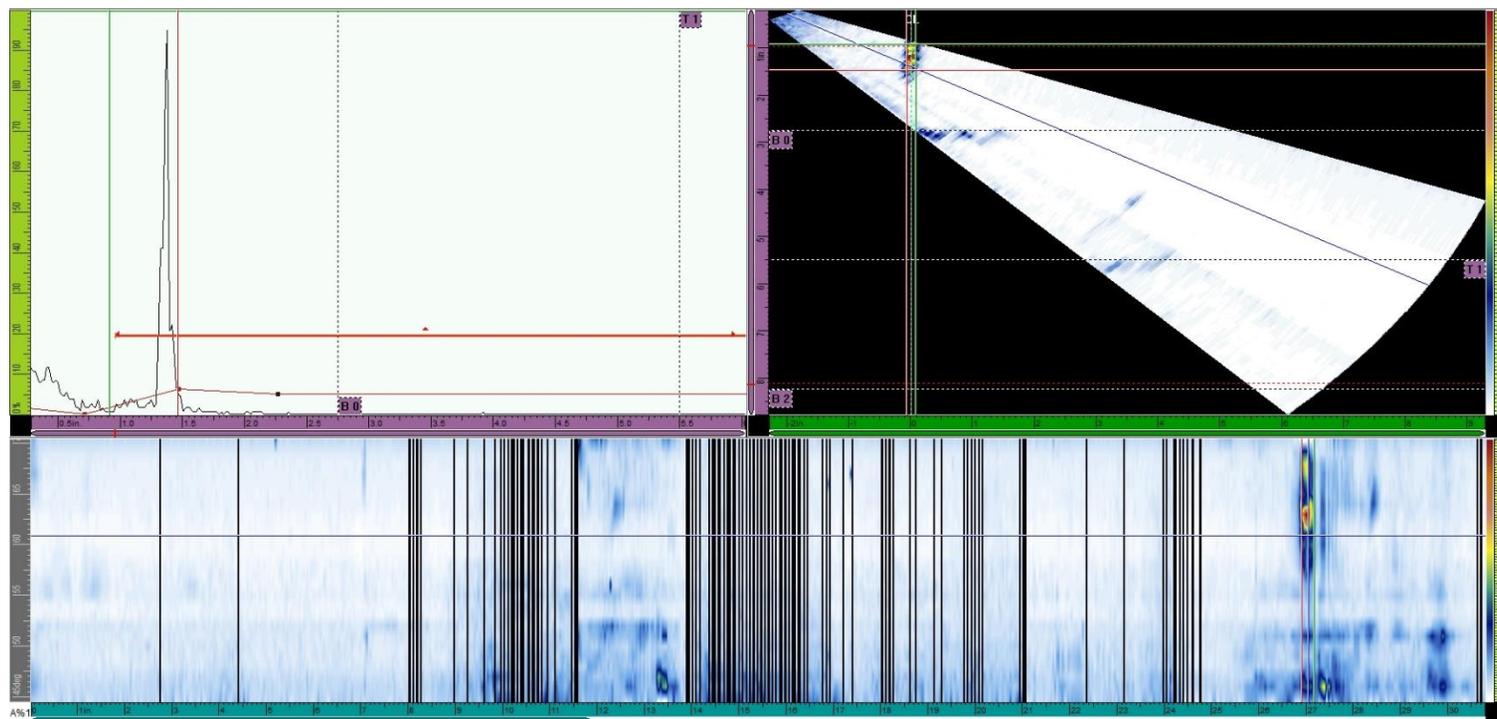
H1 Inclusion / volumetric defect 0.550" height in vertical direction.

Gain (dB)	Indication #	Scan (in)	Index (in)	Group	Channel	A%1 (%)	DA/1 (in)	PA/1 (in)	SA/1 (in)	U(m-r) (in)	I(m-r) (in)	I•U(m-r) (in)	S(m-r) (in)	Type
46.66	1	27.047	-6.500	PA 1	61.00°	41.1	1.313	1.869	2.708	0.550	0.148	0.569	0.265	Slag

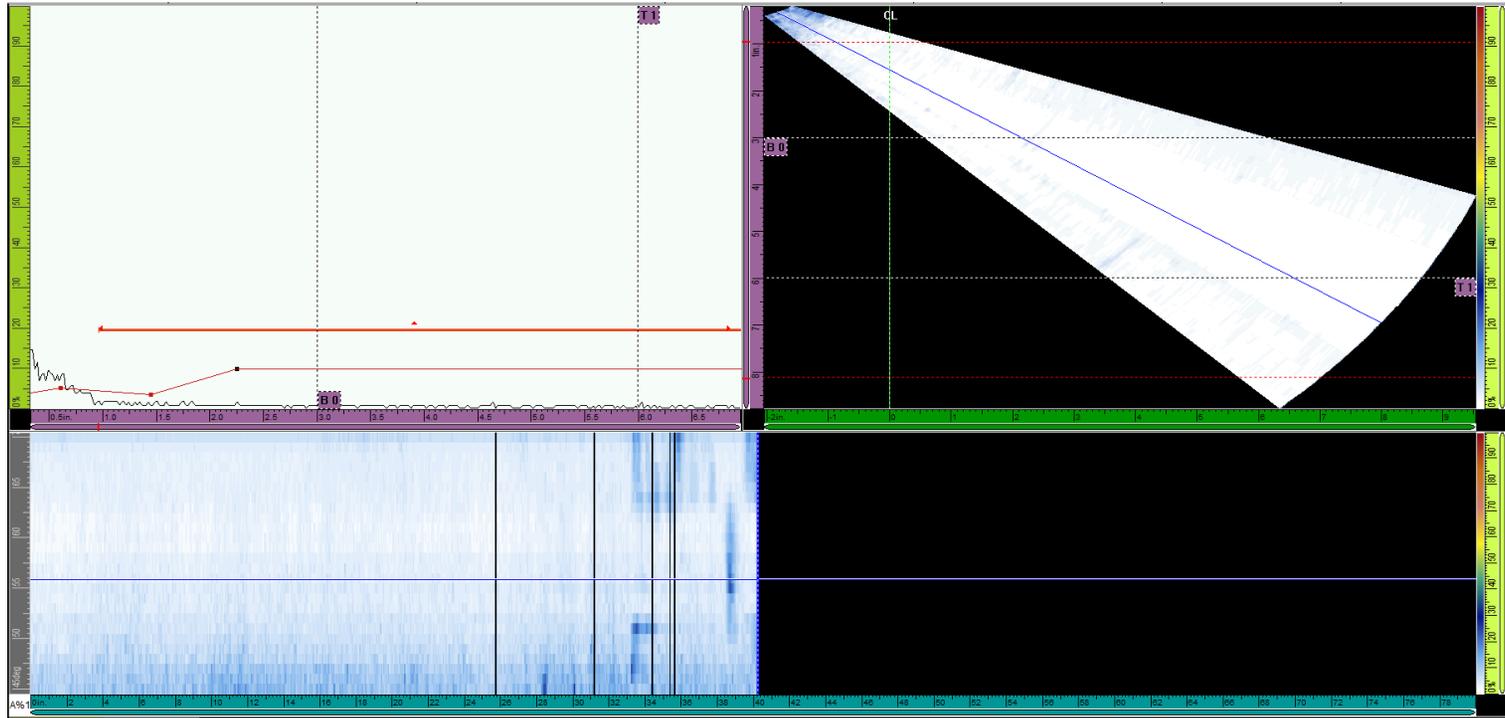
Weld	Comments													
V5b														
Gain (dB)	Indication #	Scan (in)	Index (in)	Group	Channel	A%1 (%)	DA/1 (in)	PA/1 (in)	SA/1 (in)	U(m-r) (in)	I(m-r) (in)	I•U(m-r) (in)	S(m-r) (in)	Type
46.66	1	3.071	-6.500	PA 1	67.00°	60.7	2.290	4.966	5.862	0.213	0.135	0.252	0.596	LOP
46.66	2	3.071	-6.500	PA 1	51.00°	59.7	1.082	4.830	7.020	0.177	0.108	0.208	0.413	LOP

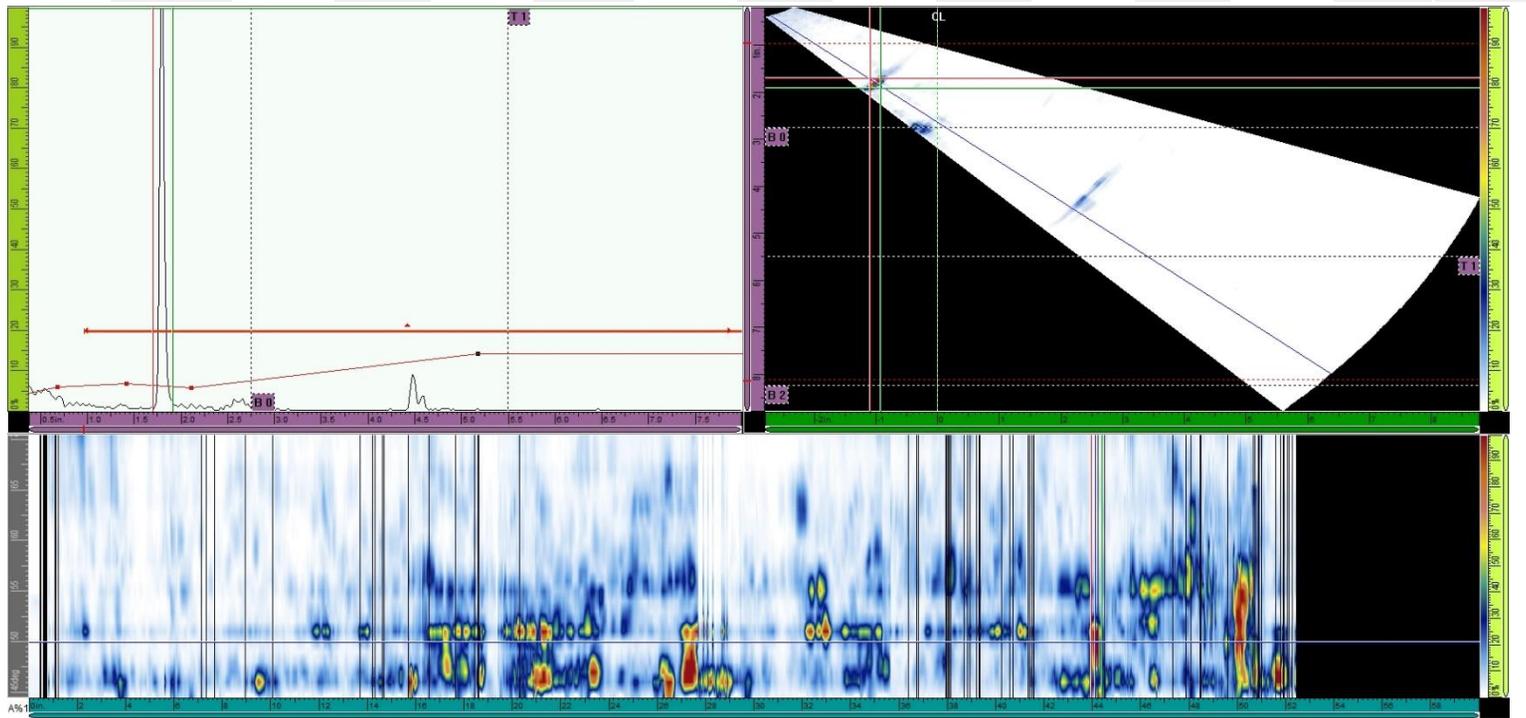
V3 Intermittent LOF from over most of weld. Flaw height ranging from 0.142” to 0.319”.

Gain (dB)	Indication #	Scan (in)	Index (in)	Group	Channel	A%1 (%)	DA/1 (in)	PA/1 (in)	SA/1 (in)	U(m-r) (in)	I(m-r) (in)	I•U(m-r) (in)	S(m-r) (in)	Type
40.66	1	17.267	-6.500	PA 1	48.00°	68.9	2.545	2.163	3.804	0.230	0.256	0.345	1.789	LOF
40.66	2	27.398	-6.500	PA 1	48.00°	98.9	2.719	2.356	4.063	0.213	0.283	0.354	1.376	LOF
40.66	3	32.957	-6.500	PA 1	51.00°	98.9	2.277	2.187	3.619	0.142	0.121	0.187	0.929	LOF
40.66	4	44.074	-6.500	PA 1	50.00°	98.9	1.778	1.481	2.766	0.213	0.175	0.276	0.447	LOF
40.66	5	50.105	-6.500	PA 1	54.00°	98.9	1.343	1.261	2.284	0.319	0.216	0.385	0.551	LOF
40.66	6	51.682	-6.500	PA 1	47.00°	98.9	2.476	2.566	4.434	0.142	0.175	0.225	0.619	LOF

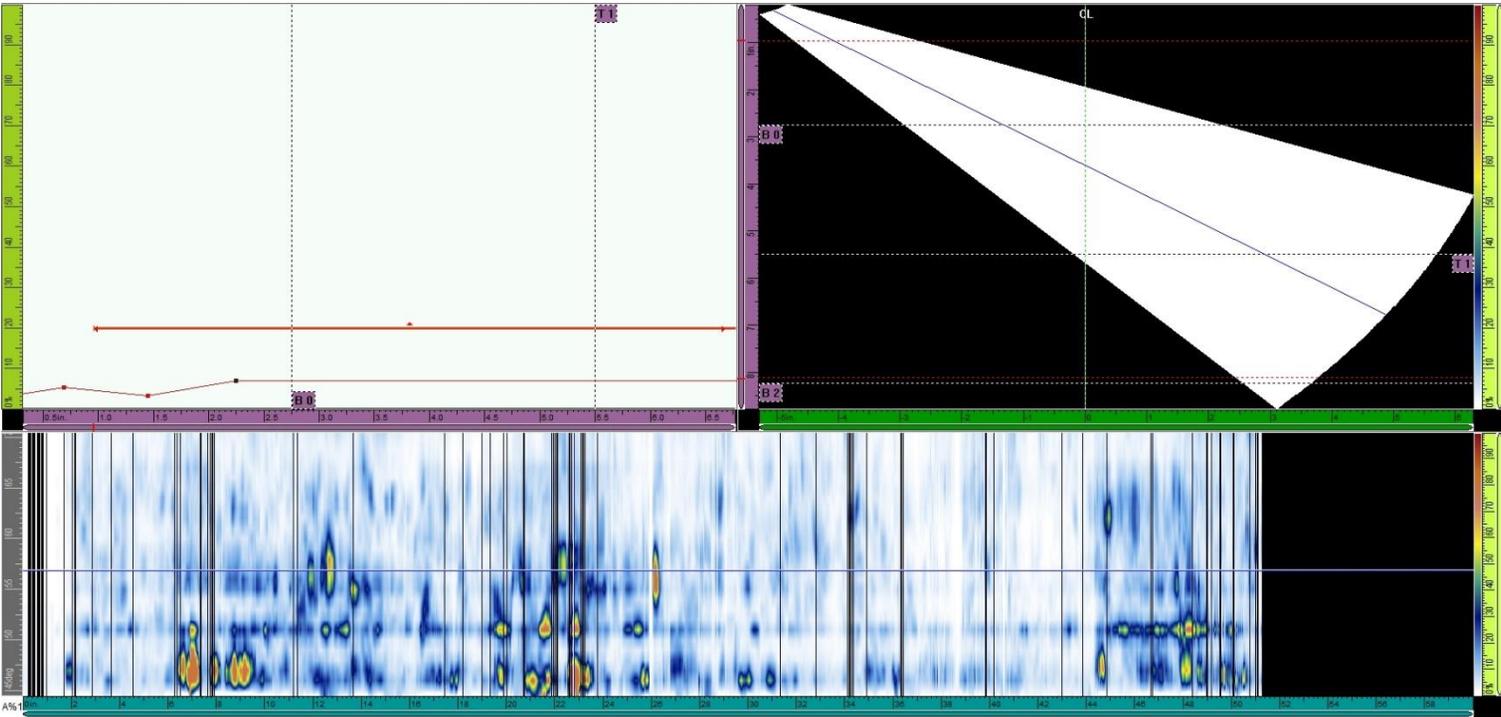
V4

No reportable indications.

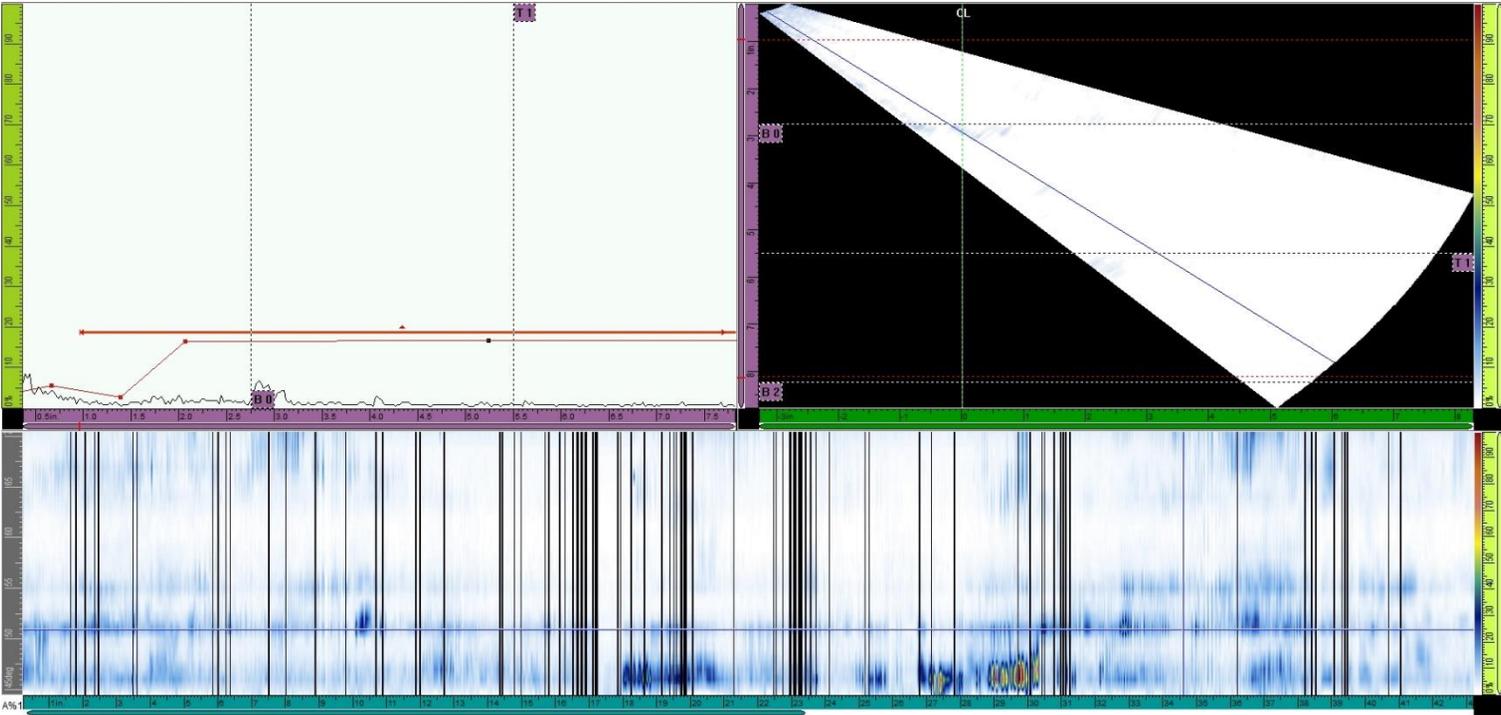
O2a

No reportable indications.

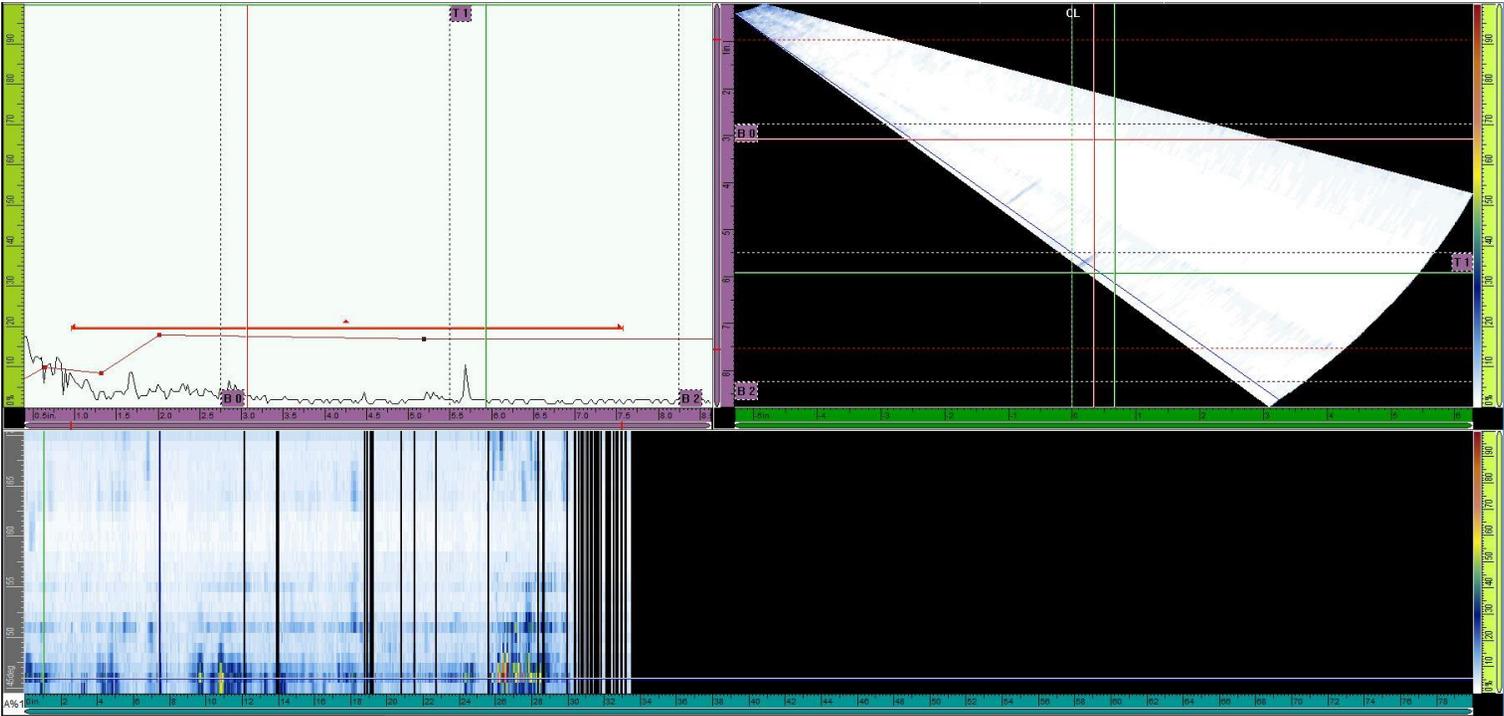
O2b

No reportable indications.

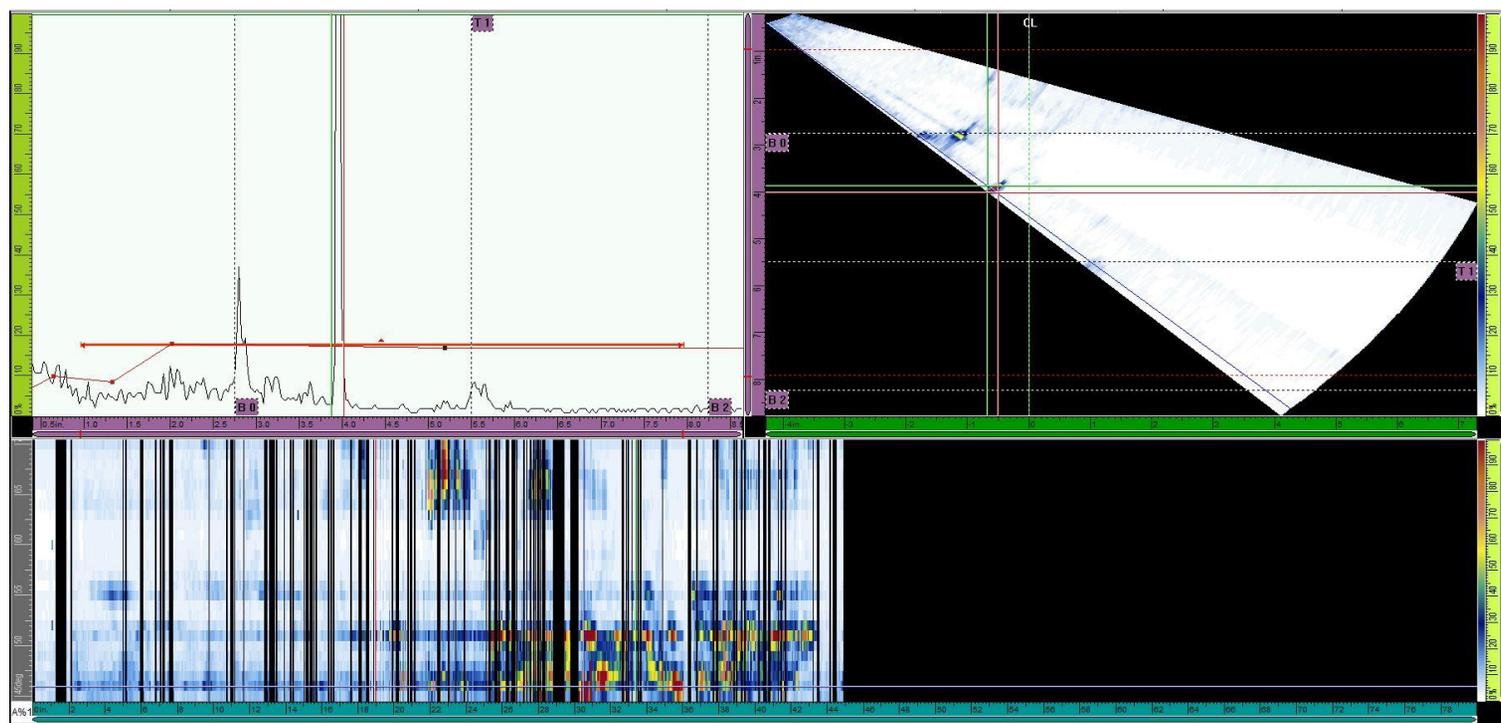
O4a

Gain (dB)	Indication #	Scan (in)	Index (in)	Group	Channel	A%1 (%)	DA/1 (in)	PA/1 (in)	SA/1 (in)	U(m-r) (in)	I(m-r) (in)	I•U(m-r) (in)	S(m-r) (in)	Type
46.66	1	22.835	-6.500	PA 1	67.00°	55.0	1.631	3.413	4.174	0.230	0.162	0.282	1.616	LOF
46.66	2	30.472	-6.500	PA 1	46.00°	106.1	1.570	3.380	5.657	0.213	0.135	0.252	0.333	LOP

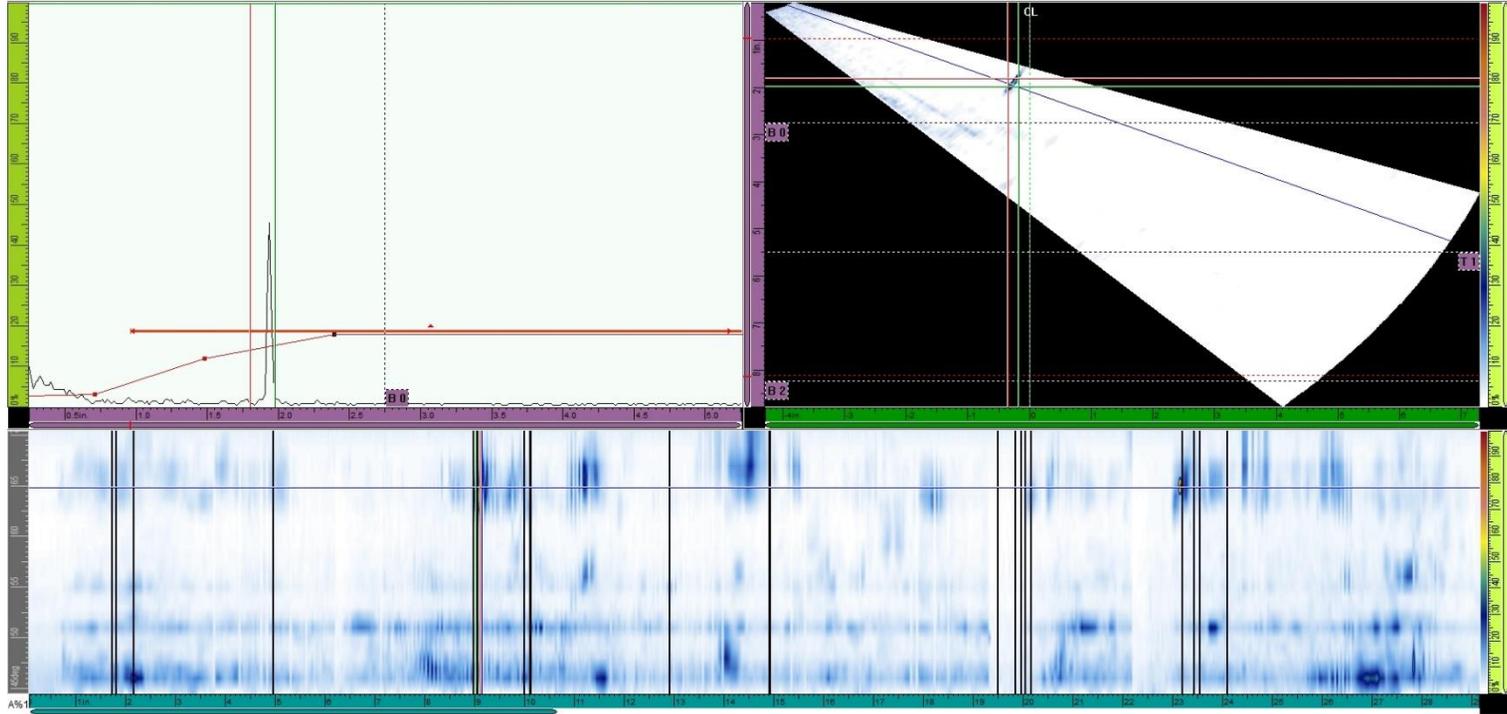
O4b

No reportable indications

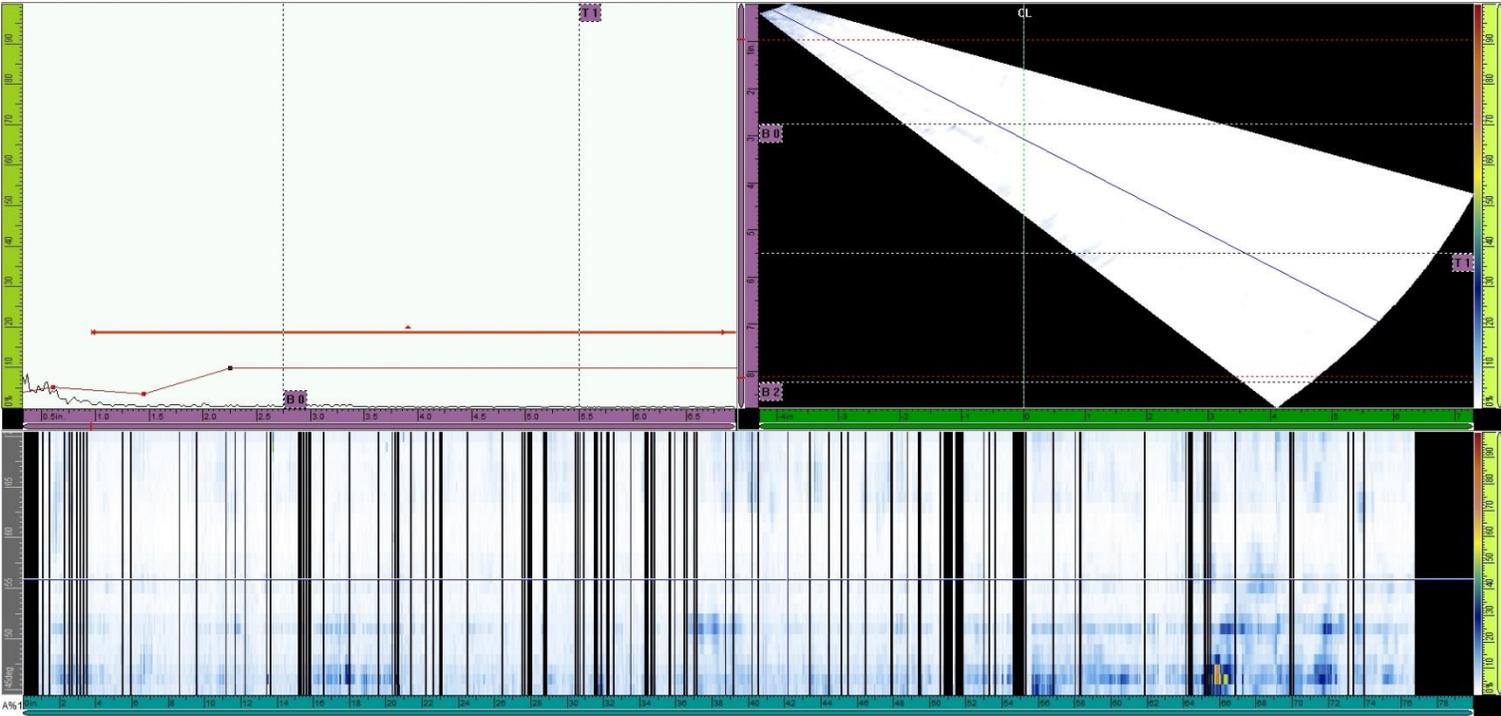
X1a

No reportable indications.

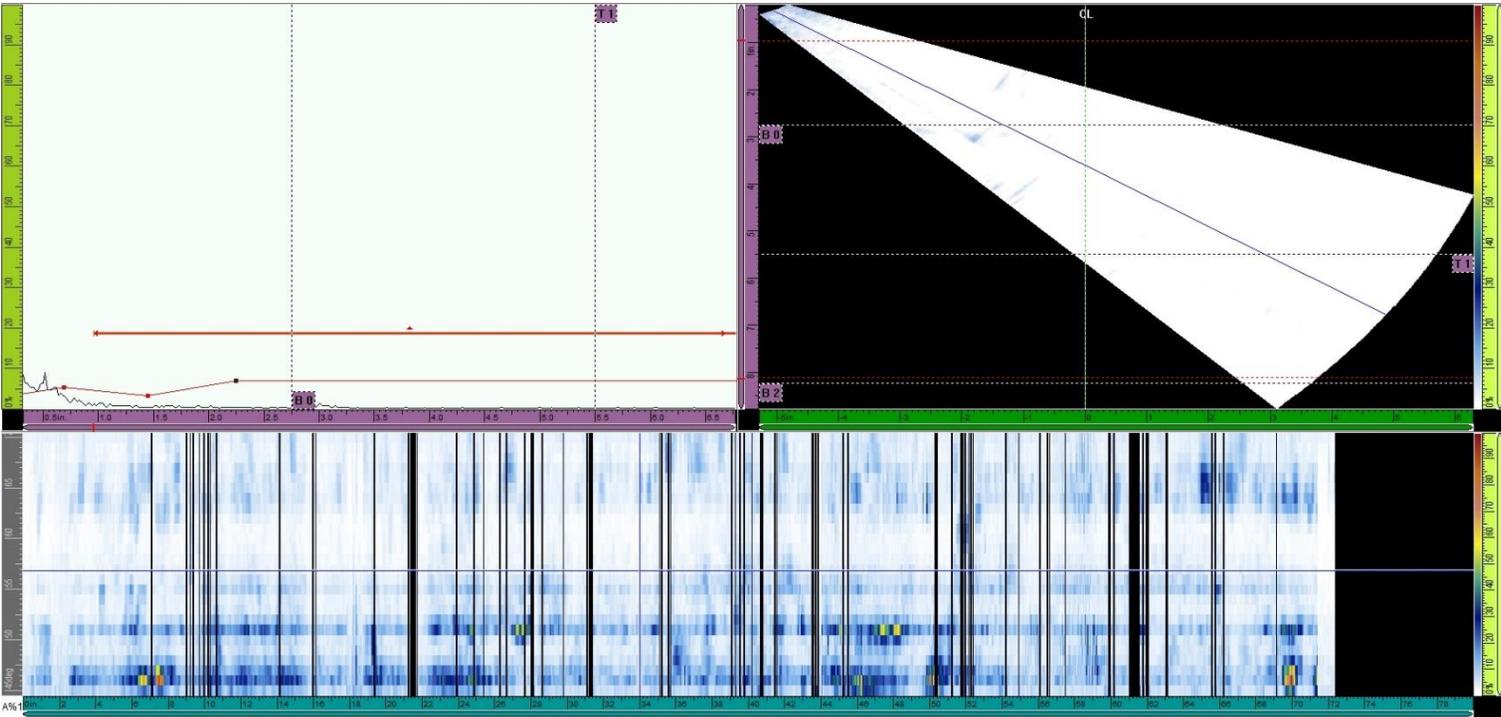
X1b

No reportable indications.

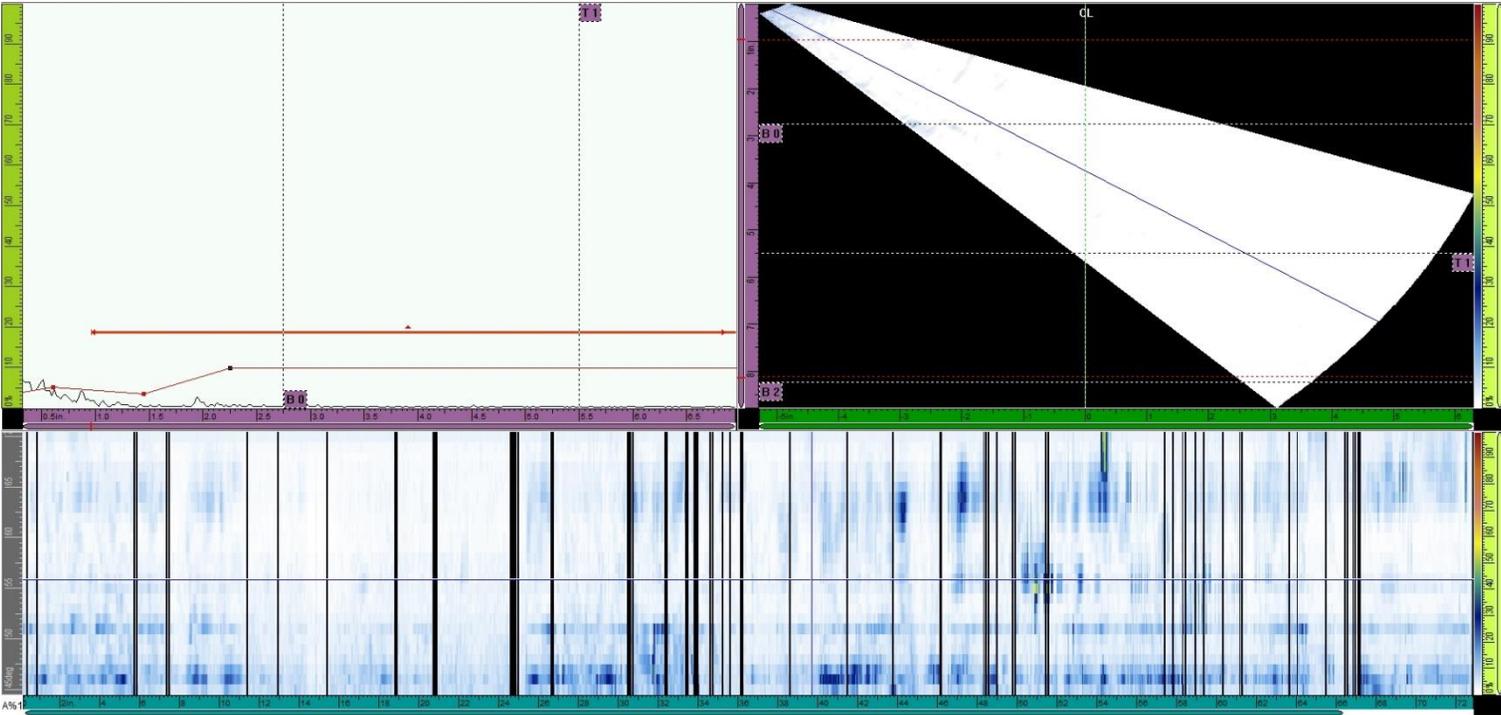
X2a

No reportable indications.
