Technical Report: Fort Peck Butterfly Valve#5 Inspection Report

FT. PECK PH#2 BUTTERFLY VALVE NDT

Date: 5/5/2020

U.S. ARMY CORPS OF ENGINEERS OMAHA DIST.
CONTRACTING OFFICE
1616 CAPITOL AVENUE
OMAHA NE 68102-4901

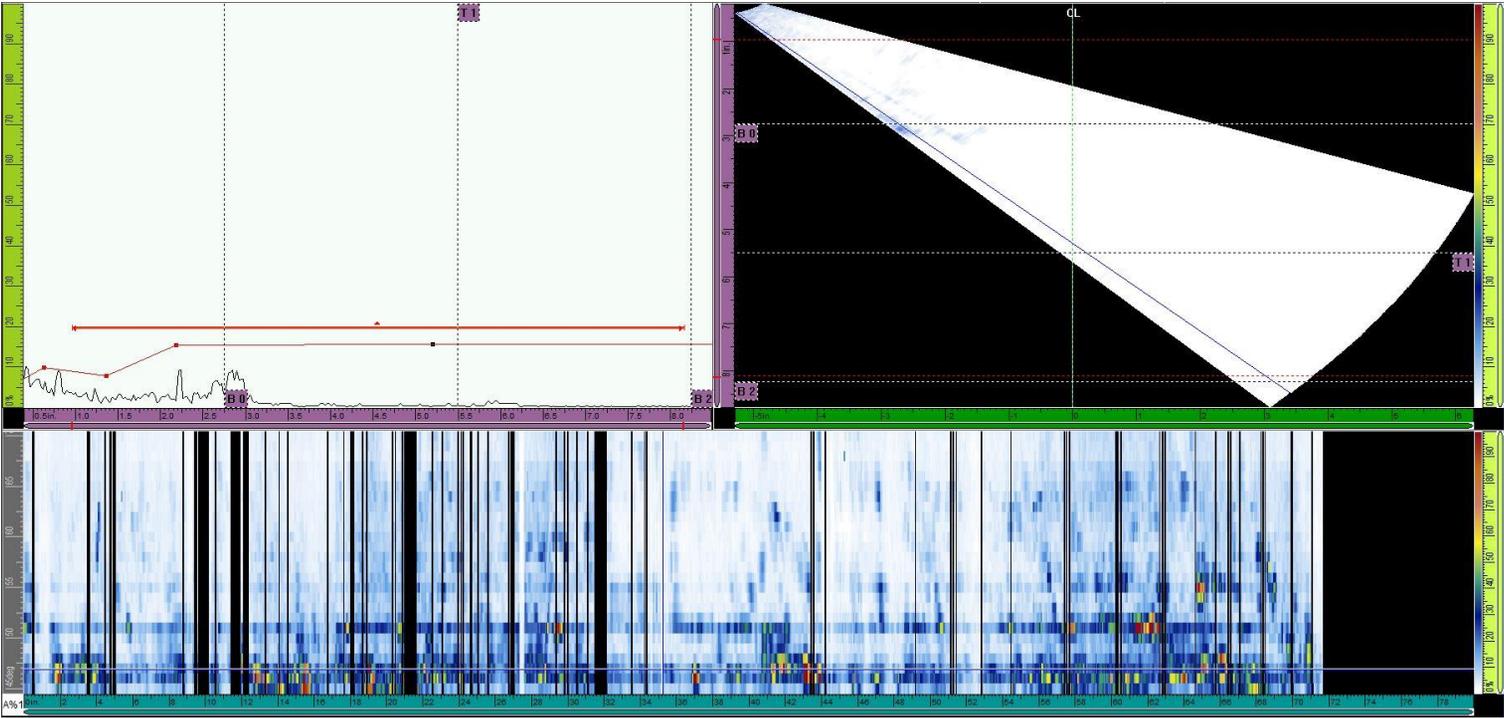
X3a

No reportable indications.

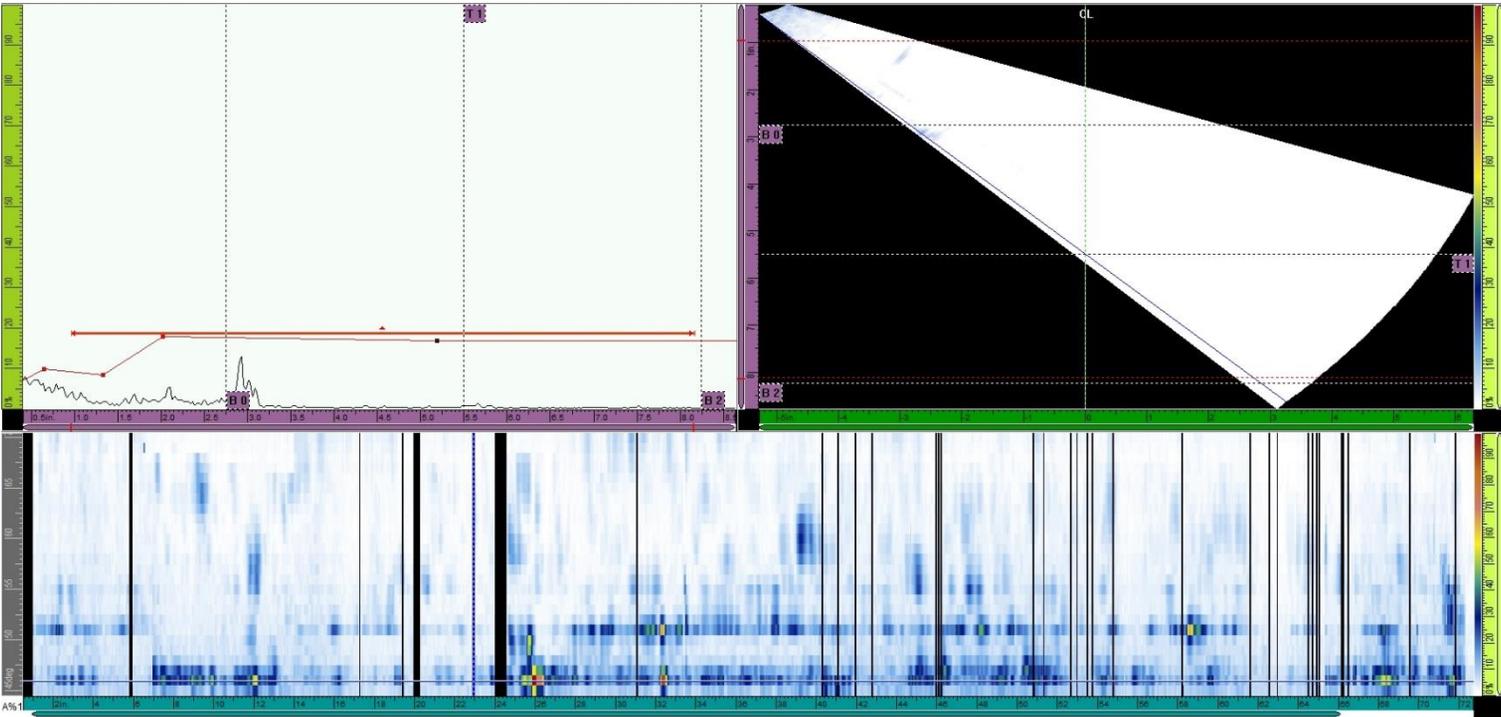
X3b

No reportable indications.

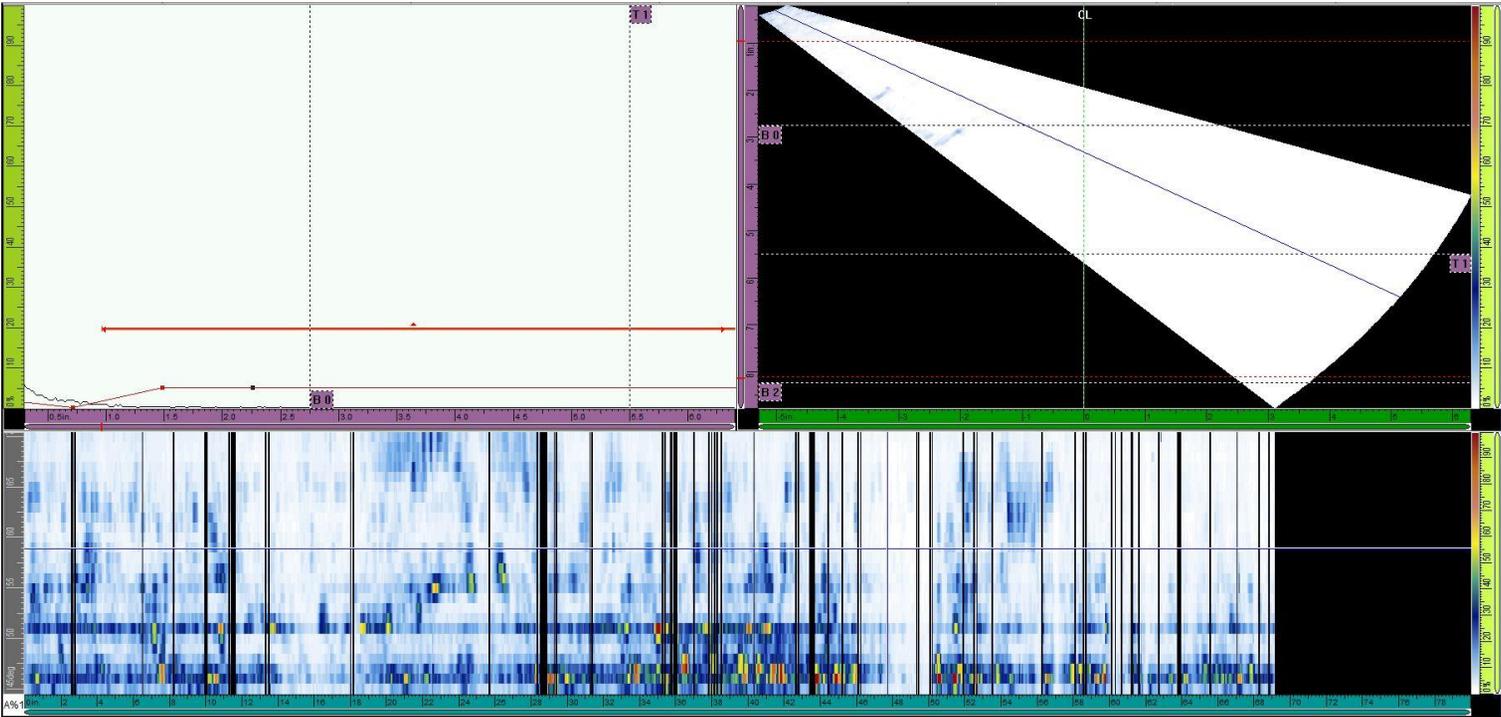
X4a

No reportable indications.

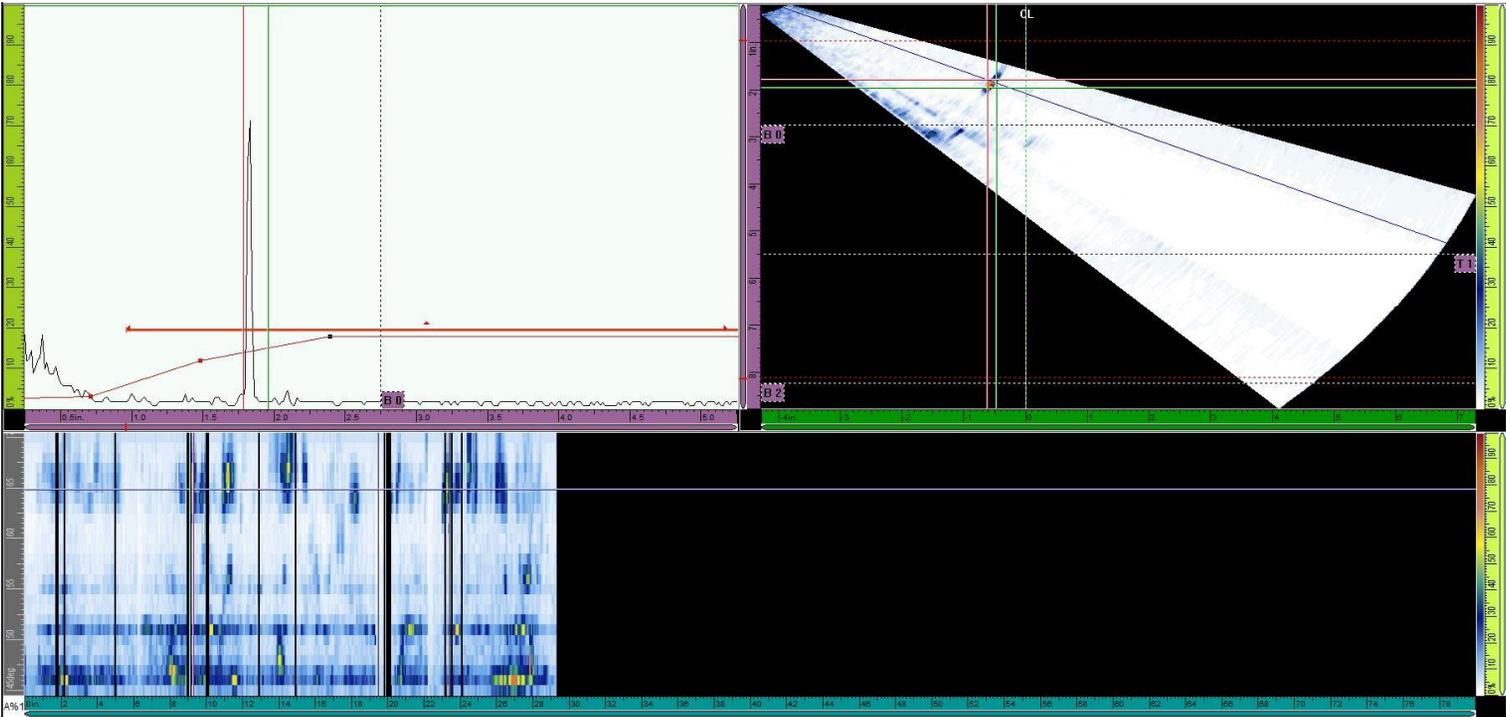
X4b

No reportable indications.

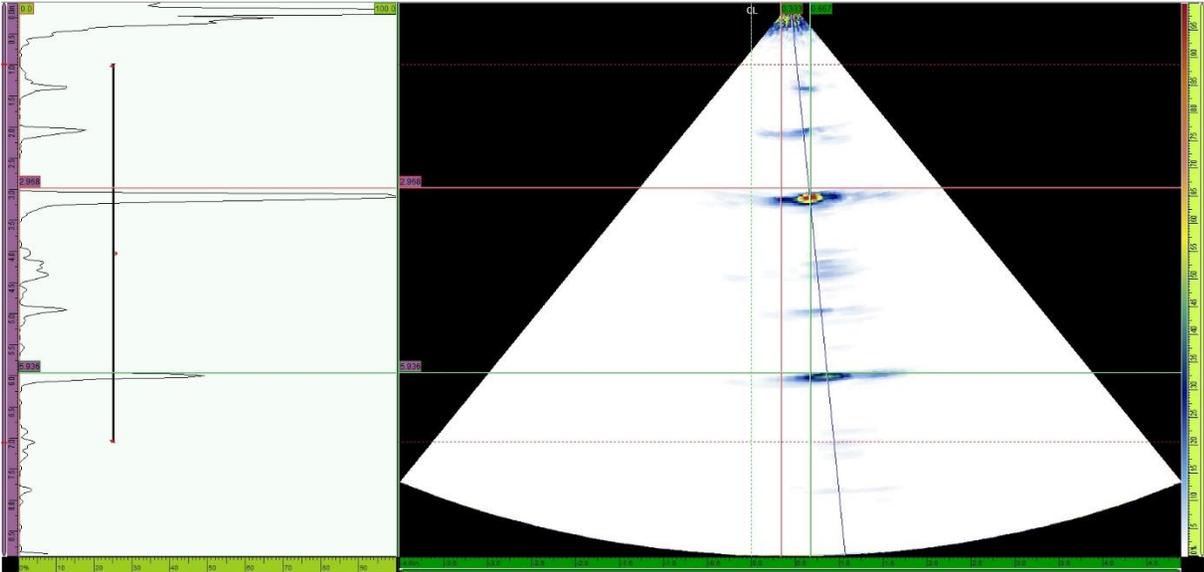
The C1 area shown in Figure 4.4 was inspected with manual PAUT. Approximately 15” of weld were inspected. No indications were detected.

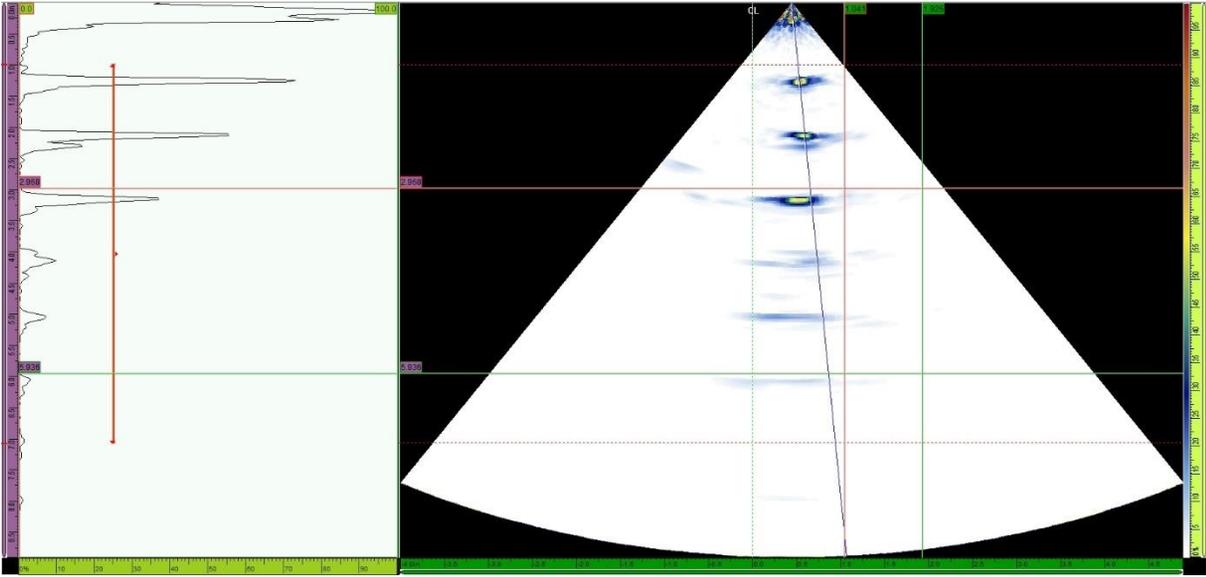
The C2 area shown in Figure 4.4 was inspected with manual PAUT. Approximately 5” of weld were inspected. No indications were detected.

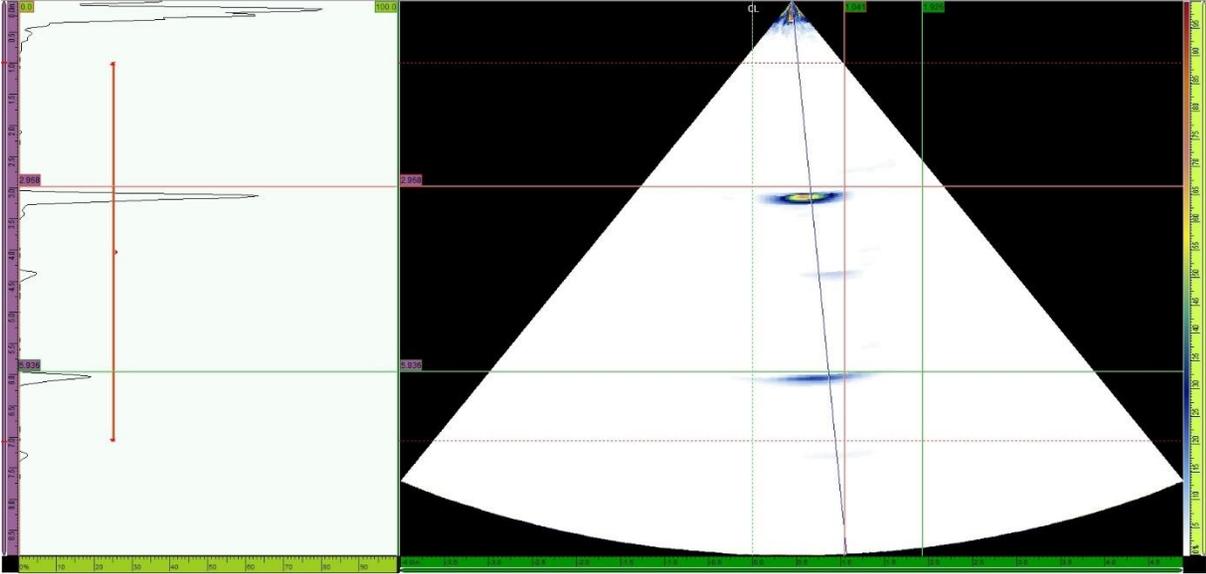
<i>Valve 5 Downstream Side</i>	
Weld	Comments
C3	<p>The C3 area shown in Figure 4.4 was inspected with manual PAUT. Approximately 40” of weld were inspected. No indications were detected.</p>
