**VOLUME II
ASBESTOS CONTAINING MATERIAL &
LEAD CONTAINING PAINT
SURVEY REPORT
BUILDING 62**

VISN 1
Bedford VA Medical Center
200 Springs Road
Bedford, Massachusetts

Project No. 2009023.008

February 15, 2011

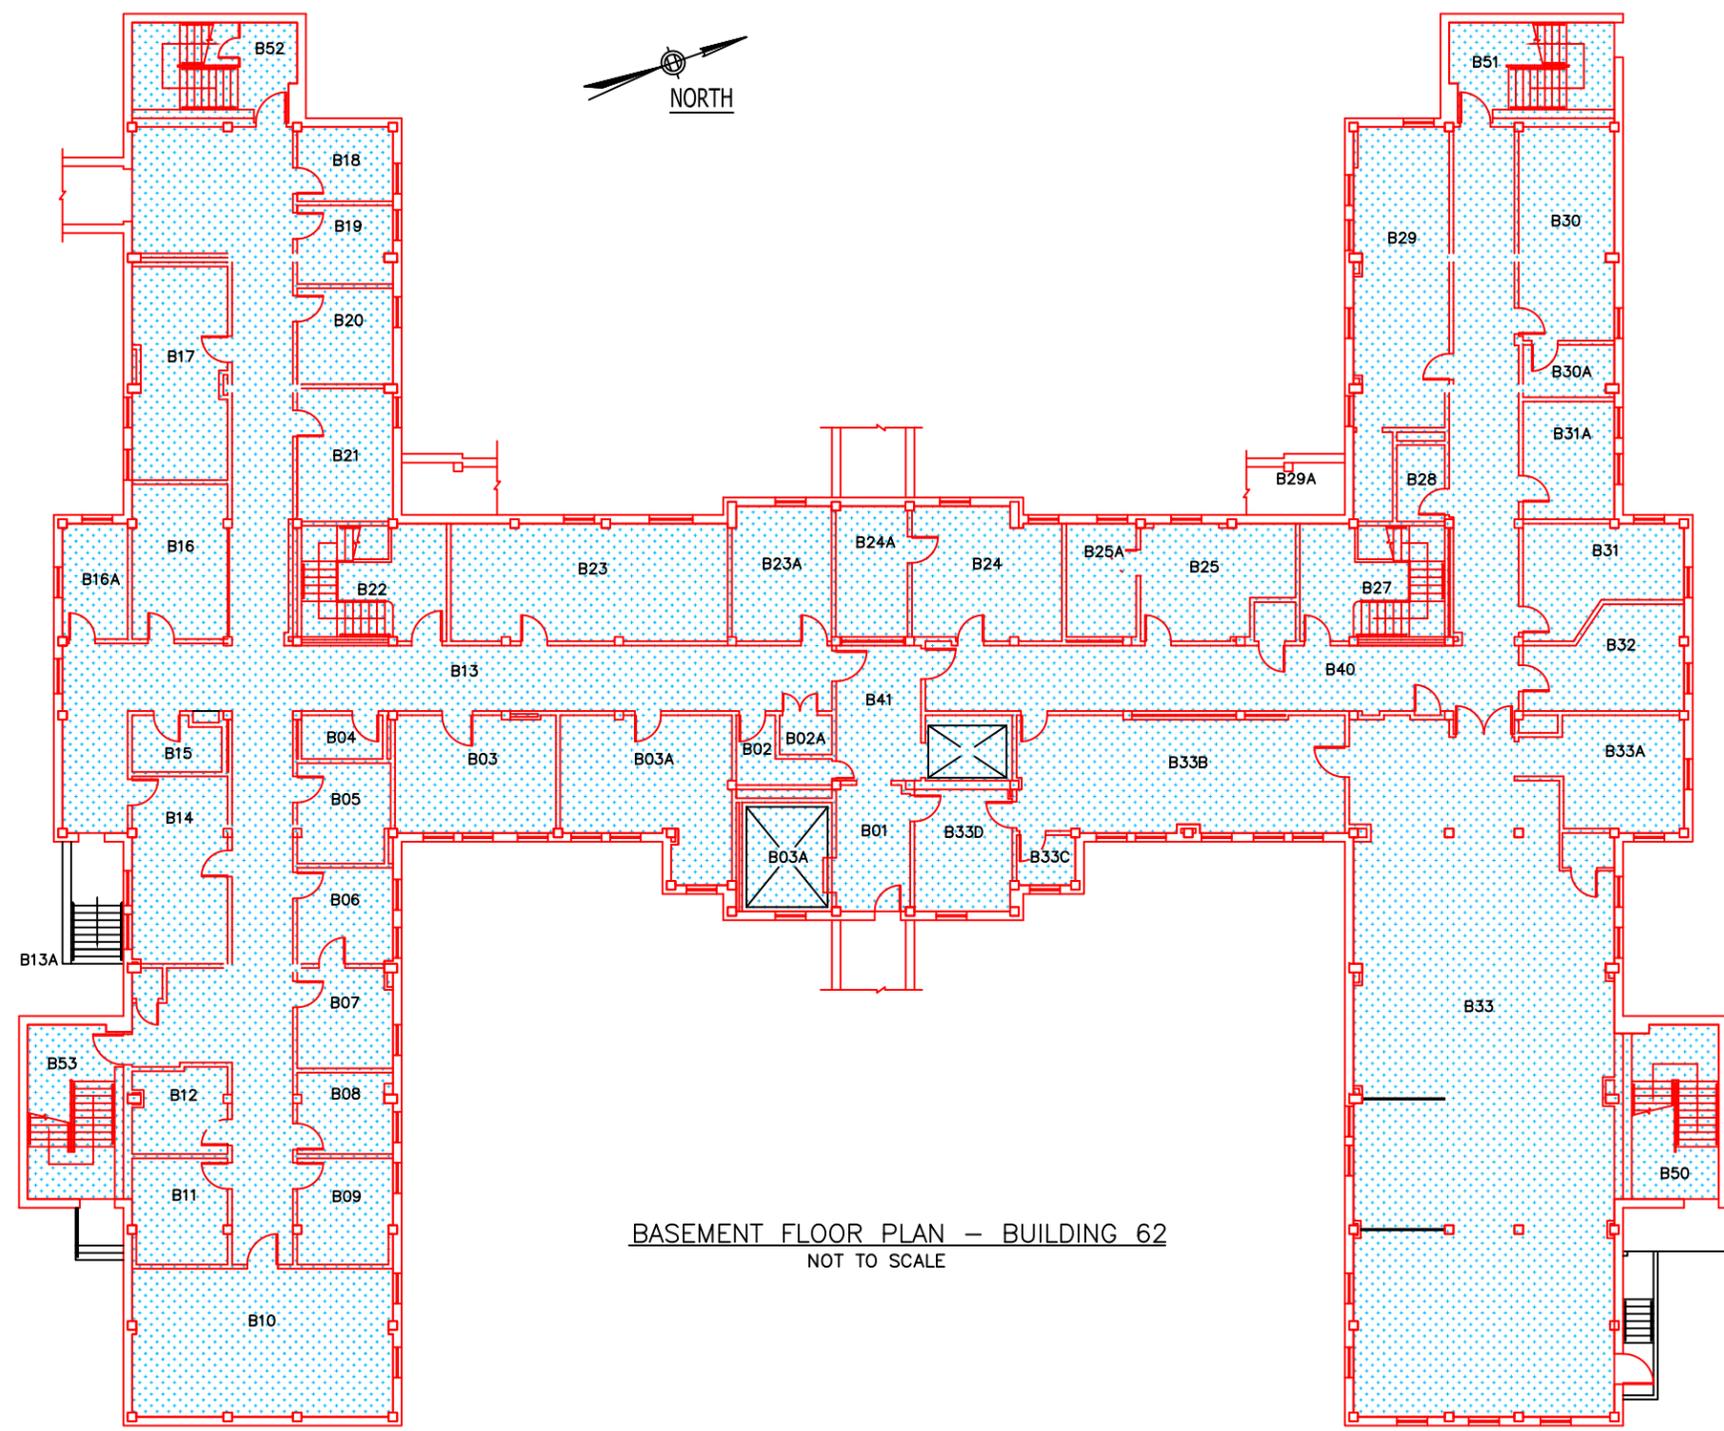
BASEMENT FLOOR PLAN — BUILDING 62
NOT TO SCALE

COMPONENT	SUBSTRATE	SYMBOL
CAGE	METAL	▨
LINTEL	METAL	▨
RADIATOR GUARD	METAL	▨

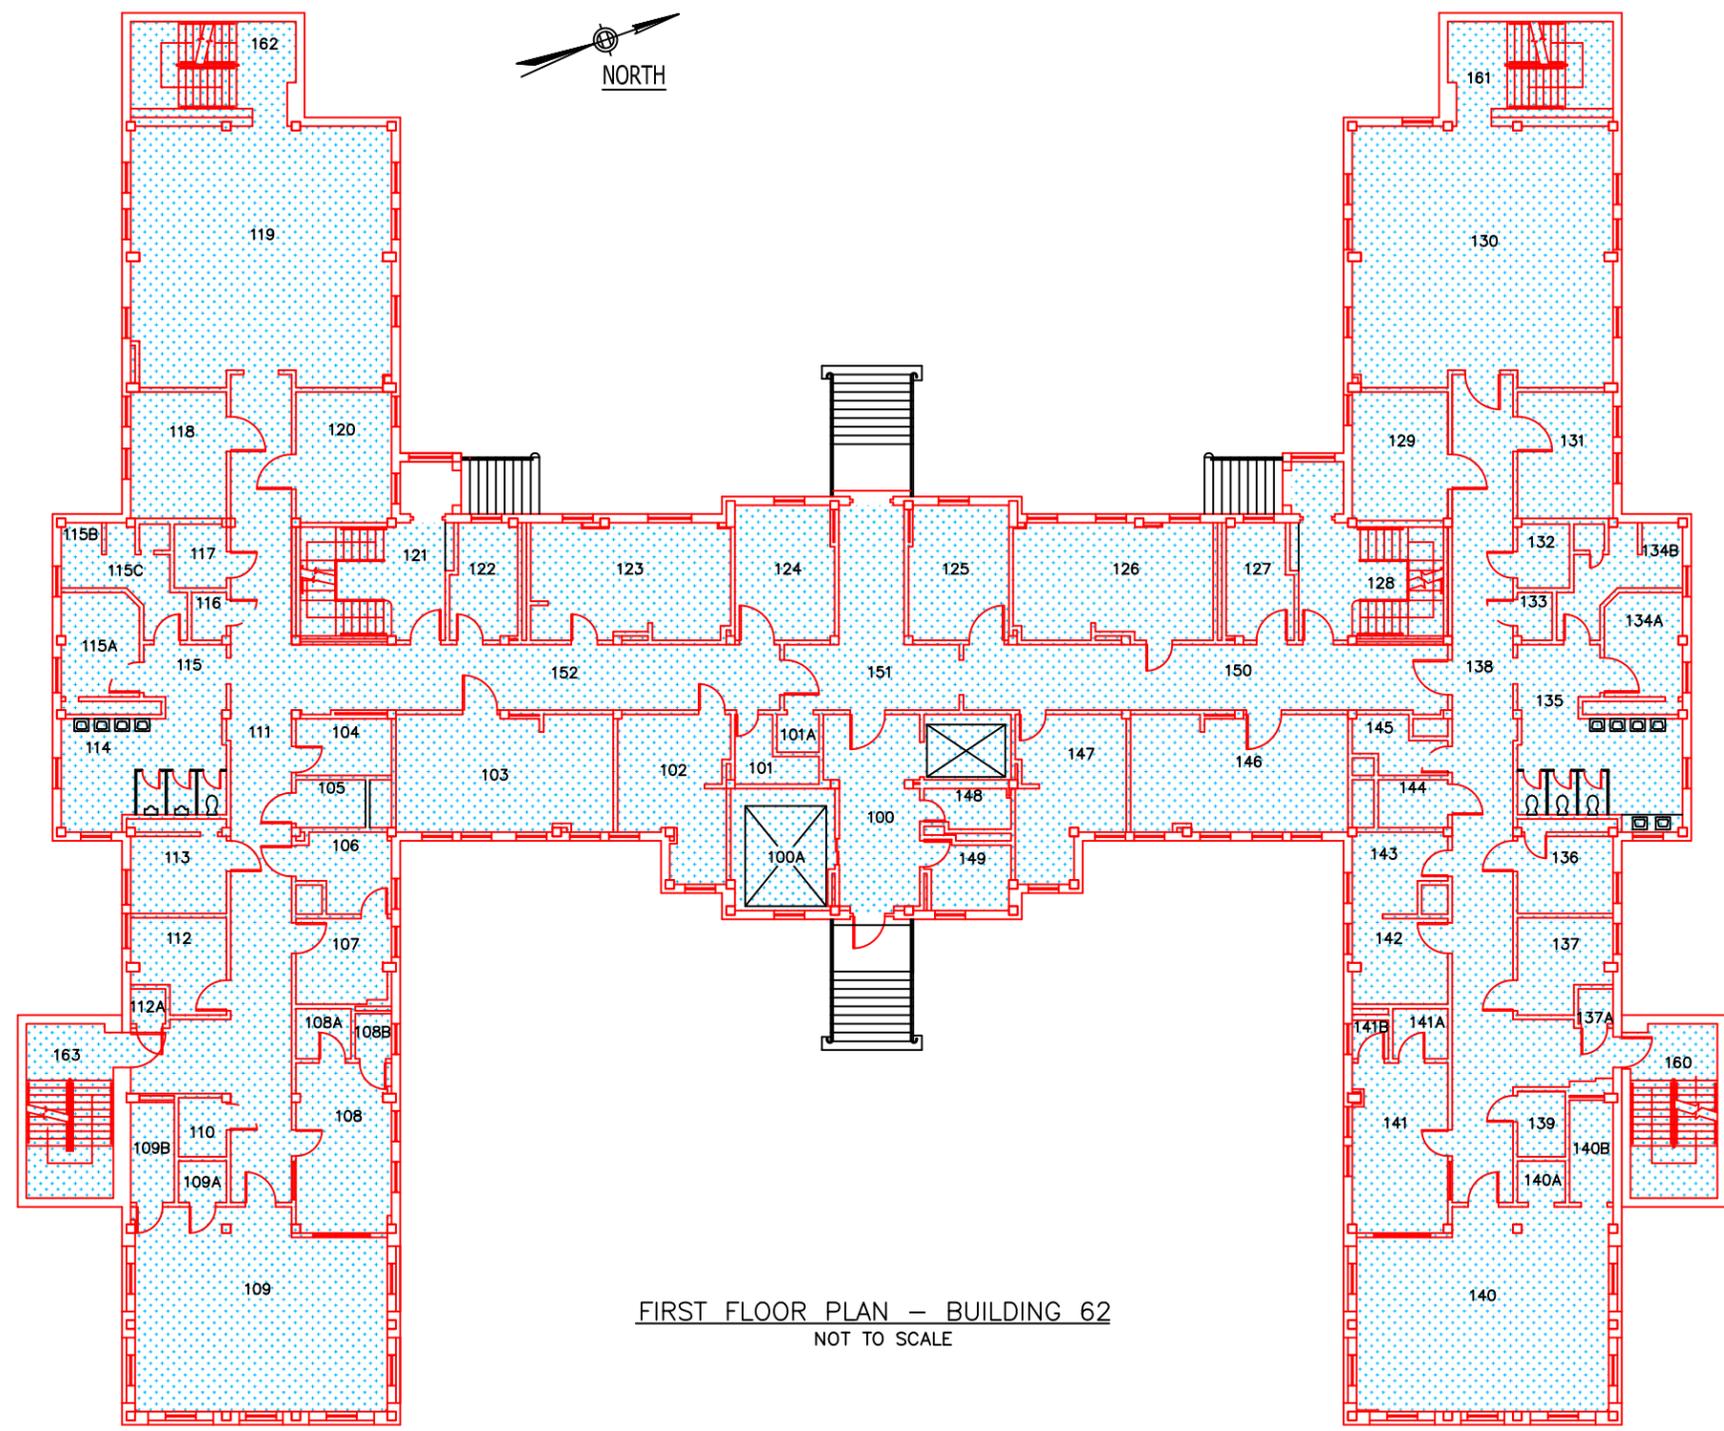
FIRST FLOOR PLAN – BUILDING 62
NOT TO SCALE

COMPONENT	SUBSTRATE	SYMBOL
CAGE	METAL	▨
LINTEL	METAL	▨
RADIATOR GUARD	METAL	▨
