## **EXECUTIVE SUMMARY**

The overall intent of this project is to upgrade and improve the EHRM Infrastructure of the St. Louis VA Medical Center campus in Missouri in support of the Electronic Health Record Modernization initiative. This report shall detail the site investigation findings and further define the intended scope of work for the EHRM Infrastructure Upgrades project. There are 21 buildings throughout the campus are included in the scope of this project.

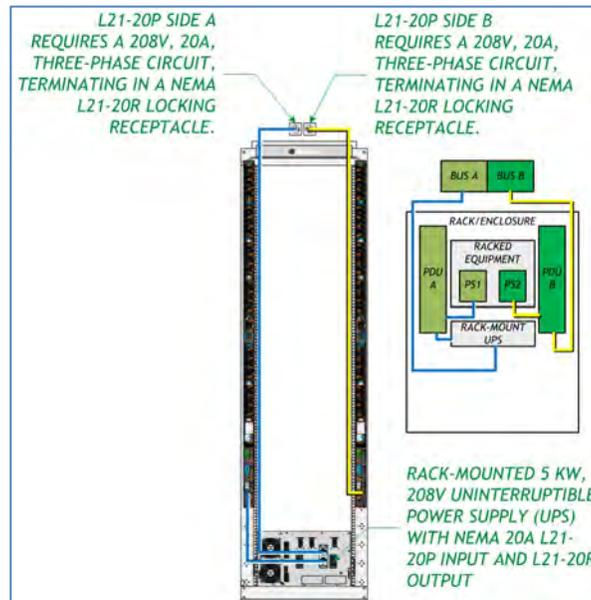
Figure 2: TR Single Rack Elevation and Power Schematic (OIT Design Guide Template, V3.1)

- All panelboards will be provided with power metering equipment.
- The schematic in Figure 2 below shows how source A and B power will be distributed to the rack. Each source (or panelboard) provides power to one of the 20A receptacles which in turn provides power to the rack equipment.
- TR rack mounted UPS systems shall be 5kW, 3-phase with L21-20 input/output connections as shown below in figure 2.

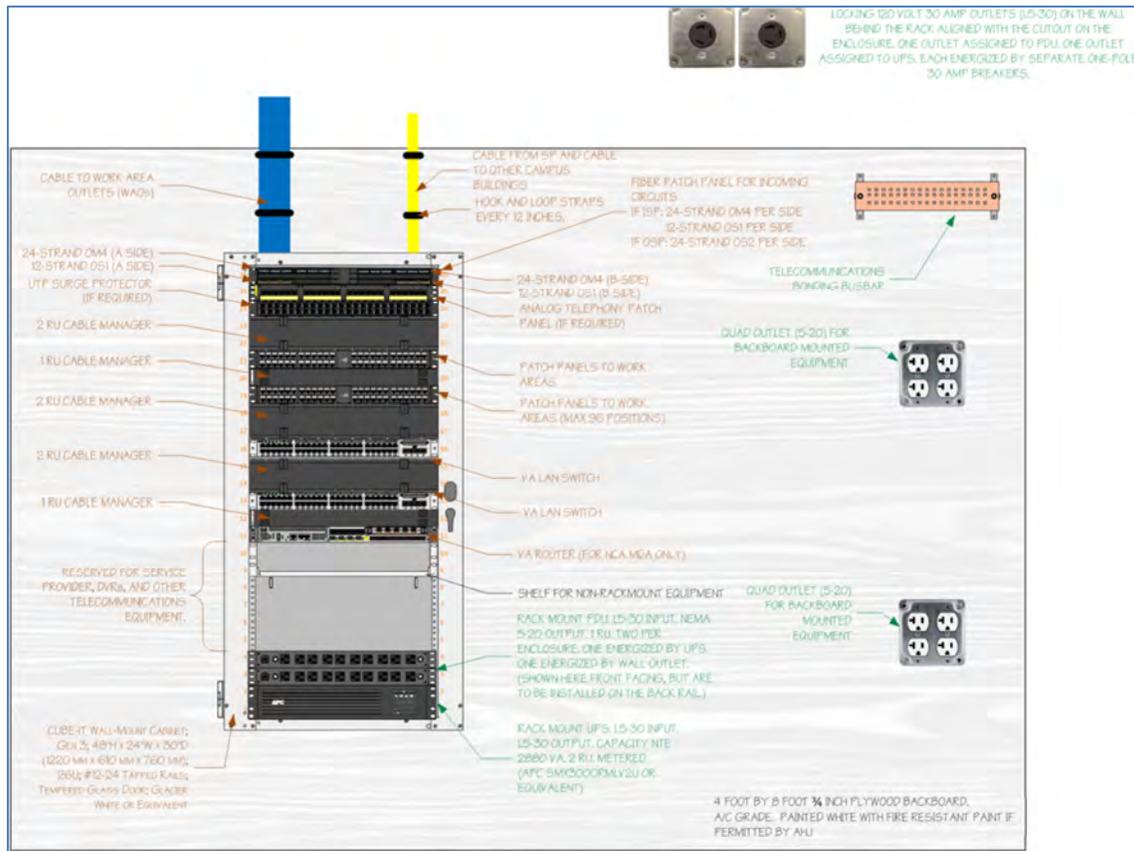
Figure 3: TE Installation Elevation (OIT Design Guide Template)

Where TRs will not physically accommodate or require a full data rack from a data standpoint, a Telecommunications Enclosure (TE) will be provided. Each TE will be designed to the below OIT TE design template as shown in figures 3 and 4:

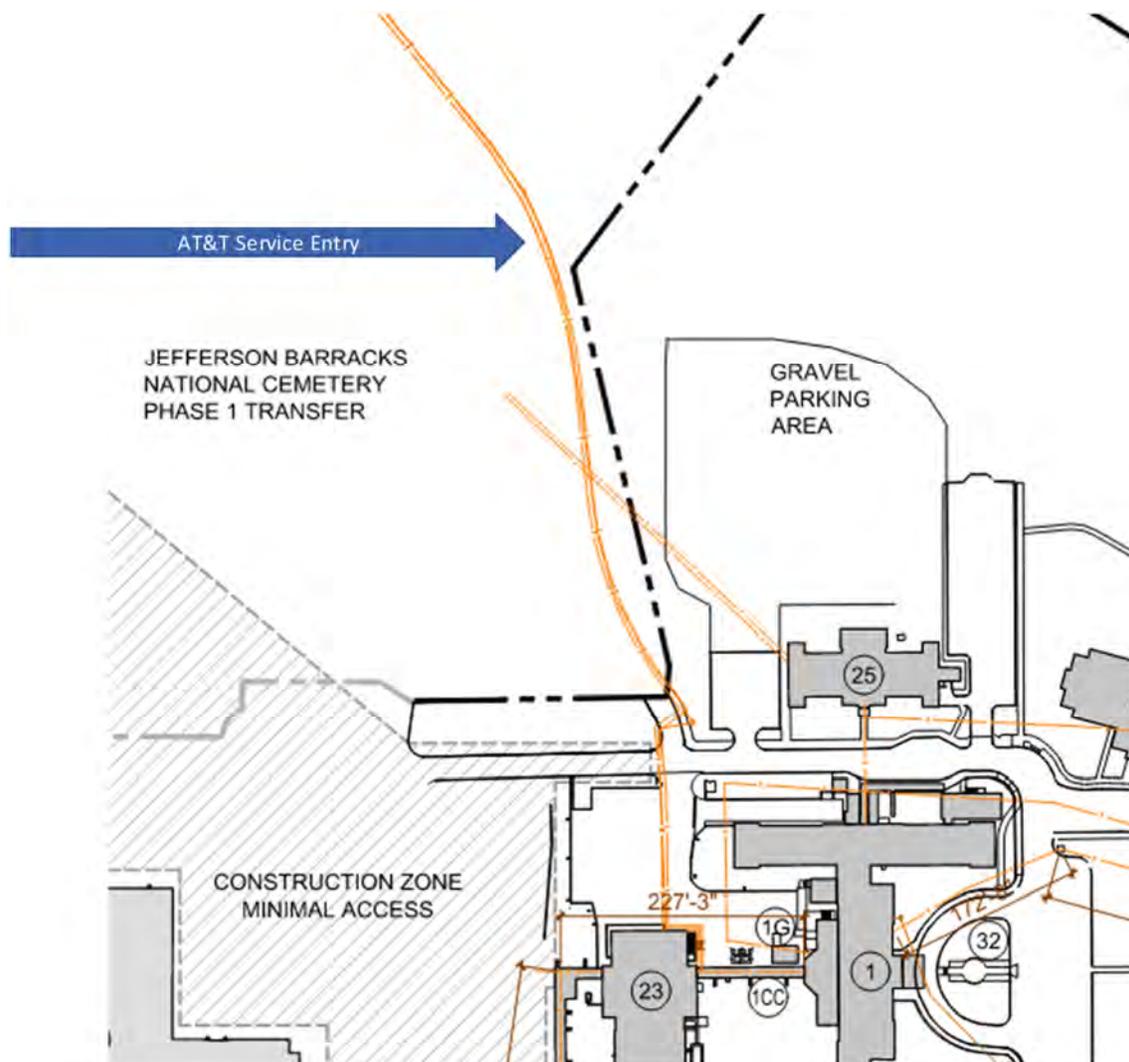
Figure 3 ATT Point of Entry

It is required that all VA campus’s source a secondary and redundant Internet Service Provider (ISP). HEFP SEP has identified this as a deficiency for this campus. Currently, ATT has a presence entering onto the campus from the North and East, traveling West into Building 23. There is no secondary provider. We have identified CenturyLink as the nearest provider with available ‘dark fiber’, along Interstate 255 at

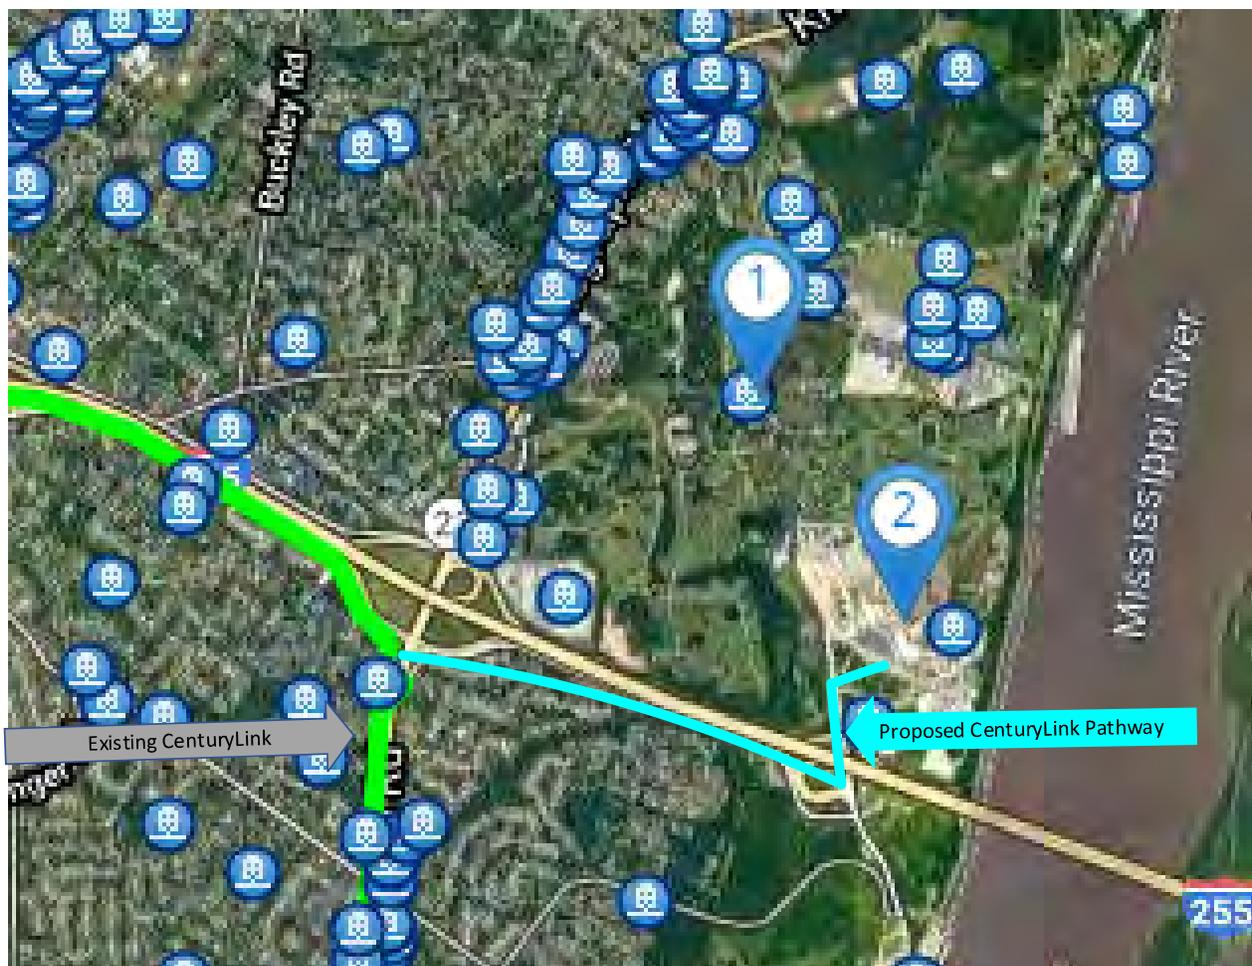
Figure 4 CentryLink Route

Should ATT not have a redundant CO to connect to, then another option is to contact CenturyLink and negotiate a connection from their existing infrastructure (I-55/I-255) traveling east to Koch Road, traveling north under the I-255 overpass, and onto the campus. From the property line, the VA would place an underground meet-me point and tie CenturyLink into building 56. This would provide geographically separate SP connections.

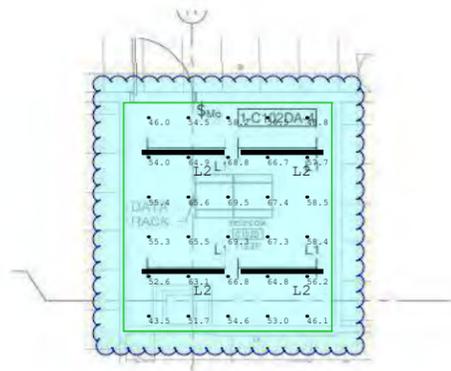
4 RM C102D - LIGHTING PLAN  
1/4" = 1'-0"

Calculation Summary							
Label	CalcType	Units	Avg	Max	Min	Avg/Min	Max/Min
RM 1E15 Workplane	Illuminance	Fc	57.87	72.3	37.8	1.53	1.91
RM 2C10 Workplane	Illuminance	Fc	50.86	69.1	22.1	2.30	3.13
RM 3C13 Workplane	Illuminance	Fc	50.83	67.3	27.3	1.86	2.47
RM C102D Workplane	Illuminance	Fc	58.69	69.5	43.5	1.35	1.60

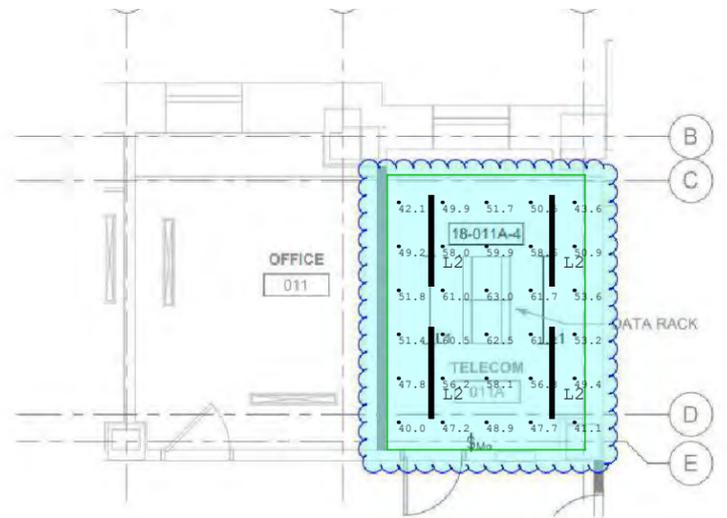
4 RM 011 - LIGHTING PLAN  
1/4" = 1'-0"

Calculation Summary						
Label	CalcType	Units	Avg	Max	Min	Avg/Min
Rm 011 Workplane	Illuminance	Fc	52.92	63.0	40.0	1.32
RM 119 Workplane	Illuminance	Fc	55.02	66.7	32.0	1.72
RM 213 Workplane	Illuminance	Fc	50.03	59.7	39.3	1.27
RM 312 Workplane	Illuminance	Fc	52.23	60.8	34.7	1.51

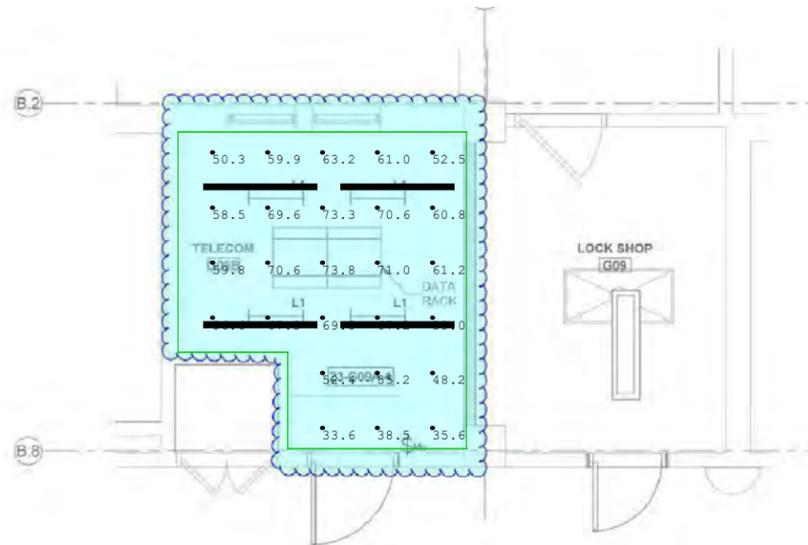
2 RM G09 - LIGHTING PLAN  
3/8" = 1'-0"

Calculation Summary							
Label	CalcType	Units	Avg	Max	Min	Avg/Min	Max/Min
RM 121 Workplane	Illuminance	Fc	52.16	62.7	35.9	1.45	1.75
RM G09 Workplane	Illuminance	Fc	59.17	73.8	33.6	1.76	2.20

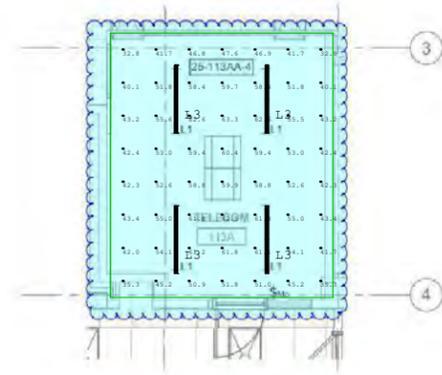
RM 113, 113A - LIGHTING PLAN  
1/4" = 1'-0"

Calculation Summary							
Label	CalcType	Units	Avg	Max	Min	Avg/Min	Max/Min
RM 113A Workplane	Illuminance	Fc	50.85	63.3	32.8	1.55	1.93
RM 208 Workplane	Illuminance	Fc	54.92	64.1	39.8	1.38	1.61
RM 307 Workplane	Illuminance	Fc	50.84	61.7	37.6	1.35	1.64

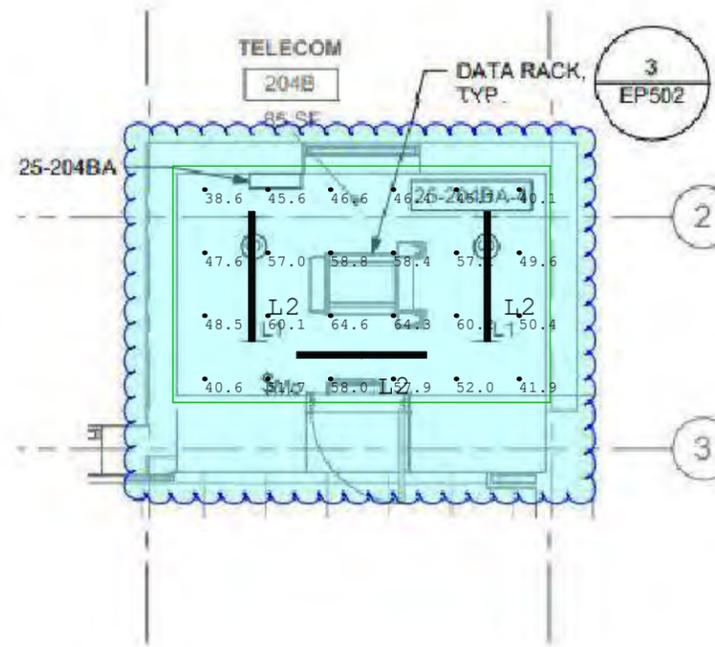
**RM 204B - LIGHTING PLAN**  
 1/4" = 1'-0" PRECISE NORTH

Calculation Summary							
Label	CalcType	Units	Avg	Max	Min	Avg/Min	Max/Min
RM 204B Workplane	Illuminance	Fc	51.74	64.6	38.6	1.34	1.67
RM 313A Workplane	Illuminance	Fc	52.25	65.5	37.6	1.39	1.74

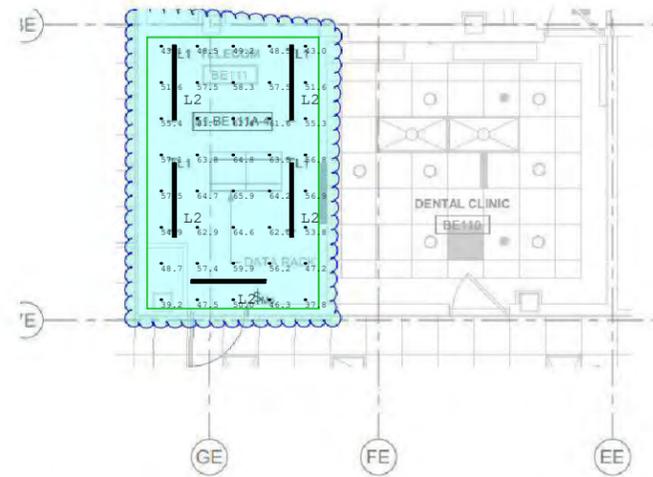
7 RM BE110 & BE111 - LIGHTING PLAN  
1/4" = 1'-0"

Calculation Summary							
Label	CalcType	Units	Avg	Max	Min	Avg/Min	Max/Min
RM 1A102 Workplane	Illuminance	Fc	54.72	64.6	43.0	1.27	1.50
RM 1A139 Workplane	Illuminance	Fc	51.38	60.3	37.8	1.36	1.60
RM 1A183 Workplane	Illuminance	Fc	59.40	70.7	34.7	1.71	2.04
RM BE111 Workplane	Illuminance	Fc	55.23	65.9	37.8	1.46	1.74

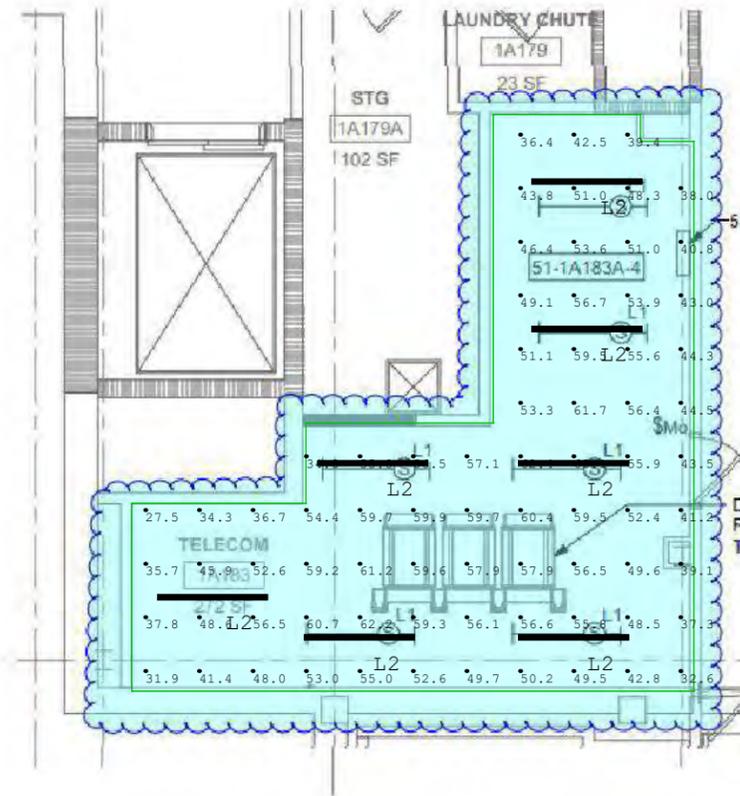
**RM 1A183 - LIGHTING PLAN**  
 1/4" = 1'-0"

Calculation Summary							
Label	CalcType	Units	Avg	Max	Min	Avg/Min	Max/Min
RM 1A102 Workplane	Illuminance	Fc	56.08	68.1	41.5	1.35	1.64
RM 1A183 Workplane	Illuminance	Fc	50.07	63.1	27.5	1.82	2.29
RM BE111 Workplane	Illuminance	Fc	54.72	65.0	35.8	1.53	1.82

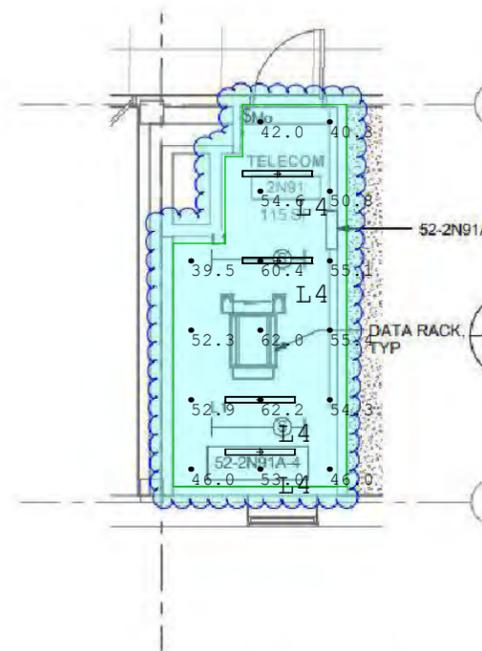
RM 2N91 - LIGHTING PLAN  
1/4" = 1'-0"

Calculation Summary								
Label	CalcType	Units	Avg	Max	Min	Avg/Min	Max/Min	
RM 1S33 Workplane	Illuminance	Fc	50.24	61.3	34.3	1.46	1.79	
RM 2N86B Workplane	Illuminance	Fc	57.43	69.8	17.0	3.38	4.11	
RM 2N91 Workplane	Illuminance	Fc	51.68	62.2	39.5	1.31	1.57

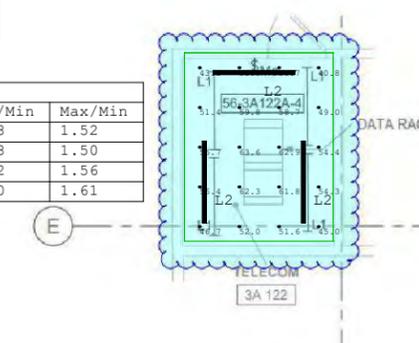
RM 3A122 - LIGHTING PLAN

Calculation Summary							
Label	CalcType	Units	Avg	Max	Min	Avg/Min	Max/Min
RM 1A109_Workplane	Illuminance	Fc	53.21	63.1	41.6	1.28	1.52
RM 2A122_Workplane	Illuminance	Fc	53.53	62.7	41.9	1.28	1.50
RM 3A122_Workplane	Illuminance	Fc	53.66	63.6	40.8	1.32	1.56
RM BA105_Workplane	Illuminance	Fc	50.84	58.3	36.3	1.40	1.61

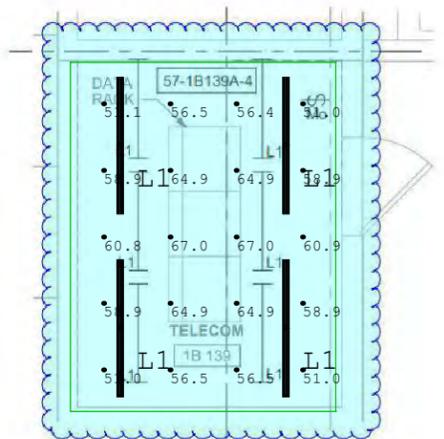
**RM 1B139 - LIGHTING PLAN**  
 3/8" = 1'-0"  
 PROJECT NORTH

Calculation Summary							
Label	CalcType	Units	Avg	Max	Min	Avg/Min	Max/Min
RM 1B120_Workplane	Illuminance	Fc	59.95	69.4	50.0	1.20	1.39
RM 1B139_Workplane	Illuminance	Fc	59.05	67.0	51.0	1.16	1.31
