# CURE Cycle 6

## Final Report

### Road Inventory and Condition Assessment of Paved Routes Curecanti National Recreation Area

Federal Highway Administration  
Eastern Federal Lands Highway Division  
Road Inventory Program (RIP)

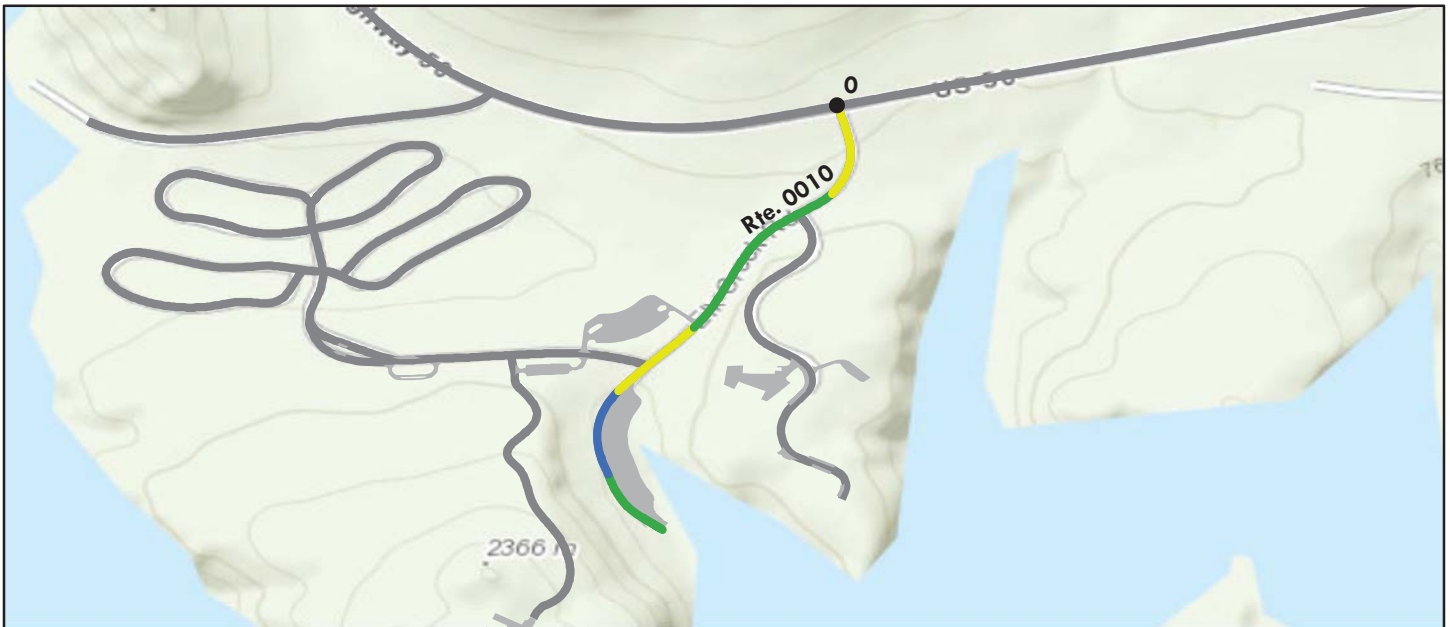
## ROUTE 0010: ELK CREEK ENTRANCE ROAD

### Data Collection Vehicle (DCV) Rating

Route Condition Legend – Pavement Condition Rating (PCR)									
Poor (0 - 60)		Fair (61- 84)		Good (85 - 94)		Excellent (95 - 100)		Not Rated	
See Appendix for definitions and formulas									
Inspection Date: 5/14/2015		Beginning Section MP	0						
Paved Length (Miles): 0.58		Section Length (MI)	0.58						
Surface Type: ASPHALT		Route Summary							
Roadway Condition Information									
Pavement Condition Rating (PCR)		88	88						
Surface Condition Rating (SCR)		94	94						
Roughness Condition Index (RCI)		79	79						
Distress Index Values									
Structural Crack Index		98	98						
Alligator Crack Index		100	100						
Longitudinal Crack Index		98	98						
Transverse Cracking Index		94	94						
Patching Index		100	100						
Rutting Index		99	99						
International Roughness Index (IRI)		171	171						
Lane & Width Information									
Number of Lanes		2	2						
Paved Width (ft)		20.8	20.8						
Lane Width (ft)		9.2	9.2

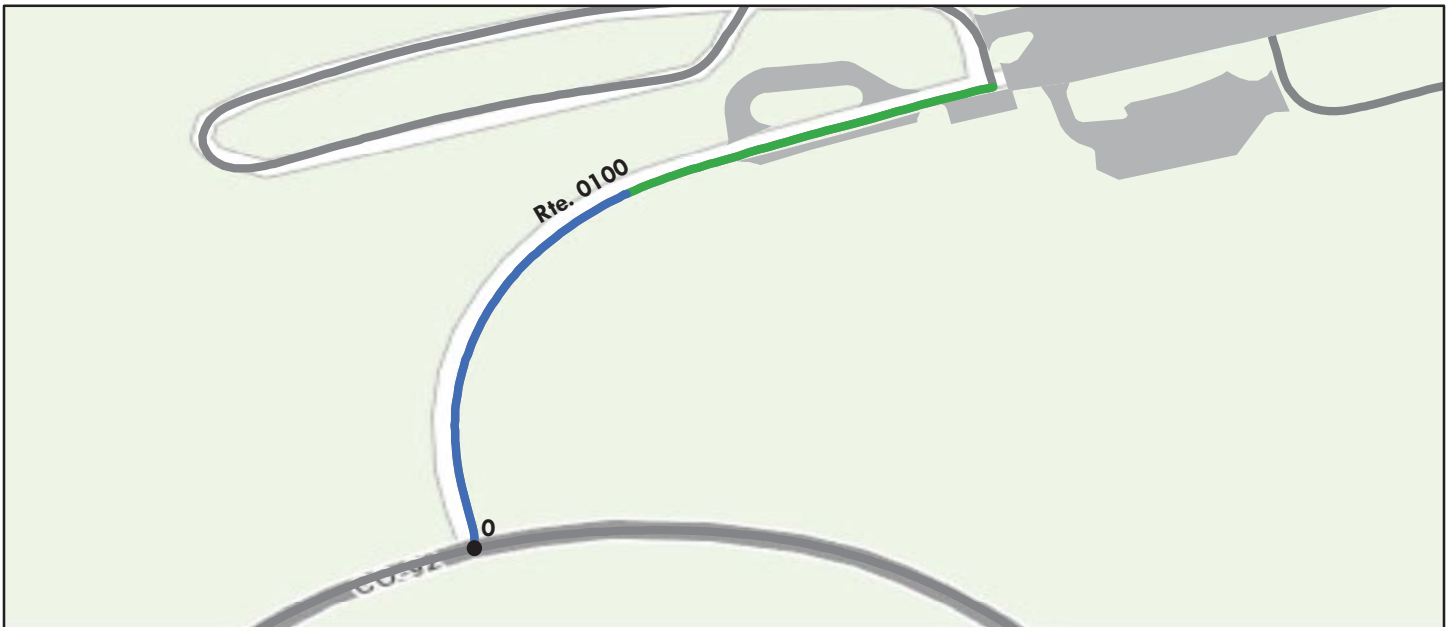
## ROUTE 0100: LAKE FORK CAMPGROUND ROAD

### Data Collection Vehicle (DCV) Rating

Route Condition Legend – Pavement Condition Rating (PCR)									
Poor (0 - 60)		Fair (61- 84)		Good (85 - 94)		Excellent (95 - 100)		Not Rated	
See Appendix for definitions and formulas									
Inspection Date: 5/14/2015		Beginning Section MP	0						
Paved Length (Miles): 0.18		Section Length (MI)	0.17						
Surface Type: ASPHALT		Route Summary							
Roadway Condition Information									
Pavement Condition Rating (PCR)		93	93						
Surface Condition Rating (SCR)		93	93						
Roughness Condition Index (RCI)		N/A	N/A						
Distress Index Values									
Structural Crack Index		96	96						
Alligator Crack Index		100	100						
Longitudinal Crack Index		96	96						
Transverse Cracking Index		93	93						
Patching Index		100	100						
Rutting Index		98	98						
International Roughness Index (IRI)		N/A	N/A						
Lane & Width Information									
Number of Lanes		2	2						
Paved Width (ft)		23.7	23.7						
Lane Width (ft)		10.2	10.2

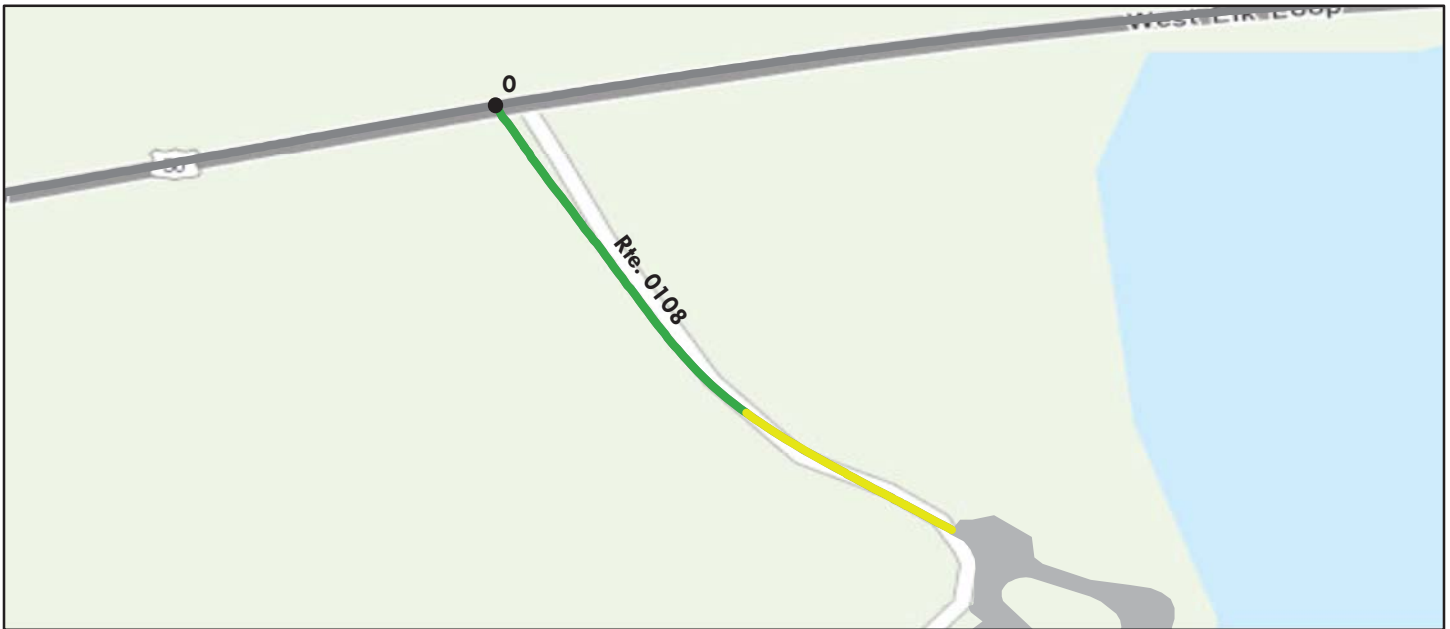
## ROUTE 0108: DRY CREEK ROAD

### Data Collection Vehicle (DCV) Rating

Route Condition Legend – Pavement Condition Rating (PCR)									
Poor (0 - 60)		Fair (61- 84)		Good (85 - 94)		Excellent (95 - 100)		Not Rated	
See Appendix for definitions and formulas									
Inspection Date: 5/14/2015		Beginning Section MP	0						
Paved Length (Miles): 0.16		Section Length (MI)	0.16						
Surface Type: ASPHALT		Route Summary							
Roadway Condition Information									
Pavement Condition Rating (PCR)		86	86						
Surface Condition Rating (SCR)		86	86						
Roughness Condition Index (RCI)		N/A	N/A						
Distress Index Values									
Structural Crack Index		93	93						
Alligator Crack Index		100	100						
Longitudinal Crack Index		93	93						
Transverse Cracking Index		86	86						
Patching Index		100	100						
Rutting Index		94	94						
International Roughness Index (IRI)		N/A	N/A						
Lane & Width Information									
Number of Lanes		2	2						
Paved Width (ft)		25.8	25.8						
Lane Width (ft)		13.7	13.7

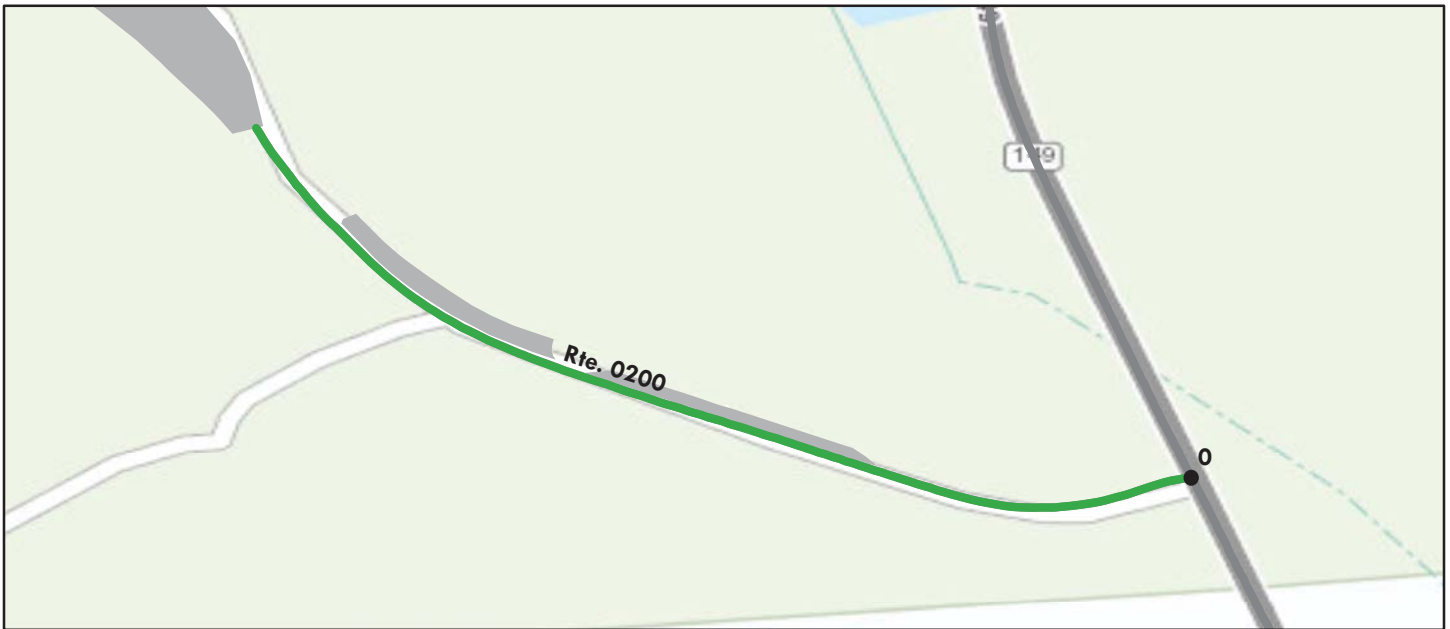
## ROUTE 0200: IOLA ROAD

### Data Collection Vehicle (DCV) Rating

Route Condition Legend – Pavement Condition Rating (PCR)						
Poor (0 - 60)	Fair (61- 84)	Good (85 - 94)	Excellent (95 - 100)	Not Rated		
See Appendix for definitions and formulas						
Inspection Date: 5/14/2015	Beginning Section MP	0				
Paved Length (Miles): 0.22	Section Length (MI)	0.22				
Surface Type: ASPHALT	Route Summary					
Roadway Condition Information						
Pavement Condition Rating (PCR)	89	89				
Surface Condition Rating (SCR)	89	89				
Roughness Condition Index (RCI)	N/A	N/A				
Distress Index Values						
Structural Crack Index	96	96				
Alligator Crack Index	100	100				
Longitudinal Crack Index	96	96				
Transverse Cracking Index	89	89				
Patching Index	100	100				
Rutting Index	99	99				
International Roughness Index (IRI)	N/A	N/A				
Lane & Width Information						
Number of Lanes	2	2				
Paved Width (ft)	21.2	21.2				
Lane Width (ft)	9.3	9.3

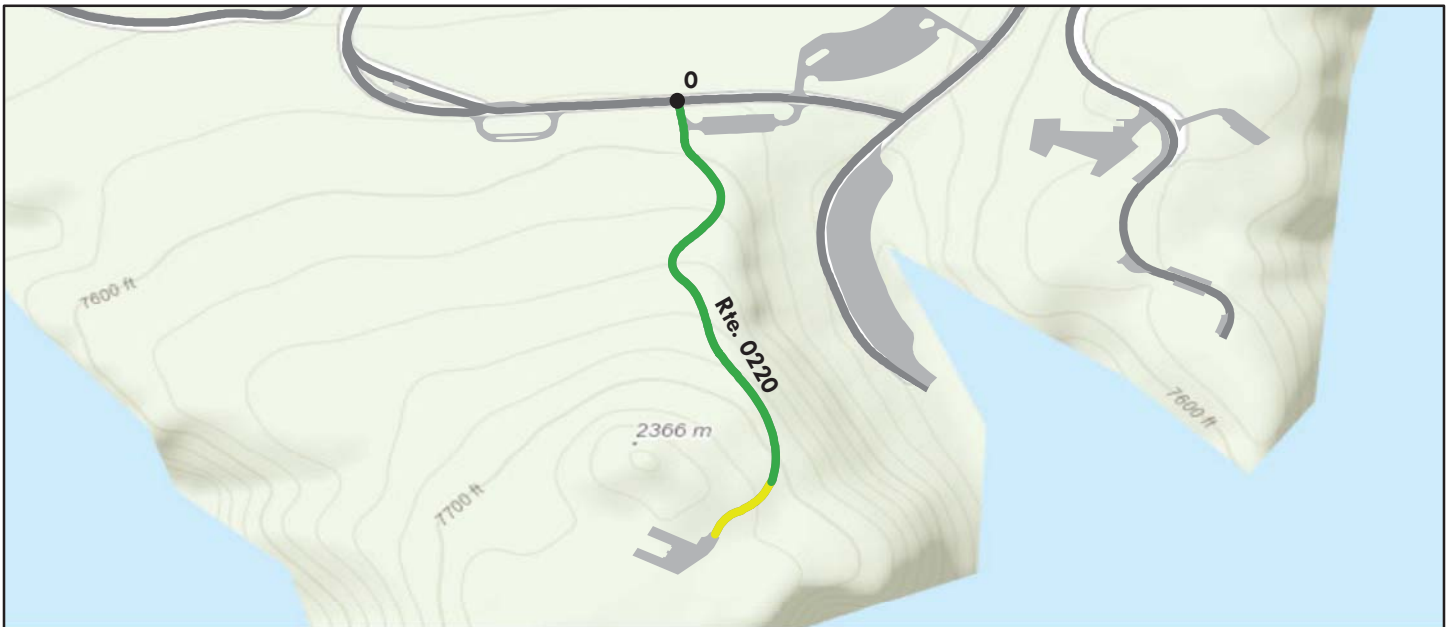
## ROUTE 0220: ELK CREEK SERVICE ROAD

### Data Collection Vehicle (DCV) Rating

Route Condition Legend – Pavement Condition Rating (PCR)									
Poor (0 - 60)		Fair (61- 84)		Good (85 - 94)		Excellent (95 - 100)		Not Rated	
See Appendix for definitions and formulas									
Inspection Date: 5/14/2015		Beginning Section MP	0						
Paved Length (Miles): 0.34		Section Length (MI)	0.34						
Surface Type: ASPHALT		Route Summary							
Roadway Condition Information									
Pavement Condition Rating (PCR)		88	88						
Surface Condition Rating (SCR)		88	88						
Roughness Condition Index (RCI)		N/A	N/A						
Distress Index Values									
Structural Crack Index		99	99						
Alligator Crack Index		100	100						
Longitudinal Crack Index		99	99						
Transverse Cracking Index		88	88						
Patching Index		100	100						
Rutting Index		95	95						
International Roughness Index (IRI)		N/A	N/A						
Lane & Width Information									
Number of Lanes		2	2						
Paved Width (ft)		17	17						
Lane Width (ft)		8.5	8.5

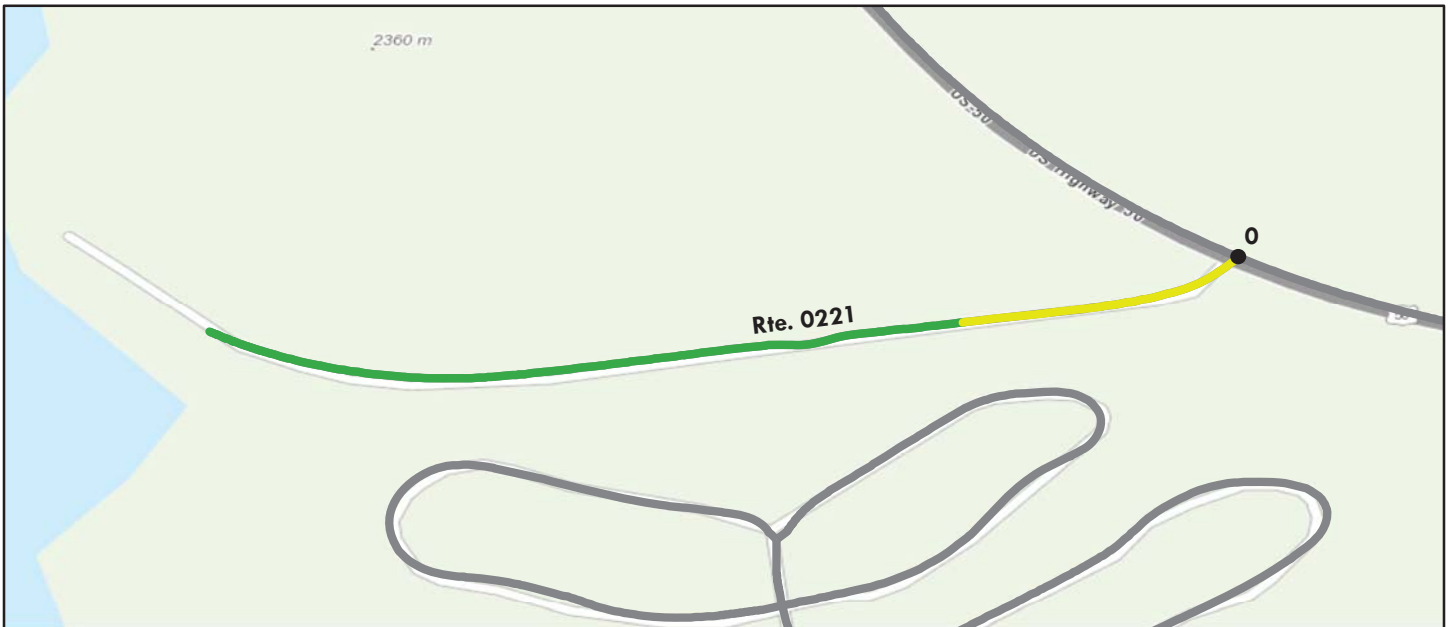
## ROUTE 0221: OLD US HIGHWAY 50

### Data Collection Vehicle (DCV) Rating

Route Condition Legend – Pavement Condition Rating (PCR)						
Poor (0 - 60)	Fair (61- 84)	Good (85 - 94)	Excellent (95 - 100)	Not Rated		
See Appendix for definitions and formulas						
Inspection Date: 5/14/2015	Beginning Section MP	0				
Paved Length (Miles): 0.37	Section Length (MI)	0.37				
Surface Type: ASPHALT	Route Summary					
Roadway Condition Information						
Pavement Condition Rating (PCR)	91	91				
Surface Condition Rating (SCR)	91	91				
Roughness Condition Index (RCI)	N/A	N/A				
Distress Index Values						
Structural Crack Index	96	96				
Alligator Crack Index	99	99				
Longitudinal Crack Index	97	97				
Transverse Cracking Index	92	92				
Patching Index	100	100				
Rutting Index	91	91				
International Roughness Index (IRI)	N/A	N/A				
Lane & Width Information						
Number of Lanes	2	2				
Paved Width (ft)	23	23				
Lane Width (ft)	11.6	11.6

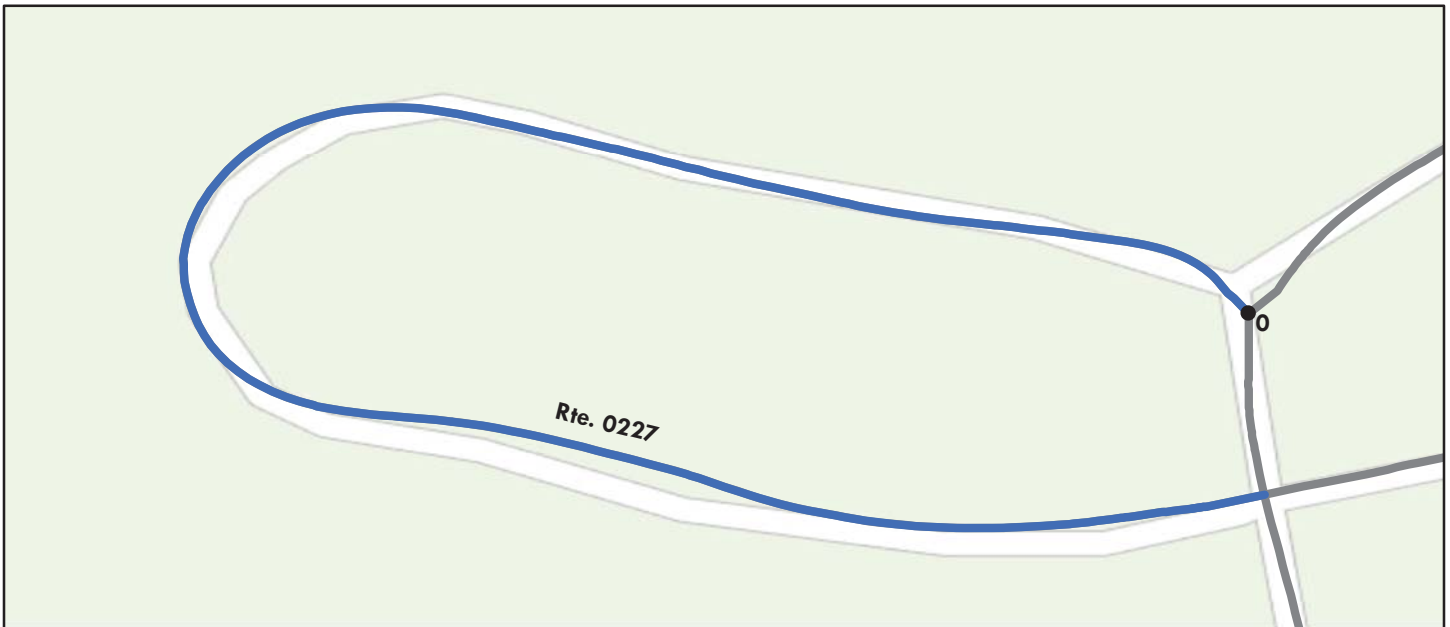
## ROUTE 0227: ELK CREEK CAMPGROUND LOOP B

### Data Collection Vehicle (DCV) Rating

Route Condition Legend – Pavement Condition Rating (PCR)									
Poor (0 - 60)		Fair (61- 84)		Good (85 - 94)		Excellent (95 - 100)		Not Rated	
See Appendix for definitions and formulas									
Inspection Date: 5/14/2015		Beginning Section MP	0						
Paved Length (Miles): 0.31		Section Length (MI)	0.31						
Surface Type: ASPHALT		Route Summary							
Roadway Condition Information									
Pavement Condition Rating (PCR)		97	97						
Surface Condition Rating (SCR)		97	97						
Roughness Condition Index (RCI)		N/A	N/A						
Distress Index Values									
Structural Crack Index		99	99						
Alligator Crack Index		100	100						
Longitudinal Crack Index		99	99						
Transverse Cracking Index		97	97						
Patching Index		100	100						
Rutting Index		99	99						
International Roughness Index (IRI)		N/A	N/A						
Lane & Width Information									
Number of Lanes		1	1						
Paved Width (ft)		13.2	13.2						
Lane Width (ft)		13.2	13.2

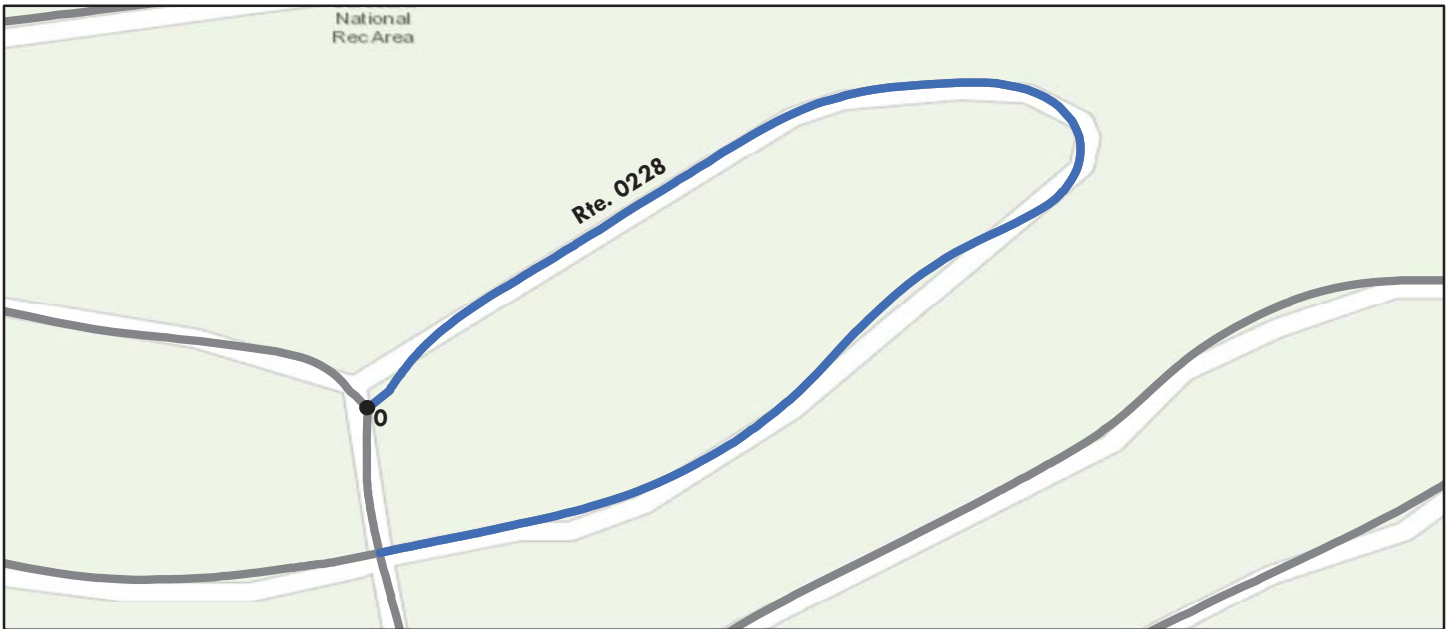
## ROUTE 0228: ELK CREEK CAMPGROUND LOOP C

### Data Collection Vehicle (DCV) Rating

Route Condition Legend – Pavement Condition Rating (PCR)						
Poor (0 - 60)	Fair (61- 84)	Good (85 - 94)	Excellent (95 - 100)	Not Rated		
See Appendix for definitions and formulas						
Inspection Date: 5/14/2015	Beginning Section MP	0				
Paved Length (Miles): 0.29	Section Length (MI)	0.29				
Surface Type: ASPHALT	Route Summary					
Roadway Condition Information						
Pavement Condition Rating (PCR)	98	98				
Surface Condition Rating (SCR)	98	98				
Roughness Condition Index (RCI)	N/A	N/A				
Distress Index Values						
Structural Crack Index	98	98				
Alligator Crack Index	100	100				
Longitudinal Crack Index	98	98				
Transverse Cracking Index	98	98				
Patching Index	100	100				
Rutting Index	98	98				
International Roughness Index (IRI)	N/A	N/A				
Lane & Width Information						
Number of Lanes	1	1				
Paved Width (ft)	14	14				
Lane Width (ft)	14	14

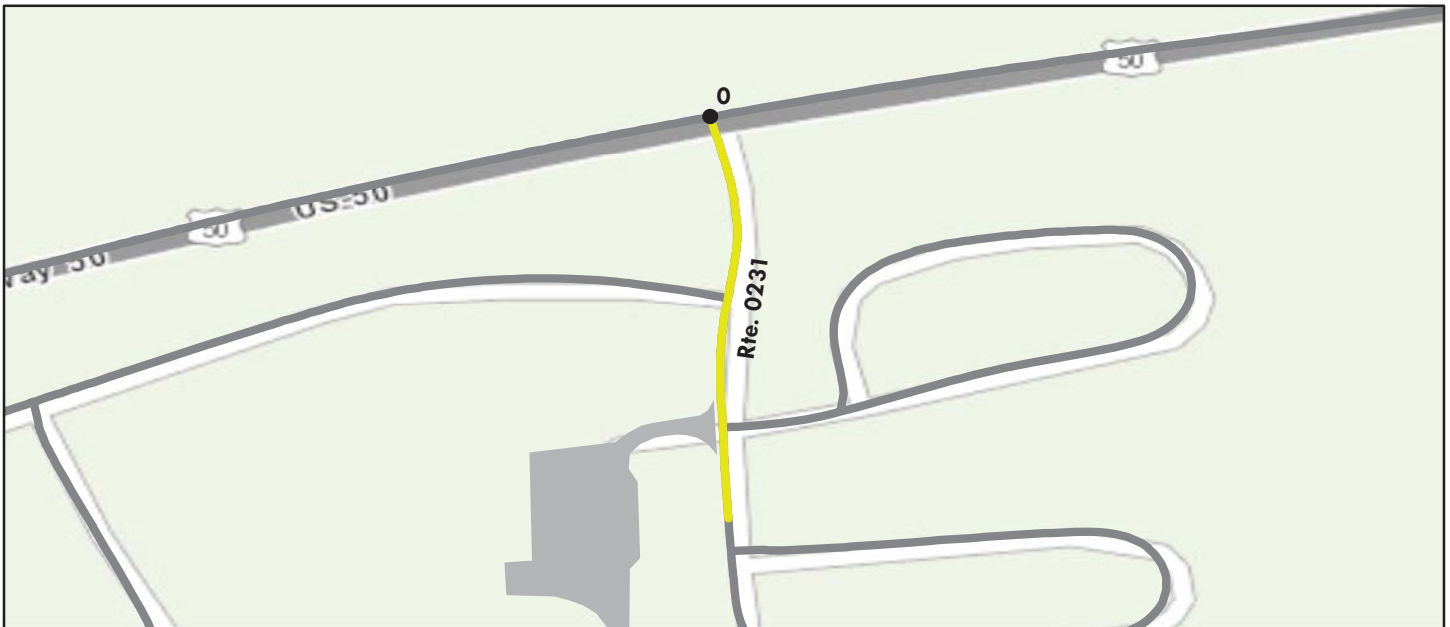
## ROUTE 0231: NEW STEVENS CREEK CAMPGROUND ROAD

### Data Collection Vehicle (DCV) Rating

Route Condition Legend – Pavement Condition Rating (PCR)						
Poor (0 - 60)	Fair (61- 84)	Good (85 - 94)	Excellent (95 - 100)	Not Rated		
See Appendix for definitions and formulas						
Inspection Date: 5/14/2015	Beginning Section MP	0				
Paved Length (Miles): 0.1	Section Length (MI)	0.1				
Surface Type: ASPHALT	Route Summary					
Roadway Condition Information						
Pavement Condition Rating (PCR)	69	69				
Surface Condition Rating (SCR)	69	69				
Roughness Condition Index (RCI)	N/A	N/A				
Distress Index Values						
Structural Crack Index	90	90				
Alligator Crack Index	100	100				
Longitudinal Crack Index	90	90				
Transverse Cracking Index	69	69				
Patching Index	100	100				
Rutting Index	98	98				
International Roughness Index (IRI)	N/A	N/A				
Lane & Width Information						
Number of Lanes	2	2				
Paved Width (ft)	22.5	22.5				
Lane Width (ft)	11.6	11.6

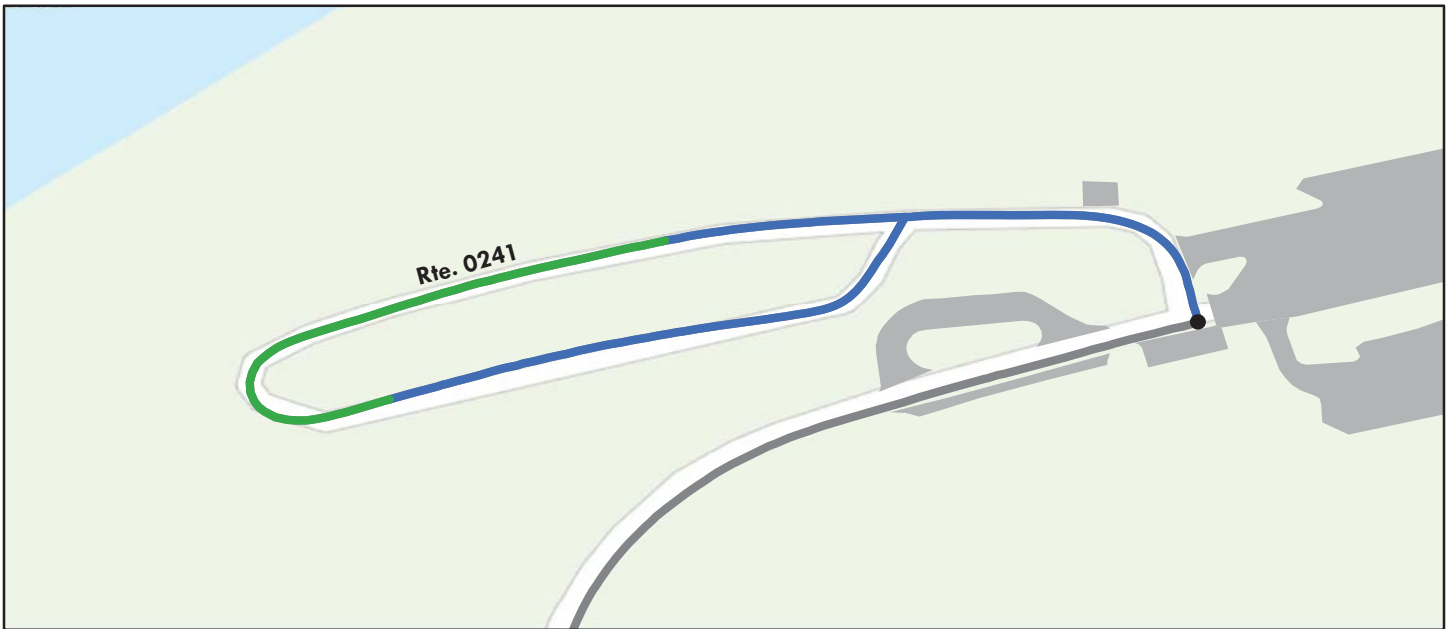
## ROUTE 0241: LAKE FORK UPPER CAMPGROUND LOOP

### Data Collection Vehicle (DCV) Rating

Route Condition Legend – Pavement Condition Rating (PCR)									
Poor (0 - 60)		Fair (61- 84)		Good (85 - 94)		Excellent (95 - 100)		Not Rated	
See Appendix for definitions and formulas									
Inspection Date: 5/14/2015		Beginning Section MP	0						
Paved Length (Miles): 0.29		Section Length (MI)	0.29						
Surface Type: ASPHALT		Route Summary							
Roadway Condition Information									
Pavement Condition Rating (PCR)		93	93						
Surface Condition Rating (SCR)		93	93						
Roughness Condition Index (RCI)		N/A	N/A						
Distress Index Values									
Structural Crack Index		93	93						
Alligator Crack Index		100	100						
Longitudinal Crack Index		93	93						
Transverse Cracking Index		97	97						
Patching Index		100	100						
Rutting Index		95	95						
International Roughness Index (IRI)		N/A	N/A						
Lane & Width Information									
Number of Lanes		2	2						
Paved Width (ft)		32.2	32.2						
Lane Width (ft)		14	14

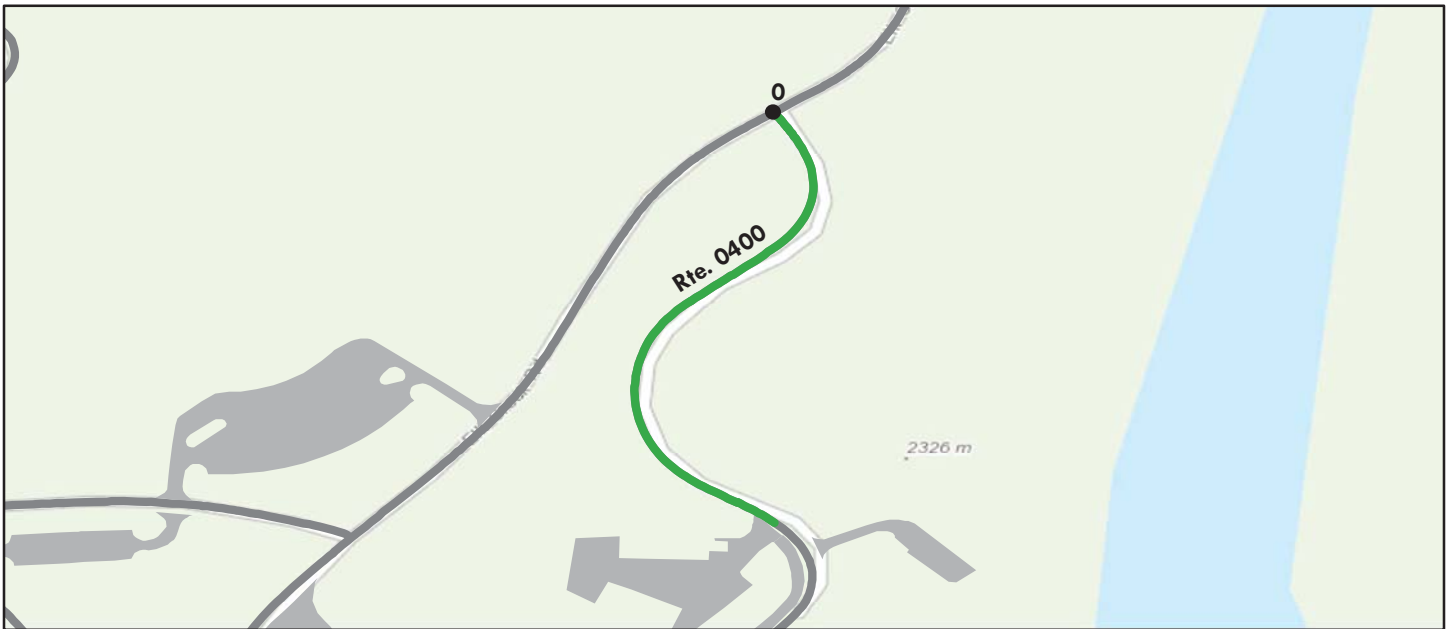
## ROUTE 0400: ELK CREEK MAINTENANCE ROAD

### Data Collection Vehicle (DCV) Rating

Route Condition Legend – Pavement Condition Rating (PCR)									
Poor (0 - 60)		Fair (61- 84)		Good (85 - 94)		Excellent (95 - 100)		Not Rated	
See Appendix for definitions and formulas									
Inspection Date: 5/14/2015		Beginning Section MP	0						
Paved Length (Miles): 0.22		Section Length (MI)	0.22						
Surface Type: ASPHALT		Route Summary							
Roadway Condition Information									
Pavement Condition Rating (PCR)		88	88						
Surface Condition Rating (SCR)		88	88						
Roughness Condition Index (RCI)		N/A	N/A						
Distress Index Values									
Structural Crack Index		95	95						
Alligator Crack Index		100	100						
Longitudinal Crack Index		95	95						
Transverse Cracking Index		88	88						
Patching Index		100	100						
Rutting Index		97	97						
International Roughness Index (IRI)		N/A	N/A						
Lane & Width Information									
Number of Lanes		2	2						
Paved Width (ft)		22.3	22.3						
Lane Width (ft)		9.8	9.8

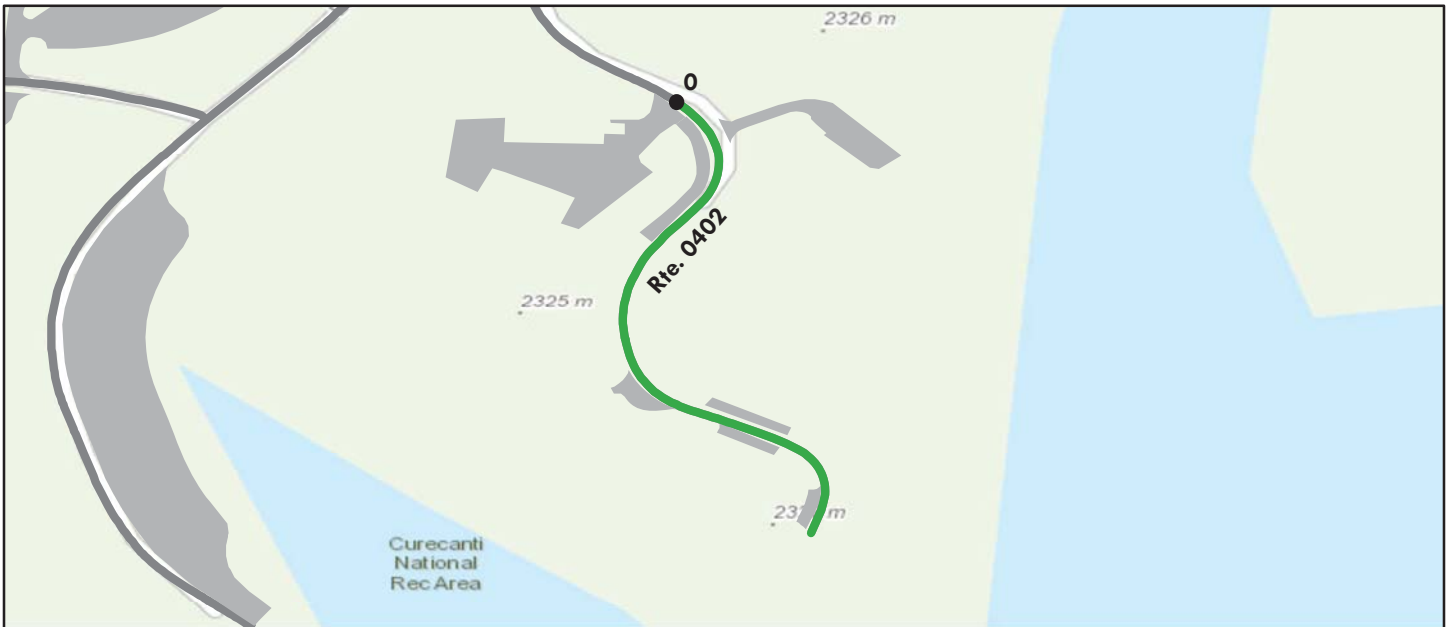
## ROUTE 0402: ELK CREEK RESIDENCE ROAD

### Data Collection Vehicle (DCV) Rating

Route Condition Legend – Pavement Condition Rating (PCR)									
Poor (0 - 60)		Fair (61- 84)		Good (85 - 94)		Excellent (95 - 100)		Not Rated	
See Appendix for definitions and formulas									
Inspection Date: 5/14/2015		Beginning Section MP		0					
Paved Length (Miles): 0.19		Section Length (MI)		0.19					
Surface Type: ASPHALT		Route Summary							
Roadway Condition Information									
Pavement Condition Rating (PCR)		85		85					
Surface Condition Rating (SCR)		85		85					
Roughness Condition Index (RCI)		N/A		N/A					
Distress Index Values									
Structural Crack Index		88		88					
Alligator Crack Index		100		100					
Longitudinal Crack Index		88		88					
Transverse Cracking Index		85		85					
Patching Index		100		100					
Rutting Index		95		95					
International Roughness Index (IRI)		N/A		N/A					
Lane & Width Information									
Number of Lanes		2		2					
Paved Width (ft)		19.8		19.8					
Lane Width (ft)		9.2		9.2

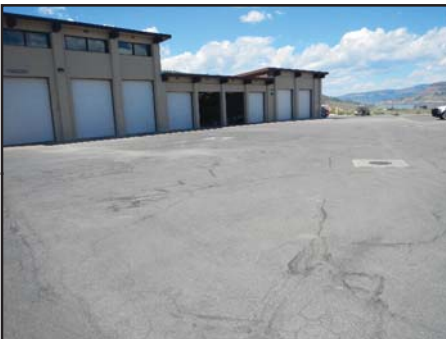
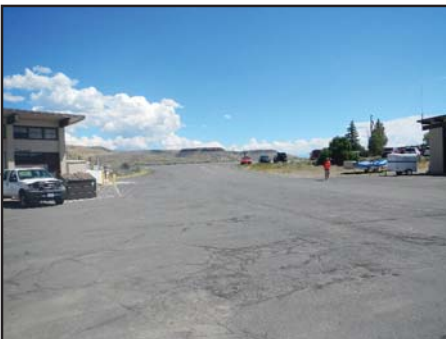
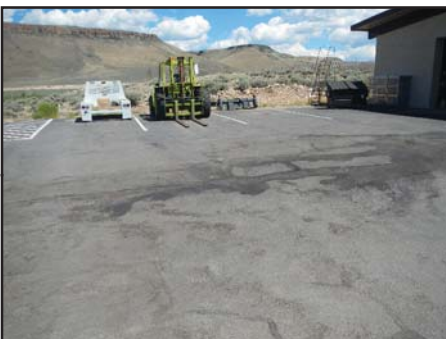
Inspection Date	FMSS Number	User Access	Surface Type	
8/7/2014	90853	NONPUBLIC	ASPHALT	
Area (Sq. Ft.)	Lane Miles (11' Widths)	Curb Reveal (Inches)	Curb Recommendation	
37,611	0.648	NOT APPLICABLE	NOT APPLICABLE	
Curb Type		Curb & Gutter Type		
NO CURB		NO CURB AND GUTTER		
Pavement Recommendation		Condition Rating / PCR		
HEAVY 3R TREATMENTS		POOR / 53		
Route Condition Legend – Pavement Condition Rating (PCR)				
Poor (0 - 60)	Fair (61- 84)	Good (85 - 94)	Excellent (95 - 100)	Not Rated
See Appendix for definitions and formulas

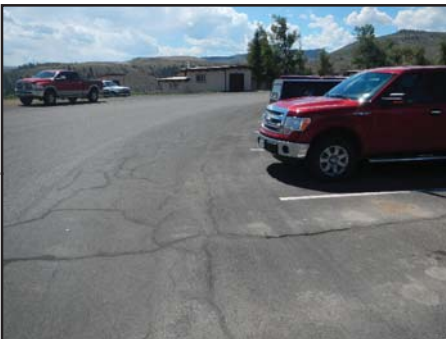
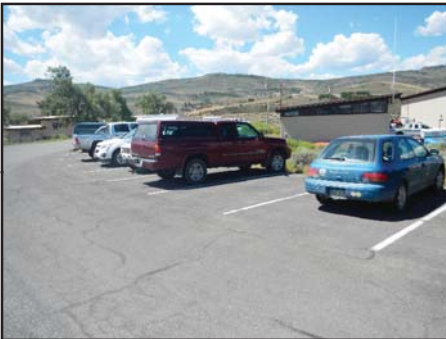
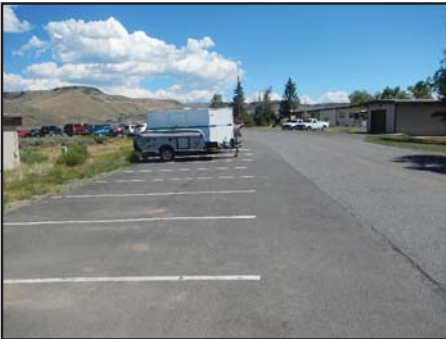
## ROUTE 0901: EMPLOYEE PARKING

Inspection Date	FMSS Number	User Access	Surface Type	
8/7/2014	90854	NONPUBLIC	ASPHALT	
Area (Sq. Ft.)	Lane Miles (11' Widths)	Curb Reveal (Inches)	Curb Recommendation	
5,750	0.099	NOT APPLICABLE	NOT APPLICABLE	
Curb Type		Curb & Gutter Type		
NO CURB		NO CURB AND GUTTER		
Pavement Recommendation		Condition Rating / PCR		
LIGHT 3R TREATMENTS		FAIR / 73		
Route Condition Legend – Pavement Condition Rating (PCR)				
Poor (0 - 60)	Fair (61- 84)	Good (85 - 94)	Excellent (95 - 100)	Not Rated
See Appendix for definitions and formulas

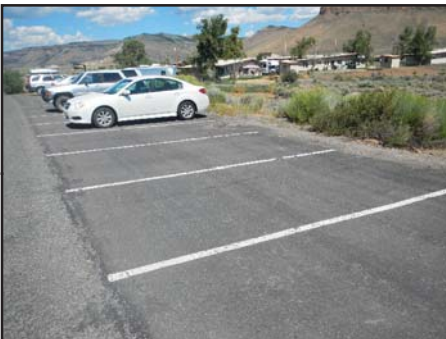
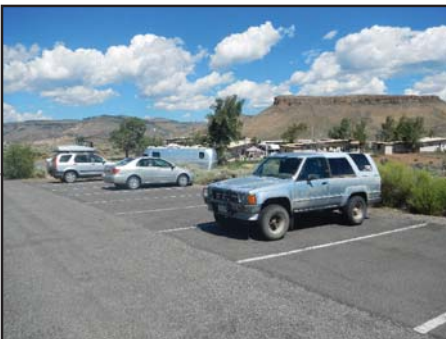
## ROUTE 0902A: EC6 PARKING

Inspection Date	FMSS Number	User Access	Surface Type	
8/7/2014	103038	NONPUBLIC	ASPHALT	
Area (Sq. Ft.)	Lane Miles (11' Widths)	Curb Reveal (Inches)	Curb Recommendation	
2,415	0.042	NOT APPLICABLE	NOT APPLICABLE	
Curb Type		Curb & Gutter Type		
NO CURB		NO CURB AND GUTTER		
Pavement Recommendation		Condition Rating / PCR		
HEAVY 3R TREATMENTS		POOR / 53		
Route Condition Legend – Pavement Condition Rating (PCR)				
Poor (0 - 60)	Fair (61- 84)	Good (85 - 94)	Excellent (95 - 100)	Not Rated
See Appendix for definitions and formulas

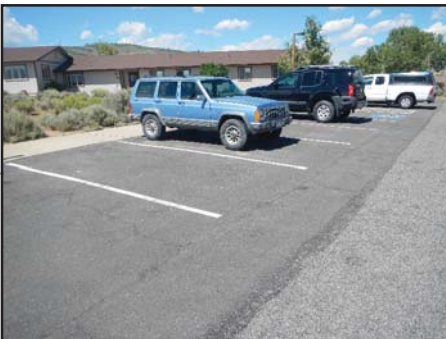
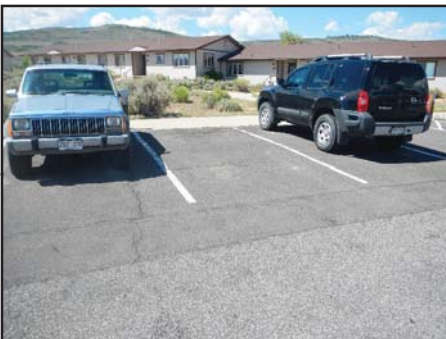
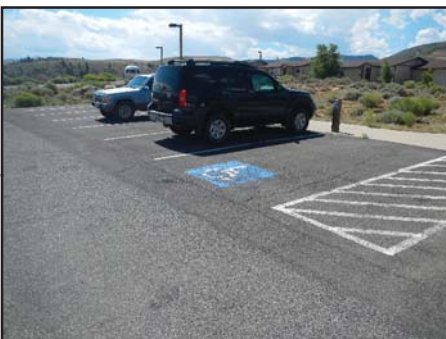
## ROUTE 0902B: EC7 PARKING

Inspection Date	FMSS Number	User Access	Surface Type	
8/7/2014	103036	NONPUBLIC	ASPHALT	
Area (Sq. Ft.)	Lane Miles (11' Widths)	Curb Reveal (Inches)	Curb Recommendation	
1,828	0.031	NOT APPLICABLE	NOT APPLICABLE	
Curb Type		Curb & Gutter Type		
NO CURB		NO CURB AND GUTTER		
Pavement Recommendation		Condition Rating / PCR		
HEAVY 3R TREATMENTS		POOR / 53		
Route Condition Legend – Pavement Condition Rating (PCR)				
Poor (0 - 60)	Fair (61- 84)	Good (85 - 94)	Excellent (95 - 100)	Not Rated
See Appendix for definitions and formulas

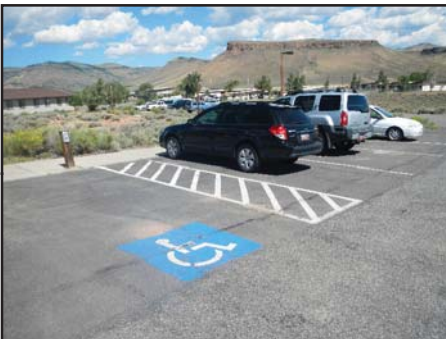
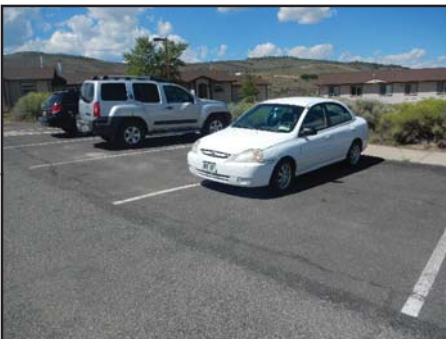
## ROUTE 0902C: EC5 PARKING

Inspection Date	FMSS Number	User Access	Surface Type	
8/7/2014	103037	NONPUBLIC	ASPHALT	
Area (Sq. Ft.)	Lane Miles (11' Widths)	Curb Reveal (Inches)	Curb Recommendation	
1,456	0.025	NOT APPLICABLE	NOT APPLICABLE	
Curb Type		Curb & Gutter Type		
NO CURB		NO CURB AND GUTTER		
Pavement Recommendation		Condition Rating / PCR		
HEAVY 3R TREATMENTS		POOR / 53		
Route Condition Legend – Pavement Condition Rating (PCR)				
Poor (0 - 60)	Fair (61- 84)	Good (85 - 94)	Excellent (95 - 100)	Not Rated
See Appendix for definitions and formulas

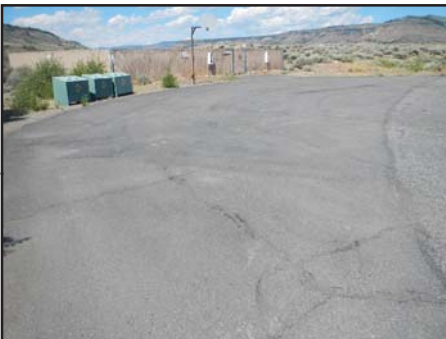
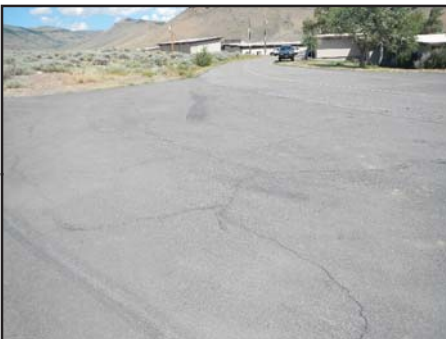
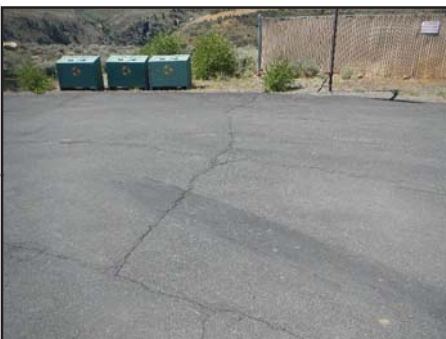
## ROUTE 0902D: SERVICE PARKING

Inspection Date	FMSS Number	User Access	Surface Type
8/7/2014	90855	NONPUBLIC	ASPHALT
Area (Sq. Ft.)	Lane Miles (11' Widths)	Curb Reveal (Inches)	Curb Recommendation
2,780	0.048	NOT APPLICABLE	NOT APPLICABLE
Curb Type		Curb & Gutter Type	
NO CURB		NO CURB AND GUTTER	
Pavement Recommendation		Condition Rating / PCR	
HEAVY 3R TREATMENTS		POOR / 53	
<b>Route Condition Legend – Pavement Condition Rating (PCR)</b>			
<b>Poor (0 - 60)</b>	<b>Fair (61- 84)</b>	<b>Good (85 - 94)</b>	<b>Excellent (95 - 100)</b>
<b>Not Rated</b>			
See Appendix for definitions and formulas

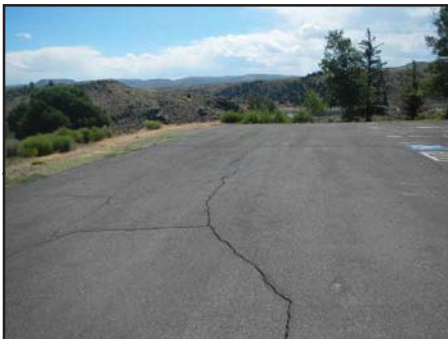
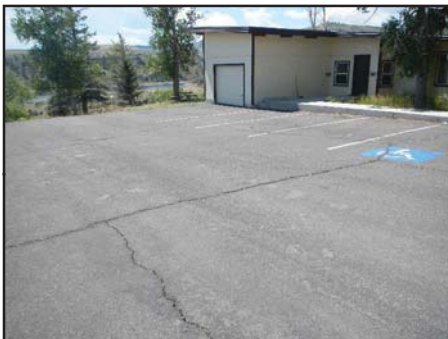
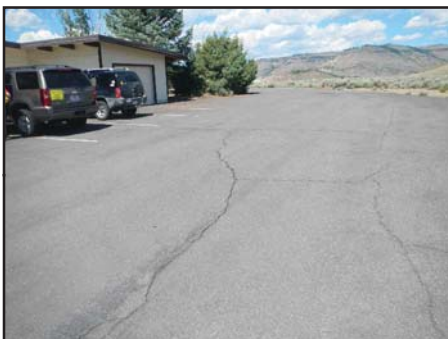
## ROUTE 0902E: EC1 PARKING

Inspection Date	FMSS Number	User Access	Surface Type	
8/7/2014	238302	NONPUBLIC	ASPHALT	
Area (Sq. Ft.)	Lane Miles (11' Widths)	Curb Reveal (Inches)	Curb Recommendation	
11,268	0.194	NOT APPLICABLE	NOT APPLICABLE	
Curb Type		Curb & Gutter Type		
NO CURB		NO CURB AND GUTTER		
Pavement Recommendation		Condition Rating / PCR		
PREVENTIVE MAINTENANCE		GOOD / 90		
Route Condition Legend – Pavement Condition Rating (PCR)				
Poor (0 - 60)	Fair (61- 84)	Good (85 - 94)	Excellent (95 - 100)	Not Rated
See Appendix for definitions and formulas

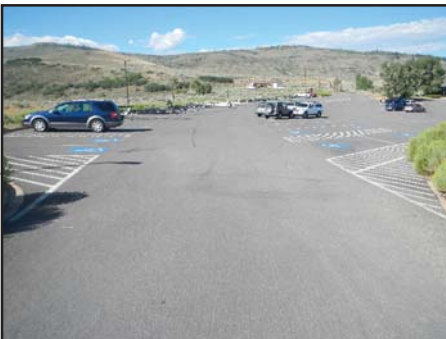
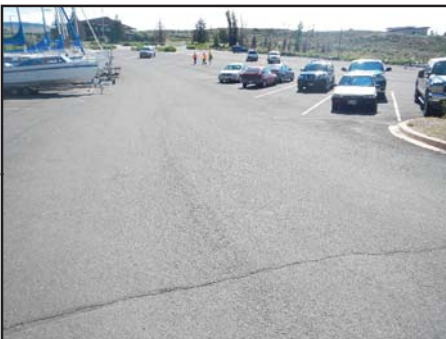
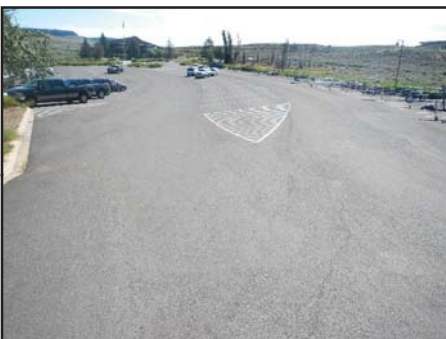
## ROUTE 0903: VISITOR CENTER PARKING

Inspection Date	FMSS Number	User Access	Surface Type	
8/7/2014	90856	PUBLIC	ASPHALT	
Area (Sq. Ft.)	Lane Miles (11' Widths)	Curb Reveal (Inches)	Curb Recommendation	
75,229	1.295	NOT APPLICABLE	LIGHT REPAIR	
Curb Type		Curb & Gutter Type		
NO CURB		CONCRETE		
Pavement Recommendation		Condition Rating / PCR		
PREVENTIVE MAINTENANCE		GOOD / 90		
Route Condition Legend – Pavement Condition Rating (PCR)				
Poor (0 - 60)	Fair (61- 84)	Good (85 - 94)	Excellent (95 - 100)	Not Rated
See Appendix for definitions and formulas

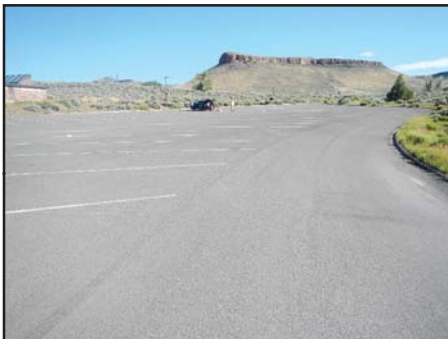
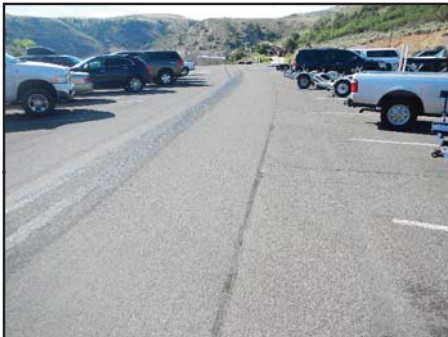
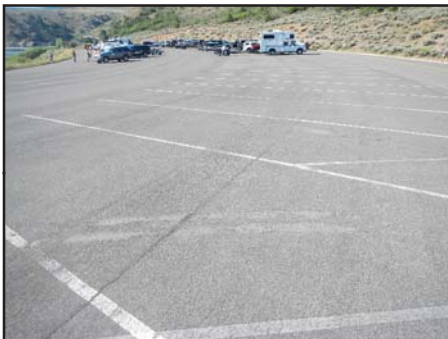
## ROUTE 0904: MARINA PARKING

Inspection Date	FMSS Number	User Access	Surface Type
8/7/2014	75233	PUBLIC	ASPHALT
Area (Sq. Ft.)	Lane Miles (11' Widths)	Curb Reveal (Inches)	Curb Recommendation
101,514	1.748	NOT APPLICABLE	DO NOTHING
Curb Type		Curb & Gutter Type	
NO CURB		CONCRETE	
Pavement Recommendation		Condition Rating / PCR	
PREVENTIVE MAINTENANCE		GOOD / 90	
<b>Route Condition Legend – Pavement Condition Rating (PCR)</b>			
<b>Poor (0 - 60)</b>	<b>Fair (61- 84)</b>	<b>Good (85 - 94)</b>	<b>Excellent (95 - 100)</b>
<b>Not Rated</b>			
See Appendix for definitions and formulas

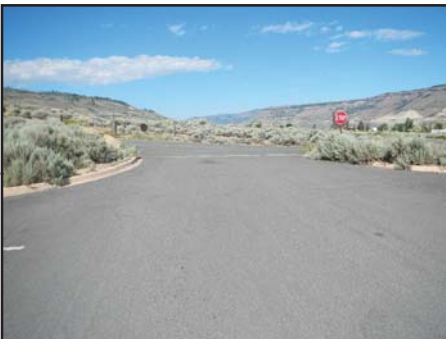
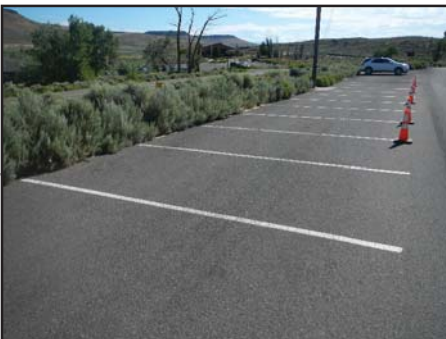
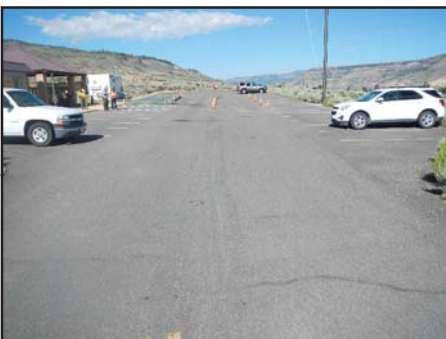
## ROUTE 0907: RV SEWER DUMP STATION

TO ROUTE 0207ZZ (ELK CREEK CAMPGROUND ROADS)

Inspection Date	FMSS Number	User Access	Surface Type	
8/7/2014	90859	PUBLIC	ASPHALT	
Area (Sq. Ft.)	Lane Miles (11' Widths)	Curb Reveal (Inches)	Curb Recommendation	
8,438	0.145	NOT APPLICABLE	DO NOTHING	
Curb Type		Curb & Gutter Type		
NO CURB		CONCRETE		
Pavement Recommendation		Condition Rating / PCR		
PREVENTIVE MAINTENANCE		GOOD / 90		
Route Condition Legend – Pavement Condition Rating (PCR)				
Poor (0 - 60)	Fair (61- 84)	Good (85 - 94)	Excellent (95 - 100)	Not Rated
See Appendix for definitions and formulas

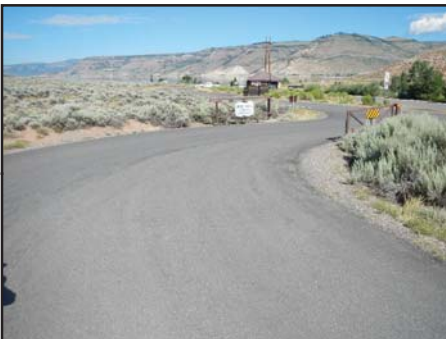
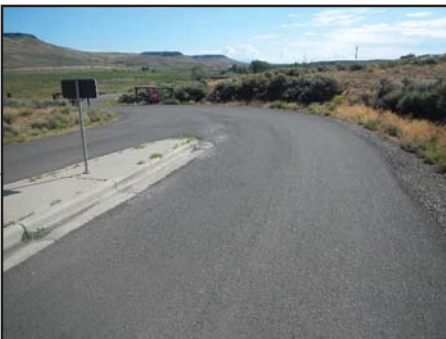
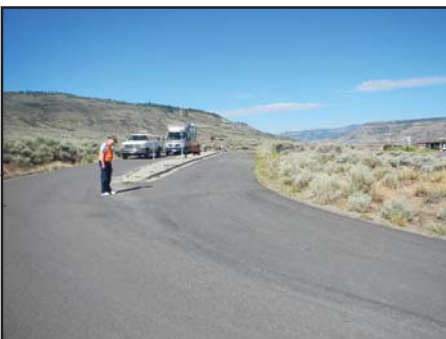
## ROUTE 0908: WASH STATION

Inspection Date	FMSS Number	User Access	Surface Type	
8/7/2014	90860	PUBLIC	ASPHALT	
Area (Sq. Ft.)	Lane Miles (11' Widths)	Curb Reveal (Inches)	Curb Recommendation	
2,067	0.036	NOT APPLICABLE	NOT APPLICABLE	
Curb Type		Curb & Gutter Type		
NO CURB		NO CURB AND GUTTER		
Pavement Recommendation		Condition Rating / PCR		
PREVENTIVE MAINTENANCE		GOOD / 90		
Route Condition Legend – Pavement Condition Rating (PCR)				
Poor (0 - 60)	Fair (61- 84)	Good (85 - 94)	Excellent (95 - 100)	Not Rated
See Appendix for definitions and formulas

Multiple Surface Types (Asphalt = 1138 Sf, Concrete = 929 Sf)

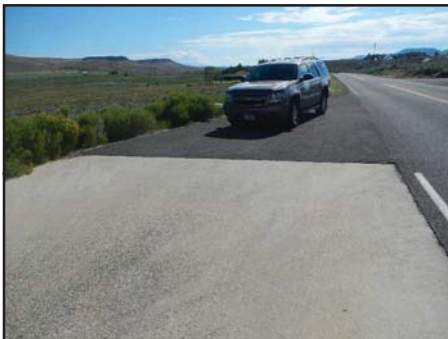
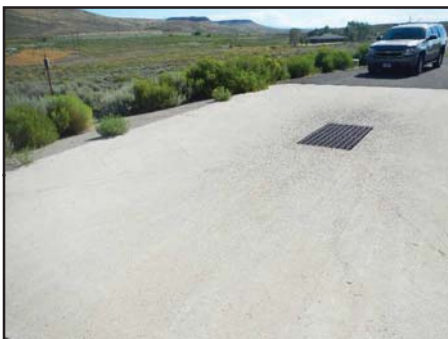
## ROUTE 0909A: KIOSK PARKING A

ADJACENT TO ROUTE 0207ZZ (ELK CREEK CAMPGROUND ROADS)

Inspection Date	FMSS Number	User Access	Surface Type	
8/7/2014	103034	NONPUBLIC	ASPHALT	
Area (Sq. Ft.)	Lane Miles (11' Widths)	Curb Reveal (Inches)	Curb Recommendation	
1,230	0.021	NOT APPLICABLE	DO NOTHING	
Curb Type		Curb & Gutter Type		
NO CURB		CONCRETE		
Pavement Recommendation		Condition Rating / PCR		
PREVENTIVE MAINTENANCE		GOOD / 90		
Route Condition Legend – Pavement Condition Rating (PCR)				
Poor (0 - 60)	Fair (61- 84)	Good (85 - 94)	Excellent (95 - 100)	Not Rated
See Appendix for definitions and formulas

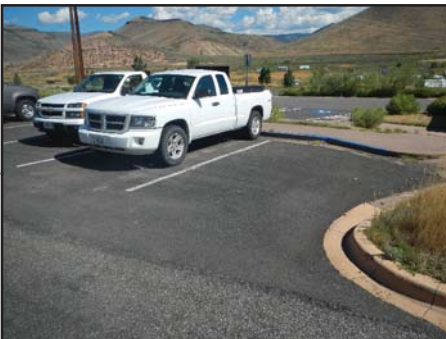
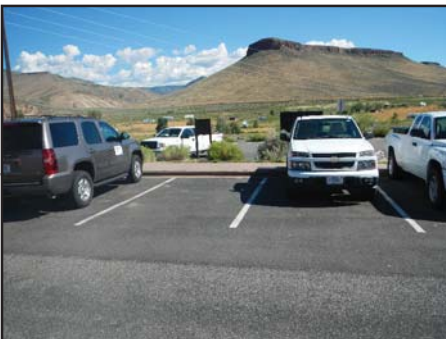
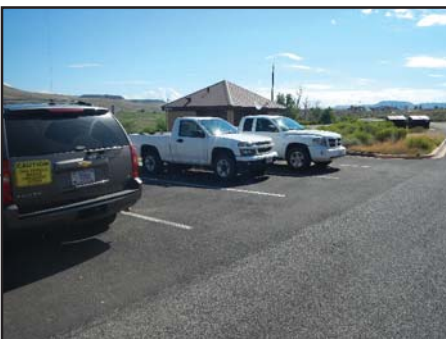
## ROUTE 0909B: KIOSK PARKING B

ADJACENT TO ROUTE 0207ZZ (ELK CREEK CAMPGROUND ROADS)

Inspection Date	FMSS Number	User Access	Surface Type
8/7/2014	90861	NONPUBLIC	ASPHALT
Area (Sq. Ft.)	Lane Miles (11' Widths)	Curb Reveal (Inches)	Curb Recommendation
833	0.014	NOT APPLICABLE	DO NOTHING
Curb Type		Curb & Gutter Type	
NO CURB		CONCRETE	
Pavement Recommendation		Condition Rating / PCR	
PREVENTIVE MAINTENANCE		GOOD / 90	
<b>Route Condition Legend – Pavement Condition Rating (PCR)</b>			
<b>Poor (0 - 60)</b>	<b>Fair (61- 84)</b>	<b>Good (85 - 94)</b>	<b>Excellent (95 - 100)</b>
<b>Not Rated</b>			
See Appendix for definitions and formulas

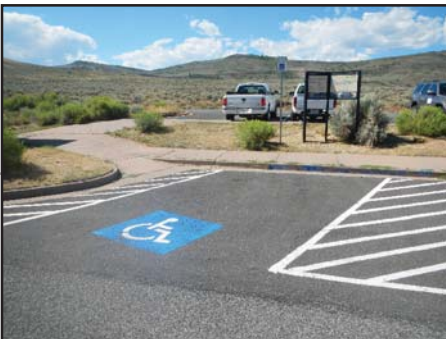
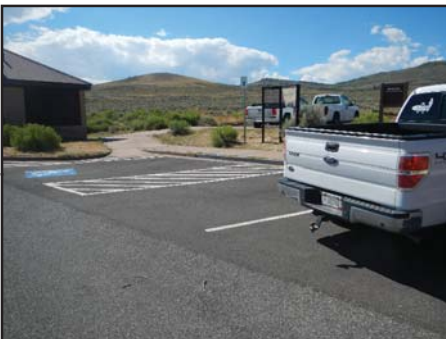
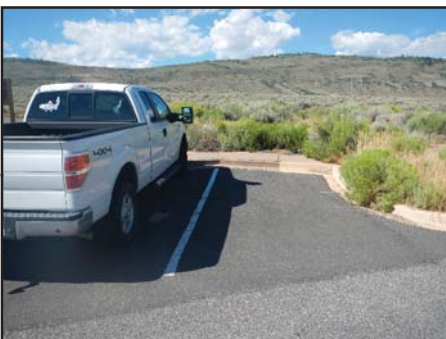
## ROUTE 0910A: LAKE FORK VISITOR CENTER PARKING A

ADJACENT TO ROUTE 0100 (LAKE FORK CAMPGROUND ROAD)

Inspection Date	FMSS Number	User Access	Surface Type
8/7/2014	75835	PUBLIC	ASPHALT
Area (Sq. Ft.)	Lane Miles (11' Widths)	Curb Reveal (Inches)	Curb Recommendation
1,865	0.032	NOT APPLICABLE	DO NOTHING
Curb Type		Curb & Gutter Type	
NO CURB		CONCRETE	
Pavement Recommendation		Condition Rating / PCR	
PREVENTIVE MAINTENANCE		GOOD / 90	
<b>Route Condition Legend – Pavement Condition Rating (PCR)</b>			
<b>Poor (0 - 60)</b>	<b>Fair (61- 84)</b>	<b>Good (85 - 94)</b>	<b>Excellent (95 - 100)</b>
<b>Not Rated</b>			
See Appendix for definitions and formulas
