# CURE Cycle 6

## Final Report

### Road Inventory and Condition Assessment of Paved Routes Curecanti National Recreation Area

Federal Highway Administration  
Eastern Federal Lands Highway Division  
Road Inventory Program (RIP)

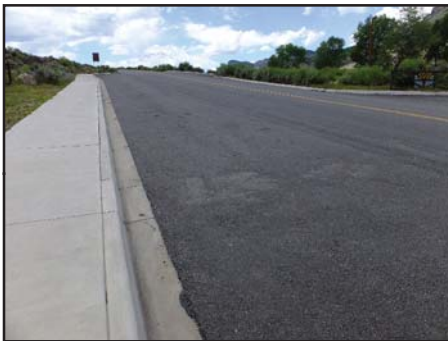
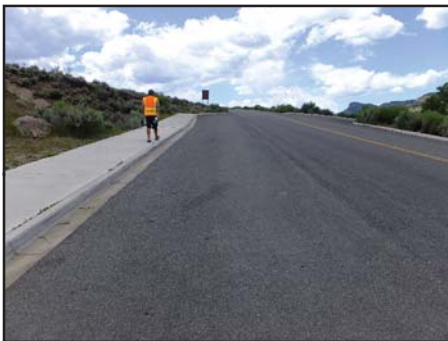
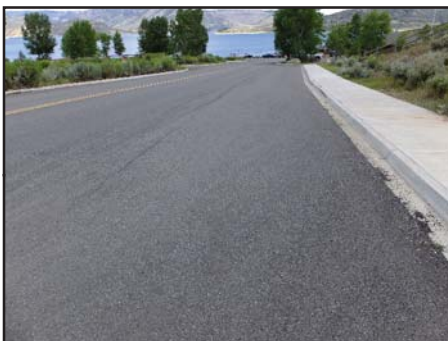
## ROUTE 0910B: LAKE FORK VISITOR CENTER PARKING B

ADJACENT TO ROUTE 0100 (LAKE FORK CAMPGROUND ROAD)

Inspection Date	FMSS Number	User Access	Surface Type
8/7/2014	103039	PUBLIC	ASPHALT
Area (Sq. Ft.)	Lane Miles (11' Widths)	Curb Reveal (Inches)	Curb Recommendation
1,963	0.034	NOT APPLICABLE	DO NOTHING
Curb Type		Curb & Gutter Type	
NO CURB		CONCRETE	
Pavement Recommendation		Condition Rating / PCR	
PREVENTIVE MAINTENANCE		GOOD / 90	
<b>Route Condition Legend – Pavement Condition Rating (PCR)</b>			
<b>Poor (0 - 60)</b>	<b>Fair (61- 84)</b>	<b>Good (85 - 94)</b>	<b>Excellent (95 - 100)</b>
<b>Not Rated</b>			
See Appendix for definitions and formulas

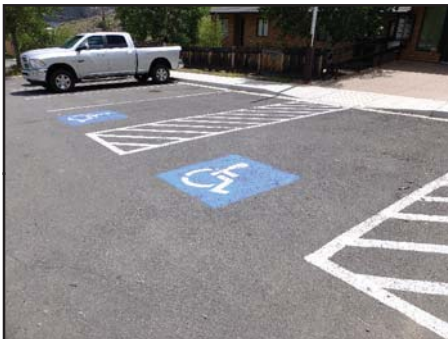
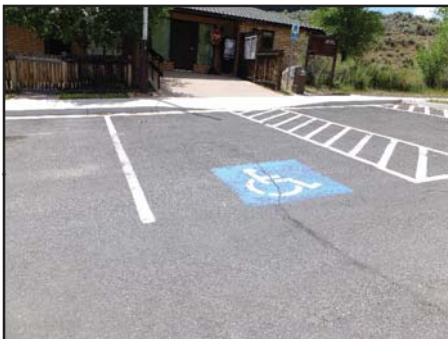
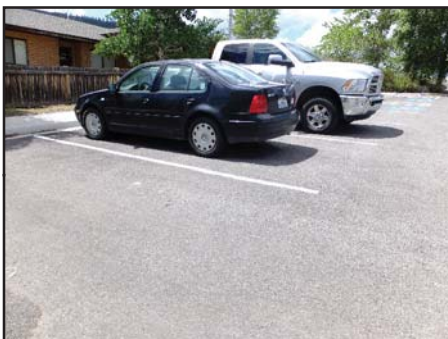
## ROUTE 0911: RV DUMP STATION

TO ROUTE 0100 (LAKE FORK CAMPGROUND ROAD)

Inspection Date	FMSS Number	User Access	Surface Type
8/7/2014	90862	PUBLIC	ASPHALT
Area (Sq. Ft.)	Lane Miles (11' Widths)	Curb Reveal (Inches)	Curb Recommendation
7,058	0.122	NOT APPLICABLE	DO NOTHING
Curb Type		Curb & Gutter Type	
NO CURB		CONCRETE	
Pavement Recommendation		Condition Rating / PCR	
PREVENTIVE MAINTENANCE		GOOD / 90	
<b>Route Condition Legend – Pavement Condition Rating (PCR)</b>			
<b>Poor (0 - 60)</b>	<b>Fair (61- 84)</b>	<b>Good (85 - 94)</b>	<b>Excellent (95 - 100)</b>
<b>Not Rated</b>			
See Appendix for definitions and formulas

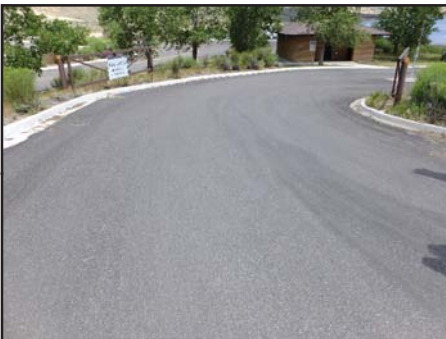
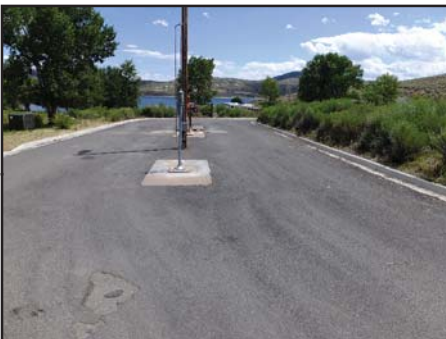
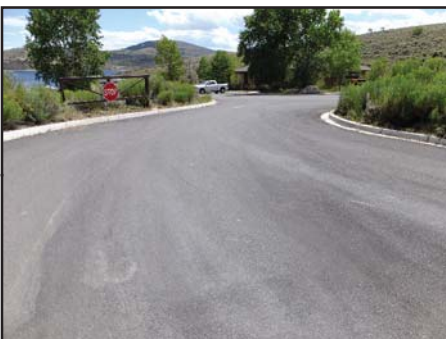
## ROUTE 0912: LAKE FORK LOWER CAMPGROUND LOOP PARKING

ADJACENT TO ROUTE 0240 (LAKE FORK LOWER CAMPGROUND ROAD)

Inspection Date	FMSS Number	User Access	Surface Type
8/7/2014	90864	PUBLIC	ASPHALT
Area (Sq. Ft.)	Lane Miles (11' Widths)	Curb Reveal (Inches)	Curb Recommendation
1,604	0.028	NOT APPLICABLE	DO NOTHING
Curb Type		Curb & Gutter Type	
NO CURB		CONCRETE	
Pavement Recommendation		Condition Rating / PCR	
PREVENTIVE MAINTENANCE		GOOD / 90	
<b>Route Condition Legend – Pavement Condition Rating (PCR)</b>			
<b>Poor (0 - 60)</b>	<b>Fair (61- 84)</b>	<b>Good (85 - 94)</b>	<b>Excellent (95 - 100)</b>
<b>Not Rated</b>			
See Appendix for definitions and formulas

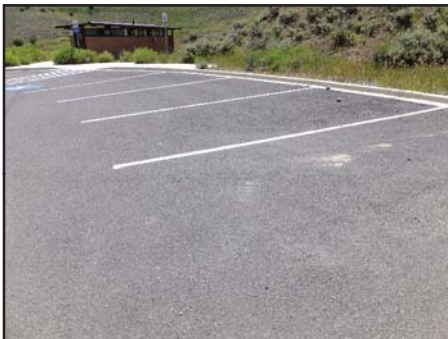
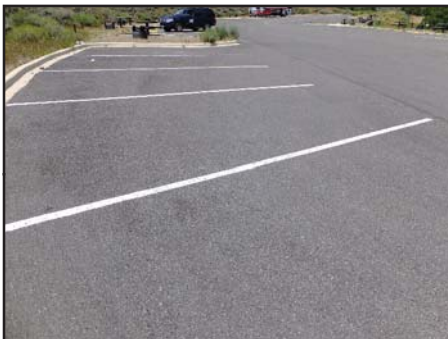
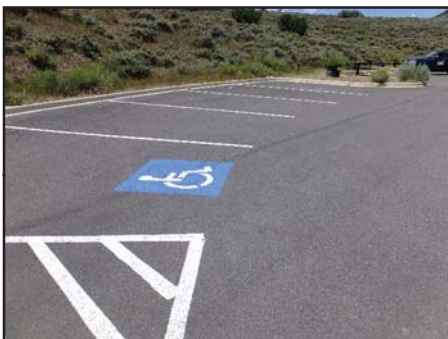
## ROUTE 0914A: LAKE FORK MARINA PARKING A

TO BOAT RAMP

Inspection Date	FMSS Number	User Access	Surface Type	
8/7/2014	90866	PUBLIC	ASPHALT	
Area (Sq. Ft.)	Lane Miles (11' Widths)	Curb Reveal (Inches)	Curb Recommendation	
62,328	1.073	NOT APPLICABLE	DO NOTHING	
Curb Type		Curb & Gutter Type		
NO CURB		CONCRETE		
Pavement Recommendation		Condition Rating / PCR		
PREVENTIVE MAINTENANCE		GOOD / 90		
Route Condition Legend – Pavement Condition Rating (PCR)				
Poor (0 - 60)	Fair (61- 84)	Good (85 - 94)	Excellent (95 - 100)	Not Rated
See Appendix for definitions and formulas

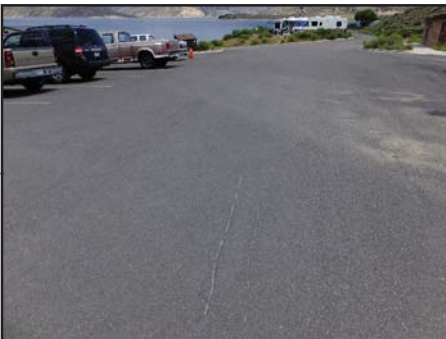
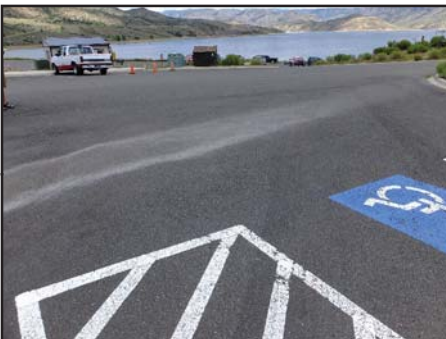
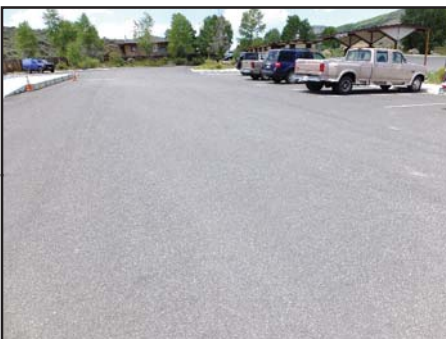
Inspection Date	FMSS Number	User Access	Surface Type	
8/7/2014	103021	PUBLIC	ASPHALT	
Area (Sq. Ft.)	Lane Miles (11' Widths)	Curb Reveal (Inches)	Curb Recommendation	
18,583	0.32	NOT APPLICABLE	DO NOTHING	
Curb Type		Curb & Gutter Type		
NO CURB		CONCRETE		
Pavement Recommendation		Condition Rating / PCR		
PREVENTIVE MAINTENANCE		GOOD / 90		
Route Condition Legend – Pavement Condition Rating (PCR)				
Poor (0 - 60)	Fair (61- 84)	Good (85 - 94)	Excellent (95 - 100)	Not Rated
See Appendix for definitions and formulas

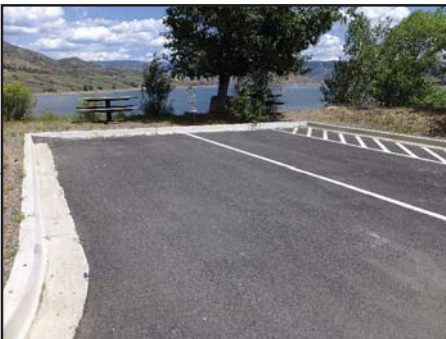
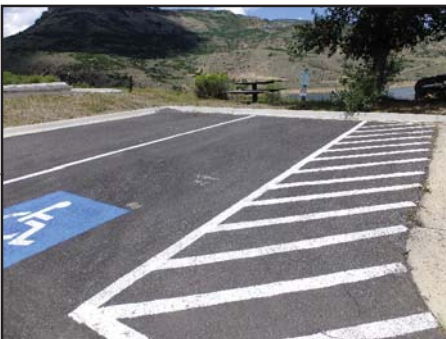
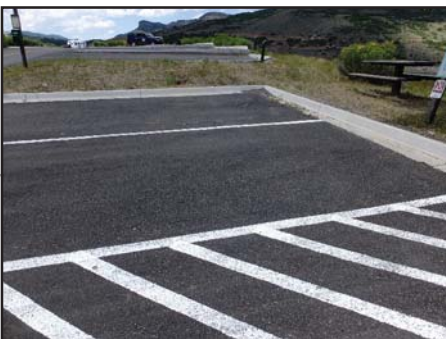
## ROUTE 0915: LAKE FORK HANDICAP PARKING

ADJACENT TO ROUTE 0241 (LAKE FORK UPPER CAMPGROUND LOOP)

Inspection Date	FMSS Number	User Access	Surface Type
8/7/2014	90867	PUBLIC	ASPHALT
Area (Sq. Ft.)	Lane Miles (11' Widths)	Curb Reveal (Inches)	Curb Recommendation
783	0.013	NOT APPLICABLE	DO NOTHING
Curb Type		Curb & Gutter Type	
NO CURB		CONCRETE	
Pavement Recommendation		Condition Rating / PCR	
PREVENTIVE MAINTENANCE		GOOD / 90	
<b>Route Condition Legend – Pavement Condition Rating (PCR)</b>			
<b>Poor (0 - 60)</b>	<b>Fair (61- 84)</b>	<b>Good (85 - 94)</b>	<b>Excellent (95 - 100)</b>
<b>Not Rated</b>			
See Appendix for definitions and formulas

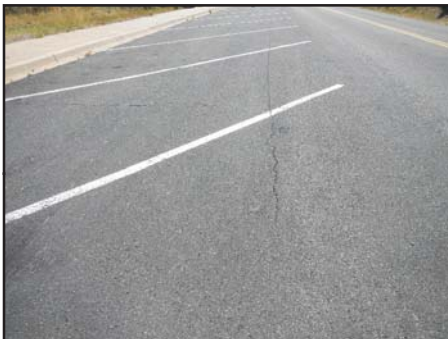
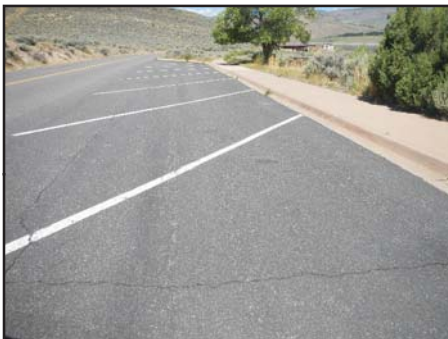
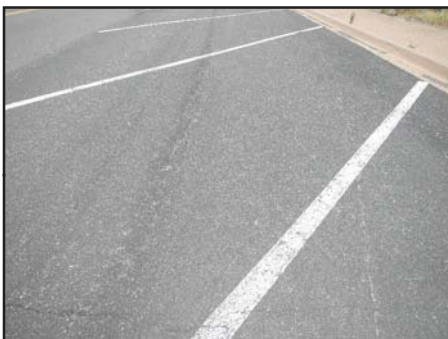
## ROUTE 0916A: IOLA PARKING A

ADJACENT TO ROUTE 0200 (IOLA ROAD)

Inspection Date	FMSS Number	User Access	Surface Type	
8/7/2014	103035	PUBLIC	ASPHALT	
Area (Sq. Ft.)	Lane Miles (11' Widths)	Curb Reveal (Inches)	Curb Recommendation	
6,039	0.104	NOT APPLICABLE	DO NOTHING	
Curb Type		Curb & Gutter Type		
NO CURB		CONCRETE		
Pavement Recommendation		Condition Rating / PCR		
PREVENTIVE MAINTENANCE		GOOD / 90		
Route Condition Legend – Pavement Condition Rating (PCR)				
Poor (0 - 60)	Fair (61- 84)	Good (85 - 94)	Excellent (95 - 100)	Not Rated
See Appendix for definitions and formulas

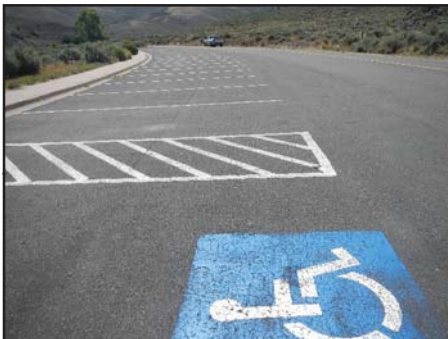
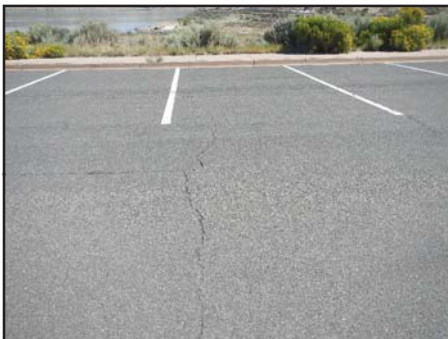
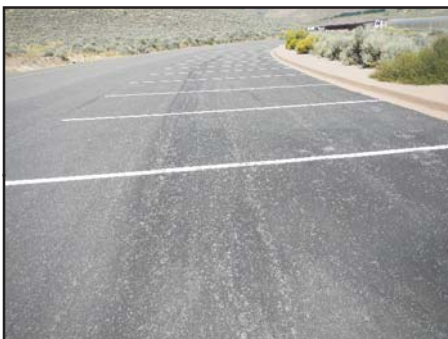
ADJACENT TO ROUTE 0200 (IOLA ROAD)

Inspection Date	FMSS Number	User Access	Surface Type
8/7/2014	75851	PUBLIC	ASPHALT
Area (Sq. Ft.)	Lane Miles (11' Widths)	Curb Reveal (Inches)	Curb Recommendation
4,178	0.072	NOT APPLICABLE	DO NOTHING
Curb Type		Curb & Gutter Type	
NO CURB		CONCRETE	
Pavement Recommendation		Condition Rating / PCR	
PREVENTIVE MAINTENANCE		GOOD / 90	
<b>Route Condition Legend – Pavement Condition Rating (PCR)</b>			
<b>Poor (0 - 60)</b>	<b>Fair (61- 84)</b>	<b>Good (85 - 94)</b>	<b>Excellent (95 - 100)</b>
<b>Not Rated</b>			
See Appendix for definitions and formulas

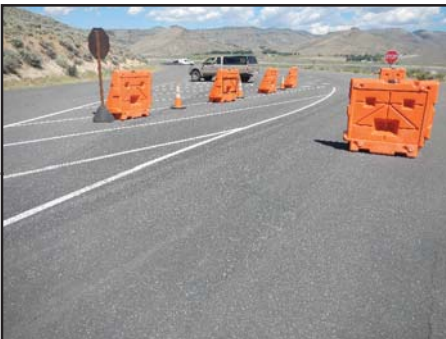
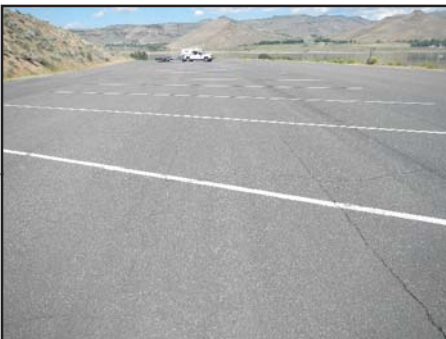
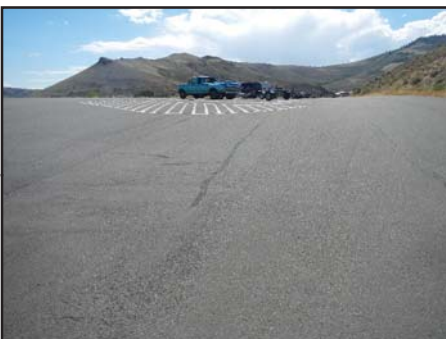
## ROUTE 0917: IOLA BOAT PARKING

TO BOAT RAMP

Inspection Date	FMSS Number	User Access	Surface Type
8/7/2014	90868	PUBLIC	ASPHALT
Area (Sq. Ft.)	Lane Miles (11' Widths)	Curb Reveal (Inches)	Curb Recommendation
60,843	1.048	NOT APPLICABLE	NOT APPLICABLE
Curb Type		Curb & Gutter Type	
NO CURB		NO CURB AND GUTTER	
Pavement Recommendation		Condition Rating / PCR	
HEAVY 3R TREATMENTS		POOR / 53	
<b>Route Condition Legend – Pavement Condition Rating (PCR)</b>			
<b>Poor (0 - 60)</b>	<b>Fair (61- 84)</b>	<b>Good (85 - 94)</b>	<b>Excellent (95 - 100)</b>
<b>Not Rated</b>			
See Appendix for definitions and formulas

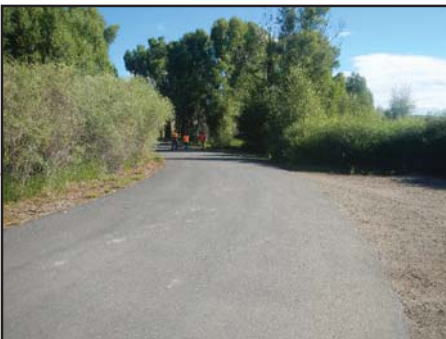
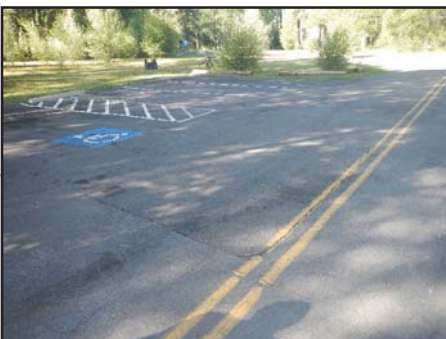
## ROUTE 0918: NEVERSINK PARKING

TO PARKING

Inspection Date	FMSS Number	User Access	Surface Type	
8/7/2014	90869	PUBLIC	ASPHALT	
Area (Sq. Ft.)	Lane Miles (11' Widths)	Curb Reveal (Inches)	Curb Recommendation	
20,555	0.354	NOT APPLICABLE	NOT APPLICABLE	
Curb Type		Curb & Gutter Type		
NO CURB		NO CURB AND GUTTER		
Pavement Recommendation		Condition Rating / PCR		
PREVENTIVE MAINTENANCE		GOOD / 90		
Route Condition Legend – Pavement Condition Rating (PCR)				
Poor (0 - 60)	Fair (61- 84)	Good (85 - 94)	Excellent (95 - 100)	Not Rated
See Appendix for definitions and formulas

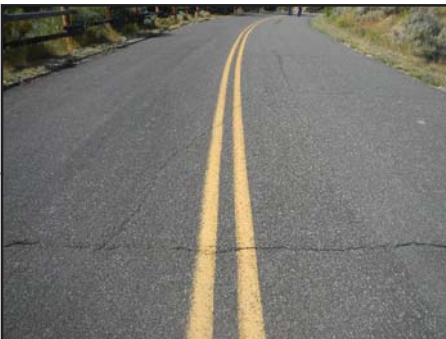
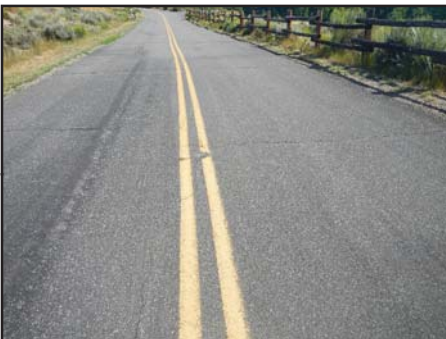
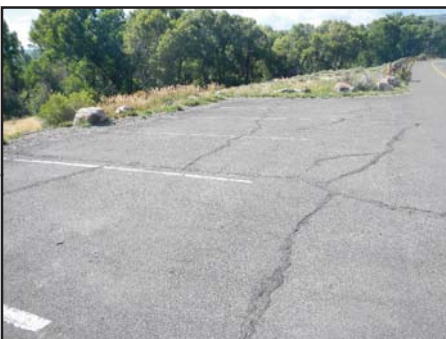
## ROUTE 0919: COOPER RANCH PARKING

TO PARKING

Inspection Date	FMSS Number	User Access	Surface Type	
8/7/2014	90870	PUBLIC	ASPHALT	
Area (Sq. Ft.)	Lane Miles (11' Widths)	Curb Reveal (Inches)	Curb Recommendation	
36,113	0.622	NOT APPLICABLE	NOT APPLICABLE	
Curb Type		Curb & Gutter Type		
NO CURB		NO CURB AND GUTTER		
Pavement Recommendation		Condition Rating / PCR		
HEAVY 3R TREATMENTS		POOR / 53		
Route Condition Legend – Pavement Condition Rating (PCR)				
Poor (0 - 60)	Fair (61- 84)	Good (85 - 94)	Excellent (95 - 100)	Not Rated
See Appendix for definitions and formulas

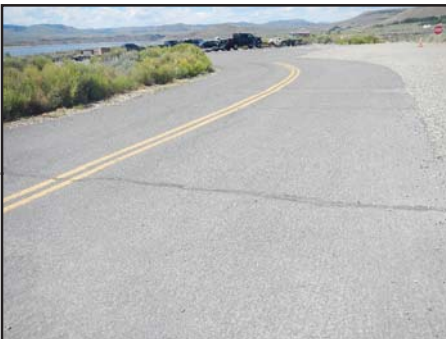
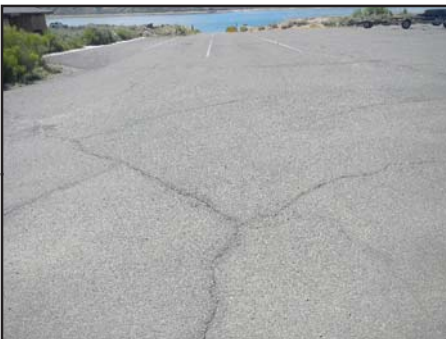
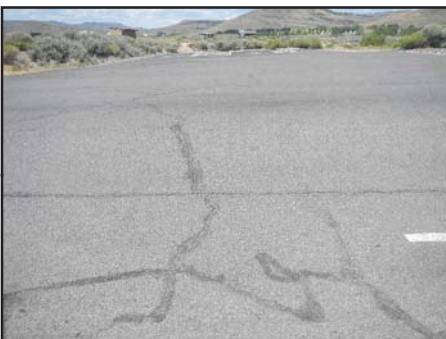
## ROUTE 0920: NEW STEVENS CREEK PARKING

TO BOAT RAMP

Inspection Date	FMSS Number	User Access	Surface Type	
8/7/2014	90871	PUBLIC	ASPHALT	
Area (Sq. Ft.)	Lane Miles (11' Widths)	Curb Reveal (Inches)	Curb Recommendation	
27,844	0.479	NOT APPLICABLE	NOT APPLICABLE	
Curb Type		Curb & Gutter Type		
NO CURB		NO CURB AND GUTTER		
Pavement Recommendation		Condition Rating / PCR		
HEAVY 3R TREATMENTS		POOR / 53		
Route Condition Legend – Pavement Condition Rating (PCR)				
Poor (0 - 60)	Fair (61- 84)	Good (85 - 94)	Excellent (95 - 100)	Not Rated
See Appendix for definitions and formulas

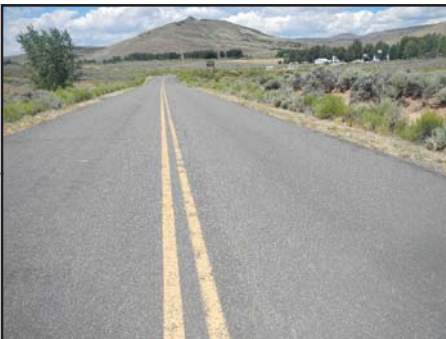
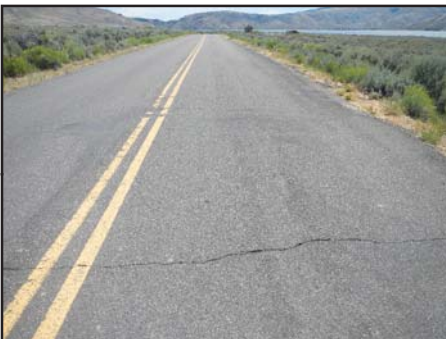
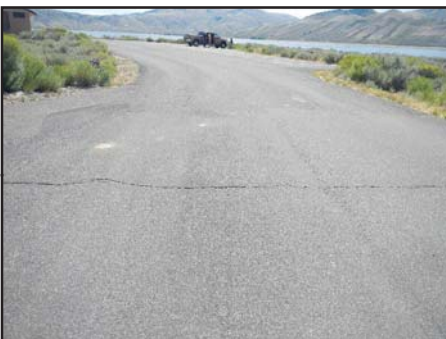
## ROUTE 0921: OLD STEVENS CREEK PARKING

TO PARKING

Inspection Date	FMSS Number	User Access	Surface Type	
8/7/2014	90872	PUBLIC	ASPHALT	
Area (Sq. Ft.)	Lane Miles (11' Widths)	Curb Reveal (Inches)	Curb Recommendation	
44,088	0.759	NOT APPLICABLE	NOT APPLICABLE	
Curb Type		Curb & Gutter Type		
NO CURB		NO CURB AND GUTTER		
Pavement Recommendation		Condition Rating / PCR		
PREVENTIVE MAINTENANCE		GOOD / 90		
Route Condition Legend – Pavement Condition Rating (PCR)				
Poor (0 - 60)	Fair (61- 84)	Good (85 - 94)	Excellent (95 - 100)	Not Rated
See Appendix for definitions and formulas

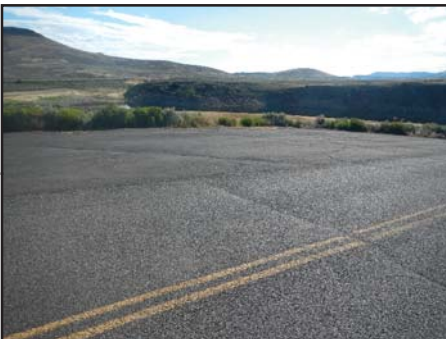
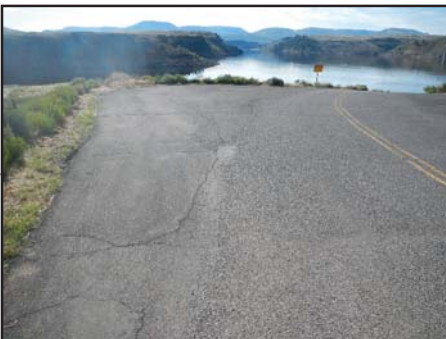
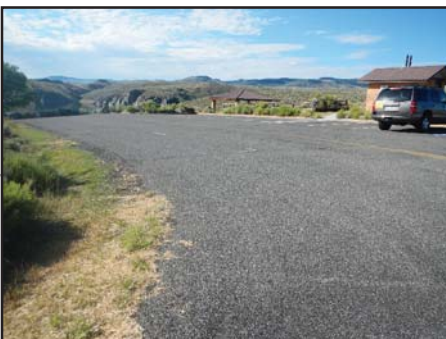
## ROUTE 0922: DRY CREEK PARKING

TO PARKING

Inspection Date	FMSS Number	User Access	Surface Type
8/7/2014	90873	PUBLIC	ASPHALT
Area (Sq. Ft.)	Lane Miles (11' Widths)	Curb Reveal (Inches)	Curb Recommendation
26,223	0.451	NOT APPLICABLE	LIGHT REPAIR
Curb Type		Curb & Gutter Type	
NO CURB		CONCRETE	
Pavement Recommendation		Condition Rating / PCR	
LIGHT 3R TREATMENTS		FAIR / 73	
<b>Route Condition Legend – Pavement Condition Rating (PCR)</b>			
<b>Poor (0 - 60)</b>	<b>Fair (61- 84)</b>	<b>Good (85 - 94)</b>	<b>Excellent (95 - 100)</b>
<b>Not Rated</b>			
See Appendix for definitions and formulas

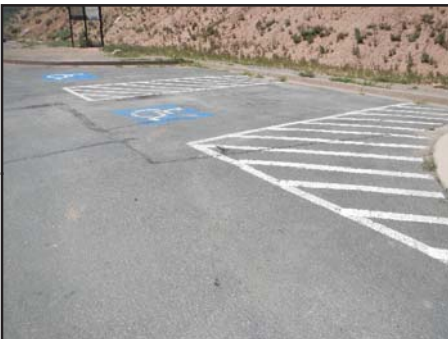
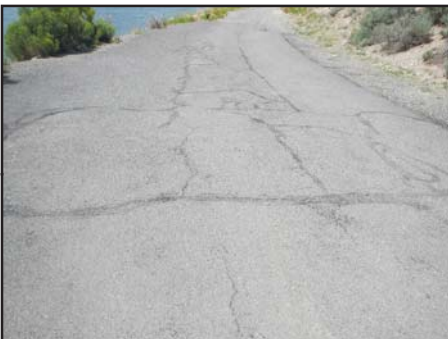
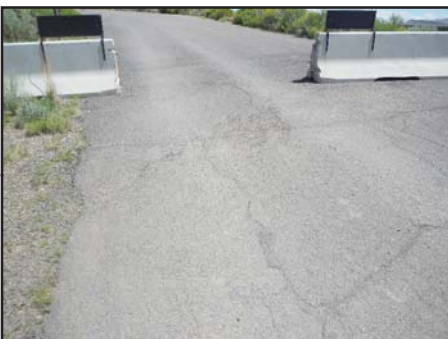
Inspection Date	FMSS Number	User Access	Surface Type	
8/7/2014	90874	PUBLIC	ASPHALT	
Area (Sq. Ft.)	Lane Miles (11' Widths)	Curb Reveal (Inches)	Curb Recommendation	
21,787	0.375	NOT APPLICABLE	DO NOTHING	
Curb Type		Curb & Gutter Type		
NO CURB		CONCRETE		
Pavement Recommendation		Condition Rating / PCR		
HEAVY 3R TREATMENTS		POOR / 53		
Route Condition Legend – Pavement Condition Rating (PCR)				
Poor (0 - 60)	Fair (61- 84)	Good (85 - 94)	Excellent (95 - 100)	Not Rated
See Appendix for definitions and formulas

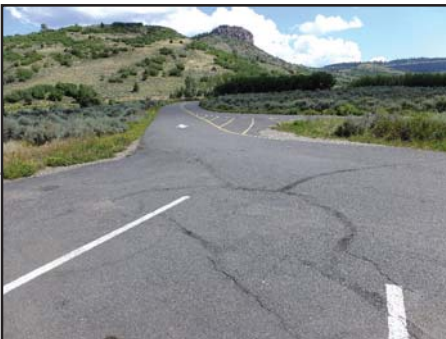
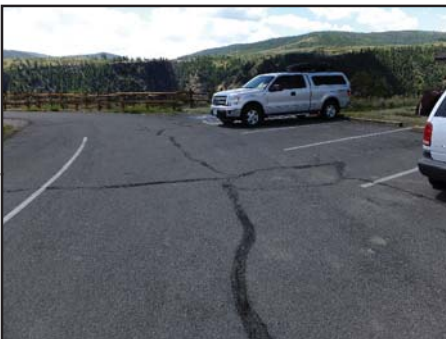
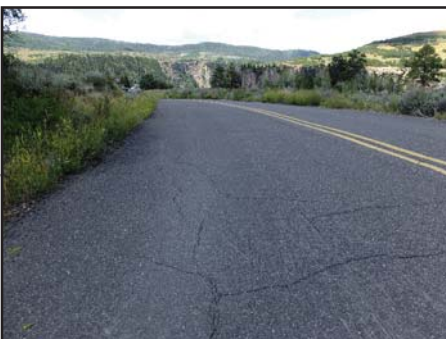
## ROUTE 0924: PIONEER POINT PARKING

Inspection Date	FMSS Number	User Access	Surface Type	
8/7/2014	90876	PUBLIC	ASPHALT	
Area (Sq. Ft.)	Lane Miles (11' Widths)	Curb Reveal (Inches)	Curb Recommendation	
20,643	0.355	NOT APPLICABLE	NOT APPLICABLE	
Curb Type		Curb & Gutter Type		
NO CURB		NO CURB AND GUTTER		
Pavement Recommendation		Condition Rating / PCR		
HEAVY 3R TREATMENTS		POOR / 53		
Route Condition Legend – Pavement Condition Rating (PCR)				
Poor (0 - 60)	Fair (61- 84)	Good (85 - 94)	Excellent (95 - 100)	Not Rated
See Appendix for definitions and formulas

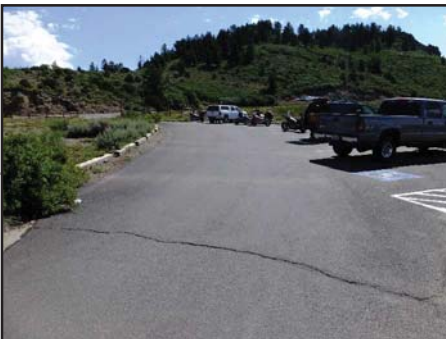
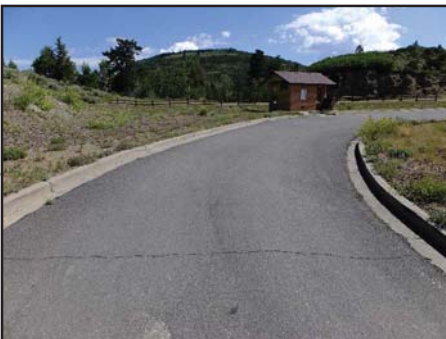
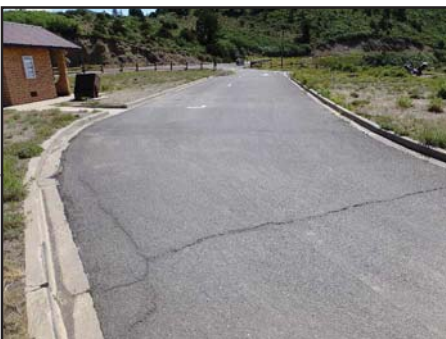
## ROUTE 0925: HERMITS REST LOOKOUT

Inspection Date	FMSS Number	User Access	Surface Type
8/7/2014	90877	PUBLIC	ASPHALT
Area (Sq. Ft.)	Lane Miles (11' Widths)	Curb Reveal (Inches)	Curb Recommendation
14,174	0.244	NOT APPLICABLE	MODERATE REPAIR
Curb Type		Curb & Gutter Type	
NO CURB		CONCRETE	
Pavement Recommendation		Condition Rating / PCR	
PREVENTIVE MAINTENANCE		GOOD / 90	
Route Condition Legend – Pavement Condition Rating (PCR)			
Poor (0 - 60)	Fair (61- 84)	Good (85 - 94)	Excellent (95 - 100)
Not Rated			
See Appendix for definitions and formulas

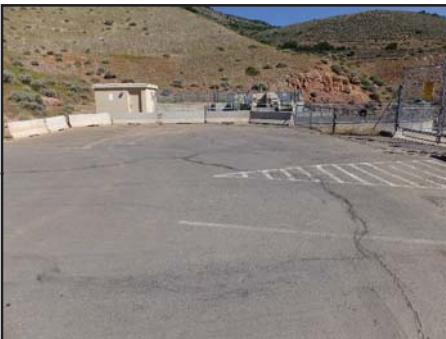
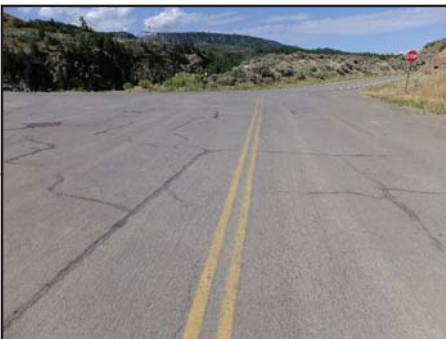
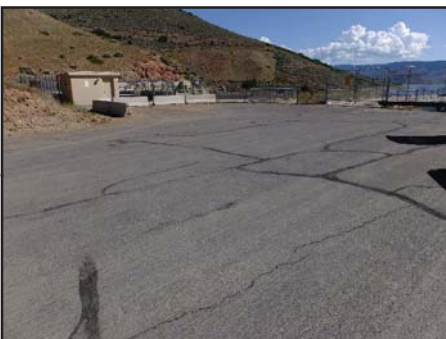
## ROUTE 0926: BLUE MESA DAM PARKING

Inspection Date	FMSS Number	User Access	Surface Type	
8/7/2014	75050	PUBLIC	ASPHALT	
Area (Sq. Ft.)	Lane Miles (11' Widths)	Curb Reveal (Inches)	Curb Recommendation	
14,099	0.243	NOT APPLICABLE	NOT APPLICABLE	
Curb Type		Curb & Gutter Type		
NO CURB		NO CURB AND GUTTER		
Pavement Recommendation		Condition Rating / PCR		
HEAVY 3R TREATMENTS		POOR / 53		
Route Condition Legend – Pavement Condition Rating (PCR)				
Poor (0 - 60)	Fair (61- 84)	Good (85 - 94)	Excellent (95 - 100)	Not Rated
See Appendix for definitions and formulas

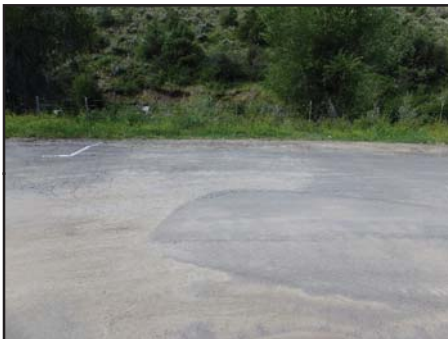
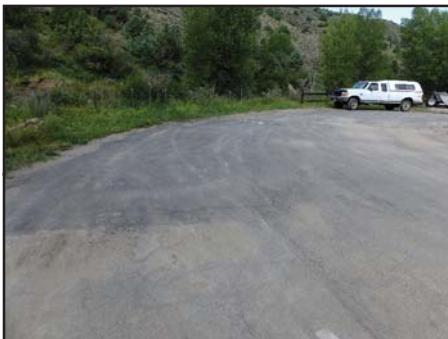
## ROUTE 0927: EAST CIMARRON PARKING

Inspection Date	FMSS Number	User Access	Surface Type	
8/7/2014	90878	PUBLIC	ASPHALT	
Area (Sq. Ft.)	Lane Miles (11' Widths)	Curb Reveal (Inches)	Curb Recommendation	
9,924	0.171	NOT APPLICABLE	NOT APPLICABLE	
Curb Type		Curb & Gutter Type		
NO CURB		NO CURB AND GUTTER		
Pavement Recommendation		Condition Rating / PCR		
RECONSTRUCTION		POOR / 30		
Route Condition Legend – Pavement Condition Rating (PCR)				
Poor (0 - 60)	Fair (61- 84)	Good (85 - 94)	Excellent (95 - 100)	Not Rated
See Appendix for definitions and formulas

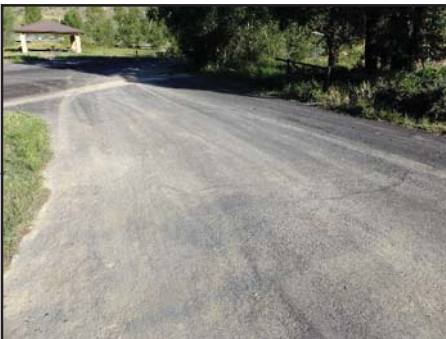
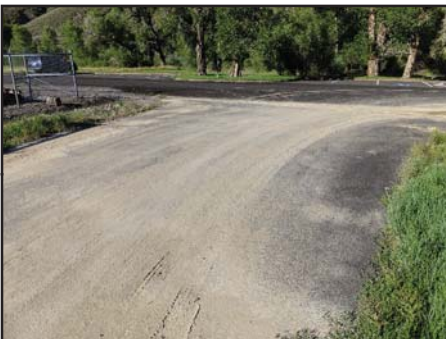
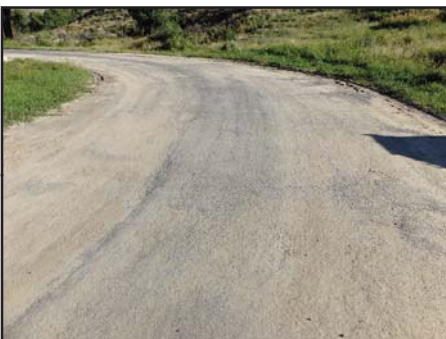
## ROUTE 0929: CIMARRON DUMP STATION

Inspection Date	FMSS Number	User Access	Surface Type	
8/7/2014	90880	PUBLIC	ASPHALT	
Area (Sq. Ft.)	Lane Miles (11' Widths)	Curb Reveal (Inches)	Curb Recommendation	
7,417	0.128	4	DO NOTHING	
Curb Type		Curb & Gutter Type		
CONCRETE		NO CURB AND GUTTER		
Pavement Recommendation		Condition Rating / PCR		
LIGHT 3R TREATMENTS		FAIR / 73		
Route Condition Legend – Pavement Condition Rating (PCR)				
Poor (0 - 60)	Fair (61- 84)	Good (85 - 94)	Excellent (95 - 100)	Not Rated
See Appendix for definitions and formulas

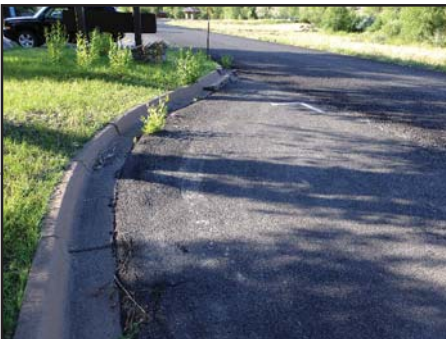
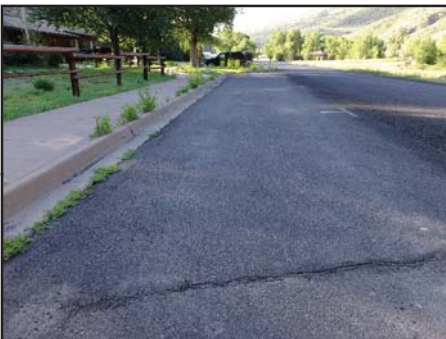
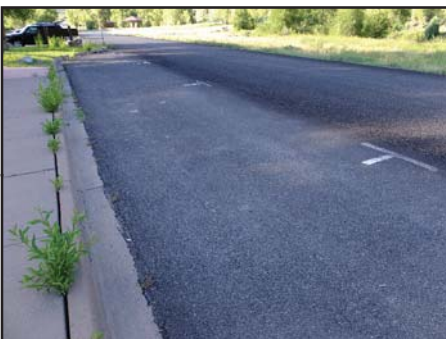
## ROUTE 0930A: CIMARRON VISITOR CENTER PARKING A

Inspection Date	FMSS Number	User Access	Surface Type
8/7/2014	90881	PUBLIC	ASPHALT
Area (Sq. Ft.)	Lane Miles (11' Widths)	Curb Reveal (Inches)	Curb Recommendation
1,162	0.02	NOT APPLICABLE	REPLACE
Curb Type		Curb & Gutter Type	
NO CURB		CONCRETE	
Pavement Recommendation		Condition Rating / PCR	
LIGHT 3R TREATMENTS		FAIR / 73	
<b>Route Condition Legend – Pavement Condition Rating (PCR)</b>			
<b>Poor (0 - 60)</b>	<b>Fair (61- 84)</b>	<b>Good (85 - 94)</b>	<b>Excellent (95 - 100)</b>
<b>Not Rated</b>			
See Appendix for definitions and formulas

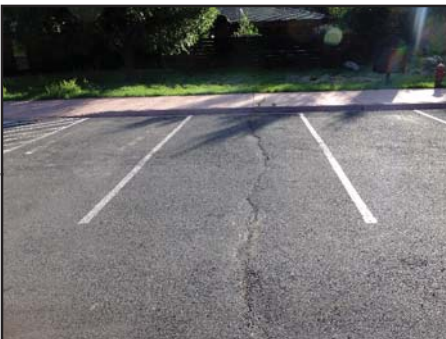
## ROUTE 0930B: CIMARRON VISITOR CENTER PARKING B

Inspection Date	FMSS Number	User Access	Surface Type
8/7/2014	103016	PUBLIC	ASPHALT
Area (Sq. Ft.)	Lane Miles (11' Widths)	Curb Reveal (Inches)	Curb Recommendation
1,804	0.031	NOT APPLICABLE	DO NOTHING
Curb Type		Curb & Gutter Type	
NO CURB		CONCRETE	
Pavement Recommendation		Condition Rating / PCR	
PREVENTIVE MAINTENANCE		GOOD / 90	
<b>Route Condition Legend – Pavement Condition Rating (PCR)</b>			
<b>Poor (0 - 60)</b>	<b>Fair (61- 84)</b>	<b>Good (85 - 94)</b>	<b>Excellent (95 - 100)</b>
<b>Not Rated</b>			
See Appendix for definitions and formulas

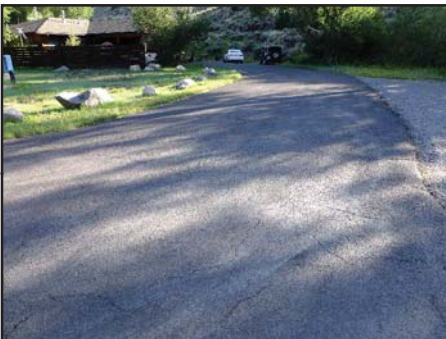
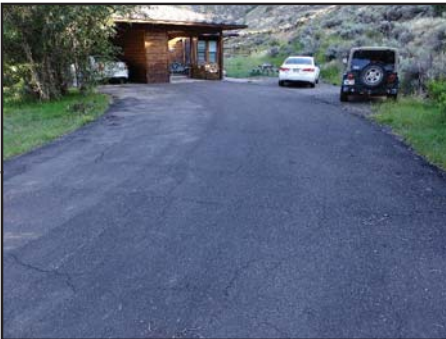
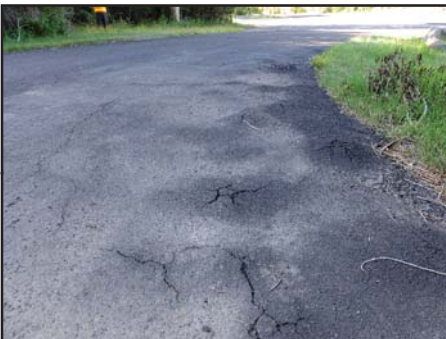
## ROUTE 0931: CIMARRON EMPLOYEE PARKING

Inspection Date	FMSS Number	User Access	Surface Type	
8/7/2014	90882	NONPUBLIC	ASPHALT	
Area (Sq. Ft.)	Lane Miles (11' Widths)	Curb Reveal (Inches)	Curb Recommendation	
3,009	0.052	NOT APPLICABLE	NOT APPLICABLE	
Curb Type		Curb & Gutter Type		
NO CURB		NO CURB AND GUTTER		
Pavement Recommendation		Condition Rating / PCR		
HEAVY 3R TREATMENTS		POOR / 53		
Route Condition Legend – Pavement Condition Rating (PCR)				
Poor (0 - 60)	Fair (61- 84)	Good (85 - 94)	Excellent (95 - 100)	Not Rated
See Appendix for definitions and formulas

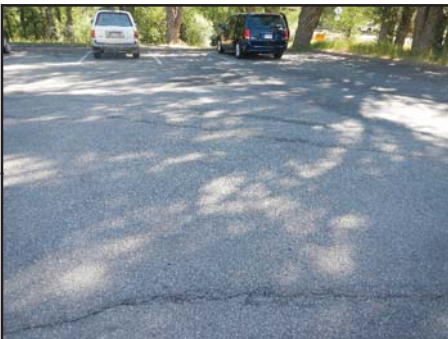
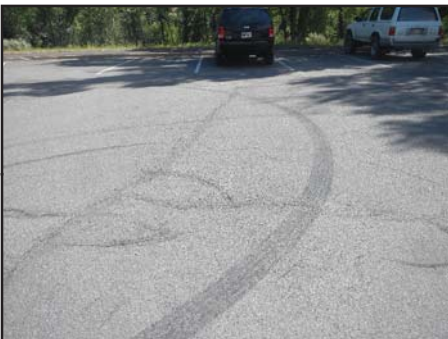
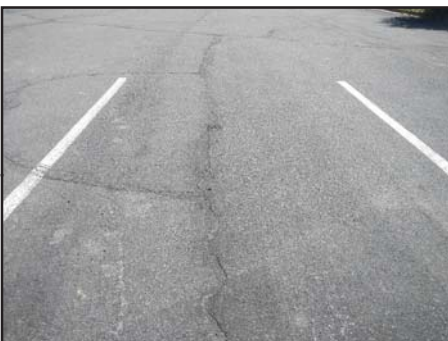
## ROUTE 0932: BEAVER CREEK PARKING

Inspection Date	FMSS Number	User Access	Surface Type	
8/7/2014	90883	PUBLIC	ASPHALT	
Area (Sq. Ft.)	Lane Miles (11' Widths)	Curb Reveal (Inches)	Curb Recommendation	
14,890	0.256	NOT APPLICABLE	LIGHT REPAIR	
Curb Type		Curb & Gutter Type		
NO CURB		CONCRETE		
Pavement Recommendation		Condition Rating / PCR		
HEAVY 3R TREATMENTS		POOR / 53		
Route Condition Legend – Pavement Condition Rating (PCR)				
Poor (0 - 60)	Fair (61- 84)	Good (85 - 94)	Excellent (95 - 100)	Not Rated
See Appendix for definitions and formulas

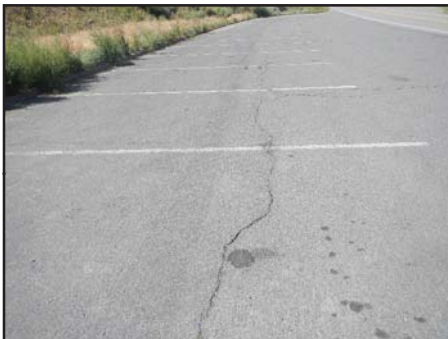
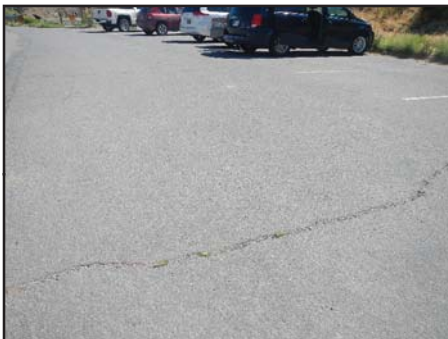
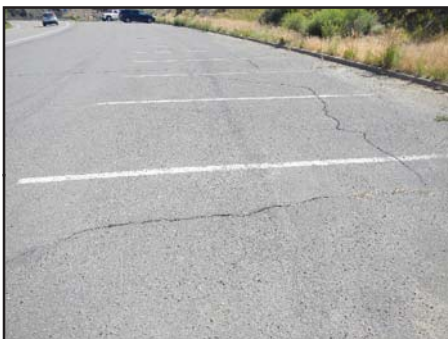
## ROUTE 0937: LAKE FORK MAINTENANCE AREA

Inspection Date	FMSS Number	User Access	Surface Type	
8/7/2014	75839	NONPUBLIC	ASPHALT	
Area (Sq. Ft.)	Lane Miles (11' Widths)	Curb Reveal (Inches)	Curb Recommendation	
41,905	0.722	NOT APPLICABLE	NOT APPLICABLE	
Curb Type		Curb & Gutter Type		
NO CURB		NO CURB AND GUTTER		
Pavement Recommendation		Condition Rating / PCR		
HEAVY 3R TREATMENTS		POOR / 53		
Route Condition Legend – Pavement Condition Rating (PCR)				
Poor (0 - 60)	Fair (61- 84)	Good (85 - 94)	Excellent (95 - 100)	Not Rated
See Appendix for definitions and formulas

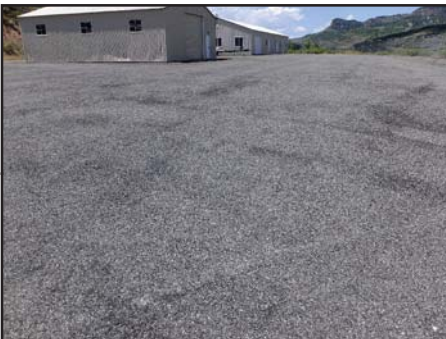
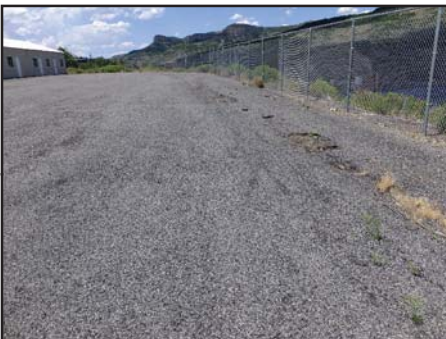
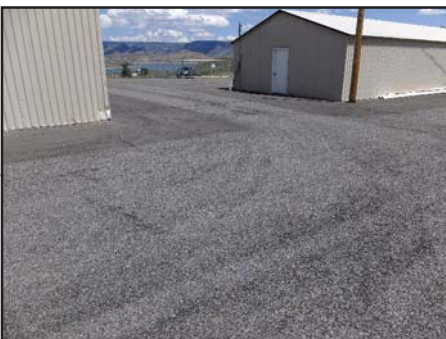
## ROUTE 0938: CIMARRON MAINTENANCE AREA

Inspection Date	FMSS Number	User Access	Surface Type	
8/7/2014	90891	NONPUBLIC	ASPHALT	
Area (Sq. Ft.)	Lane Miles (11' Widths)	Curb Reveal (Inches)	Curb Recommendation	
23,361	0.402	NOT APPLICABLE	NOT APPLICABLE	
Curb Type		Curb & Gutter Type		
NO CURB		NO CURB AND GUTTER		
Pavement Recommendation		Condition Rating / PCR		
HEAVY 3R TREATMENTS		POOR / 53		
Route Condition Legend – Pavement Condition Rating (PCR)				
Poor (0 - 60)	Fair (61- 84)	Good (85 - 94)	Excellent (95 - 100)	Not Rated
See Appendix for definitions and formulas

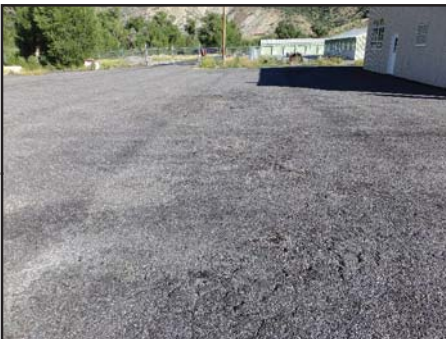
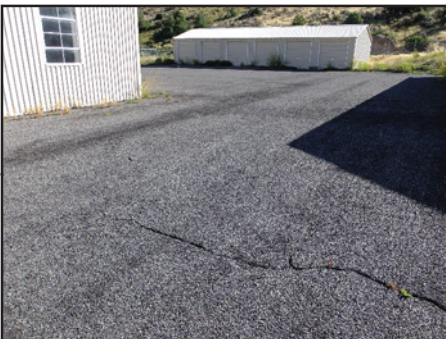
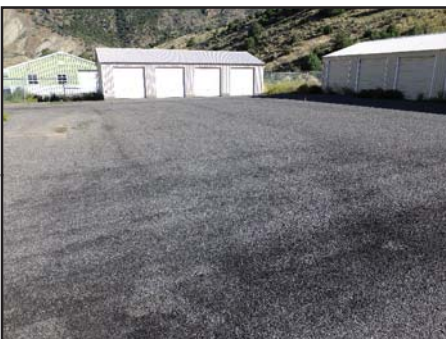
## ROUTE 0939: MORROW POINT DAM PICNIC AREA

Inspection Date	FMSS Number	User Access	Surface Type	
8/7/2014	90897	PUBLIC	ASPHALT	
Area (Sq. Ft.)	Lane Miles (11' Widths)	Curb Reveal (Inches)	Curb Recommendation	
31,277	0.539	NOT APPLICABLE	LIGHT REPAIR	
Curb Type		Curb & Gutter Type		
NO CURB		CONCRETE		
Pavement Recommendation		Condition Rating / PCR		
HEAVY 3R TREATMENTS		POOR / 53		
Route Condition Legend – Pavement Condition Rating (PCR)				
Poor (0 - 60)	Fair (61- 84)	Good (85 - 94)	Excellent (95 - 100)	Not Rated
See Appendix for definitions and formulas

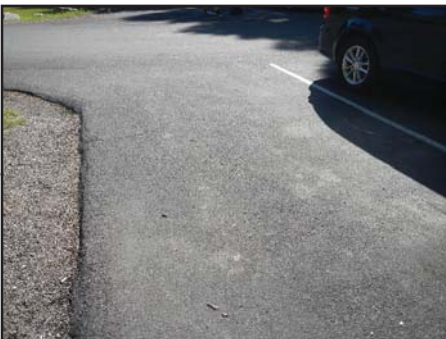
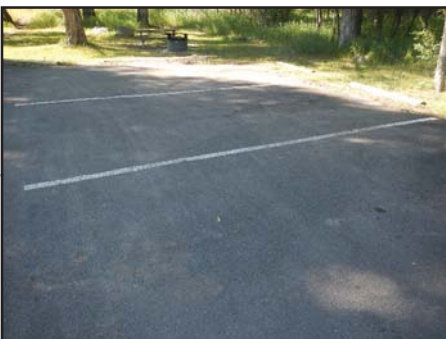
## ROUTE 0941AZ: NEVERSINK PARKING AREA A

Inspection Date	FMSS Number	User Access	Surface Type	
8/7/2014	90899	PUBLIC	ASPHALT	
Area (Sq. Ft.)	Lane Miles (11' Widths)	Curb Reveal (Inches)	Curb Recommendation	
935	0.016	NOT APPLICABLE	NOT APPLICABLE	
Curb Type		Curb & Gutter Type		
NO CURB		NO CURB AND GUTTER		
Pavement Recommendation		Condition Rating / PCR		
PREVENTIVE MAINTENANCE		GOOD / 90		
Route Condition Legend – Pavement Condition Rating (PCR)				
Poor (0 - 60)	Fair (61- 84)	Good (85 - 94)	Excellent (95 - 100)	Not Rated
See Appendix for definitions and formulas

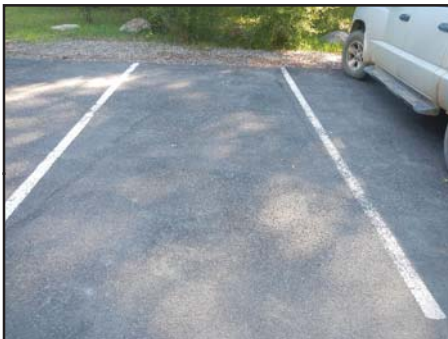
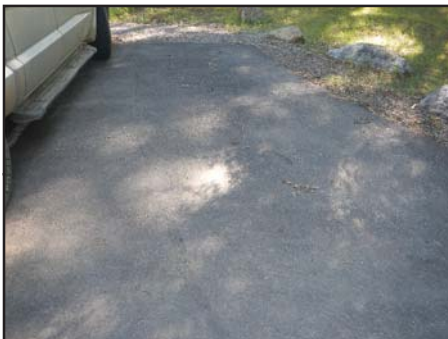
## ROUTE 0941BZ: NEVERSINK PARKING AREA B

Inspection Date	FMSS Number	User Access	Surface Type	
8/7/2014	90899	PUBLIC	ASPHALT	
Area (Sq. Ft.)	Lane Miles (11' Widths)	Curb Reveal (Inches)	Curb Recommendation	
886	0.015	NOT APPLICABLE	NOT APPLICABLE	
Curb Type		Curb & Gutter Type		
NO CURB		NO CURB AND GUTTER		
Pavement Recommendation		Condition Rating / PCR		
PREVENTIVE MAINTENANCE		GOOD / 90		
Route Condition Legend – Pavement Condition Rating (PCR)				
Poor (0 - 60)	Fair (61- 84)	Good (85 - 94)	Excellent (95 - 100)	Not Rated
See Appendix for definitions and formulas

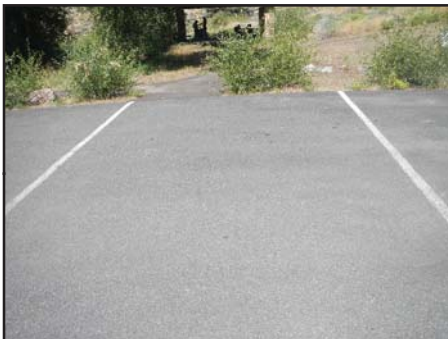
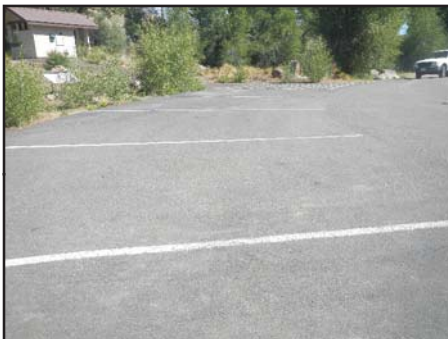
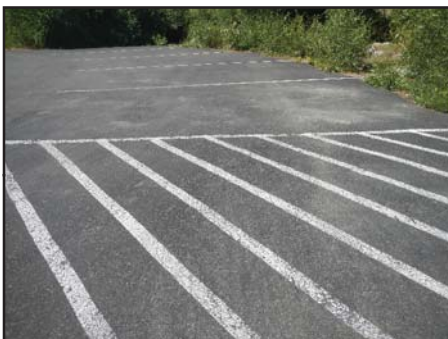
## ROUTE 0943: COOPER RANCH COMFORT STATION PARKING

Inspection Date	FMSS Number	User Access	Surface Type
8/7/2014	90901	PUBLIC	ASPHALT
Area (Sq. Ft.)	Lane Miles (11' Widths)	Curb Reveal (Inches)	Curb Recommendation
1,341	0.023	NOT APPLICABLE	NOT APPLICABLE
Curb Type		Curb & Gutter Type	
NO CURB		NO CURB AND GUTTER	
Pavement Recommendation		Condition Rating / PCR	
DO NOTHING		EXCELLENT / 97	
<b>Route Condition Legend – Pavement Condition Rating (PCR)</b>			
<b>Poor (0 - 60)</b>	<b>Fair (61- 84)</b>	<b>Good (85 - 94)</b>	<b>Excellent (95 - 100)</b>
<b>Not Rated</b>			
See Appendix for definitions and formulas

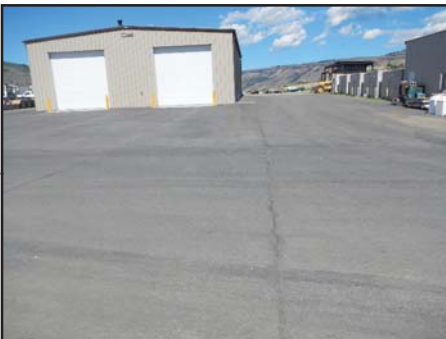
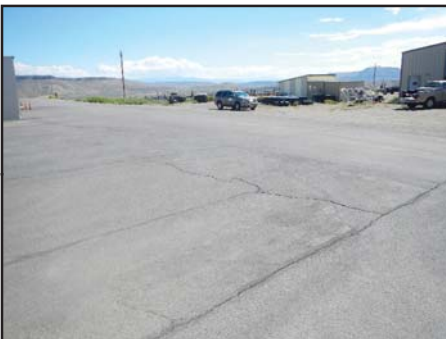
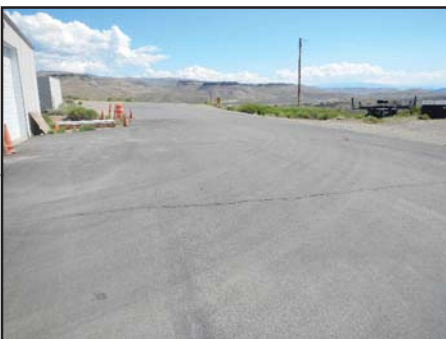
## ROUTE 0960: WAREHOUSE STORAGE AREA

Inspection Date	FMSS Number	User Access	Surface Type	
8/7/2014	238303	NONPUBLIC	ASPHALT	
Area (Sq. Ft.)	Lane Miles (11' Widths)	Curb Reveal (Inches)	Curb Recommendation	
19,143	0.33	NOT APPLICABLE	NOT APPLICABLE	
Curb Type		Curb & Gutter Type		
NO CURB		NO CURB AND GUTTER		
Pavement Recommendation		Condition Rating / PCR		
PREVENTIVE MAINTENANCE		GOOD / 90		
Route Condition Legend – Pavement Condition Rating (PCR)				
Poor (0 - 60)	Fair (61- 84)	Good (85 - 94)	Excellent (95 - 100)	Not Rated
See Appendix for definitions and formulas

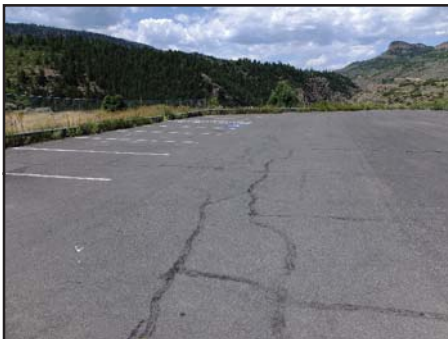
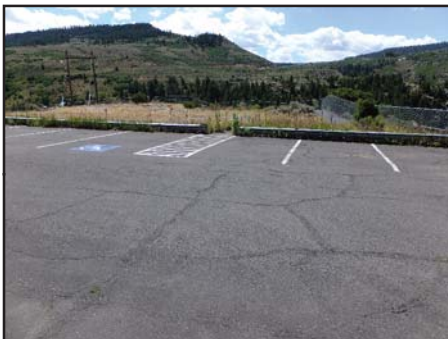
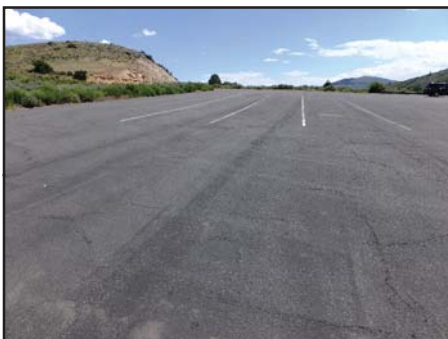
## ROUTE 0963: BLUE MESA OVERLOOK PARKING

Inspection Date	FMSS Number	User Access	Surface Type	
8/7/2014	238306	PUBLIC	ASPHALT	
Area (Sq. Ft.)	Lane Miles (11' Widths)	Curb Reveal (Inches)	Curb Recommendation	
35,720	0.615	NOT APPLICABLE	NOT APPLICABLE	
Curb Type		Curb & Gutter Type		
NO CURB		NO CURB AND GUTTER		
Pavement Recommendation		Condition Rating / PCR		
HEAVY 3R TREATMENTS		POOR / 53		
<b>Route Condition Legend – Pavement Condition Rating (PCR)</b>				
<b>Poor (0 - 60)</b>	<b>Fair (61- 84)</b>	<b>Good (85 - 94)</b>	<b>Excellent (95 - 100)</b>	<b>Not Rated</b>
See Appendix for definitions and formulas

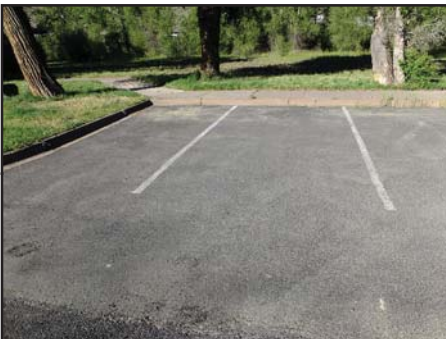
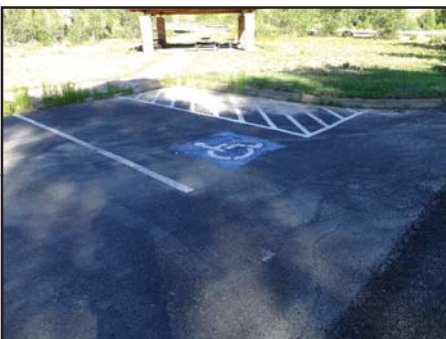
ADJACENT TO ROUTE 5000 (MORROW POINT DAM ROAD)

Inspection Date	FMSS Number	User Access	Surface Type
8/7/2014	N/A	PUBLIC	ASPHALT
Area (Sq. Ft.)	Lane Miles (11' Widths)	Curb Reveal (Inches)	Curb Recommendation
1,875	0.032	NOT APPLICABLE	LIGHT REPAIR
Curb Type		Curb & Gutter Type	
NO CURB		CONCRETE	
Pavement Recommendation		Condition Rating / PCR	
PREVENTIVE MAINTENANCE		GOOD / 90	
<b>Route Condition Legend – Pavement Condition Rating (PCR)</b>			
<b>Poor (0 - 60)</b>	<b>Fair (61- 84)</b>	<b>Good (85 - 94)</b>	<b>Excellent (95 - 100)</b>
<b>Not Rated</b>			
See Appendix for definitions and formulas

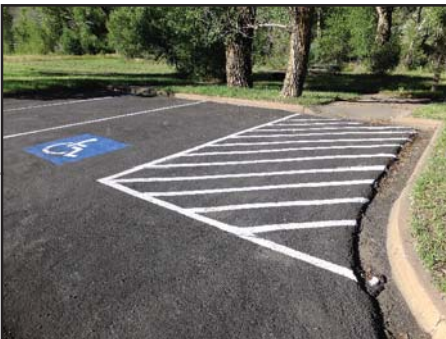
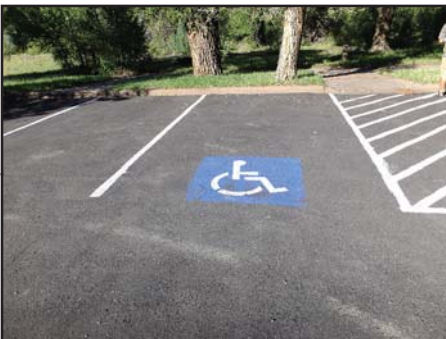
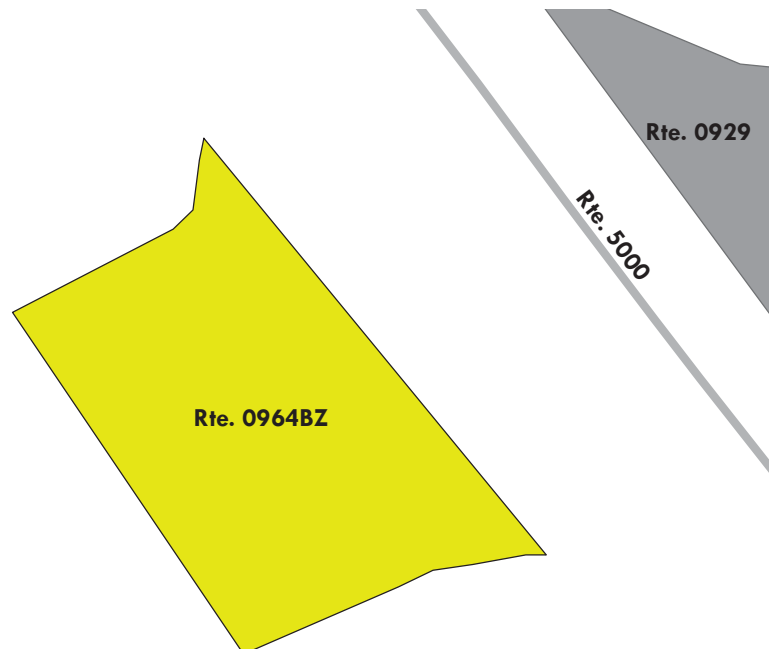
## ROUTE 0964BZ: CIMARRON CS WEST PARKING

Inspection Date	FMSS Number	User Access	Surface Type
8/7/2014	N/A	PUBLIC	ASPHALT
Area (Sq. Ft.)	Lane Miles (11' Widths)	Curb Reveal (Inches)	Curb Recommendation
855	0.015	NOT APPLICABLE	DO NOTHING
Curb Type		Curb & Gutter Type	
NO CURB		CONCRETE	
Pavement Recommendation		Condition Rating / PCR	
LIGHT 3R TREATMENTS		FAIR / 73	
<b>Route Condition Legend – Pavement Condition Rating (PCR)</b>			
<b>Poor (0 - 60)</b>	<b>Fair (61- 84)</b>	<b>Good (85 - 94)</b>	<b>Excellent (95 - 100)</b>
<b>Not Rated</b>			
See Appendix for definitions and formulas

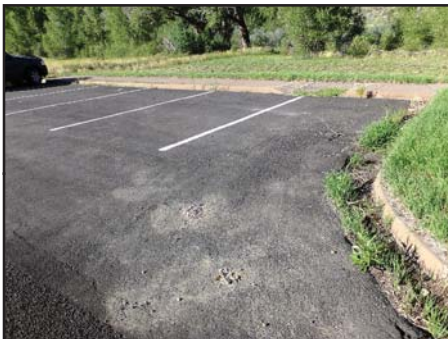
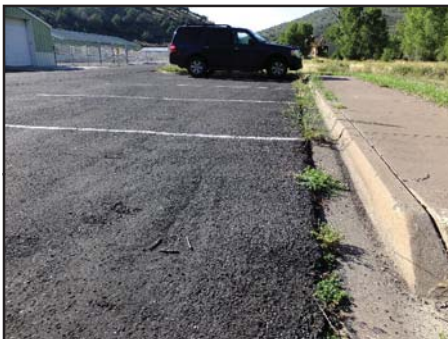
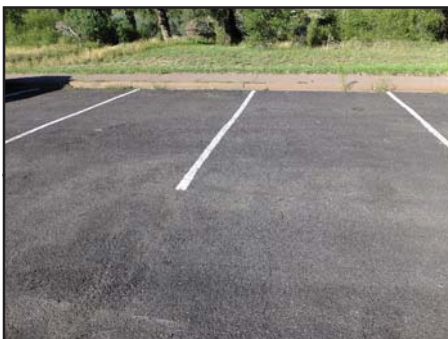
## ROUTE 0964CZ: CIMARRON CS EAST PARKING

Inspection Date	FMSS Number	User Access	Surface Type	
8/7/2014	N/A	PUBLIC	ASPHALT	
Area (Sq. Ft.)	Lane Miles (11' Widths)	Curb Reveal (Inches)	Curb Recommendation	
1,415	0.024	NOT APPLICABLE	LIGHT REPAIR	
Curb Type		Curb & Gutter Type		
NO CURB		CONCRETE		
Pavement Recommendation		Condition Rating / PCR		
LIGHT 3R TREATMENTS		FAIR / 73		
Route Condition Legend – Pavement Condition Rating (PCR)				
Poor (0 - 60)	Fair (61- 84)	Good (85 - 94)	Excellent (95 - 100)	Not Rated
See Appendix for definitions and formulas
