**2018 ASBESTOS & LEAD INSPECTION REPORT**

**BUILDING I  
JOHN J. PERSHING V.A.M.C  
1500 WESTWOOD BLVD  
POPLAR BLUFF, MO. 63901**

**RIVERFRONT PROJECT NO. SH1457  
November 19, 2018**

**INTRODUCTION**  
**2018 ACM & LBP REINSPECTION REPORT**  
**POPLAR BLUFF V.A. MEDICAL CENTER**  
**BUILDING 1**

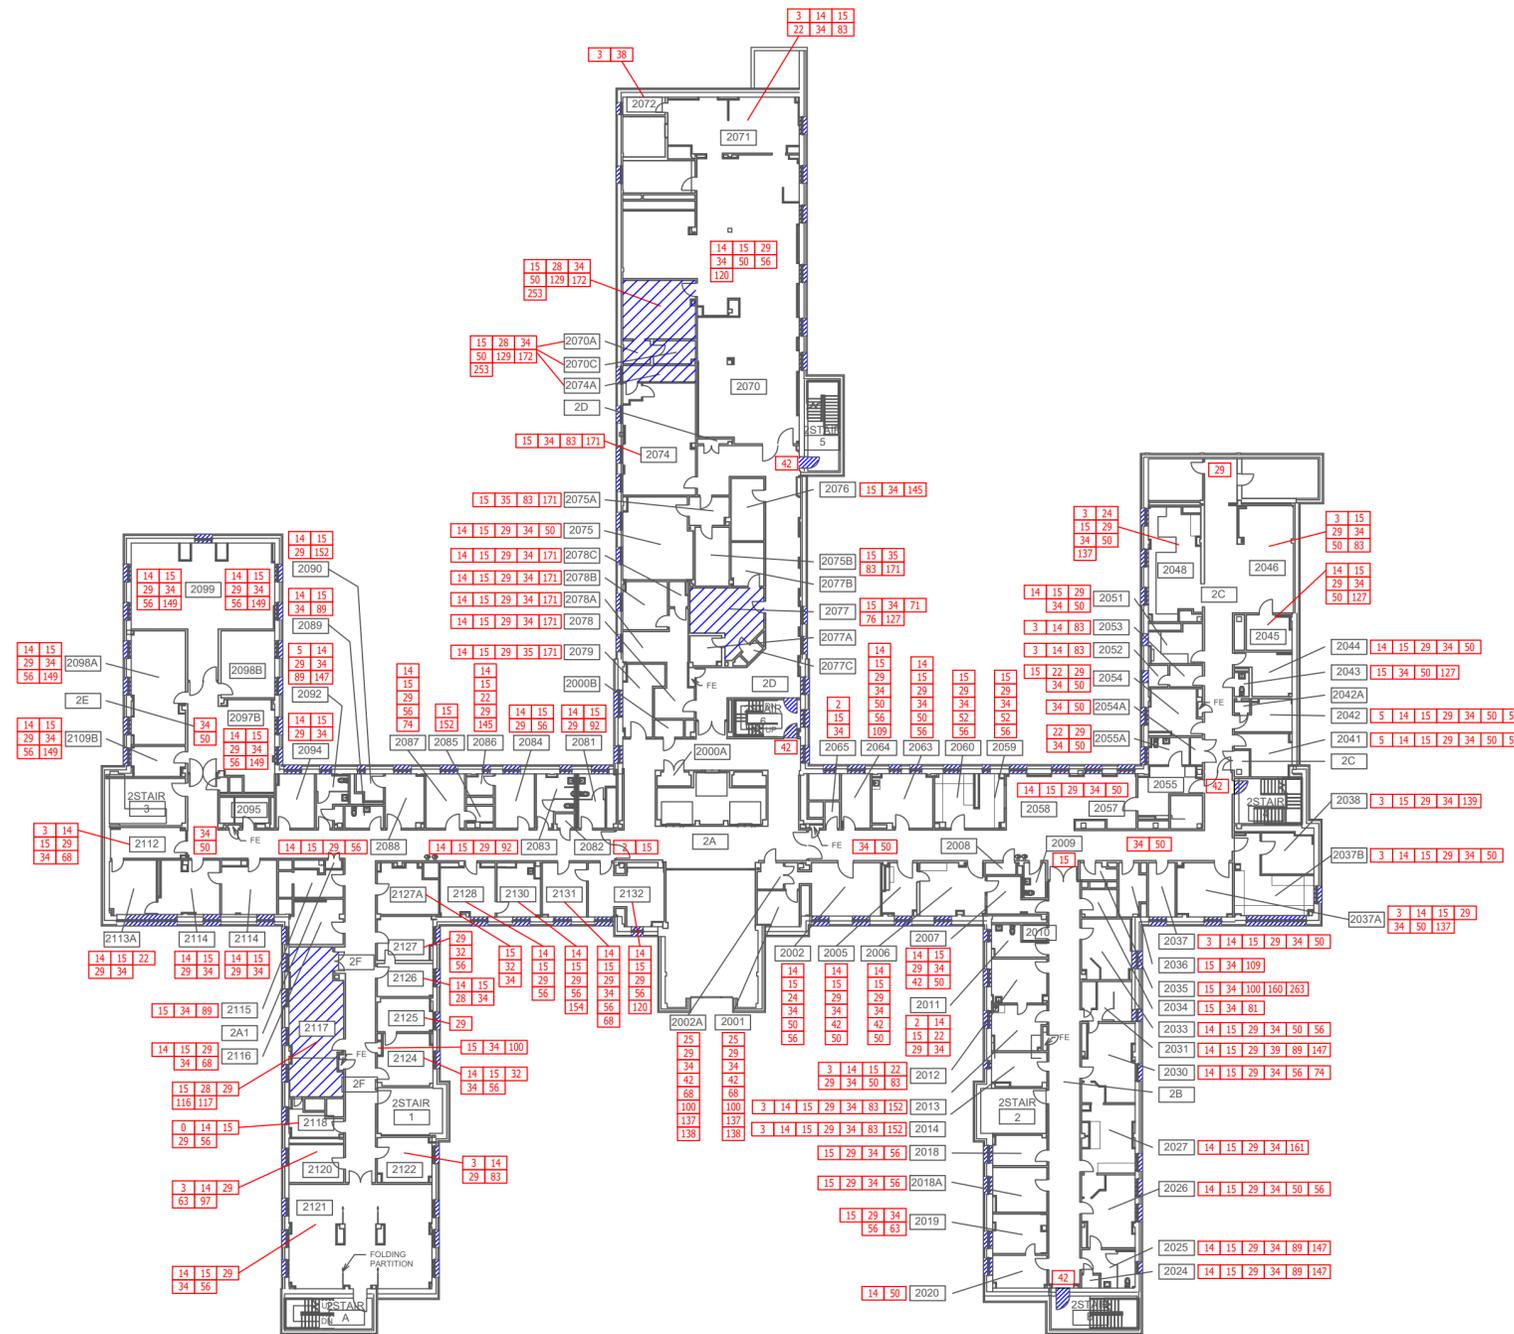
## SECOND FLOOR - CEILING HMA MAP

- 0 Concrete
- 4 2'x4' CT- Fiberglass
- 5 2'x4' CT- Pinhole w/ 1" Wormhole
- 12 2'x4' CT- Textured Drywall
- 15 Plaster
- 70 2'x4' ceiling tile - pinhole and large defined henpeck
- 142 2'x4' CT- Pinhole w/ Wavy Defined Wormholes
- 150 2'x2' ceiling tile - smooth, white, solid
- 151 2'x2' ceiling tile - pinhole w/ 1" wormhole
- 162 2'x4' ceiling tile - white w/ small and large pinholes

- X HMA Numbers
- XXXX Room Numbers

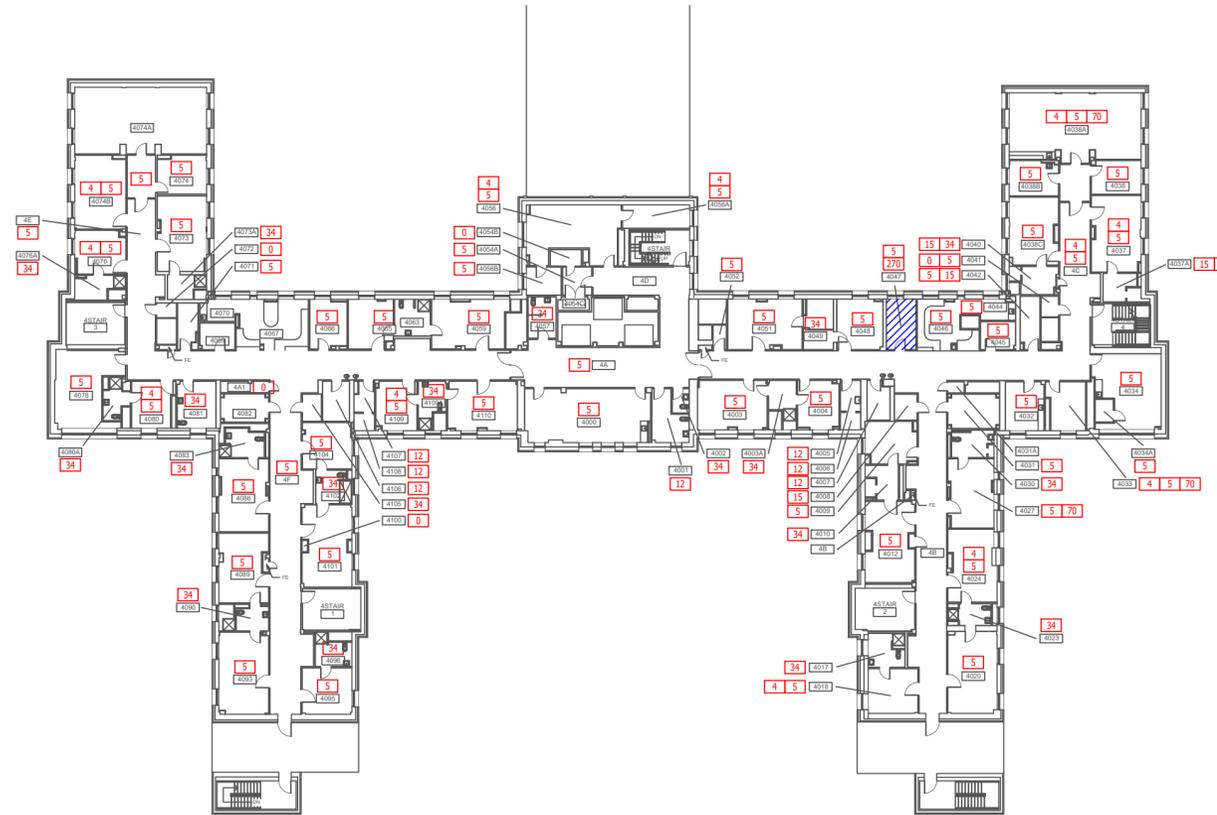
## FOURTH FLOOR - TSI MAP

- X ACM amounts per room
- XXXX Room Numbers

All asbestos pipe insulation is presumed to be in good condition unless otherwise noted as D (damaged) or SD (significantly damaged)

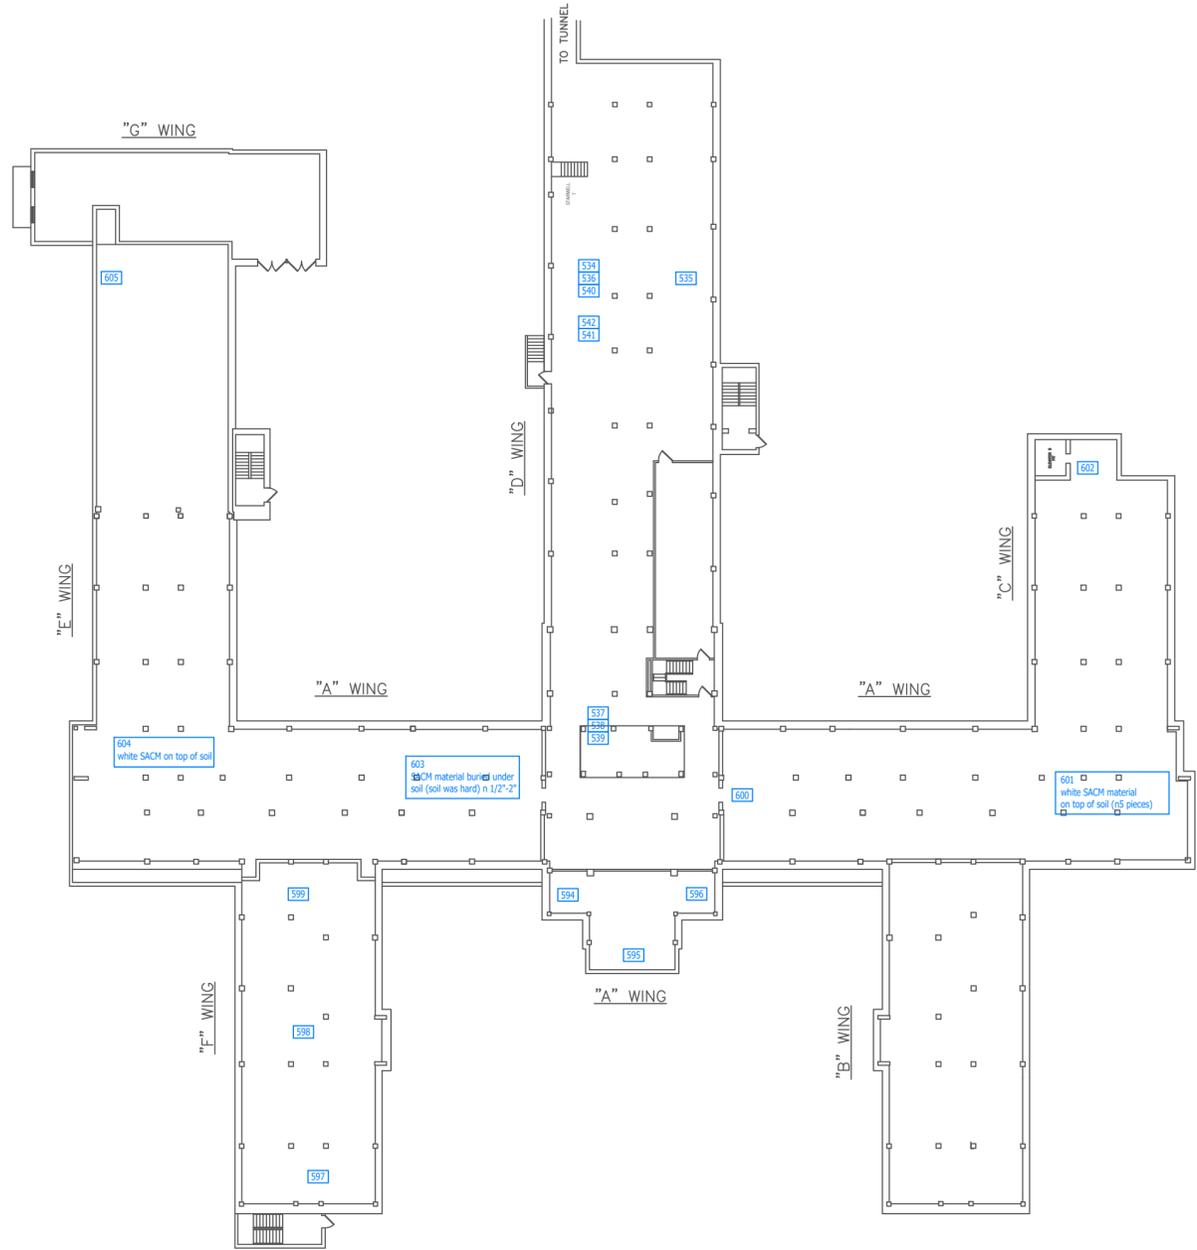
**LEGEND**  
**BASEMENT FLOOR - SAMPLE LOCATION MAP**  
 SCALE: 1/16" = 1'-0"

XXX Sample Number

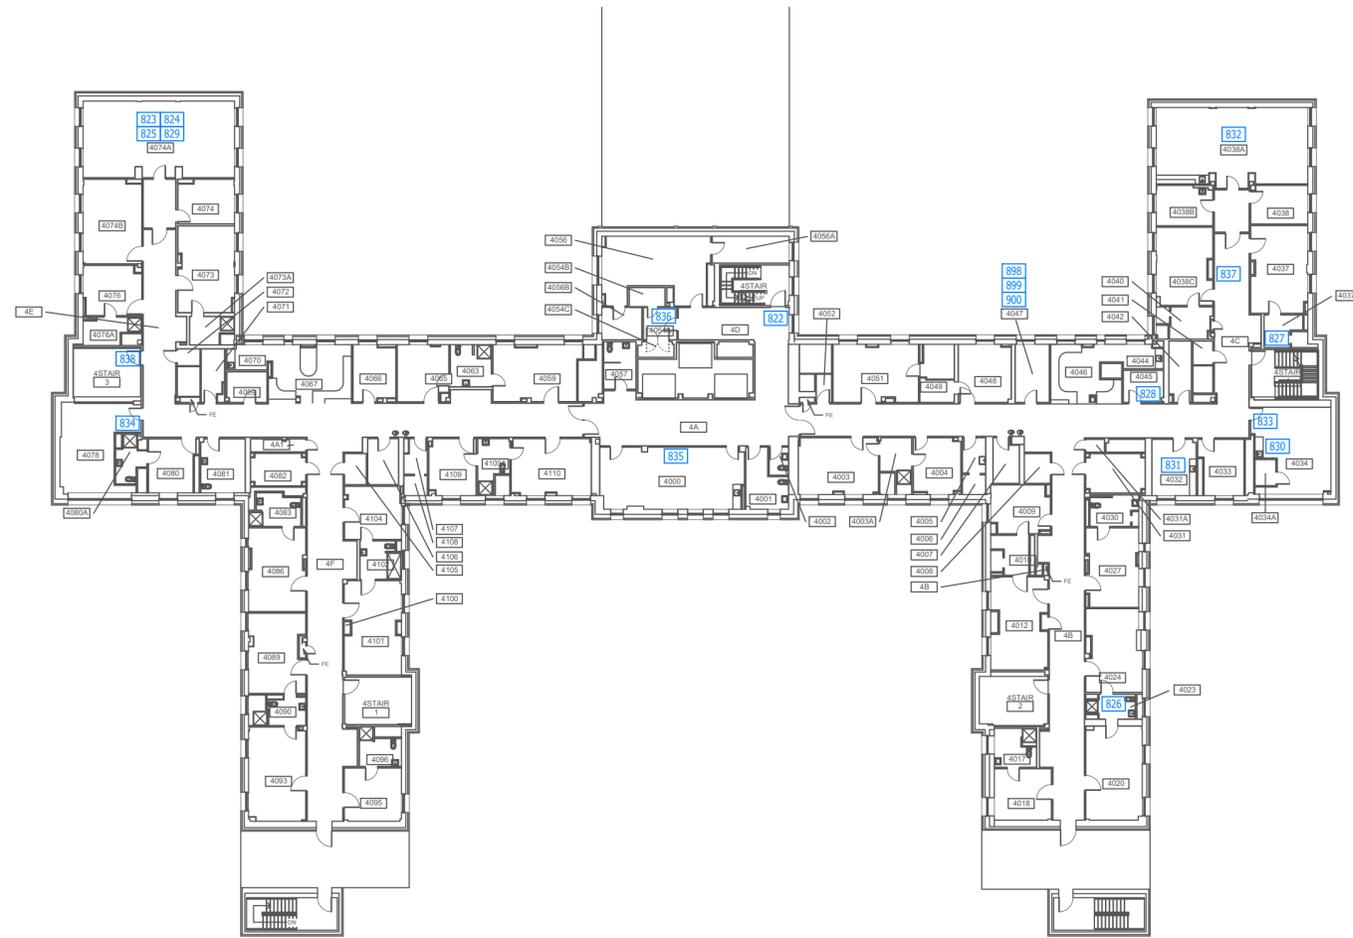
**LEGEND**  
**FOURTH FLOOR - SAMPLE MAP**  
 SCALE: 1/16" = 1'-0"

832 Sample Number

Drawing Title BUILDING 1 - 4th Floor Sample Locations		Project Title 2018 ASBESTOS ASSESSMENT		Date 11/19/2018
Approved Division Chief	Drawn JRR	Building No. 1	Project No. SH1457	
Approved Service Director	Checked JRR	Location JOHN J. PERSHING VA MEDICAL CENTER 100 NORTH WESTWOOD BLVD. POPULAR BLUFF, MISSOURI STATION 857A		
Drawing Number			Dwg. of X
