OR DOT 18(2) OR-58: FIX-IT CORRIDOR CULVERTS HYDRAULICS REPORT

MAY 23, 2022

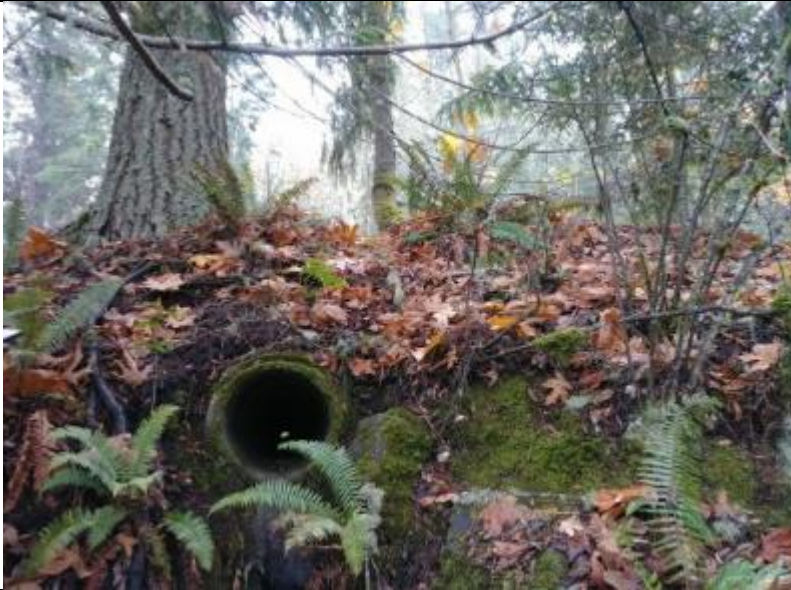
4	D027828	13.56	<p>Dense vegetation at entrance (sheet flow)</p> <p>No vegetation at outlet (discharge to Dexter Lake)</p>

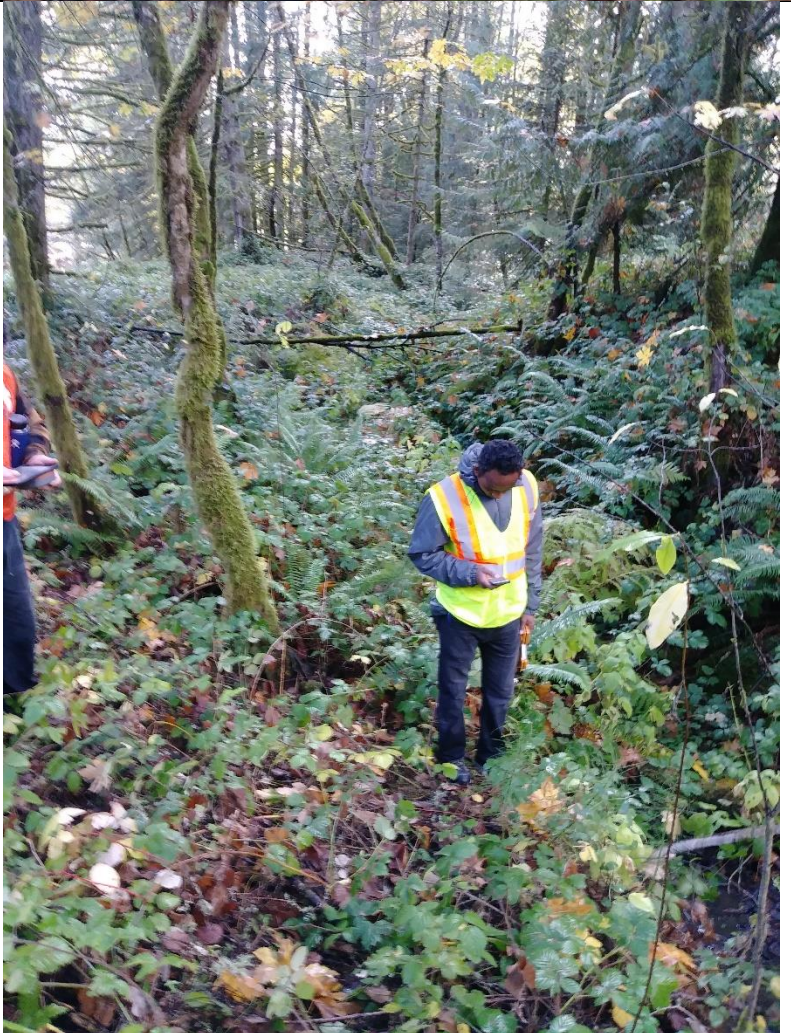
5	D027842	15.51	<p>D027842 is a stream culvert. The road slopes to the outlet and sheet flows through 750 ft of dense forest to Lookout Point Lake.</p>

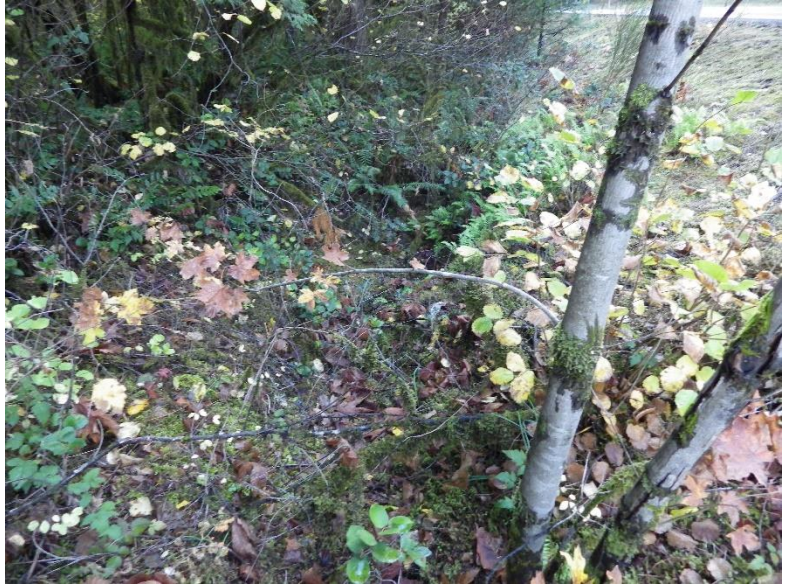
9	D028033	31.47	<p>The flow from outlet goes through 1550 ft of a dense vegetation and discharges into the Middle Fork-Willamette River.</p>

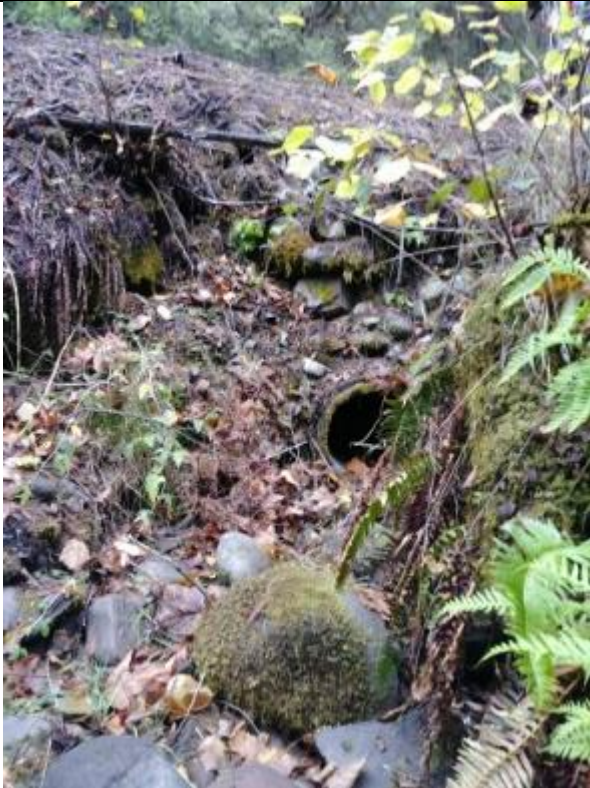
10	D028052	37.68	The flow from outlet goes through 50 ft of a dense vegetation and discharges into Salt Creek.

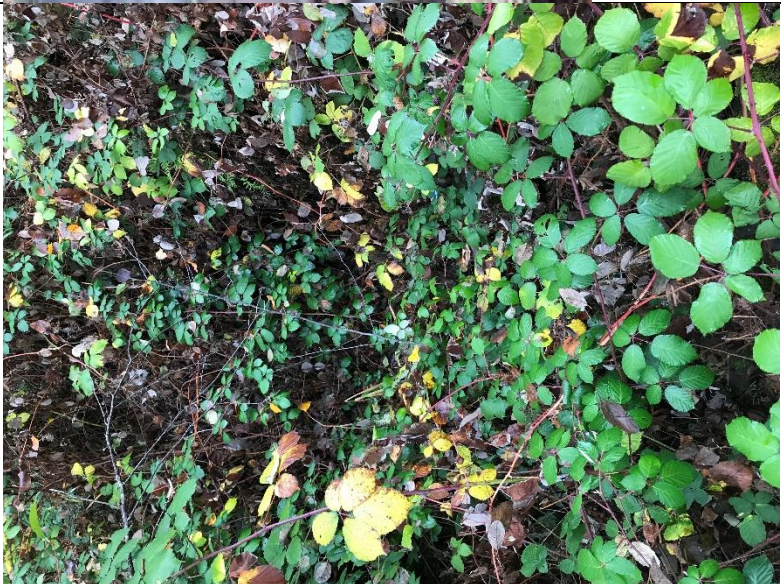
11	D028053	37.89	The flow from outlet goes through 150 ft of a dense vegetation and discharges into Salt Creek.

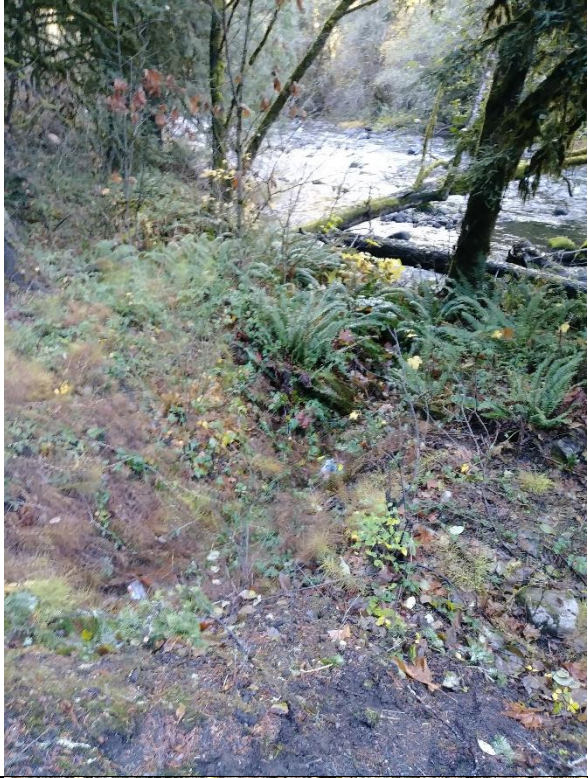
12	D028074	41.5	The flow from outlet goes through 35 ft of a dense vegetation and discharges into Salt Creek.

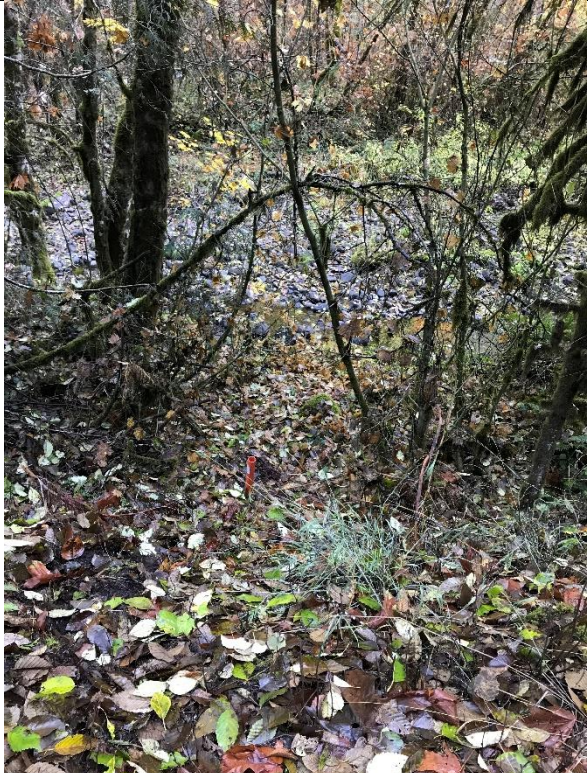
13	D028076	41.91	Stream culvert. The road slopes to the outlet and sheet flows through 100 ft of dense forest to Salt Creek.

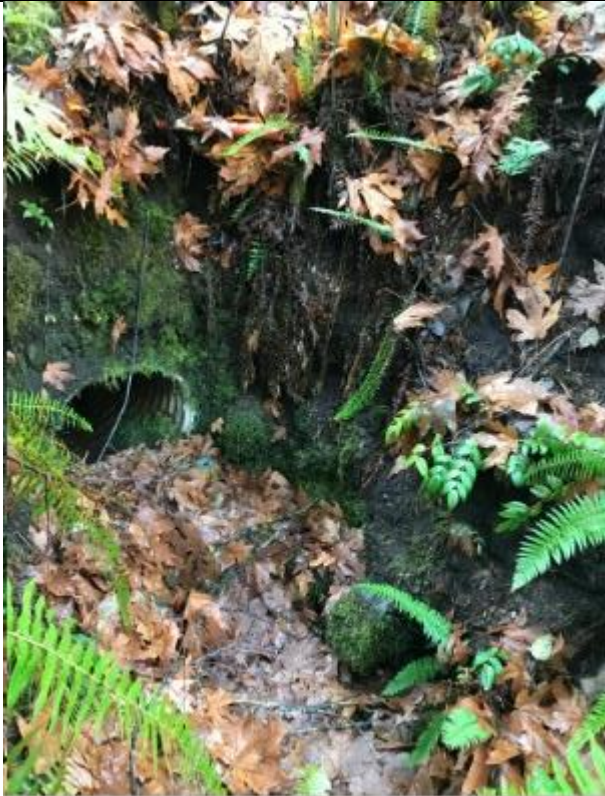
14	D028078	42.12	The flow from outlet goes through 25 ft of a dense vegetation and discharges into Salt Creek.

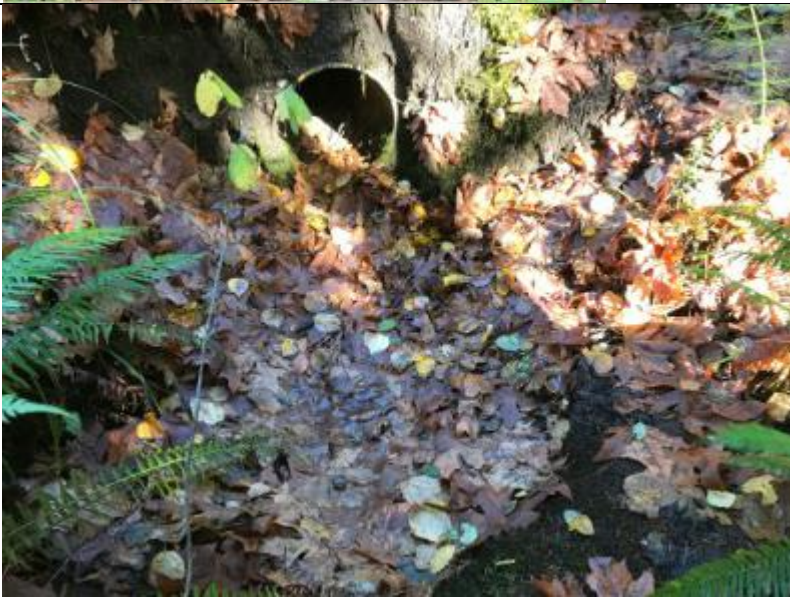
15	D028090	43.54	The flow from outlet goes through a sparse vegetation and discharges into Salt Creek.

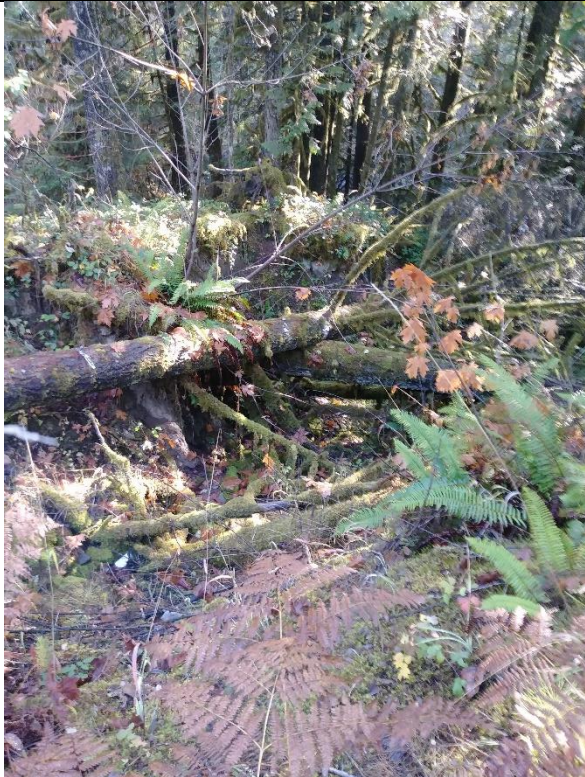
16	D028095	44.06	Stream culvert. The road slopes to the outlet and sheet flows through 150 ft of dense forest to Salt Creek.

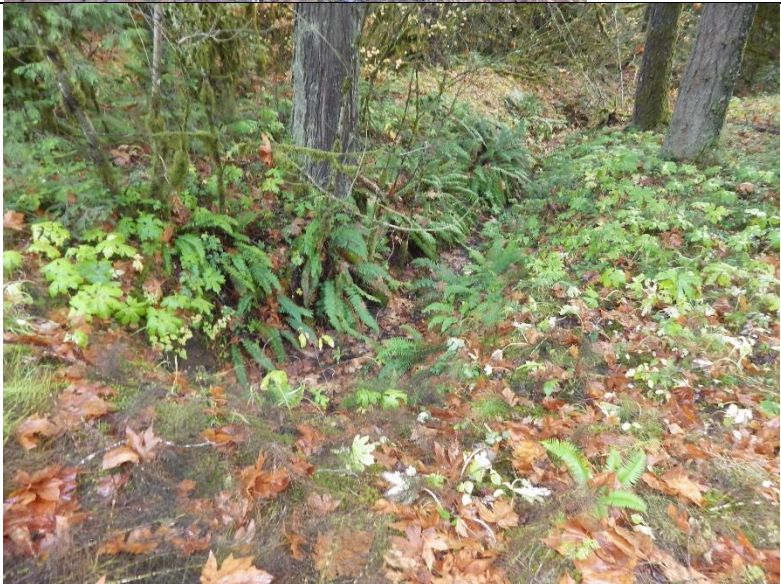
17	D028100	44.36	The flow from outlet goes through 275 ft of a dense vegetation and discharges into Salt Creek.

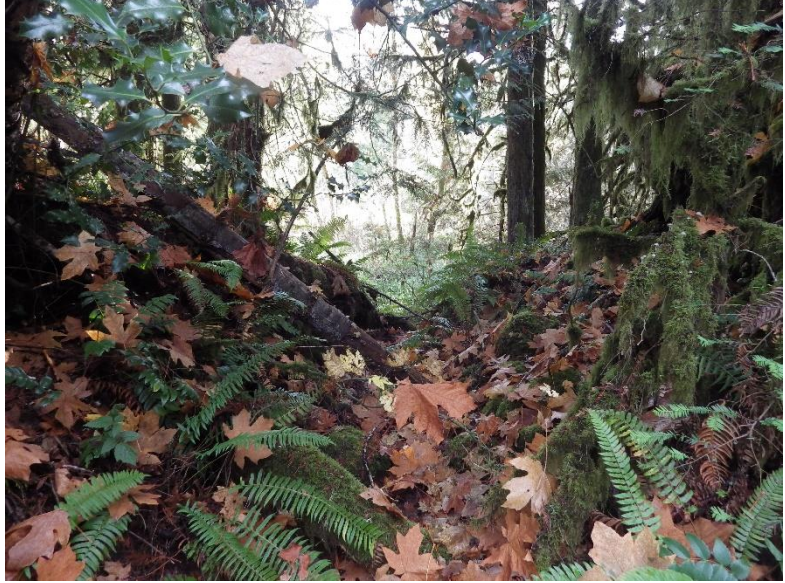
19	D028107	44.96	The flow from outlet goes through a dense vegetation and discharges into Salt Creek.

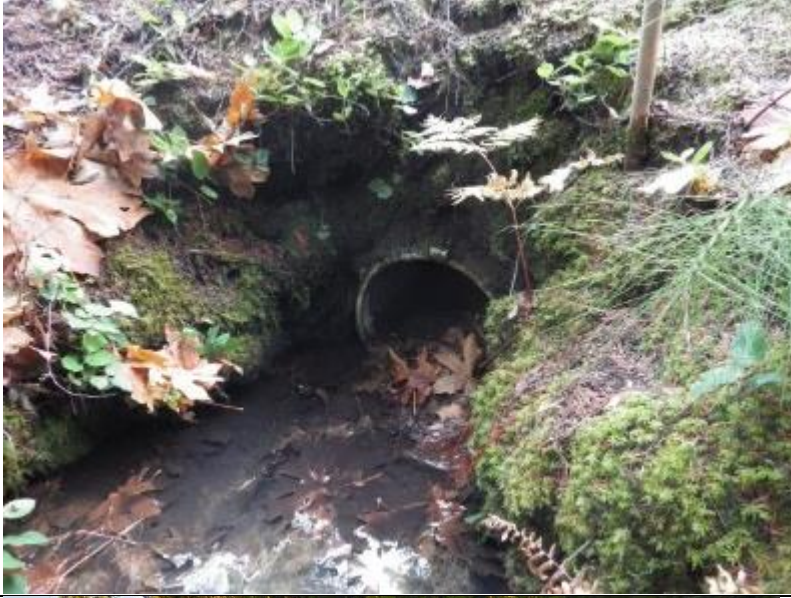
20	D028108	45.03	Stream culvert. The road slopes to the outlet and sheet flows through 350 ft of dense forest to Salt Creek.

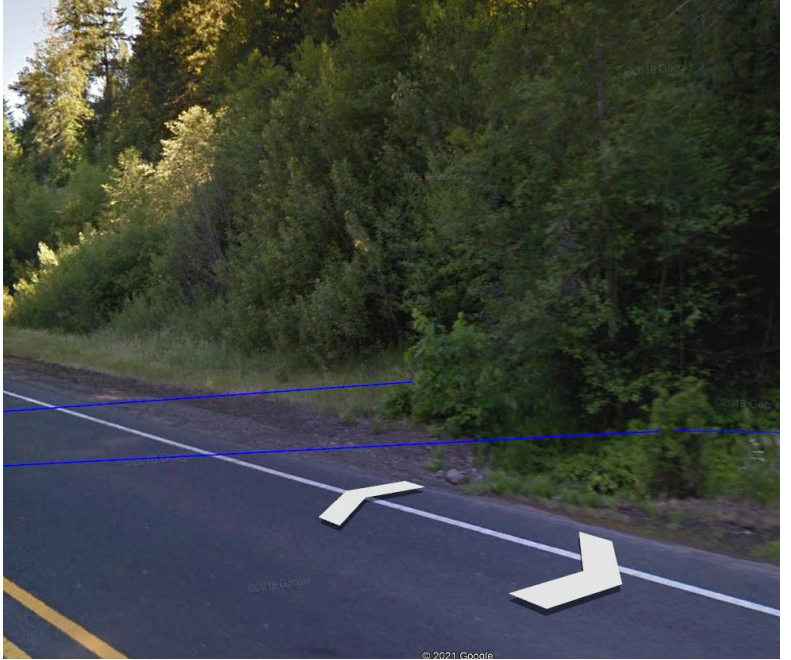
21	D028124	46.75	Stream culvert. The road is crowned. Half of the road sheet flows over 4 ft of embankment and along a vegetated v-ditch before reaching the inlet. The other half, on the outlet side, sheet flows over 500 ft of dense forest to Salt Creek.

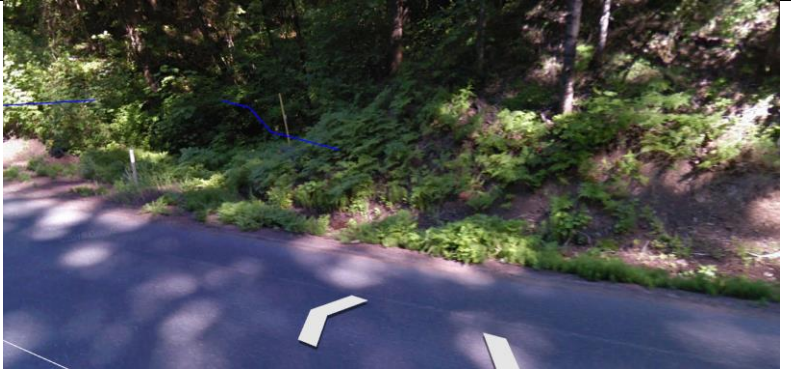
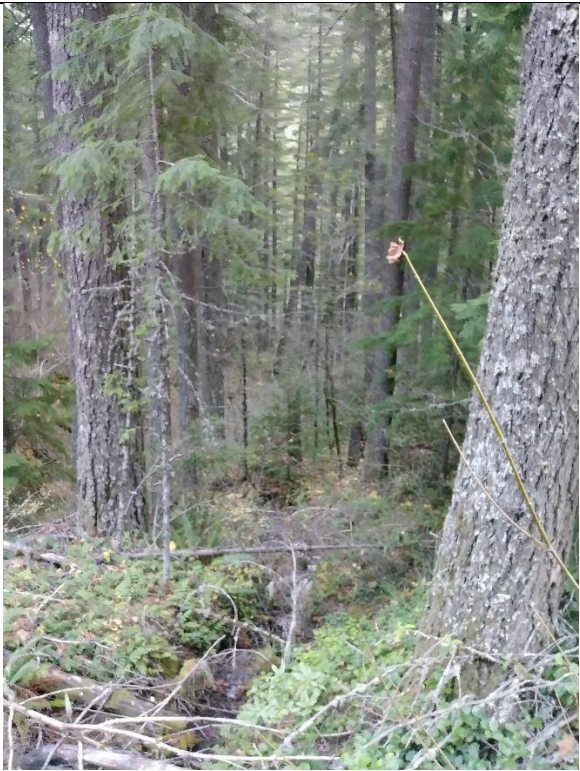
23	D028159	53.69	Stream culvert. The road slopes towards the inlet. Flow to the culvert inlet is along a 300-foot-long ditch against the cliff. Downstream half of the v-ditch is vegetated and the depression at the culvert inlet is wide and heavily vegetated.

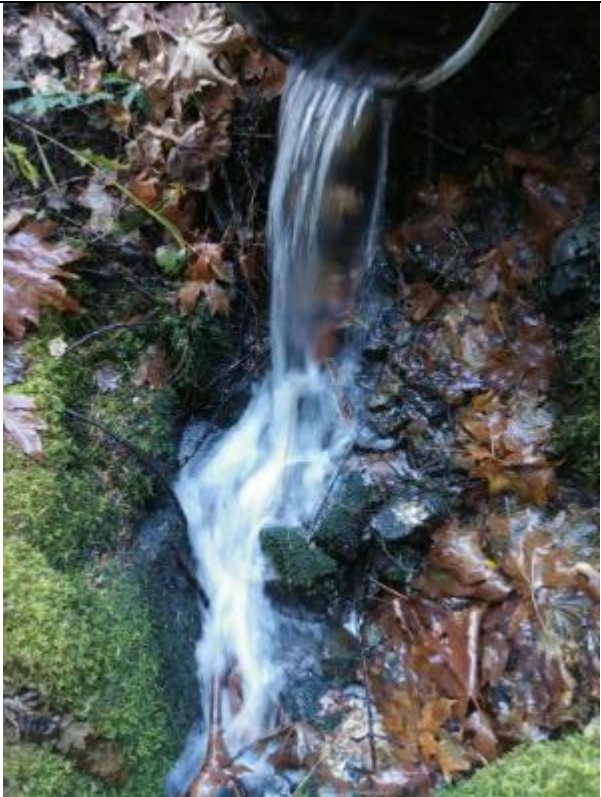
24	D028160	53.76	Stream culvert. The road slopes towards the inlet and sheet flows over 15 ft of embankment and along a wide vegetated ditch before reaching the inlet.

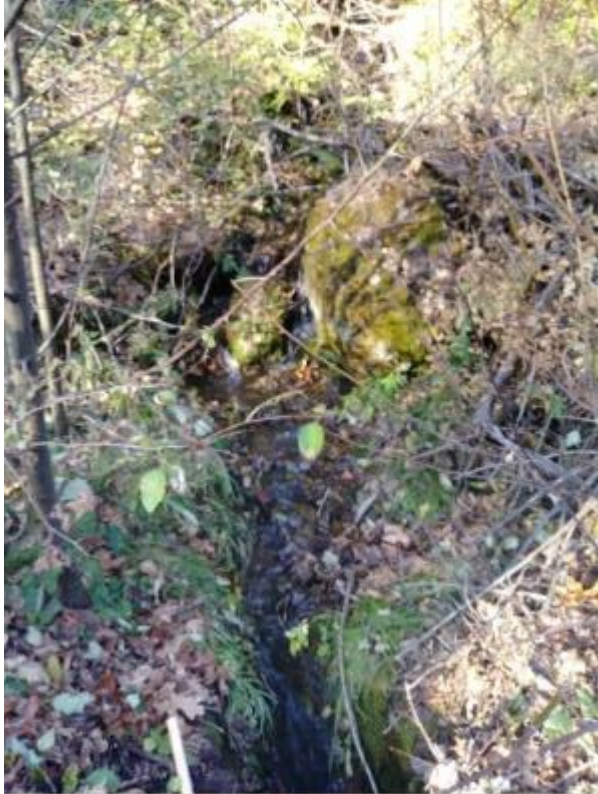
25	D028161	53.83	Stream culvert. The road slopes to the outlet and sheet flows through 1300 ft of dense forest to Salt Creek

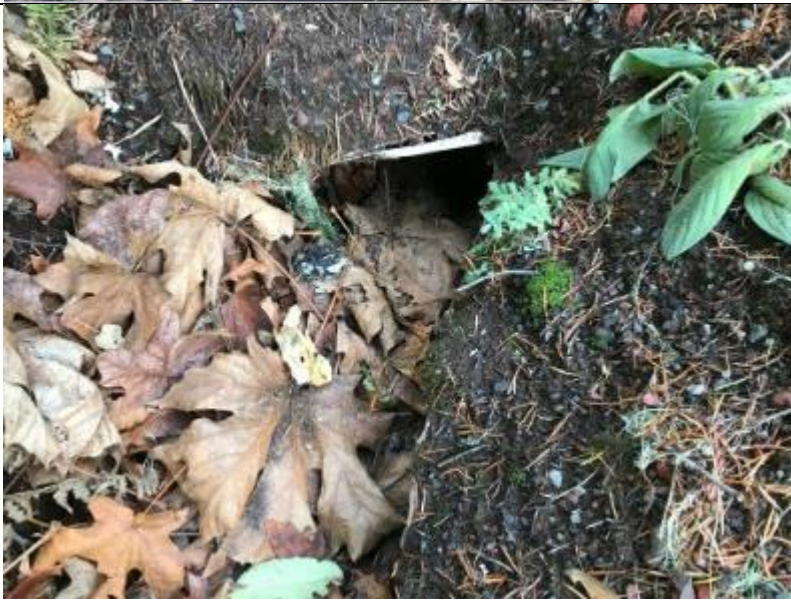
26	D028163	53.95	The flow from outlet goes through 430 ft of a dense forest and discharges into an unnamed tributary.

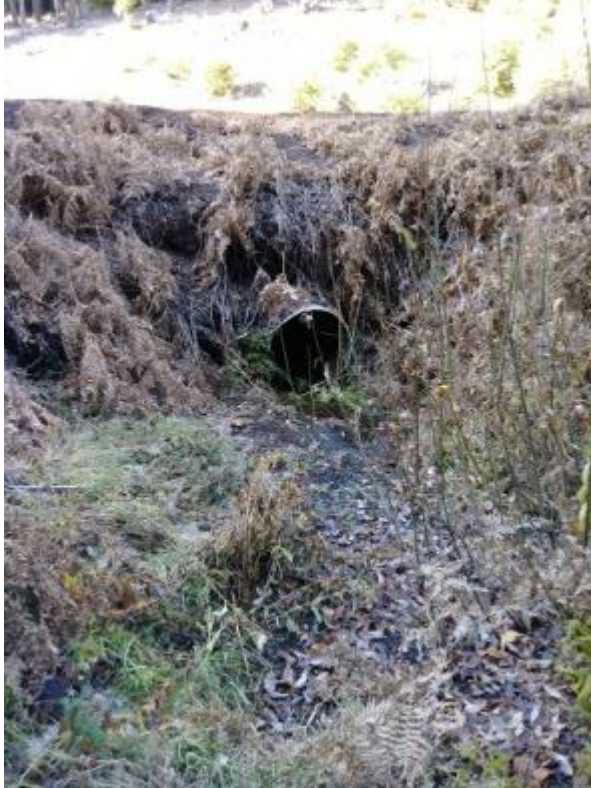
27	D028186	57.77	Stream culvert. The road slopes towards the inlet and sheet flows over 13 ft of embankment and along a 400-foot-long vegetated ditch. 180 ft to Salt Creek from the culvert outlet.
