**VETERANS ADMINISTRATION  
SAN DIEGO HEALTHCARE SYSTEM**  
3350 La Jolla Village Drive  
San Diego, California 92161

Project Name: **ASBESTOSAHERA AND LEAD-BASED PAINT MATERIALS INSPECTION**  
Project Number: **P14320.V11** Dates: **10-27-2014 to 1-14-2015**  
Inspectors: **F.B., L.P., A.B., B.B.** Drawn by: **A.B., D.B.**

Building: **Building 1**  
Location: **4th Floor - Interstitial Ceiling**  
Materials: **Asbestos Containing Materials**

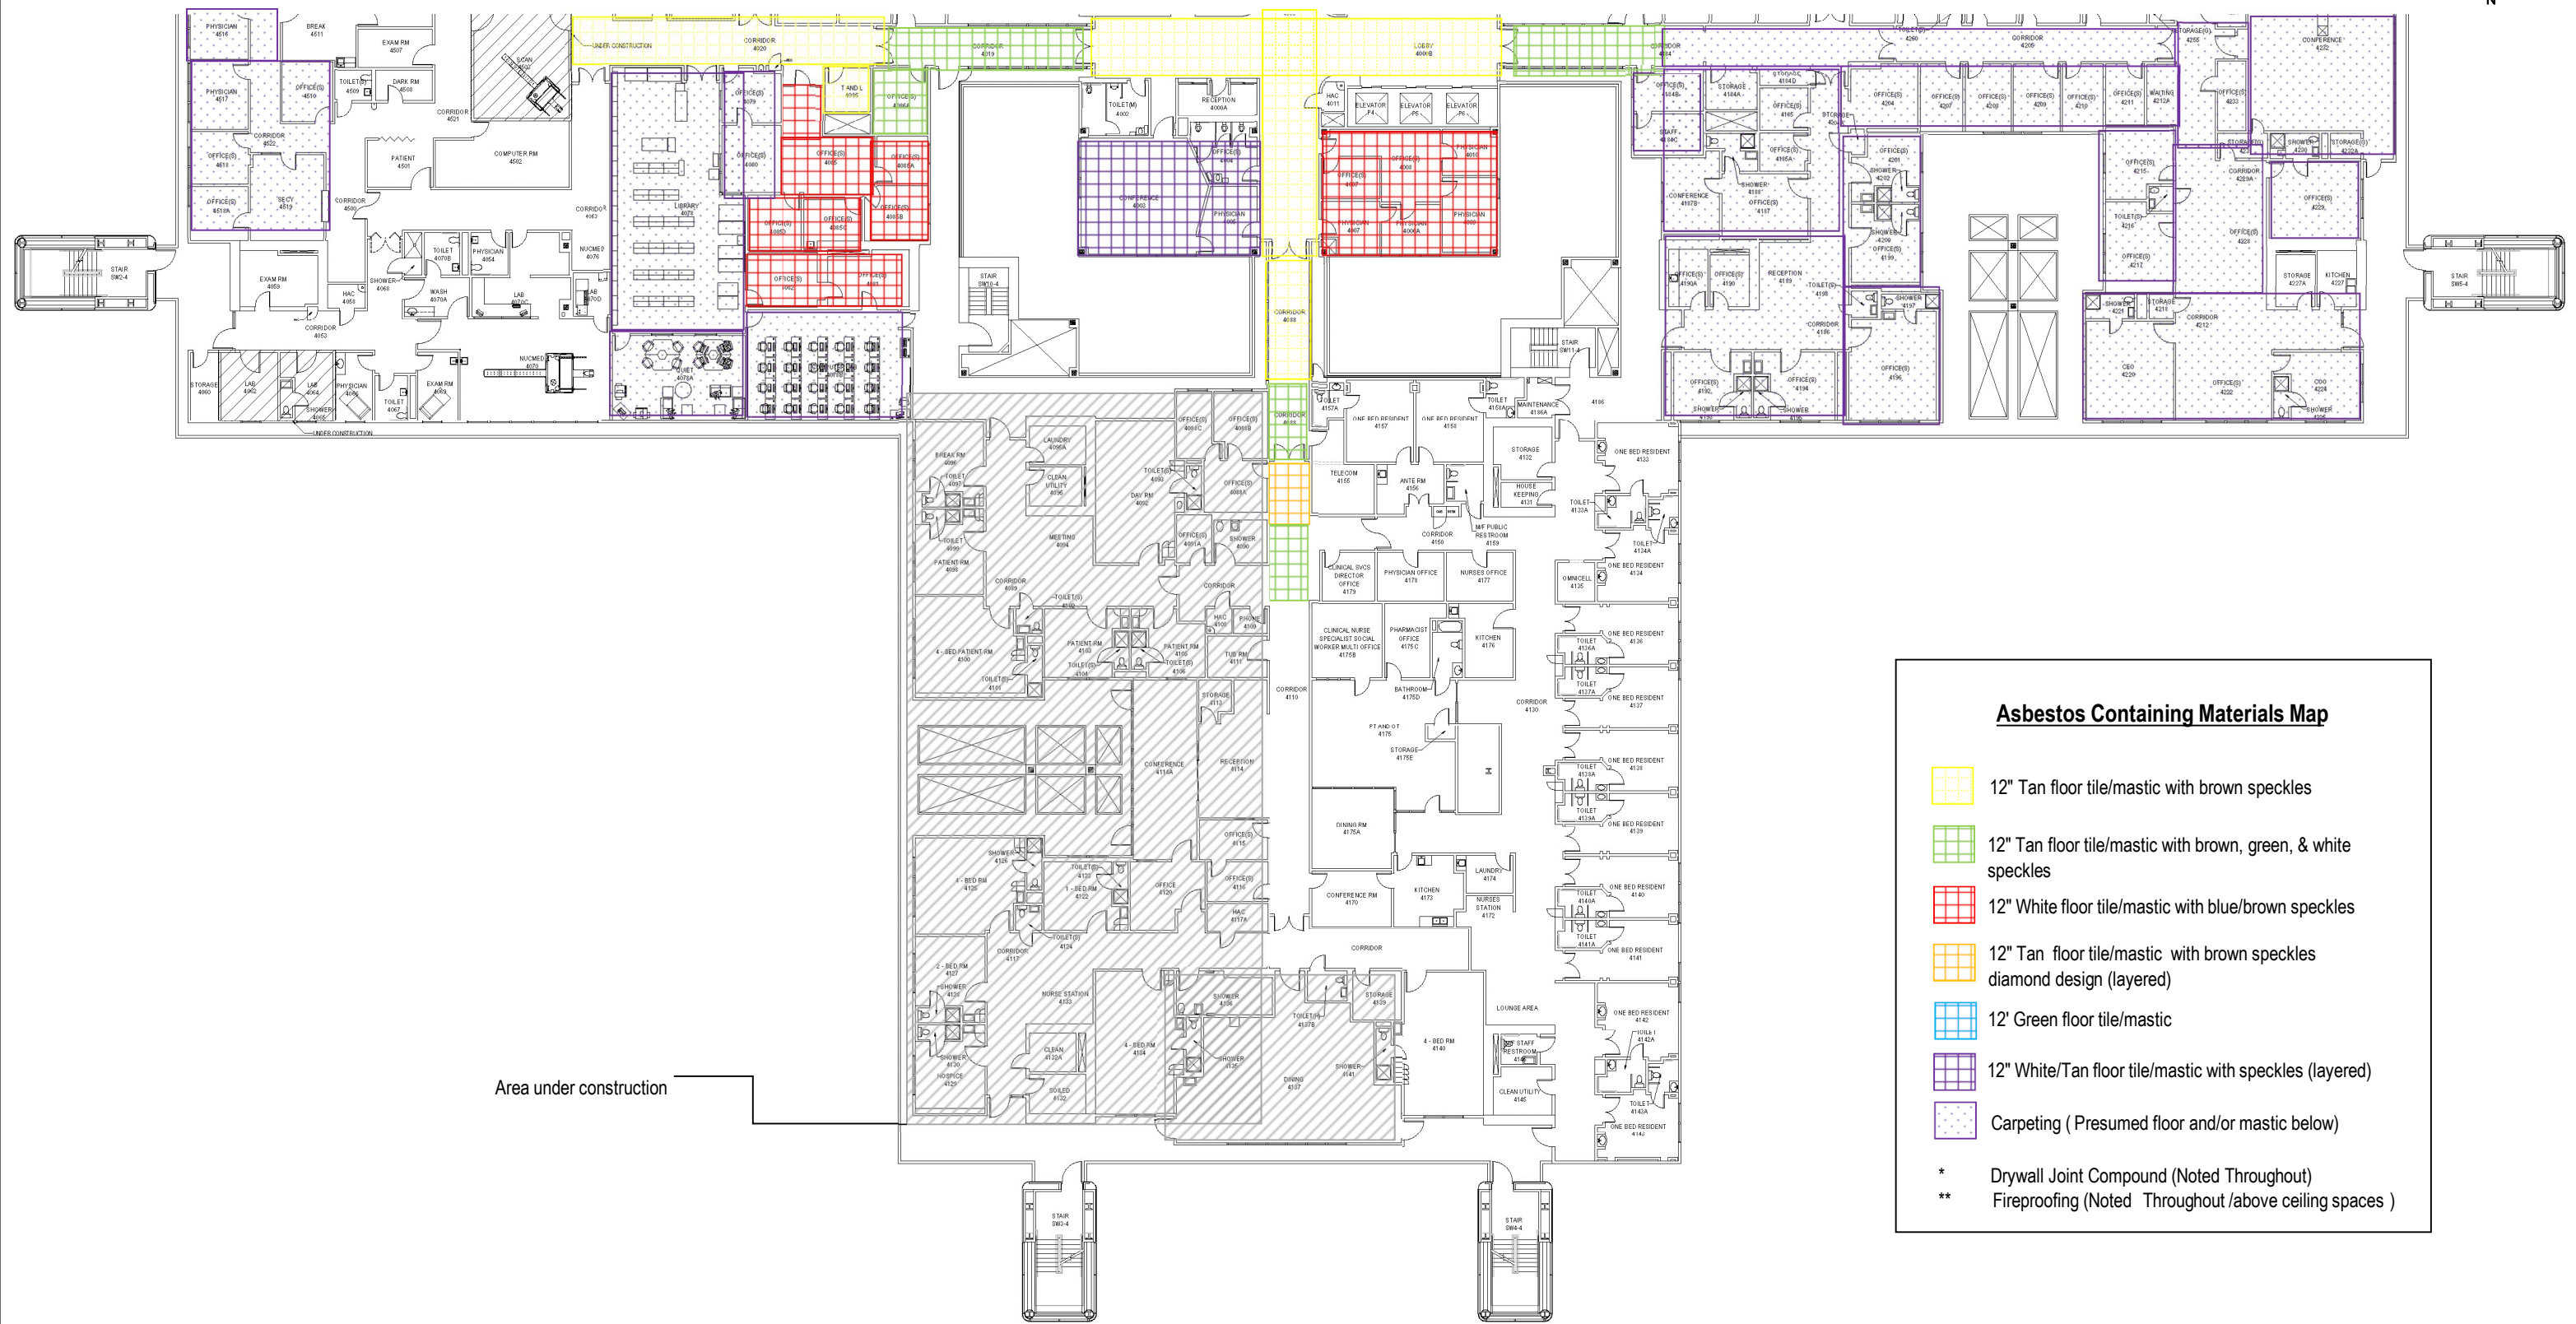
Sheet No:  
**23 of 59**

### Asbestos Containing Materials Map

12" Tan floor tile/mastic with brown speckles
-

12" Tan floor tile/mastic with brown, green, & white speckles
-

12" White floor tile/mastic with blue/brown speckles
-

12" Tan floor tile/mastic with brown speckles diamond design (layered)
-

12' Green floor tile/mastic
-

12" White/Tan floor tile/mastic with speckles (layered)
-

Carpeting ( Presumed floor and/or mastic below)

- \* Drywall Joint Compound (Noted Throughout)
- \*\* Fireproofing (Noted Throughout /above ceiling spaces )

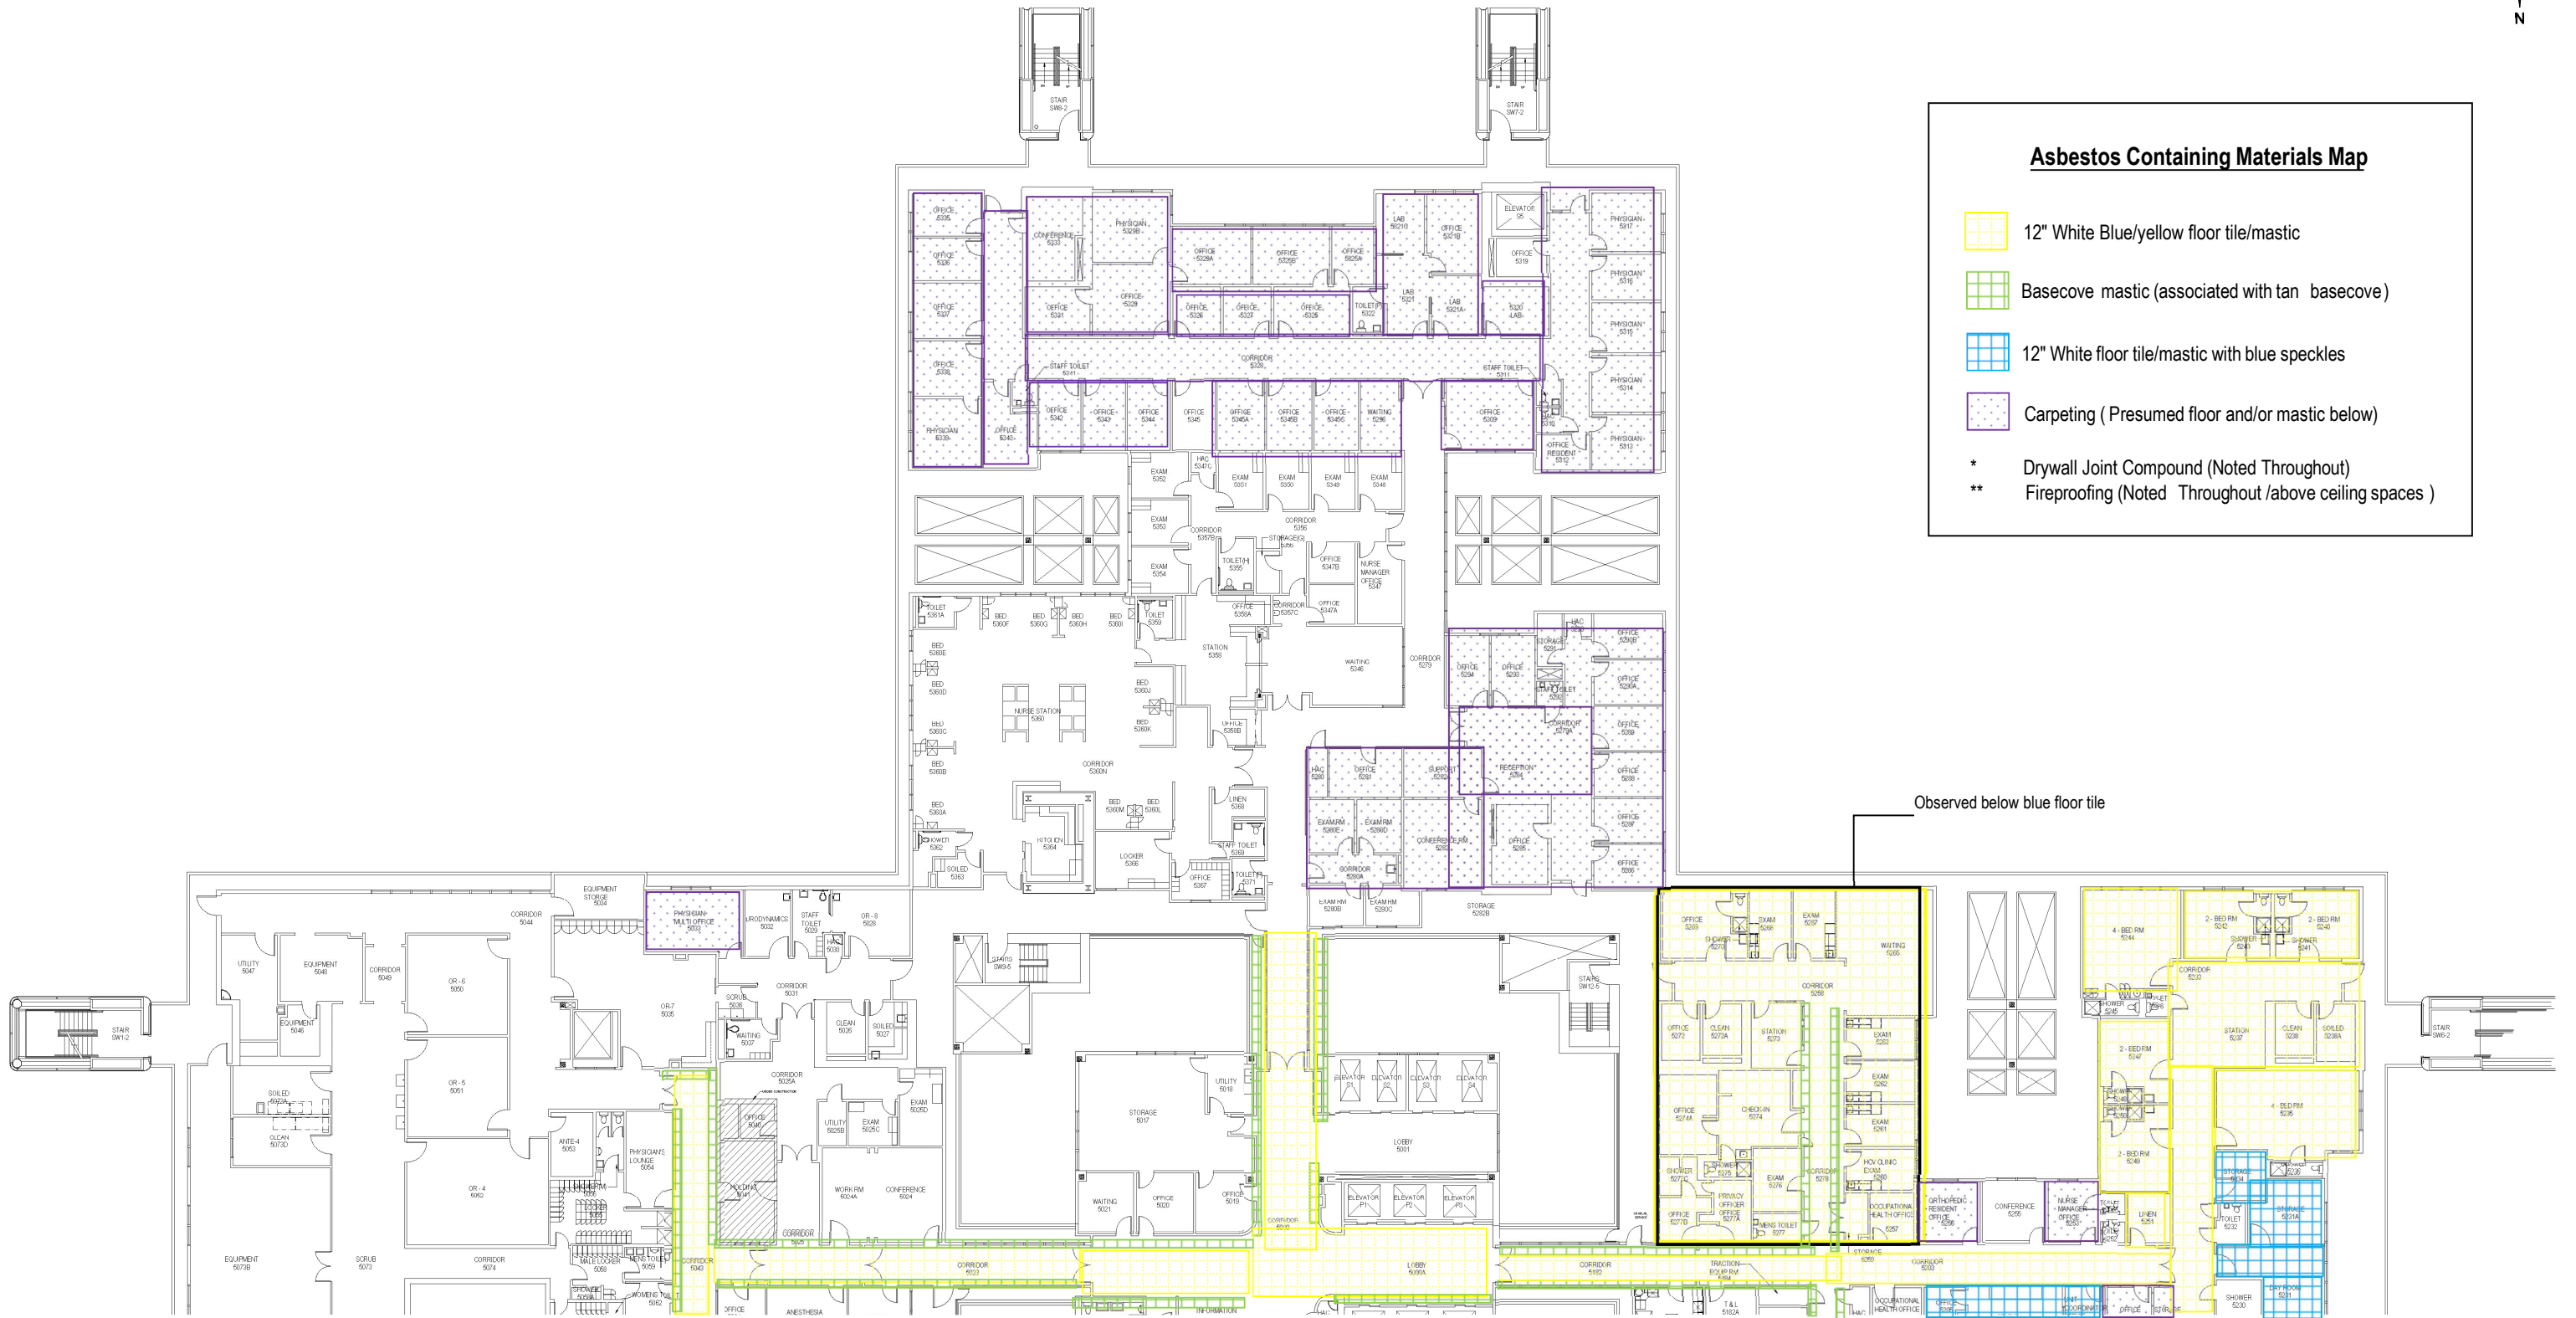
**Asbestos Containing Materials Map**

12" White Blue/yellow floor tile/mastic
-

Basecove mastic (associated with tan basecove)
-

12" White floor tile/mastic with blue speckles
-

Carpeting ( Presumed floor and/or mastic below)
- \* Drywall Joint Compound (Noted Throughout)
- \*\* Fireproofing (Noted Throughout /above ceiling spaces )

Observed below blue floor tile

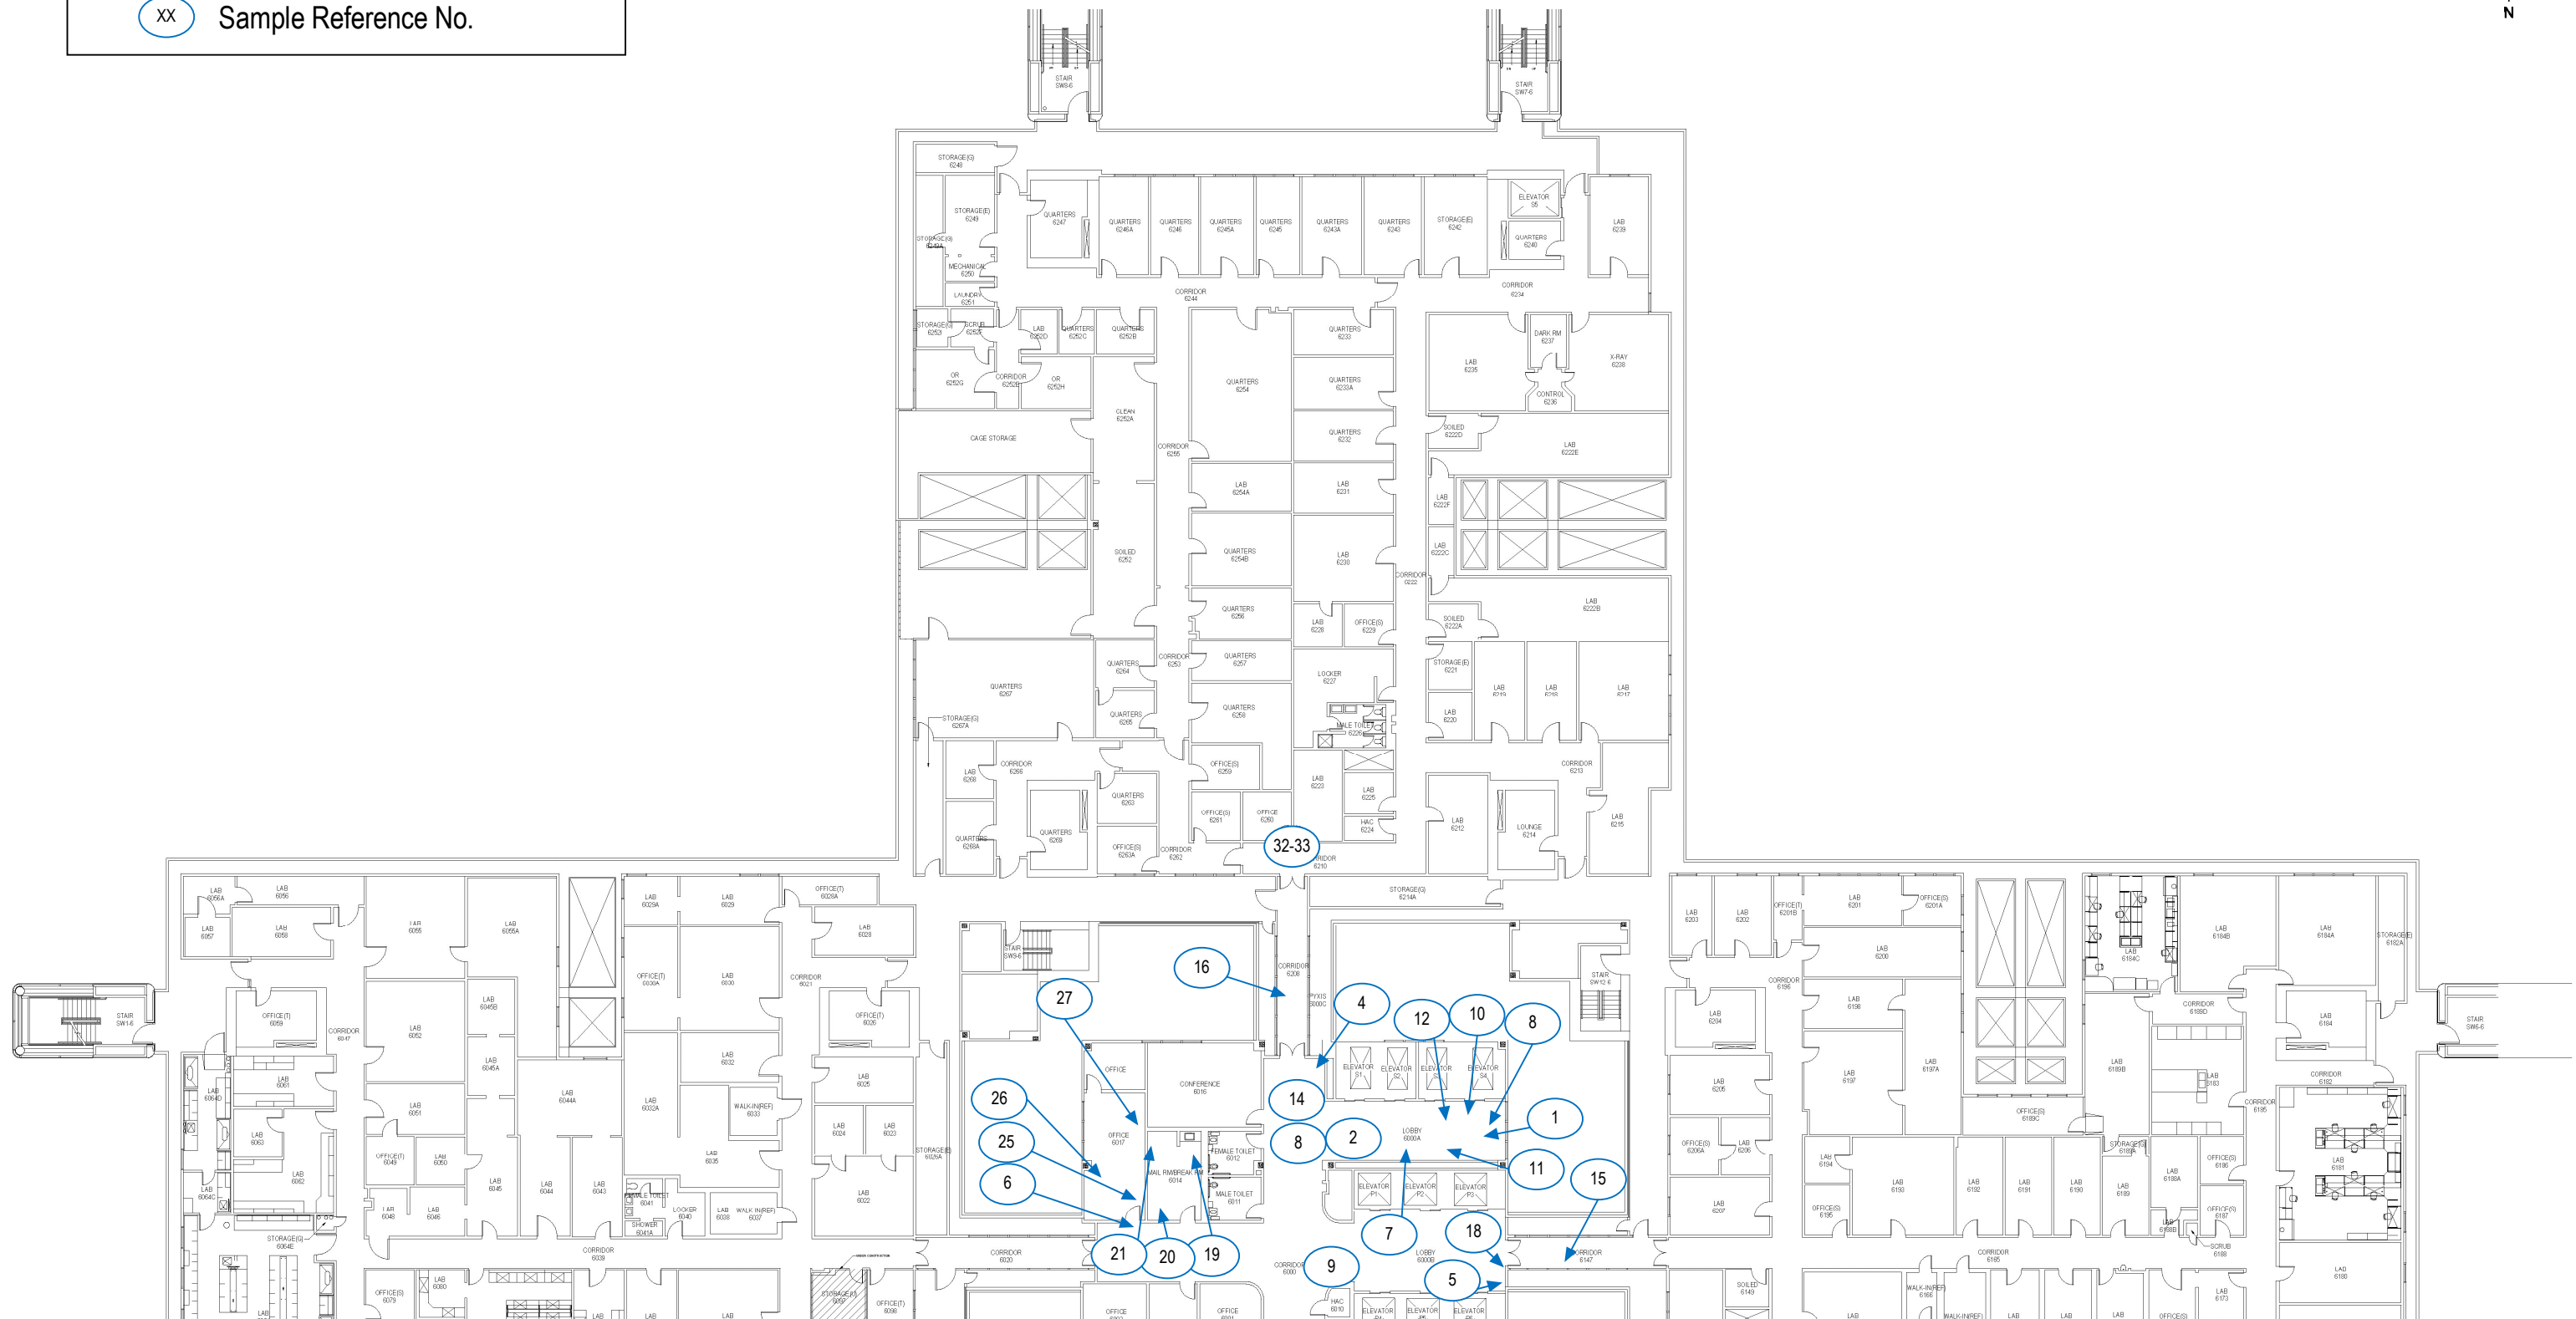
**Sheet No:**  
**29 of 59**

**Building:** Building 1  
**Location:** 6th Floor - North Half Section  
**Materials:** Asbestos Sampling Locations

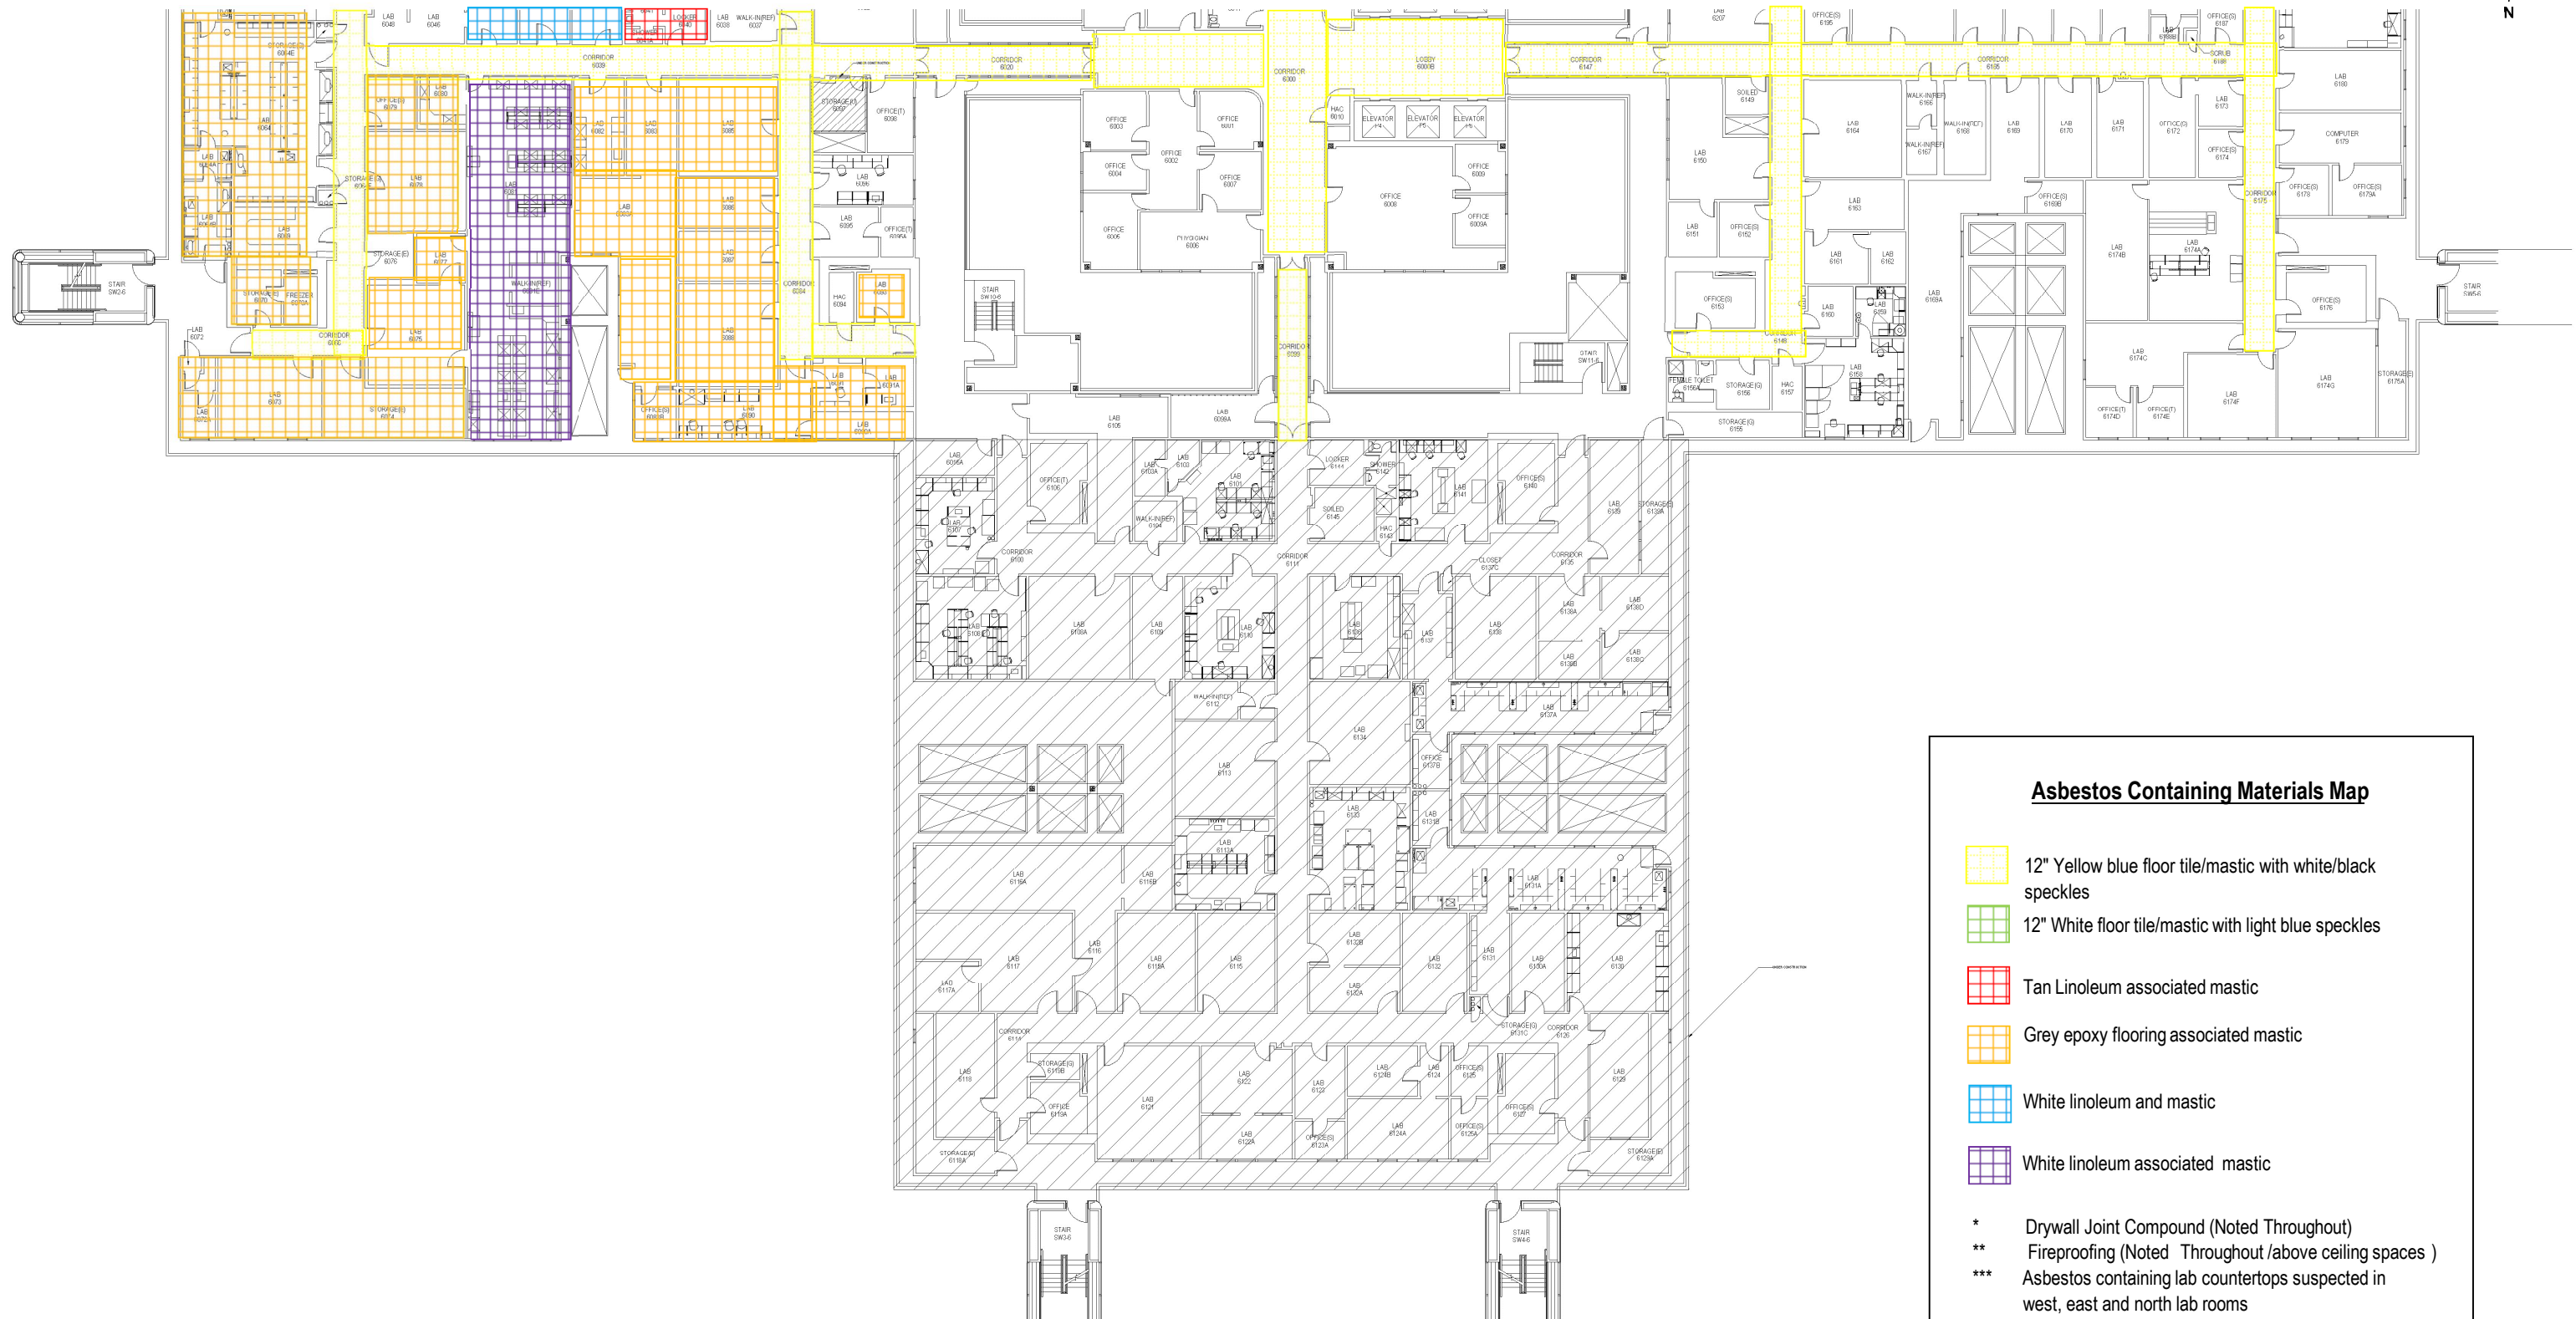
### Asbestos Containing Materials Map

12" Yellow blue floor tile/mastic with white/black speckles
-

12" White floor tile/mastic with light blue speckles
-

Tan Linoleum associated mastic
-

Grey epoxy flooring associated mastic
-

White linoleum and mastic
-

White linoleum associated mastic
- \* Drywall Joint Compound (Noted Throughout)
- \*\* Fireproofing (Noted Throughout /above ceiling spaces )
- \*\*\* Asbestos containing lab countertops suspected in west, east and north lab rooms

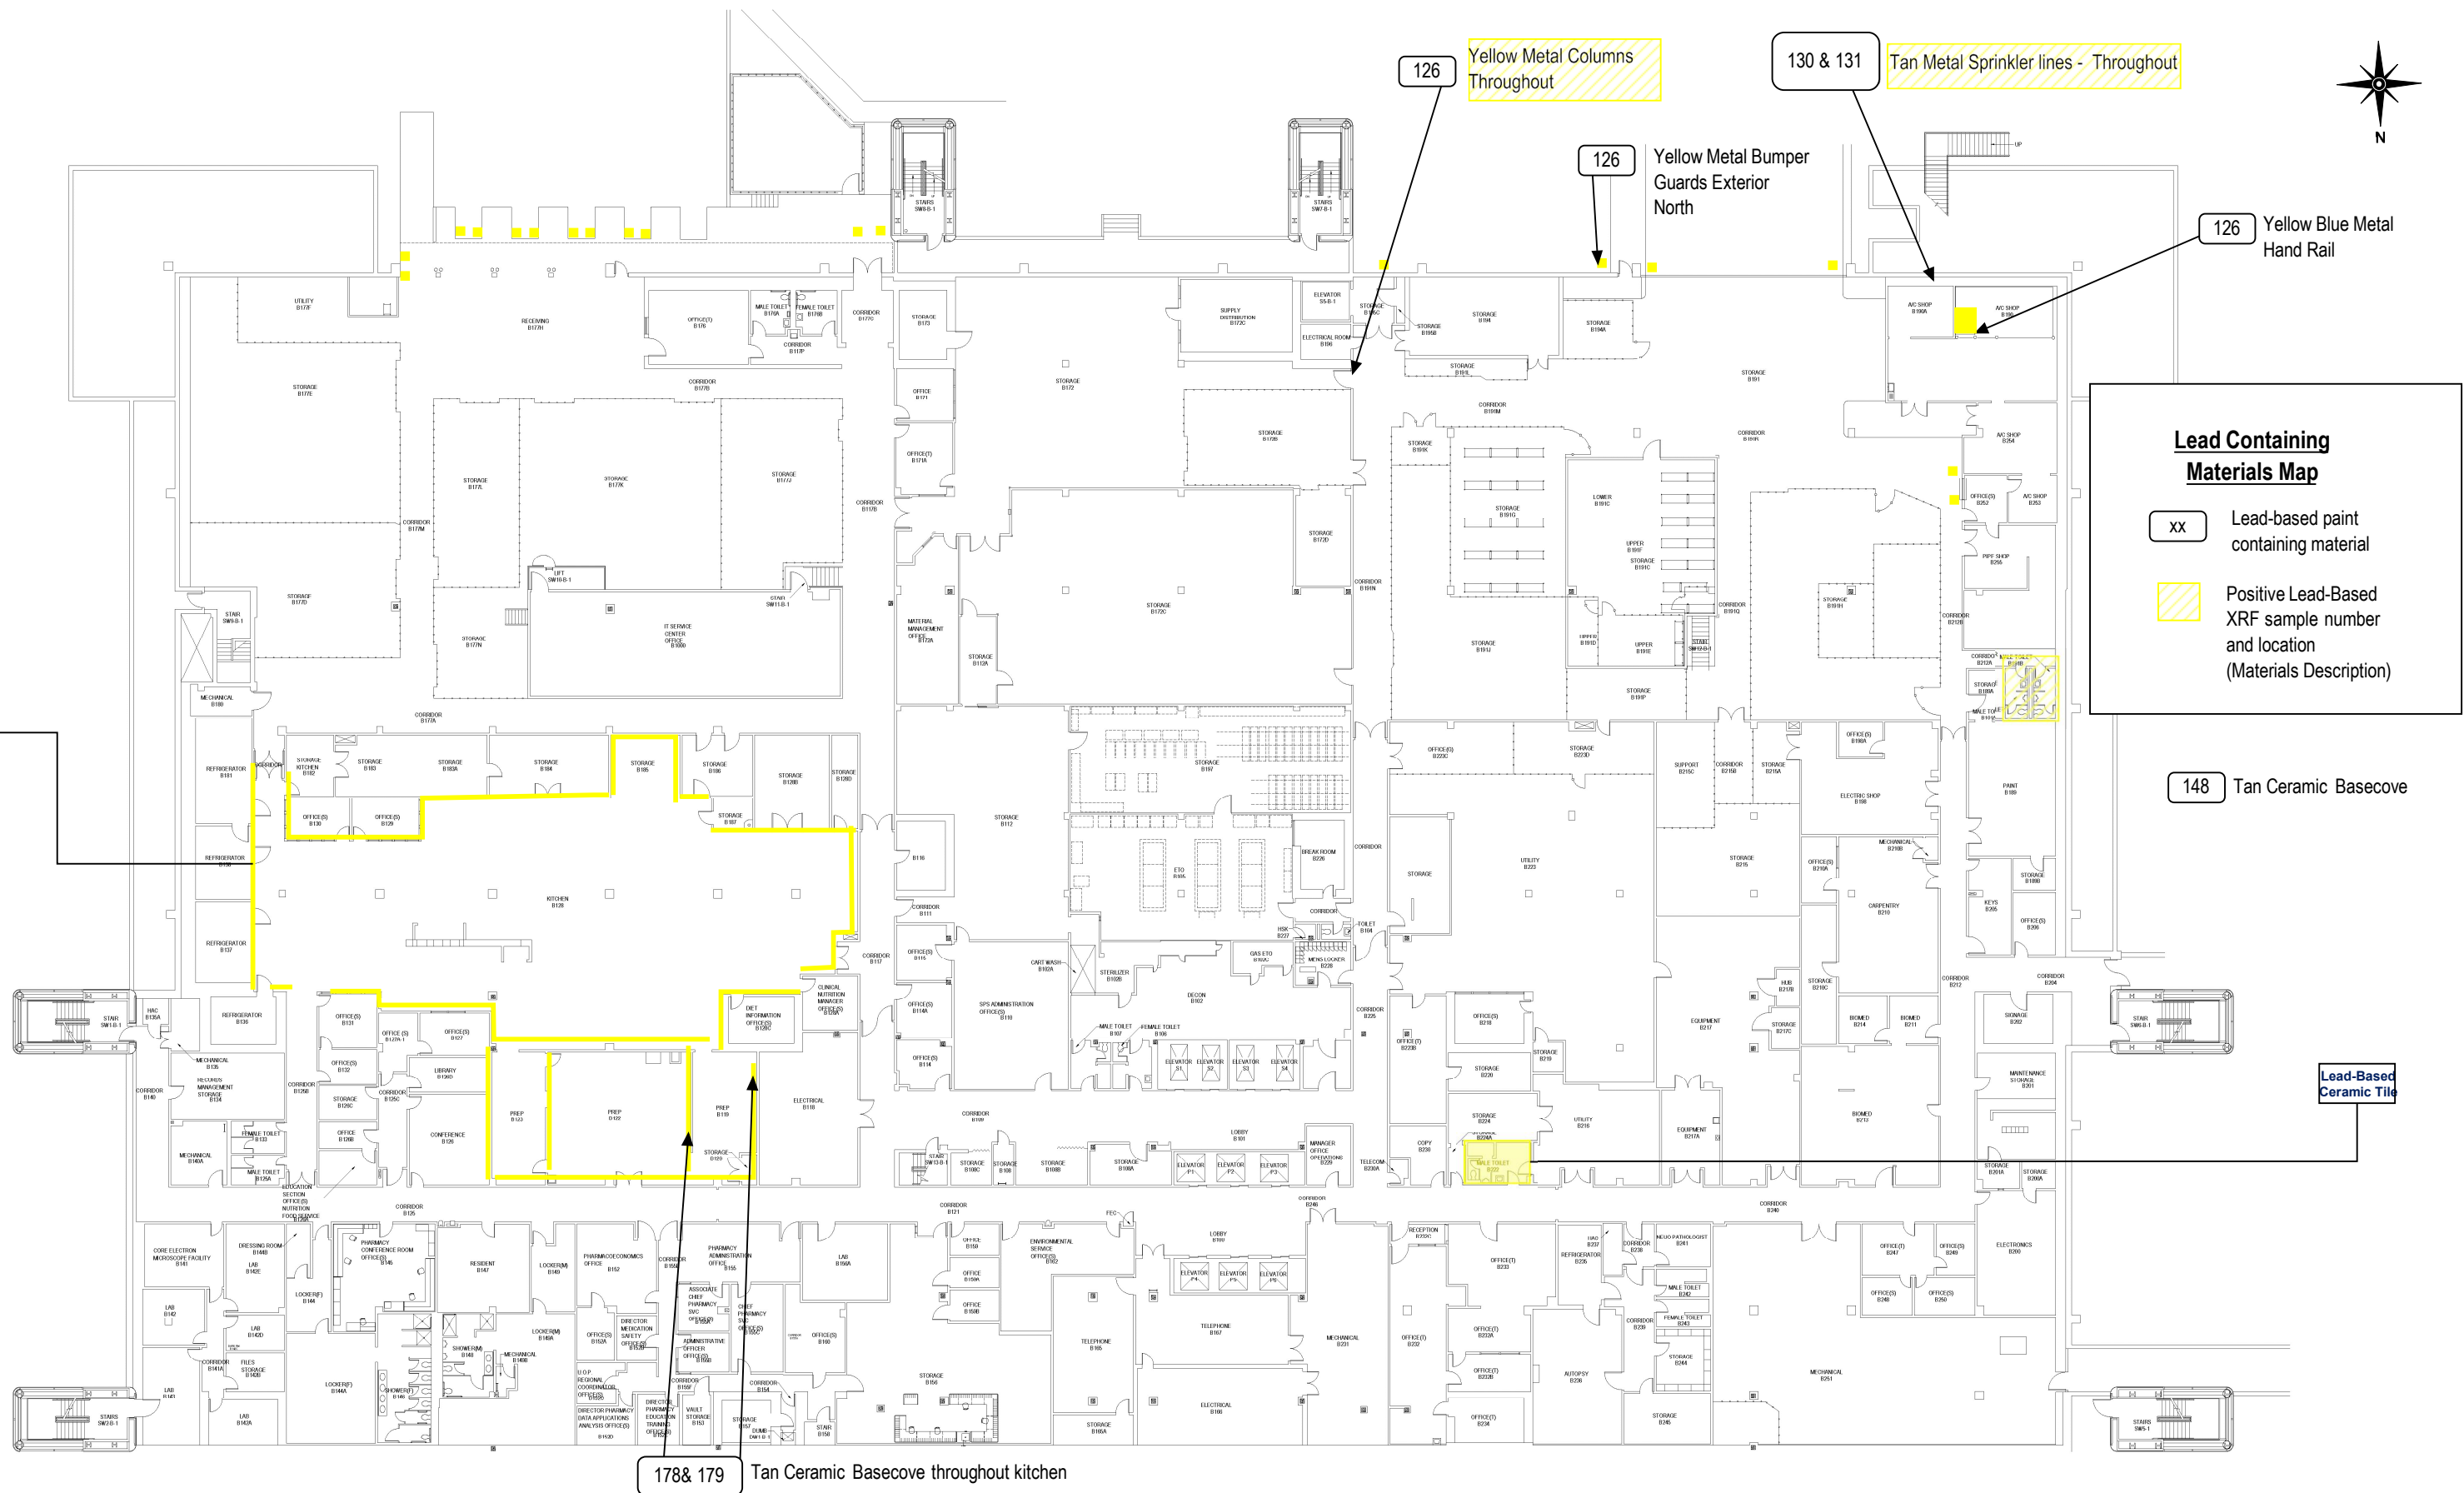
Sheet No:  
**39 of 59**

Lead-Based  
Ceramic Tile

178& 179 Tan Ceramic Basecove throughout kitchen

Building: **Building 1**  
Location: **Basement**  
Materials: **Lead-Based Materials**

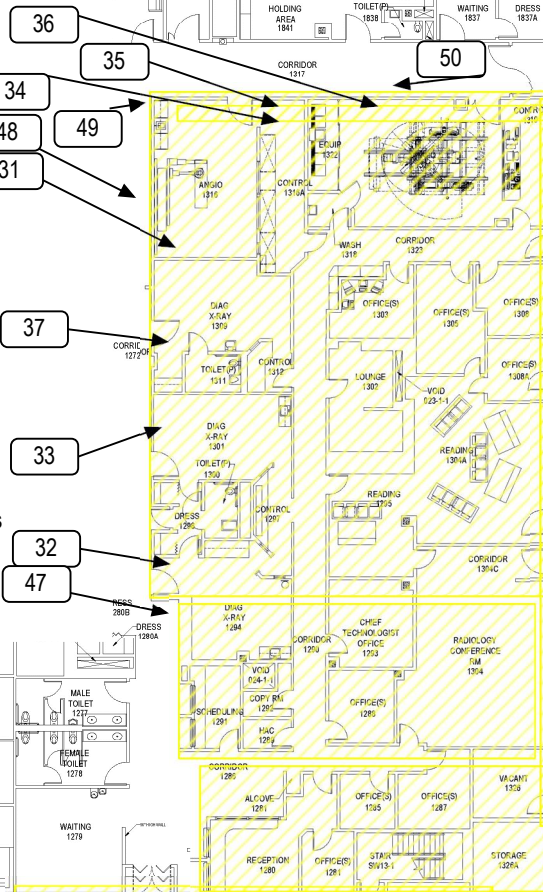
Sheet No:  
**40 of 59**

# Lead Containing Materials Map

91 White ceramic wall tile  
- at drinking fountain

Drywall Walls - Possible  
lead shield in walls

Tan metal door  
Possible lead shield

Building: **Building 1**  
Location: **1st Floor - North Half Section**  
Materials: **Lead-Based Materials**
