**SOLICITATION # 36C77623B0010**

**PROJECT NAME: Poplar Bluff EHRM Training and Administrative Support Construction**

**TECHNICAL QUESTIONS AND VA RESPONSE TRACKING SHEET**

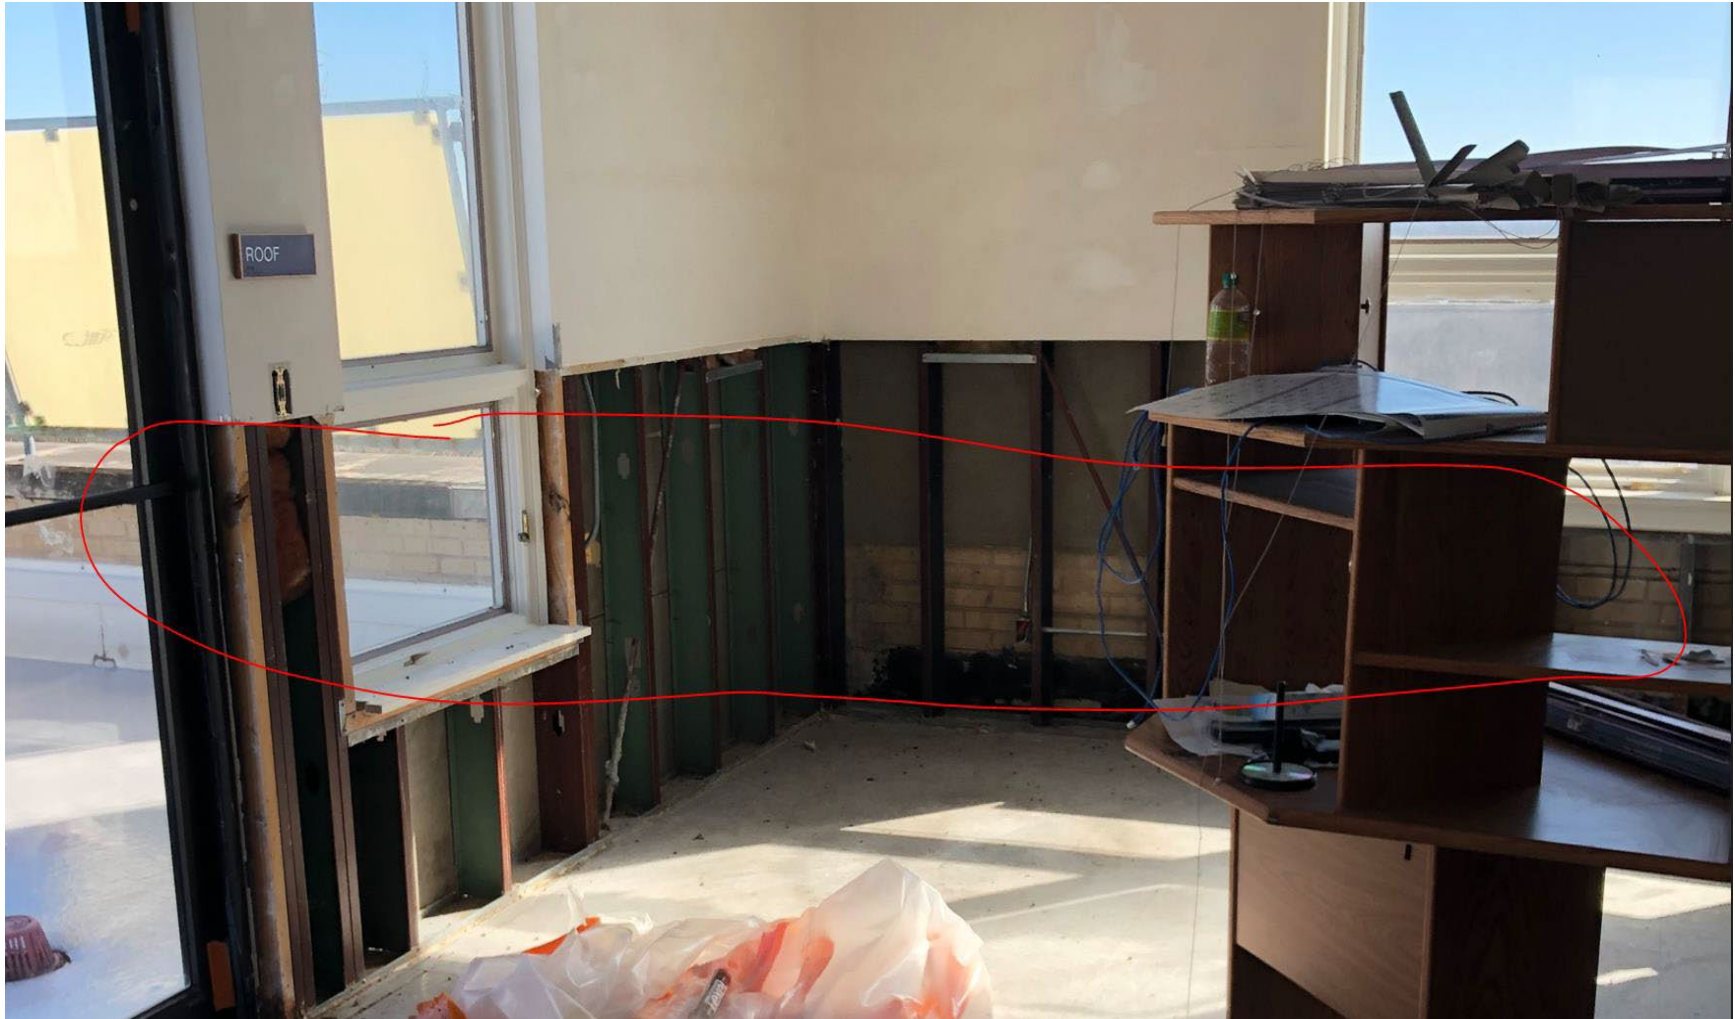
Attachment 1

13.	2-16-23		From the site visit it appears the old addition was built “inside” or on top of the existing parapets walls? Drawing 01-A3 detail 1 indicates we are demoing the exterior walls including the parapet? Is this correct? This may affect the structural integrity of the building. See photos below. <b>See Attachment 1</b>	Parapet wall is being taken down to the 5th floor slab/roof level, details are provided in our design. Building on top of the parapet wall was not feasible from either an architectural or structural perspective.

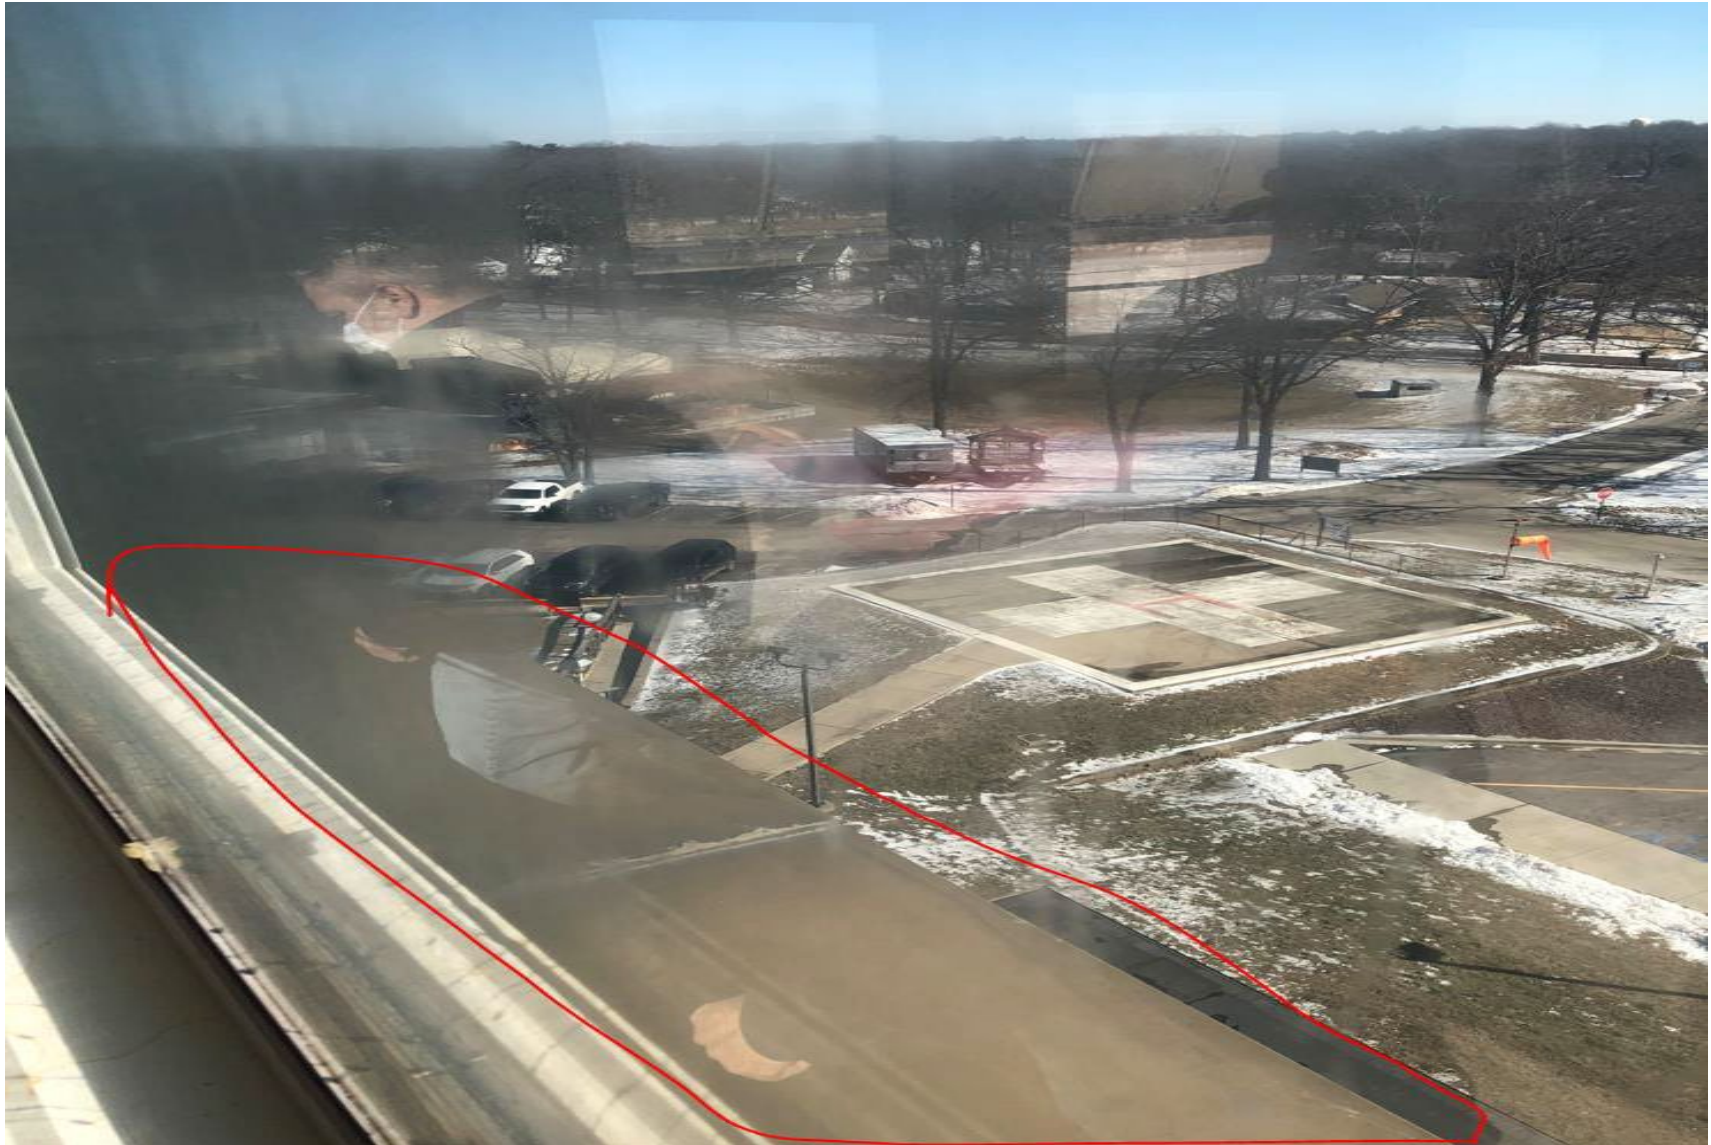
Attachment 2

14.	2-16-23		Also drawing 01-A6 detail 2 wall section does not indicate the existing parapet, therefore, are we to assume we are removing the parapet? Or are we building the new walls on top of the existing parapet? <b>See Attachment 2</b>	The “Design Intent” is to remove the existing parapet wall where the new walls will be located.

15.	2-16-23		If the parapet is to be removed, we will need wall section views at the corners showing how the wall will tie to remaining existing parapet. <b>See Attachment 2</b>	Contractor will need to refer to the existing drawings provided by the VA. Current existing conditions cannot be verified until demolition. Contractor's means & methods shall apply while any coordination questions will be reviewed by the design team.

16.	2-16-23		If parapet stays, please indicate this on detail 2 on 01-A6. <b>See Attachment 2</b>	Refer to item #14
17.	2-16-23		Drawing 01-A6 detail 2 and 4 do not indicate the existing building precast or brick veneer. Please provide details showing the existing exterior veneer. <b>See Attachment 2</b>	Contractor to verify existing brick veneer type and color. On details where existing walls are shown, it is indicated that the "G.C to verify existing structure".

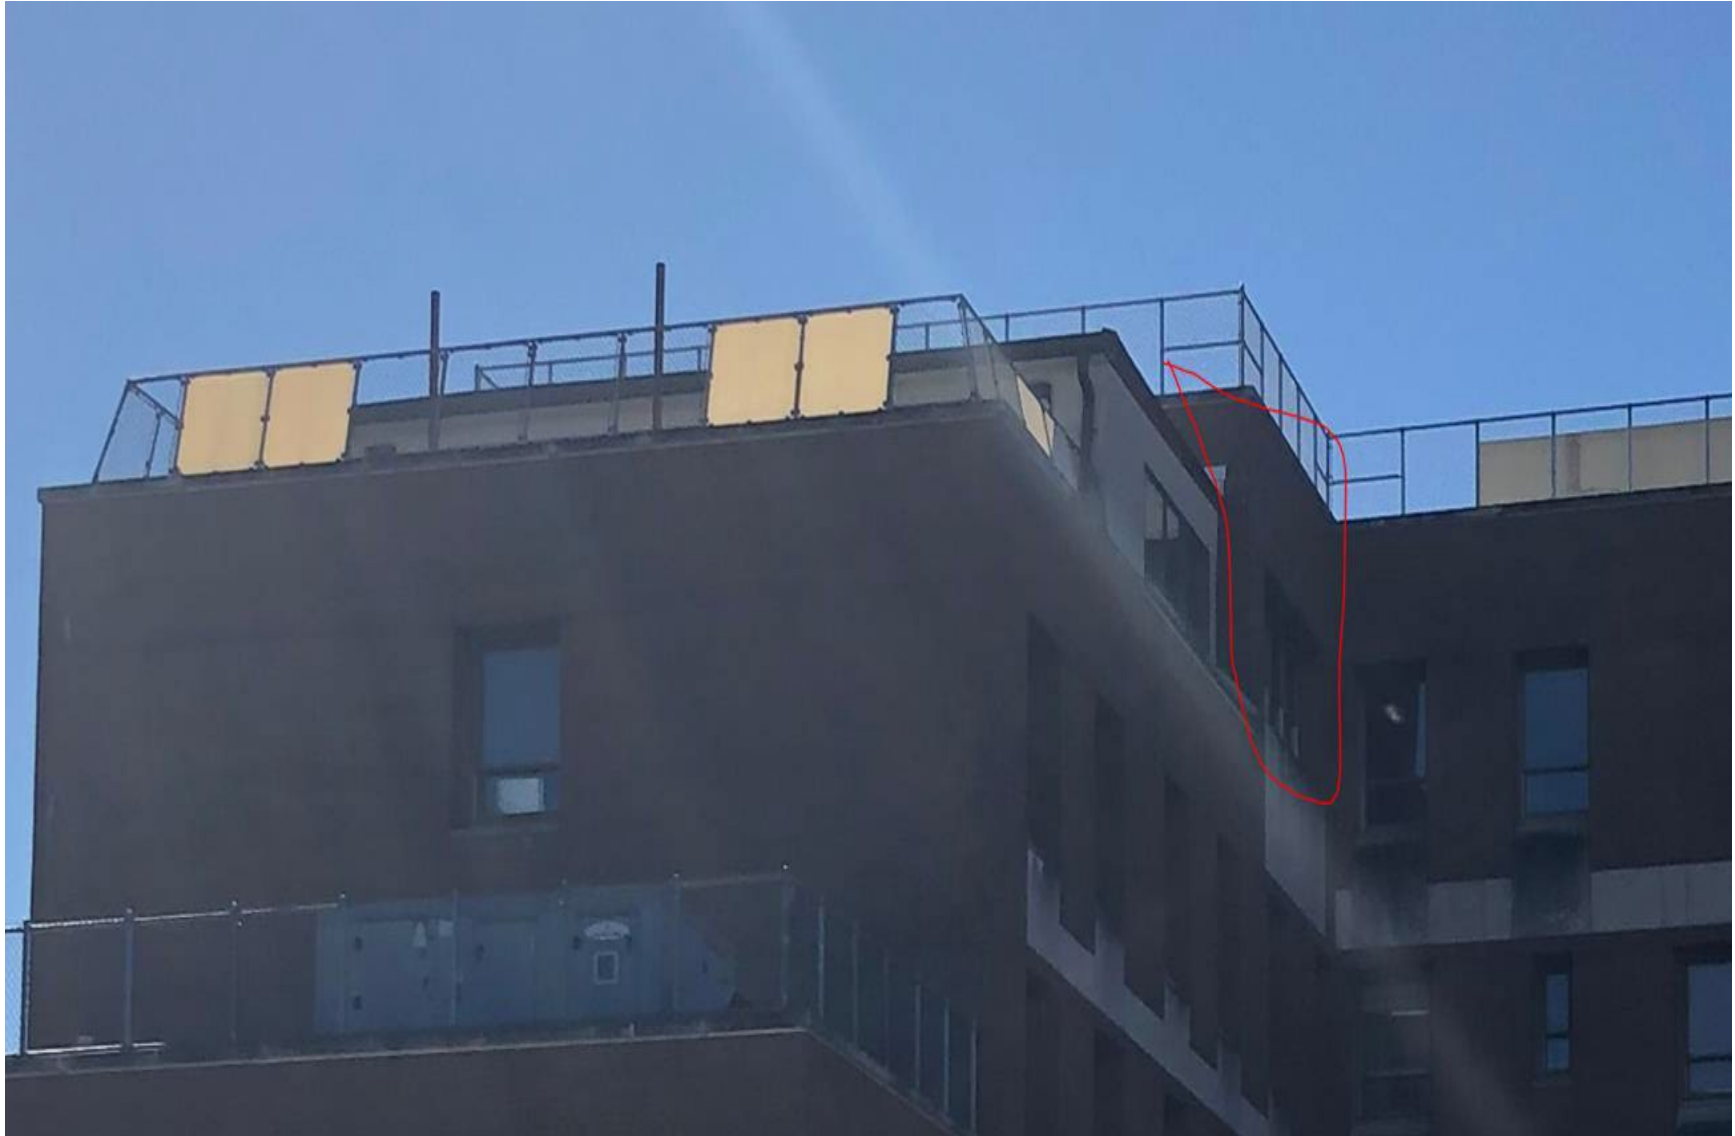
Attachment 4

19.	2-16-23		Are we removing the original existing cast in place concrete structure with brick and replacing with metal studs per detail 2-drawings 01-A6? See photo below. <b>See Attachment 4</b>	Correct, that is the intent of the design.

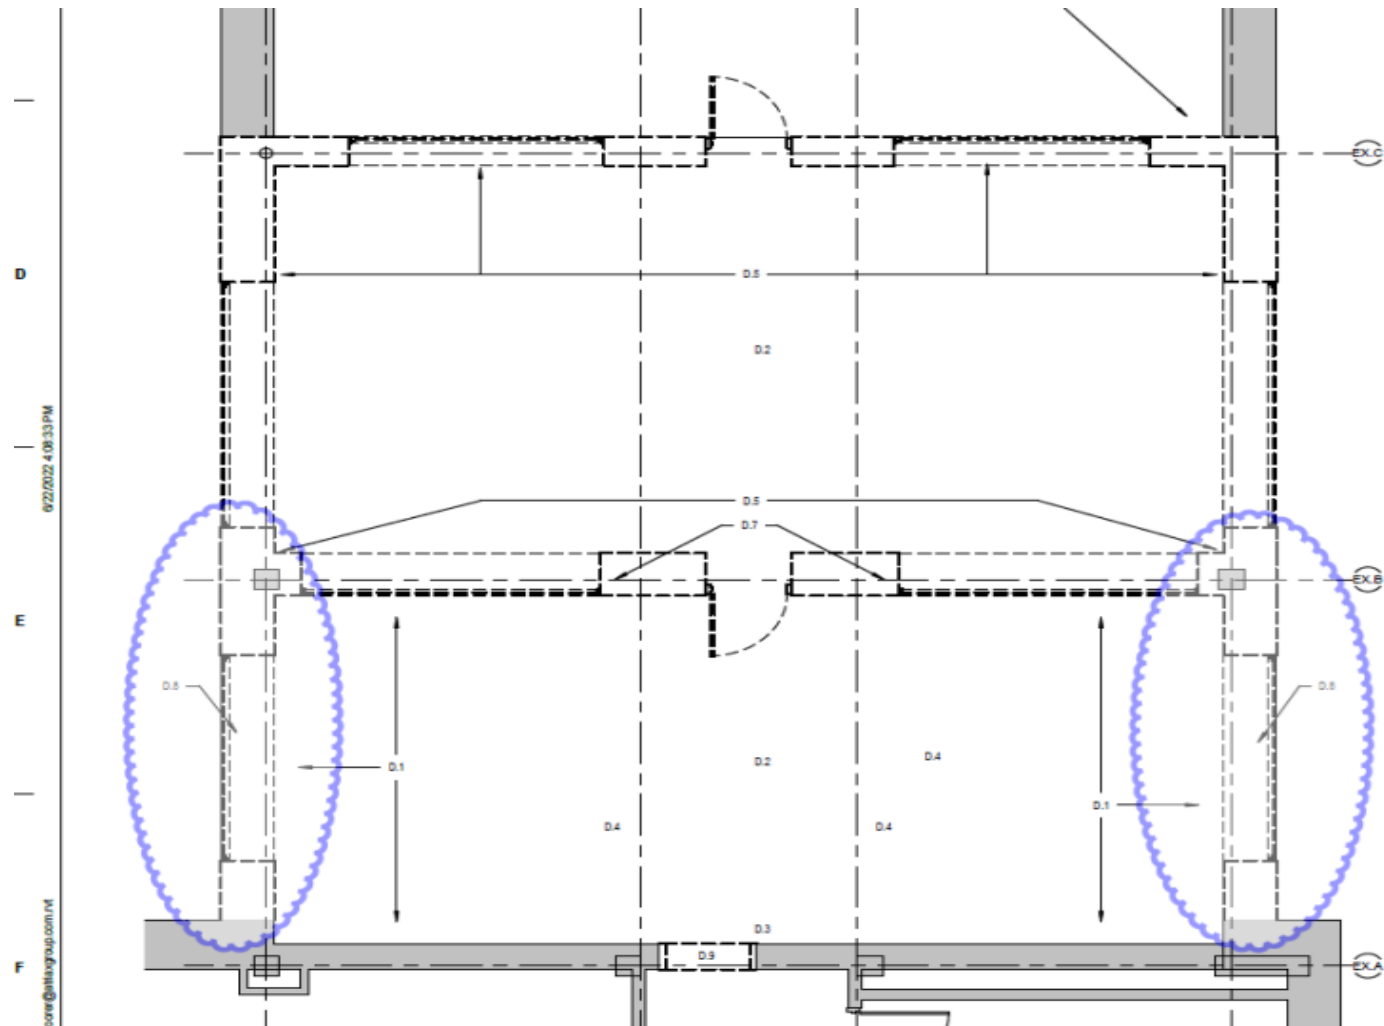
## Attachment 5

21.	2-21-23		<b>RFI #1:</b> Please clarify the extent of wall demolition required from grid lines EX. A – EX. B. If complete wall demolition is required, please provide existing condition details for this wall. If these walls were included in the previous Seismic Improvement project, it would indicate existing walls in question are approximately 27"-30" thick concrete and rebar. <b>See Attachment 5</b>	Walls between EX.A and EX.B are to be demolished down to the slab per the design intent.

23.	2-21-23		Drawing 01-A3 Detail 1 – Demolition Line Type and Weight appear to indicate COMPLETE removal of walls on grid lines EX.1 and EX.4 from grid lines EX. A – EX.B. <b>See Attachment 5</b>	Correct, selective demolition to account for the new construction. Down to floor level. Construction is limited to the 5 <sup>th</sup> floor.

24.	2-21-23		Drawing 01-A3 Keynote D.8 informs to <b><i>Remove existing window. Prep for opening for new window.</i></b> <b><i>See Attachment 5</i></b>	The existing walls are to be demolished completely, this includes the windows.
